**Project Number 13451.000.001**

### **Site Management Plan**

Drury Development Stage 2,  
64-120 Flanagan Road, Drury

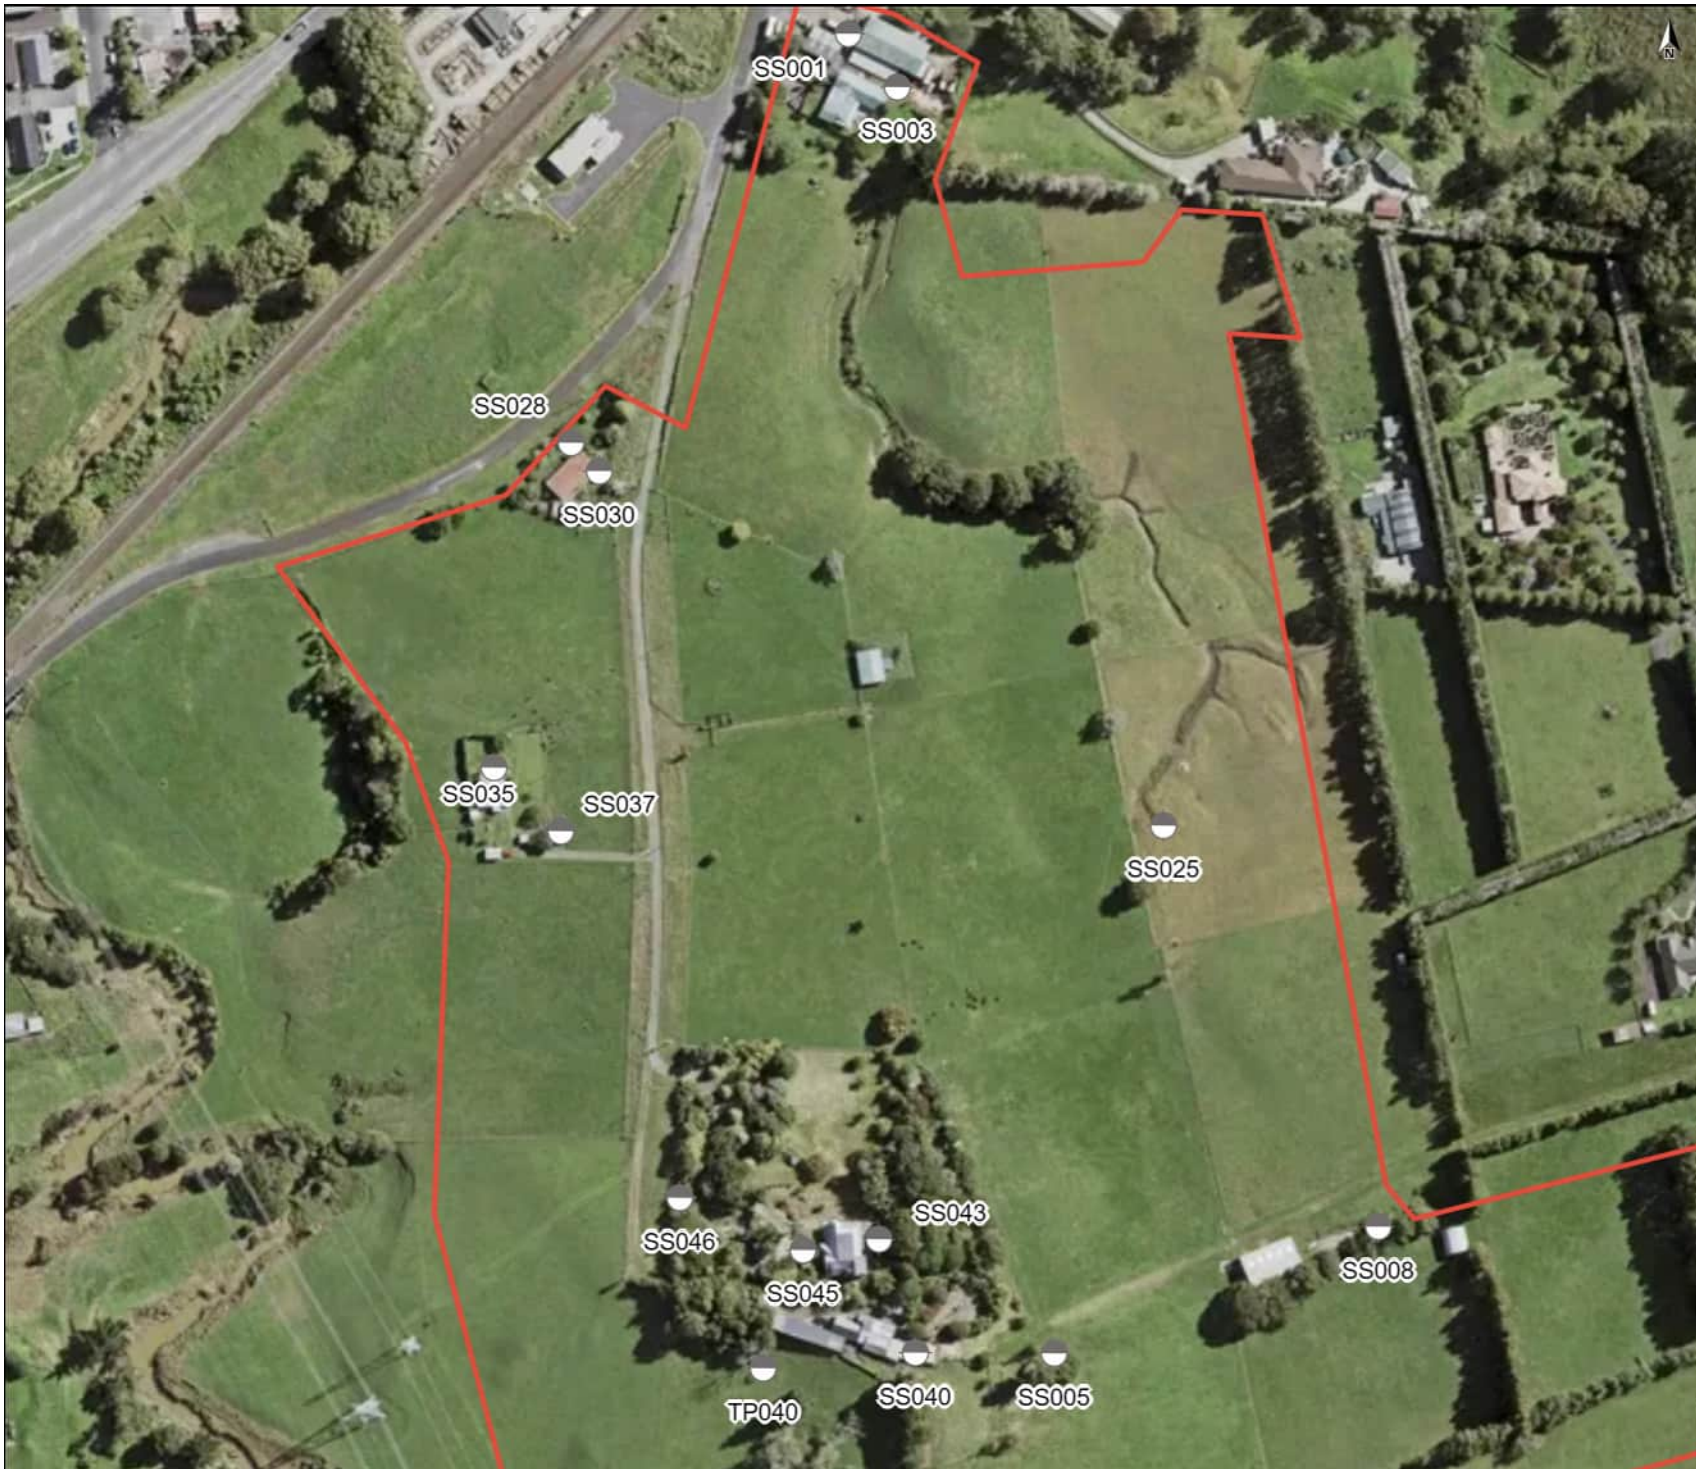
- Aurecon (2021) Location
- Stage 2 Boundary

This report should be read in its entirety for details of the investigation methodology and findings. A summary of relevant laboratory analytical results (extracted from the DSI) is included in Appendix 1 (Table A1.1); the sample location plan from this investigation is provided in Appendix 1 (Figure A1).

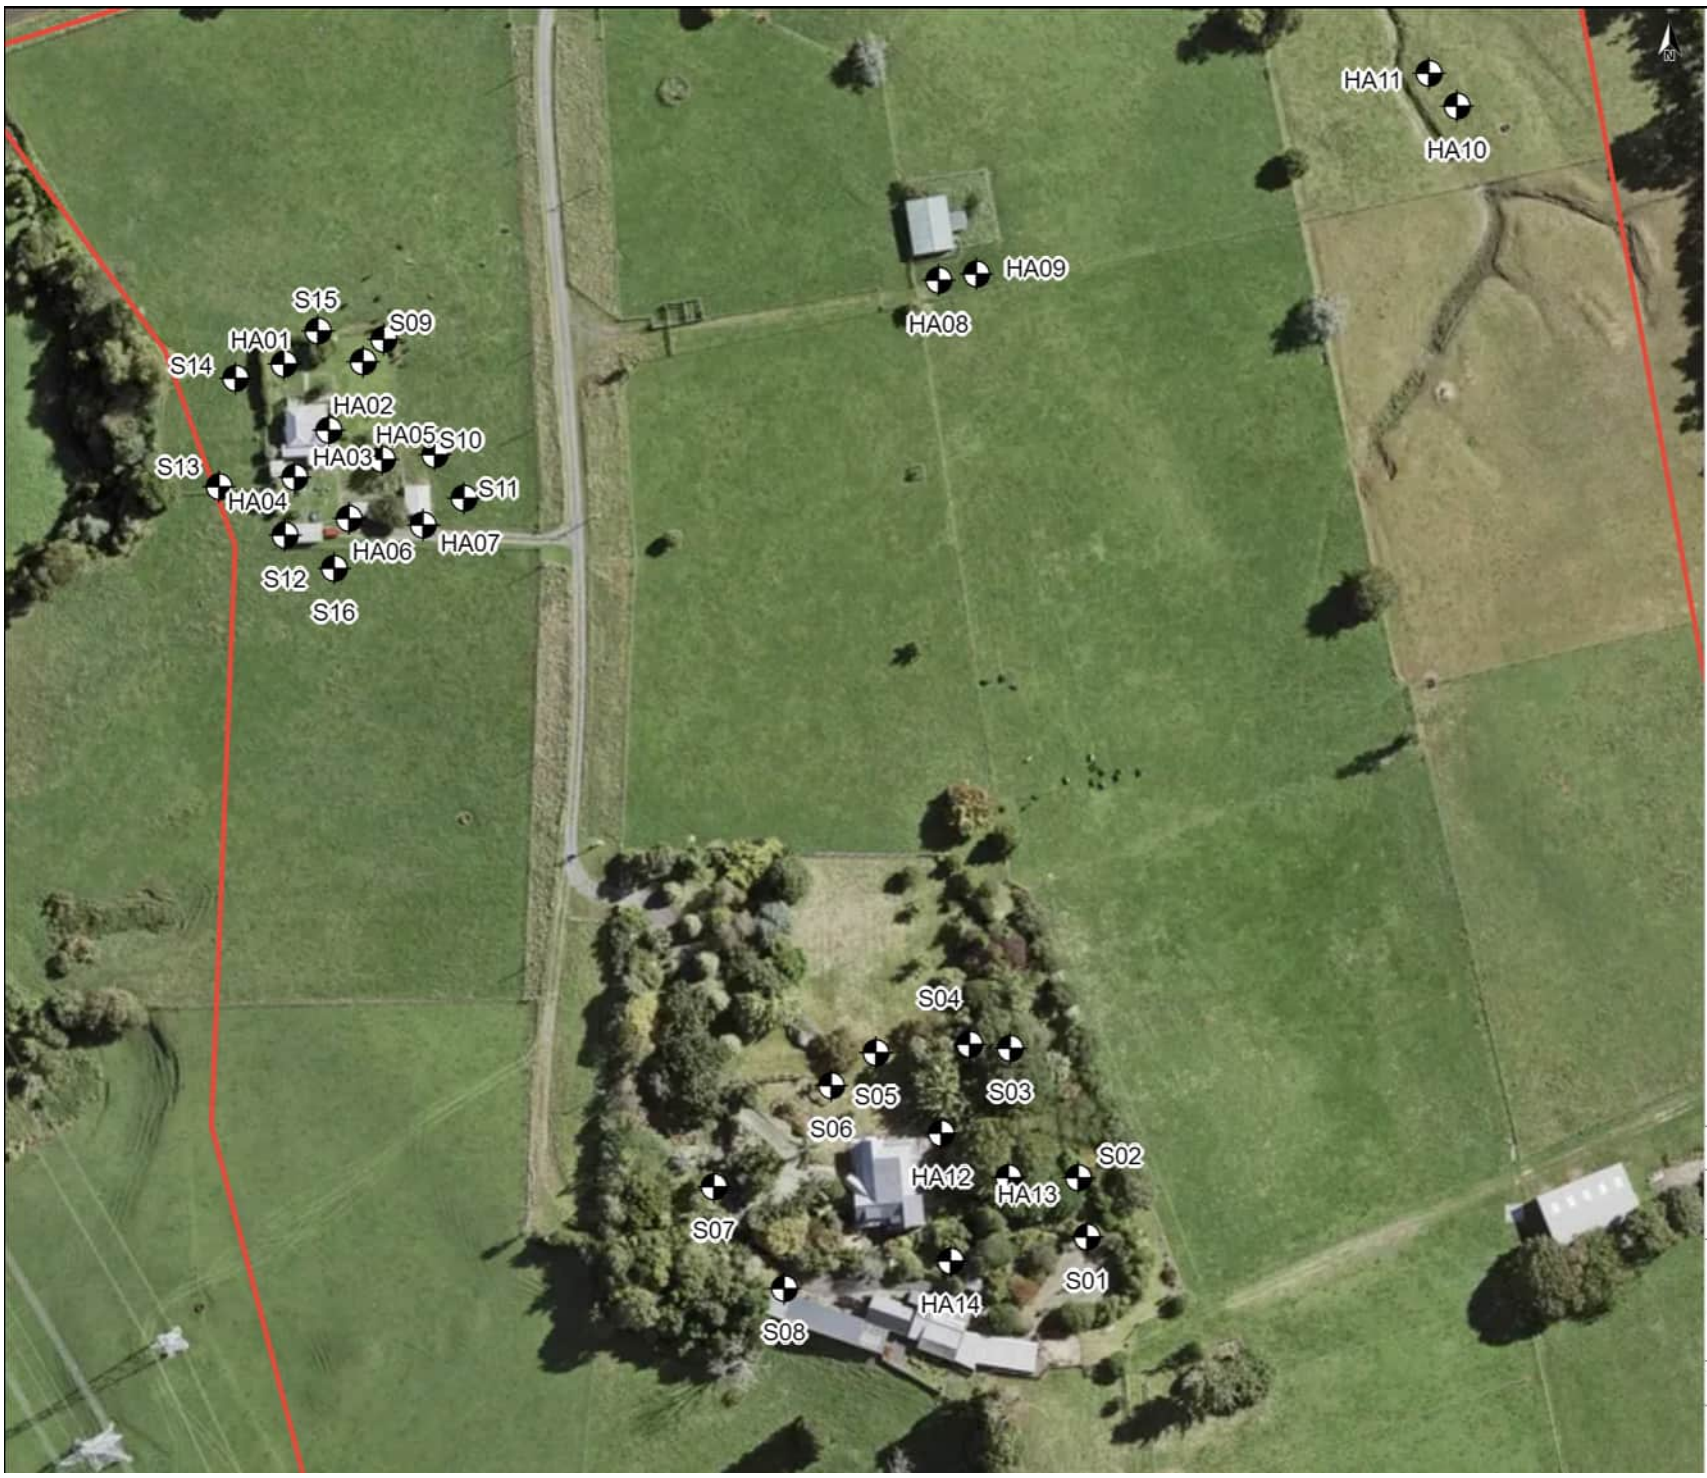
- ENGEO Laboratory Sample Locations
- Stage 2 Boundary

Samples were collected from 14 locations around the site including around the former residence located at 114 Flanagan Road (HA01–HA07), on the eastern side of the residence located at 120 Flanagan Road (120 Flanagan Road), and in the vicinity of the two suspected fill locations at 120 Flanagan Road (HA08–HA11; refer Section 3.1.2). The sample location plan is provided in Appendix 2 (Figure A2.1).

Eight samples were collected around each of the former residences (S09-S16, 114 Flanagan Road; S01-S08, 120 Flanagan Road). The sample location plan is provided in Appendix 2 (Figure A2.1).

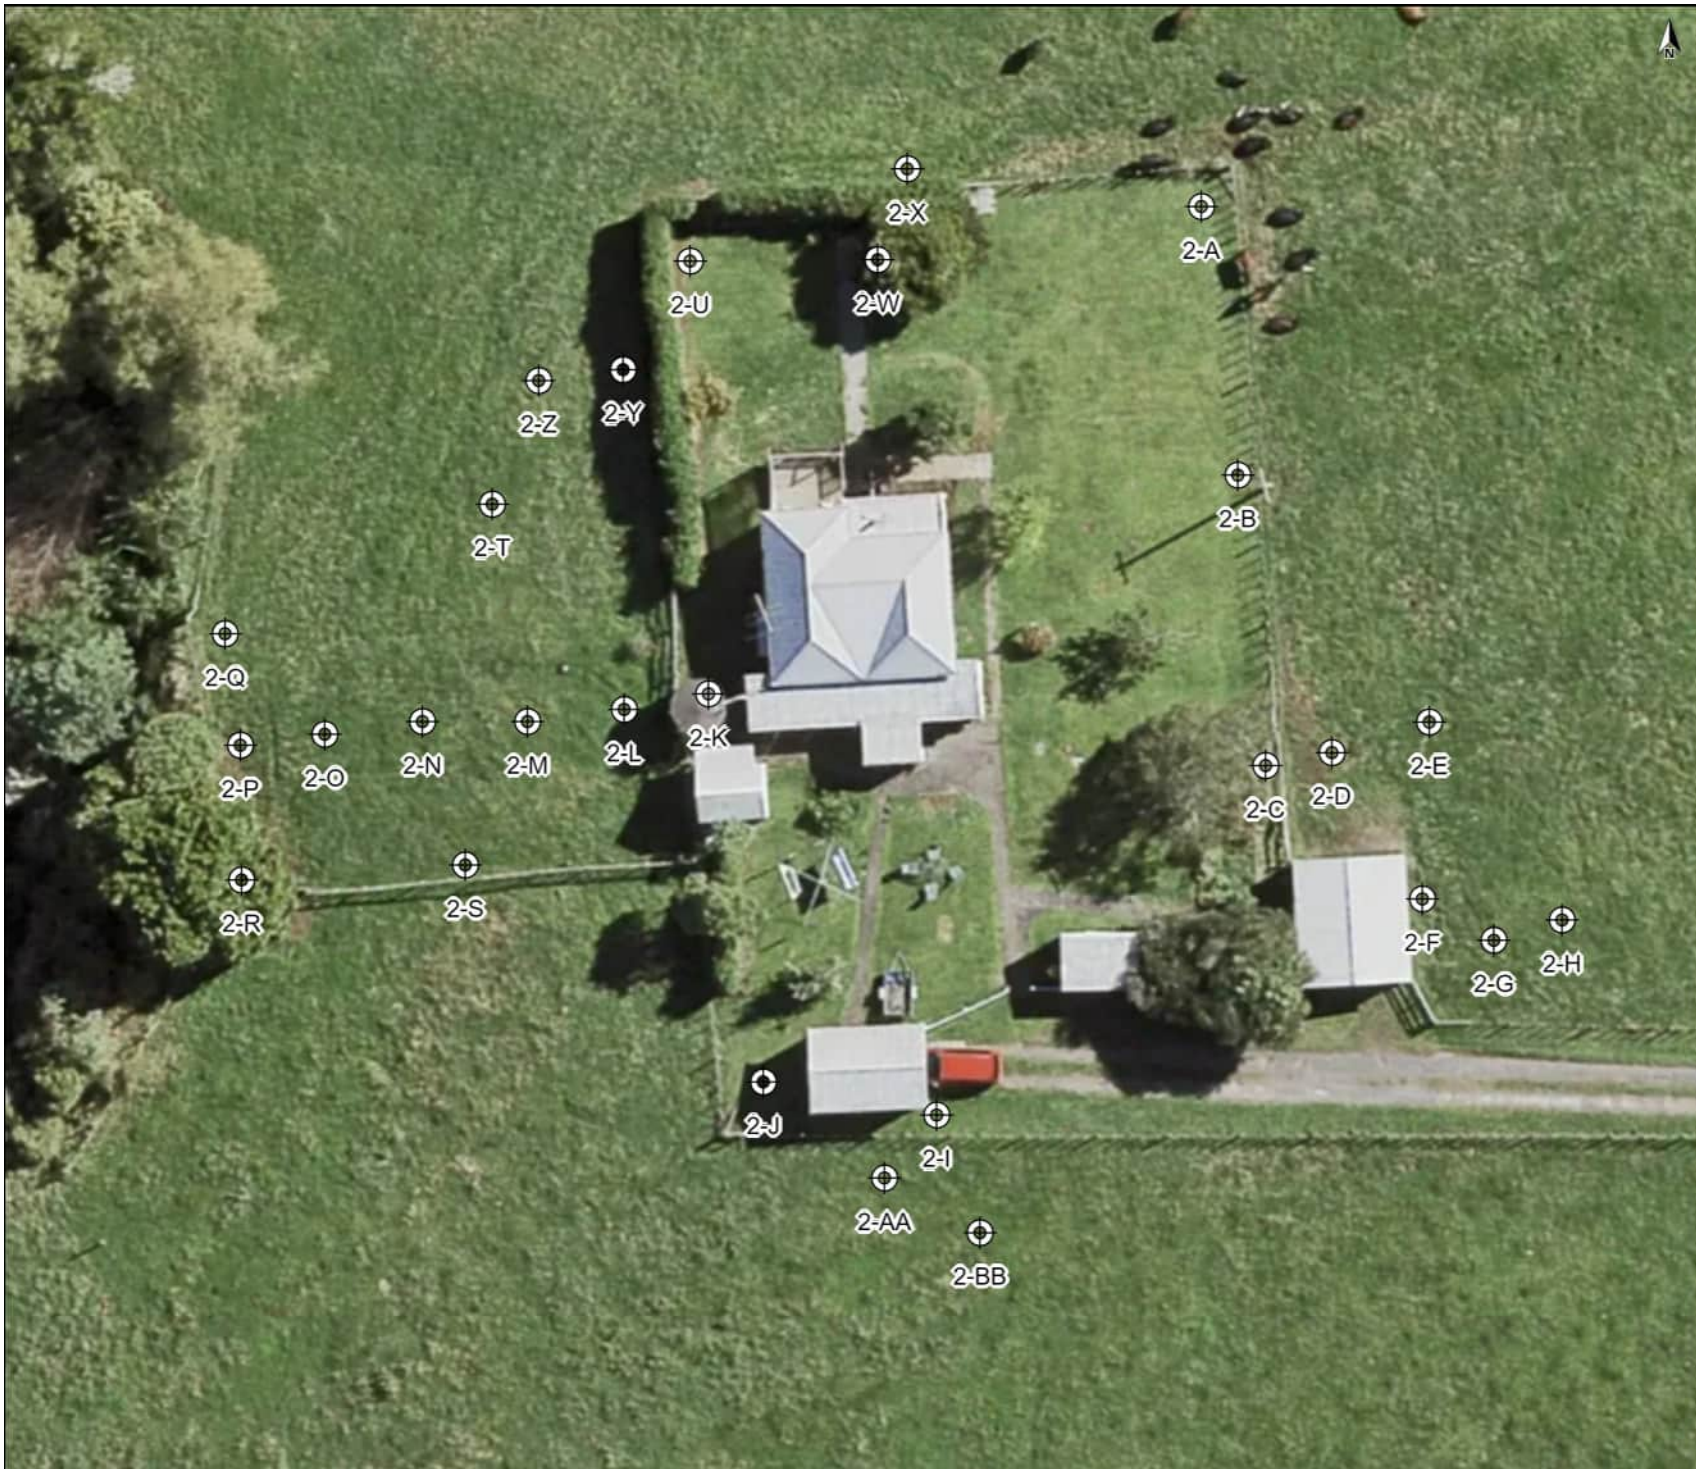
⊕ XRF Locations

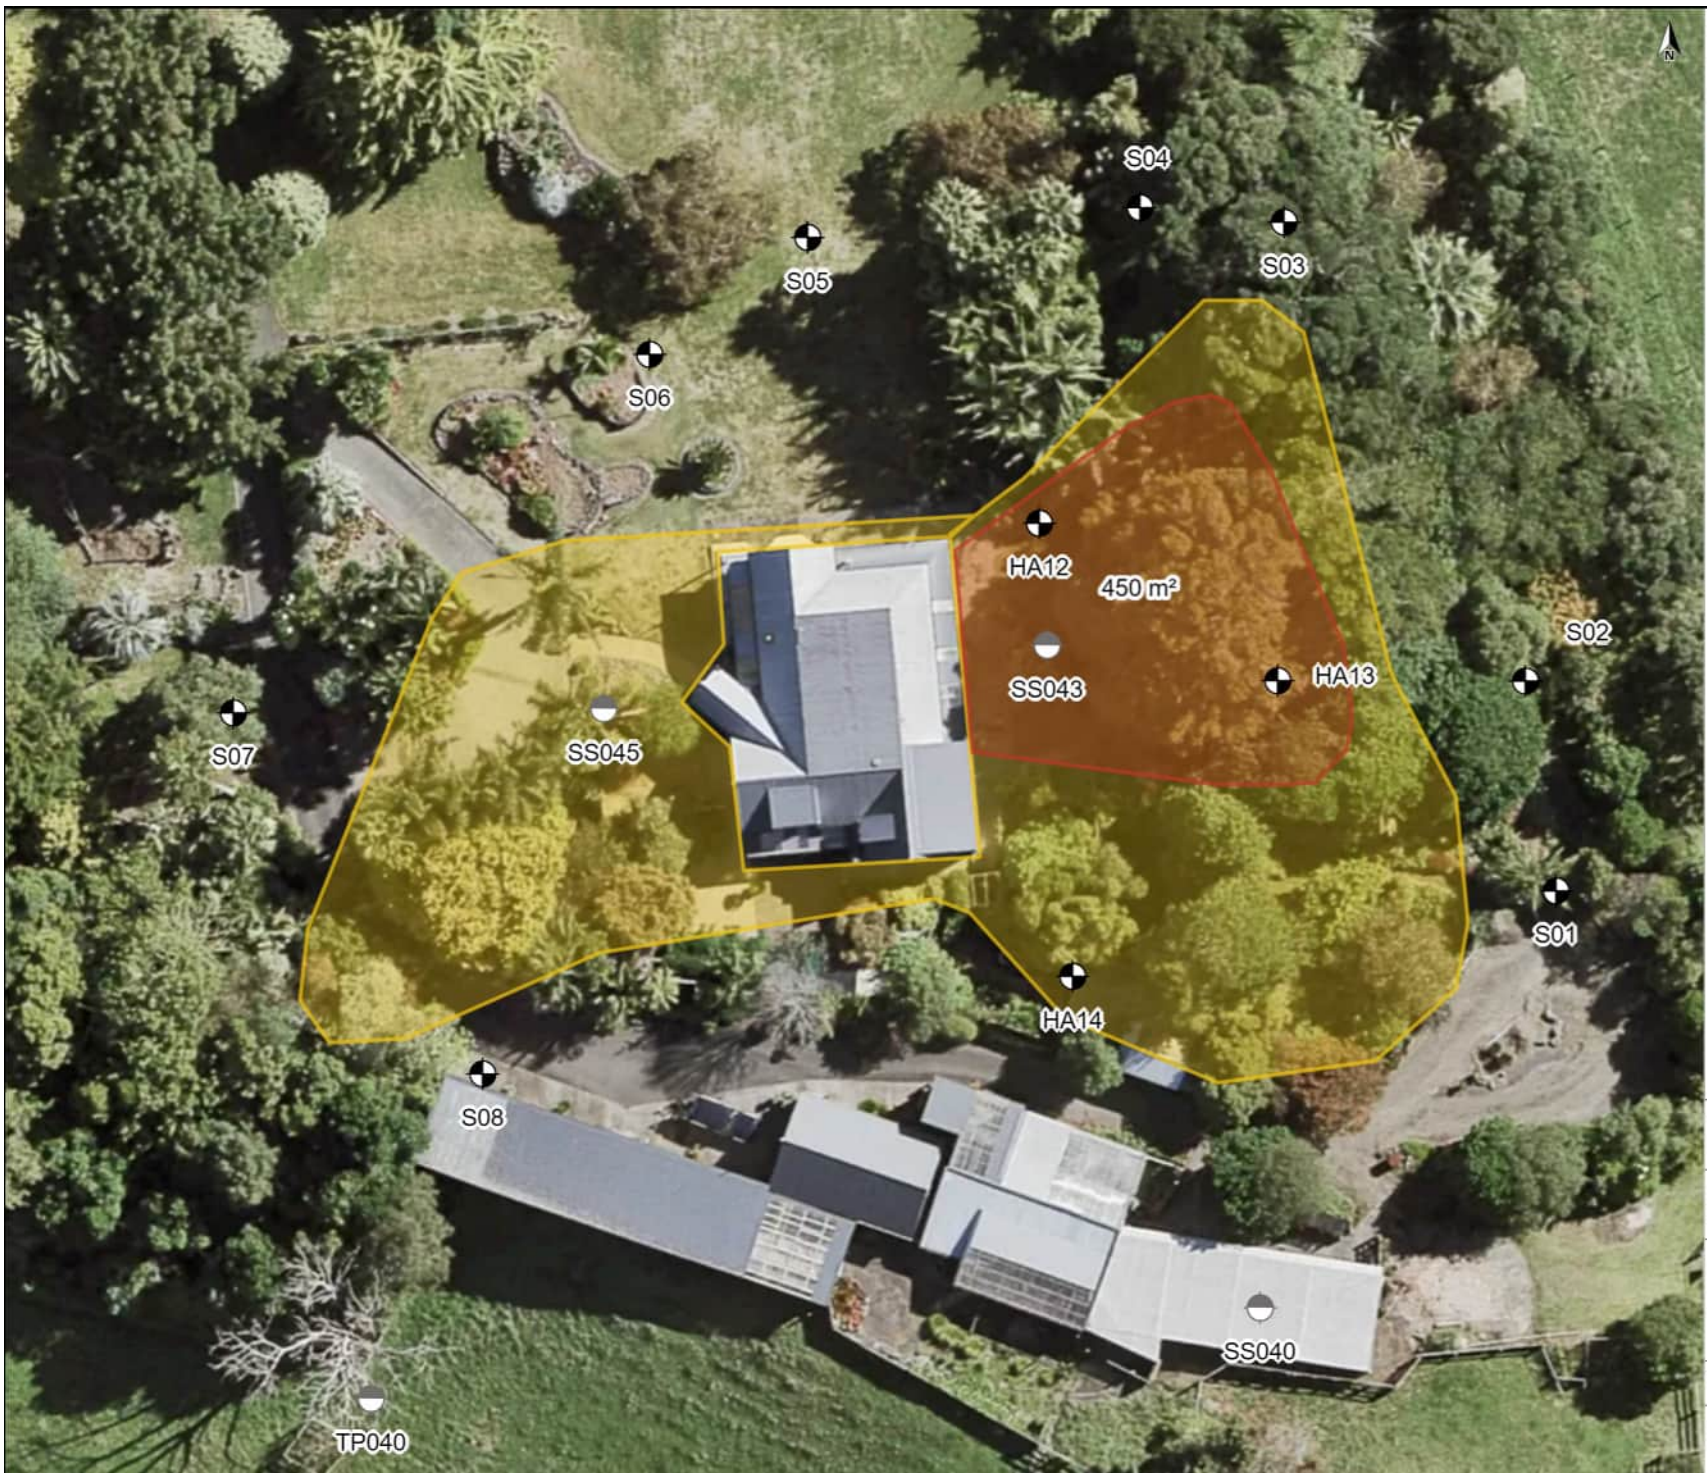
Project: Drury Development Stage 2	Drawn: OB	Figure: A2.4
Date: 19-02-2024	Checked: LN

- Legend**
- ENGEO Laboratory Sample Locations
  - Aurecon (2021) Location
  - Approximate Pb > AUP PA
  - Approximate Pb > Background
