**Soil Contamination Risk
Preliminary Site Investigation Report**

**64, 86 & 94 Barters Road, Templeton,
Canterbury**

December 2023

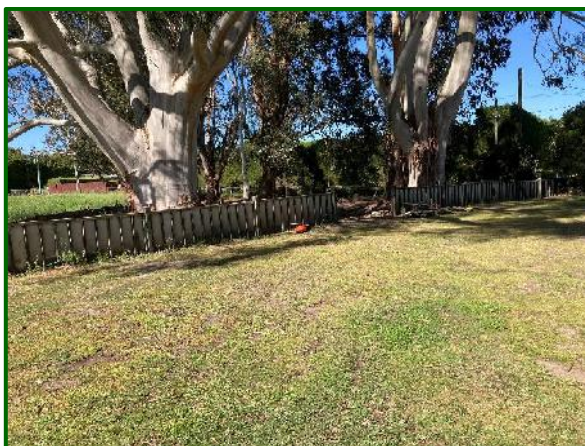
Photo 7 – Cement board fence with broken pieces

Two cement board fences are present within the residential curtilage area. One has some broken sections. Asbestos-like fibre clusters were visible along the broken edges indicating the cement board is asbestos containing material (ACM). The broken cement board fence may pose a risk of contamination of the surrounding soils. The unbroken cement board fence is unlikely to pose a risk of contamination. Beyond the more southern ACM fence is an area of gum trees that has recently been cleared of low-level vegetation. Some concrete pieces were visible in this area. There is no evidence of former buildings or structures in this area on the historical aerial photographs so these concrete pieces are unlikely to indicate a source of contamination.

Two cement board fences are present within the residential curtilage area of 64 Barters Road. Asbestos-like fibres were visible along the broken edges of one fence indicating the cement board is asbestos containing material (ACM). The broken cement board fence may pose a risk of contamination of the surrounding soils.

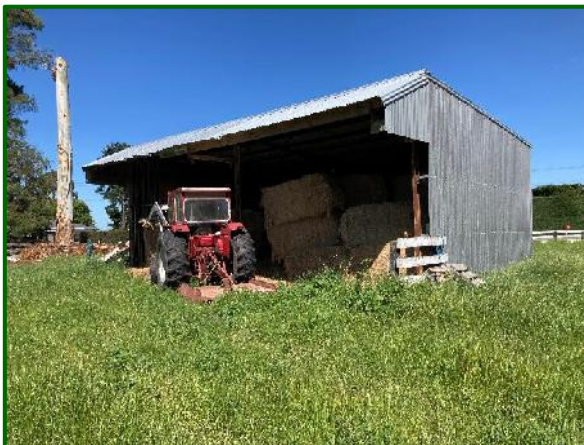
Photo 20 – Hayshed

To the south of the driveway is a paddock containing a metal & timber hayshed. The property file indicates this shed has a concrete floor. The shed is currently used to store hay. To the north of the hayshed is a green waste pile sourced from felling the trees previously located on the southern corner of the property. Between the hayshed and the green waste pile is an area with bare soils which could indicate material has previously been stored at this location. If the stored items included treated timber or agrichemicals this could have caused contamination of the underlying soils.

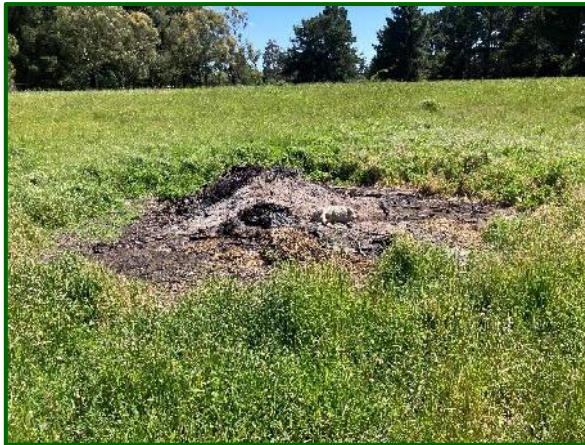
Photo 35 – Burn area on northernmost paddock

A burn area is present within a gully on the northern end of the property. Burnt scrap metal and timber items were visible within the burn area. It is considered likely that burning of material other than green waste has occurred, potentially causing contamination of the underlying soils. No other potential sources of contamination were observed within the paddocks. It is noted that the grass was very long and may have obscured smaller burn areas. However, there are no other likely burn areas indicated on the historical aerial photographs.

A burn area is present within a gully on the northern end 86 Barters Road. Burnt scrap metal and timber items were visible within the burn area. A burn area is also present within a paddock at 94 Barters Road. It is considered likely that burning of material other than green waste has occurred, potentially causing contamination of the underlying soils.

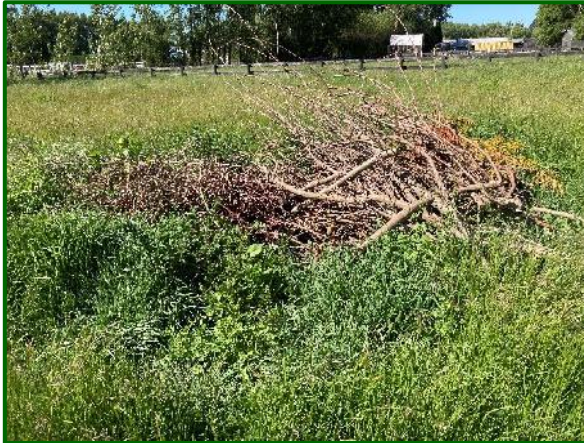
Photo 50 – Burn area

Beyond the residential and yard areas are paddocks currently used to graze a few cattle and pigs. A burn area is present within a paddock on the eastern side of the property. Only green waste was visible within the burn area at the time of the site inspection. However, historical burning of non-green waste cannot be ruled out. Balage is being stored near the northern boundary of the property along with a few wooden pallets and two tyres. A bare area of soil was present in the largest of the paddocks, on the western side of the property. This was located within a depression and there was no evidence of burning. It is considered most likely that the bare soils are due to water saturation rather than storage of materials or burning. A bund of soils is present along the western side of this paddock. Demolition debris was visible with a pile of bricks at the southern end of the bund and embedded concrete pieces visible along

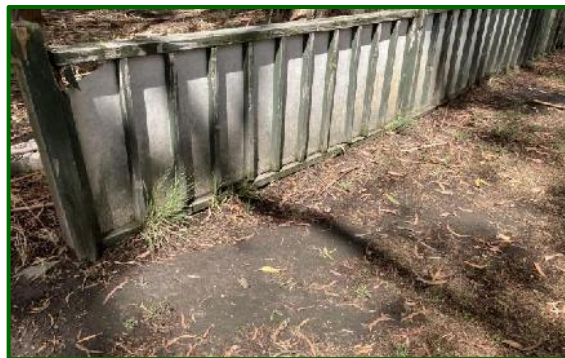
Photo 1 – Area cleared of ACM pieces

The pile of broken asbestos cement board observed during the site inspection had been removed from the property by the time of sampling. A soil sample (SS42A) was taken at the location of the former pile to confirm whether asbestos contamination of the underlying soils had occurred. A fragment of cement board fence panel was removed from the fence and submitted for asbestos presence analysis to confirm the fence panels do contain asbestos.

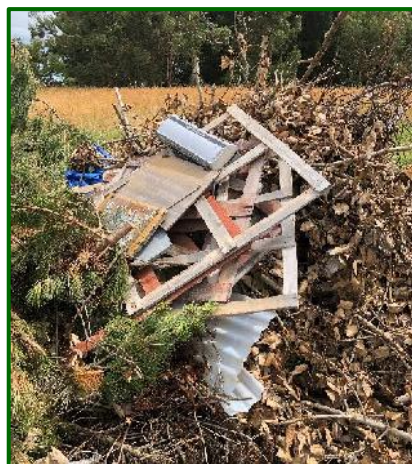
Photo 2 – Burn area at 86 Barters Road

Surface soils were XRF tested in and around the current waste pile at the burn area on the north of the property. The XRF testing indicated that arsenic exceeding the 'commercial/industrial' SGV was present. A surface soil sample (BP1@50) was taken at the location of the highest XRF arsenic reading. The soil sample was submitted for heavy metal analysis.

While no other areas of the site contain soil contamination with concentrations above the 'commercial/industrial' guideline values, it is recommended that soils at sample location BP1, the burn area at 86 Barters Road, are also remediated due to the high levels of cadmium, copper, lead and zinc. Remediation of this burn area will likely assist with future soil disposal during the development phase.

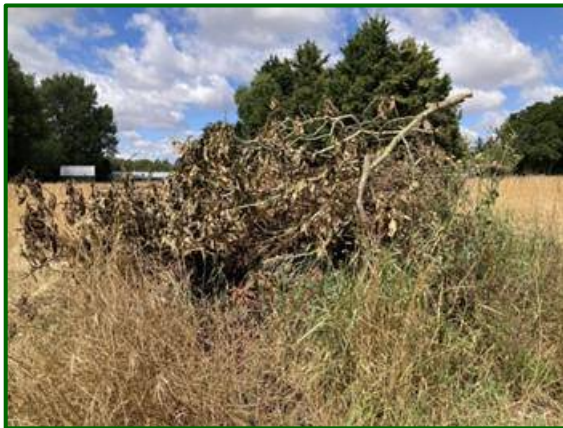
Photo 3 – 94 Barters Road burn area

Surface soils were XRF tested in and around the current waste pile at the burn area on the north of the property. The waste pile included some timber and wire as well as green waste. The XRF testing indicated that arsenic likely exceeded the 'commercial/industrial' SGV. A surface soil sample (BP2@50) was taken at the location of the highest XRF arsenic reading. The soil sample was submitted for heavy metal analysis.

Soil sampling was undertaken on 24 January 2024 as part of the DSI. The soil sampling results have shown one location contains concentrations of arsenic above the 'commercial/industrial' soil guideline values (SGV). This sampling location, BP2, is a burn area at 94 Barters Road.

- The DSI has identified two burn areas where remediation is recommended at 94 and 86 Barters Road. A Remediation Action Plan (RAP) will be required to support the remediation of the two burn areas

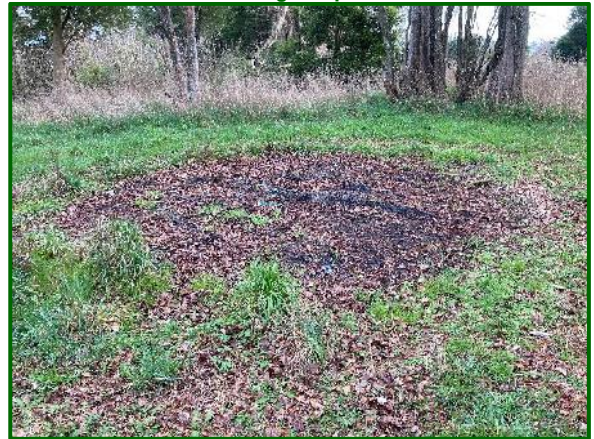
Photo 8 – Burn Area B

A second burn area was observed on the eastern end of the subject site. 'Burn Area B' is an approximate 5m diameter circle of bare, blackened soils with charred waste items including glass and metal. An XRF test within this area confirmed arsenic contamination exceeding the 'commercial/industrial' SGV is present within this area. Lead contamination above background levels but below the 'commercial/industrial' SGV is also present.

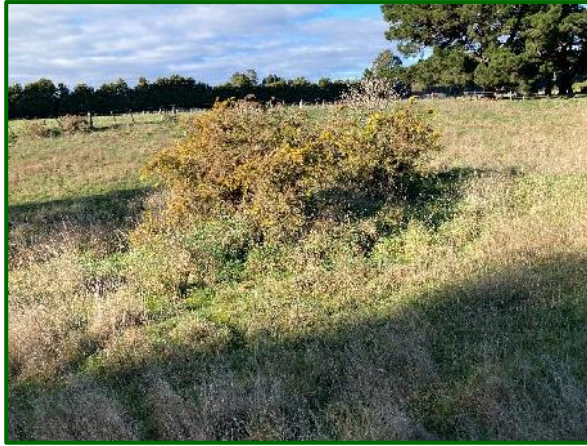
Photo 22 – Gorse bush (Possible Burn Area E)

The possible burn area observed on aerial photographs on the eastern end of the subject site was observed to be gorse bushes on a small mound within a gully (Possible Burn Area E). No ash or charred items were visible. Three XRF readings within this area detected no elevated heavy metals. Therefore, it is considered unlikely burning, in particular burning of non-green waste, has occurred in this location.

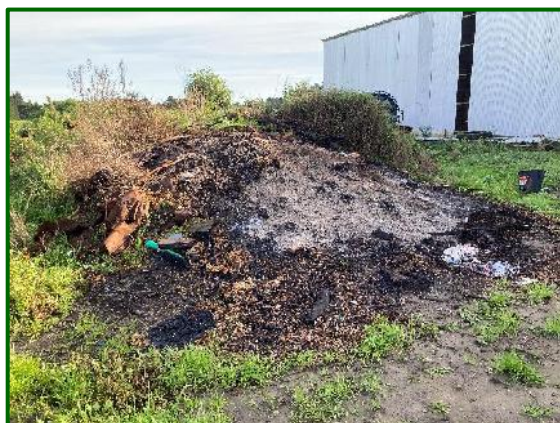
Photo 25 – Burn area at end of stockpile

The stockpile with a burn area at the eastern end appears similar to during the PSI site inspection. XRF screening of the burn area and stockpile indicates that arsenic contamination exceeding the ‘commercial/industrial’ SGV is likely present in the visually dirty/ashy soils but the remaining stockpiled material is clean. Sample BP1.1 was a surface sample taken from ashy soils, sample BP1.2 was taken at 150mm where the soils no longer appeared burnt. Samples BP2.1 and BP2.2 were taken at the other end of the stockpile where no burning was apparent. Some rubbish items (baling twine, scrap metal) are present in the surface soils of the stockpile. The majority of the stockpile consists of loamy silt and gravel.

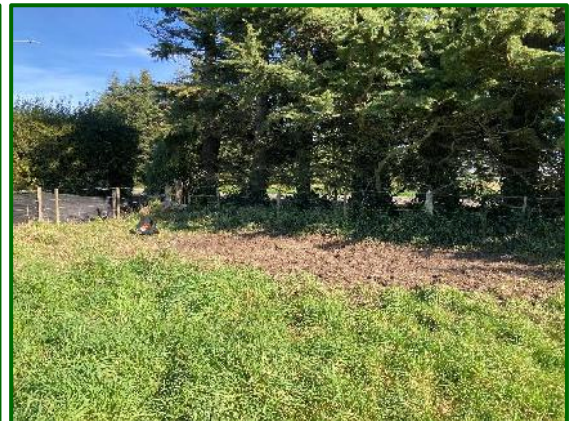
Photo 34 – Disturbed soil at former shed location

Disturbance of the soils has occurred in the location of the former pre-1941 shed, possibly due to recent geotechnical investigations. XRF testing of undisturbed soils across this area identified lead concentrations elevated above expected background levels but well below the 'commercial/industrial' SGV. A surface and 250mm depth sample were taken at the XRF location with the highest lead reading.

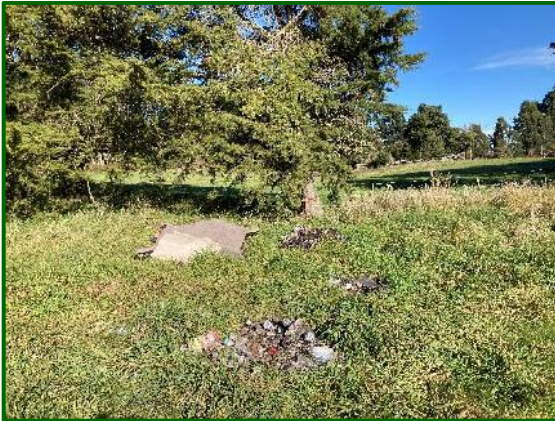
Photo 35 – Newly dumped ash/rubbish piles

Additional dumping of ash, waste items and soil has occurred at 22 Hasketts Road since the PSI site inspection. XRF testing of the new piles of dumped material indicates arsenic contamination exceeding 'commercial/industrial' SGVs is present. A pile of soil and rubbish items covered by a piece of carpet had the appearance of the contents of an excavated pit. White fibres, most likely fibreglass, were observed within the soil. Sample 22H-BP3 was taken from the pile and submitted for heavy metal analysis, sample 22H-ASB1 was submitted for semi-quantitative asbestos analysis and a sample of the white fibres was submitted for asbestos presence analysis as sample 'Bulk 1'. The newly dumped material appears to be on top of pieces of plywood or pallets which may have limited any contamination of the underlying soils.
