WESTPOWER LTD. PROPOSED WAITAHA HYDRO SCHEME

ASSESSMENT OF ENVIRONMENTAL EFFECTS

VEGETATION

Dated June 2025

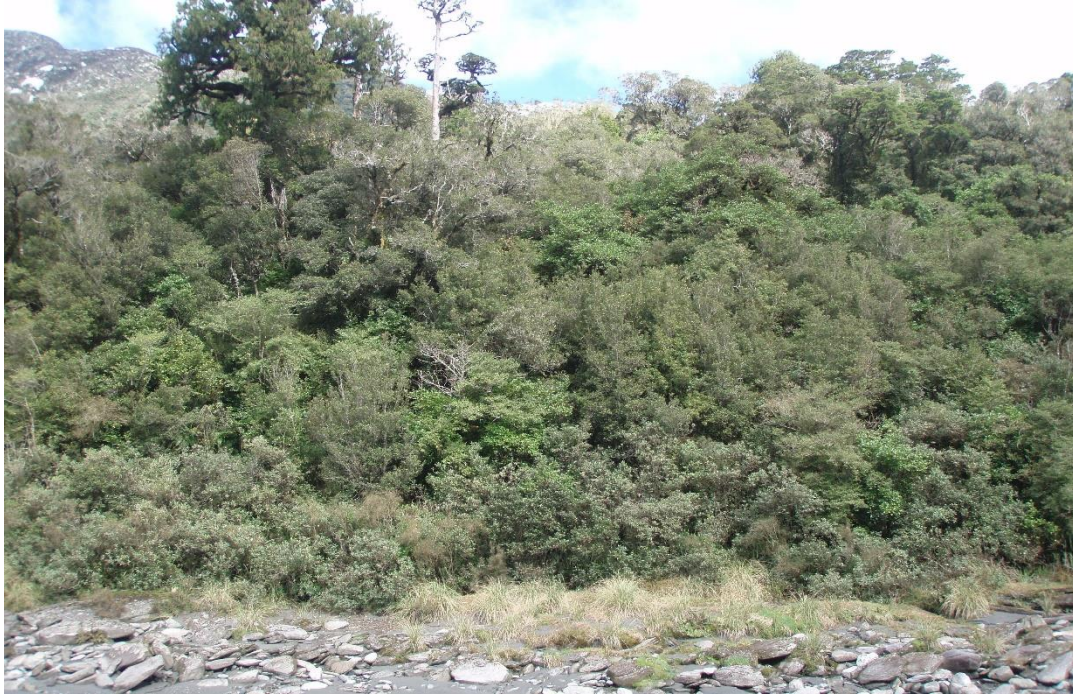
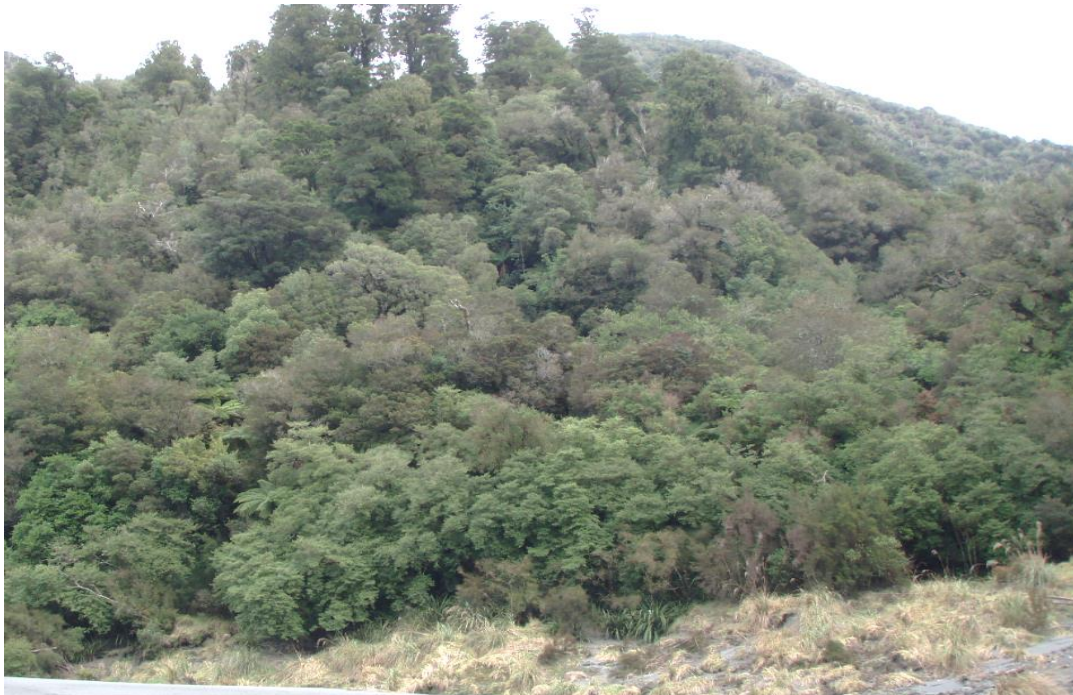
1a - State in 2012:

Vegetation Type 1/1 occupies a narrow strip of c. 3 – 6 metres between the active Waitaha River bed and the shrub hardwood margin of Vegetation Type 1/3 at the foot of the slope beyond the river bank.

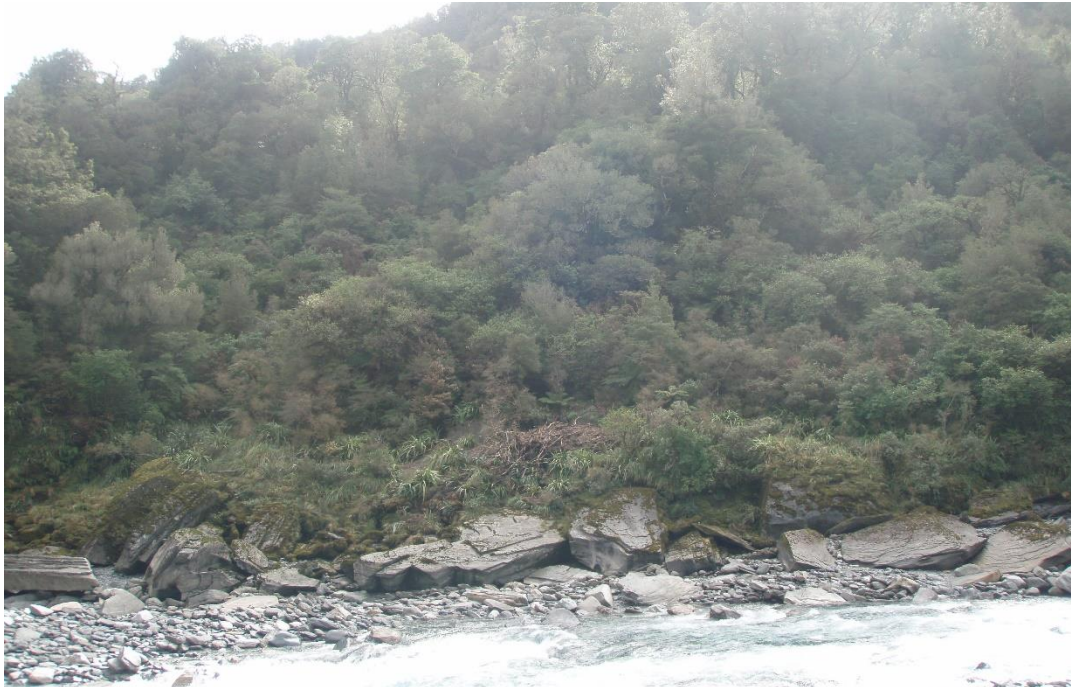
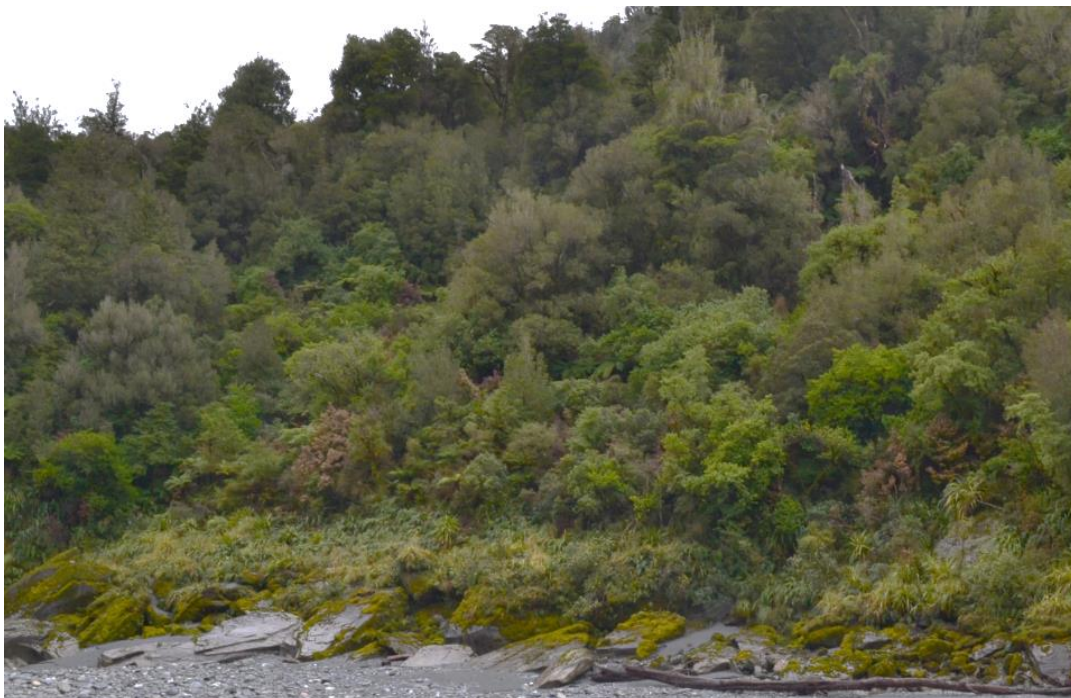
2a - State in 2012:

Vegetation Type 1/2 occupies the foot slope face and upper terrace margins at the entry to Morgan Gorge. Moss and herbaceous components of Vegetation Type 1/1 occur in a very narrow strip on the large rocks between the active Waitaha River bed and the margin of Vegetation Type 1/2.

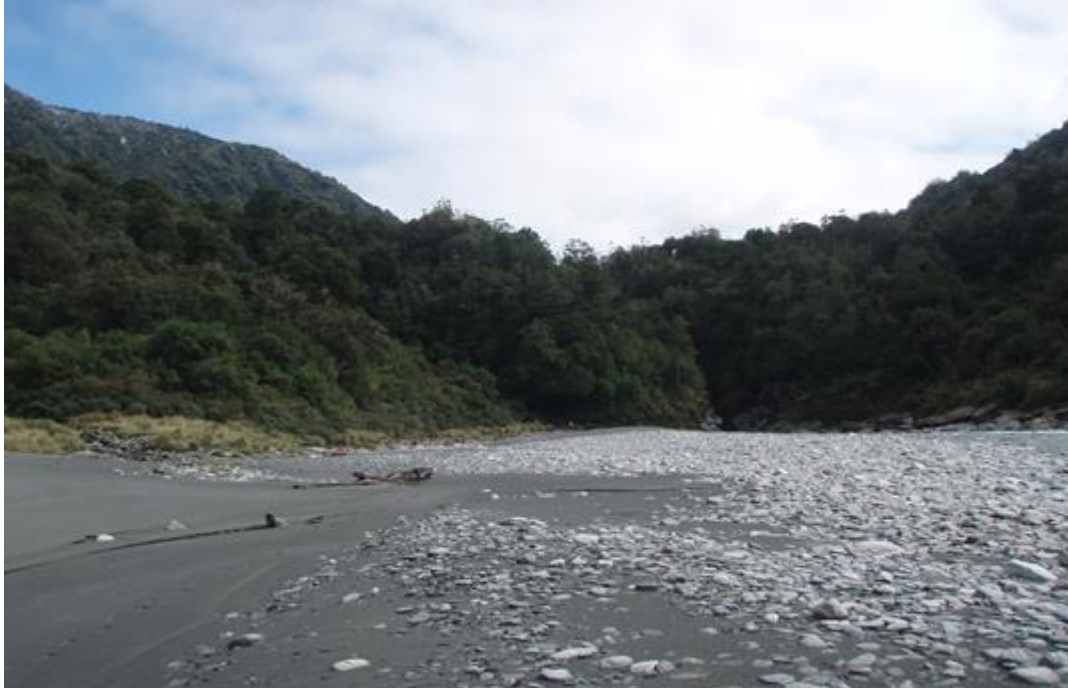
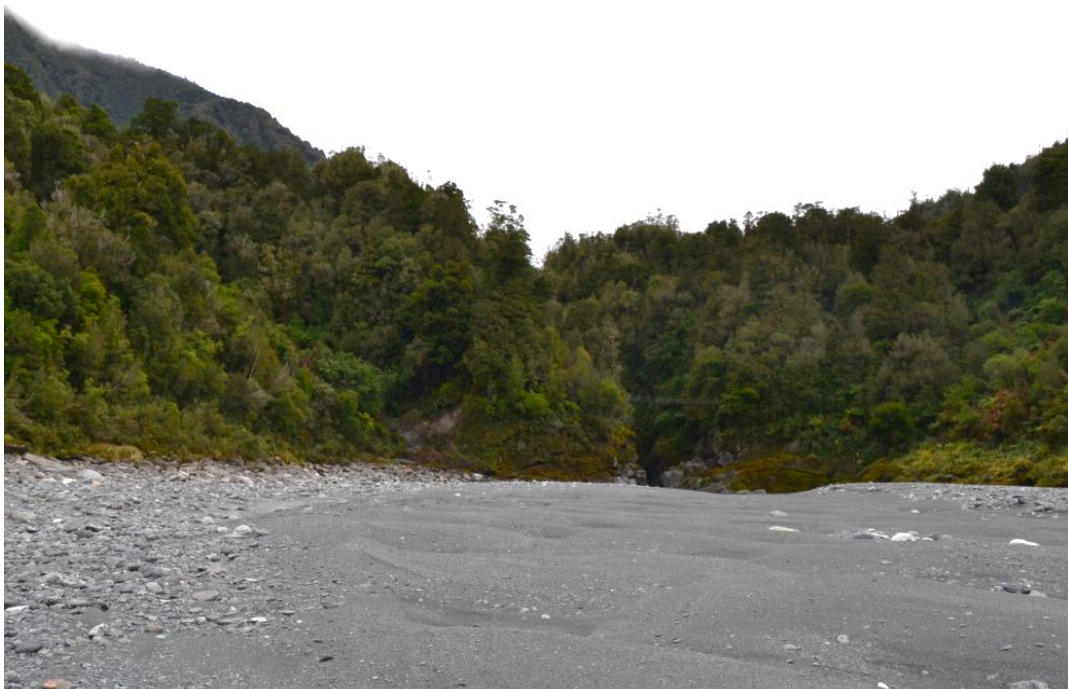
3a - State in 2012:

Vegetation Type 1/3 occupies terrace faces and upper terrace margins at the entry to Morgan Gorge.
Vegetation Type 1/1 extends in a strip between the active river bed and the margin of Vegetation Type 1/3 on the hill face at left of the photograph.

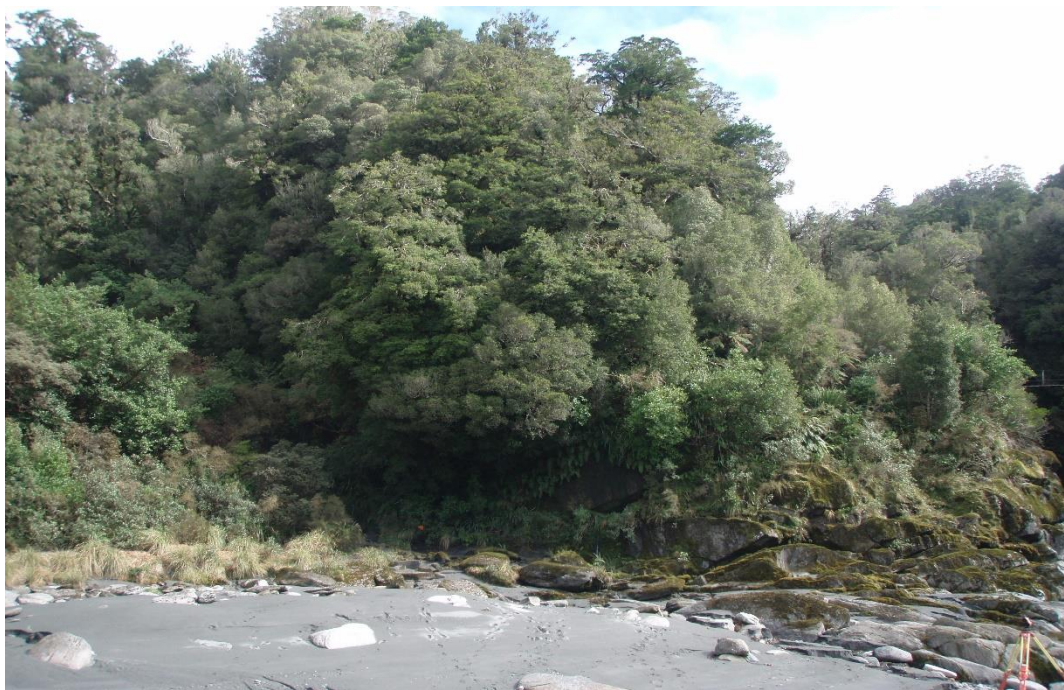
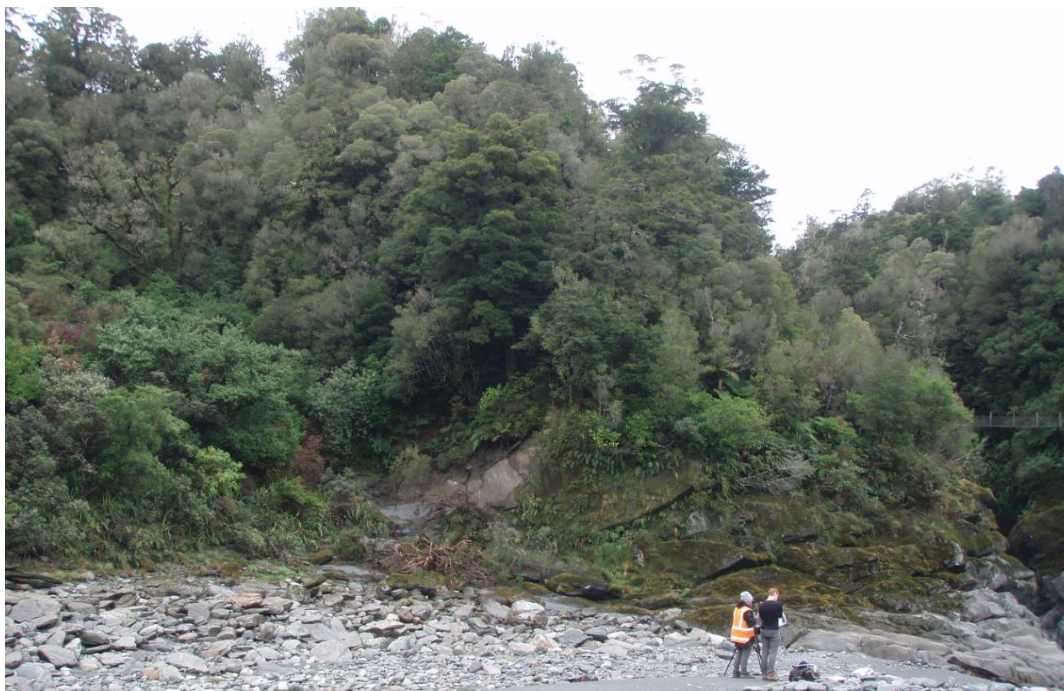
Figures 4a & 4b - Example of Vegetation Types 1/1 & 1/3.

Vegetation Type 1/3 on the terrace face at the true-left entry to Morgan Gorge. Vegetation Type 1/1 extends in a strip between the active river bed and the margin of Vegetation Type 1/3 at left of the photograph and the moss/herb/monocot component rises around the bedrock of the gorge entrance to occupy a margin c. 6 metres wide at the actual gorge entry.

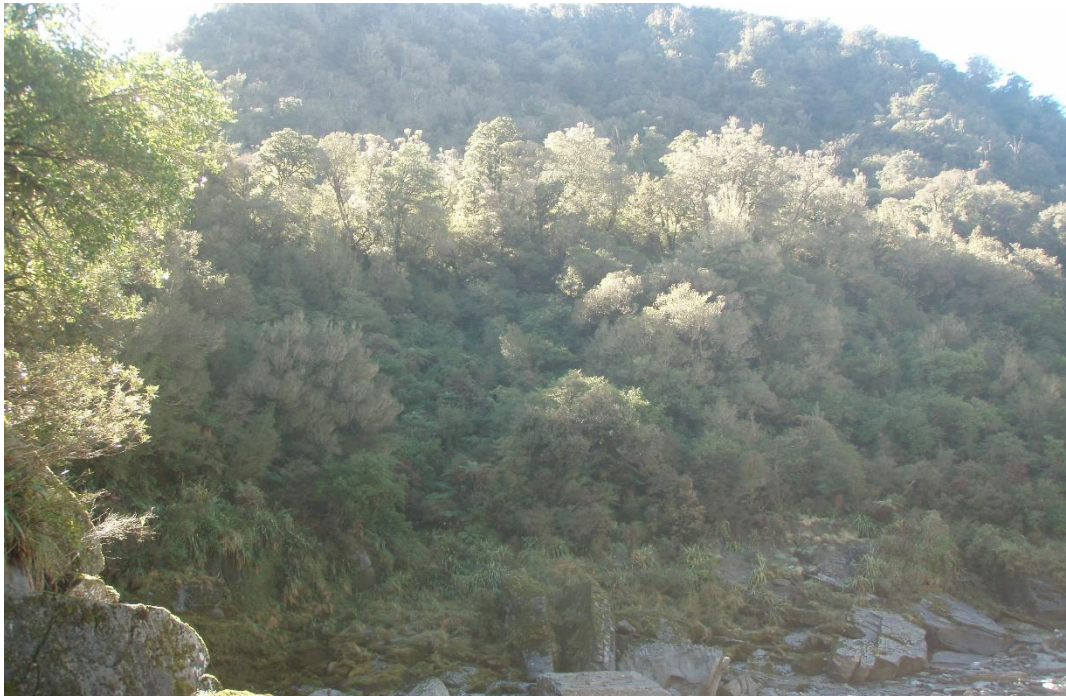
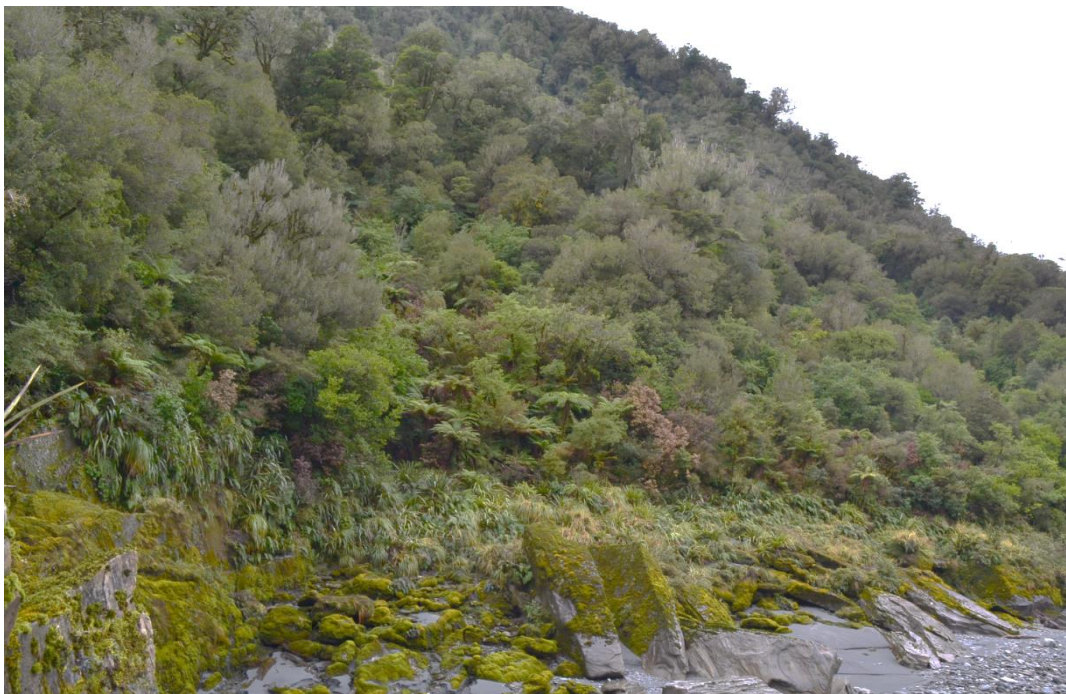
Figures 5a & 5b - Example of Vegetation Type 1/3.

Vegetation Type 1/3 on the terrace edge and mid to upper face at the true-right entry to Morgan Gorge – possible site of the tunnel portal entrances is approximately at lower left corner of photograph.

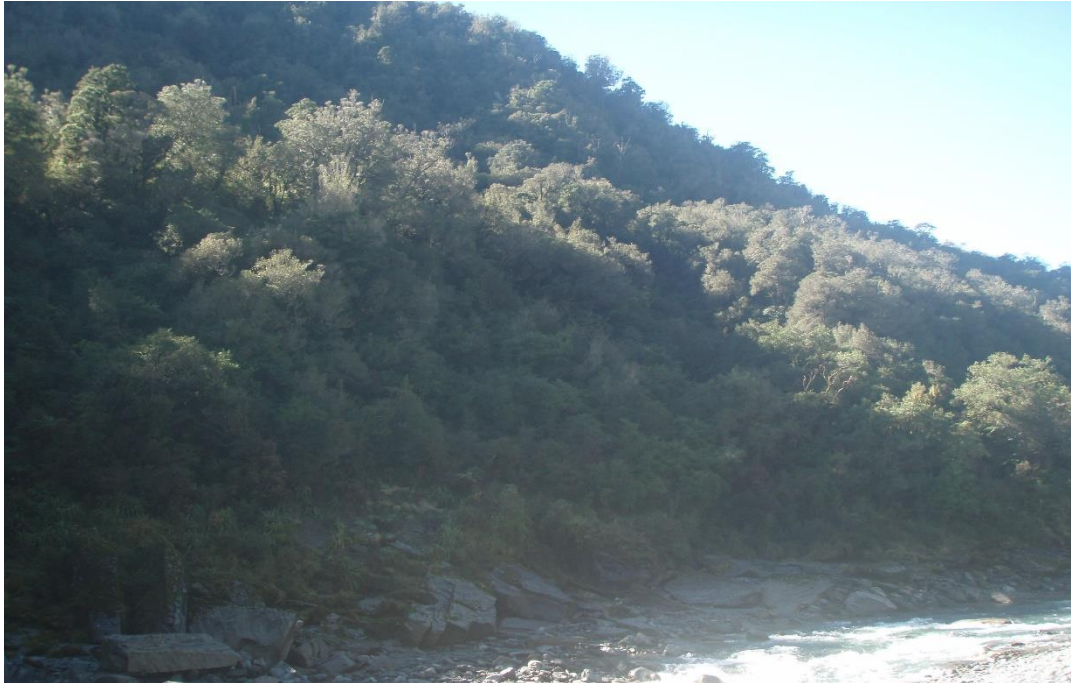
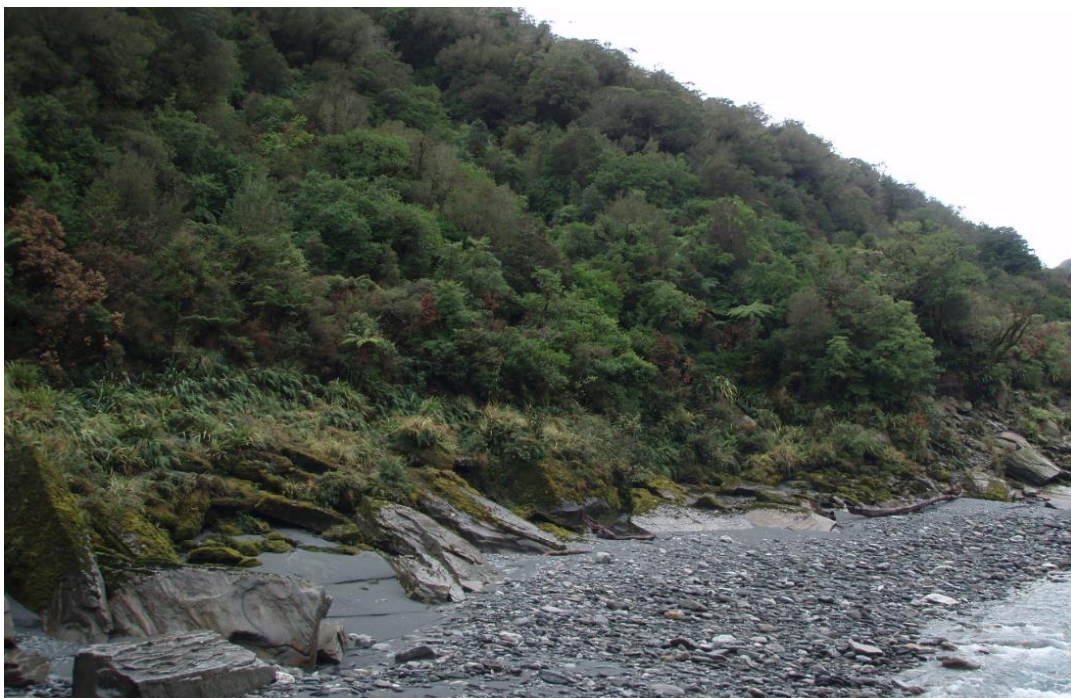
Figures 6a & 6b - Example of Vegetation Type 1/3:

Vegetation Type 1/3 on the terrace edge and mid to upper face on the true-right of the Waitaha River upstream of Morgan Gorge in the zone to be traversed by access roading to the contractors' facilities area.

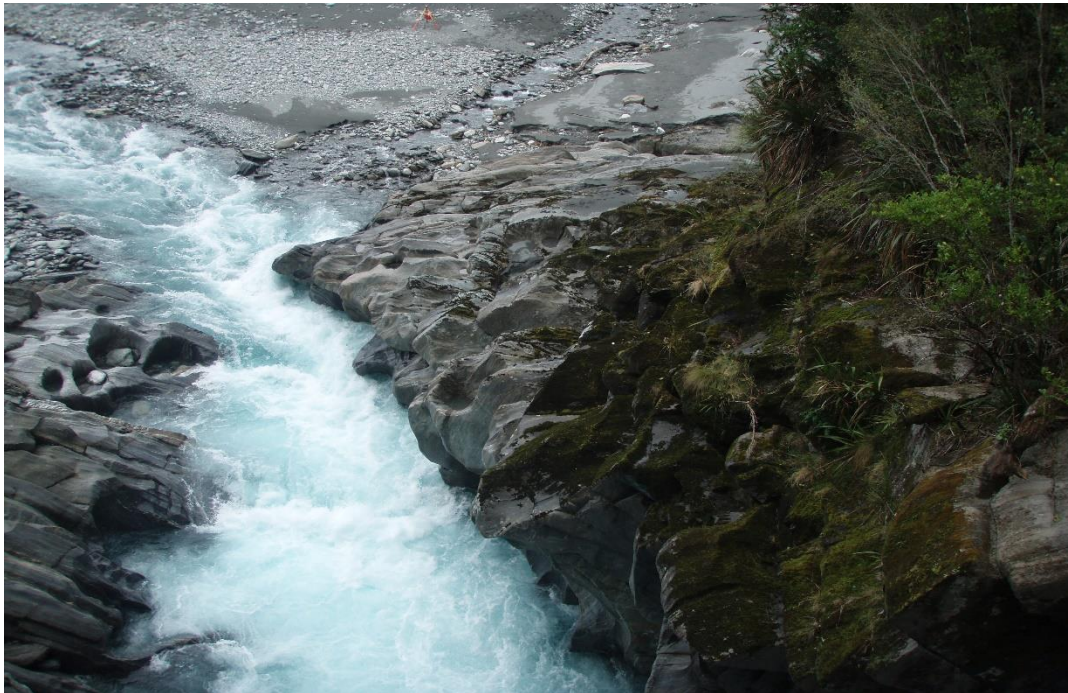
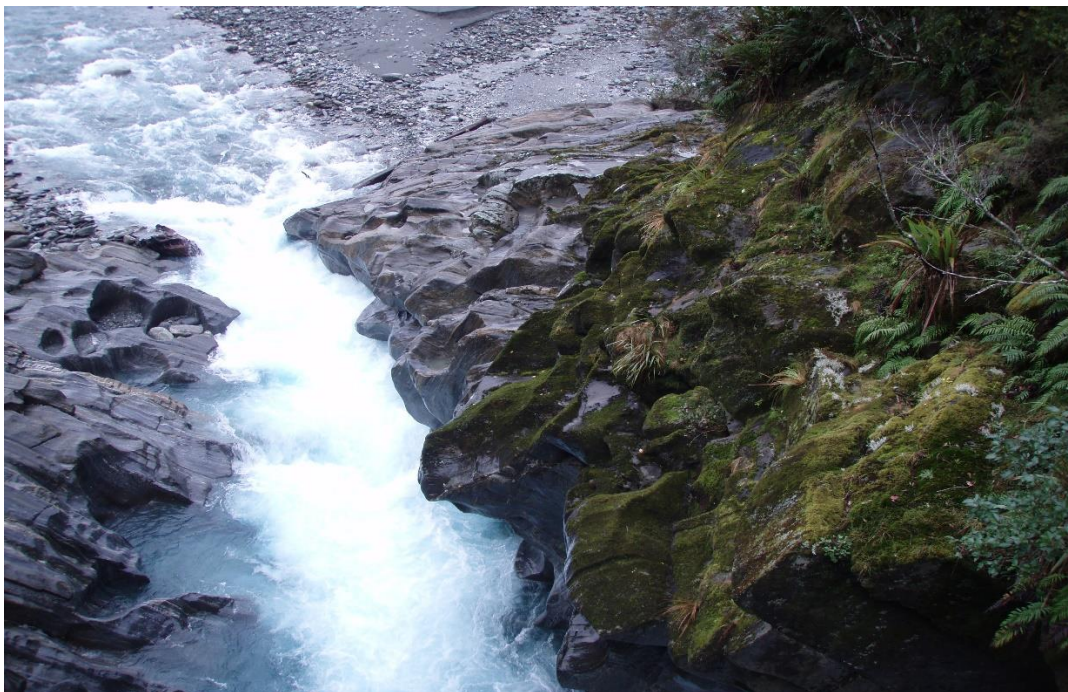
Figures 7a & 7b - Example of Vegetation Types 1/1 & 1/3:

Example of Vegetation Type 1/1 grading to Vegetation Type 1/3 hardwood shrub component cover on the true-left wall at the entrance to Morgan Gorge.

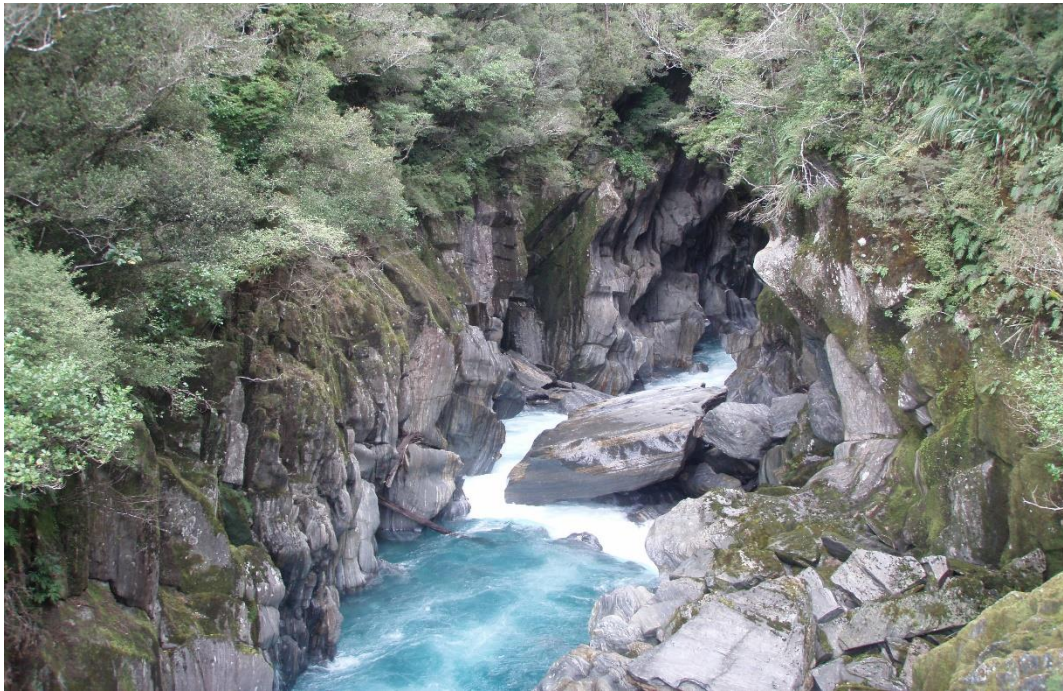
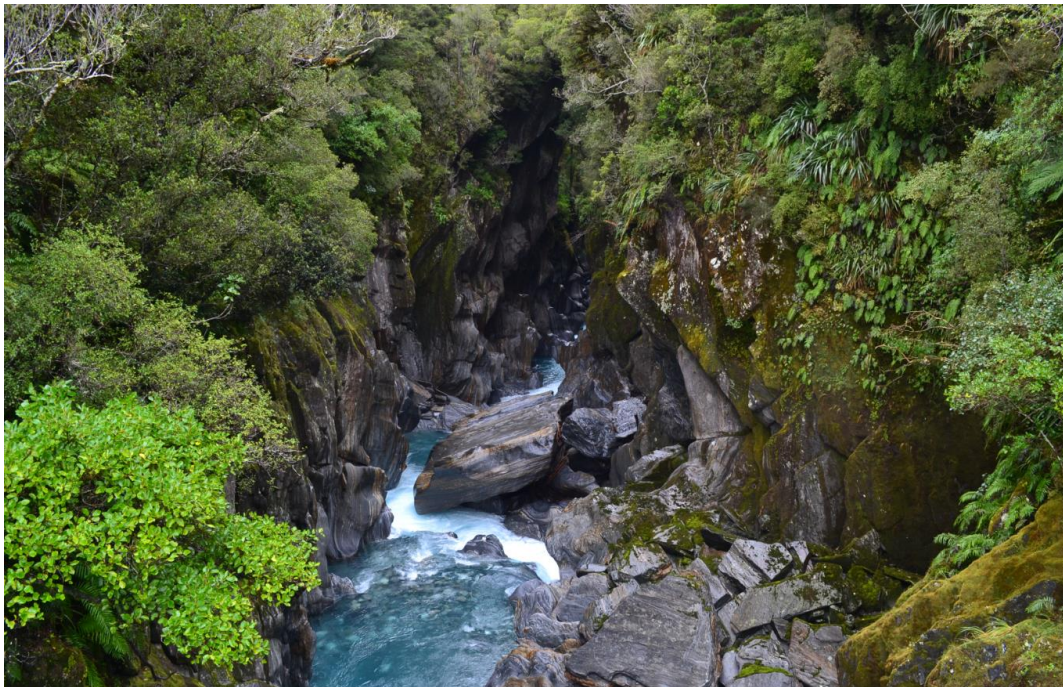
Figures 8a & 8b - Example of Vegetation Type 1/3 Shrub Component:

Vegetation Type 1/3 hardwood shrub cover on faces of Morgan Gorge. This grades uphill to higher-stature hardwood canopy forest cover, with a minor podocarp element.

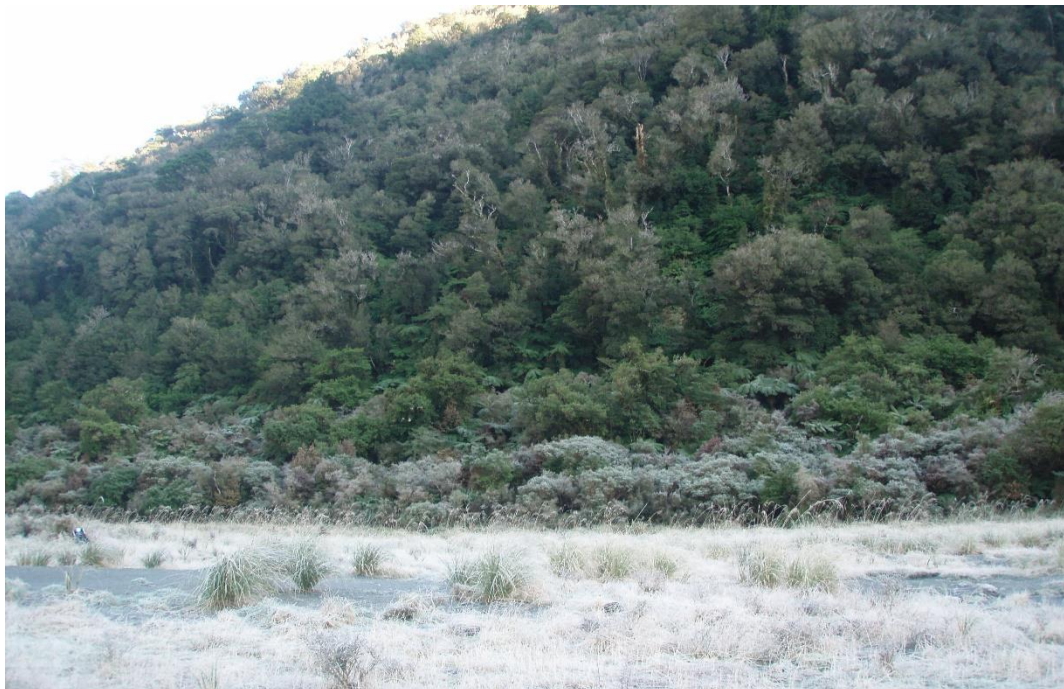
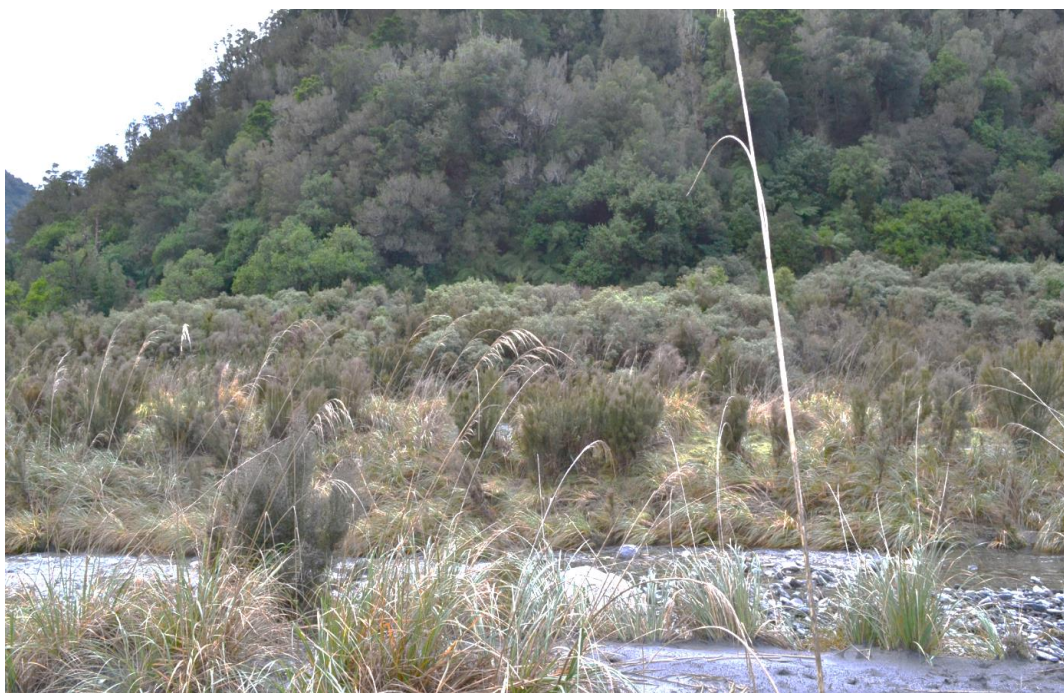
Figures 9a & 9b - Example of Vegetation Type 1/3:

Vegetation Type 1/3 on lower hill foot slopes above the northern margin of Kiwi Flat (note that this is not part of the proposed headworks area – it is included as an illustration of the stature and composition of this type of hardwood footslope forest cover with very low to no incidence of large podocarp emergents).

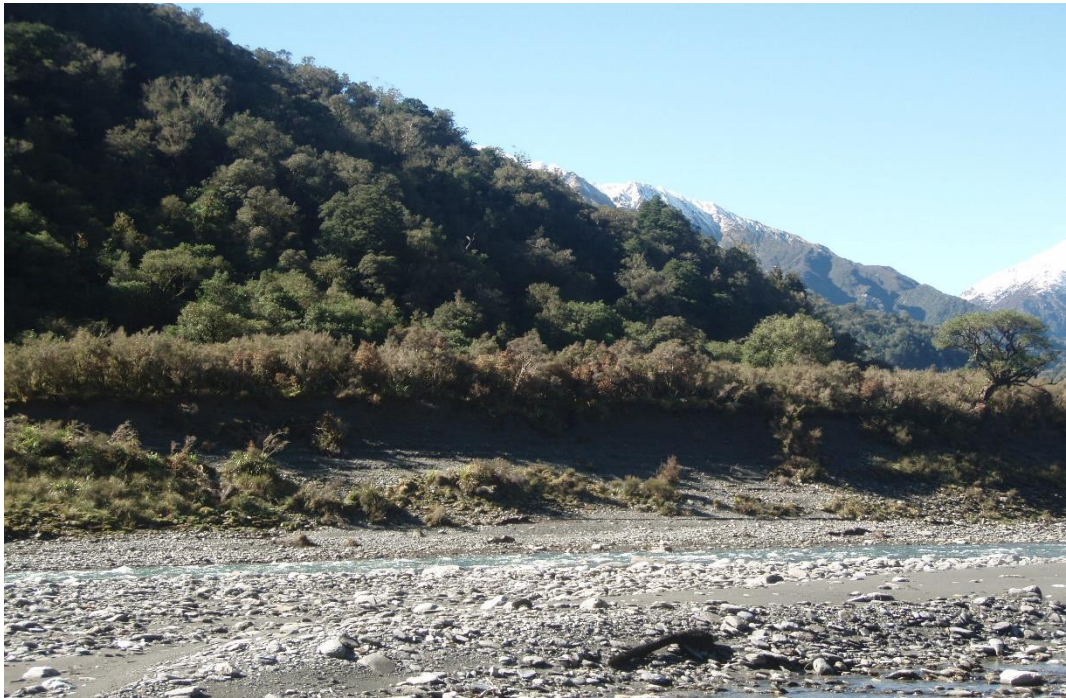
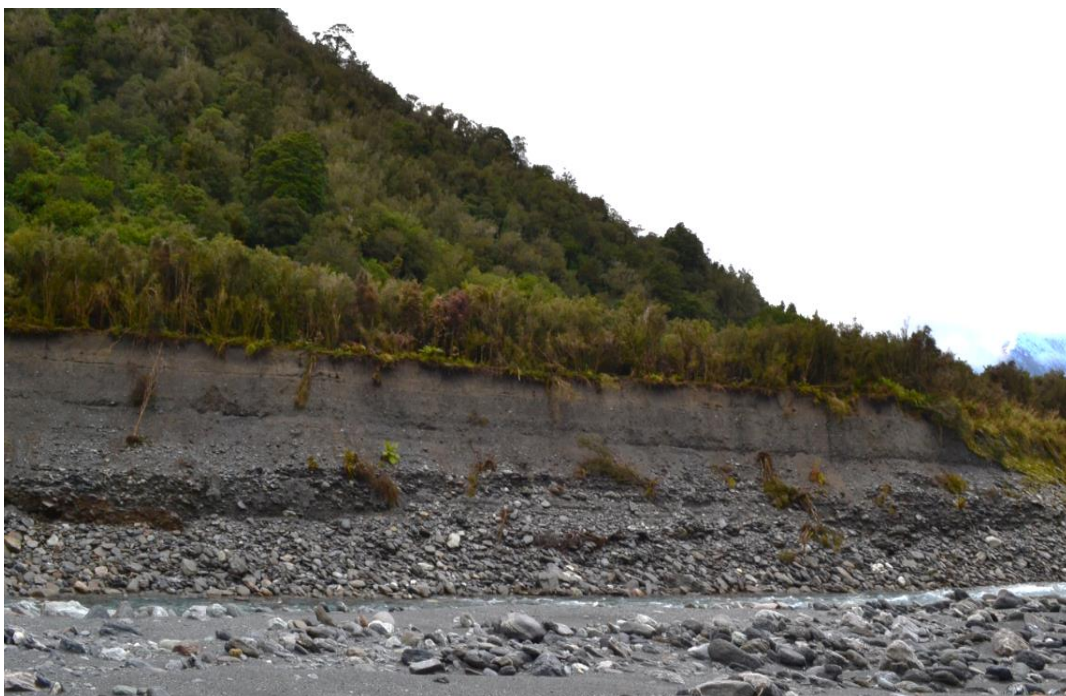
10a - State in 2012:

Typical stature and composition of Vegetation Type 1/4 as seen along the edge of the alluvial terrace above the active bed of the Waitaha River, northern margin of Kiwi Flat.

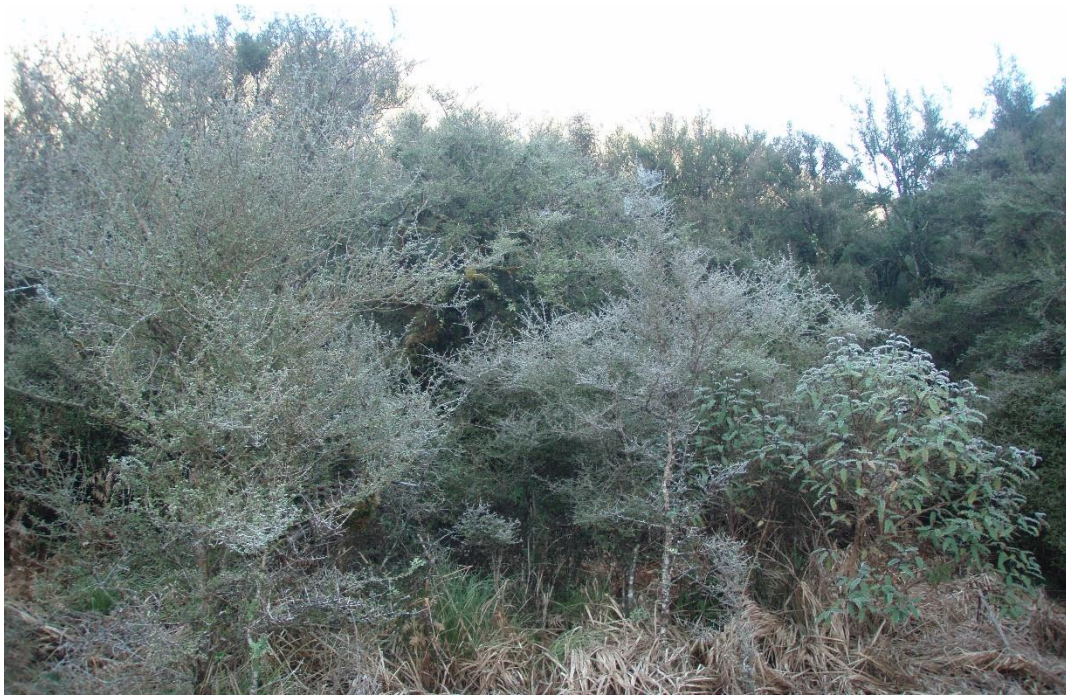
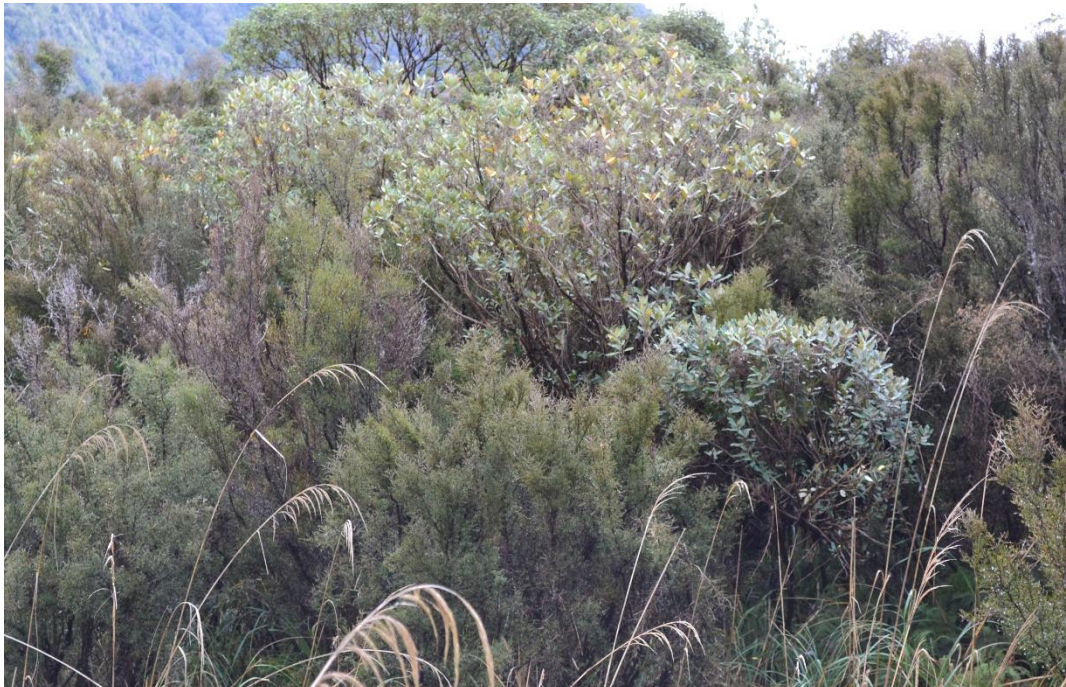
Figures 11a & 11b - Example of Vegetation Type 1/4:

Typical stature and species composition of Vegetation Type 1/4.

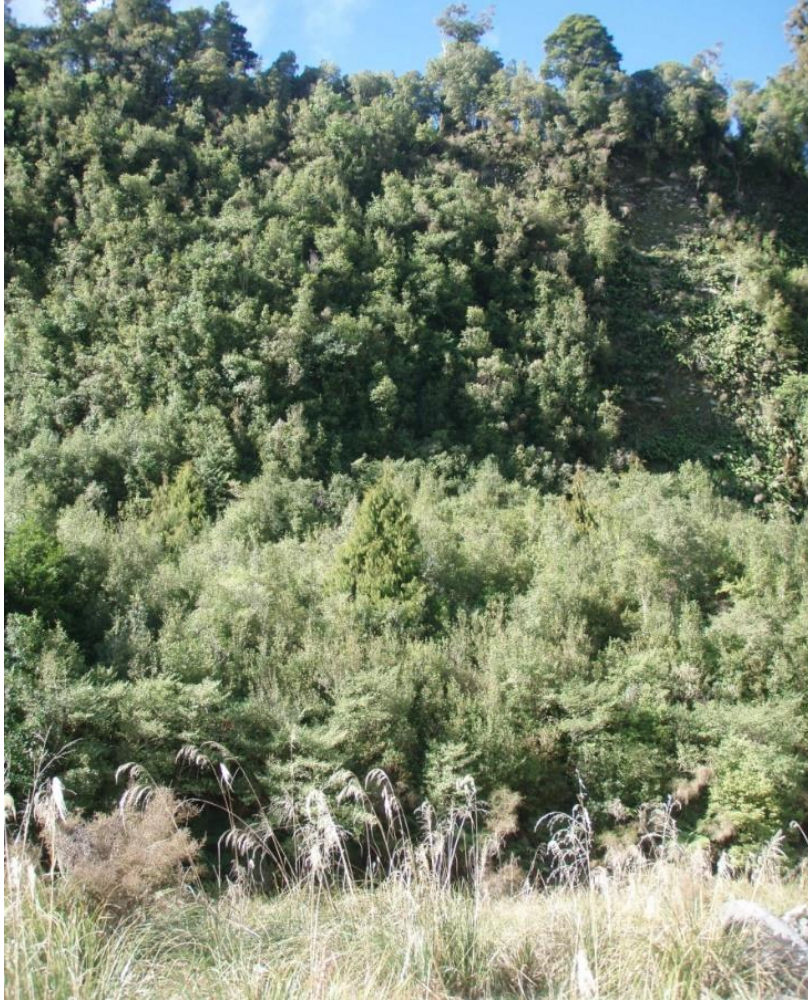
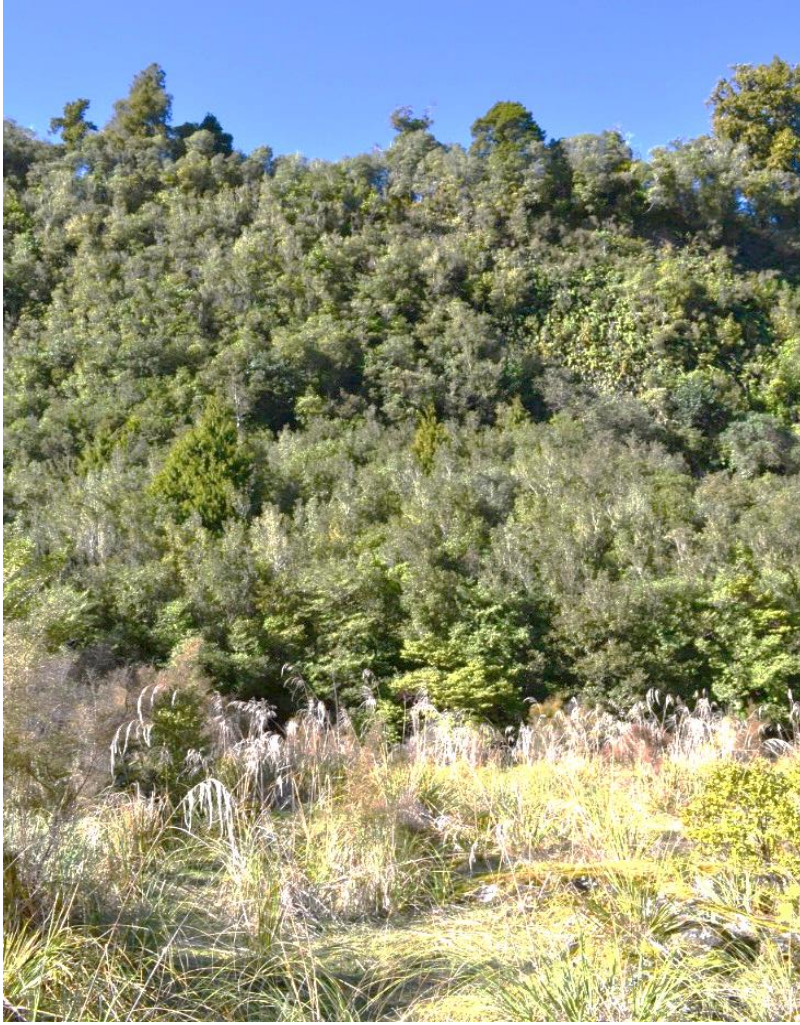
12a - State in 2012:

Vegetation Type 2/1 stature and composition on the low terrace in the foreground and on the terrace face and regenerating slip in the background.

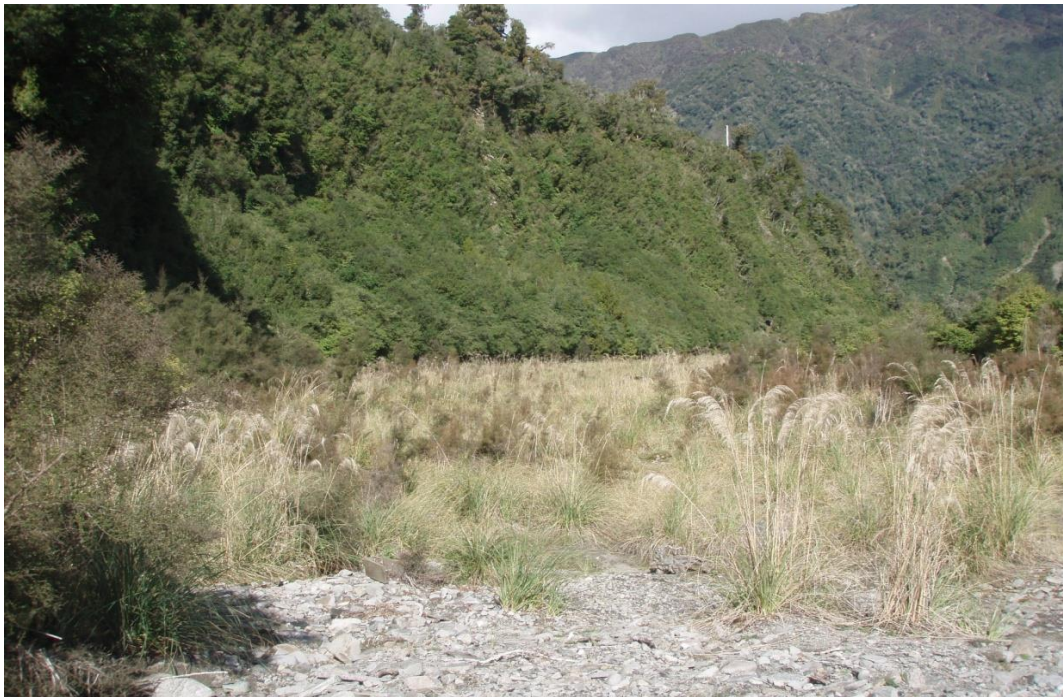
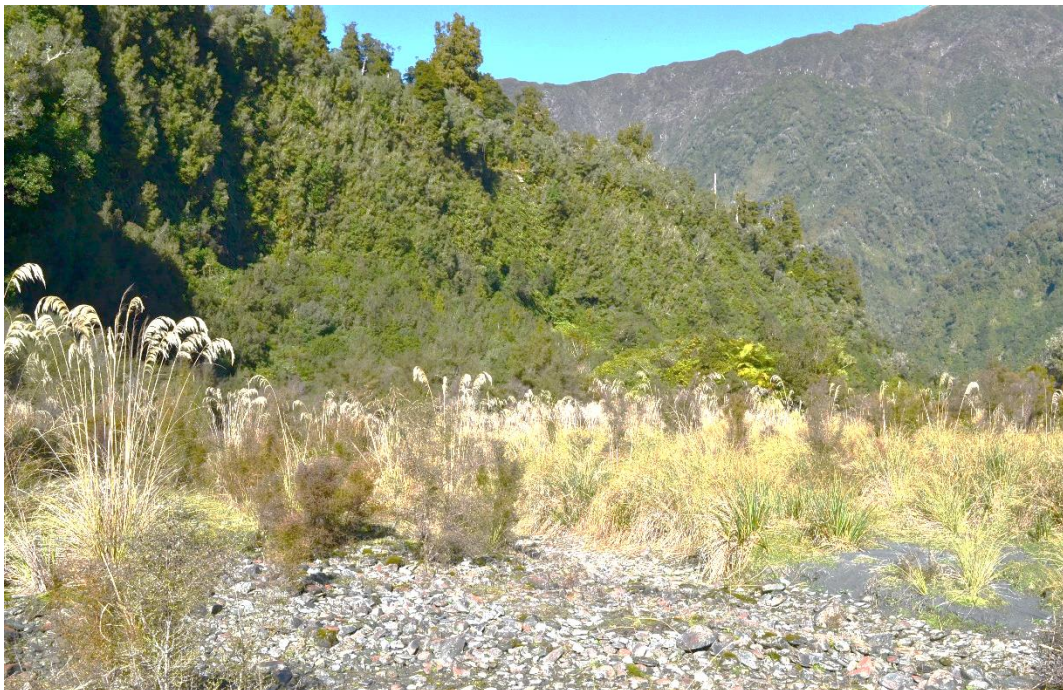
13a - State in 2012:

Vegetation Type 2/2 composition and cover of the river flat and historic channel.

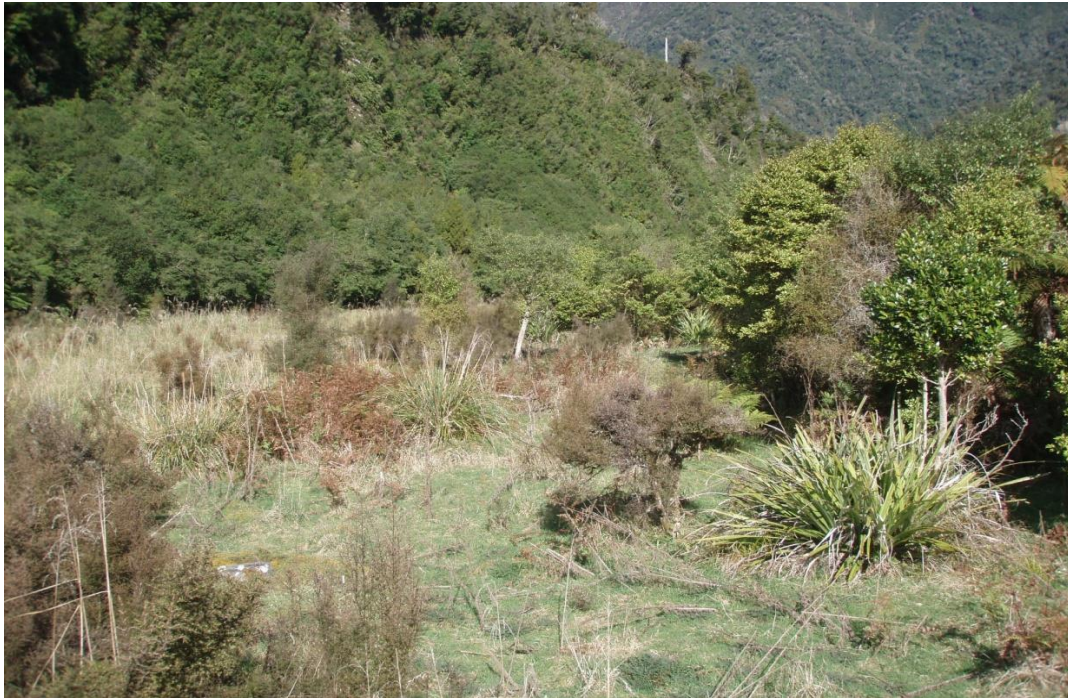
Figures 14a & 14b - Example of Vegetation Type 2/2:

Vegetation Type 2/2 composition and cover on the river flat.

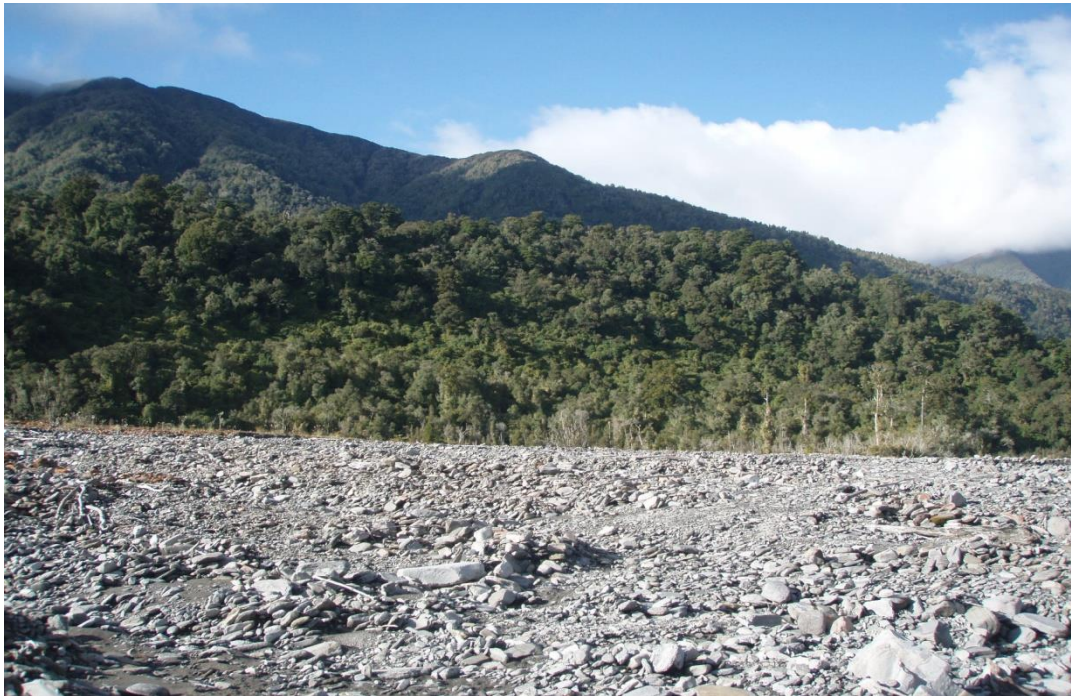
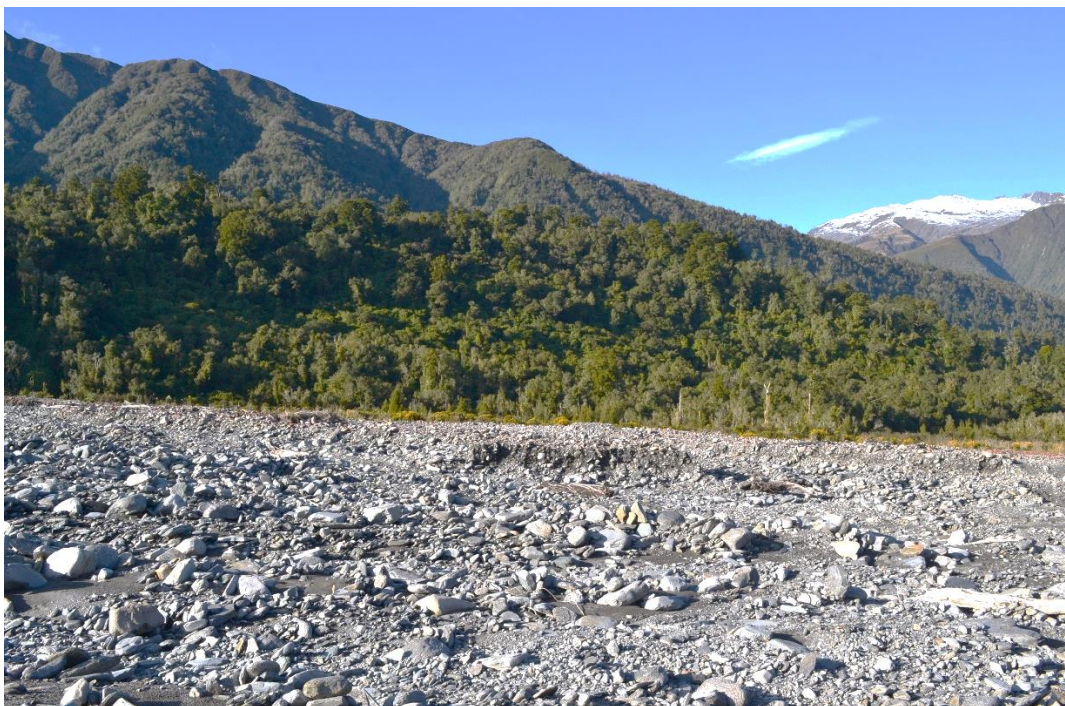
15a - State in 2012:

Typical composition and stature of Vegetation Type 2/3A on face terrain, grading into Vegetation Type 2/3 in higher ridge areas.
