WESTPOWER LTD. PROPOSED WAITAHA HYDRO SCHEME

ASSESSMENT OF ENVIRONMENTAL EFFECTS

VEGETATION

Dated June 2025

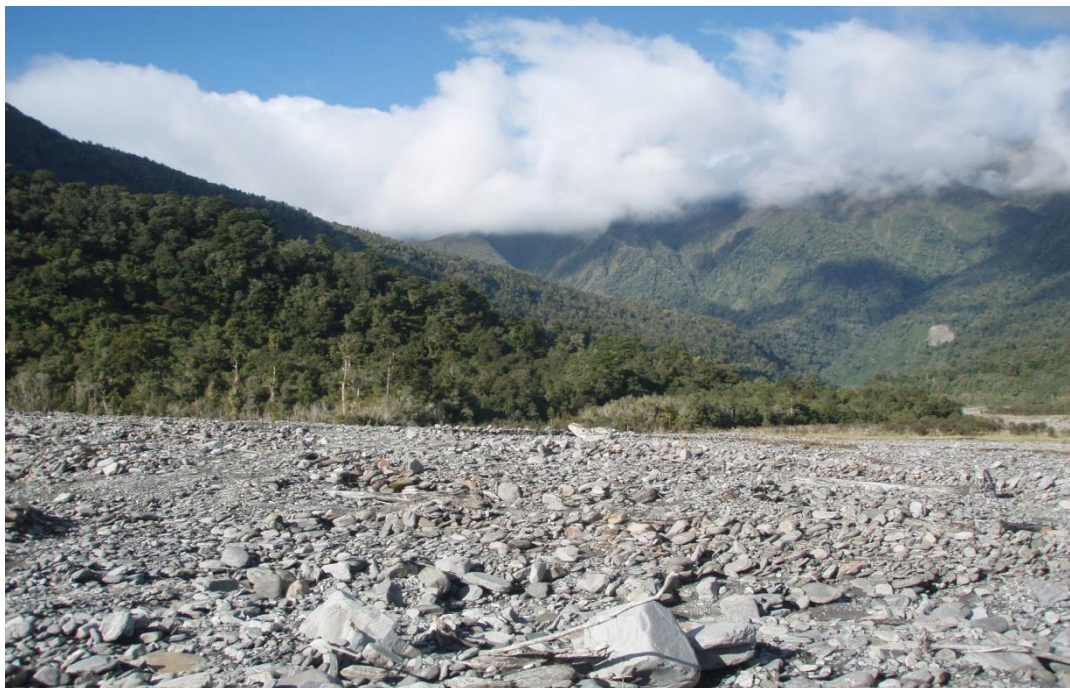
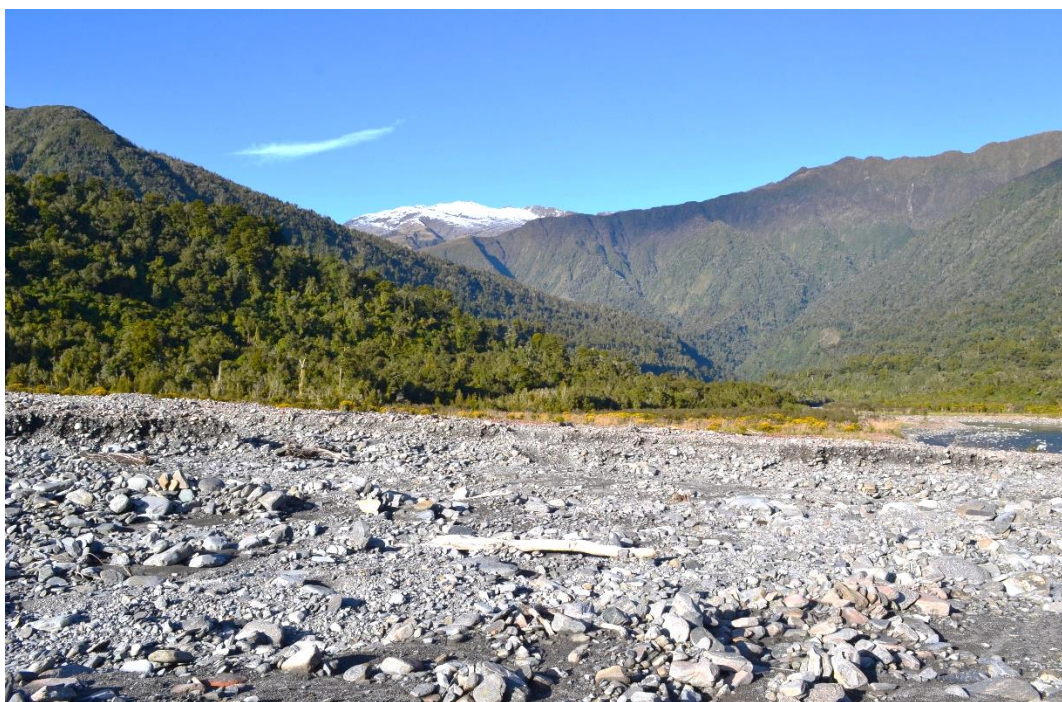
16a - State in 2012:

Vegetation Type 2/3B occurs at middle-left of the picture adjacent to Macgregor Creek. The relatively small area of this type is evident as naturally occurring dieback of hardwoods and emergent *Dacrydium cupressinum* trees along the true-left creek margin.

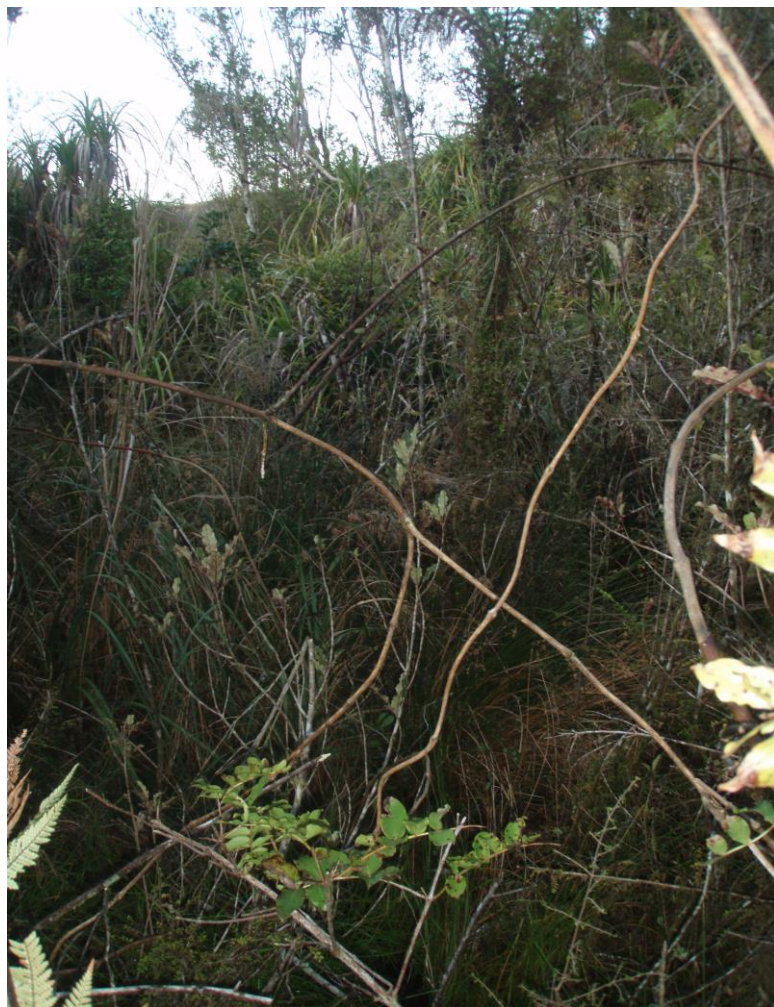
Figure 17 - Example of Vegetation Sub-type 2/3B Wetland:

Sub-type 2/3B Wetland occupies a small area of slight depression formed between a recent alluvial flat on the Waitaha River true right, rising ground to the east, and gravel buildup from the southern margin of the Macgregor Creek outwash fan. It appears to receive water possibly from Macgregor Creek subsurface seepage and the same from the rising forested ground to its east, in addition to precipitation. This is Site W8 in 2024.

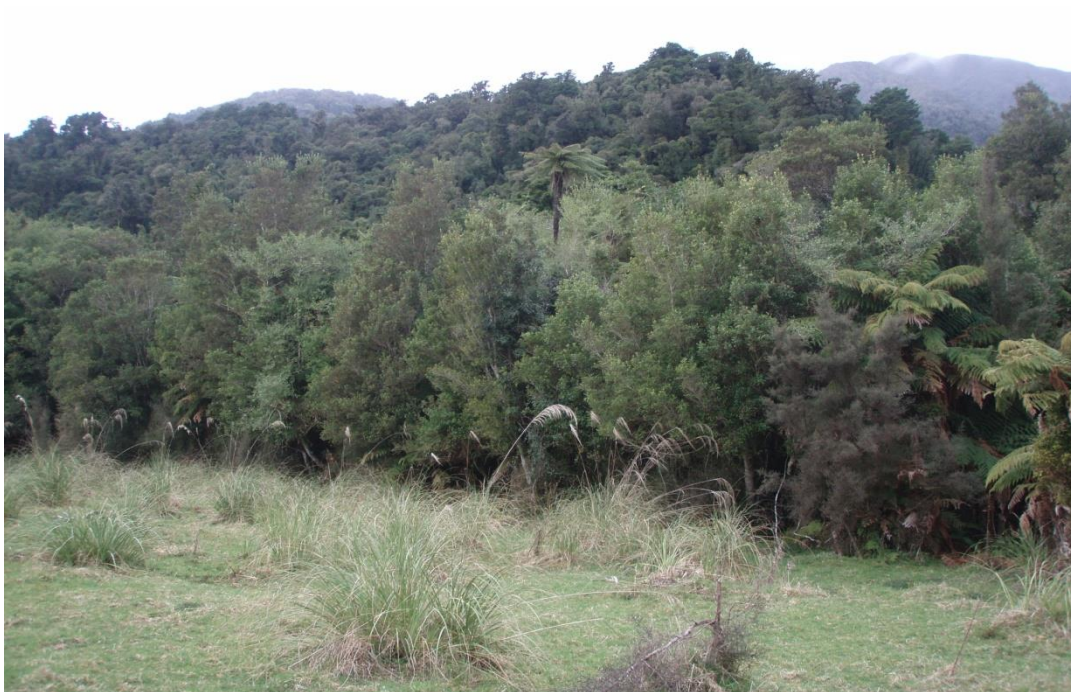
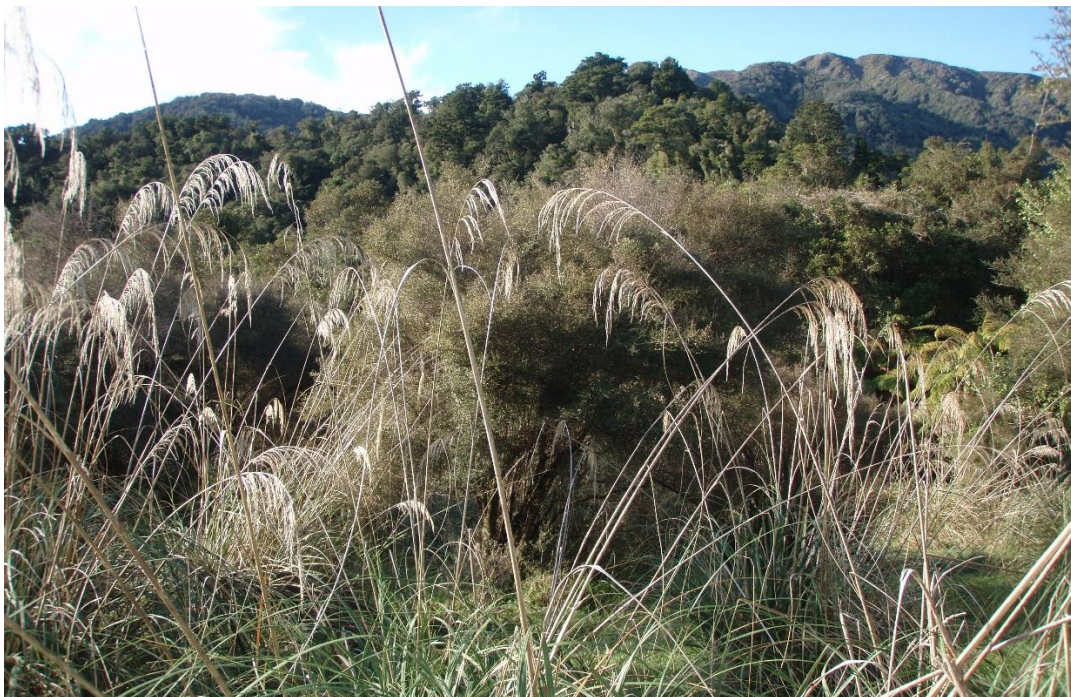
18a - State in 2012:

Typical Vegetation Type 2/4 composition and cover – i.e. the hardwood/tree fern regeneration extending from the grassed flat margin back to the foot of the ridge in middle distance where it grades into Vegetation Type 2/3.

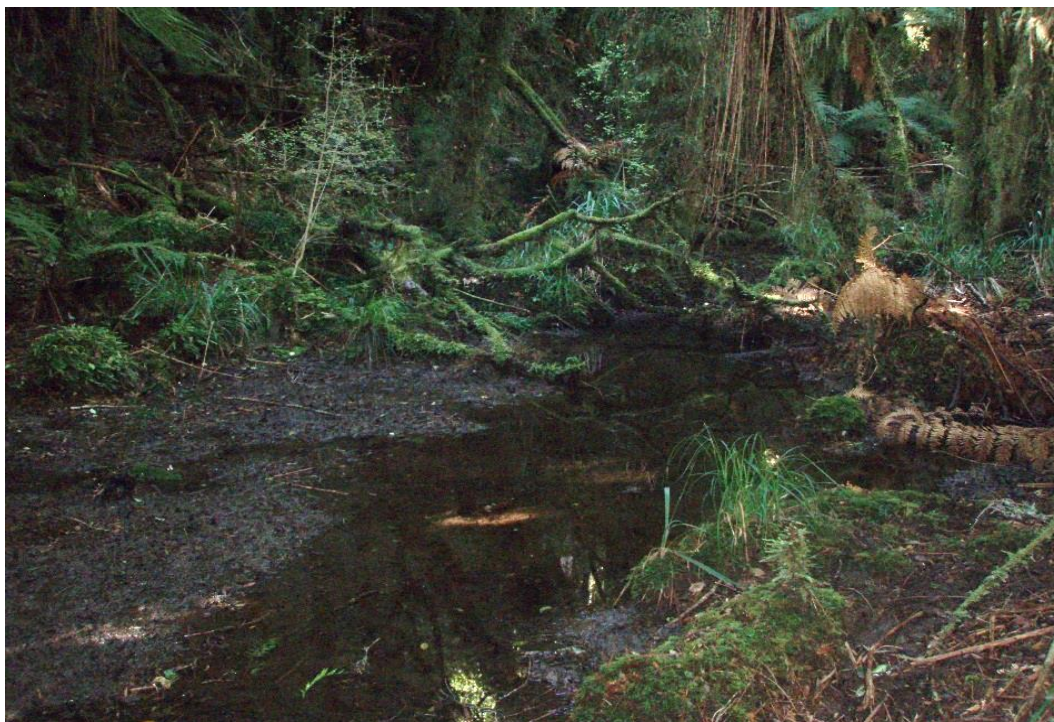
Figure 19 – Example of Vegetation Sub-type 2/4 Wetland Zone:

Sub-type 2/4 Wetland physical attributes and vegetation, being an expanded zone either side of a minor forest waterway. This is Site W1 in 2024.

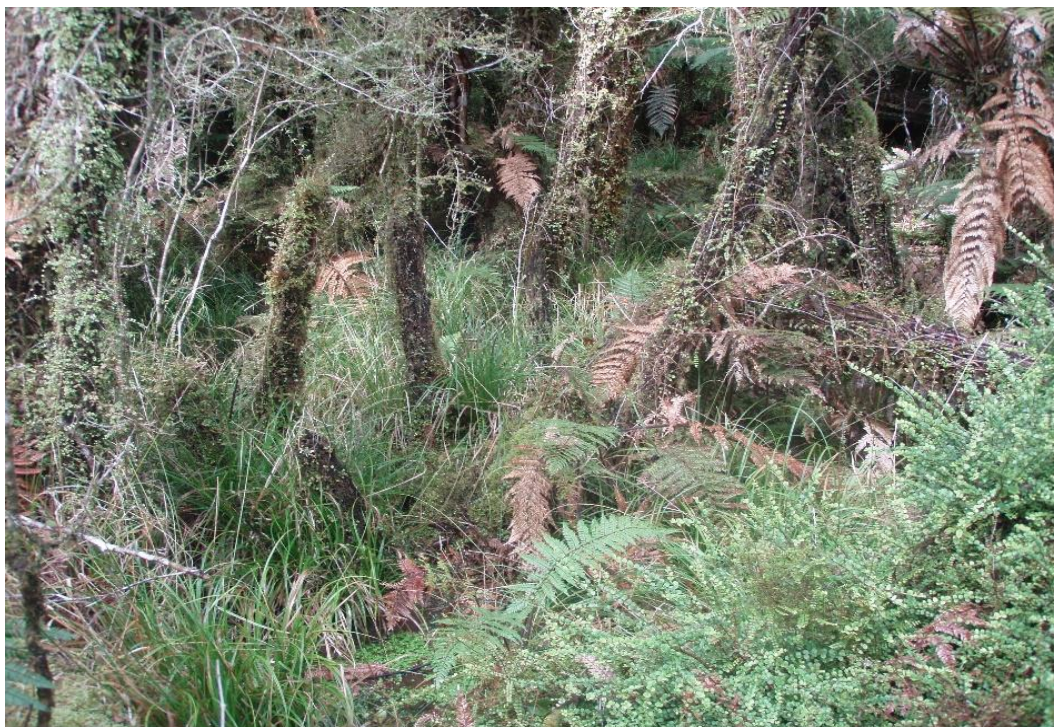
Figure 20 – Example of Vegetation Sub-type 2/4 Wetland Zone

Sub-type 2/4 Wetland showing ground cover and shrub vegetation, being an impeded zone of a minor forest waterway at an upper terrace margin. *Metrosideros diffusa* is prevalent as a climber on the tree fern stems and as ground cover, along with *Carex* spp. This is Site W2 in 2024.

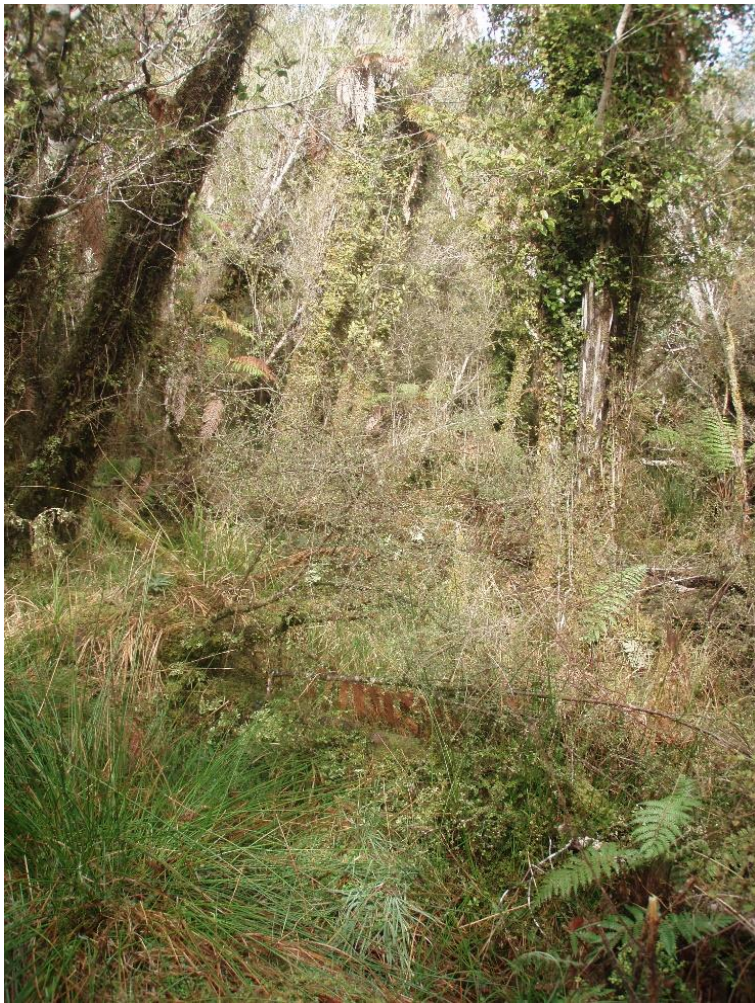
Figure 21 – Example of Vegetation Sub-type 2/4 Wetland Zone

Sub-type 2/4 Wetland, occupying a slight depression on an otherwise flat, low terrace. Shows typical ground cover, shrub and tree strata composition and stature. This is Site W3 in 2024.

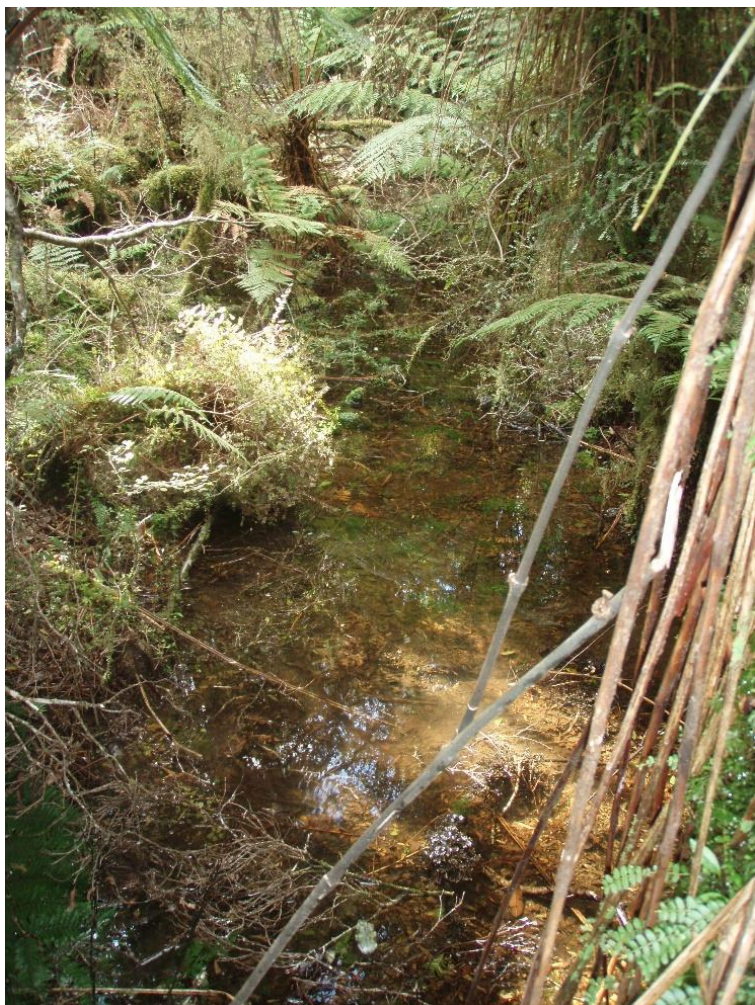
Figure 22 - Example of Vegetation Sub-type 2/4A Wetland Zone

Sub-type 2/4A Wetland, occupying a slight depression that appears to have been part of an historical minor waterway. Shows typical ground cover and shrub strata composition and stature, with *Metrosideros diffusa* evident as a climber on the tree fern stems and as ground cover. This is Site W5 in 2024.

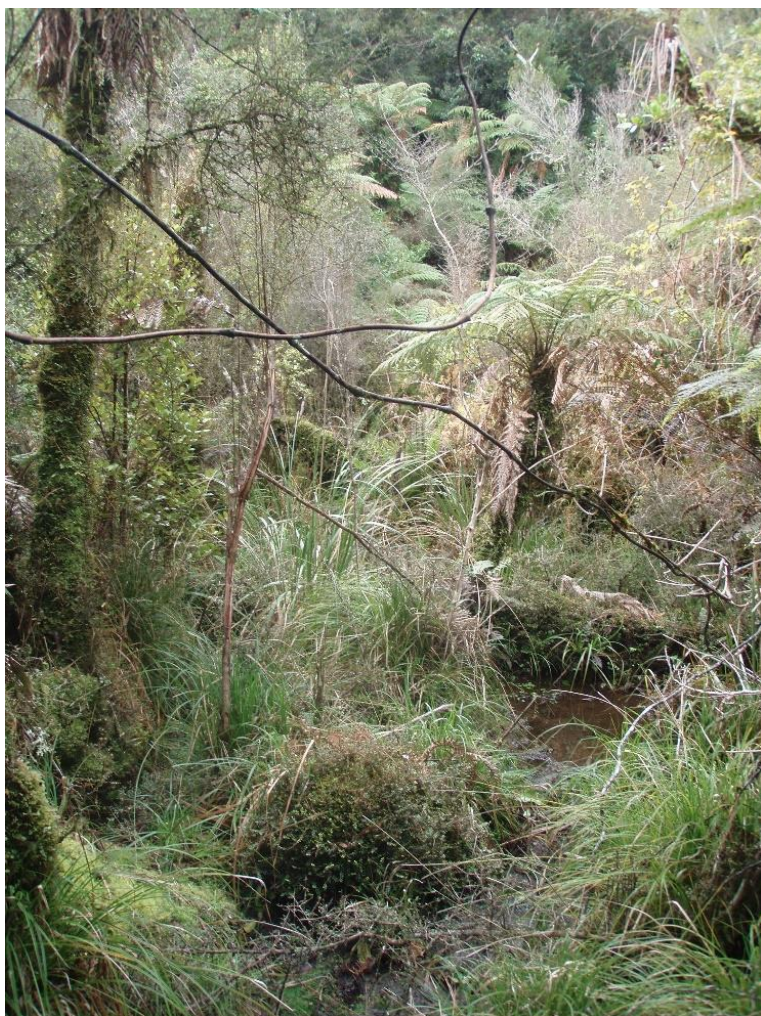
Figure 23 - Example of Vegetation Sub-type 2/4A Wetland Zone

Sub-type 2/4A Wetland, occupying a depression that appears to have been part of, or an end to, an historical overflow channel of Granite Creek. Shows typical ground cover and shrub strata composition and stature. This is Site W7 in 2024.

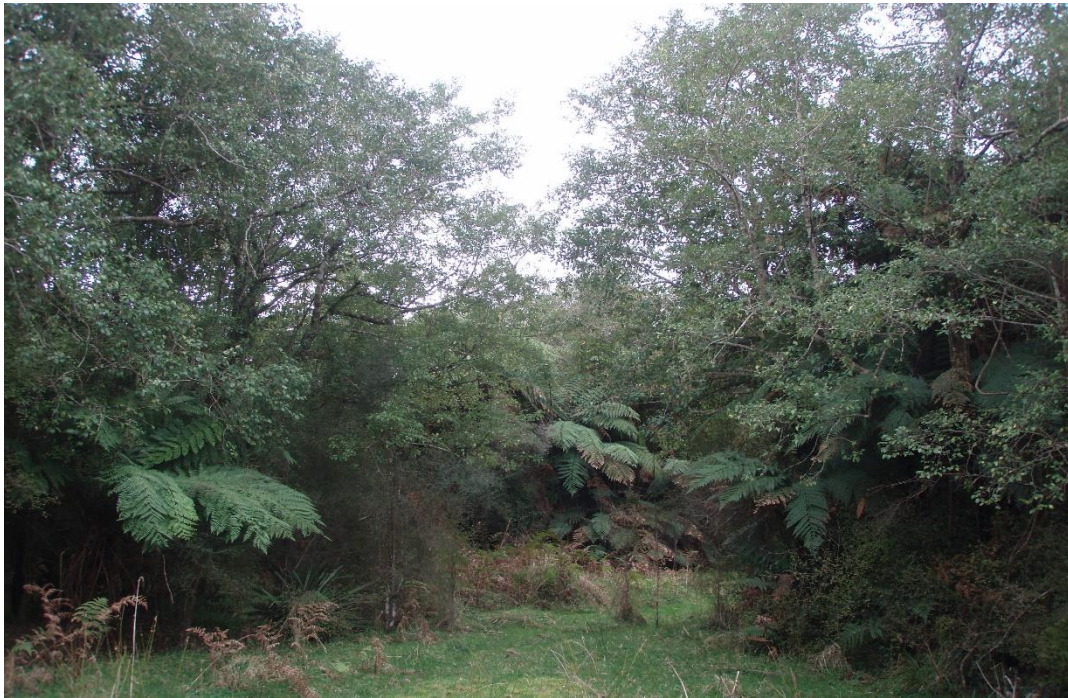
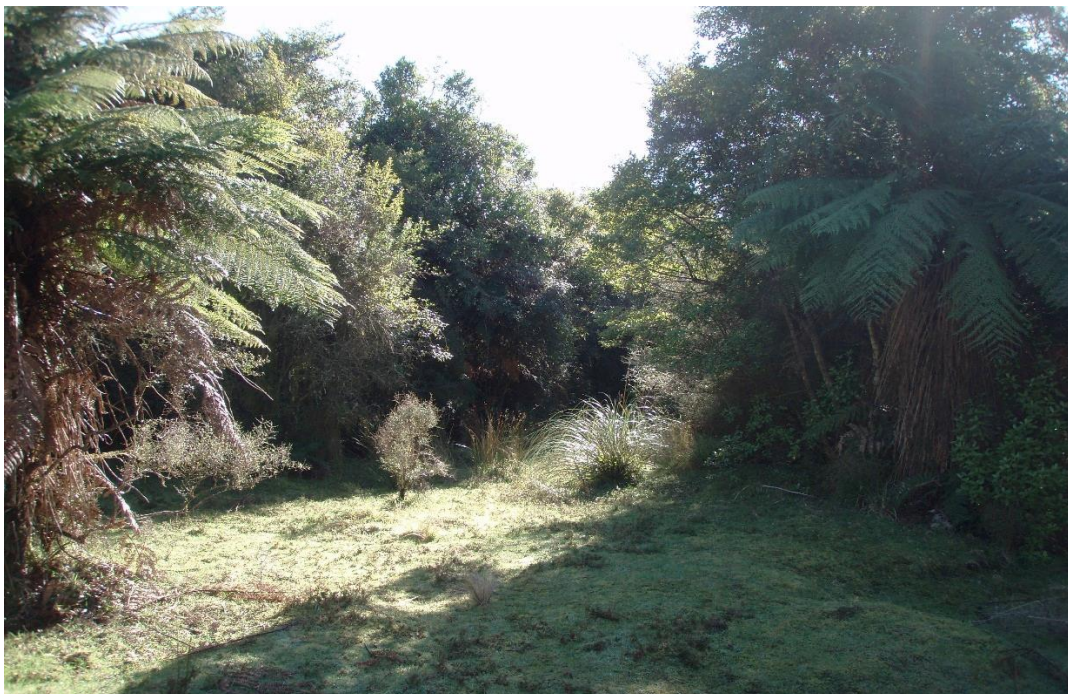
24a - State in 2012:

Vegetation Type 2/5 composition and cover at the southern end of its area, grading into Vegetation Type 2/6.

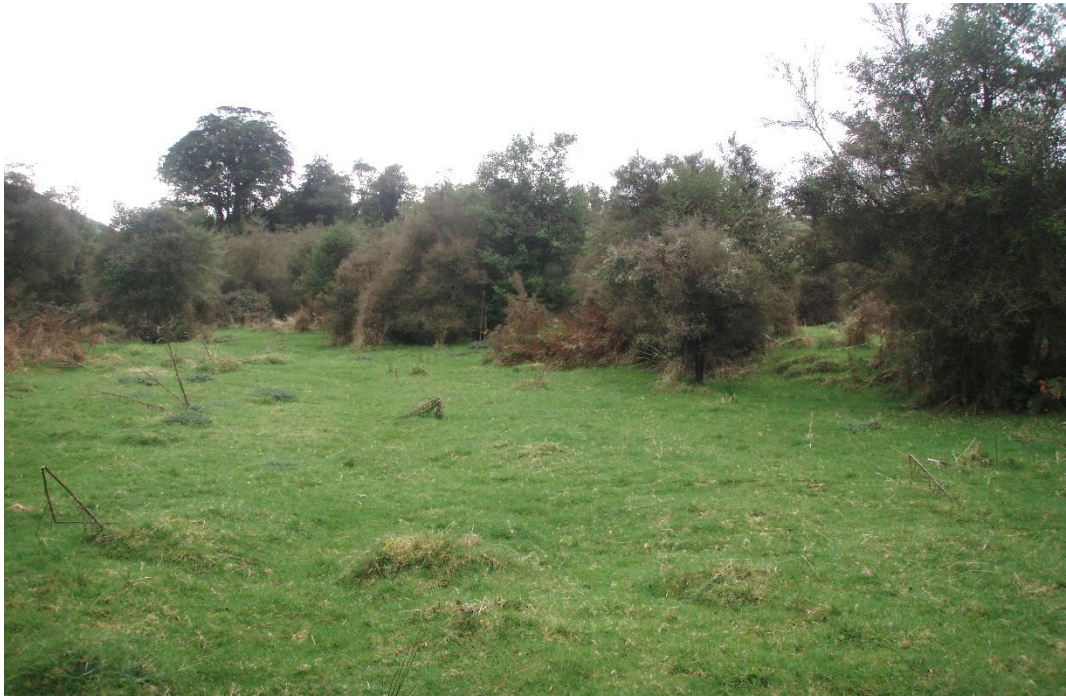
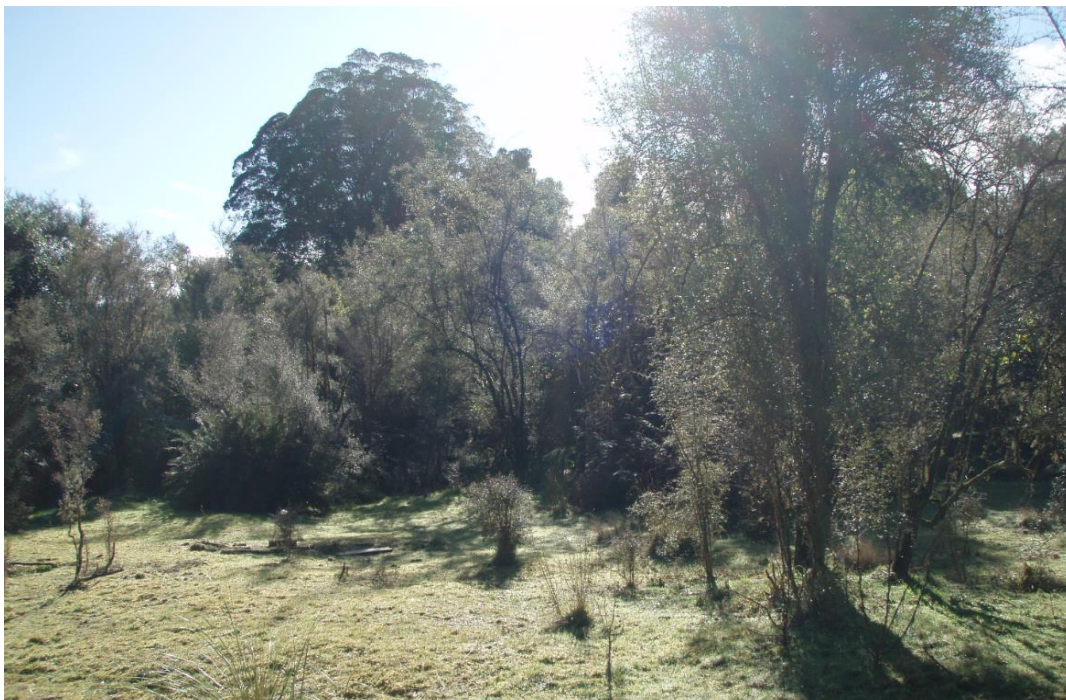
25a - State in 2012:

Emergent trees and the higher canopy of Vegetation Type 2/5 are shown in the background, with typical Vegetation Type 2/6 composition and cover in the foreground.

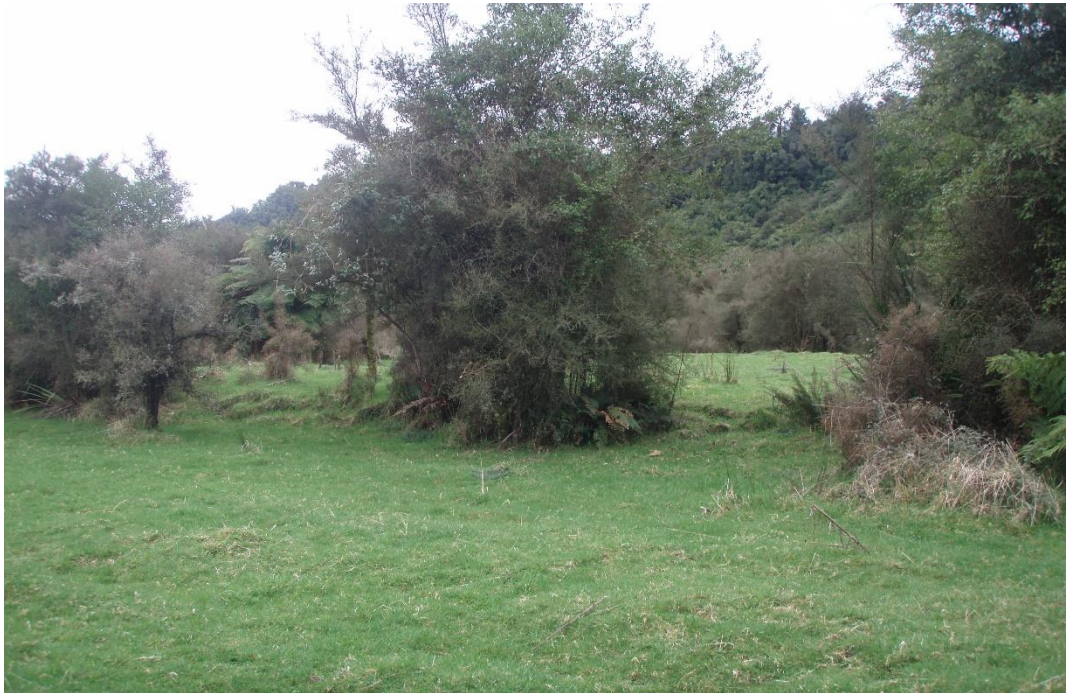
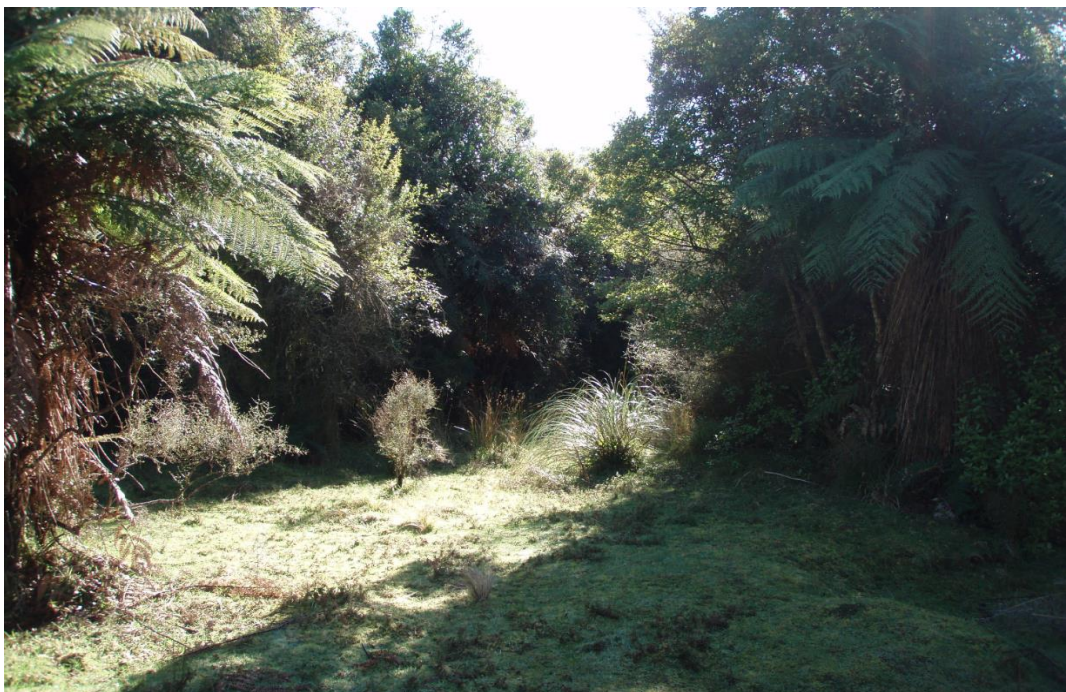
Figures 26a & 26b - Example of Vegetation Type 2/6:

Typical Vegetation Type 2/6 composition and cover – grassed clearings interspersed with shrub hardwood and tree fern clusters.

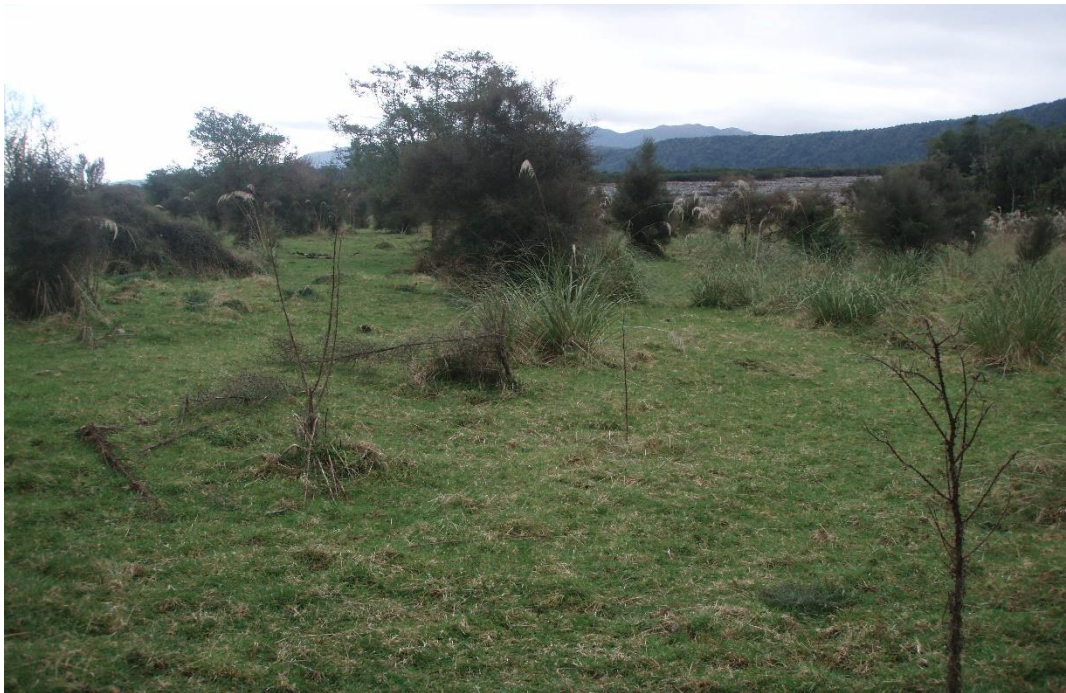
27a - State in 2012:

Typical Vegetation Type 2/7 composition and cover.

A change noted in Vegetation Type 2/7 between 2012 and 2024 is increased site cover by *Coprosma* spp., *Austroderia richardii*, and the *Ulex europaeus* weed incursion. (See Figures 21a – 21b).

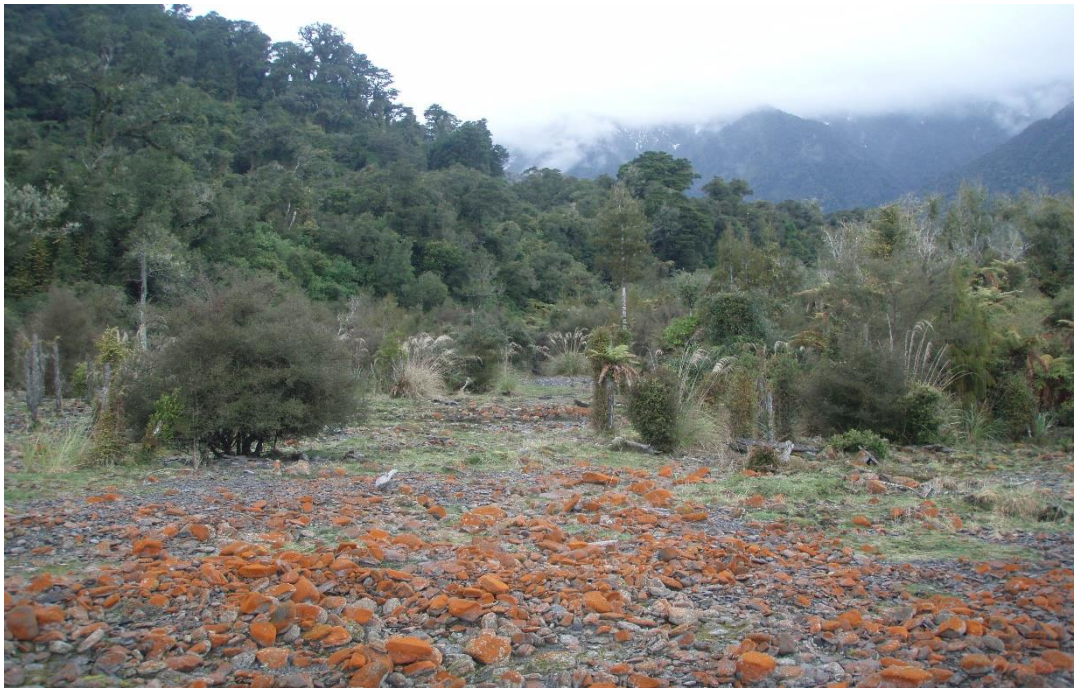
28a - State in 2012:

Typical Vegetation Type 2/8 composition and cover is shown in the mid foreground.

A change noted here is the increased occurrence of *Ulex europaeus* since 2012.
(See Figures 22a – 22b).

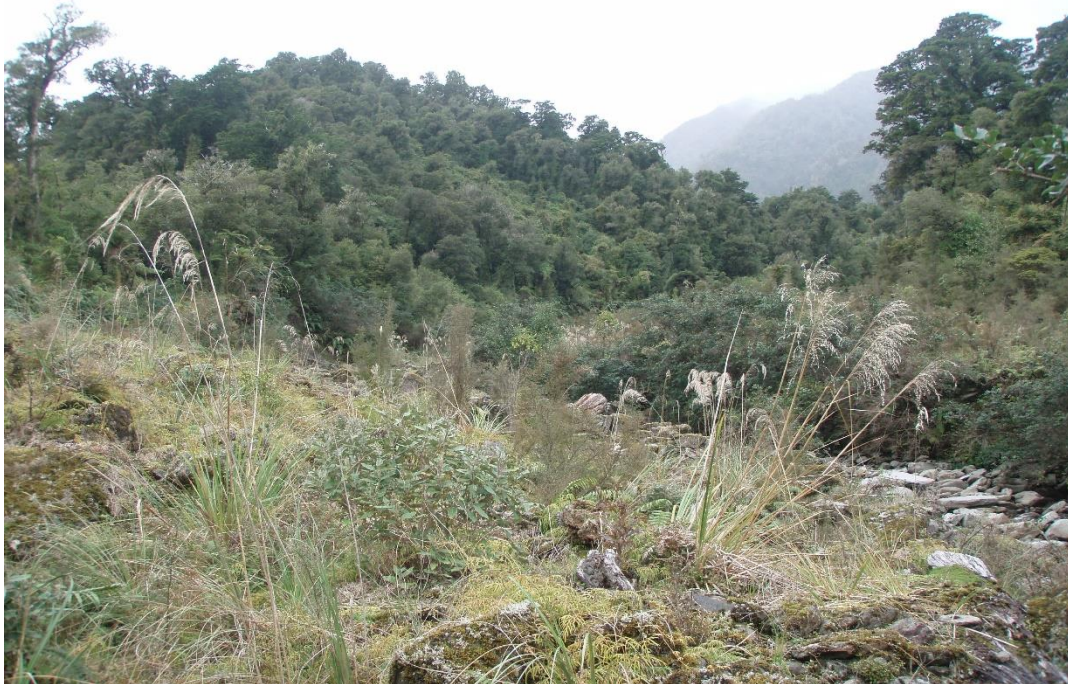
29a - State in 2012:

Typical Vegetation Type 2/9 composition and cover is shown in the foreground.

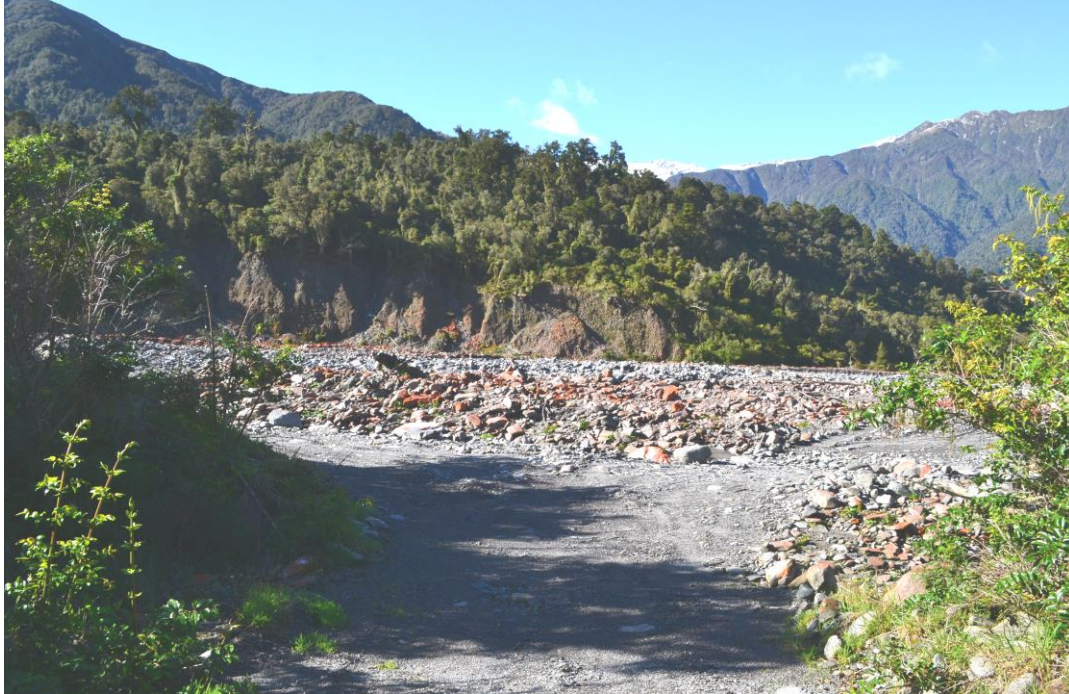
View looking south from southern margin of Vegetation Type 2/10 across the unvegetated active bed of Macgregor Creek (this track entry is at or proximal to the proposed access road/transmission line traverse of Vegetation Type 2/10, and the view across Macgregor Creek indicates the vegetation and footslope (middle distance) on which the transmission line pole to gain span height could be located.

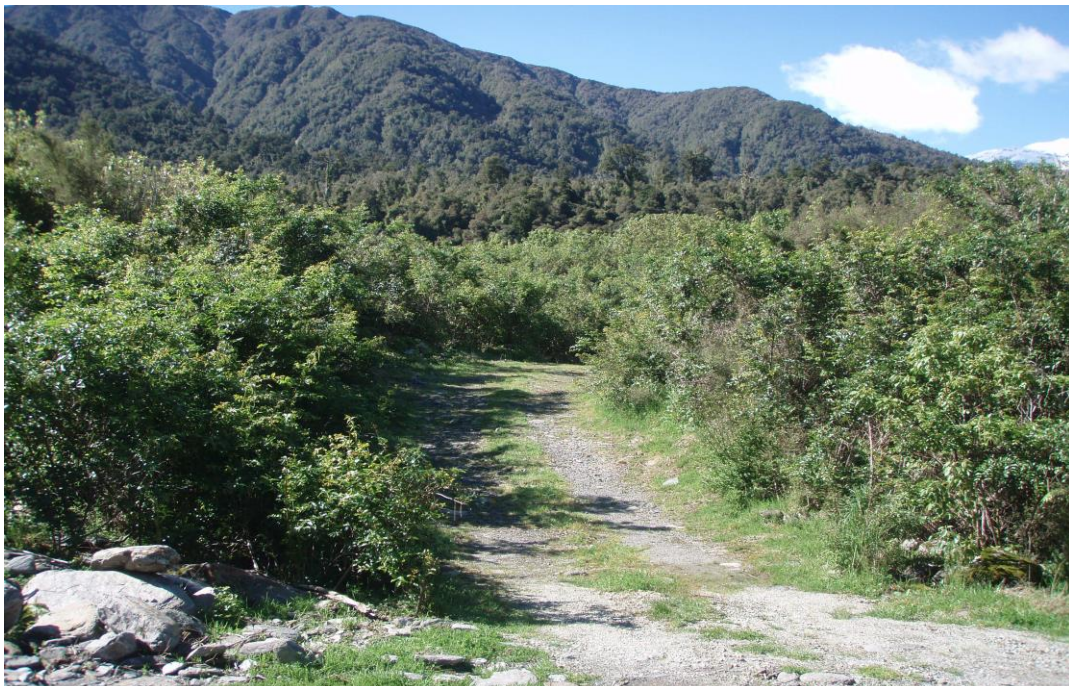
Figure 31 - Example of Vegetation Type 2/10:

Typical Vegetation Type 2/10 composition and cover is shown to left and right of the access track (this track is at or proximal to the proposed access road/transmission line traverse location. View is looking south from approximately half way through the width of the Vegetation Type 2/10 strip.

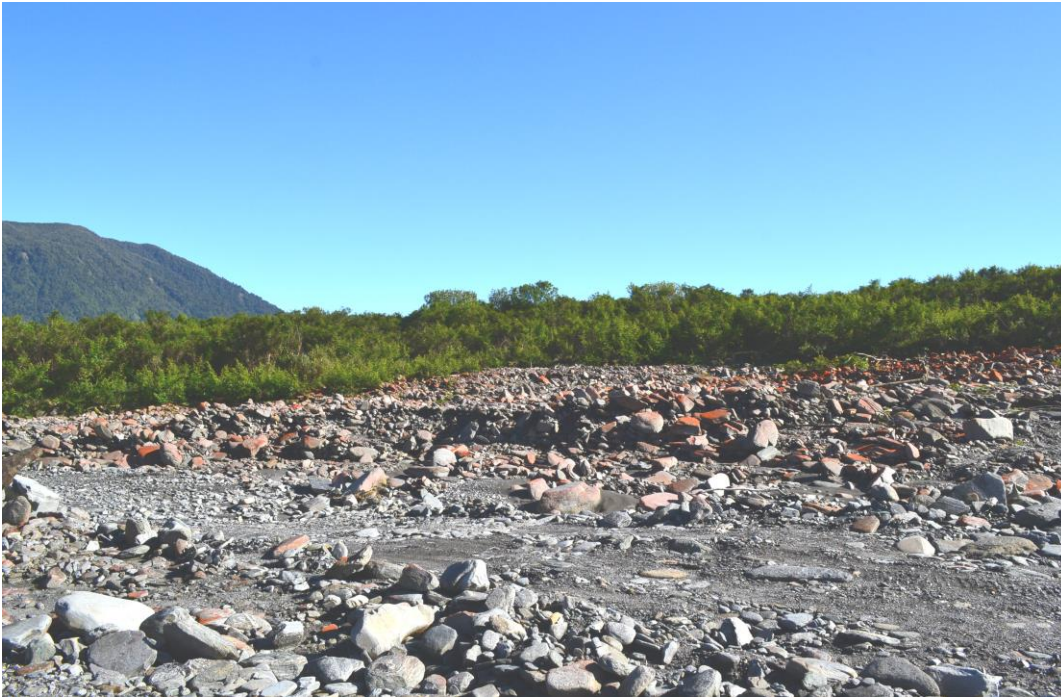
View north across Macgregor Creek active bed to Vegetation Type 2/10 margin illustrating shrub cover stature and density, with complete absence of trees.

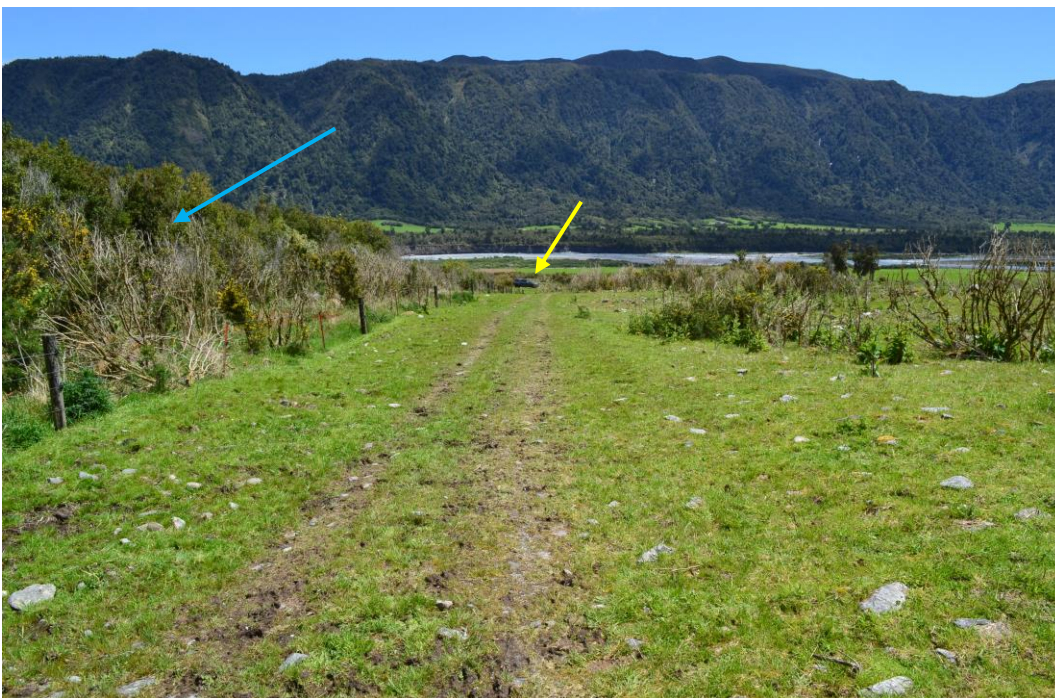
Figure 33 - Example of Vegetation Type 2/10 Northern Margin With Freehold Farmland:

The Vegetation Type 2/10 strip northern margin is at left (blue arrow). This view is looking south from the upper southeastern corner of the proposed staging area, with the vehicle in the middle distance (arrowed) parked at the upper southeastern corner of the larger of the two proposed spoil disposal areas. An example of open, exotic vegetation cover of the staging area is at right of photograph.

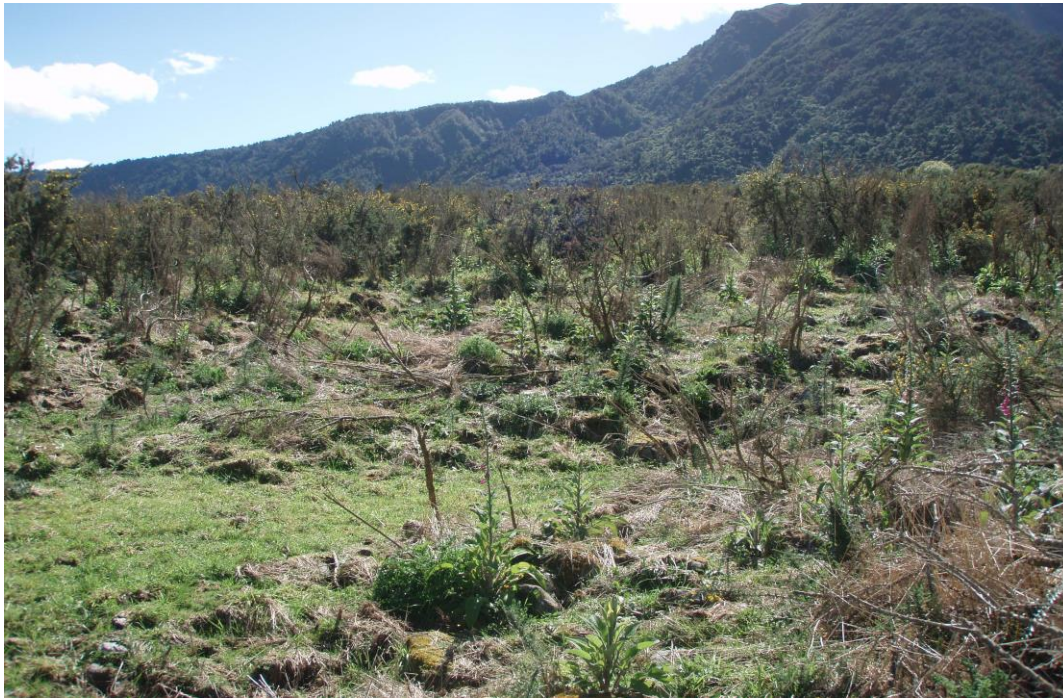
Typical predominant exotic species cover type, species composition and density within Vegetation Type 3/1 where *Ulex europaeus* is up to 2.0 metres high and an increased cover component. This photograph is taken c. mid-way through the larger proposed spoil disposal area, looking north northeast.

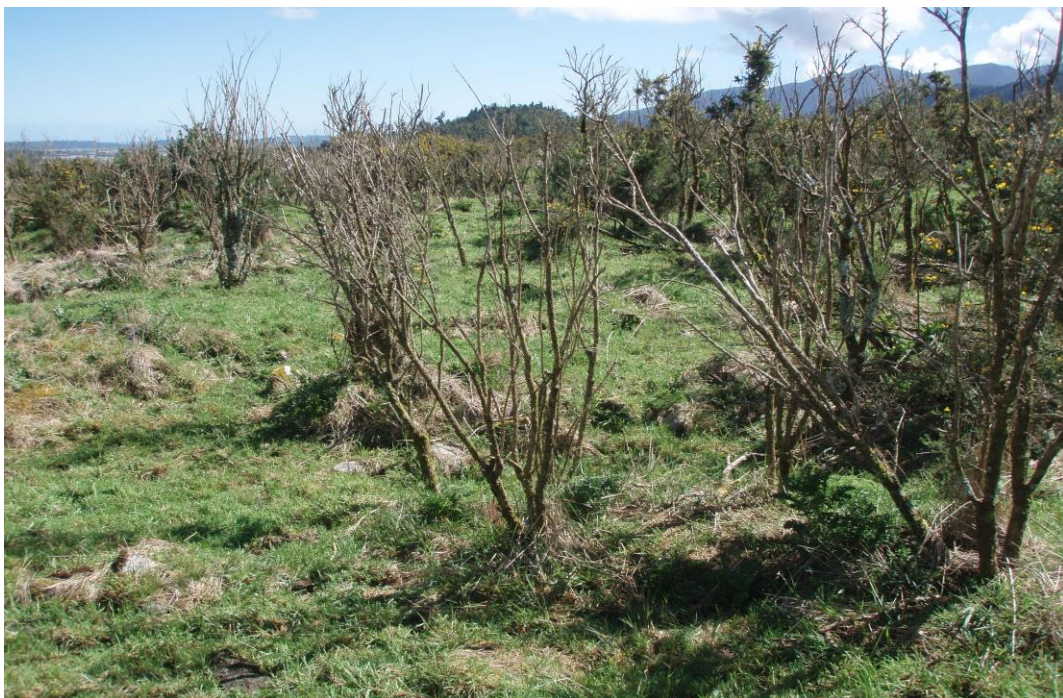
Figure 35 – Example of Vegetation Type 3/1 in Larger Proposed Spoil Disposal Area:

Typical predominant exotic species ground cover type, species composition and density within Vegetation Type 3/1 where *Ulex europaeus* is a less dense cover component. This photograph is taken c. one third of the way through the larger proposed spoil disposal area, looking north.

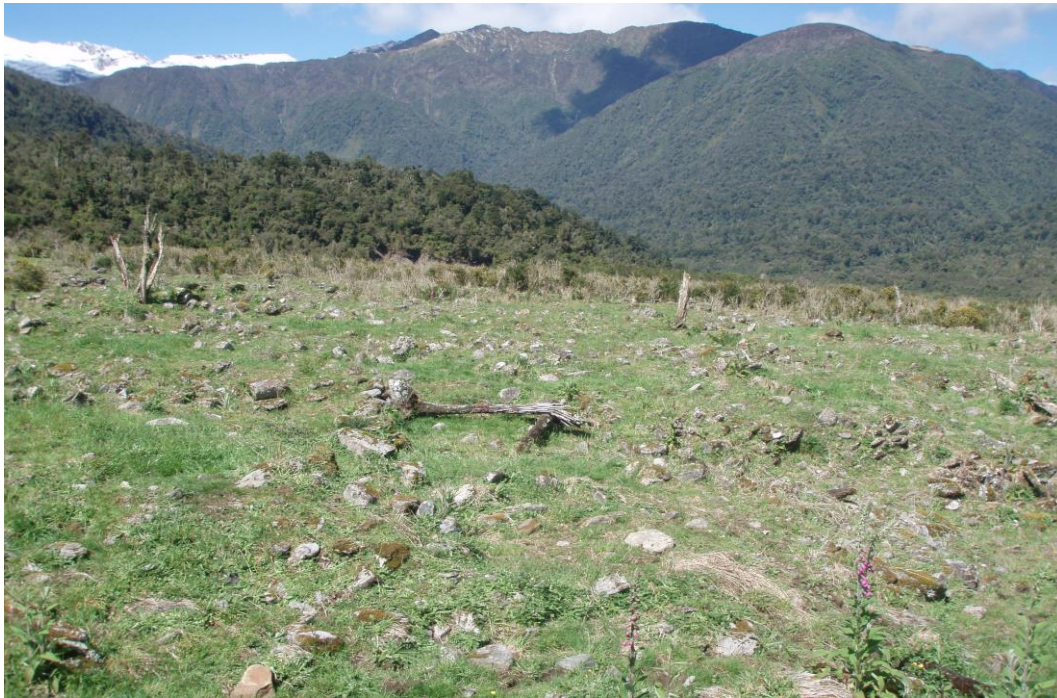
Figure 36 - Example of Vegetation Type 3/1 in Larger Proposed Spoil Disposal Area:

Typical predominant exotic species ground cover type, species composition and density within Vegetation Type 3/1 where *Ulex europaeus* is not a cover component. This photograph is taken near the northern boundary of the largest proposed spoil disposal area with the well-developed farmland, looking south across the centre of the spoil disposal area.

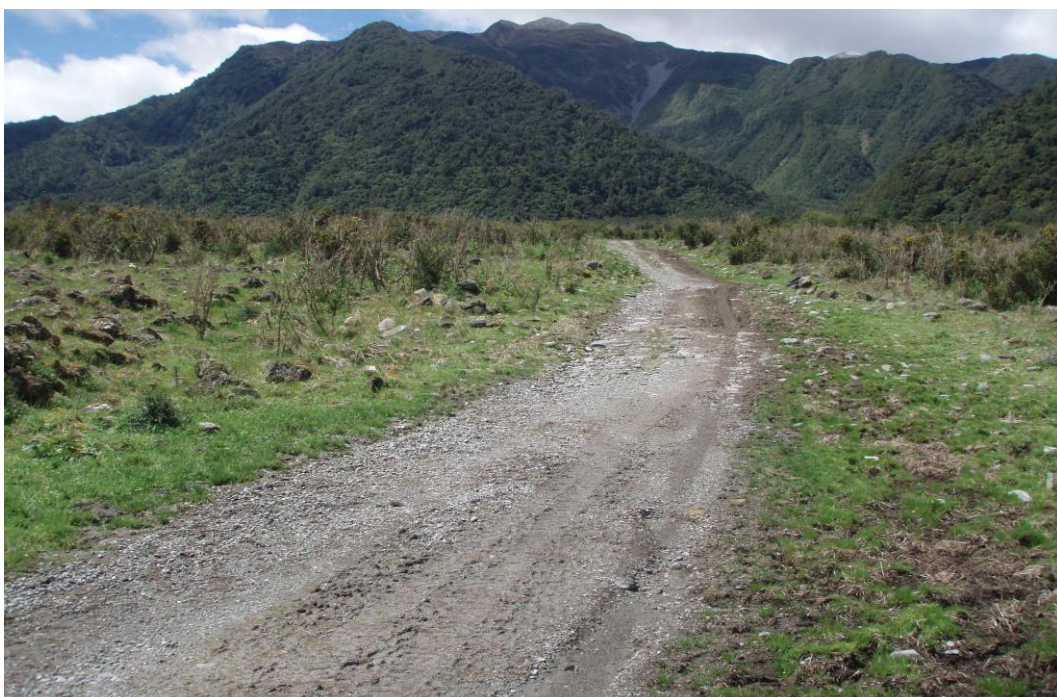
Figure 37 - Existing Modification In Vegetation Type 3/1 in Larger Proposed Spoil Disposal Area:

Degree of existing modification by grazing and farm track establishment and illustrating typical exotic vegetation type and cover. Photograph is taken from the track that bisects this larger proposed spoil disposal area and view is looking east up the approximate middle of the area from c. 60 metres inside the area from its western margin with the fully developed farmland.

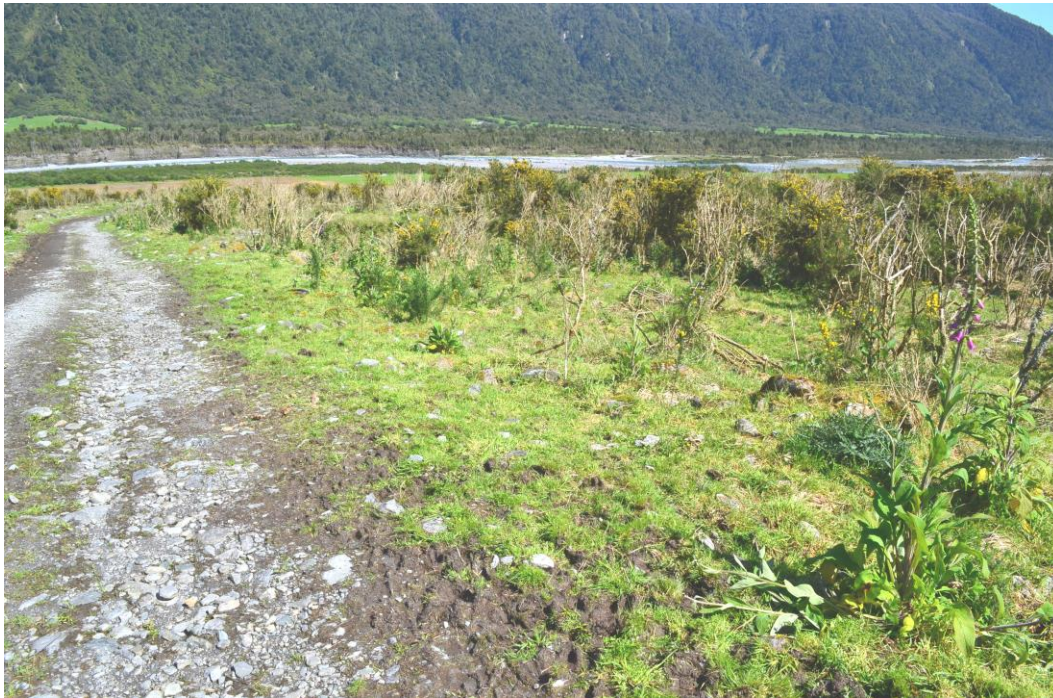
Figure 38 - Existing Modification In Vegetation Type 3/1 in Larger Proposed Spoil Disposal Area:

Degree of existing modification by grazing and farm track establishment and illustrating typical exotic vegetation type and cover. Photograph is taken from the track that bisects this larger proposed spoil disposal area and view is looking west down the approximate middle of the area.
