WESTPOWER LTD. PROPOSED WAITAHA HYDRO SCHEME

ASSESSMENT OF ENVIRONMENTAL EFFECTS

VEGETATION

Dated June 2025

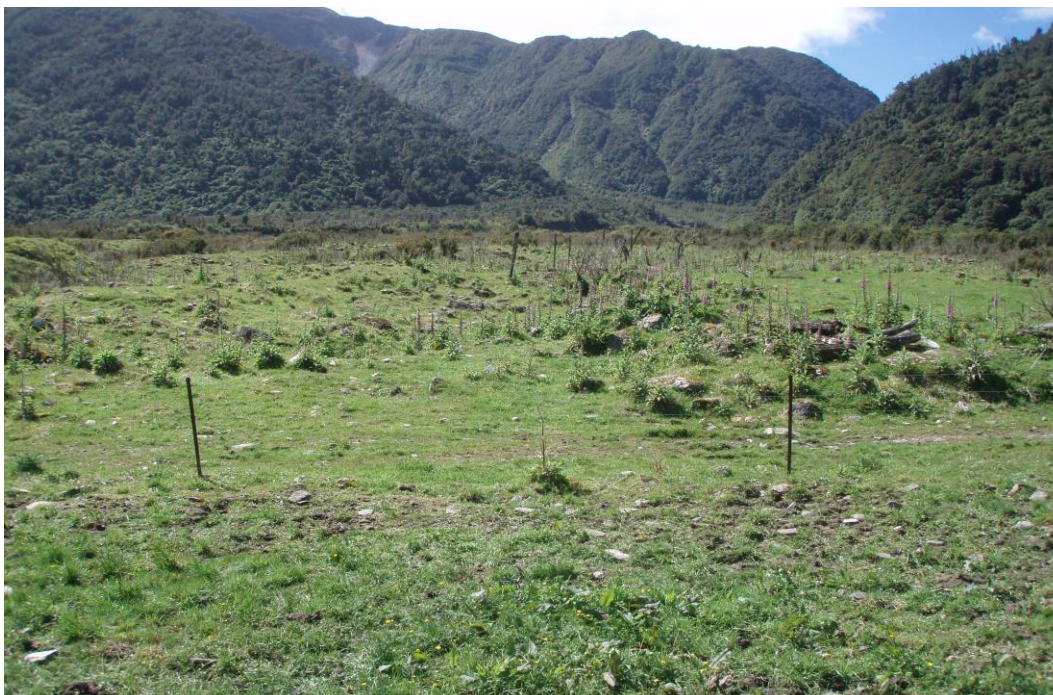
Figure 39 - Example of Vegetation Type 3/1 in Staging Area:

Typical predominant exotic species ground cover type, species composition and density within Vegetation Type 3/1 where *Ulex europaeus* is not a cover component. This photograph is taken mid way along the southern boundary of the proposed staging area, looking east across it, toward the smaller proposed spoil disposal area, located in the middle distance.

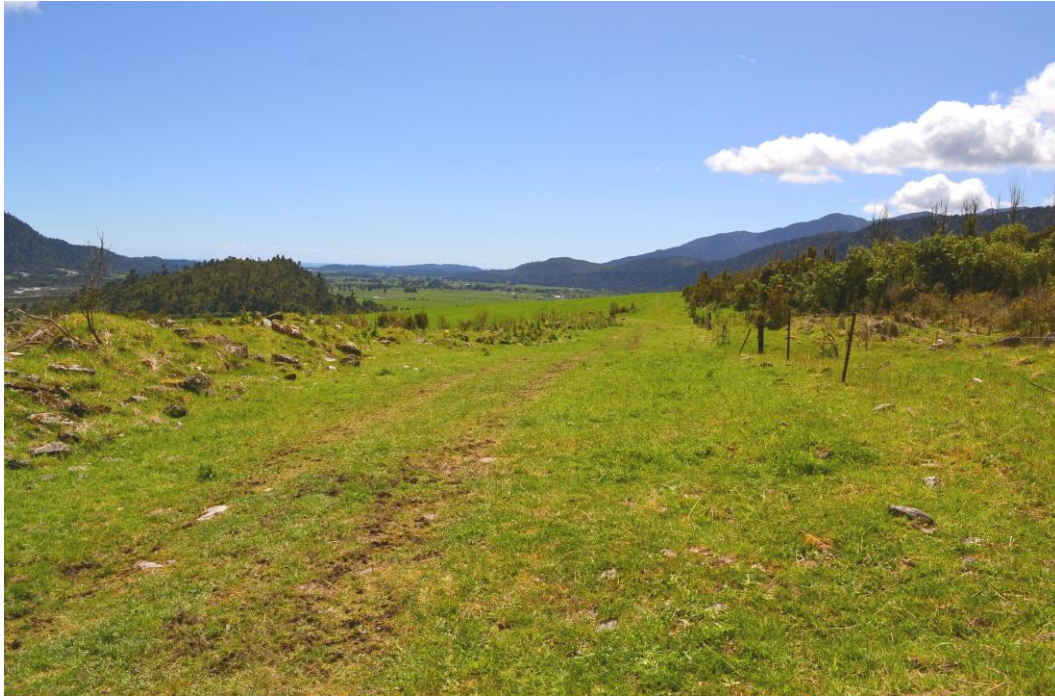
Figure 40 - Existing Modification in Vegetation Type 3/1 in Smaller Proposed Spoil Disposal Area:

Exotic vegetation cover and degree of existing modification by grazing and farm track establishment in the smaller of the two proposed spoil disposal areas and illustrating typical exotic vegetation type and cover. View is looking north along a possible route for heavy vehicle access, from the southeastern corner of the spoil disposal area, with the fully developed farmland in the middle distance.

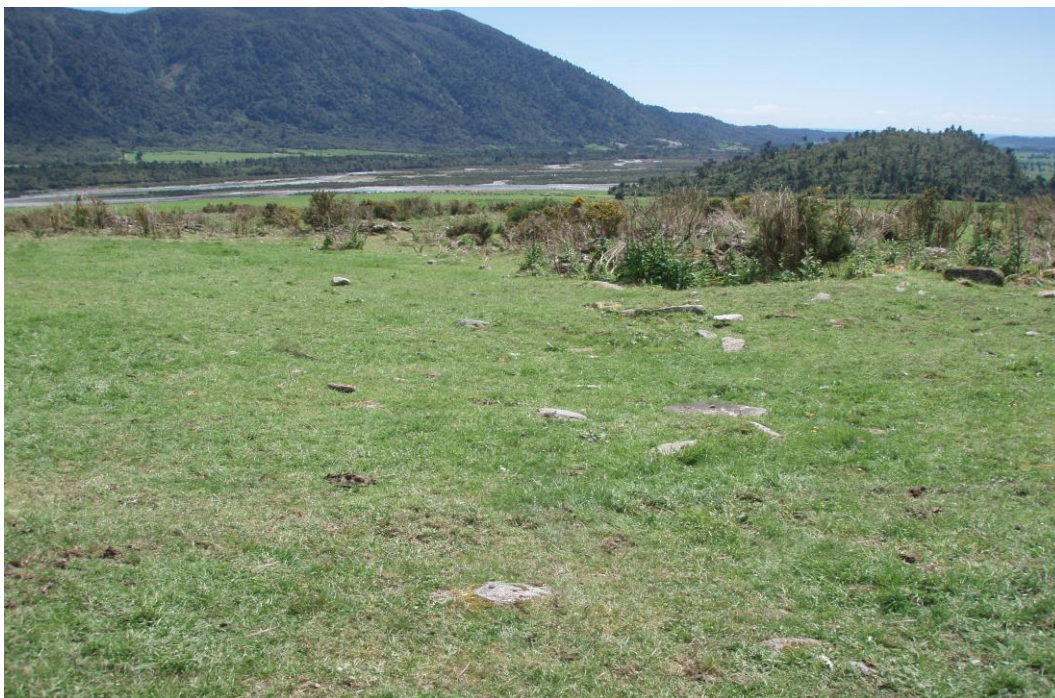
Figure 41 - Example of Vegetation Type 3/1 in Smaller Proposed Spoil Disposal Area:

Exotic vegetation cover and illustration of absence of indigenous vegetation in the smaller proposed spoil disturbance area. View is northwest from near the spoil area's southeastern corner.

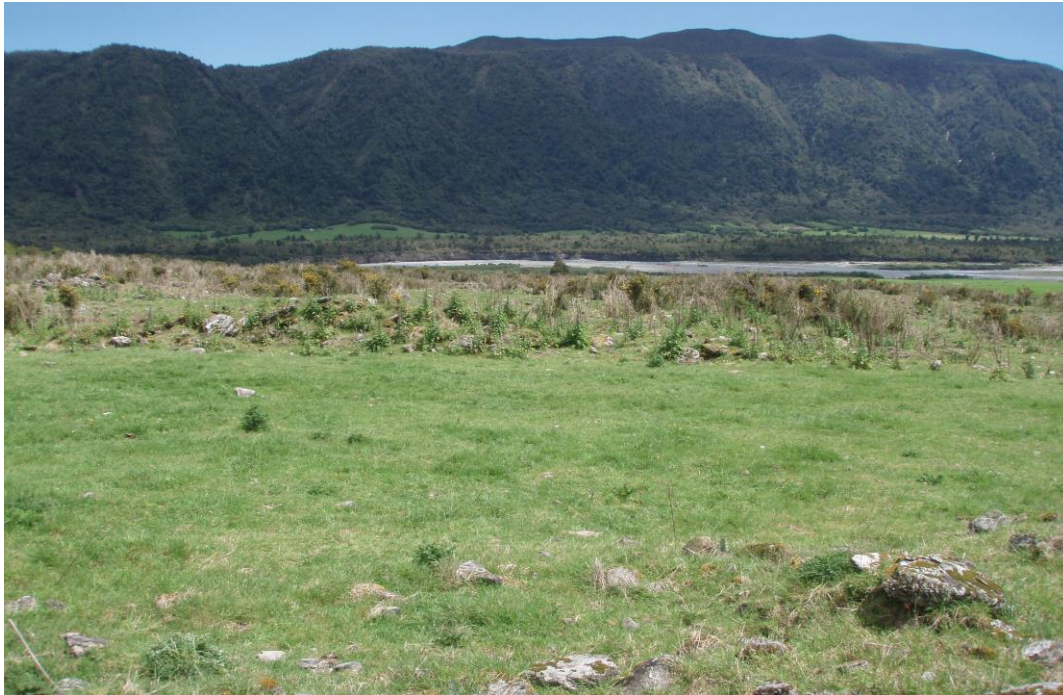
Exotic vegetation cover and illustration of absence of indigenous vegetation in the smaller proposed spoil disturbance area. View is west from part way along the spoil area's eastern margin.

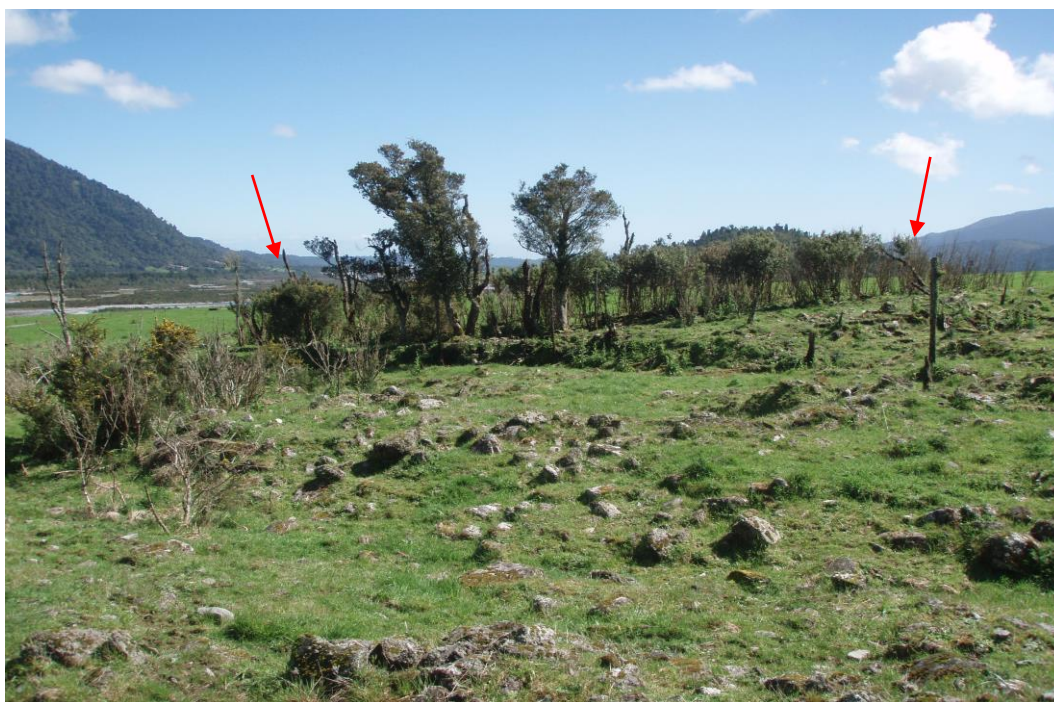
One of two minor instances of indigenous woody species present in the larger of the two proposed spoil disposal areas (taller emergent stems are unthrifty *Pterophylla racemosa* and the linear band between the arrows is sparse shrub status *Fuchsia excorticata* and *Ulex europaeus* mix). This area centres on NZTM E1415980 N5226022.

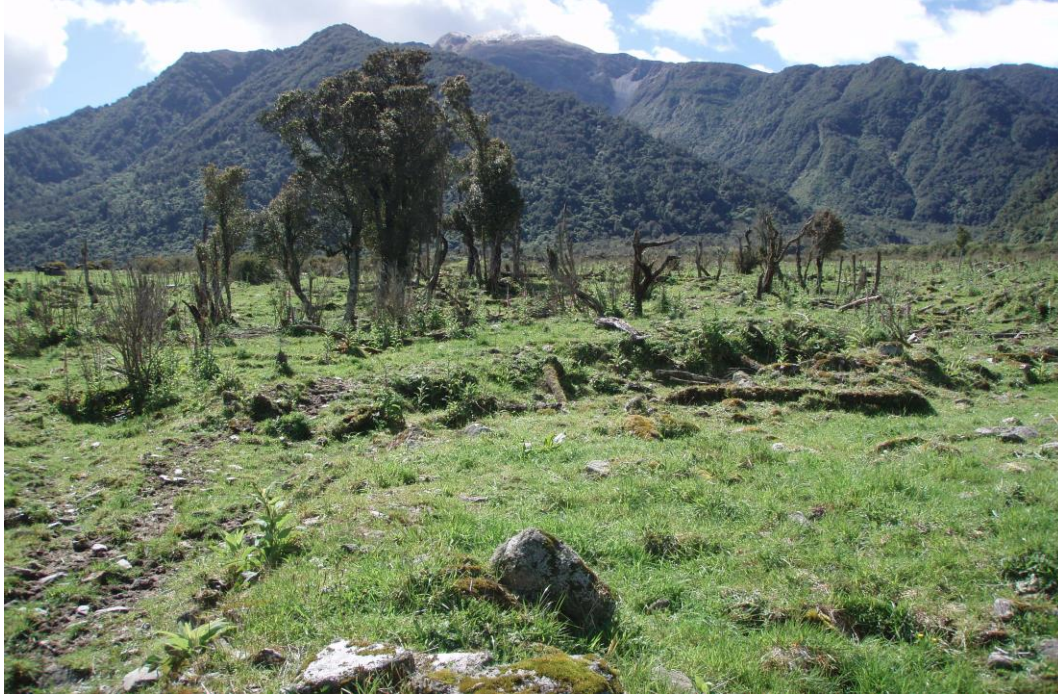
Figure 44 - Woody Indigenous Vegetation in Vegetation Type 3/1:

Second of two minor instances of indigenous woody species present in the larger of the two proposed spoil disposal areas (stems are unthrifty *Pterophylla racemosa*). This area centres on NZTM E1416110 N5226040. Note absence of all other indigenous cover and prevalence of exotic species grass and broadleaved herbaceous ground cover.

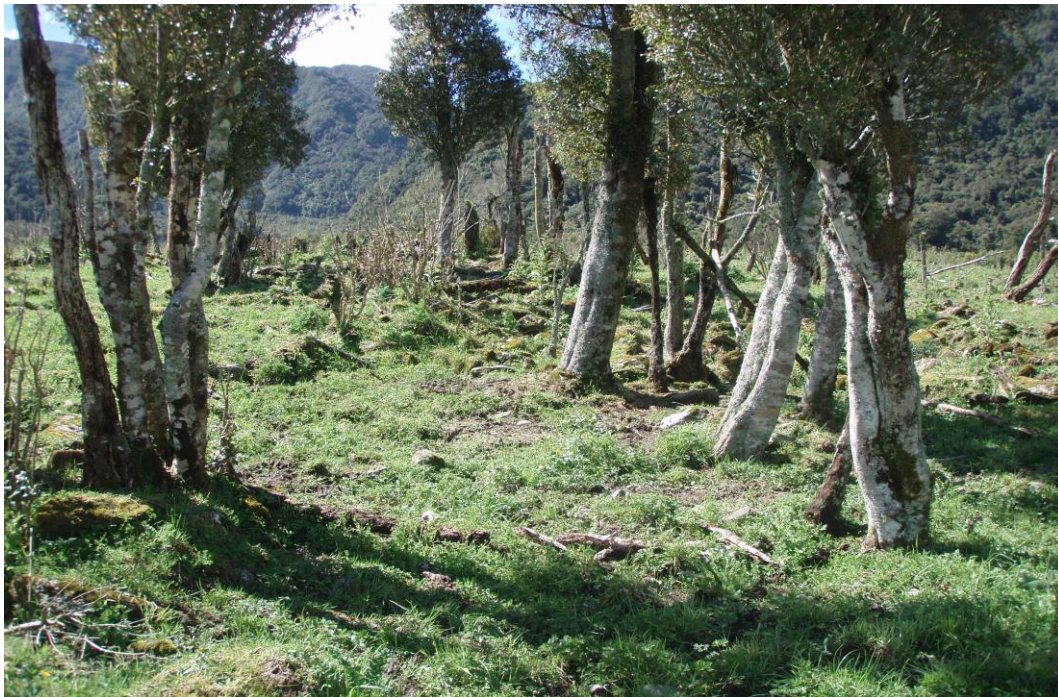
Figure 45 – Exotic/Indigenous Species in Vegetation Type 3/1:

Example of ground cover consisting of exotic grass and broadleaved herbaceous species beneath the small tree and pole stem *Pterophylla racemosa* in the patch shown in Figure 44.

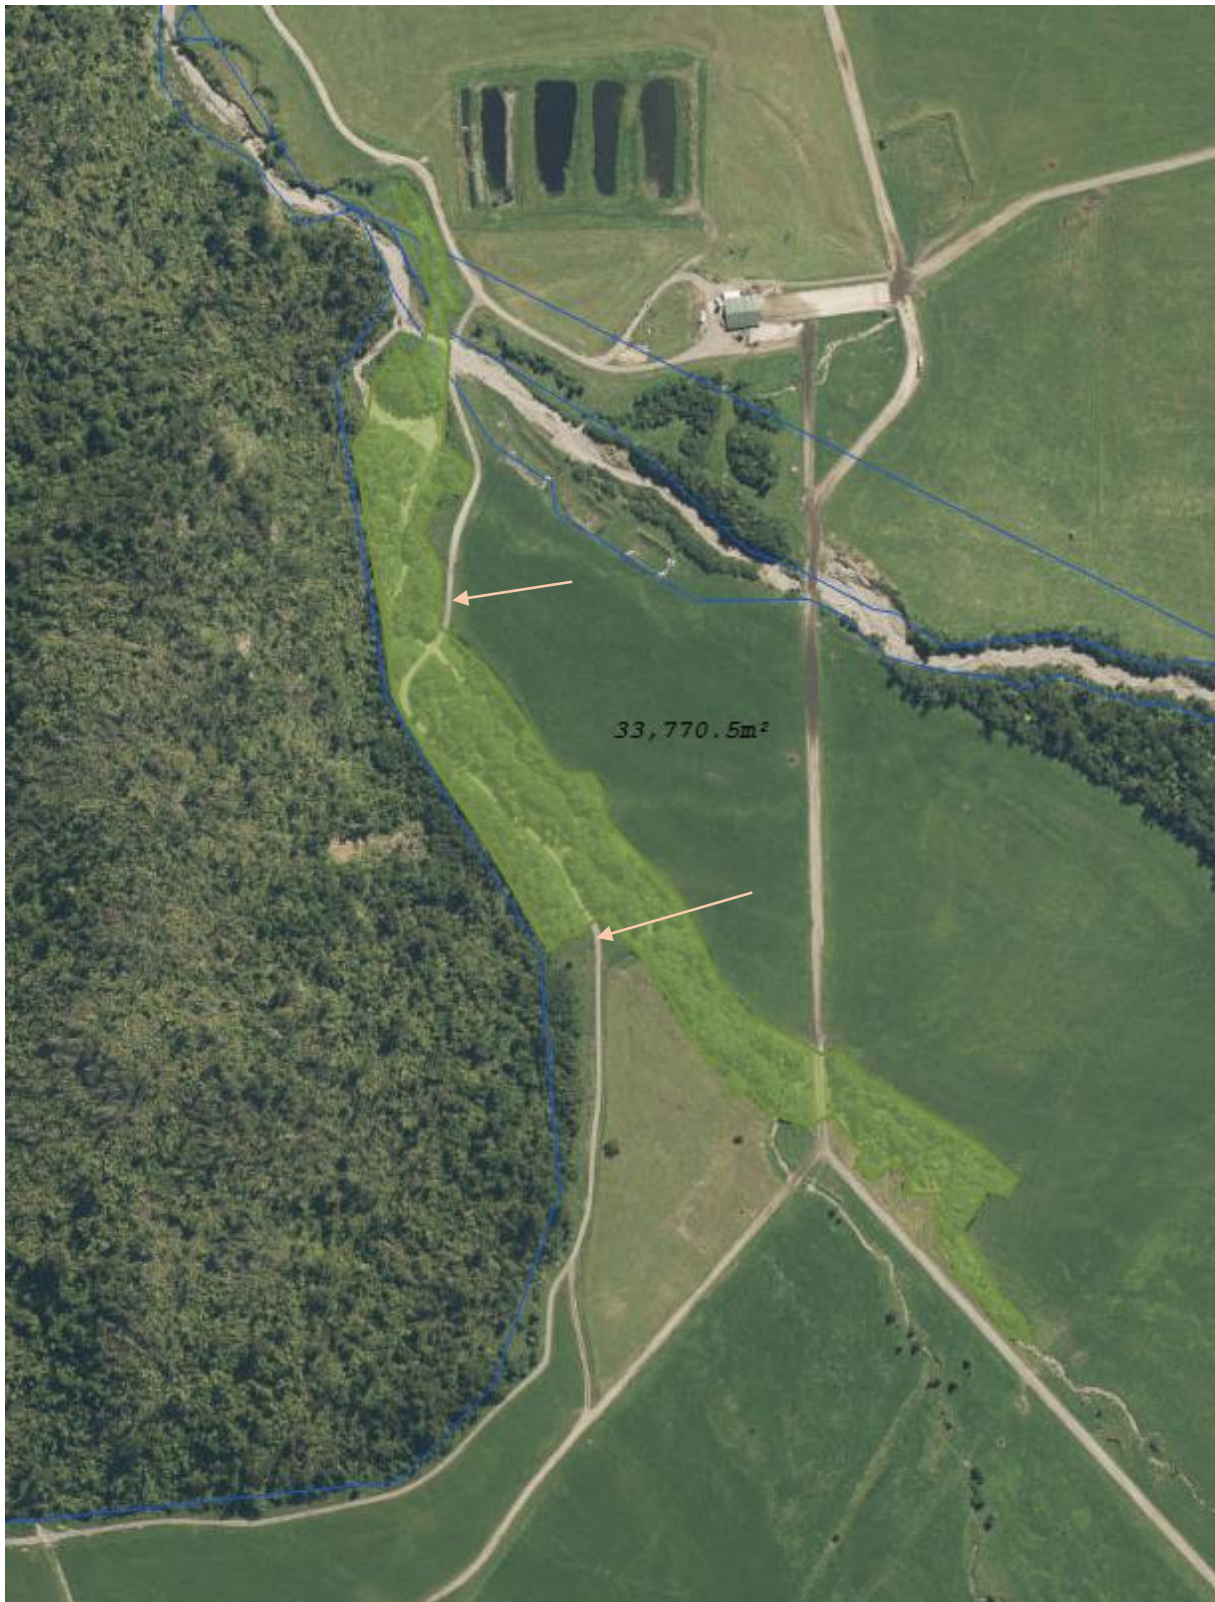
Figure 46 - Location and Extent of Vegetation Type 4/1:

The semitransparent yellow-green shaded area delineates Vegetation Type 4/1 as 3.377 hectares. The existing farm track/accessway bisecting the area is indicated by the pink arrows, and the proposed access road upgrade utilises this. Note: If an estimated 5% (1688 square metres) is deducted for the existing vehicle access (indicated by the pink arrows), streambed and other non-indigenous vegetated areas is deducted, total vegetated area of Type 4/1 reduces to c. 3.210 hectares for vegetation effect assessment purposes.

The c. 3.21 hectares (reduced from total delineation area of 3.377 hectares to adjust for existing farm tracking and waterway bed) of Vegetation Type 4/1 and its partial riparian location is shown in **Figure 46** and **Figure 47**.

Scheme design/infrastructure placement avoids effect of the new components on indigenous community/assemblages in the majority of the Scheme's Area 4 footprint except for two sites on the freehold land within the McLean Farm (see **Appendix I, Map 5** and **Figures 46** and **47**) described under F5.1 and F5.2.

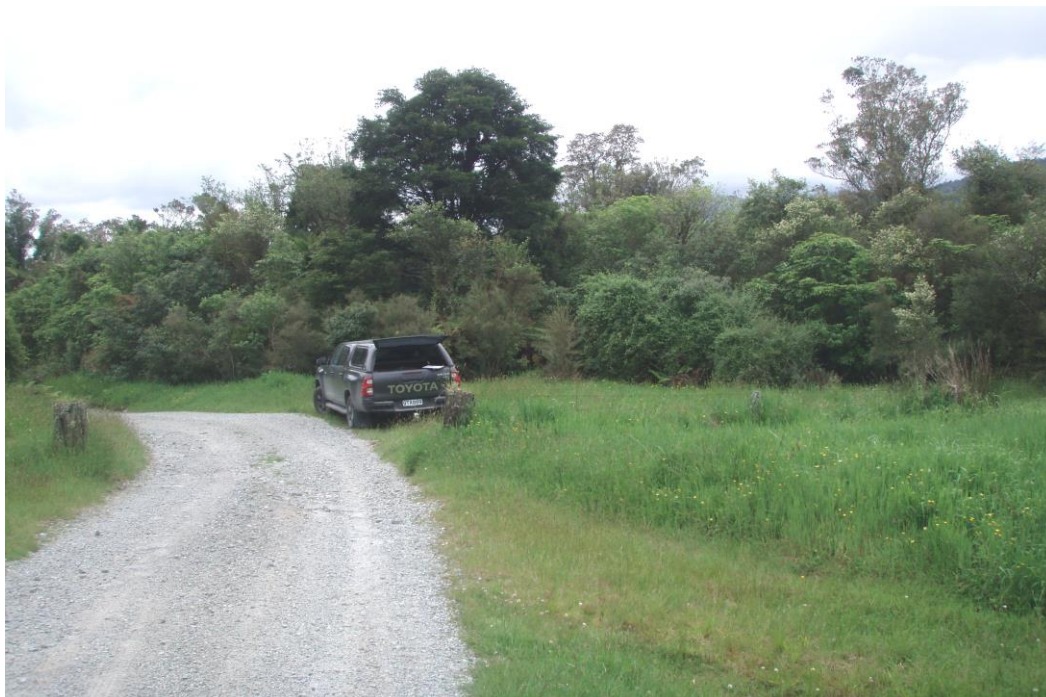
Figure 48 – Example of Vegetation Type 4/1:

This view shows typical species composition, stature, and cover of Vegetation Type 4/1. View is looking north from the proposed (existing gravelled road in foreground) access road upgrade route along the indicative route of the new transmission line where it likely bisects the Vegetation Type 4/1 strip (passes left of the emergent *Pectinopitys ferruginea* tree showing against the sky beyond the vehicle).

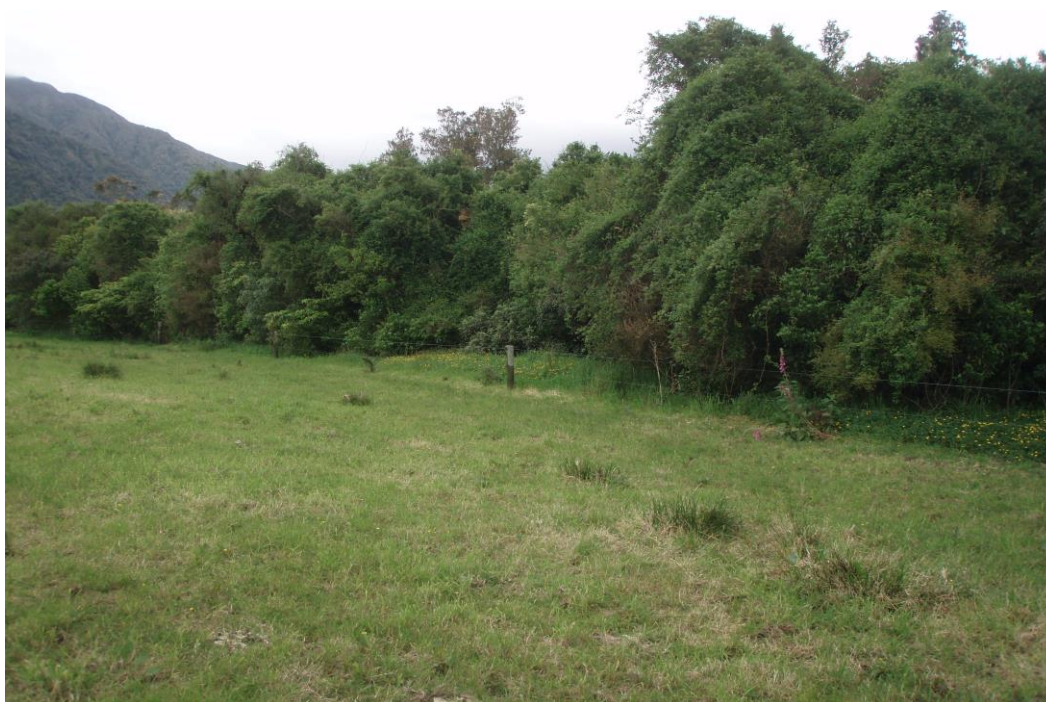
Figure 49 - Example of Vegetation Type 4/1:

View along the northern margin of the Vegetation Type 4/1 strip with the pasture border, showing typical species composition, stature, and cover.

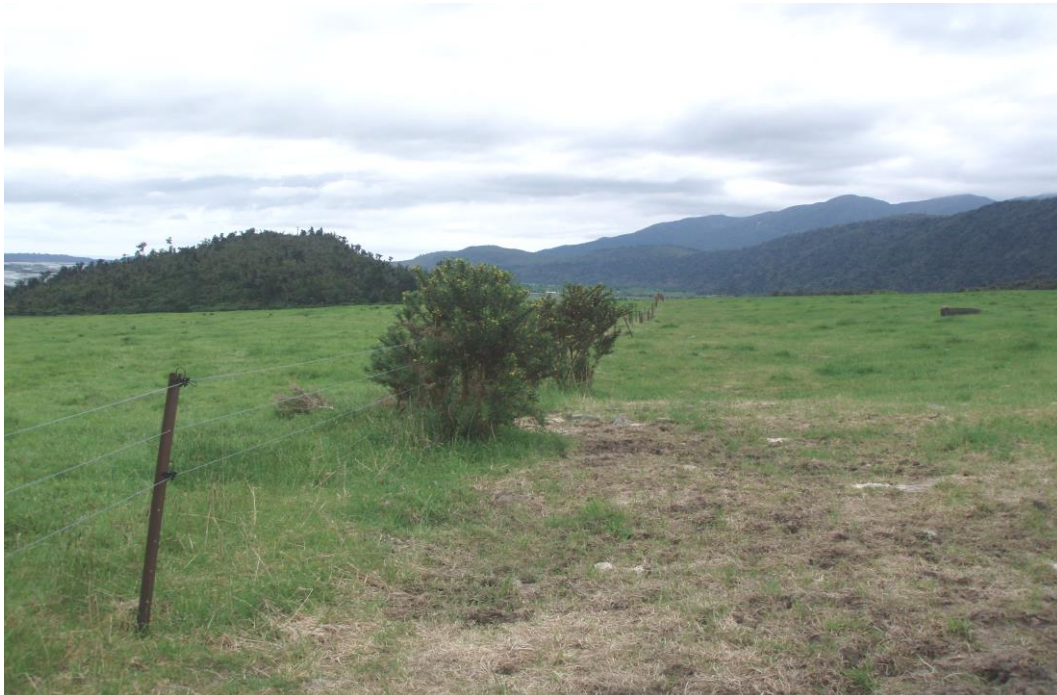
Figure 50 - Exotic Vegetation on Developed Farmland of the Rural Development Area:

View looking north from the northern margin of the Scheme's proposed Construction Staging Area 3 along the proposed route of the new access road and transmission line through developed pasture/farmland with no indigenous vegetation community.

The non-indigenous assemblage of the farmland/rural development area is principally pasture or roadside grass verge and pertains to the majority (c. 11.7 kilometre distance or c. 87%) of the Area 4 Scheme footprint. Typical cover in this zone is illustrated by Figures 50 - 62 being a sequence progressing northward from the north margin of the proposed staging area, through the developed farmland along the Waitaha Road, justifying the non-indigenous community/assemblage assignment. Therefore, Scheme infrastructure is deemed to have no clearance effect attributable here.

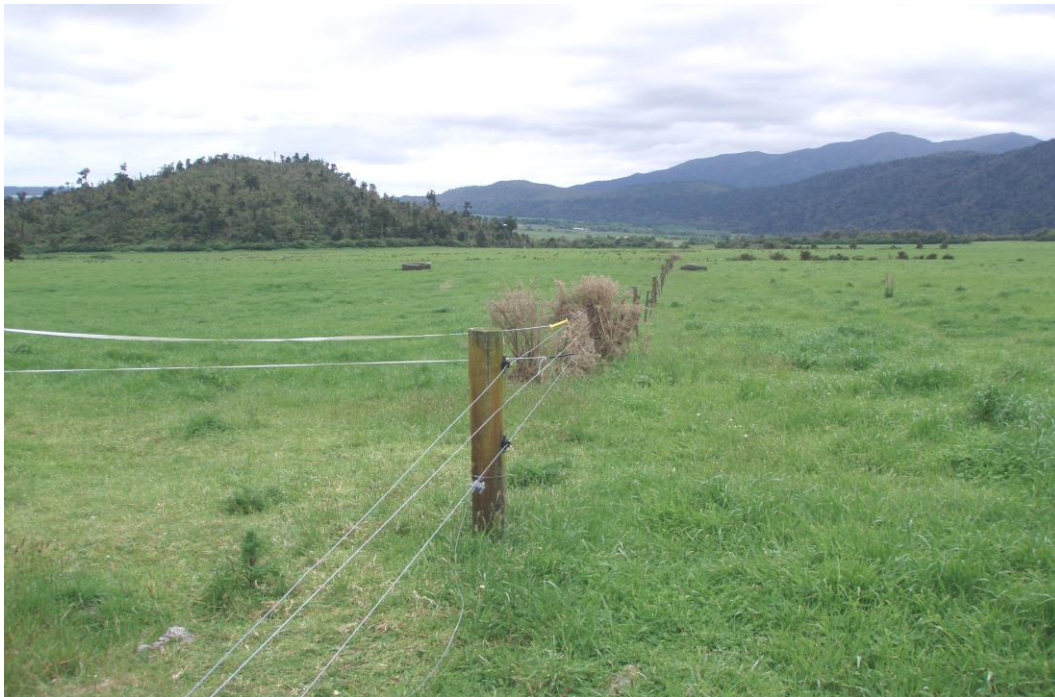
Figure 51 - Exotic Vegetation on Developed Farmland of the Rural Development Area:

Northward progressional step - looking north along the proposed route of the new access road and transmission line (approximately following fenceline) through developed pasture/farmland with no indigenous vegetation community.

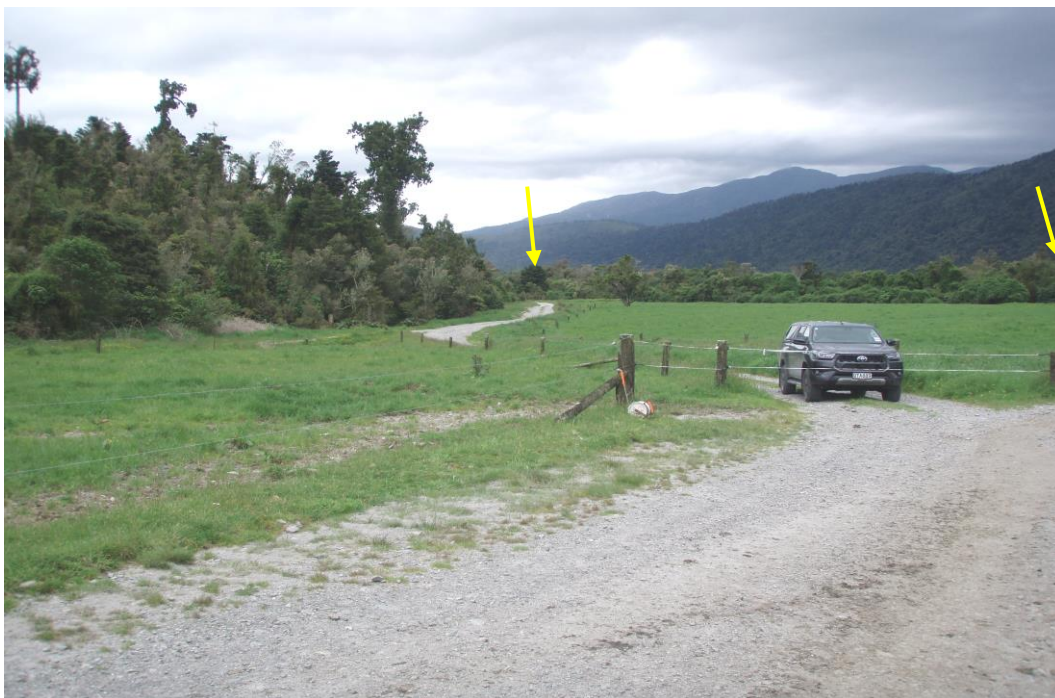
Figure 52 - Exotic Vegetation on Developed Farmland of the Rural Development Area:

Further northward progression step - looking north along the proposed route of the new access road and transmission line through developed pasture/farmland with no indigenous vegetation community, until the strip of Vegetation Type 4/1, part indicated between the yellow arrows.

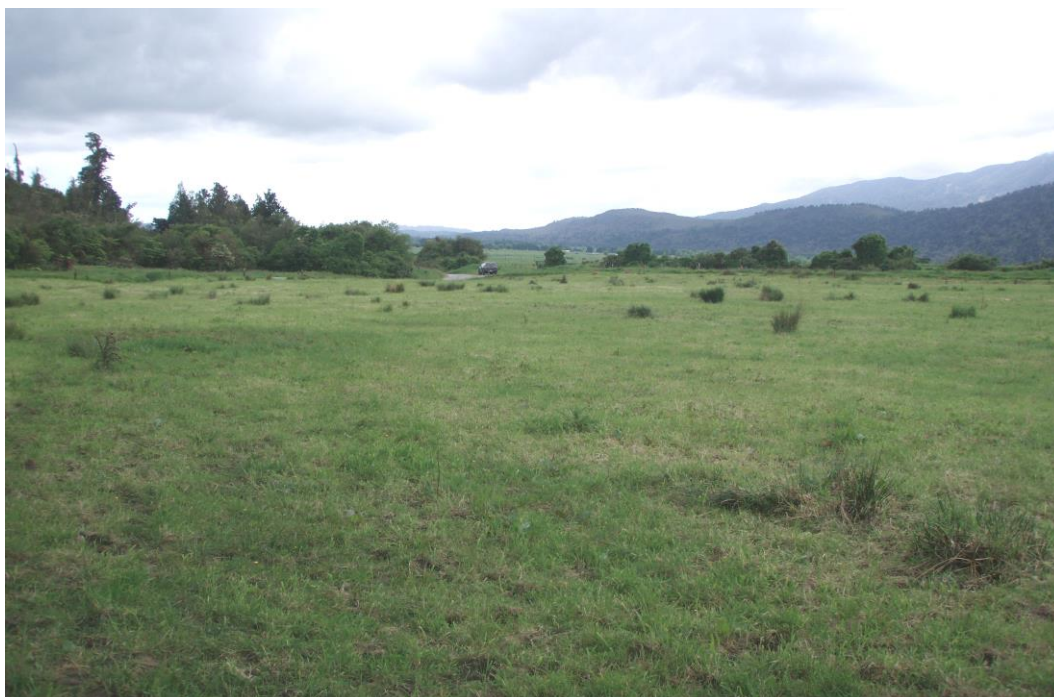
Figure 53 - Exotic Vegetation on Developed Farmland of the Rural Development Area:

Further northward progression step - view looking north from the northern margin of Vegetation Type 4/1, along the proposed route of new transmission line through developed pasture/farmland with no indigenous vegetation community.

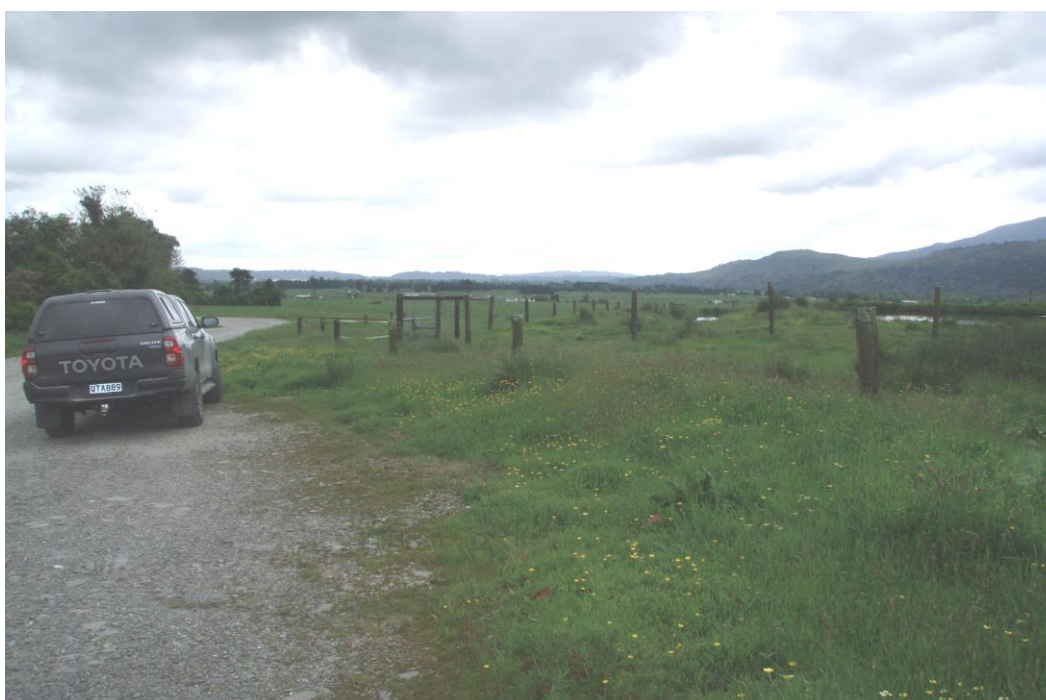
Figure 54 - Exotic Vegetation on Developed Farmland of the Rural Development Area:

Further northward progression step - looking north along the approximate route of new transmission line (likely along the right-hand side of the formed farm road (to be upgraded as part of the Scheme's access road) and through the developed pasture to the Waitaha Road) with no indigenous vegetation community.

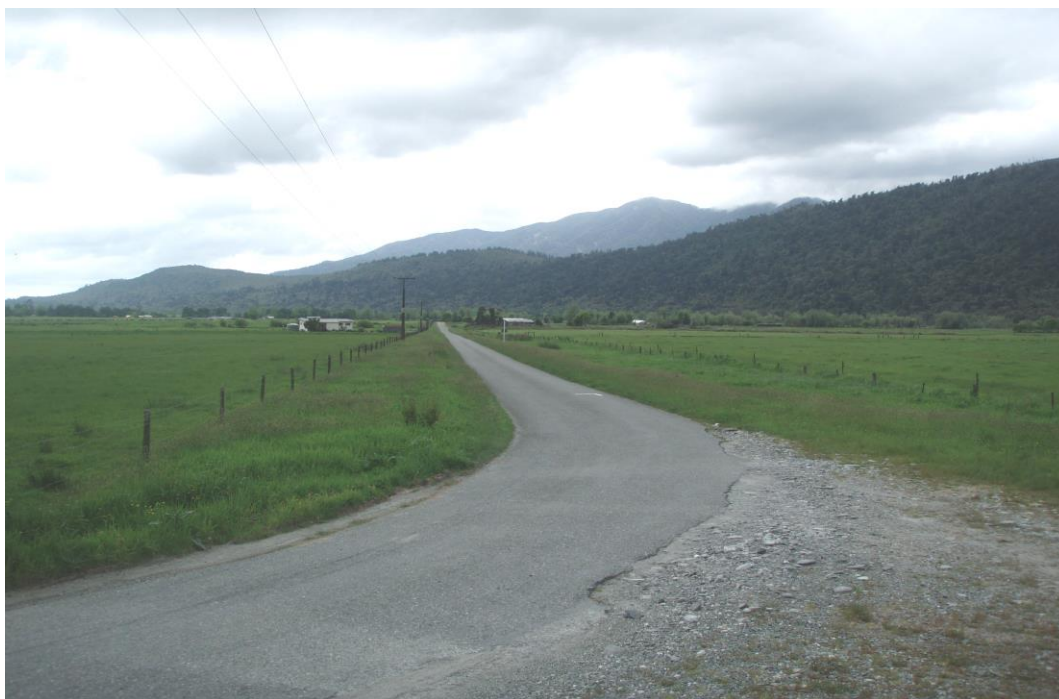
Figure 55 - Exotic Vegetation on Developed Farmland of the Rural Development Area:

Further northward progression step - looking north along the proposed route of existing transmission line upgrade along the Waitaha Road from a point near where the new section of transmission line will link to the existing line, with no indigenous vegetation community.

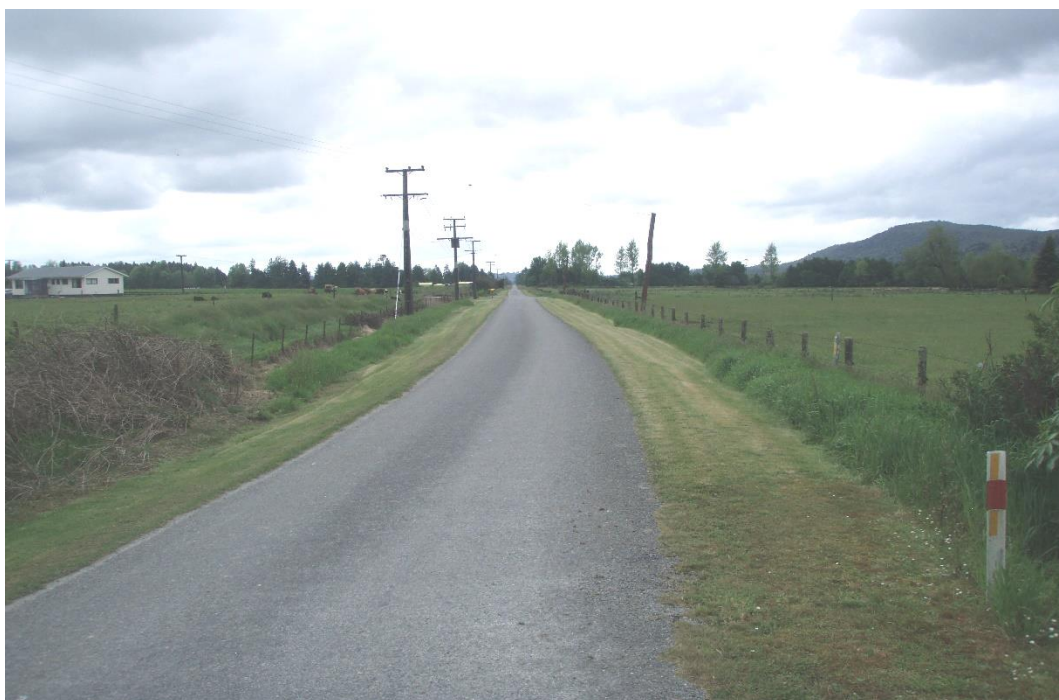
Figure 56 - Exotic Vegetation on Developed Farmland of the Rural Development Area:

Further northward progression step - looking north along the proposed route of existing transmission line upgrade along the Waitaha Road, with no indigenous vegetation community.

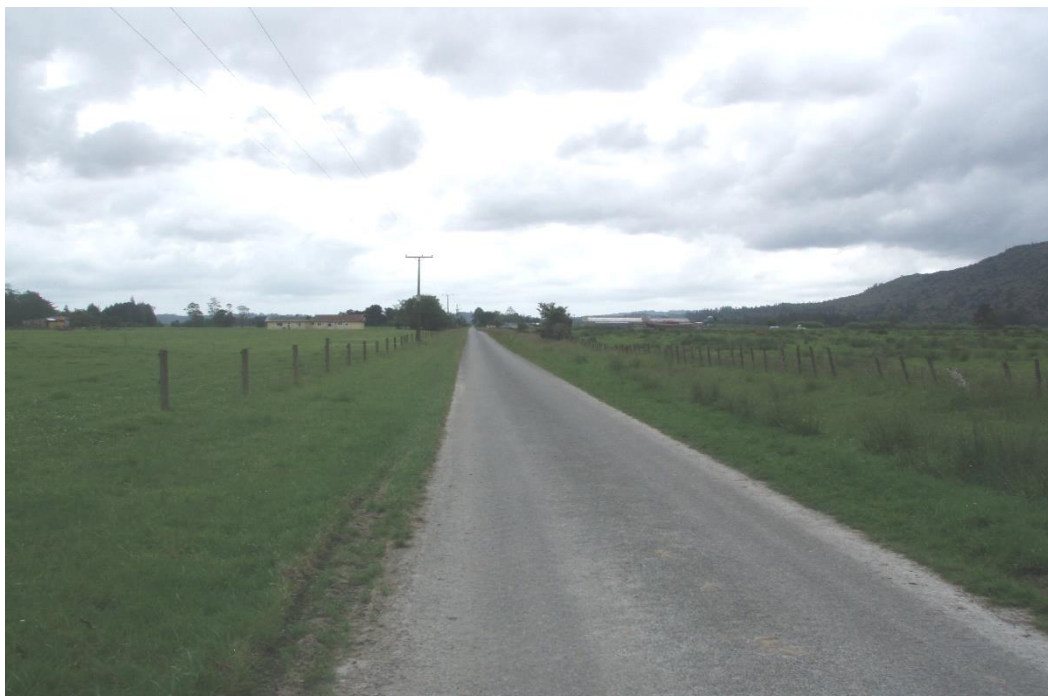
Figure 57 - Exotic Vegetation on Developed Farmland of the Rural Development Area:

Further northward progression step - looking north along the proposed route of existing transmission line upgrade along the Waitaha Road, with no indigenous vegetation community.

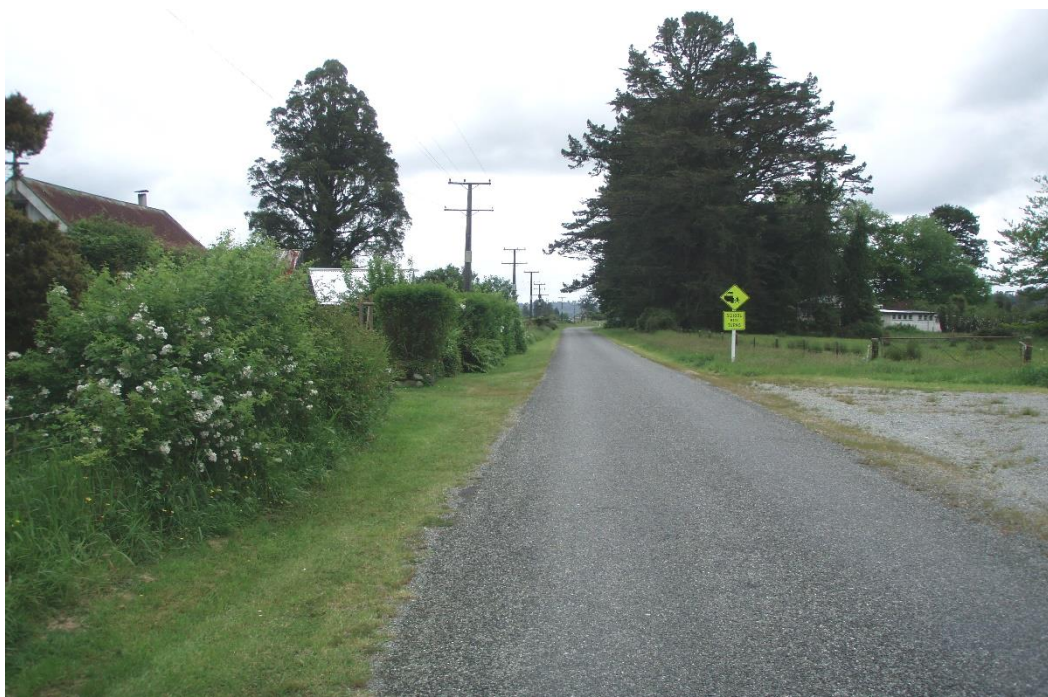
Figure 58 - Exotic Vegetation on Developed Farmland of the Rural Development Area:

Further northward progression step - looking north along the proposed route of existing transmission line upgrade along the Waitaha Road, with no indigenous vegetation community.

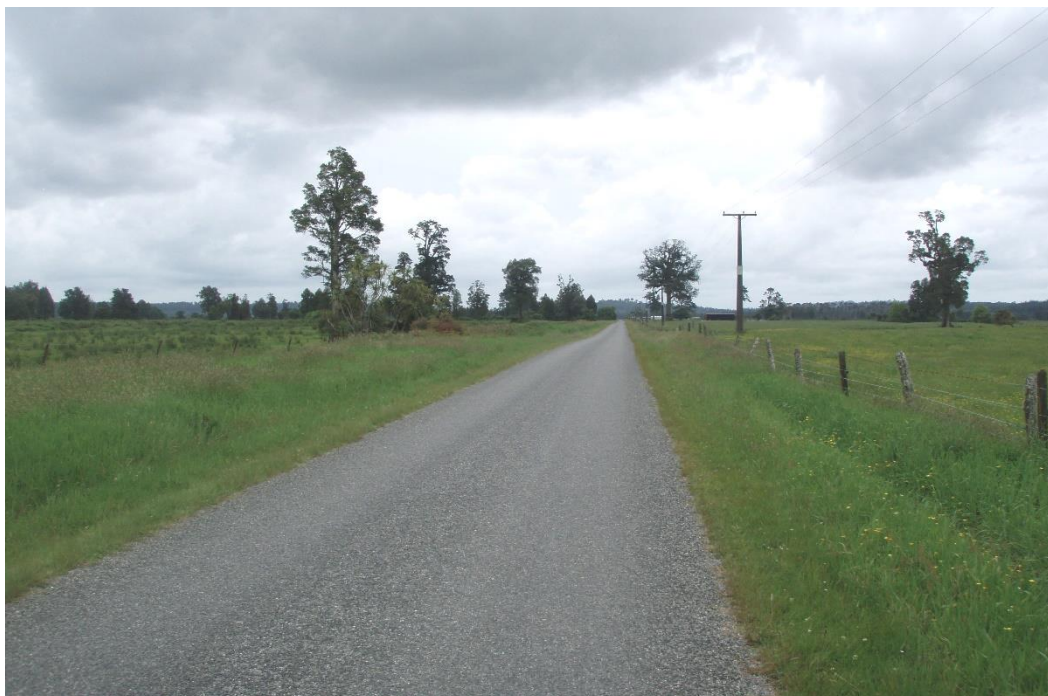
Figure 59 - Exotic Vegetation on Developed Farmland of the Rural Development Area:

Further northward progression step - looking north along the proposed route of existing transmission line upgrade along the Waitaha Road, with no indigenous vegetation community.

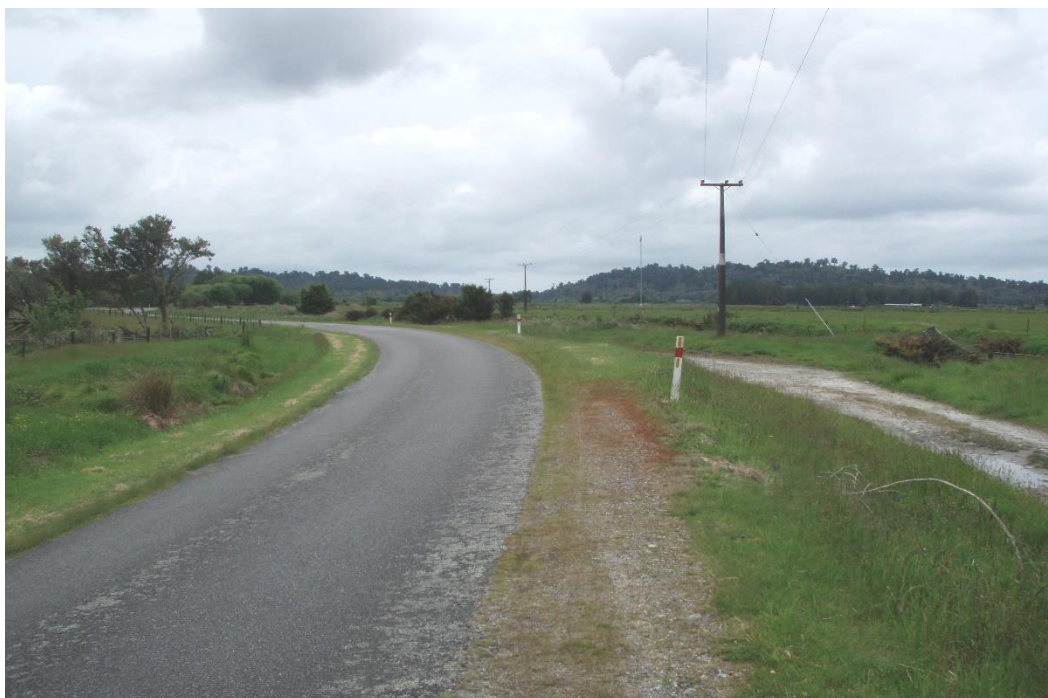
Figure 60 - Exotic Vegetation on Developed Farmland of the Rural Development Area:

Further northward progression step - looking north along the proposed route of existing transmission line upgrade along the Waitaha Road, with no indigenous vegetation community.

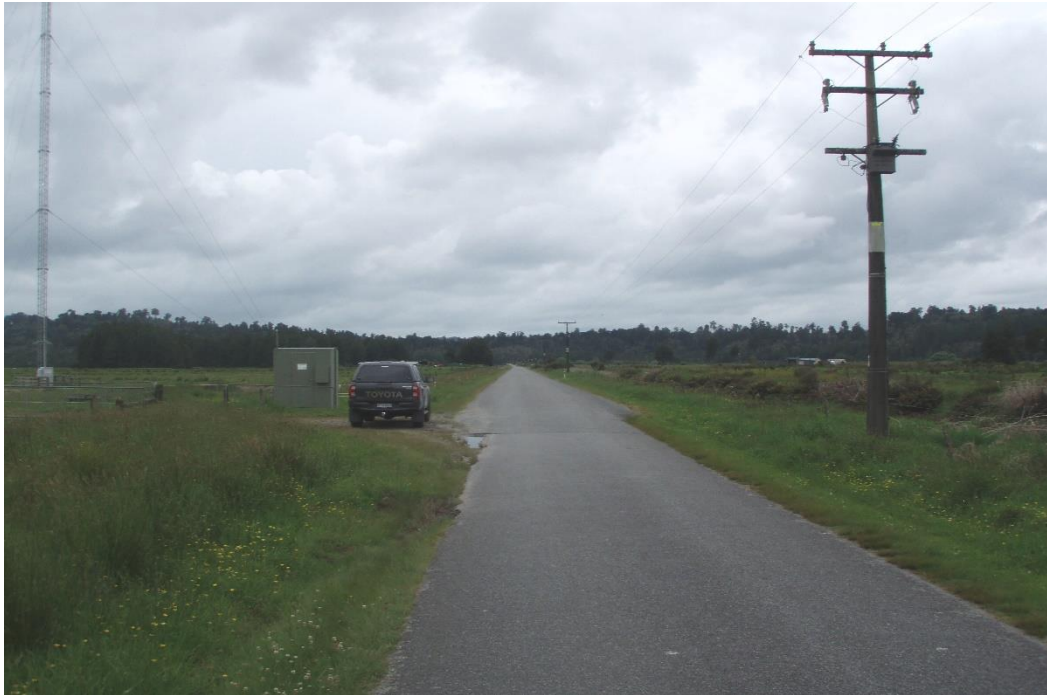
Figure 61 - Exotic Vegetation on Developed Farmland of the Rural Development Area:

Further northward progression step - looking north along the proposed route of existing transmission line upgrade along the Waitaha Road, with no indigenous vegetation community.

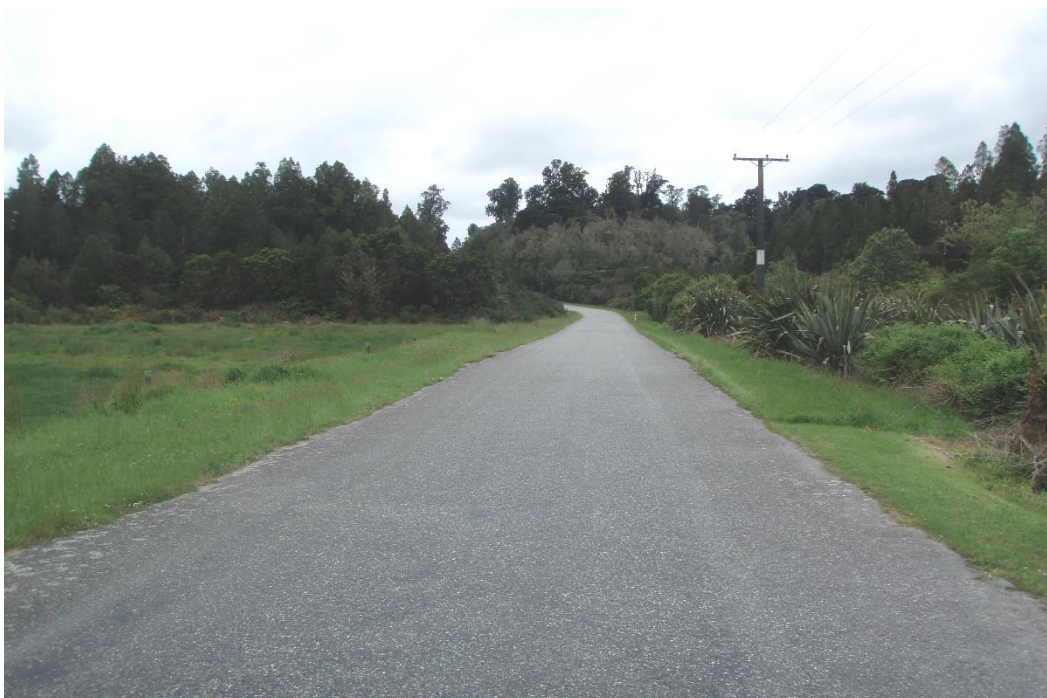
Figure 62 - Exotic Vegetation of the Rural Development Area and Commencement of Indigenous Vegetation:

Further northward progression step - looking north along the proposed route of existing transmission line upgrade along the Waitaha Road, with indigenous vegetation community at right and in middle distance. Note: This illustrates the commencement of the nett zero effect area of transmission line upgrade on indigenous vegetation in Area 4.

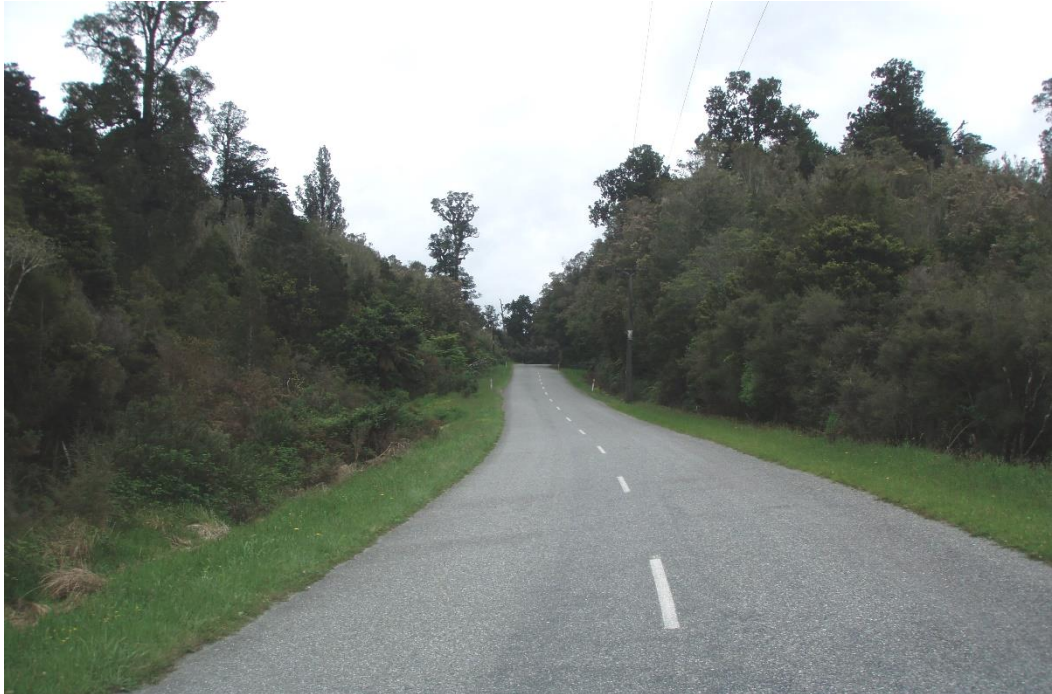
Figure 63 - Indigenous Vegetation Adjacent to Waitaha Road:

Further northward progression step - looking north along the proposed route of existing transmission line upgrade along the Waitaha Road showing the corridor in the podocarp/hardwood forest that will be utilised, to give zero nett clearance area effect of transmission line upgrade on indigenous vegetation in Area 4. The State Highway 6/Waitaha Road junction is in the photograph's middle distance.

Typical cover and condition in this zone are shown by Figures 63 – 72 being a sequence continuing from that of Figures 50 - 62, to and around State Highway 6 and to the Waitaha Substation at Bold Head Road, illustrating the indigenous vegetation subject to zero nett effect by the Scheme.

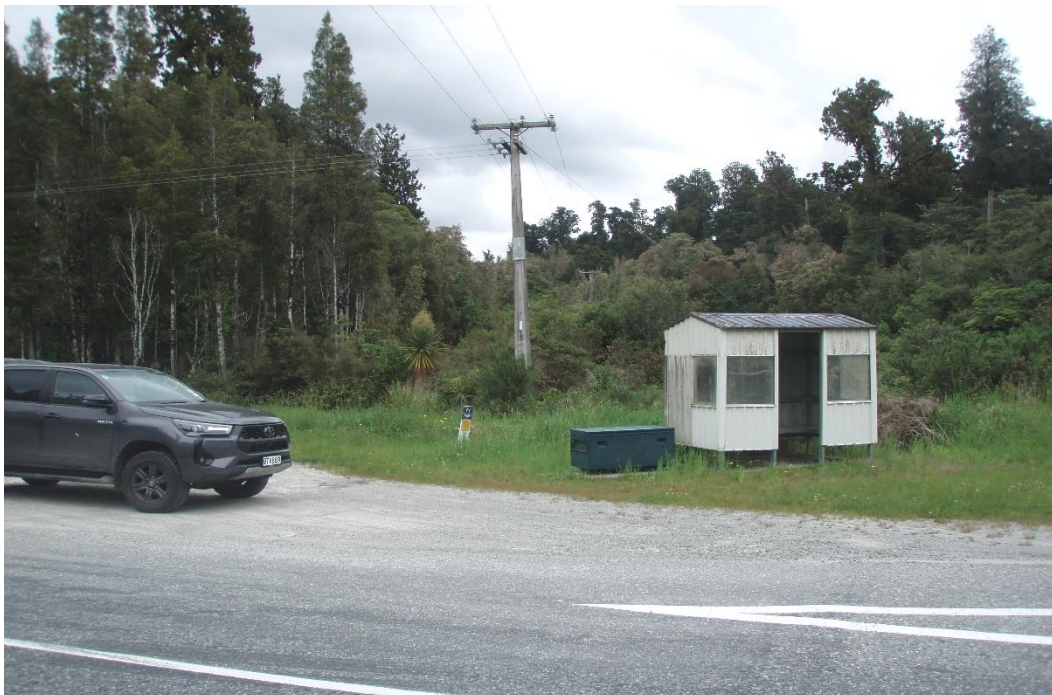
Figure 64 - Indigenous Vegetation at Waitaha Road/State Highway 6 Junction:

West-running corridor in the podocarp/hardwood forest traversed by the existing transmission line – view is west from the Waitaha Road/ State Highway 6 junction. Zero nett clearance area effect of the Scheme's transmission line upgrade on indigenous vegetation pertains here.
