WESTPOWER LTD. PROPOSED WAITAHA HYDRO SCHEME

ASSESSMENT OF ENVIRONMENTAL EFFECTS

VEGETATION

Dated June 2025

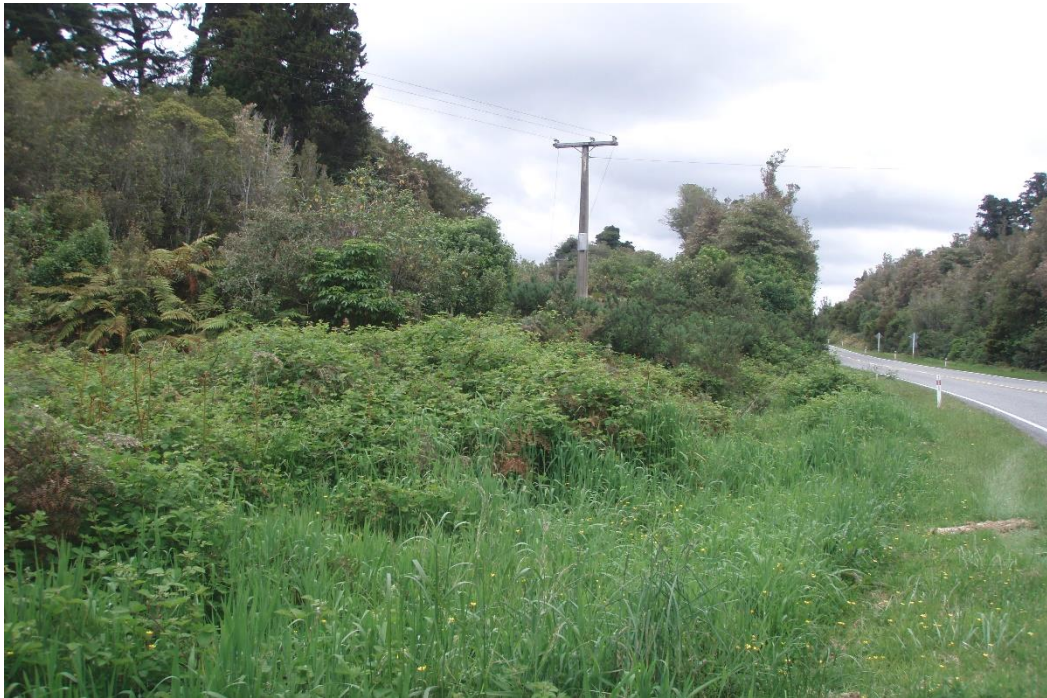
Figure 65 - Indigenous Vegetation Adjacent to State Highway 6:

Further westward progression step – looking west along the corridor in the podocarp/hardwood forest and forest regeneration traversed by the existing transmission line, with State Highway 6 to the right. Zero nett clearance area effect of the Scheme's transmission line upgrade on indigenous vegetation pertains here.

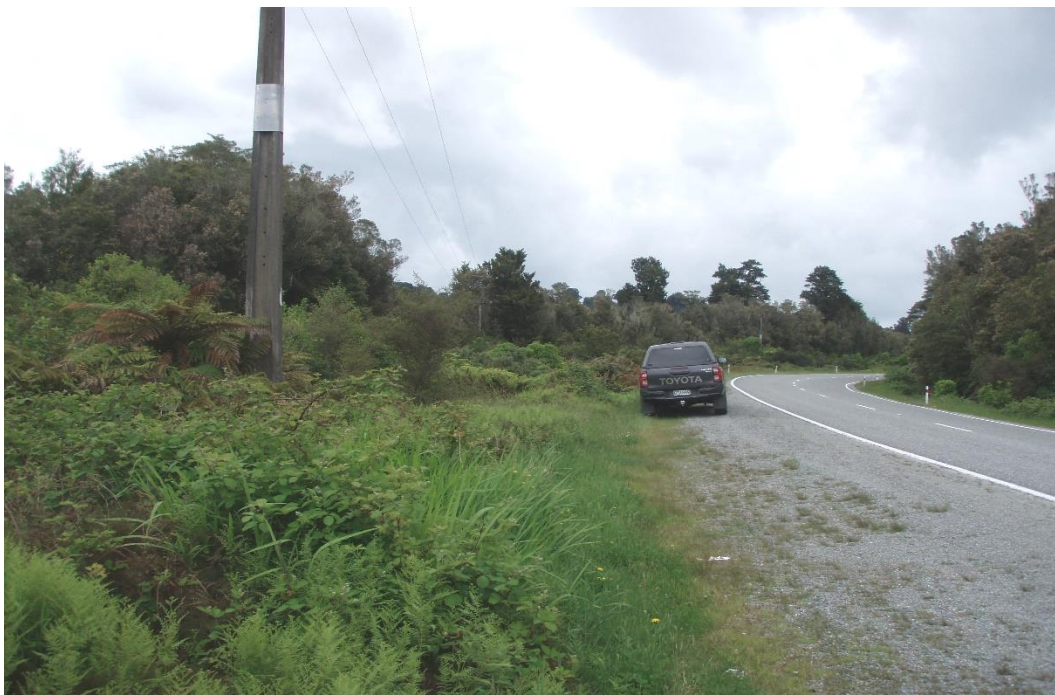
Figure 66 - Indigenous Vegetation Adjacent to State Highway 6:

Further westward progression step – looking west along the corridor in the podocarp/hardwood forest and forest regeneration traversed by the existing transmission line, with State Highway 6 to the right. Zero nett clearance area effect of the Scheme's transmission line upgrade on indigenous vegetation pertains here.

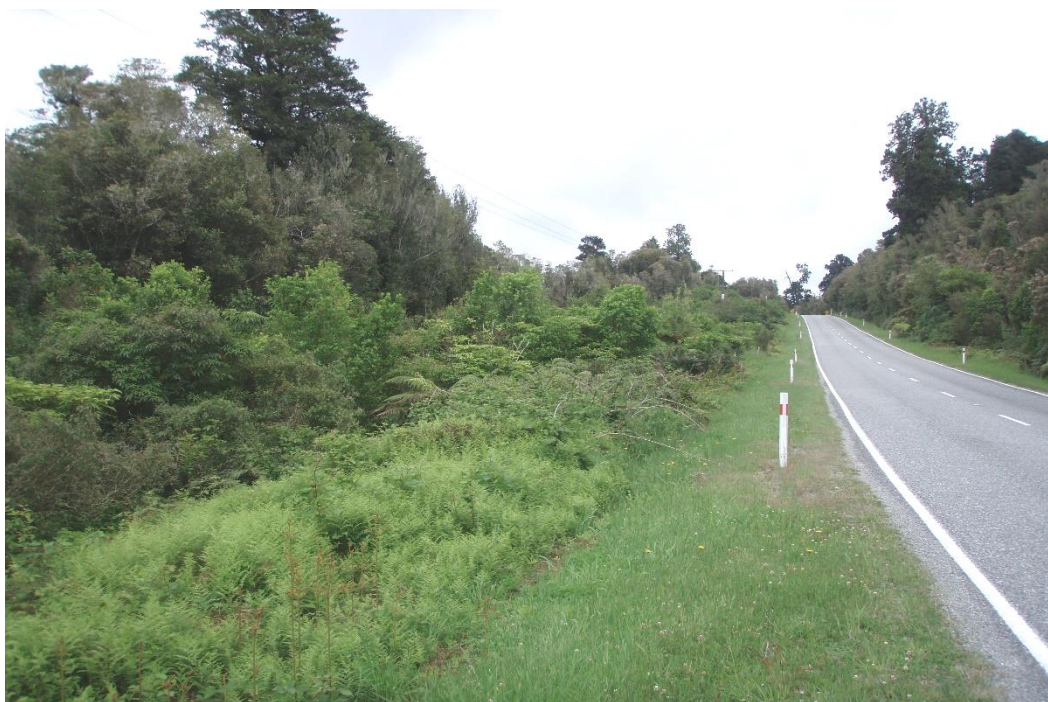
Figure 67 - Indigenous Vegetation Adjacent to State Highway 6:

Further westward progression step – looking west along the corridor in the podocarp/hardwood forest and forest regeneration traversed by the existing transmission line, with State Highway 6 to the right. Zero nett clearance area effect of the Scheme's transmission line upgrade on indigenous vegetation pertains here.

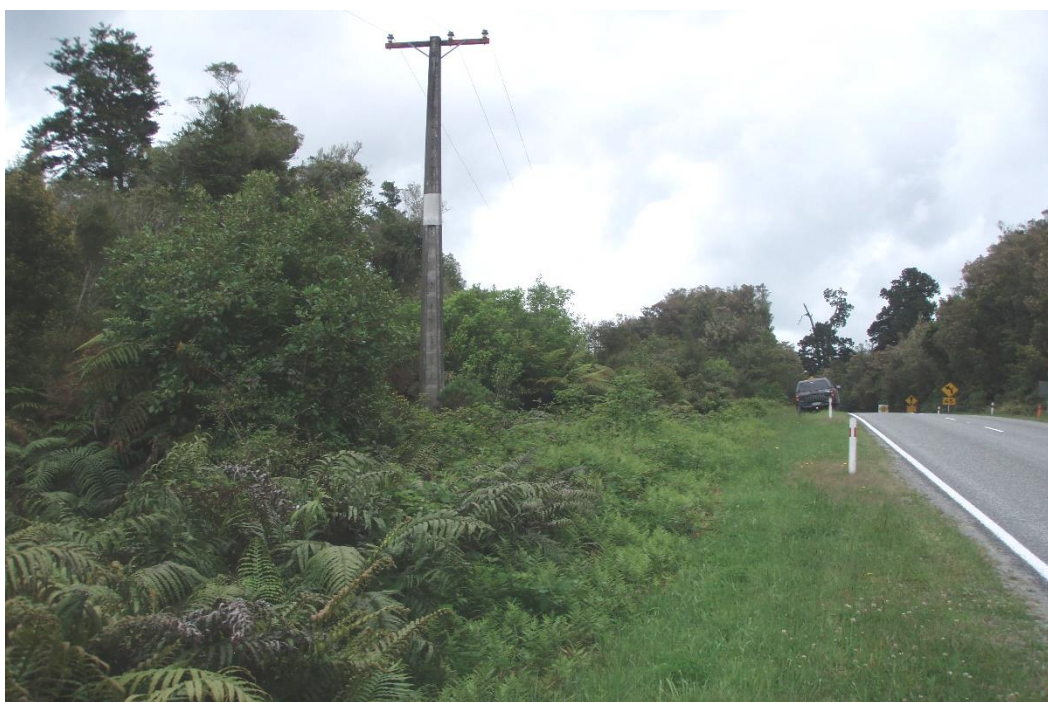
Figure 68 - Indigenous Vegetation Adjacent to State Highway 6:

Further westward progression step of transmission line upgrade – Waitaha River Bridge is beyond the brow in State Highway 6. Zero nett clearance area effect of the Scheme's transmission line upgrade on indigenous vegetation pertains here.

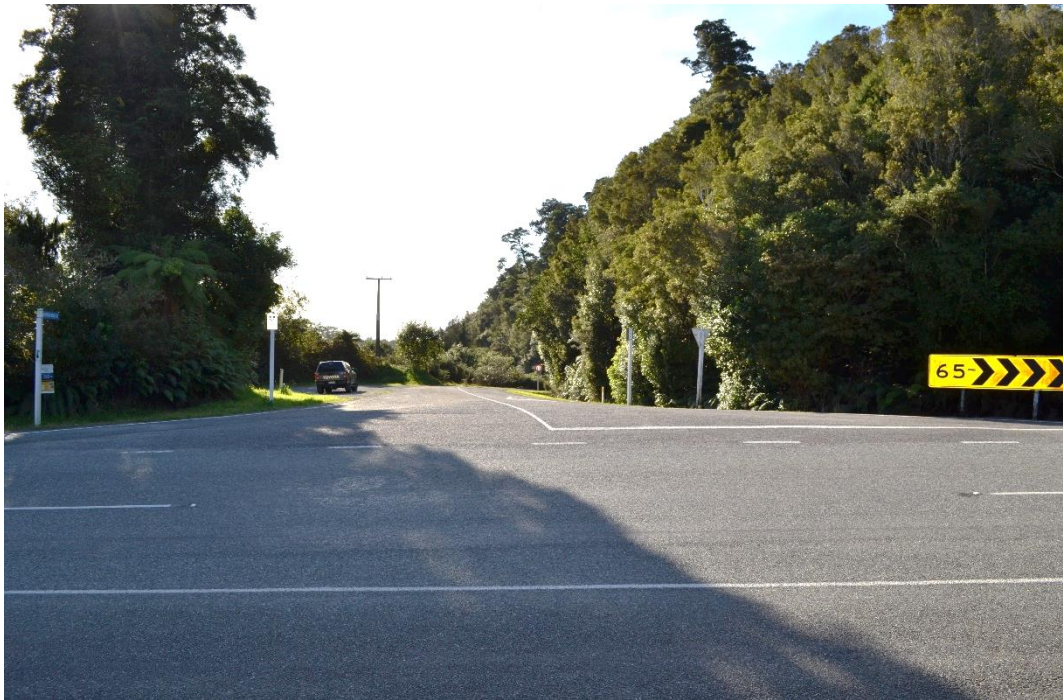
Figure 69 - Indigenous Vegetation - State Highway 6 to Kakapotahi River:

Northward progression step of transmission line upgrade from State Highway 6 junction (in foreground) with Beach Road, toward the Waitaha Substation. Zero nett clearance area effect of the Scheme's transmission line upgrade on indigenous vegetation pertains here.

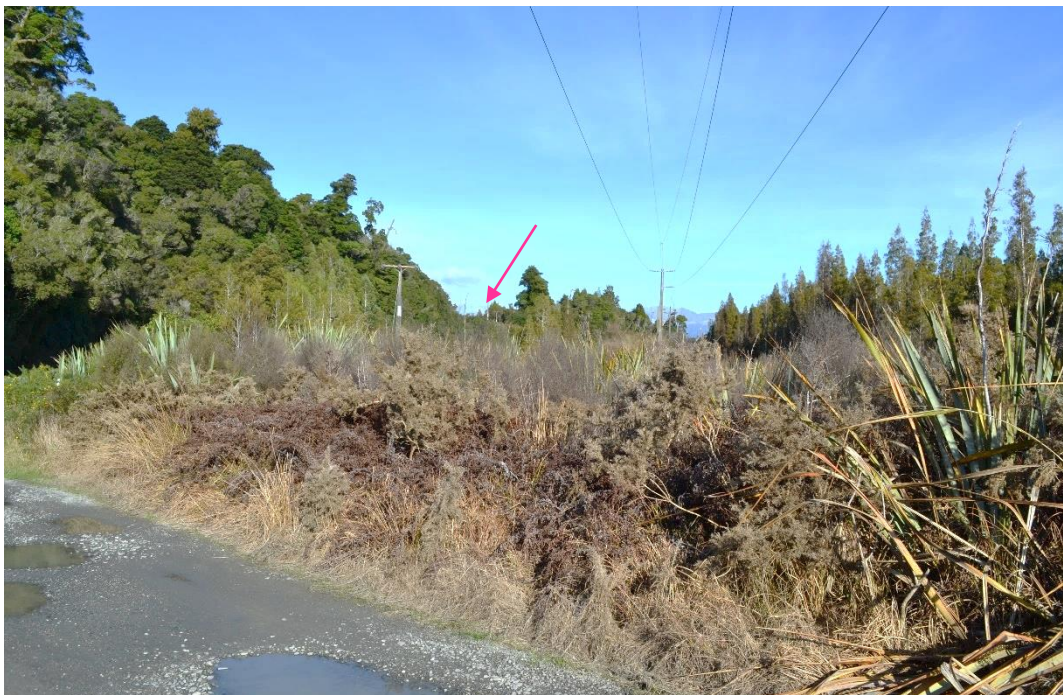
Figure 70 - Indigenous Vegetation - State Highway 6 to Kakapotahi River:

Illustrates typical vegetation in the existing transmission line corridor from S.H. 6/Beach Road junction - this view is looking south parallel to Beach Road on its western side, toward the location of the Figure 68, with the point where Figure 68 was taken from indicated by the pink arrow. Both existing network transmission lines are shown here, 11kV at right, 66kV at left. Zero nett clearance area effect of the Scheme's transmission line upgrade on indigenous vegetation pertains here.

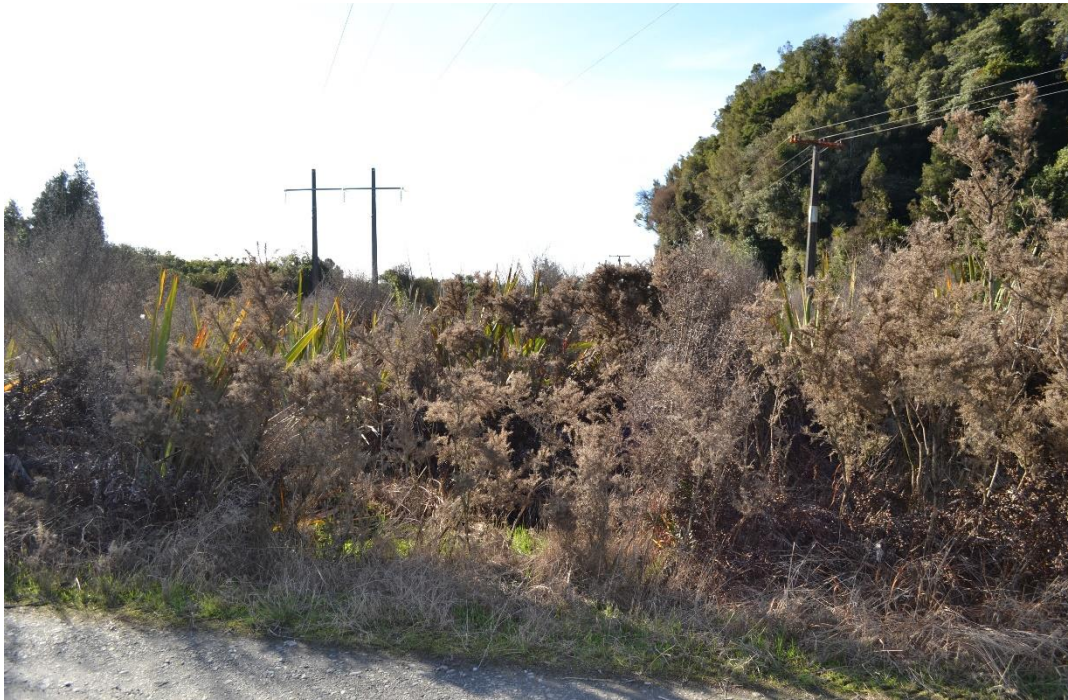
Figure 71 - Indigenous Vegetation - State Highway 6 to Kakapotahi River:

North-northeastward progression step of transmission line upgrade from State Highway 6 to the Waitaha Substation, this view is from Beach Road showing the typical vegetation on east side of Beach Road, just prior to the Kakapotahi River crossing. Zero nett clearance area effect of the Scheme's transmission line upgrade on indigenous vegetation pertains here.

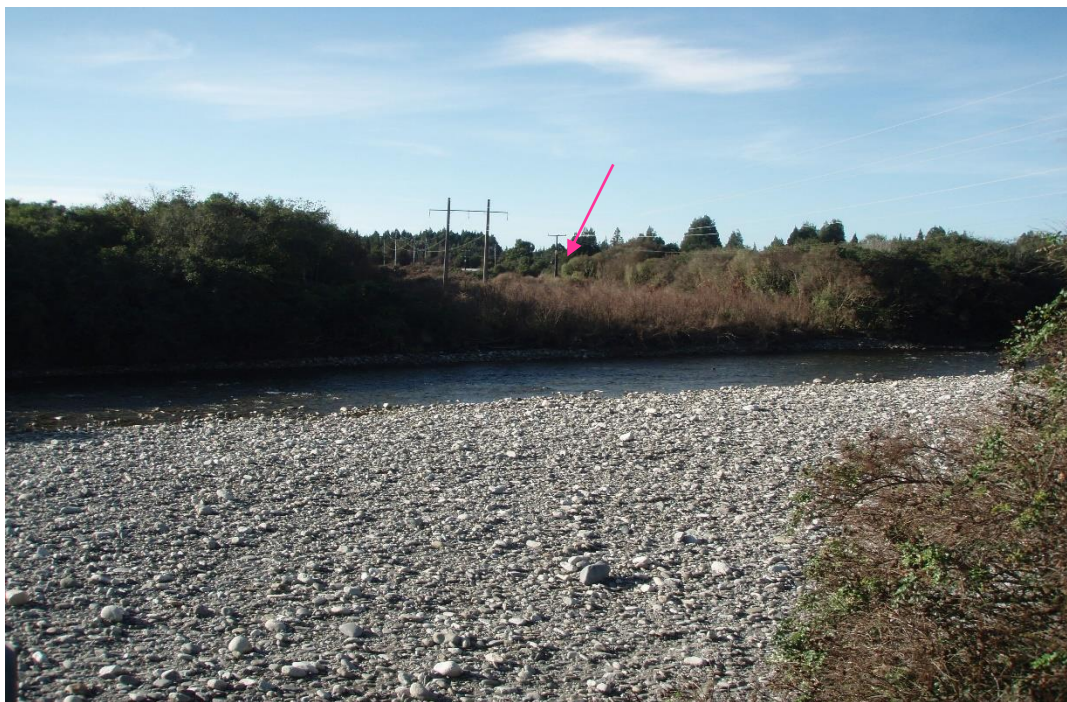
Figure 72 - Indigenous Vegetation - Kakapotahi River to Bold Head Road and Waitaha Substation:

Further north-northeastward progression step of transmission line upgrade from State Highway 6 to Waitaha Substation. This section is from the Kakapotahi River crossing to the Waitaha Substation on Bold Head Road. Zero nett clearance area effect of the Scheme's transmission line upgrade on indigenous vegetation pertains here. The Waitaha Substation is located c. 80 metres to right of the building's roof that is visible beyond and beyond the two poles in the middle distance, the pink arrow indicating its location.

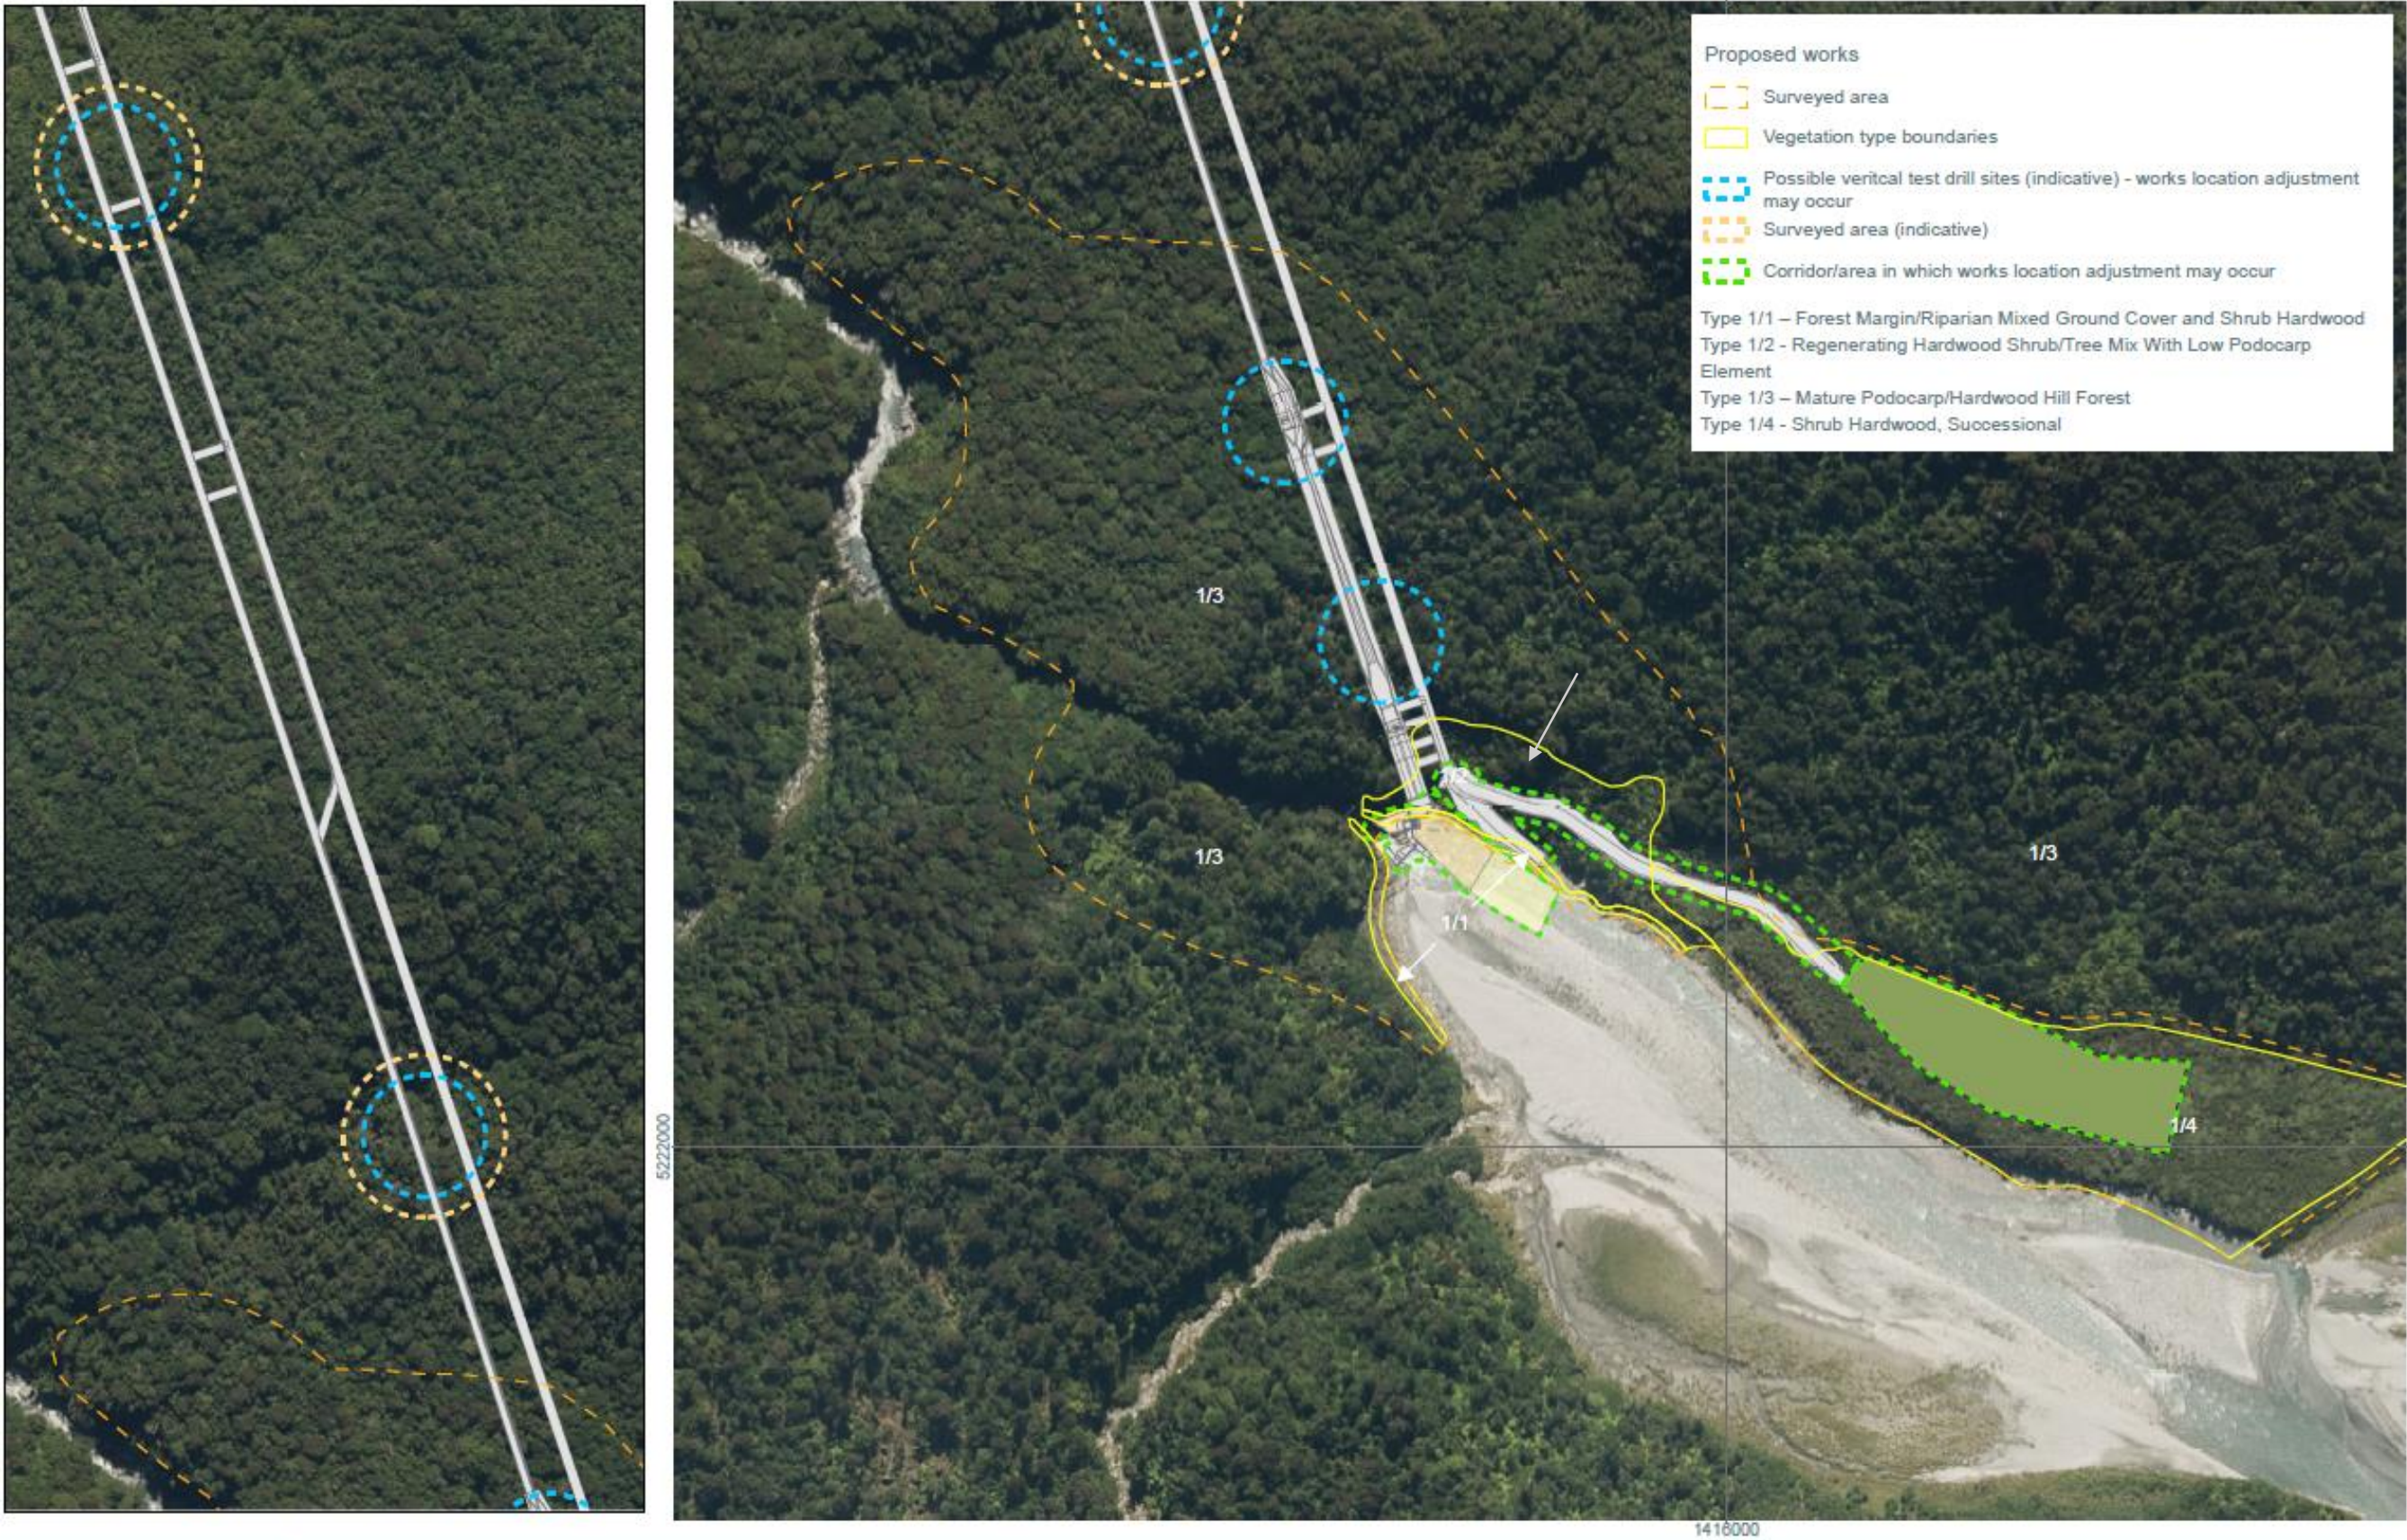
Note to Map 2: The label identifying the small area that is Vegetation Type 1/2 is partially obscured by the intake infrastructure overlay, so grey arrow is used to indicate Vegetation Type 1/2.
