# Auckland Surf Park Community - Stage 2 Development

## Ecological Impact Assessment

Prepared for: AW Holdings 2021 Ltd

June 2026

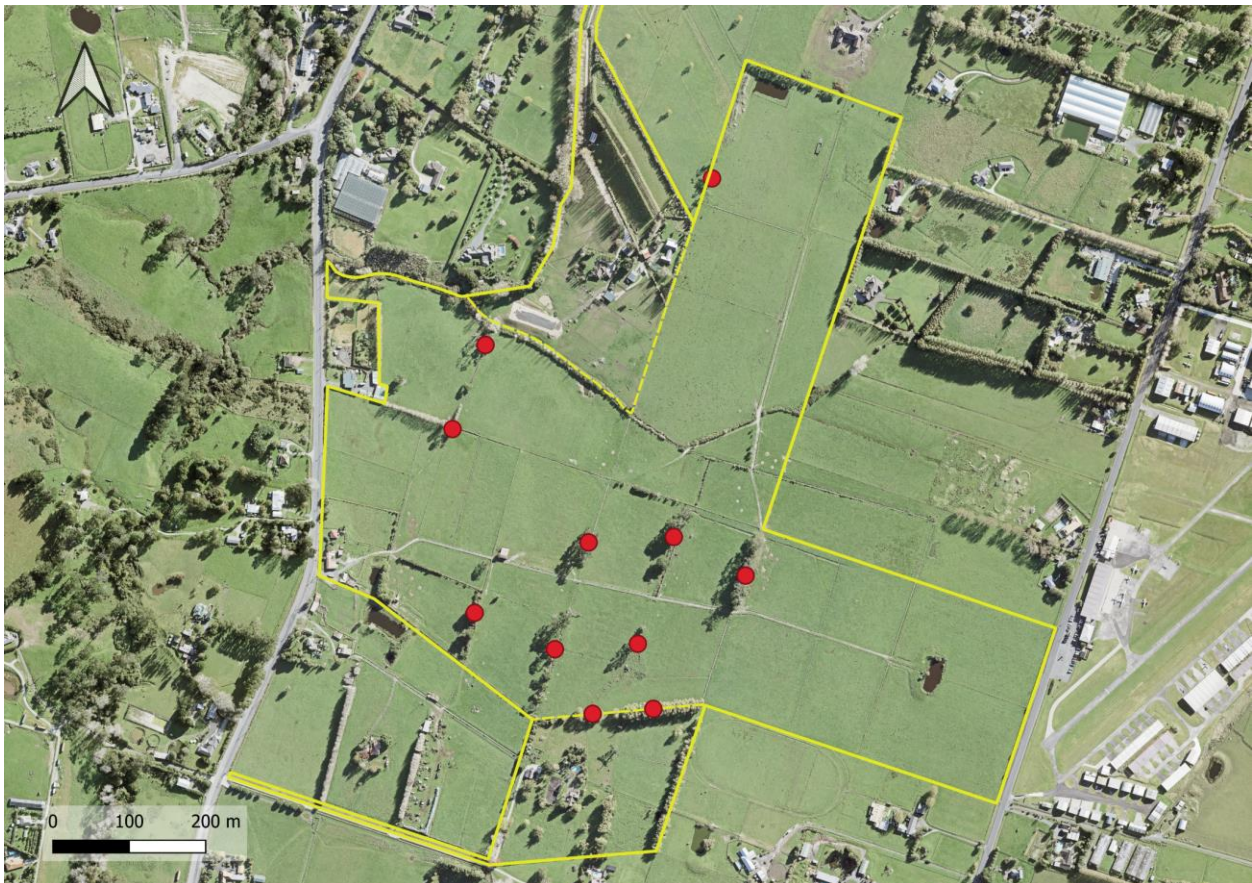
*Figure 3. ABM location within the site (map source: LINZ 2017).*

Bat activity was monitored using Automatic Bat Monitors (ABMs; Song Meter Mini Bat 2 acoustic detectors), which were deployed across the site for varying periods between 13 and 29 January 2025. ABMs were placed in a range of habitats, including riparian edges, shelterbelts, pasture margins and likely flyways, to maximise detection probability. Devices were mounted and oriented to minimise obstruction and interference.

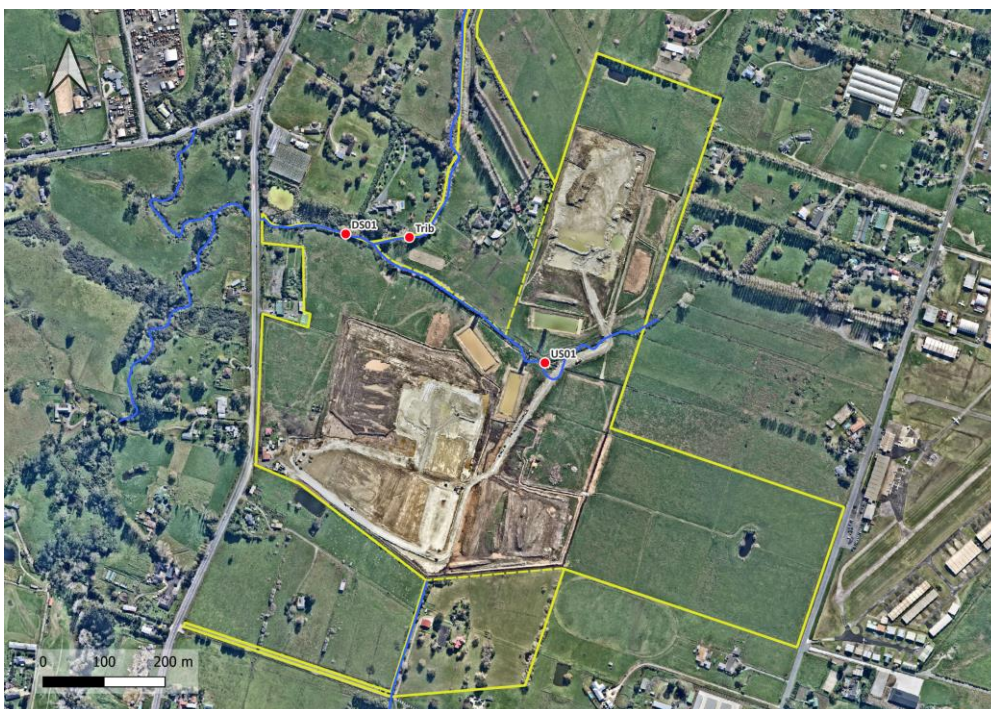
**Figure 4. Macroinvertebrate sampling locations.**

Three macroinvertebrate samples were collected within the site (Figure 4) using a D-net and the quantitative soft-bottomed stream sampling method described in NEMS (2022). All samples were preserved in 70% isopropyl alcohol for subsequent identification and counting. Benthic macroinvertebrates were identified and enumerated to a level appropriate for calculating the Macroinvertebrate Community Index (MCI) and Quantitative MCI (QMCI), following NEMS (2022) protocols. The NPS-FM provides Attribute Bands (A–D) for MCI and QMCI scores to assist interpretation.

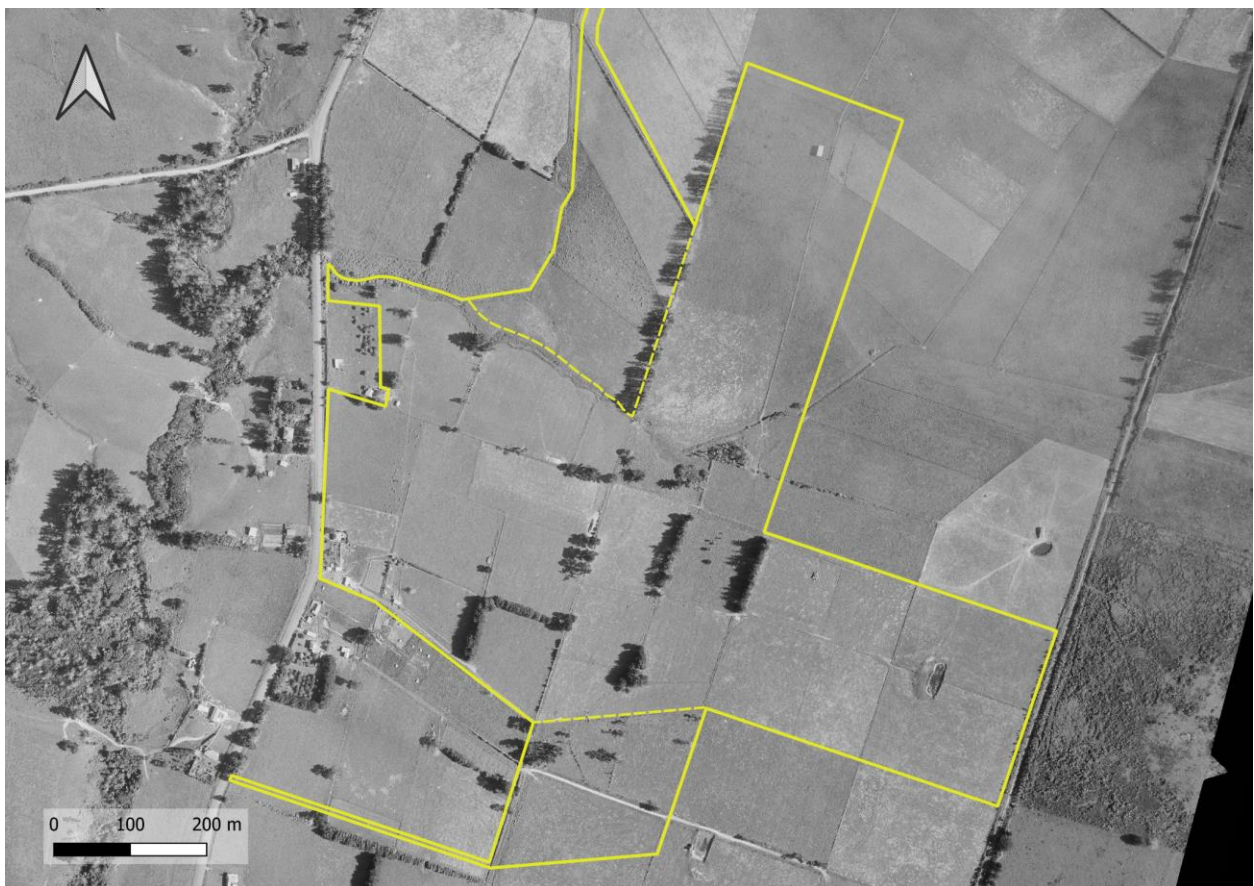
**Figure 5. Historical aerial imagery of the site, dated 1957.**

The site is situated in the Rodney Ecological District of the Auckland region. Historically (pre-human), the site comprised of the ecosystem type pūriri forest (WF7-3) (Singers *et al.*, 2017). This ecosystem type would have supported a diverse range of invertebrates, amphibians, reptiles, birds, and bats. However, a review of the earliest available aerial imagery indicates that the site, and much of the surrounding landscape, was cleared over 85 years ago for agricultural land uses. As farming in the area likely commenced prior to this, it is expected that the landscape has been largely devoid of significant native vegetation for a considerably longer period than the available imagery indicates (Figure 5).

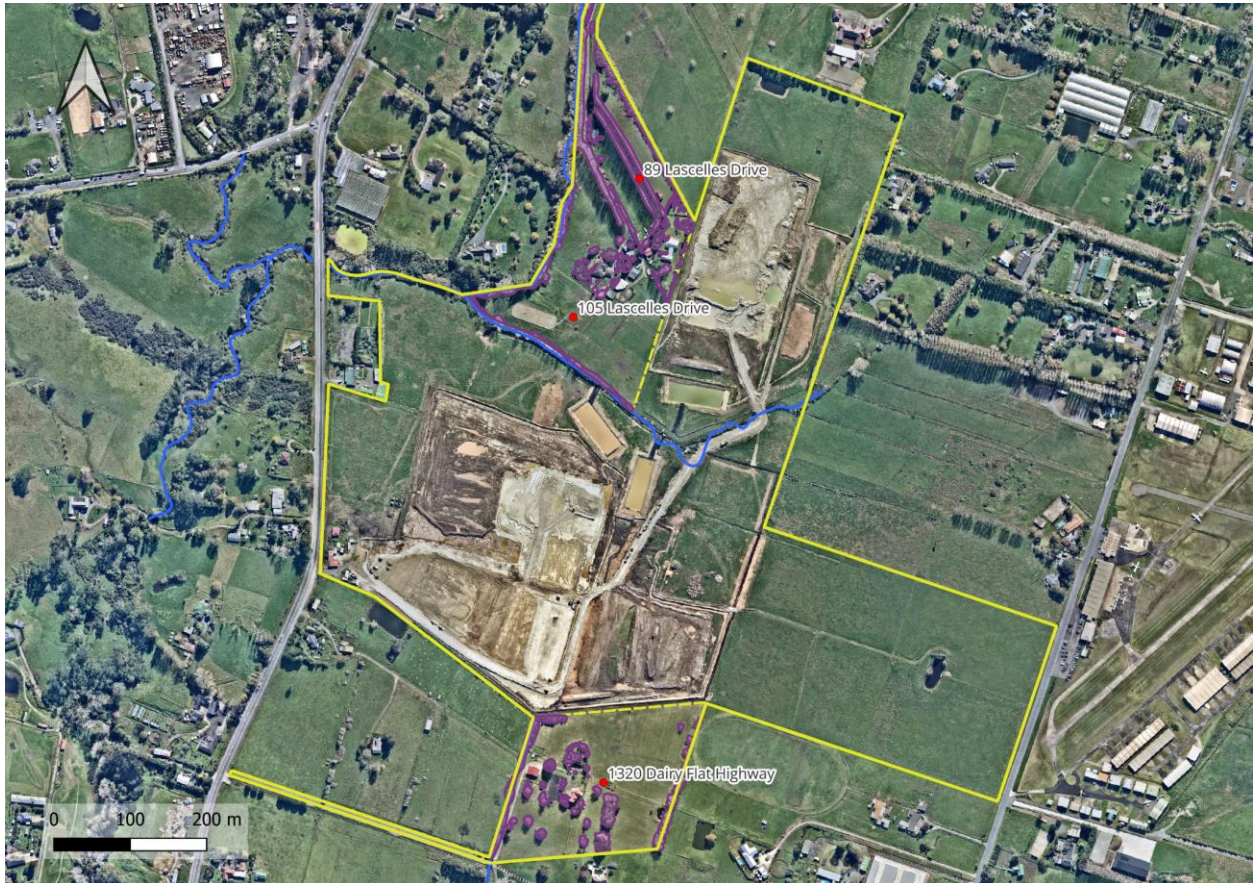
**Figure 6. Exotic dominant trees and shrubs (purple polygons) within Stage 2.**

Overall, vegetation within the Stage 2 area is highly modified, dominated by exotic pasture grasses and pest plant species, and provides limited indigenous biodiversity or habitat diversity. As a result, the botanical and ecological value of the terrestrial vegetation is assessed as low.

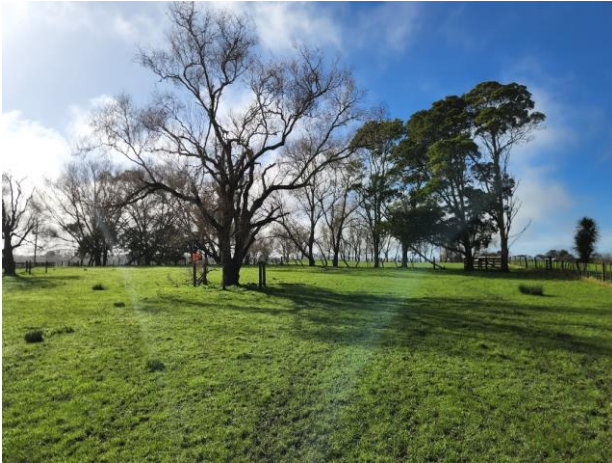
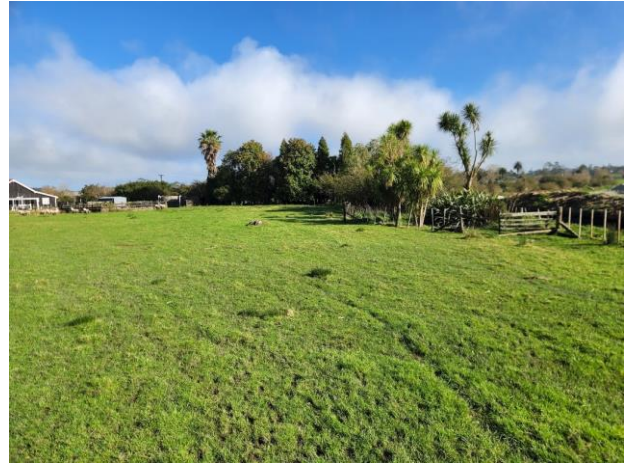
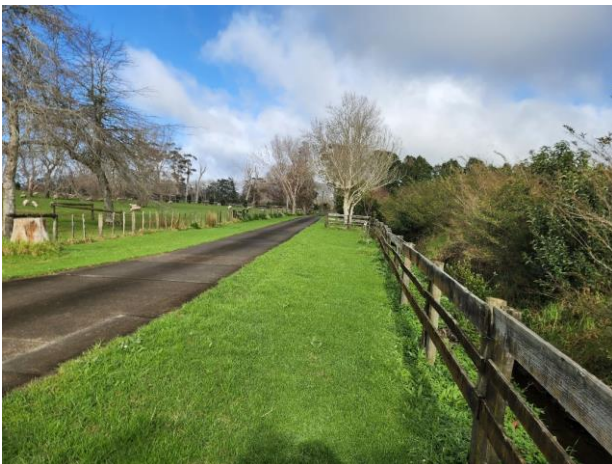
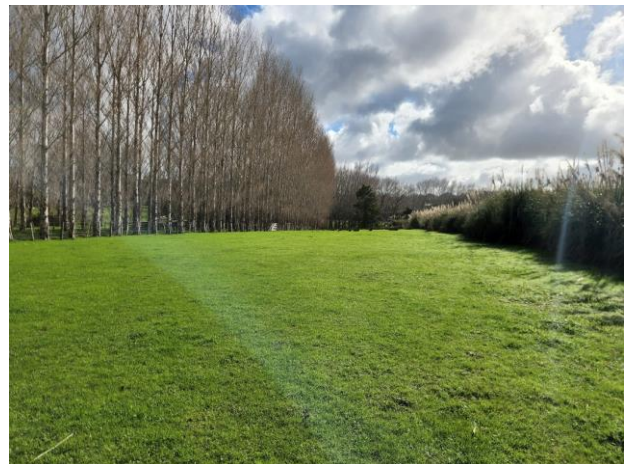
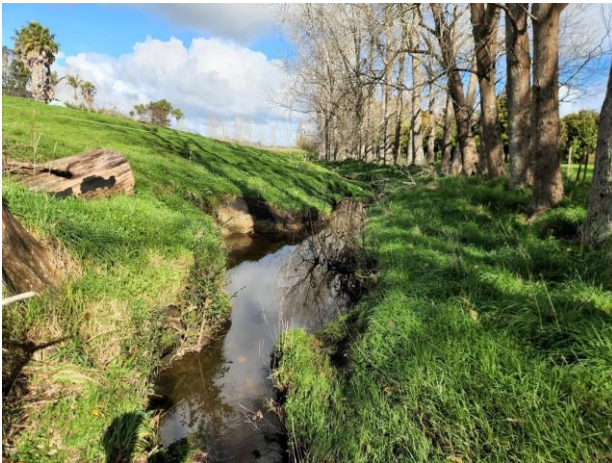
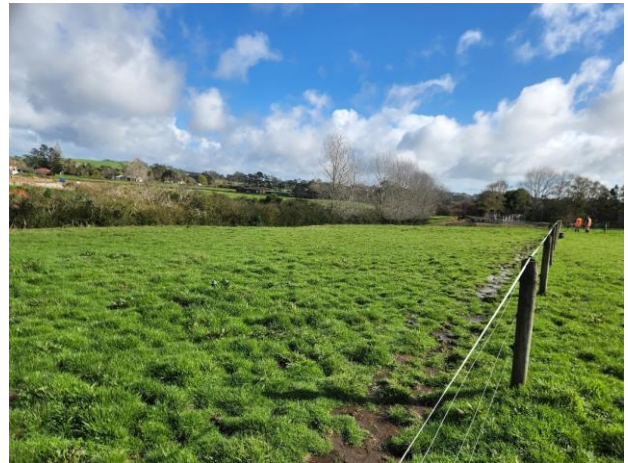
**Figure 7. Typical vegetation within Stage 2: a) scattered trees at 105 Dairy Flat Highway; b) small patch of native vegetation interspersed with exotics at 105 Dairy Flat Highway; c) Chinese privet along the riparian margin at 105 Dairy Flat Highway; d) poplar shelterbelt and pampas at 89 Lascelles Drive; e) upper reach riparian margin at 105 Lascelles Drive; and f) Chinese privet along the lower reach riparian margin at 105 Dairy Flat Highway.**

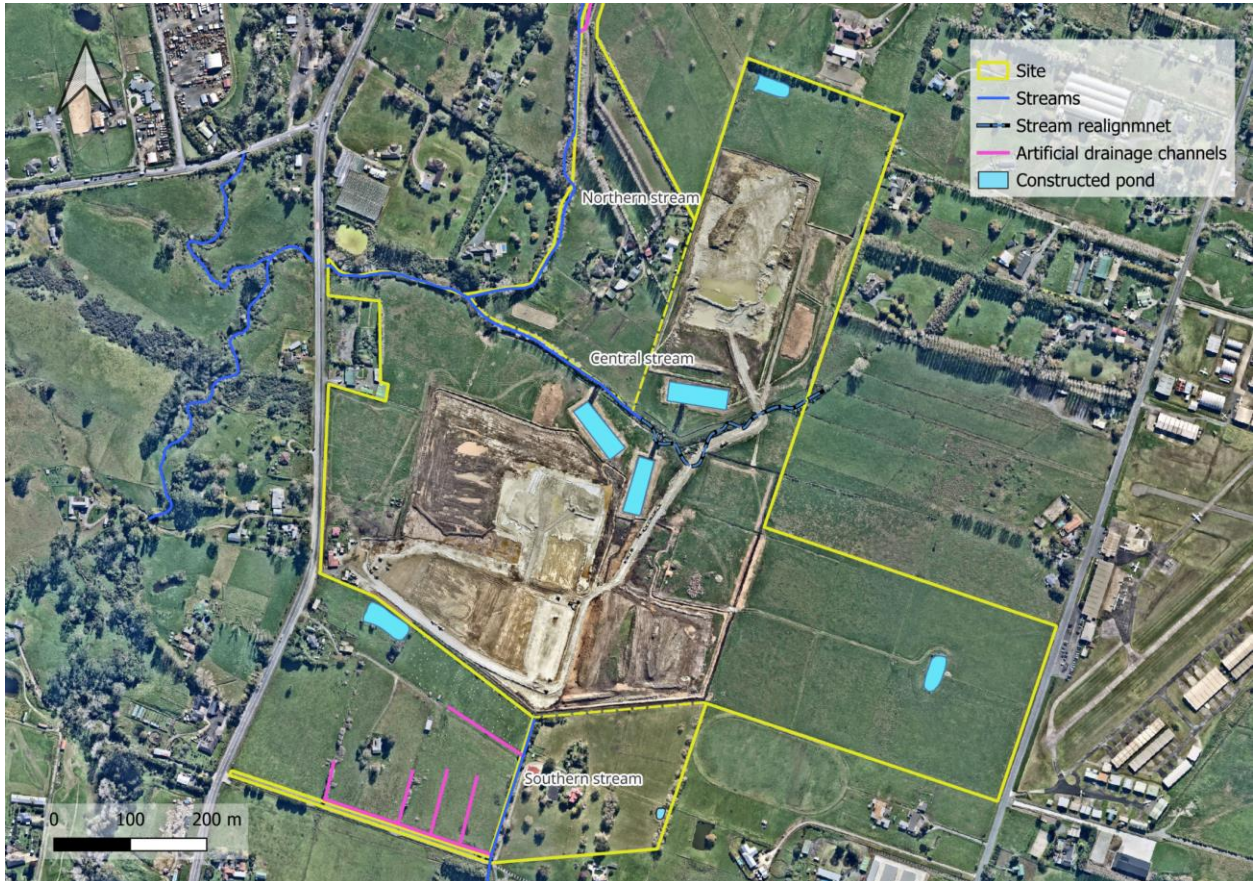
**Figure 9. Freshwater features within the site.**

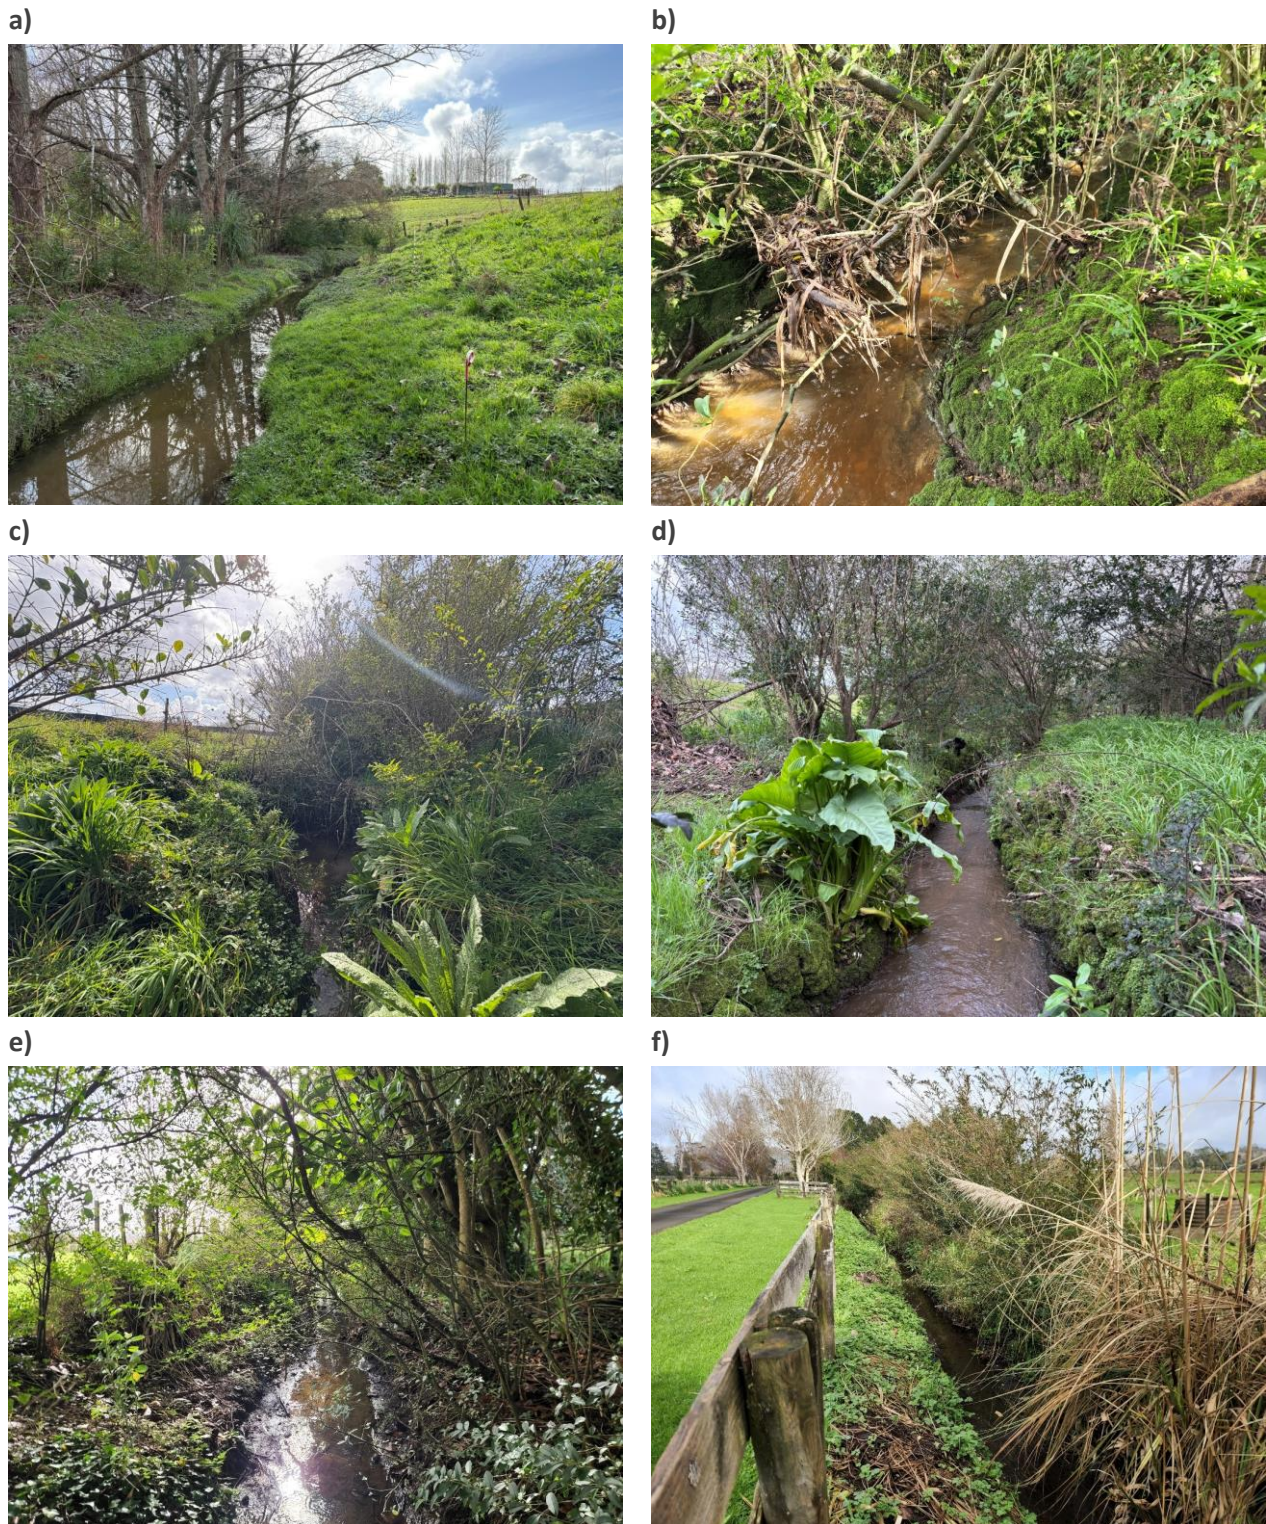
**Figure 10. The northern stream a) upper and b) lower reach, the central stream c) upper and d) lower reach, and the southern stream e) upper and f) lower reach.**

Riparian margins also exhibited low ecological condition (Figure 10c, e & f). The riparian strip within 1320 Dairy Flat Highway was dominated by Chinese privet with patches of arum lily. On the southern edge of 105 Lascelles Drive, riparian vegetation was similarly dominated by dense privet, and extensive pampas grass occurred along the northern boundary of 89 Lascelles Drive.

Overall, the combination of highly modified channels, degraded riparian margins, limited in-stream structure, and poor water quality results in low ecological value for all streams within the site. Native fish diversity is expected to be low, and habitat conditions provide limited support for high-quality freshwater communities.

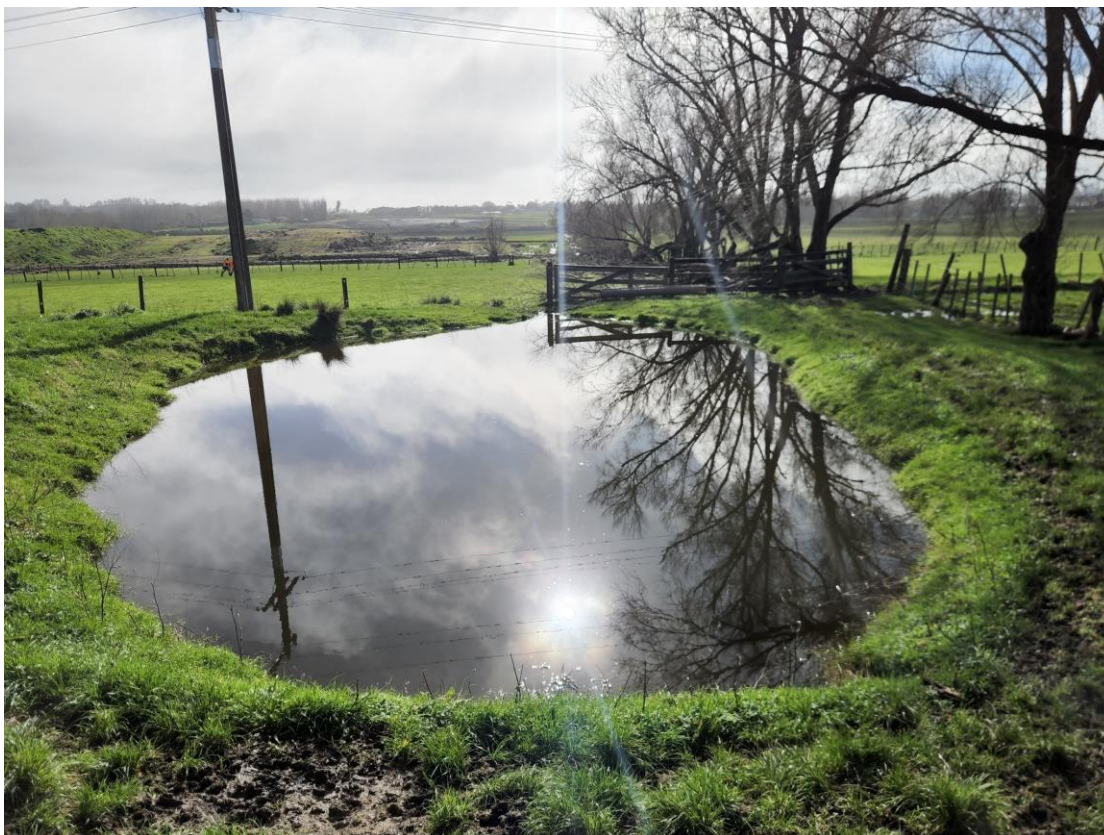
**Figure 11. The farm pond within 1320 Dairy Flat Highway.**

The remaining farm pond is located in the corner of a paddock at the eastern end of 1320 Dairy Flat Highway and is proposed to be removed. The pond is small, shallow, stagnant, of poor water quality and is not connected to any other freshwater features, as such it is of very low ecological value. Due to the lack of connectivity and very poor condition, the pond is unlikely to support native fish. However, the presences of highly resilient native species such as shortfin eels cannot be ruled out. Mitigation measures, including a native fish capture and relocation plan and sediment controls, are proposed to address potential adverse effects.

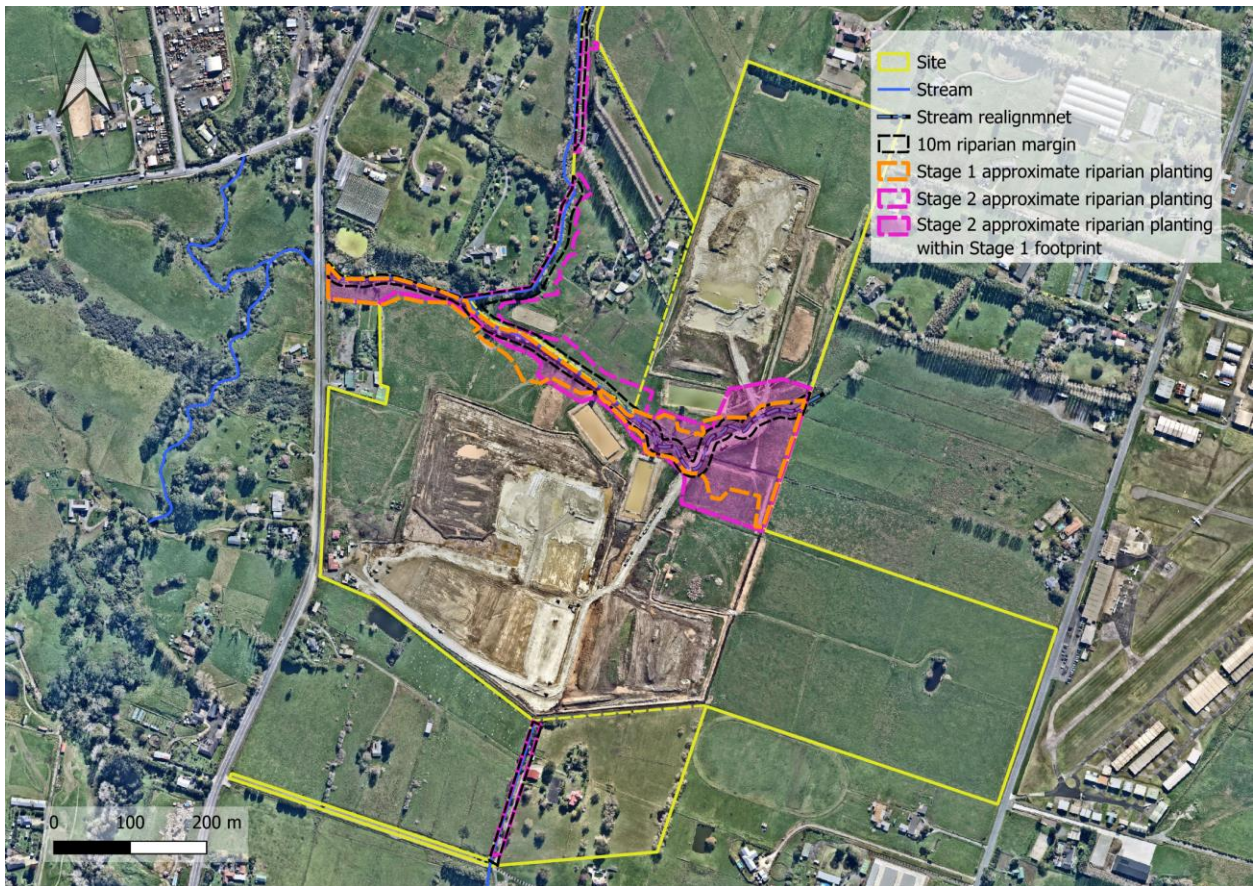
**Figure 13. Proposed riparian planting.**

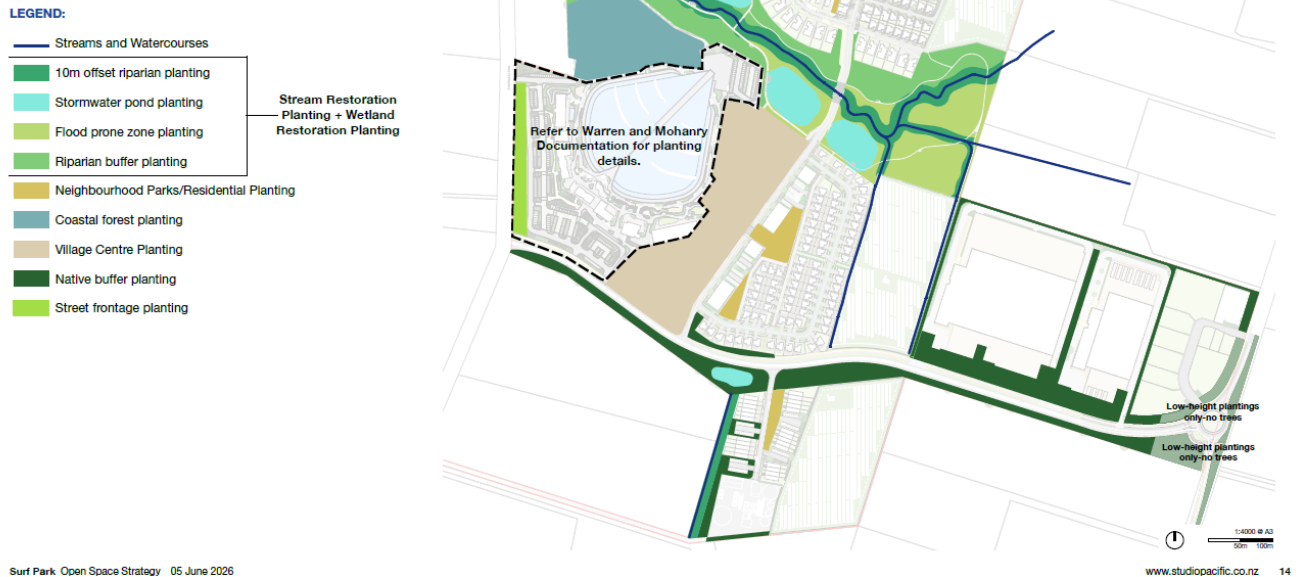
**Figure 14. Vegetation strategy from Studio Pacific’s Open Space Strategy Design Report (November 2025).**

Overall, while the vegetation removal results in a short-term loss of low-value exotic cover, the extensive programme of native riparian and landscape planting (Figure 14) will produce a net ecological gain, delivering long-term improvements to vegetation structure, habitat quality and biodiversity values for indigenous birds, lizards, bats and invertebrates.
