TEST PIT LOG - TP01-22

Client: Fulton Hogan Land Development Ltd
 Project: Precinct 3, Argent Lane
 Site Location: Milldale
 Project No.: AKL2022-0138
 Date: 24/08/2022

PHOTOGRAPH SHEET - TP01-22

TEST PIT PHOTOGRAPHS: TP01-23

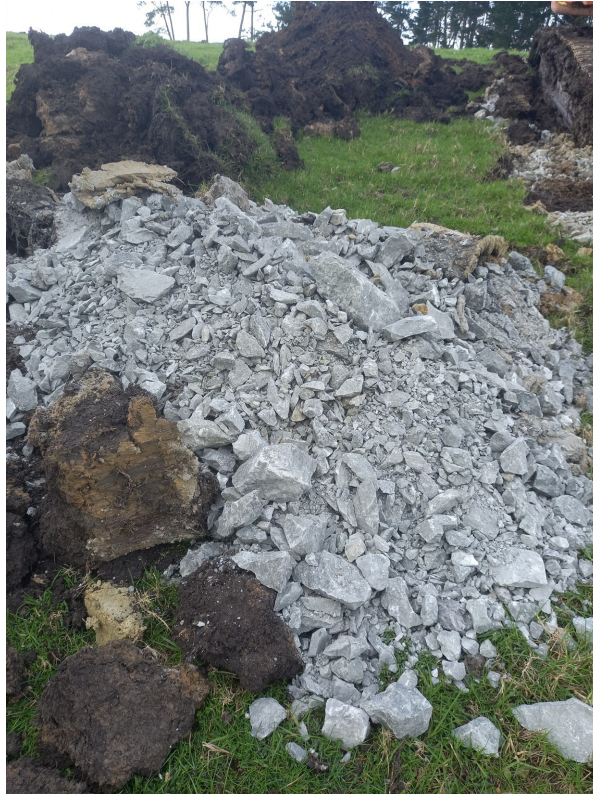
Spoil

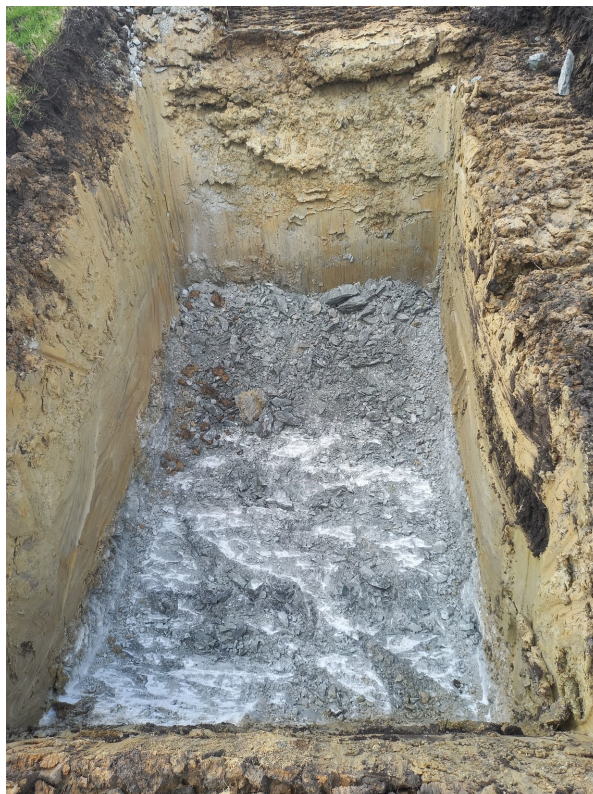
57.1			OL: TOPSOIL: Dark brown. Low plasticity. Minor rootlets.							
	0.5	Peak = 66kPa Residual = 30kPa	56.9			MH: Clayey SILT: Light brownish orange streaked grey. High plasticity. Minor limonite straining. (RS Northland Allochthon)		St

1.0	Peak = 40kPa Residual = 13kPa		1			M to W	F					
	1.5	Peak = UTP						H					
			55.1	2		Highly weathered blocky LIMESTONE. Limonite staining. Calcareous. Light grey mottled ashy white. Sheared structure. Strong. Some moisture on surfaces. : ... at 2.20m, Less oxidation	M						
						Test pit terminated at 2.30 m	D						
				3									
				4									
				5

Test pit

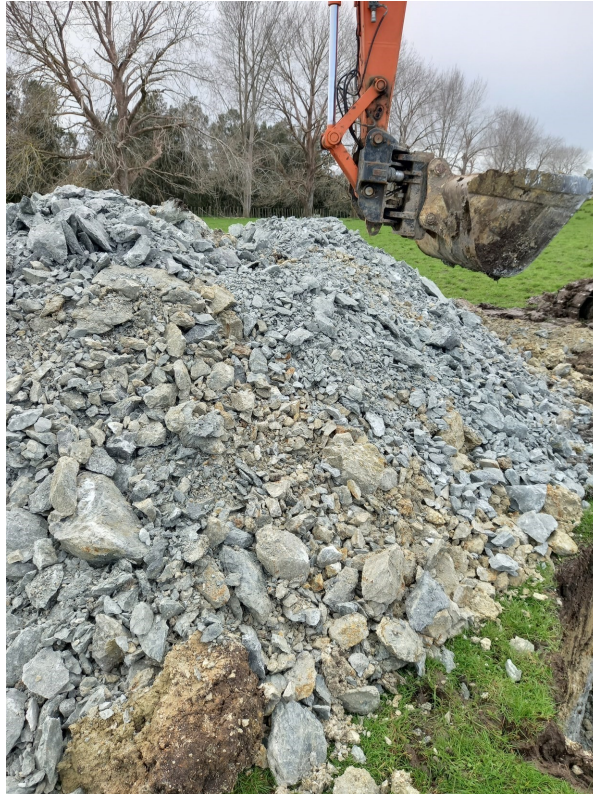
Spoil

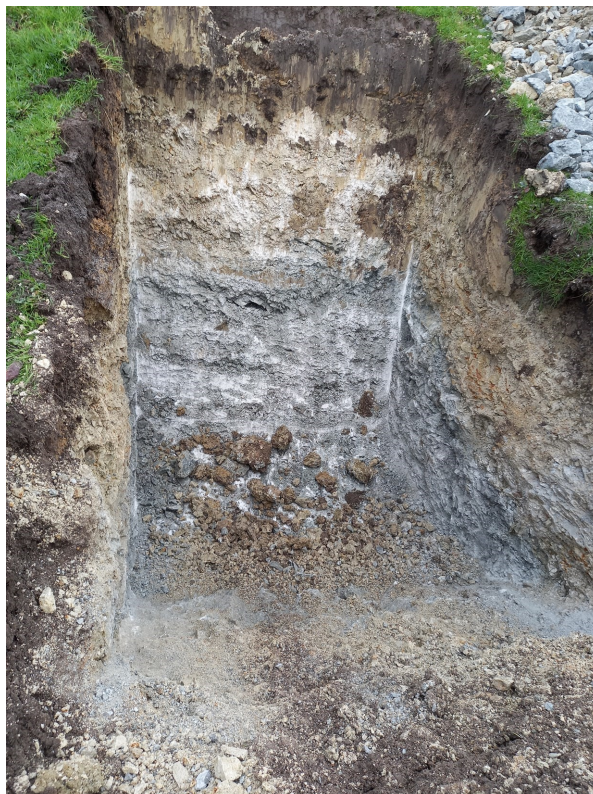
55.2			OL: TOPSOIL: Brown. Low plasticity.							
	0.5	Peak = 66kPa Residual = 43kPa	55.0			MH: Clayey SILT: Light orange brown streaked grey. High plasticity. Blocky structure. Large gravel sized, very weak silt clasts. Minor limestone clasts inclusions. (RS Northland Allochthon)	M	St

1.0	Peak = UTP	54.4			Highly weathered dark grey MUDSTONE. Weak. Sheared structure. Clay on sheared surfaces. Some ashy white moderately strong limestone inclusions.: (Mangakahia Complex)							
				1									
				2									
				3									
				4									
				5									
						Test pit terminated at 2.50 m

Test pit

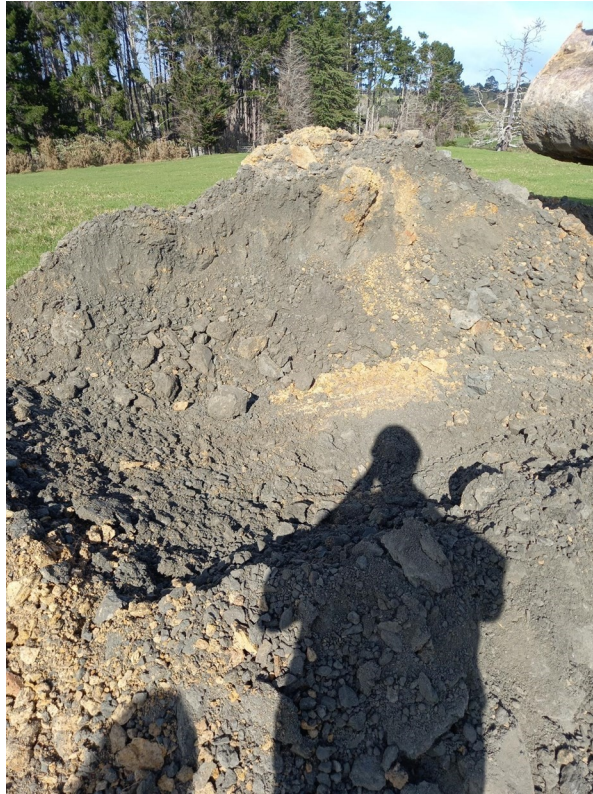
Spoil

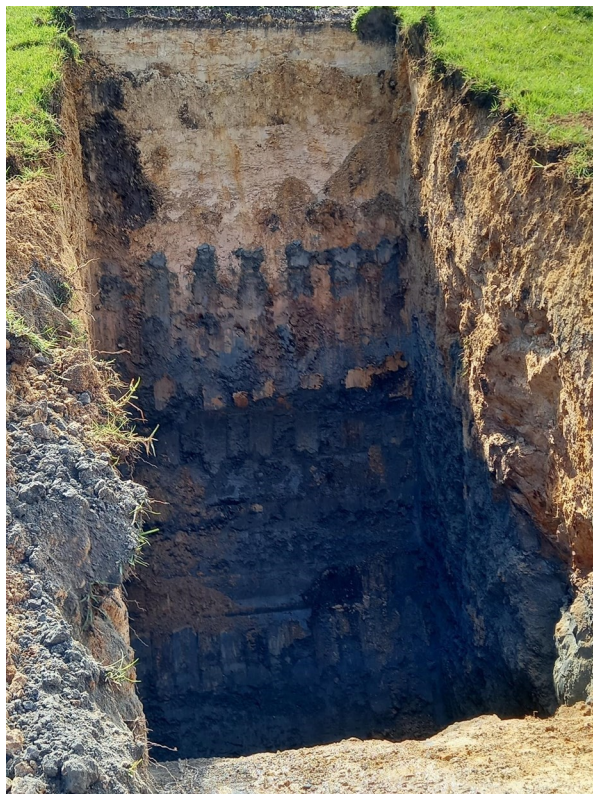
59.5			OL: TOPSOIL: Brown. Low plasticity.				
			59.4			ML: Clayey SILT: Light orange brown streaked light grey. Low plasticity. Blocky structure. Some large gravel to 30cm silt clasts/ blocks. Silt blocks are extremely weak. Limonite staining on surfaces. (RS Northland Allochthon)

0.5	Peak = 112kPa Residual = 30kPa								
	1.0	Peak = 182kPa Residual = 63kPa		1			VS to H			
	1.5	Peak = UTP					M			
			57.7			Completely weathered dark grey MUDSTONE. Extremely weak. Recovered as silty clay with some mudstone blocks. Sheared structure. Glossy surfaces on fracture faces with minor limonite staining. : (Mangakahia Complex)				
				2		... at 2.20m, Becoming with some minor light bluish grey mudstone clasts inclusions				
				3						
						... at 3.50m, Becoming with some highly weathered to moderately weathered 20-40cm mudstone blocks. Very weak.	D			
				4						
						Test pit terminated at 4.10 m				
				5

Test pit

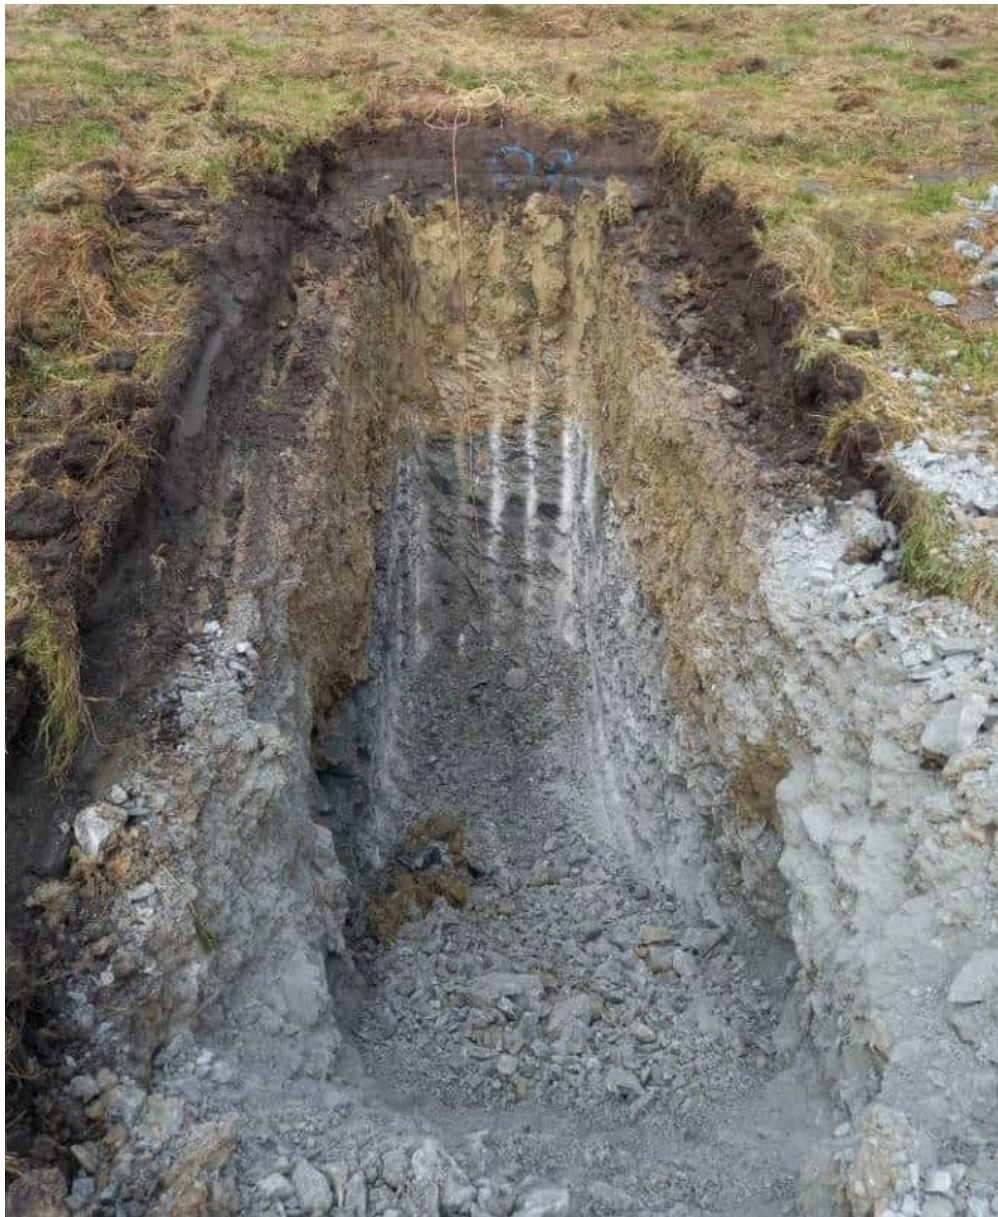
TP02-23 – TEST PIT EXCAVATION

51.8			CH: Silty CLAY: Greyish brown mottled grey. High plasticity. (RS Northland Allochthon)	F						
			51.2	1		Moderately weathered light brownish grey LIMESTONE: Very weak. Blocky structure. Minor limonite staining. Recovered as GRAVEL with trace clay, grey, medium to coarse angular clasts. (Northland Allochthon)	S

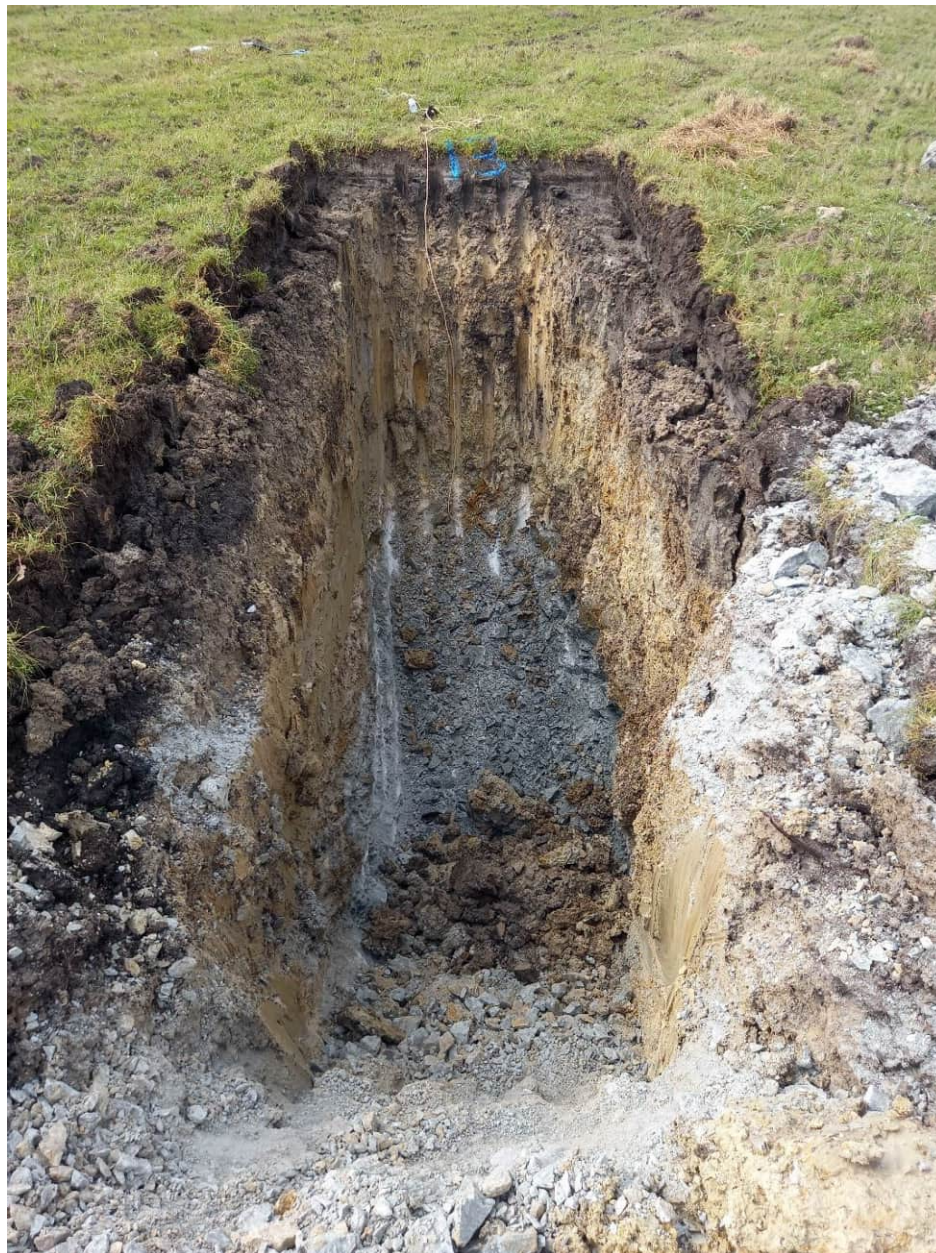
TP13-23 – TEST PIT EXCAVATION

1.0	Peak = 68kPa Residual = 32kPa		1			S	St					
			36.0	2		Highly weathered light brownish grey. Sheared structure. LIMESTONE. Calcareous. Extremely weak. Recovered as fine gravel to large cobble sized angular blocks. Water on fractured surfaces. (Northland Allochthon)	D	H

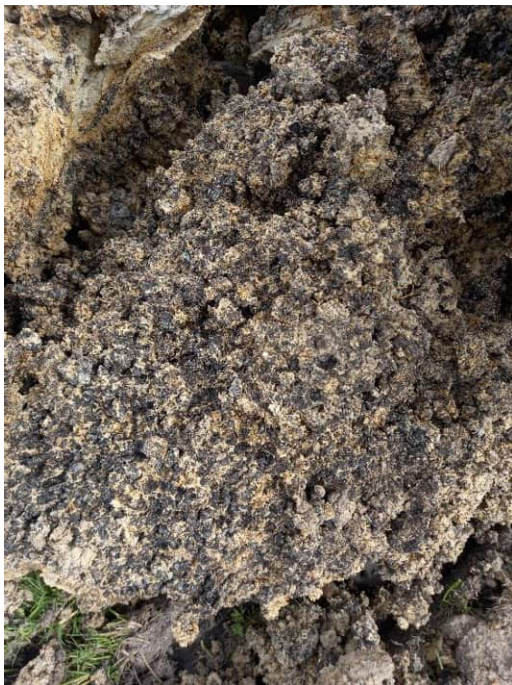
Manganese Nodules

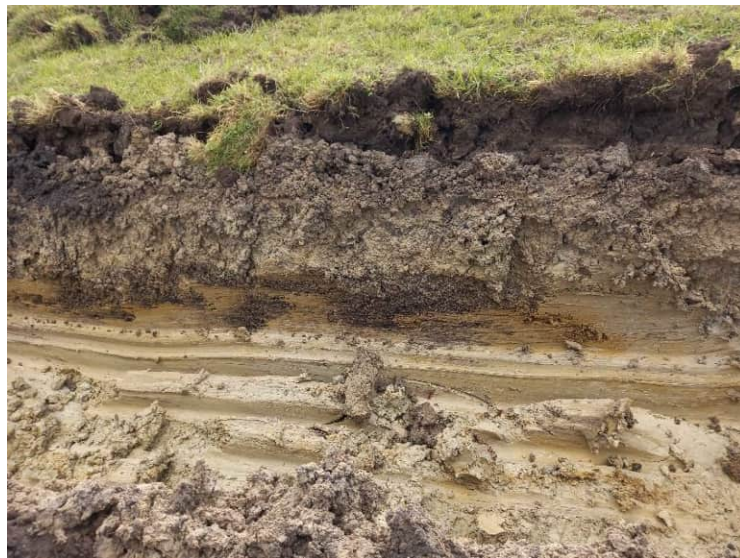
Manganese Band
