# Waihi North Project: Freshwater Ecological Assessment

Prepared for OceanaGold (NZ) Ltd

WAI-985-000-REP-LC-0007\_Rev0  
TECHNICAL REPORT  
WAIHI NORTH PROJECT ECOLOGICAL  
GENERAL AREA 000

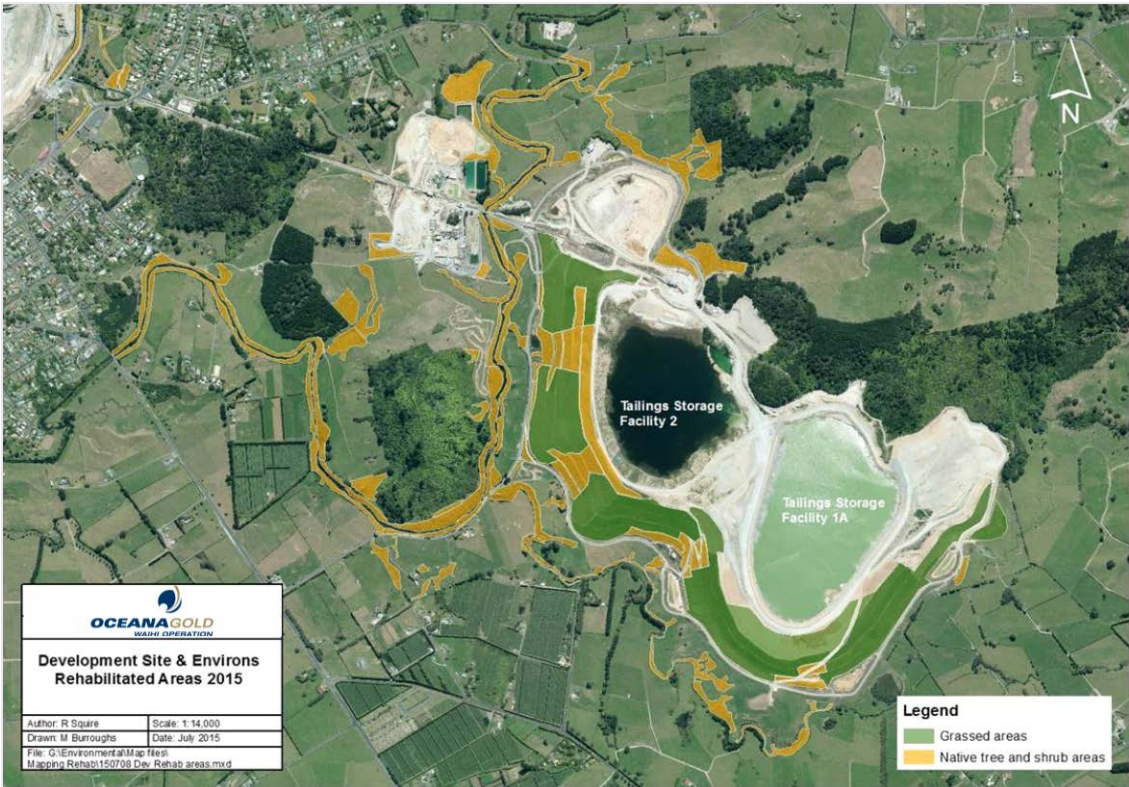
**Figure 3:** Environmental enhancement carried out at OGNZL site 1995 – 2015.

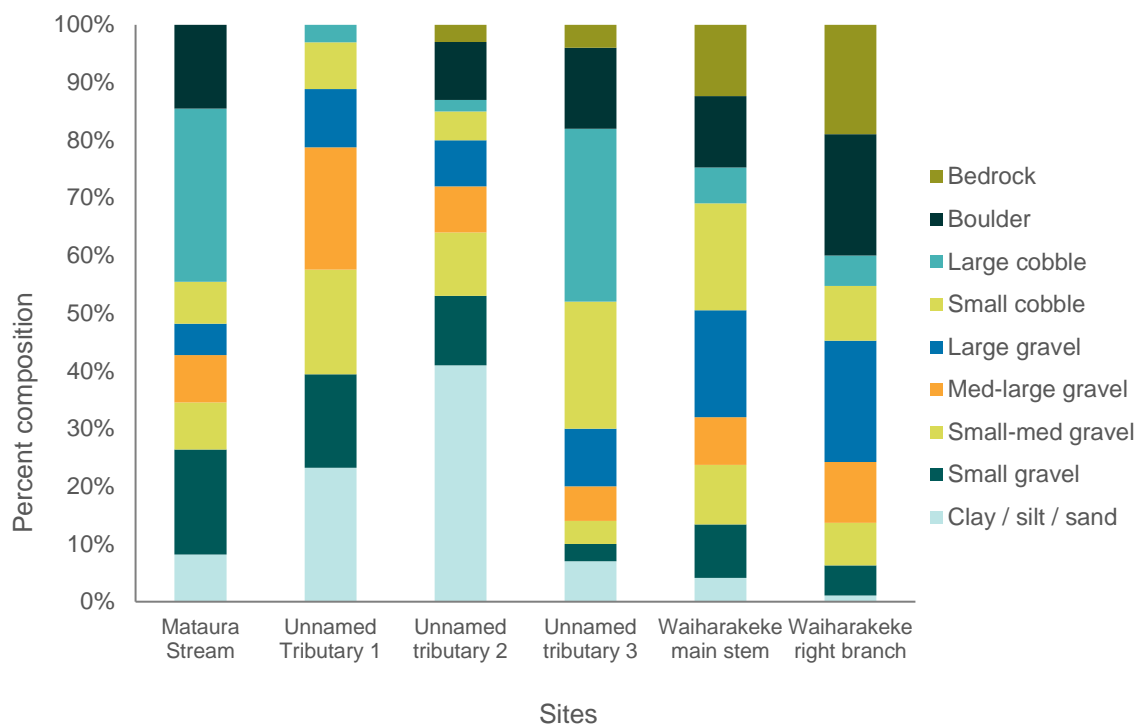
**Figure 7:** Sediment particle size for Waiharakeke Stream, Mataura Stream and Tributary 2 and 3 of the Mataura Stream catchment.

Detail of the stream morphology and substrate is provided in Appendix 4 and sediment particle size in Figure 7.

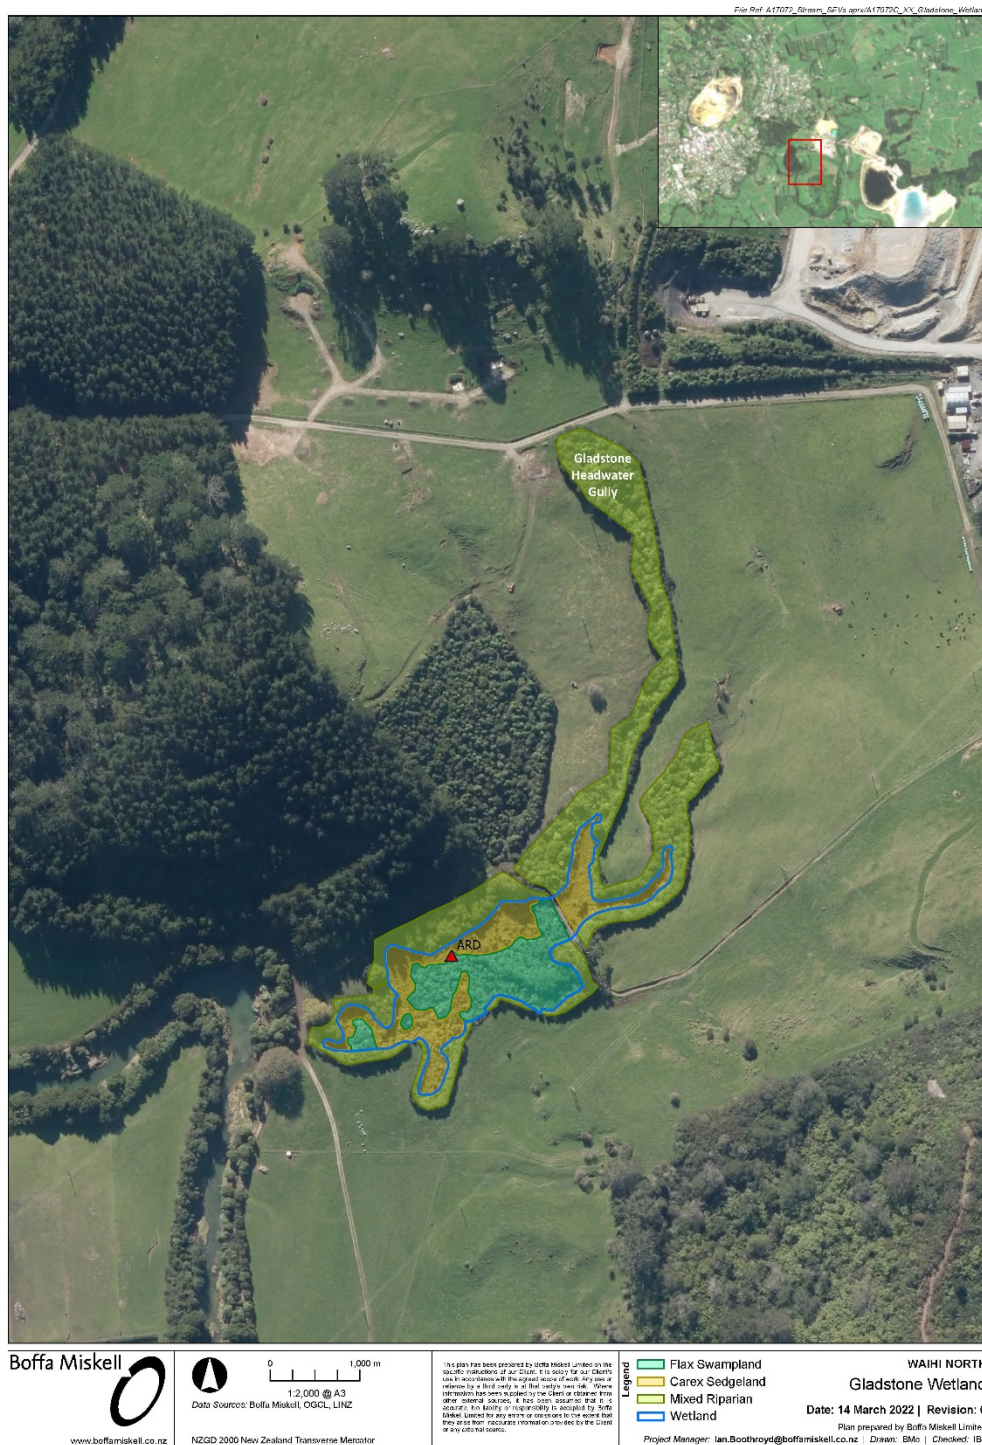
**Figure 9:** Gladstone headwater gully and Gladstone wetland. ARD = acoustic recording device

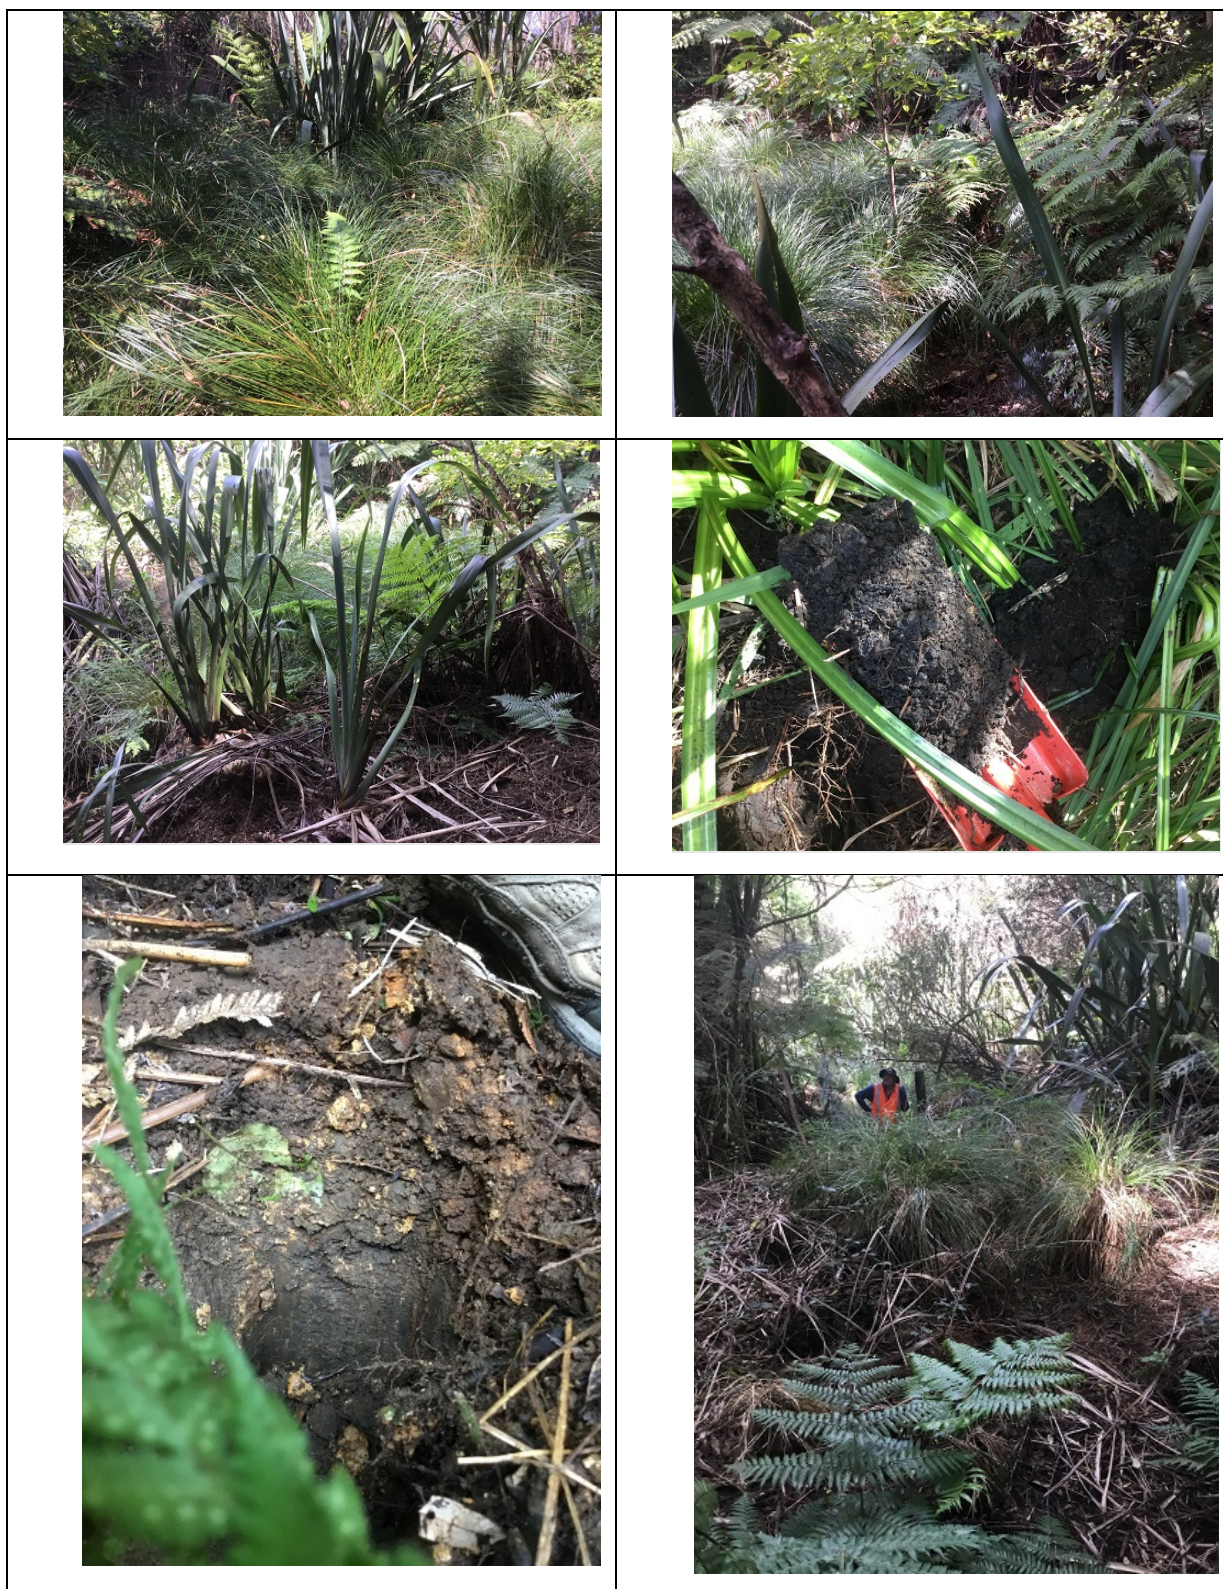
**Figure 10:** Gladstone headwater gully vegetation and soil profile.

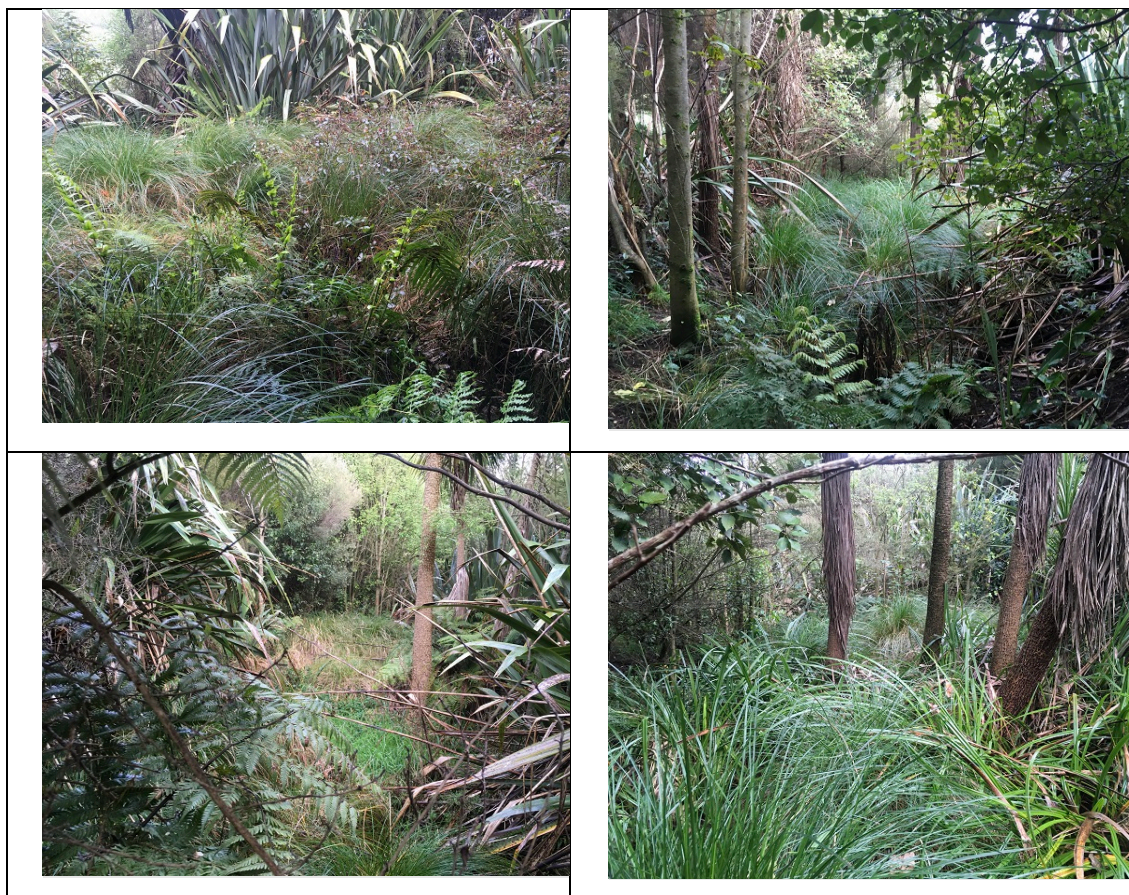
**Figure 11:** *Vegetation characteristics at Gladstone wetland.*

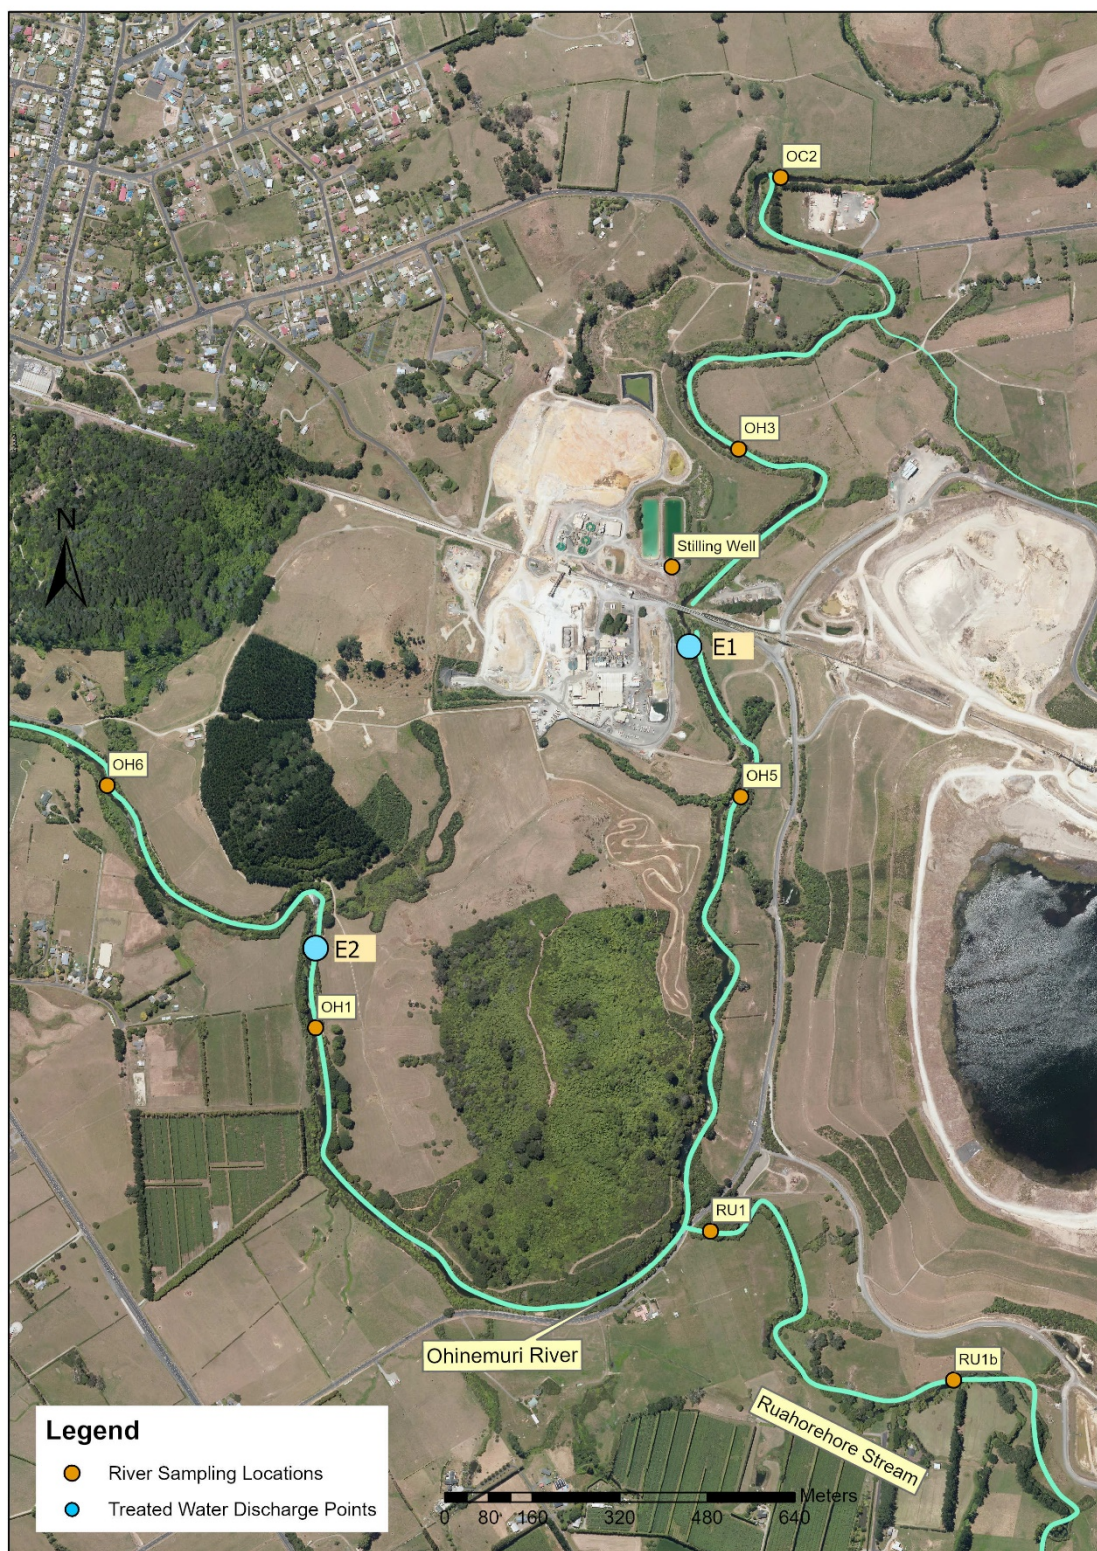
**Figure 14:** Sampling sites and treated water discharge locations, Ohinemuri River and Ruahorehore Stream (From GHD 2022B).

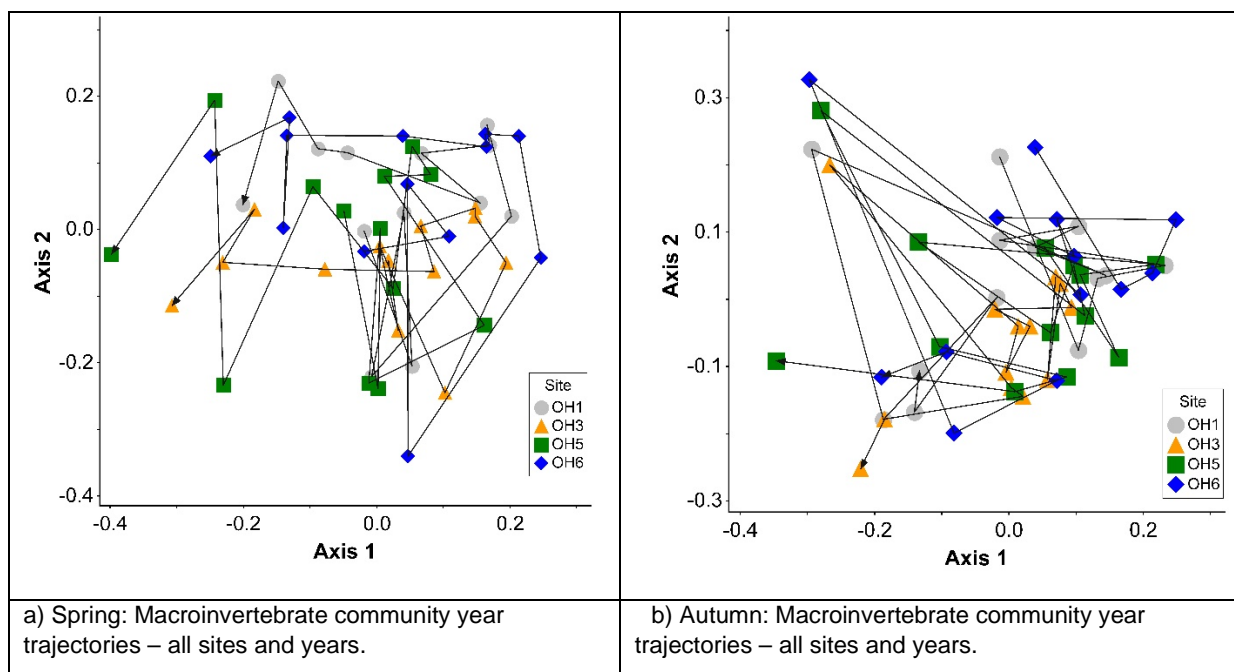
**Figure 18:** Ordination of year-to-year trajectories of macroinvertebrate communities for sites (sites OH1, OH3, OH5, OH6) on the Ohinemuri River, 2009-2021. Data from OGNZL biomonitoring programme.

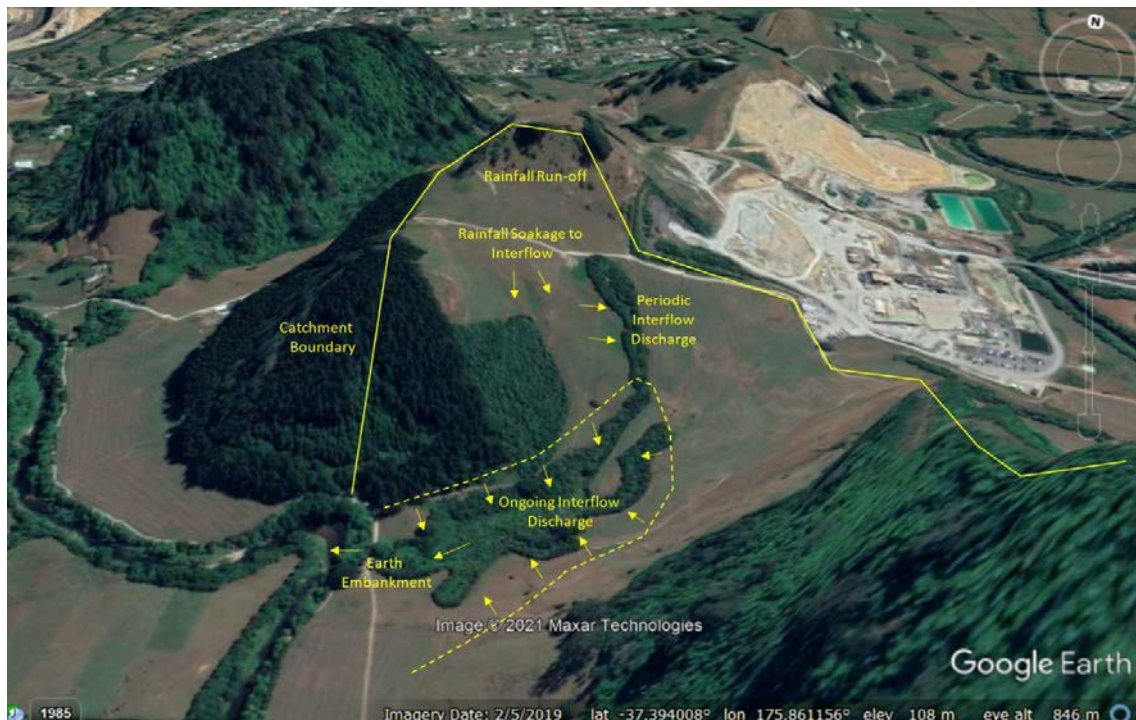
**Figure 26:** Conceptual hydrology of Gladstone Wetland (from GWS 2021).

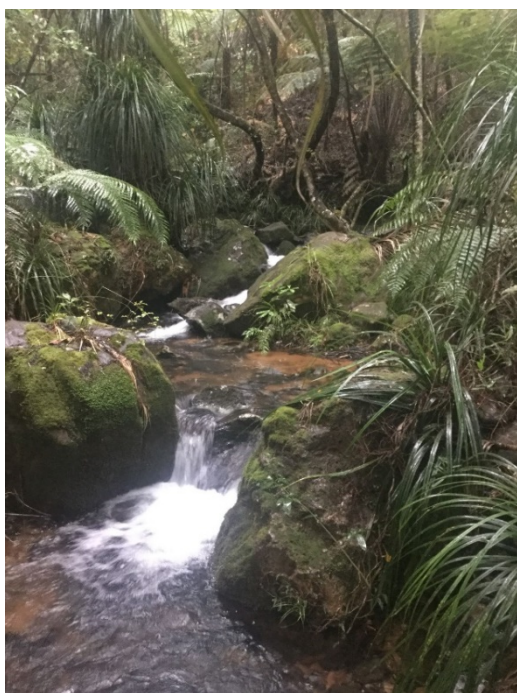
**Figure 4-2(a):** Unnamed tributary of the assessed reach of Waiharakeke main stem

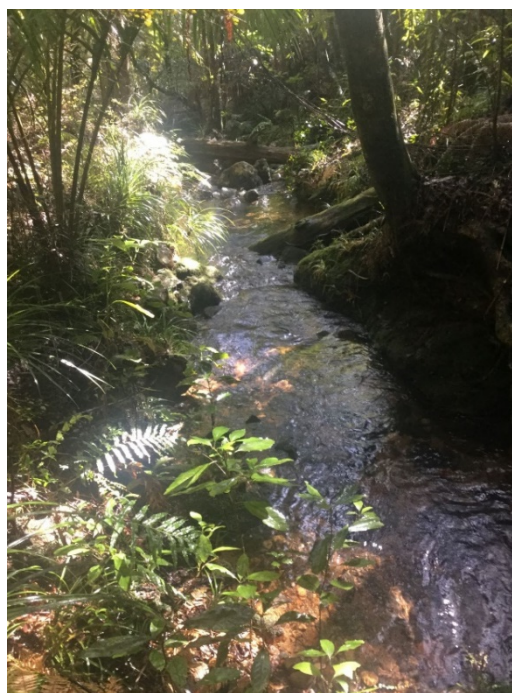
**Figure 4-2(b):** Unnamed tributary of the assessed reach of Waiharakeke main stem

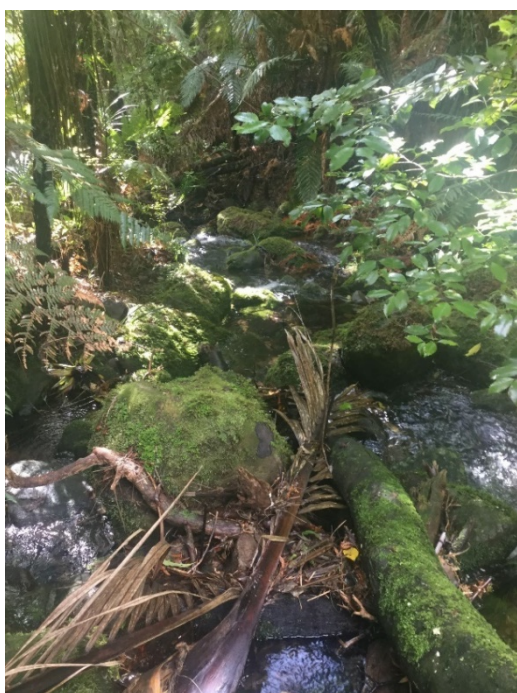
**Figure 4-2(c):** Unnamed tributary of the assessed reach of Waiharakeke right branch

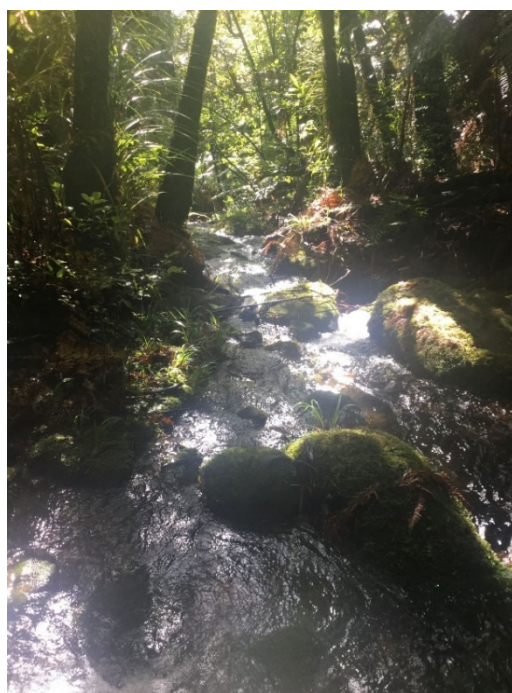
**Figure 4-2(d):** Unnamed tributary of the assessed reach of Waiharakeke right branch

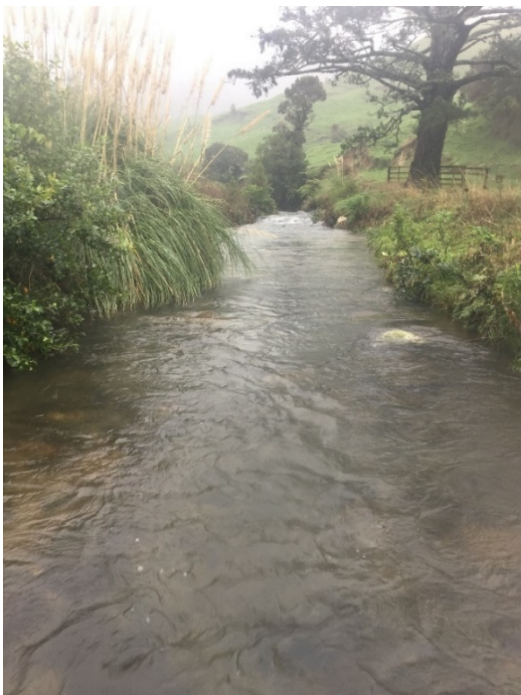
**Figure 4-3(a).** Mataura Stream reach flowing adjacent to the proposed works site.

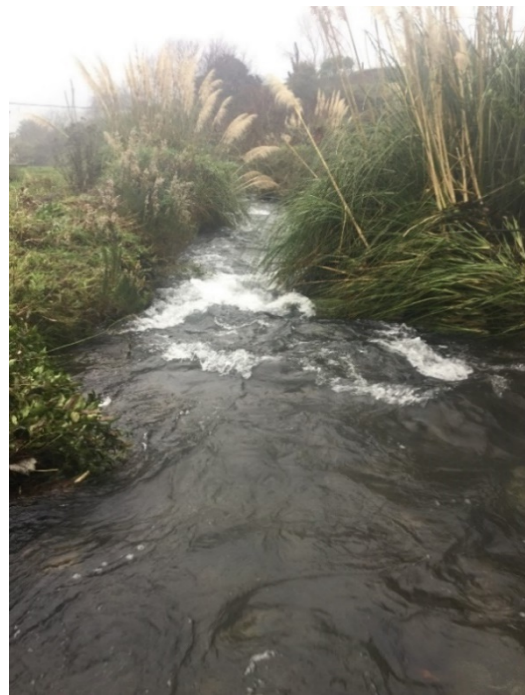
**Figure 4-3(b).** Mataura Stream reach flowing adjacent to the proposed works site.

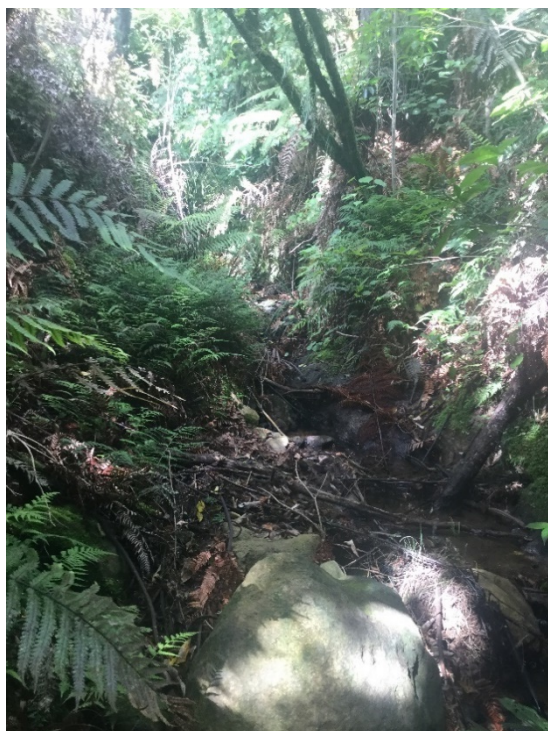
**4-4a.** Tributary 2 reach flowing through a section with more intact native riparian margin.

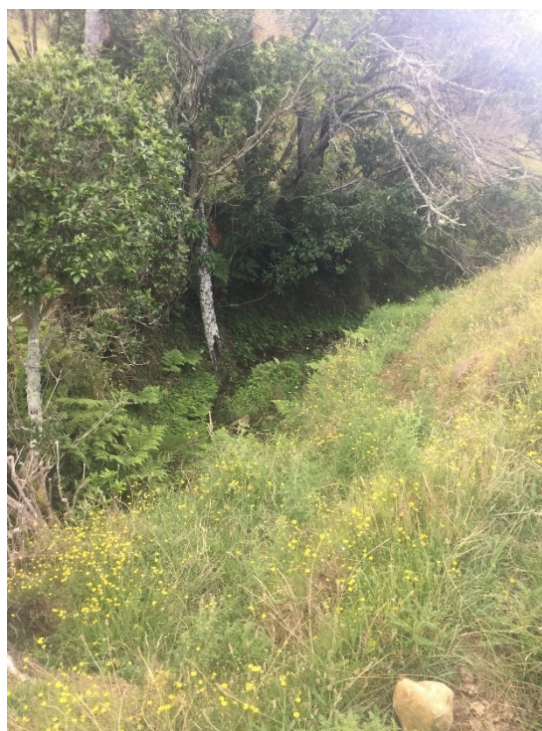
**4-4b.** Tributary 2 reach flowing through a section with minimal riparian vegetation.

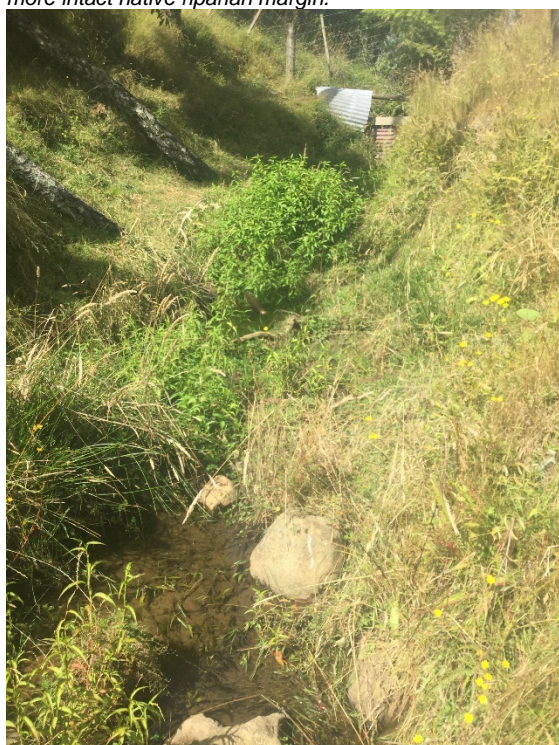
**4-4c.** Tributary 2 reach with grazed margins on both sides of the stream.

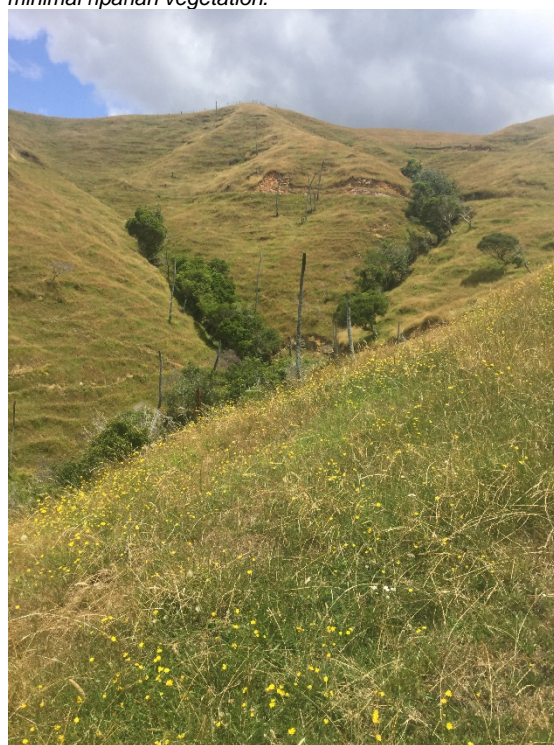
**4-4d.** The two small branches at the headwaters of the Tributary 2.

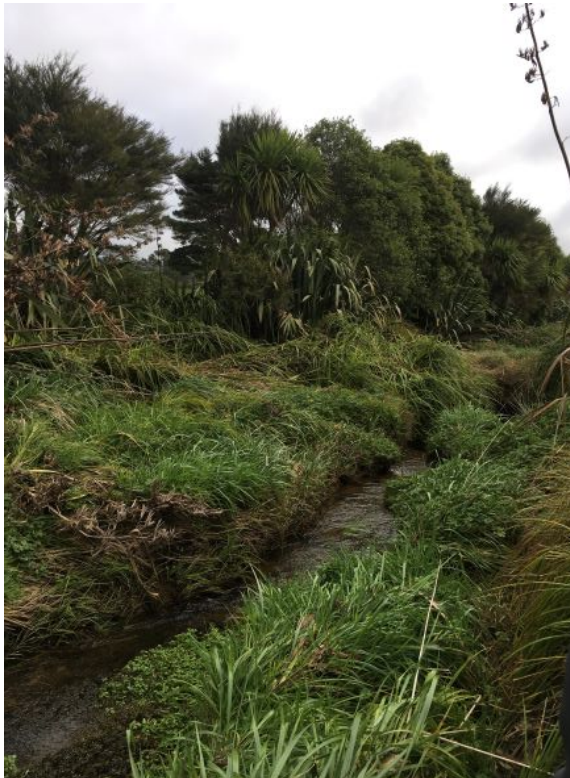
**Figure 4-5(a):** TB1 stream lower reach upstream

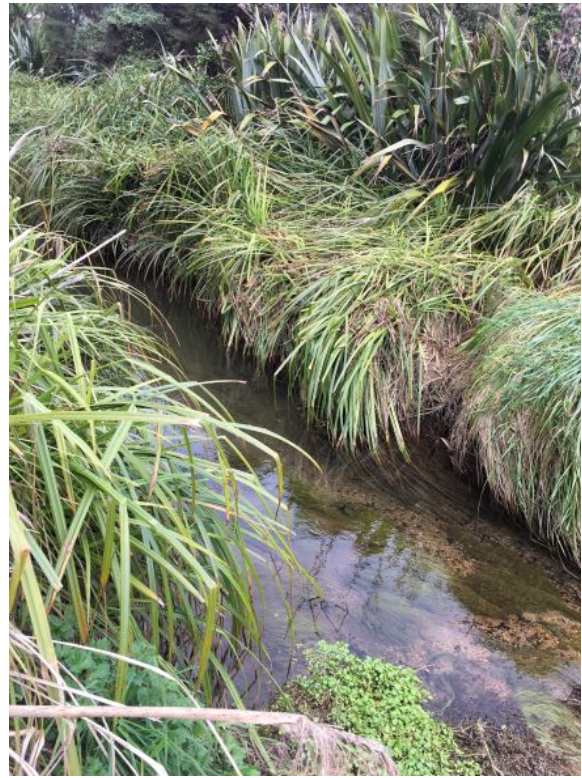
**Figure 4-5(b):** TB1 stream lower reach instream

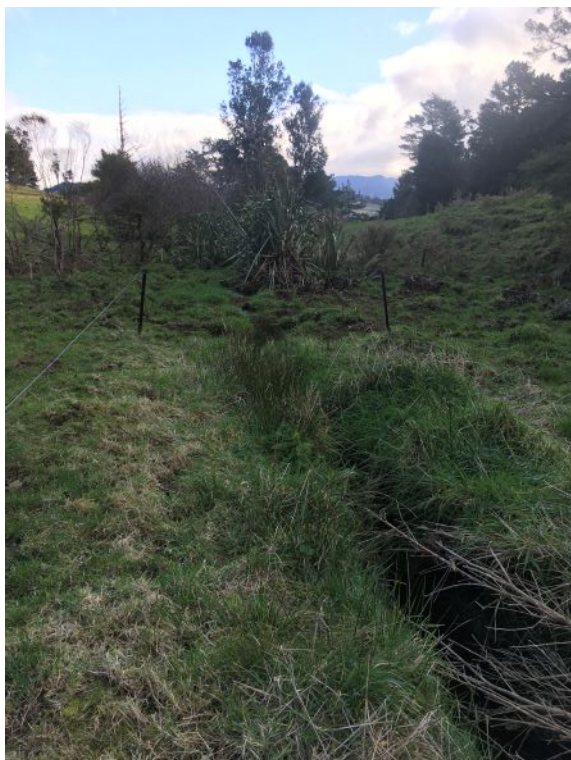
**Figure 4-6(a):** TB1 stream upper reach upstream

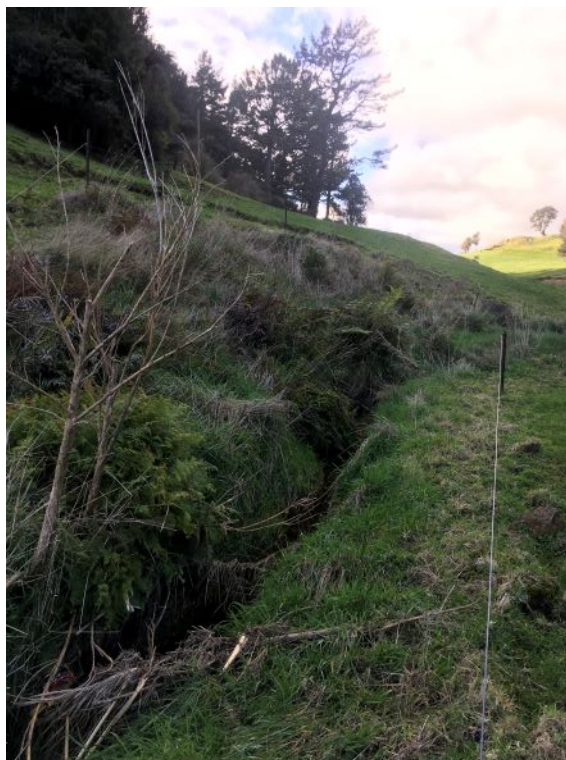
**Figure 4-6(b):** TB1 stream upper reach downstream

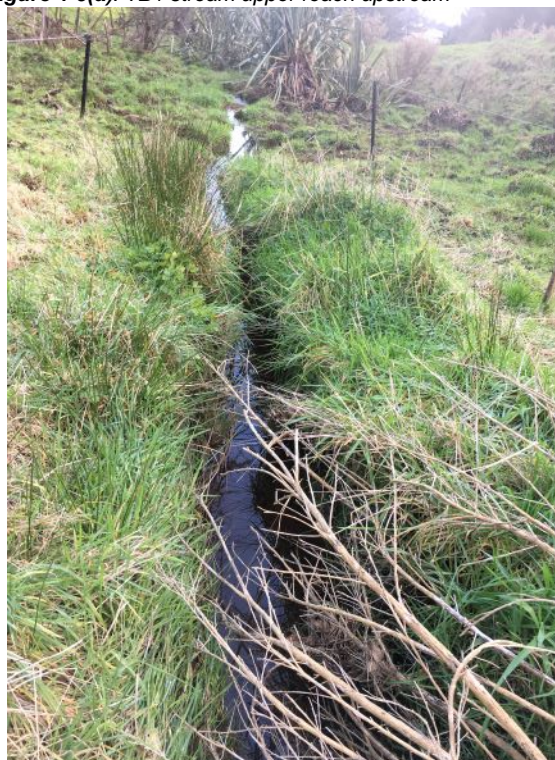
**Figure 4-6(c):** TB1 stream upper reach instream
