Project Ref: 2555087

Geotechnical Review for Proposed Development at Morven Ferry Road, Queenstown

Attachment 1 : Site Location Plan

Attachment 2 : Proposed Development Plans

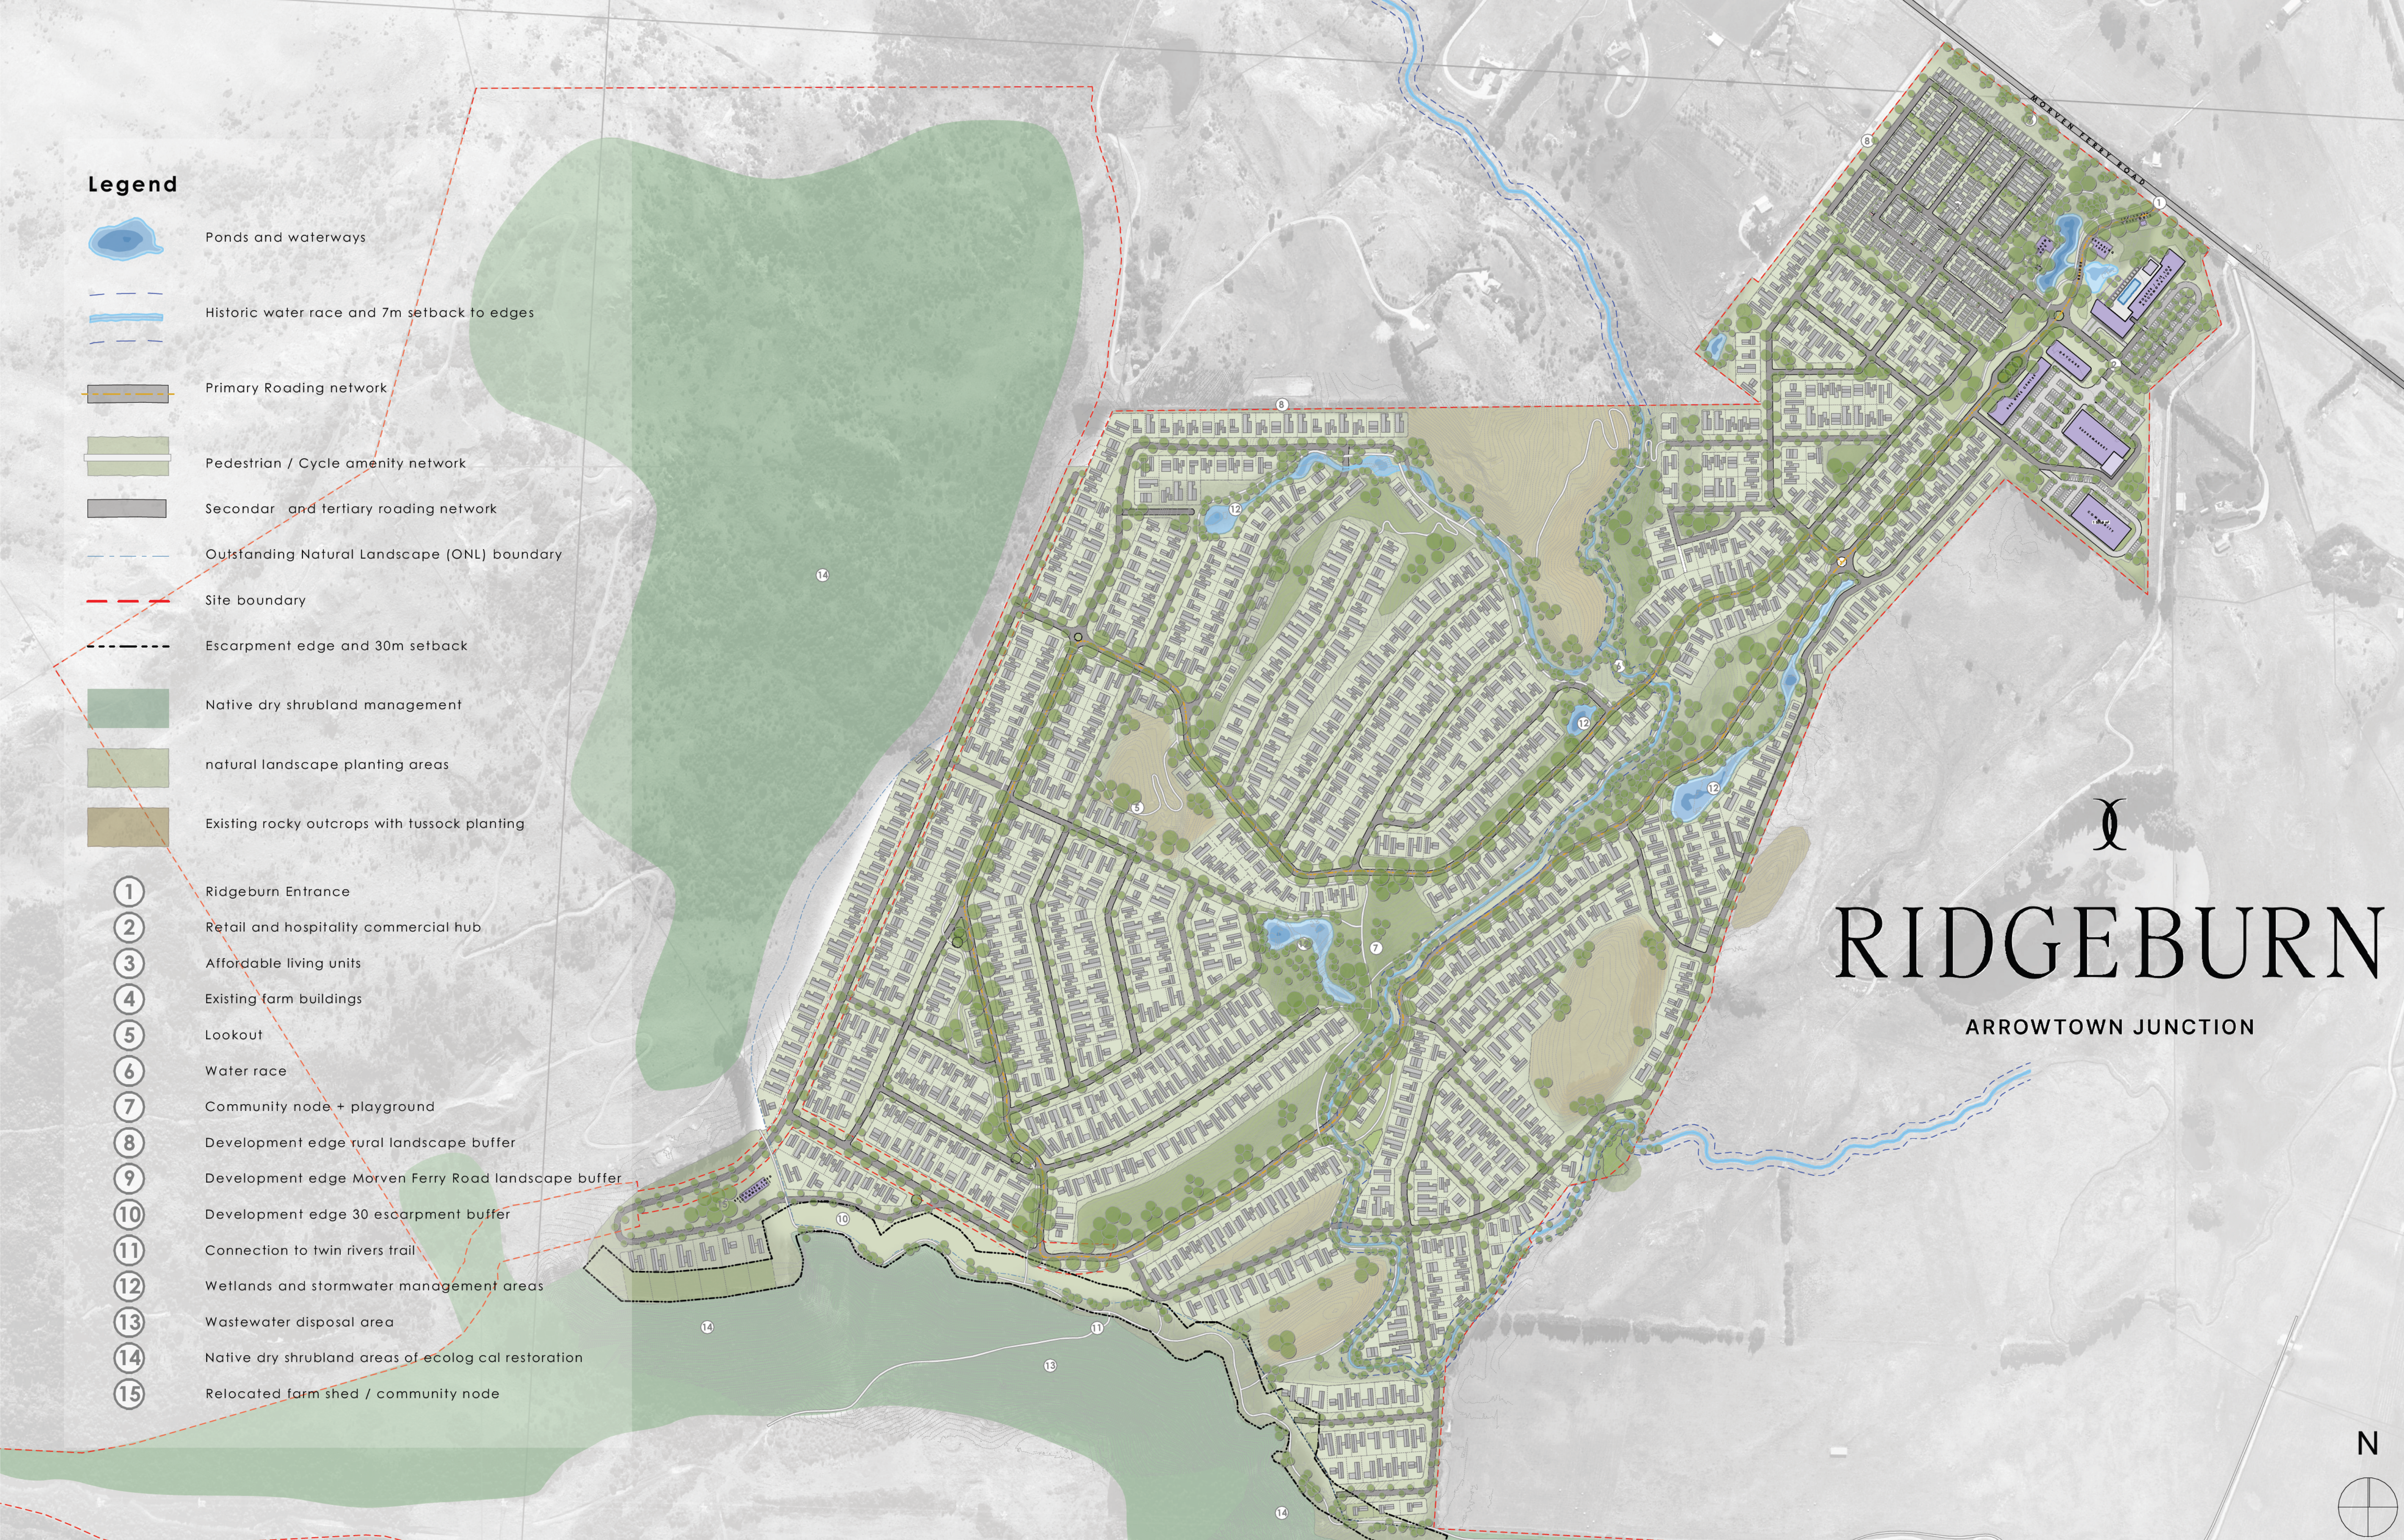
Site Master Plan

Kirk Roberts has been provided with a proposed development plan² (Master Plan) showing the development of 1,242 residential lots. The existing dwelling and ancillary buildings will be demolished and removed from the site. The proposed development plans are included in Attachment 2.
