# **OPARURE QUARRY SOUTH-WESTERN PIT**

## **OPARURE ROAD, WAITOMO**

### **TRAFFIC IMPACT ASSESSMENT**

**Prepared for Graymont New Zealand Limited  
June 2026**

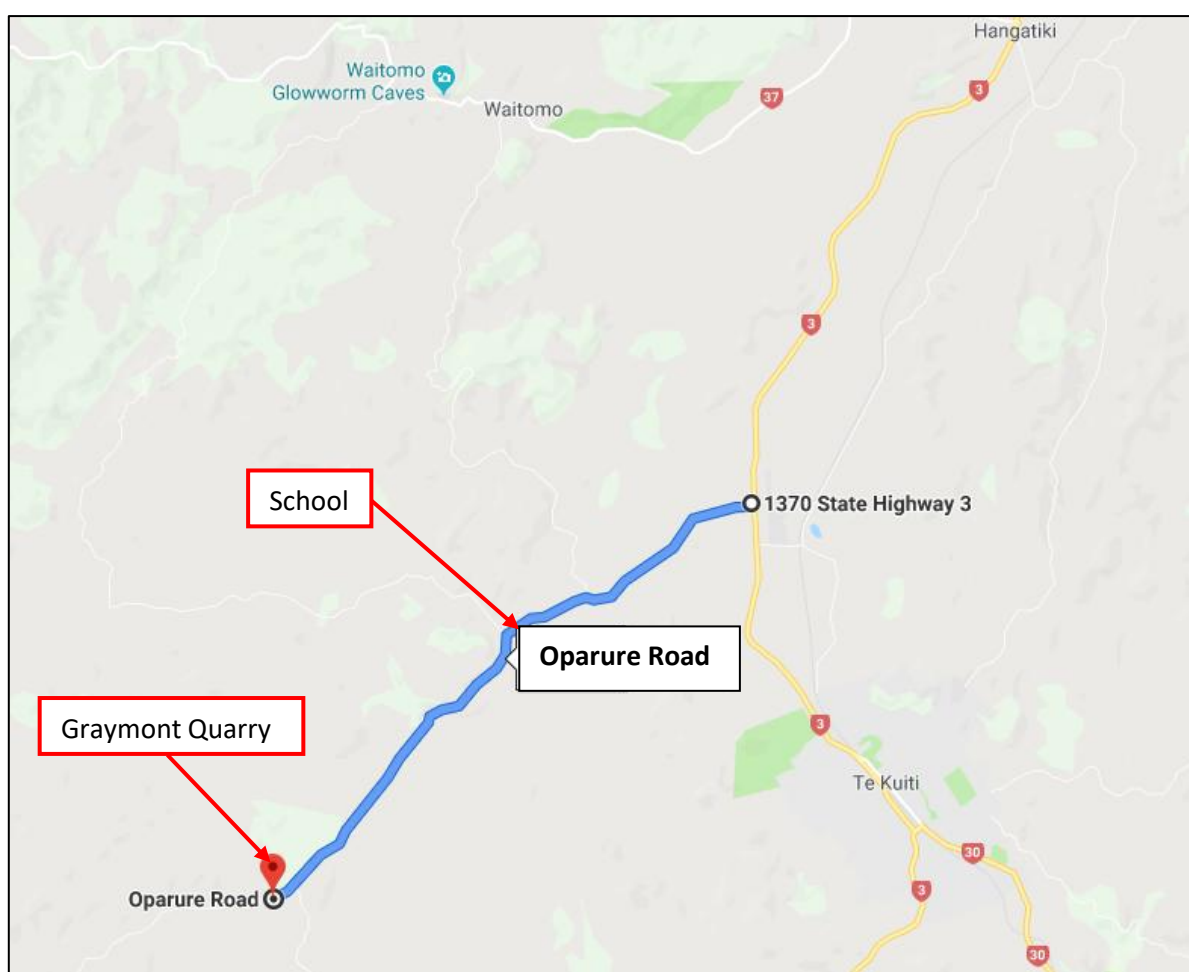
Figure 1: Location of the site relative to the roading network

The entrance to the Graymont Quarry is located approximately 8 kilometres west along Oparure Road from the intersection with State Highway 3. The location of the site relative to the local road network and a school on Oparure Road is shown in Figure 1, with Figure 2 showing an aerial view of the quarry site.

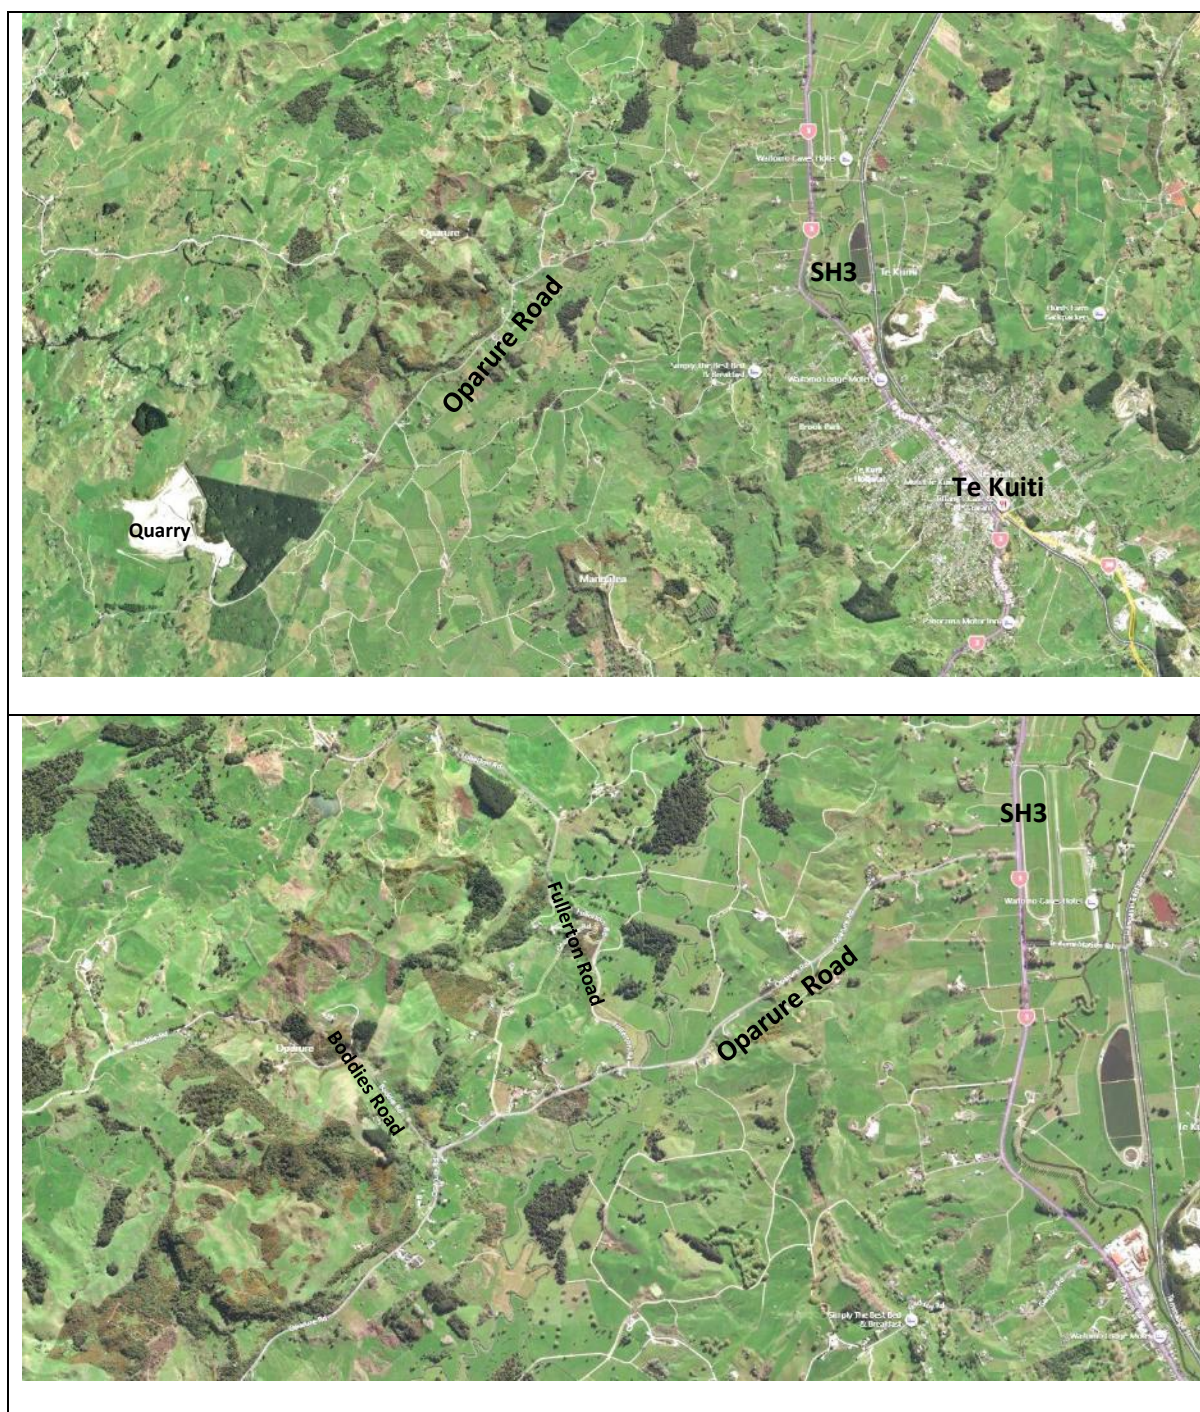
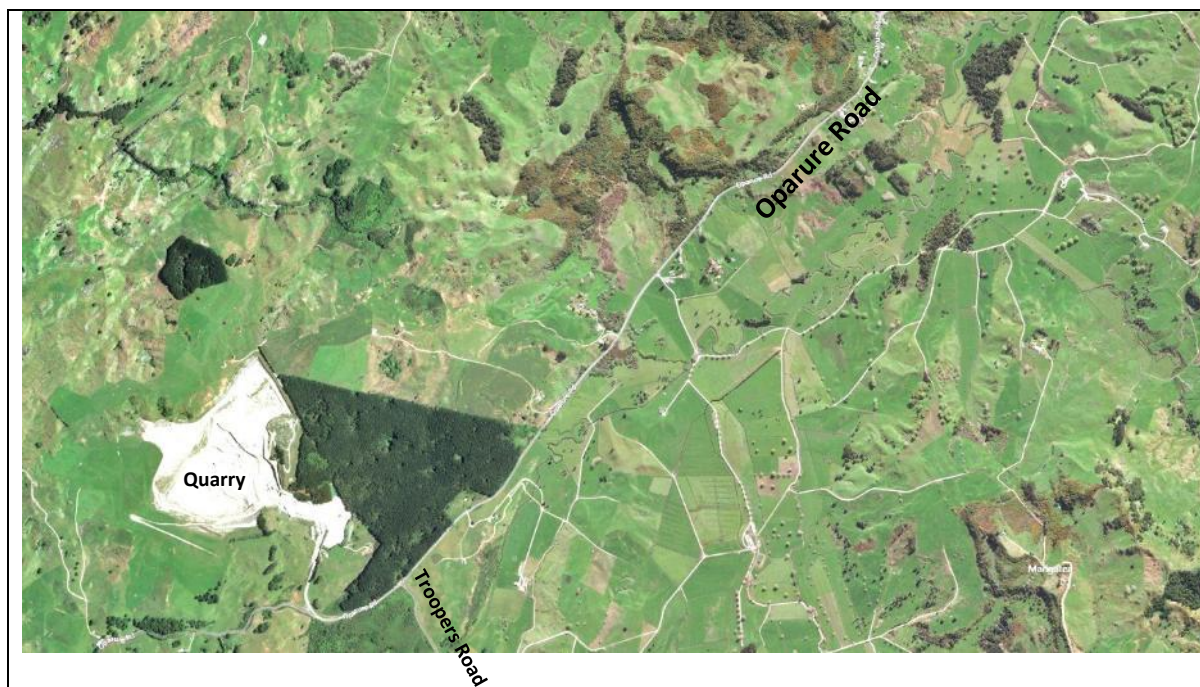
**Figure 3: Local and Regional Roading Network**

State Highway 3 provides a key strategic north-south route though the region, with Oparure Road and Troopers Road providing two local routes linking the quarry to State Highway 3.

Oparure Road has typically been constructed to a relatively high standard with formation widths that vary due to the topography of the area and constraints such as bridges and culverts.

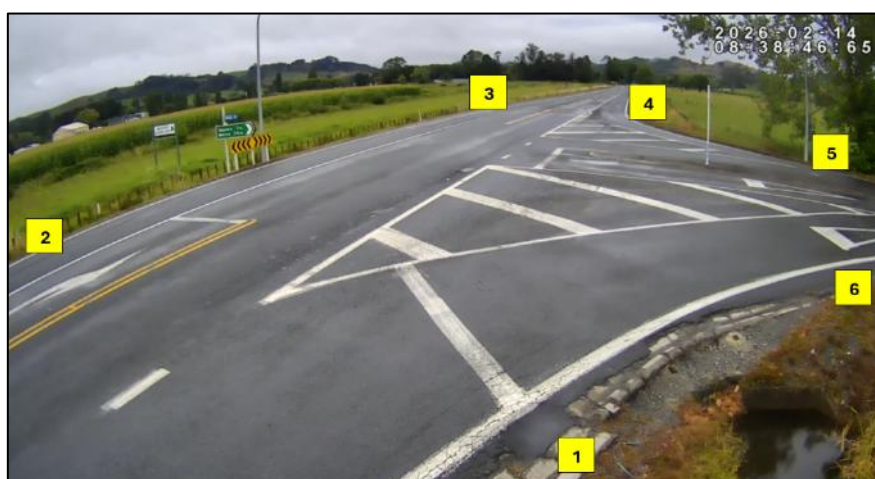
*Figure 13: Origin-Destination zones for Active modes at SH3/Oparure Road intersection*

Observations of the movements relating to pedestrian and cyclist activity (active modes) in all directions at the SH3/Oparure Road intersection over the surveyed period 0500-2000 Wednesday 11 February, Thursday 12 February and Saturday 14 February 2026 showed the following movements occurred between the zones identified in the following illustration.

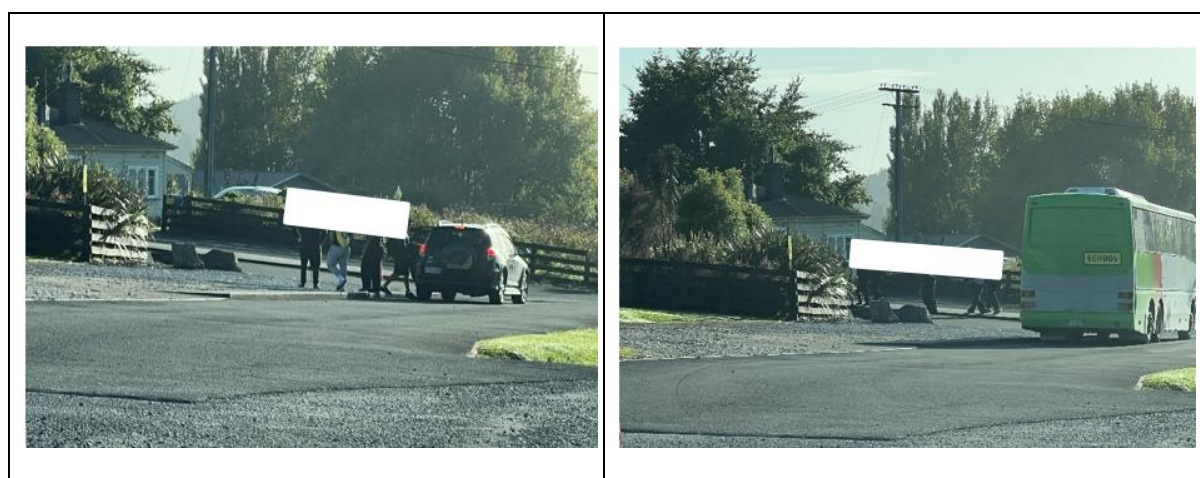
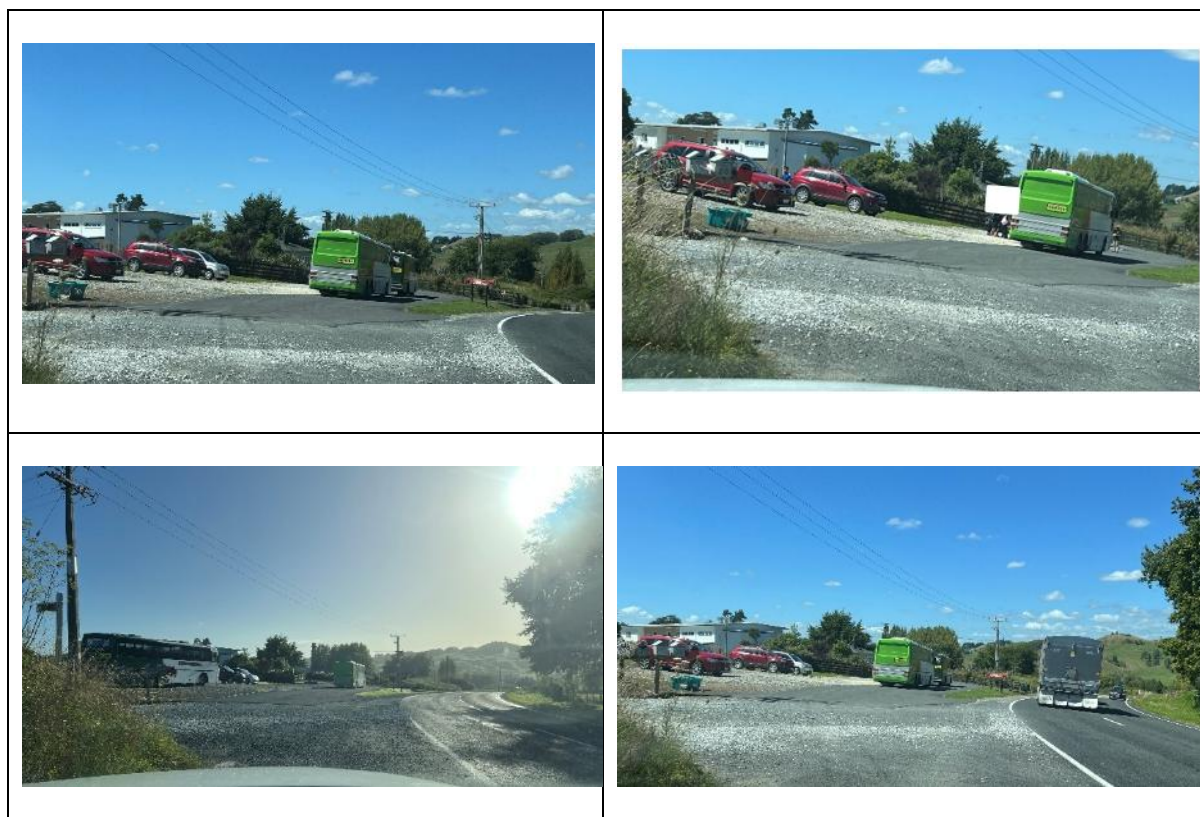
No parking or pedestrian activity associated with the school was observed occurring on either side of the carriageway or its shoulders of the road and nor was any parking or student movement observed occurring across the road or along the shoulders of the road to/from adjacent properties.

All of this activity therefore occurs in locations that are physically separated from the road, with no pedestrian-vehicle interaction observed occurring on the road or with passing quarry trucks.

Representative photographs showing this activity during these time periods are provided below (faces have been obscured for privacy reasons).

From the observations outside the school, close to the ‘twin bridges’ and at the SH3 intersection it has been concluded that:

- There is no evidence of any parking occurring on either side of the sealed lanes associated with the collection or dropping-off of school children at the Te Wharekura o Maniapoto school.

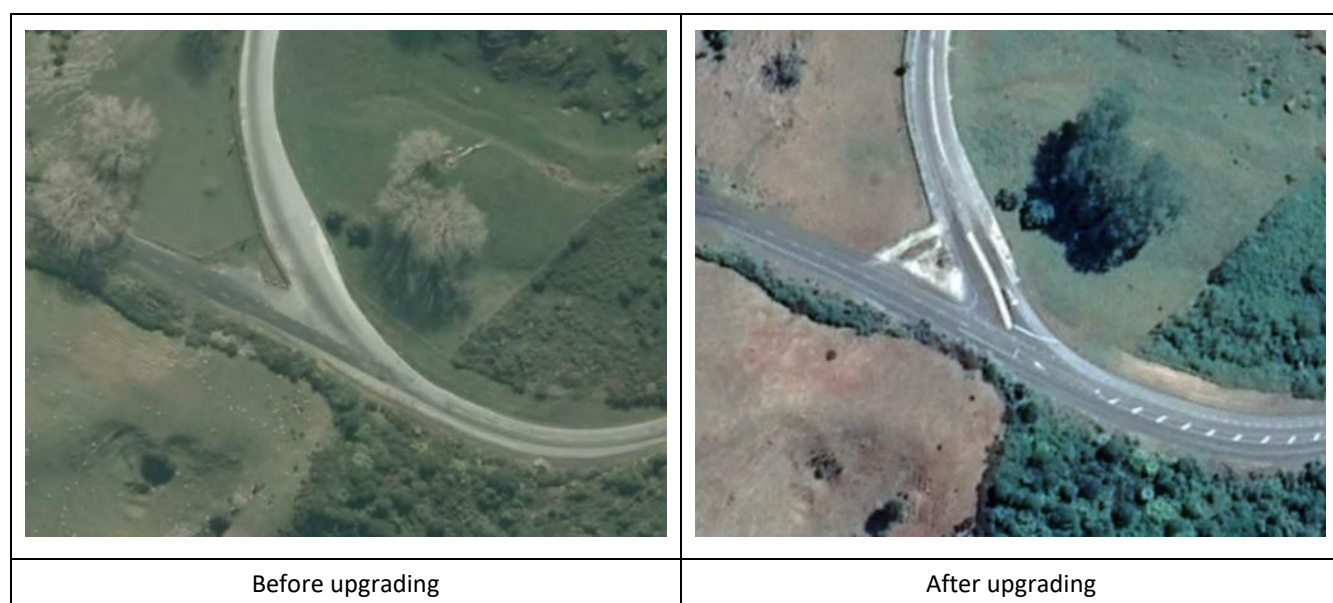
*Figure 15: Quarry access changes*

This resulted in a substantial upgrade of the intersection of Oparure Road and the main access road that serves the quarry occurring a short time later. The upgrade works undertaken included road widening and the provision of a formal right turn bay.

Imagery of the previous layout and the upgraded layout taken from Google Earth is shown in Figure 15 below.

The upgraded intersection with formal right turn bay has now been in operation for a number of years and has proven to be successful in achieving the much safer and higher quality access than was previously provided.
