an application for approvals by **NZ Transport Agency Waka Kotahi** to construct, operate and maintain the State Highway 1 Wellington Improvements project

**STATE HIGHWAY 1 WELLINGTON IMPROVEMENTS PROJECT  
TECHNICAL REPORT #12  
MARINE ECOLOGY ASSESSMENT**

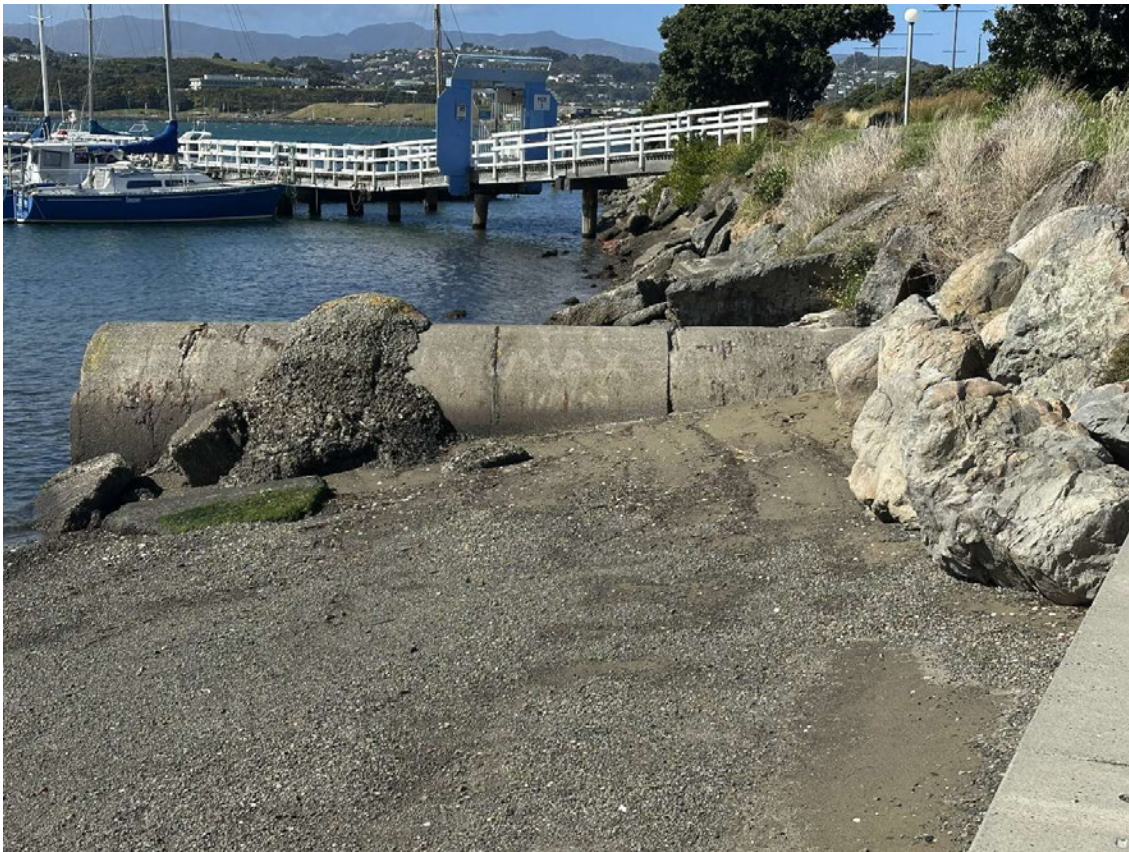
**Figure 4 - Evans Bay stormwater outfall looking East, including the fine sediment/gravel beach to the west of the stormwater outfall**

70. The coastal zone of Evans Bay where the existing Evans Bay stormwater outfall (Figure 4) and SH1 stormwater discharge is proposed, has a range of largely manmade structures which influence local ecology below mean high water springs. The embayment contains soft sediment/gravel subtidal habitat and natural or artificial cobble, boulder and rocky shore habitat. Evans Bay is highly modified and reclamation has occurred in the area. To the southeast of the Evans Bay stormwater outfall, the shoreline has been armoured with rock revetment and rubble. The intertidal habitat directly northwest of the stormwater outfall is a gravel and fine sediment beach extending for c.20 m toward the northern section of the coastline and the marina (Annexure A).

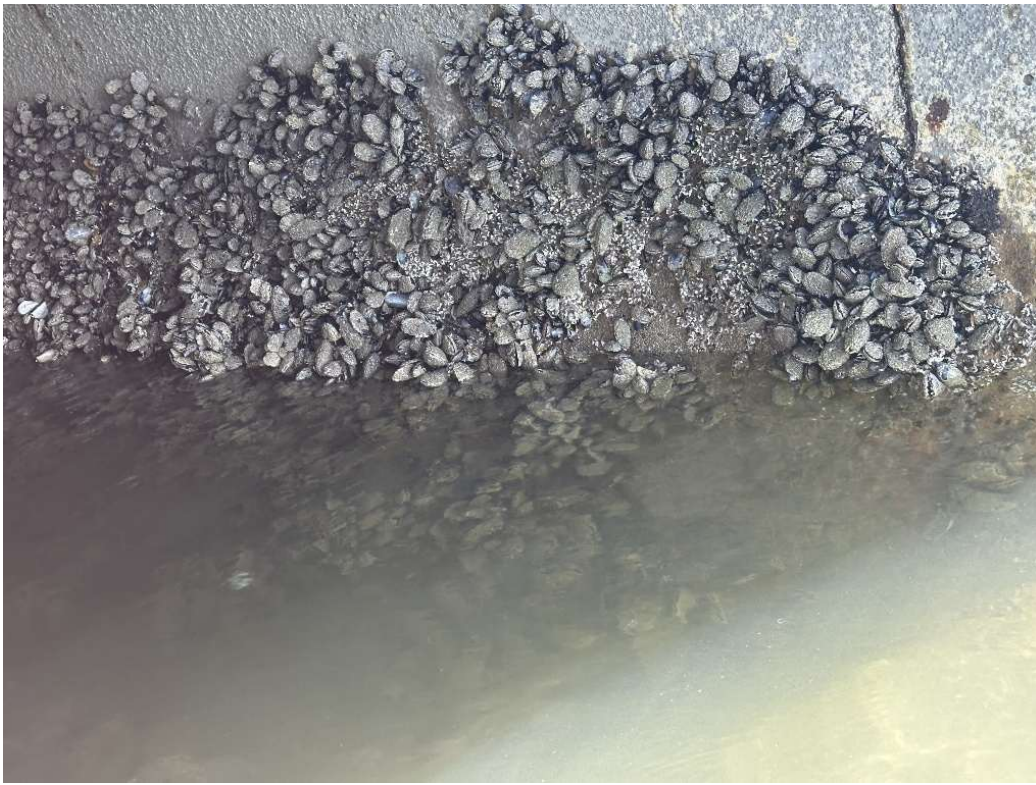
**Figure 7 - Mussel beds lining the inner barrel of the Evans Bay stormwater outfall. Photo taken September 2025**

stormwater from the Hataitai catchment. The Evans Bay stormwater outfall remains permanently subtidal, lined with dense mussel beds (primarily *Mytilus edulis*), and surrounded by boulders, cobbles, and fine sediments.

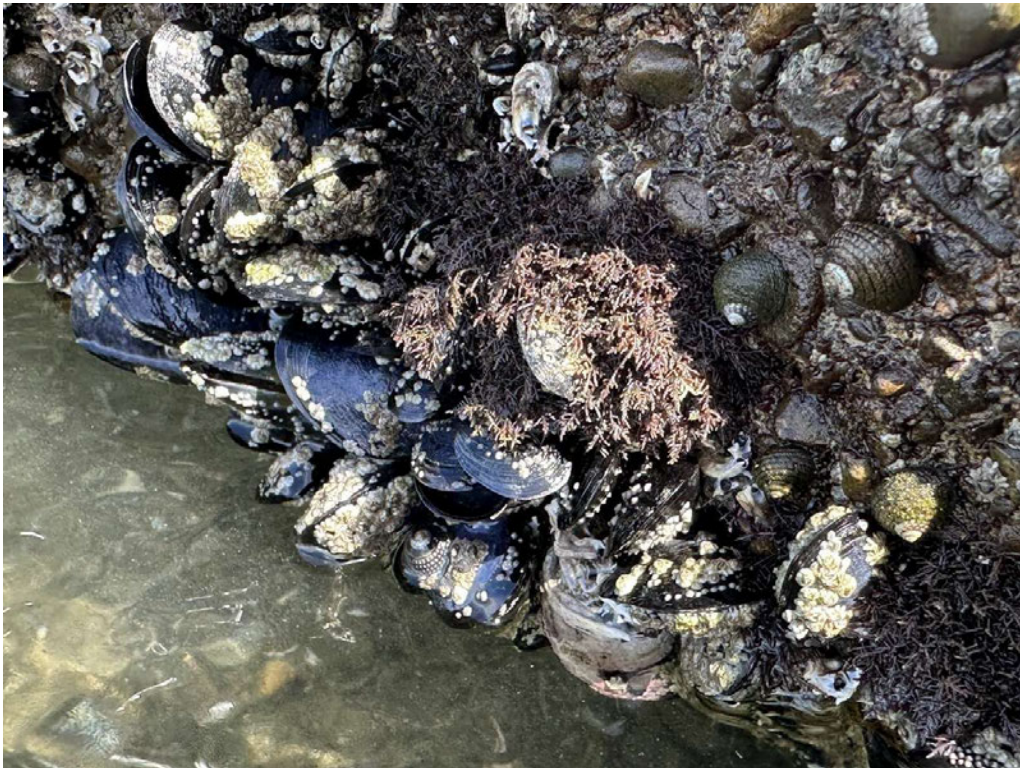
**Figure 8 - Mussel beds with a mosaic of invertebrate species on artificial rocky substrate. Photo taken September 2025**

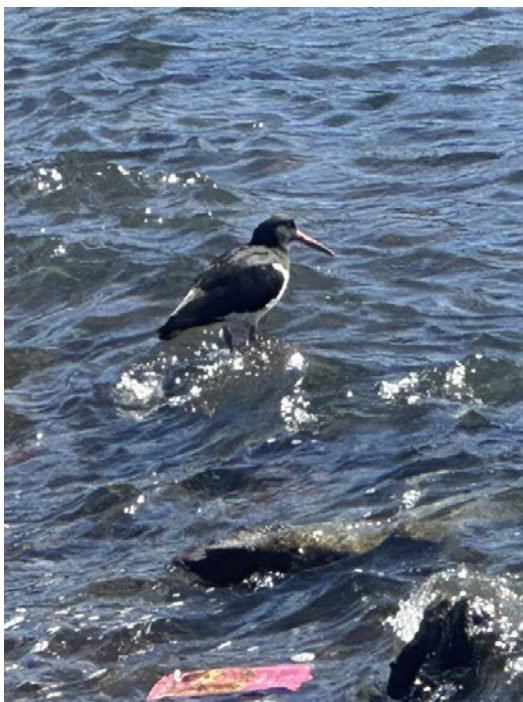
**Figure 10 - South Island Pied oystercatcher present within a flock of variable oystercatchers among the revetment, east of the Evans Bay stormwater outfall. Photo taken September 2025**

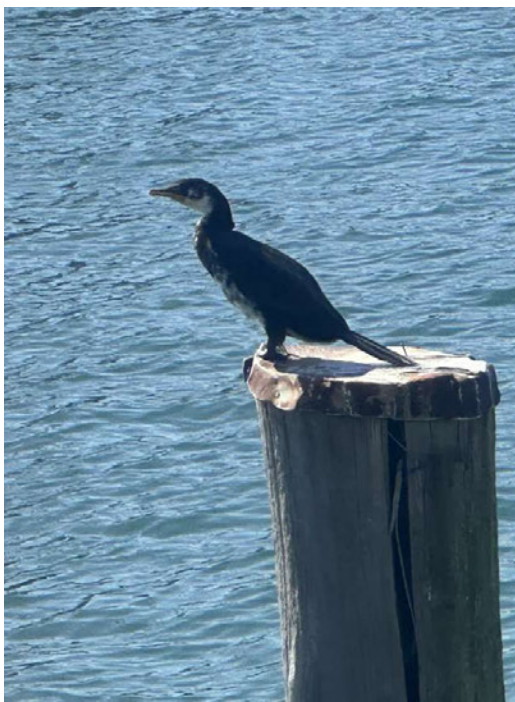
**Figure 11 - Little shag resting on pile, east of the Evans Bay stormwater outfall in the subtidal. Photo taken September 2025**

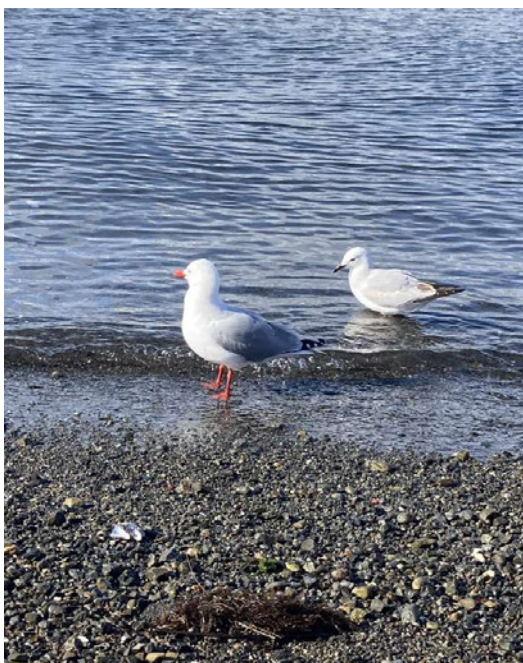
**Figure 12 - Adult and juvenile Red billed gulls on gravel/ sand beach west of Evans Bay stormwater outfall. Photo taken September 2025**

106. The intertidal gravel beach provides habitat for roosting birds higher on the shoreline, as was observed in September 2025. A flock of adult and juvenile red billed gulls (*Chroicocephalus novaehollandiae scopulinus*) were observed resting and foraging west of Evans Bay stormwater outfall and on the gravel beach. Mallard ducks (*Anas platyrhynchos*) were also present. Variable oystercatchers (*Haematopus unicolor*) and one South Island pied oystercatcher (*H. finschi*) were present to the east of the stormwater outfall, resting on the revetment. There is a likelihood that they could use the gravel beach west of the Evans Bay stormwater outfall as roosting habitat as well. A little shag (*Microcarbo melanoleucos*) was observed to the east of the stormwater outfall, resting on a lone pile. Little shags are widespread along the Wellington City coastline, with noticeably higher densities present at Evans Bay (McArthur, 2025). Spotted shag (*Phalacrocorax punctatus*) has also been observed at Evans Bay during annual surveys carried out between 2018 and 2022 (McArthur, 2022).

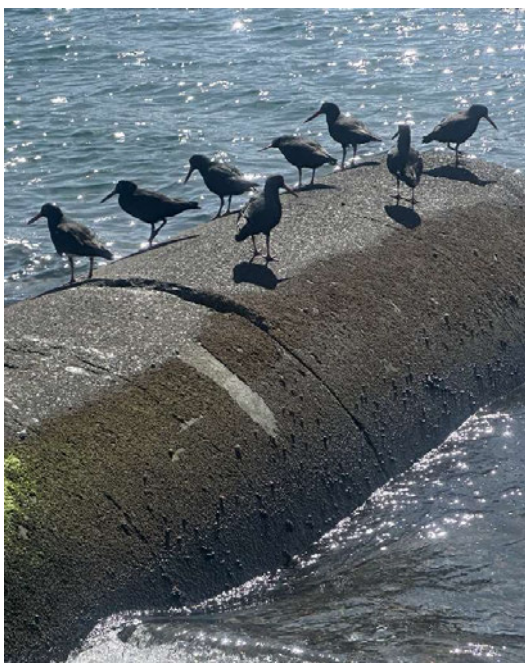
**Figure 13 - Flock of variable oystercatchers resting on the eastern stormwater outfall along Cobham Drive. Photo taken September 2025**

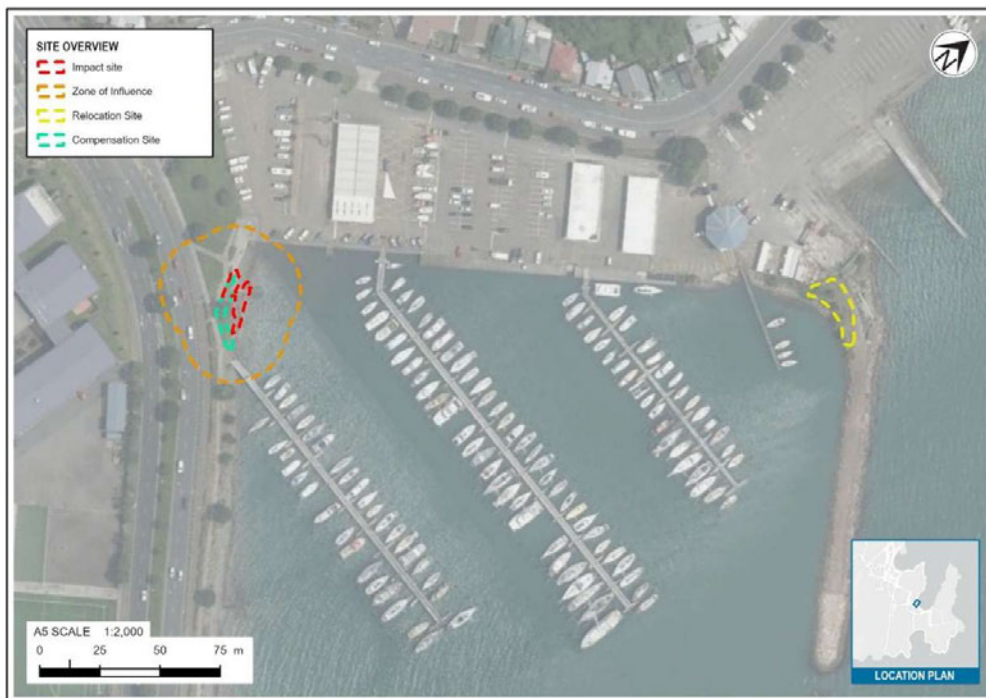
**Figure 16 - Site overview showing the impact within the zone of influence at the Evans Bay Outfall**

286. For ease of reference, Figure 16 below shows the key relevant kororā locations, which are:
  - i. The relevant part of the Project site (impact site) and associated secondary ZOI<sup>16</sup> for potential noise effects on kororā

- ii. The proposed site for relocation of kororā during construction (if required)
  - iii. The proposed location for the compensation measures (nesting structures, planting and fencing)

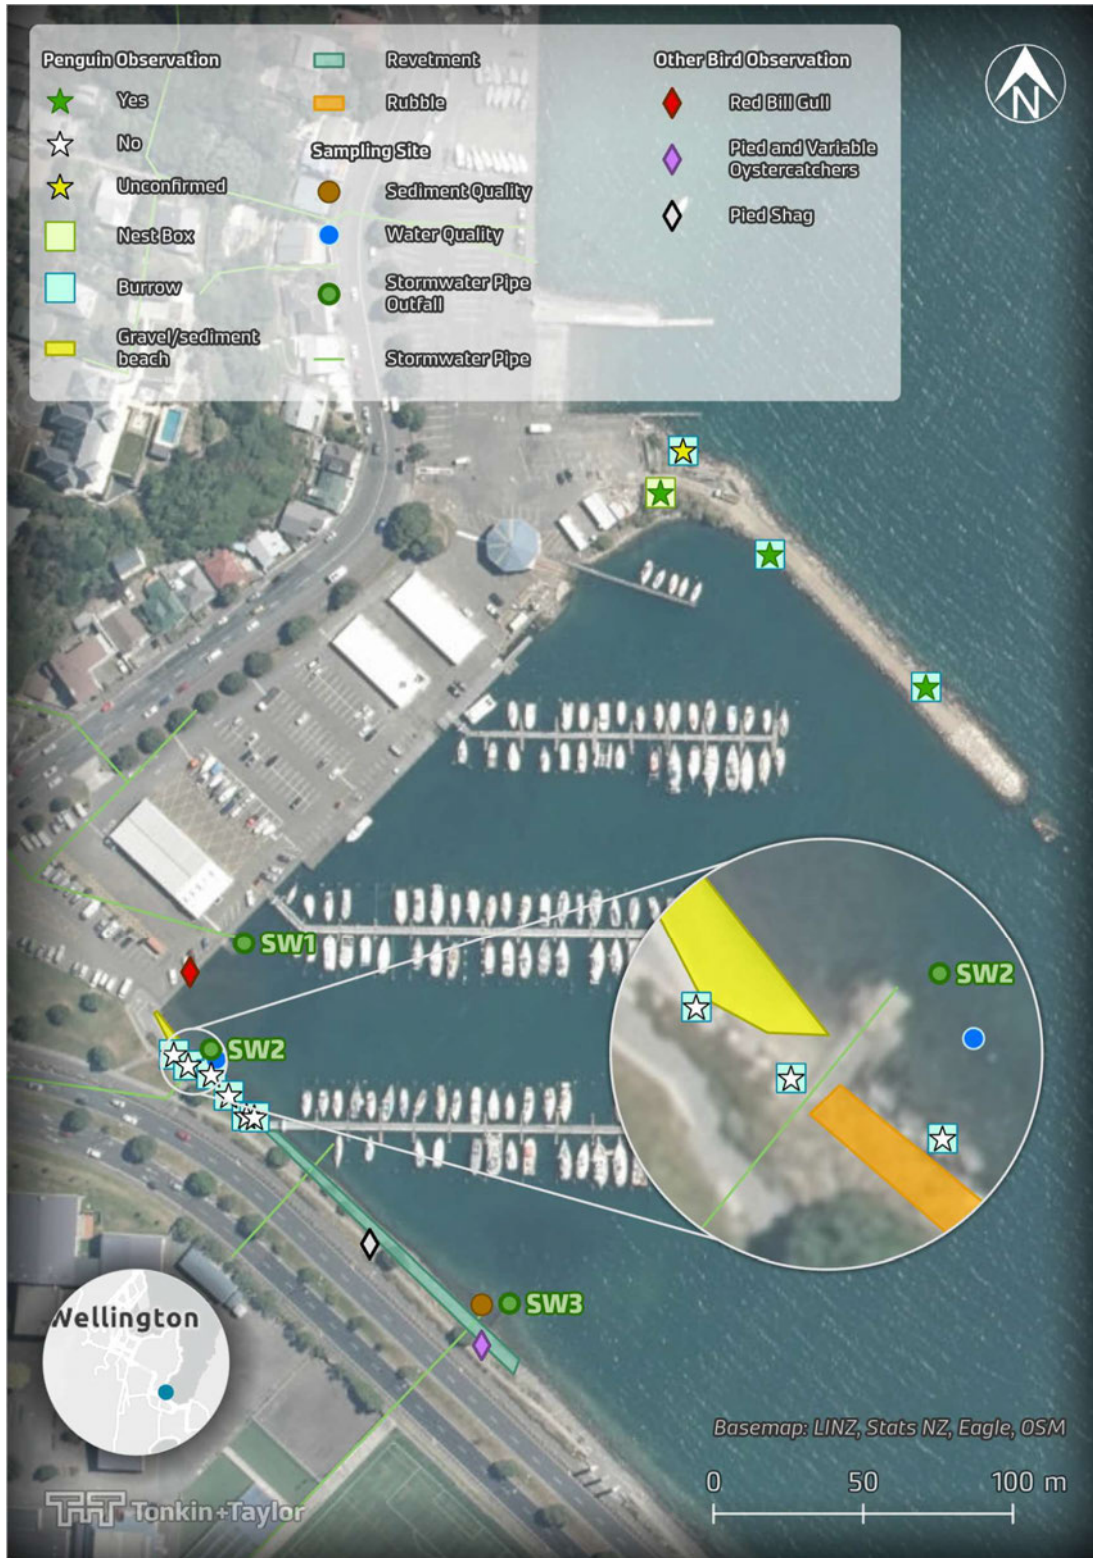
## ANNEXURE A: Evans Bay habitat map and sample site locations

Figure 17 - Marine sampling sites and observations at Evans Bay

90. Sediment samples were collected from adjacent to the discharge locations of three stormwater drain discharge locations within Evans Bay (see Annexure A for locations).
91. Analysis of heavy metals across the three discharges monitored for sediment contaminants found elevated levels of copper (30 to 60 mg/kg), lead (68 to 105 mg/kg) and zinc (159 to 230 mg/kg). All of the results for lead and zinc exceeded Environmental Response Criteria (ERC) red guidelines for lead and zinc, and for copper at SW1 and SW3. All results for arsenic, chromium, cadmium and nickel were below the Australia and New Zealand Guidelines Default Guideline Values (ANZG DGV) guidelines (Table 3).
