Appendix D: Laboratory Test Results

DIRECT SHEAR (SHEAR BOX) TESTING

Re: MILLDALE STAGE 7

Report Number: 63282#L/SB Milldale Stage 7 MH01-23 7.15 - 7.41m

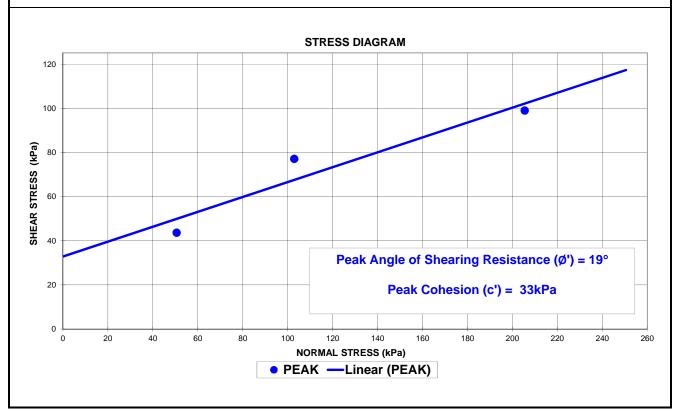
Job No:	63282#L		Page 4 of 4
Reg No:	2766	Report No:	63282#L/SB Milldale Stage 7 MH01-23 7.15 - 7.41m
	N /		VIECTACE 7

SILTSTONE, very weak, greenish grey.

Initial Dry Density (t/m³)	Initial Moisture Content (%)	Normal Stress (kPa)	Normal Displacement (mm)	PEAK Shear Stress (kPa)	Displacement at Failure (mm)	Average Rate of Displacement (mm/minute)
		SHEA	R CYCLE 1 - FA	ILURE VALUES		
1.54	25.0	50.6	0.058	43.6	0.856	0.012
	SHEAR CYCLE 2 - FAILURE VALUES					
1.52	24.8	102.9	0.023	77.1	1.010	0.011
	SHEAR CYCLE 3 - FAILURE VALUES					
1.53	25.2	205.5	0.063	99.0	1.148	0.010

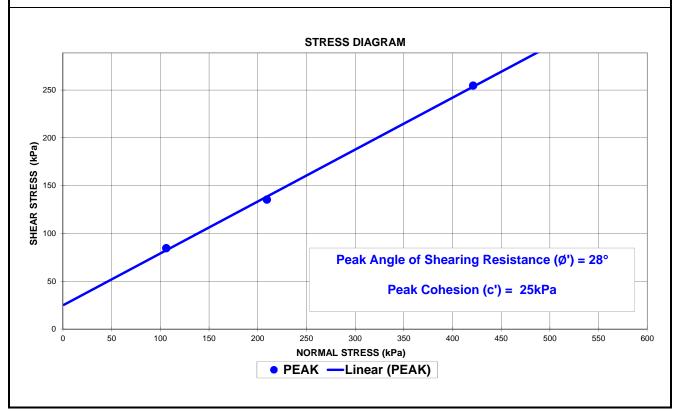
Job No:	63282#L		Page 4 of 4
Reg No:	2766	Report No:	63282#L/SB Milldale Stage 7 MH01-23 14.00 - 14.25m

SILTSTONE, very weak, grey, sheared & slickensilded.

Initial Dry Density (t/m³)	Initial Moisture Content (%)	Normal Stress (kPa)	Normal Displacement (mm)	PEAK Shear Stress (kPa)	Displacement at Failure (mm)	Average Rate of Displacement (mm/minute)
		SHEA	R CYCLE 1 - FA	ILURE VALUES		
1.49	26.4	106.1	0.066	84.6	2.394	0.014
	SHEAR CYCLE 2 - FAILURE VALUES					
1.53	25.5	209.4	0.124	135.3	2.007	0.011
	SHEAR CYCLE 3 - FAILURE VALUES					
1.49	25.7	421.2	0.153	254.5	2.365	0.009

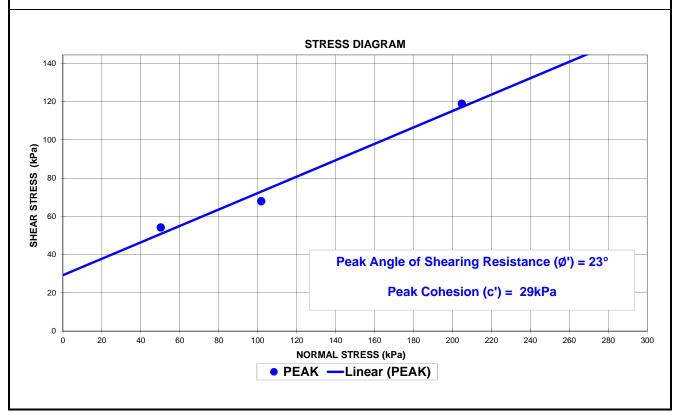
Job No:	63282#L		Page 4 of 4
Reg No:	2766	Report No:	63282#L/SB Milldale Stage 7 MH02-23 2.85 - 3.00m

SILTSTONE with thin sandstone bands, very weak, sheared, grey.

Initial Dry Density (t/m³)	Initial Moisture Content (%)	Normal Stress (kPa)	Normal Displacement (mm)	PEAK Shear Stress (kPa)	Displacement at Failure (mm)	Average Rate of Displacement (mm/minute)
		OHEA	K O TOLL T TA	MEGNE VALUES		
1.45	30.1	50.2	0.080	54.2	0.484	0.009
	SHEAR CYCLE 2 - FAILURE VALUES					
1.49	27.0	101.8	0.021	67.9	0.512	0.008
	SHEAR CYCLE 3 - FAILURE VALUES					
1.46	29.4	204.8	0.082	118.8	0.986	0.009

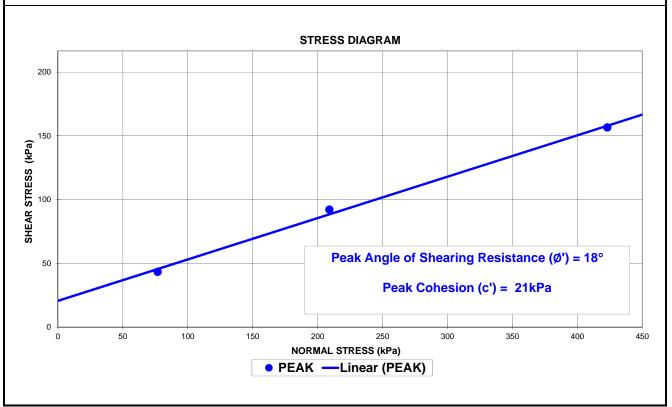
Job No:	63282#L		Page 4 of 4
Reg No:	2766	Report No:	63282#L/SB Milldale Stage 7 MH03-23 5.65 - 5.90m

brown, shiny smooth surfaces, hard brown chert inclusions, slightly moist.

(Hot IANZ endorsed)			•		• •	
						Average Rate
Initial Dry	Initial Moisture	Normal	Normal	PEAK	Displacement	of
Density	Content	Stress	Displacement	Shear Stress	at Failure	Displacement
(t/m ³)	(%)	(kPa)	(mm)	(kPa)	(mm)	(mm/minute)
		SHEA	R CYCLE 1 - FA	ILURE VALUES		
1.63	22.7	76.8	0.005	43.3	0.653	0.011
		SHEA	R CYCLE 2 - FA	ILURE VALUES		
	·		1			1
1.60	24.3	209.0	0.101	92.1	1.930	0.013
		SHEA	R CYCLE 3 - FA	ILURE VALUES		
	T		1			ı
1.69	22.1	423.1	0.173	156.5	2.565	0.012
	•		•			•

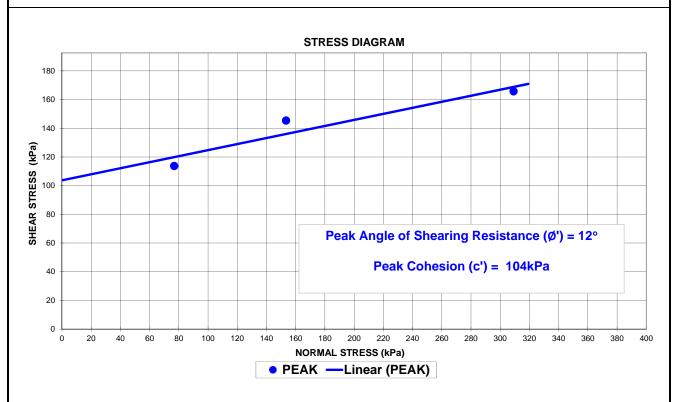
Job No:	63282#L		Page 4 of 4
Reg No:	2766	Report No:	63282#L/SB Milldale Stage 7 MH03-23 7.20 - 7.50m

siltstone gravel inclusions, banding set up perpendicular to direction of shear.

Initial Dry Density (t/m³)	Initial Moisture Content (%)	Normal Stress (kPa)	Normal Displacement (mm)	PEAK Shear Stress (kPa)	Displacement at Failure (mm)	Average Rate of Displacement (mm/minute)
		SHEA	R CYCLE 1 - FA	ILURE VALUES		
1.82	18.6	76.9	0.089	113.7	0.695	0.008
	SHEAR CYCLE 2 - FAILURE VALUES					
1.81	17.8	153.4	0.054	145.3	0.867	0.007
	SHEAR CYCLE 3 - FAILURE VALUES					
1.81	18.3	309.2	0.008	165.8	1.358	0.009

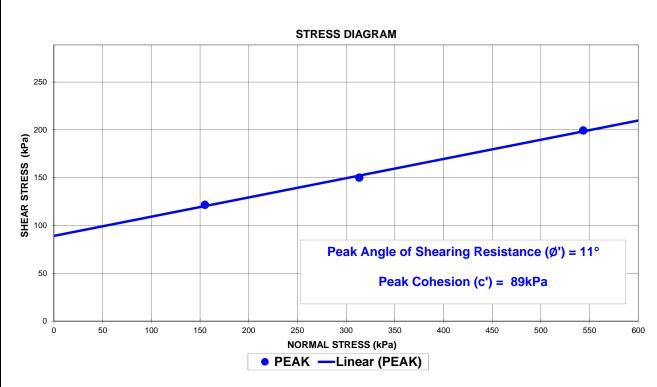
Job No:	63282#L		Page 4 of 4
Reg No:	2766	Report No:	63282#L/SB Milldale Stage 7 MH03-23 16.95 - 17.20m

bands, weathered highly plastic clays, slightly moist.

not IANZ endorsed)			•			
					_	Average Rate
Initial Dry	Initial Moisture	Normal	Normal	PEAK	Displacement	of
Density	Content	Stress	Displacement	Shear Stress	at Failure	Displacement
(t/m³)	(%)	(kPa)	(mm)	(kPa)	(mm)	(mm/minute)
		SHEA	R CYCLE 1 - FA	NILURE VALUES		
			1			
1.83	18.8	155.0	0.032	121.6	1.367	0.010
		SHEA	R CYCLE 2 - FA	AILURE VALUES		
	· · · · · · · · · · · · · · · · · · ·				I	
1.78	19.2	313.5	0.228	150.0	1.997	0.011
		SHEA	R CYCLE 3 - FA	AILURE VALUES		
	1 1		1			
1.76	19.3	543.4	0.443	199.3	3.406	0.012
	_11		I.

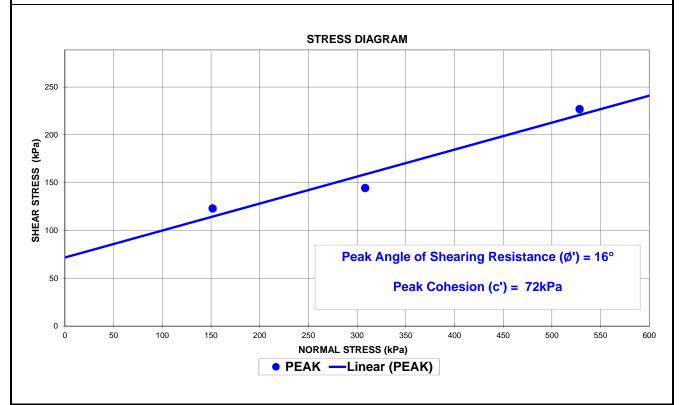
Job No:	63282#L		Page 4 of 4
Reg No:	2766	Report No:	63282#L/SB Milldale Stage 7 MH03-23 17.20 - 17.50m

Sample Description: (not IANZ endorsed) SILTSTONE, very weak, highly weathered, mottled red & greenish grey, slightly moist, occasional weakly cemented siltstone inclusions.

(•				
					•	Average Rate
Initial Dry	Initial Moisture	Normal	Normal	PEAK	Displacement	of
Density	Content	Stress	Displacement	Shear Stress	at Failure	Displacement
(t/m ³)	(%)	(kPa)	(mm)	(kPa)	(mm)	(mm/minute)
		SHEA	R CYCLE 1 - FA	AILURE VALUES		
	•					
1.79	18.2	151.7	0.128	122.9	1.031	0.009
		SHEA	R CYCLE 2 - FA	NILURE VALUES		
	•					
1.78	19.8	308.3	0.120	144.3	1.236	0.009
	SHEAR CYCLE 3 - FAILURE VALUES					
1.78	18.6	528.4	0.295	226.7	2.457	0.010
	·	·		·	·

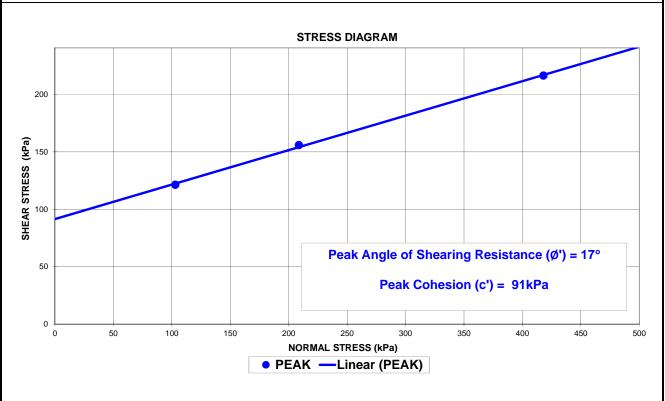
Job No:	63282#L		Page 4 of 4
Reg No:	2766	Report No:	63282#L/SB Milldale Stage 7 MH04-23 7.12 - 7.31m

SILTSTONE, very weak, occasional weakly cemented inclusions, light greenish grey with red laminations, slightly moist.

(Hot IAIVE Chaolisca)		9,	,	,		
Initial Dry Density	Initial Moisture Content	Normal Stress	Normal Displacement	PEAK Shear Stress	Displacement at Failure	Average Rate of Displacement
(t/m³)	(%)	(kPa)	(mm)	(kPa)	(mm)	(mm/minute)
		SHEA	R CYCLE 1 - FA	AILURE VALUES		
1.73	20.5	103.0	0.099	121.3	1.033	0.009
		SHEA	R CYCLE 2 - FA	AILURE VALUES		
1.75	20.0	208.8	0.068	155.9	1.878	0.011
	•					•
SHEAR CYCLE 3 - FAILURE VALUES						
1.78	19.7	418.0	0.166	216.5	2.021	0.009
		·	·	·	·

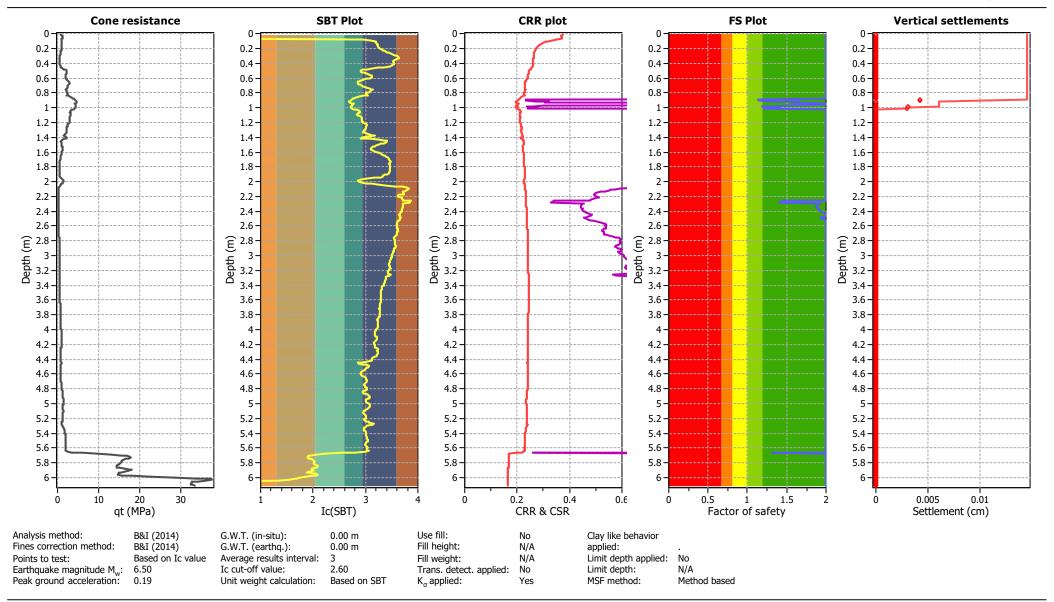
CPT: AKL-2024-0257_CPT01

Total depth: 6.11 m

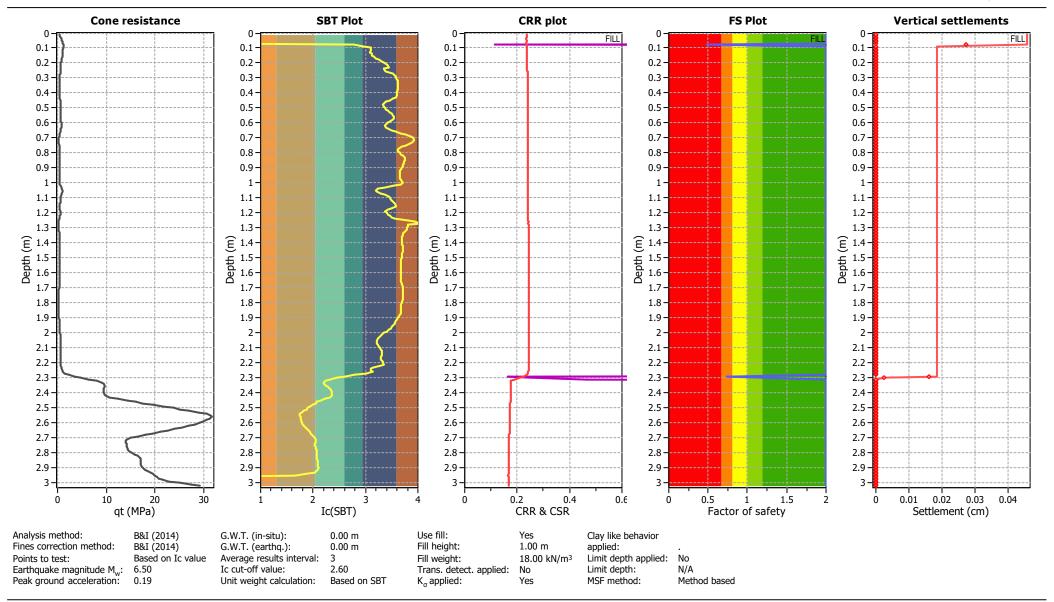
CPT: AKL2024-0257_CPT02

Total depth: 3.02 m

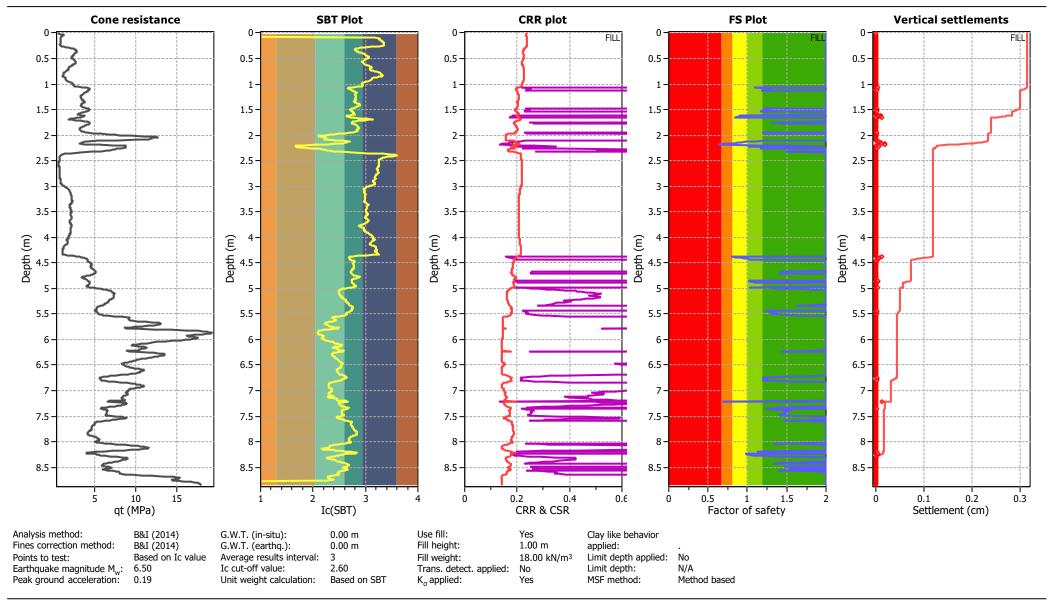
CPT: AKL2024-0257_CPT03

Total depth: 8.84 m

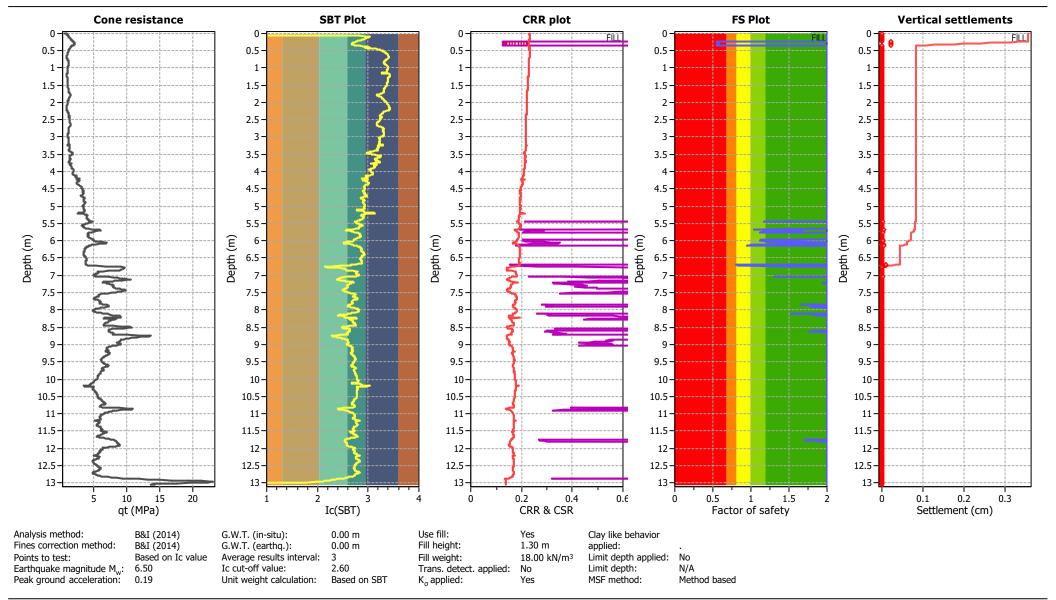
CPT: AKL2024-0257_CPT04

Total depth: 13.05 m

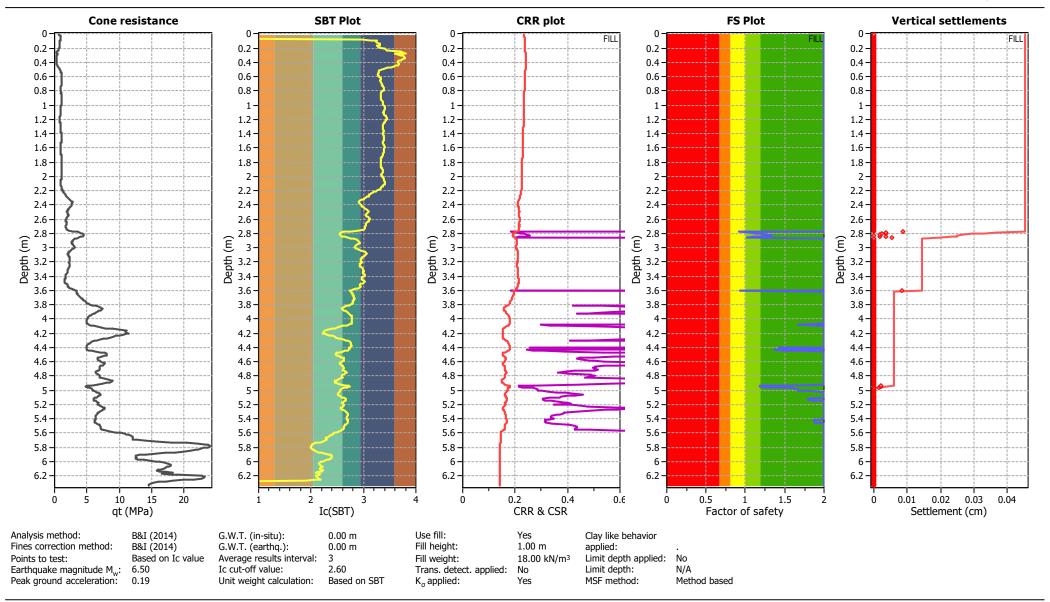
CPT: AKL2024-0257_CPT05

Total depth: 6.34 m

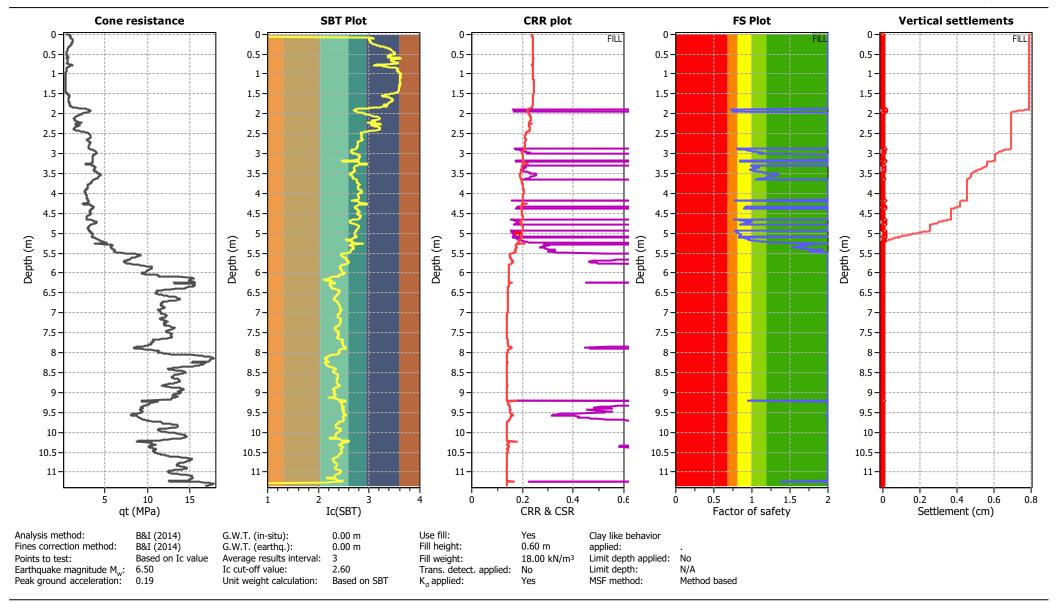
CPT: AKL2024-0257_CPT06

Total depth: 11.34 m

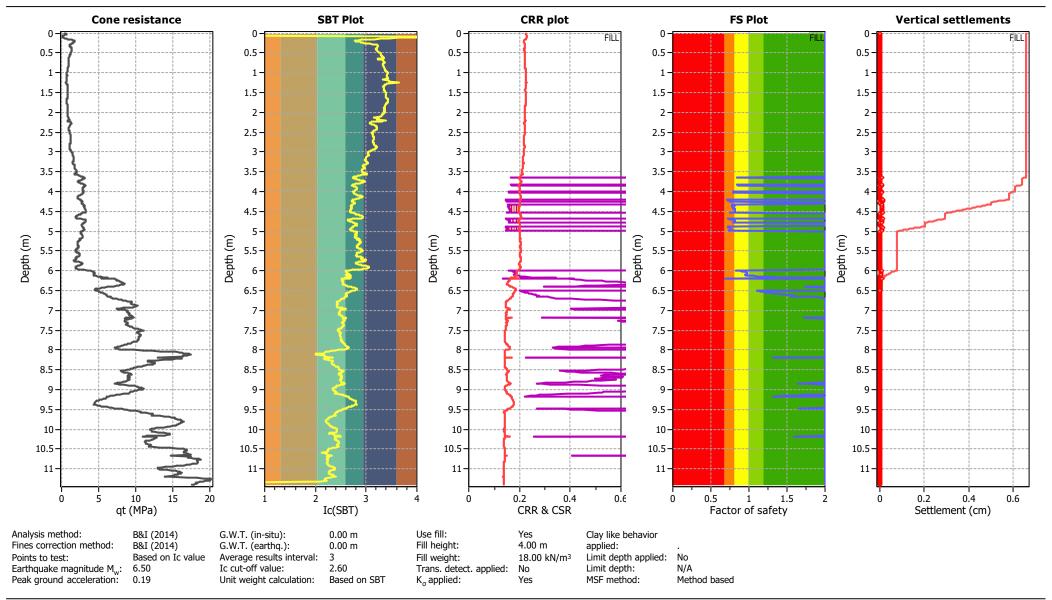
CPT: AKL2024-0257_CPT07

Total depth: 11.40 m

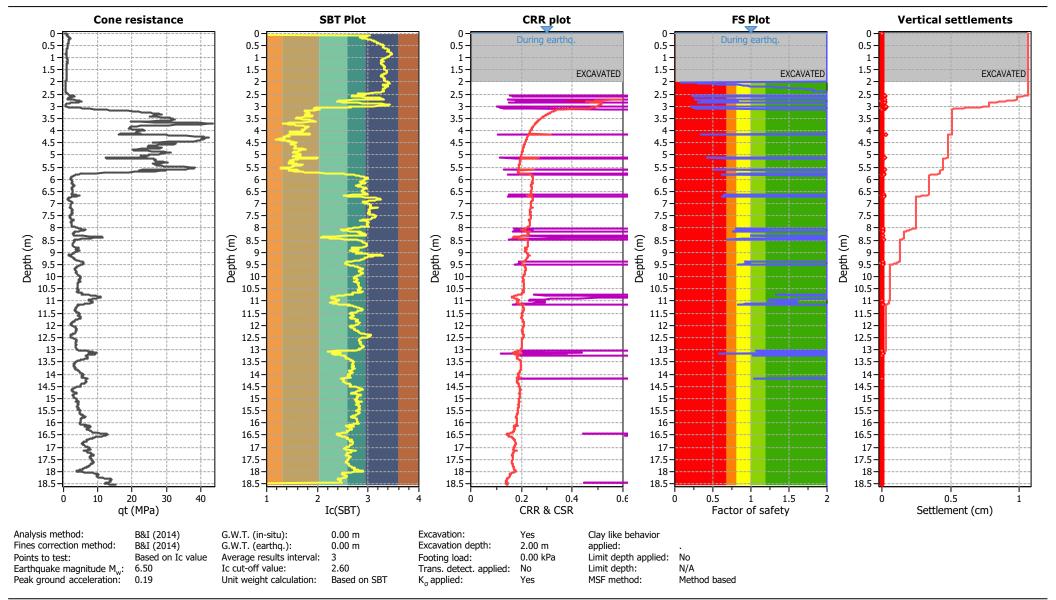
CPT: AKL2024-0257_CPT08

Total depth: 18.54 m

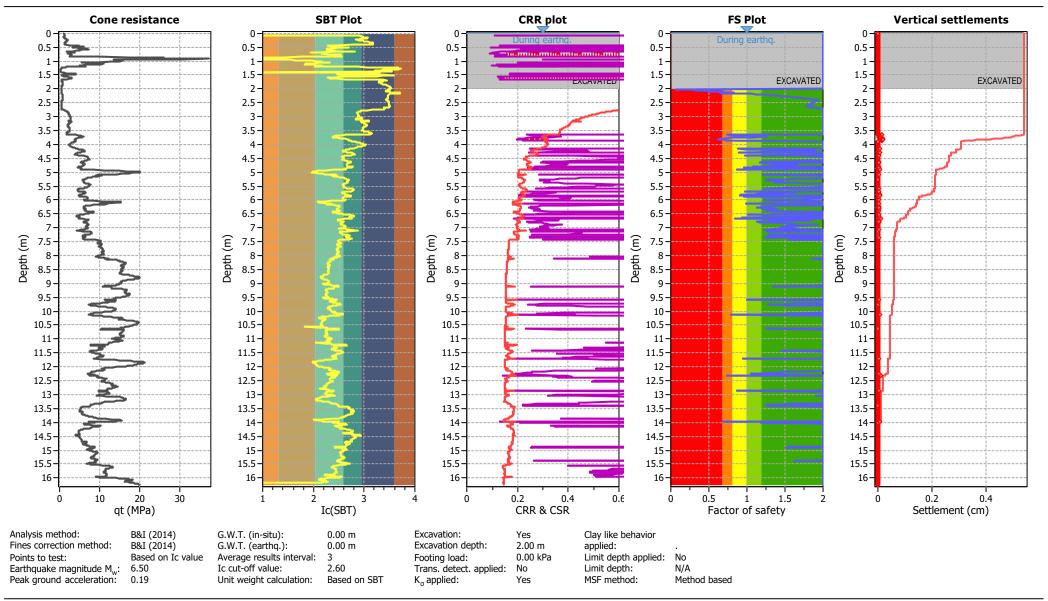
CPT: AKL2024-0257_CPT09

Total depth: 16.24 m

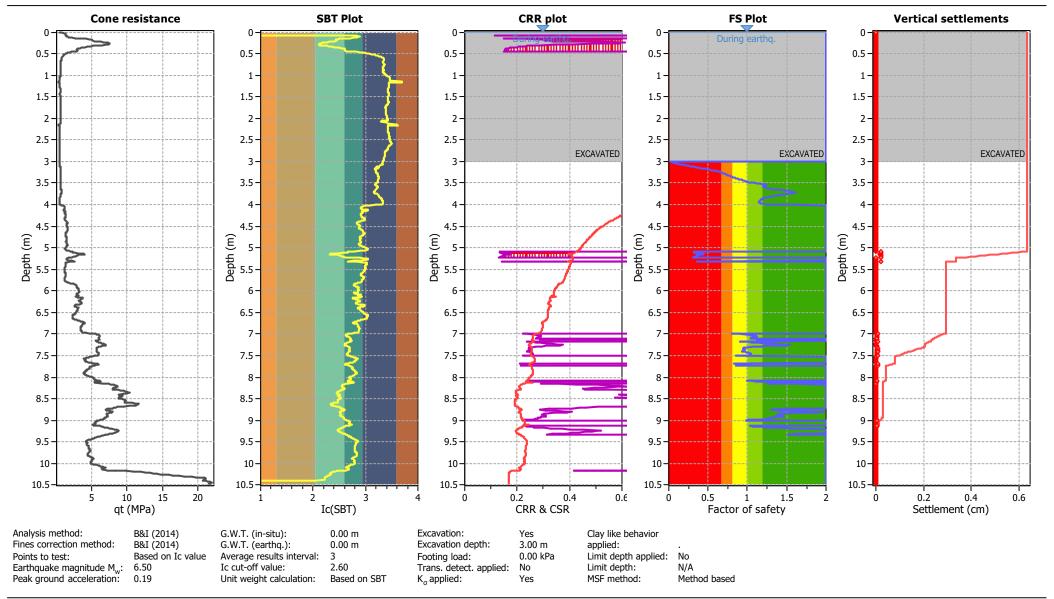
CPT: AKL2024-0257_CPT10

Total depth: 10.47 m

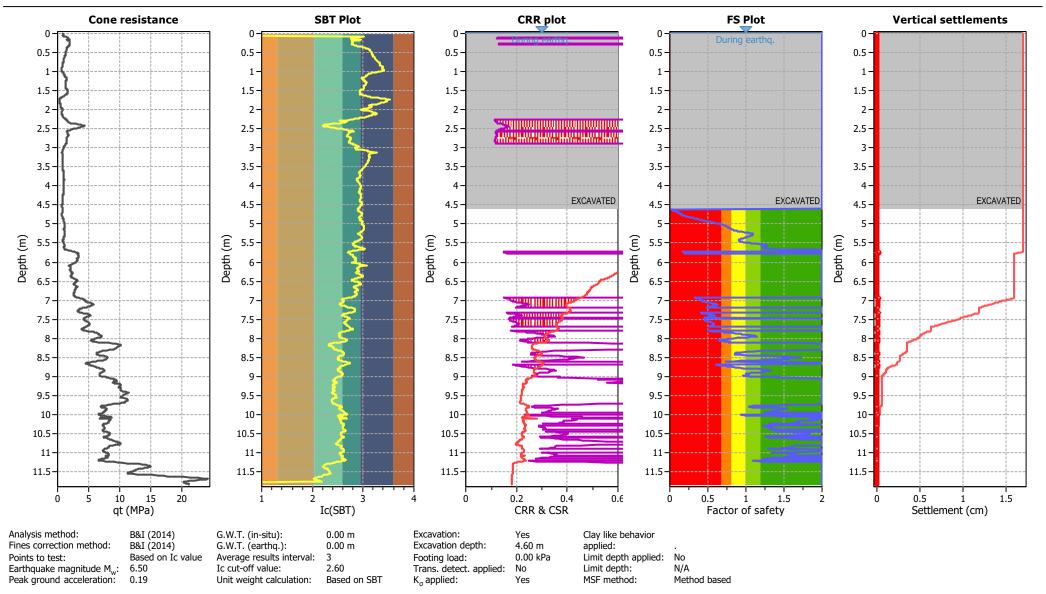
CPT: AKL2024-0257_CPT11

Total depth: 11.83 m

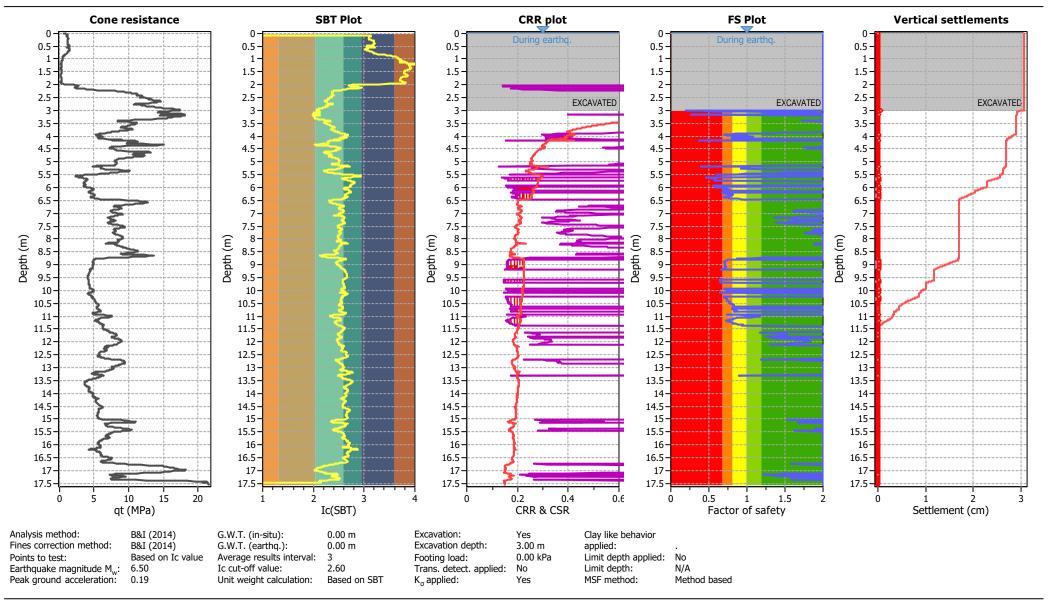
CPT: AKL2024-0257_CPT12

Total depth: 17.55 m

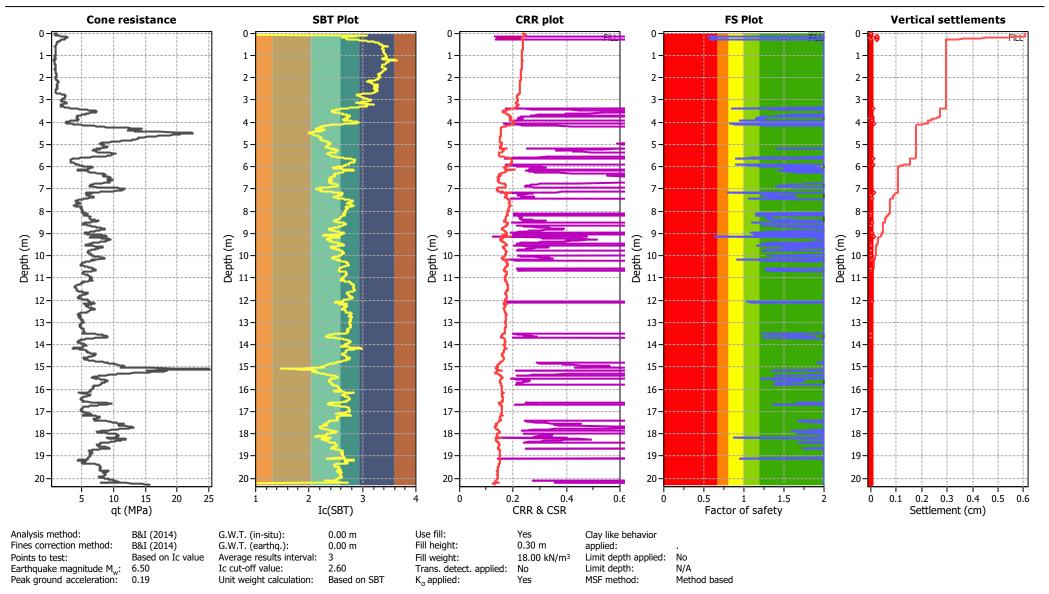
CPT: AKL2024-0257_CPT13

Total depth: 20.29 m

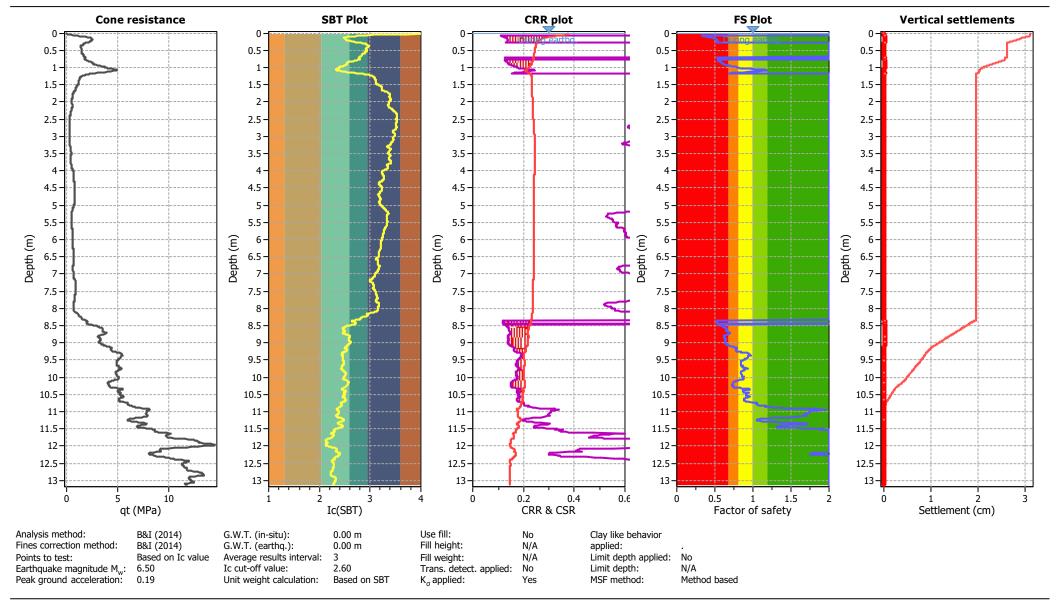
CPT: AKL2021-0014_CPT13

Total depth: 13.12 m

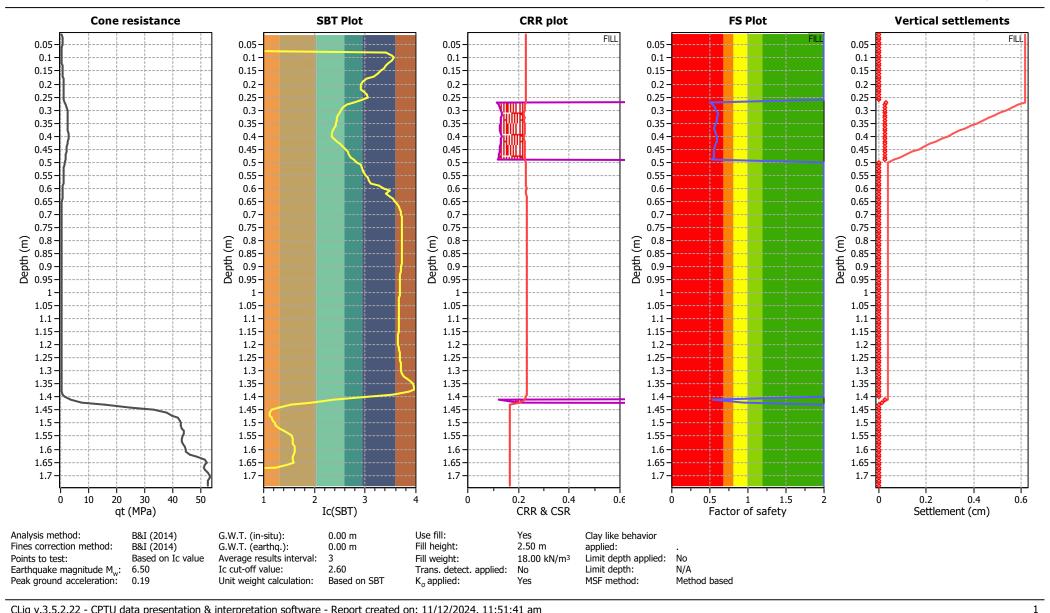
CPT: AKL2024-0257_CPT14

Total depth: 1.74 m

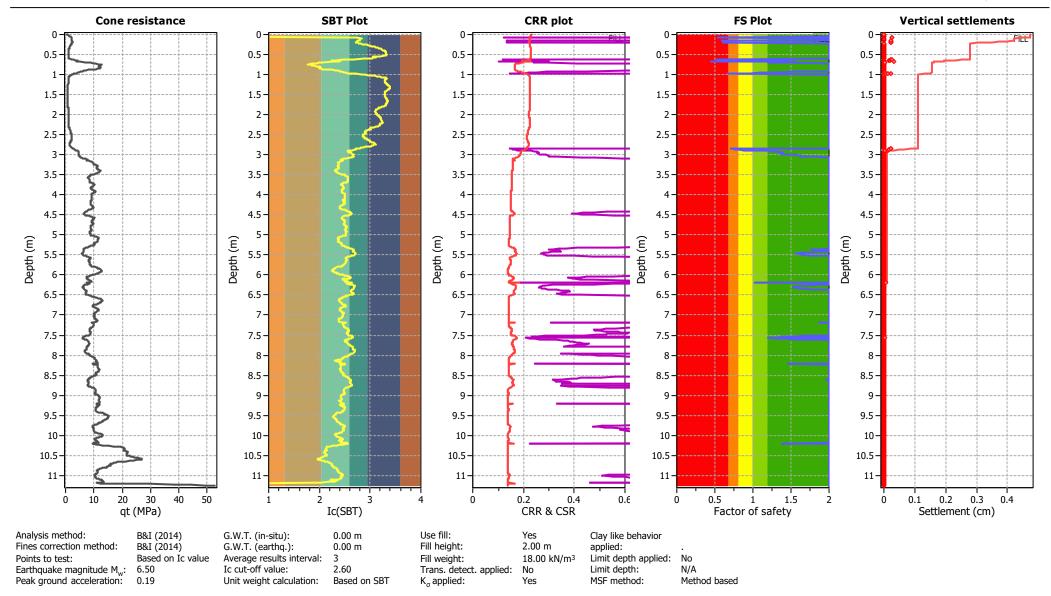
CPT: AKL2024-0257_CPT15

Total depth: 11.25 m

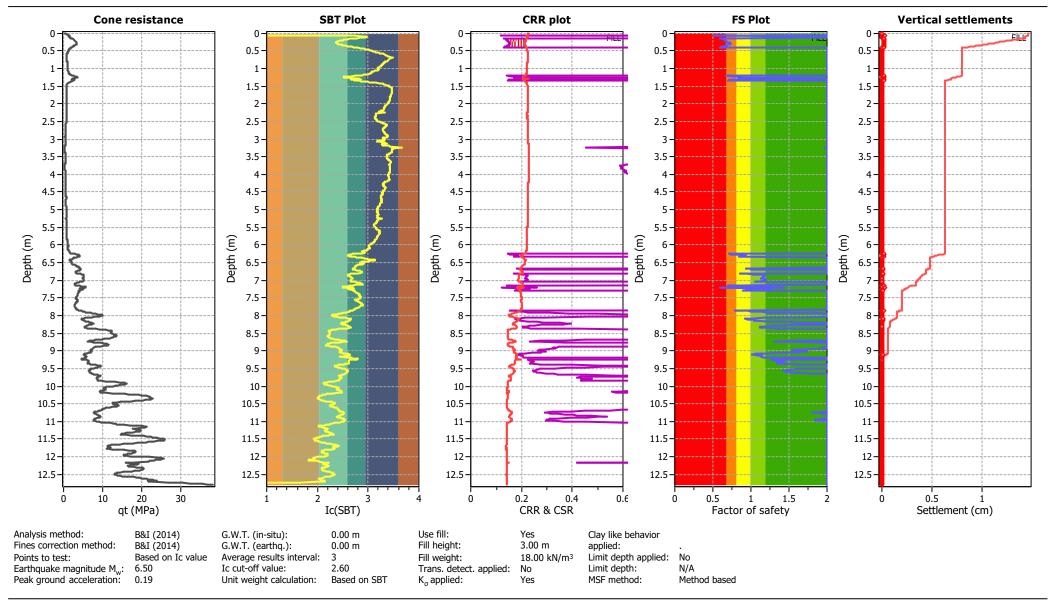
CPT: AKL2024-0257_CPT16

Total depth: 12.79 m

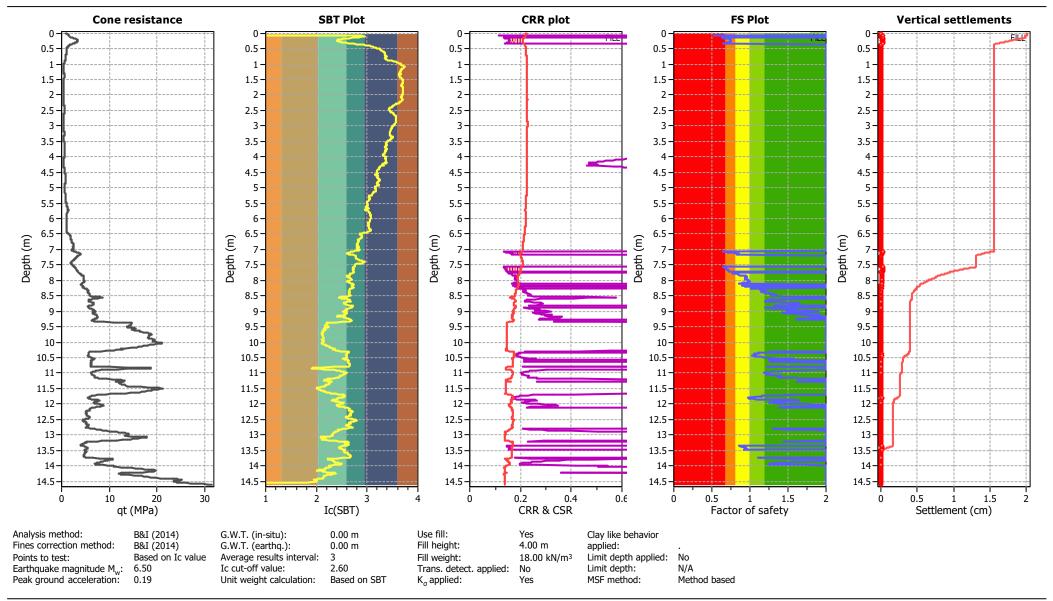
CPT: AKL2024-0257_CPT17

Total depth: 14.61 m
