# **Waihi North**

## **Groundwater Assessment Appendices WAI-985-000-REP-LC-0012\_Rev2**

Oceana Gold (New Zealand) Ltd

| <b>Document title</b> | Waihi North Groundwater Assessment WAI-985-000-REP-LC-0012_Rev2 |

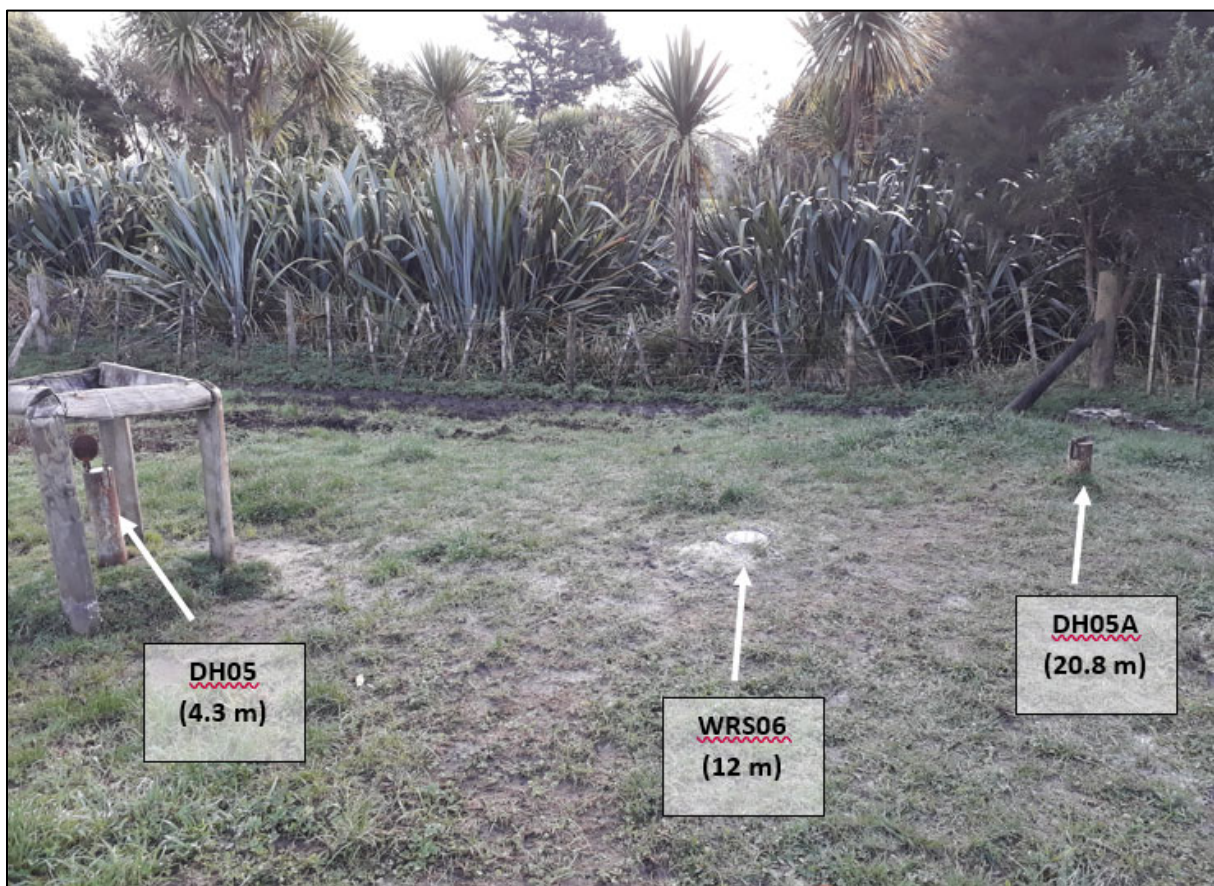
Figure A.1 Three wells showing older OGNZL well pair (shallow DH05 and deeper well DH05A) and GHD intermediate well (WRS06)

The wells were generally installed as paired units, where deep wells are denoted by an “a” in the well ID label. In some locations where existing OGNZL wells were present, an adjacent well was installed to act as the paired (or third) well (e.g as shown in Figure A.1). Where used, the existing wells are included in the groundwater monitoring data (Appendix C).

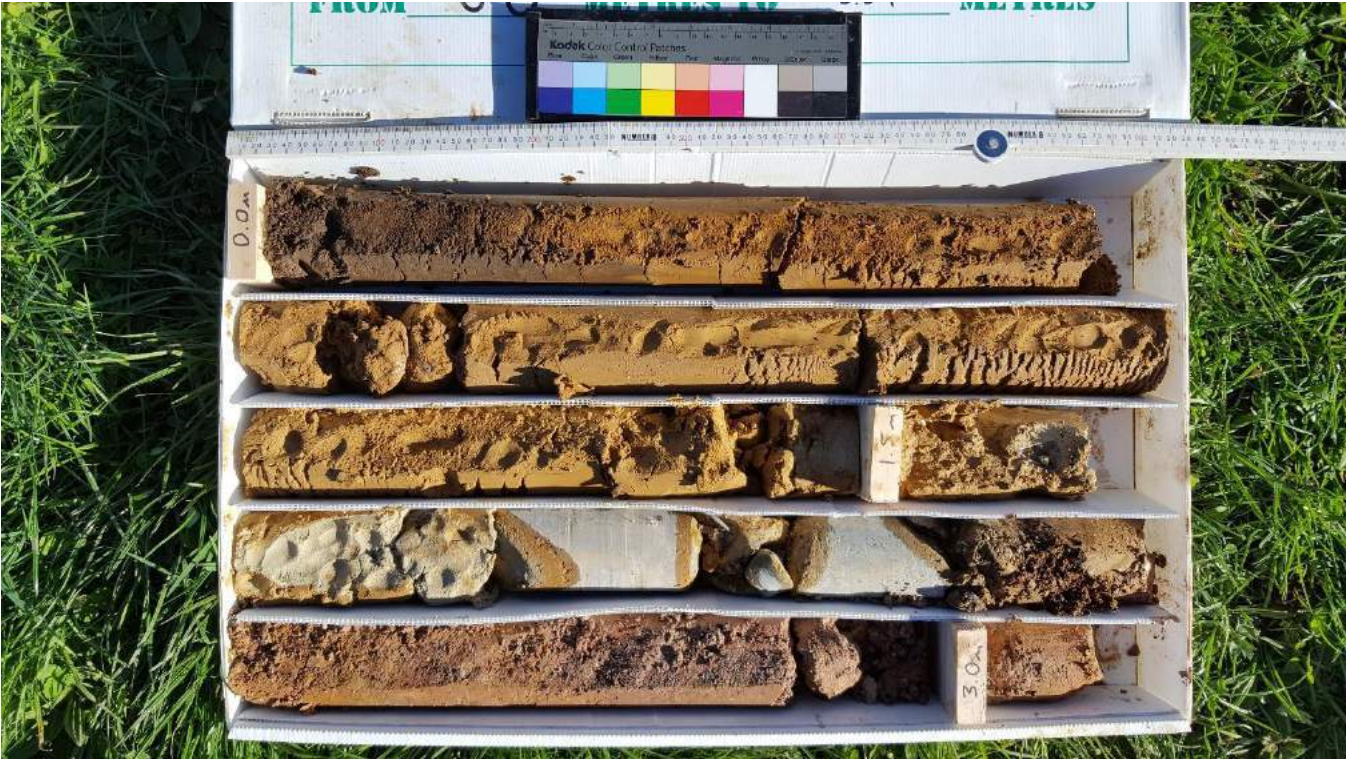
| Title: | <b>WRS4A CORE BOX PHOTOGRAPHS</b> | | | | |

Depth: 0 m to 3.09m

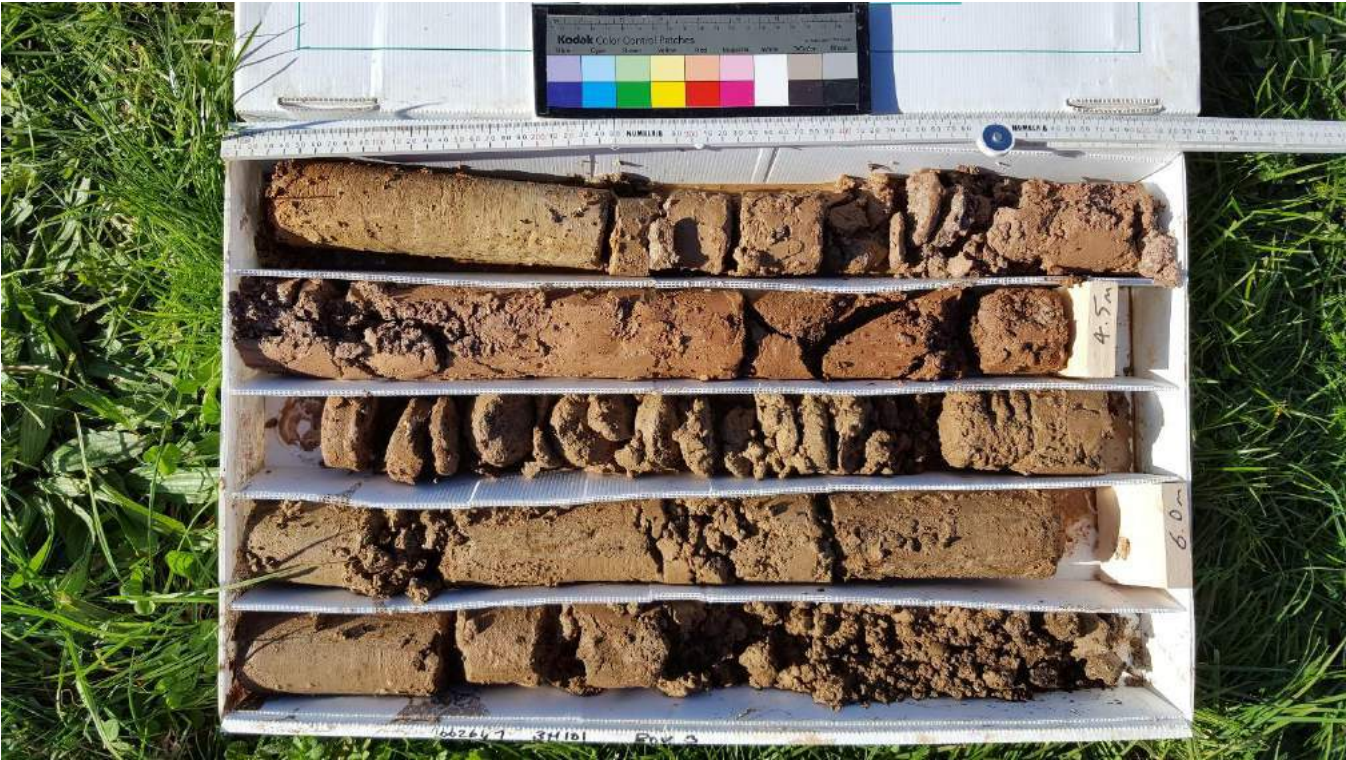
Depth: 3.09 m to 6.6 m

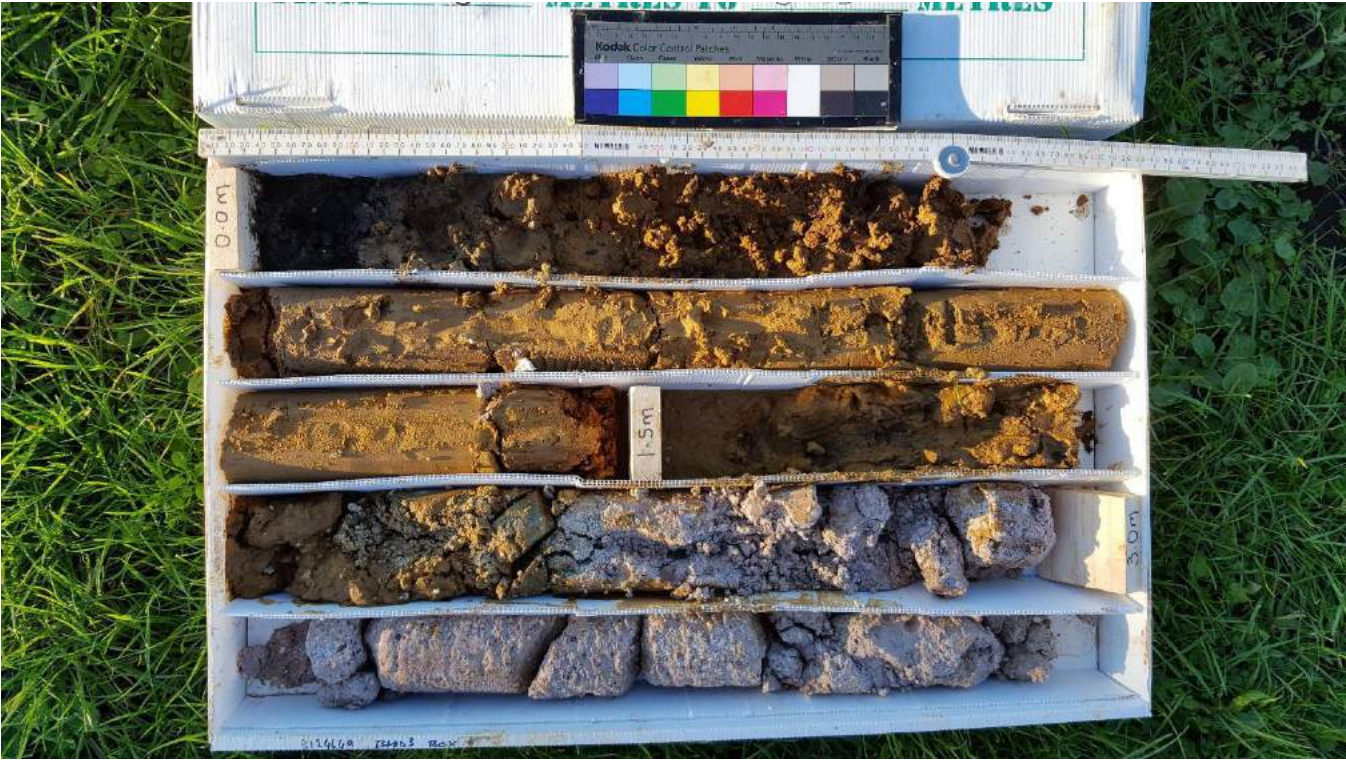
| Title: | <b>WRS5A CORE BOX PHOTOGRAPHS</b> |

**Depth: 0 m to 3.53m**

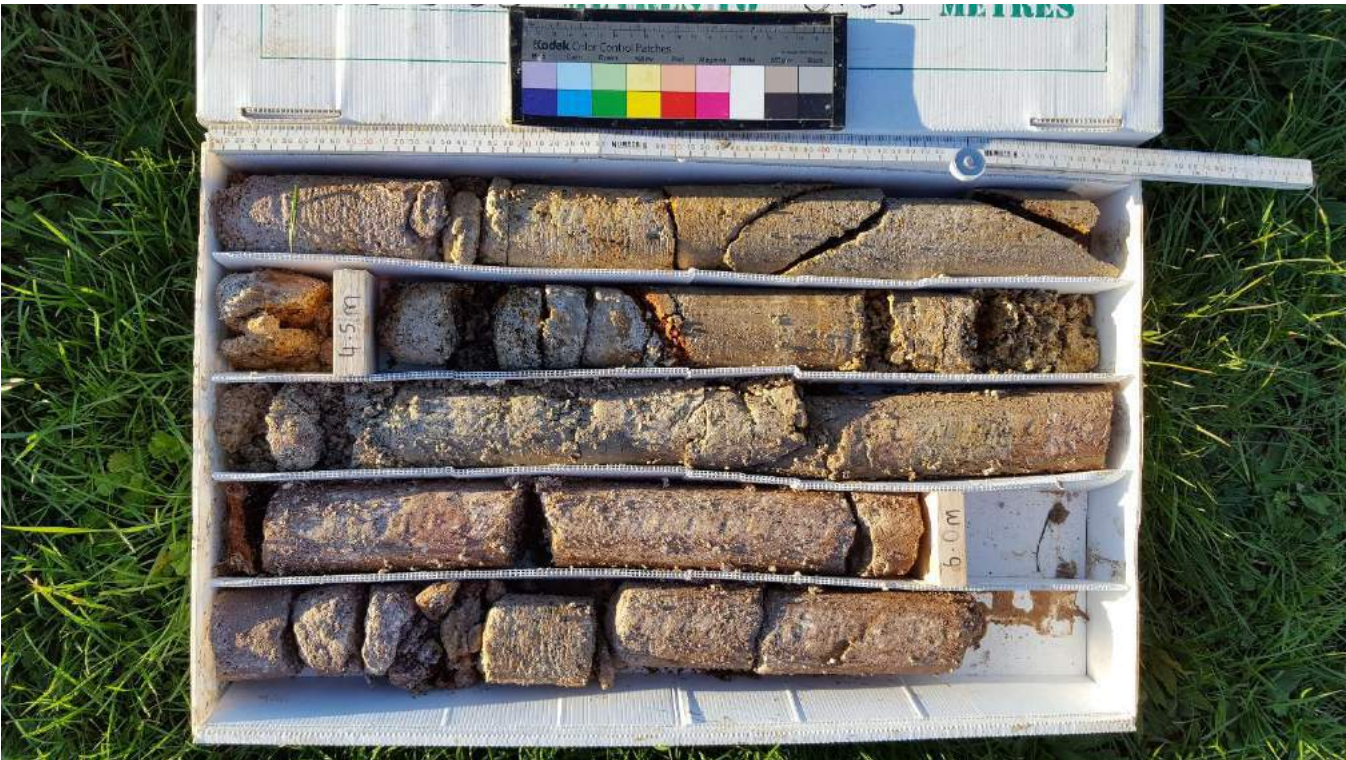
**Depth: 3.53 m to 6.53 m**

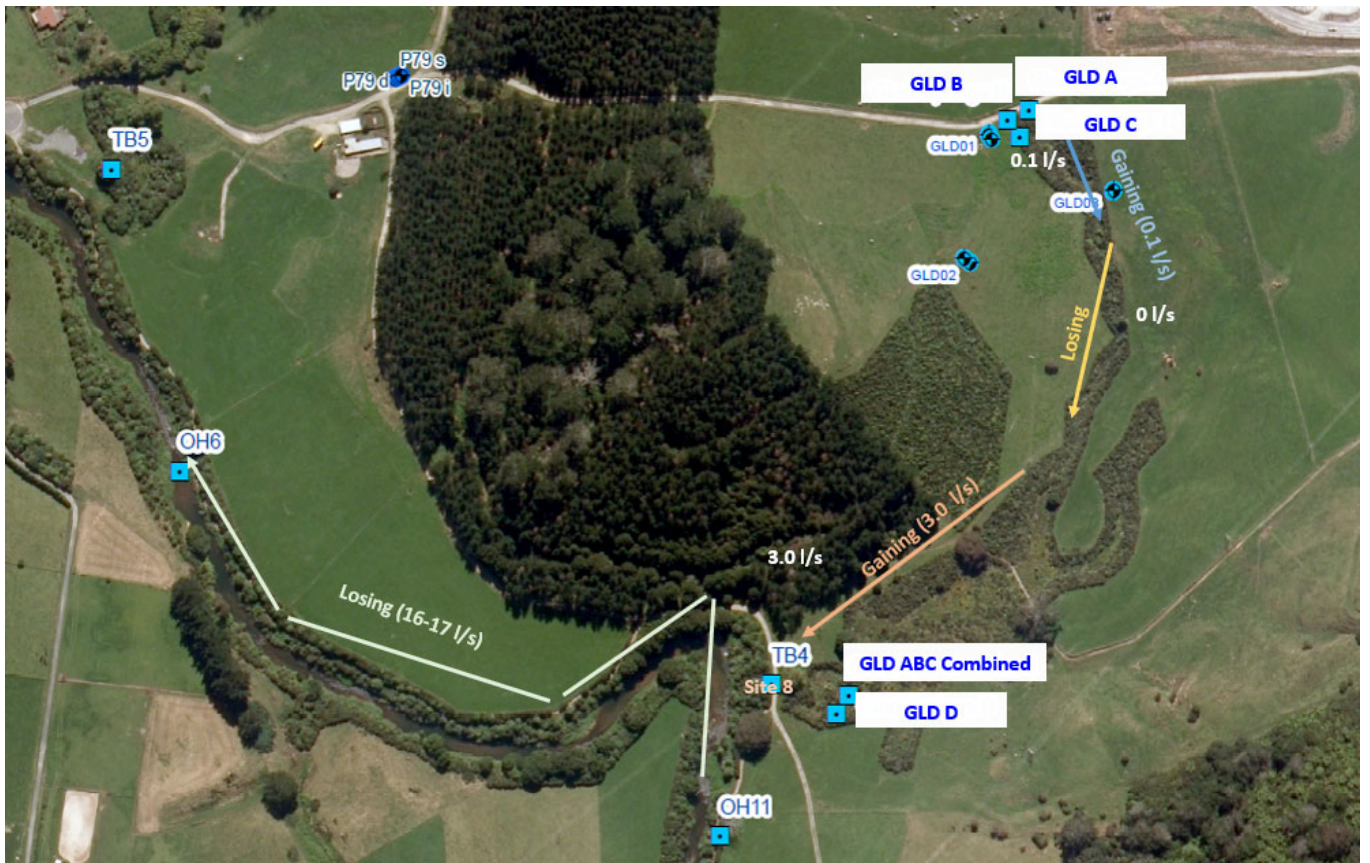
Figure F.1 Plan showing Gladstone baseflow data (TB4 June 2017, Ohinemuri June 2019 & January 2020)

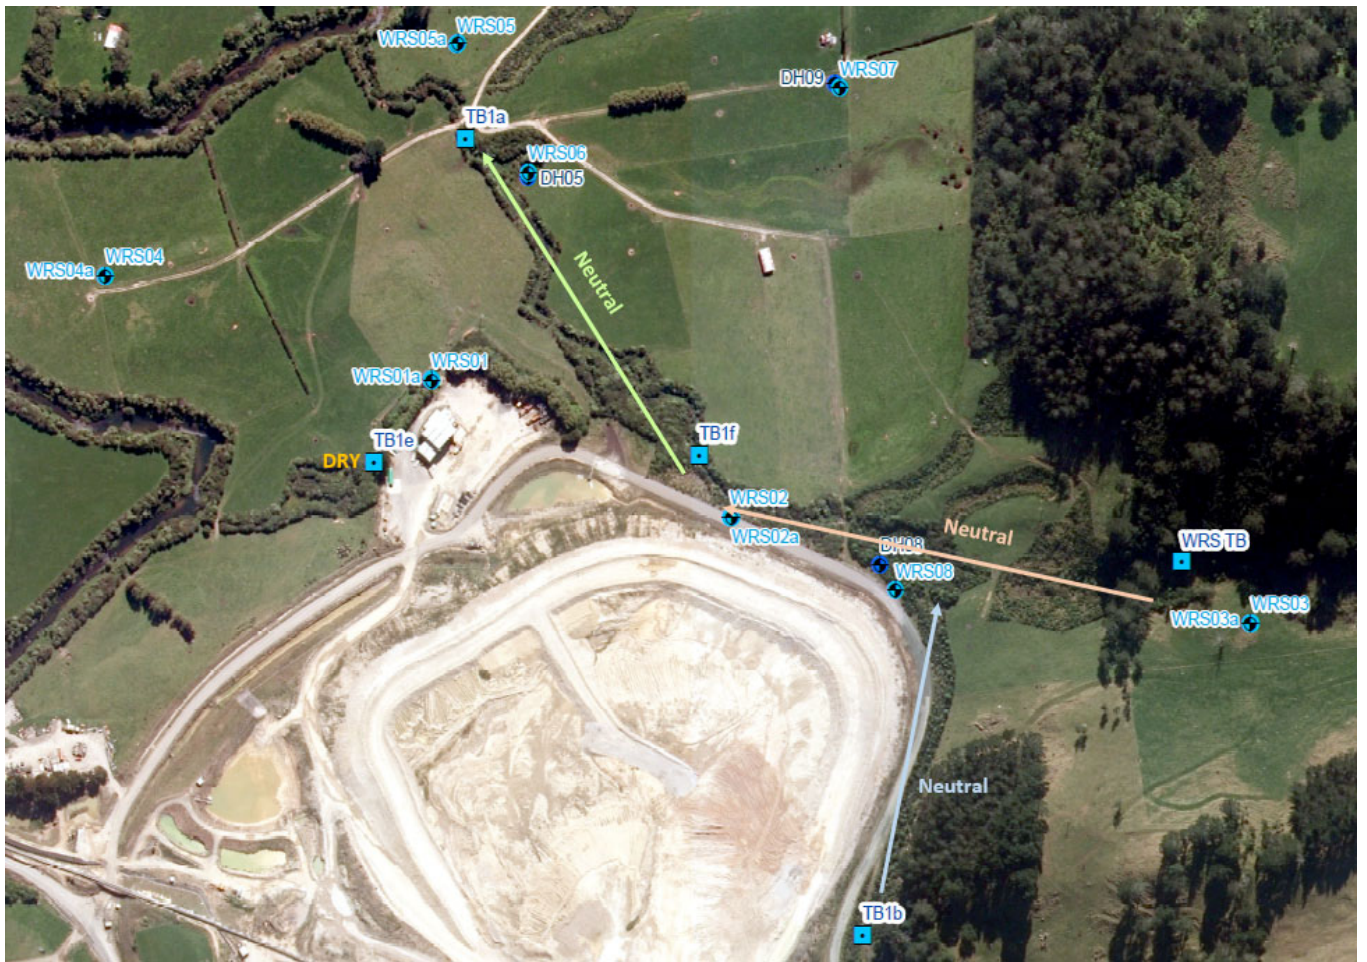
**Figure F.2** Plan showing NRS tributary TB1 baseflow data

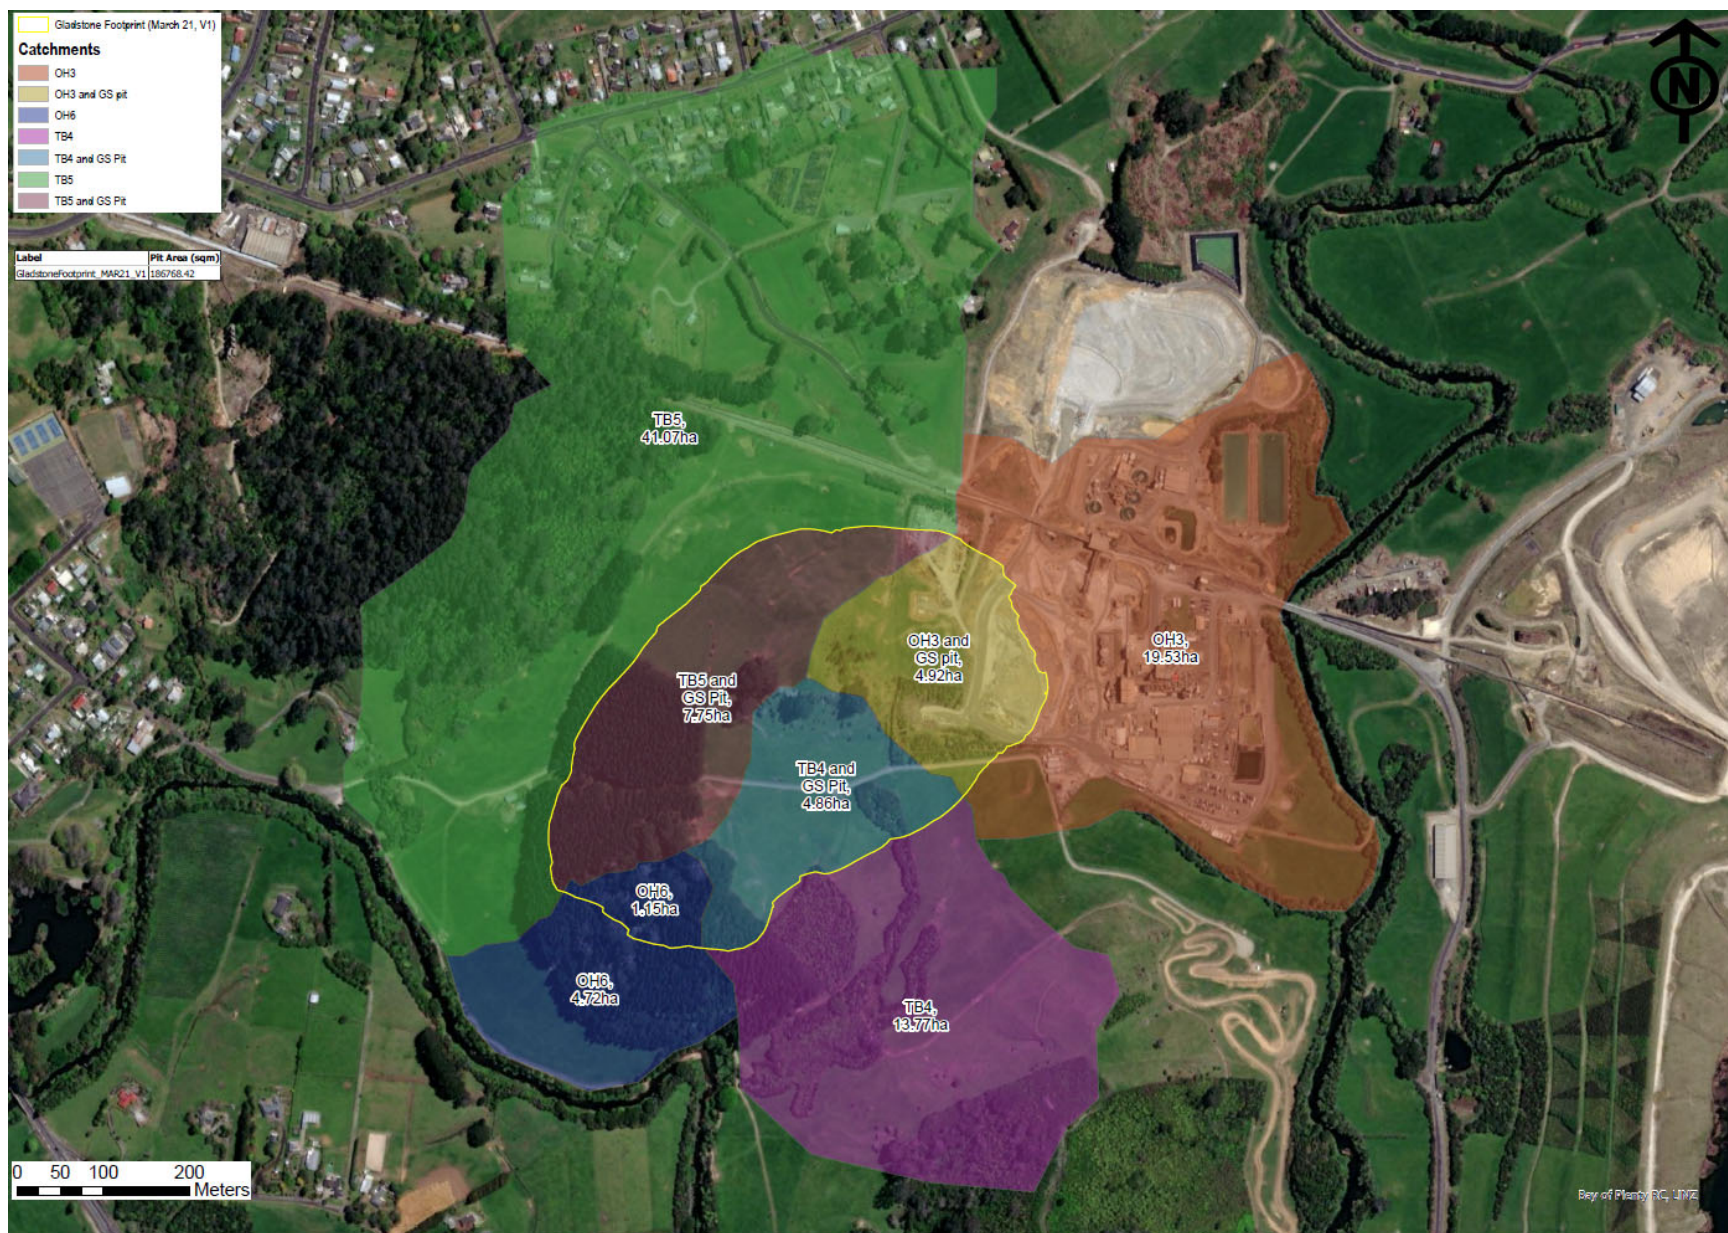
Figure G.7 Surface water catchments that intersect with the proposed Gladstone Pit
