# Geotechnical Assessment Sutton Block Extension

Drury Quarry, Drury

Part 1 of 2 – Report to Appendix D

Report reference: 220245-C (Issue 2.0)

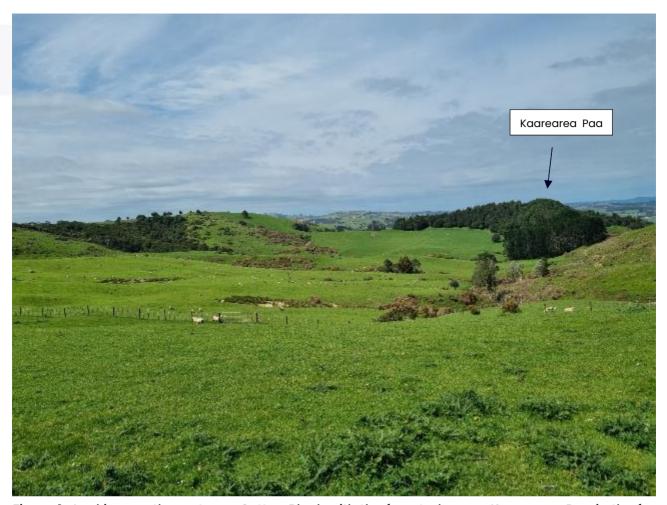
Figure 1: Looking south-east over Sutton Block with the forested crown Kaarearea Paa in the far right of the photo.

The Sutton Block site is located to the north of the existing Drury Quarry operation and Kaarearea Paa volcanic cone, as shown in Figure 1, and on Riley Site Plan Dwg: 220245-10, appended.

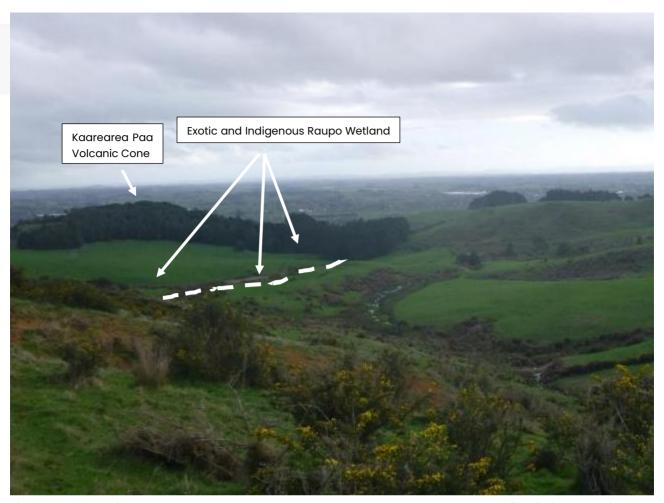
Figure 2: Looking south-west towards Kaarearea Paa and an area of existing exotic and Indigenous Raupo wetland areas to the south of the proposed quarry extent. The portion of eastern exotic wetland that extends further upslope from the site annotated in the photo. The indicative southern extent of the quarry shown by a dashed white line. The indicative location of the main southern wetland areas outside of the proposed quarry extent are highlighted in the photo.

There are existing areas of both exotic and indigenous Raupo wetlands located between the proposed quarry extent and Kaarearea Paa in the area indicated in Figure 2, and on attached Riley Dwg: 220245-10 and -11. It is proposed as far as practical to maintain the wetland areas in the final quarry design.

There are three main wetland areas to be retained to the south of the proposed quarry extent within the northern portion of the Kaarearea Paa area. These include a more elevated area of exotic wetland that drains into a lower elevation indigenous Raupo wetland adjacent to the proposed southern quarry extent. Both are sited to the east of the Kaarearea Paa volcanic cone. There is another smaller wetland area directly north of the volcanic cone. The indicative locations of these wetland areas are shown on Figure 2 and Riley Dwgs: 220245–10 and –11.

The elevated portion of exotic wetland to the south of the proposed quarry excavation and east of the Kaarearea Paa volcanic cone is separated from the proposed pit extent by a small spur (Figures 2, 6 and 15). Based on the current geotechnical model this area is assessed to be underlain predominantly by residual greywacke soils with a surficial layer of WCM material. The western portion of this eastern exotic wetland and the Raupo wetland into which it drains are located in a lower elevation area inferred to be underlain by a significant (approximately 36m) depth of WCM material, as shown in Figure 15 below. The northern portion of the Raupo wetland is located adjacent to the projected quarry pit extent.

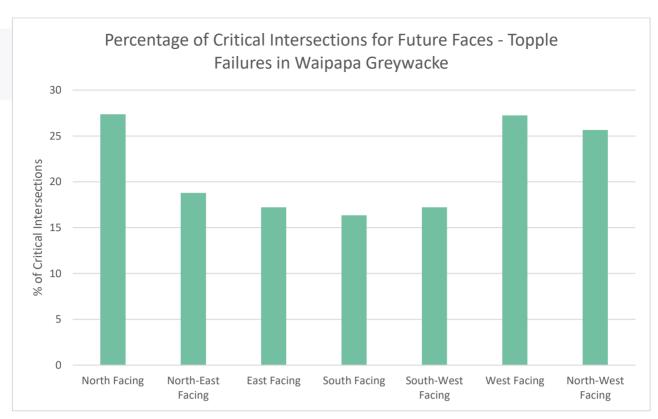
Figure 11: Greatest probability for topple failures within Waipapa Greywacke material each proposed inter-bench faces for pit slope orientation and slope angles analysed (as outlined in Tables 7 and 10)

Table 10: Kinematic Analysis Results for Topple Type Failures in Waipapa Greywacke for Proposed Inter-bench Slopes Outlined in Table 7

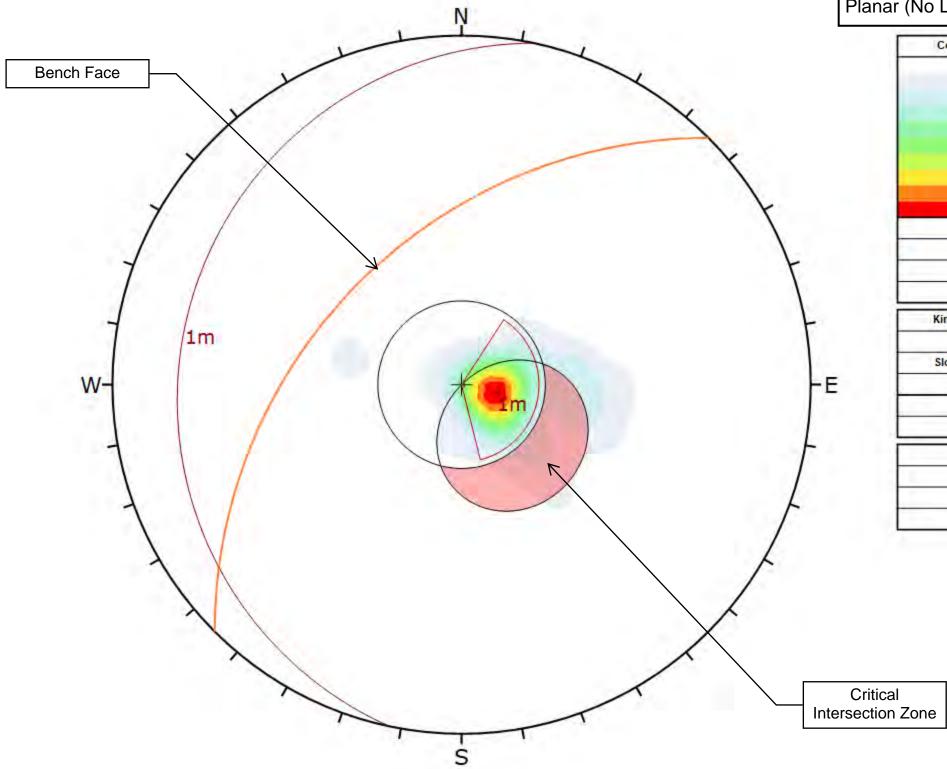
#### Drury Quarry - Sutton Block Extension Topple Failure - Point A Waikato Coal Measures Feature Symbol Critical Intersection Color **Density Concentrations** 3.60 - 5.40 - 7.20 - 9.00 - 10.80 12.60 14.40 14.40 - 16.20 16.20 18.00 **Contour Data** Pole Vectors **Maximum Density** 17.67% **Contour Distribution** Fisher **Counting Circle Size**

Kinematic Analysis	Direct Topp	Direct Toppling			
Slope Dip	45				
Slope Dip Direction	315				
Friction Angle	27°				
Lateral Limits	30°				
		Critical	Total	%	
Direct Toppling (In	tersection)	261	40755	0.64%	
Oblique Toppling (Intersection)		53	40755	0.13%	
Base	Plane (All)	138	286	48.25%	
Page Di	ane (Set 1)	99	101	98.02%

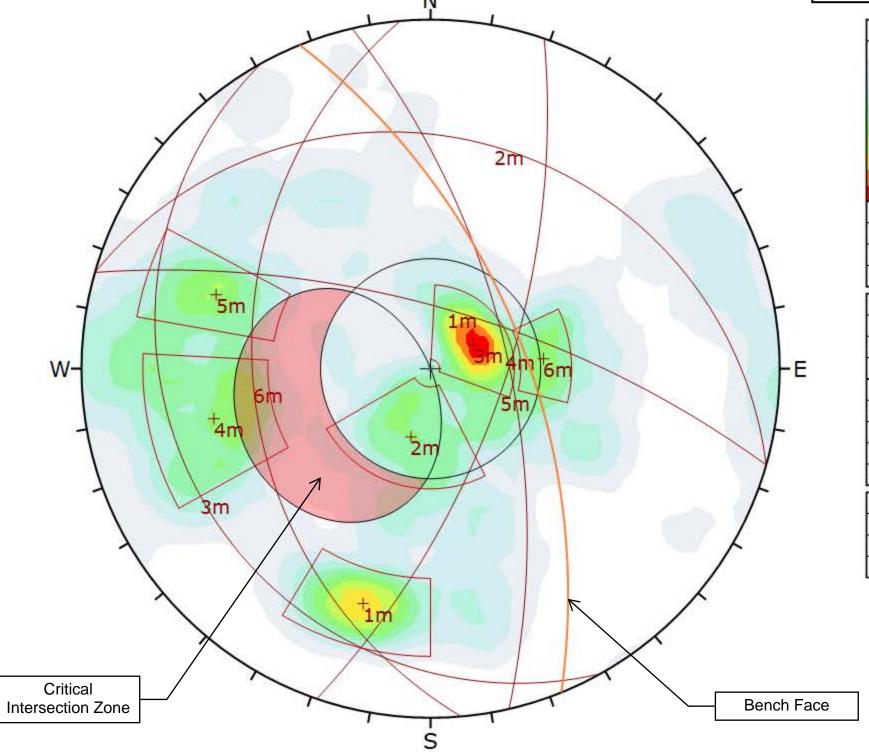
## Planar (No Limits) Failure - Point F Waipapa Greywacke

Color Den	sity C	once	entrations
1 11	0.00	-57	0.45
	0.45	*	0.90
	0.90	*	1.35
	1.35	*	1.80
	1.80	23	2.25
	2.25	23	2.70
3	2.70	23	3.15
- 3	3.15	€3	3.60
	3.60	€3	4.05
	4.05	23	4.50
Contour Data	Pol	e Ved	ctors
Maximum Density	4.2	9%	
Contour Distribution	Fis	her	
Counting Circle Size	1.0	%

Kinematic Analysis	Planar Slid	ing		
Slope Dip	60			
Slope Dip Direction	68			
Friction Angle	35°			-0-
		Critical	Total	%
Planar S	Sliding (All)	49	569	8.61%
Planar Slid	ling (Set 2)	4	58	6.90%
Planar Slid	ling (Set 4)	13	50	26.00%
Planar Slid	ling (Set 5)	1	27	3.70%

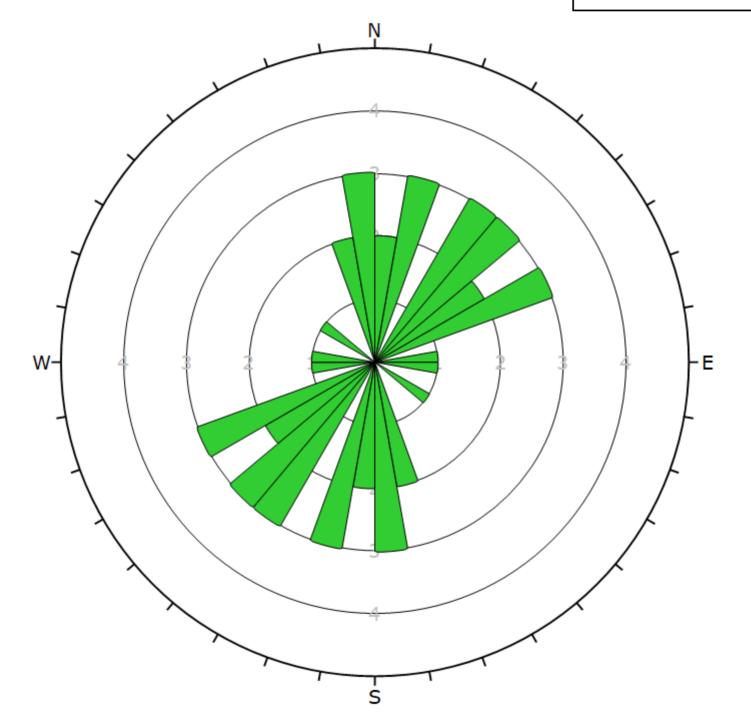
# Orientation of RDCL Bedding Plane Defects Within Waikato Coal Measures

Plot Mode	Rosette
Plot Data	Apparent Strike
Face Normal Trend	0.0
Face Normal Plunge	90.0
Bin Size	10°
Outer Circle	5 planes per arc
Planes Plotted	24
Minimum Angle To Plot	0.0°
Maximum Angle To Plot	90.0°

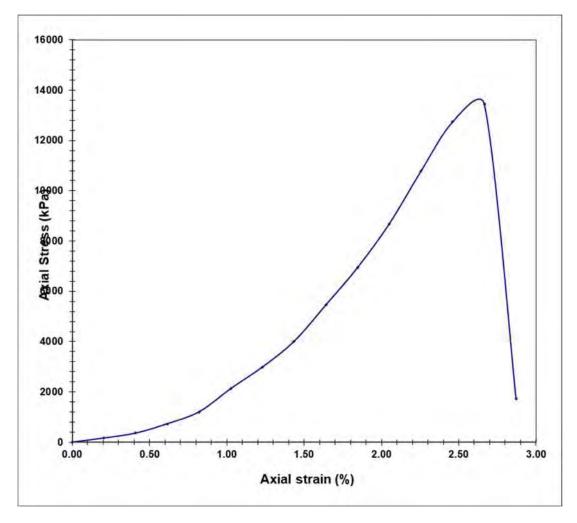
Sample		Sandy MST, DH104
Sample Number		UCS1
Sample Depth	(m)	23.3-23.55
Sample Diameter	(mm)	59.7
Sample Height	(mm)	48.8
Wet Density	(t/m³)	2.21
Water Content	(%)	3.4
Dry Density	(t/m³)	2.15
Unconfined compressive strength	(kPa)	13000
Strain at failure	(%)	2.7
Rate of Axial Compression used	(mm/min)	0.2
Mode of failure		Brittle

Note: Sample was unable to be trimmed to 2:1 Ratio

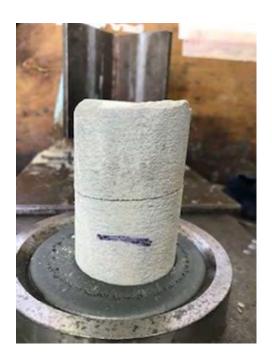
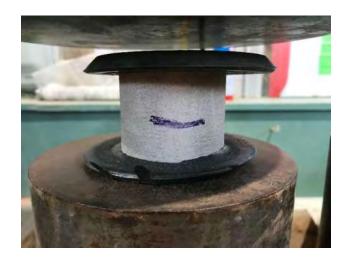
Material:	Sandy MST – DH104 UCS1	Test No.:	230285
Source:	23.3m-23.55m	Date Sampled:	10 <sup>th</sup> January 2023
Job:	Project Number 220245	Reference No.:	-

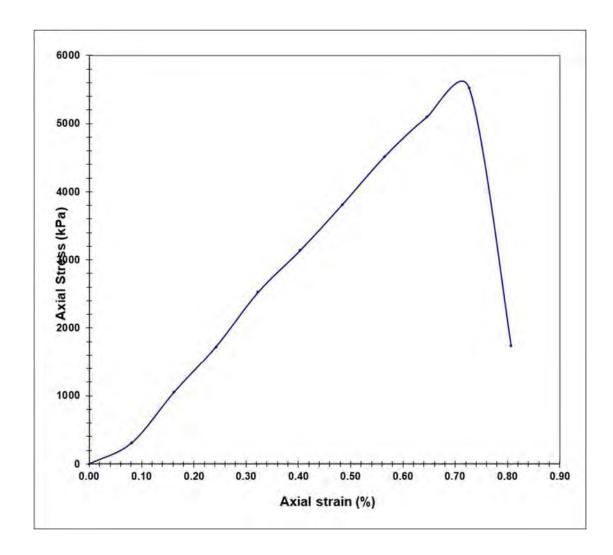
Material:
 Conglomerate – DH104 UC\$2
 Test No.:
 230286

Sample		Conglomerate – DH104
Sample Number		UCS2
Sample Depth	(m)	28.2-28.5
Sample Diameter	(mm)	60.3
Sample Height	(mm)	123.9
Wet Density	(t/m³)	2.07
Water Content	(%)	4.6
Dry Density	(t/m³)	2.00
Unconfined compressive strength	(kPa)	5500
Strain at failure	(%)	0.7
Rate of Axial Compression used	(mm/min)	0.2
Mode of failure		Brittle

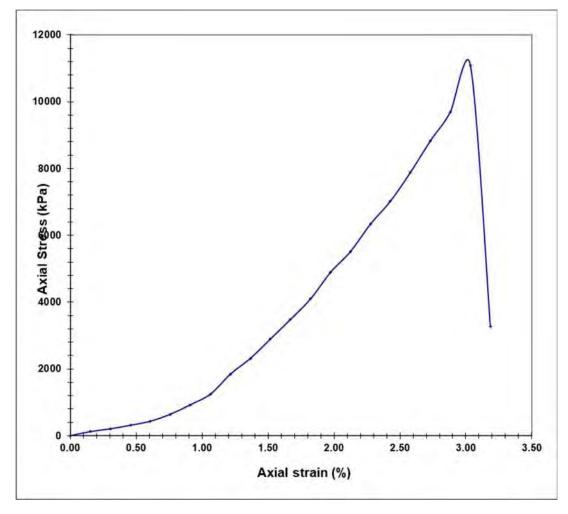
Sample Number		Silty MST - DH104
Sample Number		UCS3
Sample Depth	(m)	12.5-12.35
Sample Diameter	(mm)	60.1
Sample Height	(mm)	65.9
Wet Density	(t/m³)	2.14
Water Content	(%)	4.3
Dry Density	(t/m³)	2.05
Unconfined compressive strength	(kPa)	11000
Strain at failure	(%)	3.0
Rate of Axial Compression used	(mm/min)	0.2
Mode of failure		Brittle

Note: Sample was unable to be trimmed to 2:1 Ratio

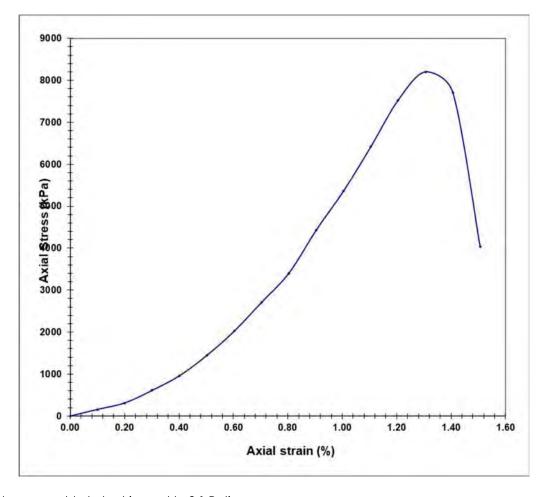
Sample		Conglomerate – DH104
Sample Number		UCS6
Sample Depth	(m)	29.1-29.3
Sample Diameter	(mm)	60.3
Sample Height	(mm)	99.5
Wet Density	(t/m³)	2.05
Water Content	(%)	4.2
Dry Density	(t/m³)	1.95
Unconfined compressive strength	(kPa)	8200
Strain at failure	(%)	1.3
Rate of Axial Compression used	(mm/min)	0.2
Mode of failure		Brittle

Note: Sample was unable to be trimmed to 2:1 Ratio

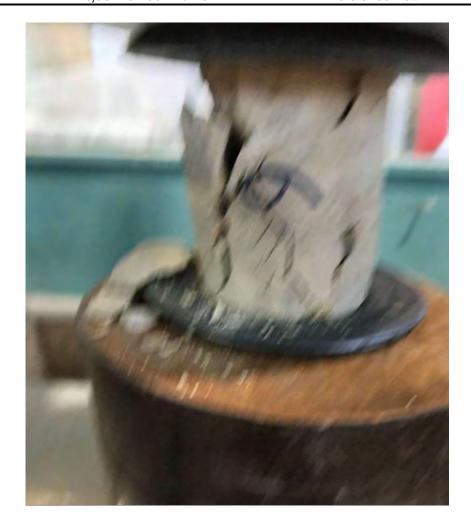
Material: Conglomerate – DH104 UCS6 Test No.: 230290
Source: 29.1m-29.3m Date Sampled: 10<sup>th</sup> January 2023
Job: Project Number 220245 Reference No.: -

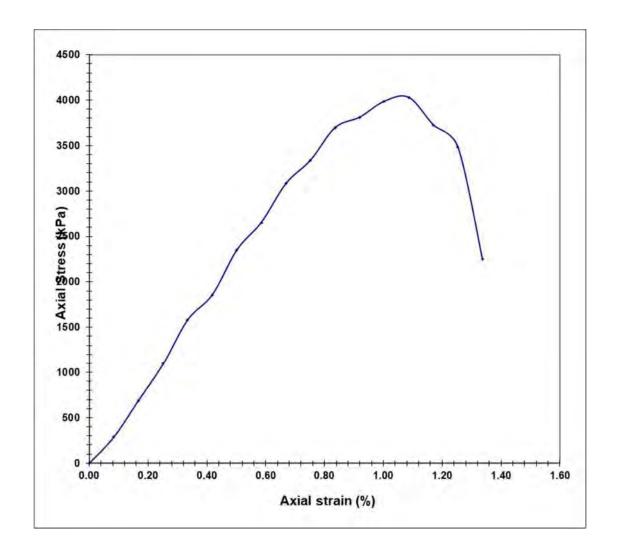
Material: Conglomerate - DH104 UCS7 Test No.: 230291

Sample		Conglomerate - DH104
Sample Number		UCS7
Sample Depth	(m)	26.5-26.7
Sample Diameter	(mm)	60.4
Sample Height	(mm)	119.7
Wet Density	(t/m³)	2.08
Water Content	(%)	5.6
Dry Density	(t/m³)	1.95
Unconfined compressive strength	(kPa)	4000
Strain at failure	(%)	1.1
Rate of Axial Compression used	(mm/min)	0.2
Mode of failure		Brittle

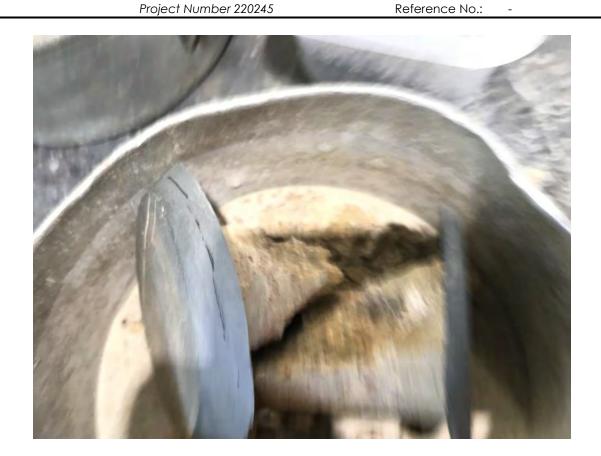
Source: 26.5-26.7 Date Sampled: 10<sup>th</sup> January 2023
Job: Project Number 220245 Reference No.: -

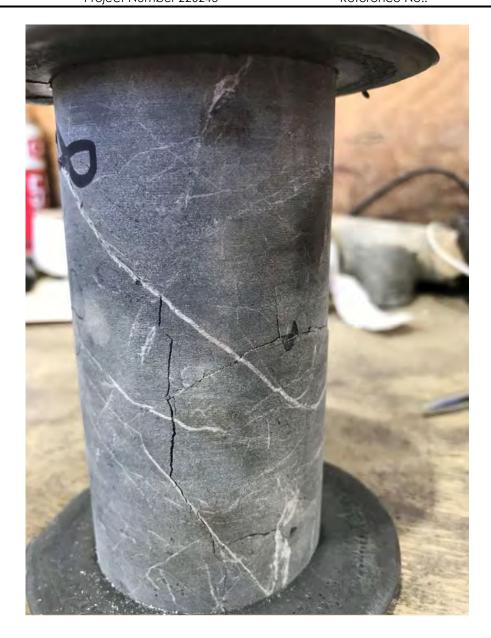
- i. Sample exceeded testing capabilities of CBR machine (50kN).
- ii. Sample tested in concrete compression machine, which only provides a peak strength, and does not measure compression displacement.
- iii. Rate of compression measured in N/s as concrete compression machine does not measure displacement.
- iv. Strain unable to be calculated as displacement is not measured.

Material:Greywacke - DH101 UCS8Test No.:230292Source:50.35m-50.60mDate Sampled:10th January 2023Job:Project Number 220245Reference No.:-

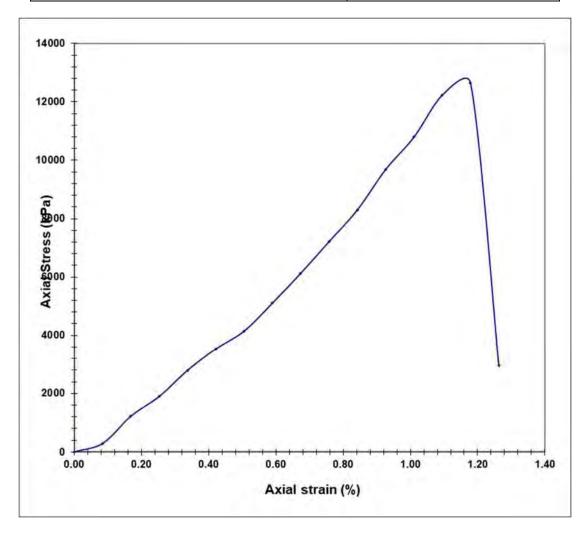
Material: Greywacke - DH101 UC\$12 Test No.: 230294

Sample		Greywacke – DH101
Sample Number		UCS12
Sample Depth	(m)	38.1-38.7
Sample Diameter	(mm)	60.6
Sample Height	(mm)	118.8
Wet Density	(t/m³)	2.21
Water Content	(%)	4.4
Dry Density	(t/m³)	2.10
Unconfined compressive strength	(kPa)	13000
Strain at failure	(%)	1.2
Rate of Axial Compression used	(mm/min)	0.2
Mode of failure		Brittle

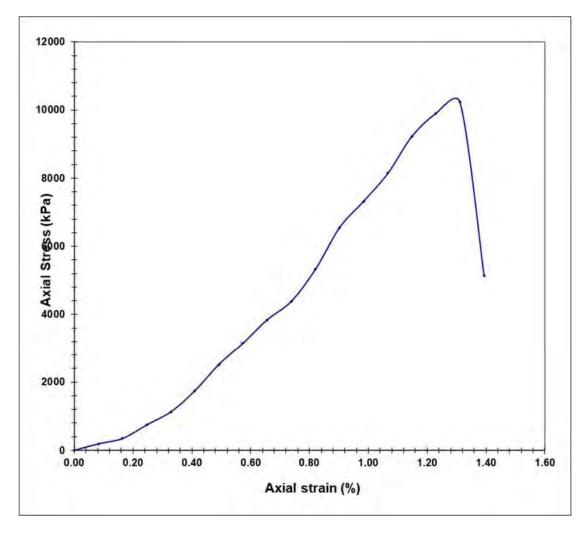
Material: Greywacke - DH103 UC\$13 Test No.: 230295

Sample		Greywacke – DH103
Sample Number		UCS13
Sample Depth	(m)	76.5-76.7
Sample Diameter	(mm)	59.4
Sample Height	(mm)	122.0
Wet Density	(t/m³)	2.00
Water Content	(%)	4.9
Dry Density	(t/m³)	1.90
Unconfined compressive strength	(kPa)	10000
Strain at failure	(%)	1.3
Rate of Axial Compression used	(mm/min)	0.3
Mode of failure		Brittle

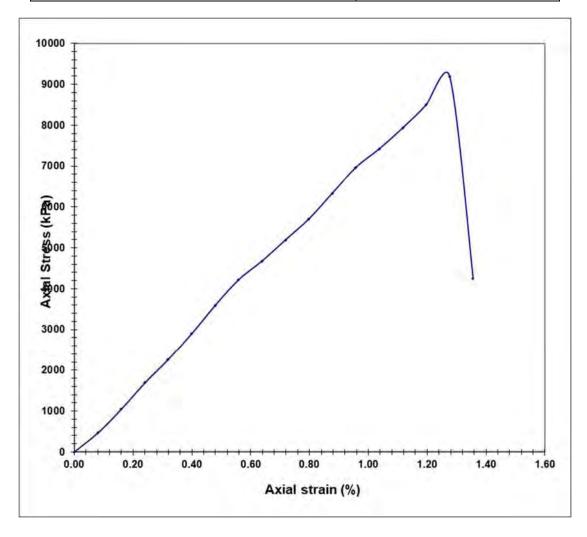
Sample		Greywacke – DH103
Sample Number		UCS14
Sample Depth	(m)	76.95-77.15
Sample Diameter	(mm)	60.0
Sample Height	(mm)	125.4
Wet Density	(t/m³)	2.13
Water Content	(%)	4.4
Dry Density	(t/m³)	2.05
Unconfined compressive strength	(kPa)	9100
Strain at failure	(%)	1.3
Rate of Axial Compression used	(mm/min)	0.2
Mode of failure		Brittle

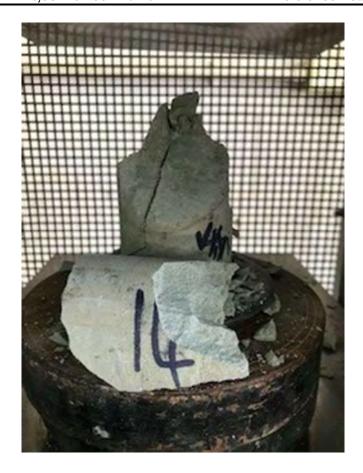
Material: Greywacke - DH103 UC\$14 Test No.: 230296

Source: 76.95m-77.15m Date Sampled: 10<sup>th</sup> January 2023
Job: Project Number 220245 Reference No.: -

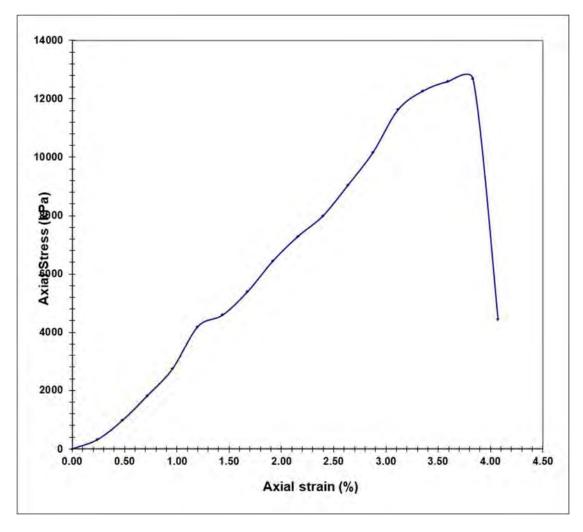
Sample		MST-DH103
Sample Number		UCS15
Sample Depth	(m)	39.3-39.55
Sample Diameter	(mm)	58.0
Sample Height	(mm)	41.8
Wet Density	(t/m³)	2.06
Water Content	(%)	6.9
Dry Density	(t/m³)	1.95
Unconfined compressive strength	(kPa)	13000
Strain at failure	(%)	3.8
Rate of Axial Compression used	(mm/min)	0.2
Mode of failure		Brittle

Note: Sample was unable to be trimmed to 2:1 Ratio

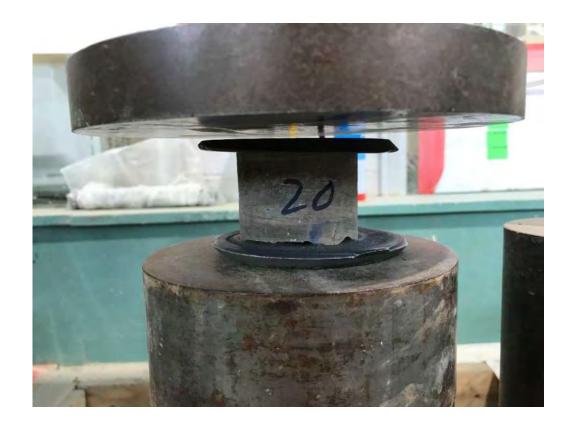
Material: MST - DH103 UCS20 Test No.: 230299

Source: 71.15m-71.3m Date Sampled: 10<sup>th</sup> January 2023
