PRELIMINARY SITE INVESTIGATION: ORCHARD GROVE

Prepared for Gordon Litt Farms Ltd

Prepared by Swiftsure Consultants Ltd

13 November 2025

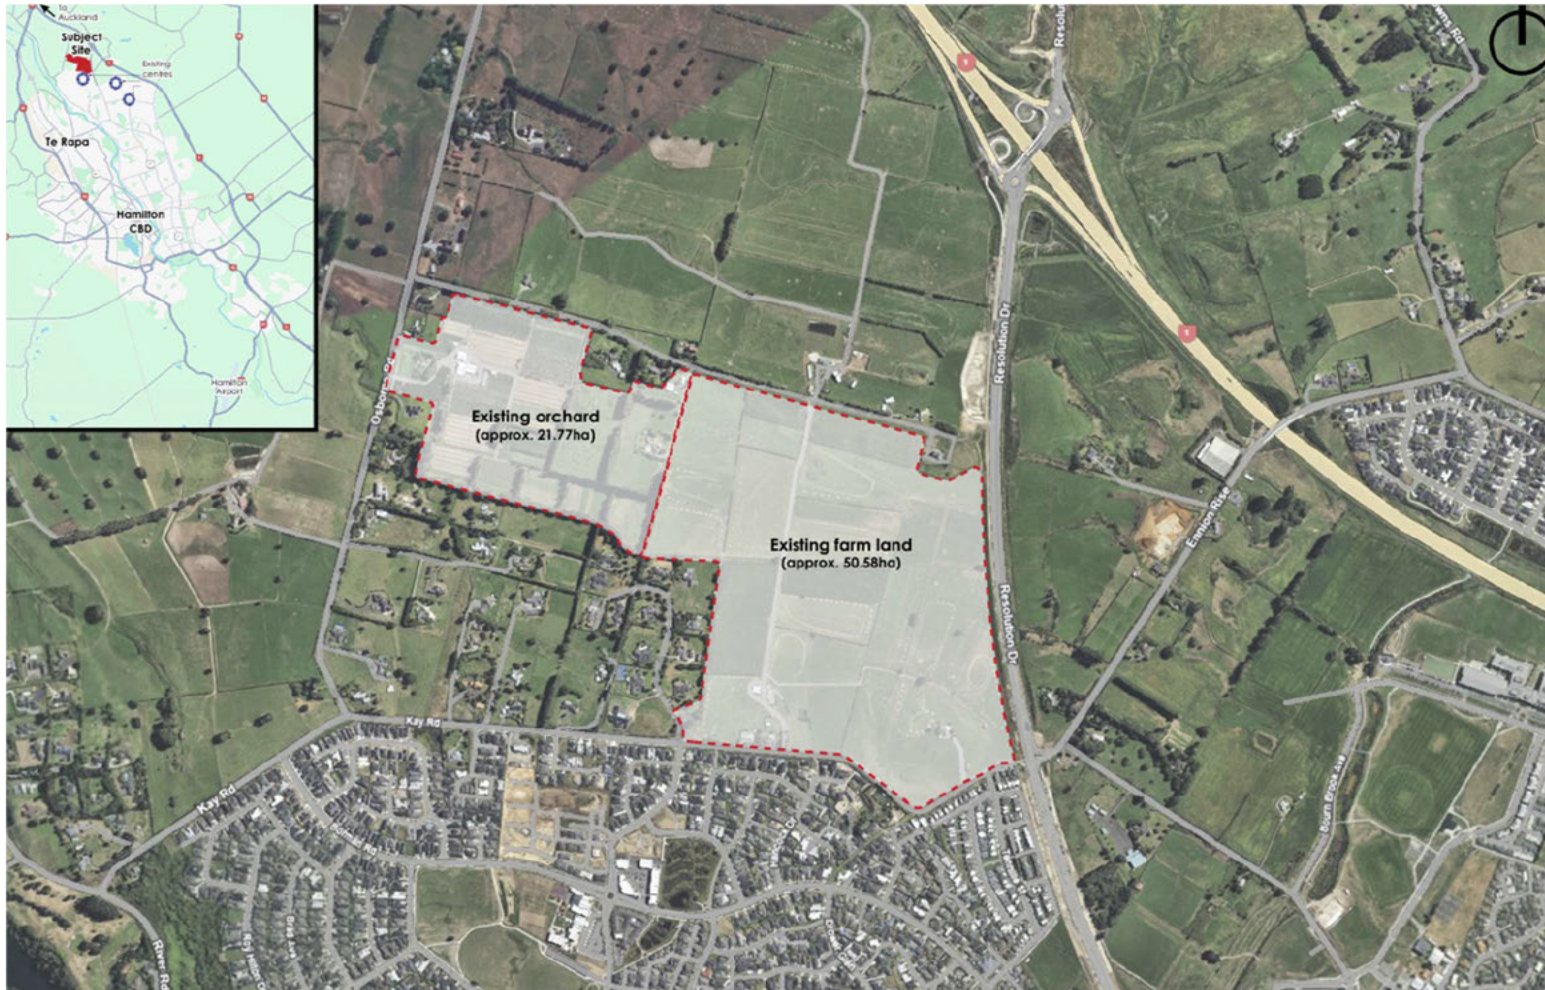
The site is approximately 72 hectares in area. The site has a relatively flat topography with no notable stands of vegetation. The site is zoned 'Rural' under the Waikato District Plan – Operative in Part (WDP-OiP) and is also within an urban expansion area and has a portion of Designation NZTA-8 applicable to the south-east corner. **Figure 1** provides the site location.
