SITE RECORD INVENTORY

NZAA SITE NUMBER: G41/584

SITE RECORD FORM (METRIC)

Metric map number **G41** NZAA METRIC SITE NUMBER **(41) 584**
 Metric map name Cromwell DATE VISITED 2,3/11/2005
 Metric map edition 2000 SITE TYPE Water race
 SITE NAME: MAORI
 OTHER Rise and Shine water race

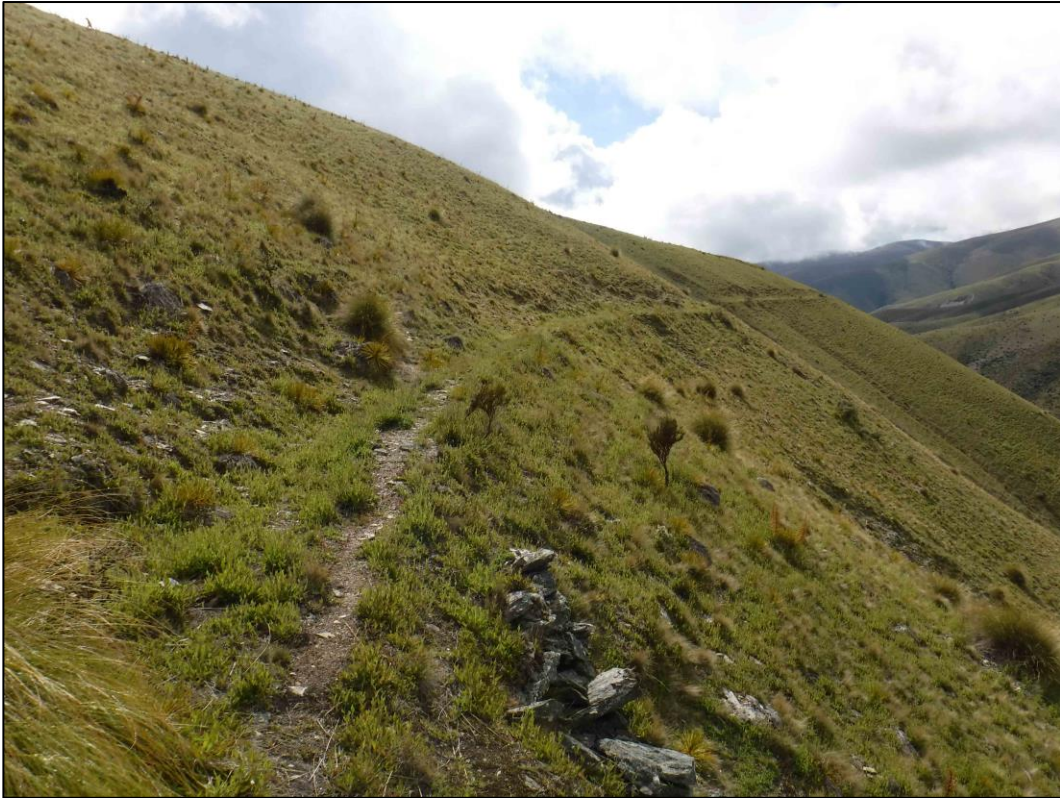
Figure 1 Photograph looking southeast at the upper extent of the water race recorded as G41/584. Photograph taken by Jasmine Weston on 14/12/2018.

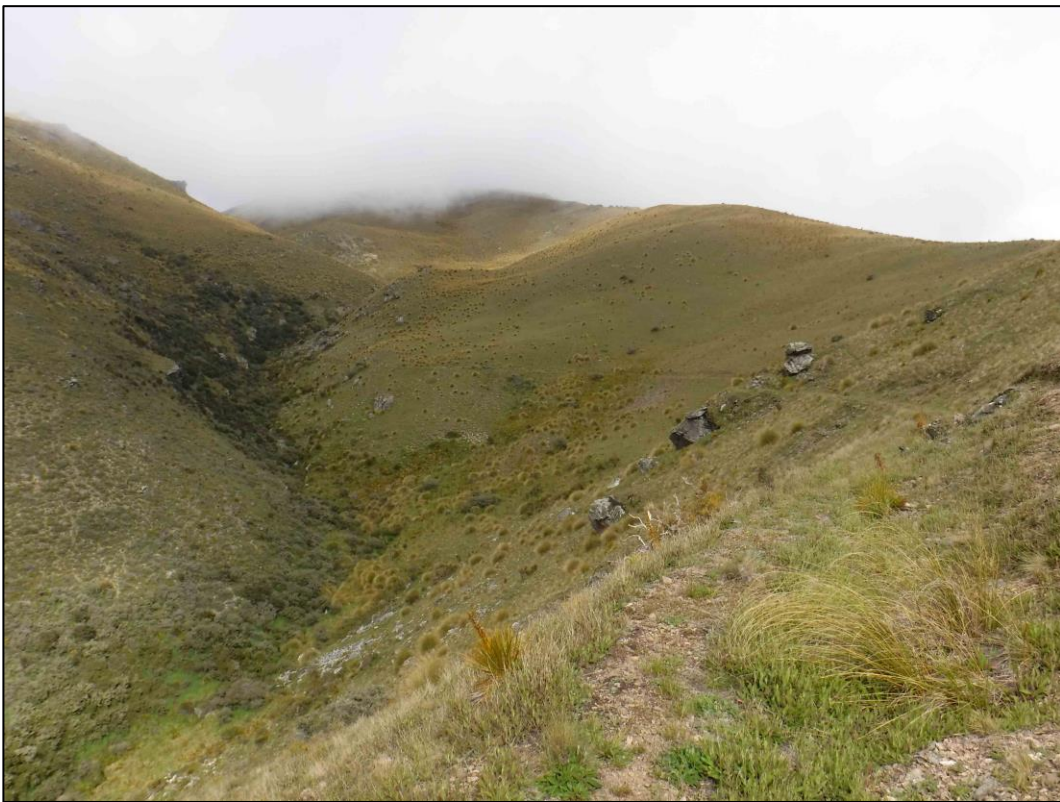
Figure 2 Photograph looking northwest at the upper extent of the water race recorded as G41/584. Photograph taken by Jasmine Weston on 14/12/2018.

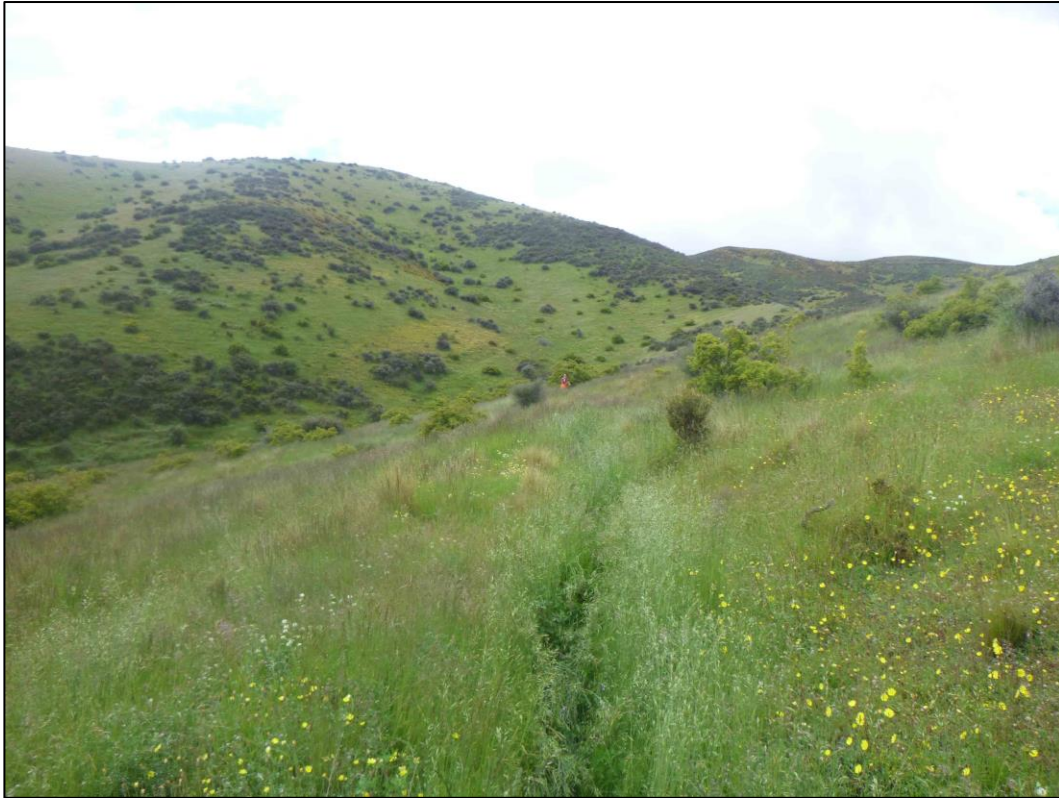
Figure 3 Photograph looking west at the lower extent of the water race recorded as G41/584. Photograph taken by Megan Lawrence on 14/12/2018.

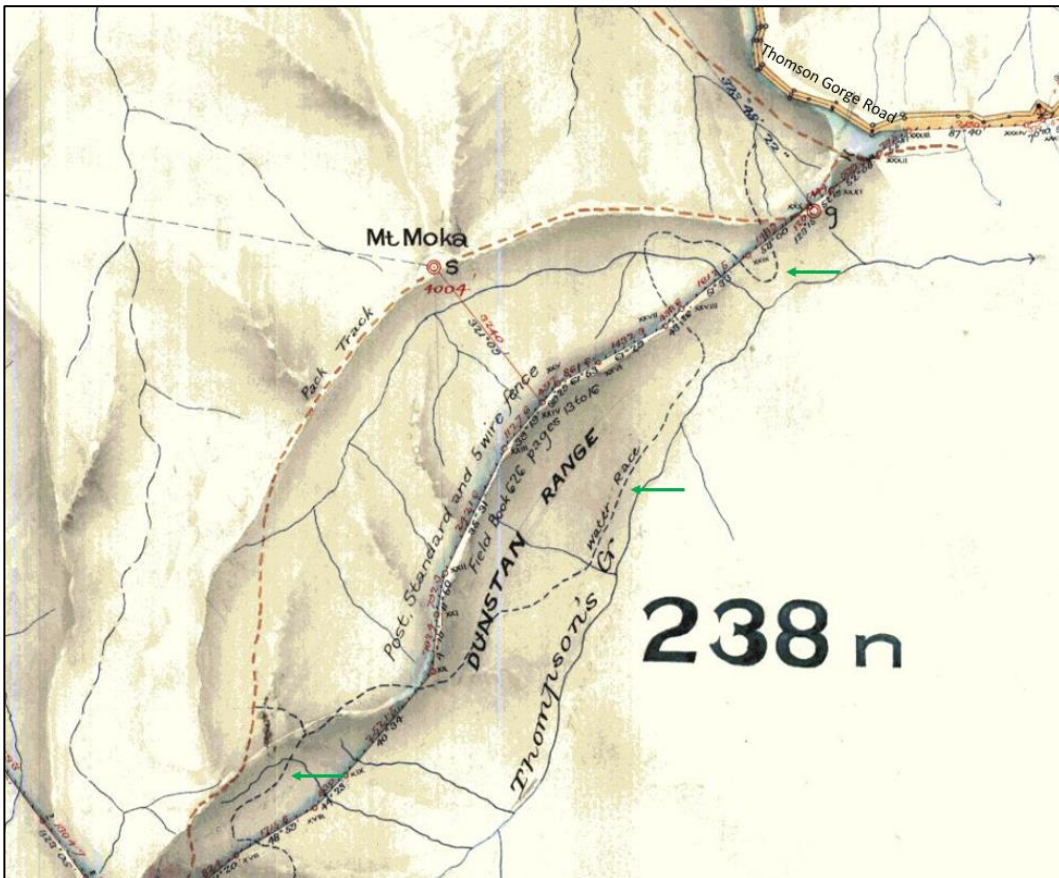
Figure 4 Survey plan SO 1204 (1909) showing the Rise and Shine water race (green arrows) around Mount Moka (QuickMaps).

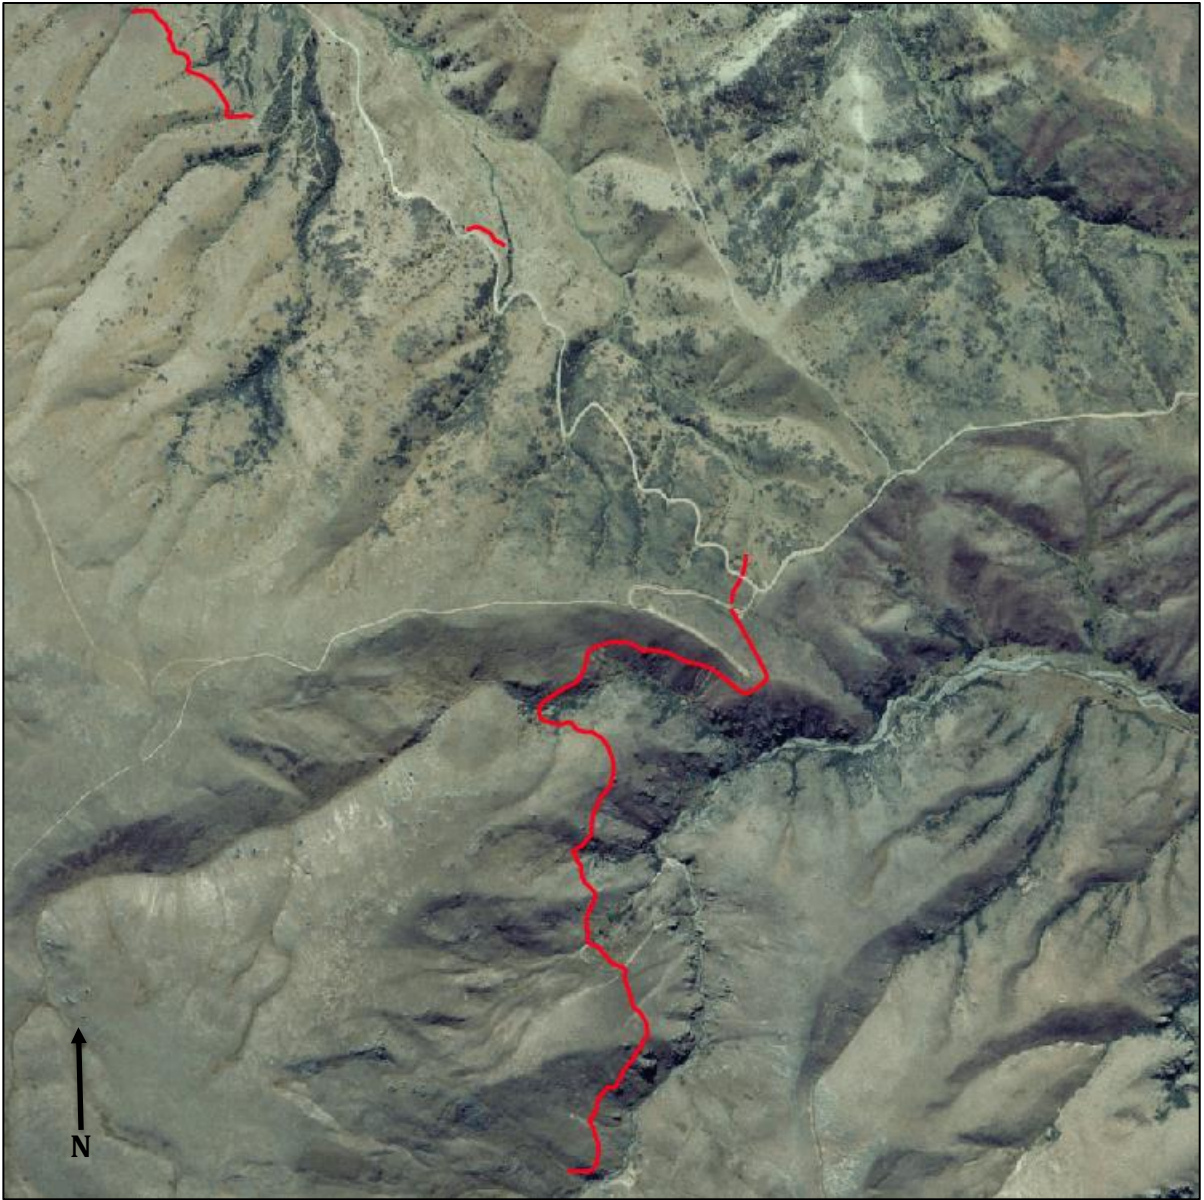
Figure 5 Aerial photograph showing the approximate extent of the water race recorded as G41/584. Approximate site extent based on recorded archaeological features, pedestrian survey, aerial photographs and LiDAR.

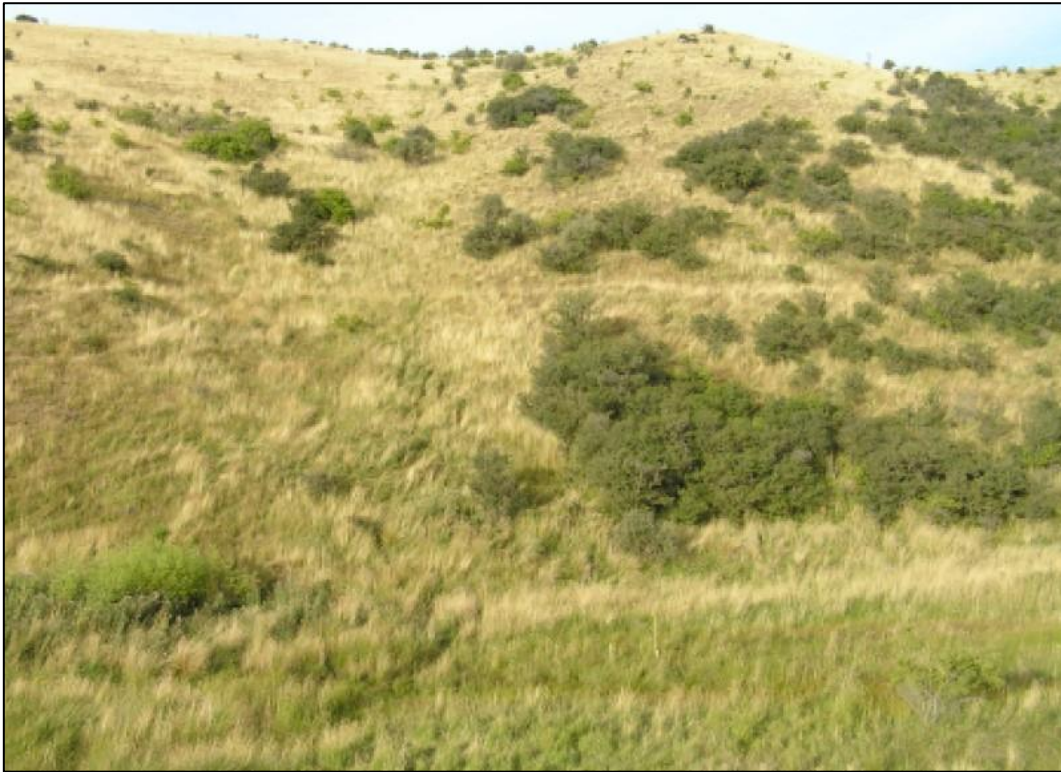
Some disturbance from later mining and road formation but mostly intact.

Figure 1. Site G41/586 viewed in 2005 from site G41/277 in Rise and Shine valley (Nichol & Wright, 2006).

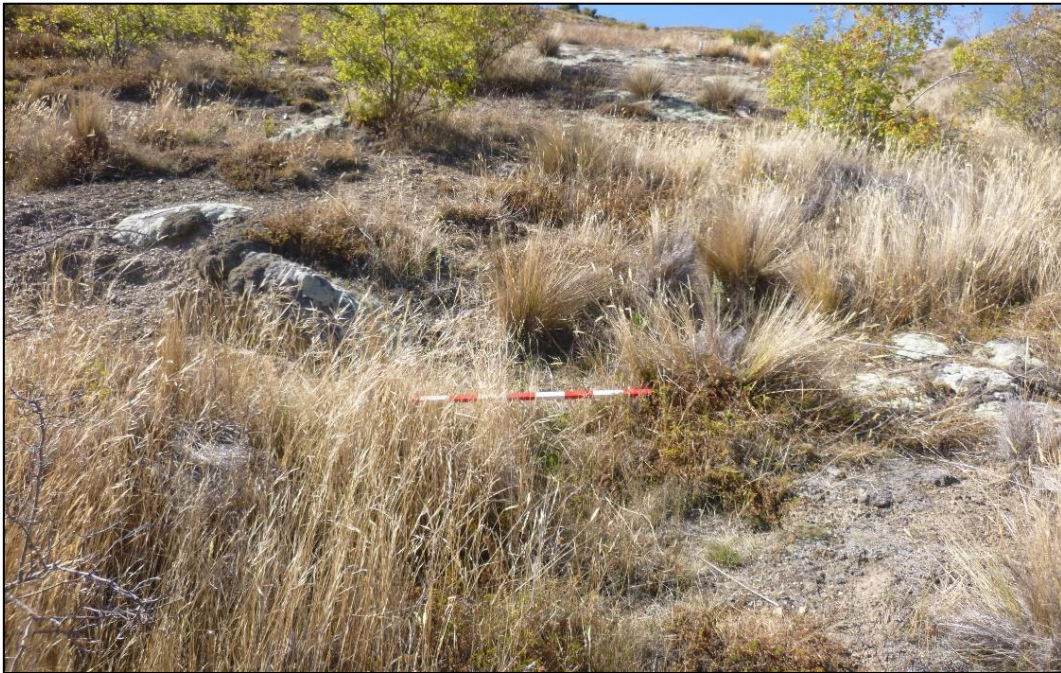
The northeast end of the race was identified during a February 2018 survey where it crosses site G41/604. Closer inspection of current LiDAR and 1958 aerial imagery indicates that the water race splits in two, close to where it intersects with present day Thomson Gorge Road. One section turns back in a hair pin turn at Thomson Gorge Road and heads towards Shepherds Creek while the second race heads southwest towards a tributary of Bendigo Creek . The latter aligns with Nichol & Wright's on site observations. Modern mining has occurred in and around the water race, in particular late 1980s drill holes along the section leading to Shepherds Creek. While some damage has occurred to this race, the 2018 LiDAR data still shows the race at these locations. The southern extent of the Come-in-Time water race was sighted during a December 2018 survey.

Figure 2. Photograph looking south at the Come-in-Time water race where it passes through G41/604, February 2018.

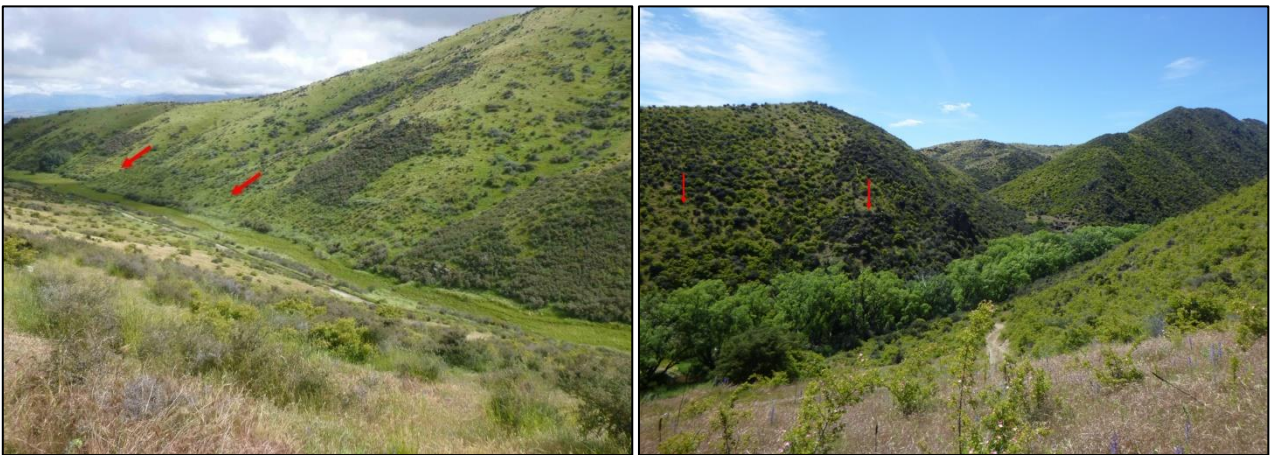
Figure 4. Left: photograph looking north at the Come-in-Time water race. Right: photograph looking northeast at the water race. Both photographs taken December 2018.

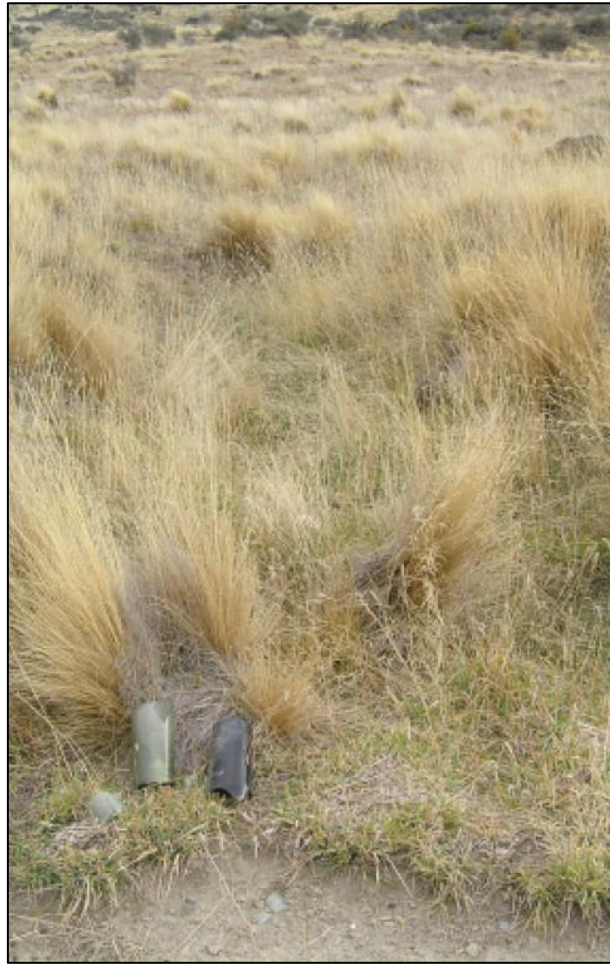
Figure 1. Nineteenth century bottle fragments with slot excavation behind at site G41/588 in 2005 (Nichol & Wright, 2006).

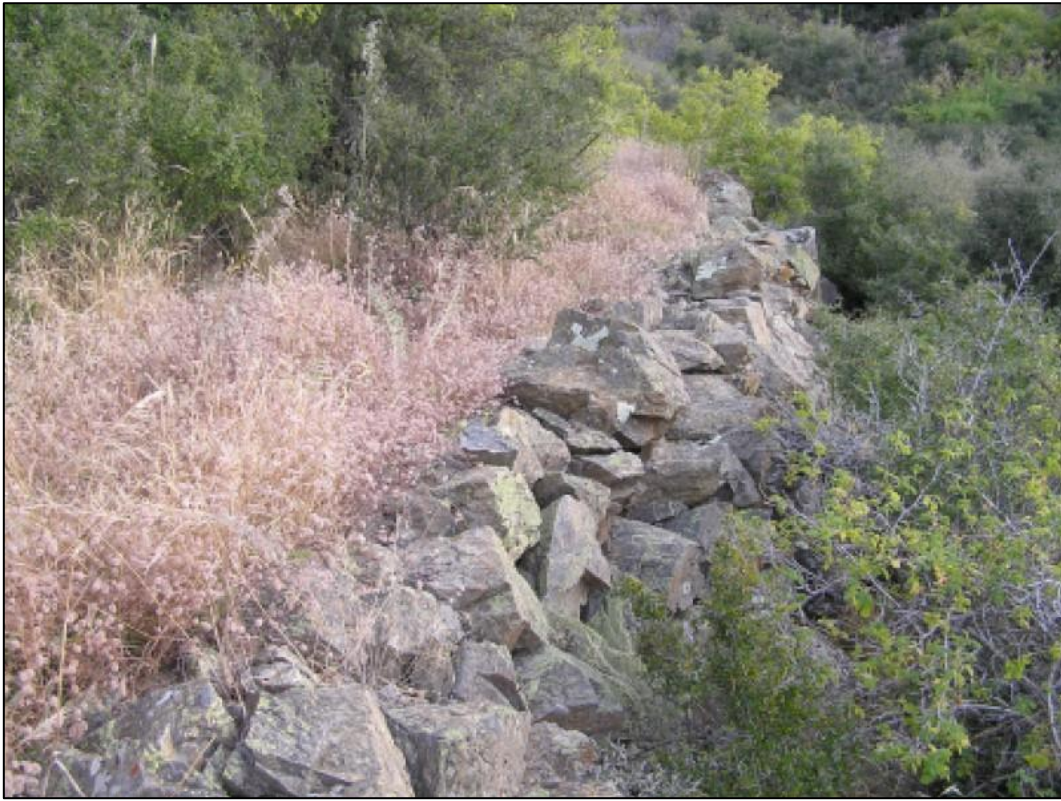
Appears to be largely intact but not viewed close up.

Figure 1. Site G41/589 in 2005 (Nichol & Wright, 2006).

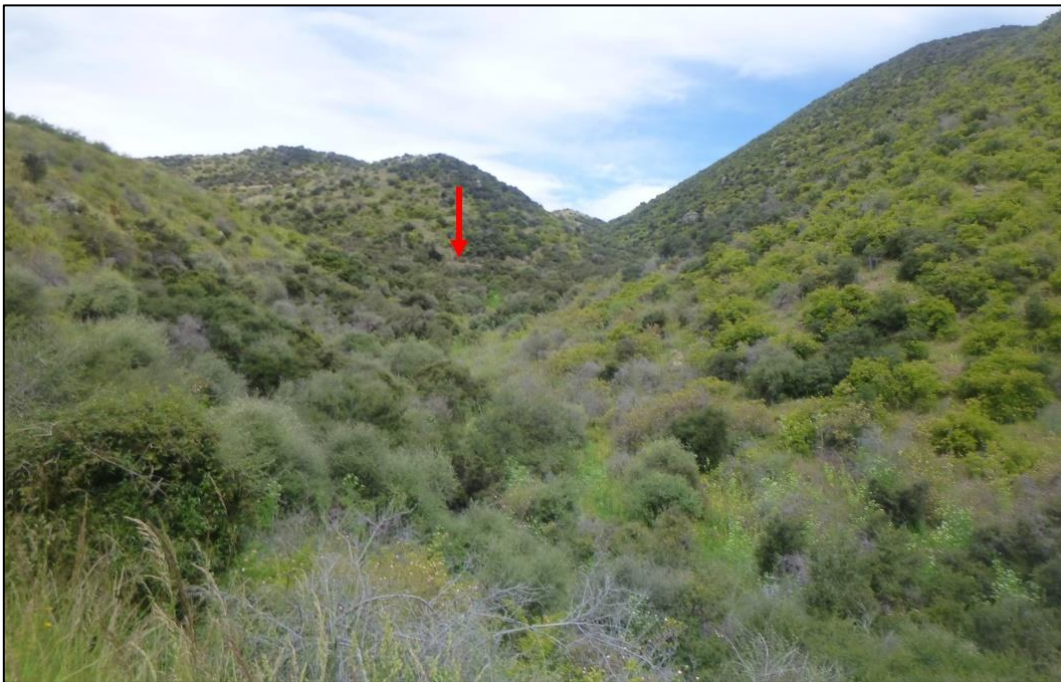
Figure 2. Photograph looking northeast at the revetted road recorded as G41/589 (red arrow), taken 2018.

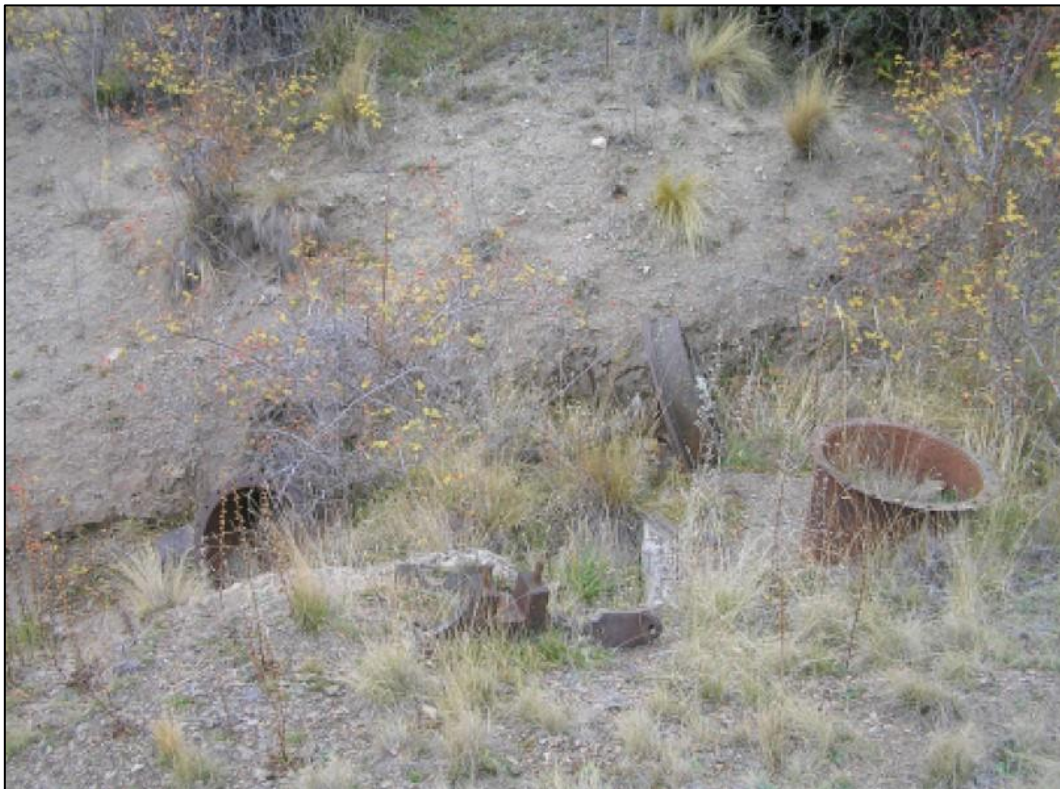
Figure 2. Potential turbine remains at site G41/604 in 2005 (Nichol & Wright, 2006).

Adjacent to the impeller are decayed timbers in the ground with 32 mm diam. bolts, 950 mm apart but not in line. Longest is 500 mm above ground. Alongside, in the bottom of the natural gully, is a channel in the rock c. 750 mm wide. Below the turbine remains is a levelled area c. 6 m long and 2.5 m wide on the hillside (not shown by Hamel). Pipe bend below the machinery as shown by Hamel not sought.

Hamel (1993: 15) says there was a water turbine at the Matilda battery, and it could later have been moved to this site. But this "bush turbine" was almost certainly inadequate to power the 20-stamp Matilda battery, and it is more likely that the Matilda turbine inspired the Red Mine North operators to develop this "bush turbine". As it may not even have driven the small battery at this site the battery may then have been taken over the ridge to the Come-in-Time site.

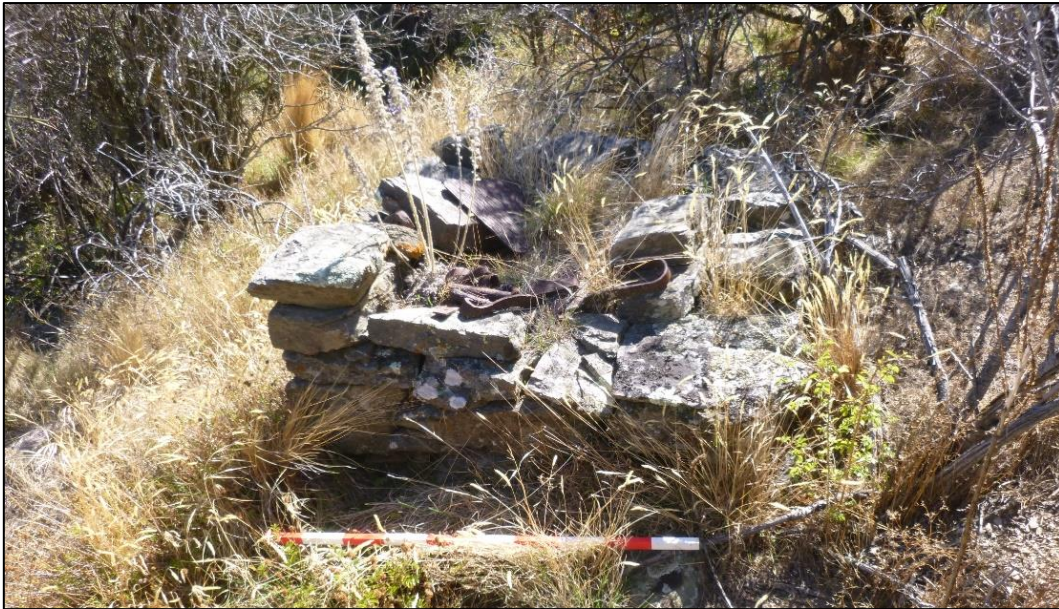
Figure 3. Stacked stone chimney or forge remains with metal artefacts on top (G41/604), photographed February 2018.

Shown as chimney on Hamel (1993: fig 20a). Fireplace (forge?) 1.2 m wide, 1.3 m deep and 0.75 m high at front. 2.4 m from front of fireplace to front of terrace and about 2 m each side of fireplace. Metal relics on top include an eye-bolt used in bracing a timber building; a pin used in securing a structure to its foundations; a pipe bracket; a rail joiner; and possibly part of the chassis from a small rail wagon or tub. One item is thought to be a riffle plate of a Wilfley table, used in gold recovery, suggesting that a battery was operating close by (identification from Jim Staton).

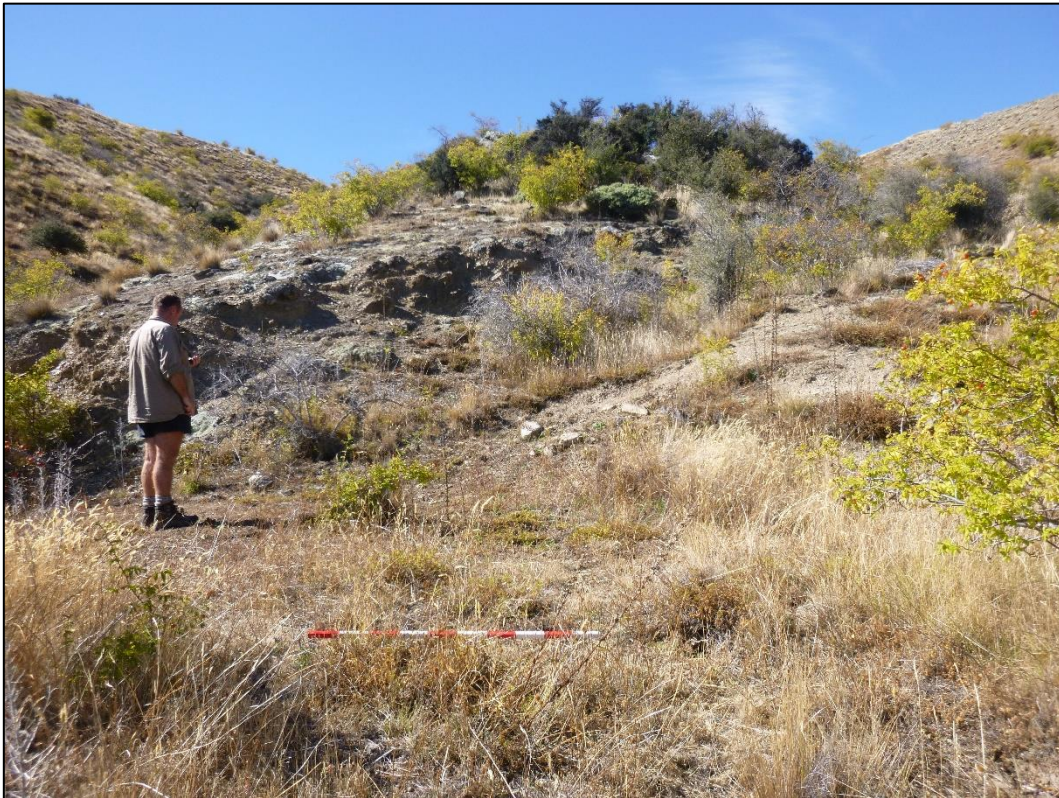
Visited in November 2017 and February and December 2018. Found to be largely as described in earlier site record form updates. Intact features included a stacked stone chimney or forge, pieces of machinery and metal pipe, trenches and chasms. Twentieth century vehicle tracks have modified the site.

Figure 4. Looking southeast towards site G41/604, February 2018.

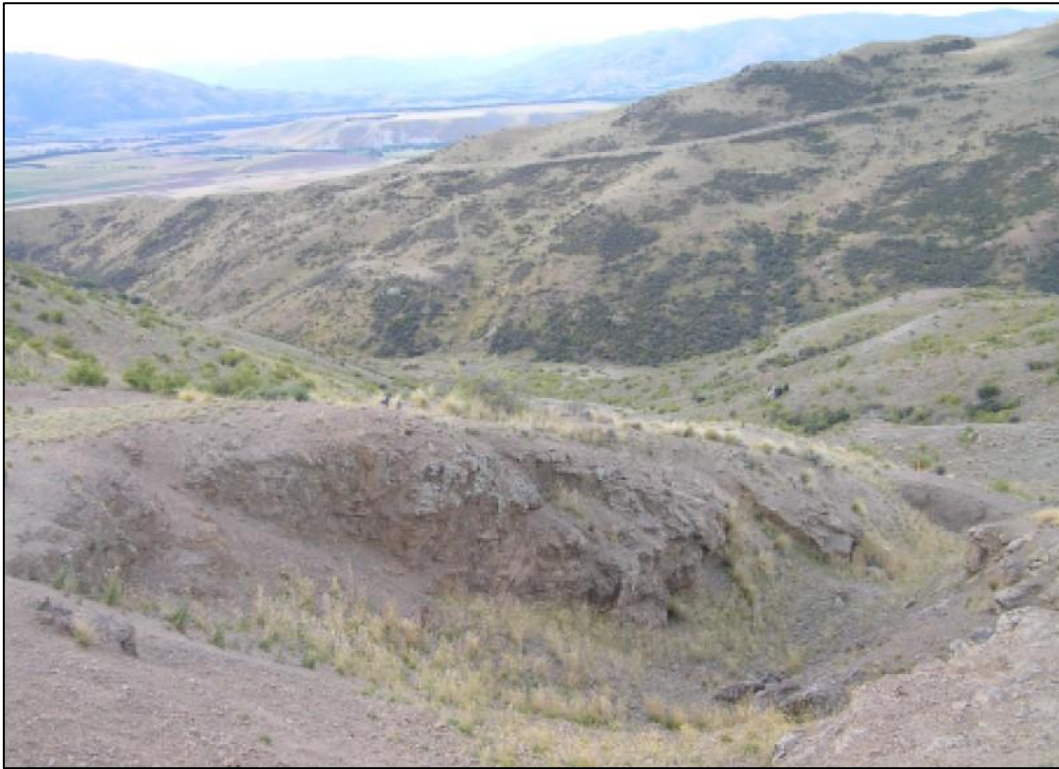
Some modern disturbance but many features remain intact.

Figure 1. Looking north over site G41/605 in 2005 (Nichol & Wright, 2006).

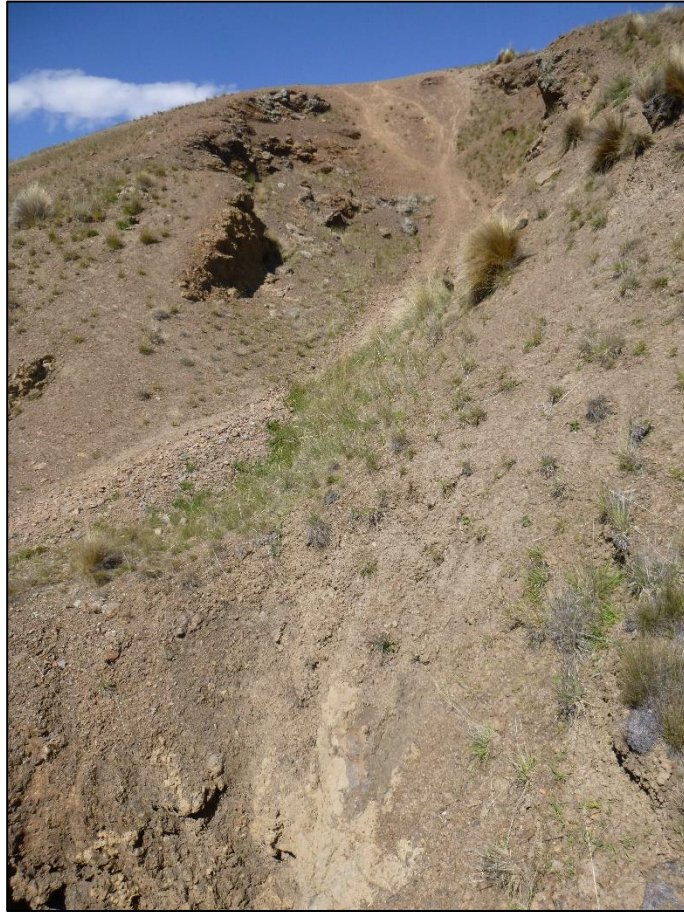
Visited in November 2017 and February and December 2018. Found to be largely as described in earlier site record form. Twentieth century vehicle activity have modified the site.

Figure 3. Looking southeast at G41/605, towards Thompsons Gorge Road (at top of ridge), showing motorcycle tracks, November 2017.

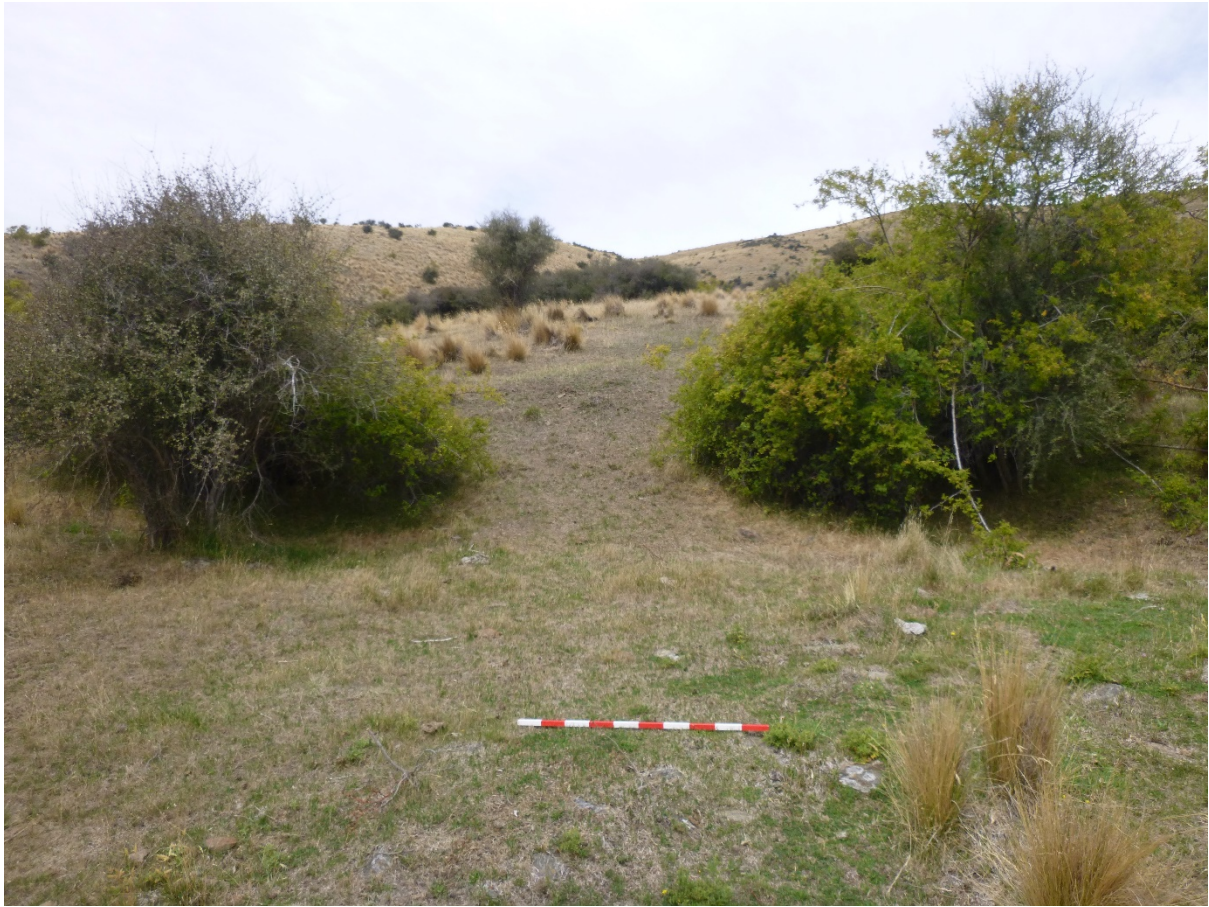
Terrace, bank and prospecting pit are in good condition and easily identifiable. no obvious structural features remain but surface artefacts suggest there may be surviving subsurface archaeology

Figure 1. House/hut terrace looking south.

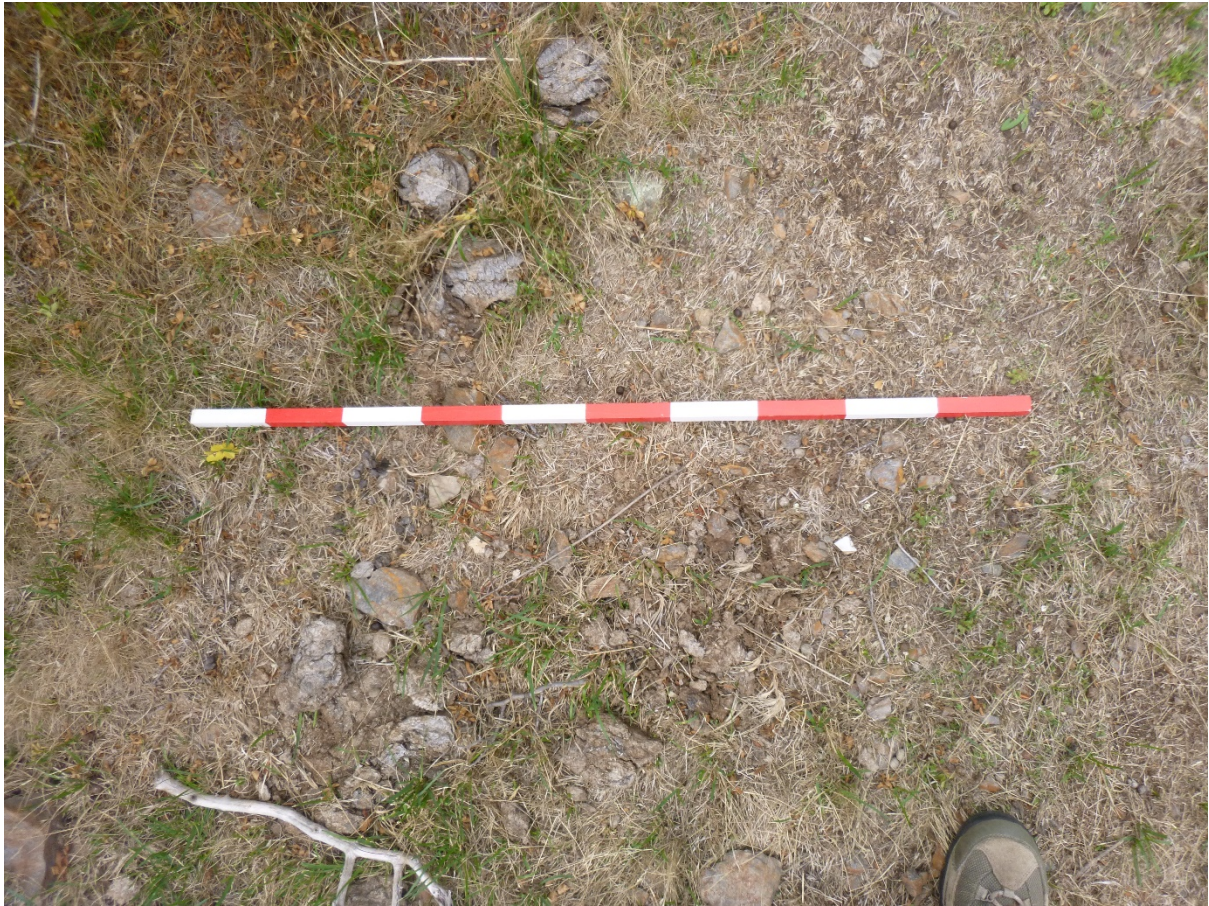
Figure 2. Surface artefacts on terrace.

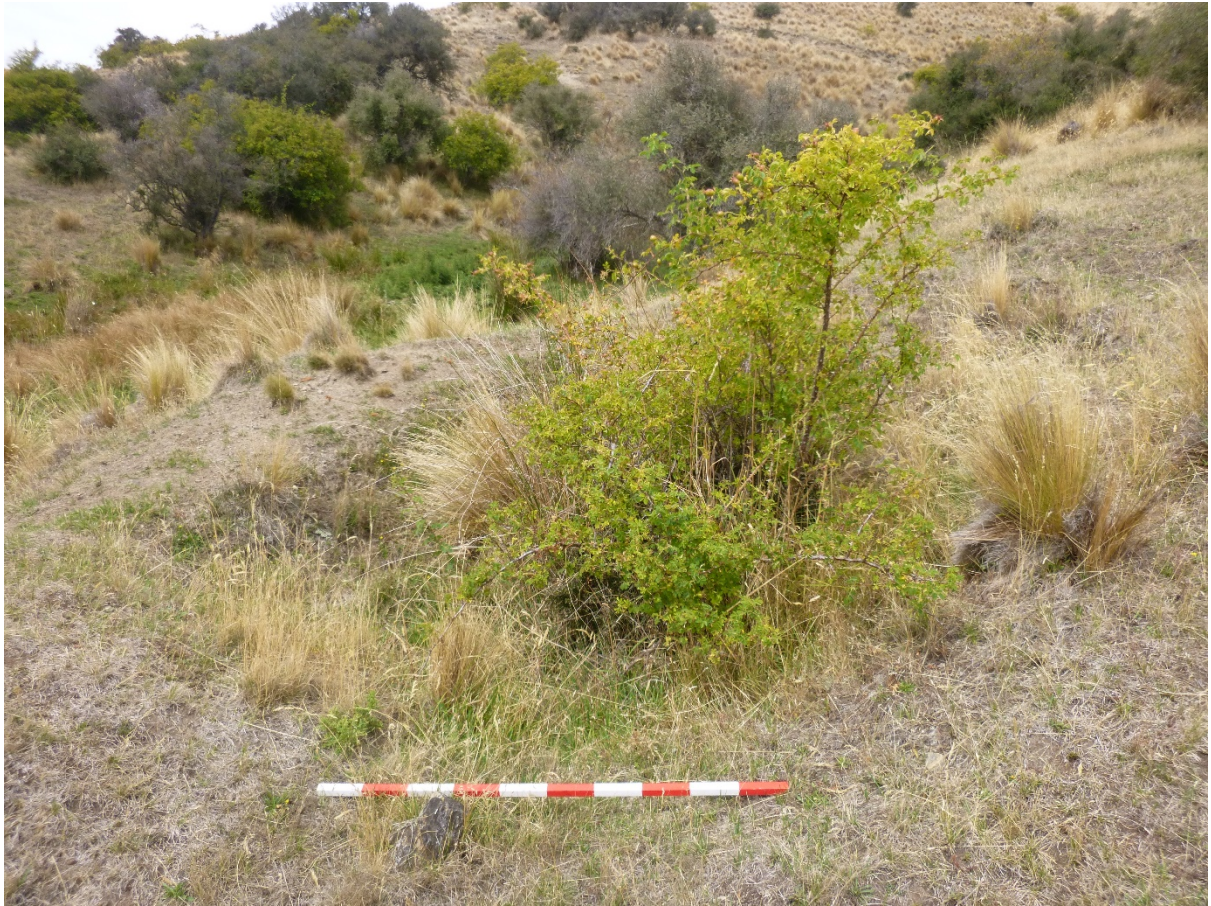
Figure 3. Prospecting pit downslope from house/hut terrace.

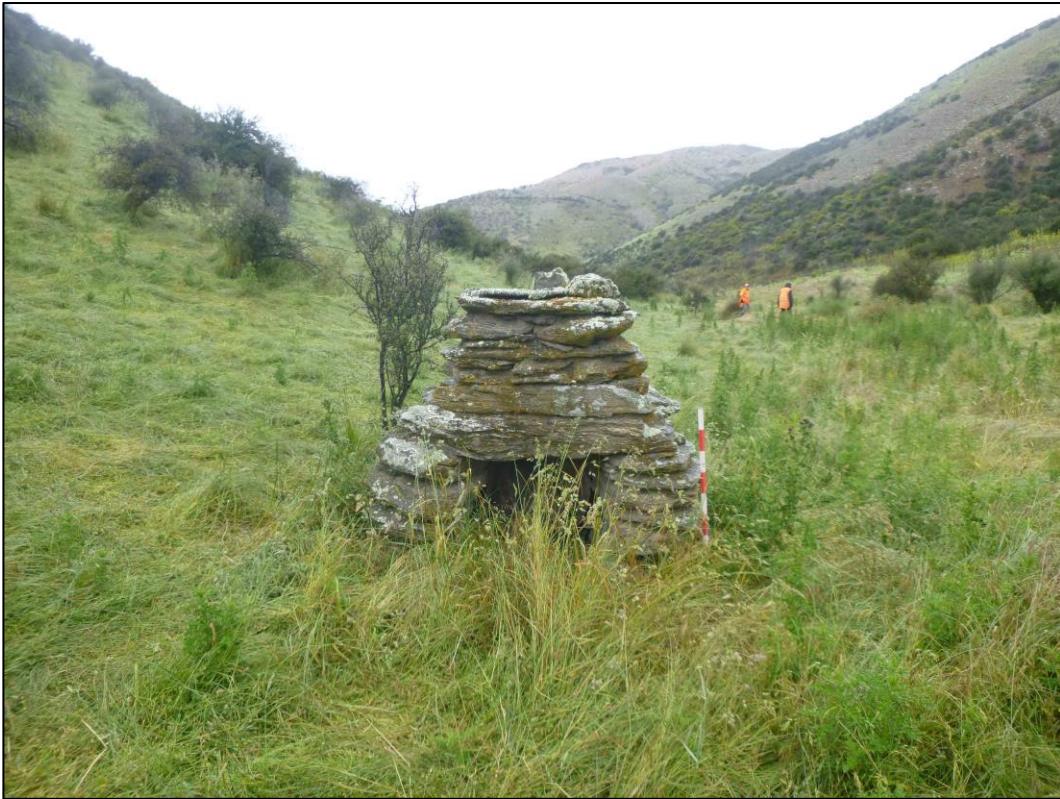
Figure 1 Photograph looking southeast at chimney recorded as G41/678. Photograph taken by Phoebe Scrivener on 19/12/18.

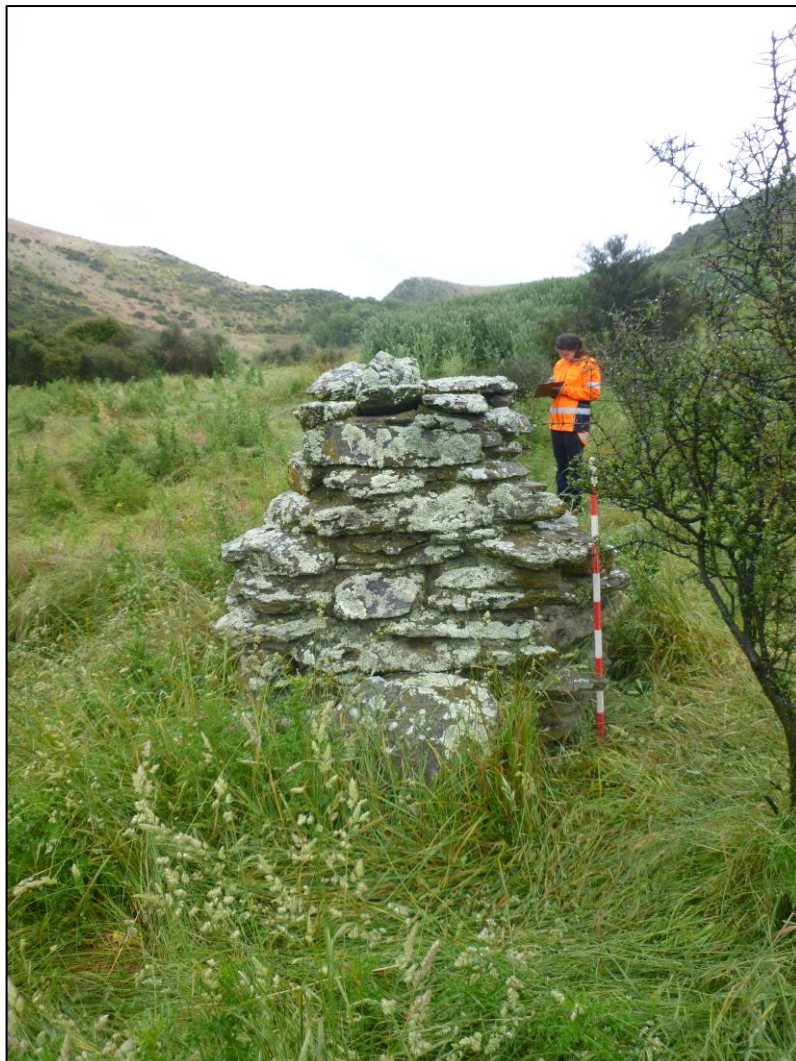
Figure 2 Photograph looking northwest at chimney recorded as G41/678. Photograph taken by Phoebe Scrivener on 19/12/18.

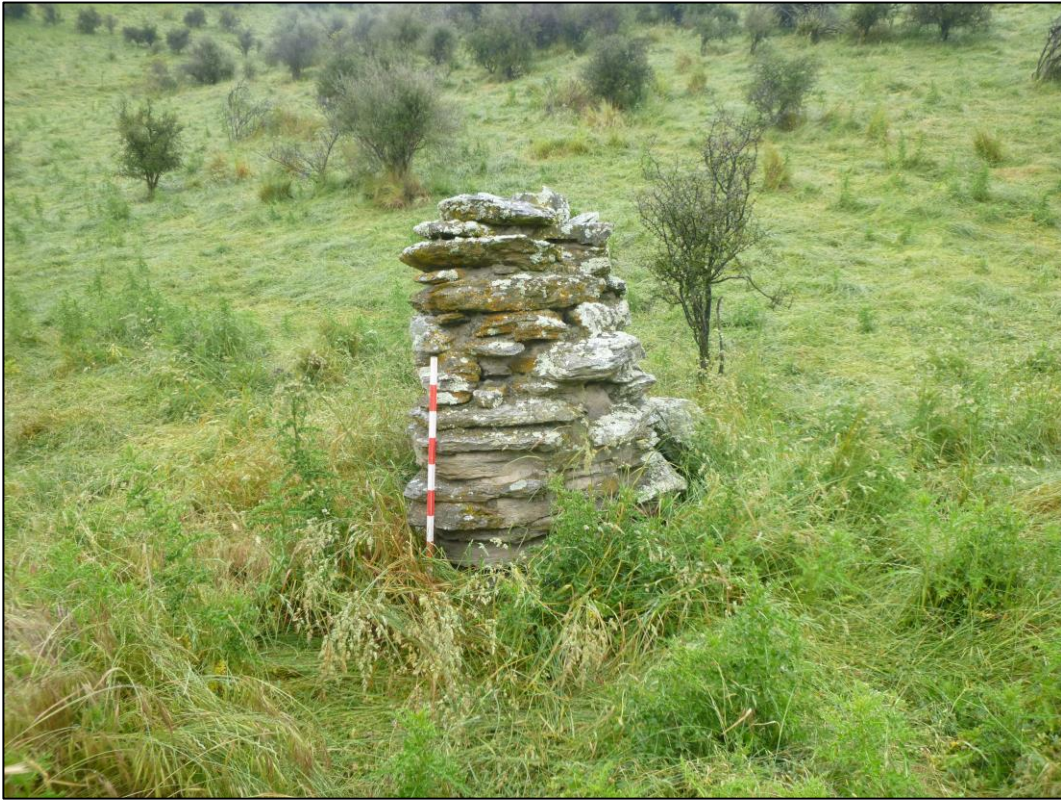
Figure 3 Photograph looking northeast at chimney recorded as G41/678. Photograph taken by Phoebe Scrivener on 19/12/18.

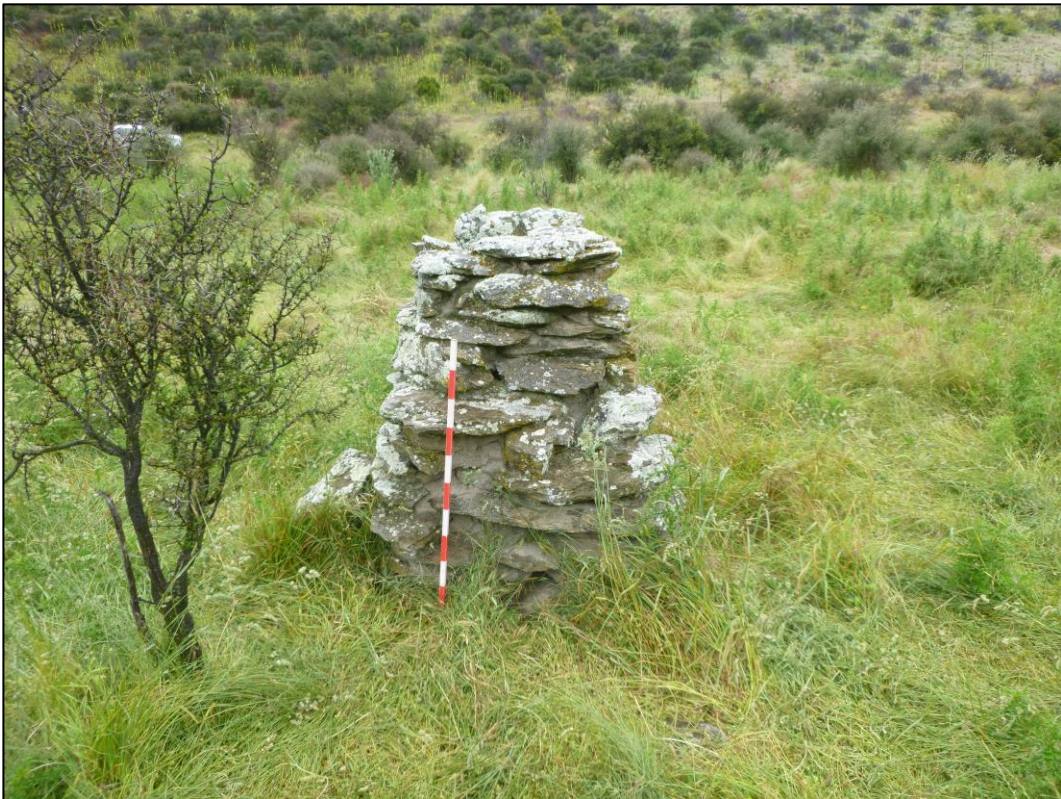
Figure 4 Photograph looking southwest at chimney recorded as G41/678. Photograph taken by Phoebe Scrivener on 19/12/18.

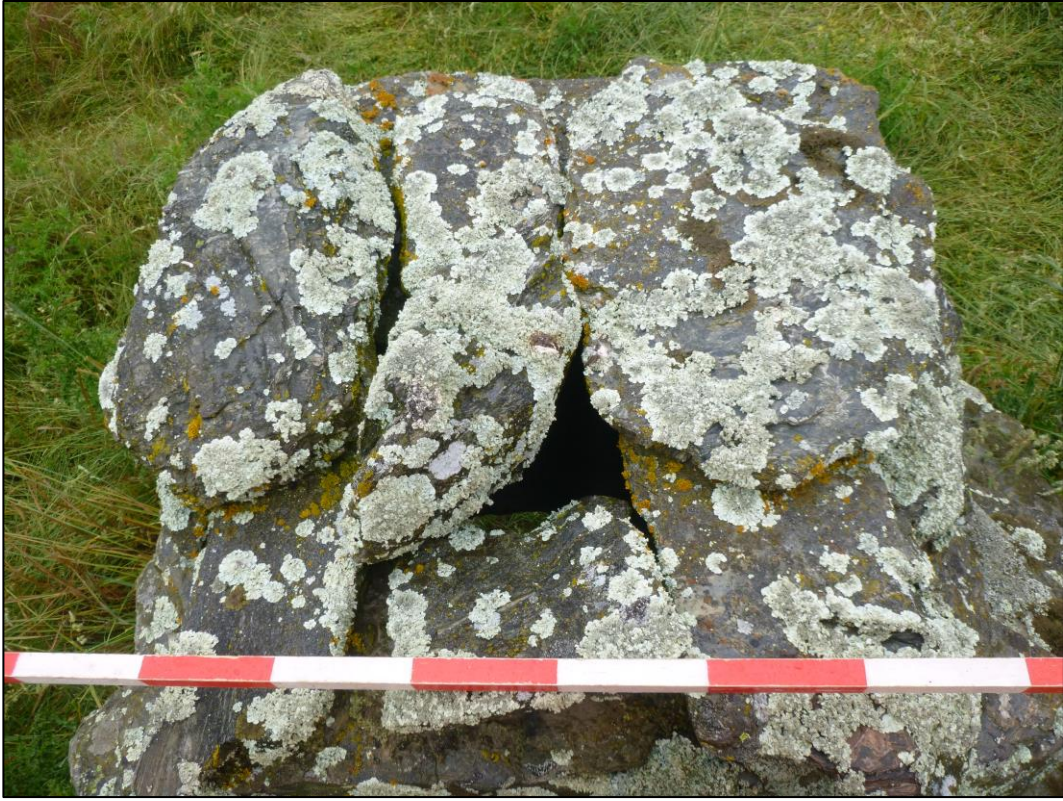
Figure 5 Photograph looking at top of chimney recorded as G41/678. Photograph taken by Phoebe Scrivener on 19/12/18.

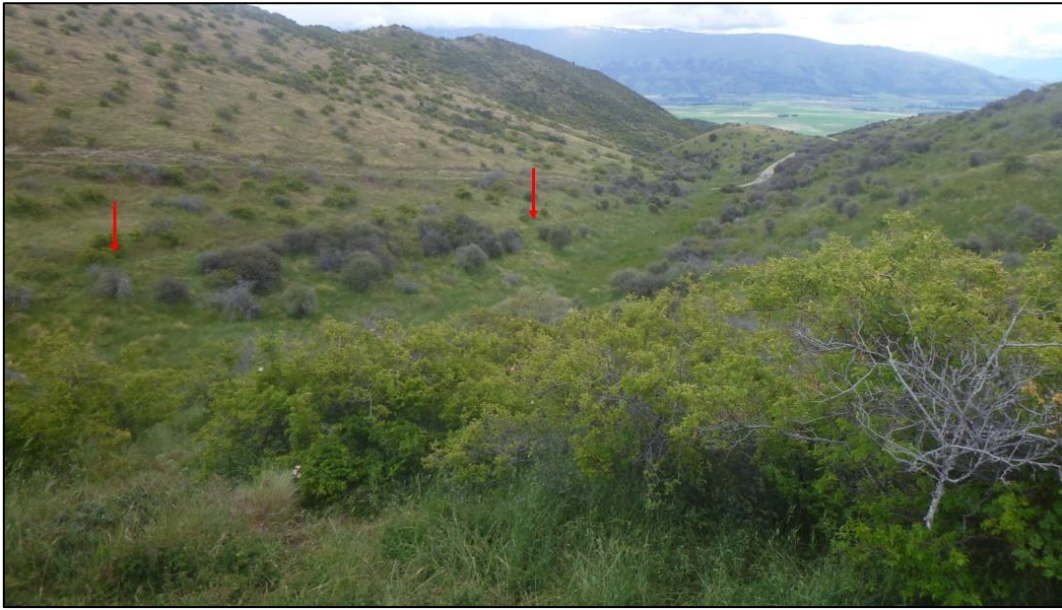
Track still discernible but overgrown.

Figure 1. Photograph looking west at possible pre-1900 track (red arrows).
