SITE RECORD INVENTORY

NZAA SITE NUMBER: G41/584

SITE RECORD FORM (METRIC)

Metric map number **G41** NZAA METRIC SITE NUMBER **(41) 584**
 Metric map name Cromwell DATE VISITED 2,3/11/2005
 Metric map edition 2000 SITE TYPE Water race
 SITE NAME: MAORI
 OTHER Rise and Shine water race

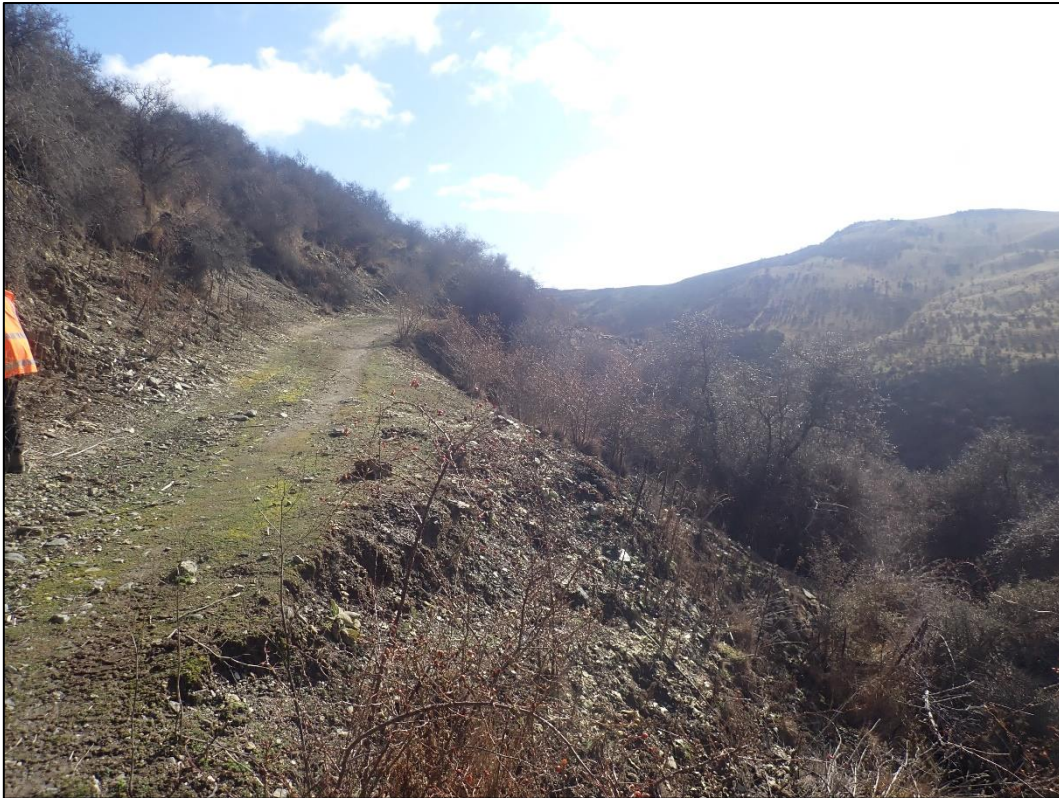
The rough wide portion of the road is still used today. The stone revetments and culverts are in good condition, except for a couple that have collapsed and or have been partially infilled.

Figure 3. Photograph looking northwest at main vehicle track currently used along the Matakanui-Bendigo Road.

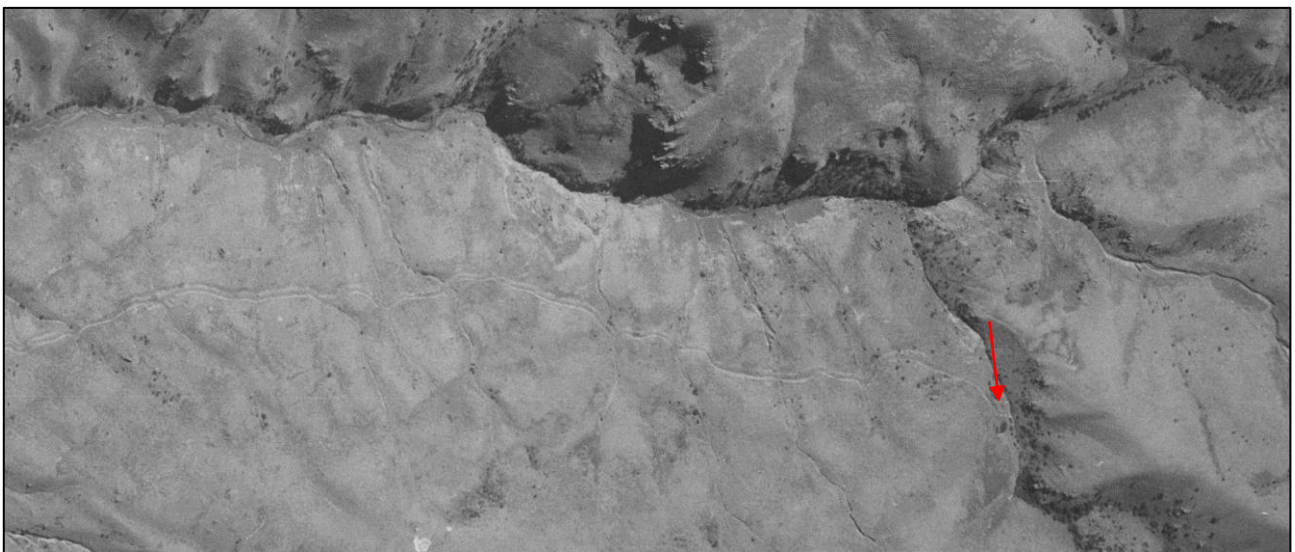
Figure 4. Aerial photograph from 1958 showing the Matakanui-Bendigo Road (Retrolens, 2021). Note that following the main stone revetment (red arrow) the wide road is no longer visible.

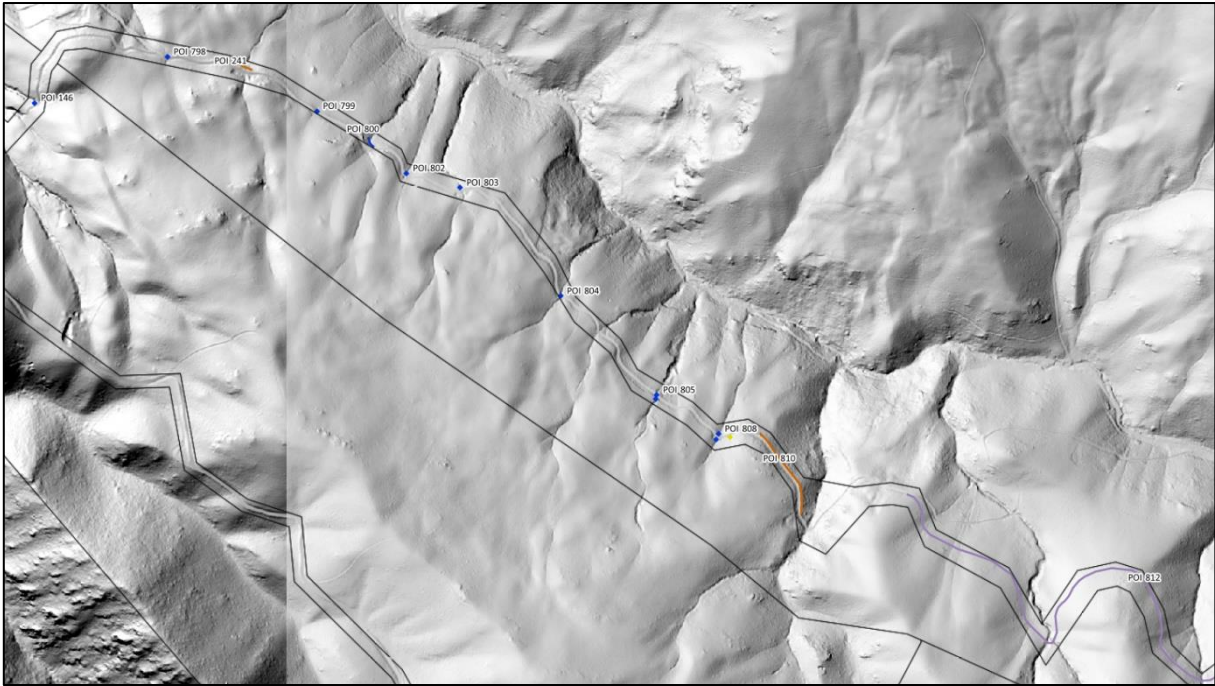
Figure 5. LiDAR imagery with land parcel boundaries shown in black. The Matakanui-Bendigo Road as surveyed is shown along with associated features. At the southeast end, the currently used road veers off to the northeast; however, a smaller narrower track continues to follow the surveyed alignment (shown in purple – POI 812), this was later determined to be a track established approximately 20 years ago, and further west it veers off from the proposed road extent. Features along the track include culverts in blue, historic drill site in yellow, and stone revetments in orange.

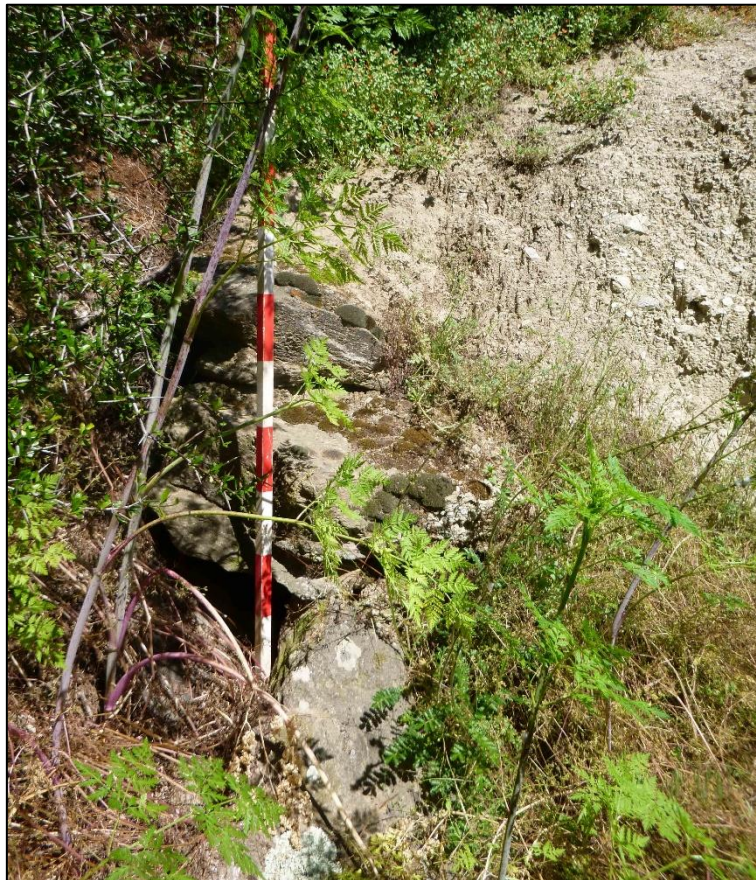
Figure 6. Photograph looking east at collapsed stacked schist culvert (POI 146).

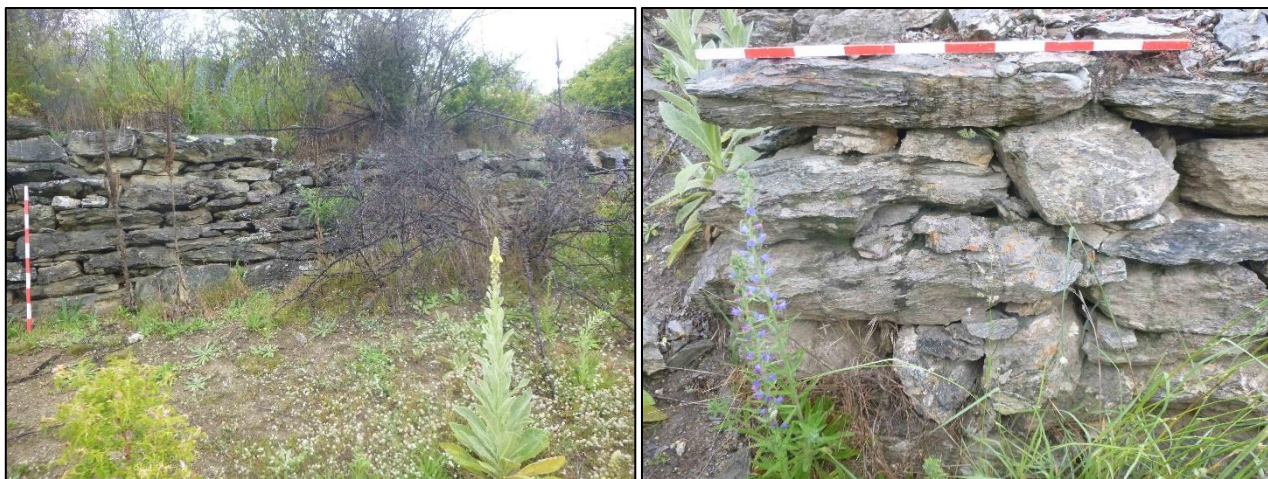
POI No.	Feature Type	Condition notes
POI 146	Culvert	Poor - collapsed
POI 241-242	Revetment	Good condition
POI 798	Culvert	Good condition, still functional
POI 799	Culvert	Good condition, still functional
POI 800	Culvert/revetment	Fair condition, collapsed on west end
POI 802	Culvert	Collapsed, poor condition
POI 803	Culvert/revetment	Good condition, still functional
POI 804	Culvert	Good condition
POI 805-806	Culvert	Good condition
POI 807-808	Culvert	Fair condition, partially infilled
POI 809	Culvert	Good condition
POI 810	Revetment	Good condition

Figure 7. Photograph looking south at stacked schist revetment (POI 241-243).

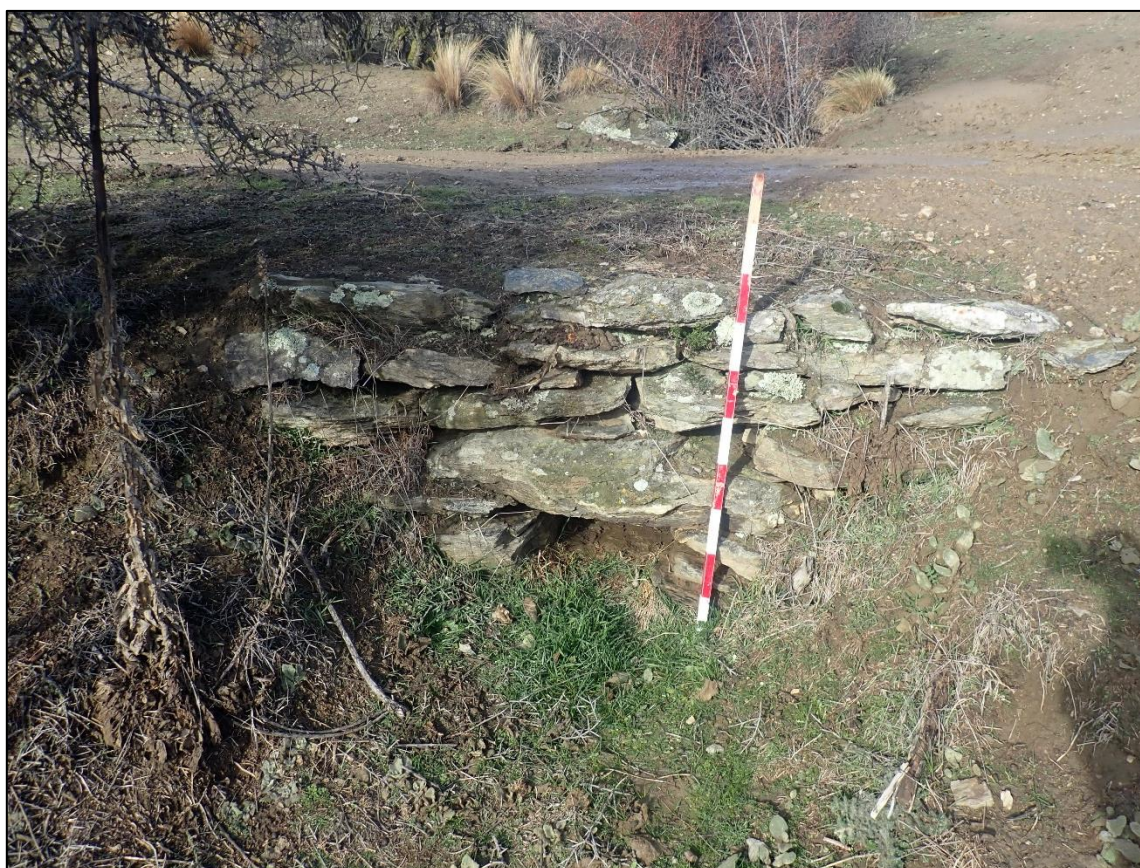
Figure 8. Photograph of culvert (POI 798) looking north.

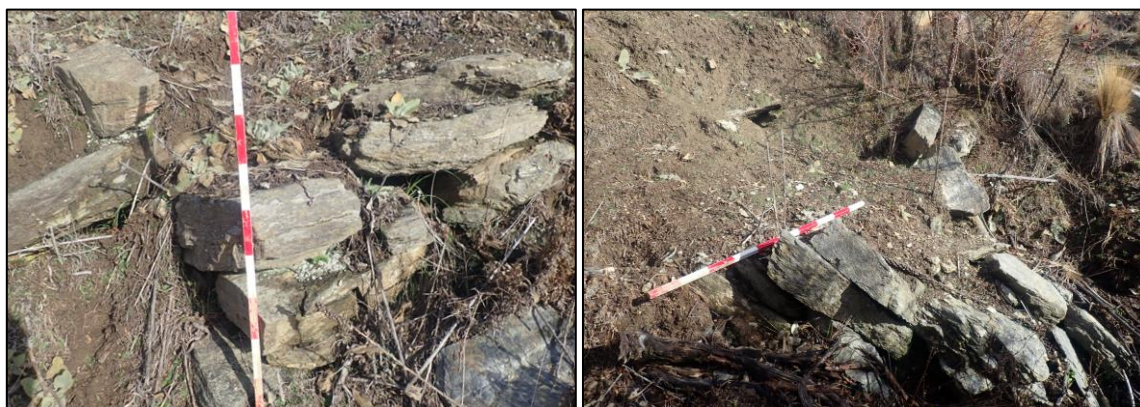
Figure 9. Photograph looking southwest at partial culvert (POI 798 – top left), collapsed culvert (POI 802 - top right)

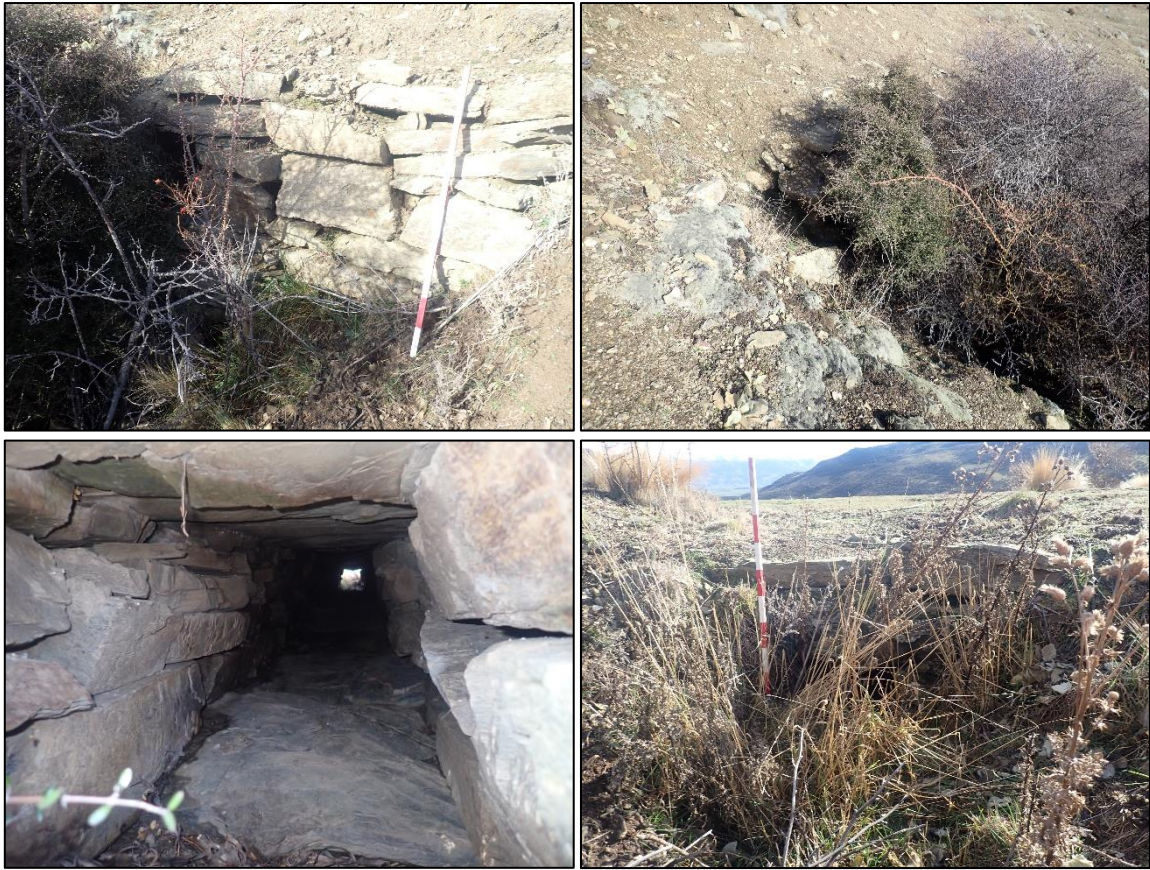
Figure 10. Photographs of culvert and revetment (POI 800) looking southeast at intact east end (top left), east at collapsed west end (top right), south at culvert (bottom left), and north at inlet (bottom right).

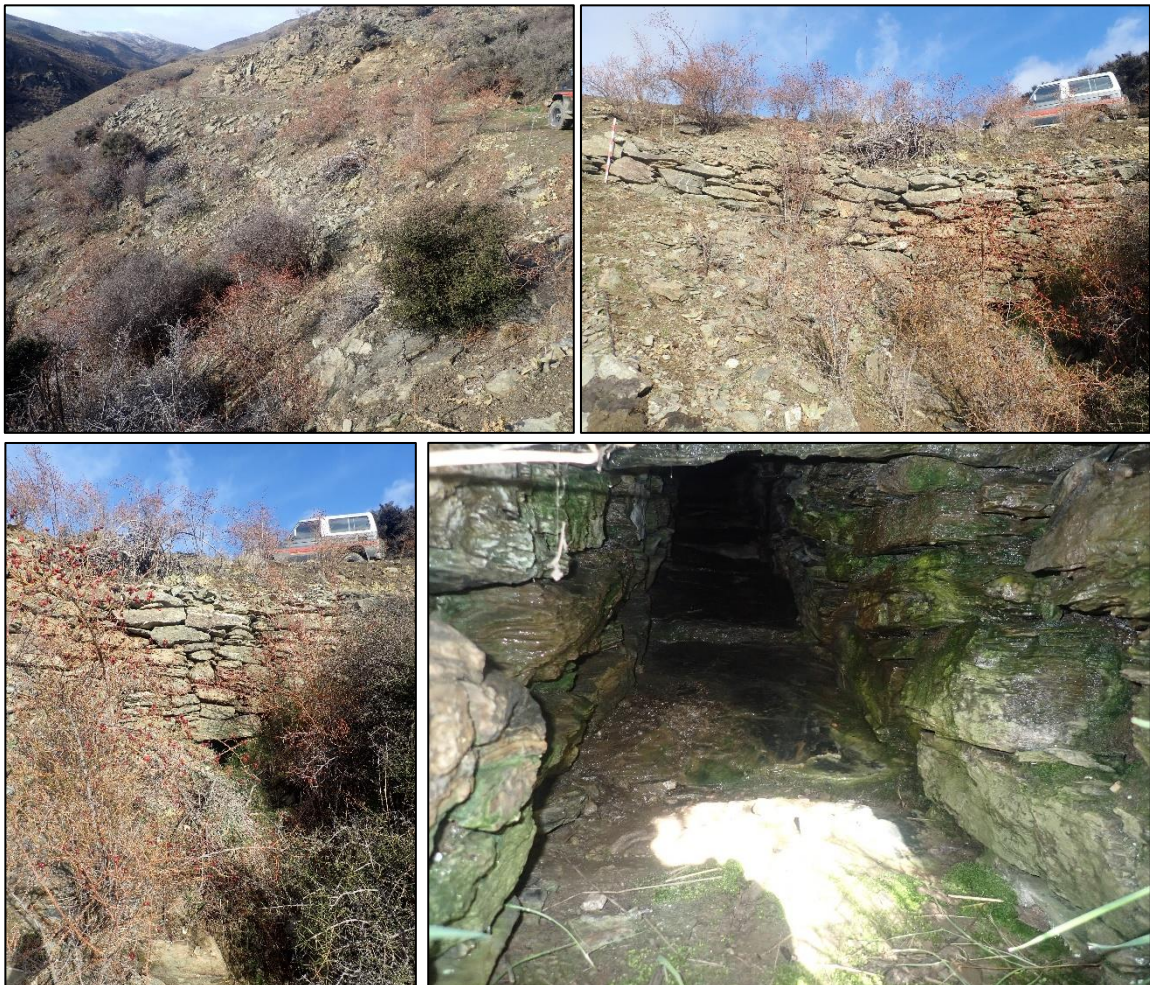
Figure 11. Photographs of culvert and revetment (POI 803) looking east (top left), north (top right), south at culvert (bottom left and right).

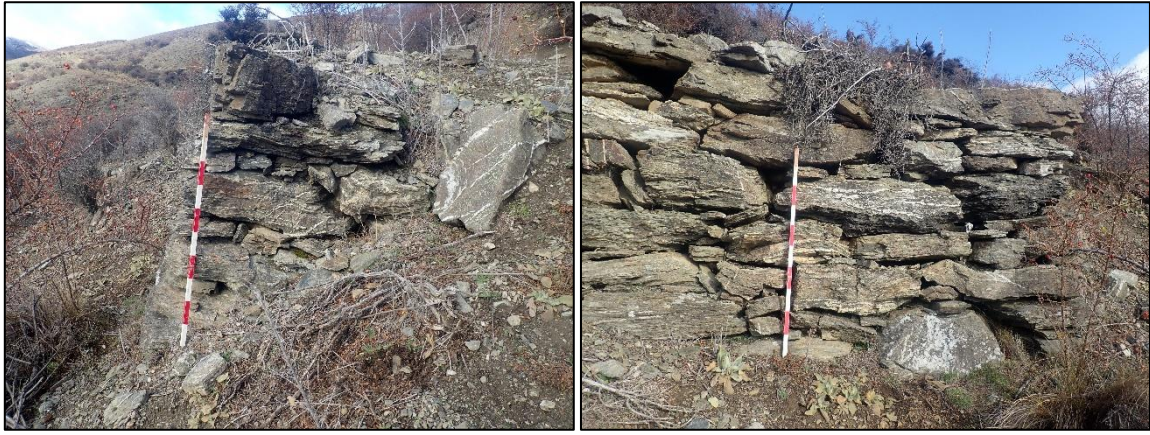
Figure 12. Photographs of stacked schist revetment (POI 810) looking southeast and southwest at the northwest end of the wall.

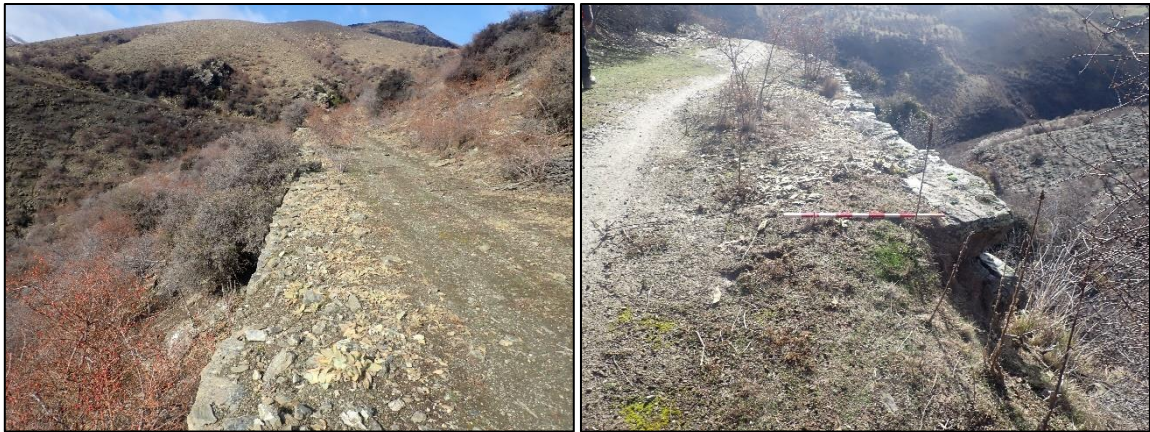
Figure 13. Photographs of stacked schist revetment (POI 810) southeast along the extent of the wall (left) and north (right) at the southeast end of the wall.

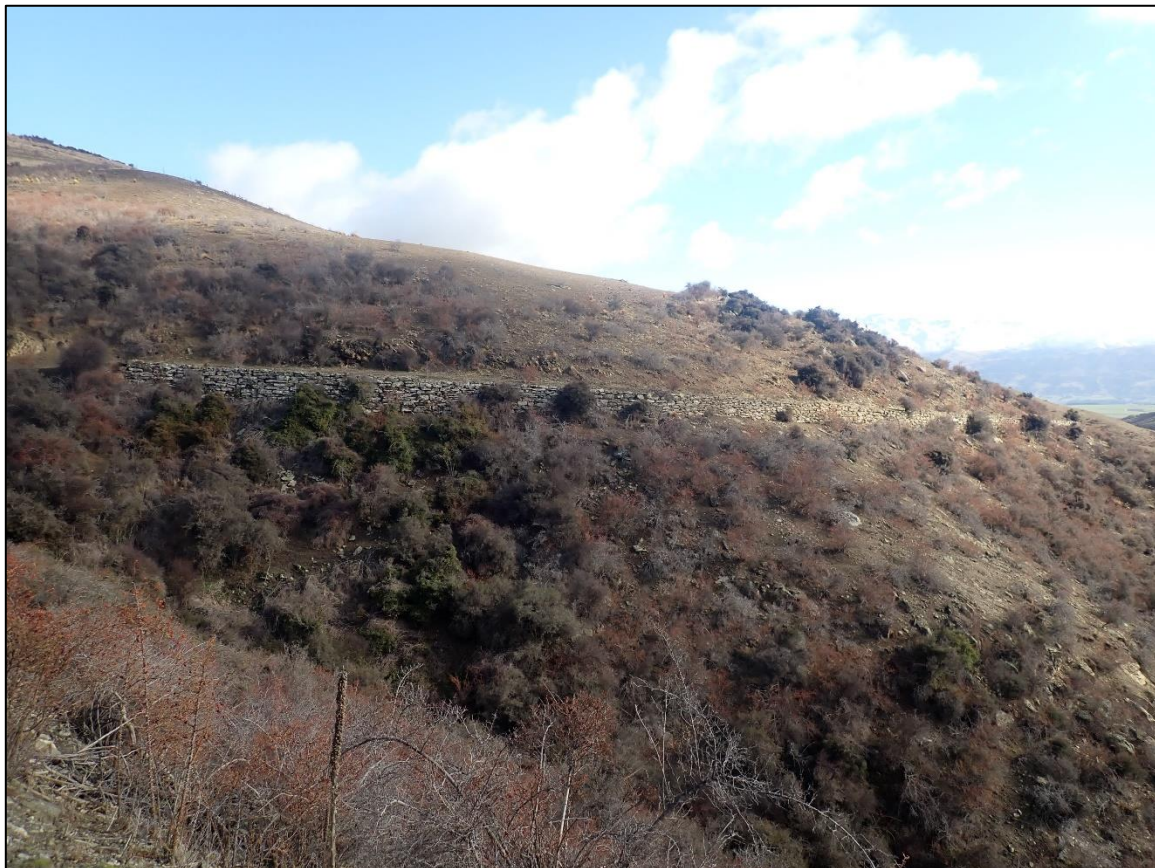
Figure 14. Photograph looking west at full extent of the stacked schist revetment (POI 810).

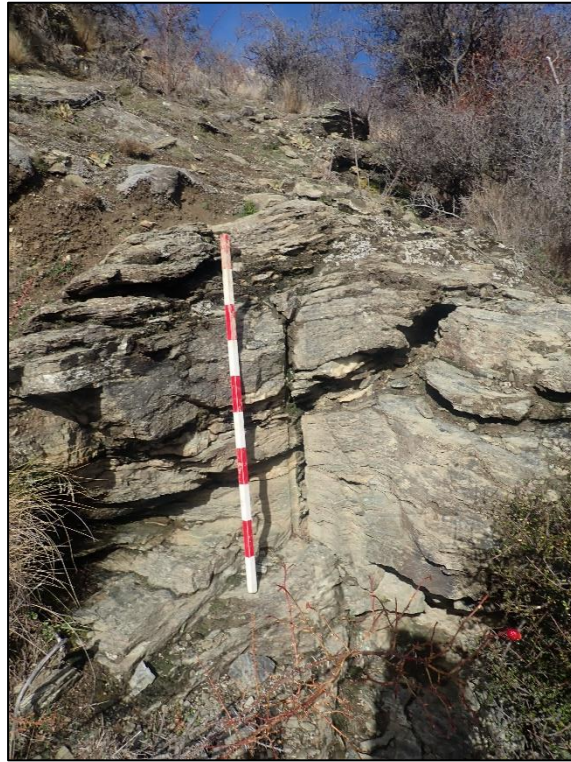
Figure 15. Photograph looking north at drill point on south (upper) side of the road.

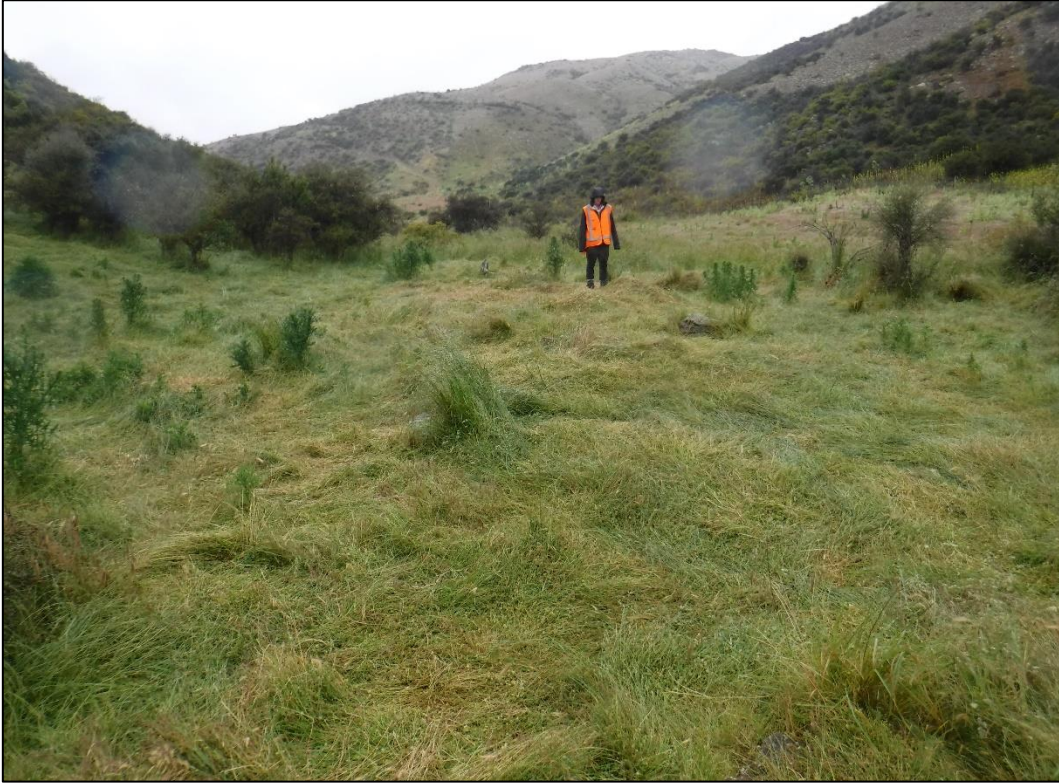
Terraces appear in fair condition.

Figure 1. Photograph looking southeast at raised platform and schist areas. Phoebe Scrivener stands on the south-eastern most raised platform.

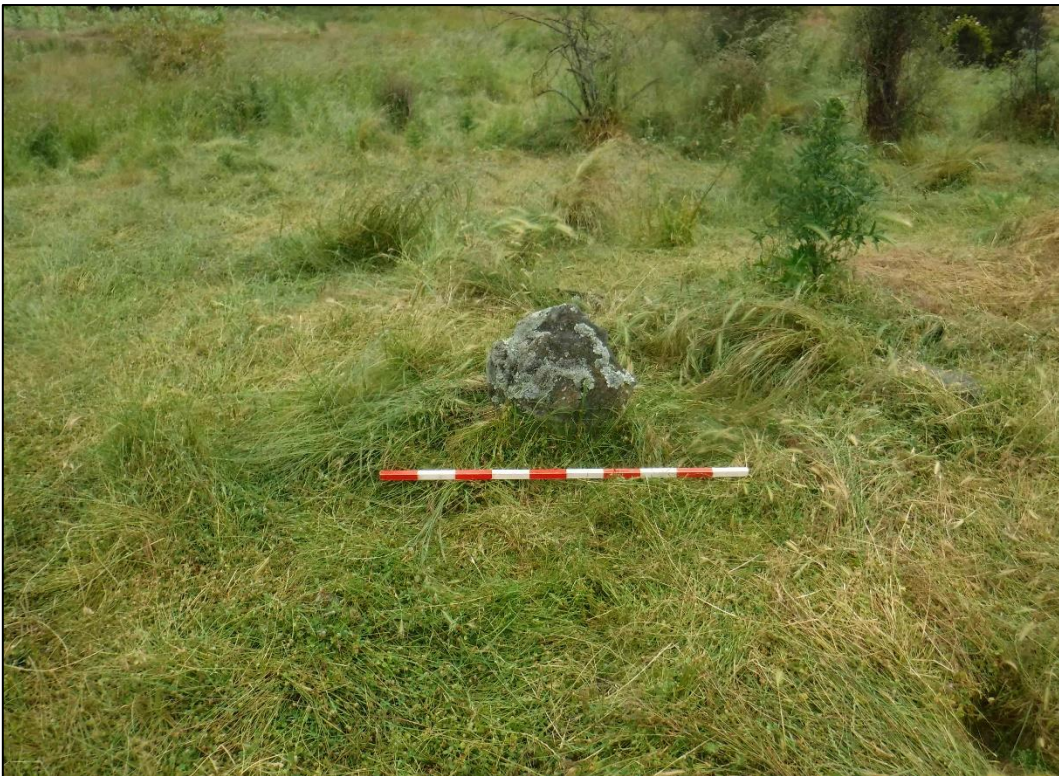
Figure 2. Photograph looking south at raised platform and schist area.

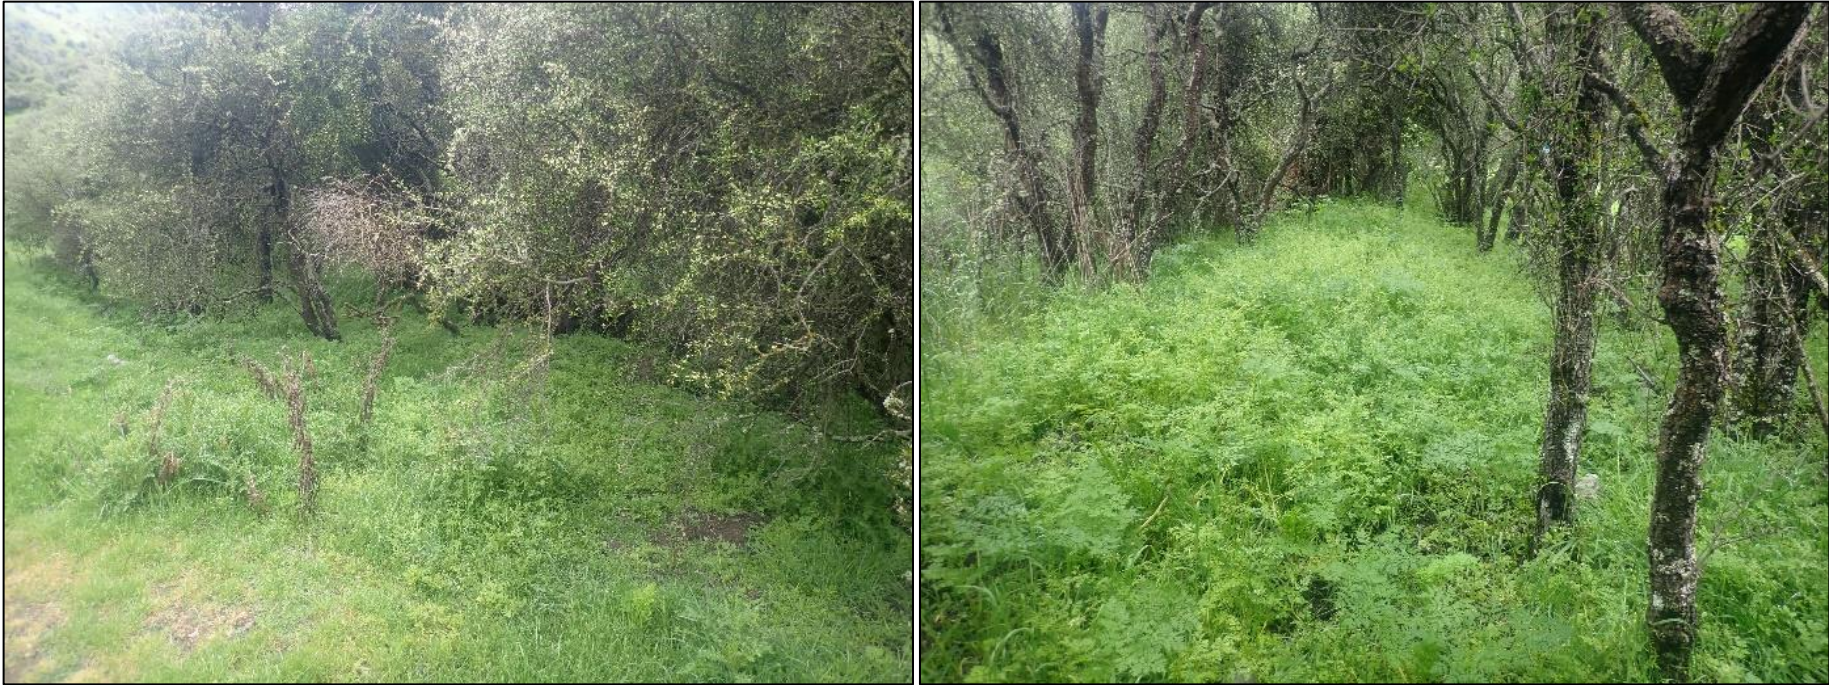
Overgrown, recent mining activity has come close to site but not impacted it directly.

Figure 1. Photographs showing mound alongside Shepherds Creek, November 2021.

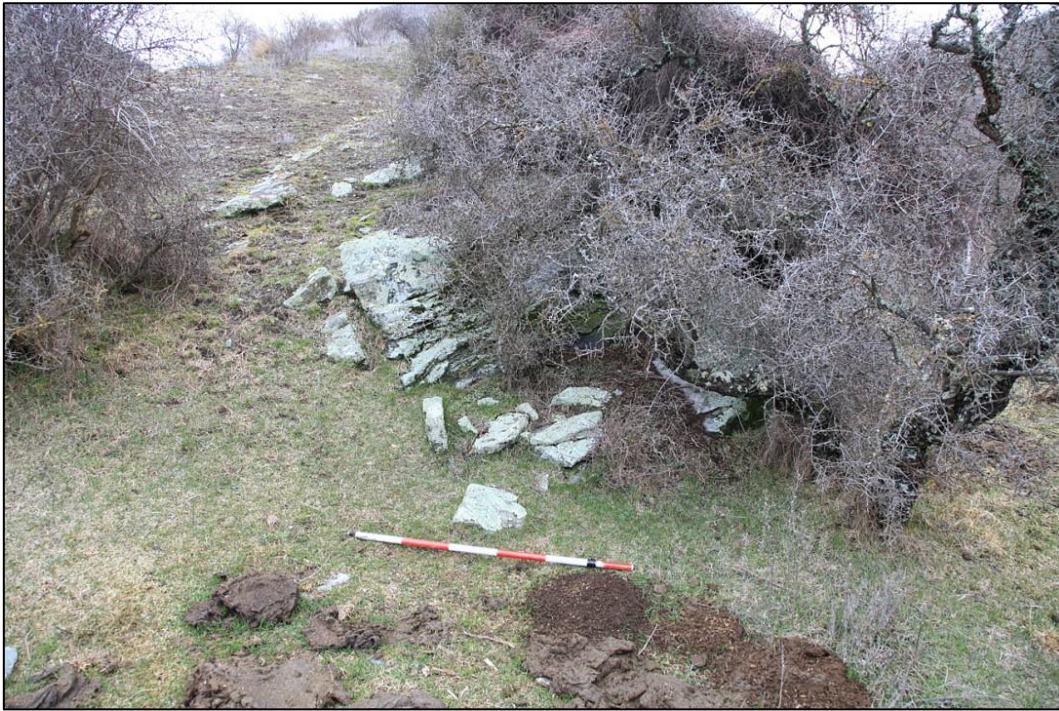
Remnants of fireplace still visible, most other surface features lost.

Figure 1. Site G41/786 looking south, August 2022.

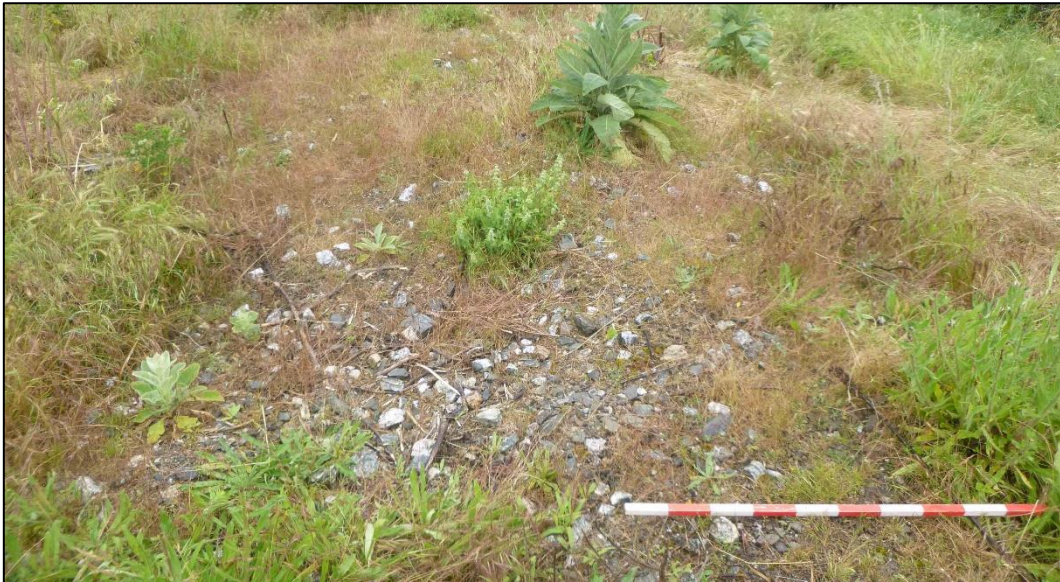
Overgrown, full extent not visible.

Figure 1. Photograph looking west at possible tailings, December 2018.

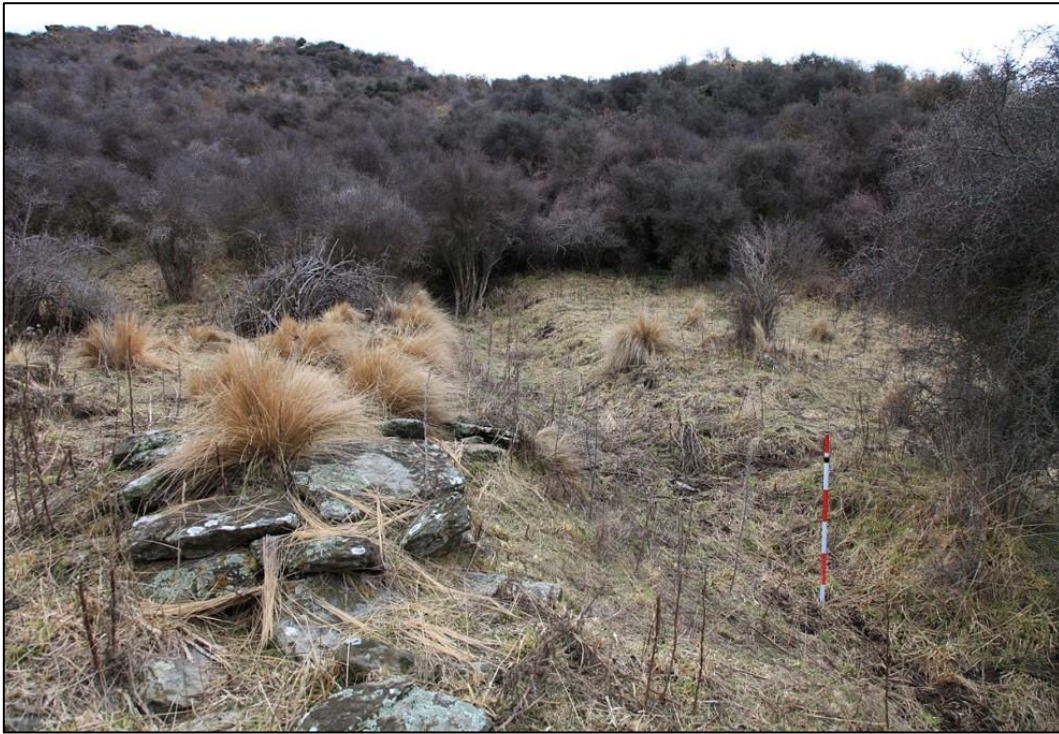
Heavily overgrown, some erosion.

Figure 1. Looking east, August 2022.

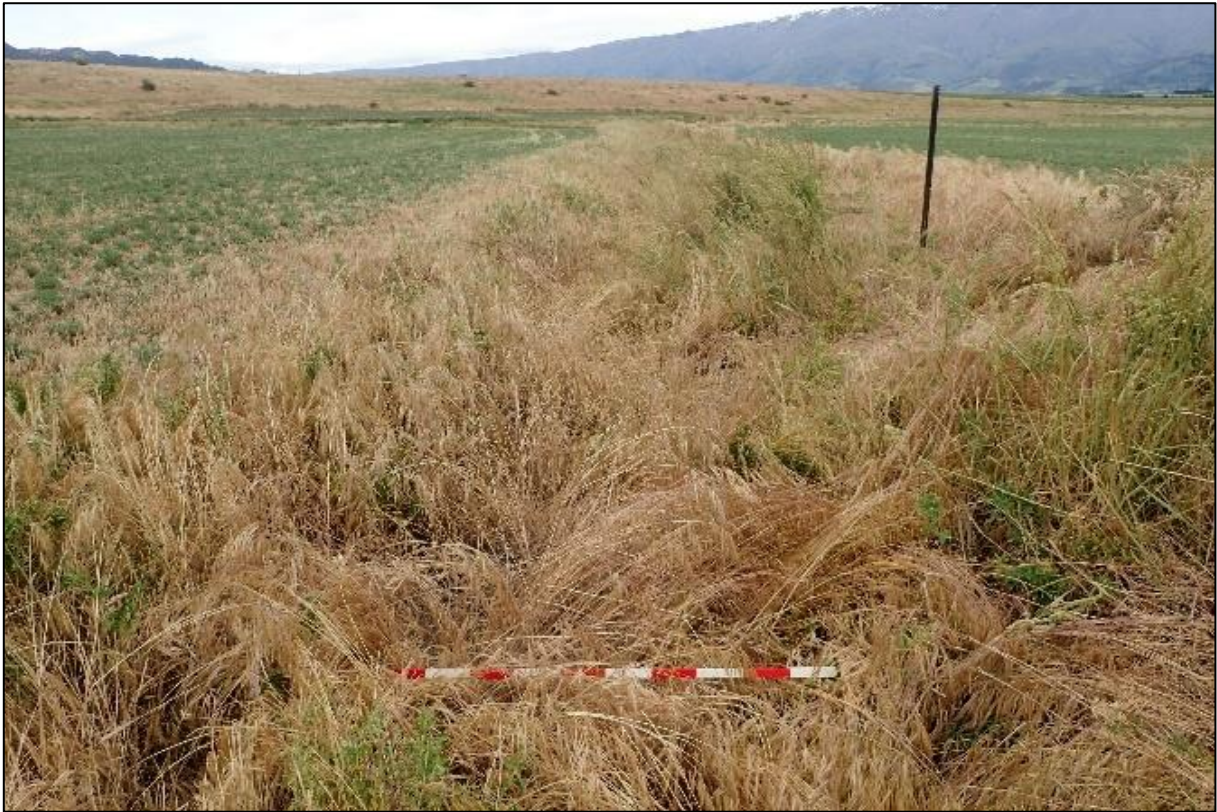
Some sections have been disturbed by modern road formation and others filled in, but race still clearly visible.

Figure 1. Looking west, December 2024.

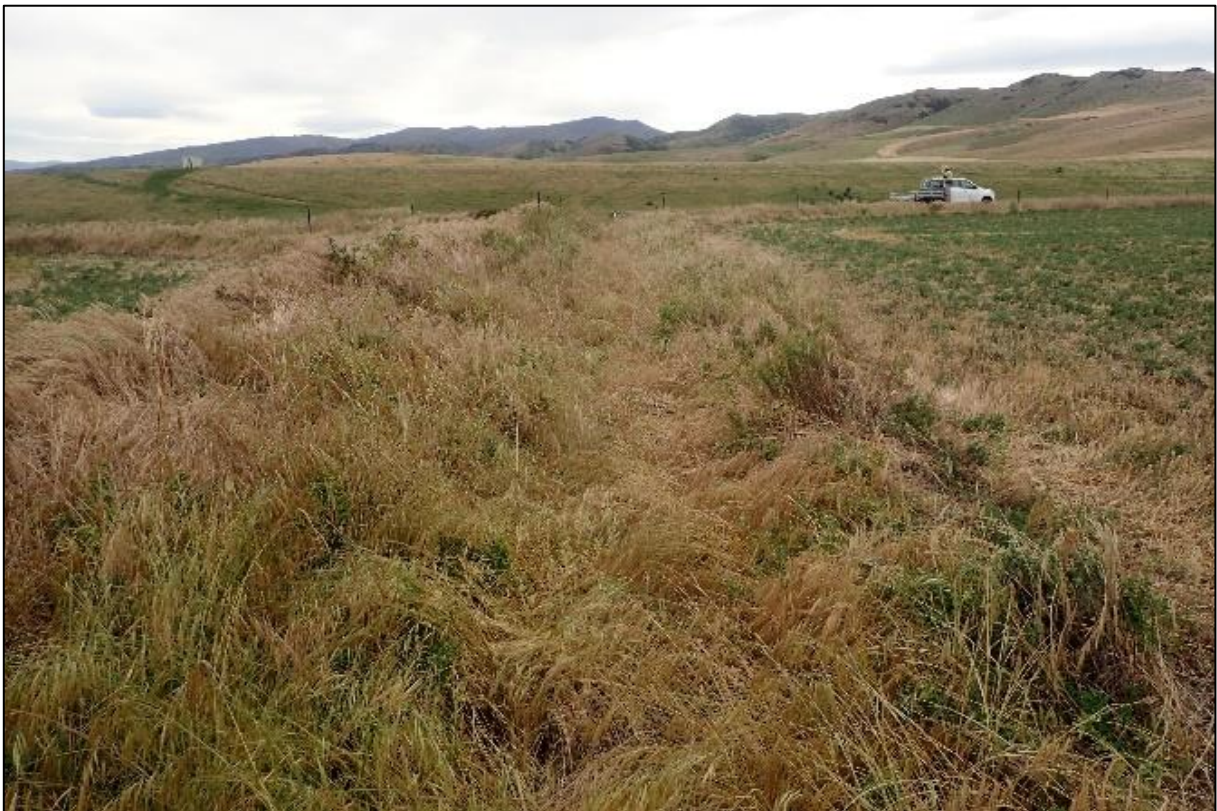
Figure 2. Looking east, December 2024.

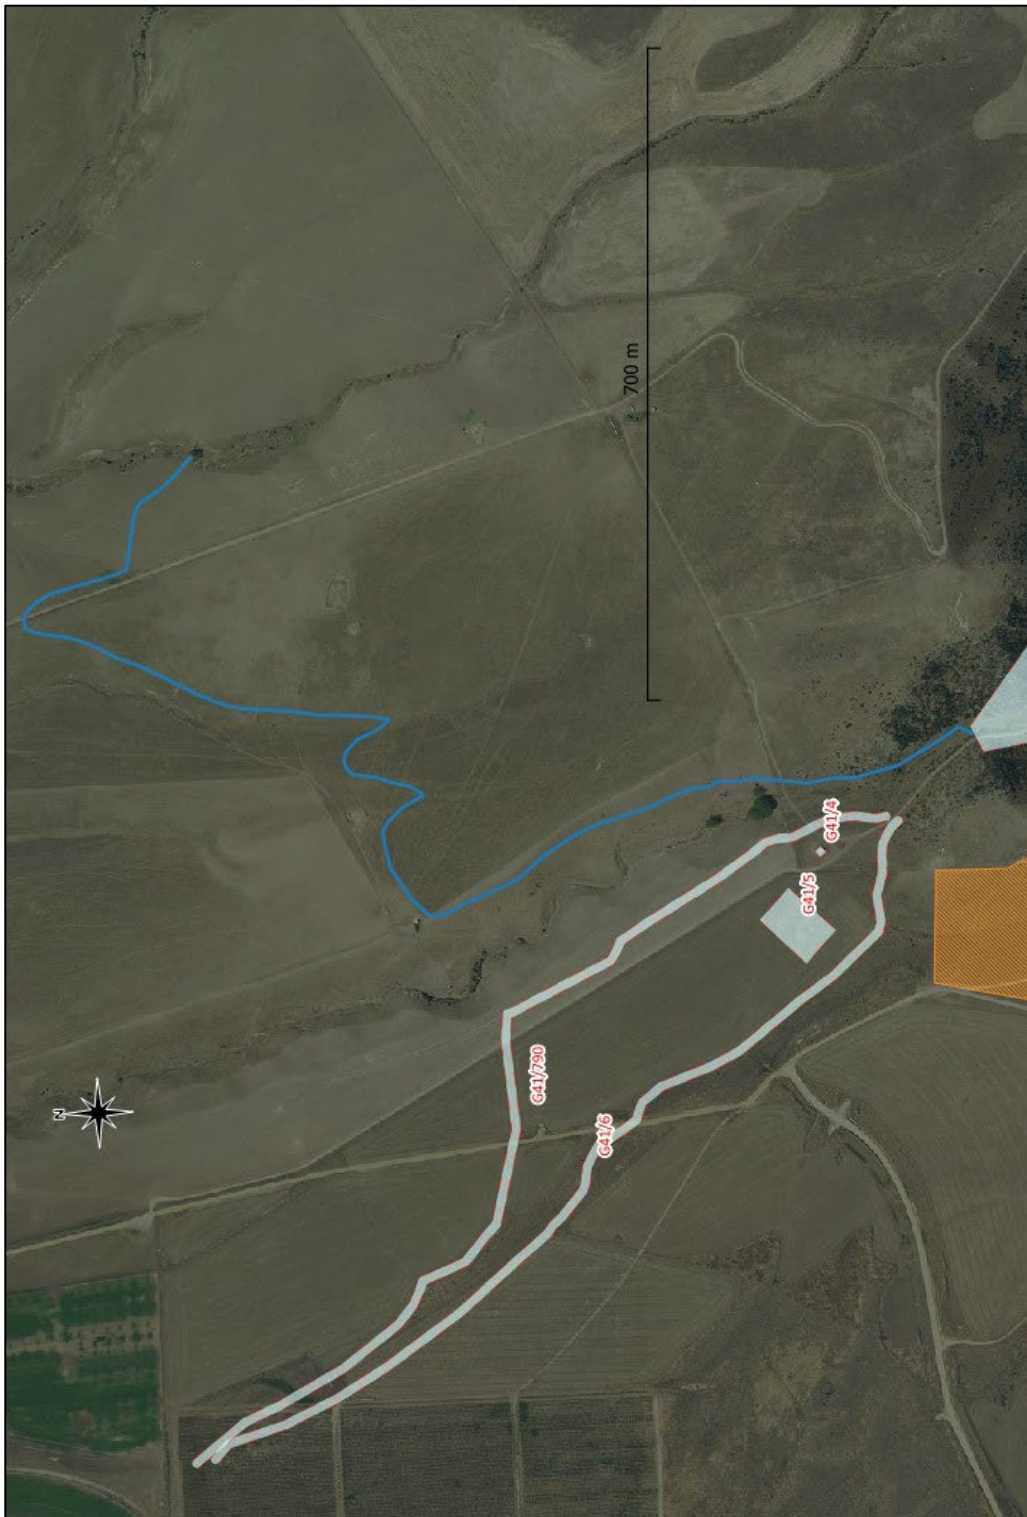
Figure 1. Location and extent of water race (blue line).

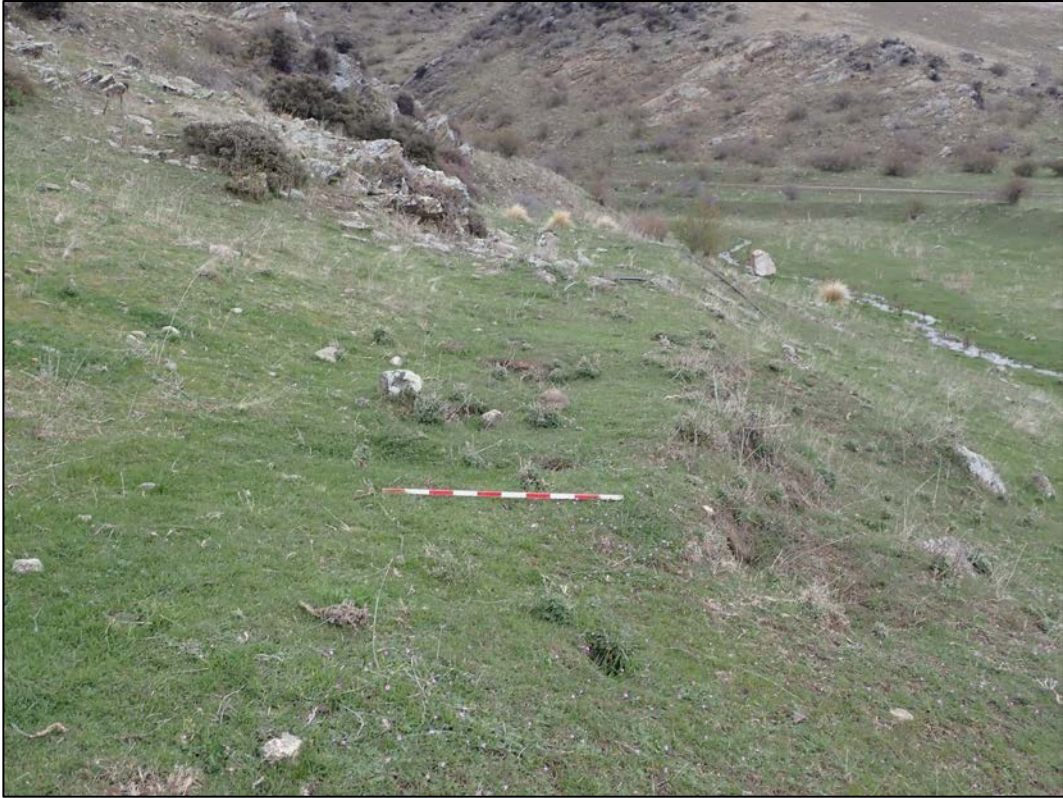
Figure 2. Photograph of the water race looking south, September 2025.

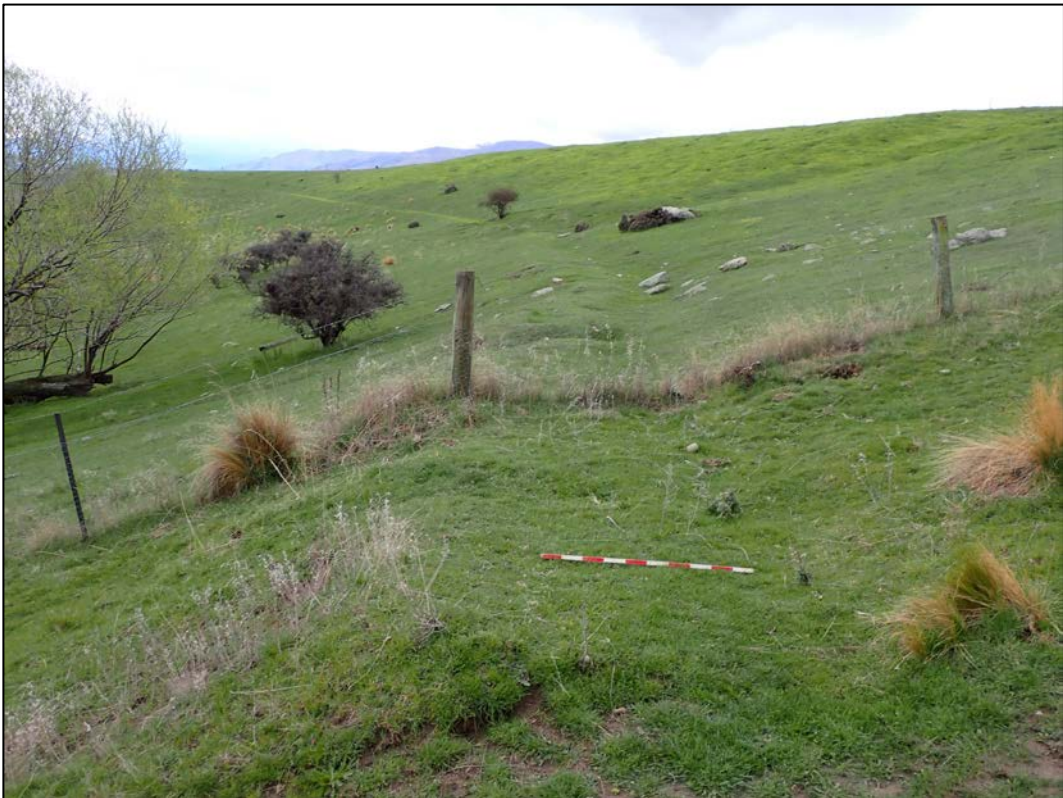
Figure 3. Looking north along water race, September 2025.
