# Ecology Assessment

## Ayrburn Screen Hub

### Waterfall Park Developments Limited

4 February 2025

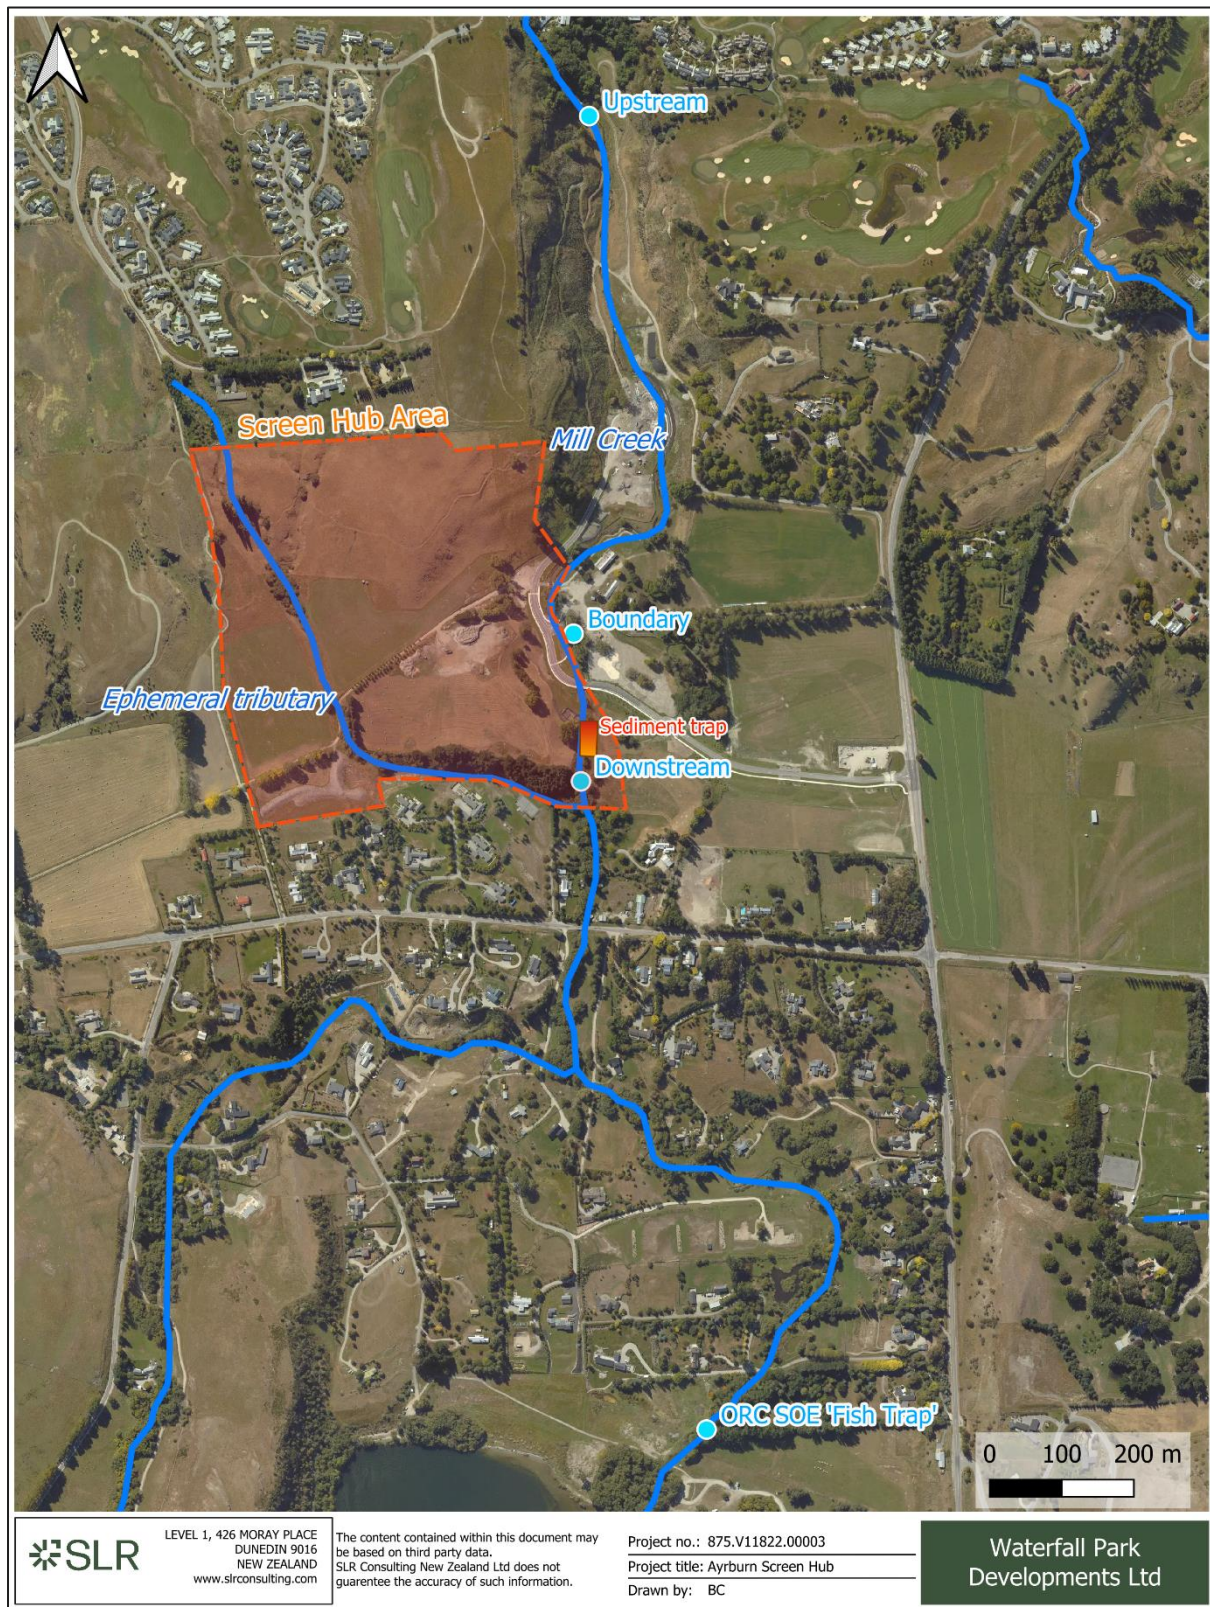
**Figure 1: Map of Mill Creek and the ephemeral tributary in the Ayrburn area, with proposed Screen Hub boundary outlined in orange. Water quality monitoring sites are shown as blue points.**

Water quality has been sampled monthly since November 2018 at three sites: Upstream, adjacent to (i.e., “Boundary”), and Downstream of the proposed Screen Hub area by WPDL (Figure 1; see photos in Appendix A). In addition, continuous loggers for turbidity have been established at the Upstream and Downstream sites. Otago Regional Council (ORC) has a long-term State of the Environment (SOE) monitoring site in Mill Creek (Fish Trap) approximately 1.5 km downstream of the proposed Screen Hub area, close to where the creek enters Lake Hayes (Figure 1).

An unnamed ephemeral spring-fed tributary of Mill Creek is located on the western side of Ayrburn Farm (Figure 1). The ephemeral watercourse is small (order 1), with a catchment area of approximately 0.43 km<sup>2</sup>. Observations made on site suggest a typical flow to 0-2 L/s, with a predicted 100-year average recurrence interval (ARI) of 750-900 L/s (Fluent Solutions 2020).

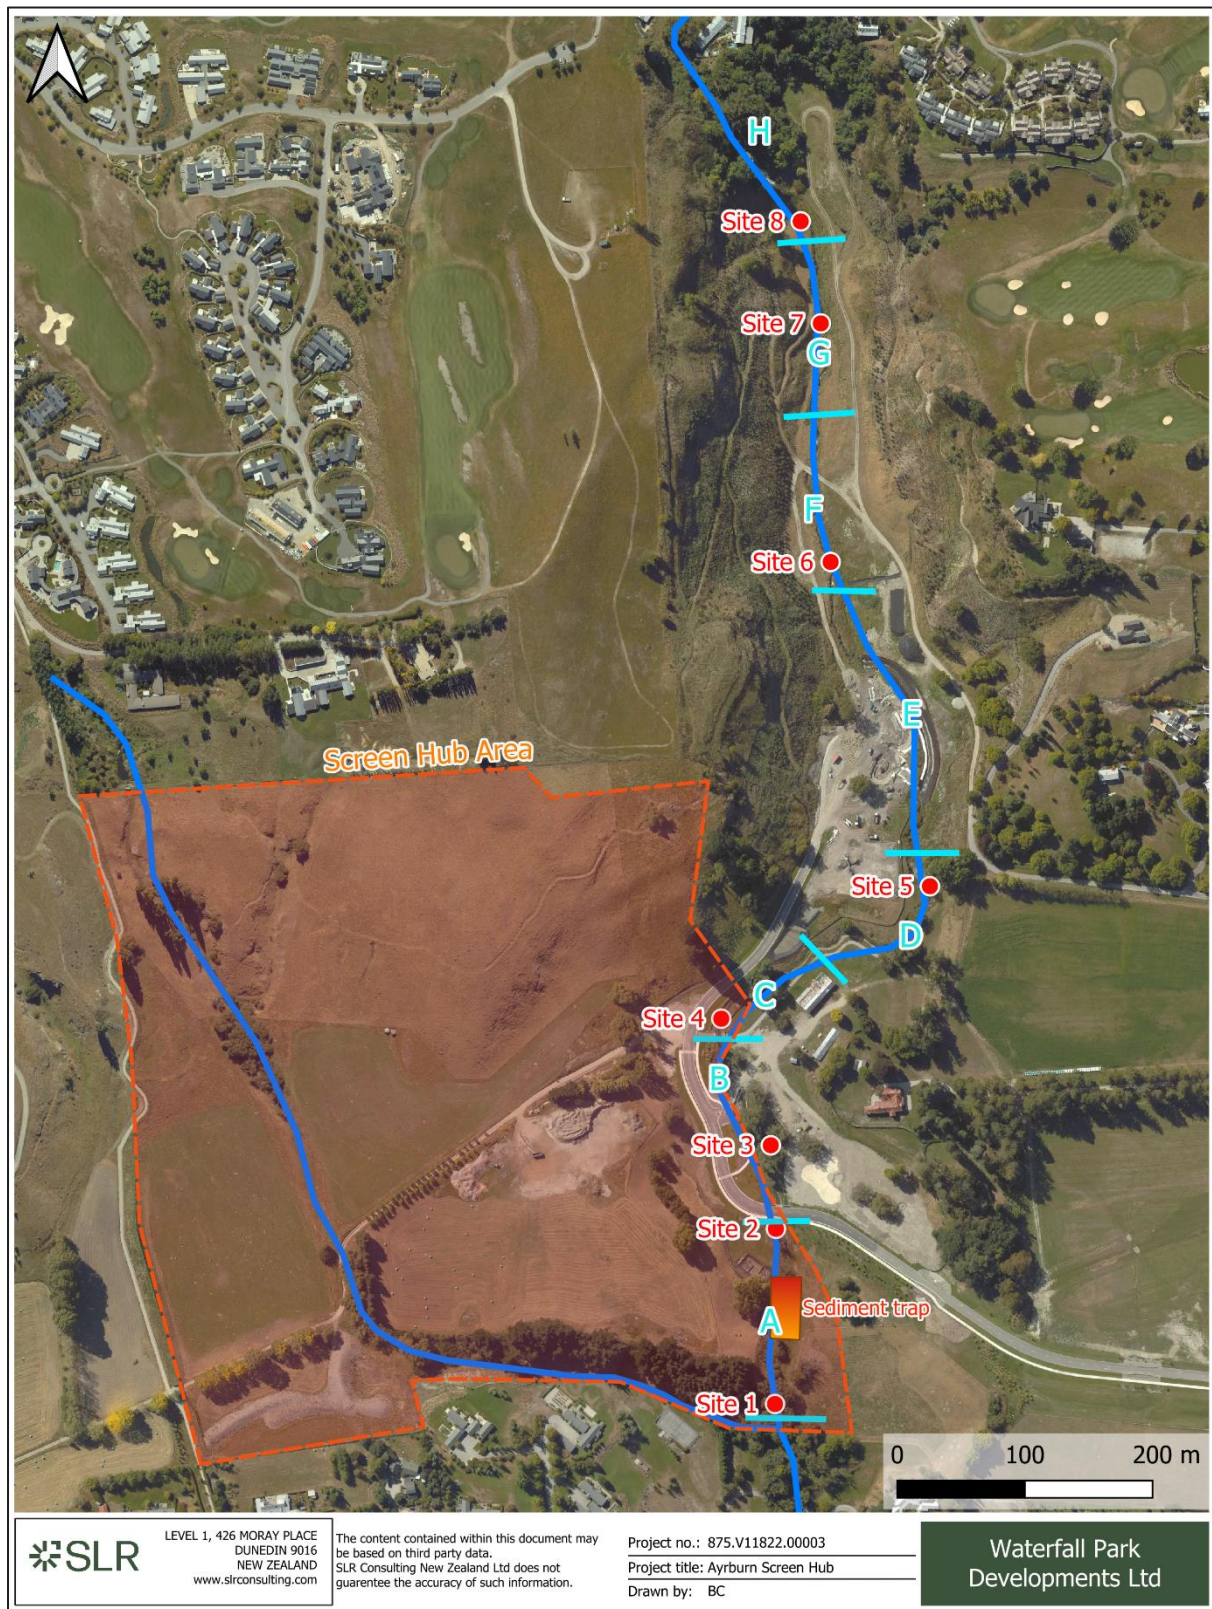
**Figure 6. Map of the sediment sampling locations (numbered red points) and reaches used in bankside sports fish and redd surveys (lettered sections in light blue) in Mill Creek.**

Substrate particle size distribution has been assessed on an annual basis in Mill Creek across eight sites (Figure 6). As the 2024 sampling followed the completion of significant instream works (e.g., channel diversion, installation of instream structures), the 2024 results therefore indicate the expected longer-term substrate sizes. Substrates were highly diverse across the Mill Creek sites but were particularly so at sites near the Downstream monitoring site (substrate sites 1-3 in Figure 6) where most substrate classes were equally abundant (Figure 7). In contrast, sites further upstream, towards the Upstream monitoring site (substrate sites 6 and 8 in Figure 6), generally contained more large gravels and small cobbles. While there was some site-specific variation overall (e.g., median substrate size at Site 7 was comparatively lower than adjacent sites), these differences were likely underpinned by local stream structure and flow characteristics.

The sediment trap will be positioned between sediment sampling sites 1 and 2 (see Figure 6), areas characterised by a diverse range of sediment sizes and moderate suitability for trout spawning (Figure 7). Additionally, the 'Downstream' macroinvertebrate site, located just below the sediment trap, and the 'Fish Trap' site further downstream, both offer habitats of 'Excellent' quality based on SQMCI scores. The streambed modification for the sediment trap will also take place within a known trout spawning area ('Reach A' in Figure 6), where between 2-6 adult trout and 2-8 redds were observed during the 2024 bankside sports fish surveys (Figure 9). Note that bankside fish surveys do not provide an accurate representation of fish densities or community composition in the direct construction area. While the project will result in the direct loss of some spawning habitat and high-quality macroinvertebrate habitat, the sediment trap is expected to enhance downstream spawning sites and improve rearing conditions in Lake Hayes by reducing the accumulation of fine sediment. Moreover, sediment traps are known to often be used as pool refuges which provide low flow resting and feeding habitats for freshwater fish. The suitability for the sediment trap to provide fish habitat will also be enhanced by riparian plantings which provide shading and cover.

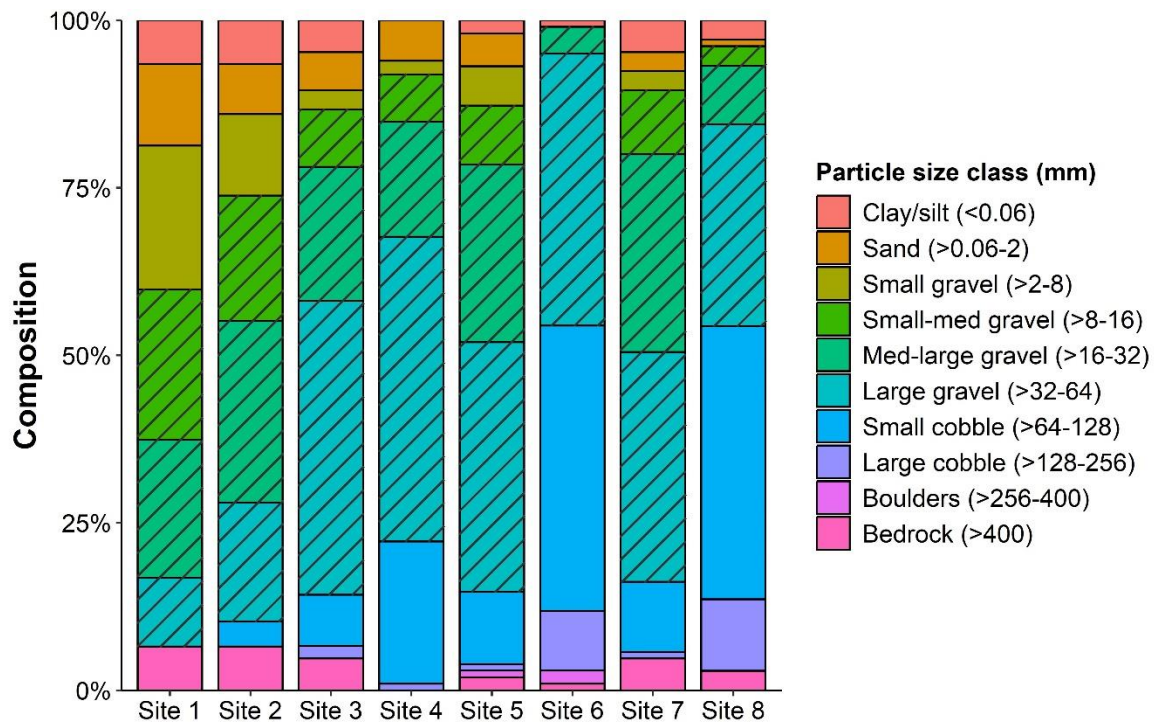
**Figure 7: Composition of particle size classes in substrate samples across Mill Creek sites, May 2024. Site numbers in order from Downstream (1) to Upstream (8). Gravels suitable for trout spawning (size range 8 to 64 mm) are dashed.**

The preferred spawning habitat of brown trout is gravels within the size range 8 to 64 mm (i.e., small-medium to large gravels; Shirvell and Dungey 1983). Gravel substrates of this size were present in great proportions at most sites within Mill Creek in May 2024, but relatively less so at Sites 1, 2, 6, and 8; these substrate sites were located within observational reaches for trout where redd counts were found to be lowest overall.

Overall, the amount of fine clay/silt and sand particles at most sites was low (combined amount  $\leq 20\%$ ), which is favourable for successful egg incubation; too much fine sediment can cause smothering of eggs within redds. There has been no indication that instream works associated with instream or bankside developments have resulted in any increase in fine sediments within Mill Creek to date.

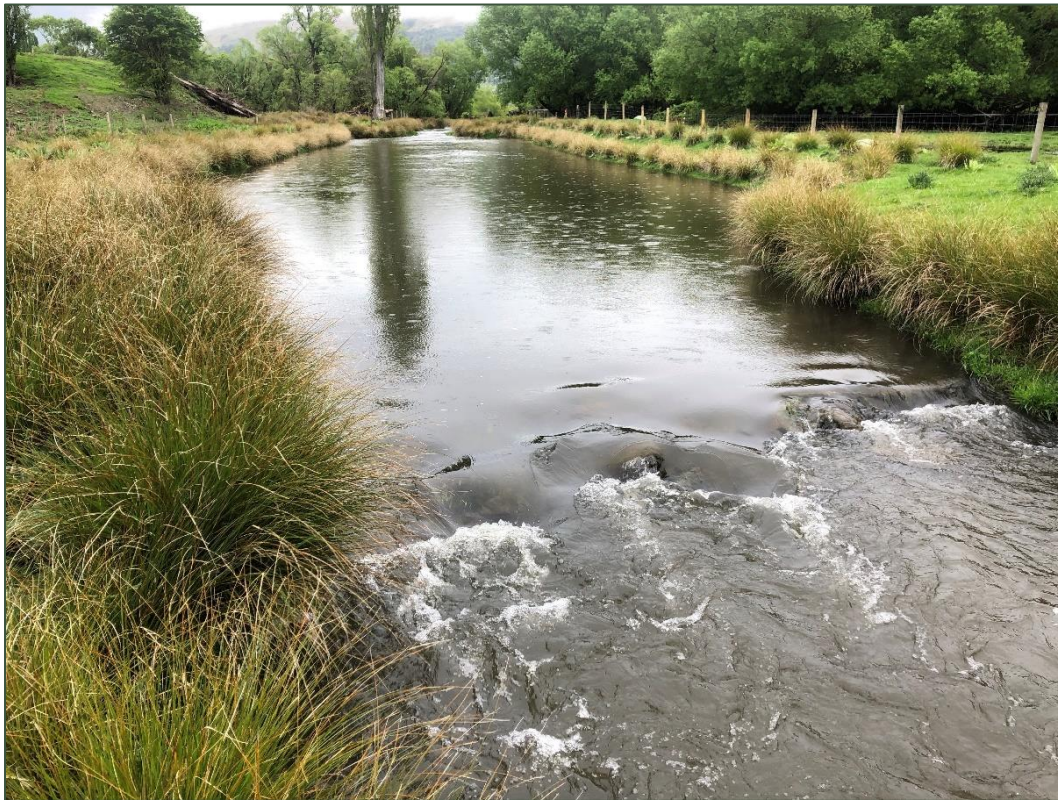
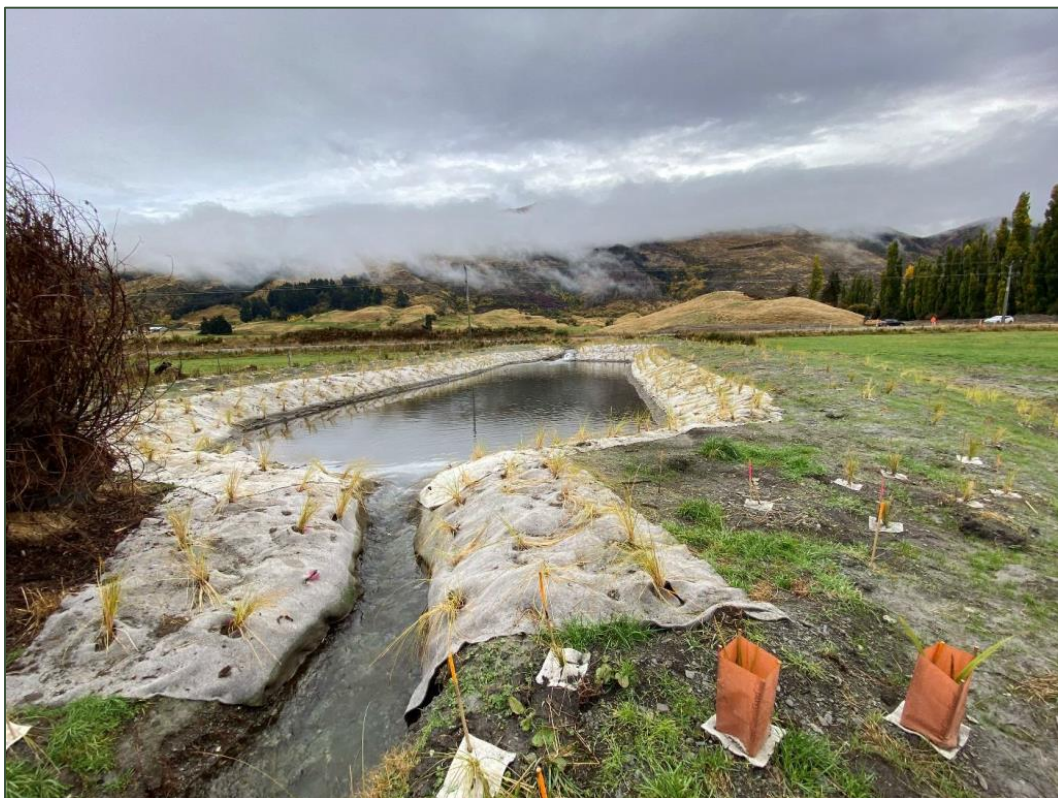
**Figure 10: Examples of existing sediment traps located in the upper Mill Creek catchment. Top photo from Friends of Lake Hayes. Bottom photo from Mana Tāhuna Charitable Trust (2023).**

The installation of an in-line sediment trap (see Figure 10 for smaller examples located in the upper Mill Creek catchment) will necessitate the temporary diversion of Mill Creek and the direct disturbance of the streambed. Stream diversions can isolate water containing fish and macroinvertebrates, directly reducing available habitat for aquatic communities, and dewatering of the isolated area can directly remove the animals from the river. Timing of diversions need to be carefully managed to avoid potential spawning periods for fish, as dewatering can isolate spawning areas from flowing water which is required to support development of fish eggs/larvae. Timing of works between January and March will avoid the spawning and migrating periods for fish potentially present in the area, however adults and larval fish could be present. Fish are likely to avoid disturbed areas, but fish salvages will be required during the trap construction when the stream is dewatered and diverted. Following diversion of the stream, and fish salvage, disturbance of the isolated stream bed should be completed under dry conditions to ensure sediment discharges into downstream environments is minimised.

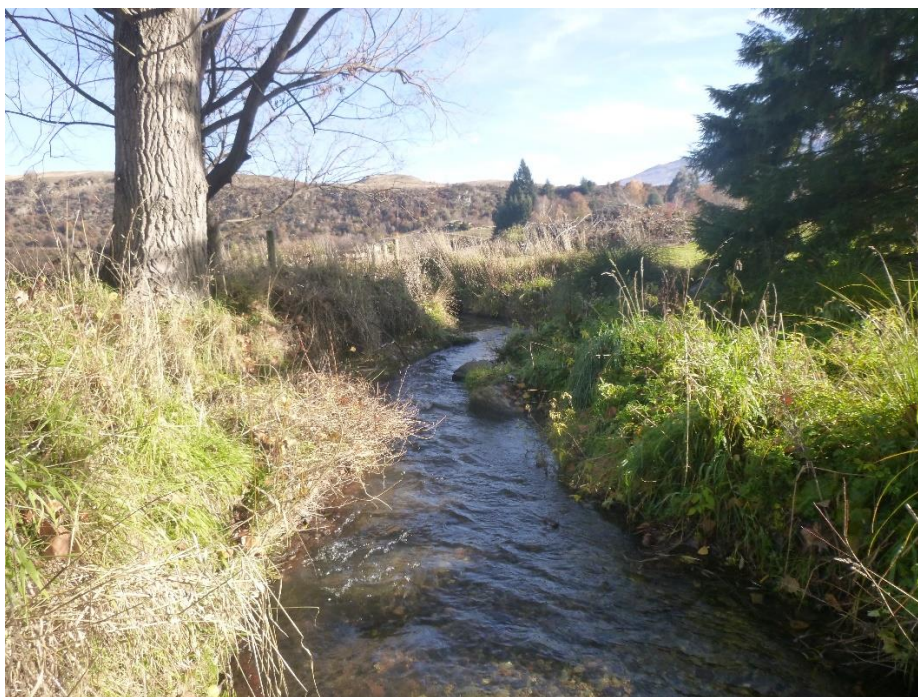
**Figure A.1: Mill Creek, 'Fish Trap' monitoring site, 2024.**

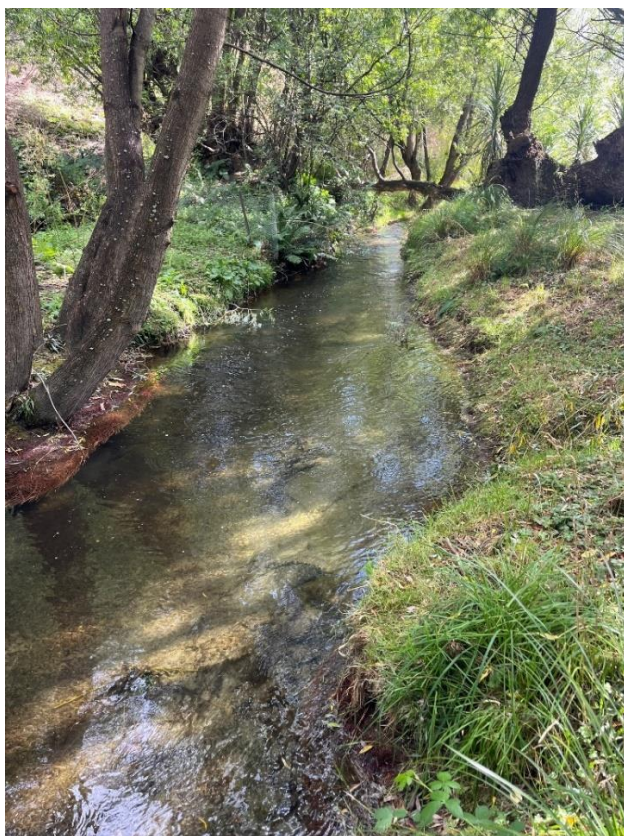
**Figure A.2: Mill Creek, 'Downstream' monitoring site, 2024.**

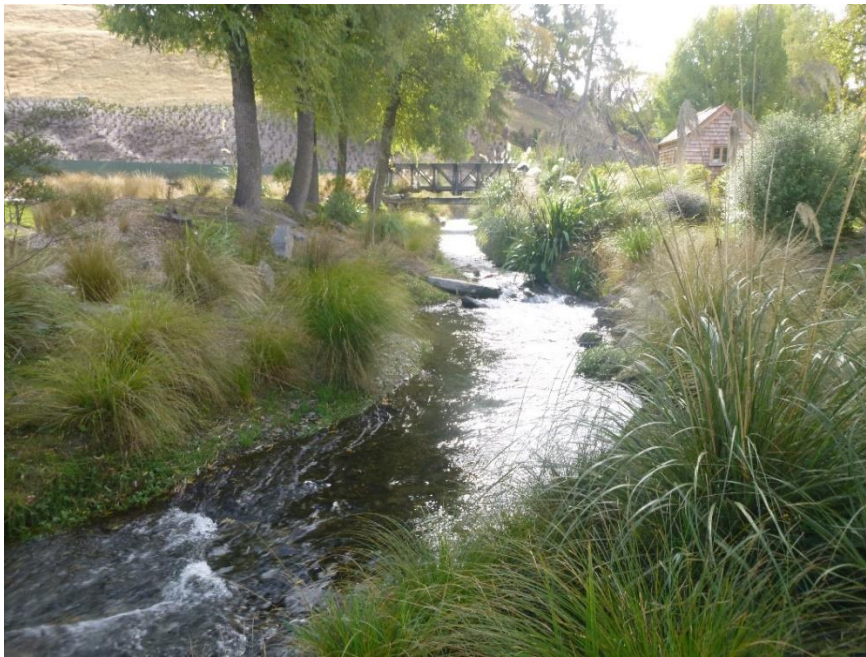
**Figure A.3: Mill Creek, 'Boundary' monitoring site, 2024.**

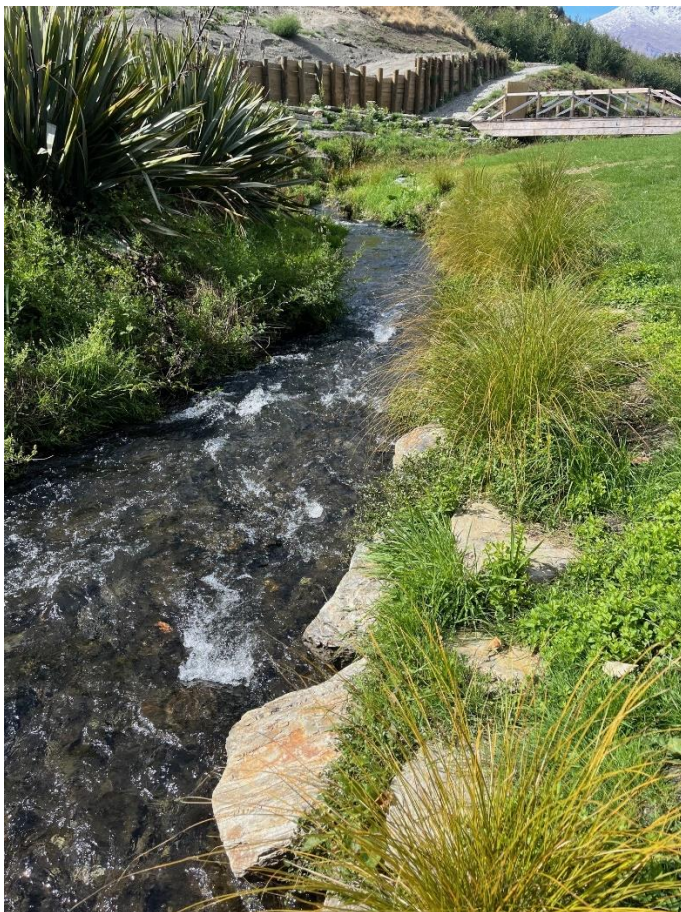
**Figure A.4: Mill Creek, 'Upstream' monitoring site, 2024.**
