Geotechnical Assessment Sutton Block Extension

Drury Quarry, Drury

Part 2 of 2 - Appendix E to Appendix I

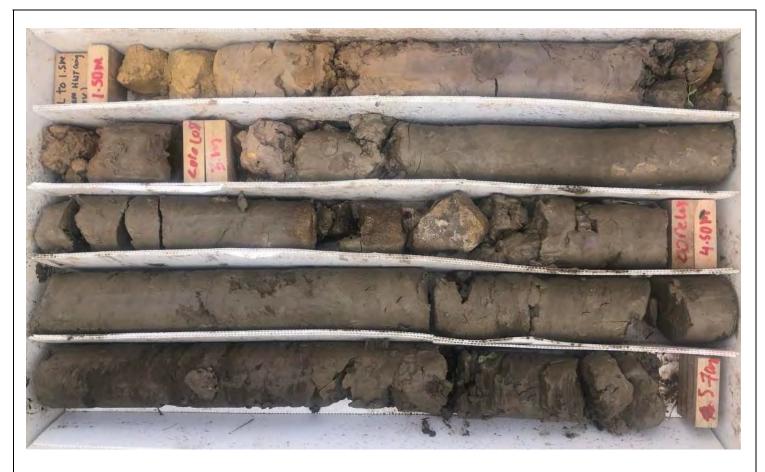
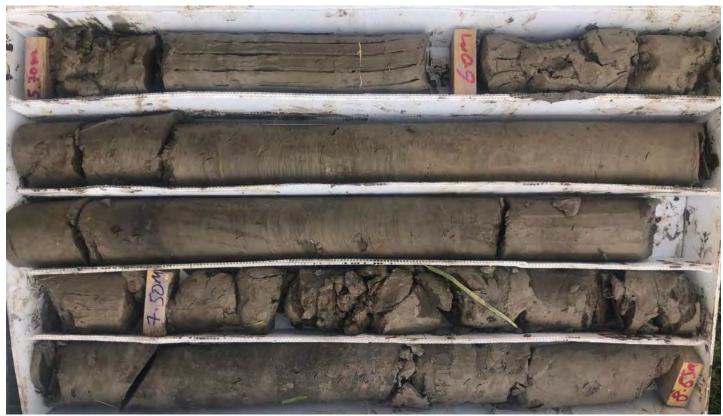
Client / Project:	Stevenson Aggregates Ltd.	Hole ID:	DH101		
	Drury Quarry—Sutton Block	Date: 14		4/11/2022	
Notes:		Box No(s). 1 an Depth from (m):		nd 2 of 23	
				1.5	
		Depth To (m)	:	8.65	
Project No.	220245—Drury Quarry—Sutton Block	Interval (m):		7.15

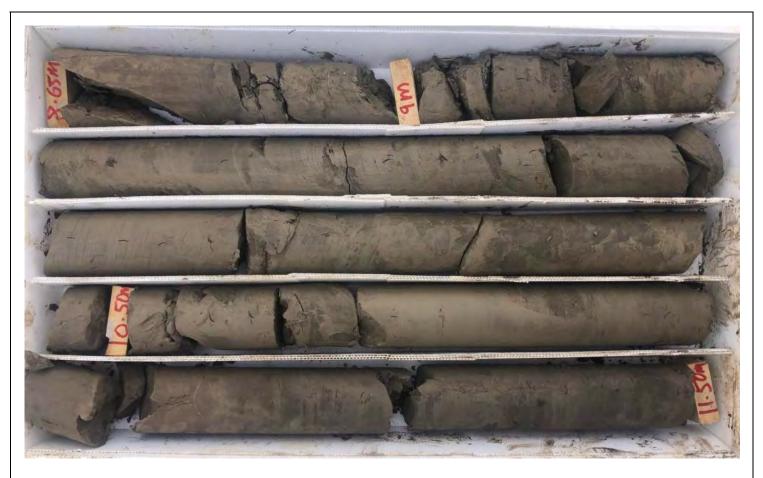
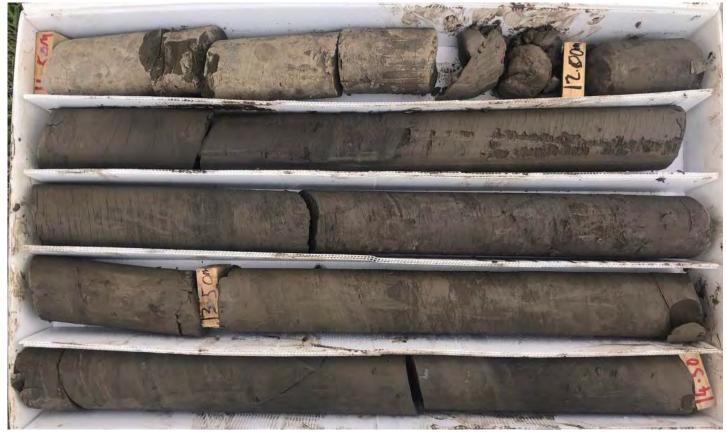
Client / Project:	Stevenson Aggregates Ltd.	Hole ID:	DH101	
	Drury Quarry—Sutton Block	Date:	14/11/2022	
Notes:		Box No(s).	(s). 3 and 4 of 23	
		Depth from (m): Depth To (m):		8.65
				14.5
Project No.	220245—Drury Quarry—Sutton Block	Interval (m):		5.75

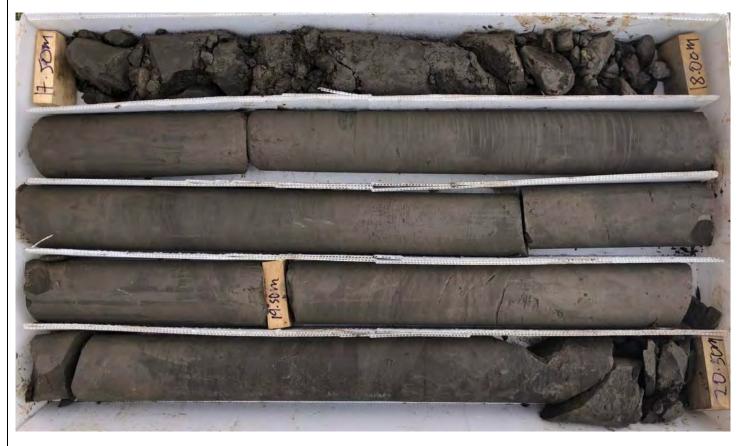
Client / Project:	Stevenson Aggregates Ltd.	Hole ID:	DH101	
	Drury Quarry—Sutton Block	Date:	e: 14/11/2	
Notes:		Depth from (m):		and 6 of 23
				14.5
				20.5
Project No.	220245—Drury Quarry—Sutton Block	Interval (m):	Interval (m):

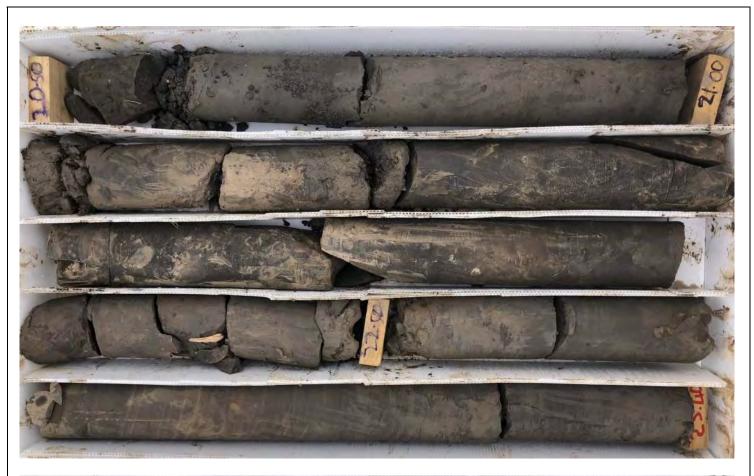
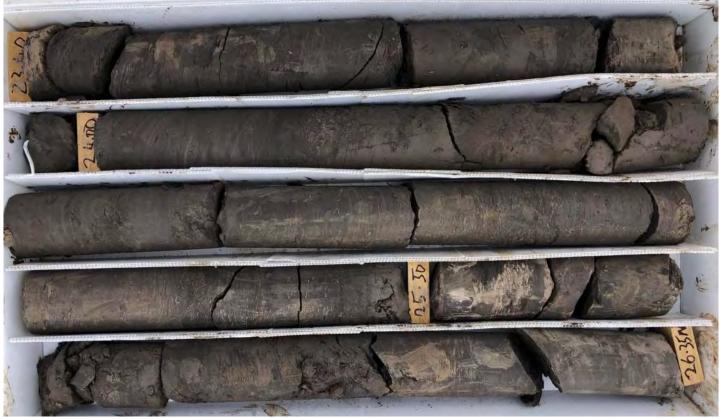
Client / Project:	Stevenson Aggregates Ltd.	Hole ID:	DH101	
	Drury Quarry—Sutton Block	Date:	14/11/2022	
Notes:		Depth from (m):		and 8 of 23
				20.5
				26.35
Project No.	220245—Drury Quarry—Sutton Block	Interval (m):		5.85

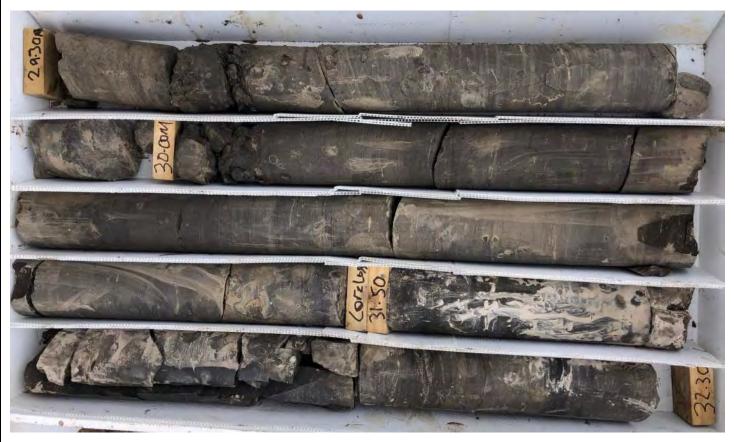
Client / Project:	Stevenson Aggregates Ltd.	Hole ID:	DH101	
	Drury Quarry—Sutton Block	Date:	1	4/11/2022
Notes:		Depth from (m):		nd 10 of 23
				26.35
				32.30
Project No.	220245—Drury Quarry—Sutton Block	Interval (m):		5.95

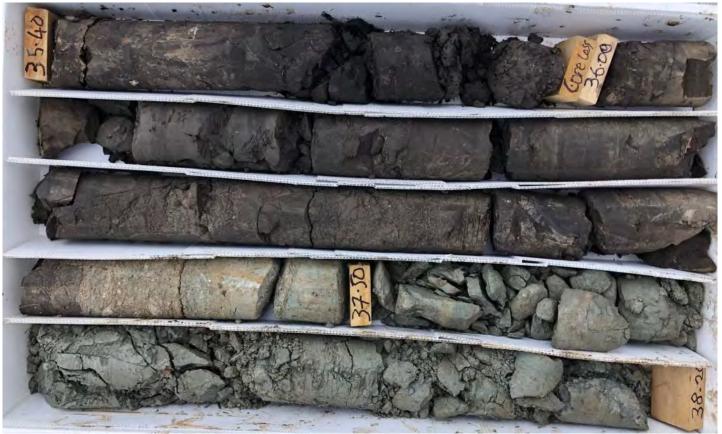
Client / Project:	Stevenson Aggregates Ltd.	Hole ID:	DH101	
	Drury Quarry—Sutton Block	Date: 14/11/2		4/11/2022
Notes:		Box No(s).	o(s). 11 and 12 of 2	
		Depth from (m): Depth To (m):		32.30
				38.20
Project No.	220245—Drury Quarry—Sutton Block	Interval (m):		5.90

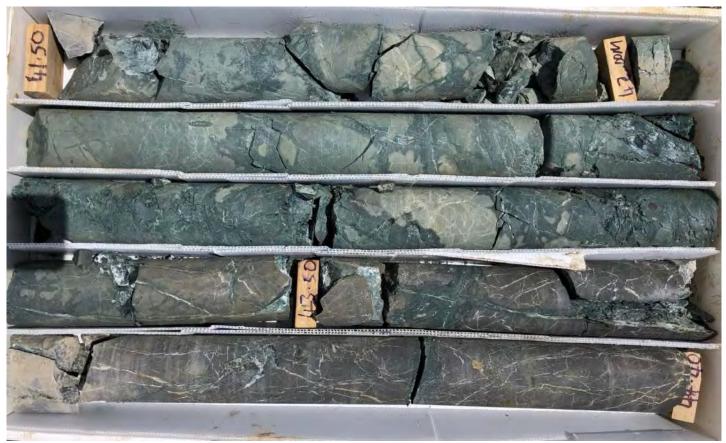
Client / Project:	Stevenson Aggregates Ltd.	Hole ID:	DH101	
	Drury Quarry—Sutton Block	Date:	14/11/2022	
Notes:		Box No(s). 13 an Depth from (m): Depth To (m):		and 14 of 23
				38.20
				44.40
Project No.	220245—Drury Quarry—Sutton Block	Interval (m):		6.20

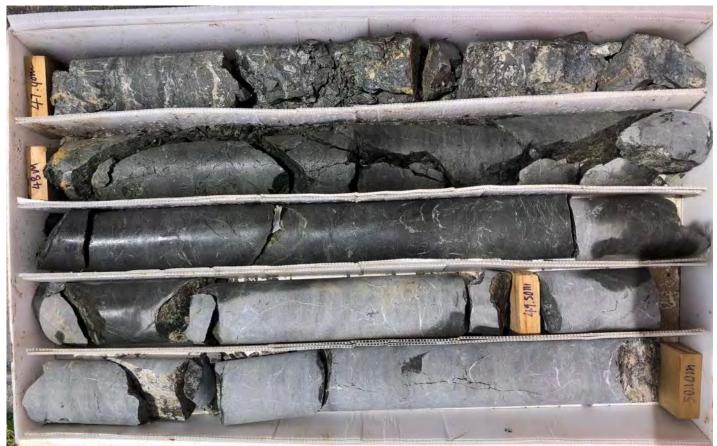
Client / Project:	Stevenson Aggregates Ltd.	Hole ID:	DH101	
	Drury Quarry—Sutton Block	Date:	1	4/11/2022
Notes:		Box No(s).	15 and 16 of 23	
		Depth from (m): Depth To (m):		44.40
				50.10
Project No.	220245—Drury Quarry—Sutton Block	Interval (m):		5.70

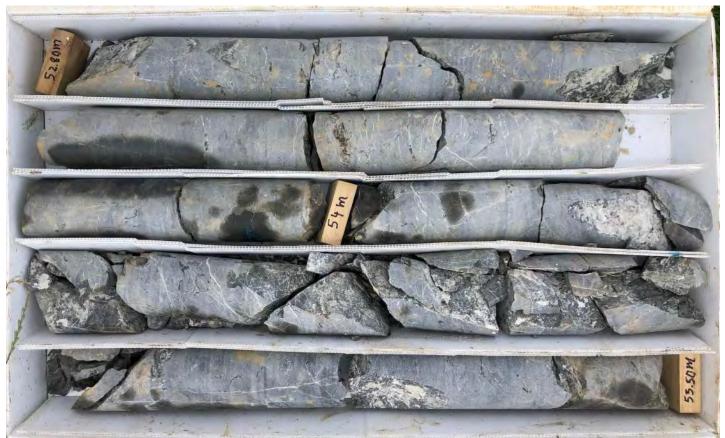
Client / Project:	Stevenson Aggregates Ltd.	Hole ID:		DH101	
	Drury Quarry—Sutton Block	Date:	1	4/11/2022	
Notes:		Box No(s).	s). 17 and 18 of 2		
		Depth from (m): Depth To (m):		50.10	
				55.50	
Project No.	220245—Drury Quarry—Sutton Block	Interval (m):		5.60

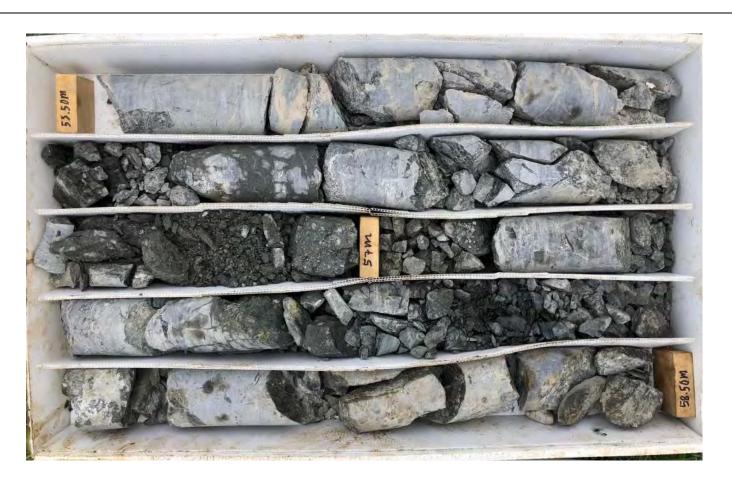
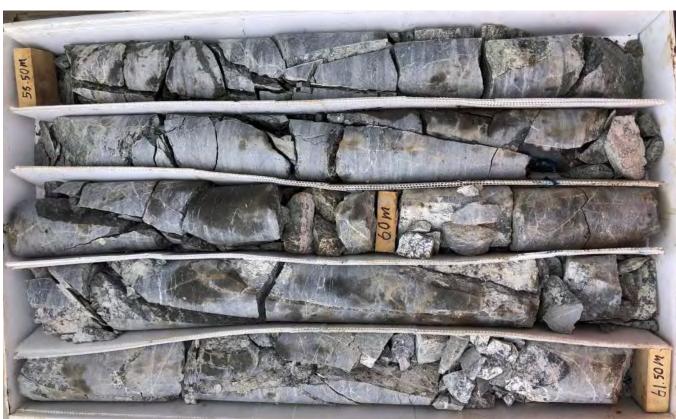
Client / Project:	Stevenson Aggregates Ltd.	Hole ID:	DH101	
	Drury Quarry—Sutton Block	Date:	14/11/2022	
Notes:		Box No(s).	Sox No(s). 19 and 20	
			m):	55.50
		Depth To (m):		61.50
Project No.	220245—Drury Quarry—Sutton Block	Interval (m):		6.0

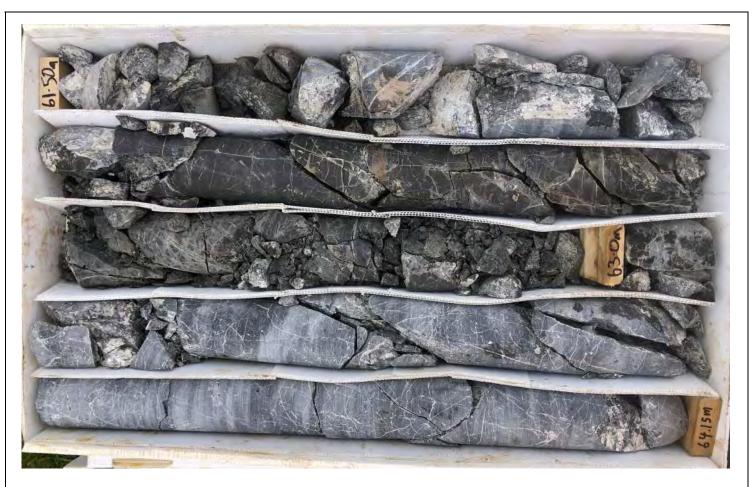
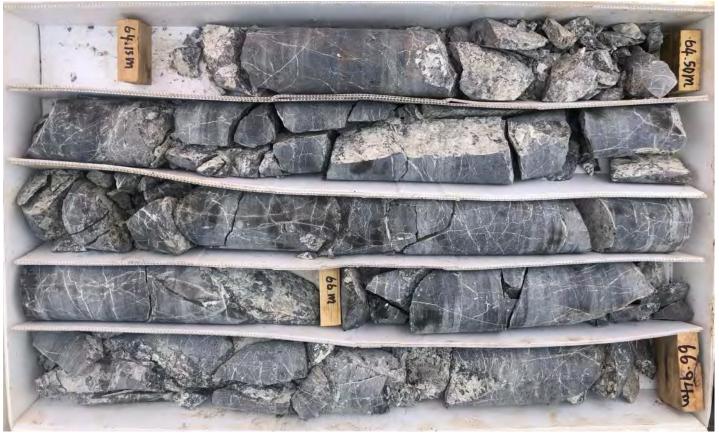
Client / Project:	Stevenson Aggregates Ltd.			DH101	
i roject.	Drury Quarry—Sutton Block	Date:	14/11/2022		
Notes:		Box No(s).	21	and 22 of 23	
		Depth from (m):		61.50	
		Depth To (m)	:	66.94	
Project No.	220245—Drury Quarry—Sutton Block	Interval (m):		5.44

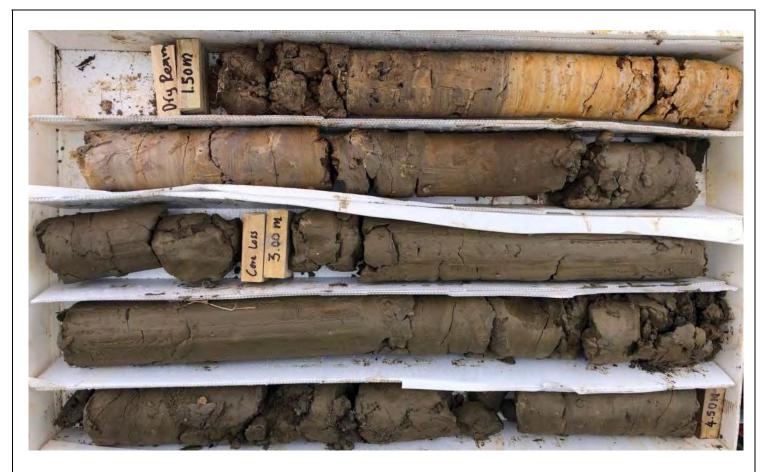
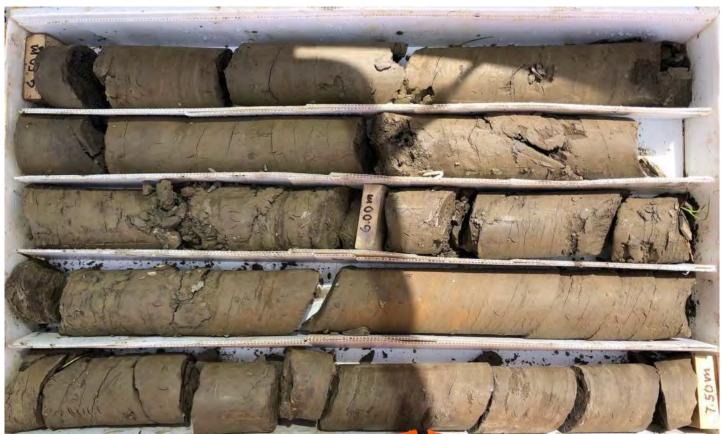
Client / Project:	Stevenson Aggregates Ltd.	Hole ID:	DH102	
i roject.	Drury Quarry—Sutton Block	Date:	0	7/11/2022
Notes:		Box No(s).	1 a	and 2 of 21
		Depth from (m):	1.5
		Depth To (m)	:	7.5
Project No.	220245—Drury Quarry—Sutton Block	Interval (m):		6

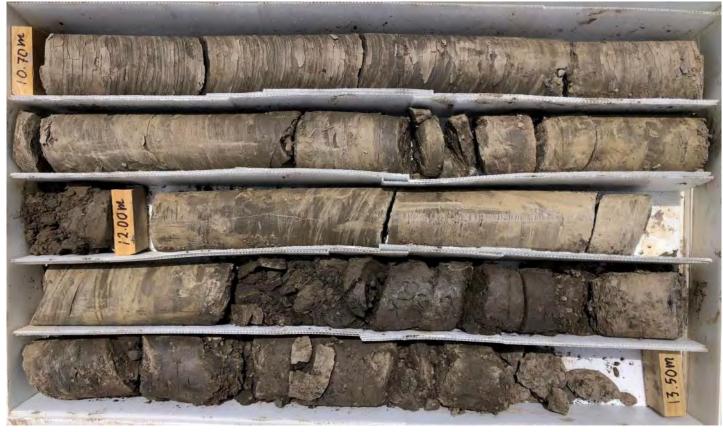
Client / Project:	Stevenson Aggregates Ltd.	Hole ID:	DH	102
5 Drury Quarry—Sutton Block	Drury Quarry—Sutton Block	Date:	0	7/11/2022
Notes:		Box No(s).	3 a	and 4 of 21
		Depth from (m):		7.5
		Depth To (m)	:	13.5
Project No.	220245—Drury Quarry—Sutton Block	Interval (m):		6

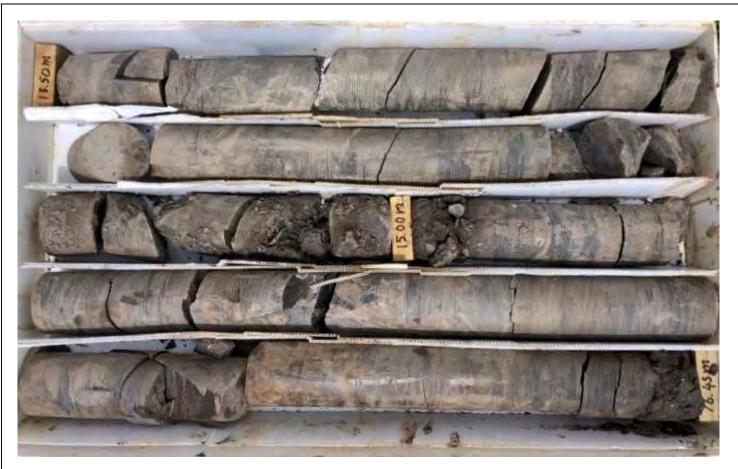
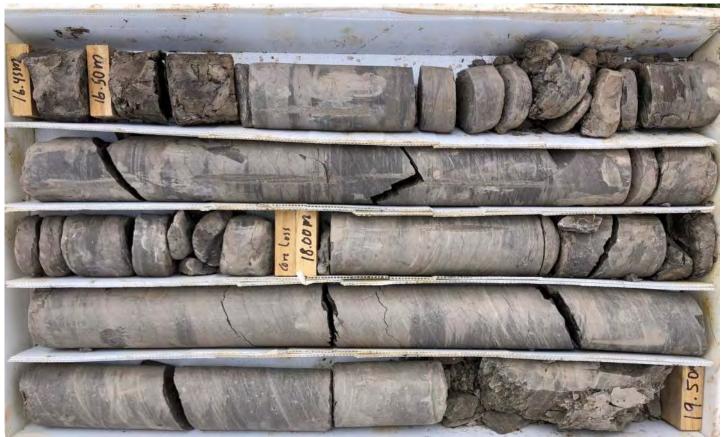
Client / Project:	Stevenson Aggregates Ltd.	Ltd. Hole ID:		102
i roject.	Drury Quarry—Sutton Block	Date:	0	7/11/2022
Notes:		Box No(s).	5 a	and 6 of 21
		Depth from (m):		13.5
		Depth To (m)	:	19.50
Project No.	220245—Drury Quarry—Sutton Block	Interval (m):	•	6

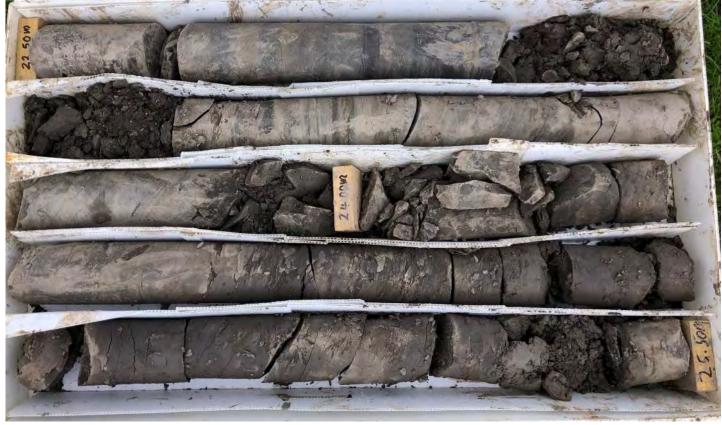
Client / Project:	Stevenson Aggregates Ltd.	Hole ID:	DH	102
i roject.	Drury Quarry—Sutton Block	Date:	0	7/11/2022
Notes:		Box No(s).	7 a	and 8 of 21
		Depth from (m):	19.5
		Depth To (m)	:	25.5
Project No.	220245—Drury Quarry—Sutton Block	Interval (m):		6

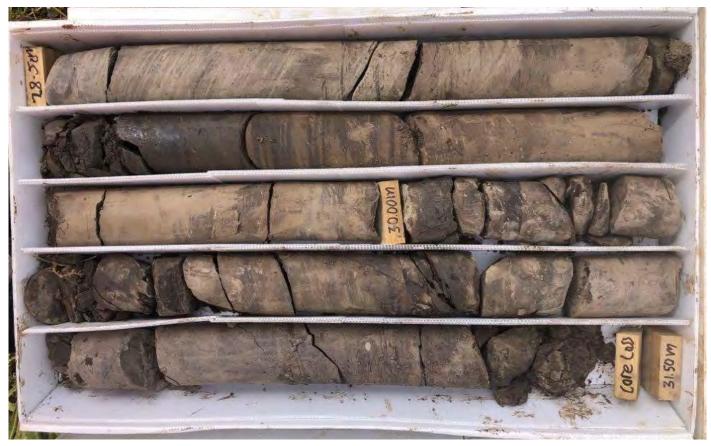
l .				
Client / Project:	Stevenson Aggregates Ltd.	Hole ID:	DH102	
i roject.	Drury Quarry—Sutton Block	Date:	0	7/11/2022
Notes:		Box No(s).	9 a	nd 10 of 21
		Depth from (m):		25.5
		Depth To (m)	:	31.5
Project No.	220245—Drury Quarry—Sutton Block	Interval (m):		6.0

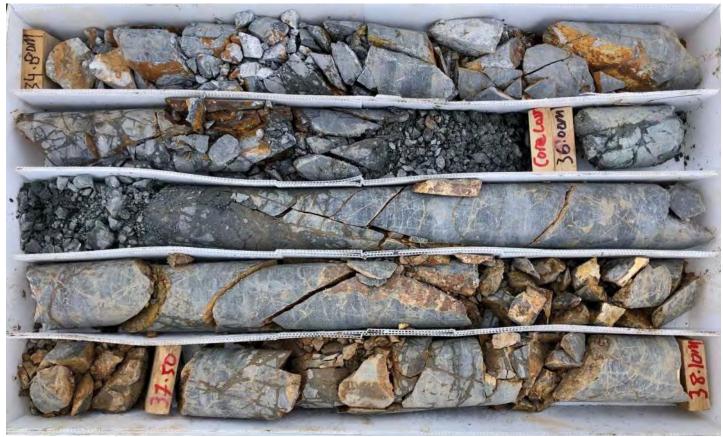
Client /	Project: Drury Quarry Sutton Block		DH	102
Drury (Drury Quarry—Sutton Block	Date:	07/11/2022	
Notes:		Box No(s).	Box No(s). 11 a	
		Depth from (m):		31.5
		Depth To (m)	:	38.1
Project No.	220245—Drury Quarry—Sutton Block	Interval (m):		6.6

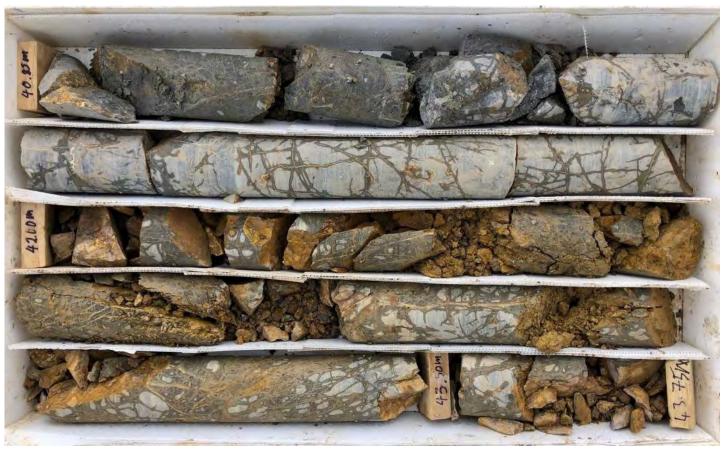
Client / Project:	Stevenson Aggregates Ltd.	Hole ID:		DH102	
Dialy Quarry—Sutton Block	Date:	0	7/11/2022		
Notes:		Box No(s).	13	and 14 of 21	
		Depth from (m):		38.1	
		Depth To (m)	:	43.75	
Project No.	220245—Drury Quarry—Sutton Block	Interval (m):		5.65

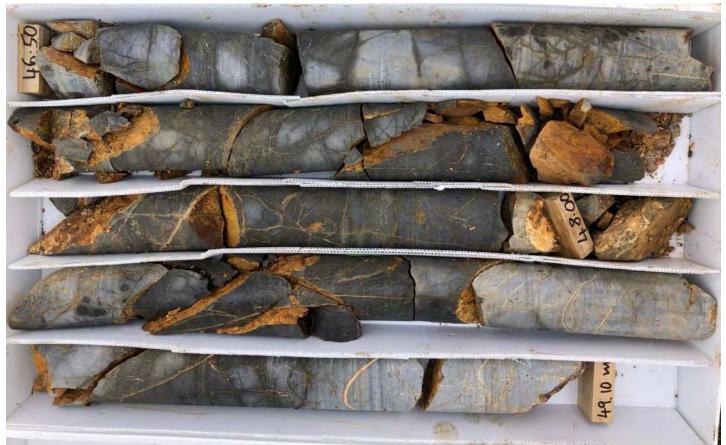
Client / Project:	Stevenson Aggregates Ltd.	Hole ID:		DH102	
l roject.	Drury Quarry—Sutton Block	Date:	0	7/11/2022	
Notes:		Box No(s).	15	and 16 of 21	
		Depth from (m):		43.75	
		Depth To (m)	:	49.10	
Project No.	220245—Drury Quarry—Sutton Block	Interval (m):		5.35

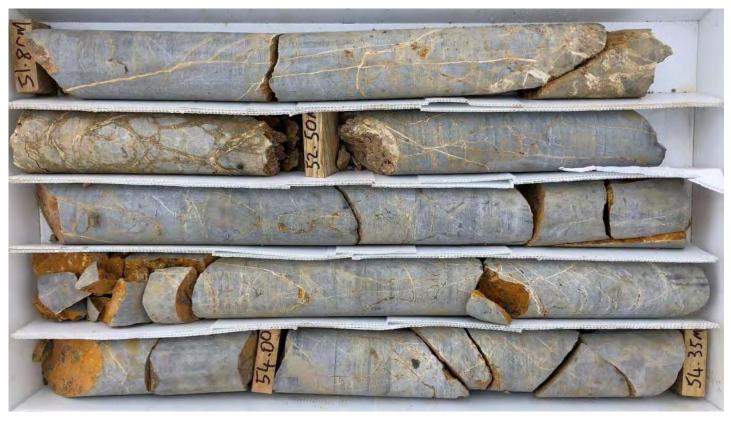
Client / Project:	Stevenson Aggregates Ltd.		DH102		
i roject.	Drury Quarry—Sutton Block	Date:		07/11/2022	
Notes:		Box No(s).	Box No(s). 17		
		Depth from (m):		49.10	
		Depth To (m)	:	54.35	
Project No.	220245—Drury Quarry—Sutton Block	Interval (m):		5.25

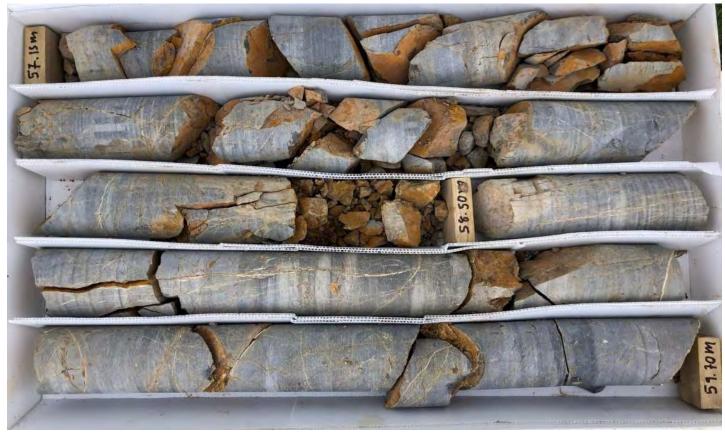
Client / Project:	Stevenson Aggregates Ltd.		DH102		
i roject.	Drury Quarry—Sutton Block	Date:	07/11/2022		
Notes:		Box No(s). 19 a		19 and 20 of 21	
		Depth from (m):		54.35	
		Depth To (m)	:	59.70	
Project No.	220245—Drury Quarry—Sutton Block	Interval (m):		5.25

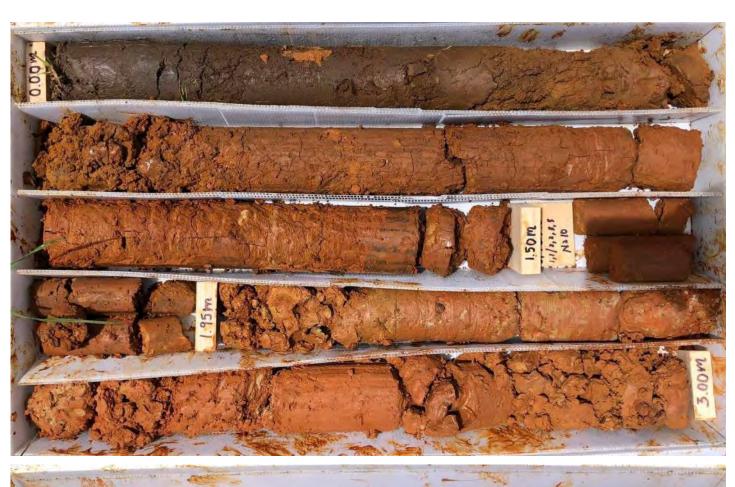
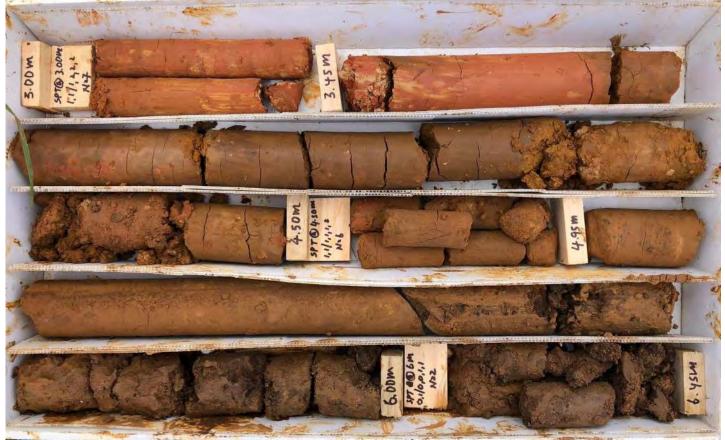
Client /	roject: Drury Quarry Sutton Block	Hole ID:	DH	103
Froject.	Drury Quarry—Sutton Block	Date: 24/1		4/11/2022
Notes:		Box No(s).	1 and 2 of 25	
		Depth from (m):		0.00
		Depth To (m)	:	6.45
Project No.	220245—Drury Quarry—Sutton Block	Interval (m):		6.45

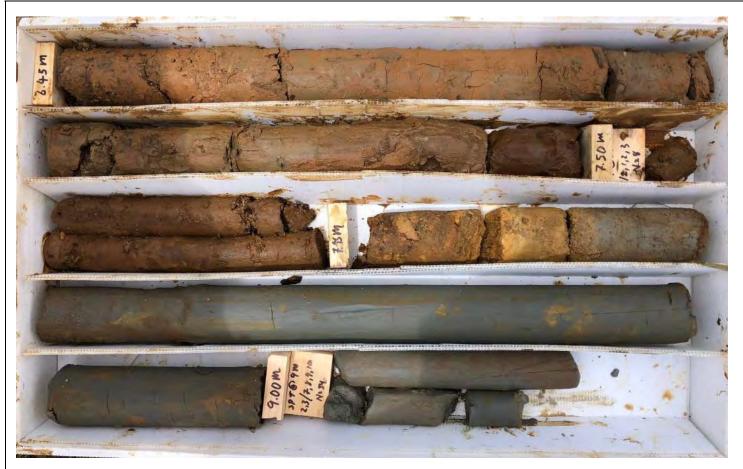
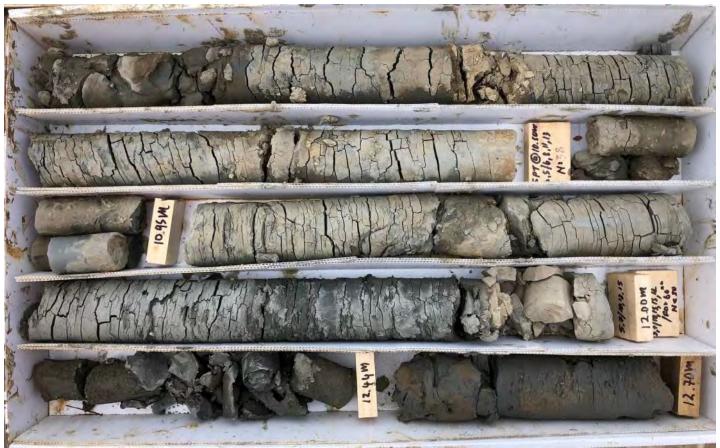
Client /	Stevenson Aggregates Ltd.		DH	103
Project.	Drury Quarry—Sutton Block	Date:	24/11/2022	
Notes:		Box No(s).	3 and 4 of 25	
		Depth from (m):		6.45
		Depth To (m)	:	12.70
Project No.	220245—Drury Quarry—Sutton Block	Interval (m):		6.25

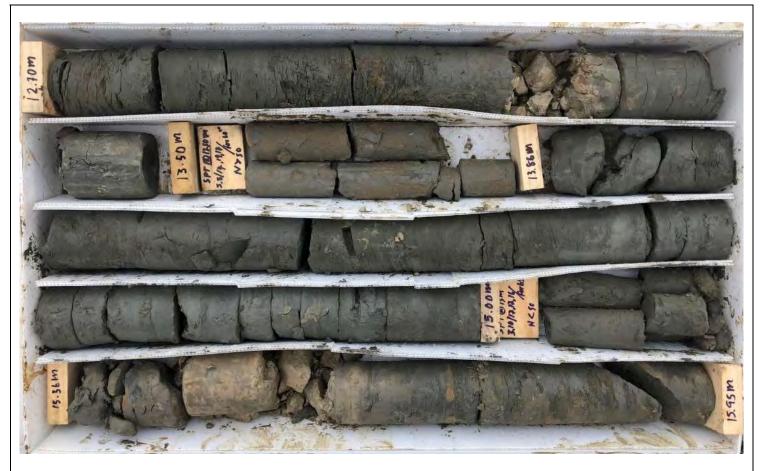
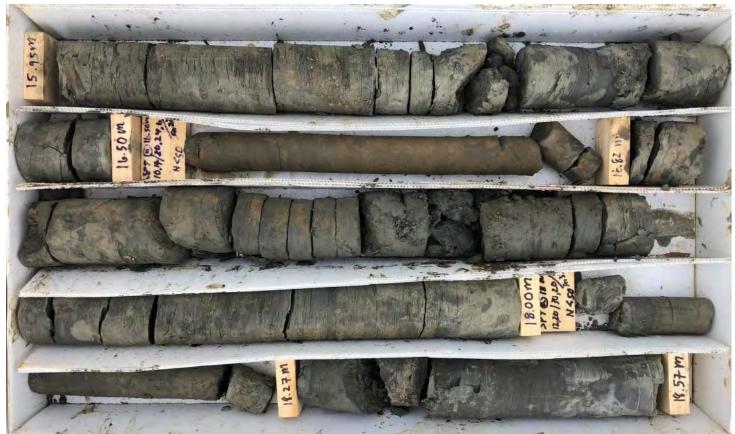
Client / Project:	Stevenson Aggregates Ltd.	Hole ID:	DH103	
i roject.	Drury Quarry—Sutton Block	Date:	2	4/11/2022
Notes:		Box No(s).	No(s). 5 and	
		Depth from (m):	12.70
		Depth To (m)	:	18.57
Project No.	220245—Drury Quarry—Sutton Block	Interval (m):		5.87

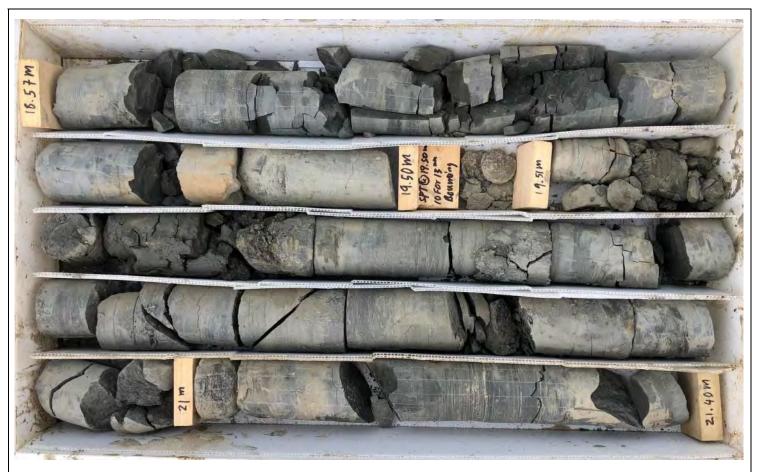
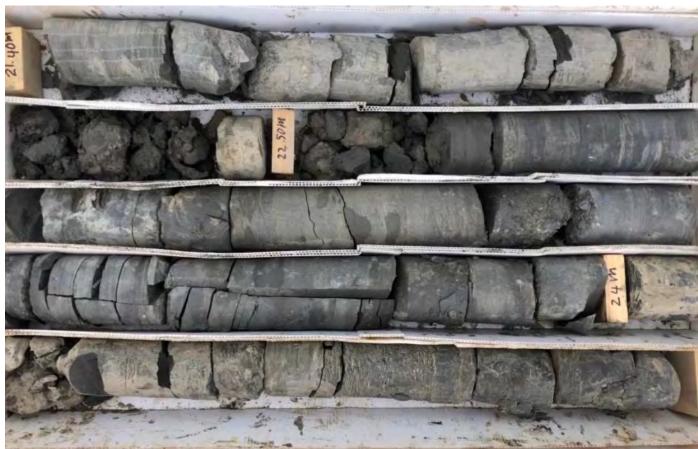
Client / Project:	Stevenson Aggregates Ltd.	Hole ID:	DH	103
i roject.	Drury Quarry—Sutton Block	Date:	0	1/12/2022
Notes:		Box No(s).	Box No(s). 7 and	
		Depth from (m):	18.57
		Depth To (m)	:	24.9
Project No.	220245—Drury Quarry—Sutton Block	Interval (m):		6.33

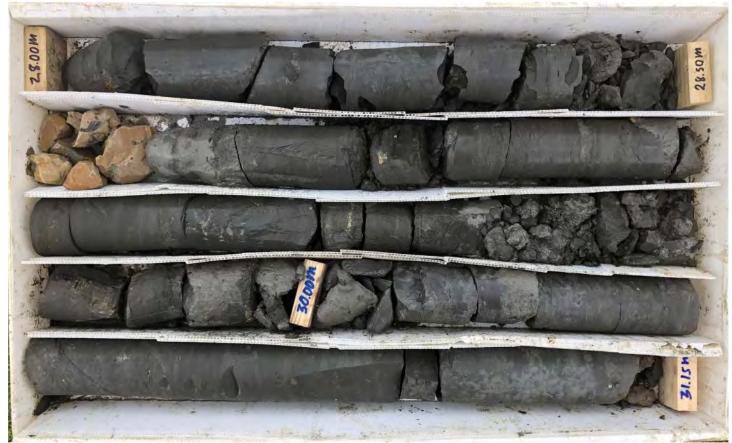
Client /	Project: Drury Quarry—Sutton Block Date:	Hole ID:	DH103	
i roject.		Date:	01/12/2022	
Notes:		Box No(s).	9 a	and 10 of 25
		Depth from (m):	24.90
		Depth To (m)	:	31.15
Project No.	220245—Drury Quarry—Sutton Block	Interval (m):		6.25

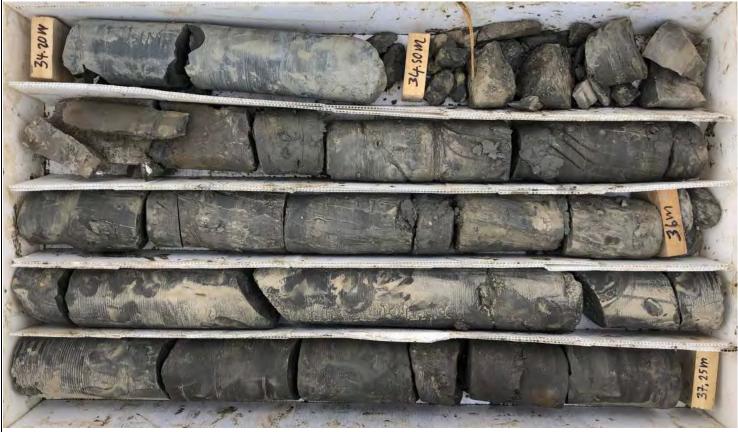
Client / Project:	Stevenson Aggregates Ltd.	Hole ID:		DH103	
Froject.	Drury Quarry—Sutton Block	Date:	3	0/11/2022	
Notes:		Box No(s).). 11 and 12 of		
		Depth from (m):		31.15	
		Depth To (m)	:	37.25	
Project No.	220245—Drury Quarry—Sutton Block	Interval (m):		6.1

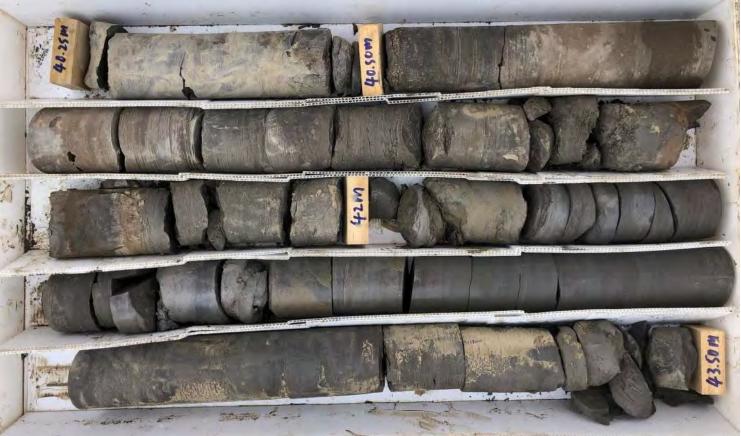
Client / Project:	Stevenson Aggregates Ltd.		DH103	
rioject.	Drury Quarry—Sutton Block	Date:	01/12/2022	
Notes:		Box No(s).	13	and 14 of 25
		Depth from (m):	37.25
		Depth To (m)	:	43.50
Project No.	220245—Drury Quarry—Sutton Block	Interval (m):		6.25

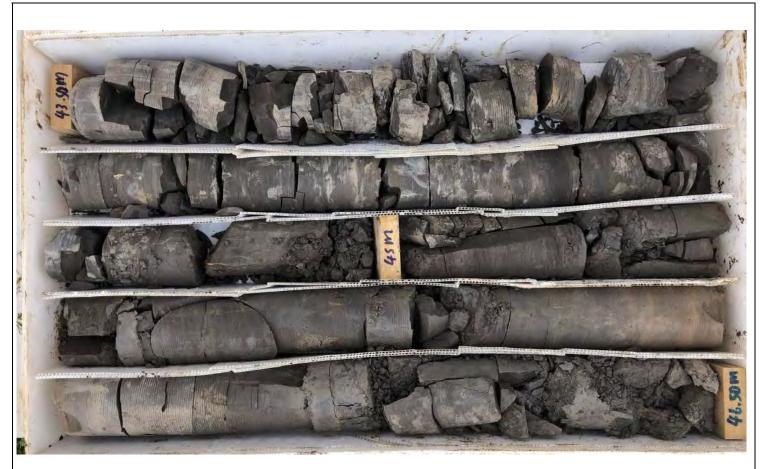
Client / Project:	Stevenson Aggregates Ltd.	Hole ID:		DH103	
Froject.	Drury Quarry—Sutton Block	Date:	01/12/2022		
Notes:		Box No(s).	ox No(s). 15 and		
		Depth from (m):		43.40	
		Depth To (m)	:	49.50	
Project No.	220245—Drury Quarry—Sutton Block	Interval (m):		6.10

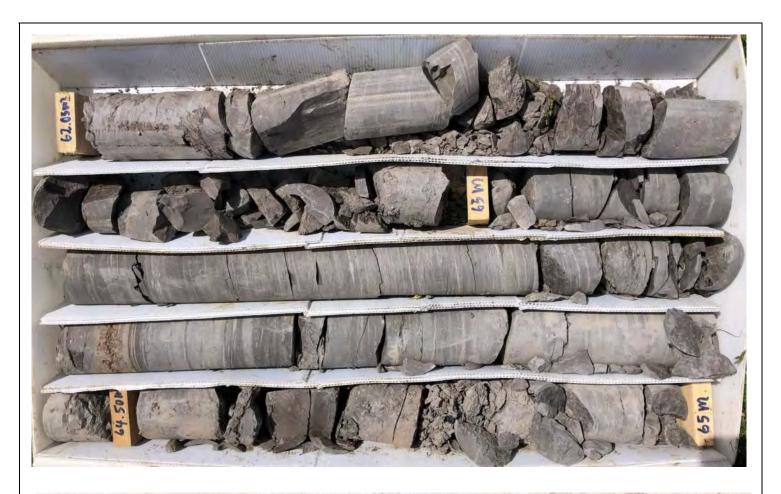
Client / Project:	Stevenson Aggregates Ltd.	Hole ID:	DH	DH103	
l roject.	Drury Quarry—Sutton Block	Date:	0	2/12/2022	
Notes:		Box No(s). 19 an		nd 20 of 25	
		Depth from (m):		55.50	
		Depth To (m)):	62.05	
Project No.	220245—Drury Quarry—Sutton Block	Interval (m):		6.55

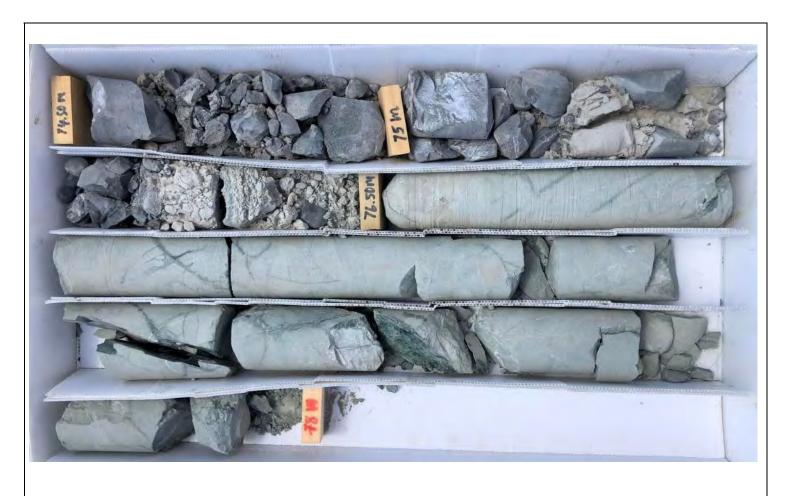
Client / Project:	Stevenson Aggregates Ltd.	Hole ID: DH10		103
	Drury Quarry—Sutton Block	Date:	05/12/2022	
Notes:		Box No(s). 23 au		nd 24 of 25
		Depth from (m):	68.40
		Depth To (m)):	74.50
Project No.	220245—Drury Quarry—Sutton Block	Interval (m):		6.10

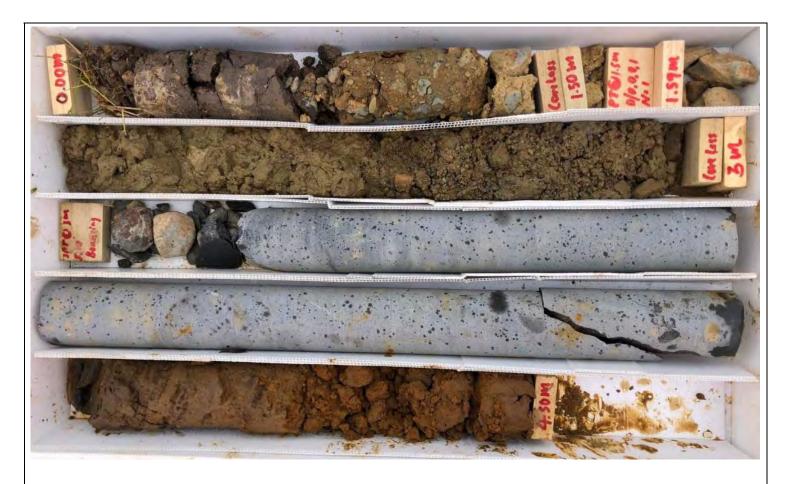
Client /	Project: Drury Quarry—Sutton Block Da Da	Hole ID:	DH	103
i roject.		Date:	0	5/12/2022
Notes:		Box No(s).	:	25 of 25
		Depth from (m):		74.5
		Depth To (m)	:	78
Project No.	220245—Drury Quarry—Sutton Block	Interval (m):		3.5

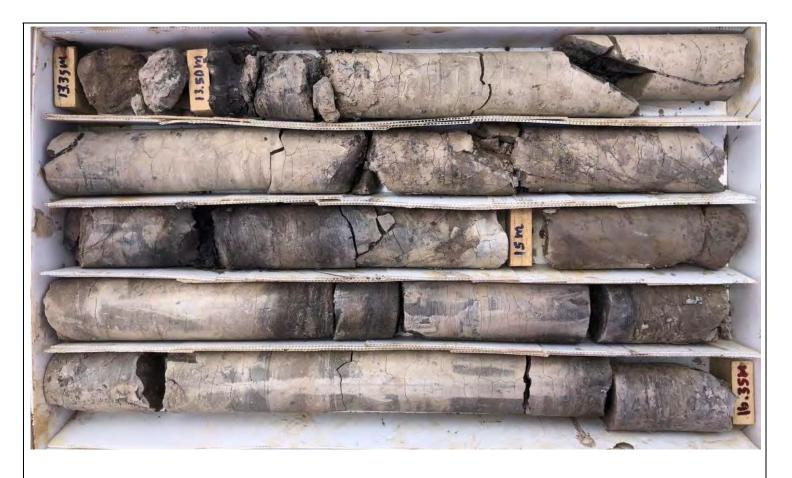
Client / Project:	Stevenson Aggregates Ltd.			104	
	Drury Quarry—Sutton Block			12/12/2022	
Notes:				and 4 of 14	
				7.5	
		Depth To (m)	:	13.35	
Project No.	220245—Drury Quarry—Sutton Block	Interval (m):		5.85

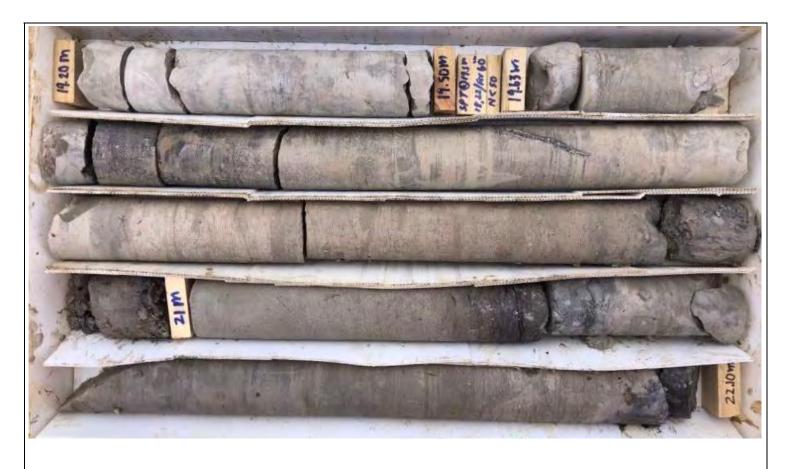
Client / Stevenson Aggregates Ltd. Project: Drury Quarry—Sutton Block	Hole ID:	DH	104		
	Drury Quarry—Sutton Block	Date: 12/12		2/12/2022	
Notes:		Box No(s). 5 :		and 6 of 14	
				13.35	
		Depth To (m)	:	19.20	
Project No.	220245—Drury Quarry—Sutton Block	Interval (m):		5.85

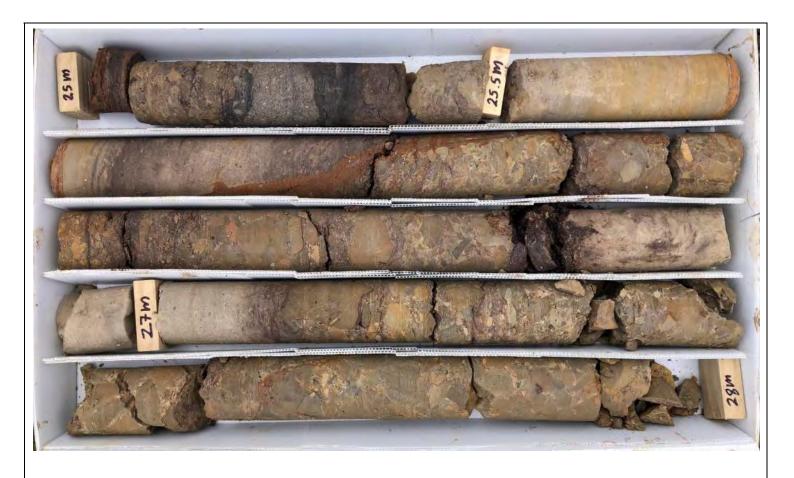
Client / Project:	Stevenson Aggregates Ltd. Drury Quarry—Sutton Block	DH104		
Drufy Quarry—Sutton Block	Date:	1	3/12/2022	
Notes:		Box No(s). 7 ar Depth from (m):		and 8 of 14
				19.20
		Depth To (m)	:	25.0
Project No.	220245—Drury Quarry—Sutton Block	Interval (m):		5.80

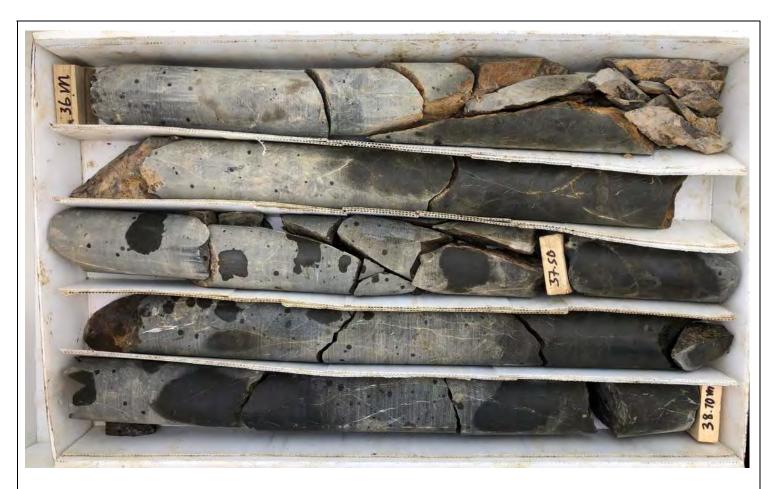
Client / Project:	Stevenson Aggregates Ltd. Drury Quarry—Sutton Block Date:	DH	104		
Drury Quarry—Sutton Block	Date:		13/12/2022		
Notes:		Box No(s). 11 a Depth from (m):		and 12 of 14	
				30.85	
		Depth To (m)	:	36.0	
Project No.	220245—Drury Quarry—Sutton Block	Interval (m):		5.15

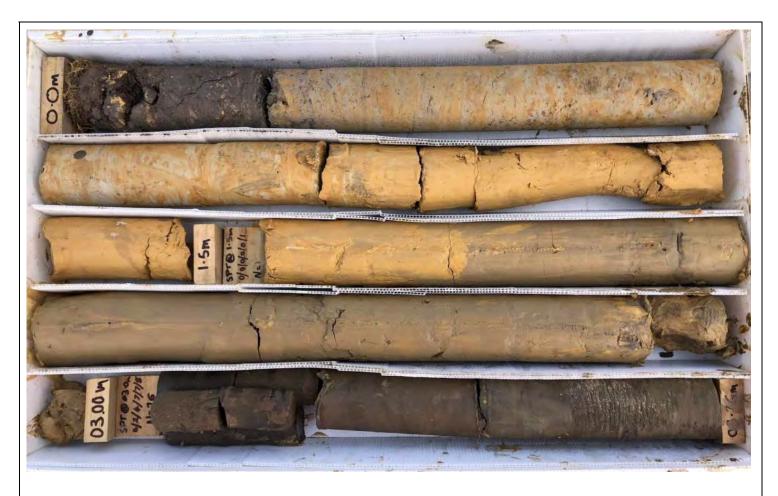
Client / Project:	Stevenson Aggregates Ltd.	Hole ID:	DH104	
Dialy Quarry—Sutton Block	Date:		3/12/2022	
Notes:		Box No(s).	13 a	and 14 of 14
		Depth from (m):		36.0
		Depth To (m)	:	40.50
Project No.	220245—Drury Quarry—Sutton Block	Interval (m):		4.50

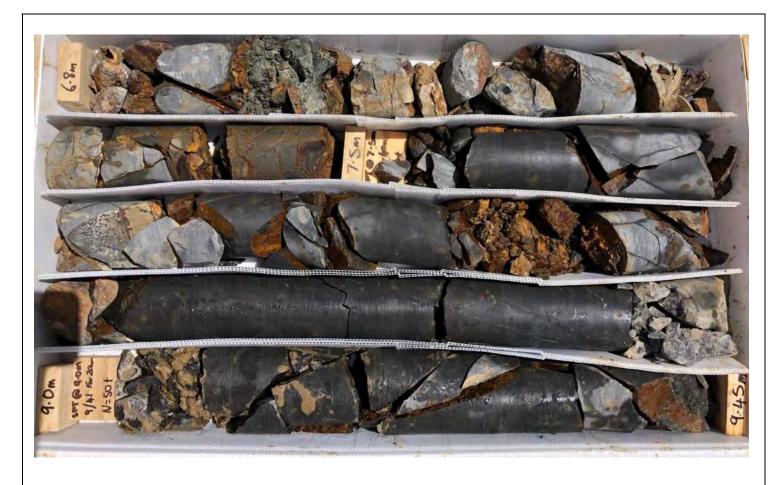
Project: Stevenson Aggregates Ltd. Drury Quarry Sutton Block	Hole ID:	DH	105	
	Drury Quarry—Sutton Block	Date:	0	1/11/2022
Notes:		Box No(s). 1 a Depth from (m):		and 2 of 17
				0.0
		Depth To (m)	:	6.8
Project No.	220245—Drury Quarry—Sutton Block	Interval (m):		6.8

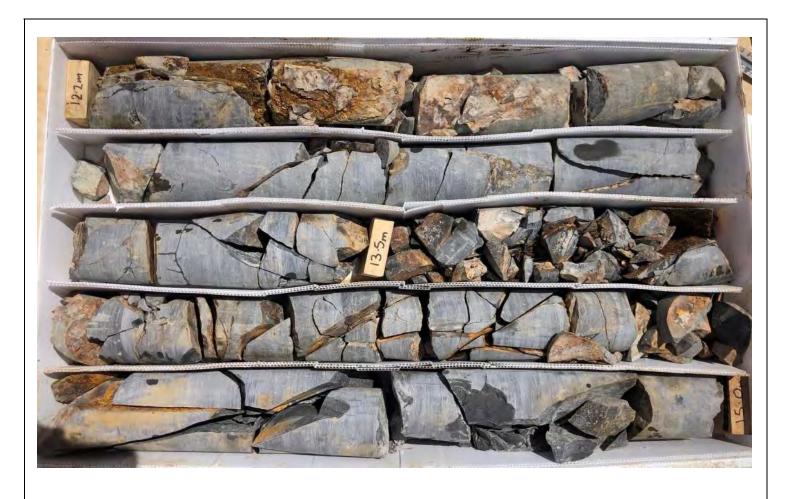
Client / Stevenson Aggregates Lt Drury Quarry—Sutton Blo	Stevenson Aggregates Ltd.	Hole ID: DH105		105	
	Drury Quarry—Sutton Block	Date: 01		1/11/2022	
Notes:		Box No(s). 3 a Depth from (m):		and 4 of 17	
				6.8	
		Depth To (m)	:	12.2	
Project No.	220245—Drury Quarry—Sutton Block	Interval (m):		5.4
