File Reference: 24290101

16 June 2025

### POUND ROAD FAST TRACK - AQUATIC ECOLOGY ASSESSMENT

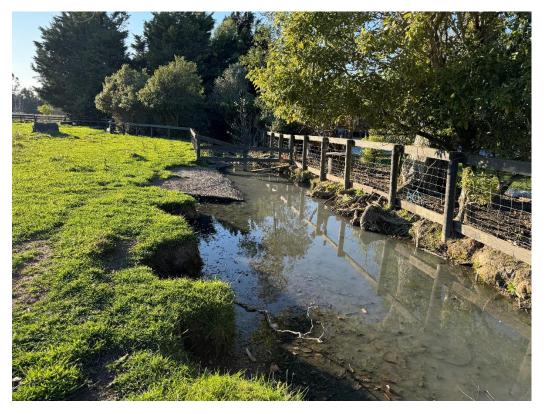
The following observations were made during the site assessment. The waterway (where water is present) had an average width of 2.8 m and an average water depth of 0.15 m, the pond was approximately 8 m in diameter, with a max depth of 0.65 m. The waterway substrate consisted of 100% fine sediment, with bank erosion visible. RHA results are summarised in Table 1. The site had a total RHA score of 36.5, indicating fair habitat quality. For context, total RHA scores of 0–25 are indicative of "poor" quality habitat, 26–50 is "fair", 51–75 is "good", and 76–100 indicates "excellent" habitat quality (Clapcott et al. 2020). Water quality showed suitable conditions for instream life, water temperature was 9.8 °C, dissolved oxygen was recorded at 66.2 % and 7.51 mg/L, conductivity at 72.0  $\mu$ s/cm and pH was near neutral at 6.94.

Figure 2: Start of wet water race reach within the Site (from Barters Road). No flow and high level of organics and fine sediment.

A fish salvage will also be required for infilling of the short reach of artificial waterway located within the Site. This should be undertaken when water levels are low to minimise the reach required to be salvaged.

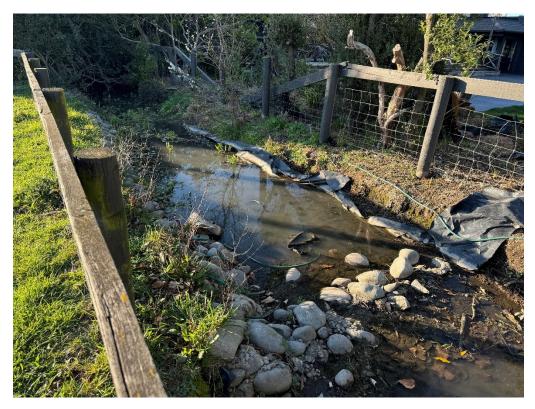
Figure 3: Wet reach along the 94 Barters Road driveway, with rock weir and lining.

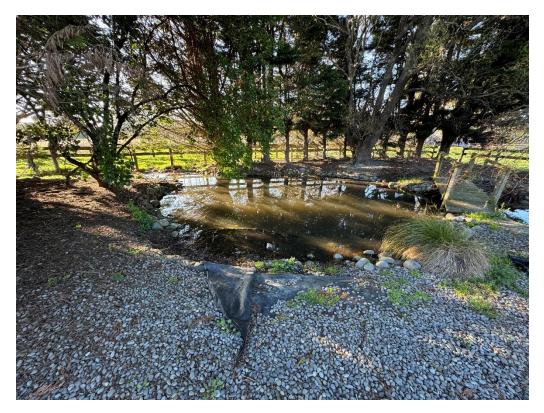
The Site has a short section of water race that terminates within the property. Discussion with the landowners indicates that the remnant water race reach has no function for the Site and has been retained for amenity values. The section of wetted channel that remains is of low ecological value, and had been highly modified for amenity values, with plastic liner and landscaping to form an ornamental pond.

Figure 5: Ponded area with lining at end of wet water race reach.

Effects of the Site's development to a general industrial subdivision are not expected to result in adverse effects to aquatic ecology values. The channel within the Site will be removed, as there is no function for a water race within the development. The current ornamental pond and channel will need to be filled in. If this work is undertaken with the works area isolated and a fish salvage undertaken by a suitably qualified freshwater ecologist, no adverse effects on the water race network are expected. To provide mitigation for the loss of the short section of artificial waterway and the change in land use adjacent to the Barters Road water race, a 5 m setback with native riparian vegetation on the true left bank (the side adjacent to the site) is proposed. With the recommended mitigation in place, it is considered that effects to aquatic ecology values will be very low.

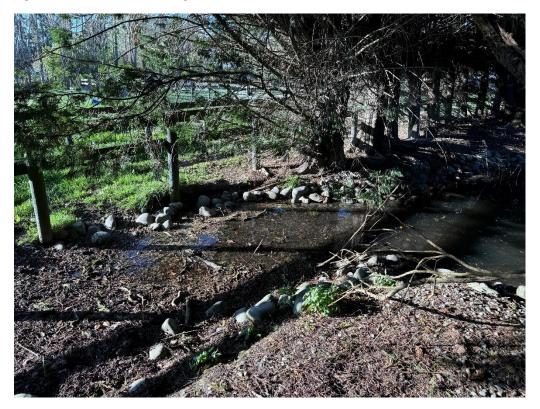
Figure 6: Pond outlet at the end of the wet water race reach.

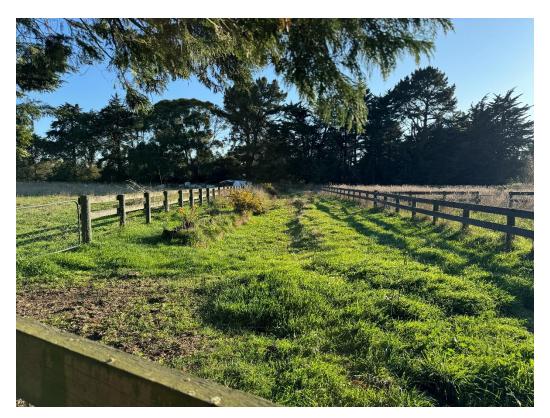
Figure 7: Dry water race reach.

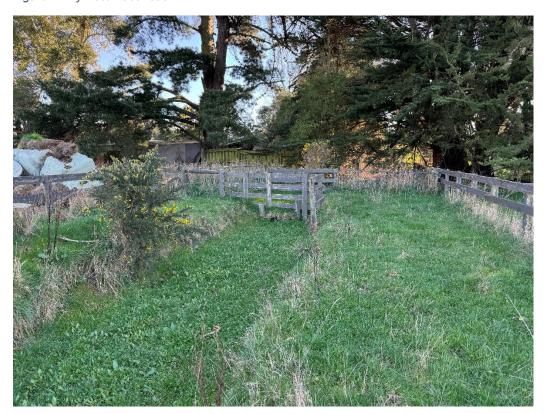
Figure 8: Dry water race reach with potential wetland vegetation within the base and culvert connection to 4 Hasketts Road.

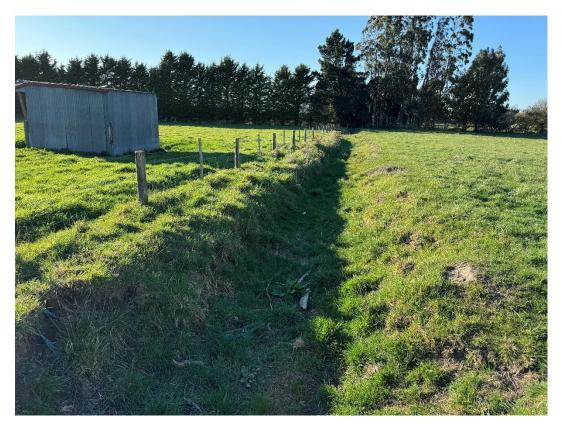
Figure 9: Dry water race reach in obsolete race reach.
