**To***Healthy Waters***From***Woods**Jasmin Moll – 3 Waters Engineer**Bidara Pathirage - Senior Associate Engineer***Reviewed***Pranil Wadan – Technical Director**W-REF: P24-646 Drury Centre – Stage 2**22 August 2025*

## Drury Metropolitan Centre Fast-track, Auckland Council Specialist Memo, Annexure 7 - Woods Response

### Stream Erosion Risk Assessment

### Drury Centre Stage 2 - Fast Track Application

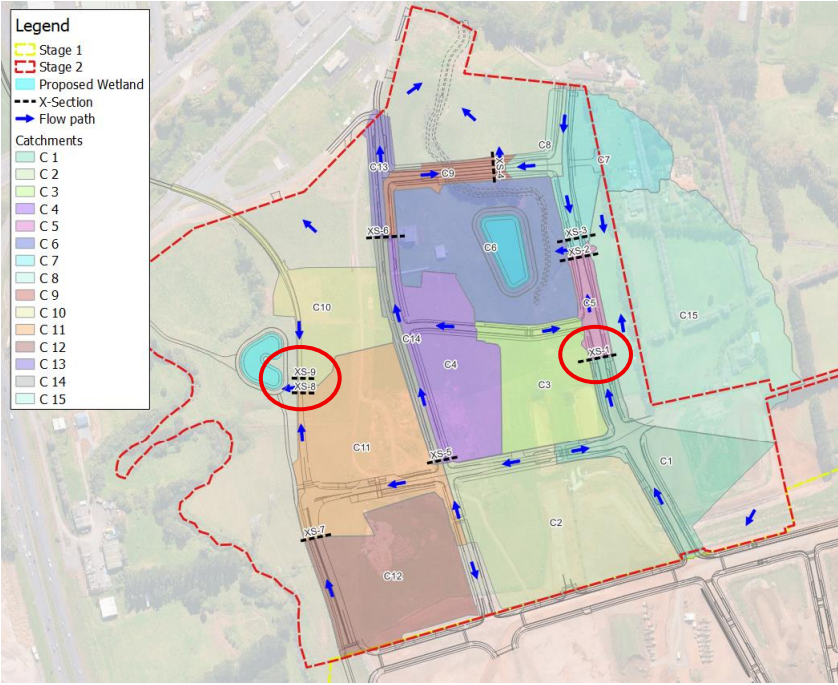
Healthy Waters Recommendation	Woods Response						
	XS-9	0.951	0.389	0.177	0.782	0.4	0.138
	<p>The location of the assessed cross sections is shown in the figure below.</p>

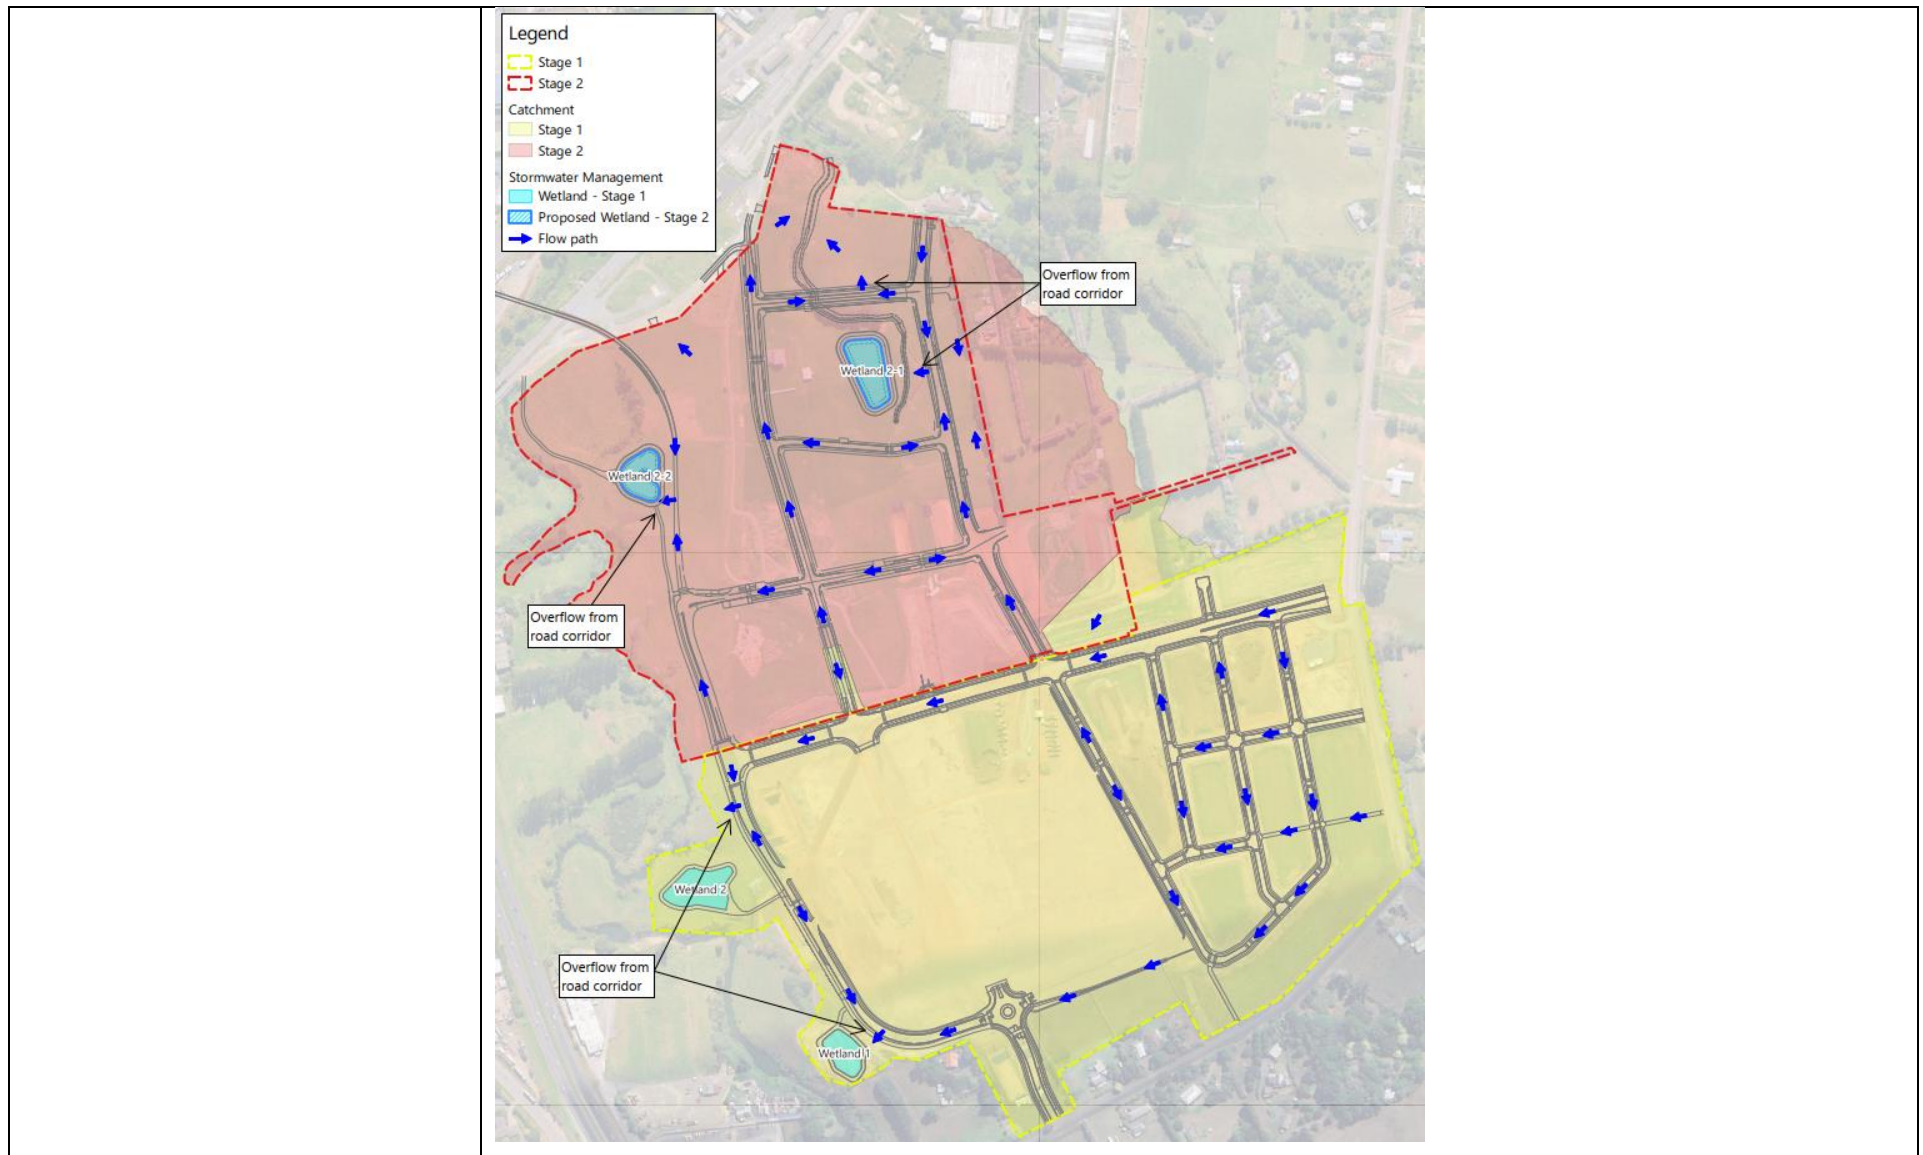
Healthy Waters Recommendation	Woods Response
	As per the proposed design no overland flows originating from Stage 1 discharge towards Stage 2. This is illustrated in Figure below that shows the intended direction of overland flows within Stages 1 and 2.

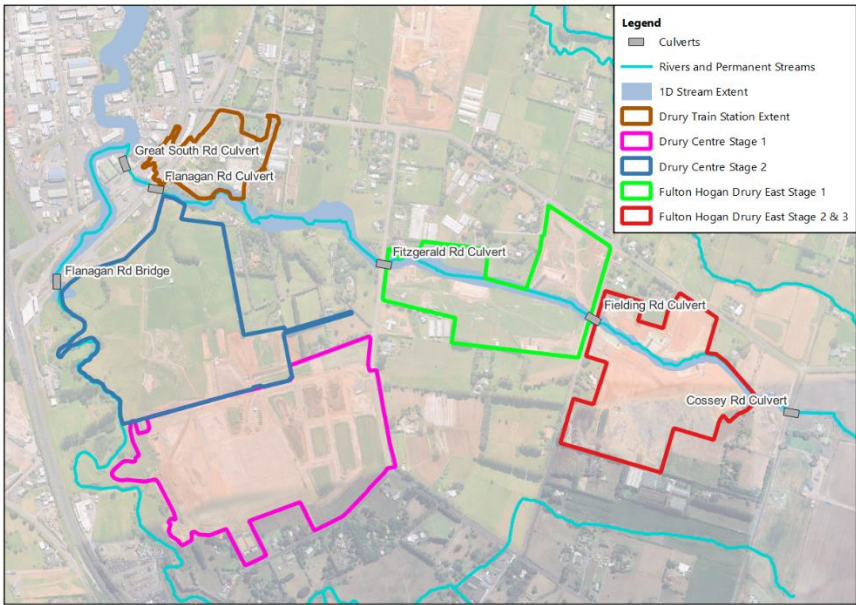
<p>Figure 1 Fitzgerald Tributary has multiple culverts located upstream of Flanagan Road</p>

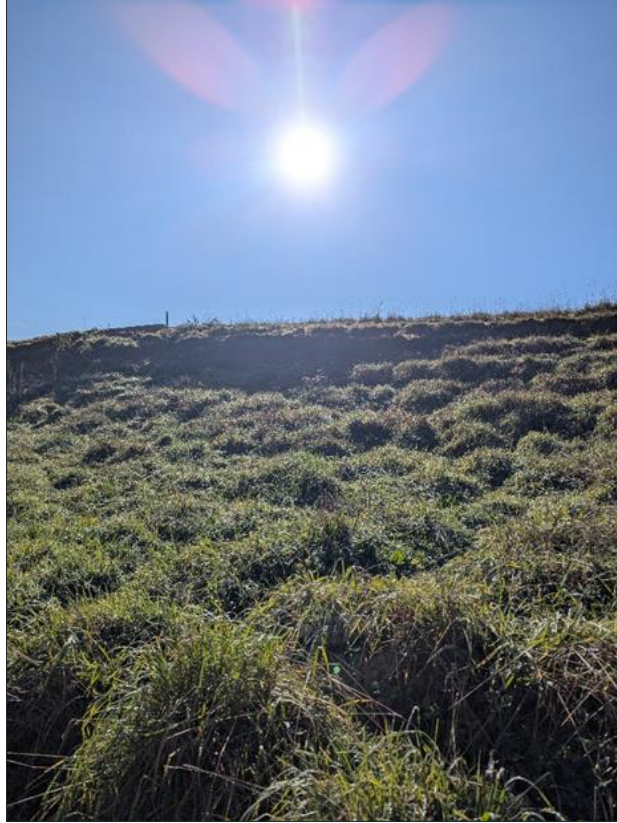
Figure A1.1: Image denotes disconnection from river

It is important to note that high flow depths during both LiDAR capture dates limits the visibility of bed morphology, making it difficult to confirm whether the bed is actively incising or aggrading. However, the observed disconnection from the floodplain, lack of in-channel bars, and depth of the channel suggests some degree of historic incision. The dominant sediment source appears to be fine material, although occasional coarser clasts were observed in low-flow margins during field inspection (refer to Figure A1.1 Appendix A).

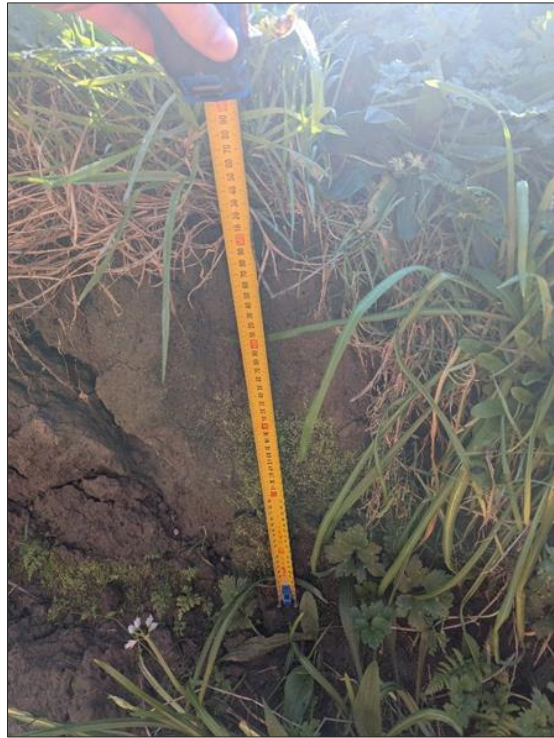
Figure A1.2: Exposed banks indicating clay substrate

The stream is generally laterally unconfined, although one bank shows partial confinement from nearby development. Bank materials are predominantly cohesive clay (Figure A1.2), producing steep, near-vertical profiles. While clay banks resist gradual erosion, undercutting and mass failure are evident (Figure A1.3), particularly along outer bends where flow is directed into the bank. Scarps and slumping were noted in several locations (Figure A1.4).

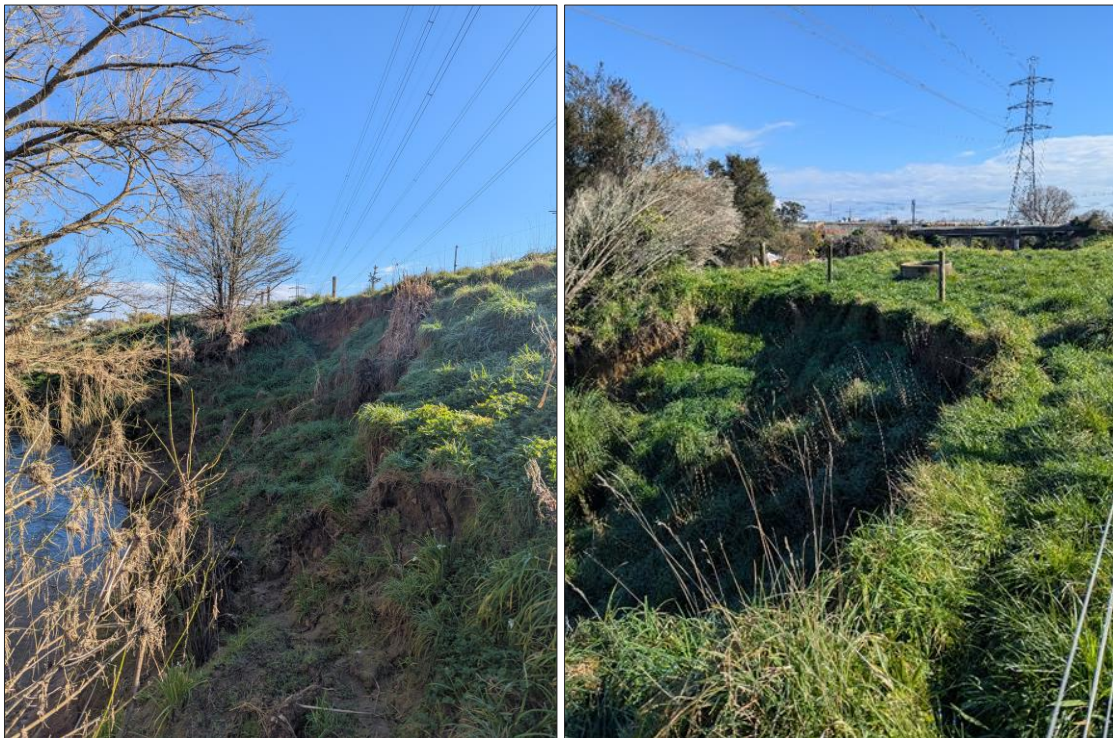
Figure A1.3: Examples of slumping along the Hingaia

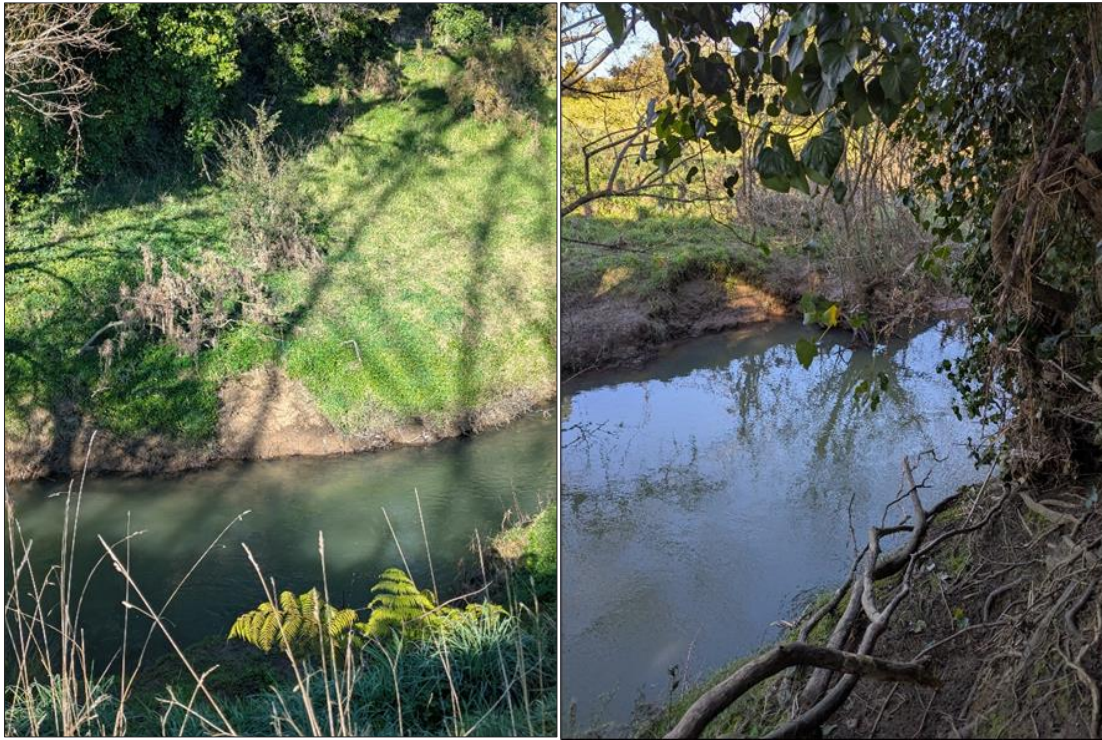
Figure A1.4: Examples of bank scarps/scarring

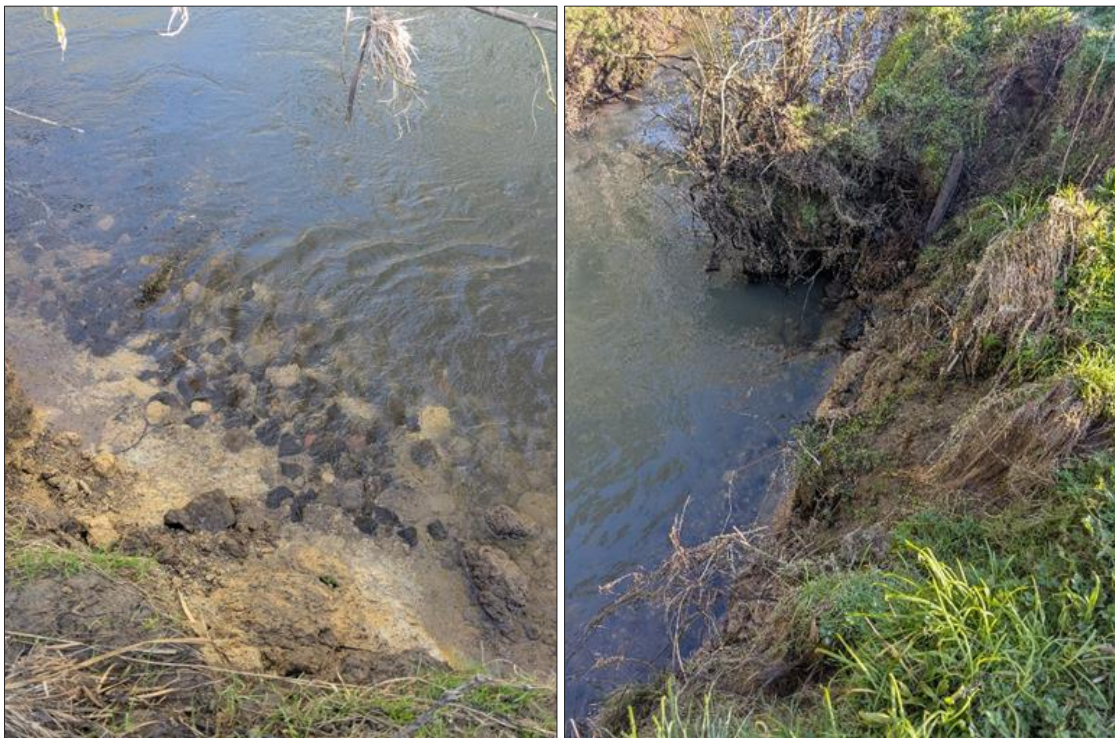
Figure A1.5: Observed mixed coarse bedload sediment

Bed material in low-flow areas comprises mixed volcanic and greywacke clasts (10–70 mm), with limited gravel and cobble deposits (Figure A1.5). These coarse materials do not appear to be part of a well-established, stable bedform. It is unclear whether they represent recent deposition or are the result of fines being washed away, exposing the underlying coarser substrate. Sediment storage within meander bends is moderate and vegetated (Figure A1.6), suggesting low bedload mobility under current flow conditions. Flow observations indicated steady transport of fine suspended sediment.

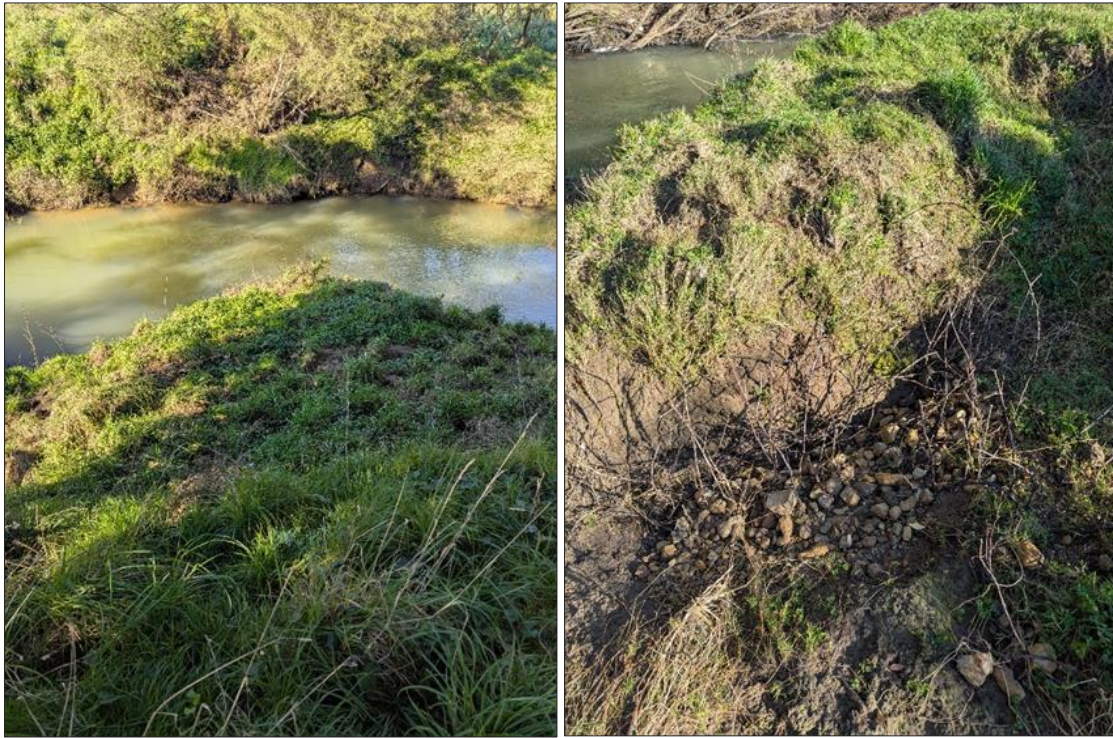
Figure A1.6: Observed long term sediment stores. Vegetated point bar (left) and evidence of deposition in adjacent former slump fill feature (right)

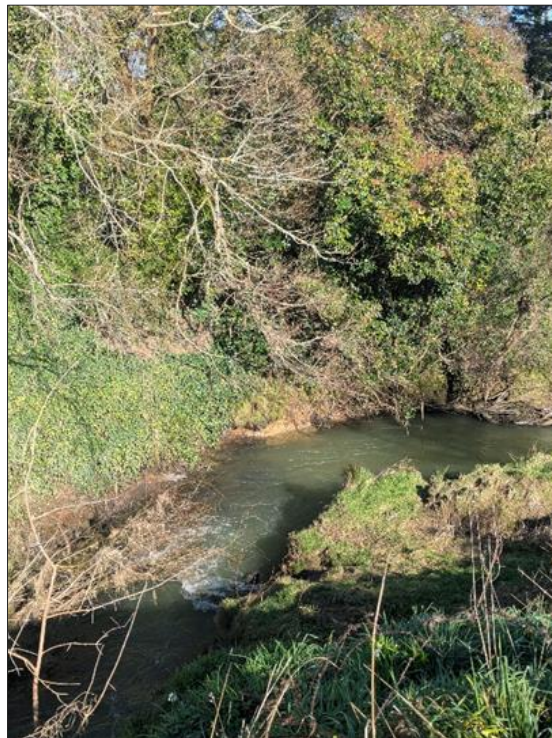
Figure A1.7: One of many riffle/run sequences within the Hingaia

The reach displays good hydraulic diversity, with riffles, runs, glides, and pools present (Figure A1.7). No knickpoints were observed, and the longitudinal profile appears stable. Signs of past high flows, including bent riparian vegetation (Figure A1.8), indicate occasional flood events capable of mobilising sediment and altering banks.

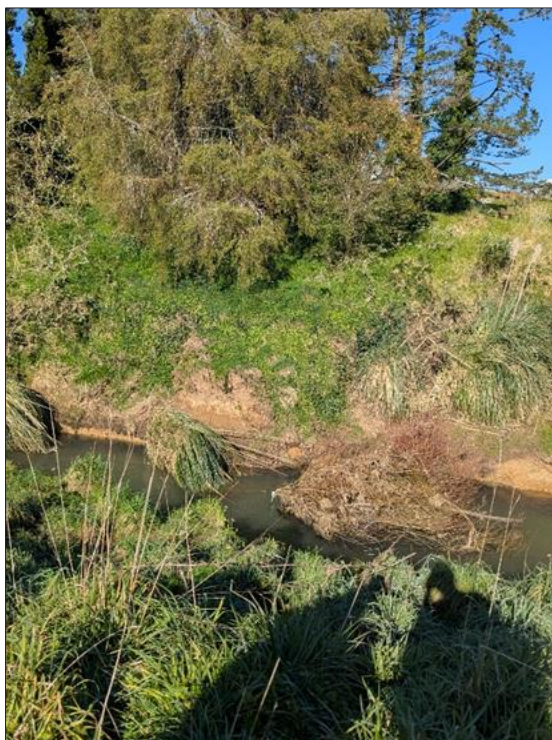
Figure A1.8: Noted debris lines and bent vegetation denoting peak flow

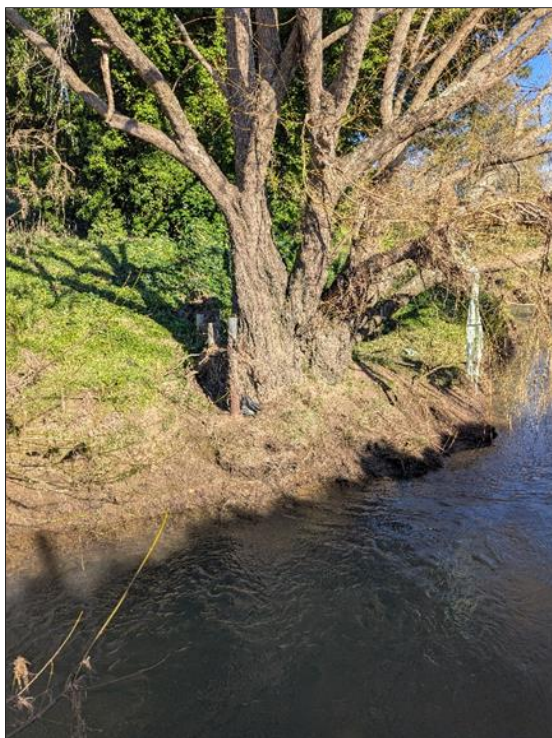
Figure A1.9: Bank Strengthening tree. One of a few areas with vegetation coverage

The riparian corridor is patchy and discontinuous, with some exposed banks lacking vegetative cover (Figure A1.9). In these areas, erosion risk is increased. Downstream, infrastructure such as bridges and built-up areas encroaches upon the riparian margin (Figure A1.10), further constraining the channel and influencing local hydraulics. Woody debris and vegetated patches within the channel provide some local habitat complexity and small-scale sediment trapping (Figure A1.11).

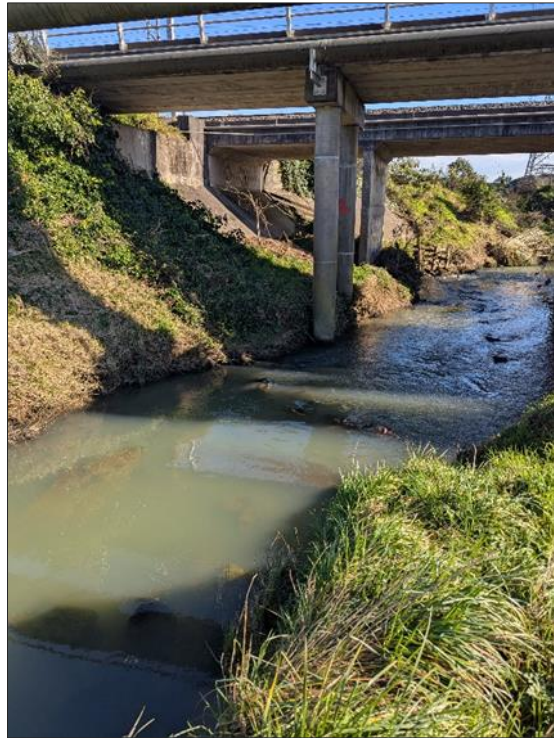
Figure A1.10: Flanagan Bridge at the lower extent of the reach

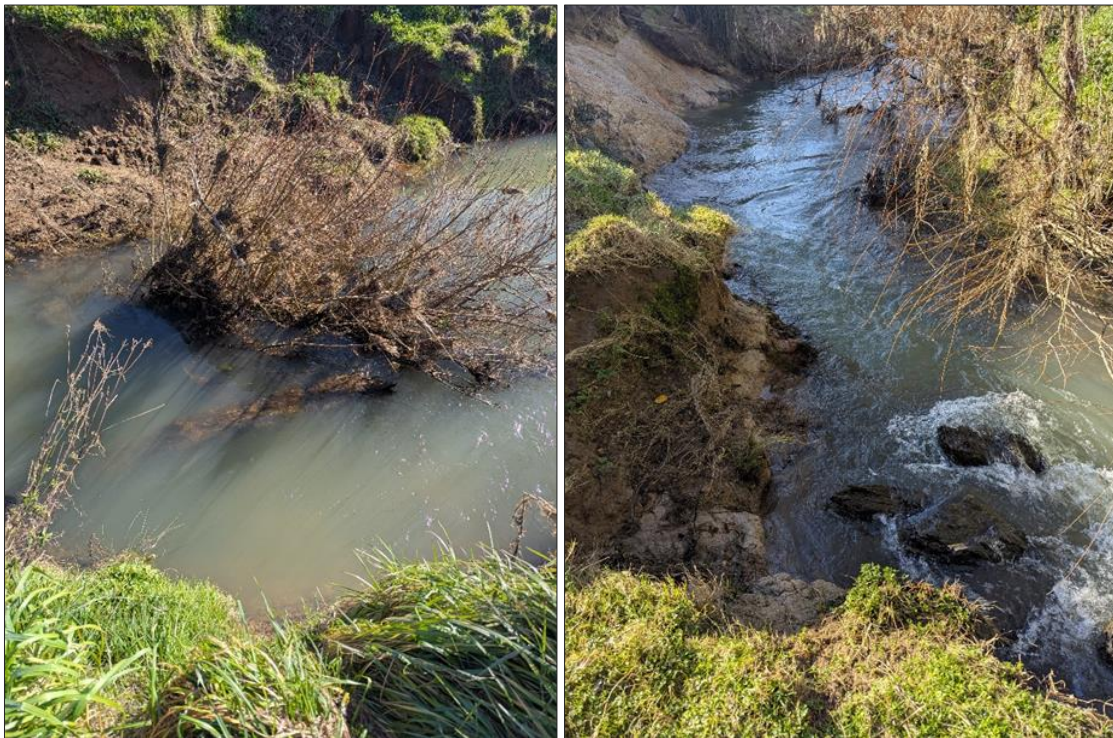
Figure A1.11: Examples of woody debris within the Hingaia, note that the right image displays imbedded wood not boulders

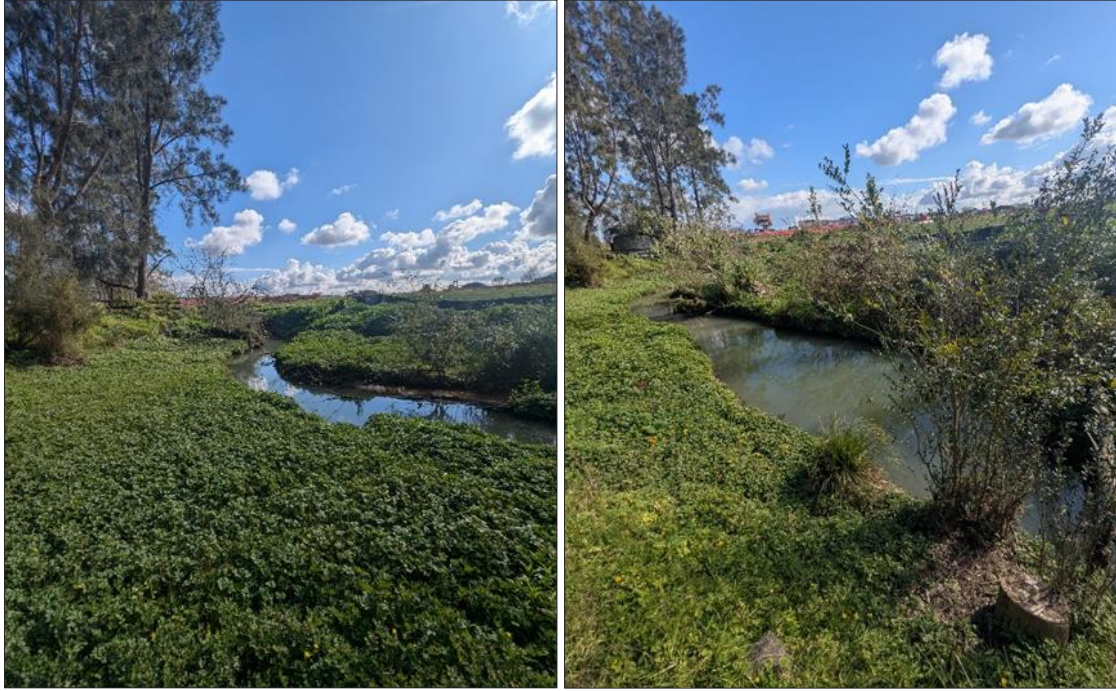
Figure A1.12: Downstream orientation, example of the Fitzgerald make up and connection to its floodplain

Fitzgerald Stream is approximately a third of the size of the Hingaia (width ratio), with a passively meandering planform and a generally unconfined setting. Some local confinement occurs where urban works encroach along one bank. The channel is narrow, with a width-to-depth ratio favouring width and retains floodplain connectivity in most areas (Figure A1.12). Bank material is predominantly cohesive clay, as indicated by exposed vertical faces along outer bends (Figure A1.13). These banks are resistant to gradual erosion but prone to undercutting and slumping when flows are concentrated against them.

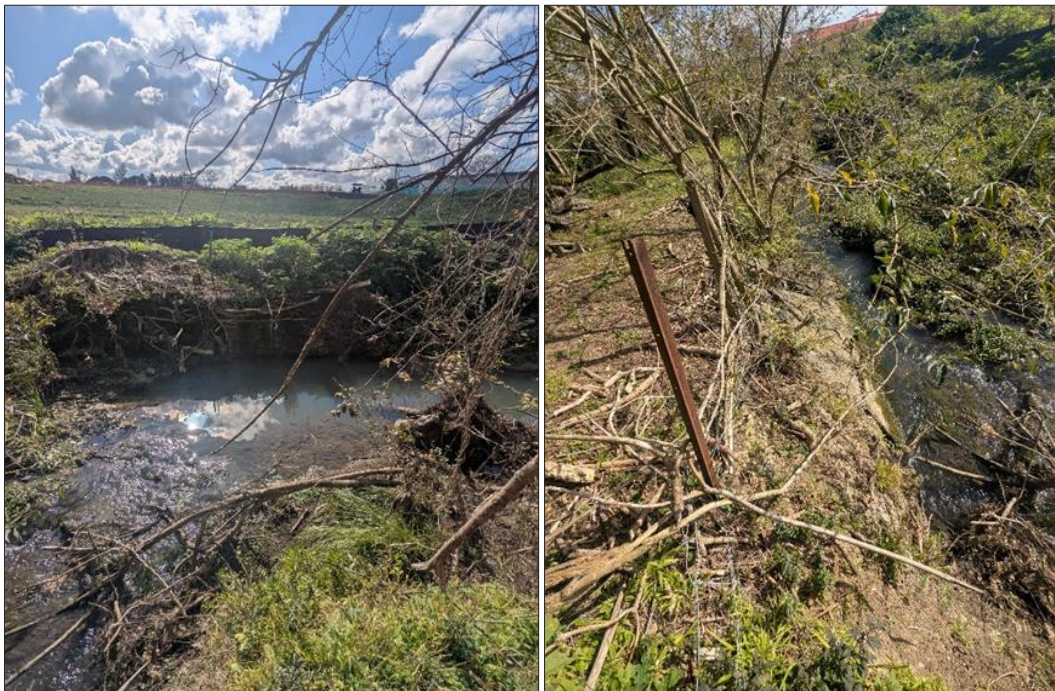
Figure A1.13: Exposed banks revealing cohesive clay substrate

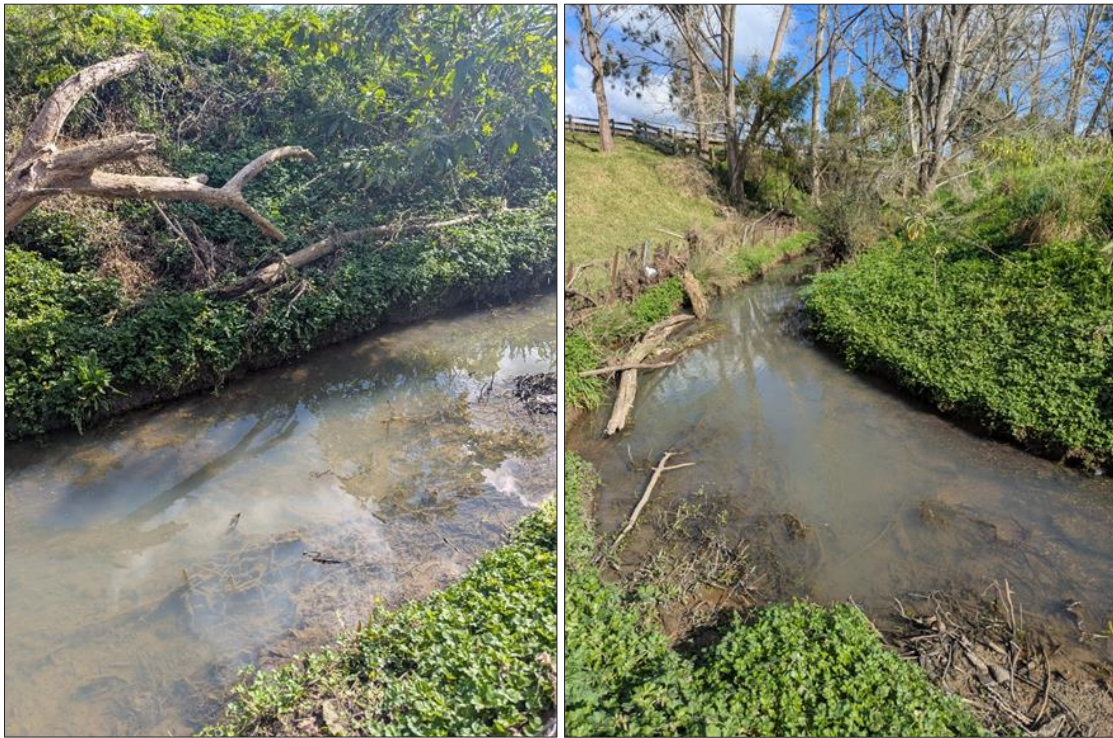
Figure A1.14: Upstream (left) and downstream (right) denoting the muddy bed surface. Woody debris was consistently featured throughout the Fitzgerald

The bed surface is primarily muddy and silty (Figure A1.14) and presume suspended sediment is the dominant mode of transport. No significant coarse-grained sediment deposits or gravel bars were identified,

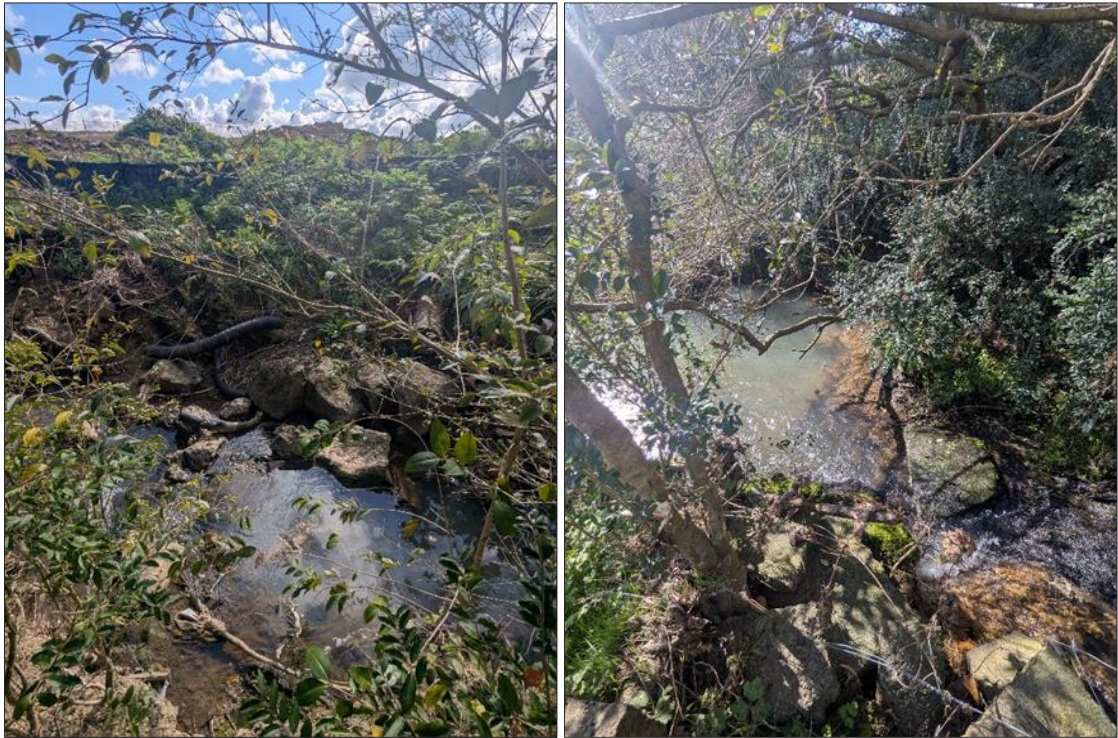
Figure A1.15: Examples of anthropomorphic armoring both in stream and banks

Riparian vegetation is mostly continuous, with wide, well-vegetated margins along many sections and only sporadic gaps. Anthropogenic armouring both instream and along the banks is present in certain locations (Figure A1.15), likely for erosion control. Hydraulic diversity includes riffles, runs, and pools, along with several small knickpoints (Figure A1.16). Evidence of bank scour is concentrated on outer bends. Woody debris, including large, felled trees across the channel, contributes to habitat complexity and local sediment retention (Figure A1.17).

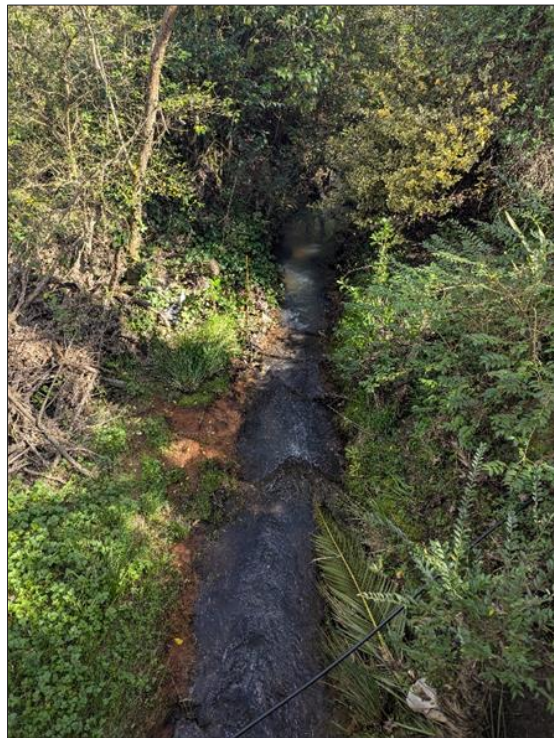
Figure A1.16: Hydraulic features were present throughout the observed section of the Fitzgerald

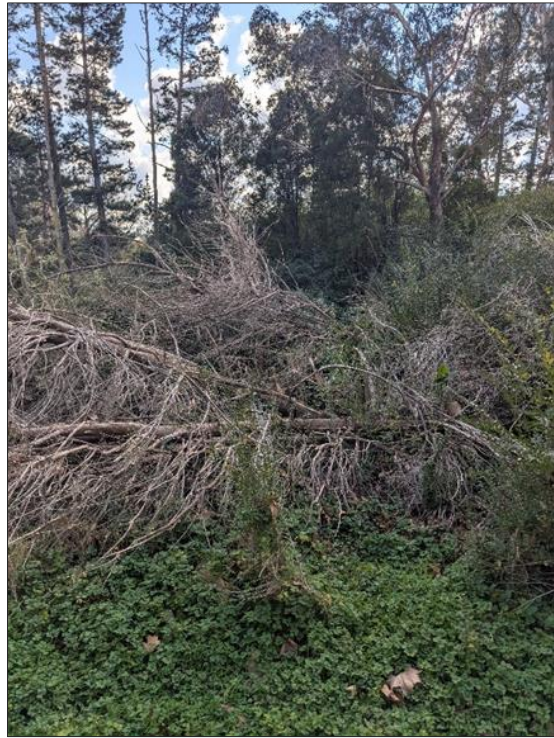
Figure A1.17: Riparian corridor was dense for large sections of the Fitzgerald with felled trees being a common feature too

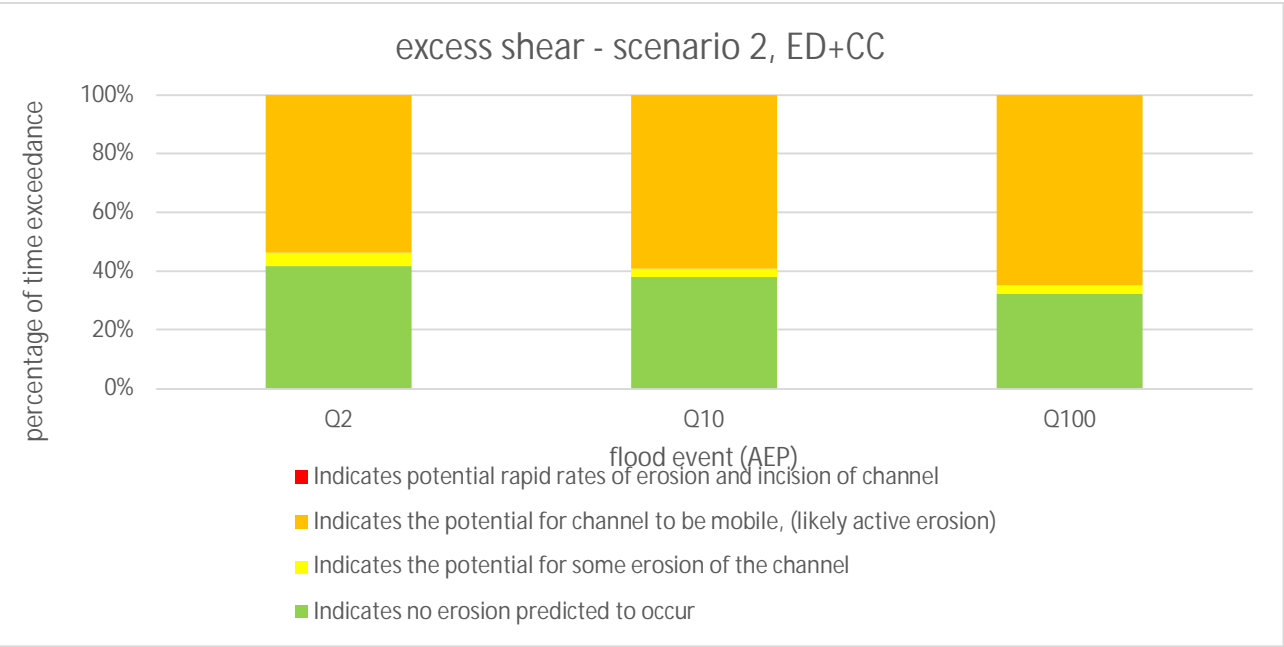
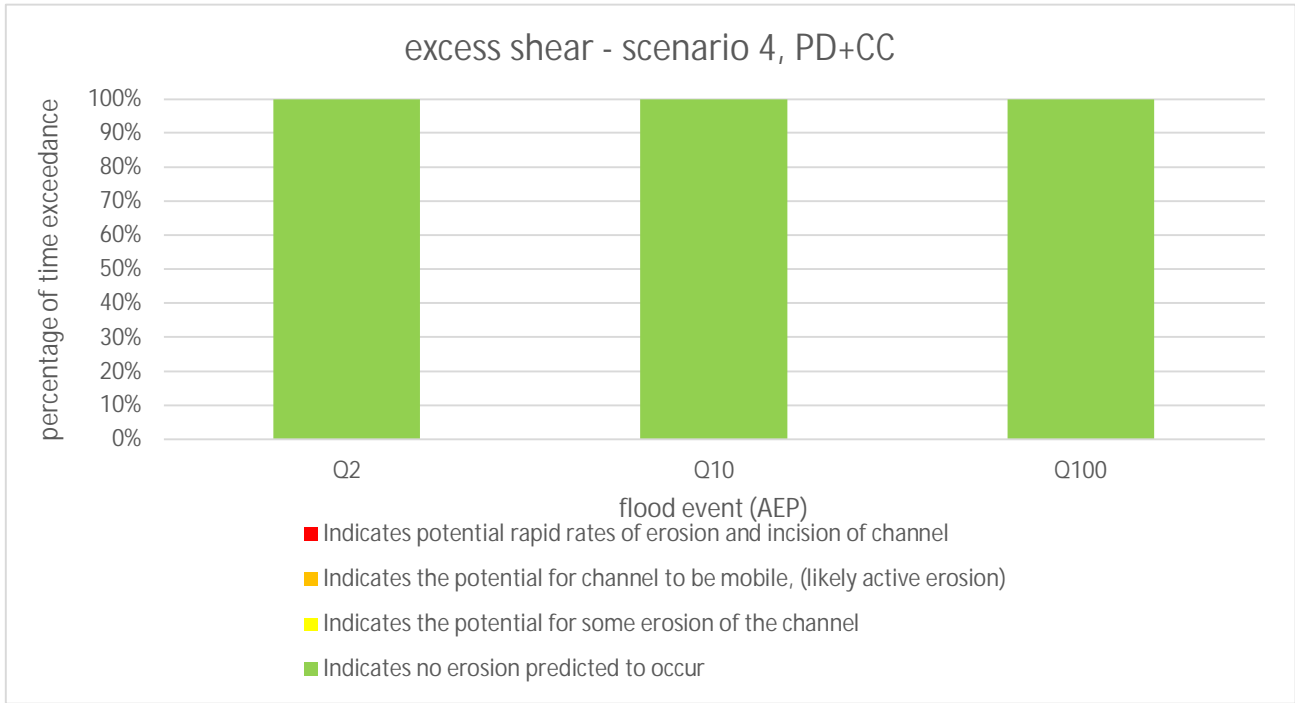
bank full channel identification		excess shear
approximate channel width (m)	21.41	
bank full water depth (m)	0.00	
* bank full flow -identified by main channel (m3/s)	#N/A	
annual fullest flow as represented by the mean annual flood (m3/s)	#DIV/0!

\* main channel identification depends on the accuracy of topographic survey
