**Project Number 13451.000.001**

### **Site Management Plan**

Drury Development Stage 2,  
64-120 Flanagan Road, Drury

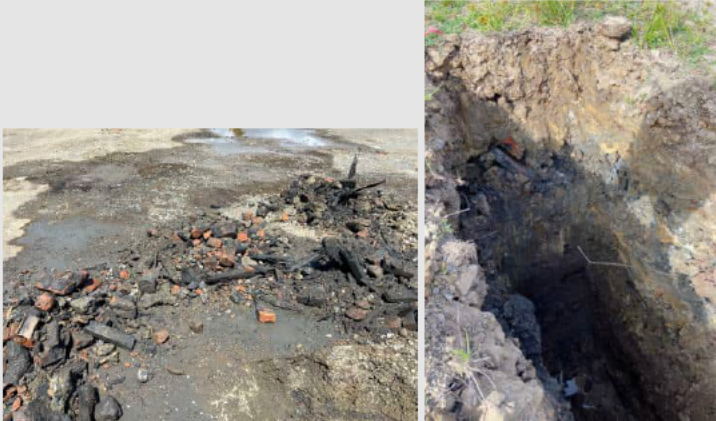
| <p><b>Uncontrolled Filling</b></p> <p>Building debris may contain asbestos or other contaminants</p> | |

- Buried waste (for example drums or tanks with unknown liquid).
- Odour (petroleum hydrocarbons, oil).
- Discoloured soil (black, purple, or green staining most common).
- Asbestos containing materials (ACM) as fragments are visible with the naked eye.
- Uncontrolled fill material.

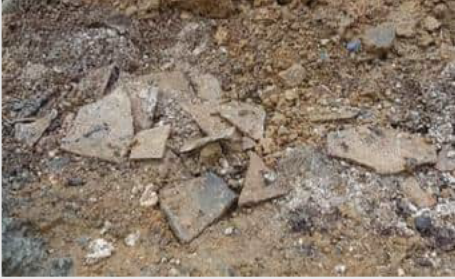
| <p><b>Asbestos Containing Material</b></p> <p>Intact sheets or broken into smaller pieces, may be mixed with other material</p> | |

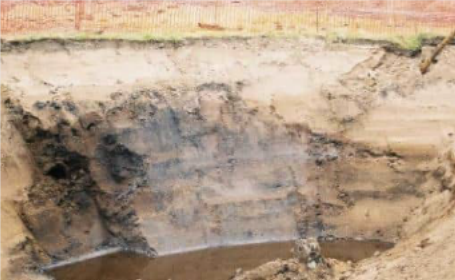
| <p><b>Separate-Phase Hydrocarbons</b></p> <p>Black liquid, odours, sheen</p> | |

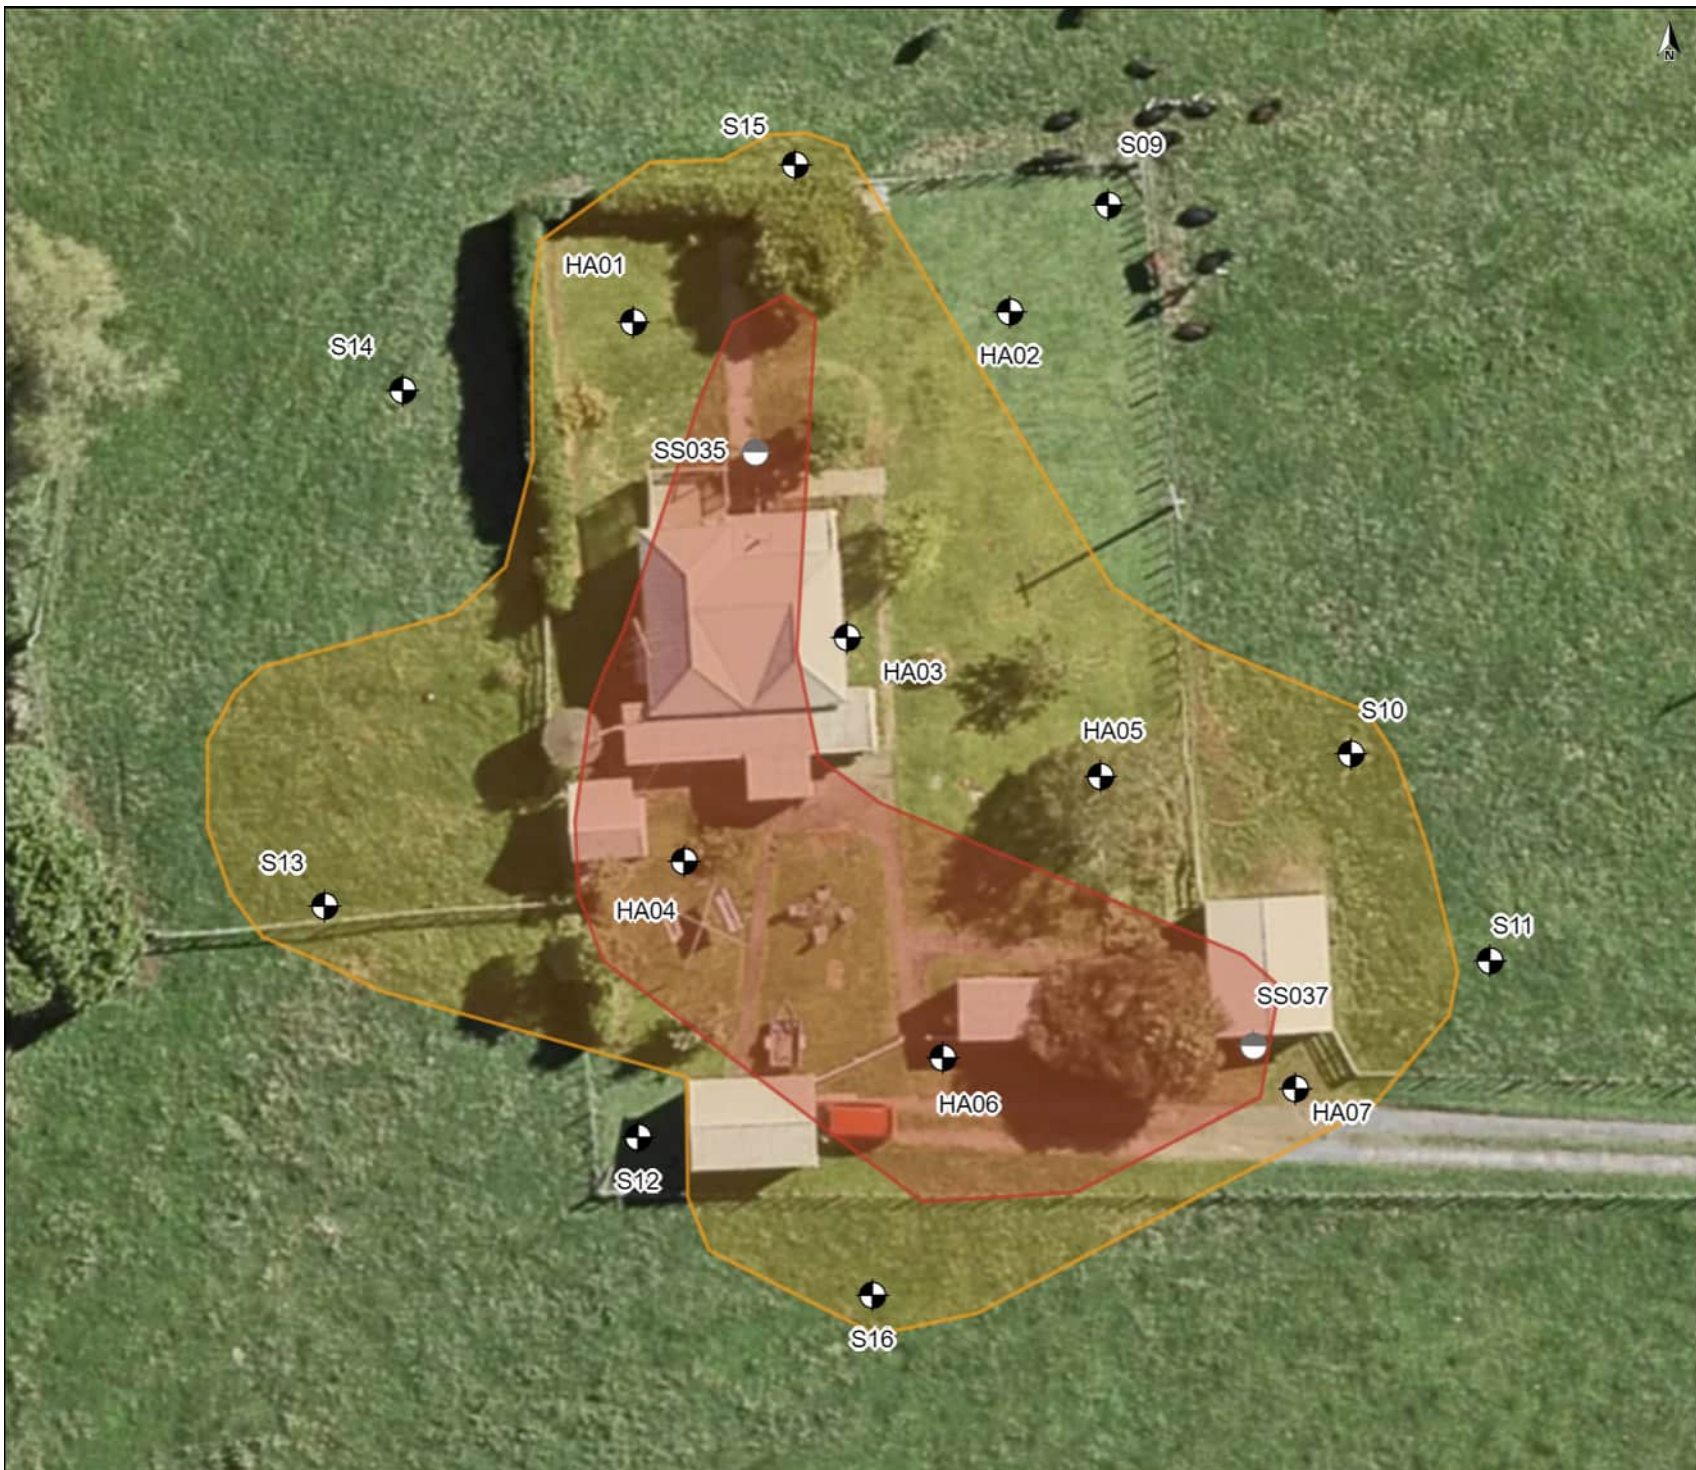
- Legend**
- ENGEO Laboratory Sample Locations
  - Aurecon (2021) Location
  - Approximate Pb > AUP PA
  - Approximate Pb > Background
