Orchard Grove Development

PRELIMINARY GEOTECHNICAL DESKTOP REPORT

Gordon Litt Farms Ltd

Job No. HAM2025-0055AB | Version 3

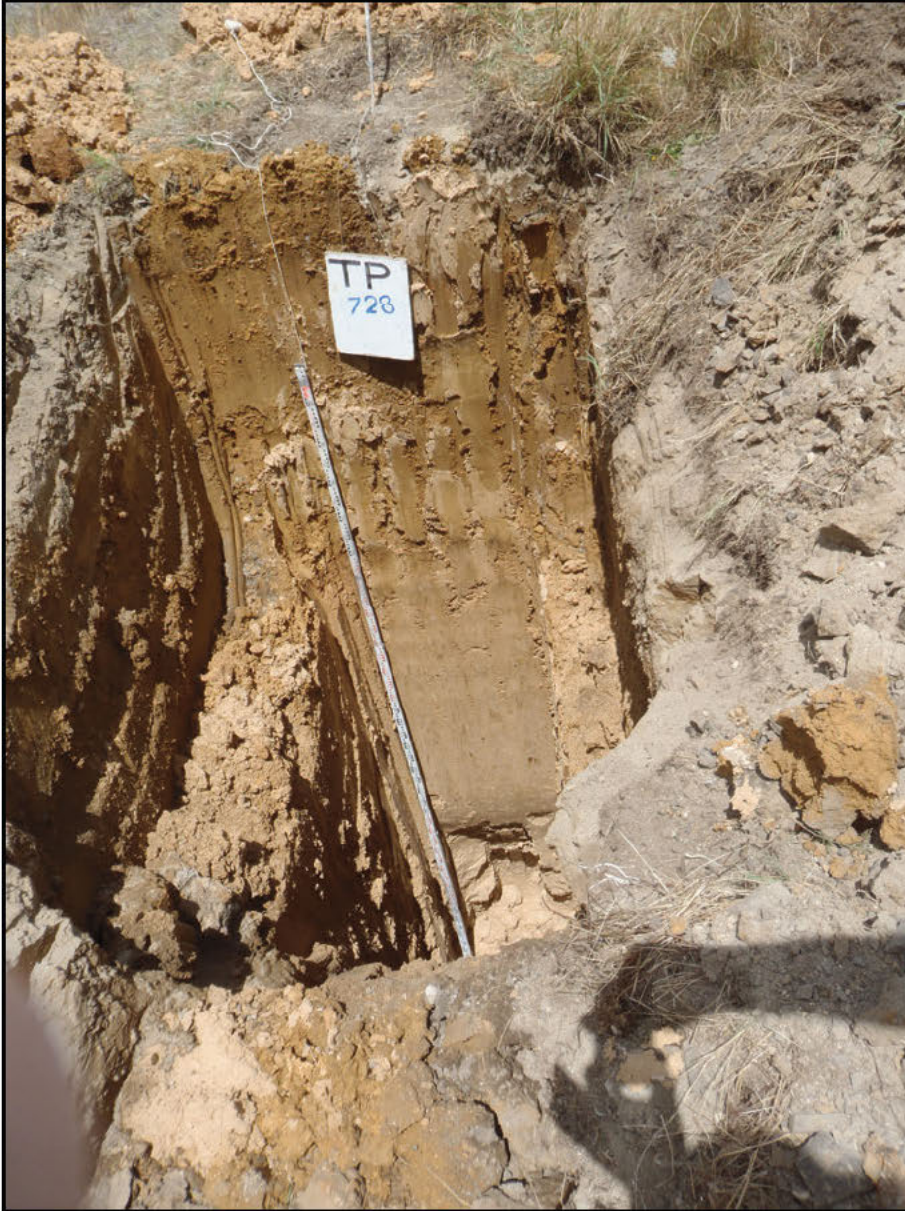
TP 728

0.70	151/22		SILT, trace Clay, orange / yellowish brown, soft, moist, slightly plastic.
0.80	79/22		Clayey SILT, reddish grey, firm, moist, highly plastic.

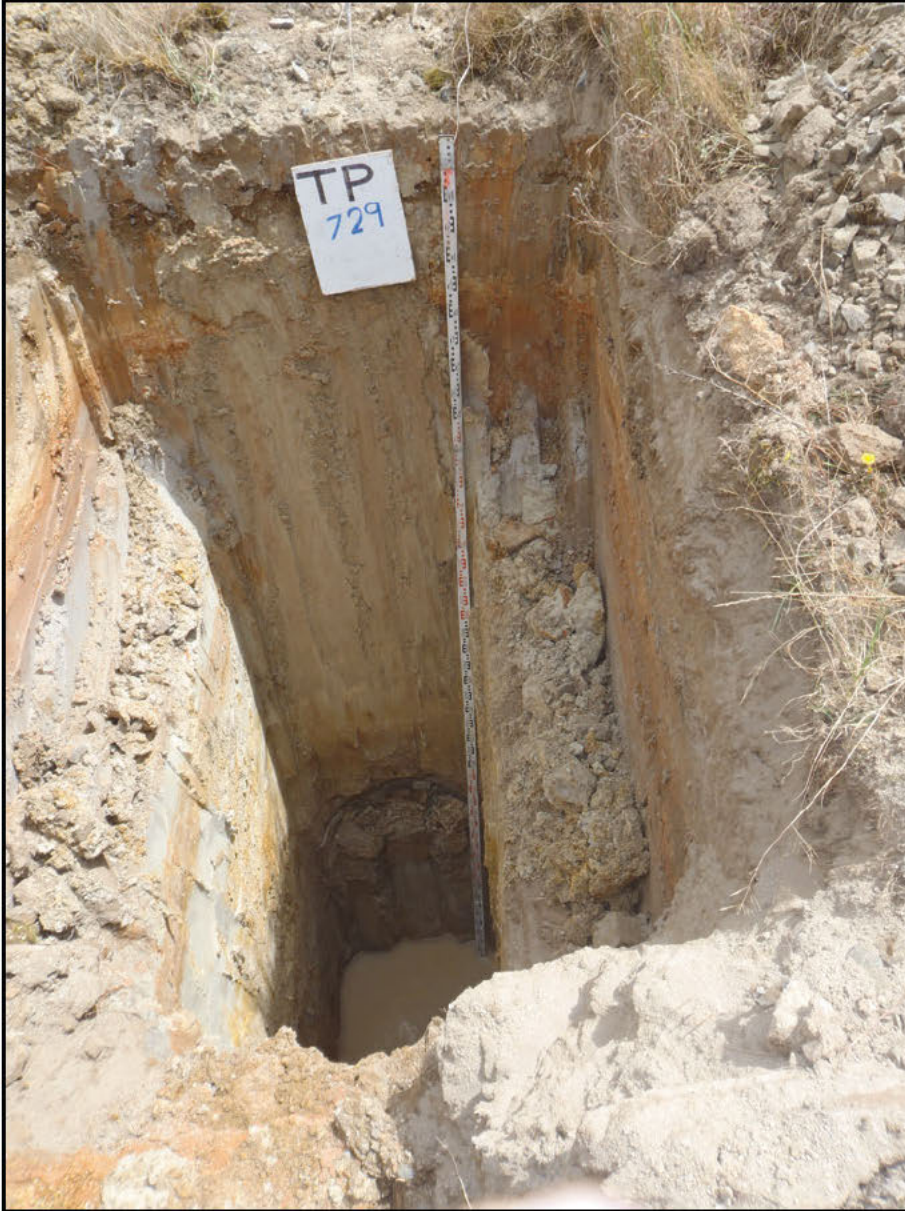
Test Pit
TP 729
Page 1 of 1

Pit Photo

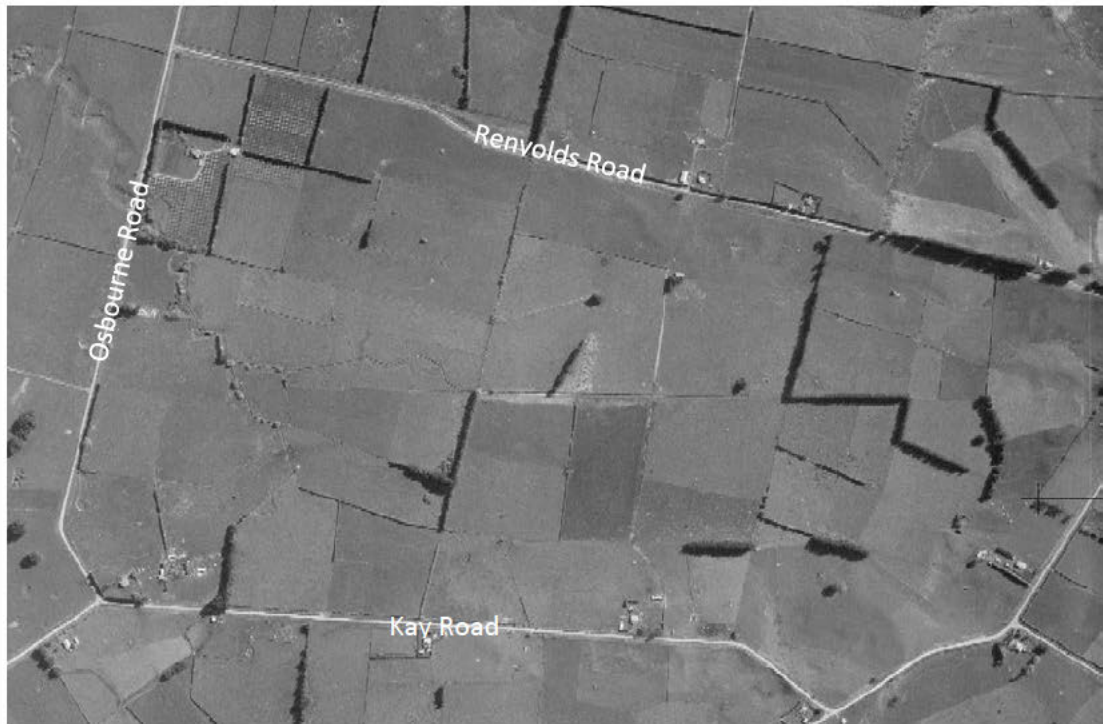
1952
Retrolens

- Orchard present in the west in the corner of Osbourne and Renvolds Road.

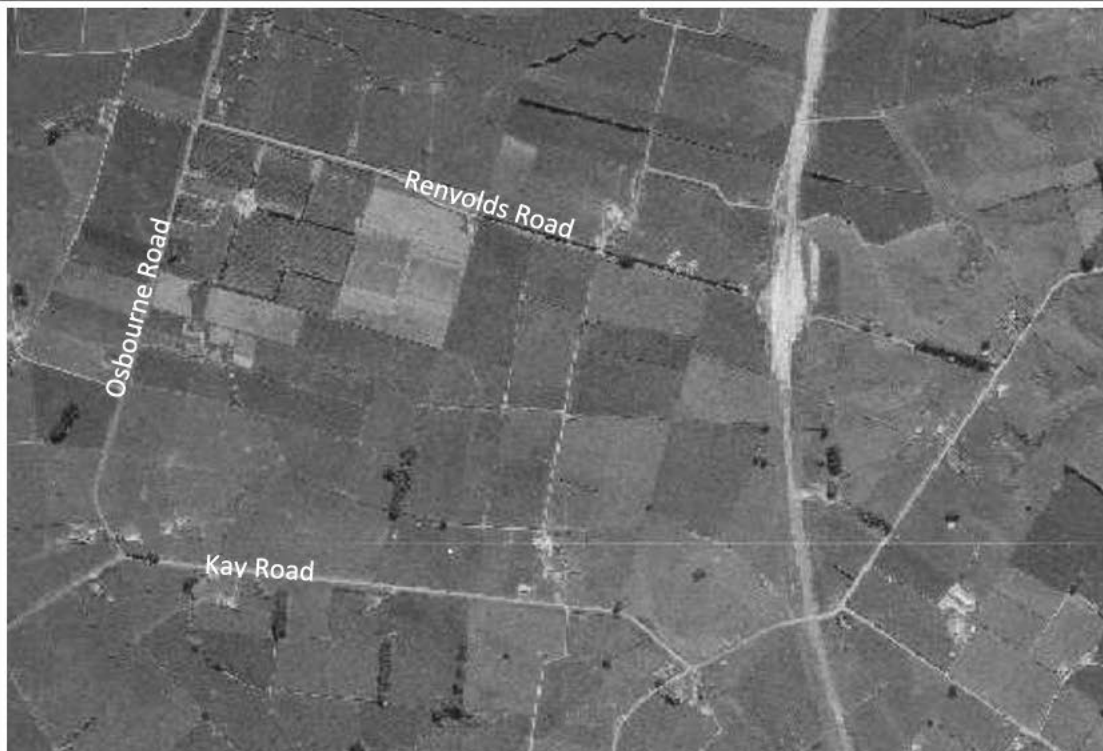
1979
Retrolens

- Construction of a road along the eastern boundary has begun.
- Orchard has expanded into nearby paddocks.
- Hedgerows within the farm have been removed.

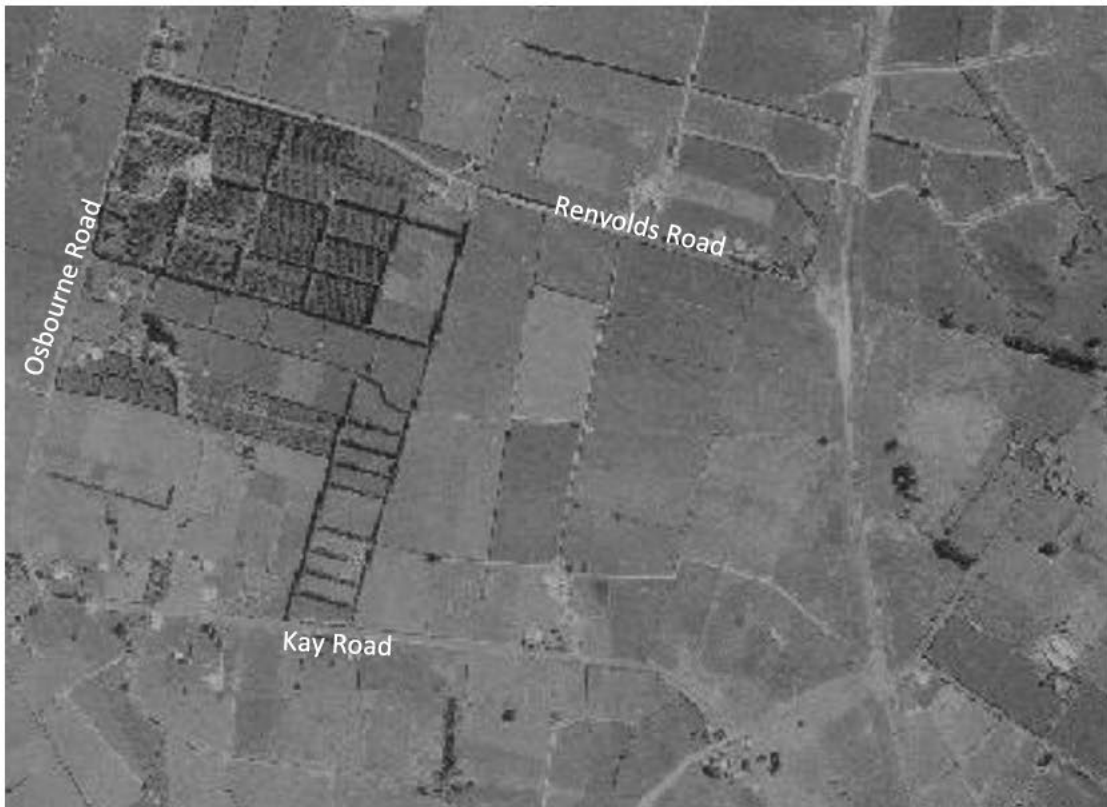
1991
Retrolens

- Orchard has expanded further, and hedgerows have been planted.

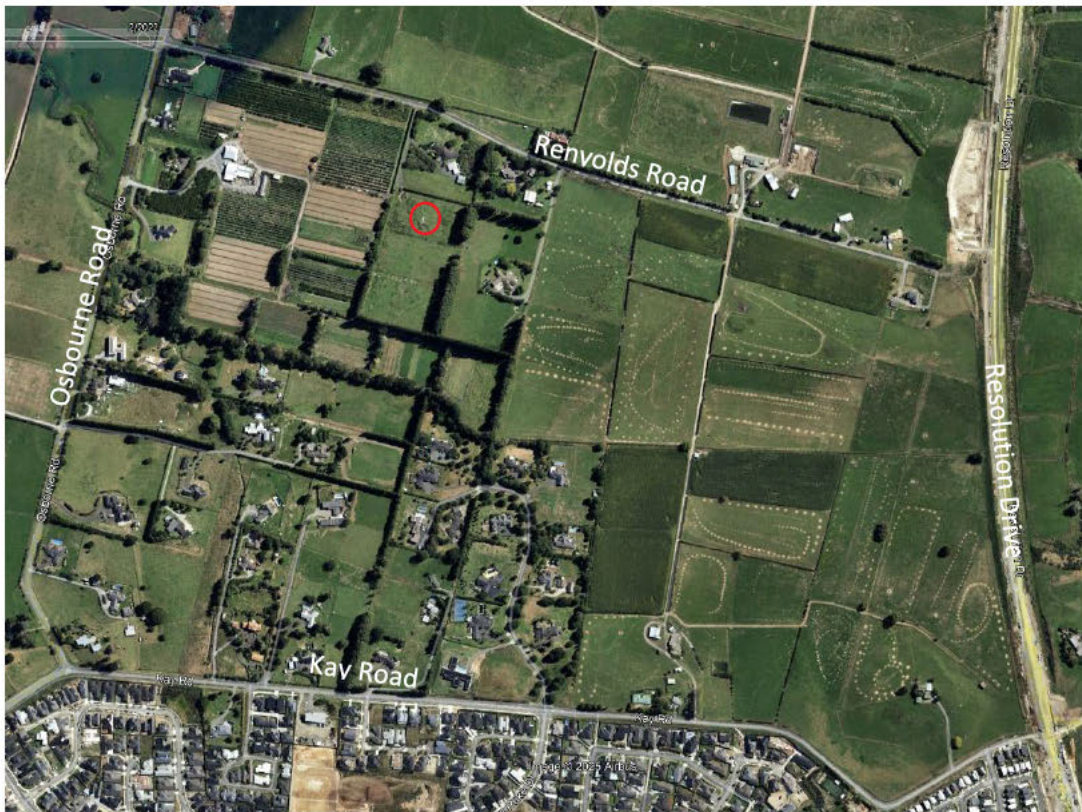
2022
Google
Earth

- Potential uncontrolled fill located behind 40B Reynolds Road (Circled in red).

Based on the site topography, it is considered that the site is not generally considered to be at risk of slope instability. Slumping or subsidence has not been observed in the historical photographs, partially around the gully and hill slopes. A site walkover by experienced engineering geologist will be required to confirm slope stability conditions.
