# Archaeological Assessment for Morven Ferry, Arrow Junction

Archaeological Sites: F41/62, F41/890

Origin Consultants Ltd

27 January 2026

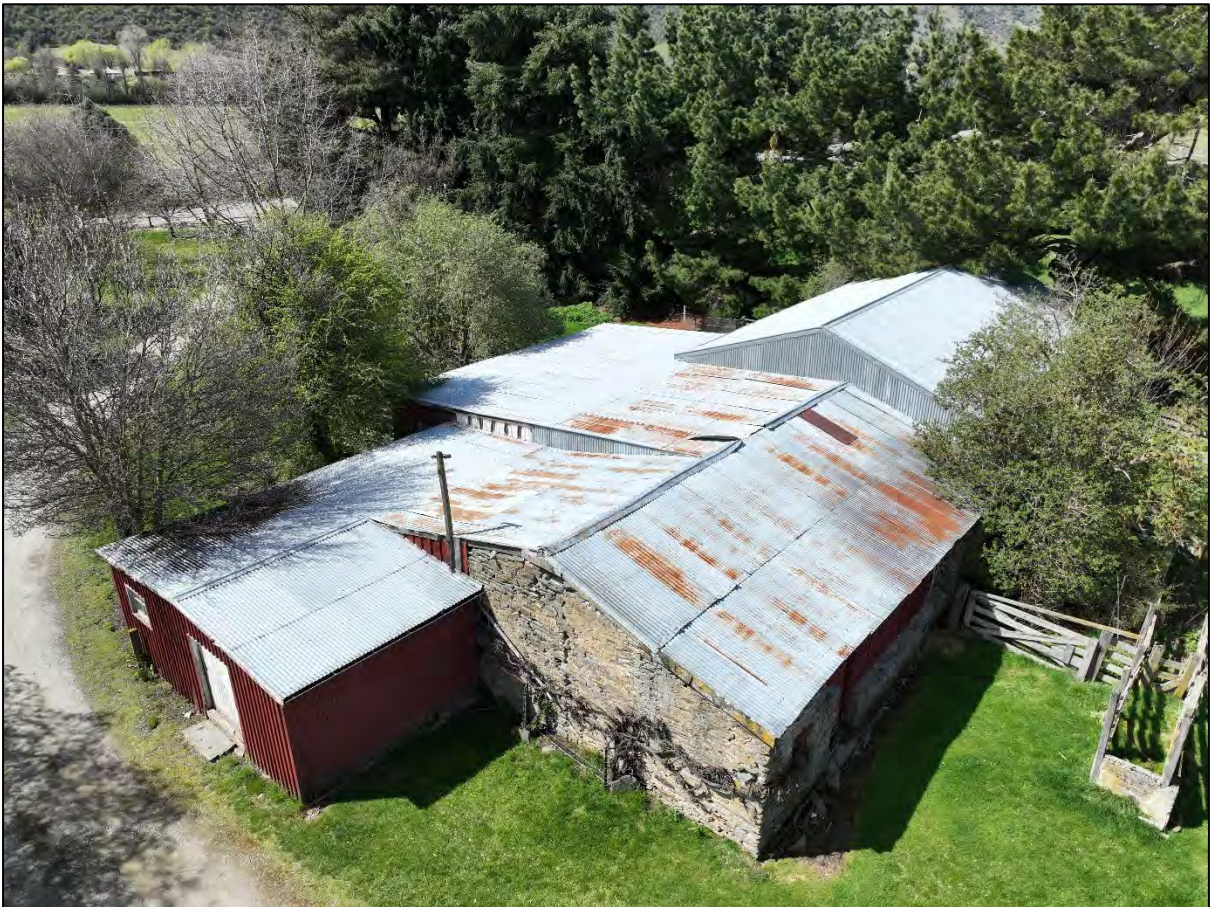
The 19<sup>th</sup> century buildings at the project area, as previously described in the History of Extant Buildings section, comprise the farmhouse, stables and hut, now referred to as The Museum. The farmhouse retains its 19<sup>th</sup> century stone form, and is now used as an office (see Figure 32, Figure 33, Figure 34). The later addition to the house by Jolly is also retained although modified by 20<sup>th</sup> century renovation. The original stone walls are still present within the frame of the house, although covered by modern cladding. The building is observed to still be in good condition and appears to be well maintained. The museum, while modified by Hamilton in the 20<sup>th</sup> century, appears to be in fair condition and retains elements of its original construction. The complete original footprint is unclear although an additional unroofed section to the west of the main structure was observed, serving an unknown purpose in the original utilisation of the building (Figure 36, Figure 37). The stables/woolshed are in a significantly deteriorated condition, with the building's stone walls showing cracking and leaning. The 20<sup>th</sup> century timber additions have also served to remove some of the original construction, although from viewing the structure internally, the original footprint of the building can be understood (Figure 41), and it is thought that the original stone floor remains under the timber slats of the building, which were installed to transition the stables into a woolshed (Figure 38-Figure 43).

Figure 38. 19th century stables, with modern timber and steel extensions.

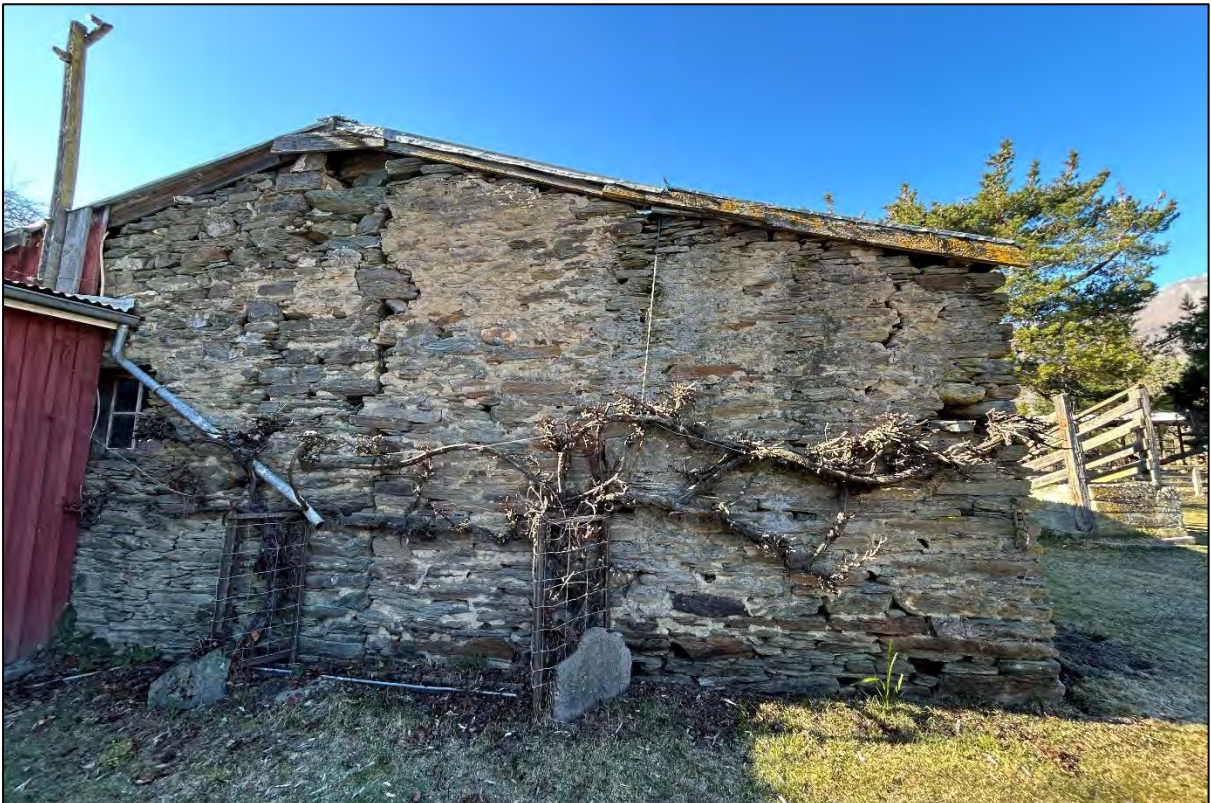
Figure 40. Western elevation of original stables, showing degradation and cracking.

The condition of the stable/woolshed is very poor with much of the historic stonework cracked, leaning and unstable. It is likely that the building's adaptive reuse will require it to be carefully dismantled and then sensitively reconstructed and adapted to meet modern requirements.

Additionally, maintaining buildings through utilisation can prevent degradation of historic elements and fabric. It is evident that action is needed to repair some elements of the historic buildings to prevent further damage. Repurposing and restoring the building is a feasible solution to prevent condition from worsening and showcase the historic buildings in a public setting.

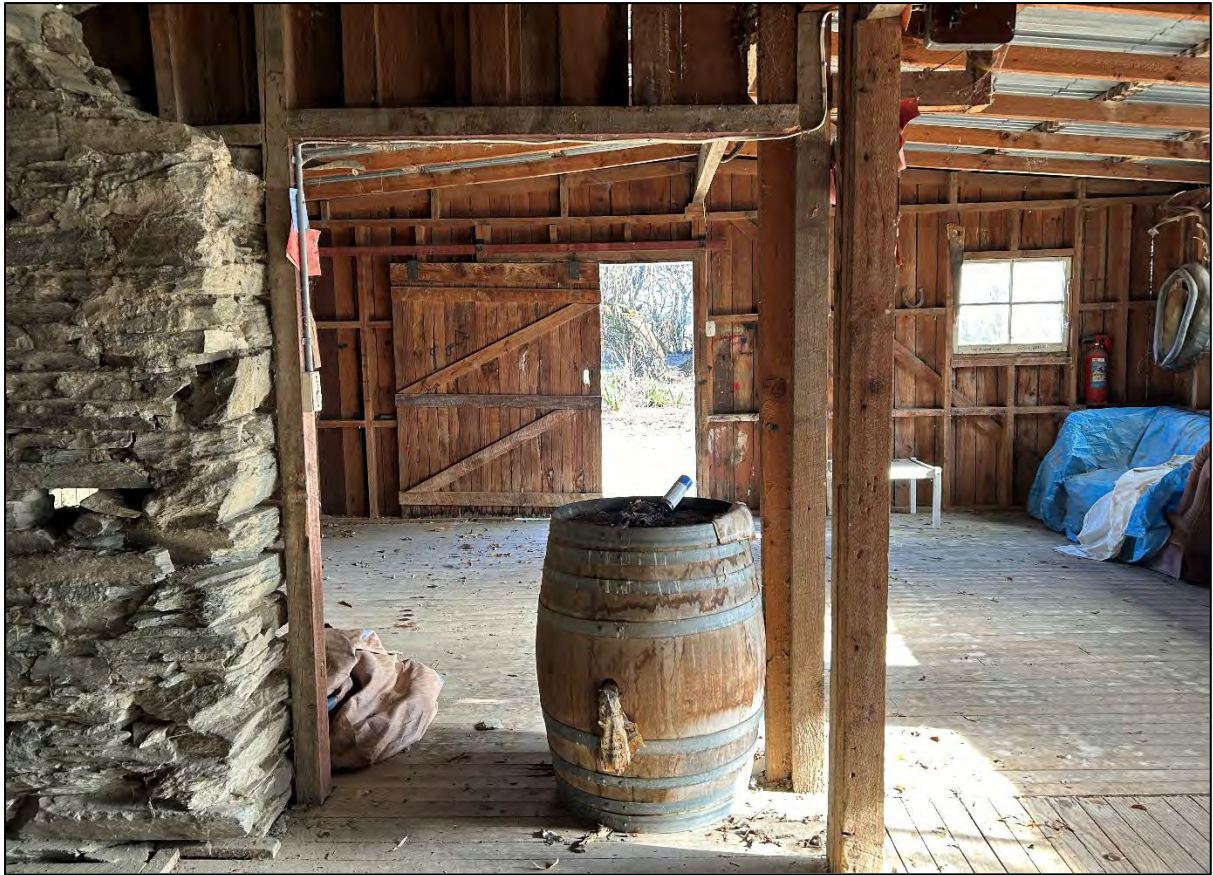
Figure 41. Image demonstrating original portions of stables remaining, beam visible along floor and stonework indicating original extent, facing west.

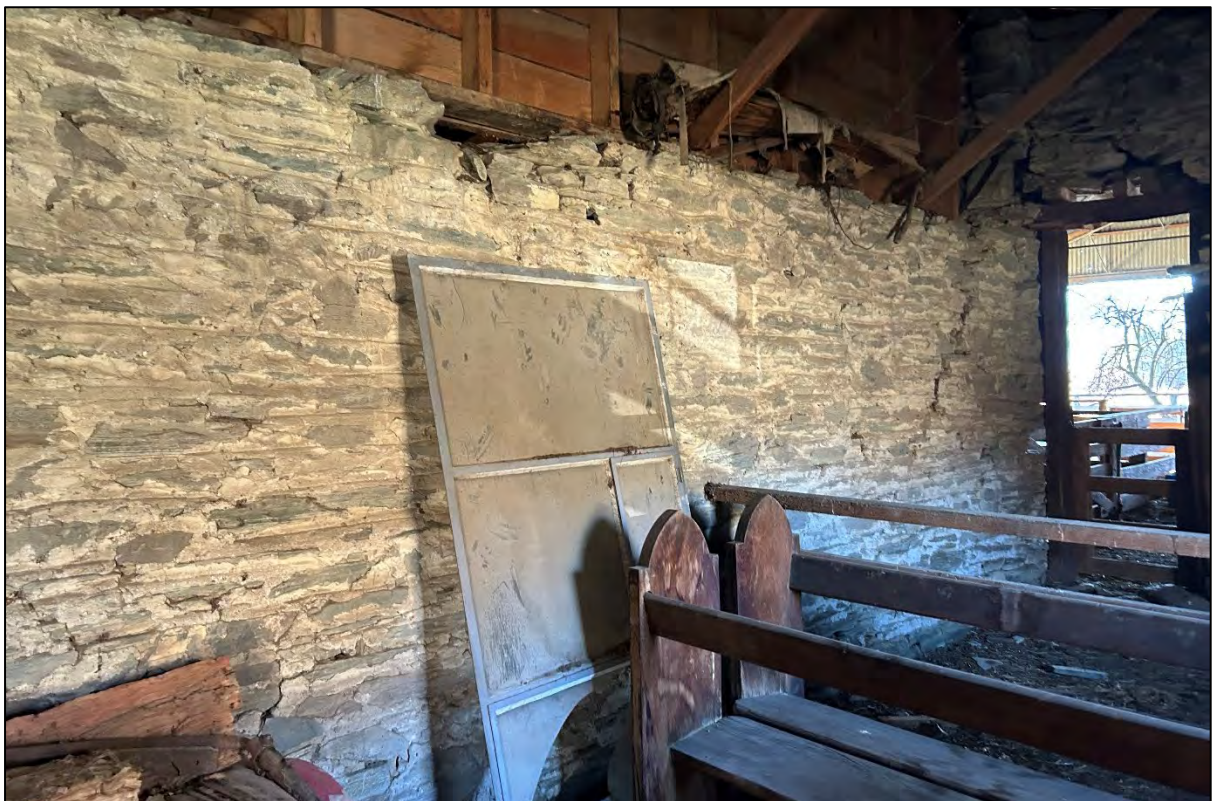
Figure 42. Internal woolshed wall showing degradation and lean.

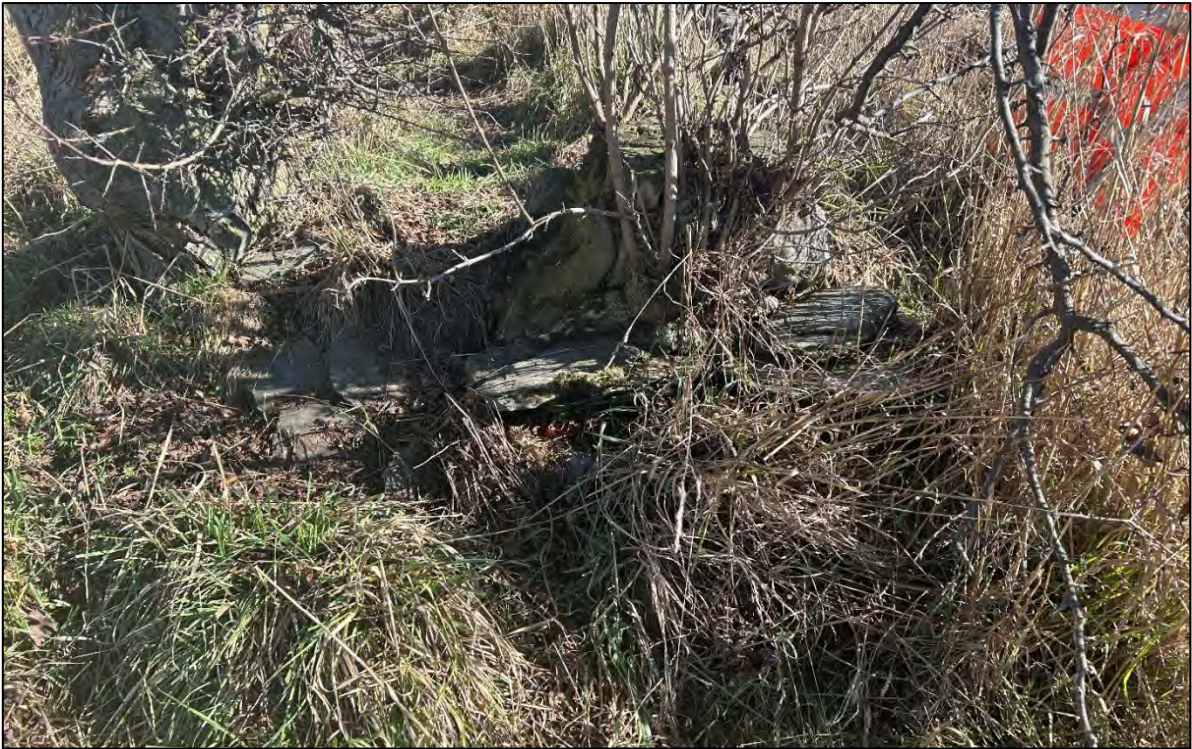
The visible remains consist of a small pile of stacked and loose schist stones measuring approximately 1m x 1m, which have been displaced and disturbed by the growth of a tree through the site. Additional disturbance via referenced repurposing of stones and animal grazing were also indicated by Hamilton. The disturbance and likely removal of stones make it impossible to determine the original dimensions of the structure. It is possible that subsurface features, such as stone footings, walls, or archaeological refuse material remain beneath the current ground surface. While Hamilton (2016) notes that elements of the Steele's hut and fireplace remained visible in the early 21st century, these features may now be obscured by vegetation or have deteriorated further due to tree root disturbance.

Figure 44. Area of stacked stone hut remains/ruins, facing north.

For Steele's hut, the limited information that can be gathered from the limited stacked stones remaining may be increased in the event that earthworks uncover subsurface portions of the original building, as described in Hamilton 2016. As this area is set for development, there is potential this feature may need to be removed, however, if further intact portions of the structure are uncovered at the site there is potential for interpretation of the site within the development. As the above ground remaining features are in significantly degraded condition, with little remaining to interpret, there are low remaining archaeological values considered for this site.

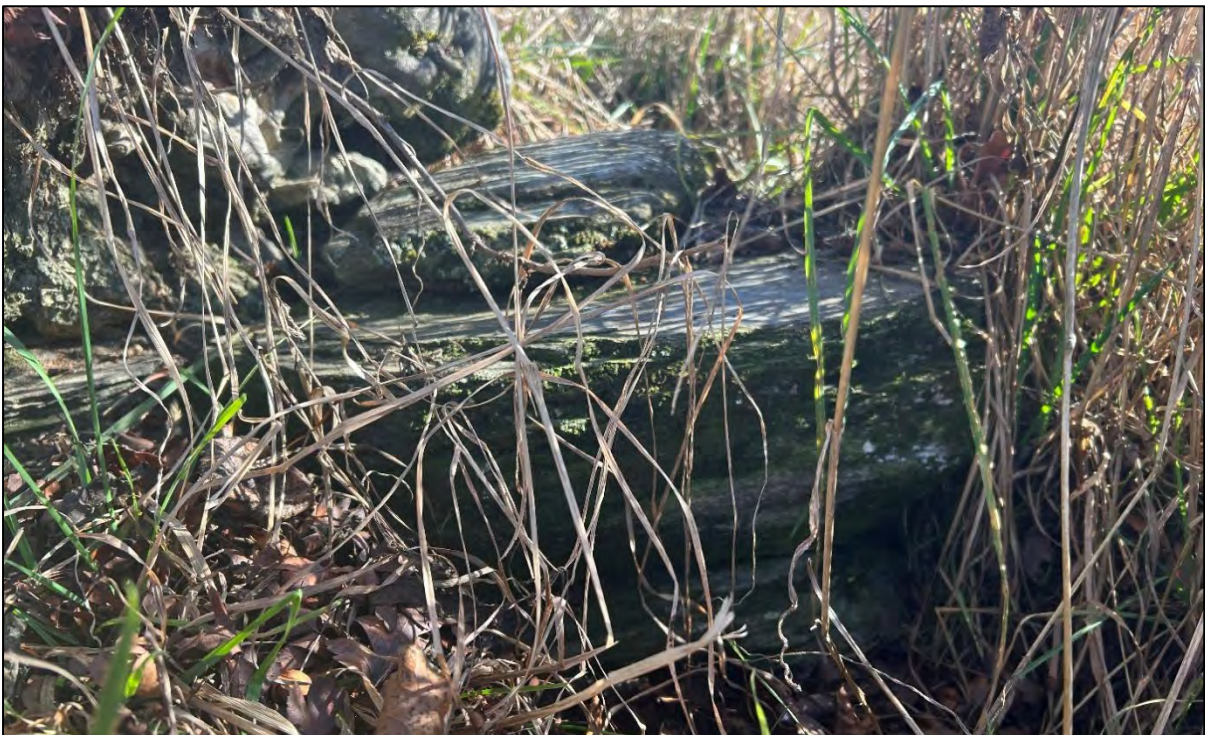
Figure 45. Closer detail of stacked stone hut remains/ruins.

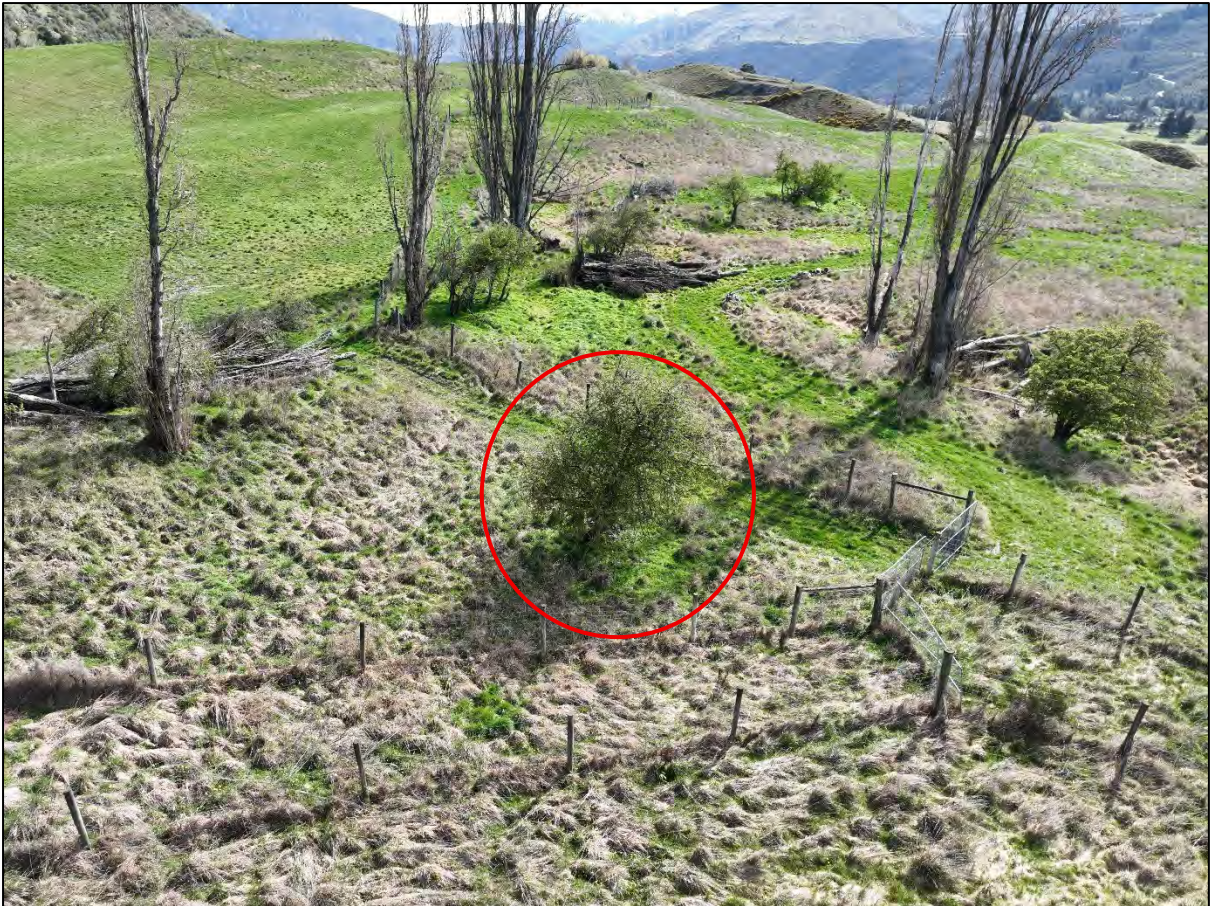
Figure 46. General area, drone survey of tree growing through the hut ruins in red, located in Section 71 Block VIII, (found per comms Janice Clear).

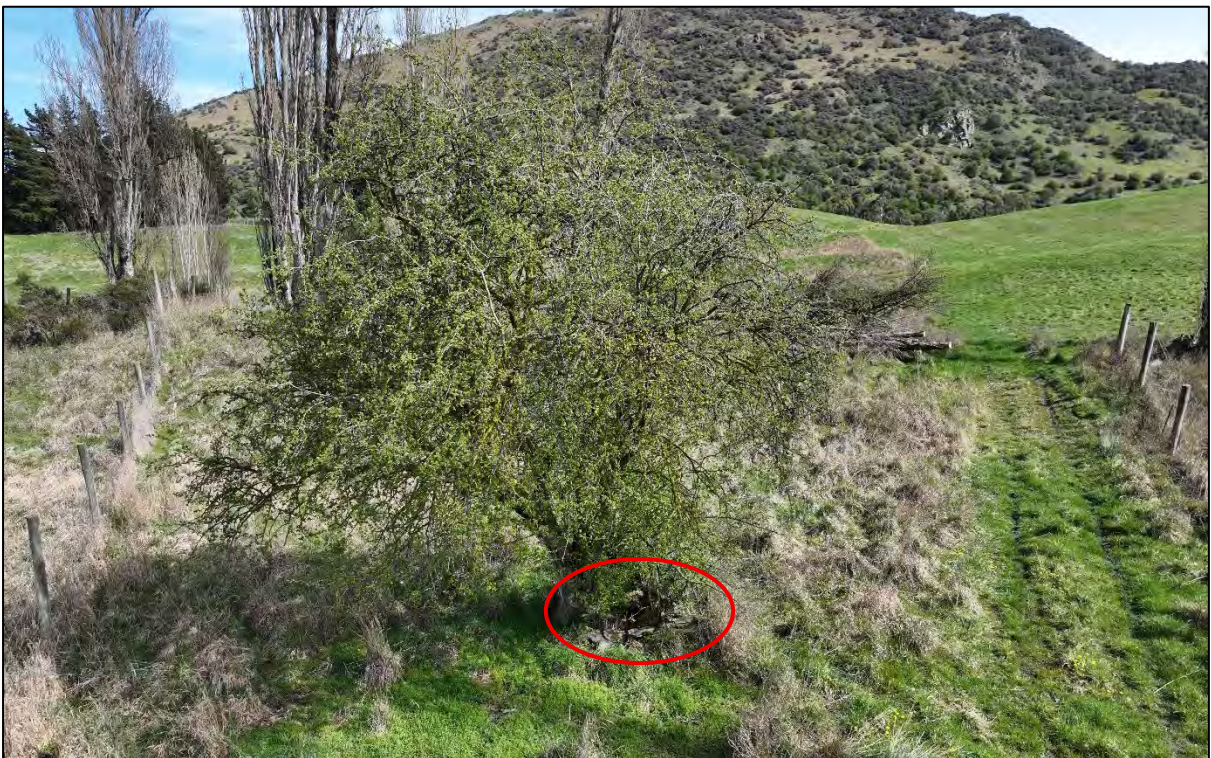
Figure 47. Closer drone image of stones at base of tree, facing west.

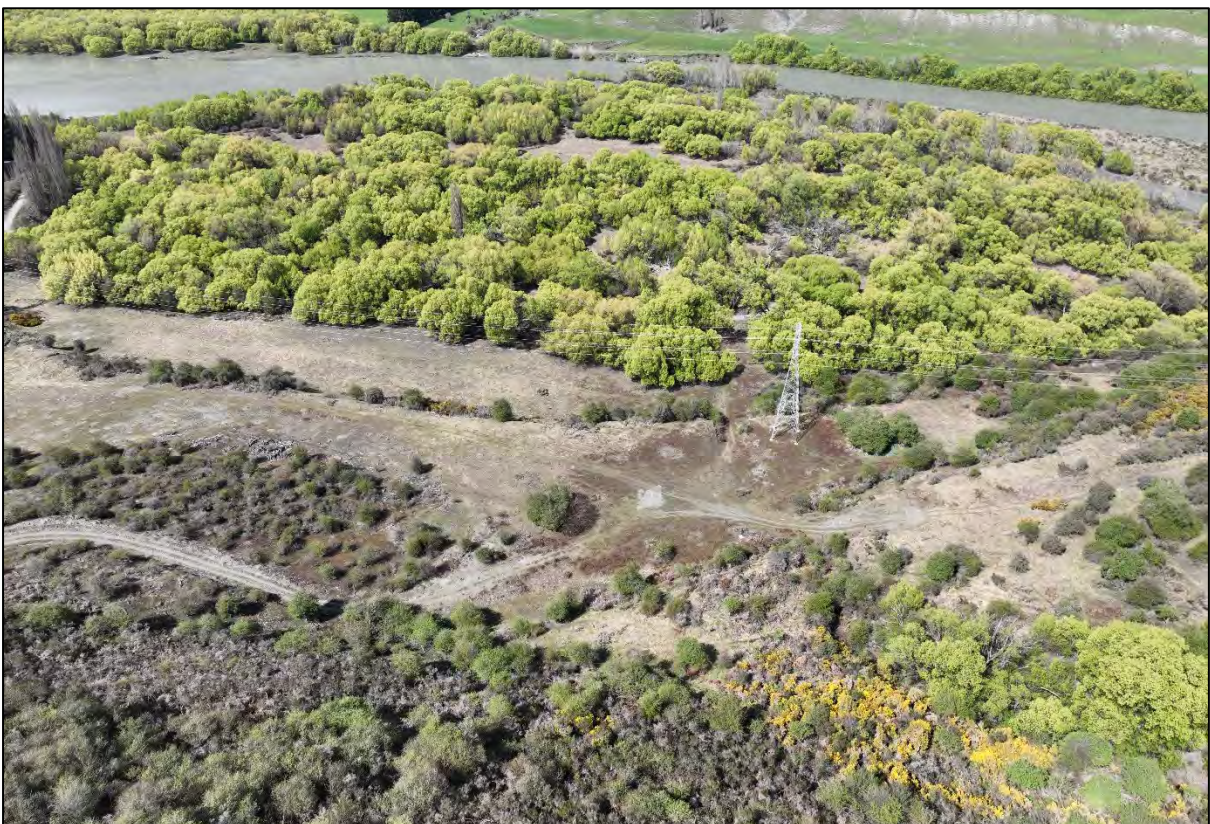
Figure 50. Potential areas of landscape modification toward river, facing southeast, partially obscured by vegetation.

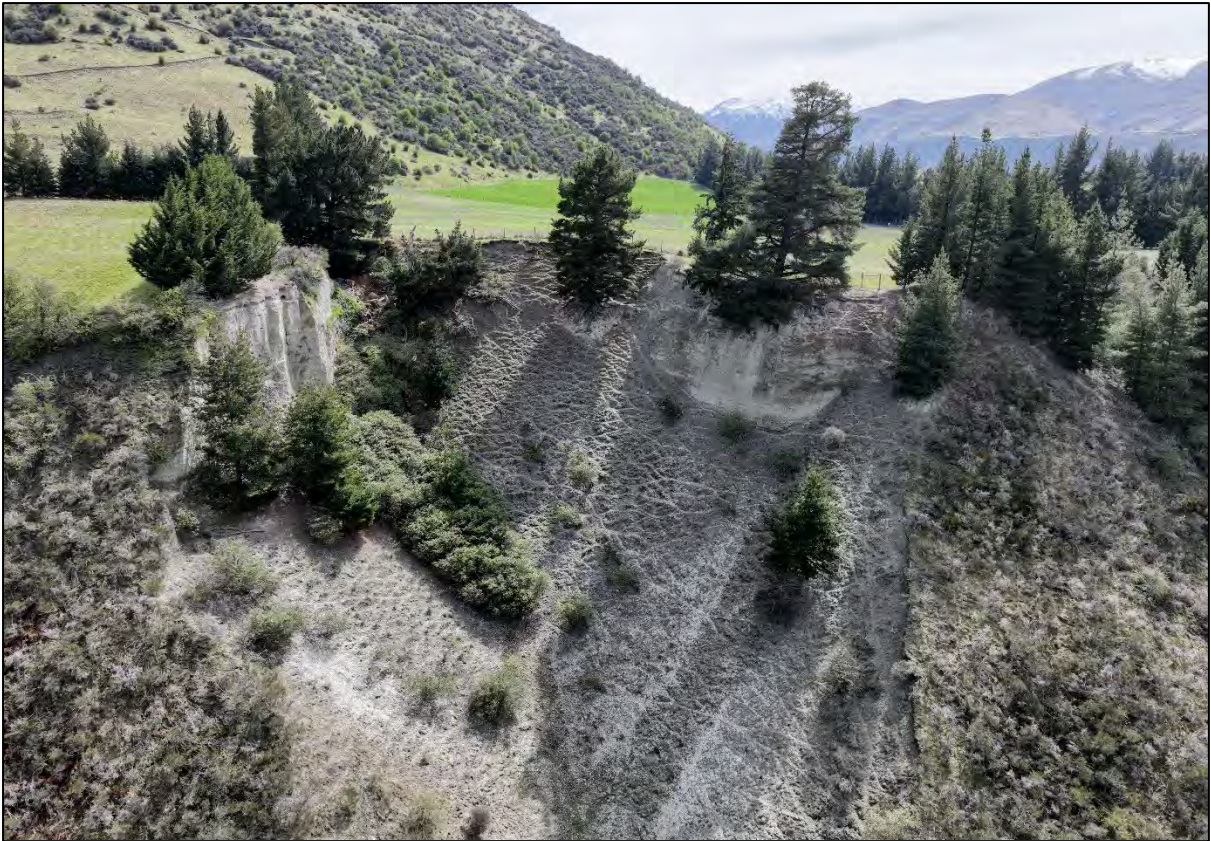
While the identified potential sluicing areas are considered to have a high likelihood of being archaeological in nature, they have not been recorded as archaeological sites as the above-mentioned limitations made it impossible to confirm at this stage.

Figure 51. Eroded potential sluiced face facing toward flat plateau designated for development – (See Figure 28) – Section 25 Block IX.

Only limited works will occur in the flattened portions of Section 25 Block IX and Lot 4 DP 300661 to the north of the banks of the Kawarau, with the observed mining features situated south of the project area. Any earthworks are likely to remove subsurface remains, but the likelihood of encountering said remains in this area is low. The works within the lower terrace are likely to have a minor impact on the archaeological remains present. The expansion of the bore holes and updating of the access way into a connection to the Twin Rivers Trail will be the least impactful, mostly utilising the existing track, with the boring activities taking place on the lower terrace which has mostly been flattened by the natural action of the Kawarau River. The creation of lizard habitats may have a minor effect as some of the areas most likely to contain remains of amorphous fan tailings are large enough that they may be impossible to avoid. However, due to the miniscule scale of these works any loss of information can be easily negated through a recording of the location and effect of the stone stacks.

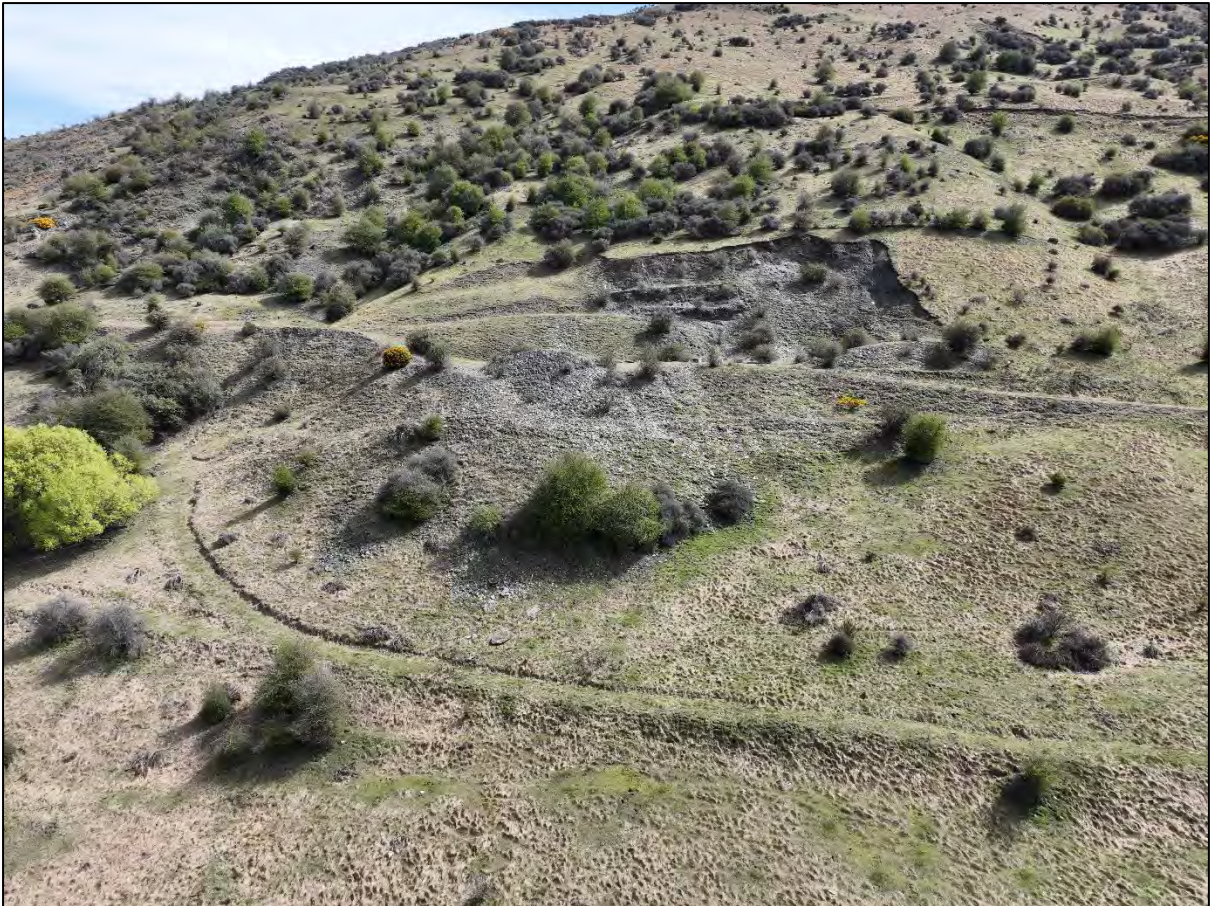
Following the results of the GIS analysis and review of secondary sources, it appears that the majority of the visible features observed on the surface of Morven Hill are 20<sup>th</sup> century. A rock quarry and cut tracks, not identified in historical aerial imagery, were observed in the current survey and recording of the Morven Hill area (Figure 54-Figure 57). The rock quarry is stated to have been created by Alan Hamilton in the 1980s. From Hamilton's book, it is stated that David Jolly cleared an area on Morven Hill to form a paddock using a hillside plough, but evidence of this was not observed in the present survey, and is likely, if still existing, to only have ephemeral traces in the landscape. The feature at the base of the hill detailed in the previous evaluation, was found to be a quarry loading zone for the 20<sup>th</sup> century quarrying activity. It should however be noted that areas which will be subject to development discussed below were obscured by enough vegetation that the identification of small scale mining features, such as exploration pits or test adits, would not have been visible, regardless of survey method.

Figure 54. 20th century quarry visible on southern area of Morven Hill, facing west.

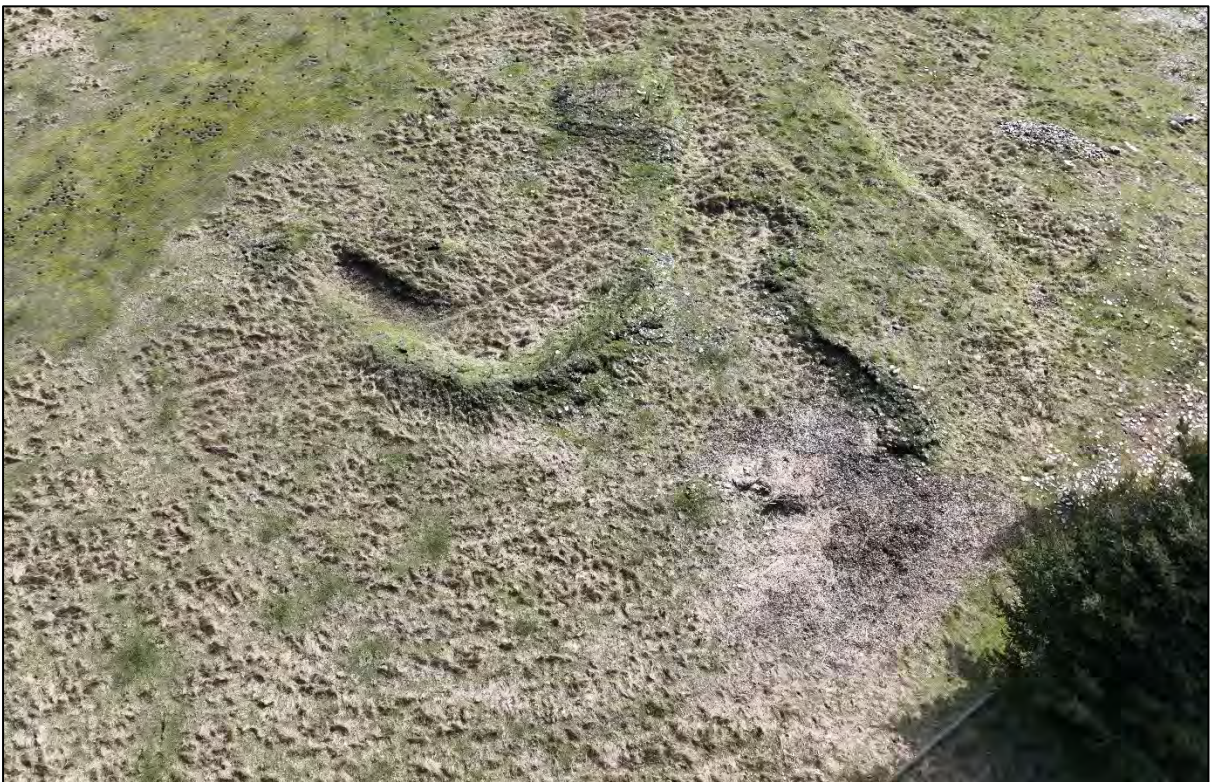
Figure 55. Features observed at the base of Morven hill beneath quarry, stated by landowner to be the result of modern quarry loading.

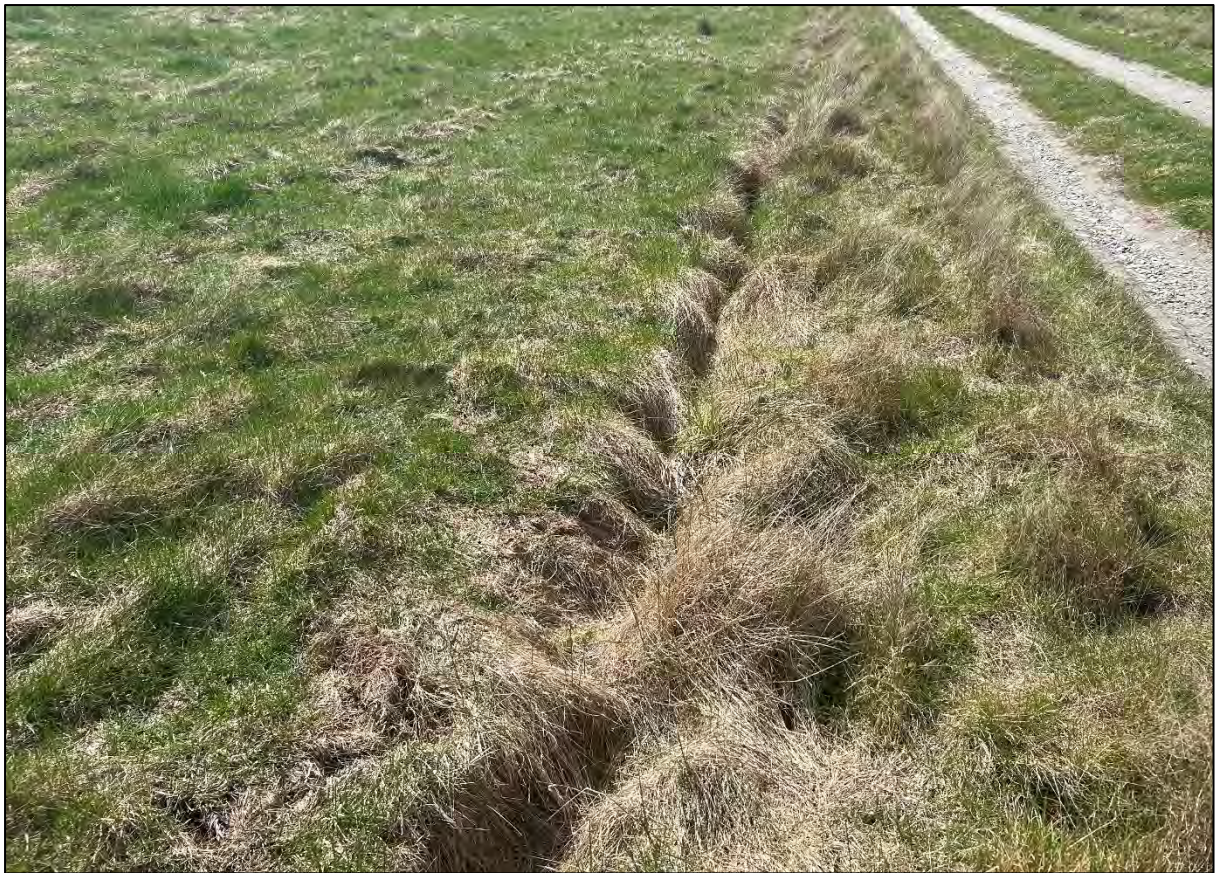
Figure 60. Potential ditch formation, to the east of main arrow irrigation race, facing north.

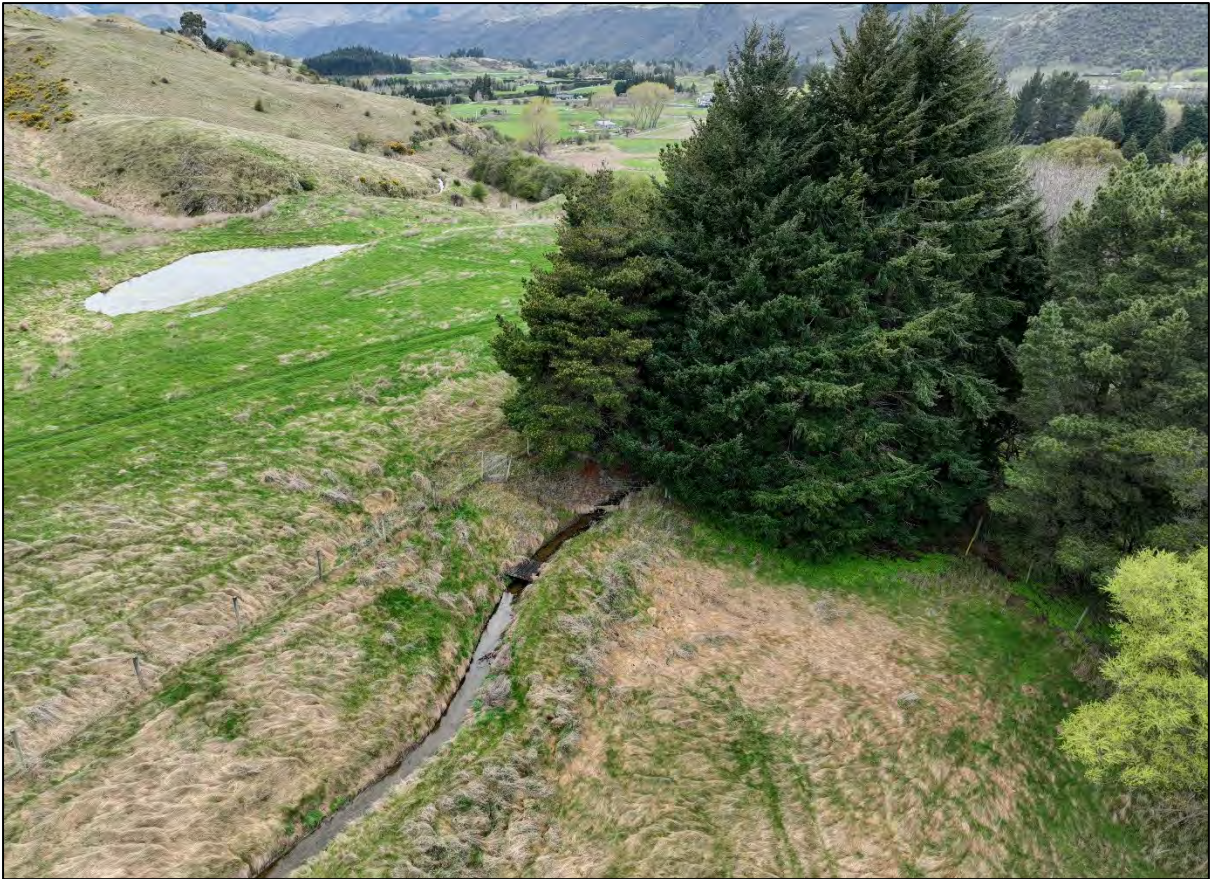
Figure 61. Water race and pond/ditch, facing north.

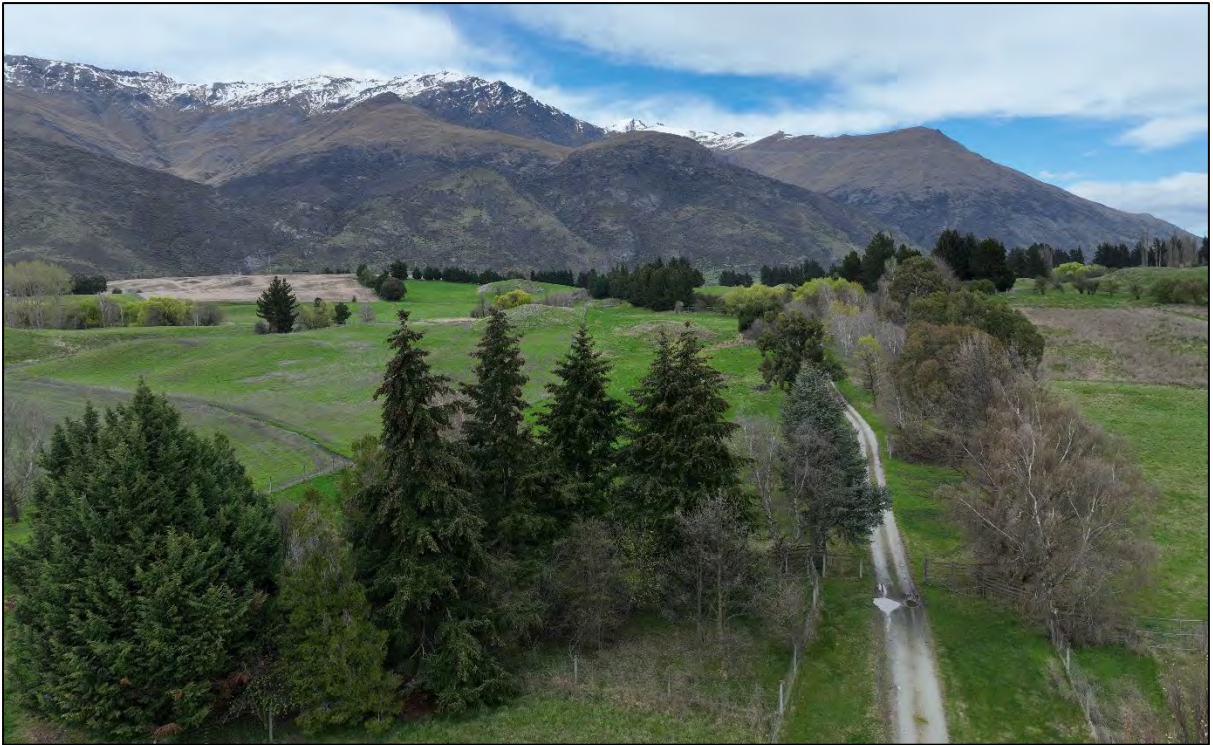
Several mound formations were identified during the GIS analysis as Areas of Potential Interest, including some not visible in historical aerial photography. Upon observation during the field survey, these appeared more consistent with 20<sup>th</sup> century landscape modification, and the extent to which the landscape in these areas was altered in the 19th century remains uncertain (Figure 62). Consequently, these mounds cannot be confidently attributed to historical occupation or activity.

Figure 62. Facing south along farm track, showing paddocks and mounds from likely 20th century landscaping

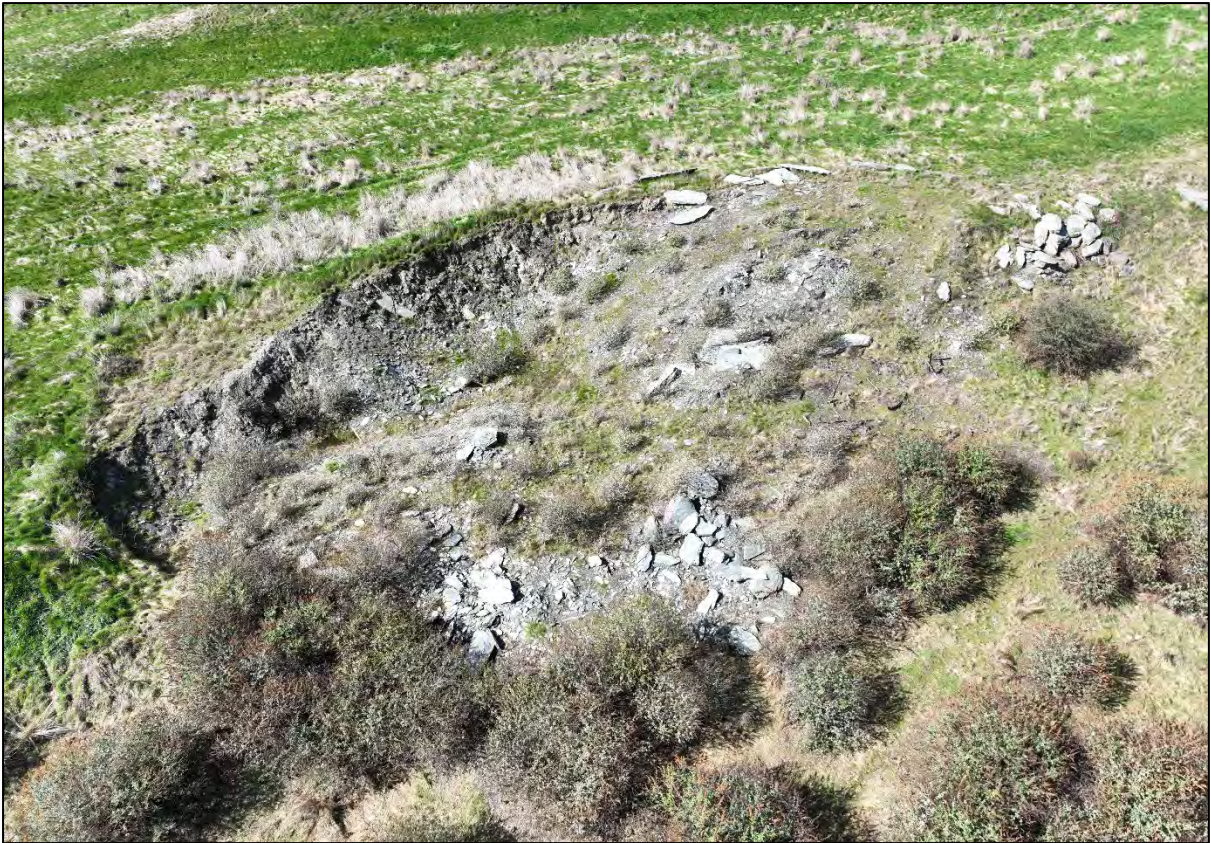
Another potential feature noted was observed in Section 64 Blk VIII Shotover Survey District, two depressions with loose rock were observed and noted, although due to not being clearly observed in the 1950s aerial imagery, it is likely these may be modern features (Grid Cells I17, K17) (Figure 66). However they may also be the remains of 19<sup>th</sup> century exploration pits that were not readily visible in the historic aerals. Further archaeological investigation would be required to confirm this.

Figure 66. Area of interest in Section 64 Block VIII.

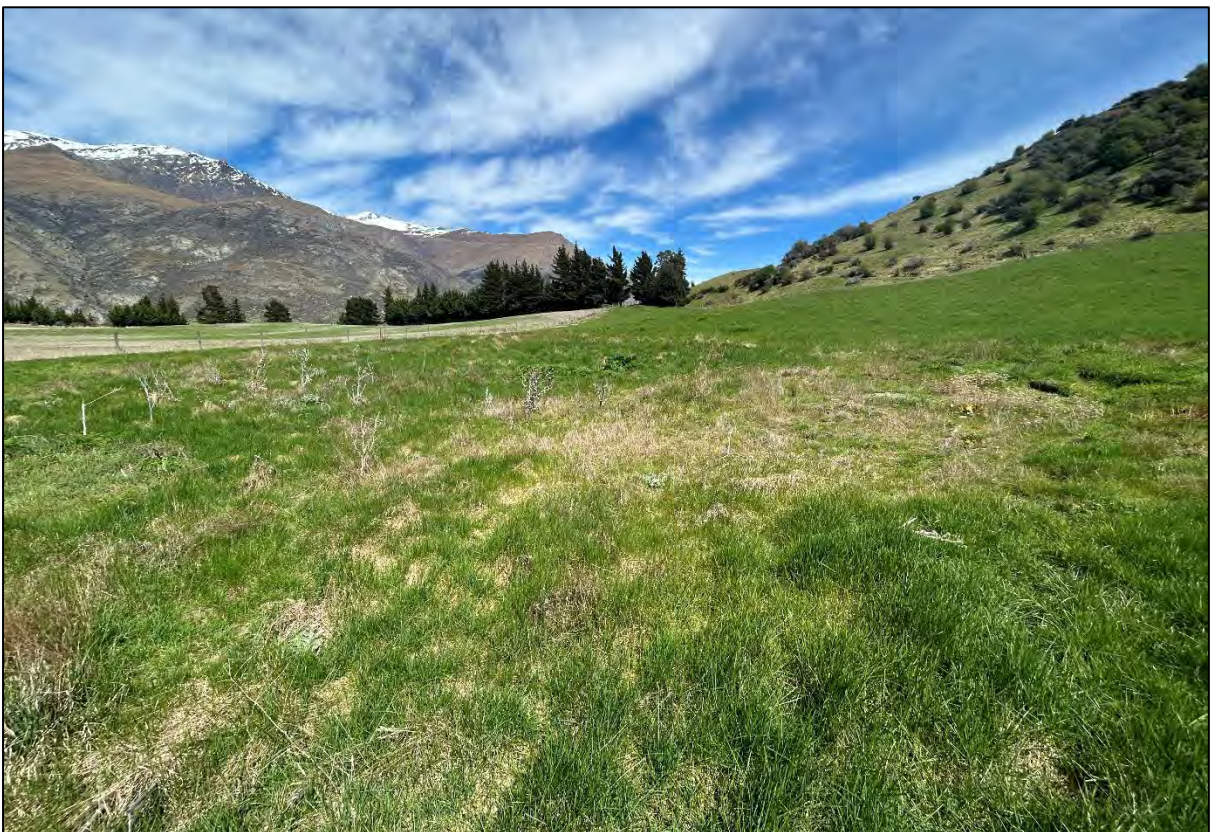
Figure 71. Facing southeast toward dry ditch formation.
