**Project Number 30002.000.001**

**Geotechnical Interpretive Report**

12 Lower Shotover Road, Lake Hayes Estate,  
Queenstown

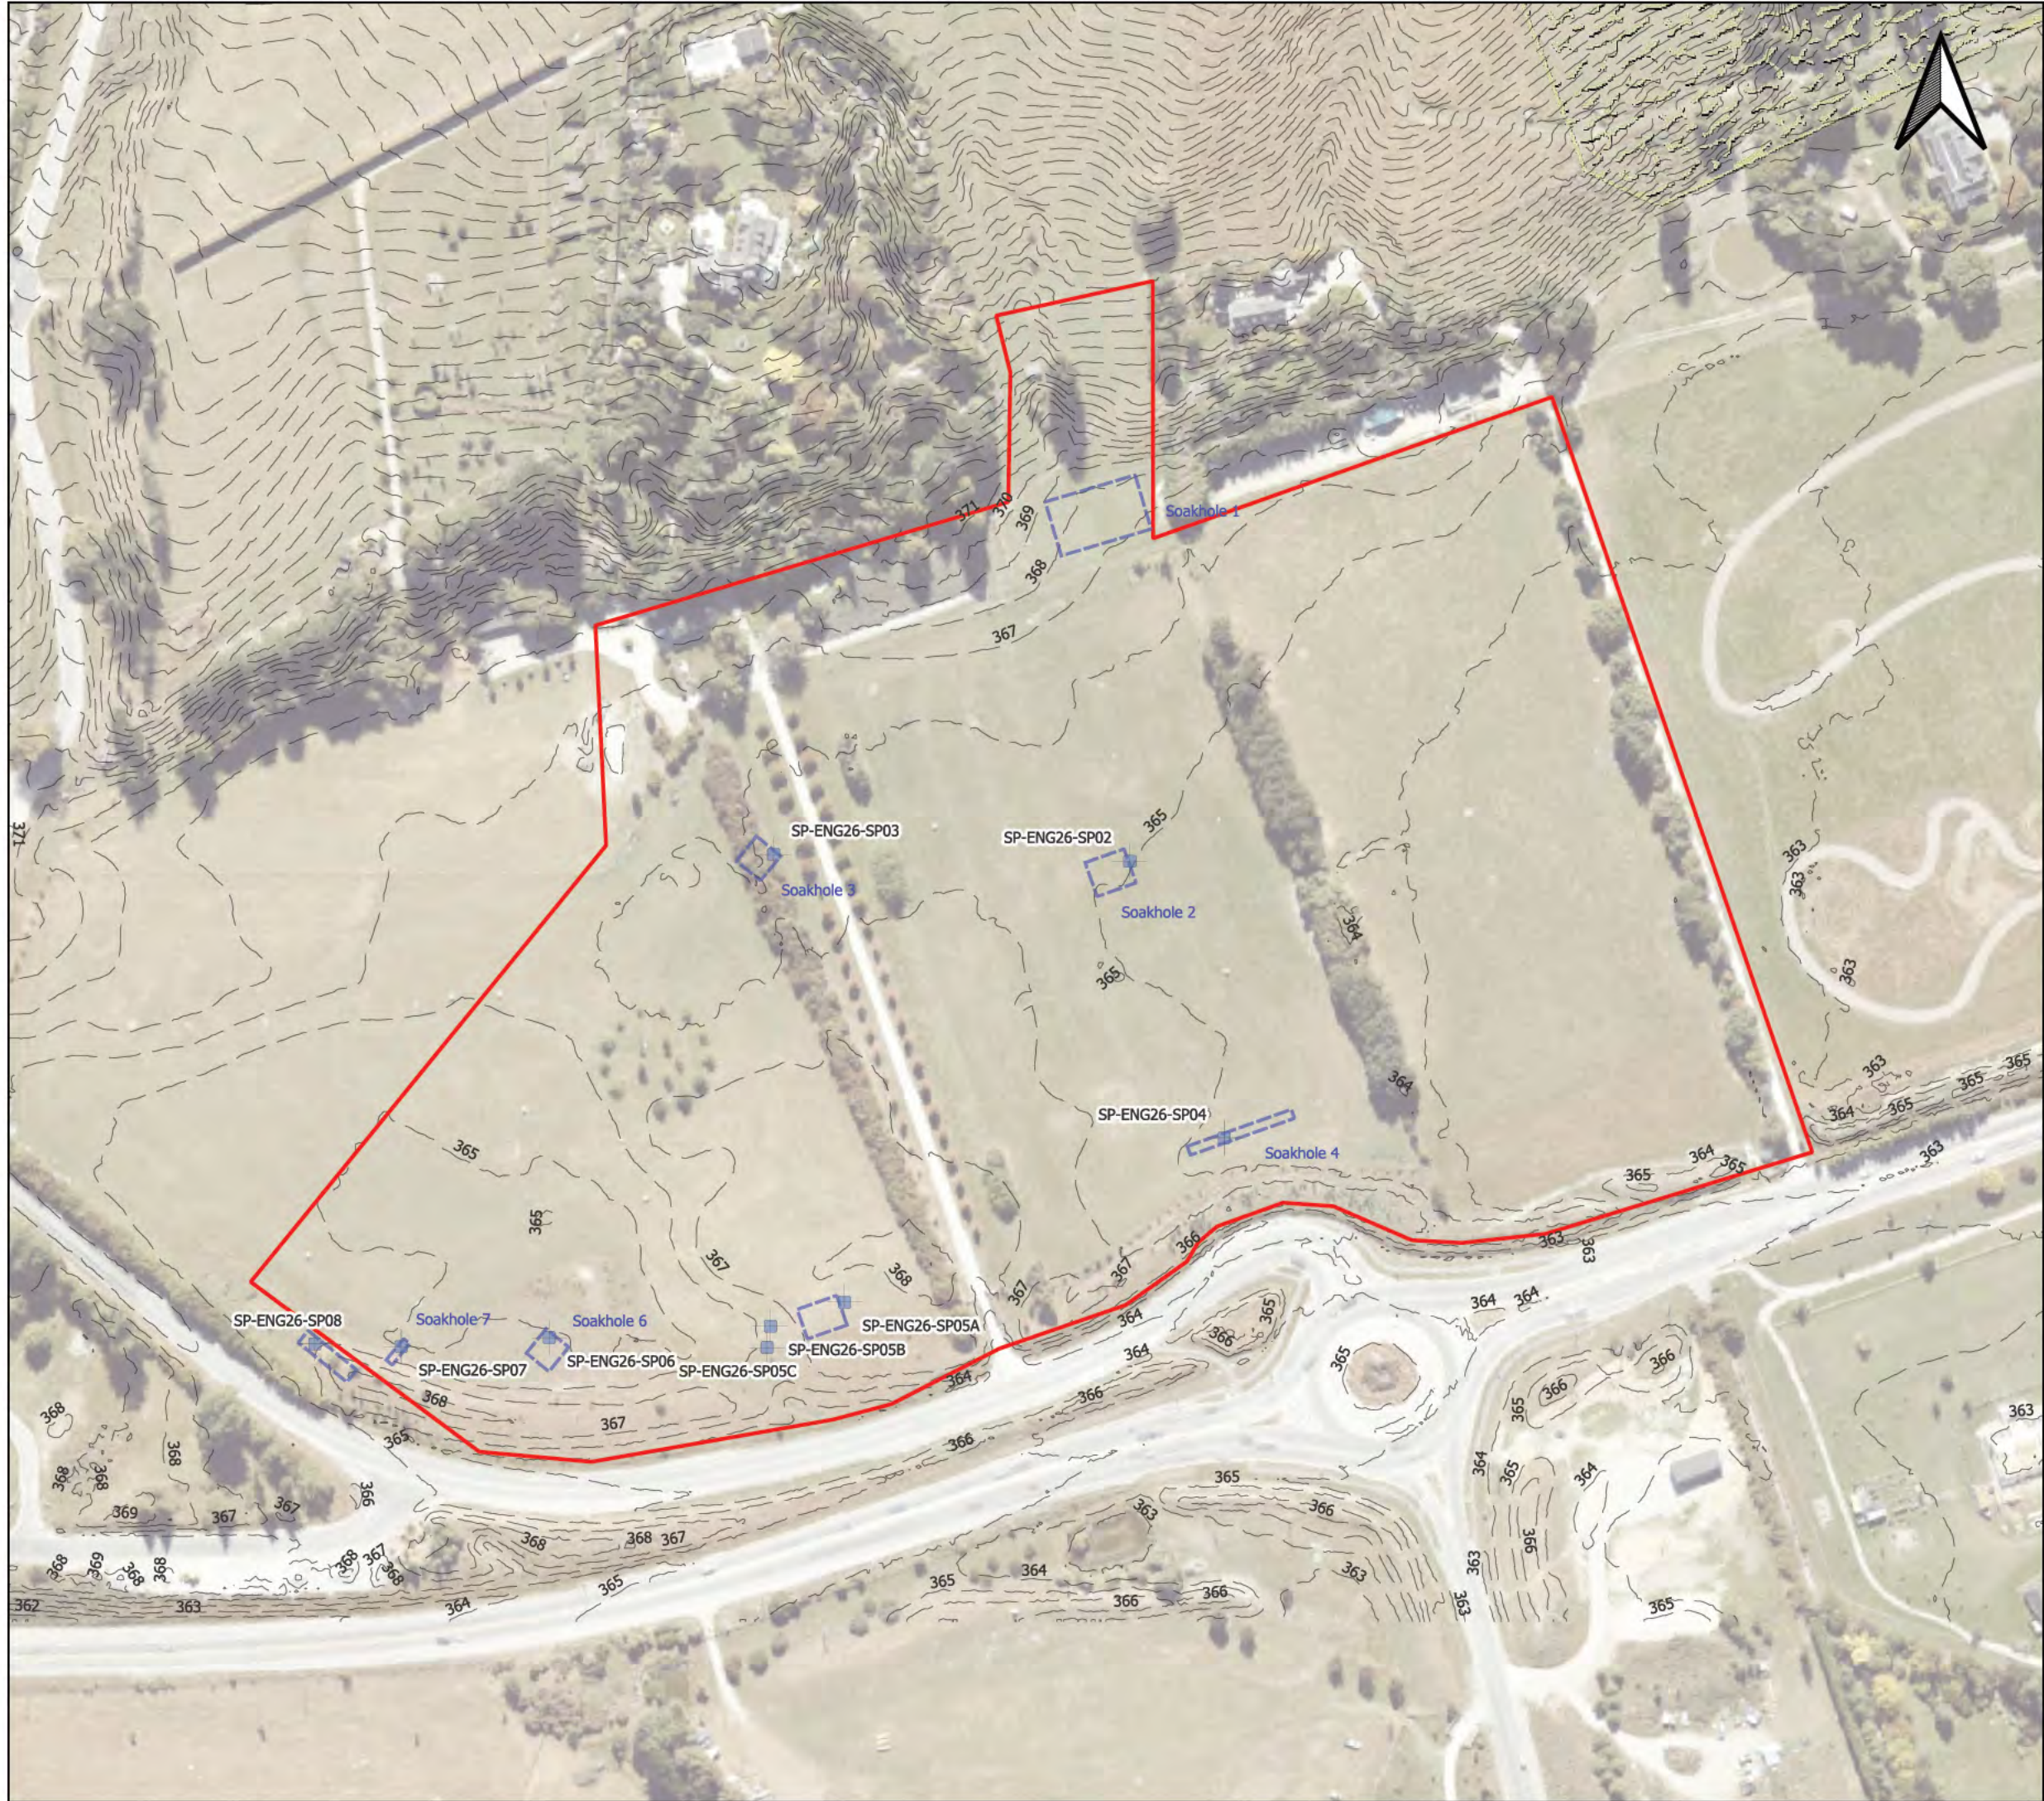
- LEGEND
- Soakage Testing Locations (ENGEO, 2026)
  - Proposed Soakholes (from McKenzie)
  - Site Boundary
  - Existing Contours (1m, QLDC LiDAR)

Notes:  
1) Soakhole locations based on plans provided by McKenzie (4163 - Simplicity Living - Soakpit locations and final surface contours 260212)  
2) Existing contours based on 2021 QLDC LINZ LiDAR.

Test pits were excavated within 10-20 m of the locations noted by McKenzie & Co as proposed for soakage devices. The test pit depth targeted coarse grained alluvium material underlying finer soils at site, as they were expected to have higher soakage potential. Test pits were logged by an Engineering Geologist in the field as per NZGS Soil and Rock Guidelines, included in Appendix 3.

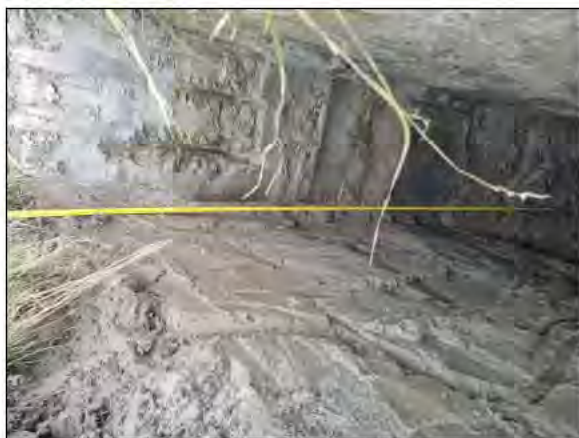
SP = Soak Pit. SP02 refers to proposed Soak Hole 2 location, as provided by McKenzie & Co Ltd (appendix 1)  
 Constant Head Test performed in test pit. TS = topsoil.

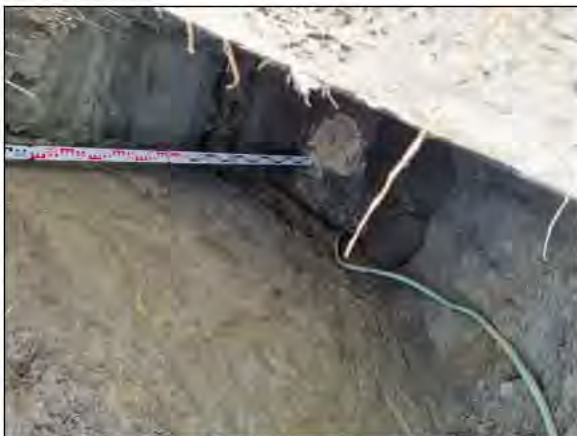
SP = Soak Pit. SP03 refers to proposed Soak Hole 3 location, as provided by McKenzie & Co Ltd (appendix 1)  
 Constant Head Test performed in test pit. TS = topsoil.

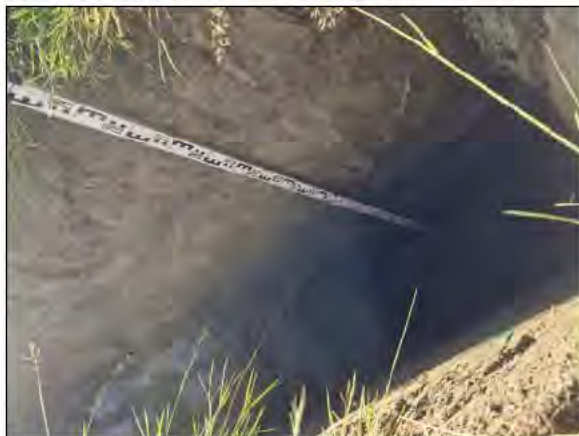
SP = Soak Pit. SP04 refers to proposed Soak Hole 4 location, as provided by McKenzie & Co Ltd (appendix 1)  
 Constant Head Test performed in test pit. TS = topsoil.

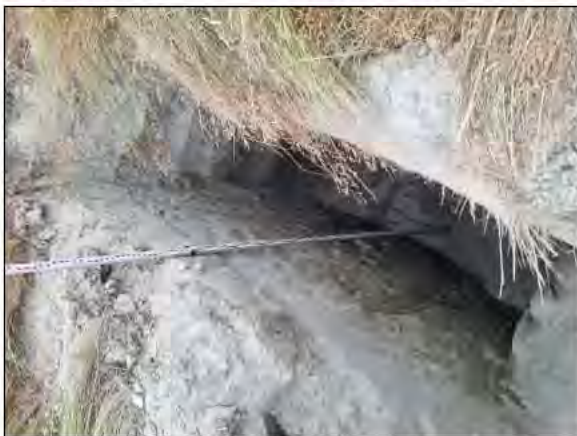
SP = Soak Pit. SP05 refers to proposed Soak Hole 5 location, as provided by McKenzie & Co Ltd (appendix 1)  
 Gravels/alluvium not encountered, no soakage test performed, test abandoned. TS = topsoil.

Two test pits were excavated within the vicinity of Soakhole 5 which did not encounter gravel Alluvium within 3 metres depth (SP05A & SP05B). This area is a local topographical high, and the proposed earthworks plan (MCC, 2026) involve excavation of approximately 3 metres depth within this area. In order to target infiltration testing within the geological unit where soakage is proposed, we excavated a further pit (SP05C) approximately 20 m downslope of Soakhole 5, where gravel Alluvium was encountered. Infiltration testing was carried out in SP05C. Infiltration test results are presented in Section 9.5 with recommendations in Section 10.3.

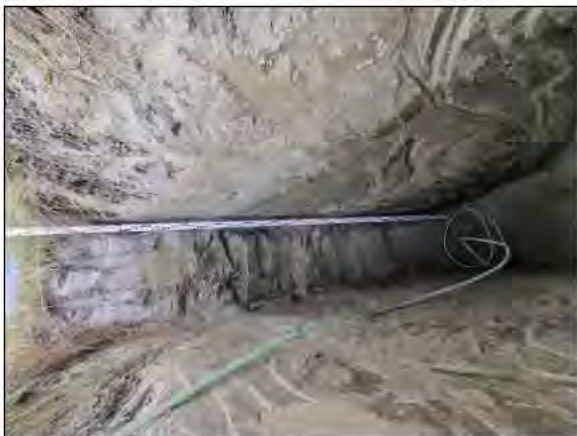
SP = Soak Pit. SP05 refers to proposed Soak Hole 5 location, as provided by McKenzie & Co Ltd (appendix 1)  
 Limited exposure of gravels/alluvium at base of test pit, limited soakage, test abandoned. TS = topsoil.

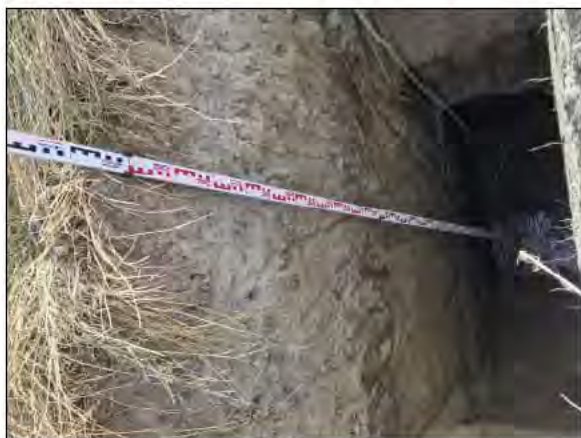
SP = Soak Pit. SP05 refers to proposed Soak Hole 5 location, as provided by McKenzie & Co Ltd (appendix 1)  
 Constant Head Test performed in test pit. TS = topsoil.

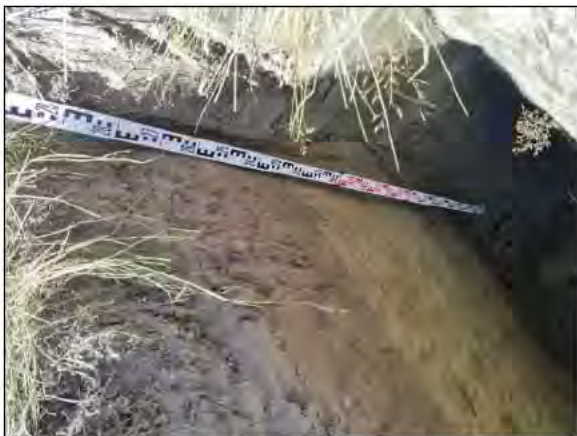
SP = Soak Pit. SP06 refers to proposed Soak Hole 6 location, as provided by McKenzie & Co Ltd (appendix 1)  
 Constant Head Test performed in test pit. TS = topsoil.

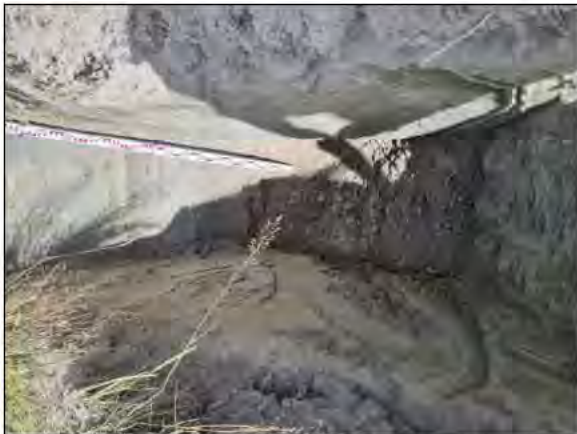
SP = Soak Pit. SP07 refers to proposed Soak Hole 7 location, as provided by McKenzie & Co Ltd (appendix 1)  
 Two falling tests performed, silt in-fill affected test. TS = topsoil.

The constant head method was preferred given the relatively high infiltration rates observed within the material, however, in one hole (SP07), silt infilled the test pit from the fine grained material above and the test was abandoned. Testing within the vicinity of Soakhole 1 was excluded due to landowner restrictions at the time of testing.

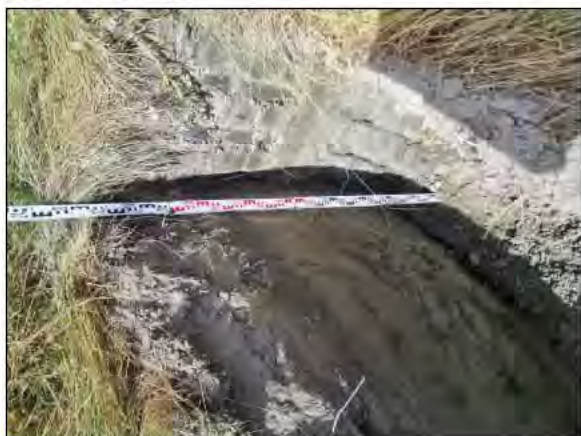
SP = Soak Pit. SP08 refers to proposed Soak Hole 8 location, as provided by McKenzie & Co Ltd (appendix 1)  
 Constant Head Test performed in test pit. TS = topsoil.

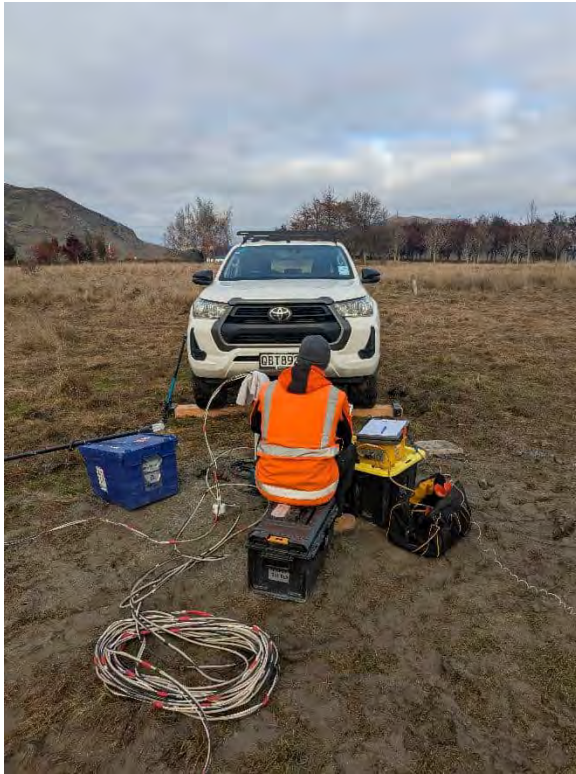
Figure A1: Data acquisition.

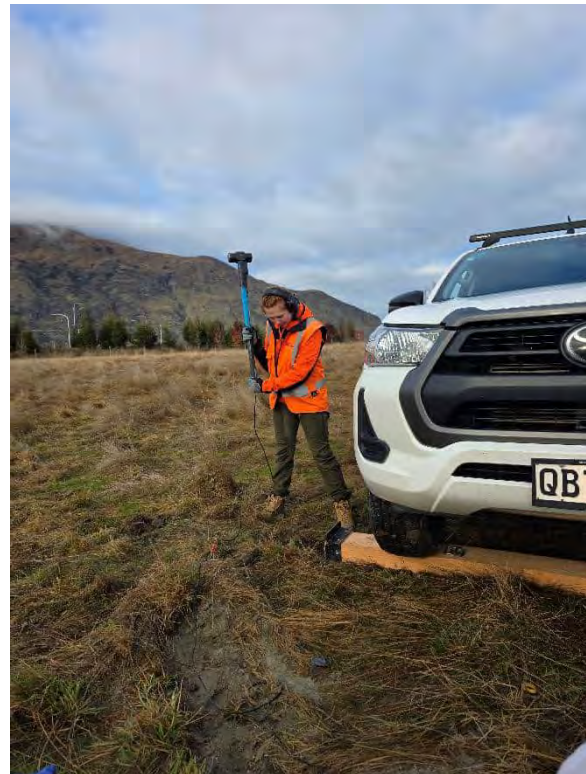
Figure A2: Striking the shear wave source.

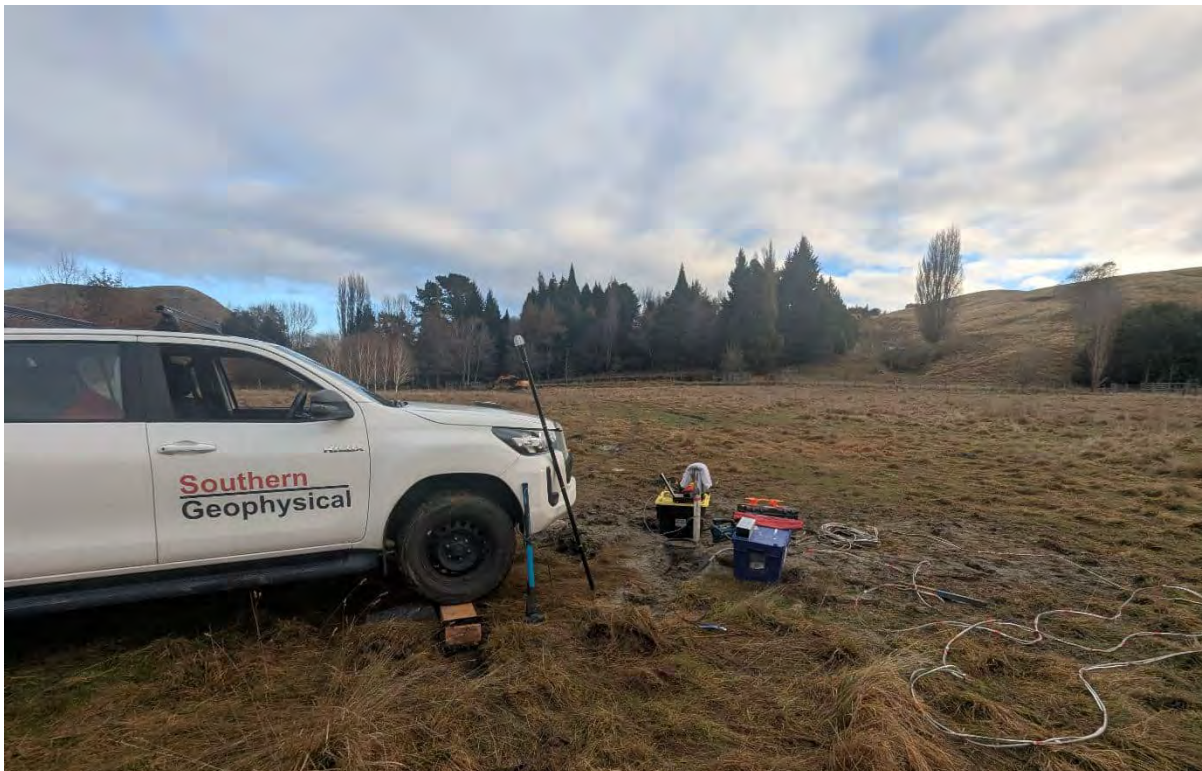
Figure A3: Shear wave source weighted down by the truck and equipment set up.
