PROPOSED RESIDENTIAL SUBDIVISION
MILLDALE STAGES 10 TO 13, WAINUI EAST

GEOTECHNICAL INVESTIGATION REPORT

Fulton Hogan Land Development Limited AKL2024-0257AB Rev 3

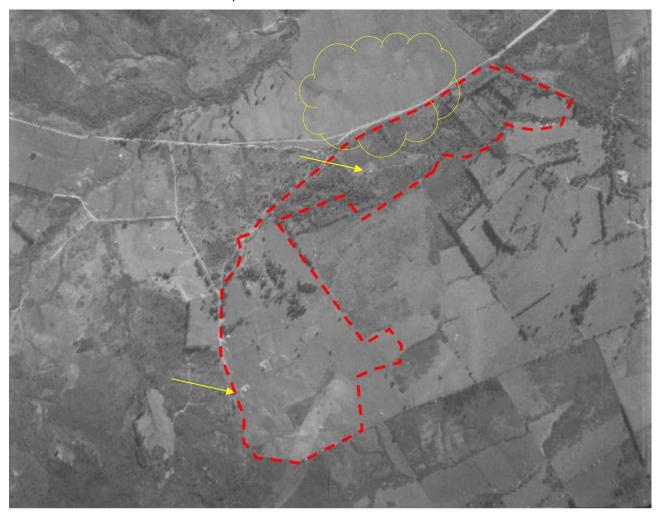
Figure 3: 1940 Aerial Imagery from Retrolens.

- Earliest aerial photos from *April 1940 (Figure 3)* show the site largely undeveloped or used as grazing farmland, with occasional farm buildings or sheds. The Stage 10/11 portion of site was largely covered in scrub and trees, whilst the Stage 12/13 portion appears to be grazing farmland, with several clusters of trees remaining in the northern part of this area. Two buildings can be seen which are interpreted to be the earliest residential dwellings on the site. To the north of Wainui Road, a fan-shaped feature observed on the slopes may be indicative of a change in geology in this area.

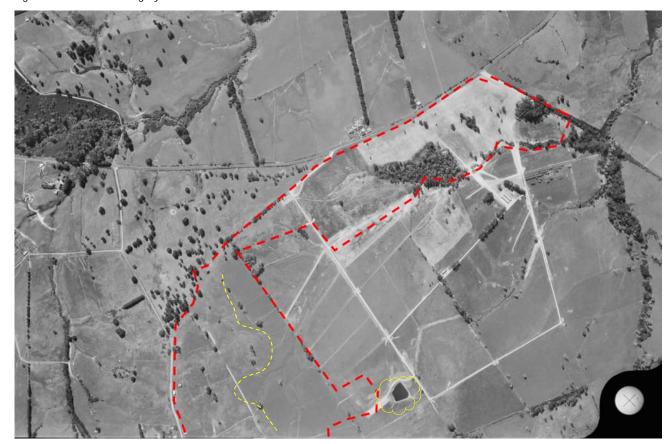
Figure 5: 1973 Aerial Imagery from Retrolens

- The aerial photo from *April 1973 (Figure 5)* shows the site had by this time undergone major development. Argent Lane and Lysnar Road are now visible as unsealed tracks. The majority of the Stage 10/11 area had been cleared with two relatively small areas of mature trees remaining. New buildings are visible in the area to the south of the site, together with a pond at the end of Argent Lane. This photograph shows a textural change in the land in Stage 12/13, possibly related to a change in geology.

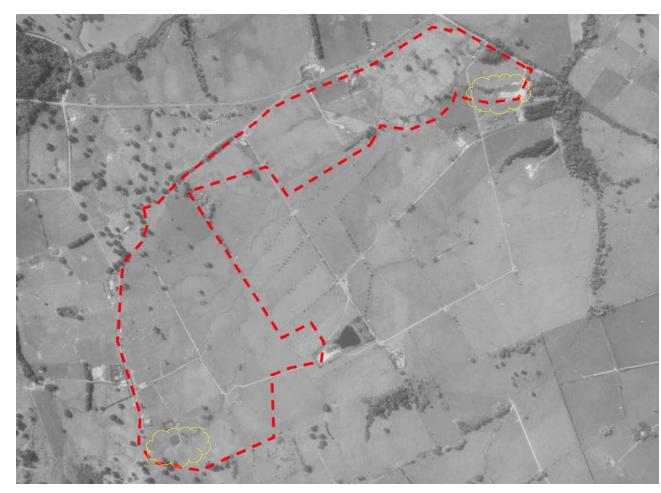
Figure 6: 1988 Aerial Imagery from Retrolens

- By March 1981 the Stage 10/11 area had been almost entirely cleared of vegetation. By March 1988 (Figure 6) the creek at the southern boundary of Stage 10/11 had been dammed to form a pond near Lysnar Road, and another pond had been formed near the southern end of Cemetery Road.

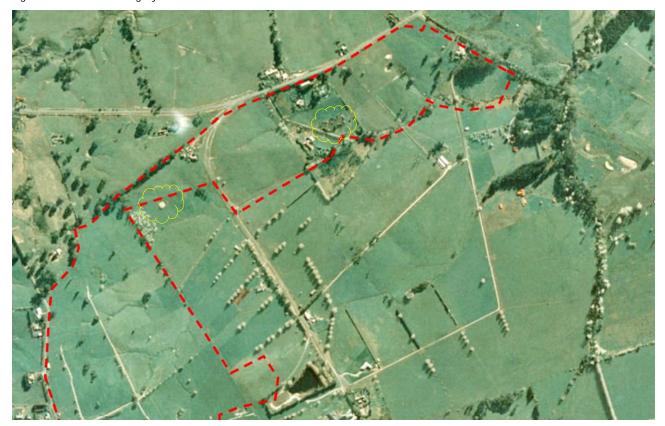
Figure 7: 1999 Aerial Imagery from Auckland Council GeoMaps

- By 1999 (Figure 7) further residential and farm buildings had been constructed within and around the site. Two additional ponds had been formed mid-slope as indicated.
- The 2010 and 2011 photograph (Figure 8) shows several new dwellings and ancillary buildings constructed within the site. Little further change is evident in the 2017 photograph (Figure 9), however commencement of construction of the first stage of Milldale can be seen to the east of the site.
- By 2024 (Figure 10), extensive earthworks of the Milldale development are evident to the south and east of the site. New residential development is visible to the south.

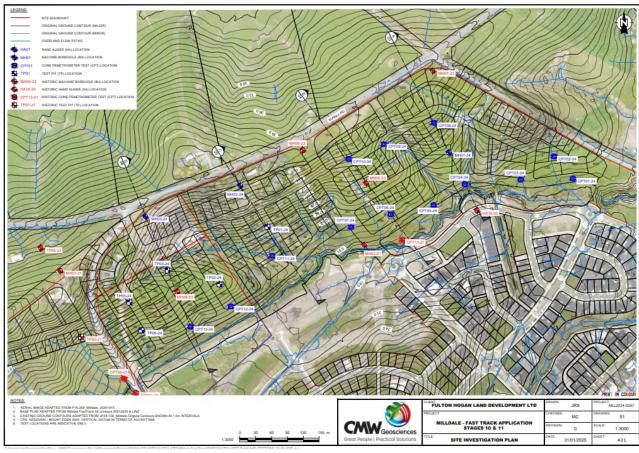
Figure 11: Site Investigation Plan – Stages 10 &11

Following a dial before you dig search, the site walkover and field investigation was carried out between late October 2024 and January 2025 during fine weather conditions. The scope of fieldwork completed is shown below:

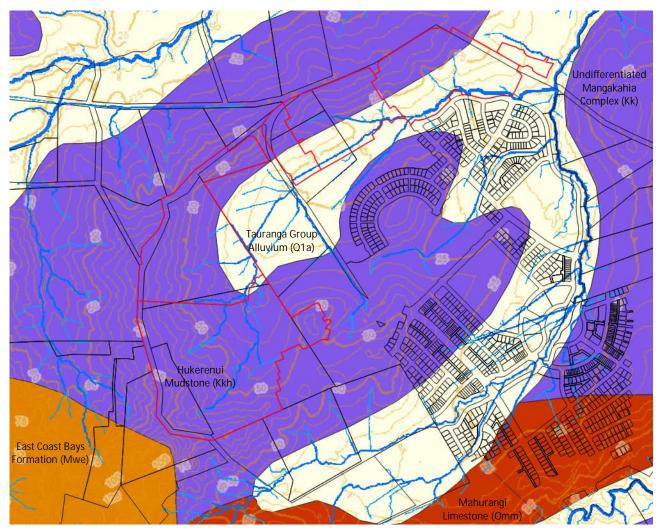
Figure 13: Regional Geology (GNS Science Web Geology Map)

The Northland Allochthon strata are part of an allochthonous (meaning removed from its formation location) mass of continental crust that was peeled from the subduction zone north of New Zealand and emplaced through low angle thrust faulting onto areas of Northland and the Silverdale area. Due to the nature of emplacement, materials are typically highly fractured or even shattered and variably weathered.

Our investigations have also encountered Undifferentiated Mangakahia Complex and Mahurangi Limestone of the Motatau Complex of the Northland Allochthon. Subtle changes in the site topography suggest the Hukerenui Mudstone lies predominantly in the ridgelines, with Mahurangi Limestone in the low-lying areas. Undifferentiated Mangakahia Complex was typically either beneath or interfingered with the Hukerenui Mudstone.

- Drainage patterns typically run south-west to north-east.
- The regional geological map (see *Figure 13*) indicates an area of East Coast Bays Formation to the southwest of the site, however the steep contour at the southern end of Cemetery Road suggests this may occur inside the site boundary also.

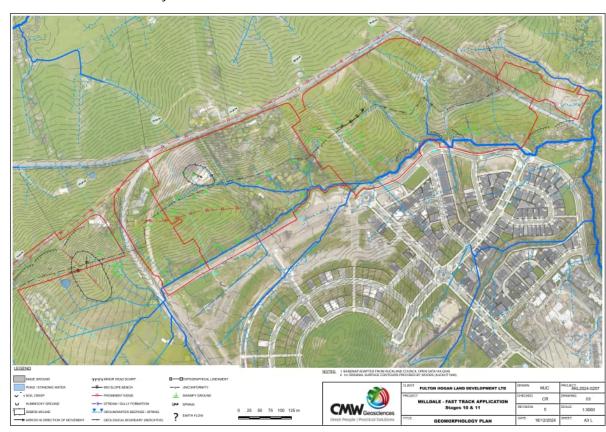
Figure 14: Geomorphology Plan (Stages 10 & 11)

- In Stages 10 & 11 near the corner of Argent Lane and Wainui Road, a tributary watercourse lies approximately parallel to the ridgeline. This may also indicate a geological contact.

- Current land use is predominantly pasture, with a scattering of trees. Stand-alone rural-residential dwellings are dotted across the Site, together with assorted farm buildings. Due to the historical farming land use, rubbish fills, offal pits and uncontrolled fills may exist within the site. Where these were observed during our site walkover, they have been noted on the *Geomorphology Plans (Figures 14 & 15)*.

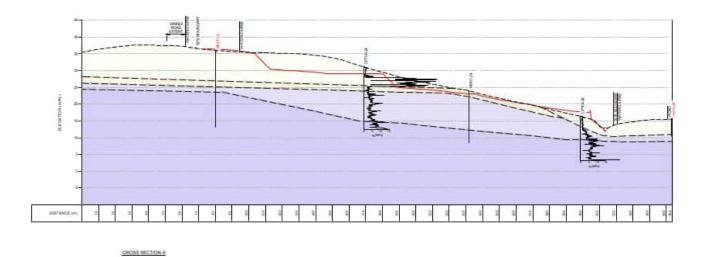
Figure 16: Section A Geological Section

Ground Model					
Geological Unit	Description					
Topsoil / Fill	Encountered in all test pits and machine holes. Thicknesses ranged from 0.1m to 0.5m averaging approx. 0.25m. Generally moist to wet across the site.					
Tauranga Group Alluvium (Stream)	Encountered in lower-lying areas in the vicinity of watercourses across the site. CPT testing indicates depths up to 7m below ground level. Described as light grey, green and blue clays and silts with limonite staining and some organic inclusions such as decomposing roots. Typically stiff to very stiff.					
Tauranga Group Alluvium (Ridge)	Encountered in the upper portion of the slopes below Wainui Road, in Stages 10 & 11. Encountered in MH02-24 to 13m below ground level. Described as light grey, green and blue clays and silts, occasionally streaked pink or with limonite staining. Some organic inclusions such as decomposing wood fragments or rootlets. Typically stiff to very stiff.

Northland Allochthon Residual Soil	Orange-brown to grey clays and silty clays which were firm to very stiff, moist and highly plastic. Typically 1 to 4m thick.					
Undifferentiated Mangakahia Complex	Grey, moderately weathered, highly fractured but interlocking angular siltstone. Extremely weak to very weak. Transitional materials identified by increased clay matrix and weathering of the rock fragments. Rapidly degrades towards complexly weathered soils over relatively short periods of time when unloaded and left exposed to the elements.					
Hukerenui Mudstone	Grey, brown, red and green mudstone in the form of hard, highly plastic clays, occasionally with fine gravel-sized angular inclusions of less weathered mudstone. Sheared surfaces within the clays. Unable to be penetrated with a shear vane. Weathered transitional materials identified by lower shear strengths (firm to very stiff).

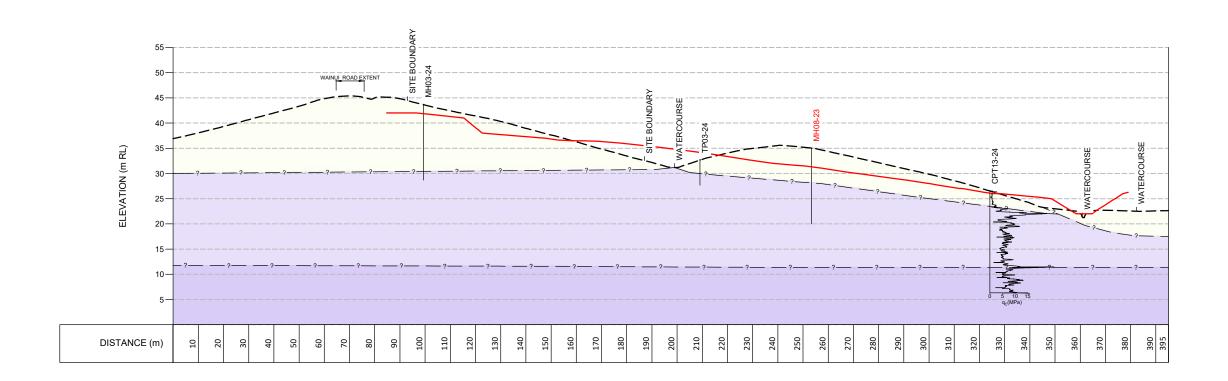
CROSS SECTION D

LEGEND: EXISTING GROUND PROFILE DESIGN PROFILE INFERRED GEOLOGY BOUNDARY TAURANGA GROUP ALLUVIUM TRANSITIONAL HUKERENUI MUDSTONE HUKERENUI MUDSTONE

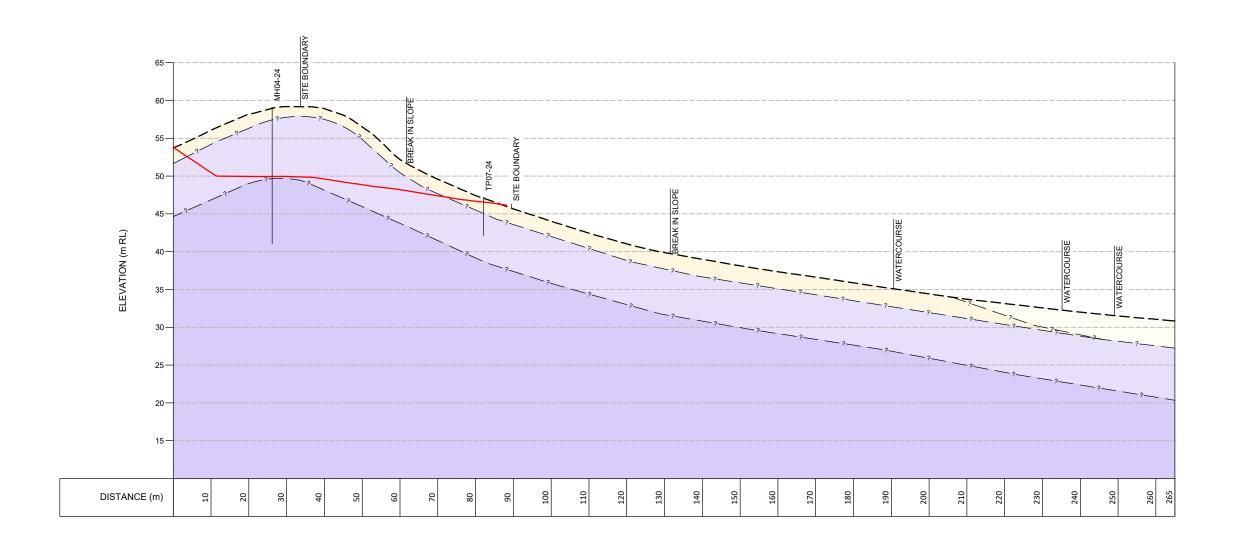
CROSS SECTION F

LEGEND: - - - EXISTING GROUND PROFILE DESIGN PROFILE DESIGN PROFILE 1. EXISTING GROUND PROFILE ADAPTED FROM xP24-128_Milldale Original Contours. DESIGN PROFILE 1. EXISTING GROUND PROFILE ADAPTED FROM Milldale FastTrack 3d contours 20012025. DESIGN PROFILE ADAPTED FROM Milldale FastTrack 3d contours 20012025. VERTICAL DATUM IN TERMS OF AUCKHT1946. 4. TEST LOCATIONS ARE INDICATIVE ONLY. TRANSITIONAL HUKERENUI MUDSTONE D 5 10 15 20 25 m HUKERENUI MUDSTONE VERT. 1:500

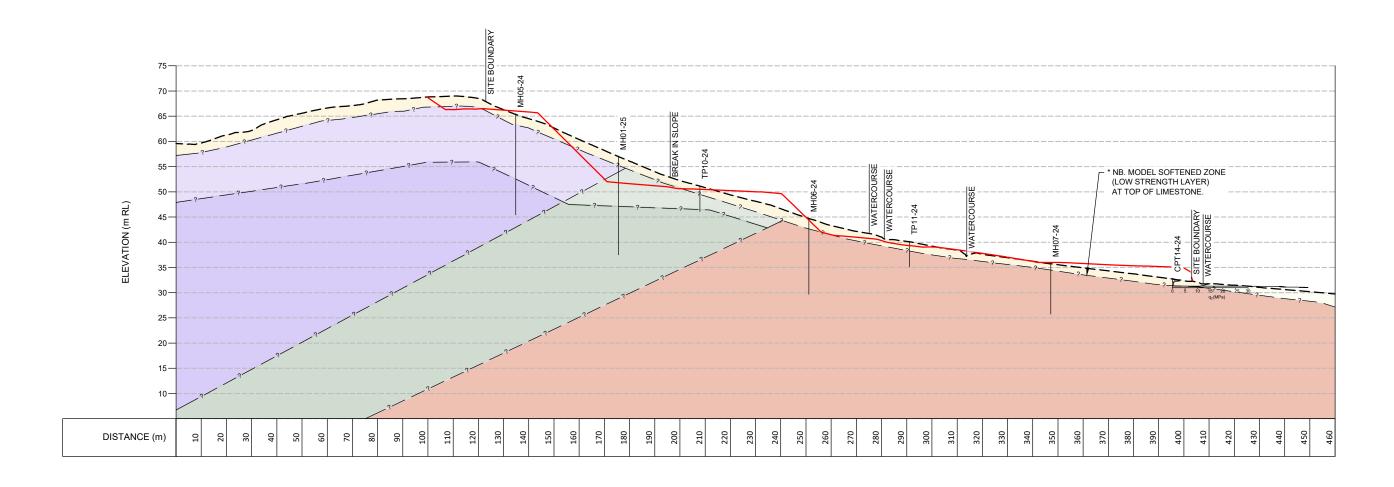
CROSS SECTION G

LEGEND: - - EXISTING GROUND PROFILE DESIGN PROFILE - 7 - INFERRED GEOLOGY BOUNDARY RESIDUAL NORTHLAND ALLOCTHON TAURANGA GROUP ALLUVIUM 1. EXISTING GROUND PROFILE ADAPTED FROM xP24-128_Milldale Original Contours. 2. DESIGN PROFILE ADAPTED FROM Milldale FastTrack 3d contours 20012025. TRANSITIONAL HUKERENUI MUDSTONE 1. EXISTING GROUND PROFILE ADAPTED FROM xP24-128_Milldale Original Contours. 2. DESIGN PROFILE ADAPTED FROM Milldale FastTrack 3d contours 20012025. 3. VERTICAL DATUM IN TERMS OF AUCKHT1946. 4. TEST LOCATIONS ARE INDICATIVE ONLY. UNDIFFERENTIATED MANGAKAHIA UNDIFFERENTIATED MANGAKAHIA ROCK MASS 0. 7.5 15 22.5 30 37.5 m MAHURANGI LIMESTONE VERT. 1:750

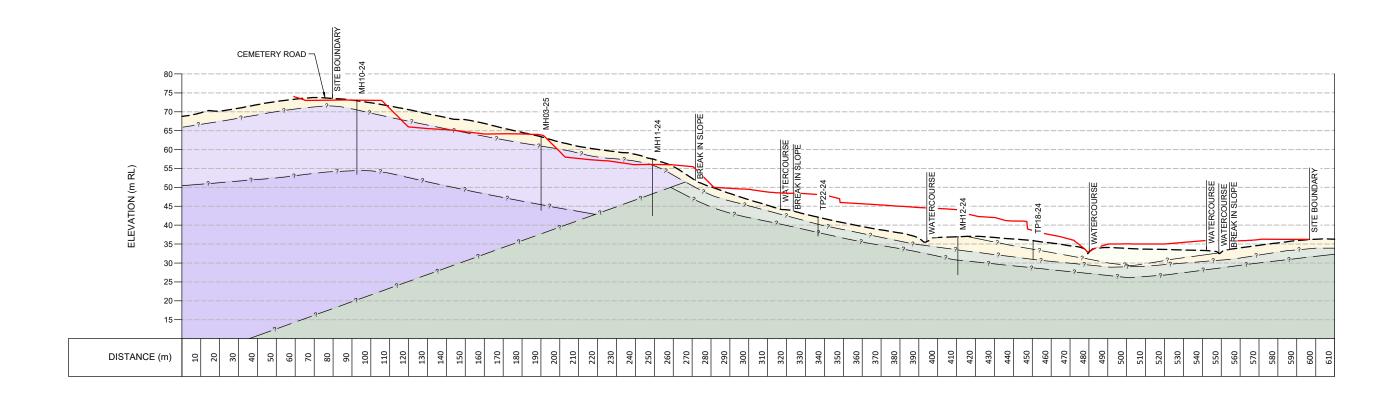
CROSS SECTION I

EXISTING GROUND PROFILE DESIGN PROFILE INFERRED GEOLOGY BOUNDARY RESIDUAL NORTHLAND ALLOCTHON TAURANGA GROUP ALLUVIUM TRANSITIONAL HUKERENUI MUDSTONE HUKERENUI MUDSTONE TRANSITIONAL UNDIFFERENTIATED MANGAKAHIA

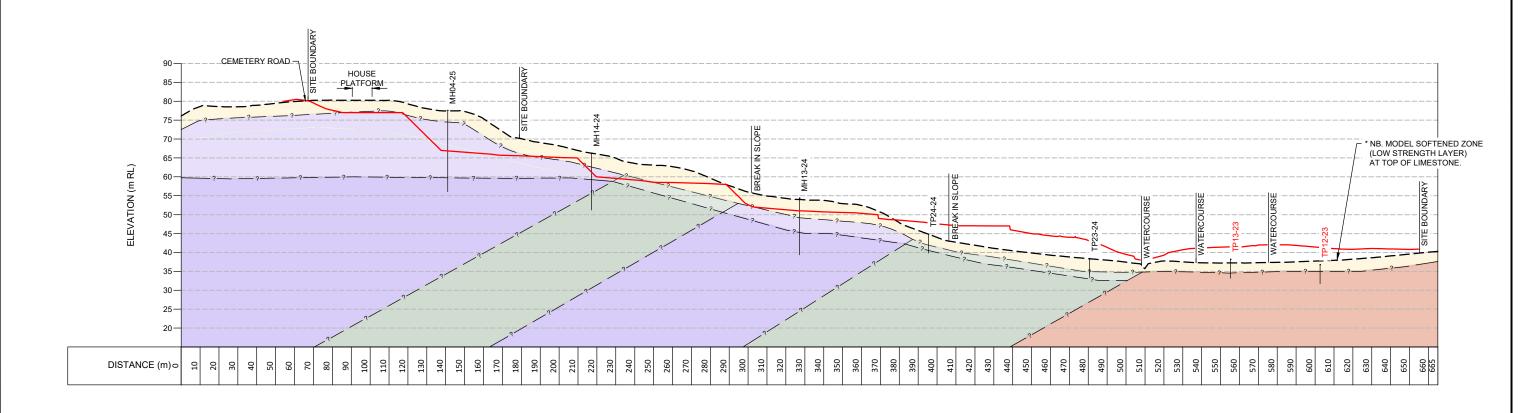
CROSS SECTION J

LEGEND: - - - EXISTING GROUND PROFILE DESIGN PROFILE - - - INFERRED GEOLOGY BOUNDARY RESIDUAL NORTHLAND ALLOCTHON TRANSITIONAL HUKERENUI MUDSTONE HUKERENUI MUDSTONE TRANSITIONAL UNDIFFERENTIATED MANGAKAHIA UNDIFFERENTIATED MANGAKAHIA ROCK MASS MAHURANGI LIMESTONE EXISTING GROUND PROFILE ADAPTED FROM xP24-128 Milldale Original Contours. DESIGN PROFILE ADAPTED FROM Mildale FastTrack 3d contours 20012025. TEST LOCATIONS ARE INDICATIVE ONLY. HORI. 1:2000 VERT. 1:1000

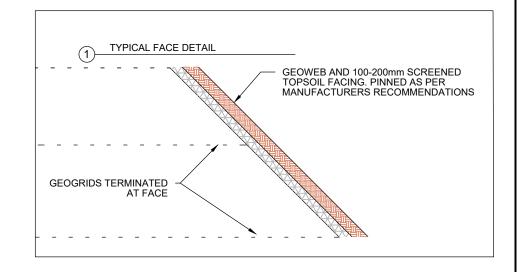
- BASE OF UNDERCUT
- 2. DRAINAGE INSTALLATION PRIOR TO BACKFILL
- 3. GRID LAYER PLACEMENT PRIOR TO BACKFILL
- 4. COMPACTION TEST ON EACH 1M LIFT PRIOR TO PLACING NEXT GRID LAYER
- 5. OVERALL LENGTH OF EXCAVATION OPEN AT ANY GIVEN TIME, PLUS HEIGHT OF BACKFILL BEFORE NEXT SECTION OF EXCAVATION COMMENCED TO BE DISCUSSED AND AGREED ON SITE BY CLIENT, CONTRACTOR, ENGINEER TO CONTRACT AND GEOTECHNICAL ENGINEER

GRID TYPE EMBEDMENT DEPTH **VERTICAL SPACING** L (m) S (m) PRIMARY 4.0 1.5

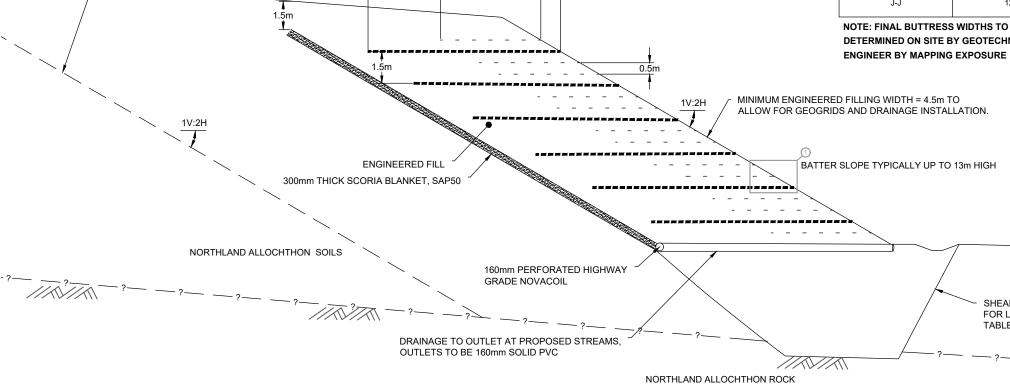
PRELIMINARY SHEAR KE	I WIDTH AND DEFTING	
BELOW UPPER RE SLOPE		
CROSS SECTION	BASE WIDTH (m)	DEPTH (m)
G-G	19.5	5
н-н	17	5
1-1	10	6
J-J	14	7
BELOW MID RE SLOPE		
I-I	10	4.5
K-K	12	4.5
BELOW LOWER RE SLOPE		
J-J	12	4.5

NOTE: FINAL SHEAR KEY DEPTHS TO BE DETERMINED ON SITE BY GEOTECHNICAL ENGINEER, MINIMUM EMBEDMENT INTO NORTHLAND ALLOCHTHON ROCK = 0.5m

SHEAR KEYS AS REQUIRED, REFER TO DRAWING 18 FOR LOCATIONS AND PRELIMINARY DIMENSIONS ON
