Ecological Impact Assessment

Milldale - Stages 10-13

Prepared for: Fulton Hogan Land Development Limited

February 2025

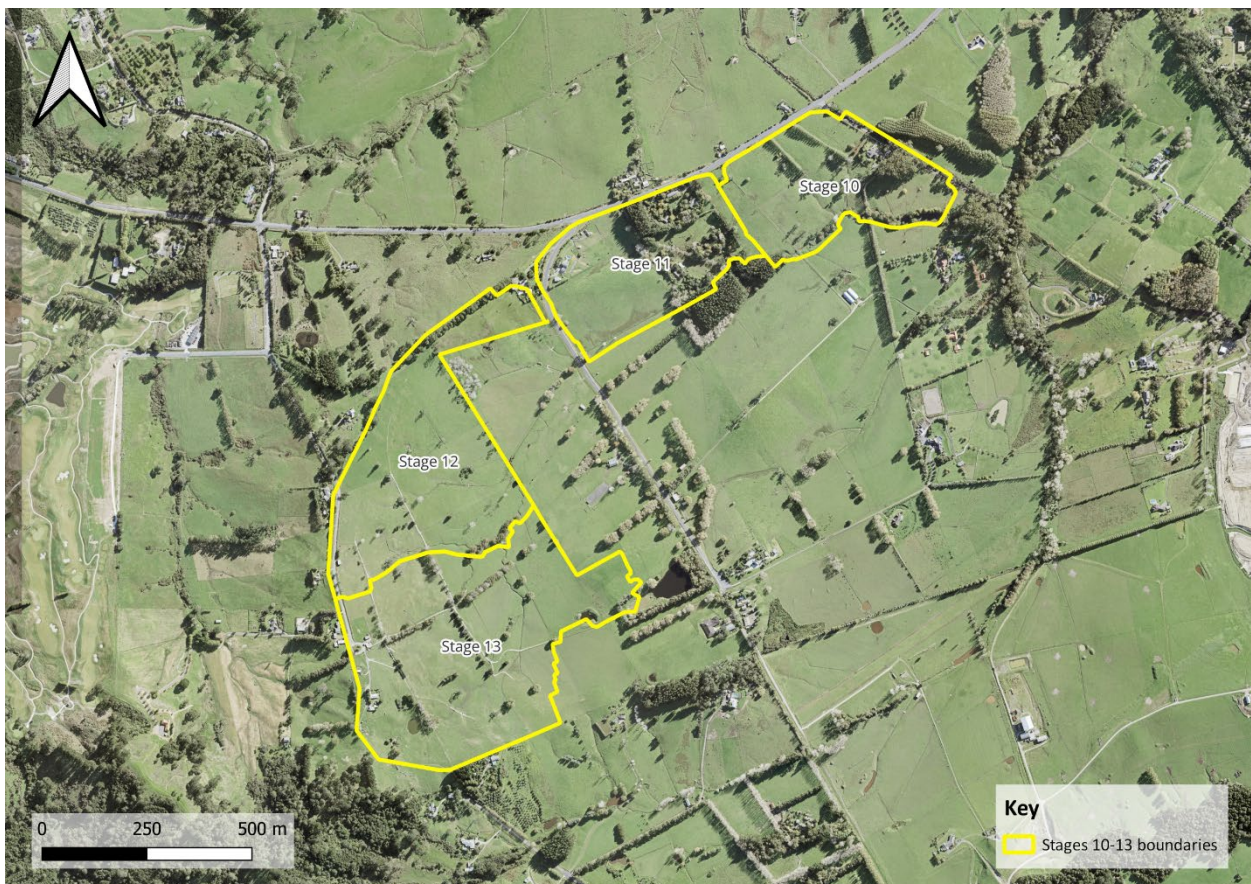
Figure 1. Map showing the boundaries of Milldale Stages 10-13 proposed for urban development under the FTAA.

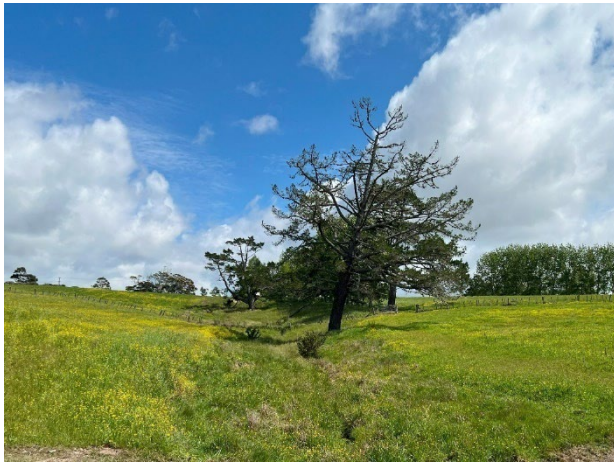
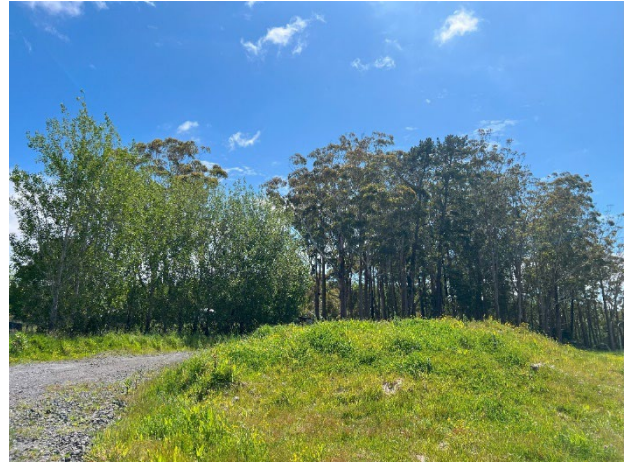
Figure 4. Examples of Stage 10 vegetation, showing a) an isolated pine tree within the riparian margin of watercourse 42, and b) poplars and a stand of gum trees.

The vegetation within the site was dominated by exotic species (Figure 4-Figure 6, Appendix A). Exotic trees constituted most of the canopy cover, including a wide variety of species identified by Viridis and Arborlab Limited (2025). The most observed tree species within the site were poplar (*Populus nigra*), pine (*Pinus radiata* & *P. pinaster*), crack willow (*Salix x fragilis*), redwood (*Sequoia sempervirens*), sheoak (*Casuarina cunninghamiana*), swamp cypress (*Taxodium distichum*), gum tree (*Eucalyptus* sp.) and English oak (*Quercus robur*).

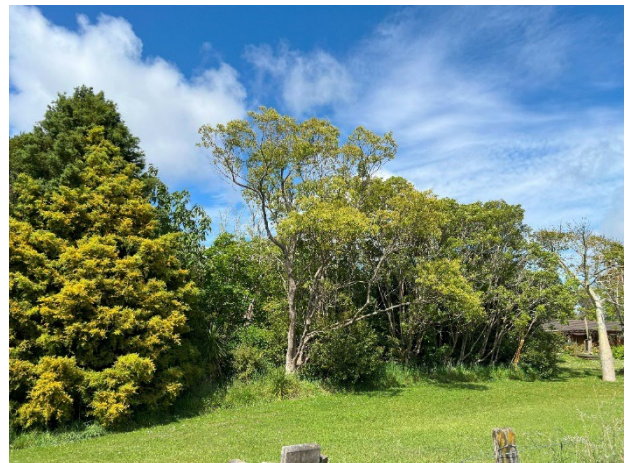
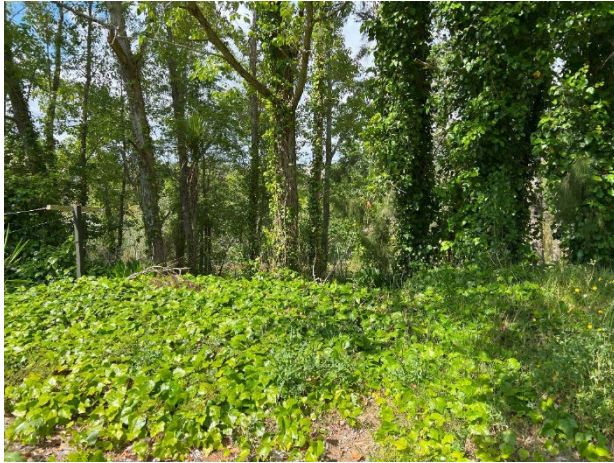
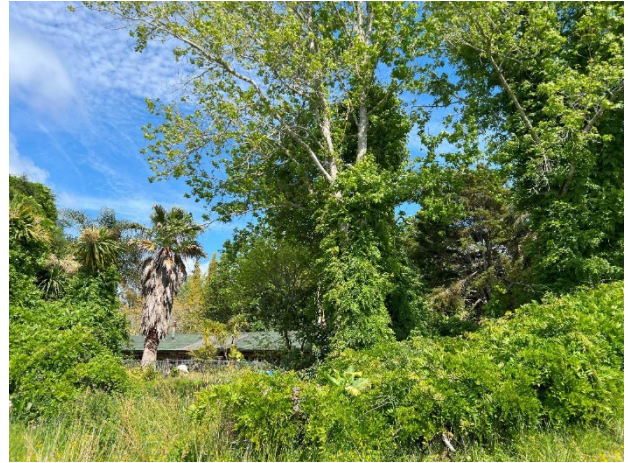
Figure 5. Vegetation within Stage 11, showing a-b) examples of exotic and native tree vegetation, and c-d) showing prevalent ivy under pine tree stand, and a high weed abundance around exotic tree and amenity plantings.

While pest plant presence was generally low across the site, the eastern portion of Stage 11 had higher infestations. Listed³ pest species observed included crack willow, hawthorn (*Crataegus monogyna*), Sydney golden wattle (*Acacia longifolia*), coastal banksia (*Banksia integrifolia*), English ivy (*Hedera helix*), monstera (*Monstera deliciosa*), watsonia (*Watsonia meriana*), Spanish heath (*Erica lusitanica*), palm grass (*Setaria palmifolia*), gorse (*Ulex europaeus*), tuber ladder fern (*Nephrolepis cordifolia*) and Chinese fan palm (*Trachycarpus fortunei*).

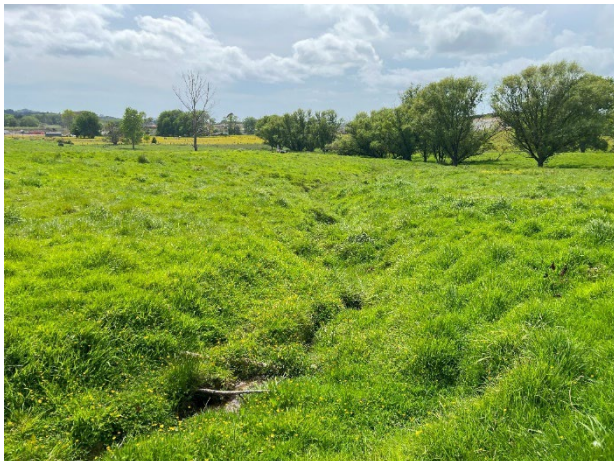
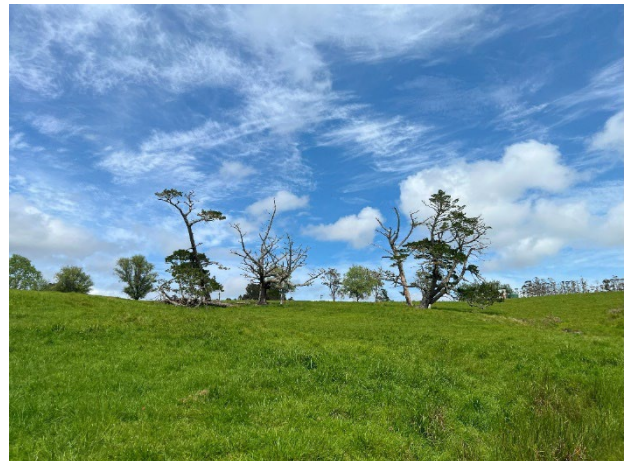
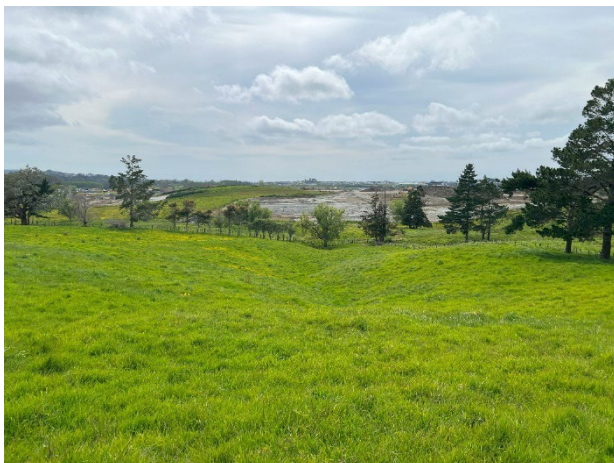
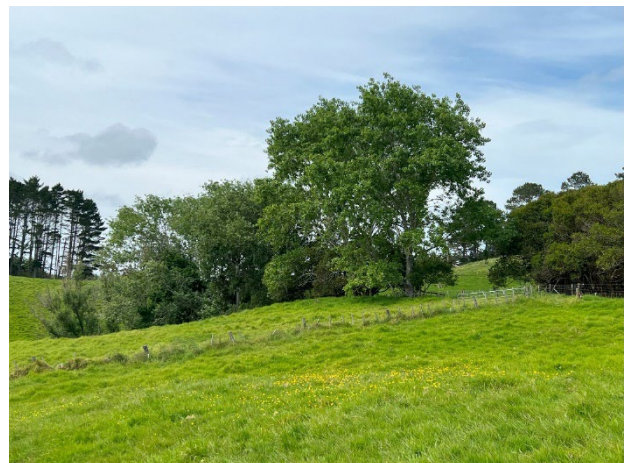
Figure 6. Isolated exotic trees such as crack willow, poplars and pines within a & b) Stage 12, and c & d) Stage 13 of the site.

In the pasture areas, isolated trees and shelterbelts consisted mainly of pine, poplar, crack willow, sheoak, and redwood (Figure 6). Small stands of treeland and amenity plantings, often featuring mixed exotic and native species, were more prevalent around rural residential dwellings.

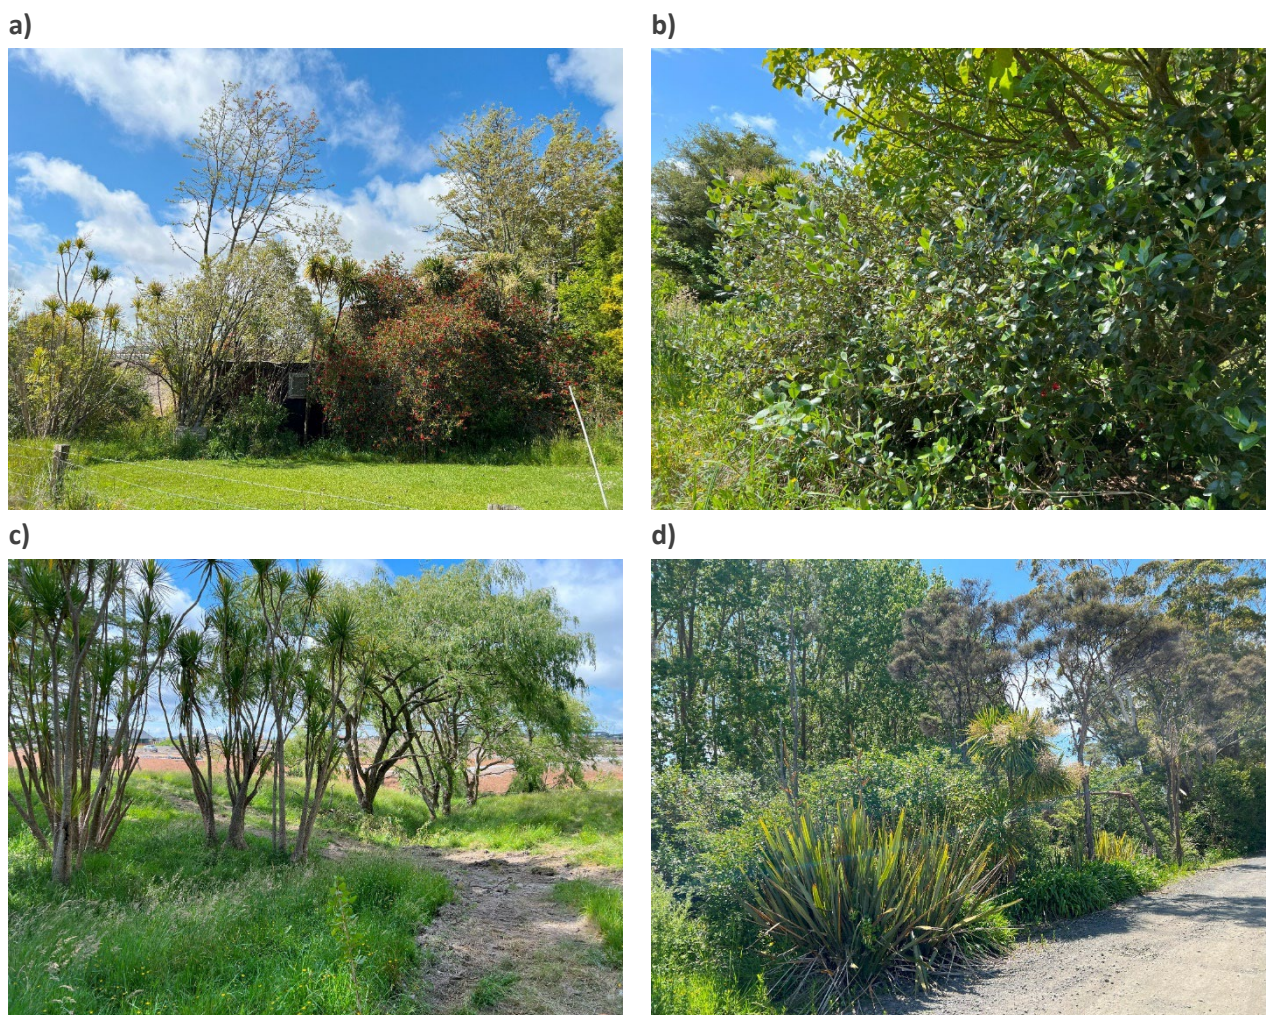
Figure 7. Examples of indigenous vegetation within the site, showing a) exotics and scattered natives (e.g., cabbage trees, tōtara) within the east of Stage 11, b) karamū amongst garden vegetation within Stage 11, c) cabbage trees within the riparian margin of watercourse 36, and d) planted natives such as mānuka and flax along Lysnar Road in the east of Stage 10.

There were no native-dominant areas of vegetation within the site. Where present, indigenous tree vegetation was largely restricted to planted specimens, primarily located in the eastern area of Stage 11 amongst exotic species, and along the riparian margin of Watercourse 21. A small number of well-established cabbage trees (*Cordyline australis*) were present within the riparian margin of Watercourse 37 (Figure 7). Small trees such as *Pittosporum* sp. were occasionally observed planted in rows along fences in paddock areas.

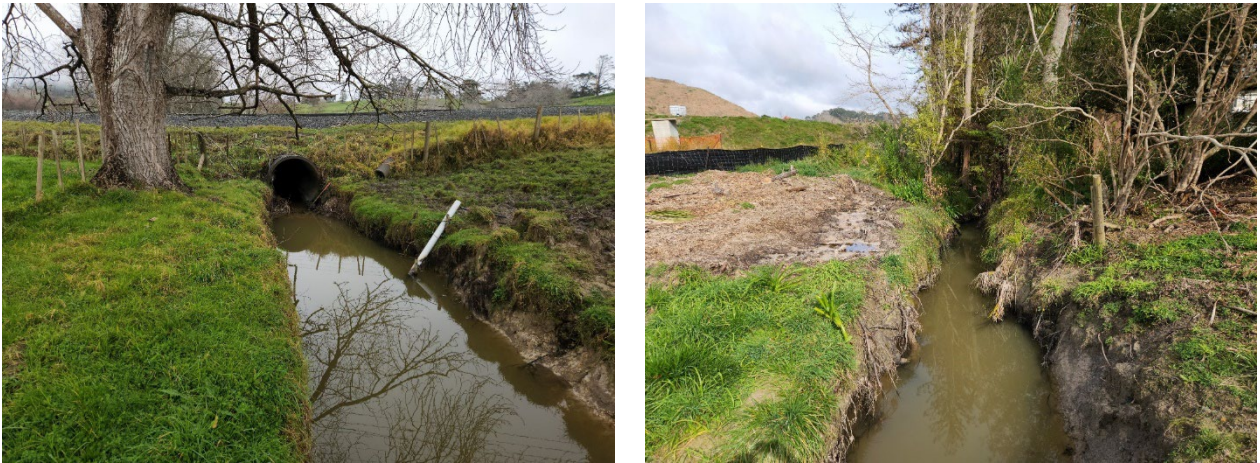
Figure 8. Photos of watercourse 21 from August 2023, showing a) the western end of Stage 11 downstream of the culvert under Argent Lane, and b) immediately downstream of the riparian vegetation within Stage 11.

Watercourse 21 had been historically modified for farm drainage, with evidence of straightening, deepening and widening observed. The eastern end of the stream within Stage 10 (approximately 200 m reach) had been diverted and realigned over the past year under an existing consent for the wider Milldale development (Figure 9b). Additional meanders had been created during these works, and riparian revegetation planting undertaken in 2024.

The stream was highly degraded due to the modified agricultural land use, with limited riparian vegetation minimising organic matter inputs, filtration, and shading functions. The substrate was soft-bottomed, and contained high sediment input due to the agricultural land use within the wider catchment.

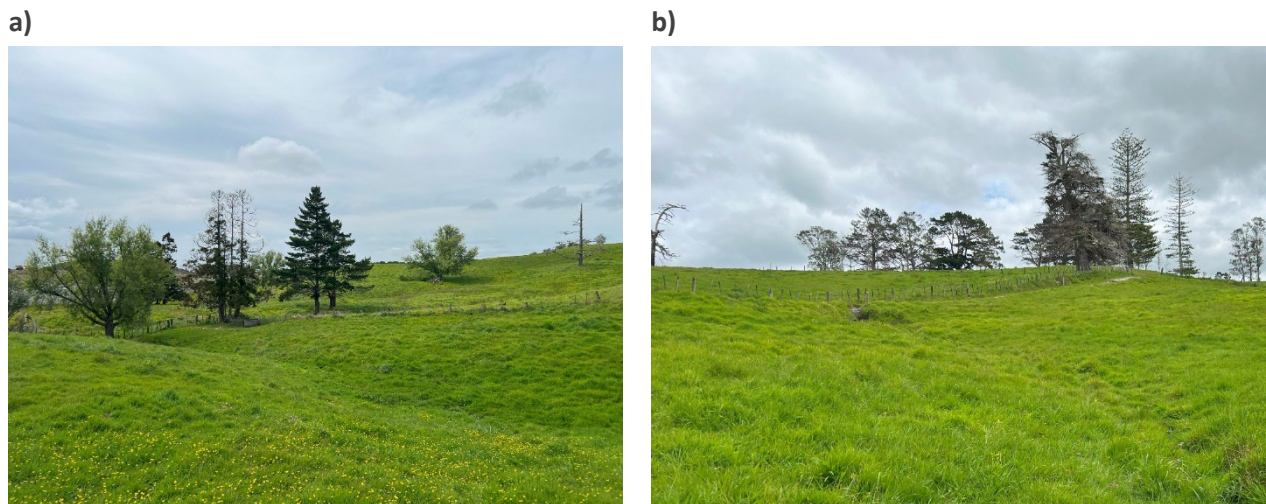
Figure 13. Examples of ephemeral flow paths showing a) watercourse 4, and b) watercourse 24.

Natural ephemeral channels identified have been mapped and labelled as per Appendix B. Ephemeral channels had very small catchments, typically contained rooted terrestrial vegetation across their channel width, showed no evidence of substrate sorting and did not contain natural pools or easily identifiable channels/banks (Figure 13). They contained no significant riparian vegetation and no instream freshwater habitat. Some appeared to have been modified for farm drainage, however, these have been considered natural where they aligned with the site's topography.

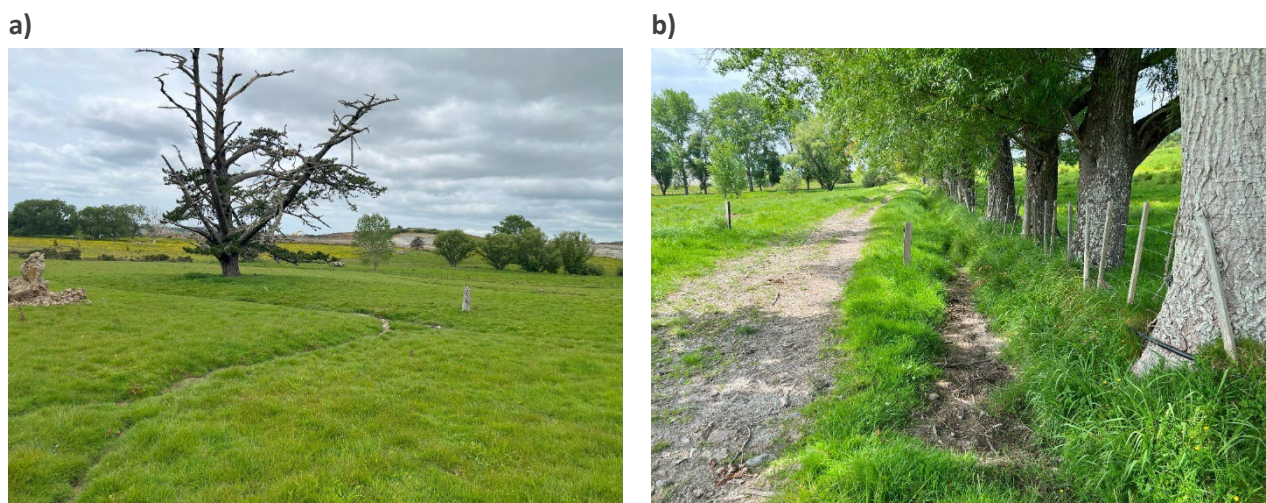
Figure 14. Examples of artificial drains showing a) watercourses 31-34, and b) watercourse 13.

Multiple artificial watercourses were present within the site (Appendix B). These features were constructed for farm drainage purposes. Drains were identified based on attributes including alignment with natural topography, presence/absence of a historic natural channel, catchment size, and artificial characteristics such as deepening and straightening. Figure 14 shows examples of drainage channels within the site. Artificial drainage channels are excluded from the relevant stream protection rules under the AUP-OP and the NPS-FM.

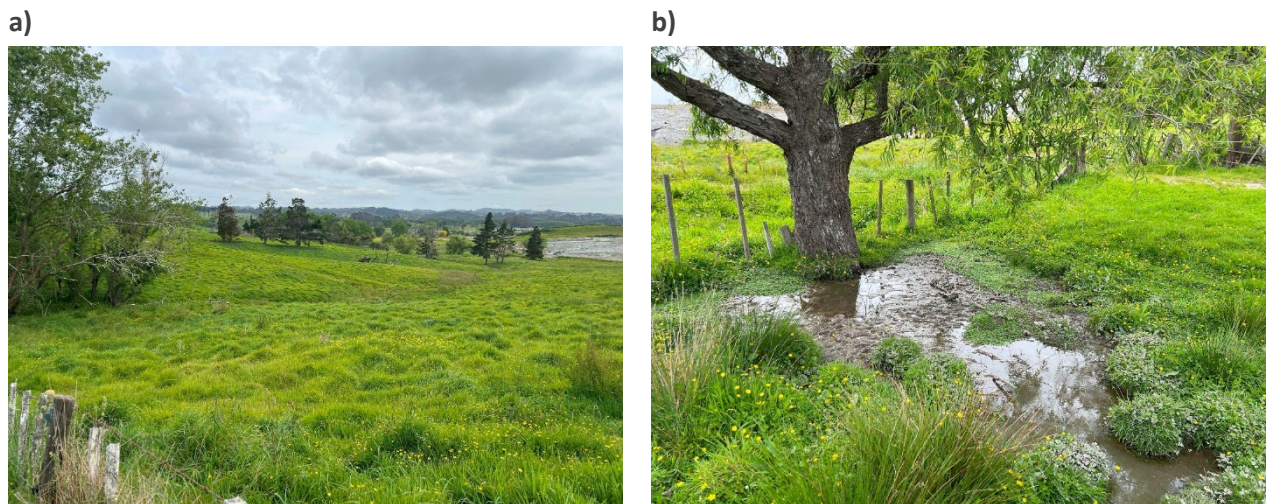
Figure 15. a) View looking across at Wetlands C and D from the south, and b) Wetland G showing pooling shallow water backing up against the fence upstream of a farm culvert.

Vegetation communities were similar across each of these wetlands, consisting primarily of exotic herb tier vegetation with occasional natives. Species recorded in these areas included soft rush (*Juncus effusus* – FACW), mercer grass (*Paspalum distichum* – FACW), sharp spike sedge (*Eleocharis acuta* – OBL), *Isolepis prolifera* (OBL), *Isolepis reticularis* (FACW), creeping buttercup (*Ranunculus repens* – FAC), curled dock (*Rumex crispus* – FAC), toad rush (*Juncus bufonius* – FACW), hairy buttercup (*Ranunculus sardous* – FAC), creeping bent (*Agrostis stolonifera* – FACW), Yorkshire fog (*Holcus lanatus* – FAC), wiwi (*Juncus edgariae* – FACW), lotus (*Lotus pedunculatus* – FAC) and sweet vernal (*Anthoxanthum odoratum* – FACU). The species composition observed across these areas was typical of degraded wetlands on rural land with a history of grazing. Examples of the degraded wetlands are shown in Figure 15 and Figure 16.

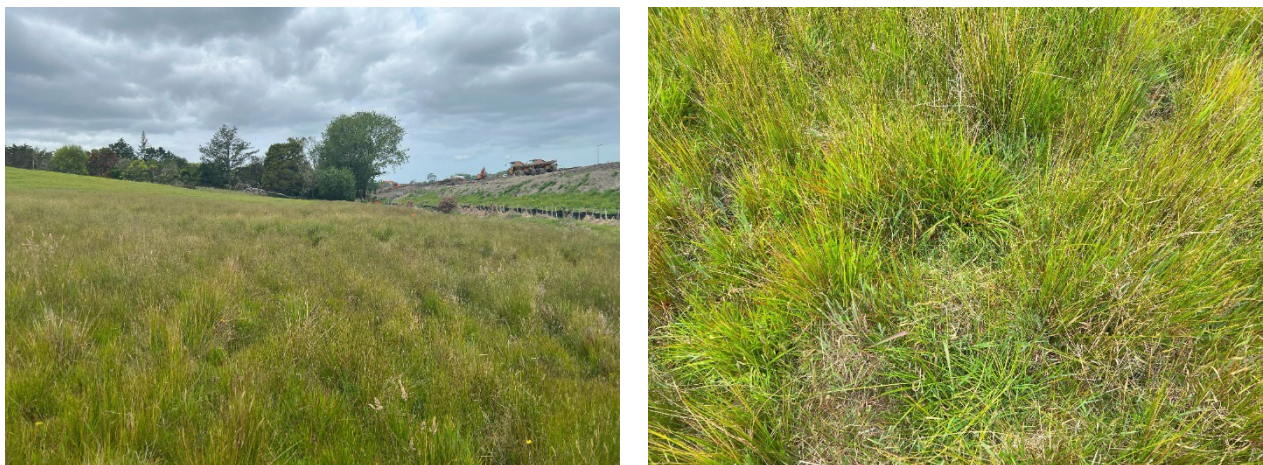
Figure 16. Wetland vegetation present within Wetland N that was limited to an exotic herb tier and contained vegetation such as *Juncus* spp., *Isolepis* spp. and creeping bent.

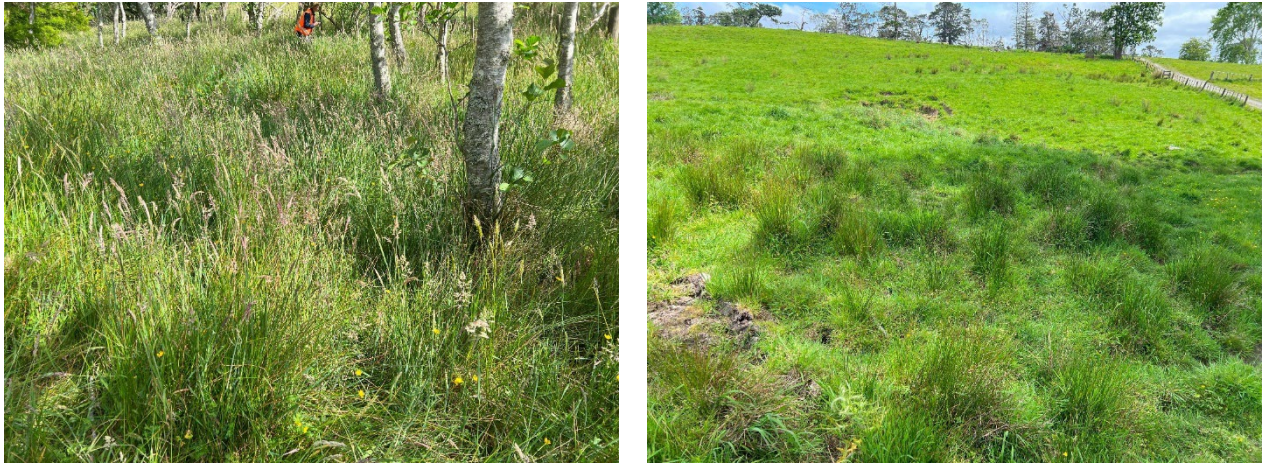
Figure 17. a) Wetland O, with sparse common alder trees and exotic species such as rushes, Yorkshire fog and sweet vernal, and b) Wetland I, showing scattered rushes amongst pasture grasses.

The ecological value of Wetlands B, I, L, and O was considered to be **low**, due to their degraded nature, small sizes, lack of indigenous flora biodiversity, general lack of structural tiers which limited habitat availability, and negligible aquatic habitat.

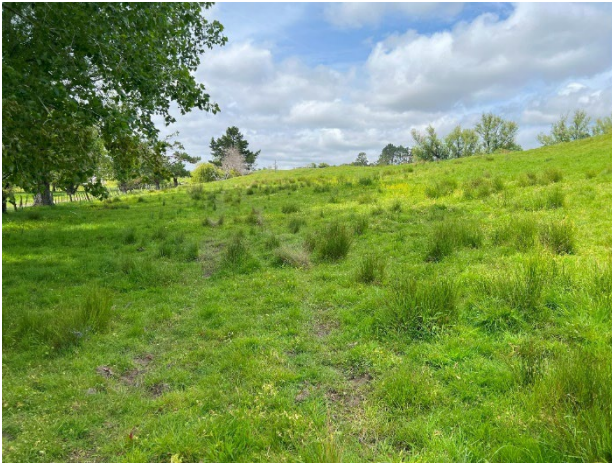
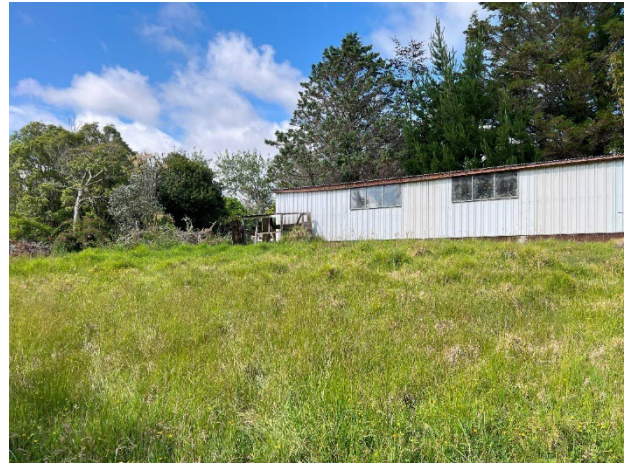
Figure 18. a) Putative wetland within Stage 13 where plots P5 and P6 were undertaken, and b) putative wetland area within Stage 11 near P15 was undertaken.

All other vegetation plots undertaken within the site failed the dominance test and prevalence indices and were not considered to be natural inland wetland areas. Some plots were undertaken within putative wetland areas, and others were undertaken to inform the extent of the identified wetlands as above (Appendix B).

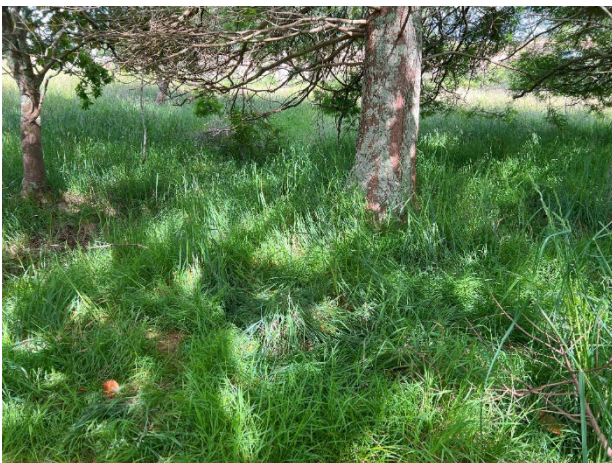
Figure 19. Location of plot P11 showing FACU grass dominance under swamp cypress trees.

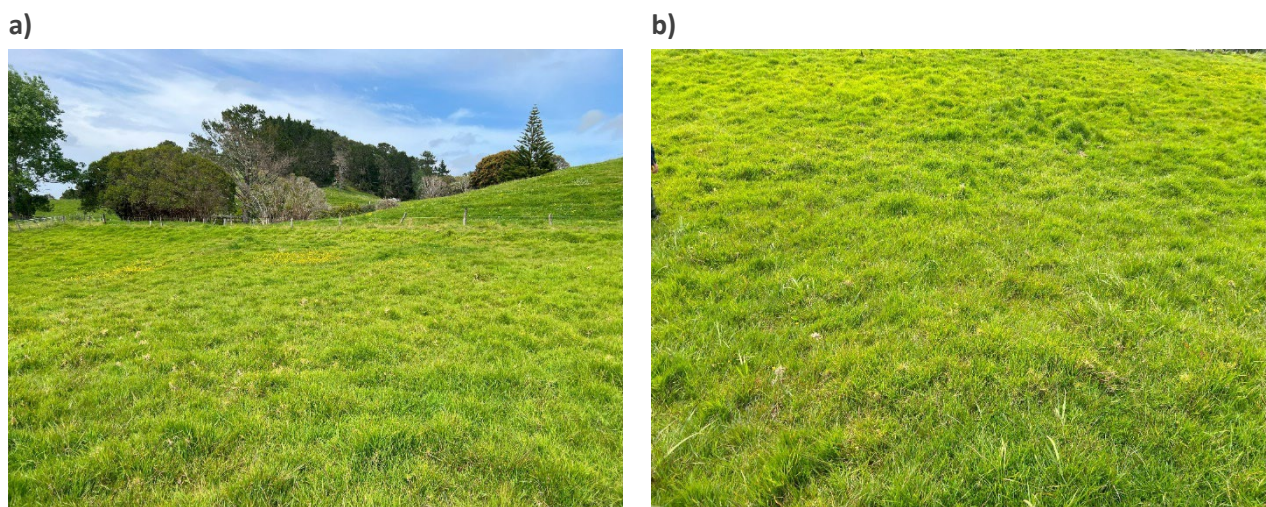
Figure 20. a) Areas on the hillside in Stage 13 showing creeping bent mixed in with pasture species such as kikuyu and dallis grass.

To provide an example of the site’s patchy FACW species coverage, three plots were undertaken in Stage 13 on an elevated area where creeping bent occurred amongst FACU vegetation (Figure 20). The results of the plots are summarised in Table 6 below, and the plot locations map and data shown in Appendix F. The plots were taken approximately 3 m apart; however, the results came out different in each plot for wetland/non-wetland vegetation. It should be noted the area where the plots were undertaken showed no evidence of soil saturation or wetland hydrology during the site visits, or on recent or historic aerial imagery.

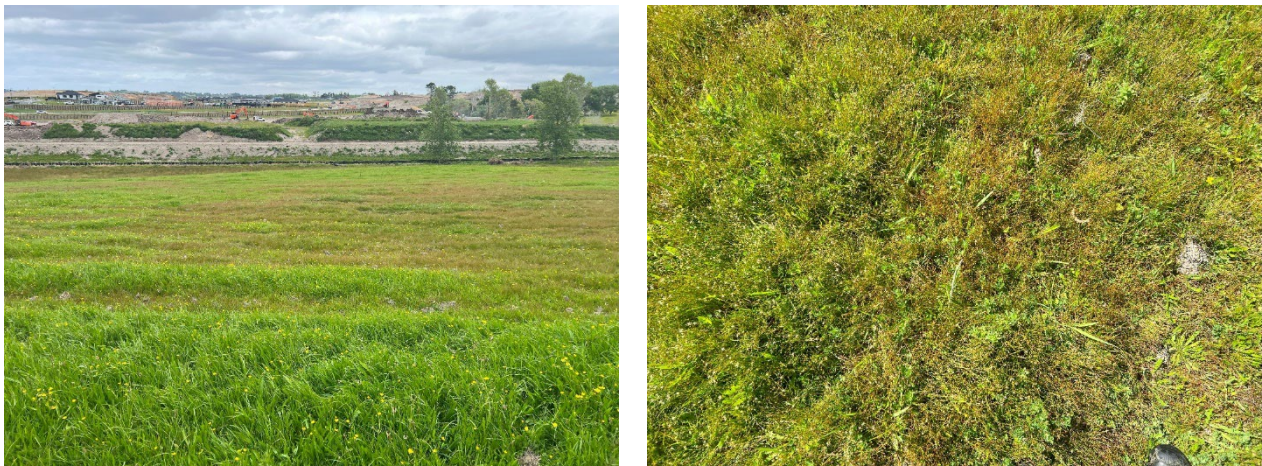
Figure 21. Examples of toad rush that has colonised large patches within Stages 10 and 11 following recent disturbance of soils for crops.

The results of the plots discussed above and the presence of toad rush in recently disturbed areas highlight that due to the difficulty of the soils and agricultural nature of the site, hydrophytic vegetation presence (namely areas containing high proportions of creeping bent or toad rush) within many parts of the site is not solely indicative of wetland status.

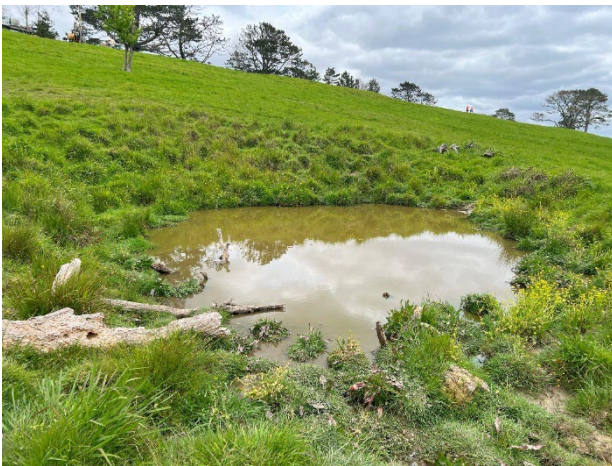
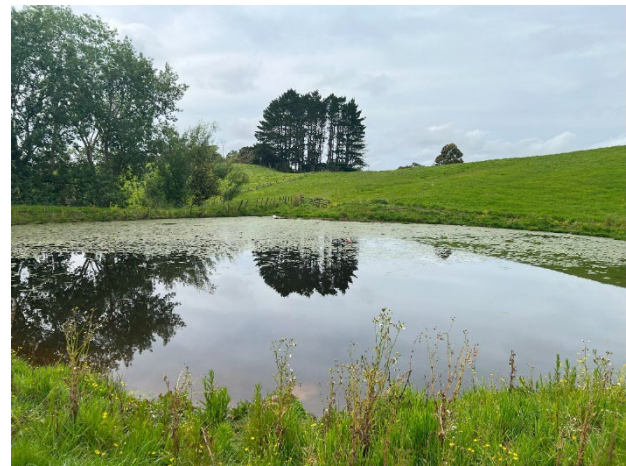
Figure 22. Examples of constructed ponds within the site, within a) Stage 12 and b) Stage 13.

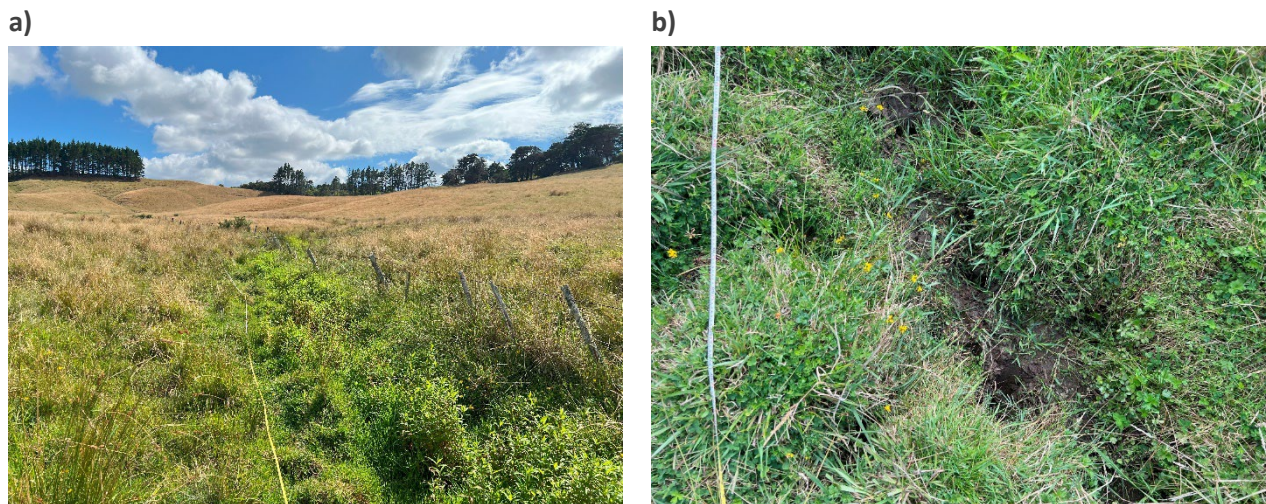
Figure 25. Photos of SEV 1 reach showing a) the reach looking upstream, and b) the intermittent stream channel.

The offset site is located within the same wider catchment as the impact site— the Ōrewa River catchment, north of the project area at 173 Upper Orewa Road, Wainui (Figure 23). Three SEV assessments were undertaken in representative reaches within the offset catchment (Figure 24). While the impact site has been heavily modified through channel deepening and straightening, the offset site has similar characteristics, including intermittent flow, a soft-bottomed substrate, and modification through agricultural practices such as stock access and riparian vegetation removal. The offset site also has a low diversity of aquatic habitat and hydrologic heterogeneity, with low current SEV scores (Figure 25 & Figure 26, Table 10).

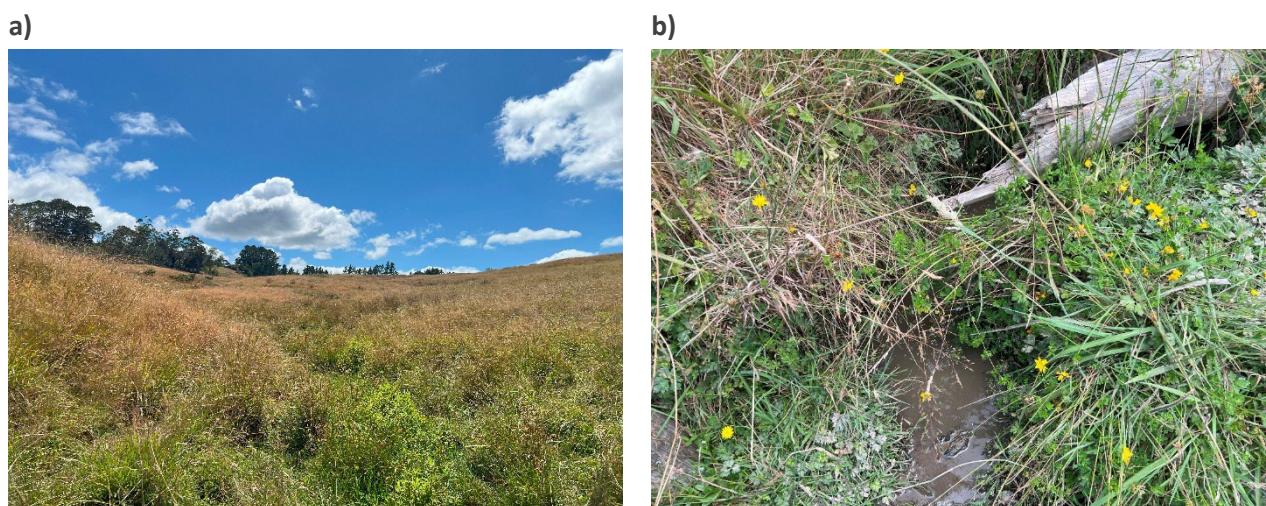
Figure 26. a) SEV 2 reach facing upstream, and b) an example of the SEV 3 intermittent stream channel.

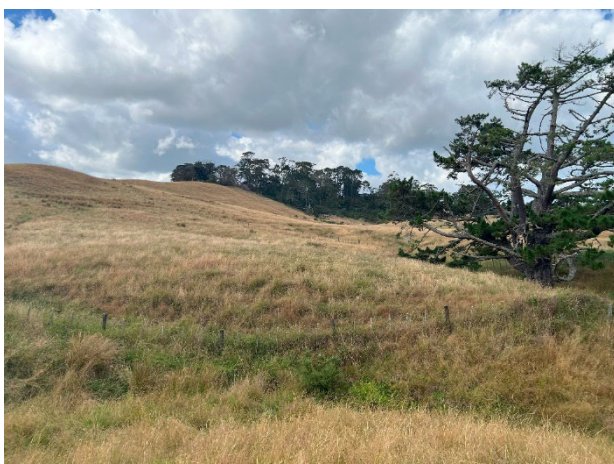
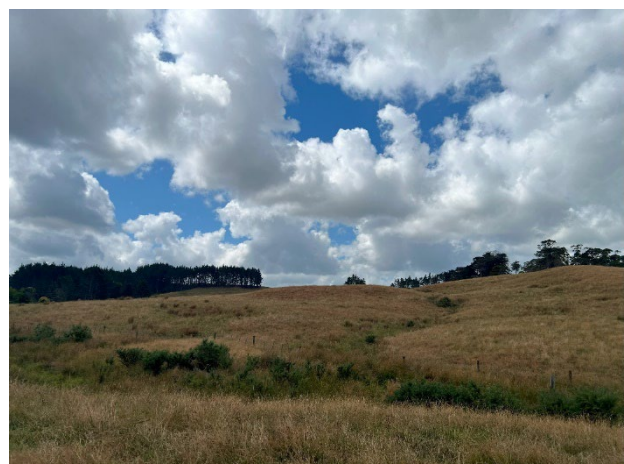
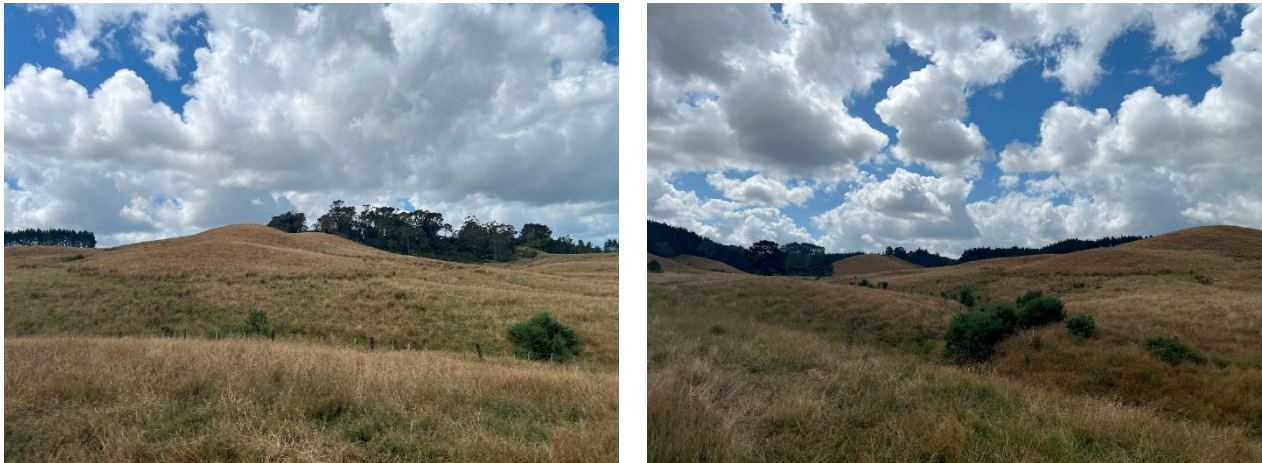
Figure 28. a - d) Photos showing the proposed wetland offset site where 2.81 ha of new wetland will be created.

The new offset wetland has a potential WEV score of 0.755. The potential score was also calculated, assuming the proposed enhancement actions are undertaken. These enhancement actions include extending/joining the adjacent wetlands, planting of the wetlands with appropriate native species, planting a 10 m buffer with appropriate native species, weed and pest control, stock fencing and legal protection (e.g., covenant). It is recommended that a wetland planting and management plan is required as a condition of consent to ensure successful establishment of a native wetland ecosystem.
