Ecological Impact Assessment

Milldale - Stages 10-13

Document title	Ecological Impact Assessment				
	Milldale - Stages 10-13				
Prepared for	Fulton Hogan Land Development Limited				
Version Final 1					
Date	ate 26 February 2025				
Document number 10015-030-1

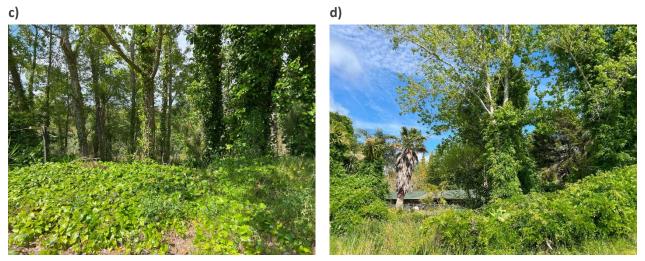
Figure 5. Vegetation within Stage 11, showing a-b) examples of exotic and native tree vegetation, and c-d) showing prevalent ivy under pine tree stand, and a high weed abundance around exotic tree and amenity plantings.

The eastern part of Stage 11 was characterized by mixed exotic-dominant vegetation, including a stand of pine and areas of planted mixed exotic and native trees and shrubs. Some of this vegetation was within the riparian margins of watercourses 21, 35 and 37 (Appendix A). Around the constructed pond in Stage 11, mature exotic trees such as swamp cypress were present. One stand of mature gum trees (*Eucalyptus* sp.) was present within the eastern part of Stage 10, however this area lacked understorey vegetation entirely.

While pest plant presence was generally low across the site, the eastern portion of Stage 11 had higher infestations. Listed³ pest species observed included crack willow, hawthorn (*Crataegus monogyna*), Sydney golden wattle (*Acacia longifolia*), coastal banksia (*Banksia integrifolia*), English ivy (*Hedera helix*), monstera (*Monstera deliciosa*), watsonia (*Watsonia meriana*), Spanish heath (*Erica lusitanica*), palm grass (*Setaria palmifolia*), gorse (*Ulex europaeus*), tuber ladder fern (*Nephrolepis cordifolia*) and Chinese fan palm (*Trachycarpus fortunei*).

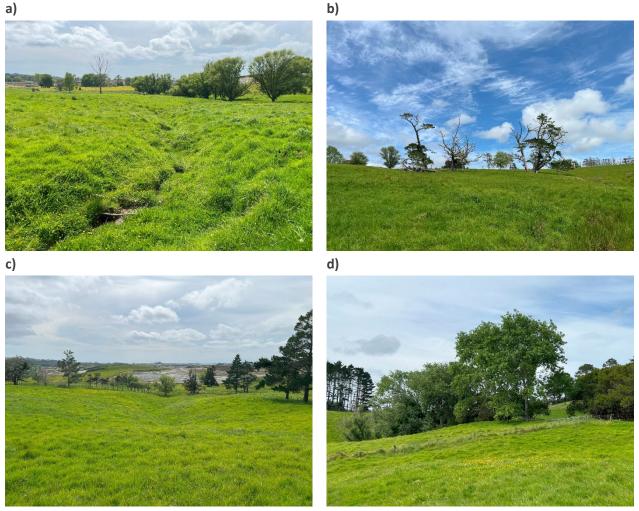
Figure 6. Isolated exotic trees such as crack willow, poplars and pines within a & b) Stage 12, and c & d) Stage 13 of the site.

In the pasture areas, isolated trees and shelterbelts consisted mainly of pine, poplar, crack willow, sheoak, and redwood (Figure 6). Small stands of treeland and amenity plantings, often featuring mixed exotic and native species, were more prevalent around rural residential dwellings.

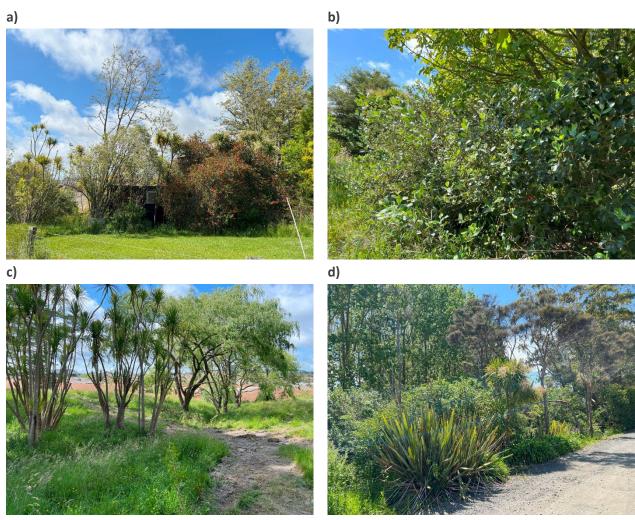
Figure 7. Examples of indigenous vegetation within the site, showing a) exotics and scattered natives (e.g., cabbage trees, tōtara) within the east of Stage 11, b) karamū amongst garden vegetation within Stage 11, c) cabbage trees within the riparian margin of watercourse 36, and d) planted natives such as mānuka and flax along Lysnar Road in the east of Stage 10.

There were no native-dominant areas of vegetation within the site. Where present, indigenous tree vegetation was largely restricted to planted specimens, primarily located in the eastern area of Stage 11 amongst exotic species, and along the riparian margin of Watercourse 21. A small number of well-established cabbage trees (*Cordyline australis*) were present within the riparian margin of Watercourse 37 (Figure 7). Small trees such as *Pittosporum* sp. were occasionally observed planted in rows along fences in paddock areas.

Indigenous species identified within the site included kānuka, kahikatea, tōtara, cabbage tree, lemonwood (*Pittosporum eugenioides*), kawaka (*Libocedrus plumosa*), flax (*Phormium tenax*), karo (*Pittosporum crassifolium*), māpou (*Myrsine australis*), kōhūhū (*Pittosporum tenuifolium*), mānuka (*Leptospermum scoparium*), and karamū (*Coprosma robusta*).

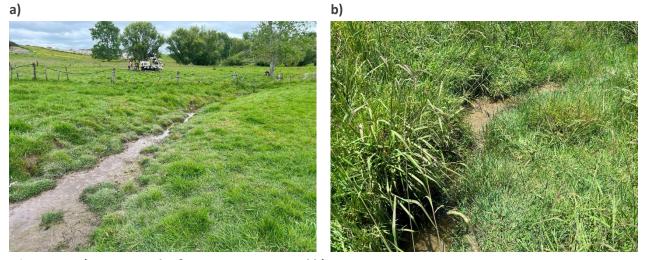
Figure 11. a) Lower reach of watercourse 27, and b) watercourse 20.

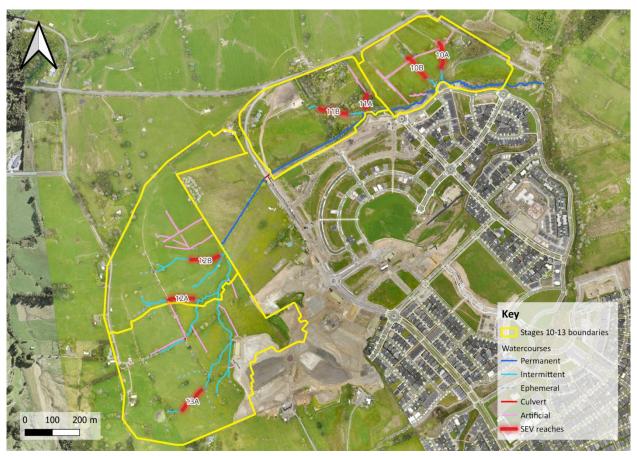
Figure 12. Map of the project site showing locations of SEV assessments undertaken by Viridis.

low ecological and functional values. Low SEV function scores generally reflect the poor-quality habitat for aquatic fauna and the poor macroinvertebrate diversity (Section 5.1.4), and the highly modified and degraded nature of the channels and riparian margins.

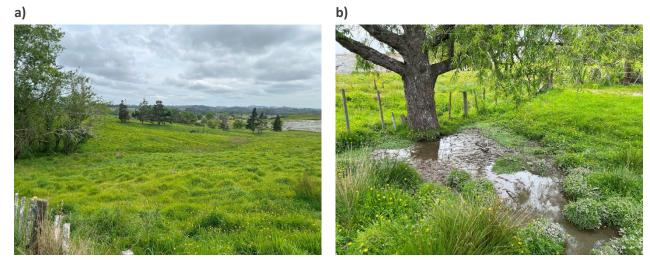
Figure 15. a) View looking across at Wetlands C and D from the south, and b) Wetland G showing pooling shallow water backing up against the fence upstream of a farm culvert.

Vegetation communities were similar across each of these wetlands, consisting primarily of exotic herb tier vegetation with occasional natives. Species recorded in these areas included soft rush (*Juncus effusus* – FACW), mercer grass (*Paspalum distichum* – FACW), sharp spike sedge (*Eleocharis acuta* – OBL), *Isolepis prolifera* (OBL), *Isolepis reticularis* (FACW), creeping buttercup (*Ranunculus repens* – FAC), curled dock (*Rumex crispus* – FAC), toad rush (*Juncus bufonius* – FACW), hairy buttercup (*Ranunculus sardous* – FAC), creeping bent (*Agrostis stolonifera* – FACW), Yorkshire fog (*Holcus lanatus* – FAC), wiwi (*Juncus edgariae* – FACW), lotus (*Lotus pedunculatus* – FAC) and sweet vernal (*Anthoxanthum odoratum* – FACU). The species composition observed across these areas was typical of degraded wetlands on rural land with a history of grazing. Examples of the degraded wetlands are shown in Figure 15 and Figure 16.

The ecological value of Wetlands A, C-H, J, K, M, N, P and Q was considered to be **low**, due to their degraded nature, relatively small size, lack of indigenous flora biodiversity, general lack of structural tiers which limited habitat availability, and negligible aquatic habitat.

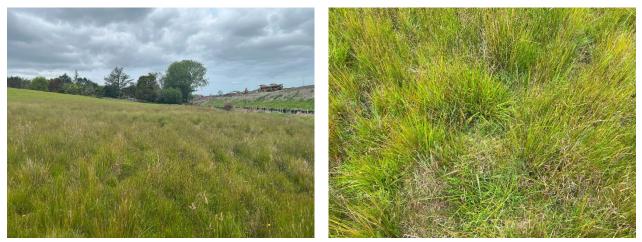
Figure 16. Wetland vegetation present within Wetland N that was limited to an exotic herb tier and contained vegetation such as Juncus spp., Isolepis spp. and creeping bent.

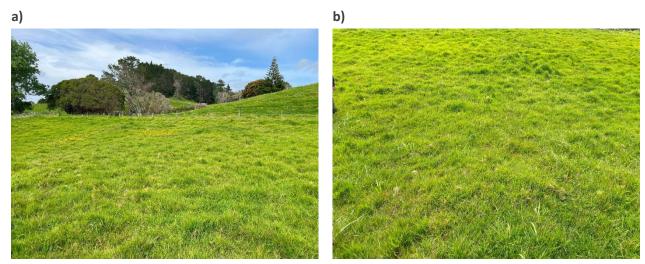
Figure 20. a) Areas on the hillside in Stage 13 showing creeping bent mixed in with pasture species such as kikuyu and dallis grass.

To provide an example of the site's patchy FACW species coverage, three plots were undertaken in Stage 13 on an elevated area where creeping bent occurred amongst FACU vegetation (Figure 20). The results of the plots are summarised in Table 6 below, and the plot locations map and data shown in Appendix F. The plots were taken approximately 3 m apart; however, the results came out different in each plot for wetland/non-wetland vegetation. It should be noted the area where the plots were undertaken showed no evidence of soil saturation or wetland hydrology during the site visits, or on recent or historic aerial imagery.

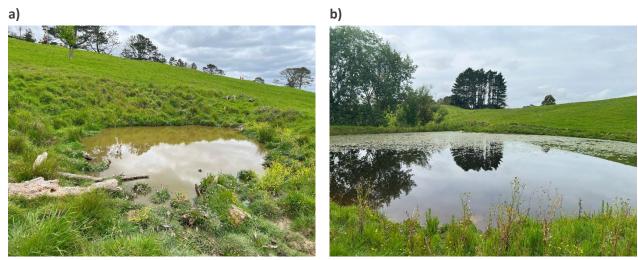
Figure 22. Examples of constructed ponds within the site, within a) Stage 12 and b) Stage 13.

Due to the poor water quality, isolated and artificial nature, poor habitat quality (e.g., lack of flow and hydrological heterogeneity), and likelihood of only a single common native fish species presence, the constructed ponds within the site were considered to be of a **low** ecological value.

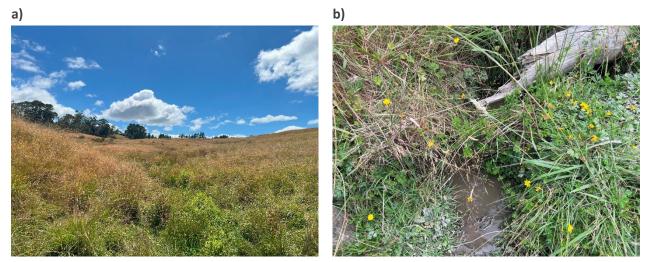
Figure 26. a) SEV 2 reach facing upstream, and b) an example of the SEV 3 intermittent stream channel.

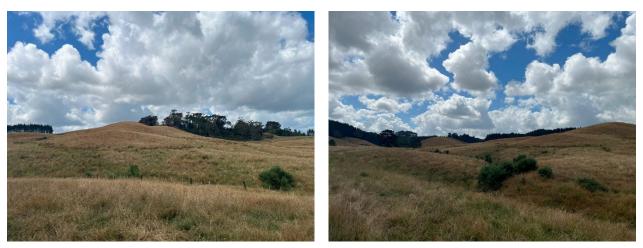
Figure 28. a - d) Photos showing the proposed wetland offset site where 2.81 ha of new wetland will be created.
