# Assessment of Potential Effects on Birds of the Proposed Stella Passage Development for Port of Tauranga

Contract Report No. 7339a

April 2025

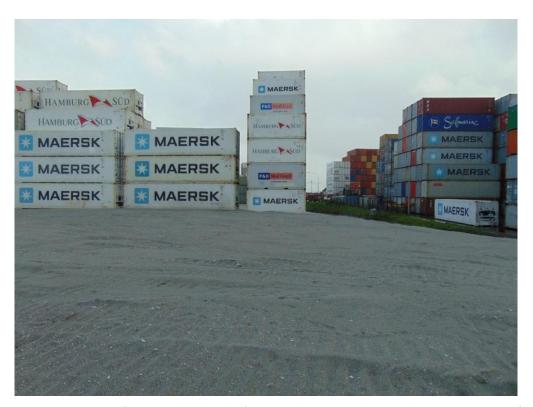
Plate 1 – A view of the northern end of the sand pile, showing the proximity to wharf activities, and the recent use of the site by tracked vehicles.

The sand pile is an active work site (Plate 1); it is used for the deposition of dredged sand from the Stella Passage, and the sand is occasionally taken for use for beach regeneration around the Tauranga area.

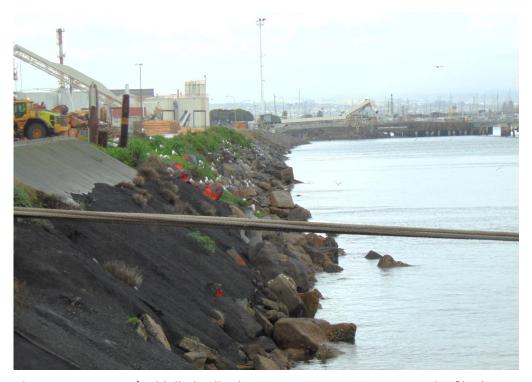
**Plate 4** – Tarāpunga/red-billed gull colony site at Mount Maunganui Wharf looking south, showing the proximity of the working wharf area including moorings. Also visible is an asphalt and concrete surface (left) installed to discourage birds from nesting. Photograph July 2019, before nesting.

The presence of the colony at the Mount Maunganui Wharf has created a health and safety issue for POTL. Dock workers are dive-bombed while working, and in particular, tying mooring ropes; mooring ropes and other surfaces are covered in gull faeces which become slippery when wet; and there is concern regarding the potential for spread of infectious organisms from faeces. Attempts have been made to reduce attacks by construction of overhead shelters to protect staff (Plate 5), and to encourage the birds to move by covering the seawall with concrete and asphalt (Plate 4). However, the birds have only moved slightly further south, and continue to dive-bomb dock workers.

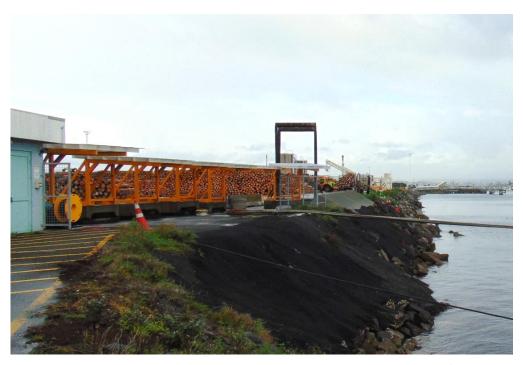
**Plate 5**— Overhead shelters built to protect dock workers from tarāpunga/red-billed gull attacks during the breeding season. Red-billed gull colony site visible in far distance. Photograph in July 2019, before nesting.

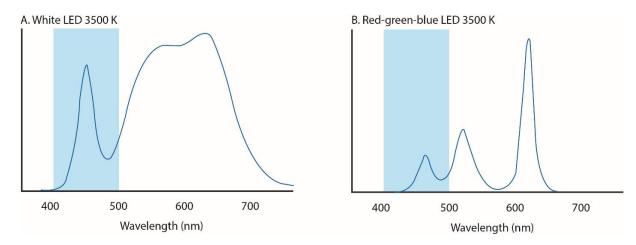
Figure 1: A comparison of the blue wavelength spectral content of two LED lights with the same CCT (3500k). The blue band shows the blue region of the visible spectrum (400–500 nm). The light in A has a much greater blue light content than B yet the two appear to the human eye as the same colour. For animals with differing sensitivities to light wavelength from humans, they may appear very different. Figure copied from National Light Pollution Guidelines (2020).

The spectral composition of lights is thought to affect attraction by birds: white and blue light is highly attractive to all seabirds (kelvin  $\geq$  2200; Longcore *et al.* 2018). All seabirds are sensitive to the violet-blue spectrum and short wavelength (380-500 nanometres). Different LED lights can have the same colour-correlated temperature (CCT) but can have very different blue content (Figure 1). This light colouration, however, can appear the same to the human eye as we are not sensitive to violet-blue spectrum.

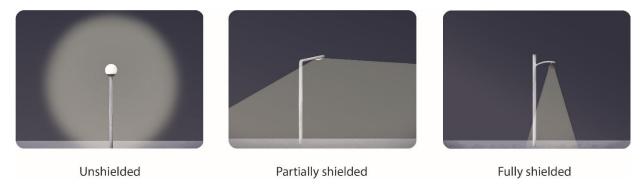
**Figure 3:** Lights should be shielded to avoid lighting anything but the target area or object. Figure copied from National Light Pollution Guidelines (2020).

The direction of the light is also extremely important. All lights must be fully shielded from above and directed onto the intended object or area to prevent light pollution and the attraction of avifauna (Figure 3). It is also important to assess the type of material the lights are directed toward. It is important that surfaces are of low reflective surface (e.g. avoid surfaces that are highly polished, shiny or of a light colour, such as white paint).

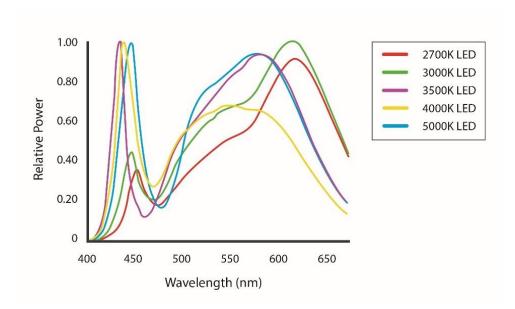
**Figure 4:** Spectral curves showing the blue content of white 2700-5000 K LED lights. Note the difference in relative power output in the blue (400-500 nanometre) wavelength range. Figure copied from National Light Pollution Guidelines (2020).

Colour correlated temperature (CCT) of a light source is one way to minimise the potential for adverse effects on avifauna. Although all LEDs contain blue light, use of a low kelvin bulb reduces the CCT. Lamps containing a warm yellow colour are of a low colour temperature (between 1000-3000 kelvin), whereas cool bluish lamps have a colour temperature over 5000 kelvin. For birds that are sensitive to blue light, LEDs with a low amount of short wavelength should be used (e.g. 2700-3500 kelvin; Figure 4). If lighting must be nearer 6000 kelvin for human safety requirements, low light intensity, long wavelength (e.g. over 560 nanometres), and downward-facing lights illuminating only the intended object or area as practicable, including motion sensor lighting where appropriate.
