**BULLER PLATEAUX CONTINUATION PROJECT,  
WESTPORT, SOUTH ISLAND:  
ARCHAEOLOGICAL AND HISTORIC HERITAGE  
ASSESSMENT  
(PART 4 – STOCKTON AND PEST EXCLUSION FENCES)**

Prepared for Bathurst Resource Ltd

April 2026

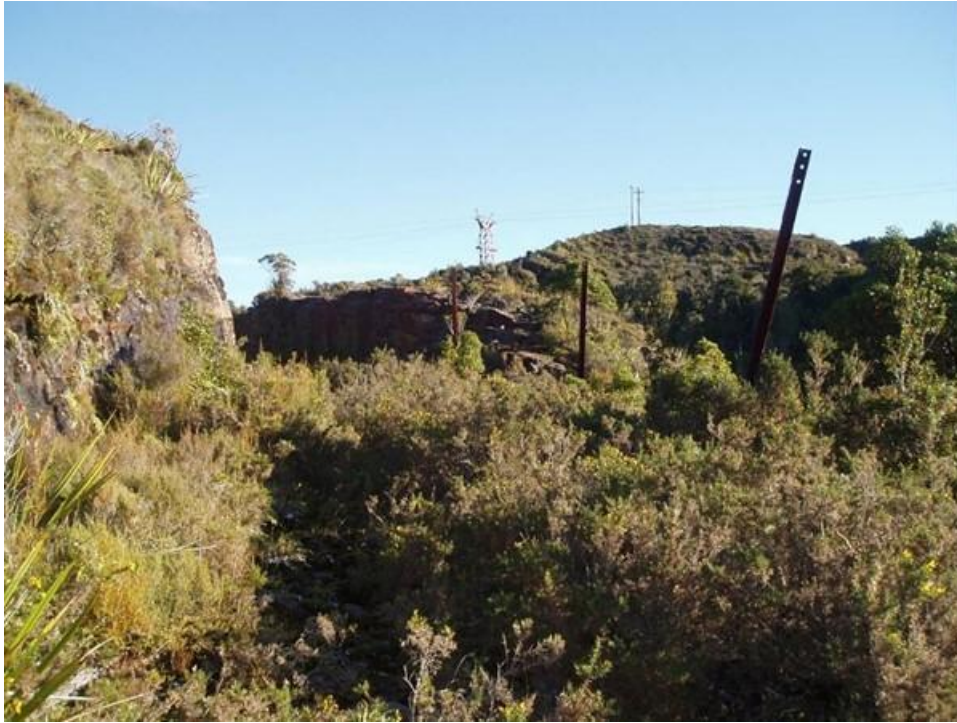
**Figure 10. A cutting through rock on the Loco Line on the First Section. Note the power poles to the right and the aerial cableway in the distance (Watson Jul 2008)**

The cutting ends shortly before the Loco Line enters 'A' Tunnel and the line has been benched around a rock face (Figure 11). An old coal tub lies at the end of the cutting (Figure 12) and there are various metal and electrical artefacts scattered along the embankment between this point and the tunnel entrance, some of which will be associated with the substation that was at this entrance. The tunnel entrance is in good condition and timbers can be seen inside the tunnel (Figure 13). Here, the Electric Loco Line ran underground through 'A' and 'B' Tunnels, emerging briefly from 'A' Tunnel to cross a small stream before entering 'B' Tunnel (Figure 14). The first section of the line was built as far as the end of 'B' Tunnel (Figure 15).

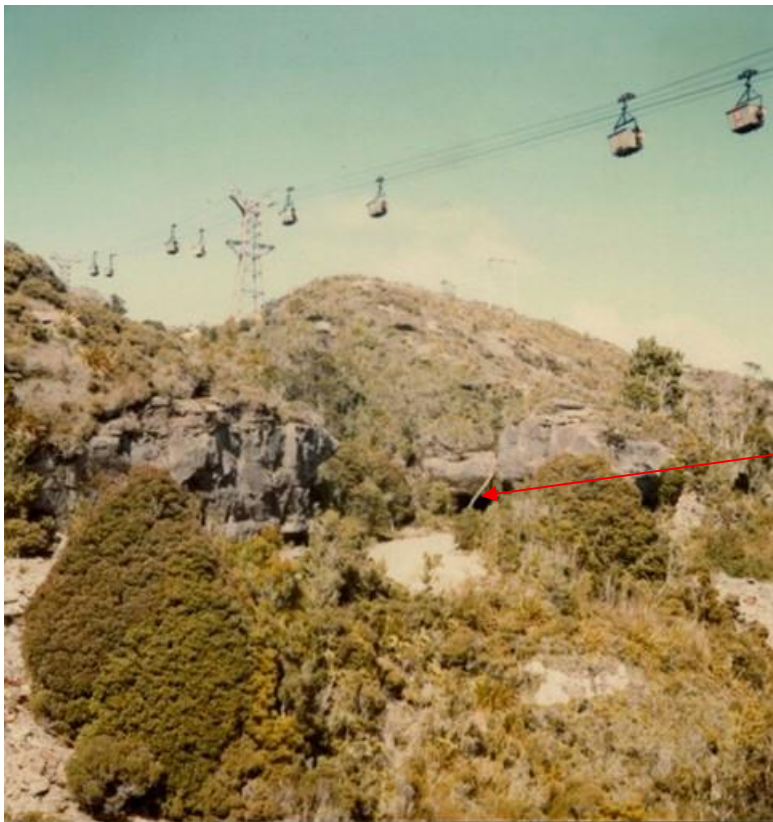
**Figure 11. View from the Mine Creek Pack-Track of aerial cableway crossing the electric railway. 'A' tunnel entrance is in centre of photo (arrowed) (source: Sumner and Sumner 1983)**

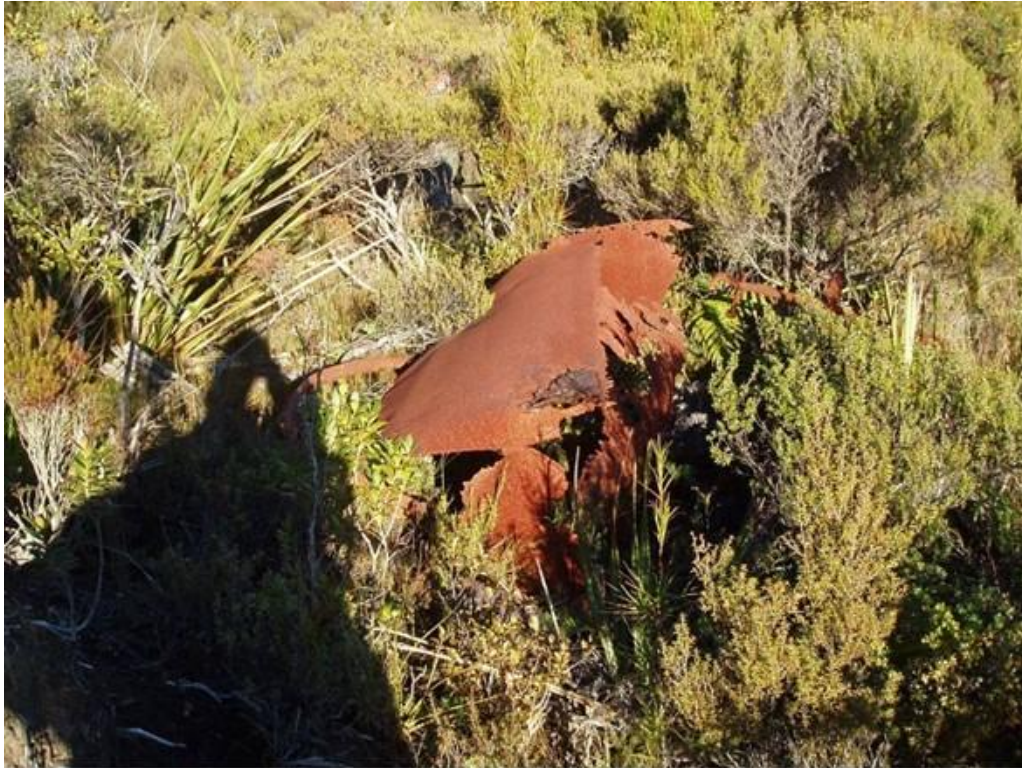
**Figure 12. The remains of a coal tub adjacent to the Electric Loco Line adjacent to the First Section (Watson Jul 2008)**

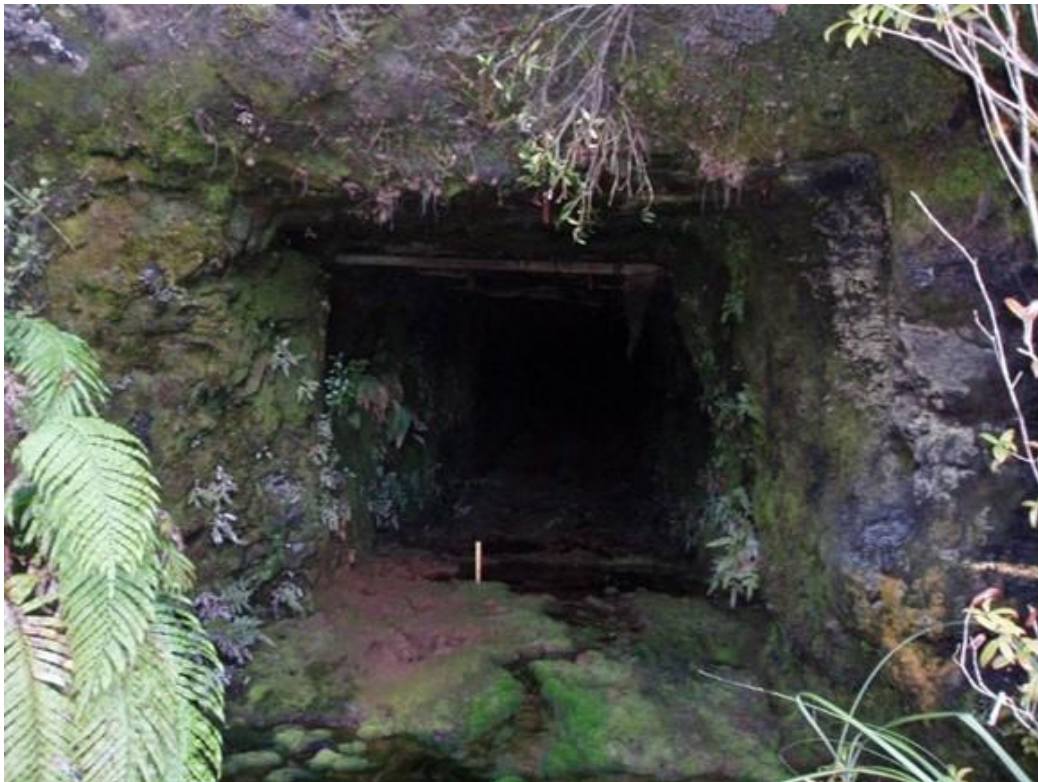
**Figure 13. 'A' Tunnel portal (Waypoint 761) (Watson Jul 2008)**

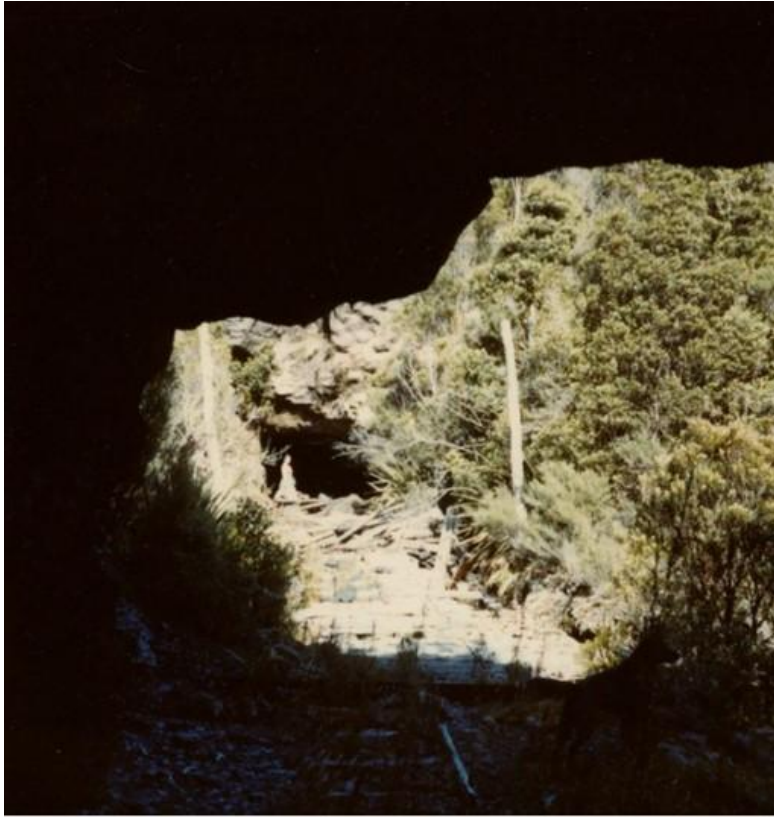
**Figure 14. View of the 'B' Tunnel from 'A' Tunnel (source: Sumner and Sumner 1983)**

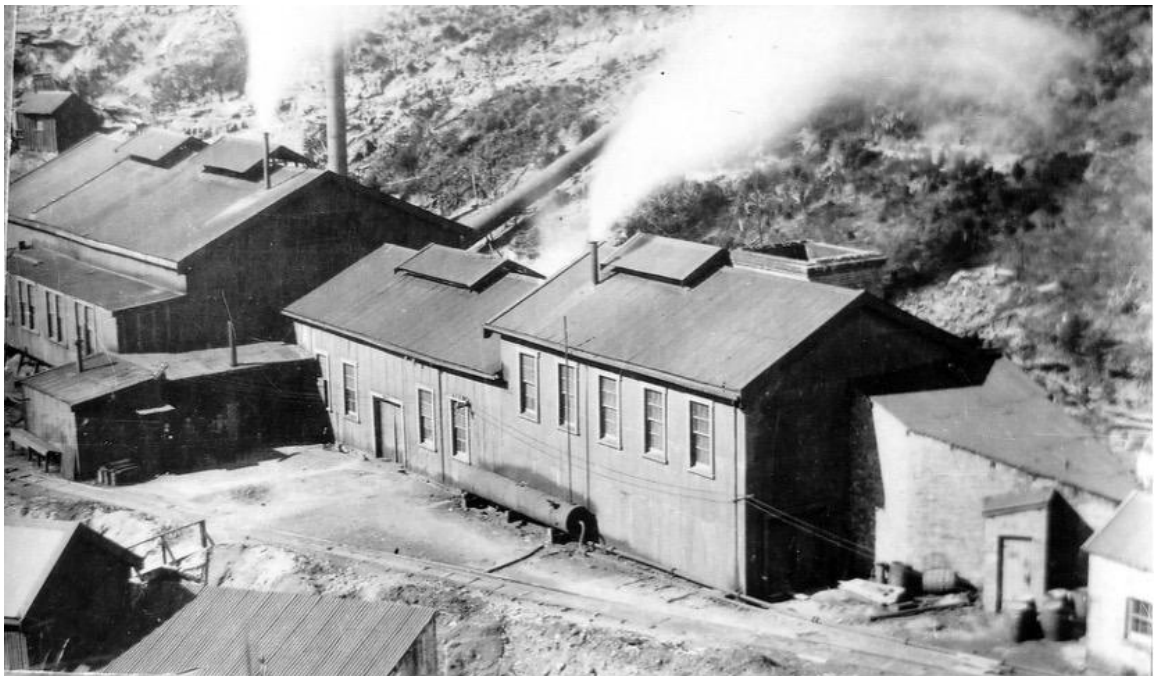
**Figure 20. Boiler and air compressor sheds at Mine Creek (source: Coaltown Museum (Ref: MN56) in Watson 2007 Plate 9 Pg. 55)**

Construction of the Mine Creek mine infrastructure began in 1899, when the boiler shed and air compressor house at Mine Creek were built (Figure 20). It is not clear when people began to live at Mine Creek, but it is possible that people were living there while the infrastructure was being built and that more came following the start of mining. The mining township appears to have been abandoned in the 1930s and the powerhouse somewhat later (Figure 21).<sup>7</sup>

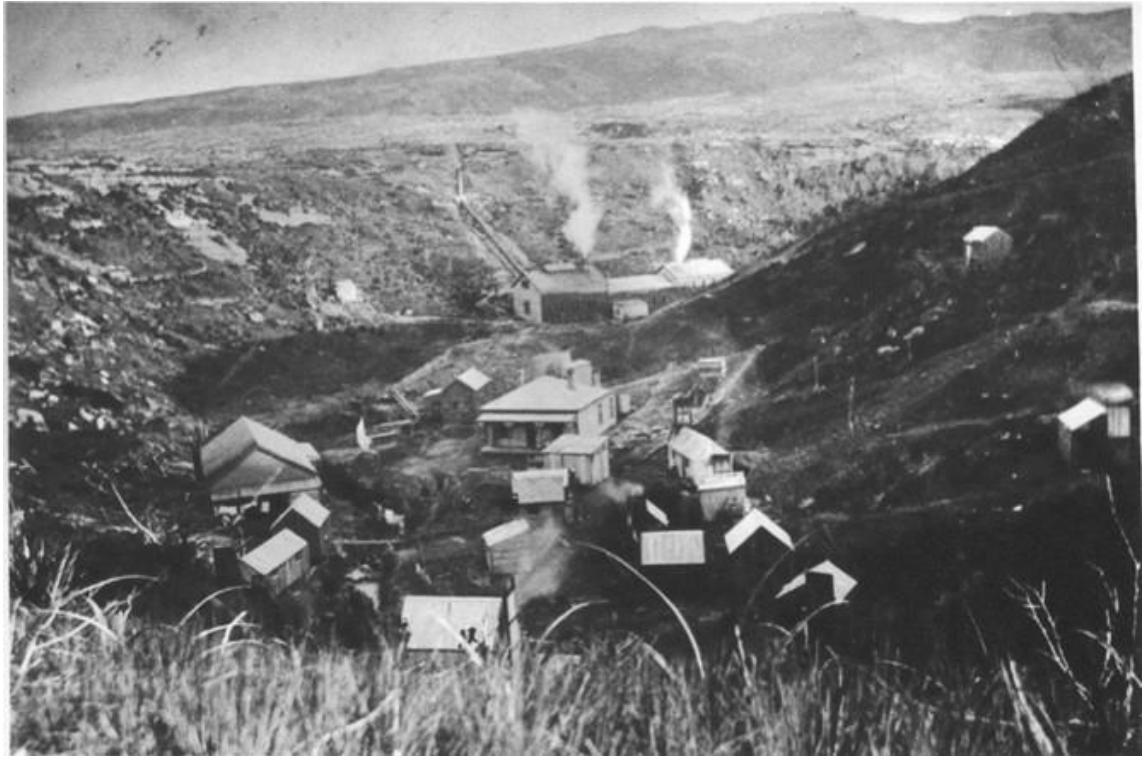
**Figure 21. Looking south over Mine Creek settlement, with the air compressor and boiler sheds smoking in the background. There is no known date for this photograph but it is likely to be one of the earliest taken of Mine Creek (source: Granity Museum; in Watson 2007:16, Plate 2 Pg.51)**

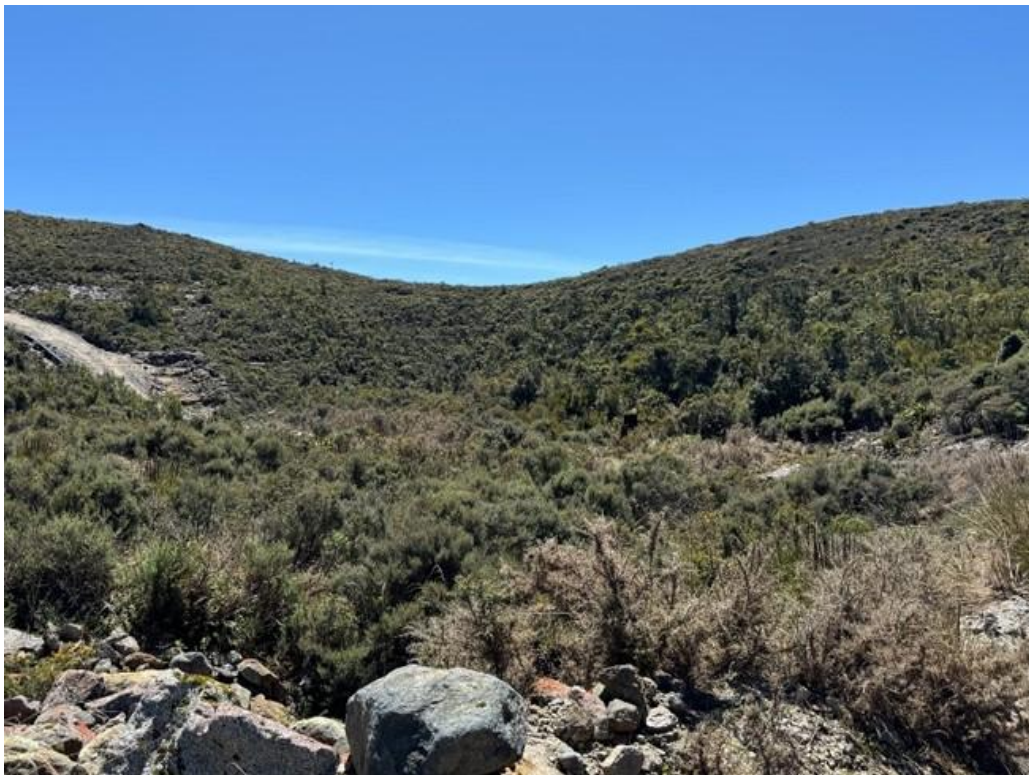
**Figure 27. Looking north from the mine road across the former site of the Mine Creek Settlement under vegetation in the valley (2024)**

The settlement is overgrown with thick gorse and dense low growing vegetation, making it difficult to identify any but the more prominent features (Figure 27). However, there has been considerable modification to the Mine Creek Settlement site by recent mining activities and prior archaeological investigation under the archaeological Authority. A mining road and water pipeline has been constructed through the centre of the site (Figure 28). Mine Creek has also been dammed to create a large reservoir immediately north and in front of the air compressor sheds and fan house (Figure 25 and Figure 29).

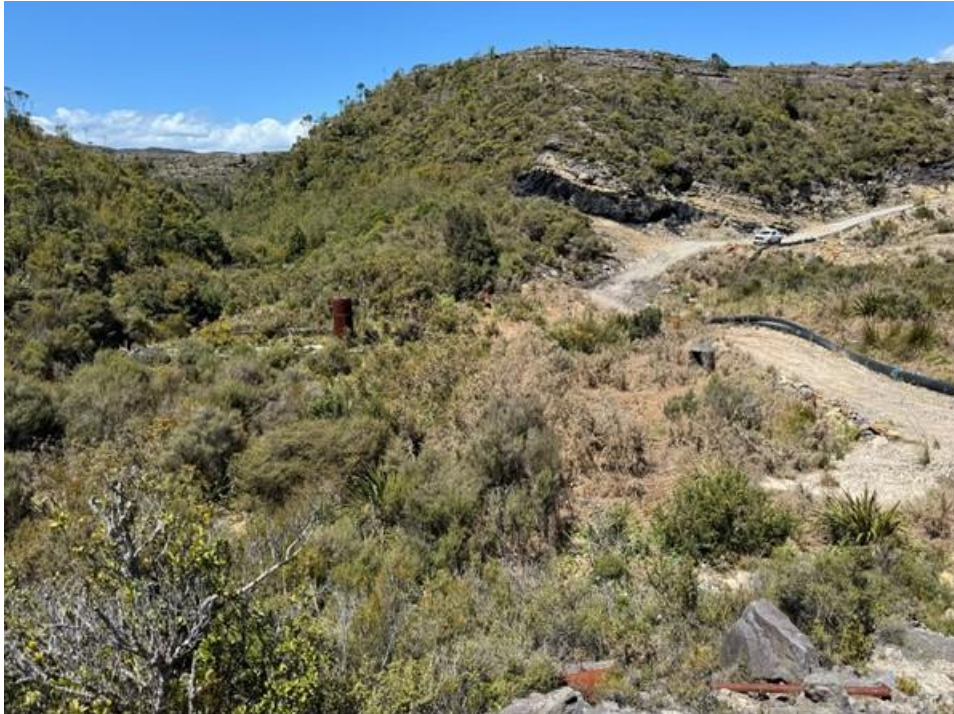
**Figure 28. Looking east over the settlement with the mine road through the Mine Creek Settlement site (right), and structural remains of a vertical boiler, a brick fireplace and chimney, a second brick structure, a concrete block and a concrete foundation (wypts 23 and 25, left); and possibly the remains of the wash house (the chimney and a copper base) and the bath house (the concrete foundation and boiler) (2024)**

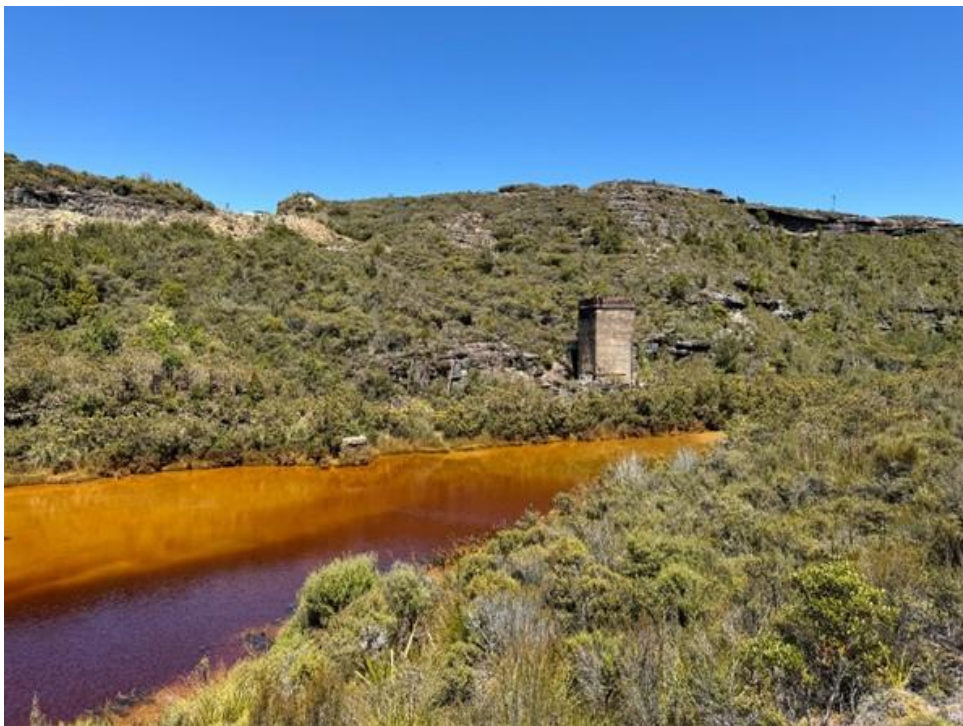
**Figure 29. Looking south across the mine reservoir that encompasses Mine Creek to the brick ventilation flue and associated concrete foundations (wypt 101). The site of the air compressor and boiler sheds (wypts 52 and 53) is located on the terrace left of the brick flue (2024)**

The brick ventilation flue for the fan house is the most prominent structure remaining south of the reservoir (Figure 29). However, other heritage sites were identified including the remains of the wash house and the bath house (wypts 23 and 25) and pack track (wypts 2, 3, 4 and 5) (Figure 30–Figure 32). Other remaining features were hidden beneath the vegetation.

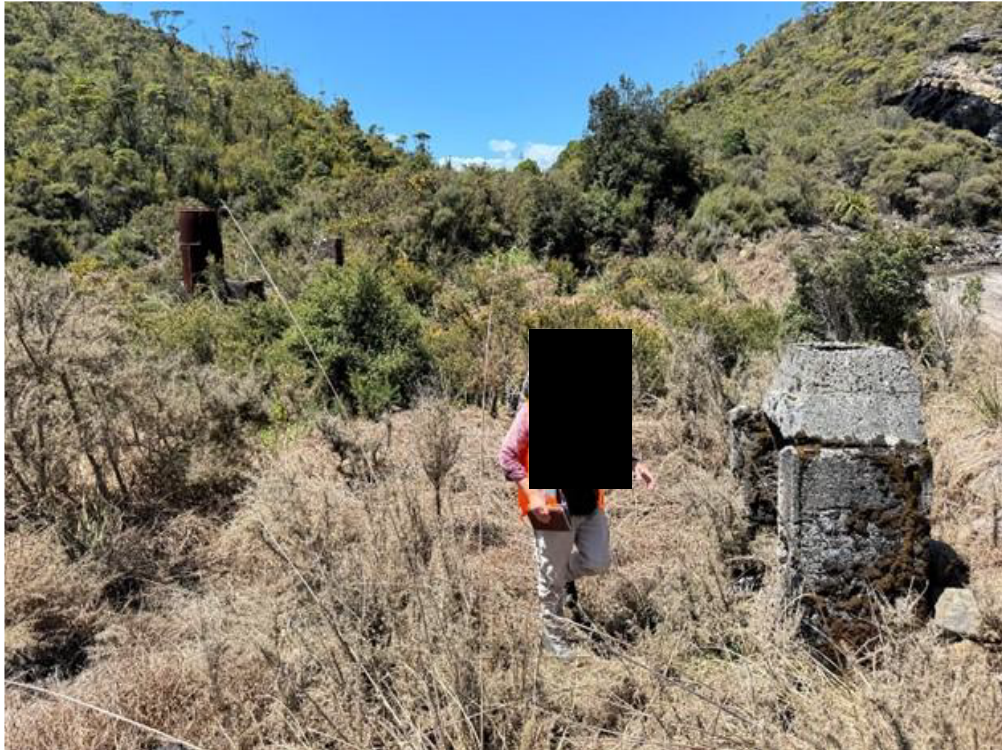
**Figure 30. Remains of the wash house (the fireplace with brick chimney and a copper base in foreground) and the bath house (the concrete foundation and boiler in the background left) at wypts 23 and 25 (2024)**

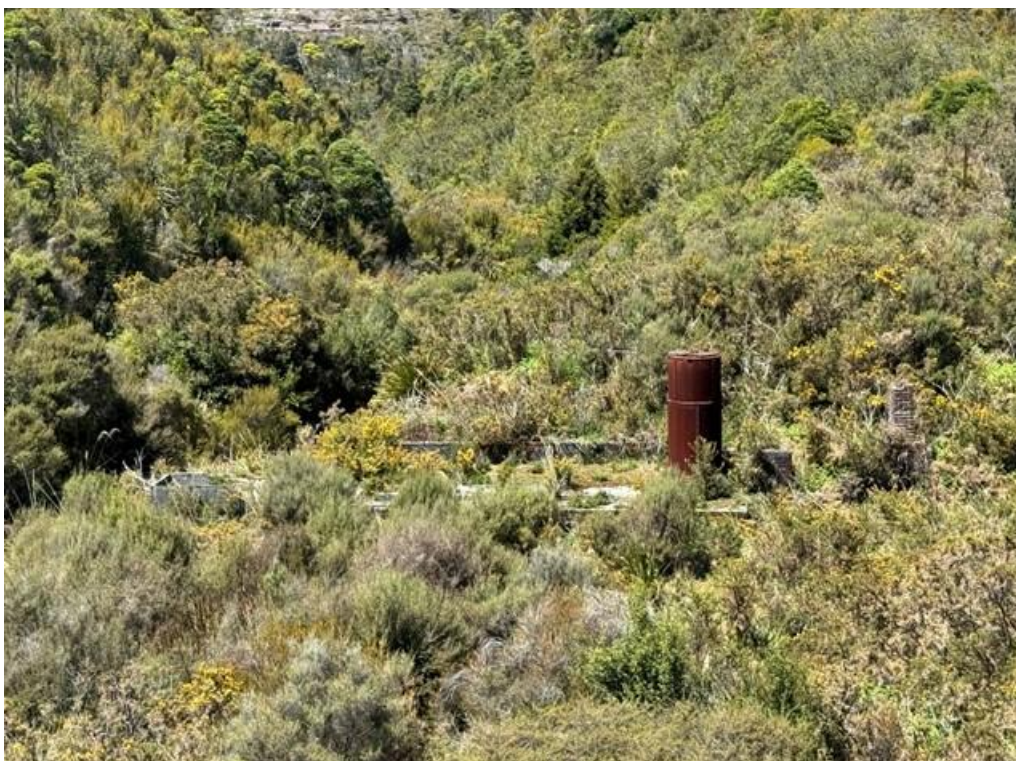
**Figure 31. Close-up of structural remains (the concrete foundation and boiler) at wypts 23 and 25 (2024)**

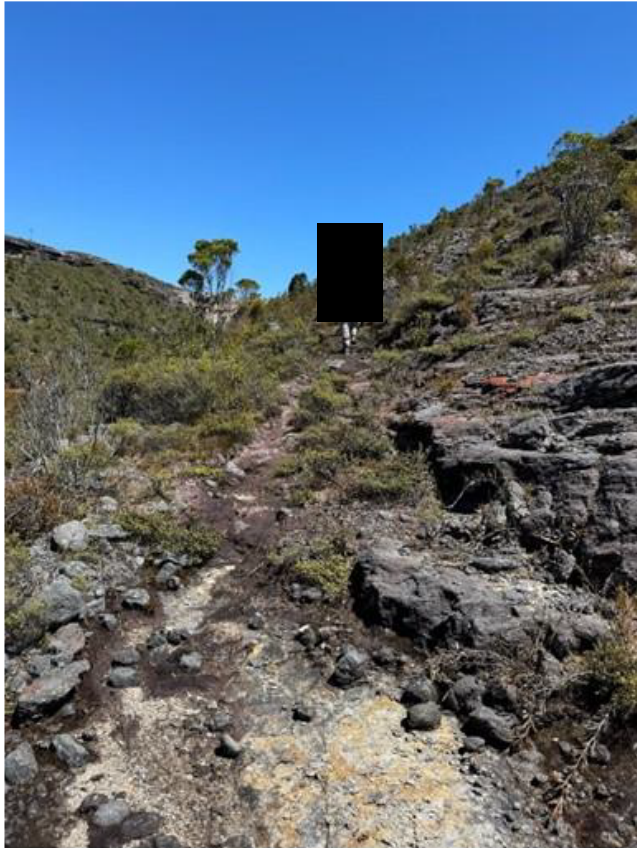
Figure 32. Remains of the pack track on the true left of Mine Creek (wypts 3, 4 and 5) (2024)

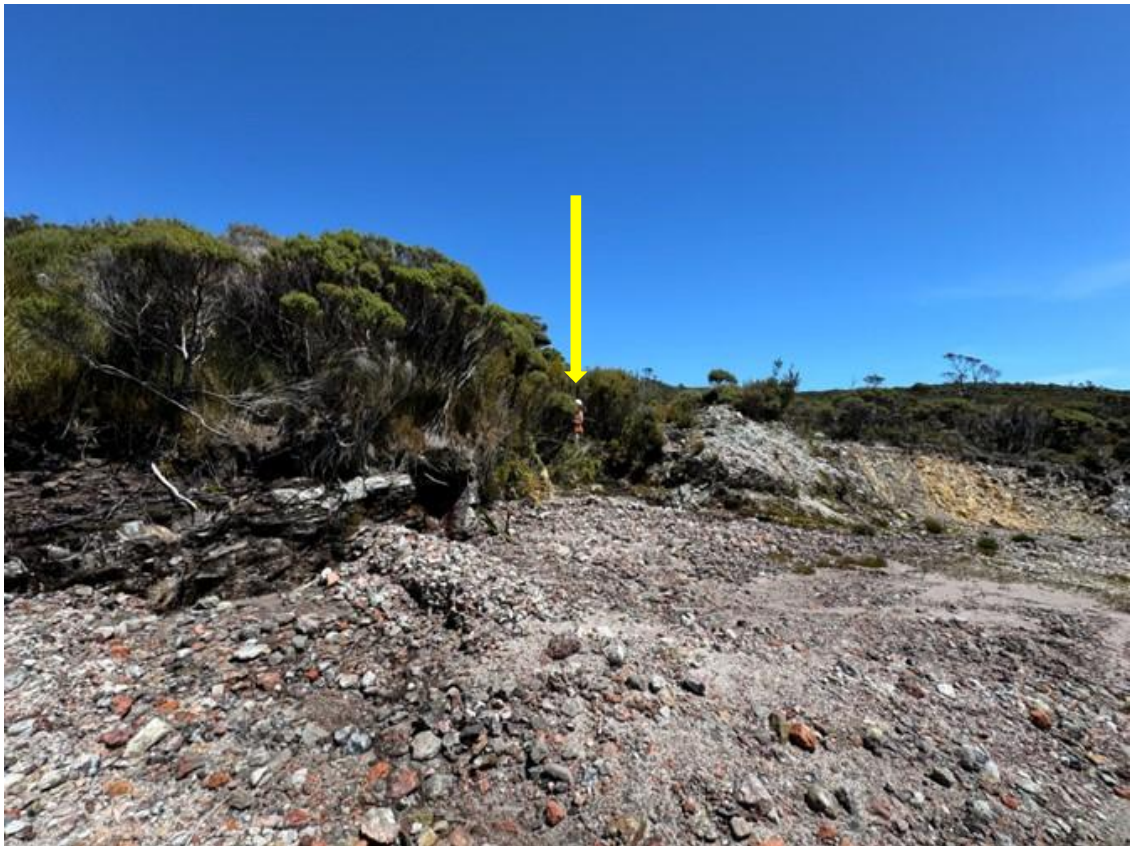
A section of Jorgen's Drive was relocated in November 2024. The drive has been intercepted and modified by modern mining where roads have been cut through the drive in at least two places along its length (Figure 37). Otherwise, the drive appears to remain intact and undamaged but covered in thick tussock, manuka and other native scrub (Figure 38 and Figure 39).

**Figure 37. Looking southwest from the mine road that has cut through and removed a section of the drive. The second author (arrowed) stands in the southern surviving section**

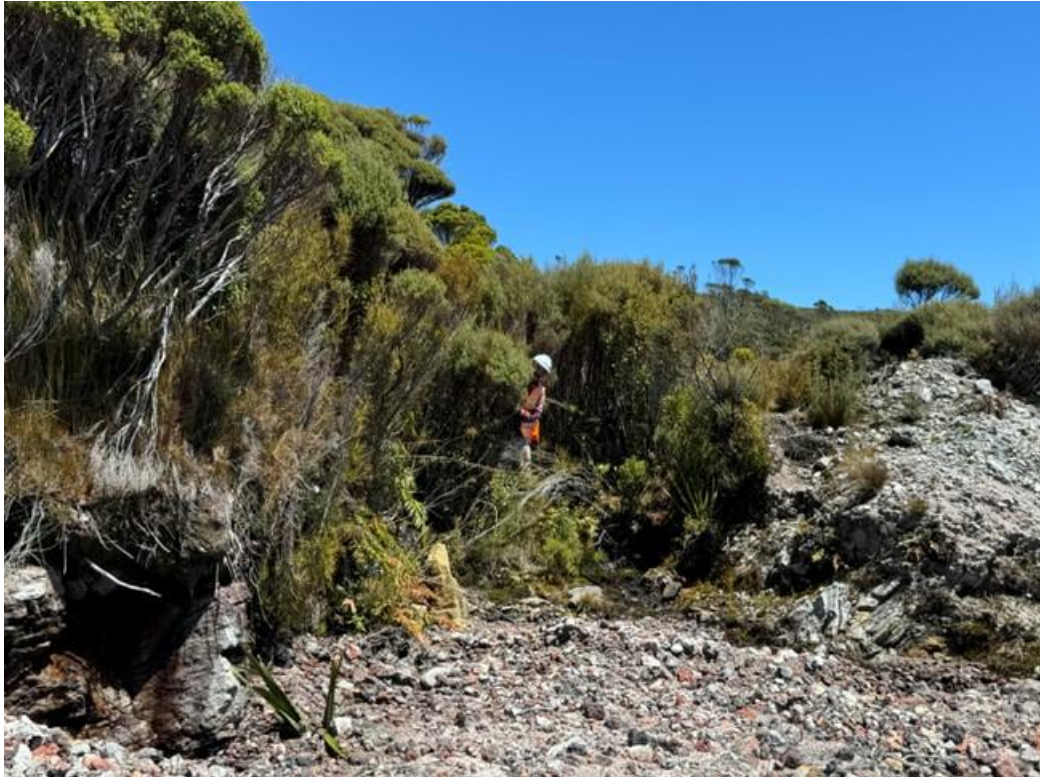
**Figure 38. A close-up of Figure 32 showing the scale of the tramway cutting formation now covered in vegetation**

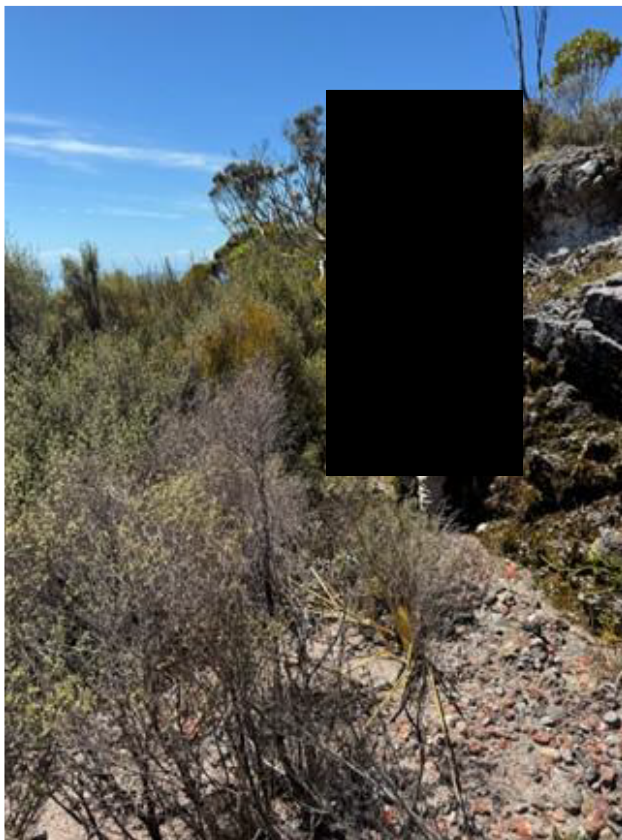
**Figure 39. Looking northeast with one of the authors standing in the tramway cutting formation**

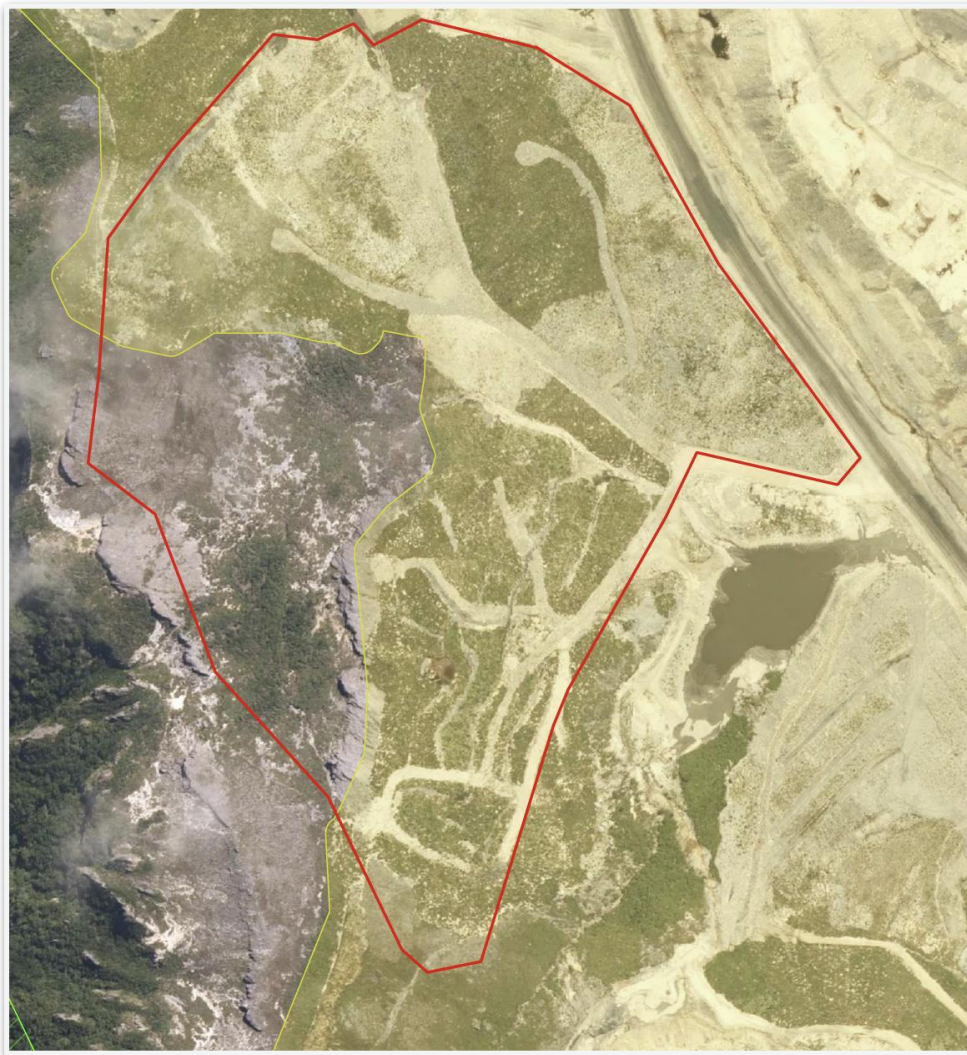
Figure 44. The proposed fence route for the Mt Augustus site (outlined in red) on Stockton Plateau

The proposed Stockton Mt Augustus fence will enclose 14.63 hectares (ha) (Figure 44). Approximately 40% of the proposed fence route is on existing roads and tracks, with the remainder requiring establishment. In most places this would be achieved by bulldozing a 3m wide bench. A 10m long section down a cliff would have to be built by hand.

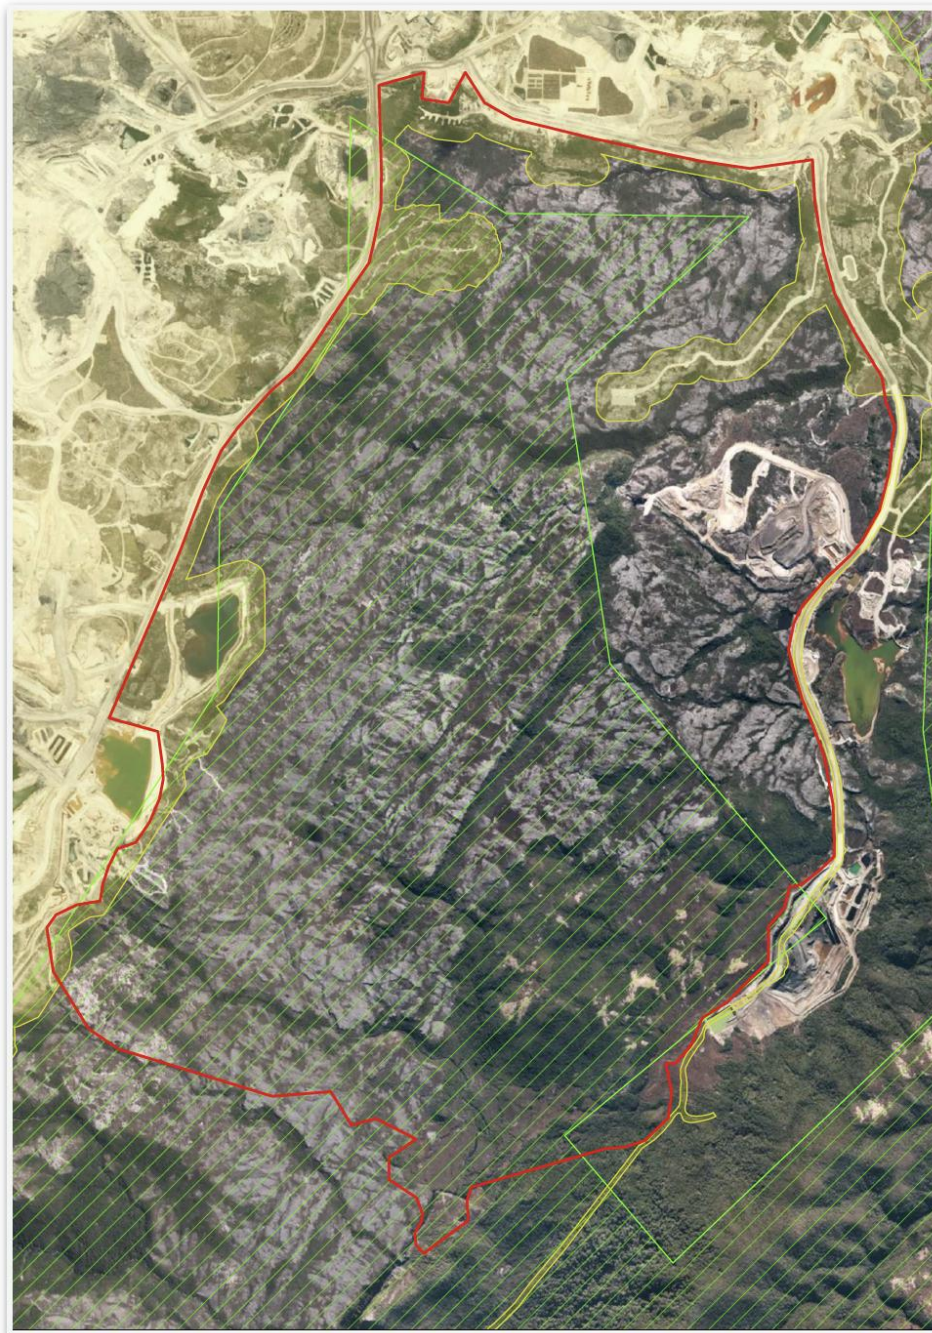
**Figure 46. The proposed Whirlwind Rise site (outlined in red) on Stockton Plateau**

The proposed Stockton Whirlwind fence is the longest (11,930m) of the proposed fences on the two plateaux and by far the largest of the proposed enclosures (nearly 700 ha) (Figure 46). About 75% of the proposed fence will be built on or alongside existing roads and tracks, with minimal additional earthworks required to establish a suitable platform. The build platform for the remaining 30% will, however, have to be established from scratch on predominantly sandstone pavements to the south of Whirlwind Rise. Four large culverts and numerous smaller ones are required for stream crossings.
