August 2026

## Brymer Farms Development Ecological Impact Assessment

Submitted to:  
Pragma Homes

## Brymer Farms Development Lizard Management Plan

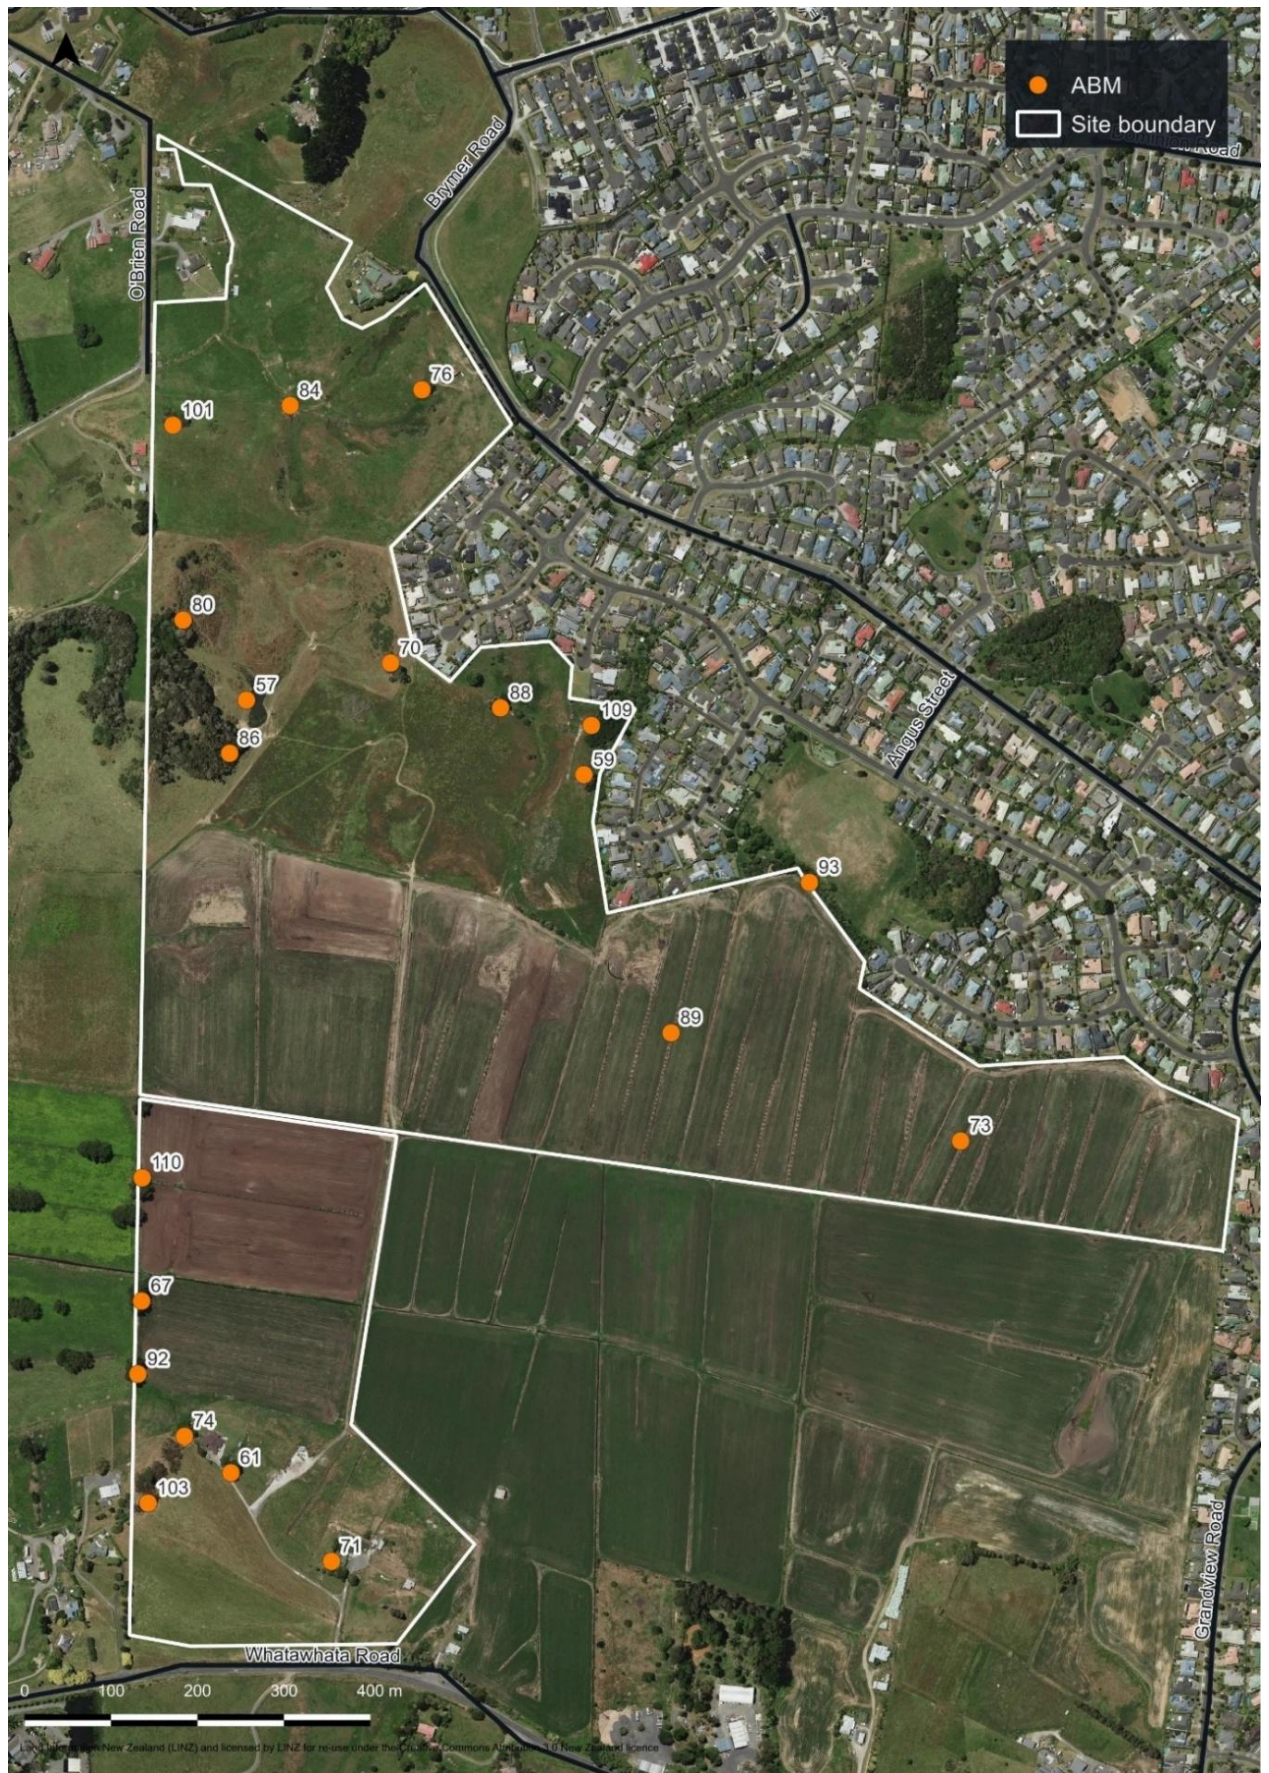
**Figure 3: Location of Automatic Bat Monitors.**

All acoustic data from the ABMs was analysed using BatSearch3.23 software developed by the Department of Conservation in accordance with the protocols described by Lloyd (2019). All potential echolocations identified via the automated software processing were verified by Paddy Stewart (Soundcounts) who holds competency 3.1 under the Department of Conservation Bat Roost Protocols (2024).

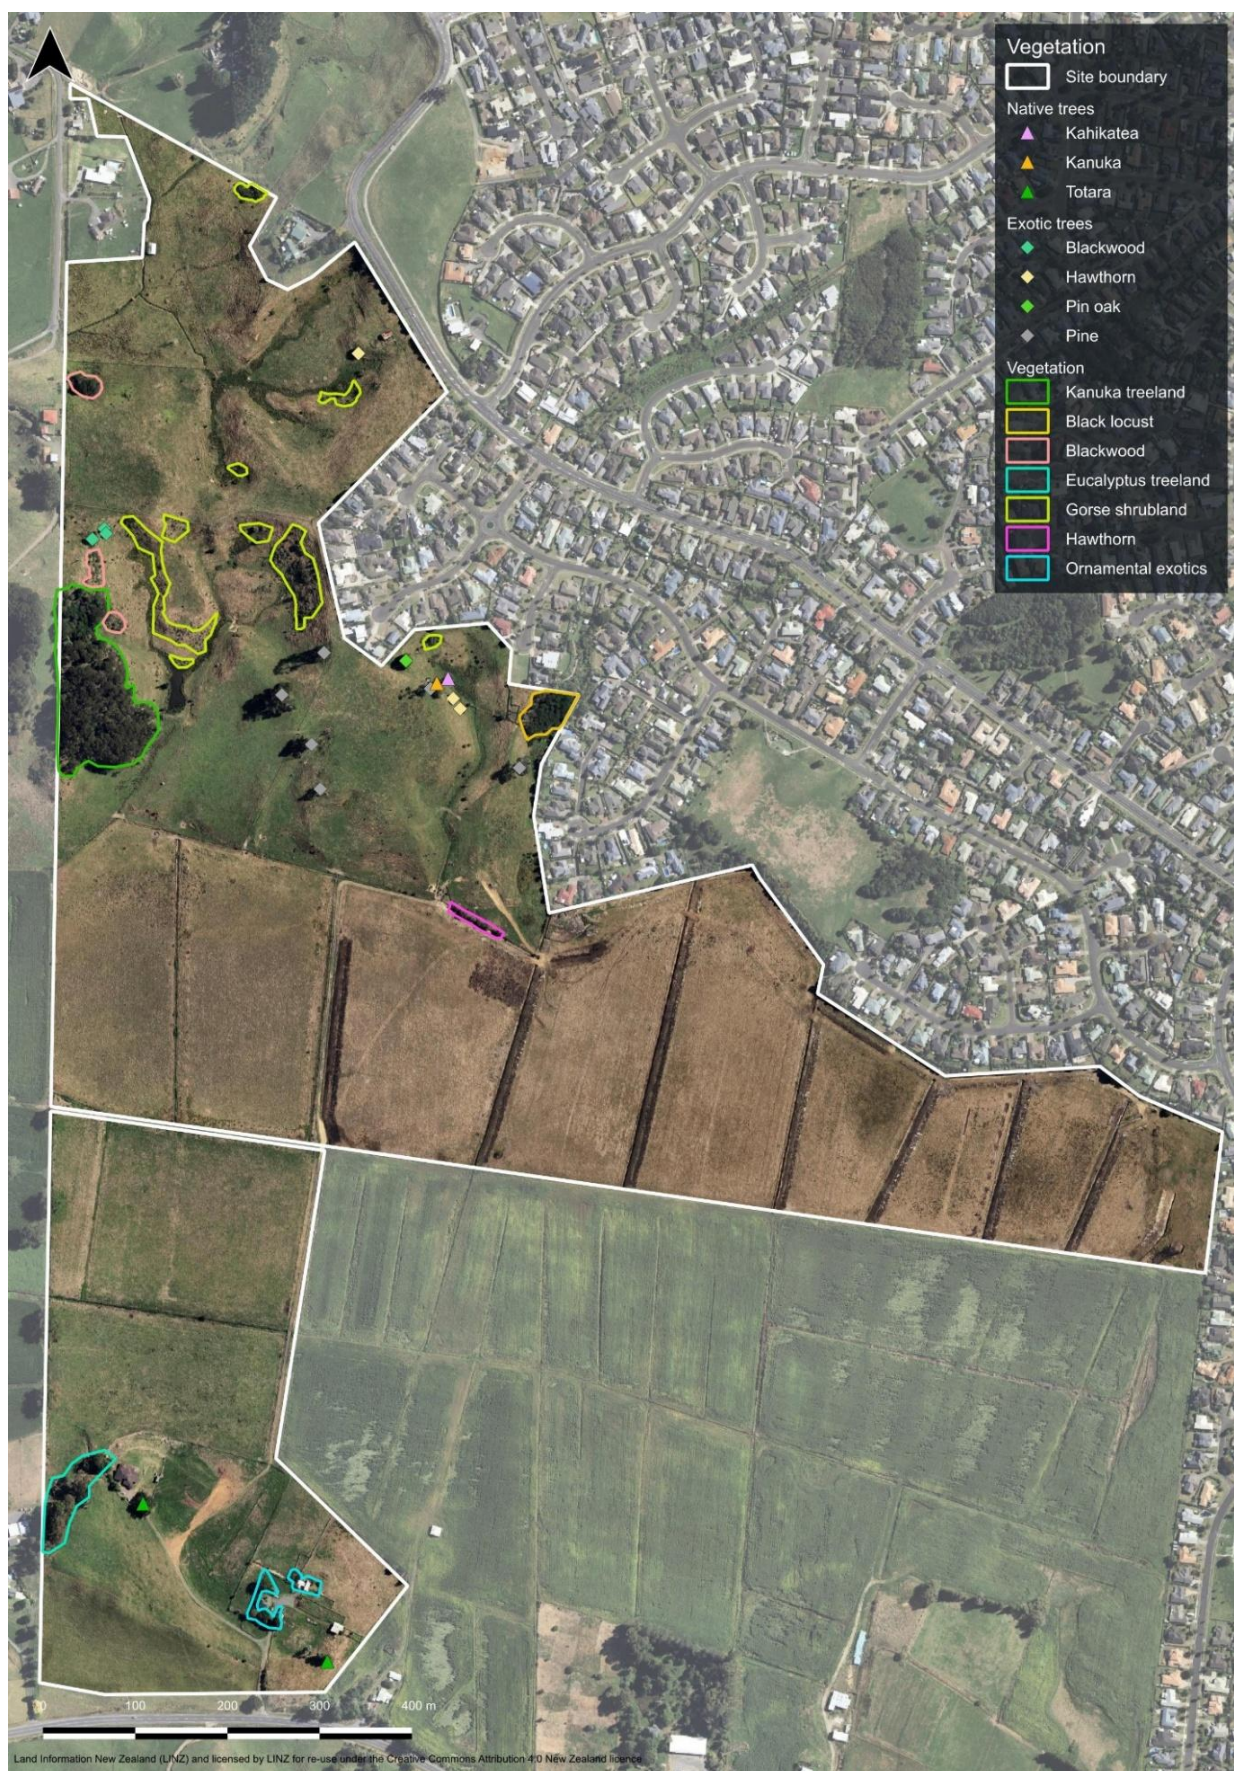
**Figure 6: Location of vegetation types within the Site.**

The majority of the Site (south and eastern flats) comprised maize cropland, while both grazed and rough pasture occurred in the northern part of the Site in the steeper hill area. Exotic trees were found scattered across the Site as well as singular native trees and a small indigenous stand of mature kānuka treeland. Further descriptions of vegetation are provided in the following sections.

Singular and small stands of exotic trees were found scattered across the Site (Figure 6), and featured several large pine (*Pinus radiata*) (Figure 7), blackwood (*Acacia melanoxylon*) and pin oak (*Quercus palustris*). Scattered gorse was frequently found on gully hillsides alongside shrubs hawthorn (*Crataegus monogyna*) and barberry. A small grove of black locust (*Robinia pseudoacacia*) was located on the north-eastern boundary (Figure 8). Occasional eucalypts (*Eucalyptus* spp.) and poplar (*Poplar x canadensis*) were also observed.

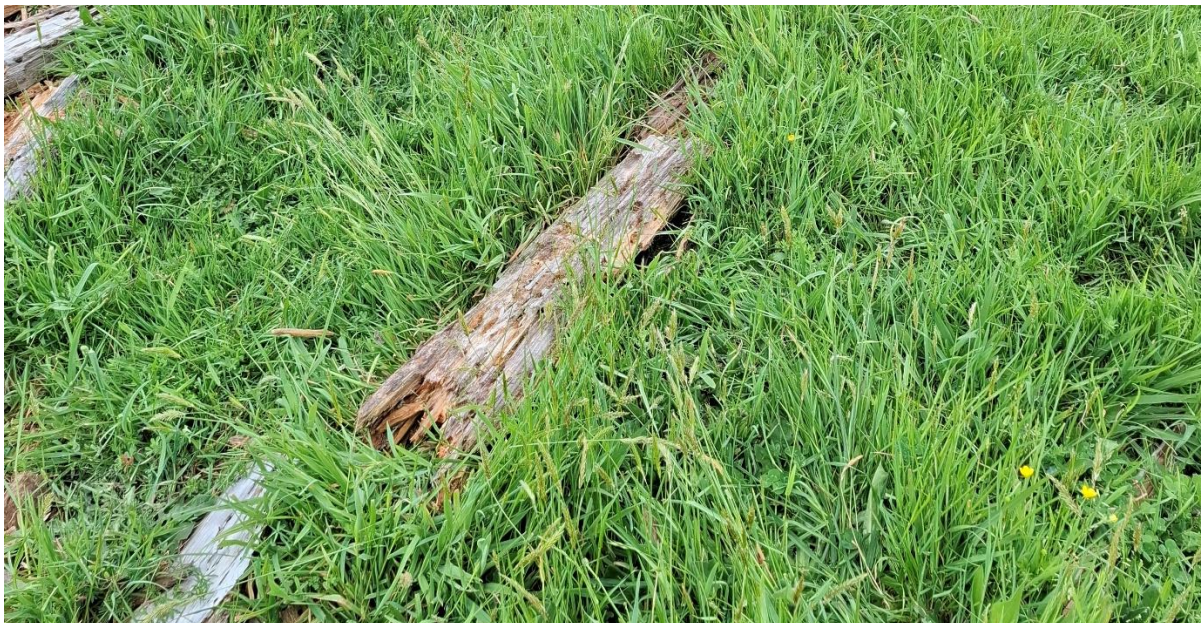
**Figure 9:** Isolated log in pasture where an unidentified skink was observed.

Two unidentified skinks, presumed to be either copper skink, ornate skink, or exotic rainbow skink due to their size, shape and the known and expected diversity of lizards in the landscape, were identified during the search of lizard habitat (Figure 10). These skinks were observed within grazed pasture under isolated logs, as shown in Figure 9.

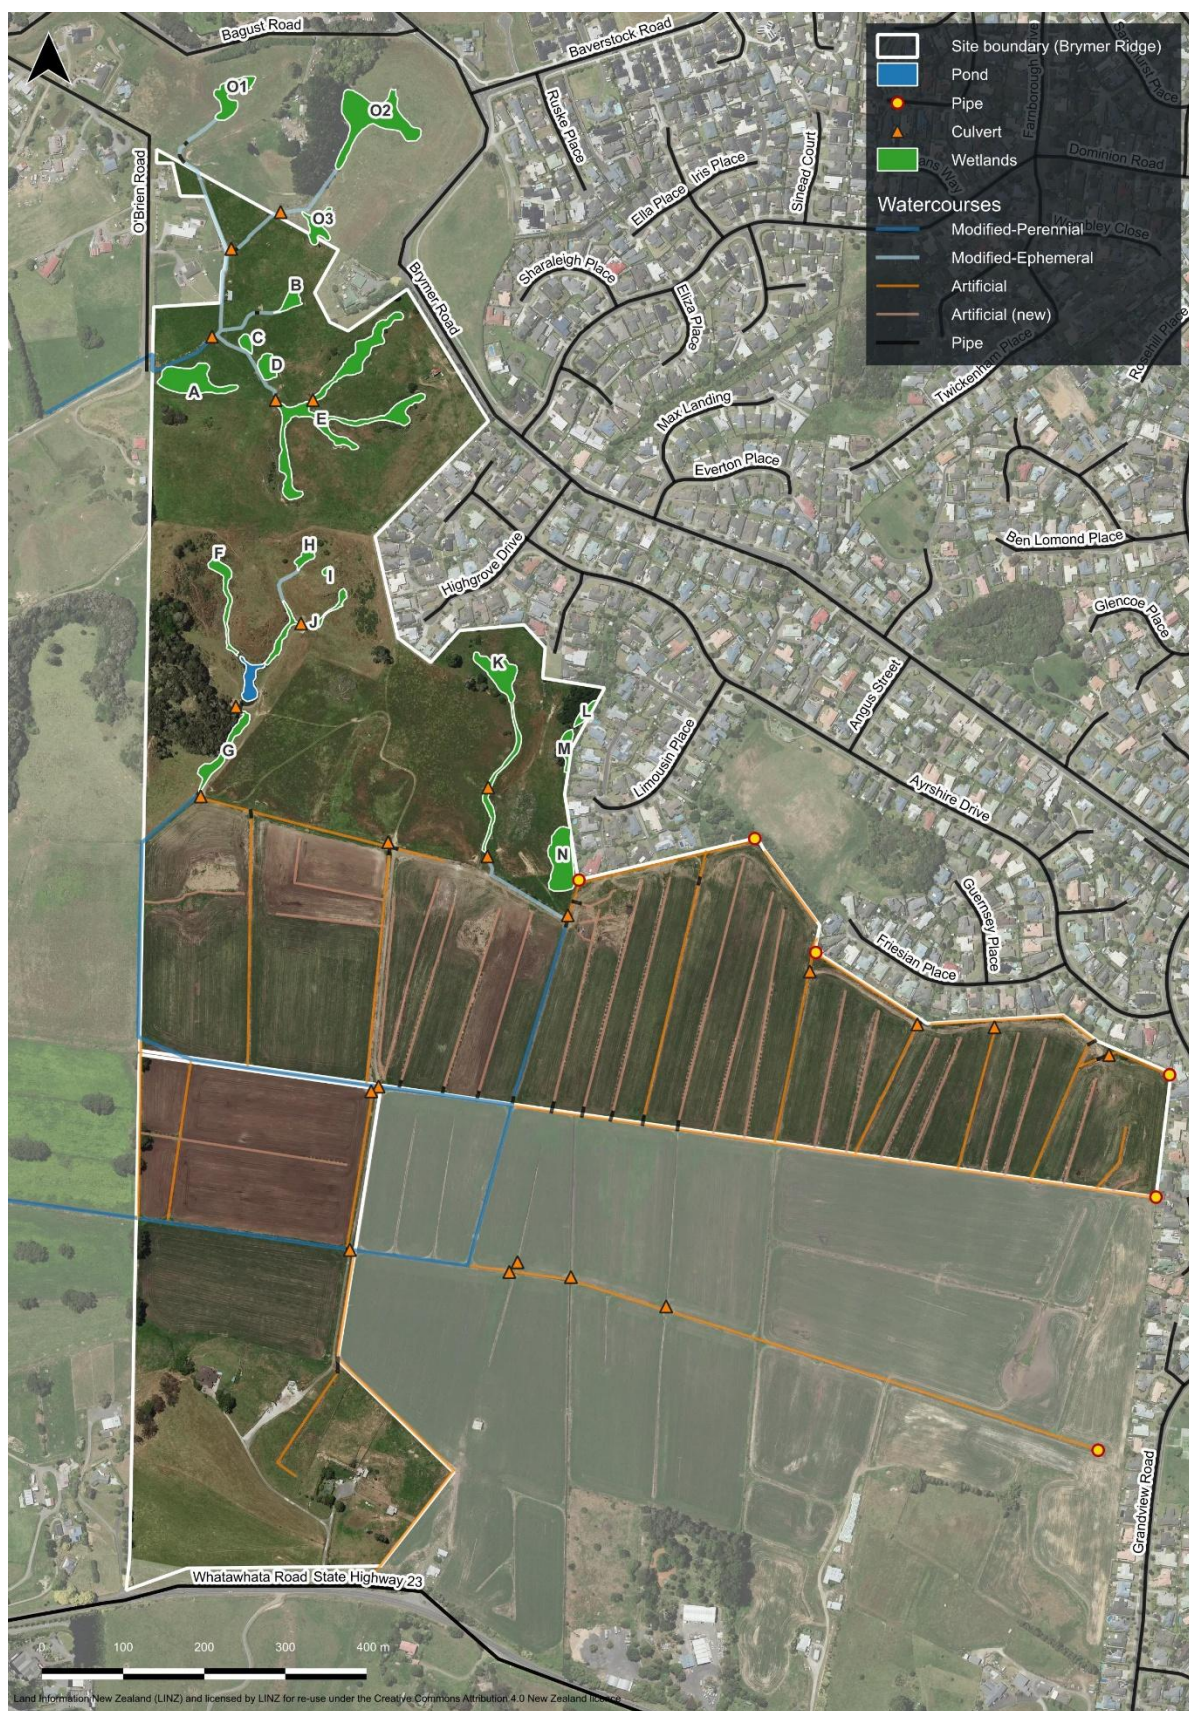
**Figure 13: Natural inland wetlands within the Site.**

The Site contained 15 'natural inland wetlands' and a small fragment of a wetland from the neighbouring property at the time of the Site survey (average size 1,063 m<sup>2</sup>, collectively covering 1.7 ha) as defined by the NPS-FM (2020). Wetlands are mapped in Figure 13, with examples shown in Figure 14 and Figure 15. Normal farm management alters the environment regularly (e.g., grazing, sowing, cropping, tilling, drain maintenance) and may change the extent and values of wetlands within the Site. Wetland plot data is presented in Appendix C.

The wetlands were located in shallow gullies upon low permeability Walton Subgroup soils, with Hamilton Ash geology forming the surrounding hillslopes and ridgelines (CMW Geosciences, unpublished draft geology map, dated 29/10/25). These wetlands were considered most likely to be supported by a combination of groundwater discharges from the Walton Subgroup sediments and/ or seepage/ spring fed as well as fed by rainwater and runoff. The hydrology for the wetlands appeared to be enduring, based on the visible changes in vegetation pattern in their respective locations in aerial imagery dating back to 1943 (i.e. Retrolens and Google Earth). Groundwater discharge appears to be important in supporting the wetlands during summer months when rainfall and runoff inputs will be lower.

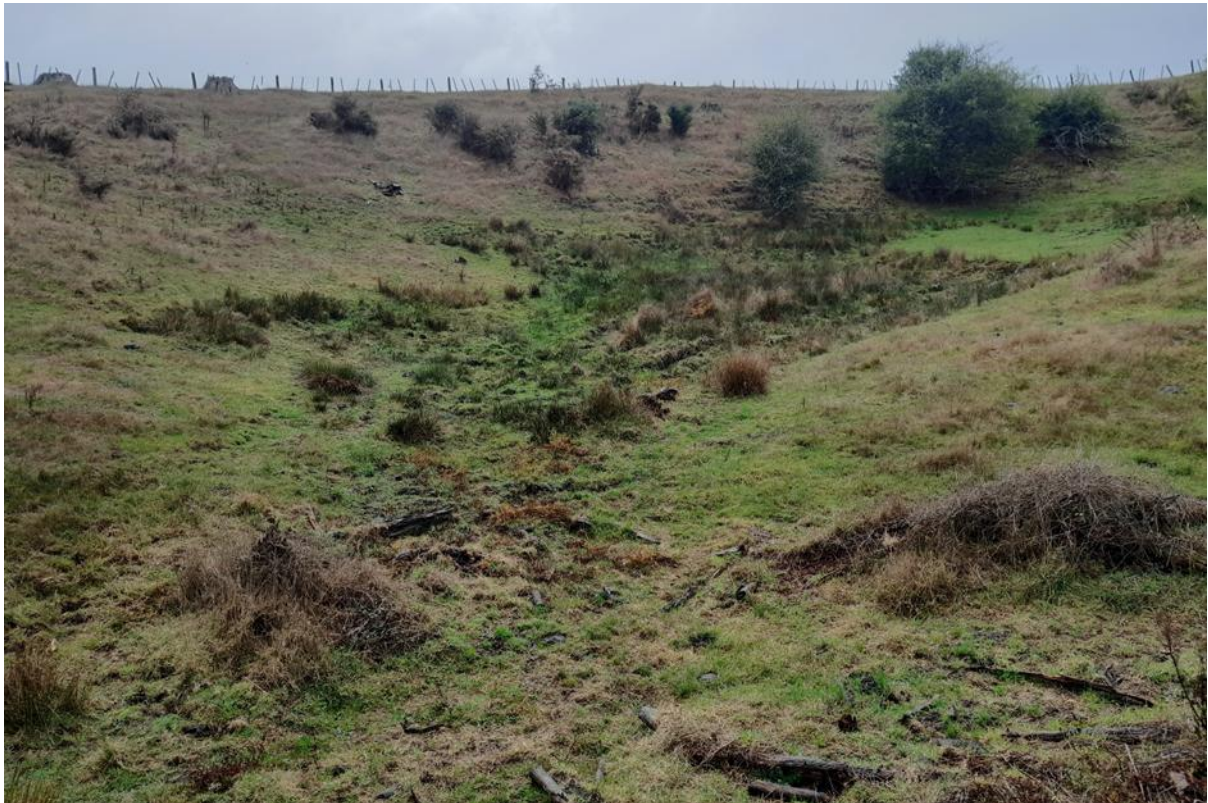
**Figure 14: Wetland H.**

Wetlands were generally riverine marsh systems damaged from historic and active farming. Exotic species dominated wetland plant communities which consisted of hydrophytic grass species such as glaucous sweet grass (*Glyceria declinata*), Mercer grass (*Paspalum distichum*) and Yorkshire fog. Other commonly occurring herbaceous and/or rush species within these grassland communities included creeping buttercup (*Ranunculus repens*), lotus (*Lotus pedunculatus*) and soft rush (*Juncus effusus*).

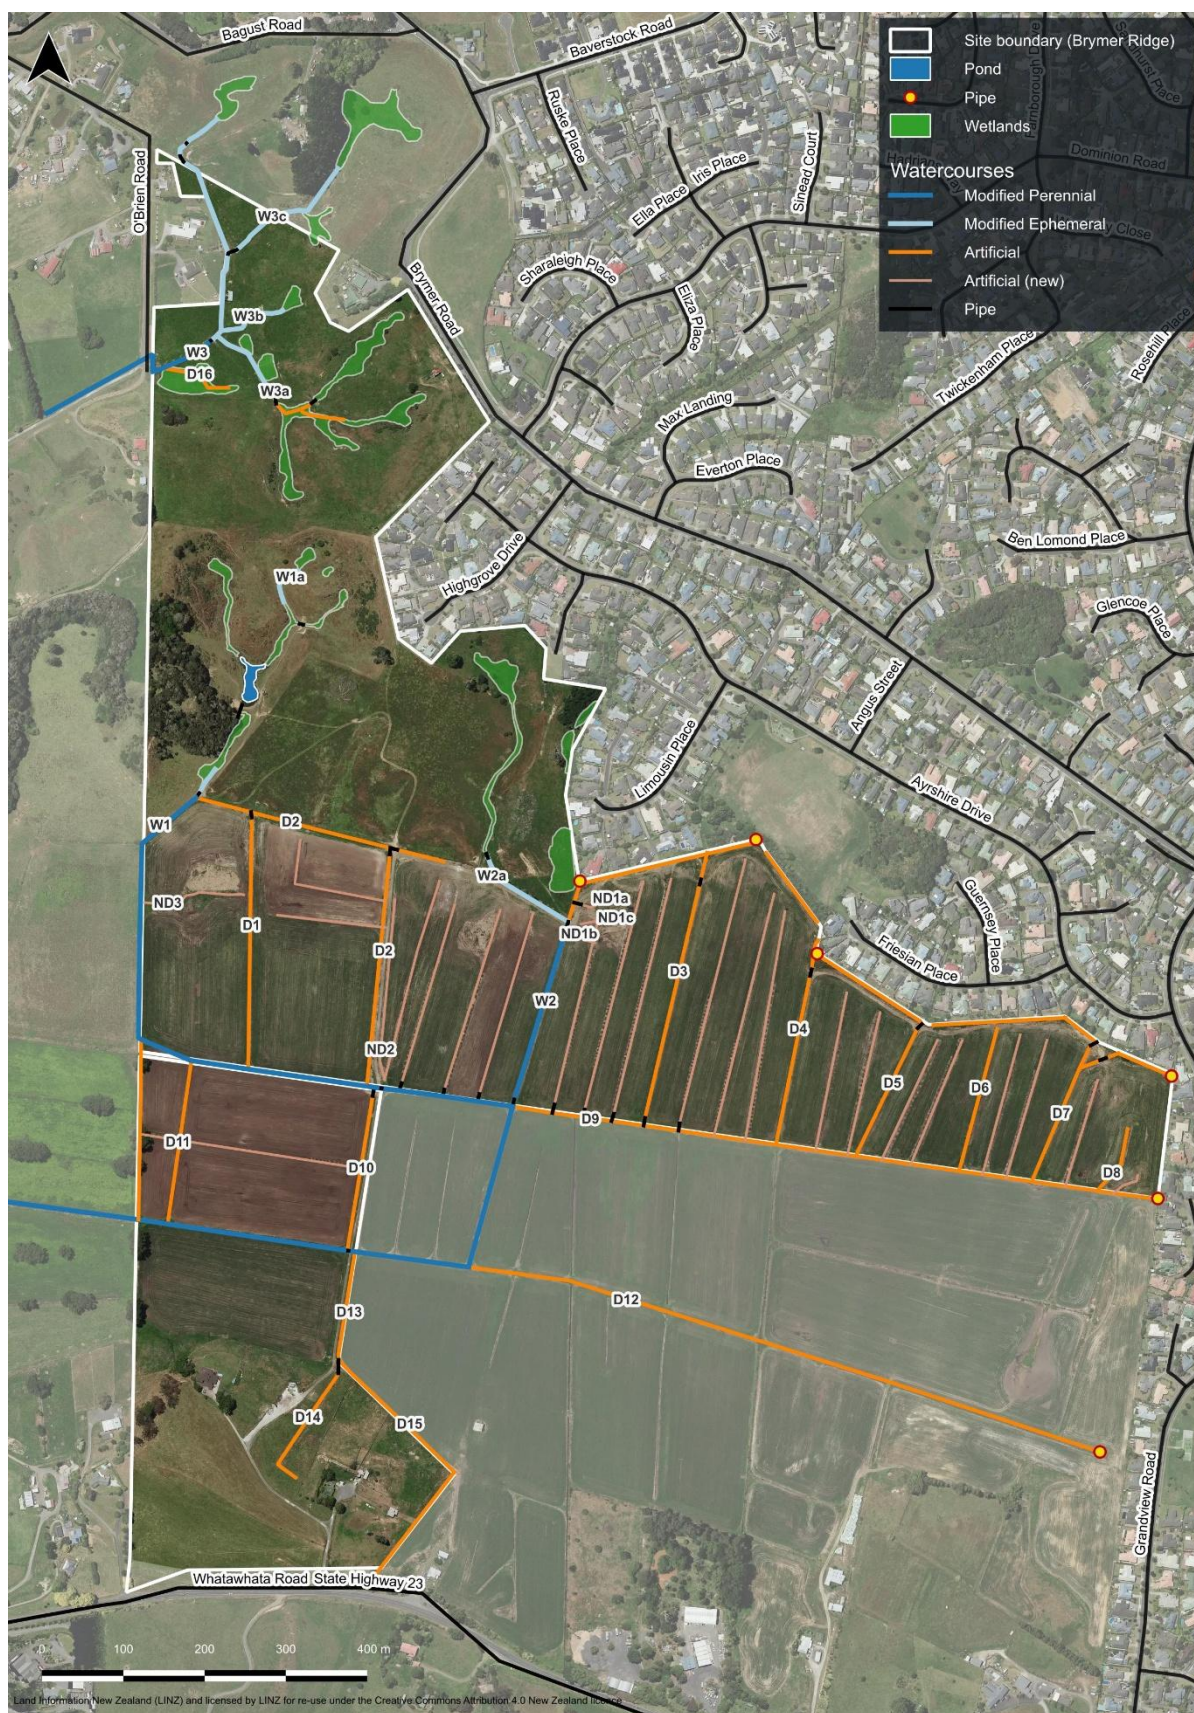
**Figure 16: Watercourse classifications within the Site.**

Although stream channels are unlikely to have naturally formed on the flat topography where Watercourses W1 and W2 are shown (i.e., historically wetland), these sections of modified watercourse have natural portions in their headwaters, so all downstream sections were classified as modified watercourse (consistent with the WRC definition) despite being highly channelised with straight alignments and having the physical appearance of drains.

Watercourse W2 flows out of the southern boundary of the central portion of the Site, re-enters the Site, and flows for 415 m before exiting the western boundary of the Site. Approximately 240 m of Watercourse W1 drains outside the Site along the western boundary.

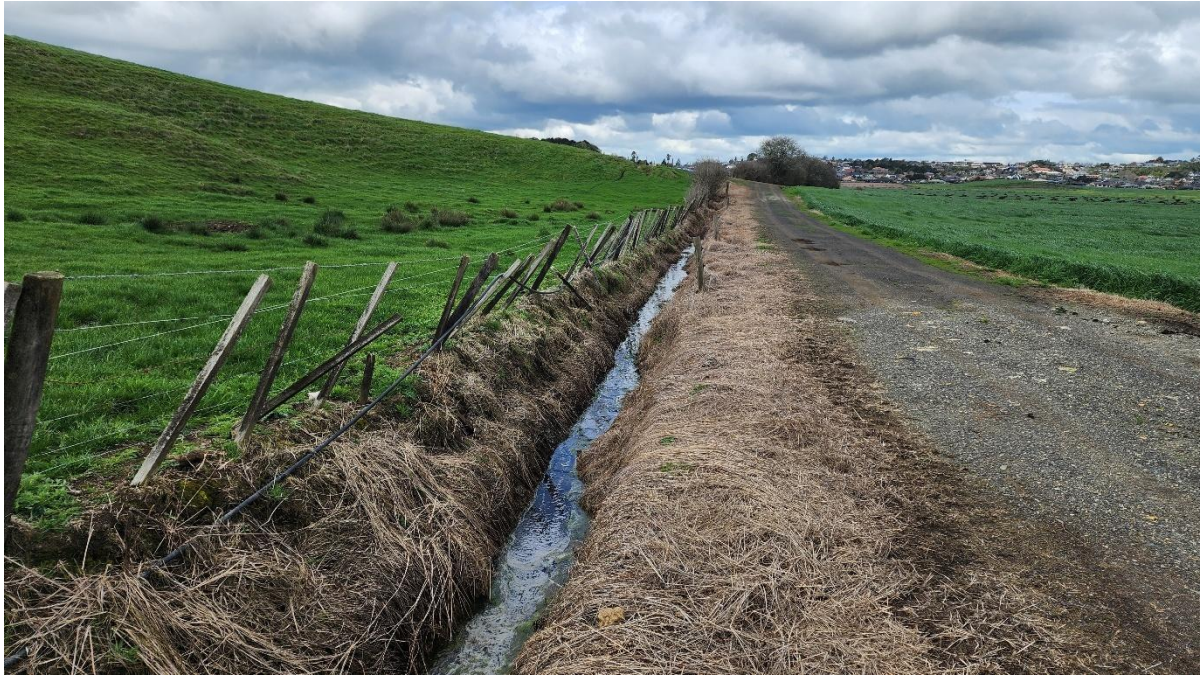
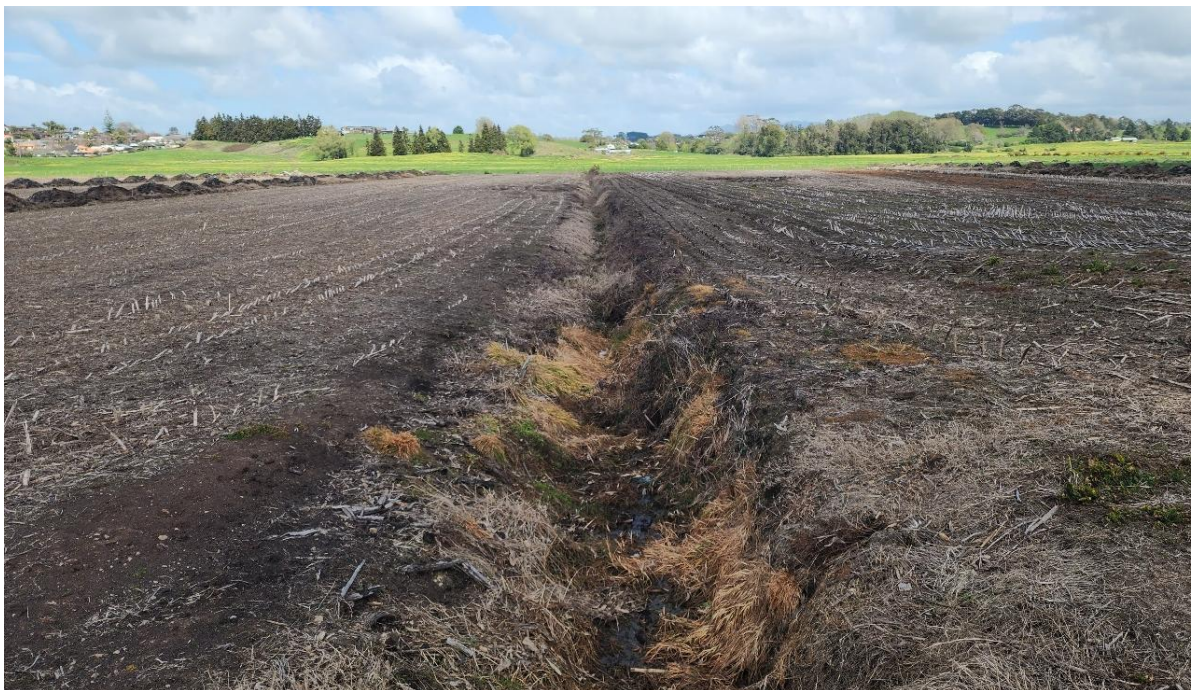
Artificial drains provided poor quality habitat for aquatic fauna due to the lack of aquatic habitat diversity (e.g., channelised, uniform run/pool, depths, widths), low channel gradient, lack of vegetated riparian margins, poor channel shade and water short nature in some drains (i.e., ephemeral). Habitat in artificial drains is shown in Figure 17 and Figure 18.

**Figure 17: Habitat in Drain 2 (D2).**

**Figure 18: Habitat in Drain 6 (D6).**

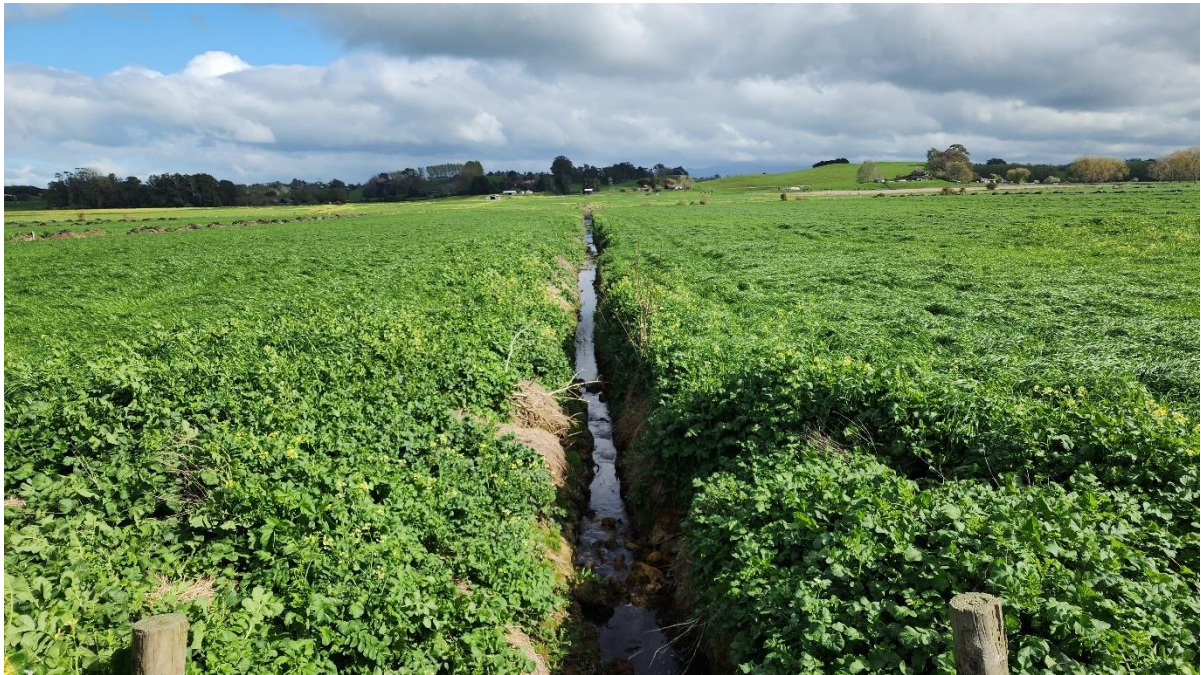
**Figure 19: Modified Watercourse.**

Modified watercourses were channelised with straight alignments and provided generally similar habitat to artificial drains. Modified ephemeral watercourses had narrow channels, shallow water depths, were stagnant in places and provided very-poor quality aquatic habitat. Modified perennial watercourses were fed by upstream catchments and artificial drains on flat areas so conveyed more water. Modified perennial watercourses were deeply incised, wide, had moderate-deep water depths, sluggish flow in uniform runs, lacked riparian vegetation, poorly shaded, high macrophyte cover and provided aquatic habitat of poor quality. Typical habitat in modified watercourses is shown in Figure 19.

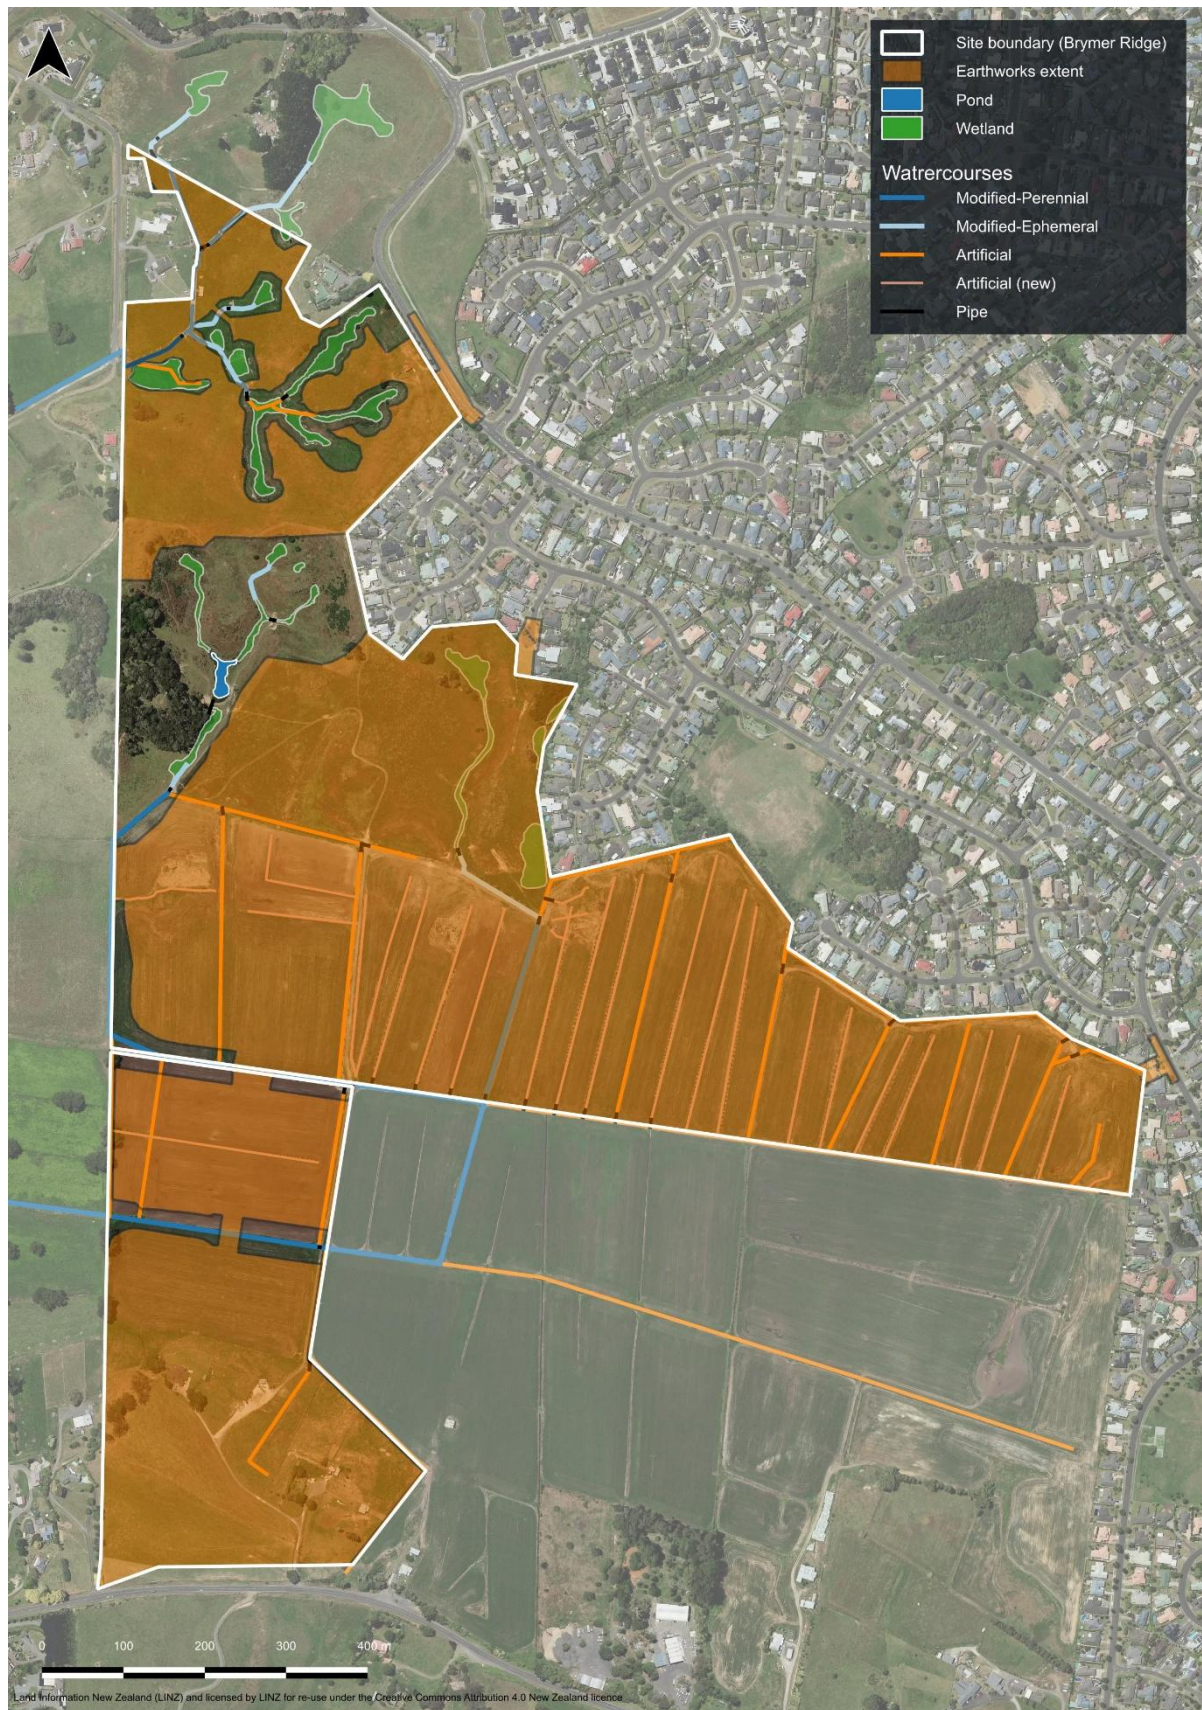
**Figure 20: Earthworks extent based on shapefiles released by Maven and Associates, 3 August 2026.**

The stormwater for the Site is summarised in the Project Infrastructure Report (Maven Associates 2026) and set out in detail within the Stormwater Management Plan (SMP), Appendix A of Maven Associates 2026. To summarise, stormwater management will be achieved through the use of several devices including

- Modified drains/ channels with landscaping.
- Roadside raingardens and artificial wetlands.
- High flow bypasses.
- Treatment wetlands with forebays (eight treatment wetlands).
- On lot retention through soakage.
- Protection of existing bush features.
- Planting of riparian and wetland areas.

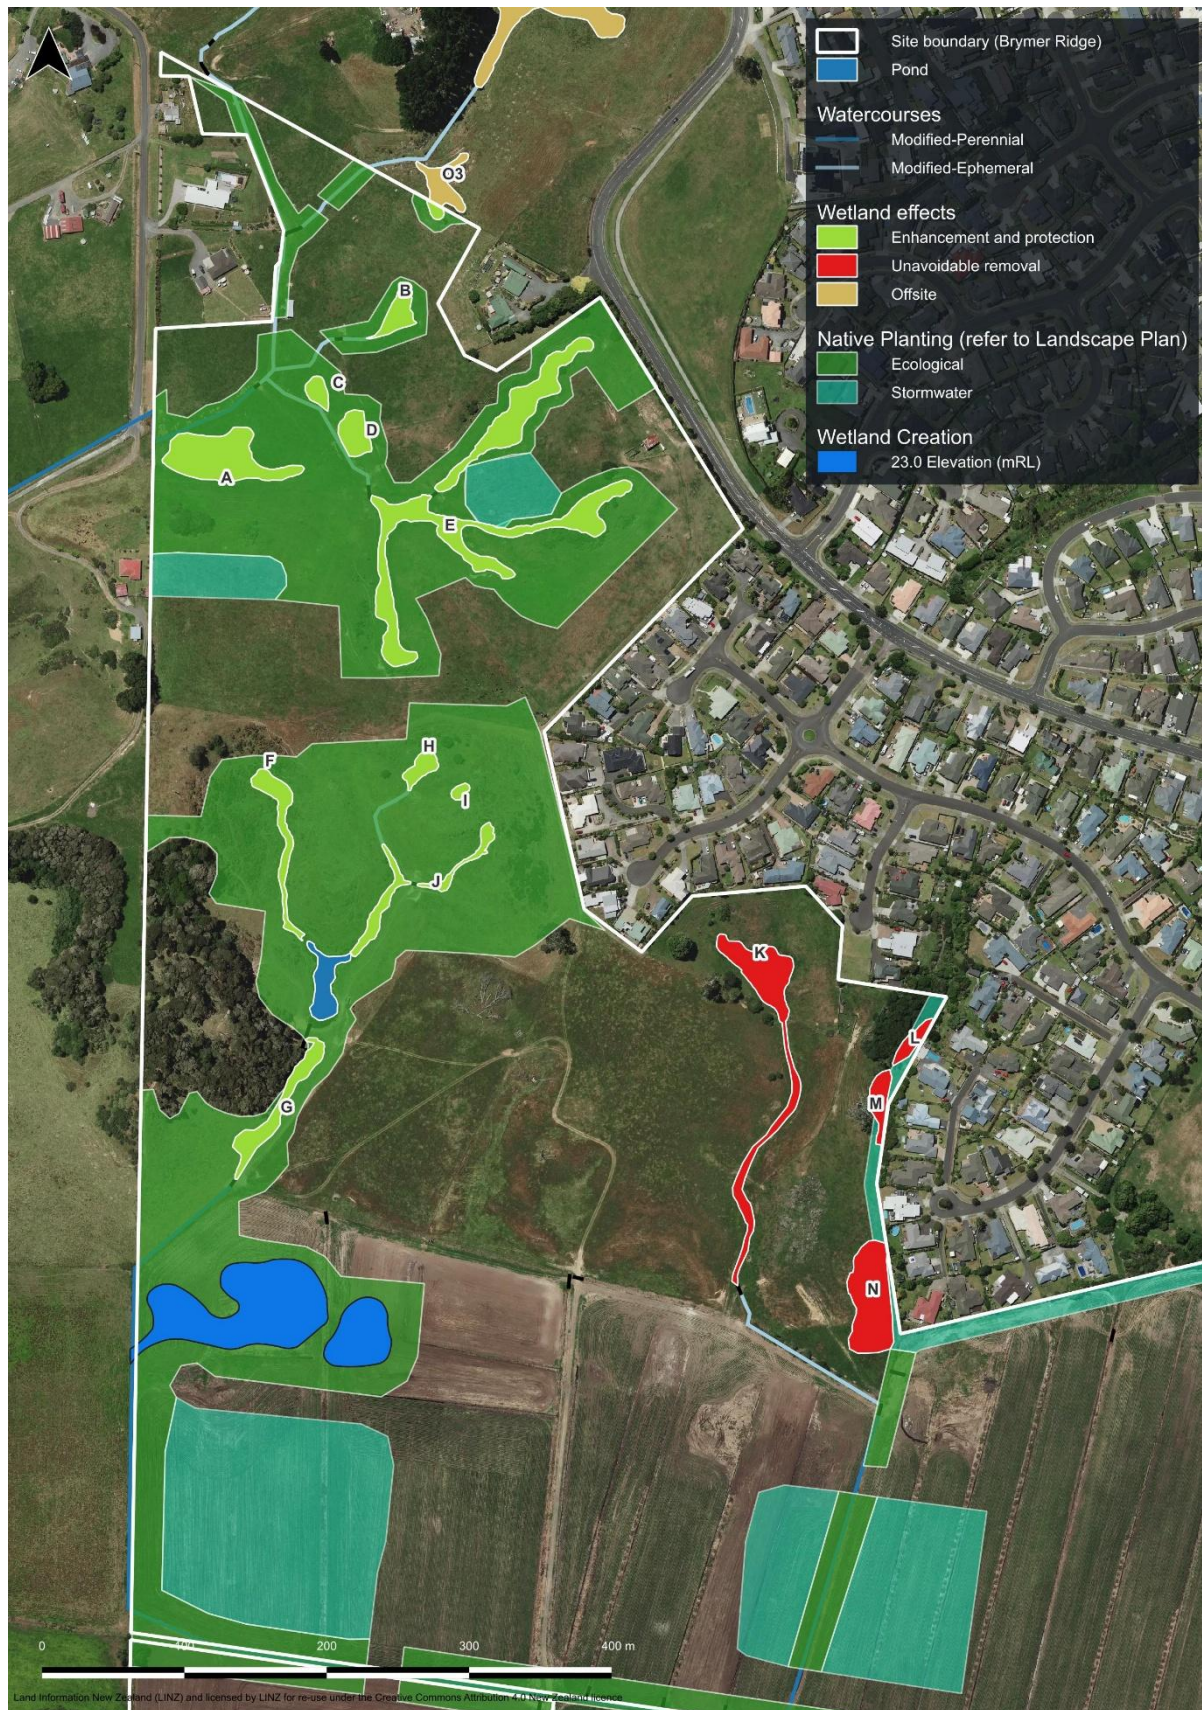
**Figure 22: Proposed wetland creation and enhancement.**

Wetland species will comprise a selection of native vegetation types that are adapted to varying moisture requirements (i.e., standing water, boggy and moist soils) as provided in the B&A Urban and Landscape Plan Set, Revision A).

Wetlands within the Site were dominated by exotic grasses, herbs and rush species and were in poor condition due to drainage and current or historic grazing. Restoration of these degraded wetlands through removing grazing, planting and implementing animal and pest control and the proposed wetland creation (discussed in Section 13.4) is expected to result in an overall net 'positive' outcome (Table 23).

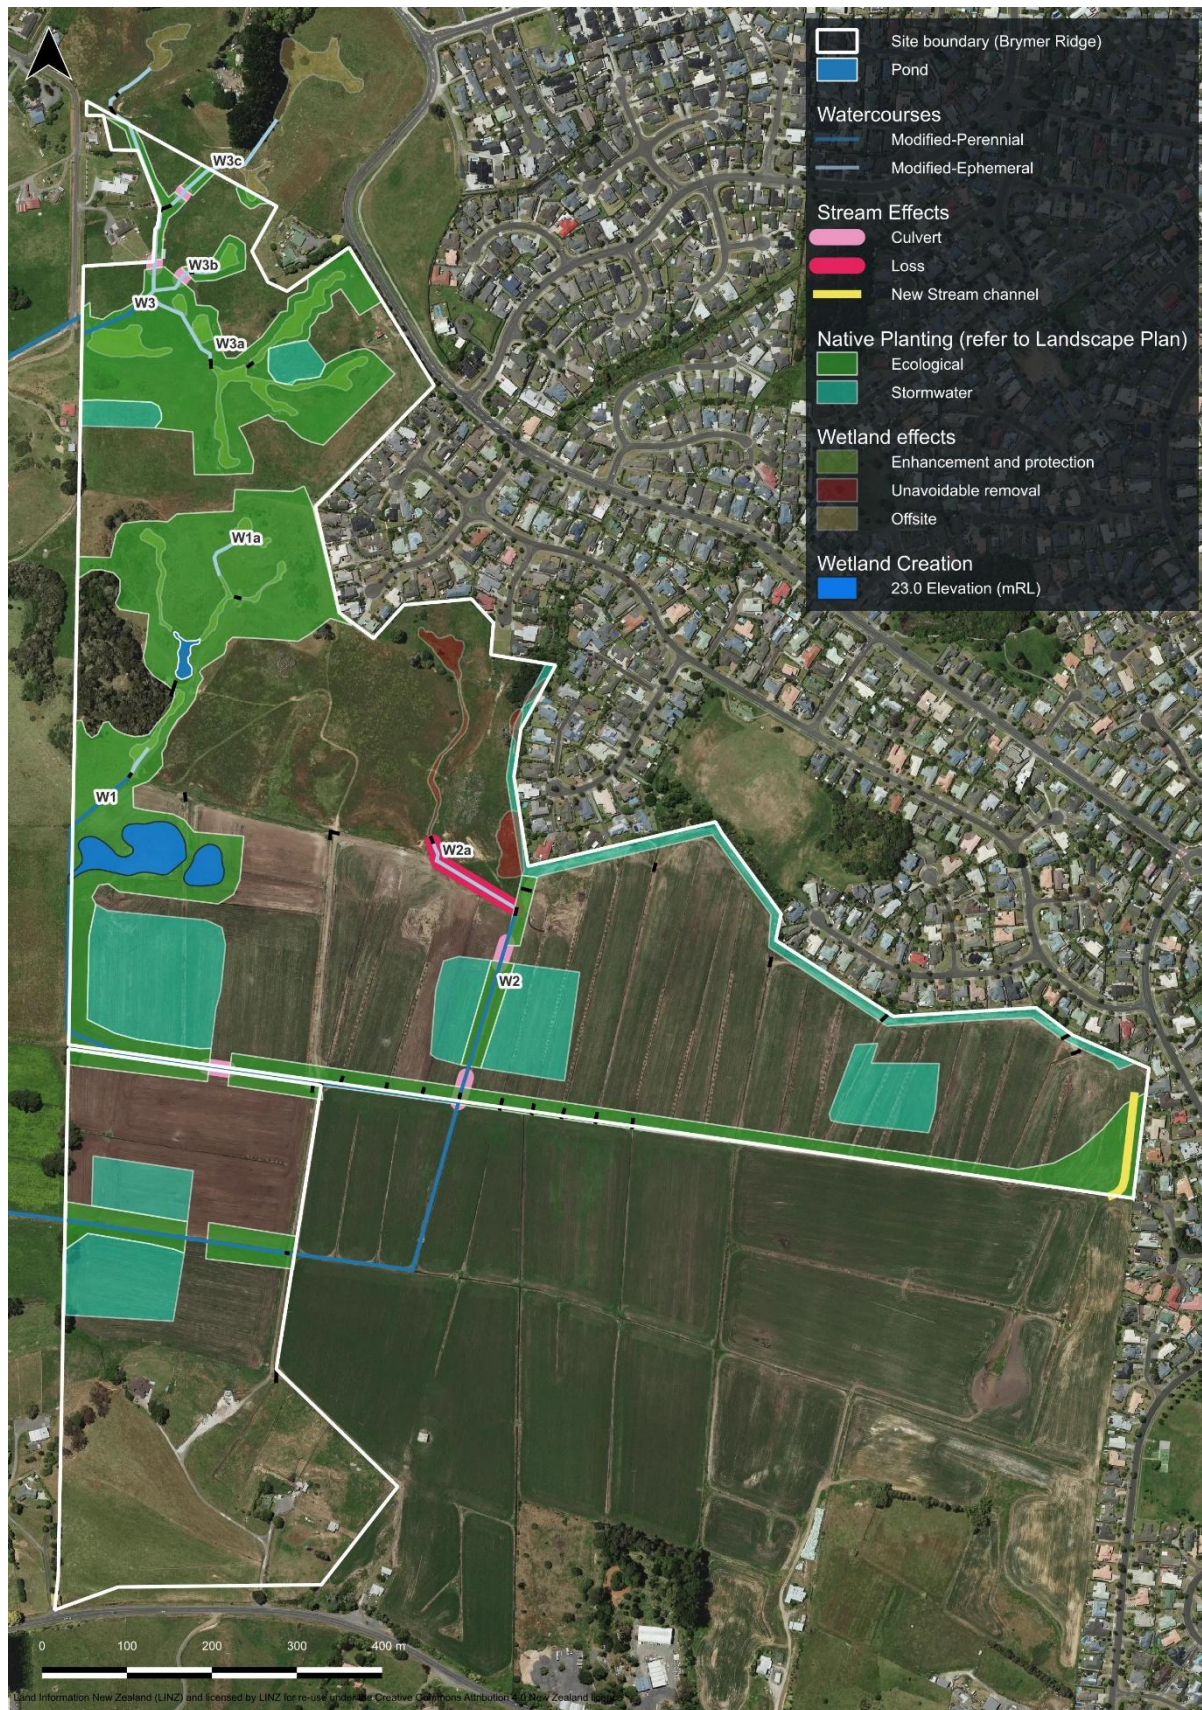
**Figure 23: Proposed stream creation and enhancement.**

Streamside species will comprise sedges (e.g., *Carex virgata* and *C. secta*) which will over hang the stream bed, providing shading and habitat for aquatic insects and fish. A selection of taller species such as, cabbage tree (*Cordyline australis*) and toetoe (*Austroderia fulvida*) will provide immediate stream shading. Lower banks will be planted with trees and shrubs including manuka (*Leptospermum scorparium* agg.), kānuka (*Kunzea*) and karamū (*Coprosma robusta*), which will provide additional shading, filtration of run off and input of organic material to the streams. Upper banks will include secondary diversity species appropriate for the Hamilton Ecological District, such as mataī (*Prumnopitys taxifolia*), tītoki (*Alectryon excelsus*) and pukatea (*Laurelia novae-zealandiae*).

Restoring watercourses is a positive outcome of the development, that has the potential to improve water quality (reducing temperatures and filtering contaminants), reduce flooding and erosion risks and improve habitat for aquatic life.
