August 2026

## Brymer Farms Development Ecological Impact Assessment

Submitted to:  
Pragma Homes

## Brymer Farms Development Lizard Management Plan

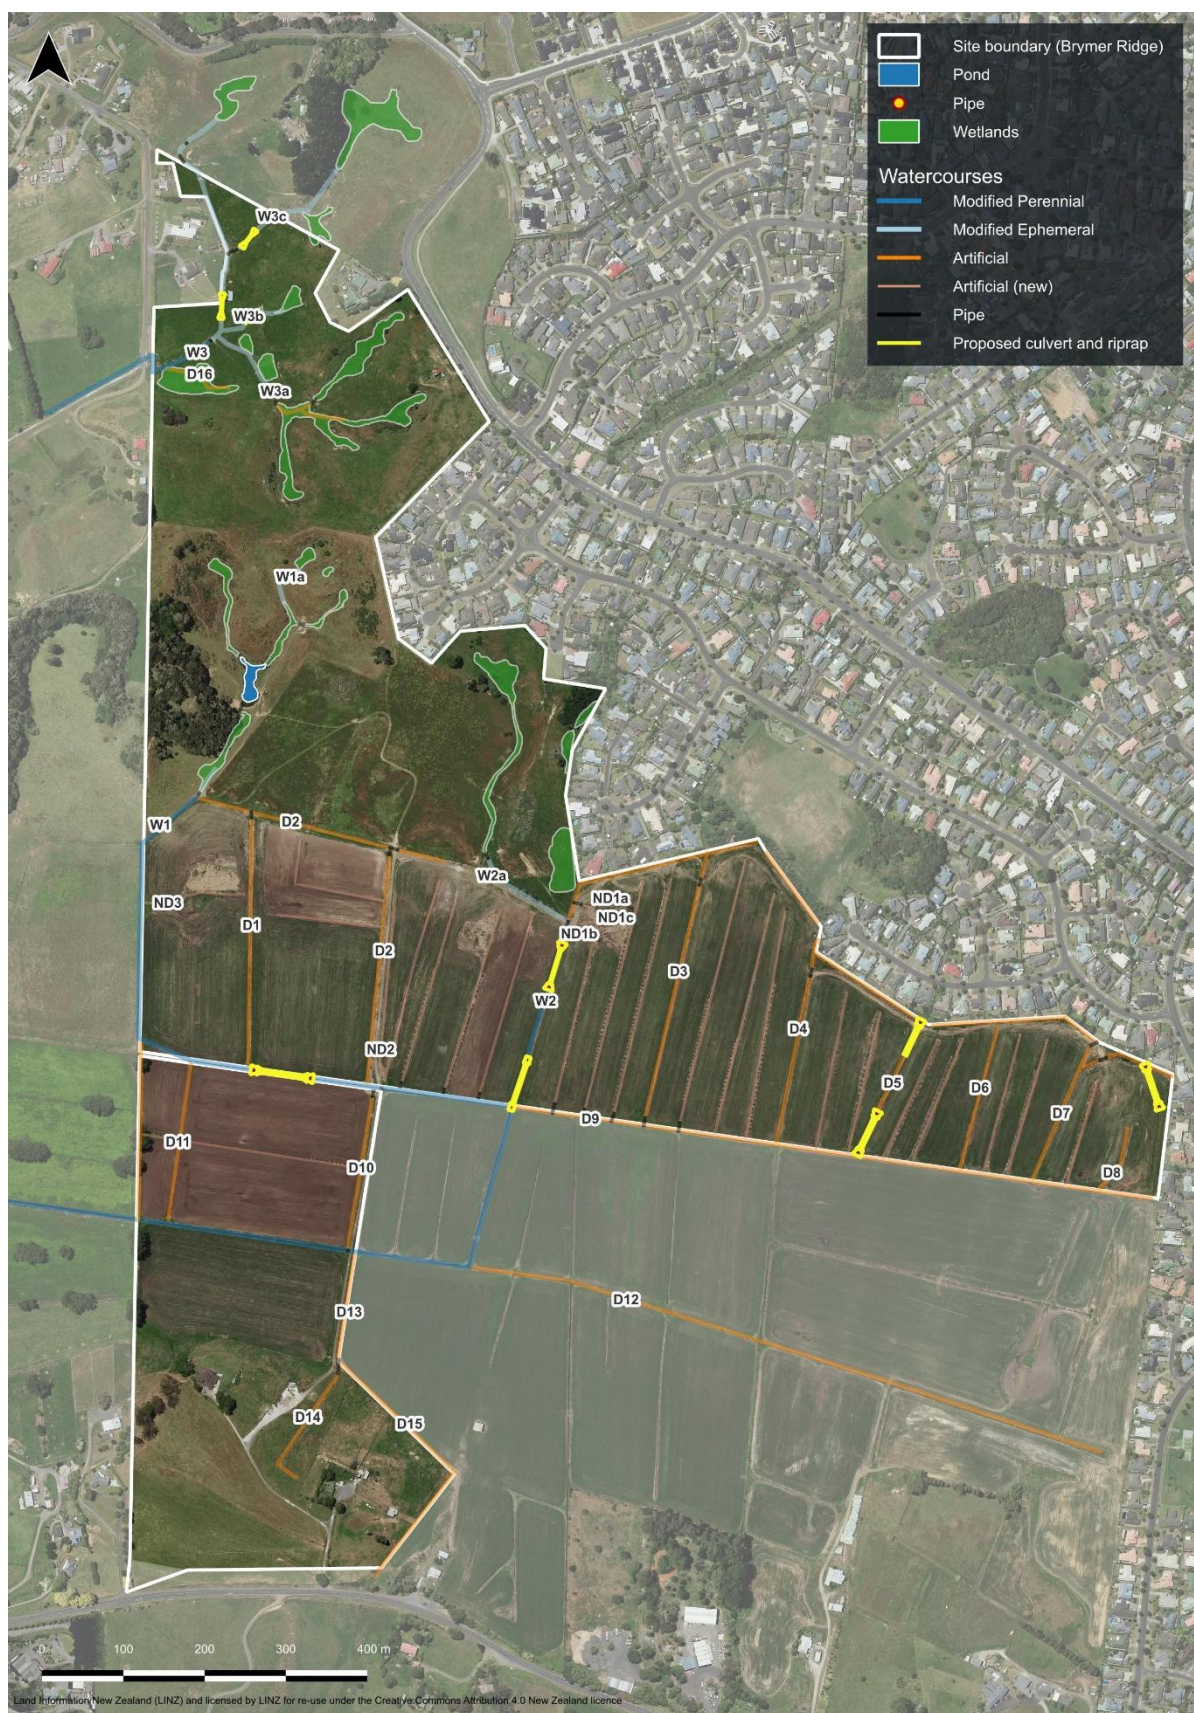
**Figure 24: Proposed culverts.**

All new culverts have been designed and will be installed in accordance with the New Zealand Fish Passage Guidelines (Franklin et al. 2024) and NES-FW (2020) regulations and provide fish passage. This will result in a 'negligible' magnitude of effect and 'very low' overall level of effect on the fish fauna.

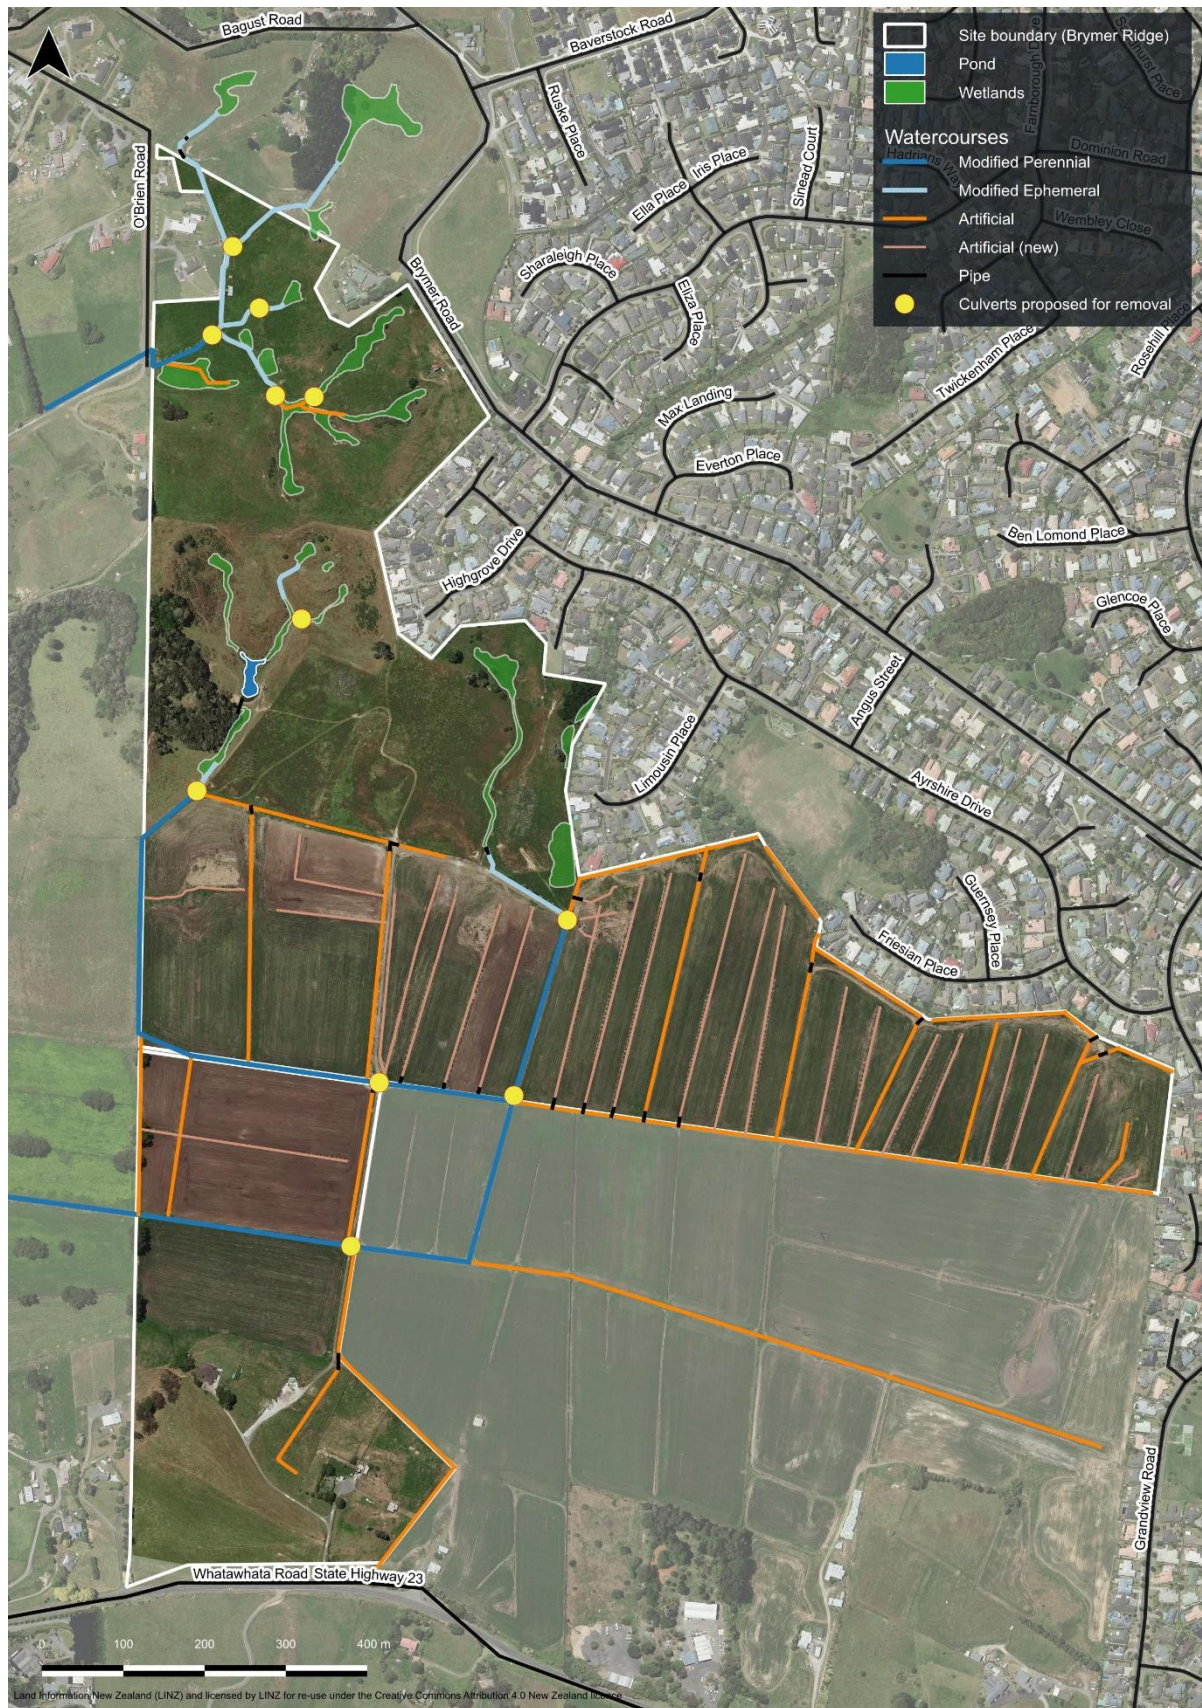
**Figure 25: Culverts proposed for removal.**

The removal of existing farm culverts from modified natural watercourses in the locations shown on Figure 25 (approx. 72m) will improve connectivity and fish passage along these reaches.

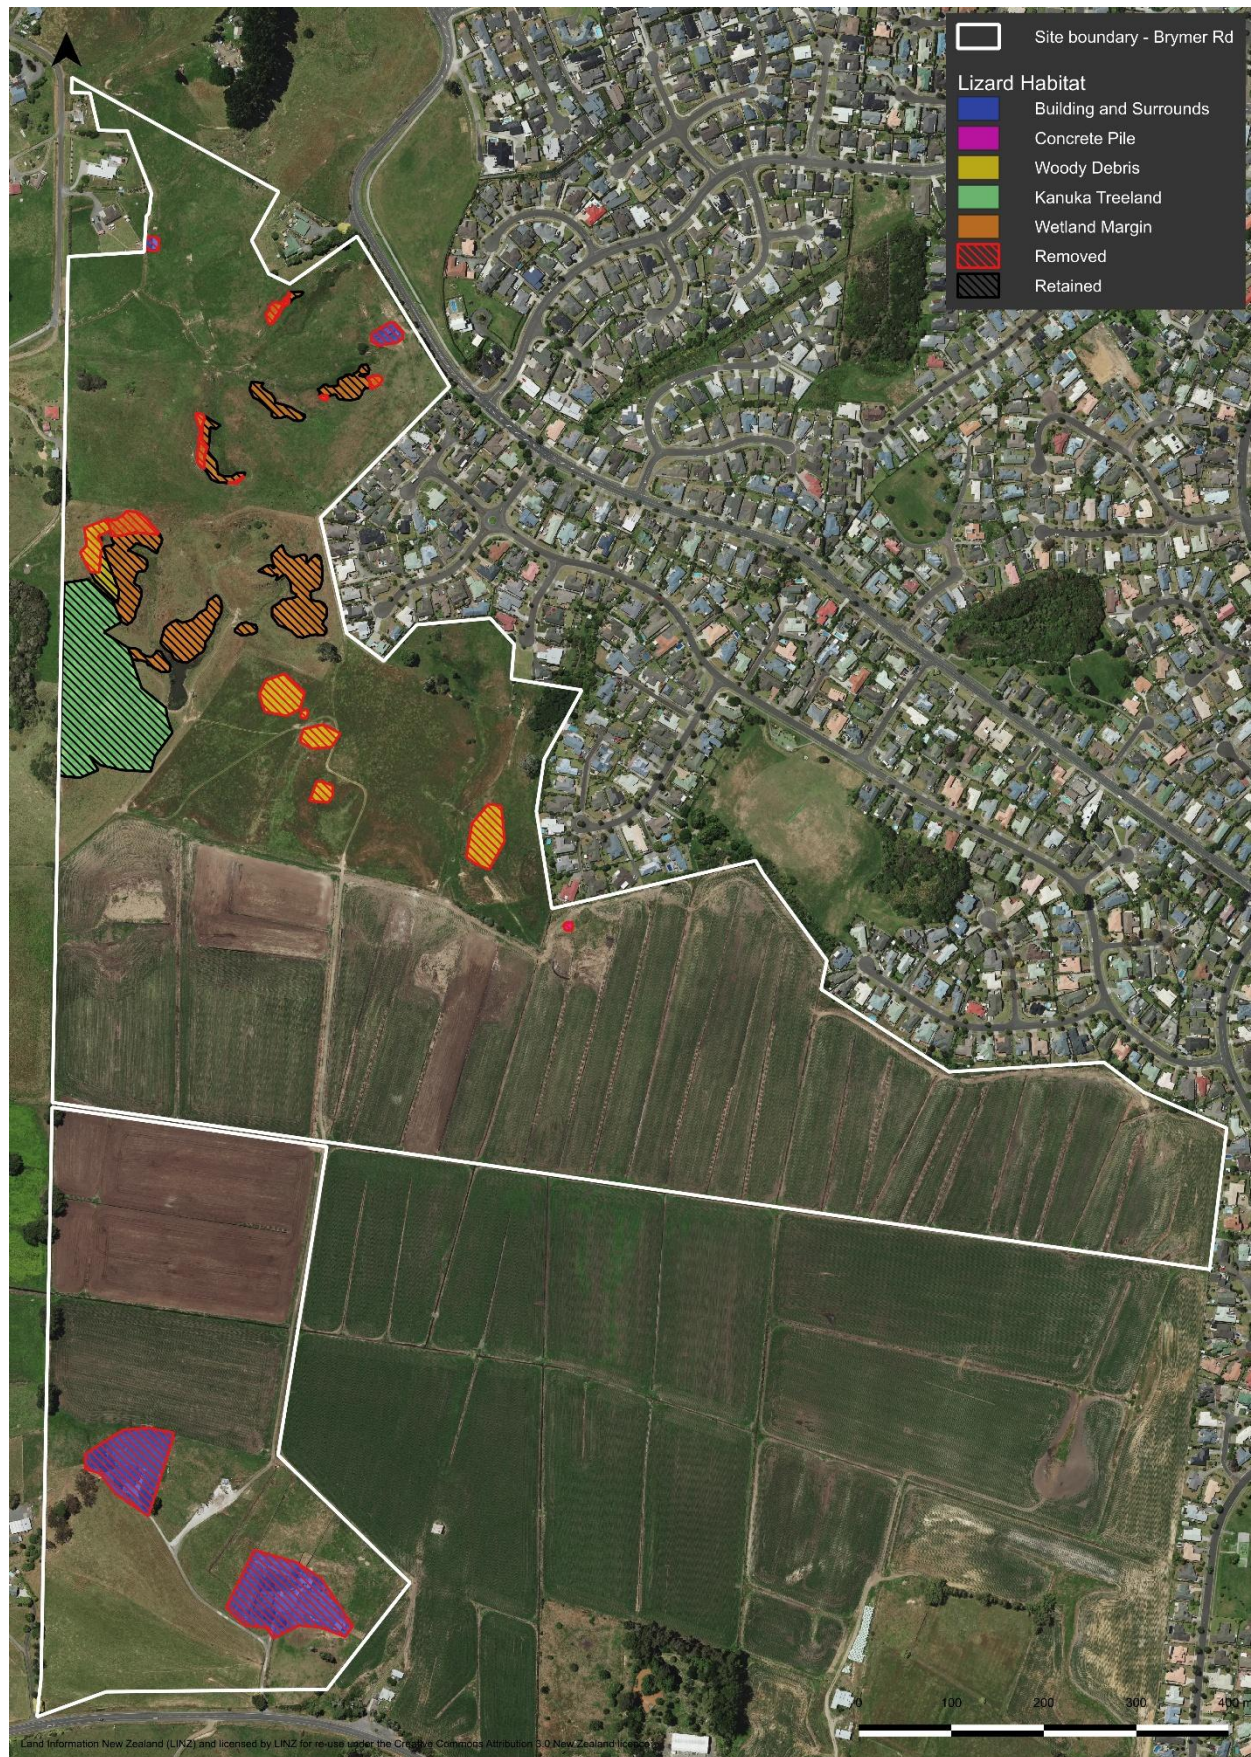
**Figure 3: Potential lizard habitat within the Site to be removed or retained.**

Table 1 summarises area of each habitat type likely to be impacted by bulk earthworks. The habitats associated with buildings and surrounds, and the concrete pile are proposed to be completely removed. Almost all woody debris habitat is proposed to be removed, with the exception of some of the area closest to the treeland. The majority of the wetland margin habitat is proposed to be retained; however, it is likely weed control and subsequent planting, will alter vegetation (and thus habitat) to some degree. All of the kanuka treeland within the western bounds of the Site is proposed to be retained. Habitat to be removed as a result of earthworks or retained is shown in Figure 3.

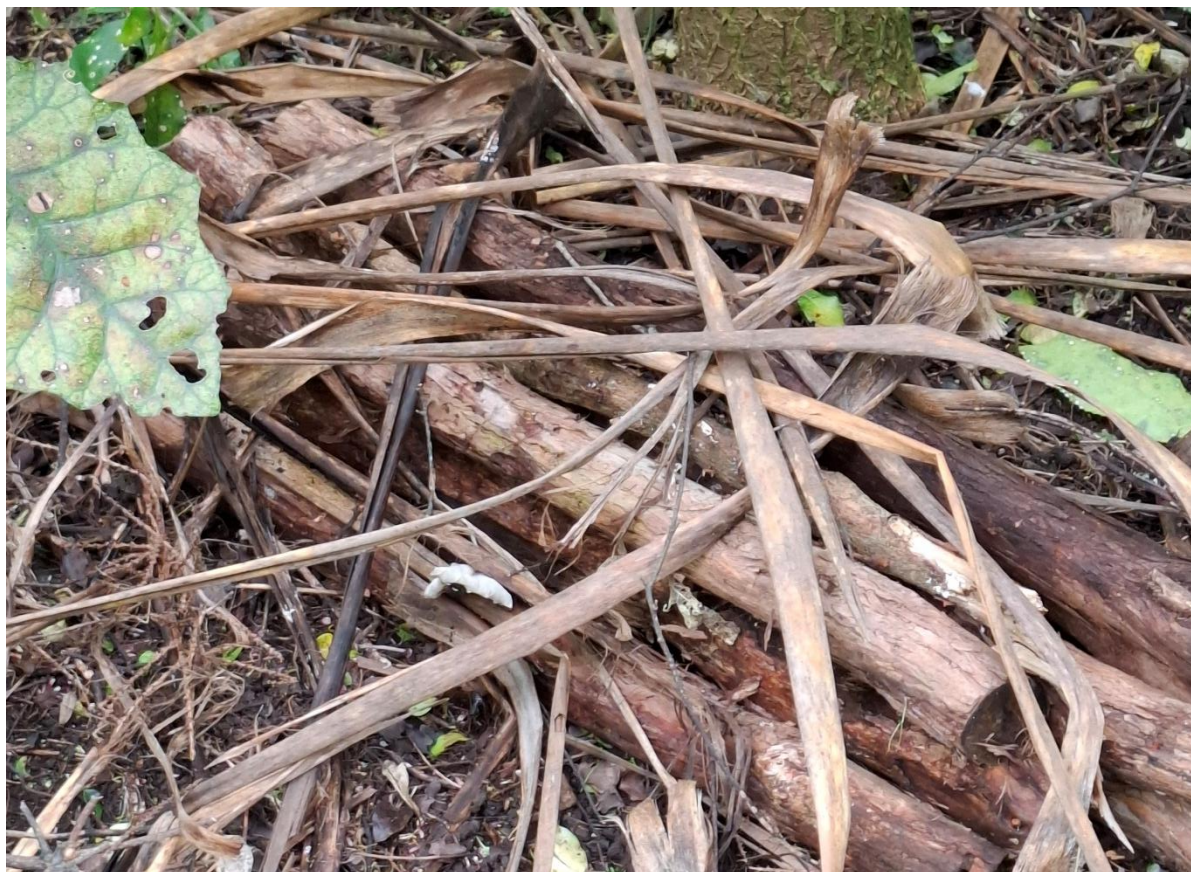
**Figure 5: Eco-stack constructed at Waiwhakareke Natural Heritage Park.**

Lizard habitat at Waiwhakareke is well developed, with several log stacks constructed for other release projects (Figure 5), and a predator proof fence currently under construction<sup>1</sup>. Discussions with Hamilton City Council are currently ongoing on how best to support lizard habitat within Waiwhakareke, and we propose constructing one eco-stack for every native lizard released. Table 2 outlines Waiwhakareke's suitability as a release site.

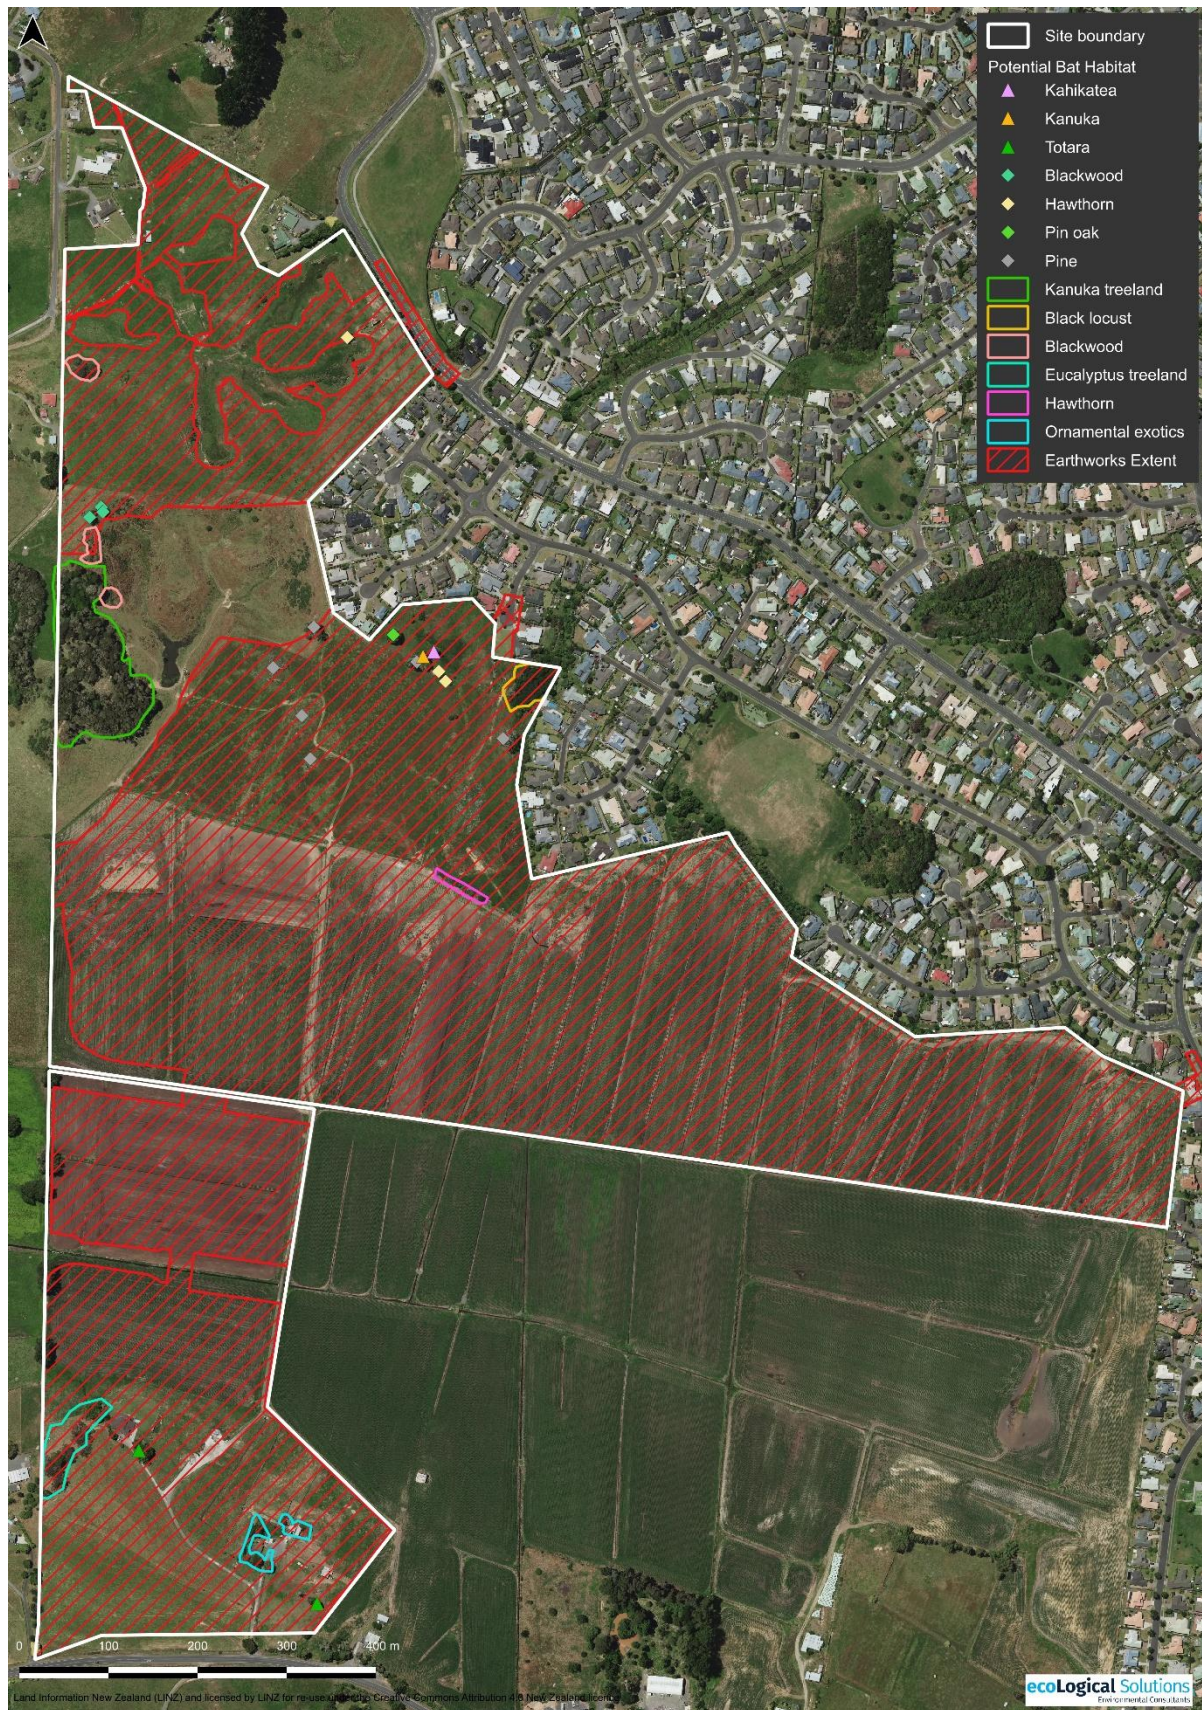
**Figure 2: Impact of earthworks on potential bat habitat features.**

The extent of earthworks covers much of the Site. Whilst the kanuka treeland and one area of blackwood are unimpacted, many areas of potential bat habitat are proposed to be removed. This includes potential roosting habitat, in the form of several specimen trees and small copses of trees, such as the Eucalyptus treeland in the south of the site. Potential habitats impacted on site are summarised in Figure 2.

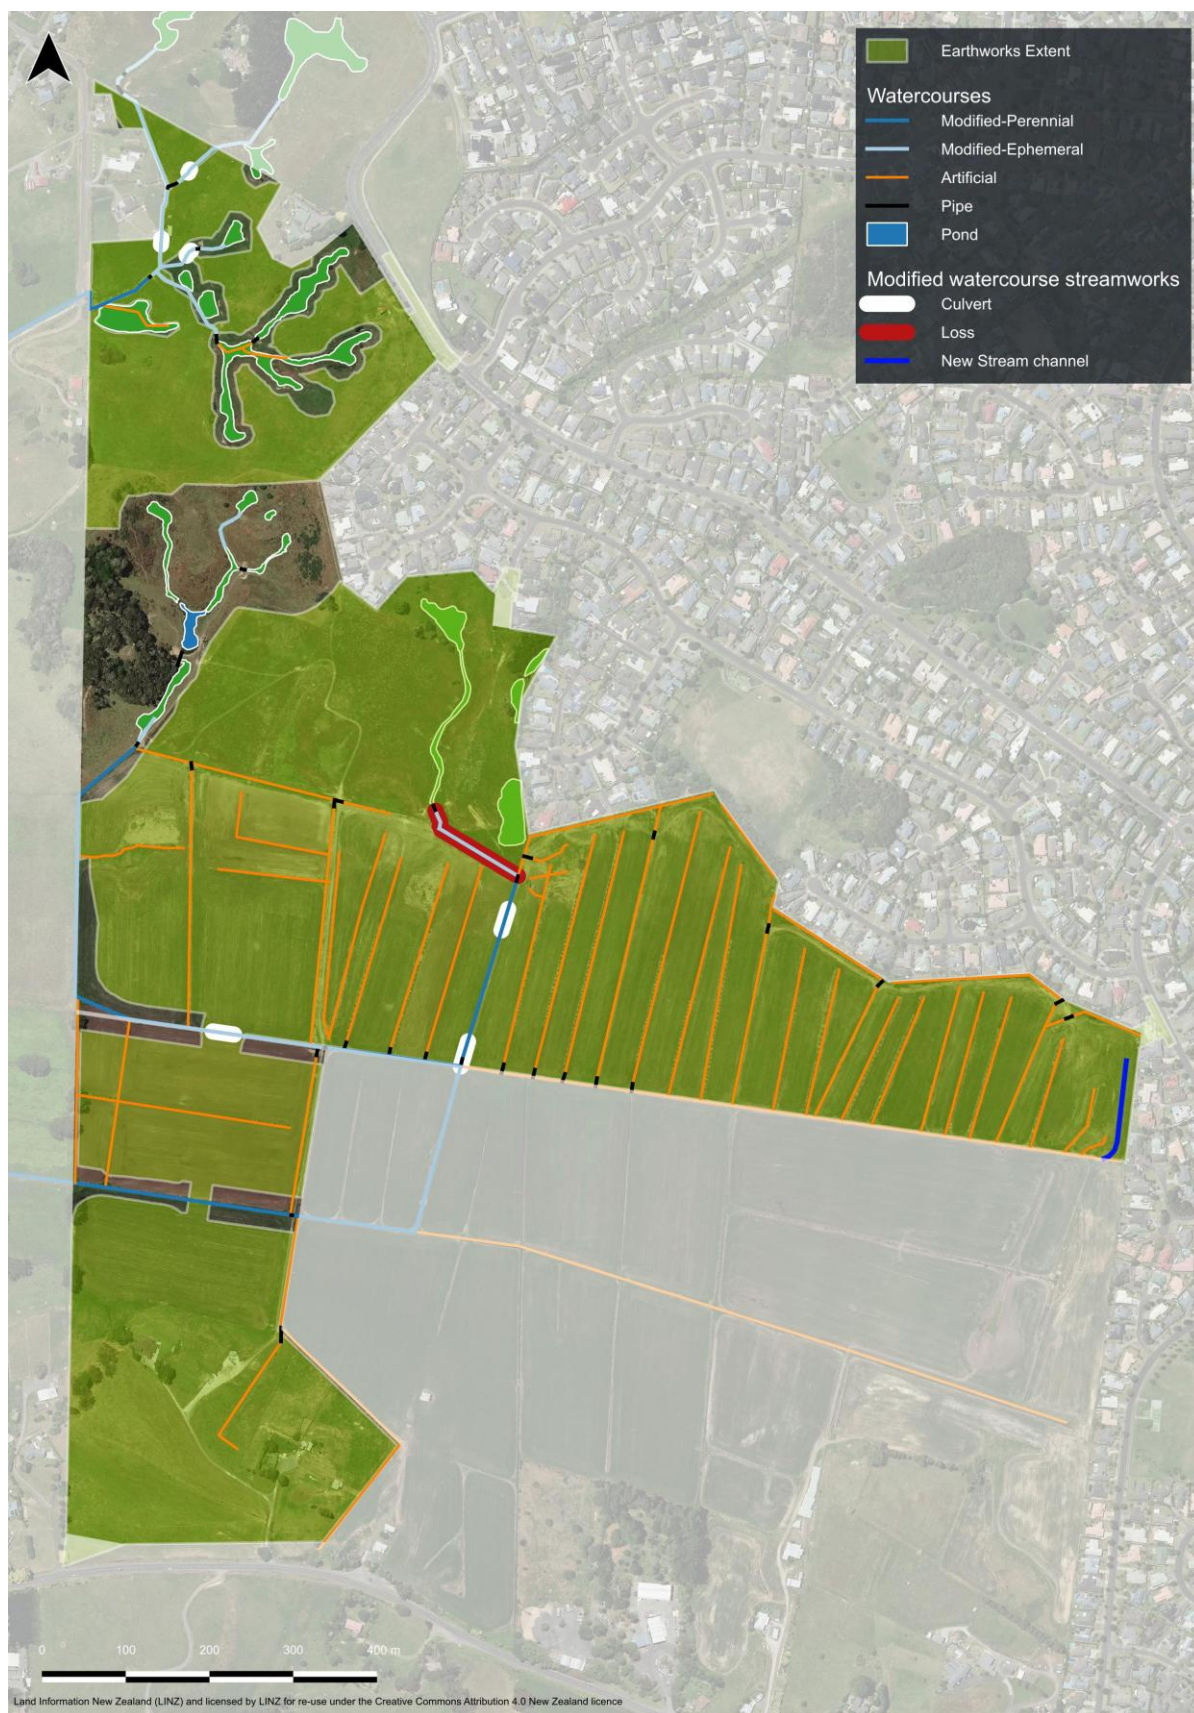
**Figure 1: The Site and proposed streamworks.**

- Recontouring and planting artificial drains which currently border the northern extent of a flat peat area where the Site abuts residential housing.
- Removal of c. 133 m of modified ephemeral watercourse.
- Removal of c. 8,374 m of artificial drains.
- Installation of three box culverts and three circular culverts along modified natural watercourses.
