**GEOTECHNICAL ASSESSMENT REPORT**

Sunfield Landholding, Ardmore

Project Reference: J01627  
December 6, 2024

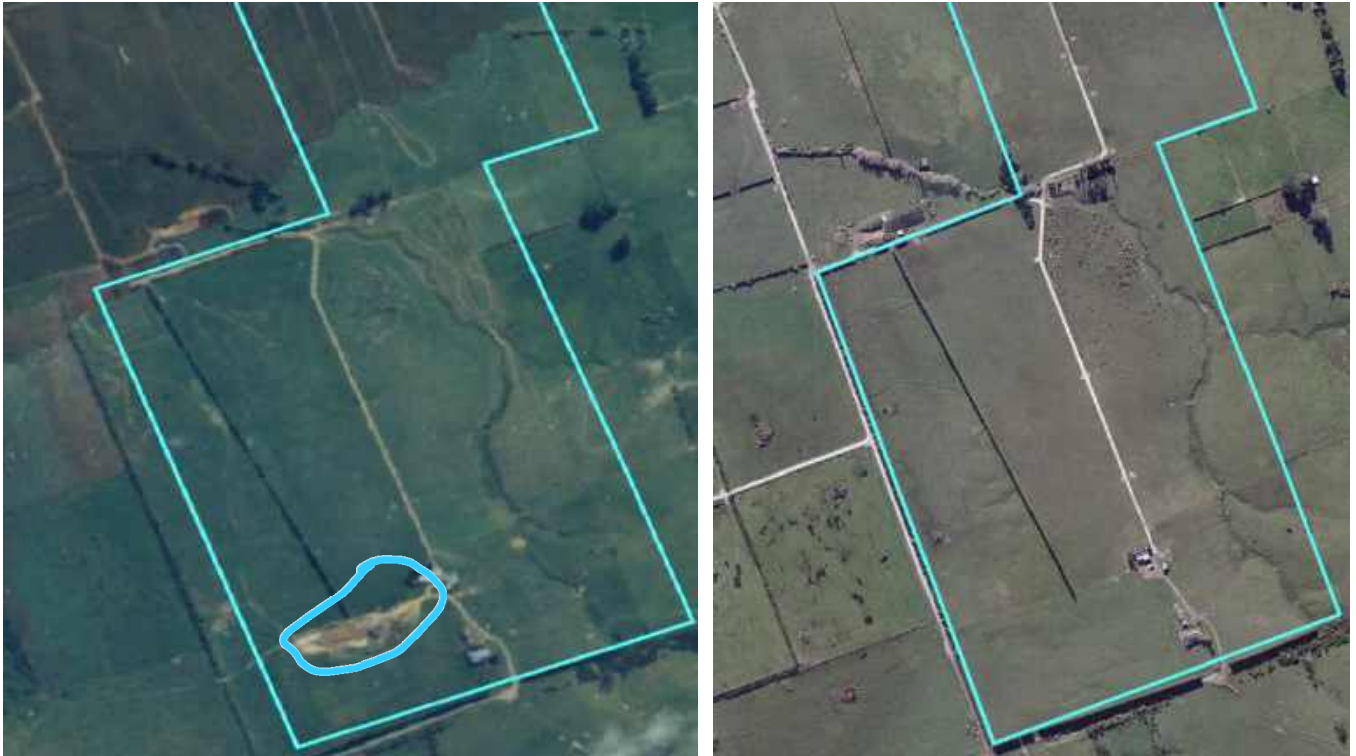
Inset A. Left: Photograph dated 1959, retrieved from Auckland Council GIS database. Area of earthworks circled in blue. Right: Photograph dated 2001.

Our interpretation of available historic photographs on Auckland Council's online GIS database, Google Earth images and historic images from Retrolens.nz generally found only minor land modification on the study area over the period 1940 to 2017, however, an area of localised earthworks is identified on or prior to 1959 within the south-western portion of 508 Old Wairoa Road. The next available aerial photograph in 2001 shows the area to be grassed and in the same condition as of the time of preparing this report. This area is discussed in further detail in Section 6.2. Historic aerial photographs dated 1959 and 2001 are inset below.

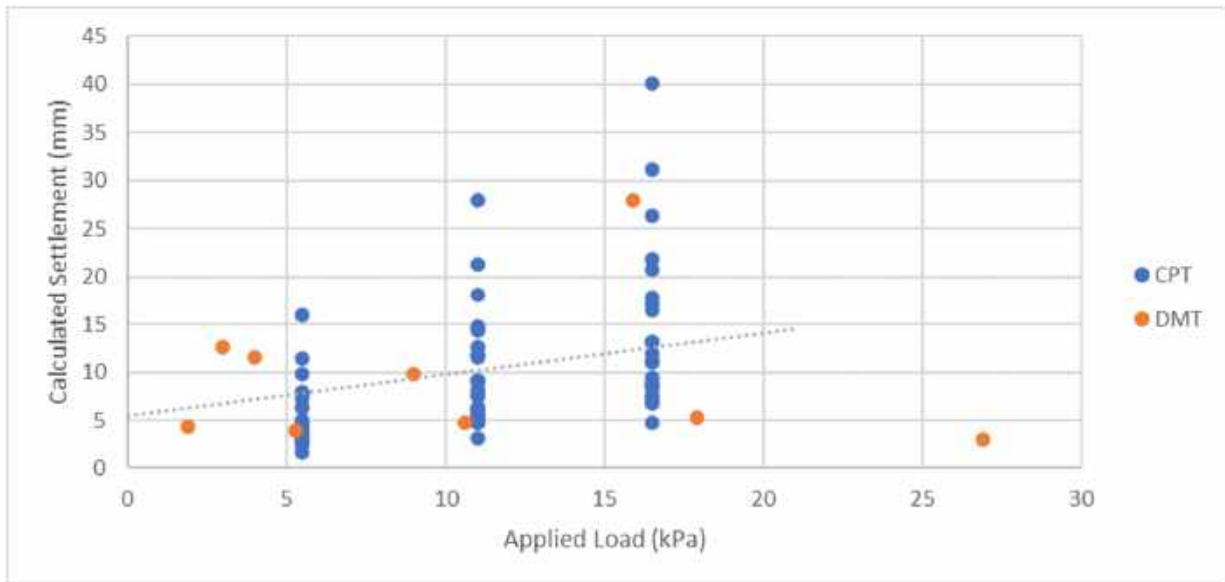
Inset D: Applied Load vs Calculated Settlement for all Zone 2 assessments.

The insets below show a summary of the expected settlements calculated for both Zones. It should be noted that there is a reasonable disparity between CPT and DMT settlement estimations. DMT methods are widely regarded as a more accurate in-situ test for estimating settlements due to the direct measurement of the soil constraint modulus (M). Notwithstanding, trial preloading as alluded to later in this section will help assess actual response of the ground to surcharge application, as opposed to reliance on widely varying theoretical estimations.

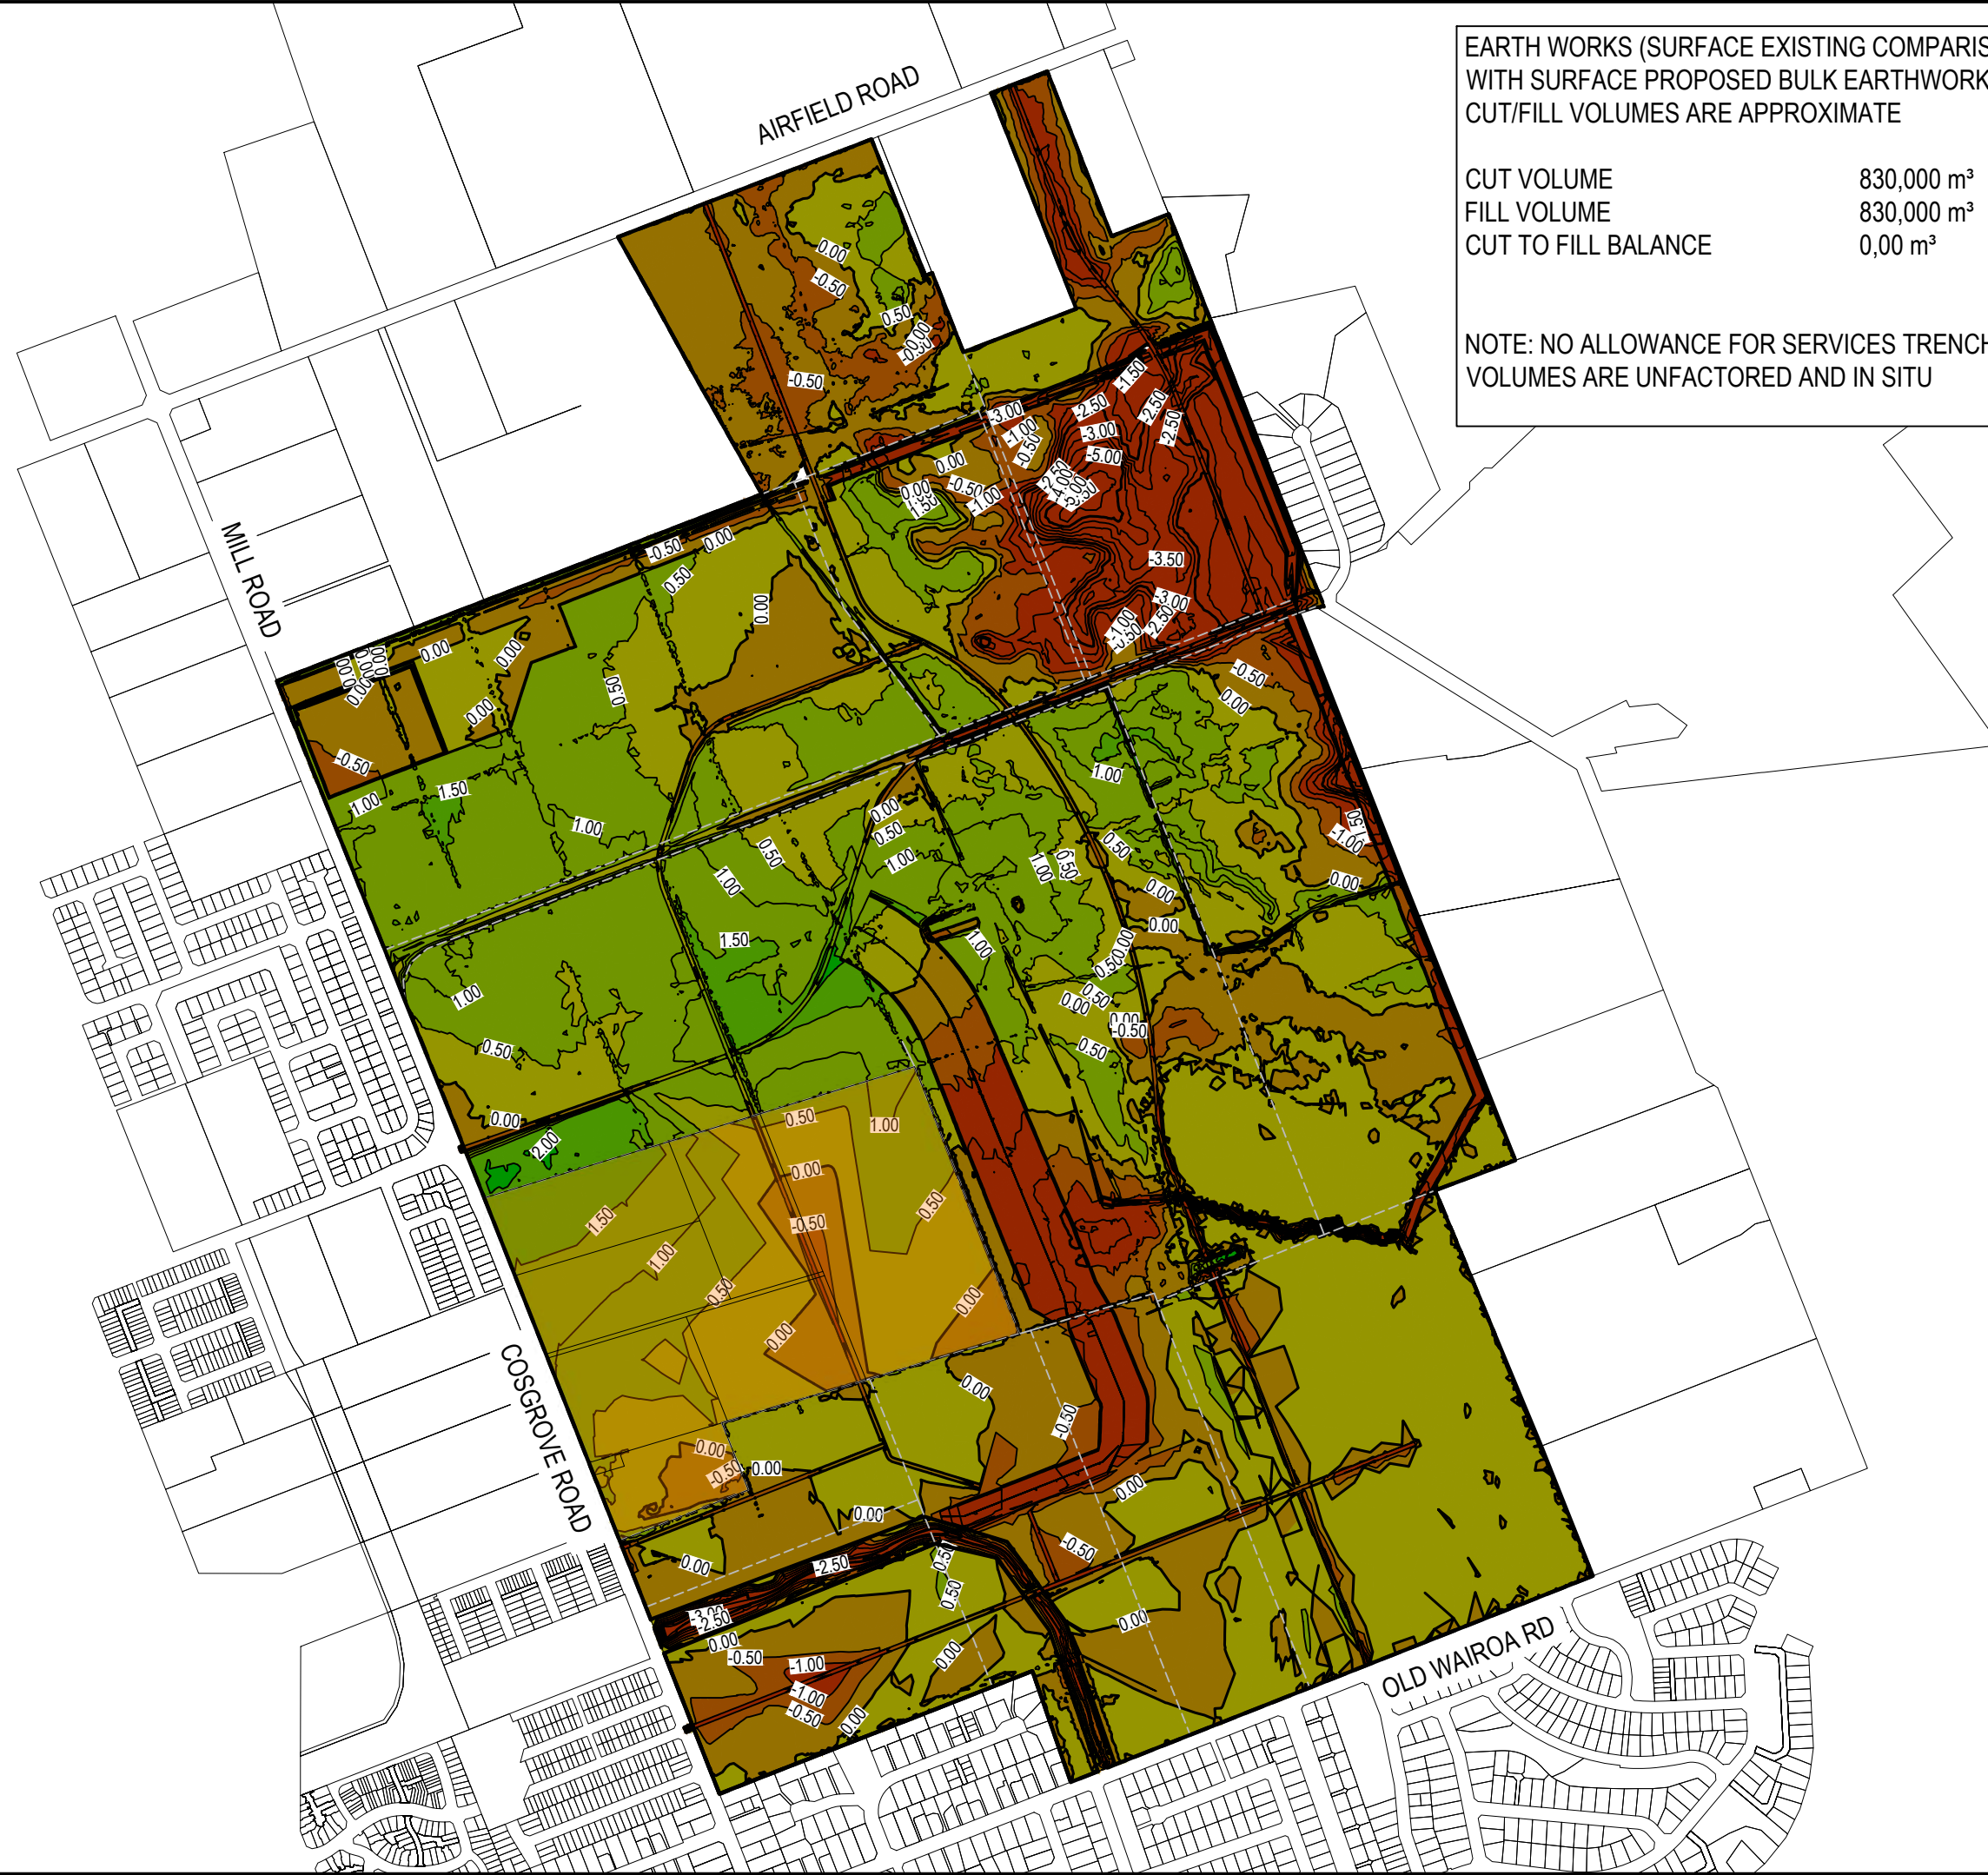
**EARTH WORKS (SURFACE EXISTING COMPARISON WITH SURFACE PROPOSED BULK EARTHWORKS) CUT/FILL VOLUMES ARE APPROXIMATE**

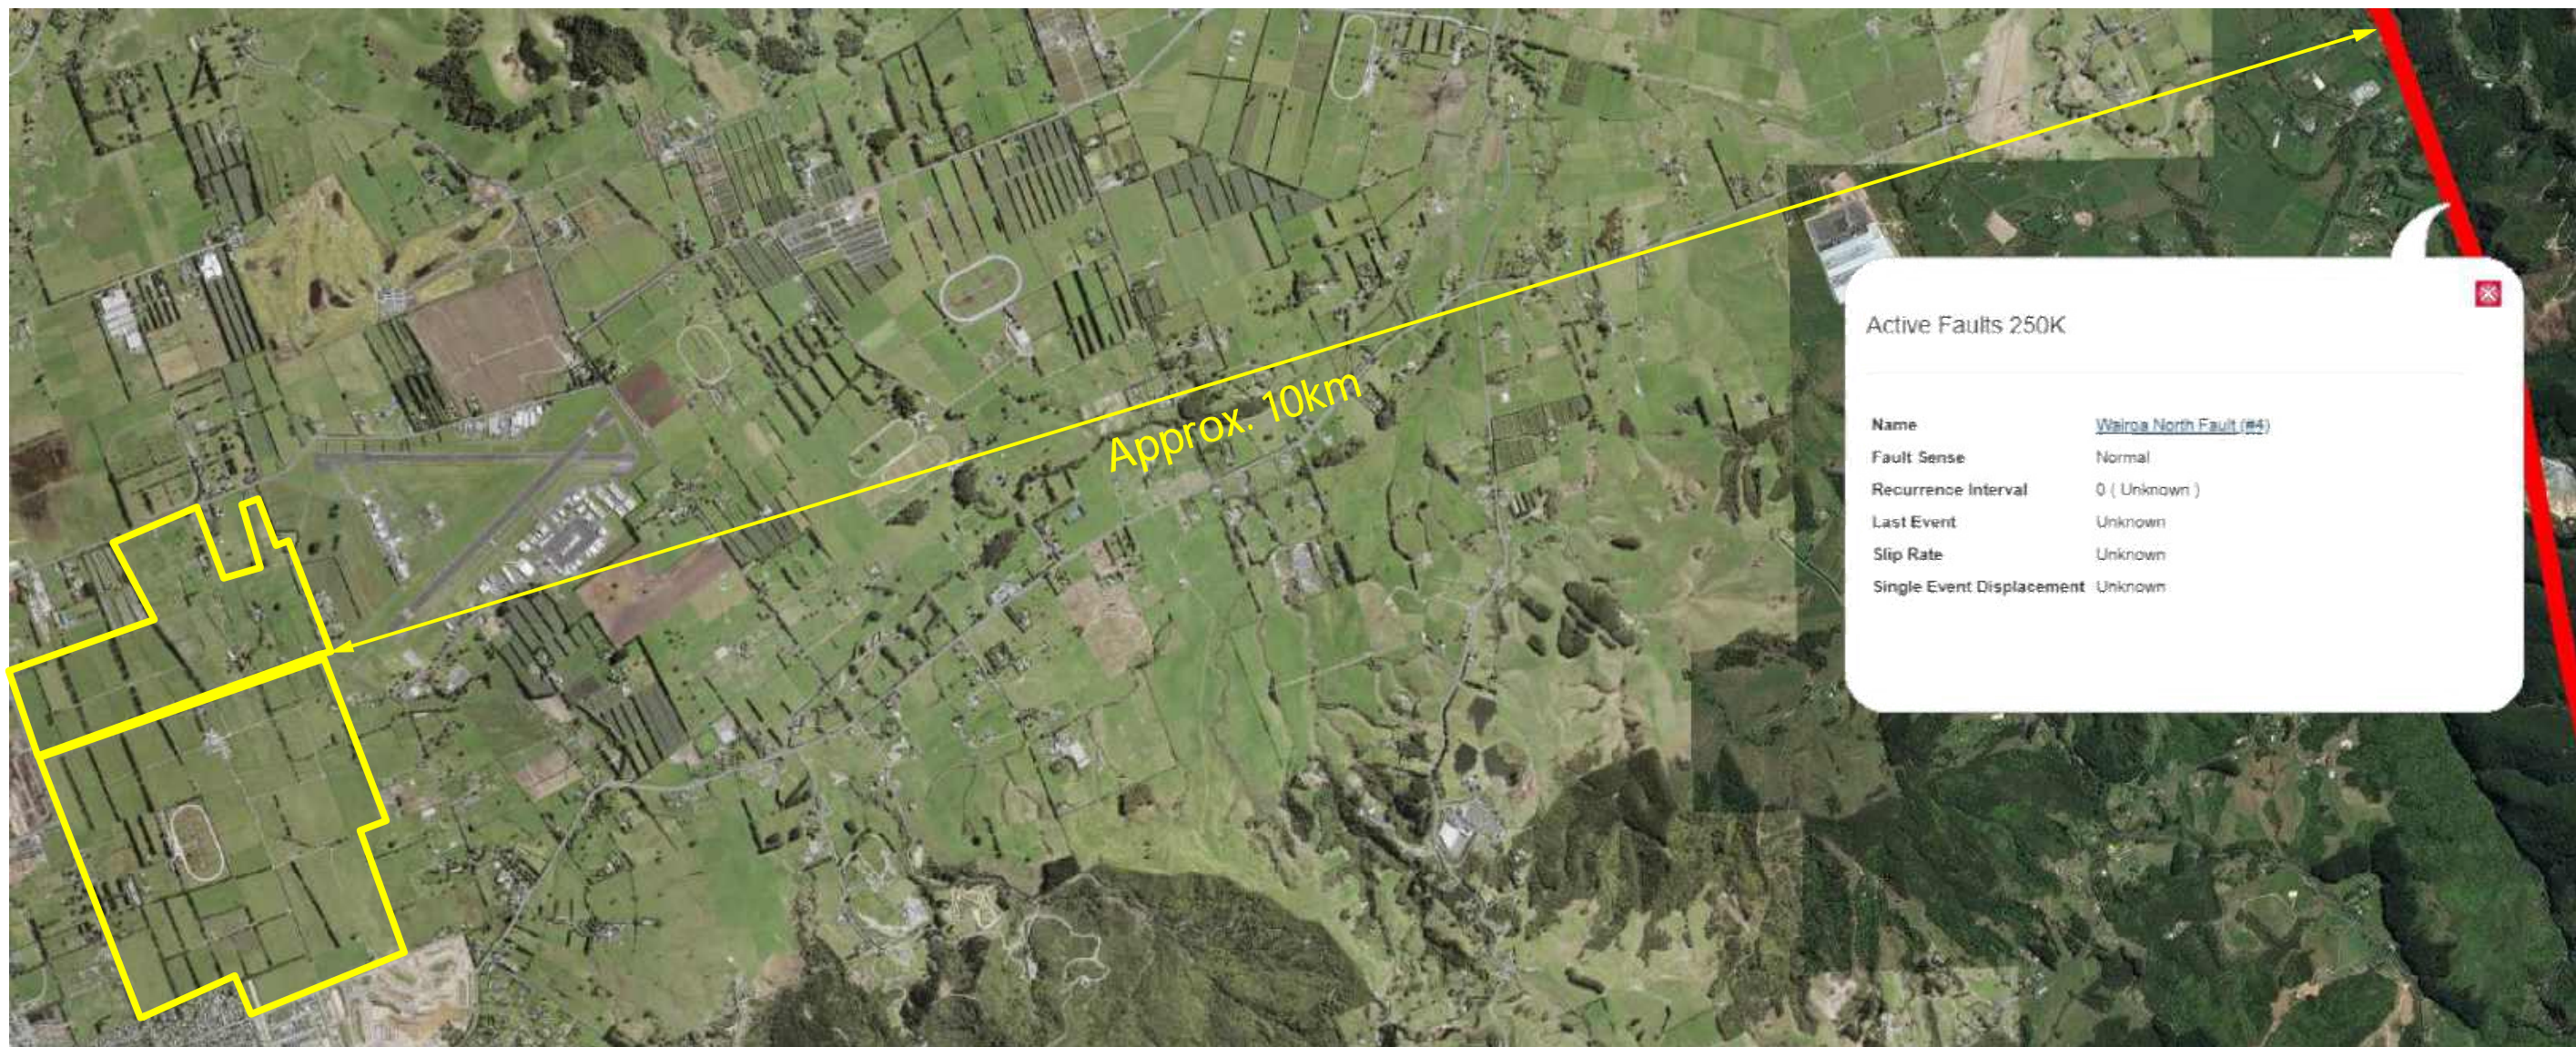
client:	<b>SUNFIELD DEVELOPMENTS LIMITED</b>		
					approved	<i>SGL</i>		project:	<b>SUNFIELDS, ARDMORE</b>		
					date	<b>28.11.23</b>		title:	<b>PROXIMITY TO ACTIVE FAULTS</b>		
					scale	<b>nts</b>		project no:	<b>J01627</b>	figure no:	<b>2.12</b>
					original size	<b>A3</b>

Active Faults 250K
