Assessment of Potential Wetlands at 111 Pound Road Industrial Development, Christchurch

Contract Report No. 7316c-i
October 2025

Access to the property at 111 Pound Road was granted on the 19th of September 2025 and it was surveyed for potential wetlands. This report summarises the findings of that survey and has been prepared as addendum to the AEE (Wildlands 2025) and should be read in conjunction with the AEE report.

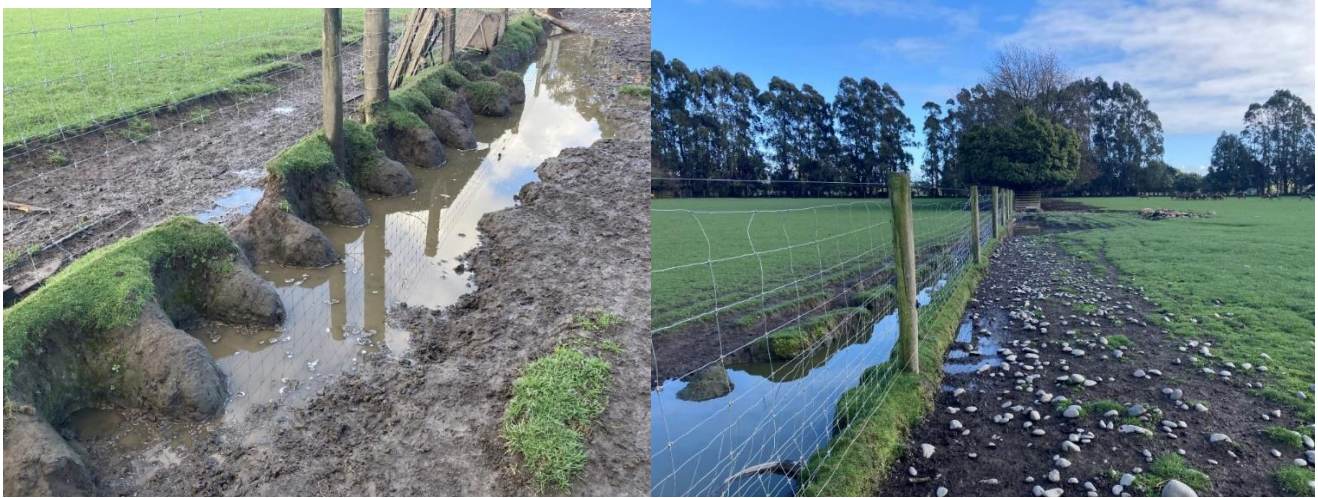
The site survey found water pooling consistent with that seen in the aerial imagery. These pools are mostly next to fence lines and appear to be induced by livestock compaction and erosion. The site has been managed as a deer farm with high stocking rates for the last 30 years¹, and shape and form of the hollows, where the water pools is consistent with animals tracking along fence lines, hoofing the ground, and deer wallows (made during the rut, Appendix 1, Plates 1-4).

Plate 1 – Heavily tracked and rutted fence lines, as a result of livestock compaction/erosion, at 111 Pound Road, Islington, Christchurch.

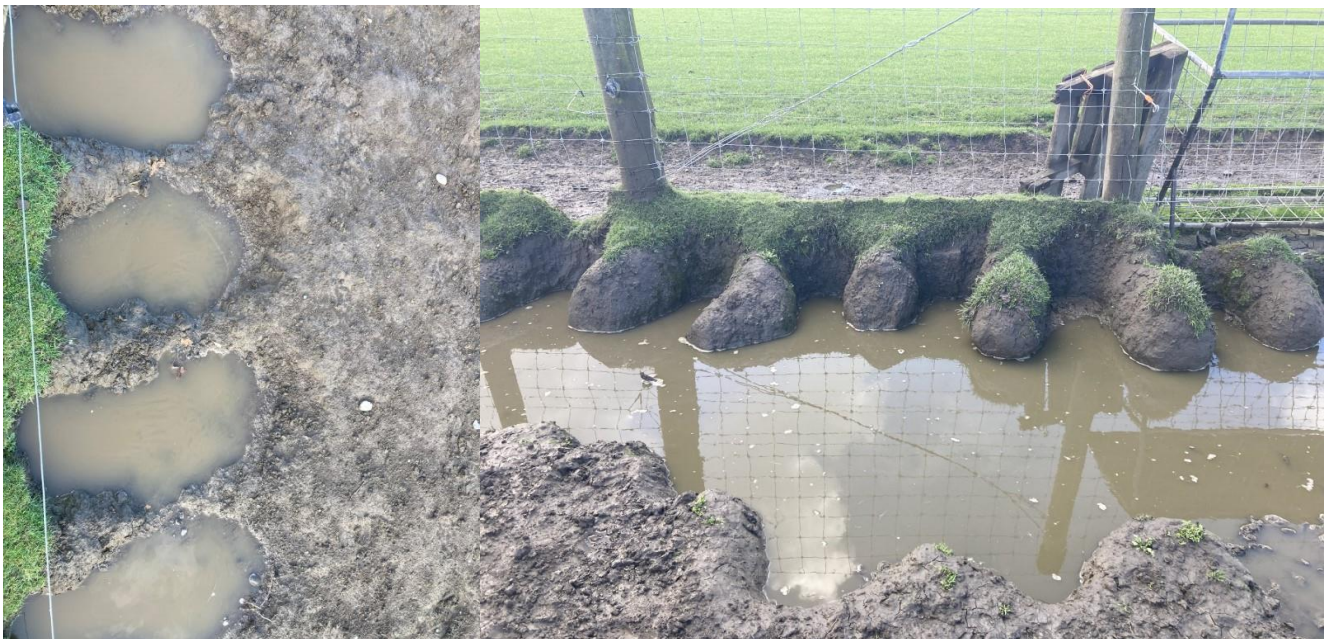
Plate 2 – Deer hoofing marks resulting in deeply rutted ground, at 111 Pound Road, Islington, Christchurch.

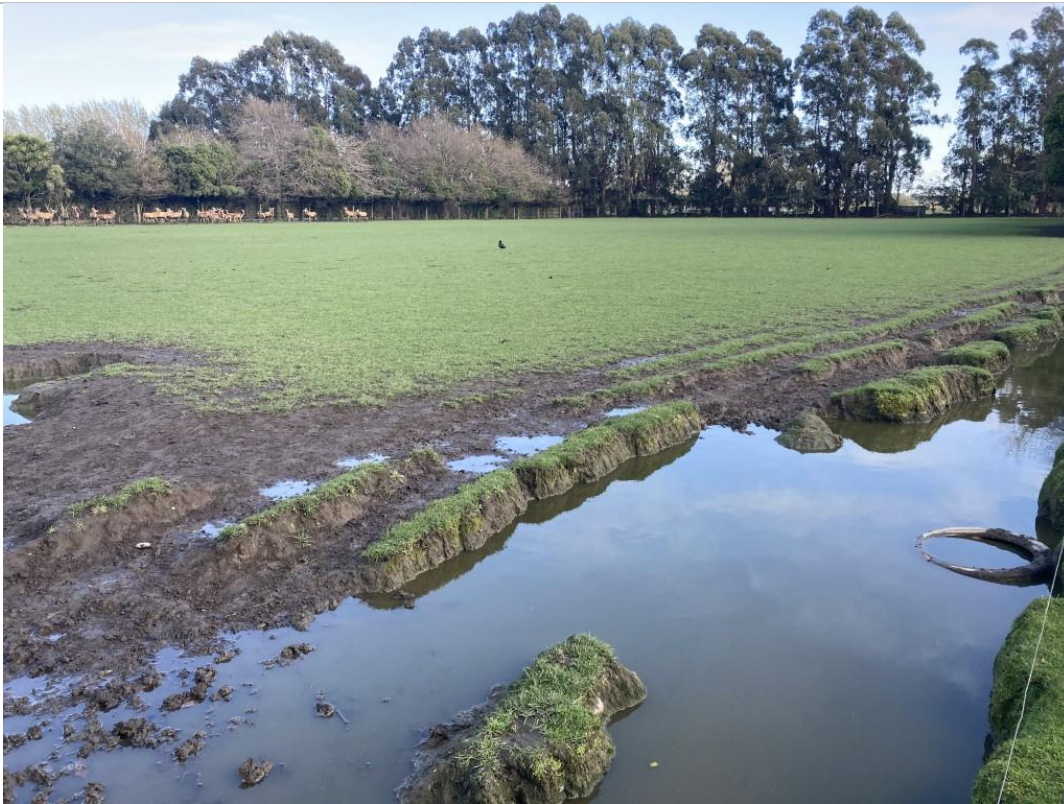
The site is regularly irrigated by a ground water bore that the landowner Warrick Wright indicated was 16 metres deep (pers comm), in line with the depth to ground water records held on Canterbury Maps. Overtime, consistent and repeated water pooling in the same location can induce wetland habitats. However, this is not the case here and these areas are best described as areas of temporary water pooling.

Plate 3 – Surface water pooling and animal tracking marks, at 111 Pound Road, Islington, Christchurch

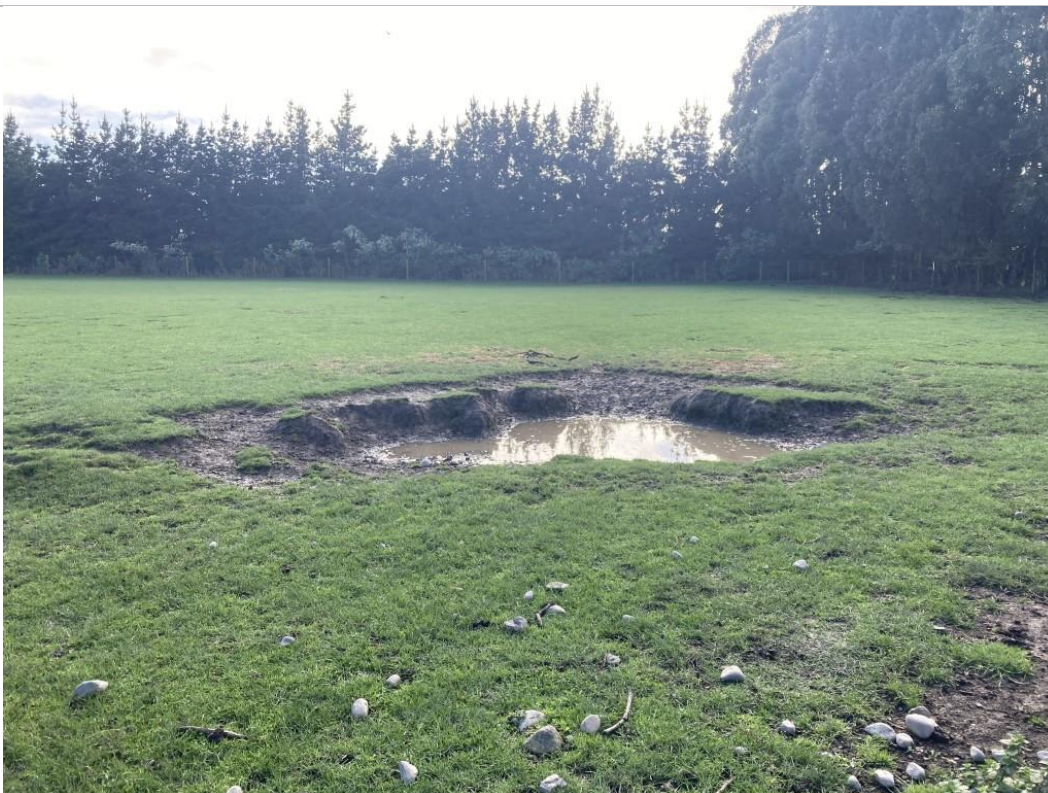
Plate 4 – Surface water pooling that appears to be the result of stag wallow, at 111 Pound Road, Islington, Christchurch.
