HAWKE'S BAY GEOTECH

GEOTECHNICAL ASSESSMENT REPORT

PROPOSED PLAN CHANGE

174 & 176 Brookvale Road, Havelock North

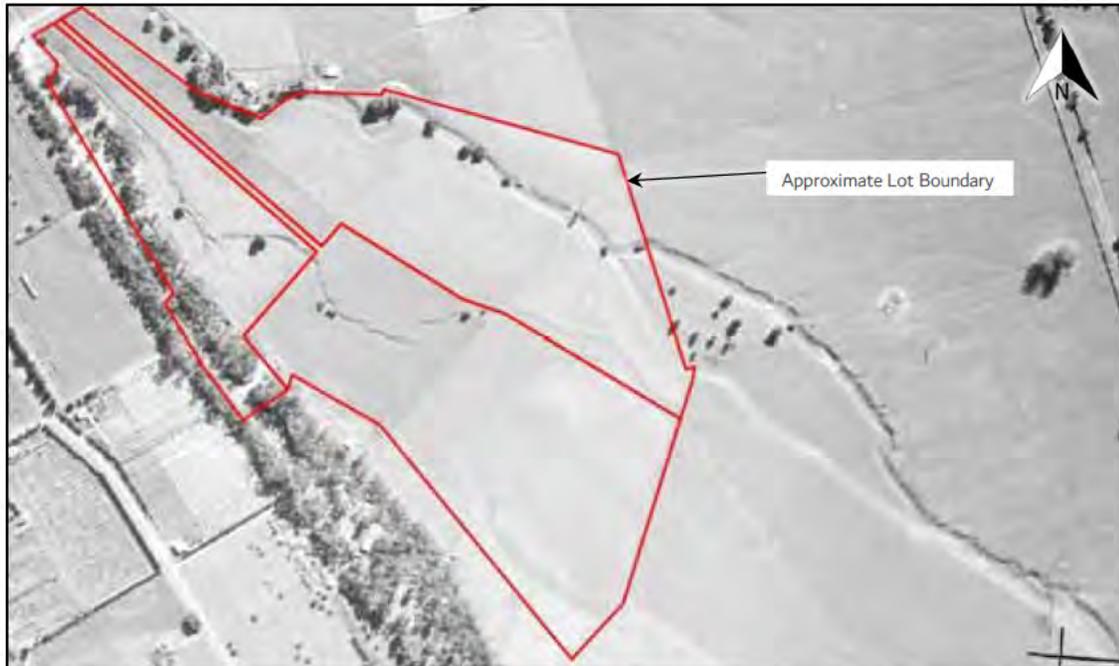
The earliest available imagery from Retrolens was acquired in 1950 (Figure 22) and indicates that the site was used for predominantly pastoral purposes at this time. The north-western and south-western elevated platforms appear to have not been constructed at this stage. Cut and fill earthworks were likely undertaken at later stages in this area.

Figure 22: Historical aerial image of the site (1950) – Maven Associates (Preliminary Infrastructure Report)

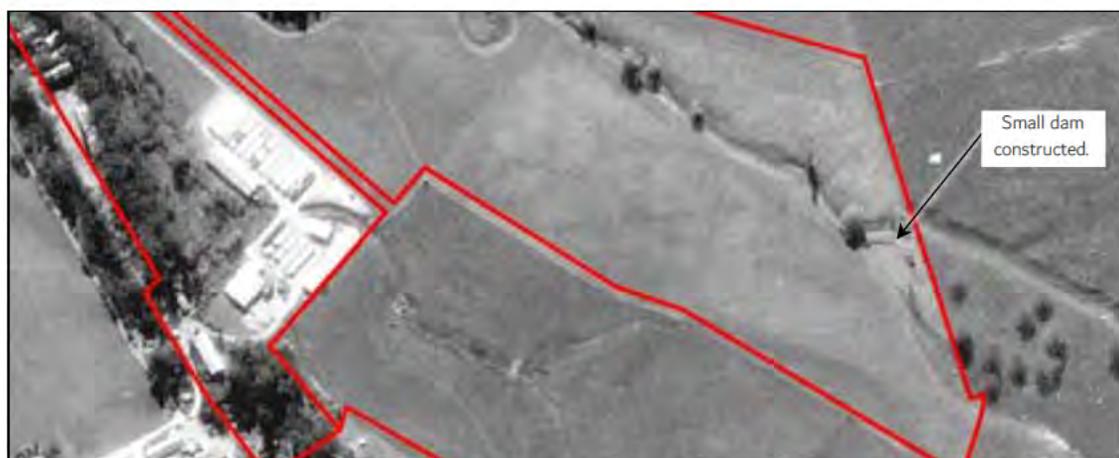
No significant changes were noted until around 1980 when development of commercial buildings began, and a small dam was constructed on one of the contributing overland flow paths which leads to the eastern ephemeral stream. Aerial Imagery indicating the small dam from 1980 is included in Figure 23.

Figure 23: Historical aerial image of the site (1980) – Maven Associates (Preliminary Infrastructure Report)

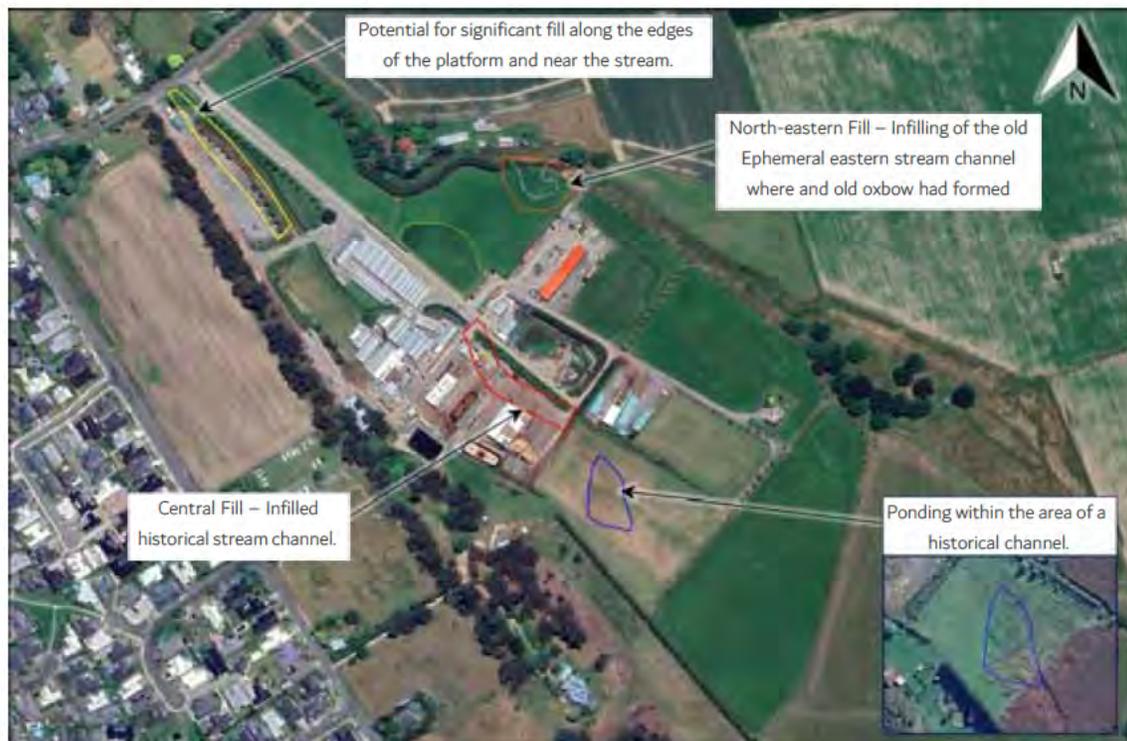
Figure 24: Recent aerial imagery with the locations of historical filling or potential filling, and ponding.

- North-eastern elevated platform - There has been some cut and fill earthworks in this area to form the current platform.
- Central Commercial Area – Infilling of the old stream channel (as indicated in Figure 25).
- Central North – Potential for shallow fill in this area from stockpiles laid out over the area.
- North-eastern Fill – Infilling of the old ephemeral eastern stream channel where and oxbow had formed (refer to Figure 26).
- Some ponding of water (in image post Cyclone Gabrielle) in the south-west of the site where an old channel is located.

A review of more recent aerial imagery (post 2009) via Google Earth Pro has identified the following features which are indicated in Figure 24 and in further detail in Figures 25 & 26.

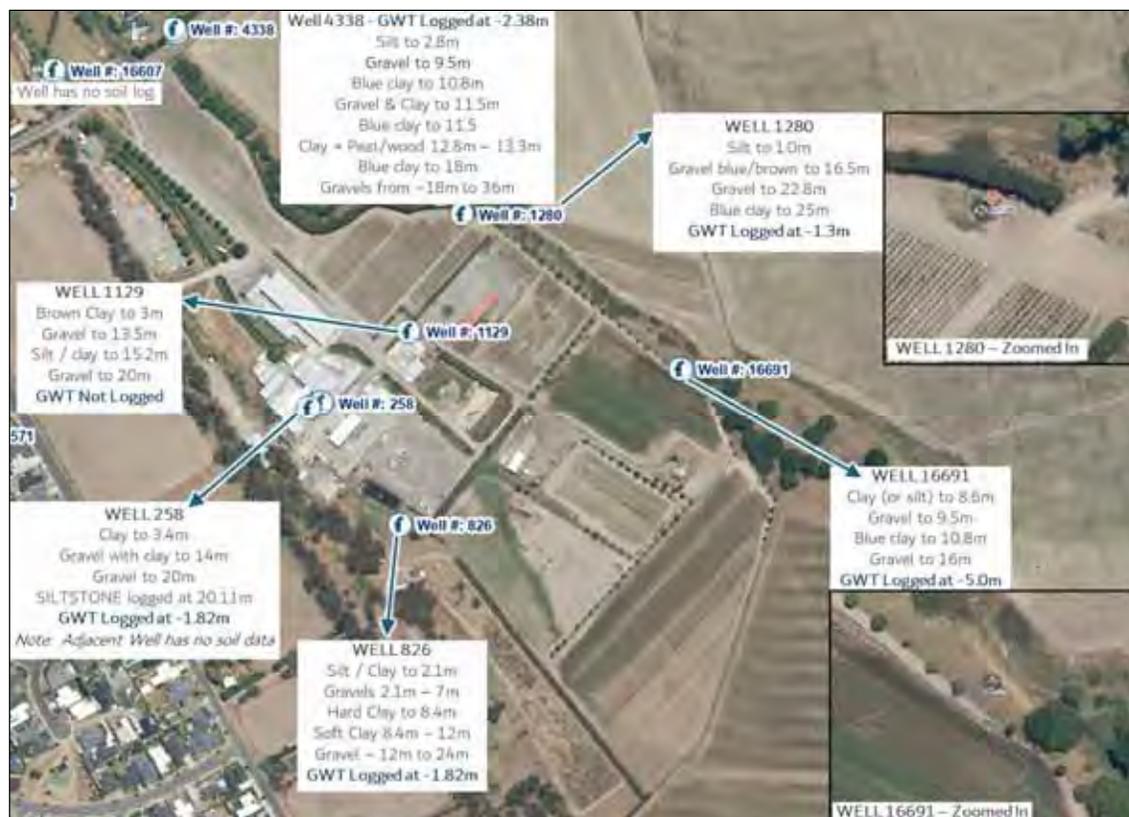
It is noted that there are a significant number of Wells across and close to the site which have been logged during drilling. The logs are typical suitable to identify fine-grained soils, sand and gravels at approximate depths. The well logs have been reviewed and interpreted in order to gain a preliminary understanding of the deeper soil profile and to supplement the two 10m deep boreholes, CPT test, and the 6m deep test pit which have been undertaken on the site. The well log locations are indicated in Figure 27 and include a brief summary of the soils logged. The complete Well Logs are included in Appendix B along with our test information.

Figure 27: Recent Well Log Locations and Log Summaries.

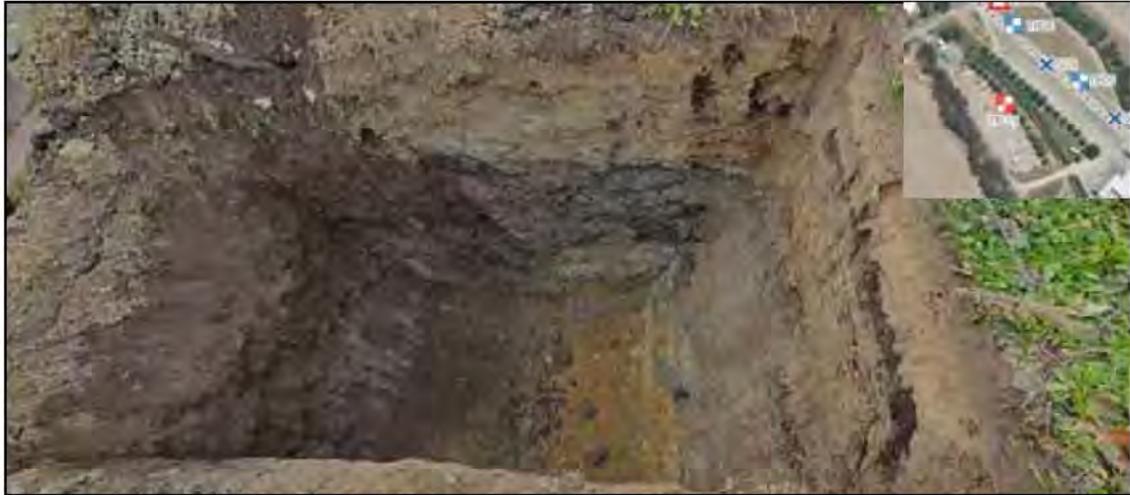
Figure 29: Site photo of uncertified fill – TP15 - North-eastern elevated platform.

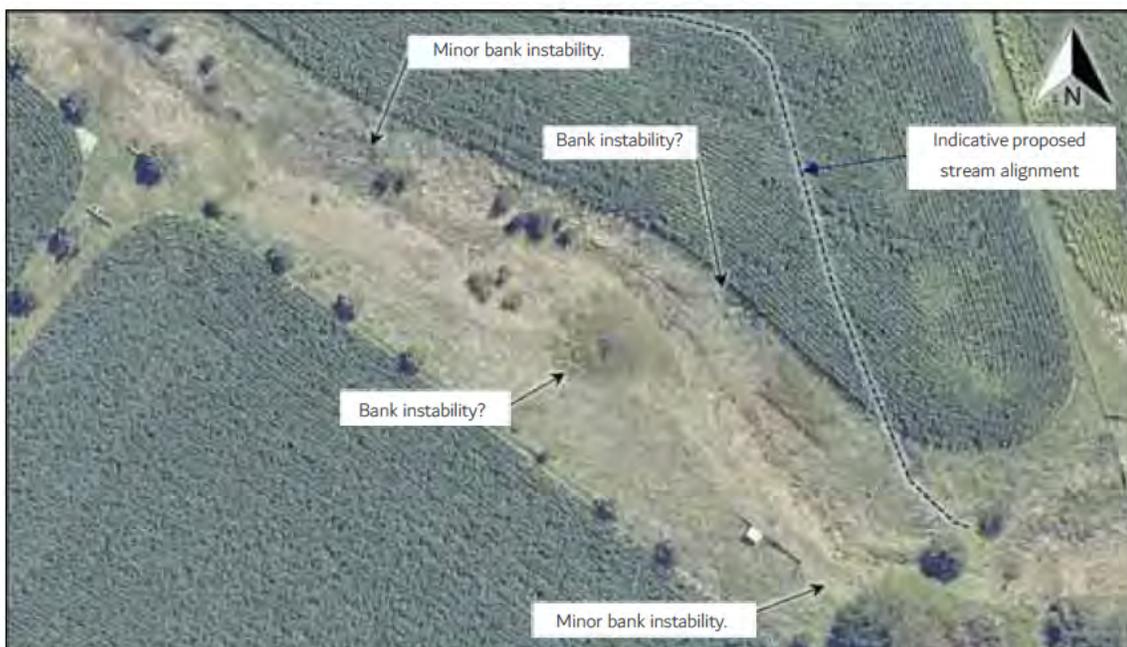
Figure 33: Aerial Imagery of the eastern ephemeral stream channel post Cyclone Gabrielle.

We have undertaken a review of recent aerial imagery obtained following Cyclone Gabrielle (Figure 33) in order to identify possible levels, flows and effects on the stream banks under extreme rainfall events. The review indicates the stream levels during the event may have reached close to the top of the banks and that some small-scale instability occurred in areas along the bank.

Based on the review of the performance of the stream banks during Cyclone Gabrielle, we consider the risk of significant bank instability is low provided that:

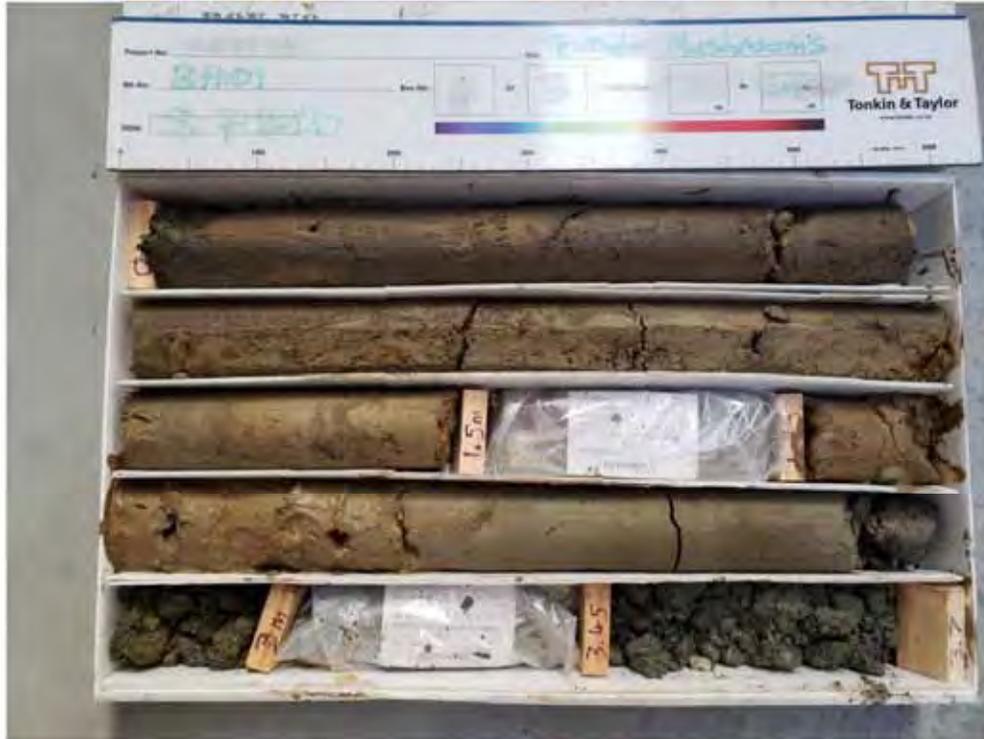
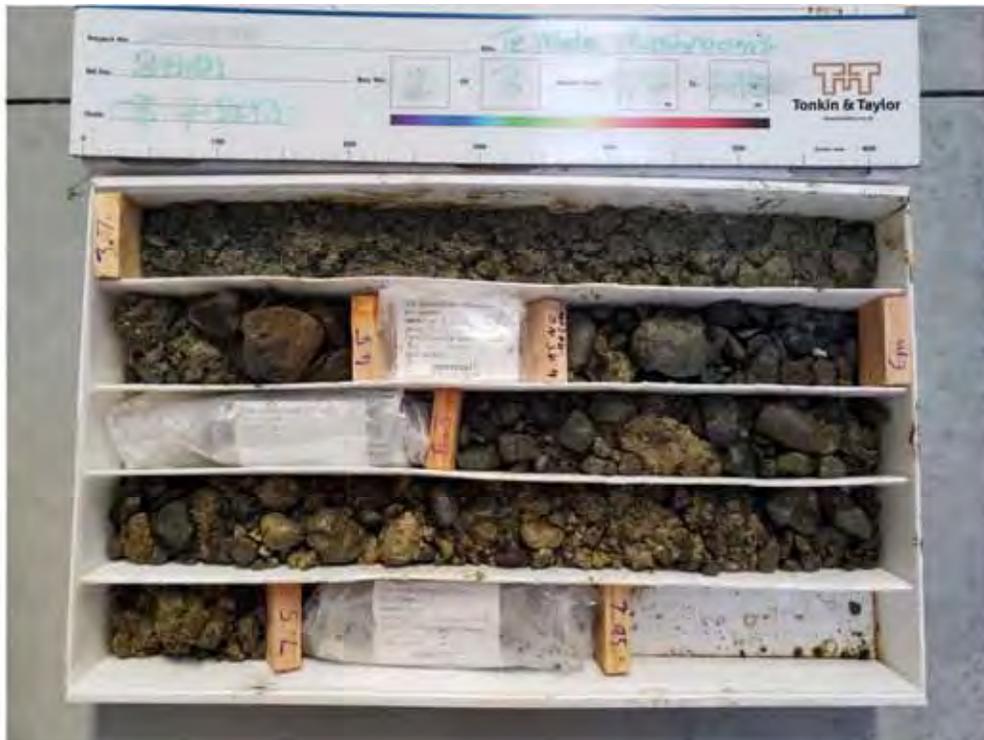
0.00-3.70m

3.70-7.95m

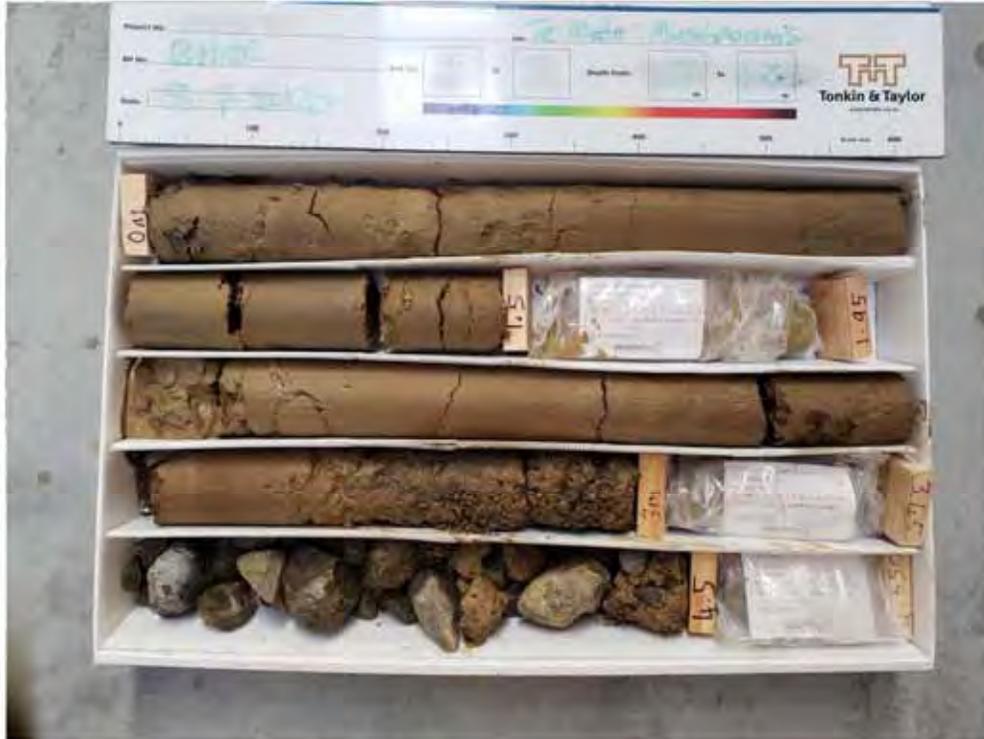
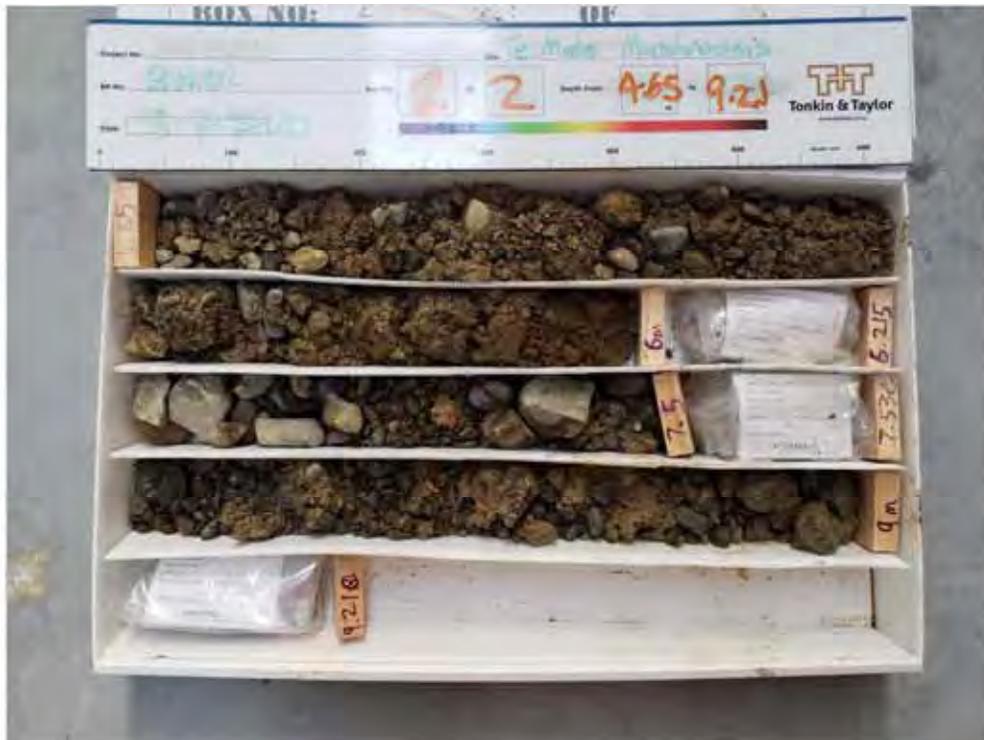
0.00-4.65m

4.65-9.21m

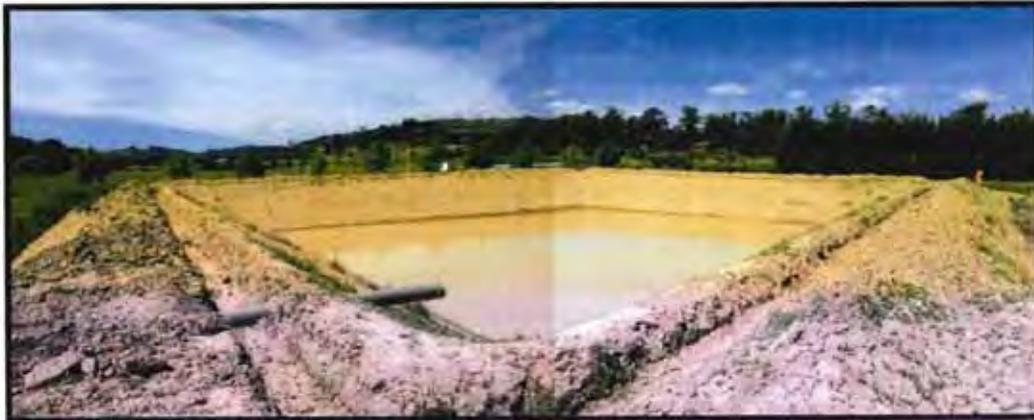
Figure 1. Photograph of TMM stormwater pond taken by HDC on 17/11/2020. (view from northern corner looking south).

Figure 1 shows a photograph taken during the Council's site visit showing the general layout of the site, including the presence of standing water in the pond. Based on the photographs the standing water level in the pond would appear to be no greater than 1 metre below natural ground level (or alternatively, of the order of 2 to 3 metres below the top of the bund).

At the time of the Council site visit (17/11/2020) the pond was not lined, nor did it have an overflow pipe. It does however currently have a discharge pipe near the top of the bund wall, close to the Northern corner of the pond, which would discharge to the North-eastern side of the pond towards an ephemeral stream approximately 20m away.

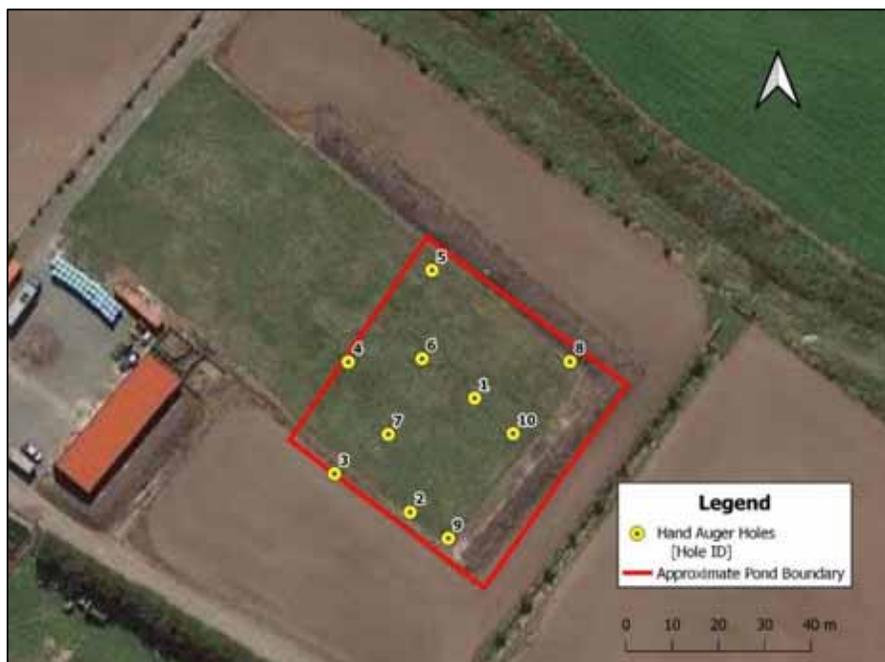
Figure 5. Location of hand auger holes utilised for the TMM pond investigations.

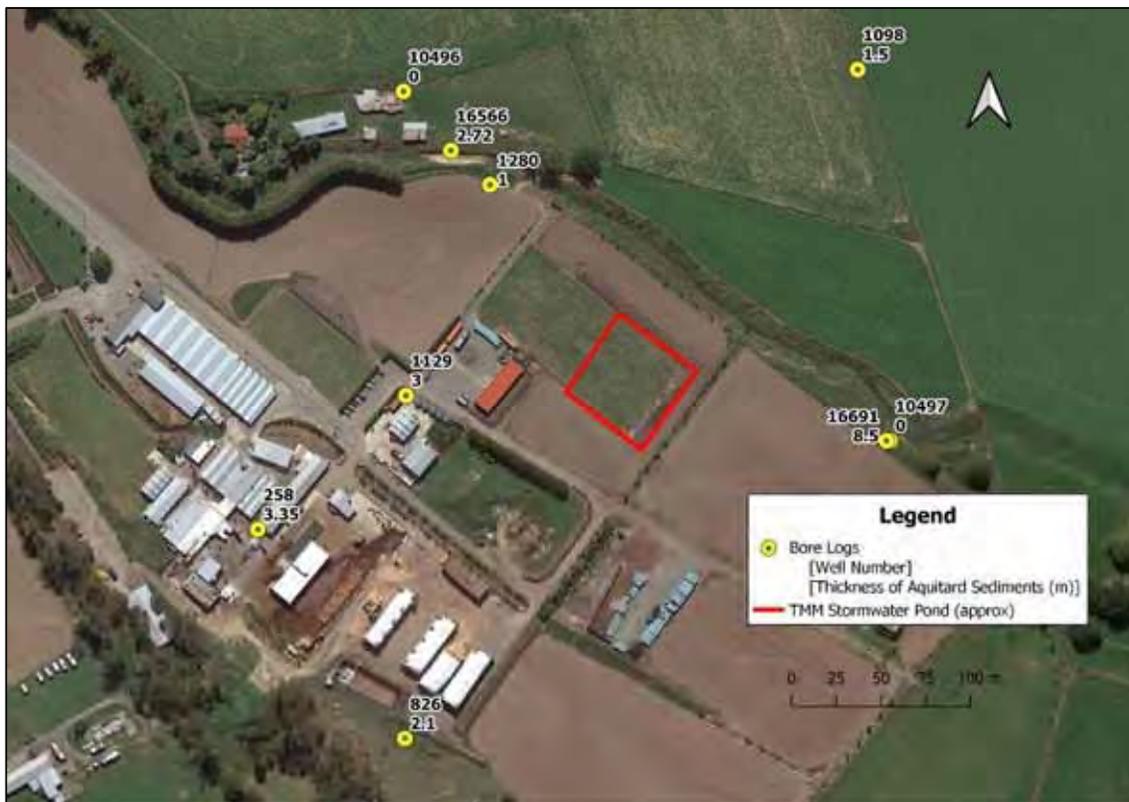
Figure 6. Thickness of surficial low permeability sediments in the vicinity of the TMM pond indicated on drillers logs (source HBRC).

The shallow groundwater system in the vicinity of Brookvale Road is overlain by a thin layer of low permeability sediments² which limit hydraulic connection between the underlying aquifer system and the surface environment. As illustrated on Figure 6 drillers logs from bores from the area surrounding the TMM pond indicate the thickness of the surficial low permeability sediments varies between 0 and 8.6 metres. However, in general, the logs tend to indicate the low permeability materials (typically described as 'brown clay' or brown clay with silt) are likely to be of the order of 2.5 to 3 metres in thickness in the vicinity of the TMM pond site.

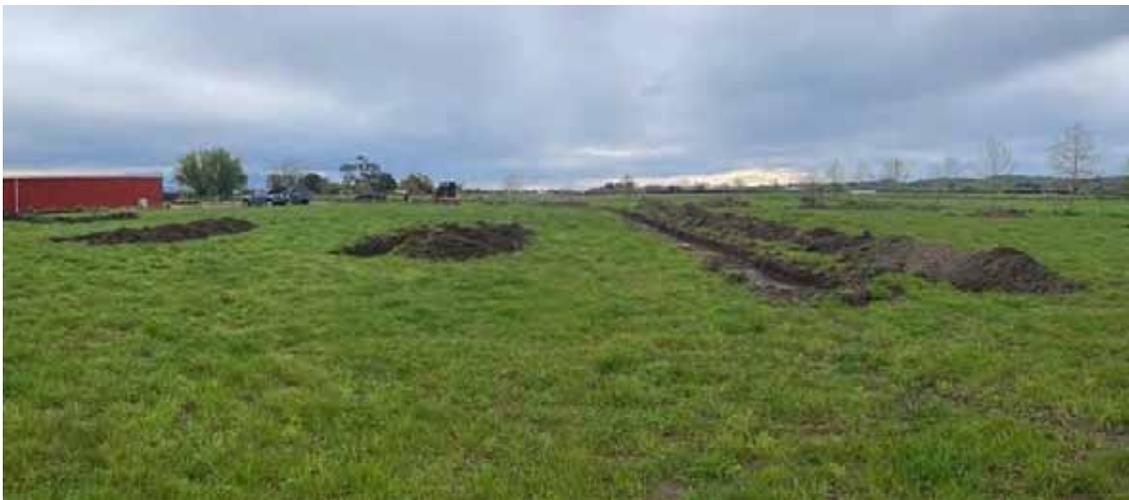
Figure 4. A series of trenches were excavated across the approximated perimeter of the footprint of the former pond (view east).

On 28 and 29 September 2022, a series of shallow trenches were scraped by the excavator to expose the near-surface soils along each side of the projected perimeter of the pond/bund footprint. An overview of the site with several of the shallow trenches is presented in Figure 4.

However, the shallow excavations only provided very approximate bounds of the pond/bund, and did not identify a well-defined fill/natural ground delineation of the perimeter. Using the soils excavation information, the approximated corners of the pond/bund footprint were surveyed by Surveying the Bay, with the plan presented in Appendix A.

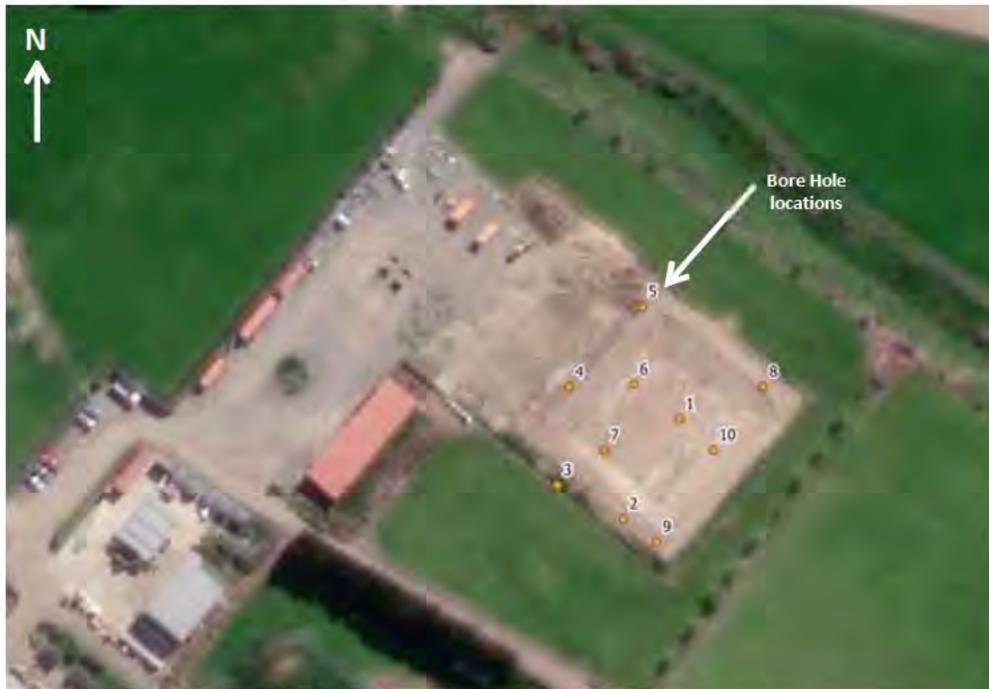
Figure 5. Aerial image of the former pond/bund area showing Bore Hole locations

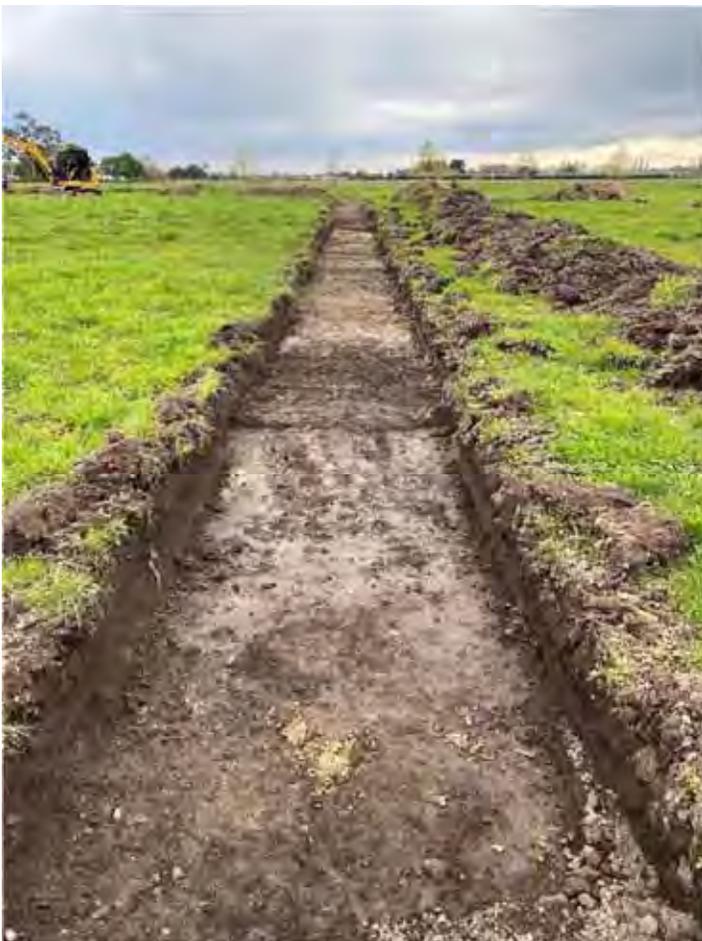
Figure C2: Shallow trench over Bore Hole Nos. 1 and 2.

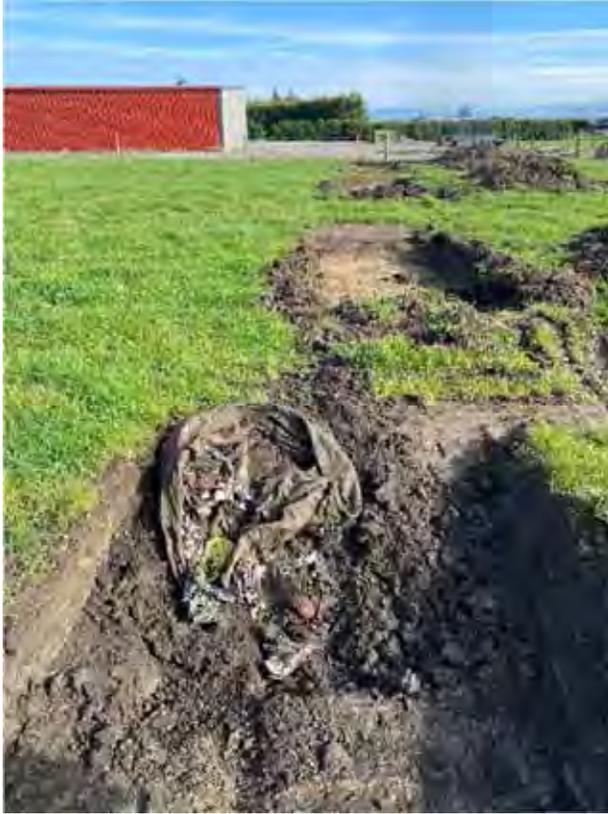
Figure C3: Shallow trench revealing rubbish bag near Bore Hole No. 6.

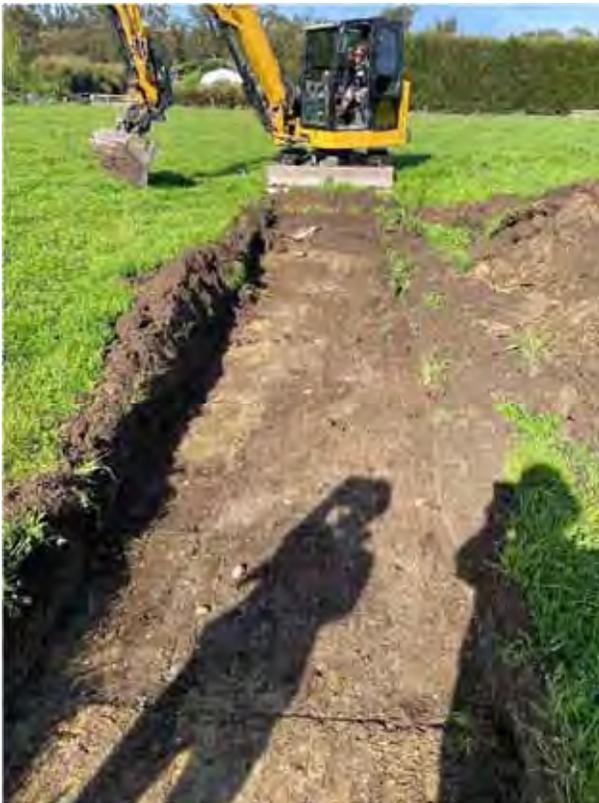
Figure C4: Shallow trench near Bore Hole No. 8.

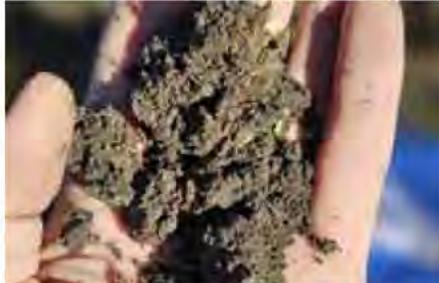
<p>Indicative Extents (white line is old channel)</p>	-1.5

3.0	Alluvium		Sandy GRAVEL with minor silt: brownish grey, loose, wet.			-3.0
Hole Depth: 3.10m Termination: Refusal in Gravels.		Remarks: Auger undertaken in an area where in filling of the old stream channel was suspected. Organics and Fill encountered in this area is expected to be very localized.		<ul style="list-style-type: none"> ● Vane peak ○ Vane residual ◆ Vane Unable to Penetrate (UTP) ▼ Standing Groundwater Level 		
Materials logged and described in general accordance with NZGS 'Field Description of Soil and Rock' (2005).

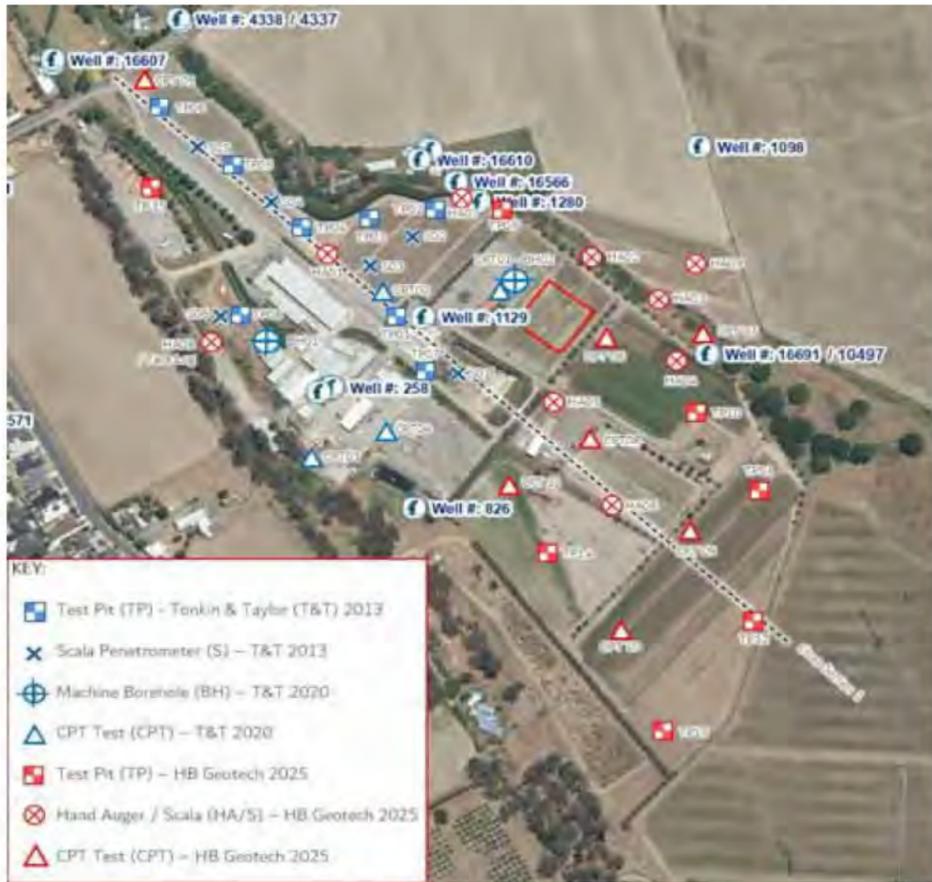
PRELIMINARY GROUND MODEL - CROSS SECTION 01 (Note 5 x Vertical Exaggeration)

- Ground profile is indicative only and RL's are based on NZVD 2016. 5 x Vertical exaggeration has been applied.
- Soil stratigraphy is based on investigations by HB Geotech and other parties including Well Logs in the area, particularly for the deeper soils.
- Well Logs are considered suitable for differentiating between gravels, sands and fine-grained soils but typically not for differentiating between clays & silts.
- Ground conditions between investigations points have been inferred and therefore natural ground conditions may vary from those assumed.
- Red underlined units are potentially liquefiable under ILS (1:100yr) events and greater.

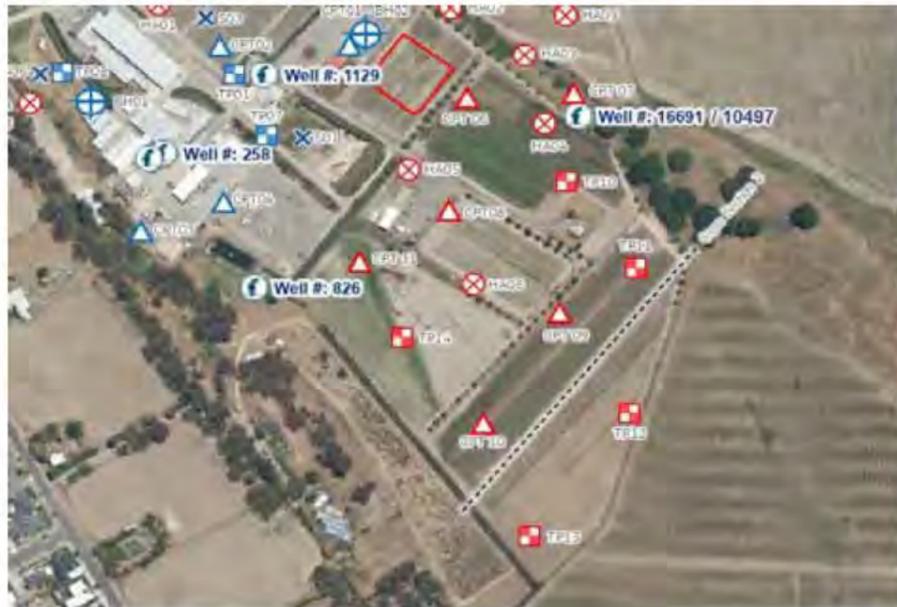
PRELIMINARY GROUND MODEL - CROSS SECTION 02 (Note 4 x Vertical Exaggeration)

- Ground profile and test locations are indicative only and RL's are based on NZVD 2016. 4 x Vertical exaggeration has been applied.
- Soil stratigraphy is based on investigations by HB Geotech and other parties including Well Logs in the area, particularly for the deeper soils.
- Ground conditions between investigations points have been inferred and therefore natural ground conditions may vary from those assumed.

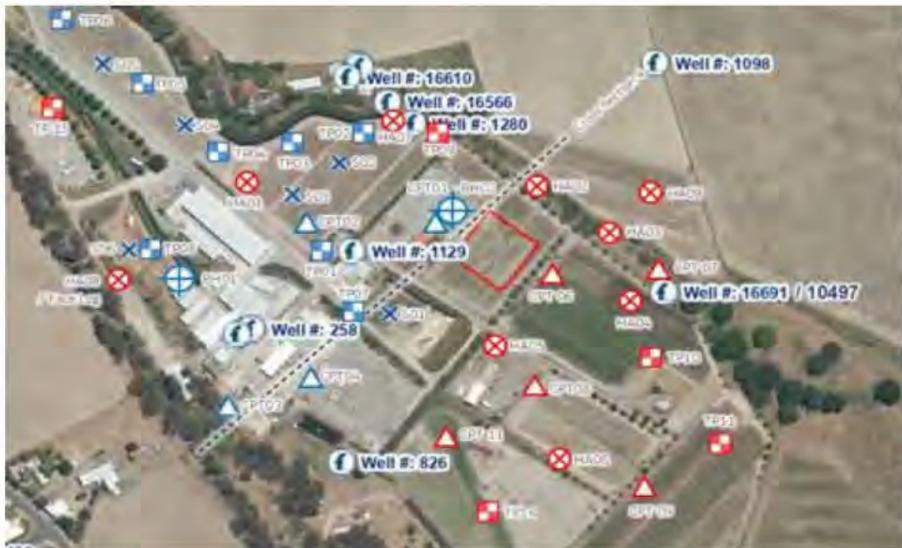
PRELIMINARY GROUND MODEL - CROSS SECTION 04 (Note 4 x Vertical Exaggeration)

- Ground profile is indicative only and RL's are based on NZVD 2016. 4 x Vertical exaggeration has been applied.
- Soil stratigraphy is based on investigations by HB Geotech and other parties including Well Logs in the area, particularly for the deeper soils.
- Well Logs are considered suitable for differentiating between gravels, sands and fine-grained soils but typically not for differentiating between clays & silts.
- Ground conditions between investigations points have been inferred and therefore natural ground conditions may vary from those assumed.

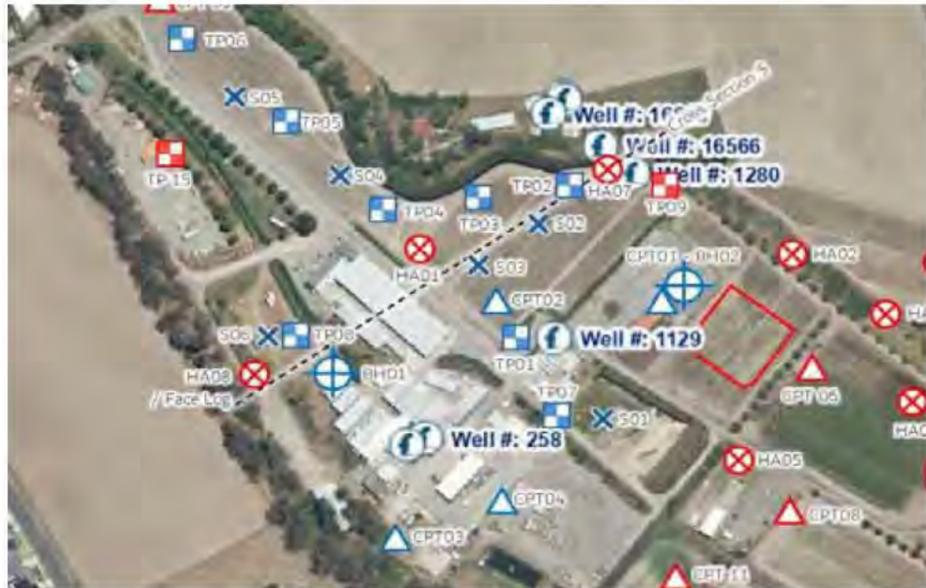
HA07 was undertaken in the location of an old infilled stream channel which has been diverted north. The image to the right indicates the likely in-fill extents and old channel location (from historical imagery)

- North-eastern Fill – Infilling of the old Ephemeral eastern stream channel where an old oxbow had formed (refer to Figure 26 – Section 3.4). HA07 (Appendix B) was undertaken in this location and encountered very weak organic fill to around 2.4m which was underlain by firm organic silty soils to ~3.0m where gravels caused refusal of the test. Fill image included in Figure 30.
