TE ARA HAUĀURU NORTHWEST RAPID TRANSIT

ARBORICULTURAL MANAGEMENT OF PŌHUTUKAWA AND NOTABLE TREES

LEON SAXON

15 DECEMBER 2025

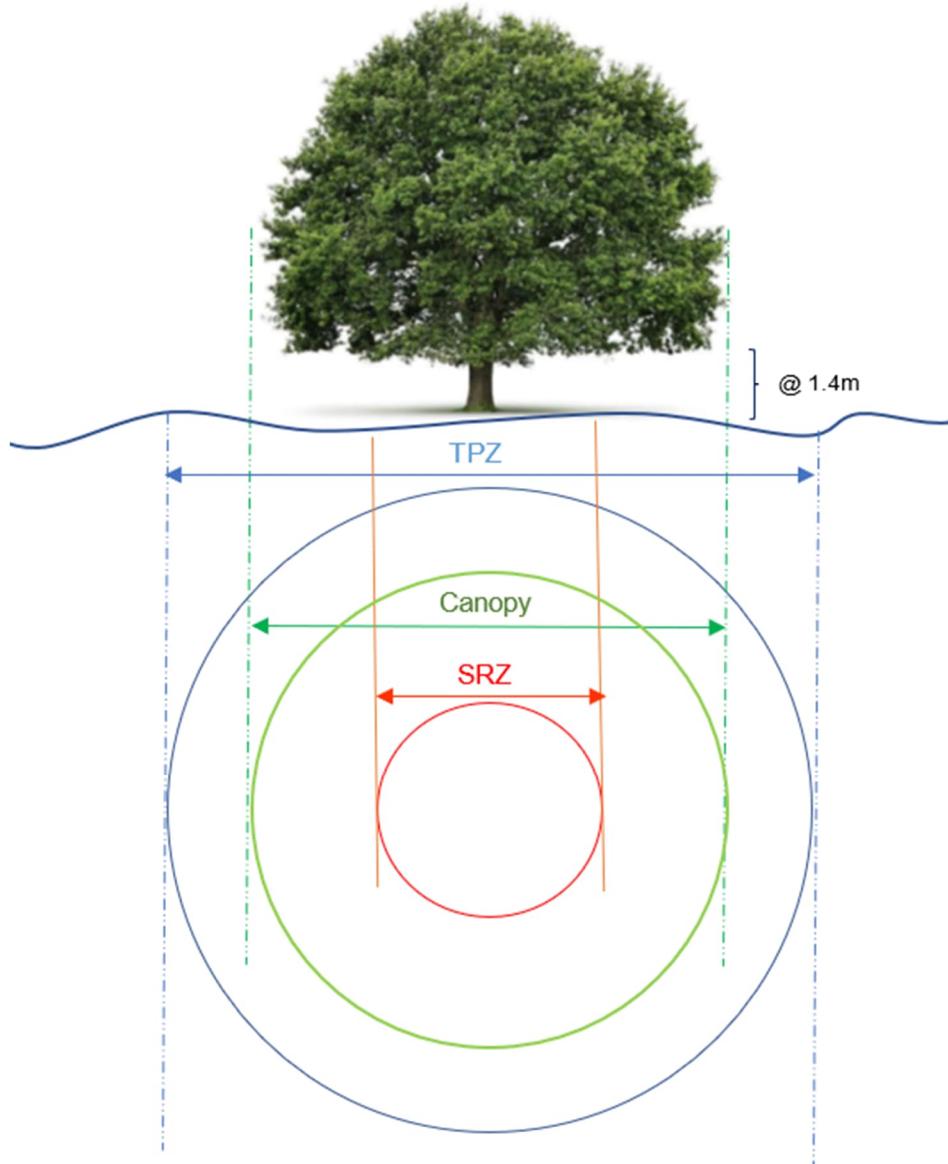
AS4970-2009, s3: The radius of the TPZ is calculated for each tree by multiplying its Diameter @ Breast Height measured @ 1.4m from ground level ($DBH \times 12 = TPZ$). ($DBH = \text{Trunk Girth @ 1.4m} \div \pi$).

To calculate the SRZ: Radius SRZ = **Diameter Above Root Crown (DRC) $\times 50$** $^{0.42} \times 0.64$. If the DRC is less than 0.15m the SRZ will be 1.5m.

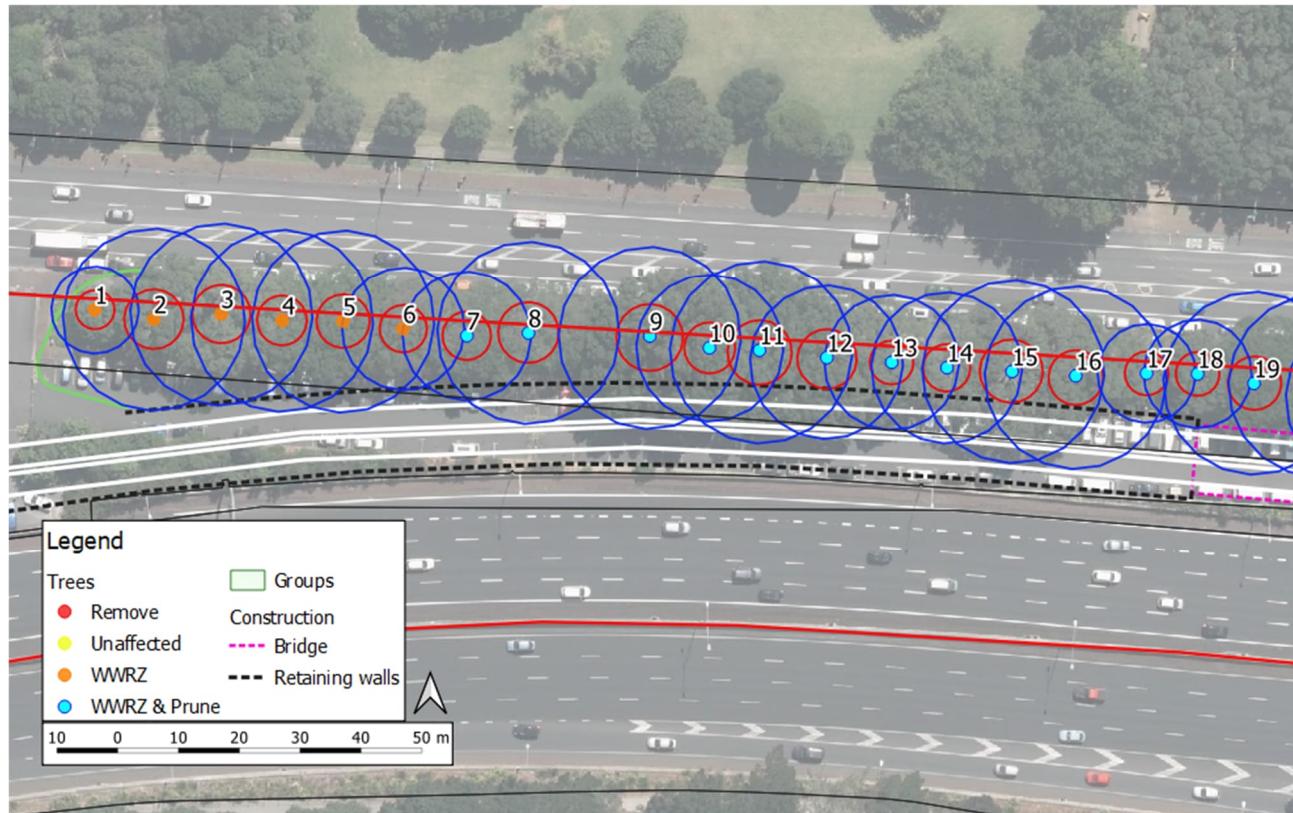
Figure 4-1: Where the busway passes Trees 1 – 18, the Indicative Design has it set at a lower level, with associated retaining wall shown above as a black dashed line

The Indicative Design, where it intersects Trees 1–18 (refer to Figure 4-1), will be set slightly lower than the trees. Its footprint will involve removing existing surfaces and stripping soil down to clay. A retaining wall along the outer edge of the busway will retain the land supporting the trees. For this assessment, the retaining wall is considered the closest edge of excavation.

My further analysis of Trees 1-18 includes:

- Trees 1-8 are slightly smaller specimens and excavations are not as close to the trees; and
- Trees 8-16 are expected to experience similar root zone impacts from the bulk earthworks associated with the proposed busway and the associated retaining wall.

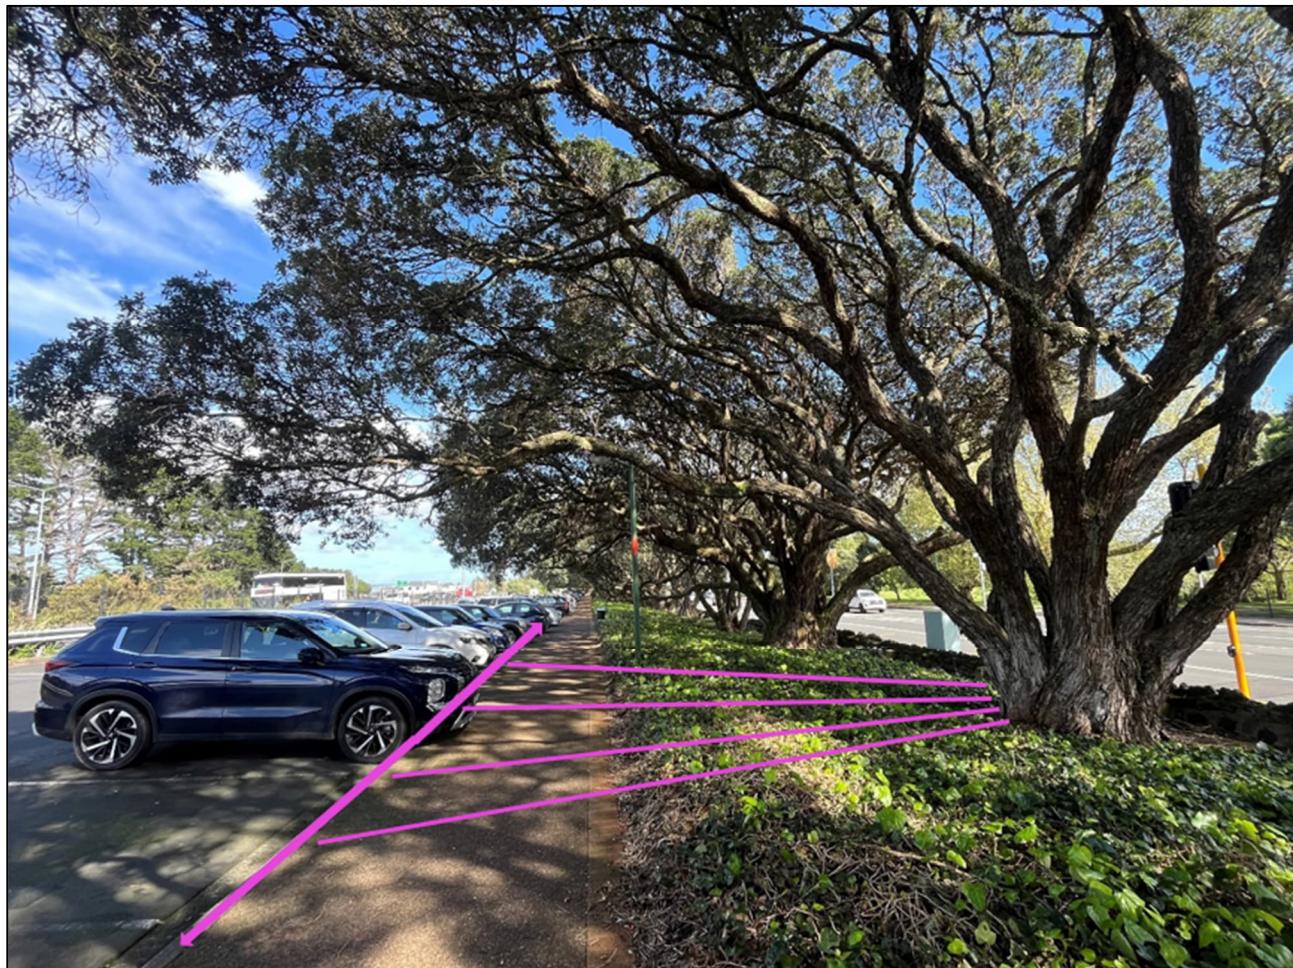
Figure 4-2: Likely root architecture of pōhutukawa adjacent to carpark

The Tree Plans in Appendix B show the TPZ as an indicative circle around each of the trees, with the largest trees having a TPZ measuring 15m radius. However, due to root limiting factors, such as the existing kerb line and hard surfacing, the root systems are unlikely to extend fully north or south and will be more concentrated within the permeable garden bed where they grow (refer to Figure 4-2 below).

The root architecture of the subject pōhutukawa trees growing between Great North Road and the carpark (Trees 1–26) is likely to develop laterally within the upper soil horizons, with roots dividing to smaller diameter as they extend further from the trunks. Roots typically spread beyond the canopy where the soil is more porous, supporting gaseous exchange and higher nutrient availability. By the time roots reach the car park kerb line, they are unlikely to exceed 100mm in diameter, though this cannot be ruled out. Smaller roots encountering obstruction, such as the kerb line (a root limiting factor), will follow the path of least resistance, often extending laterally along the kerb and occasionally beneath the asphalt. However, root density and presence are expected to be significantly lower on the far side of the kerb compared to the tree side (refer to Figure 4-2).

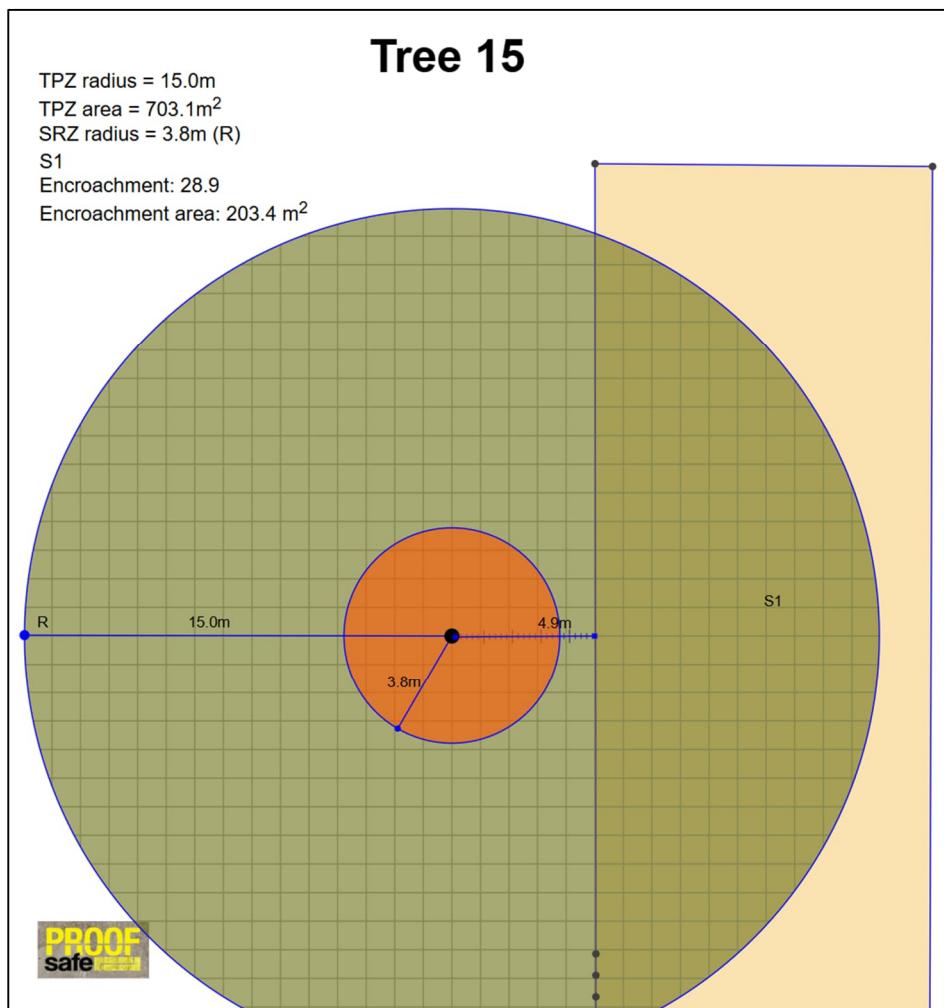
Figure 4-3: Tree 15, theoretical TPZ calculation without root limiting factors considered

Severing roots can have a negative effect on tree function, including stability and water and nutrient uptake, with the cumulative extent of root removal determining the overall impact. For example, the TPZ encroachment for Tree 15, without accounting for root limiting factors indicates that approximately 29% of its notional TPZ would be affected by the busway excavations. However, considering the root-limiting influences, actual root loss is estimated at 10–20%. A similar situation applies to Trees 9–14 and Tree 16. Trees 17 and 18 are smaller, so the proportion of their TPZ affected are correspondingly less.

Provided appropriate aftercare measures are followed, a 10–20% TPZ encroachment for these trees is not likely to affect the long-term viability of these trees.

Example of TPZ encroachment scenario without accounting for root limiting factors for Tree 15 is shown in Figure 4-3.

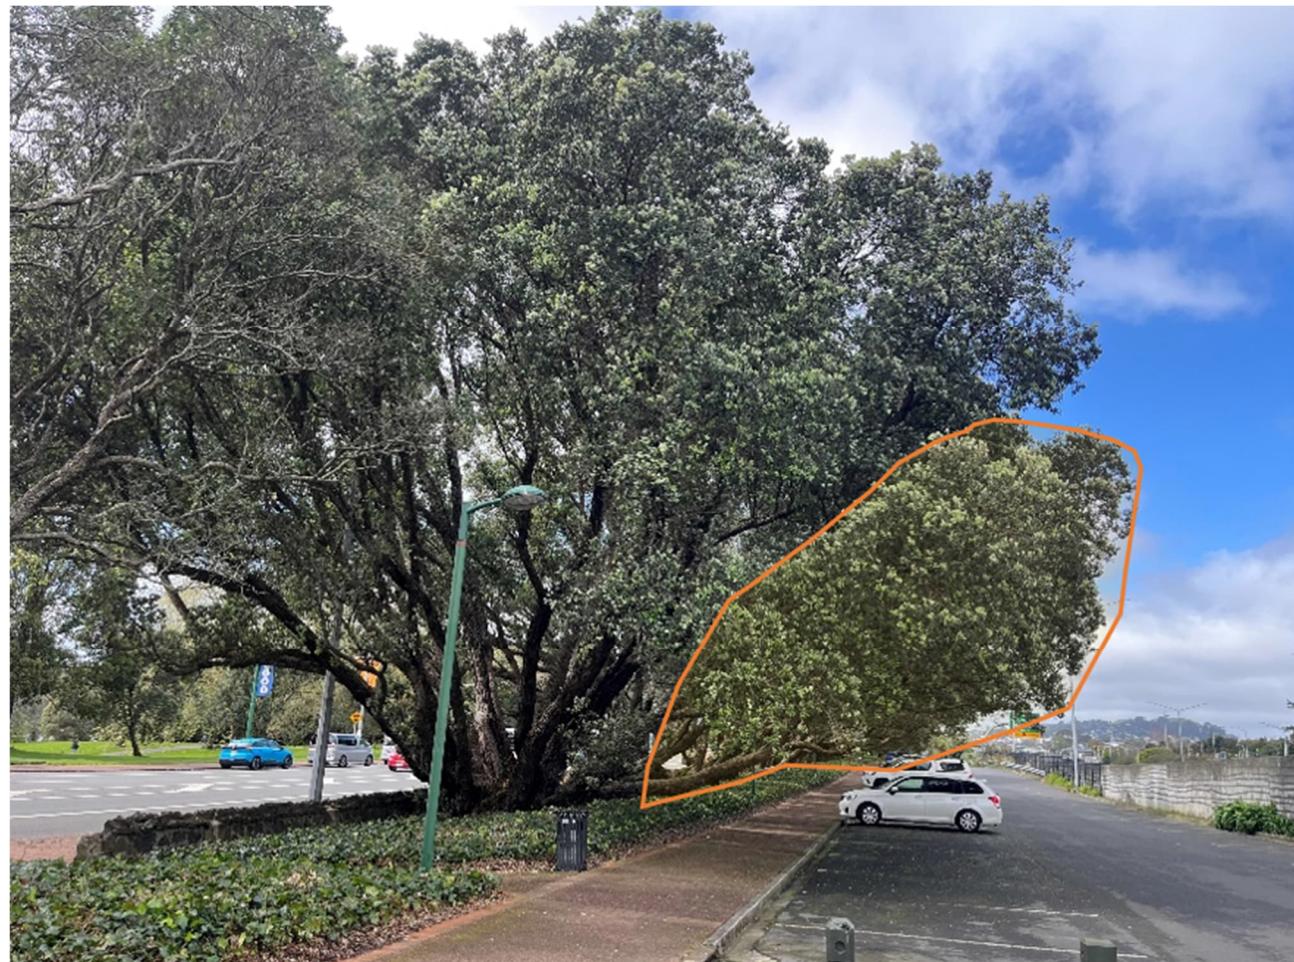
Figure 4-4: Example of likely pruning requirements – Tree 9 viewed from west with likely branch removal highlighted

In my opinion, while some large diameter branches may require removal, the proportion of foliar coverage affected is considered manageable without any long-term adverse effects. Several specimens have splayed lateral stems showing signs of settling, which describes the process of the stems slowly lowering towards the ground. Following initial pruning, structural supports such as props may be required on a case-by-case

Examples of likely pruning requirements are shown in Figure 4-4, Figure 4-5 and Figure 4-6.

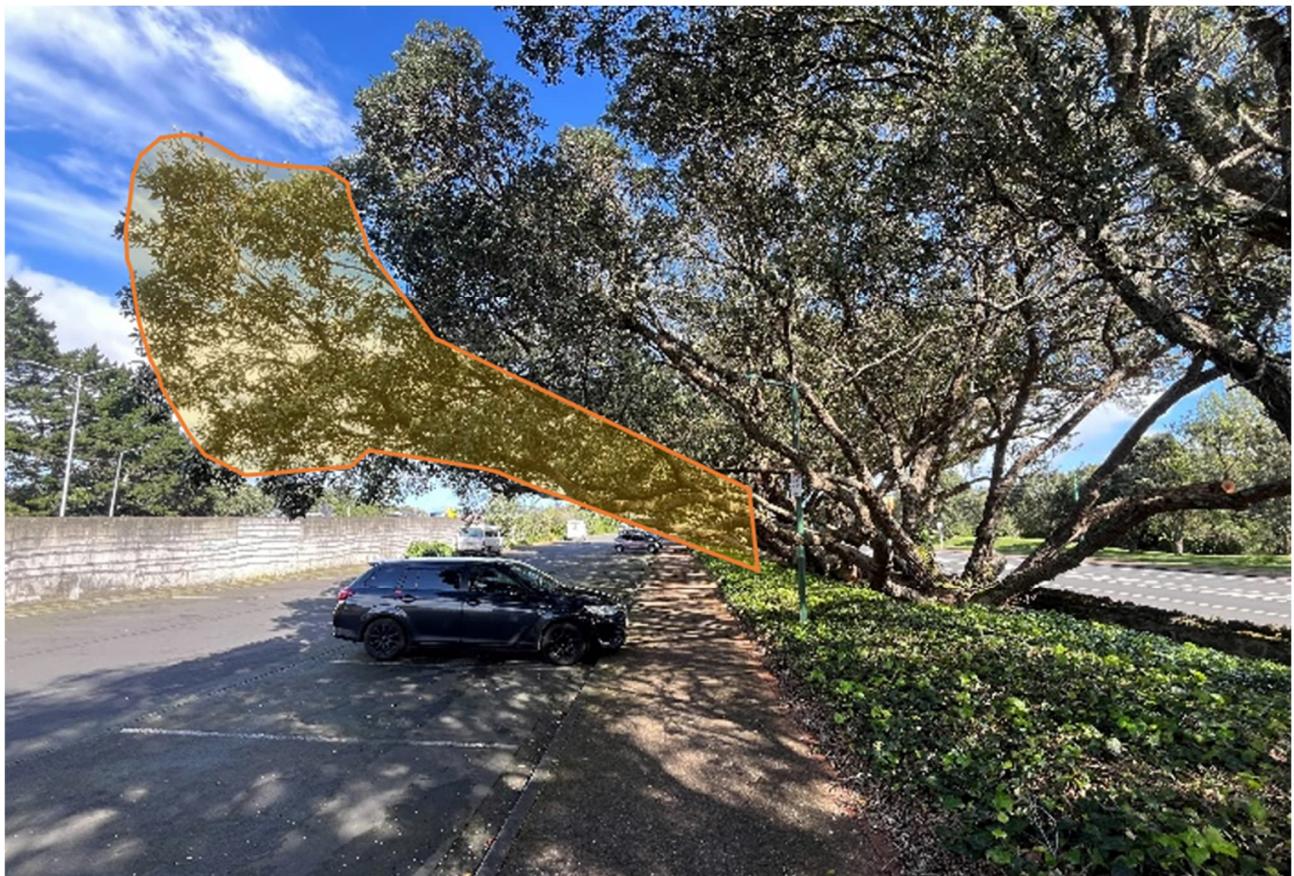
Figure 4-5: Tree 12 and likely pruning requirements

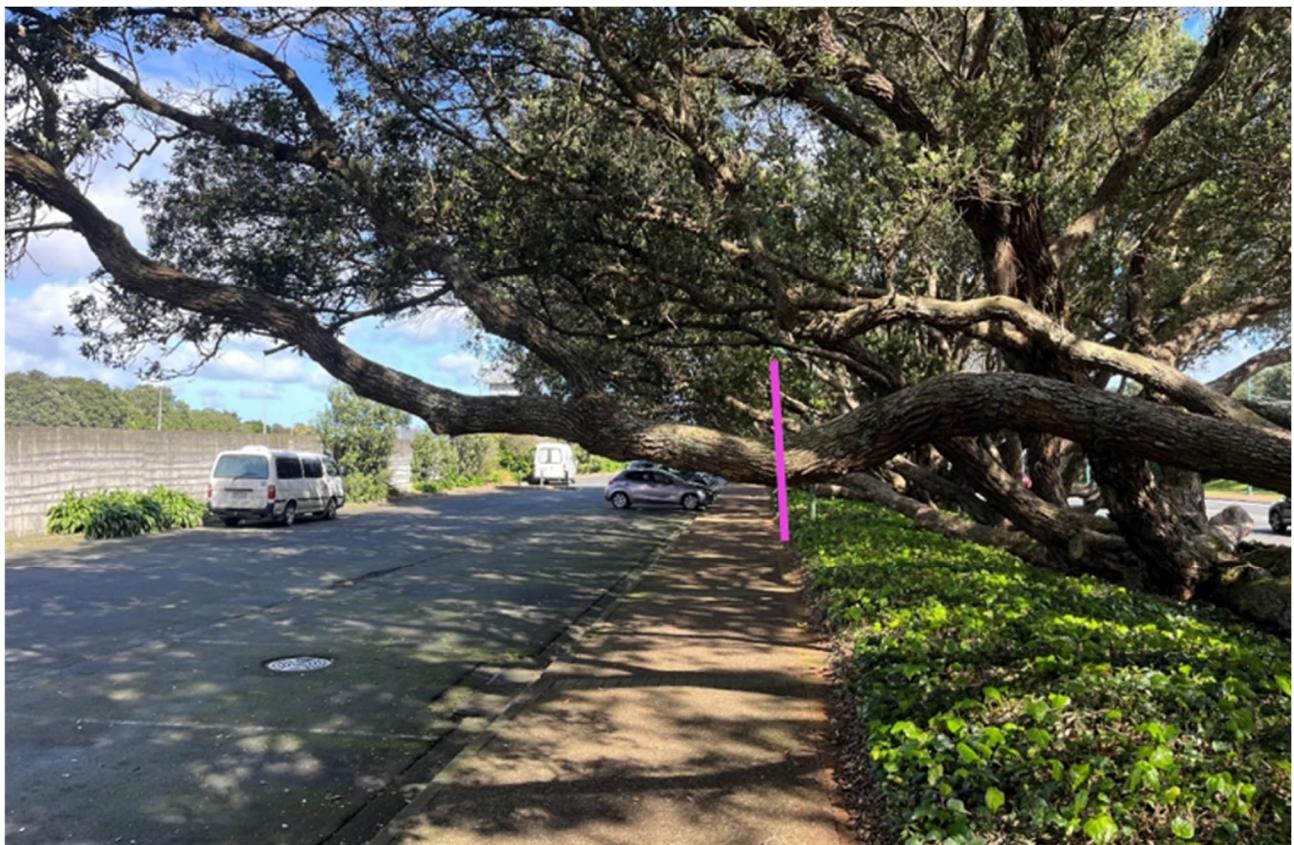
Figure 4-6: Tree 15, largest stem severance – approximately 1000mm girth

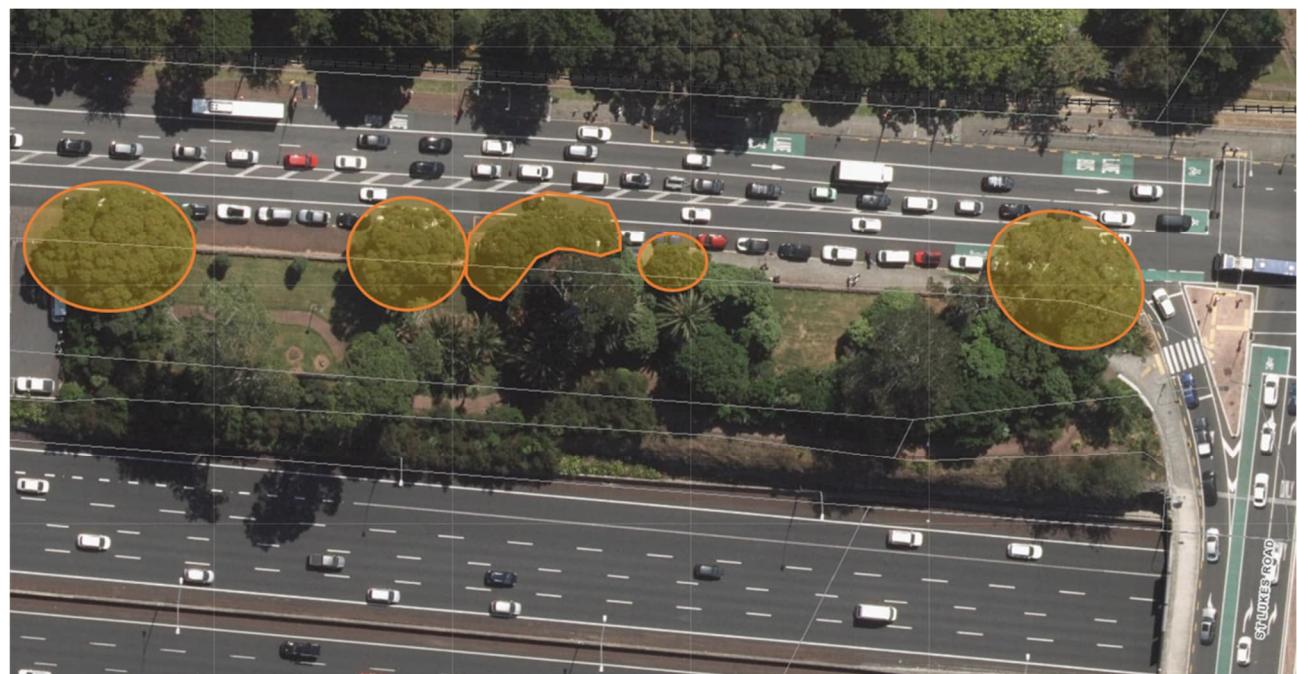
Figure 4-7: Mature pōhutukawa between carpark entrance and St Lukes Road proposed to be retained

The area between the carpark entrance and St Lukes Road overpass contains a mix of trees, including five mature pōhutukawa near Great North Road, which will be retained with minimal adverse effects (see Figure 4-7 and Figure 4-8 below). Some or all of the remaining vegetation may require removal to facilitate the construction of the busway in this location as shown in Figure 4-9.

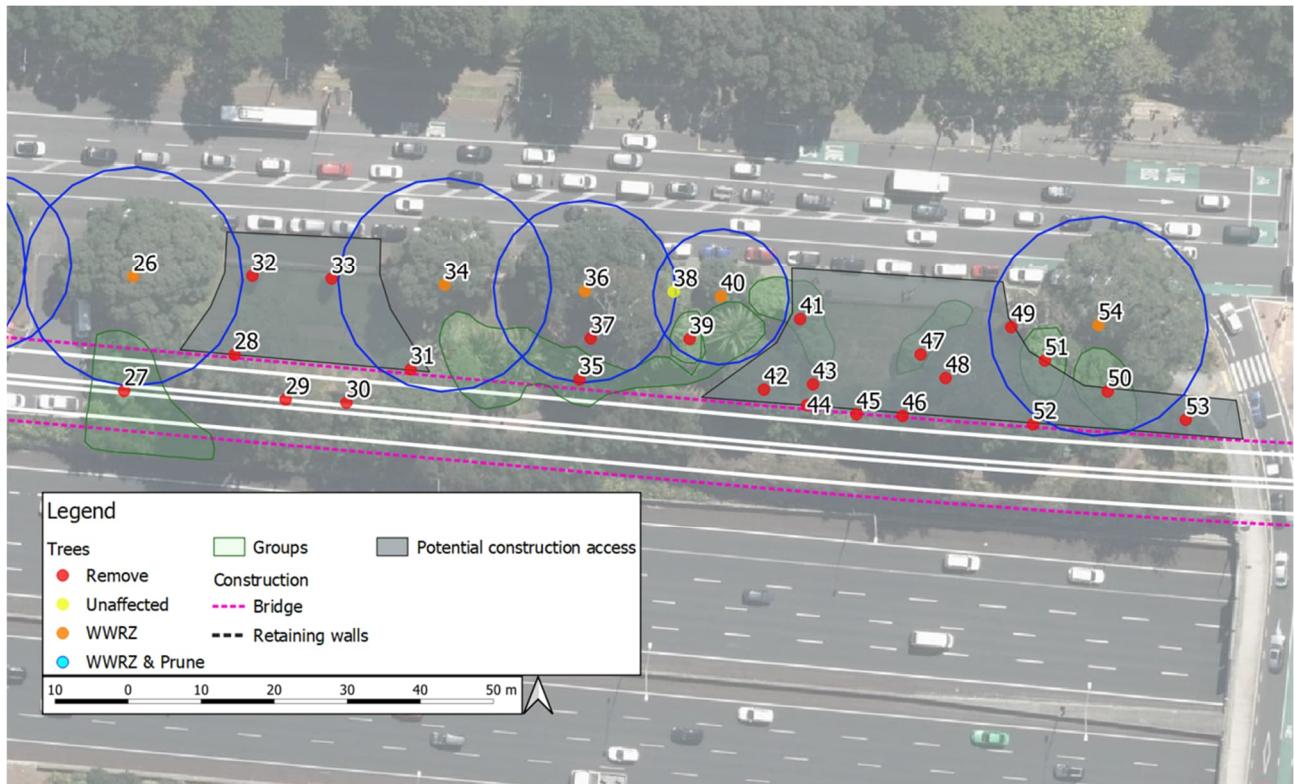
Figure 4-8: Tree removal / retention plan showing TPZs of retained trees

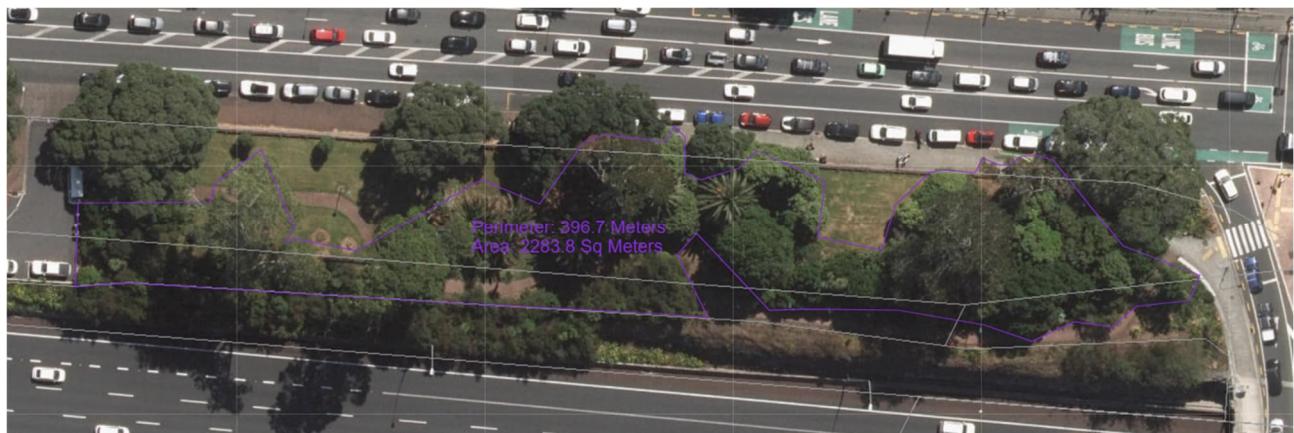
Figure 4-9: Approximate area of vegetation removal from Open Space zoned area

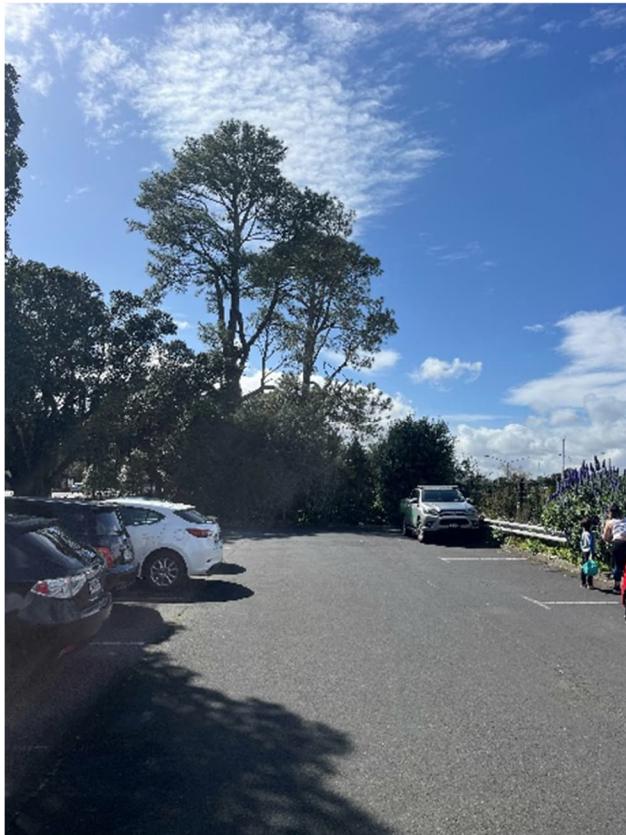
Figure 4-10: Trees 28 and 29, visible from the west

Trees requiring removal for permanent structures are a group of native revegetation (Tree 27), a group of maritime pine trees (Trees 28–31, with Trees 28 and 29 shown in Figure 4-10), one mature karaka (Tree 44), and three semi-mature pūriri (Tree 45, Tree 46 and Tree 52).

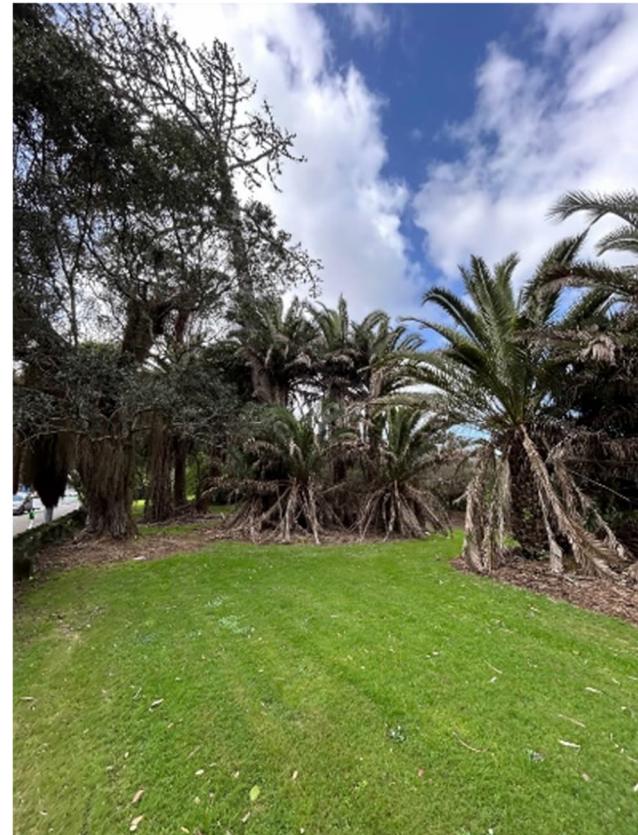
Figure 4-11: Tree 35 Group of Phoenix palms

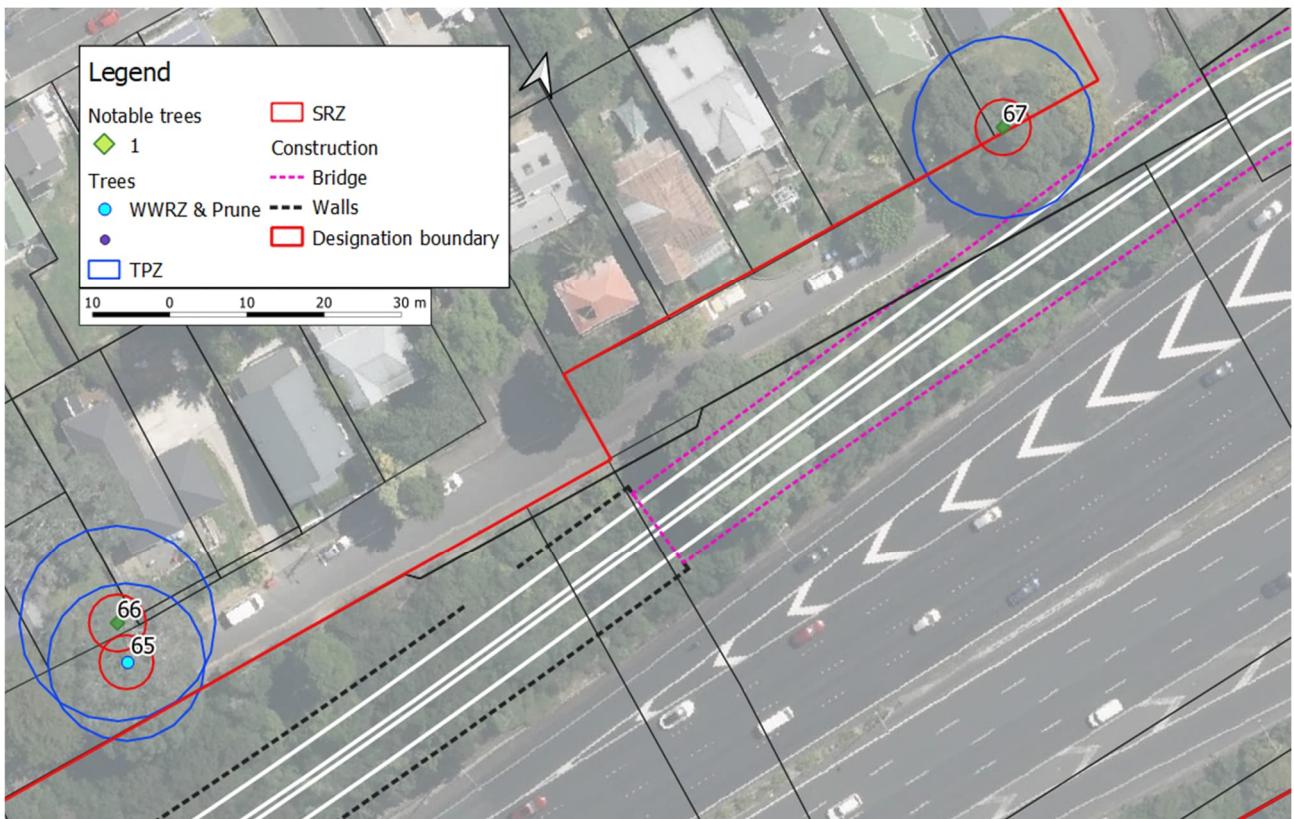
Figure 4-12: Notable trees within the Arch Hill area

I have identified two notable pōhutukawa trees located within private properties in Arch Hill adjacent to the Proposed Designation (refer to Figure 4-12):

- 30 Potatau Street (Reference: Auckland Unitary Plan (AUP) Notable Trees Overlay – 129 [Project reference Tree 66]); and
- 21 Kirk Street (Reference: Notable Trees Overlay – 837 [Project reference Tree 67]).

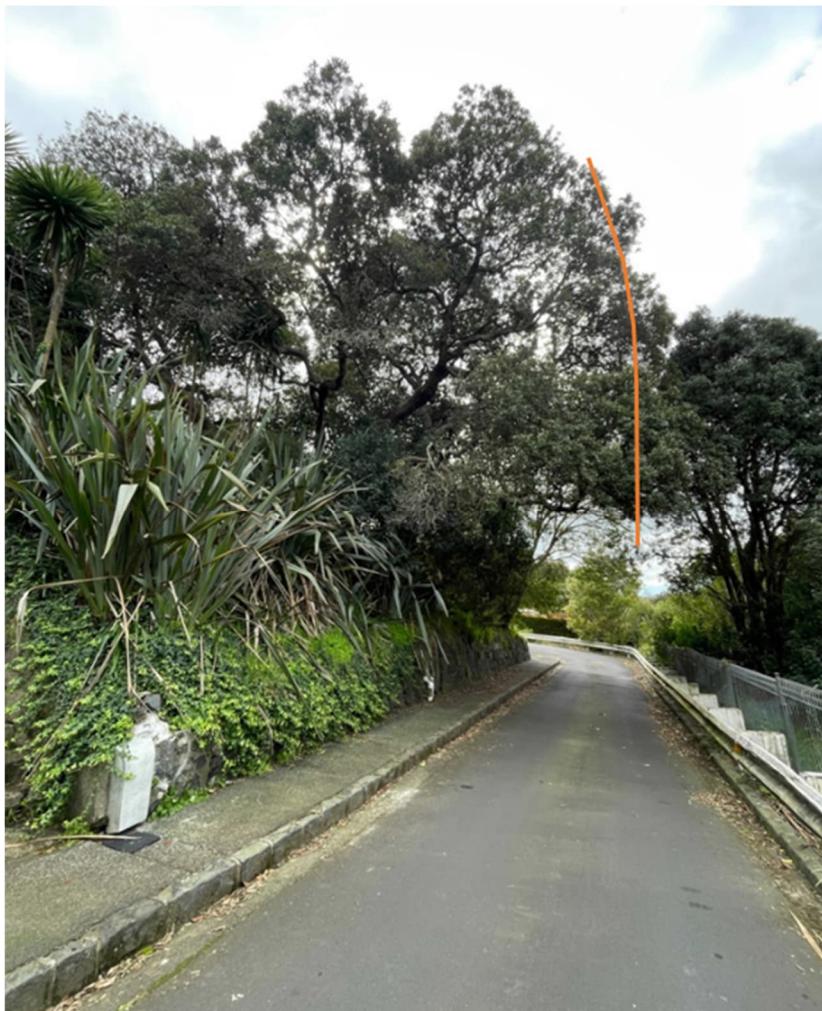
Figure 4-13: Notable Tree 837 (referenced as Tree 67 for the Project) – viewed from south. Eastern aspect of canopy may require a small amount of pruning for construction clearance, based on Indicative Design

The tree at Kirk Street originates from the southwestern corner of the property at 21 Kirk Street. This is just outside the Proposed Designation. Based on the Indicative Design, I consider a small amount of pruning may be required on Notable Tree 837 to provide lateral clearance for the above ground bridge structure. This pruning is expected to be minor in nature and is not anticipated to affect the tree's long-term health and stability, or amenity values. Refer to Figure 4-13, Figure 4-14 and Figure 4-15.

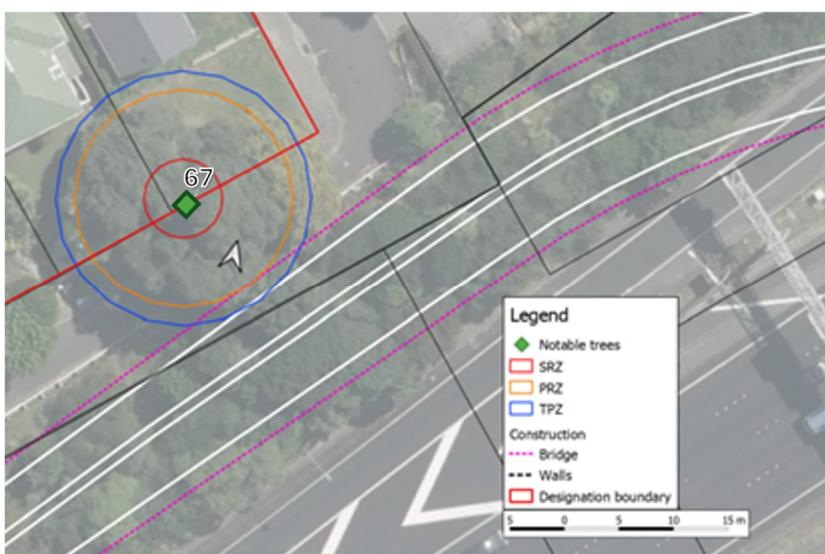
Figure 4-14: The Project bridge overpass where it is adjacent to Notable Tree 837. Note the Indicative Design does not extend any closer to the tree than the existing retaining wall on the lower side of Keppell Street

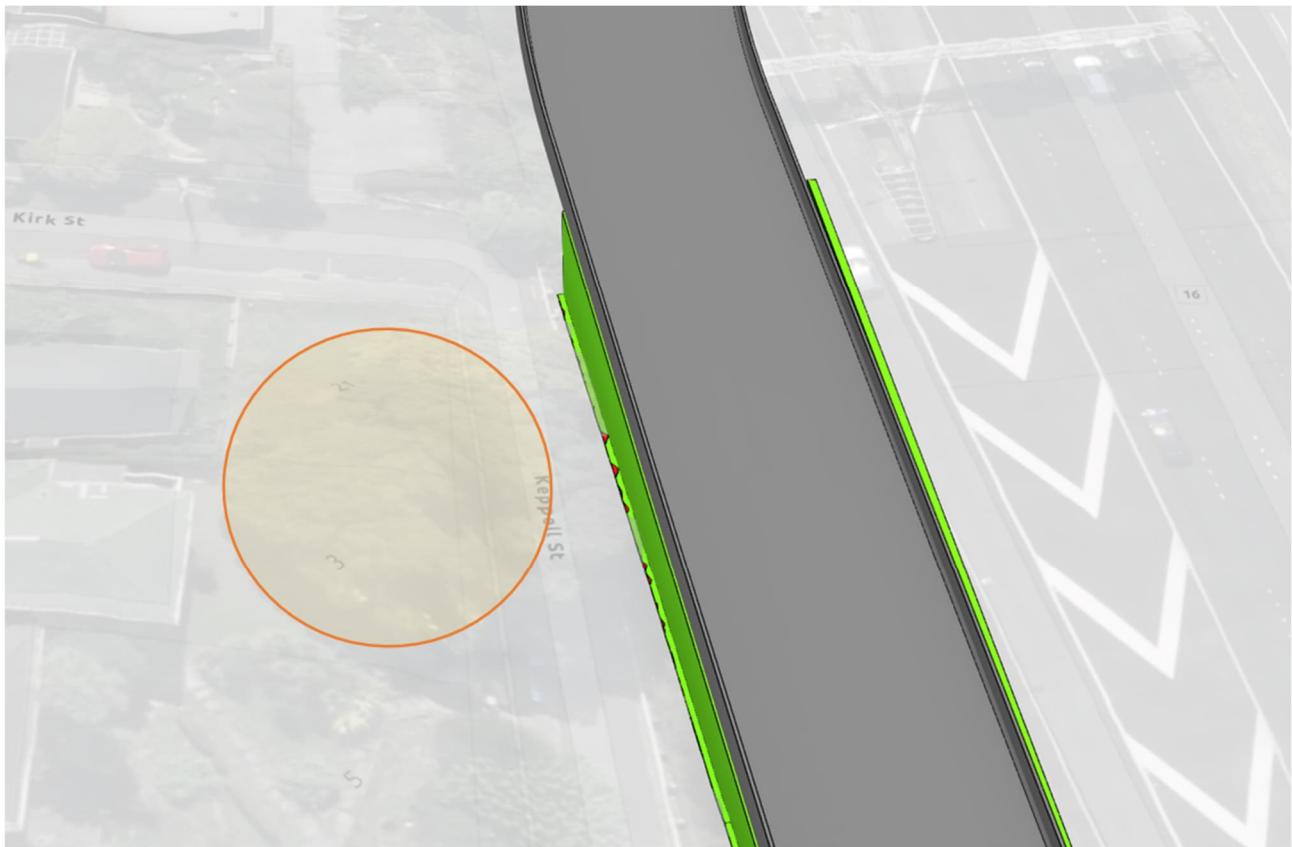
Figure 4-15: 3D imagery of the Project bridge overpass where it is adjacent to Notable Tree 837. Note the bridge does not extend any closer to the tree than the existing retaining wall on the lower side of Keppell Street

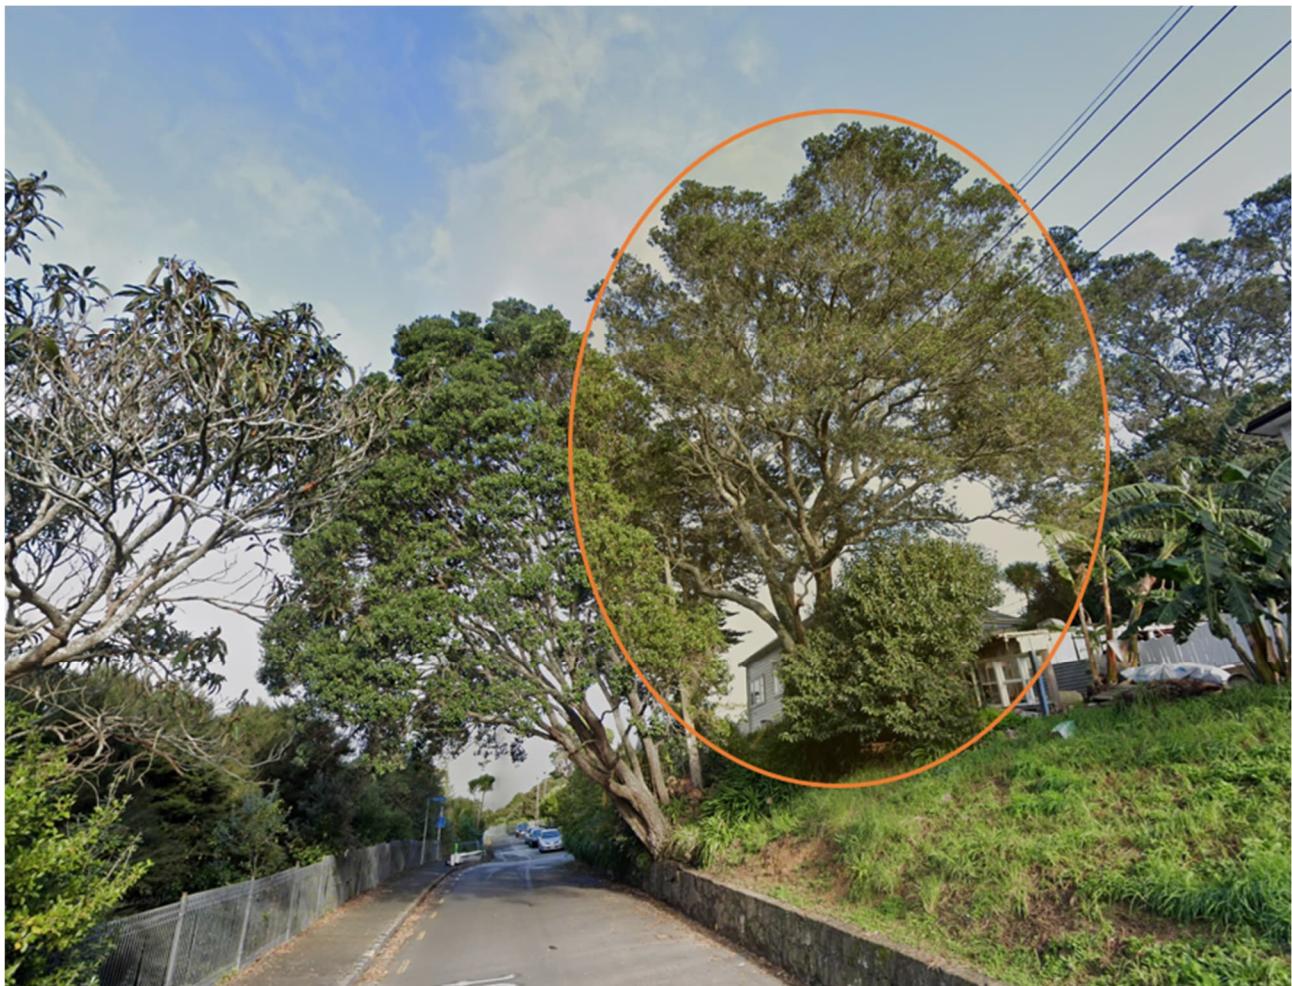
Figure 4-16: Notable Tree 129 viewed from north circled. The pōhutukawa to the left is a street tree

Notable Tree 129 (Project reference Tree 67) is located near the eastern boundary of 30 Potatau Street. The tree is set back from the Proposed Designation and will not be impacted by the Project.

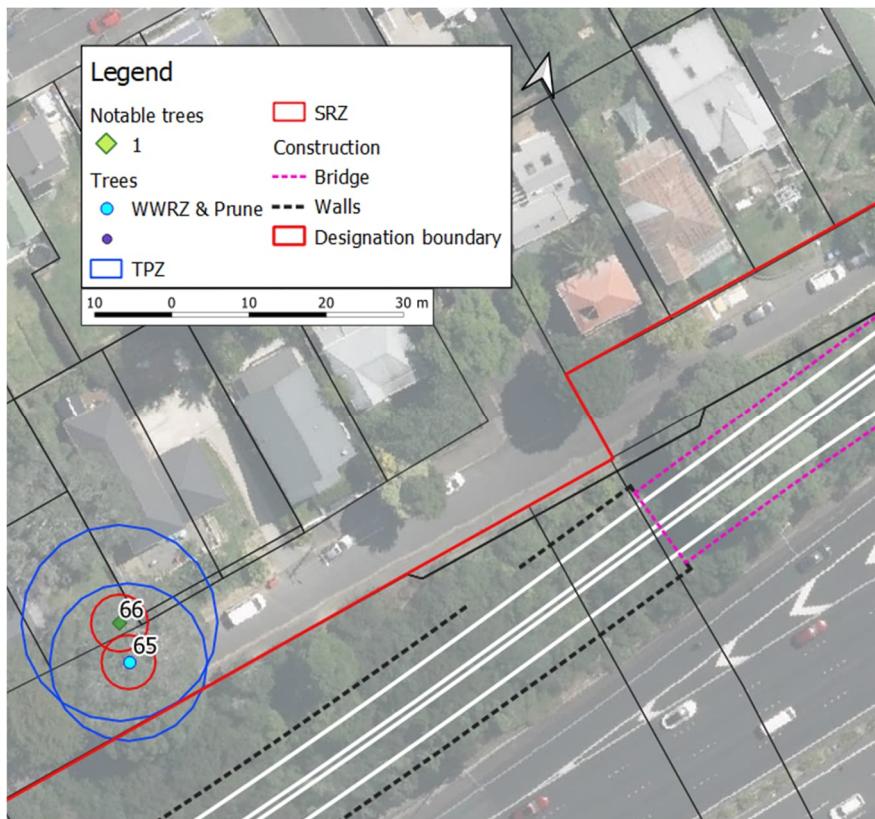
Figure 4-17: Aerial imagery of Notable Tree 129 (Arborlab Reference Tree 66)

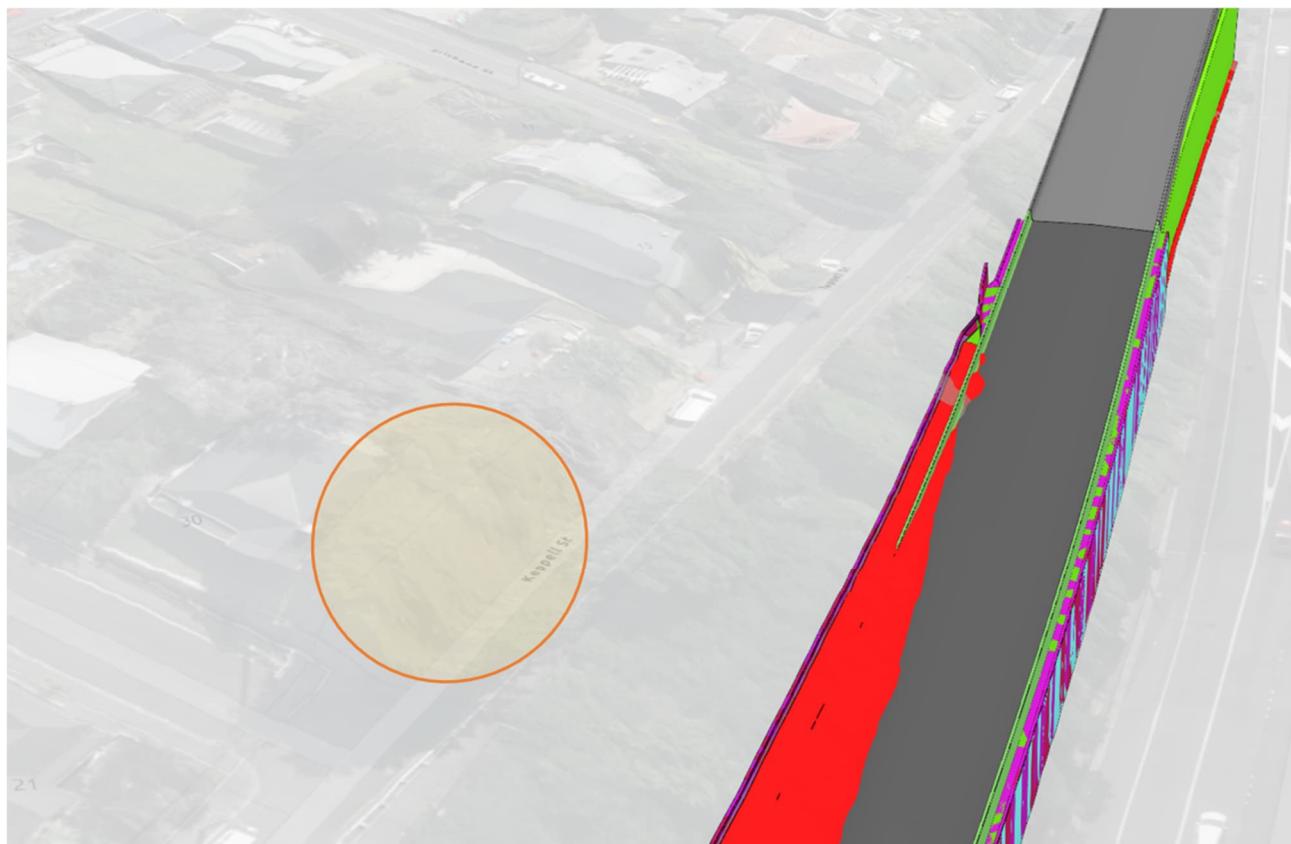
Figure 4-18: 3D imagery of Indicative Design adjacent to Notable Tree 129 (circled)

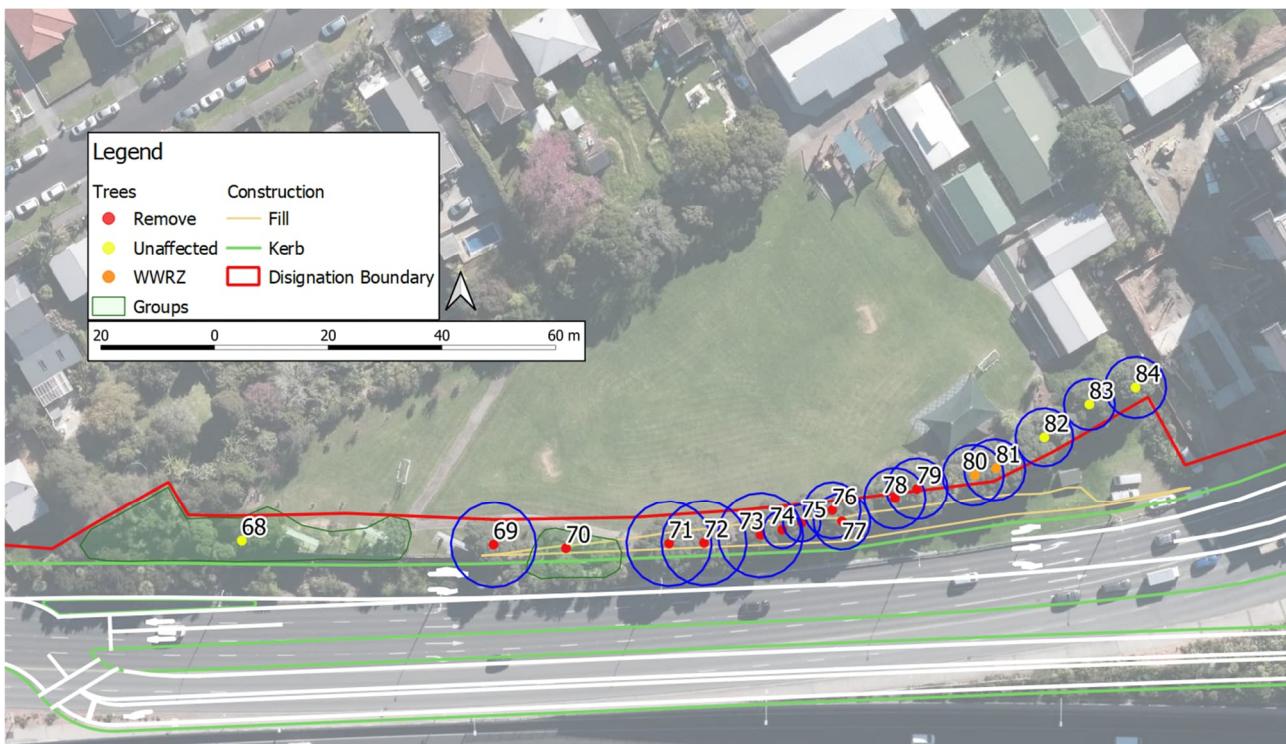
Figure 4-19: Trees at St Francis School and likely associated actions

The row of pōhutukawa alongside the playing fields at St Francis School will largely require removal due to conflicts with the Indicative Design (refer to Figure 4-19). Trees 69–79 would have extensive works within their root zones, associated with the placement of fill for a batter slope.

Trees 80 and 81 are located outside the Proposed Designation and are likely able to be retained in good health, albeit with some construction activities within their TPZs.

Trees 82, 83 and 84 are located outside the Proposed Designation and are unaffected by the Project.
