TE ARA HAUĀURU NORTHWEST RAPID TRANSIT

ARBORICULTURAL MANAGEMENT OF PŌHUTUKAWA AND NOTABLE TREES

LEON SAXON

15 DECEMBER 2025

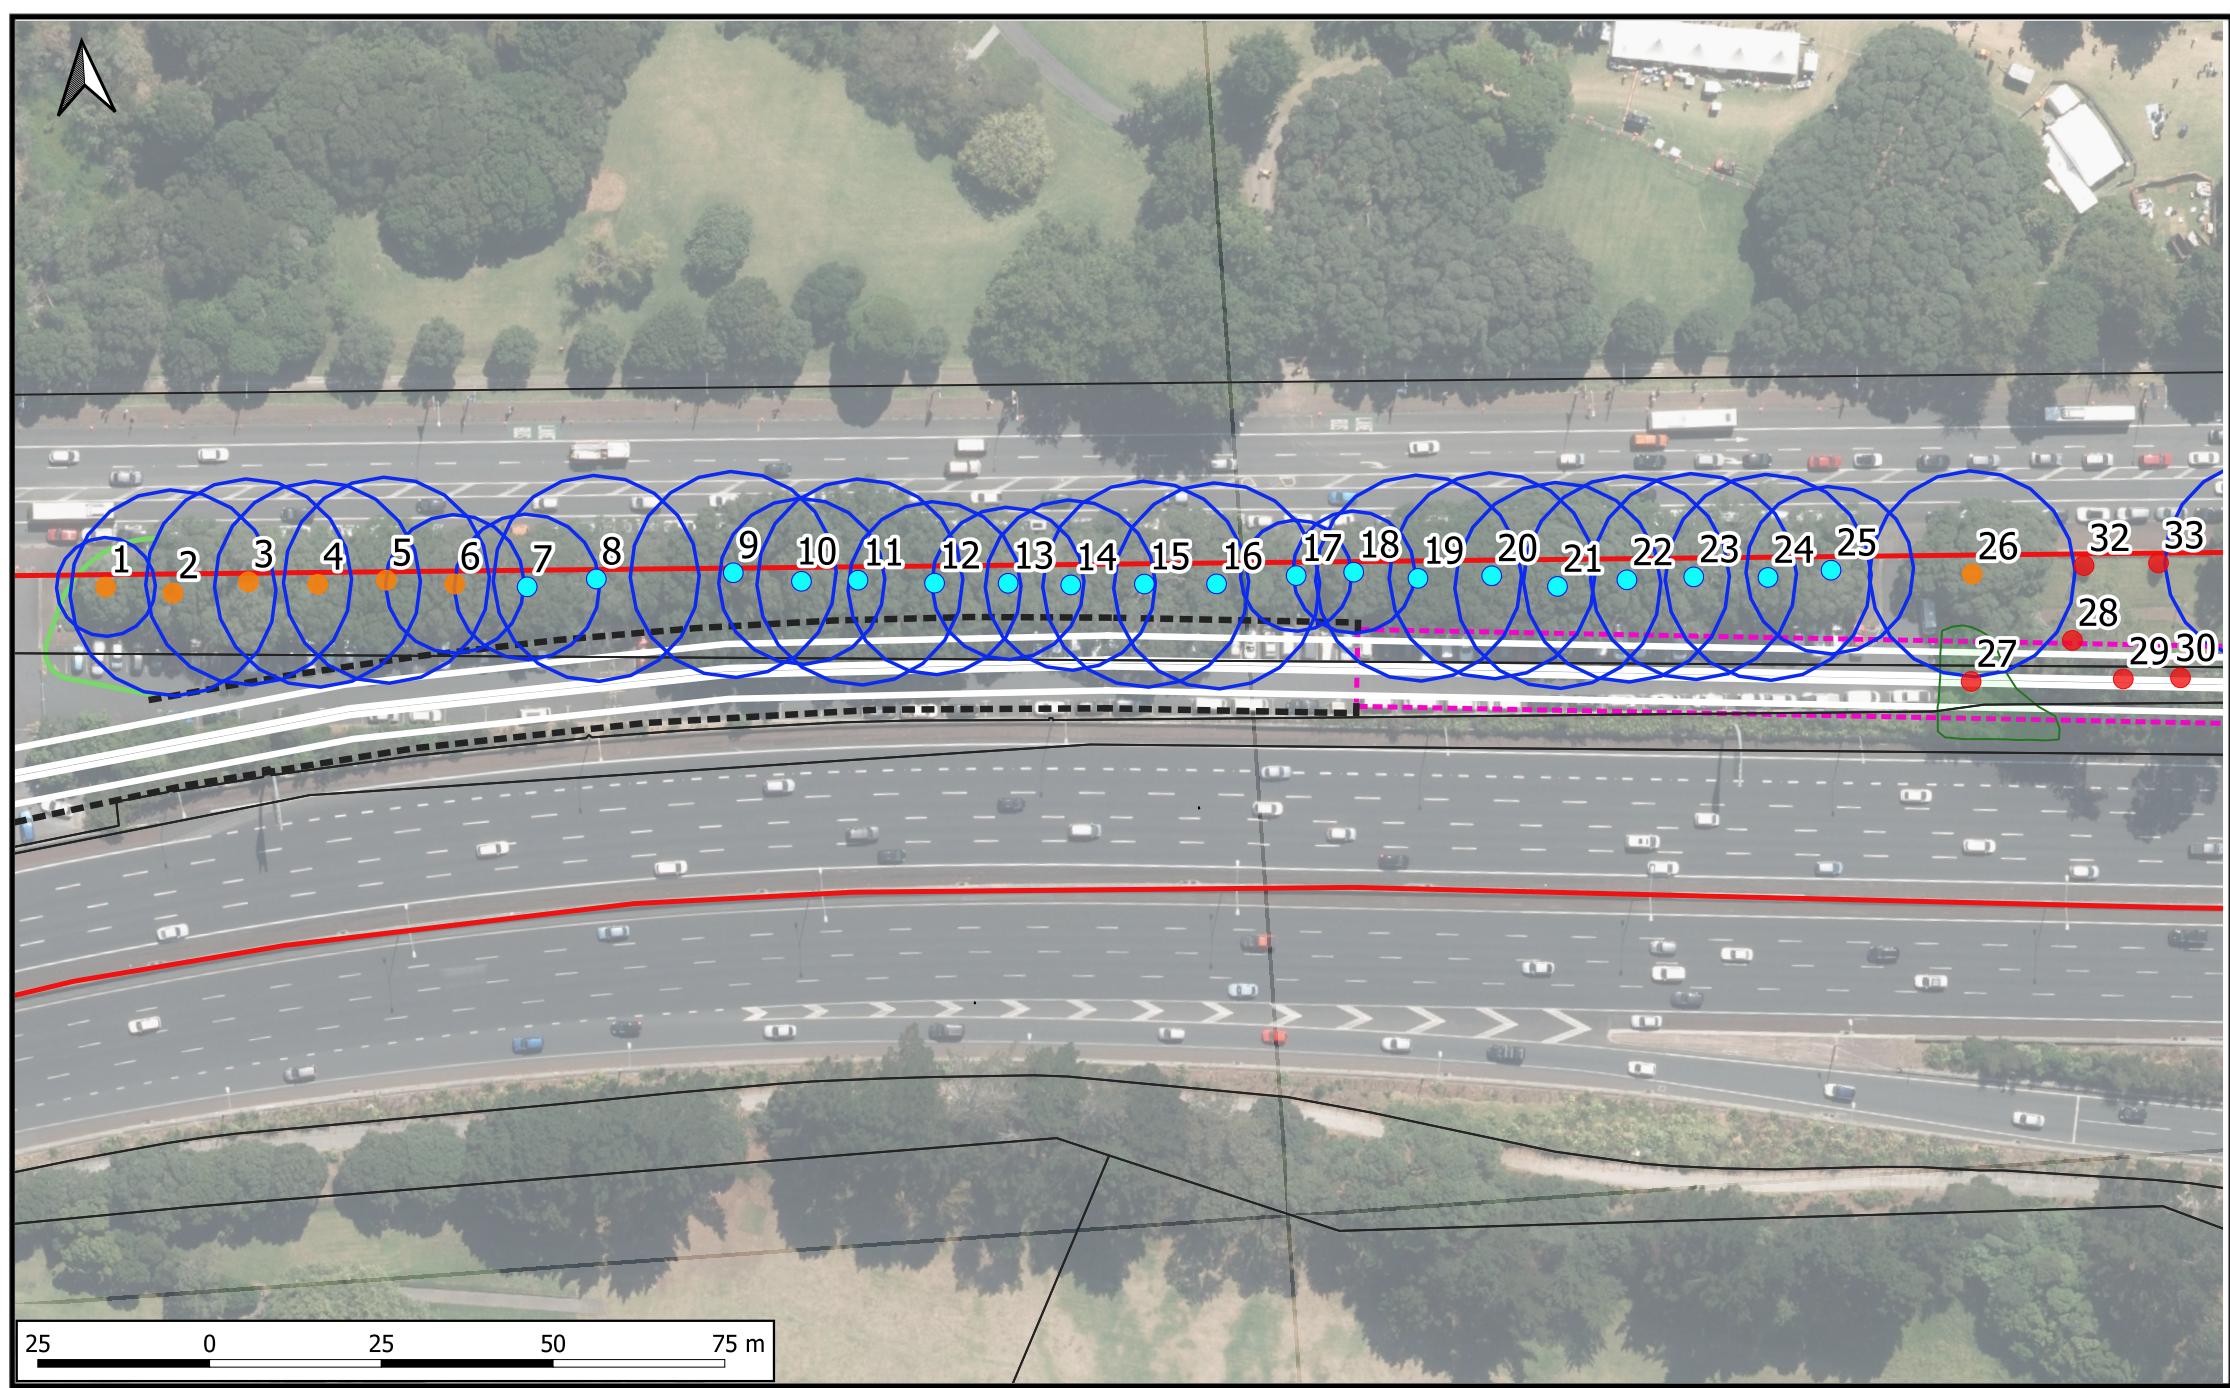
Requested by		Date
Surveyed by	DS	28/08/25
Plotted by	LGS	12/09/25
Checked by	JR	30/09/25
Drawing number	LGS-38893-01	Rev B

TREE LOCATION PLAN

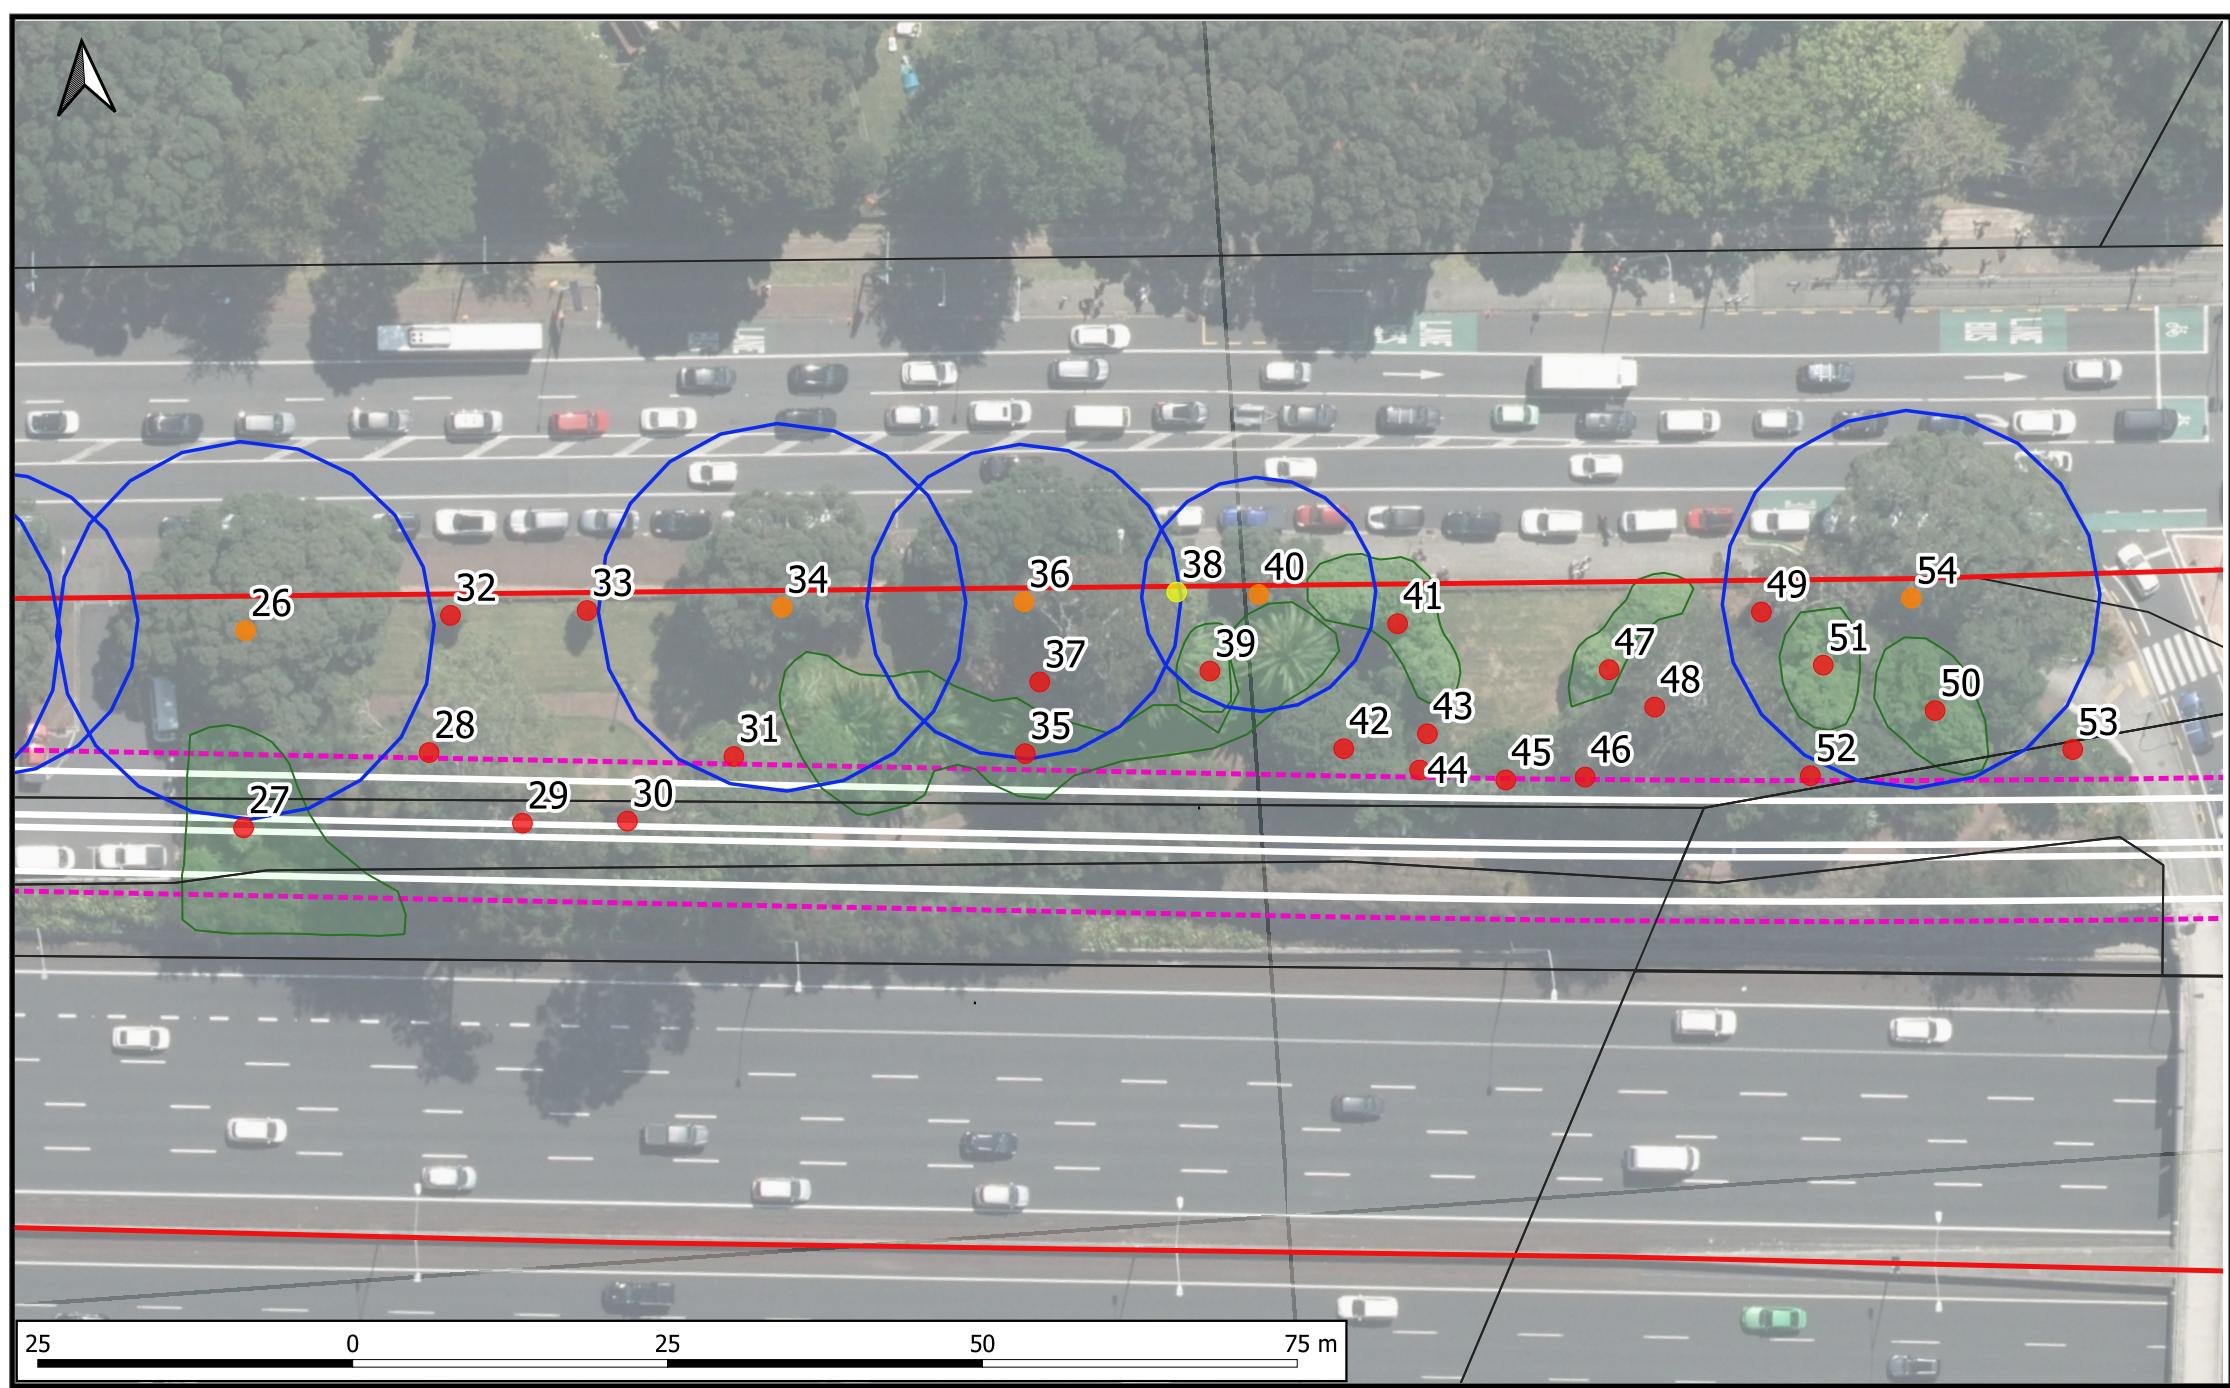
Requested by	Surveyed by	Date
	DS	28/08/25
	LGS	12/09/25
	JR	30/09/25
	Drawing number	
	LGS-38893-02	Rev B

TREE LOCATION PLAN

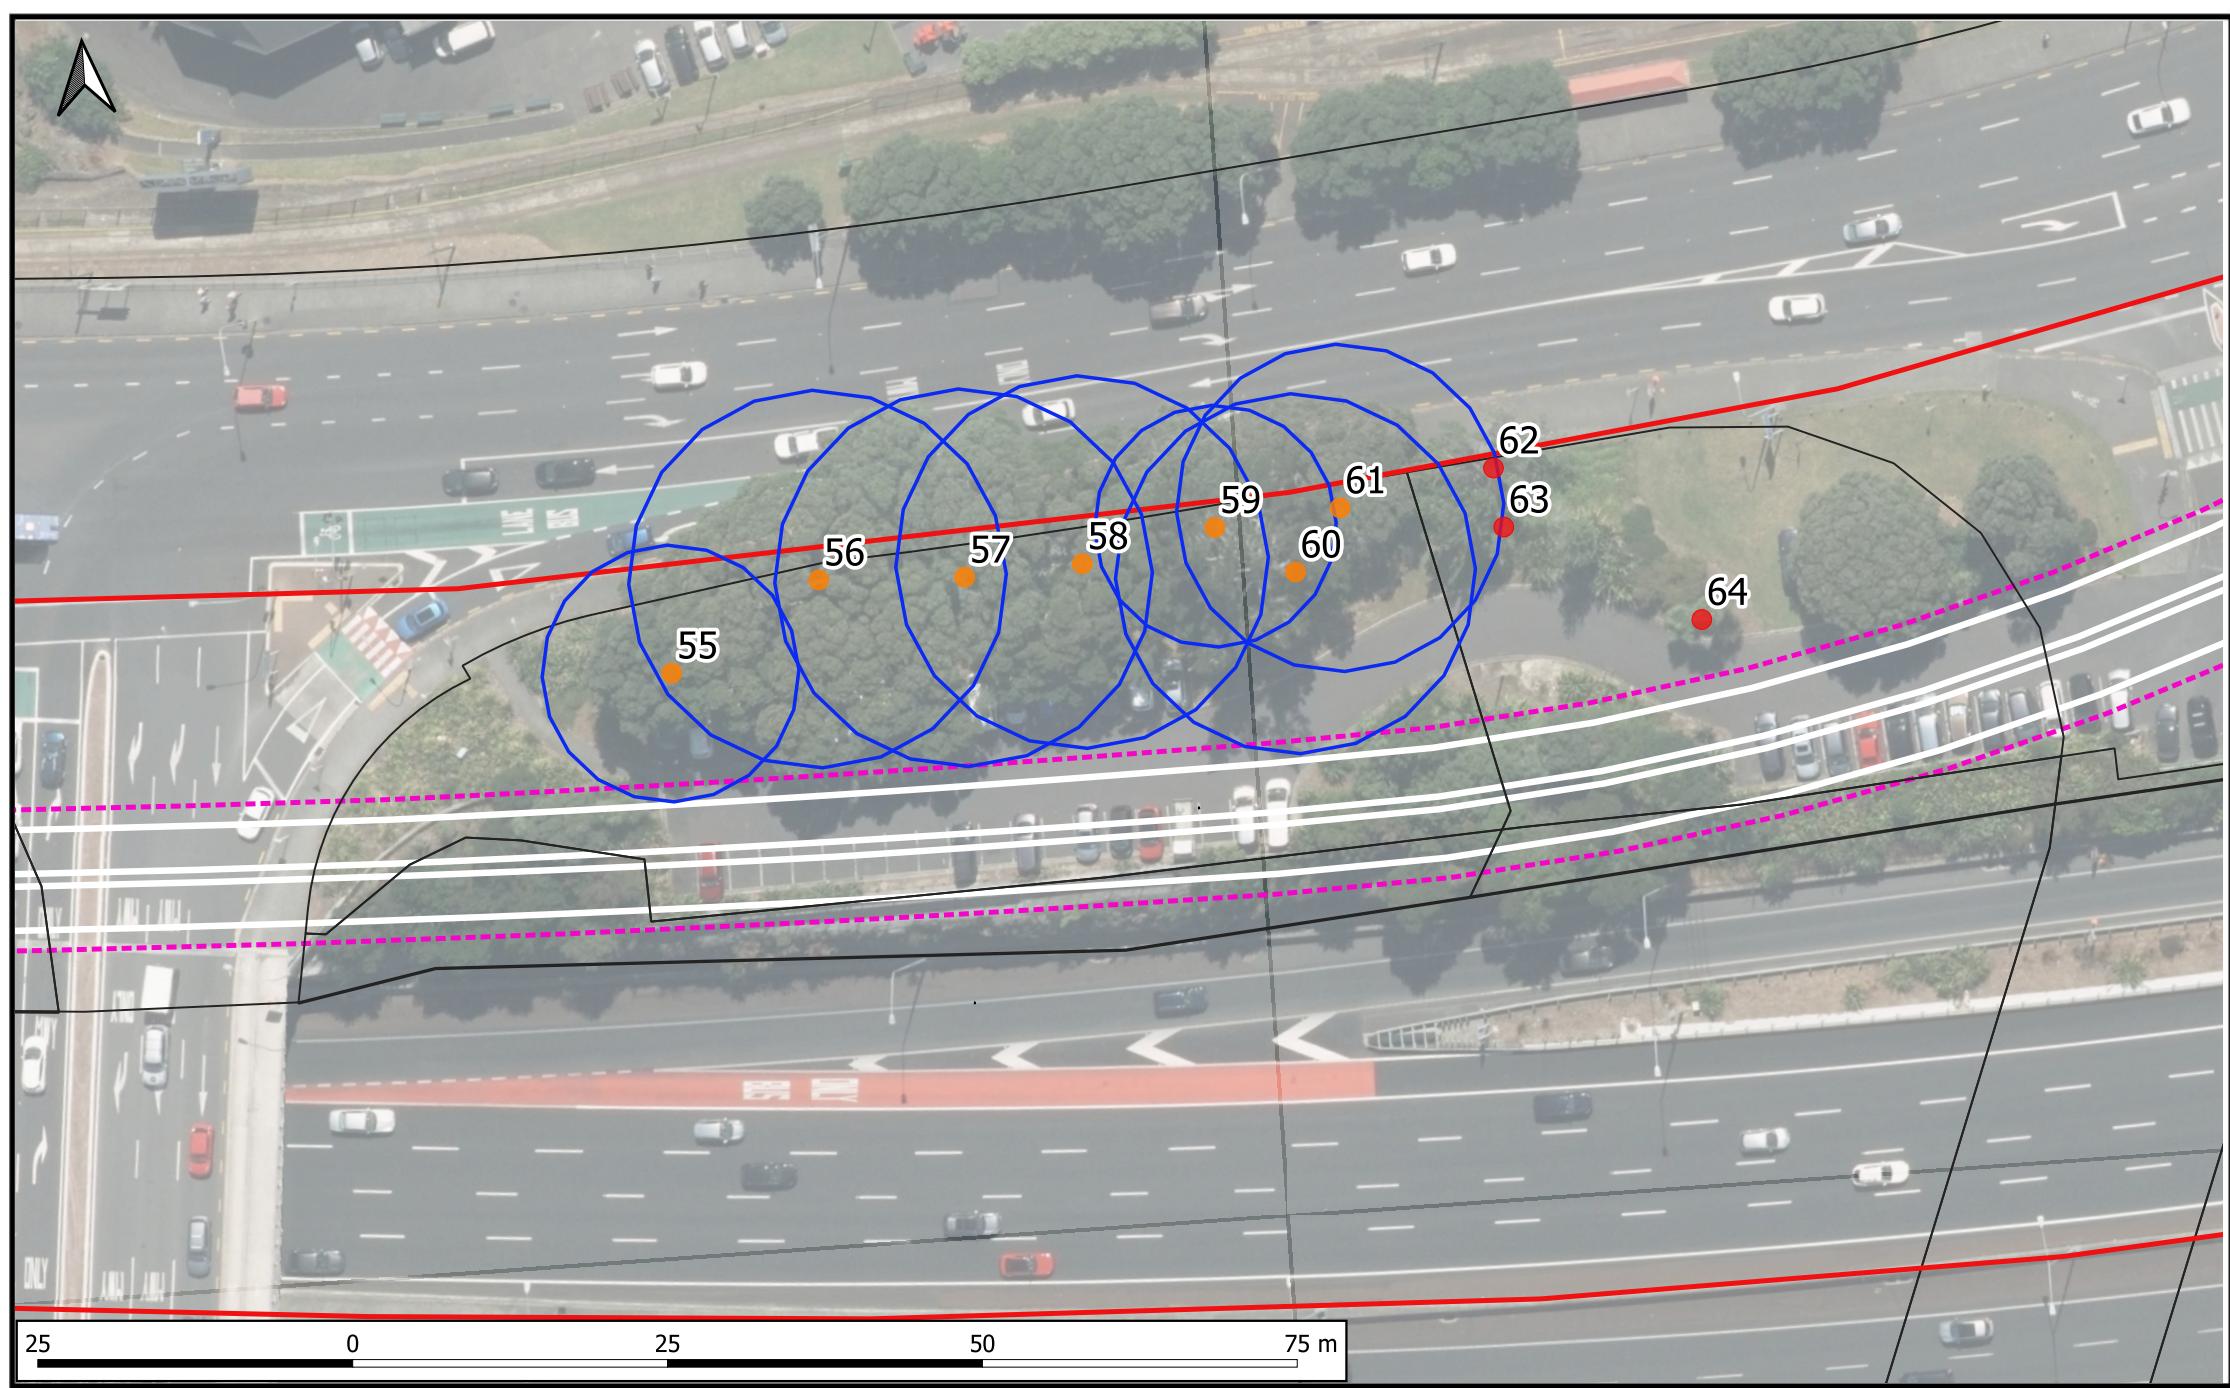
Requested by	Surveyed by	Date
	DS	28/08/25
	LGS	12/09/25
	JR	30/09/25
	Drawing number	
	LGS-38893-03	Rev B

TREE LOCATION PLAN

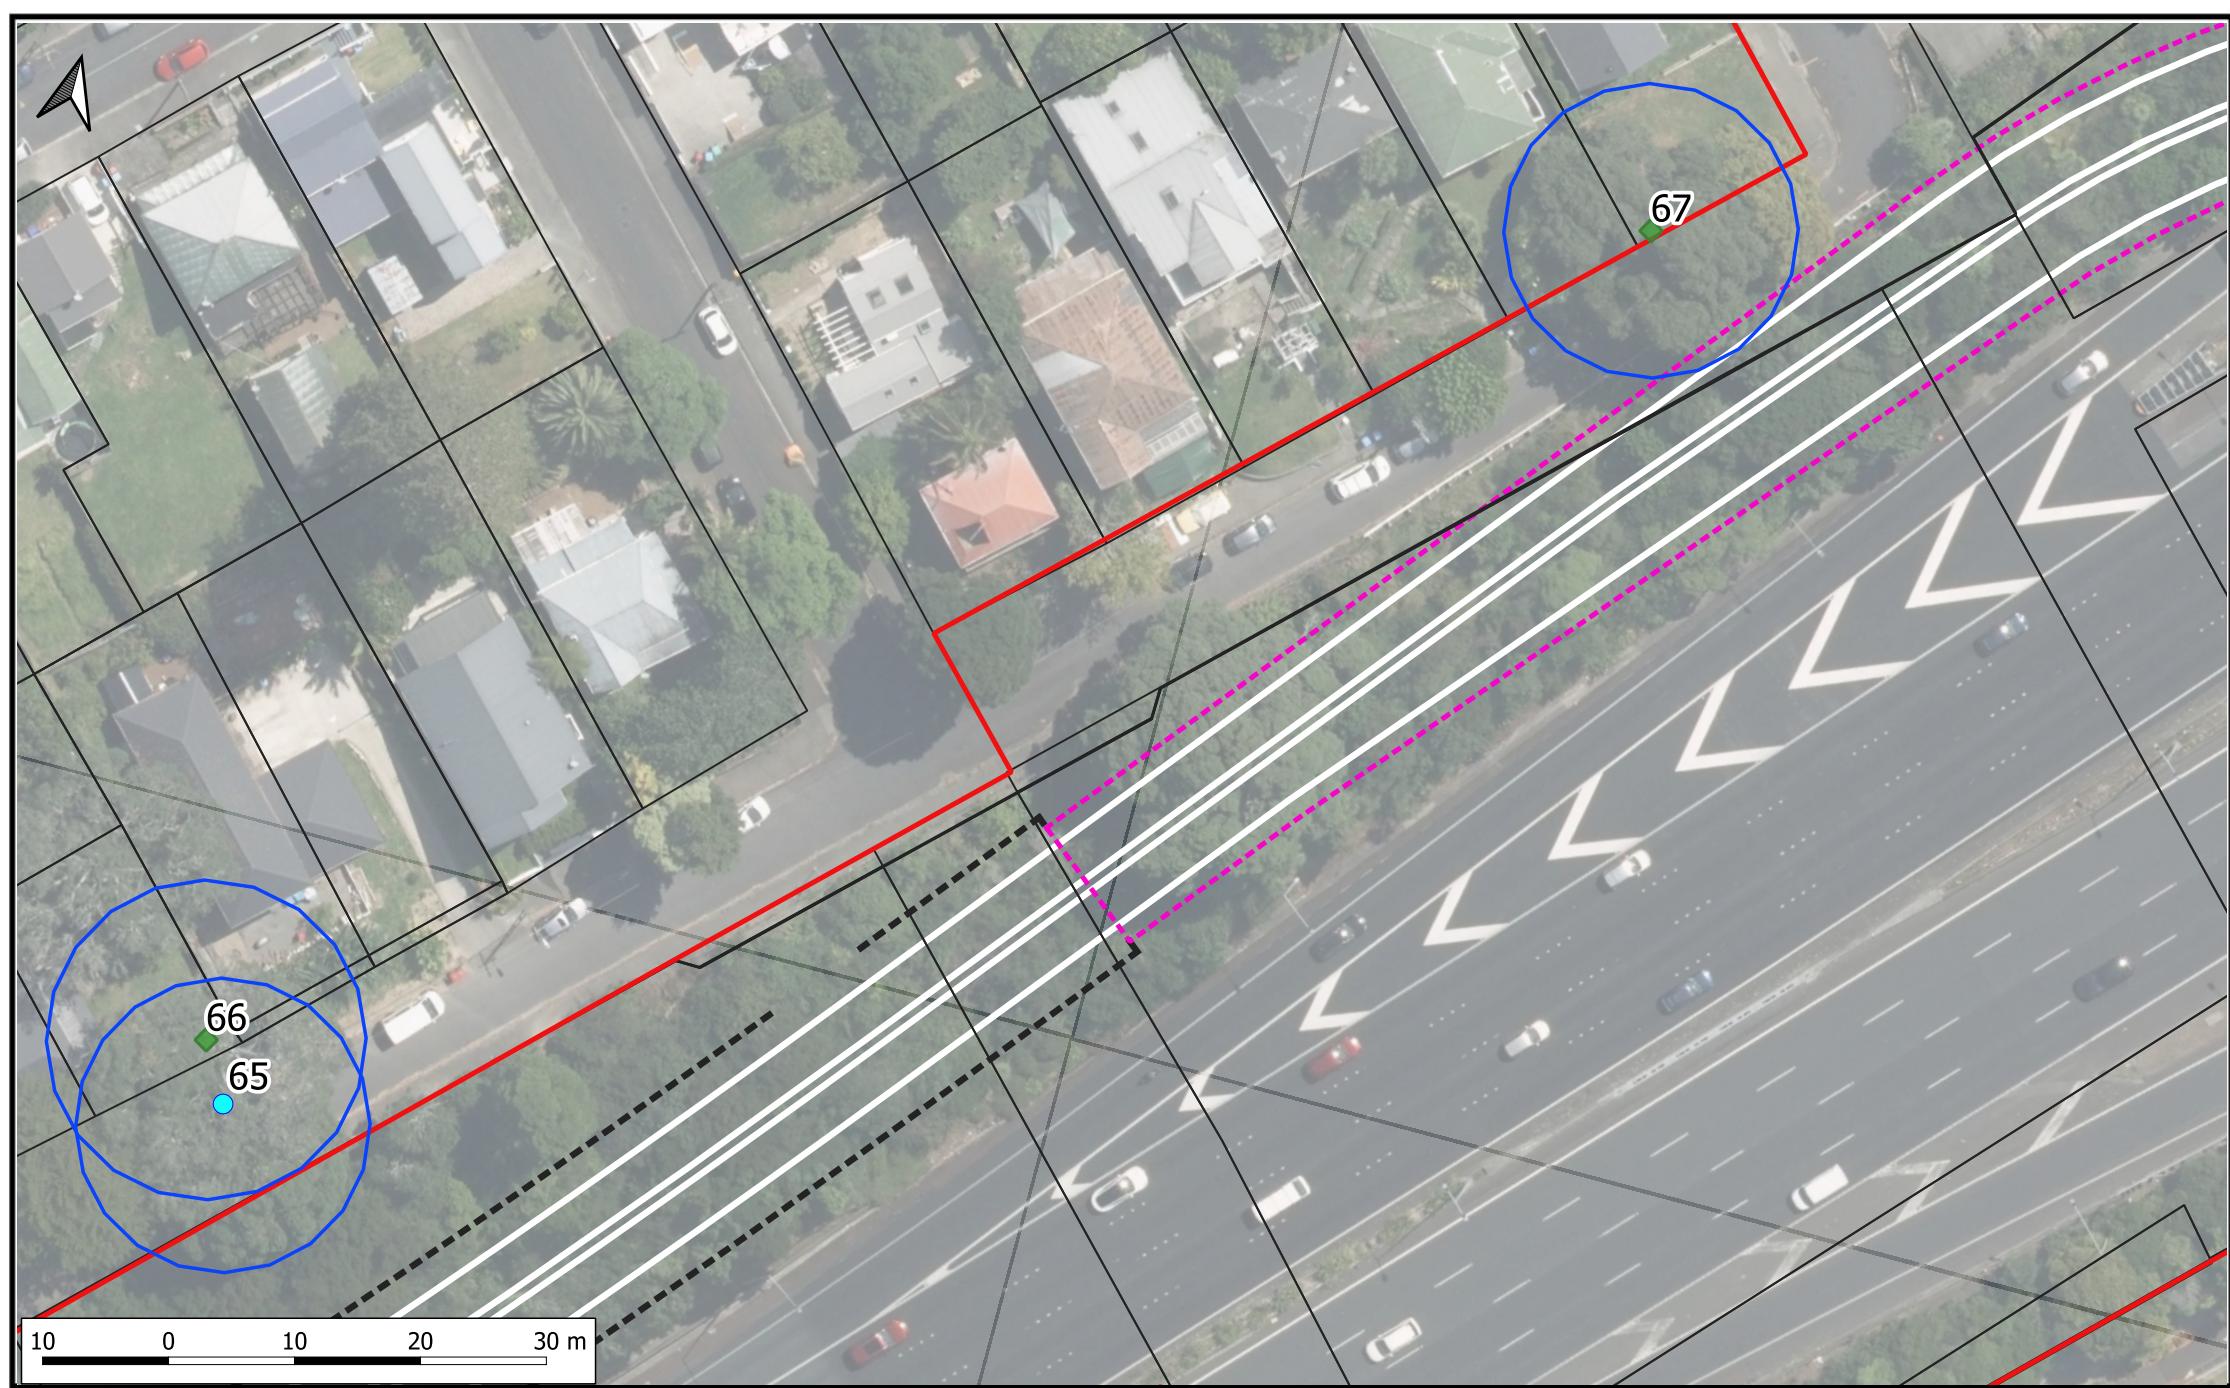
Requested by		Date
Surveyed by	DS	28/08/25
Plotted by	LGS	12/09/25
Checked by	JR	30/09/25
Drawing number	LGS-38893-04	Rev B

TREE LOCATION PLAN
