# **TE ARA HAUĀURU NORTHWEST RAPID TRANSIT CONTAMINATED LAND PRELIMINARY SITE INVESTIGATION**

TERRY WIDDOWSON

15 DECEMBER 2025

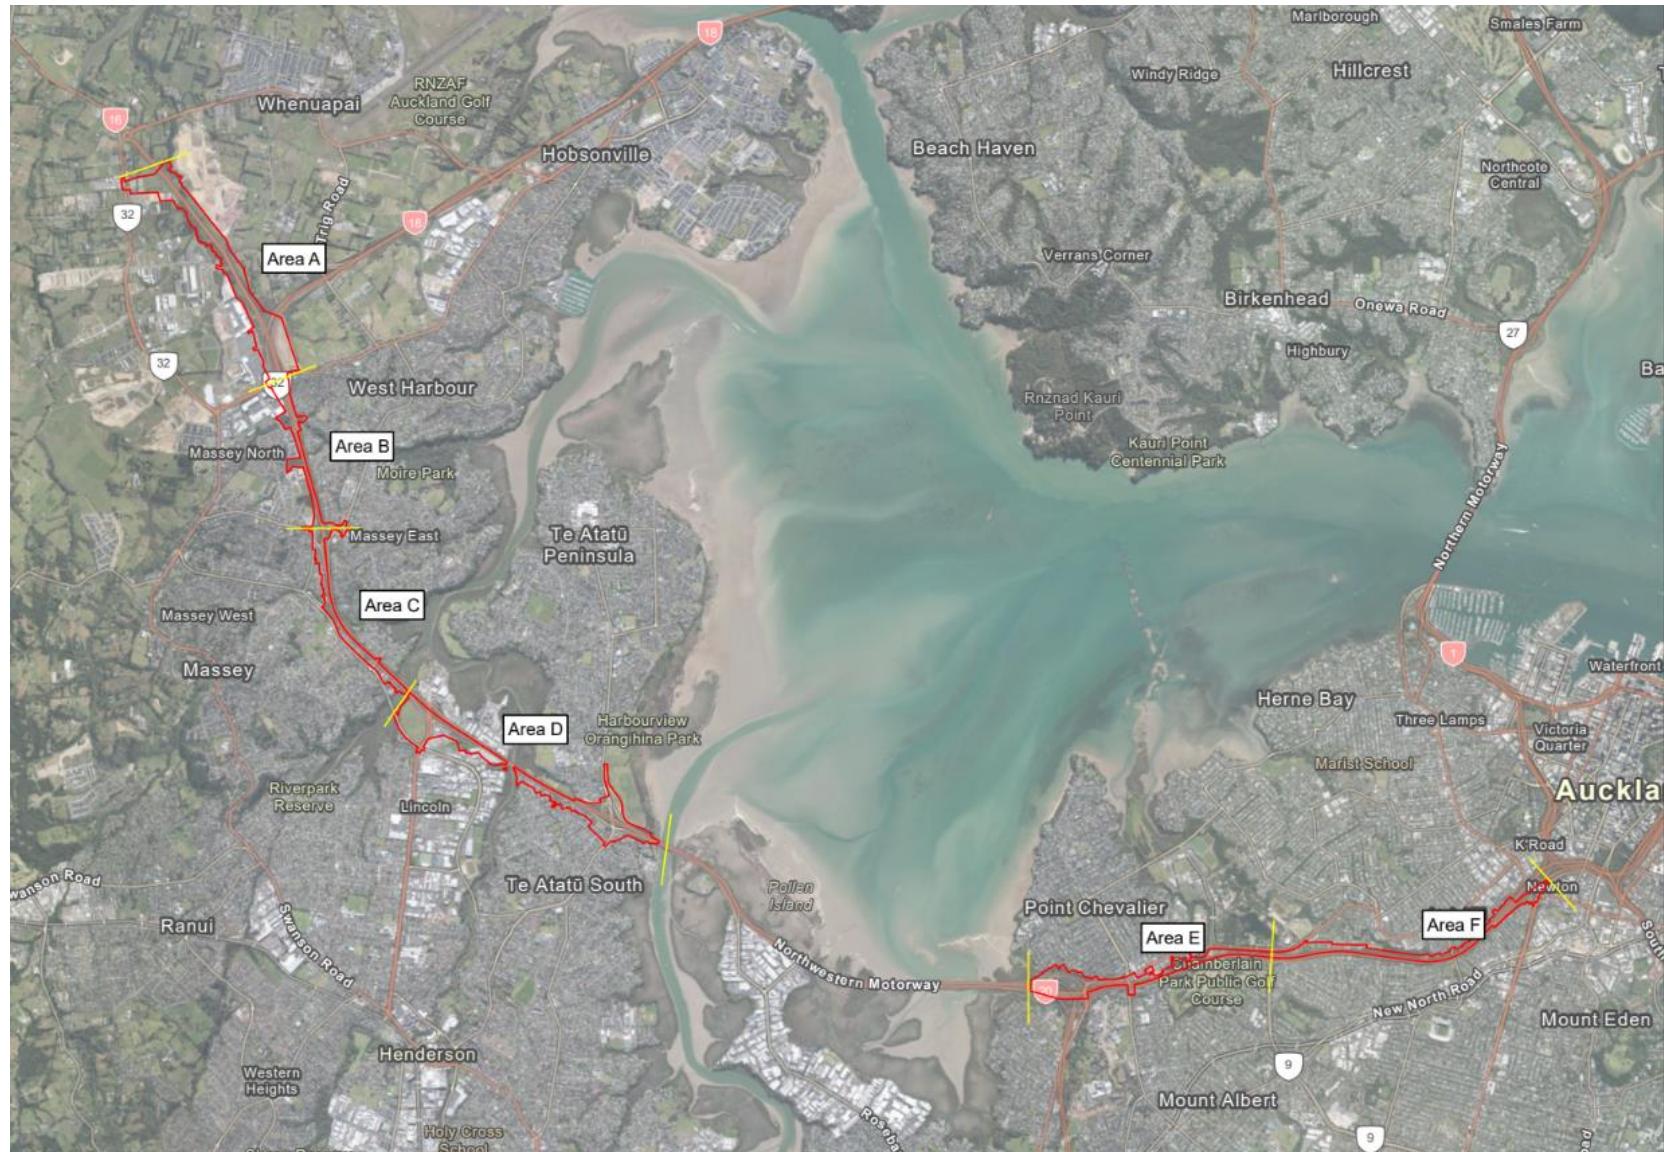
Figure 1-1: Project location plan overview

The Proposed Designation extends along State Highway 16 (SH16) for 18km. For this PSI, I have split the Proposed Designation into six assessment areas (Assessment Areas A to F) as shown in Figure 1-1.

- Assessment Area A: 143 Fred Taylor Drive to Hobsonville Road Bridge;
- Assessment Area B: Hobsonville Road Bridge to Royal Road Bridge;
- Assessment Area C: Royal Road Bridge to Momutu Stream/Henderson Creek;

- Assessment Area D: Momutu Stream/Henderson Creek to Whau River;
- Assessment Area E: Eric Armishaw Park to St Lukes Road Bridge; and
- Assessment Area F: St Lukes Road Bridge to 9 Karaka Street/the Central Motorway Junction.

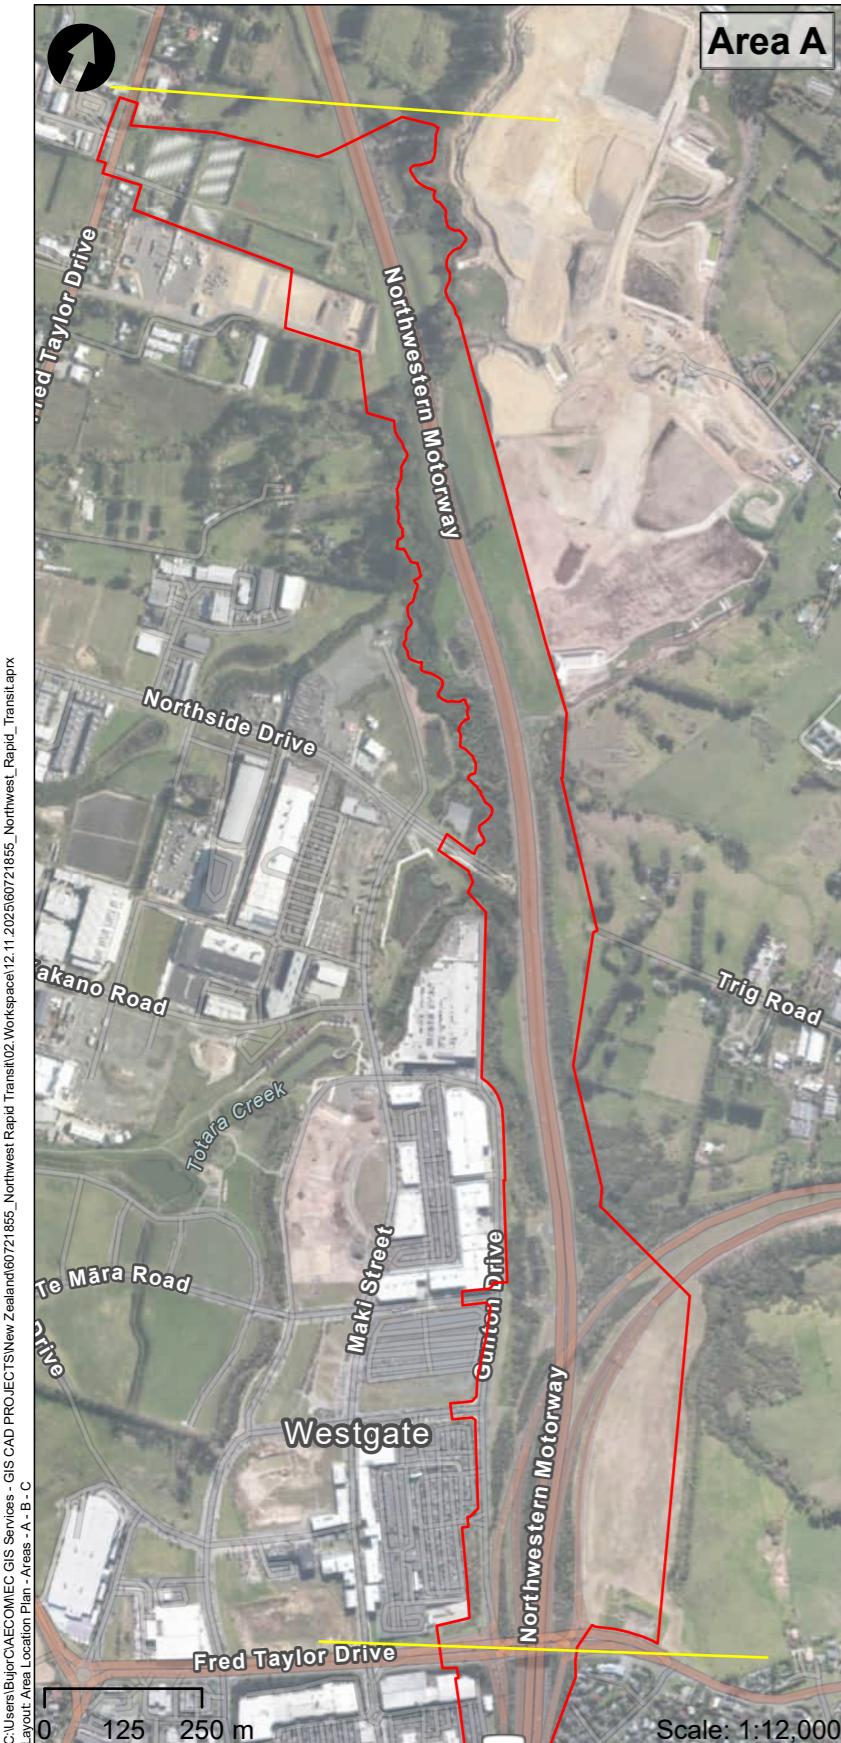
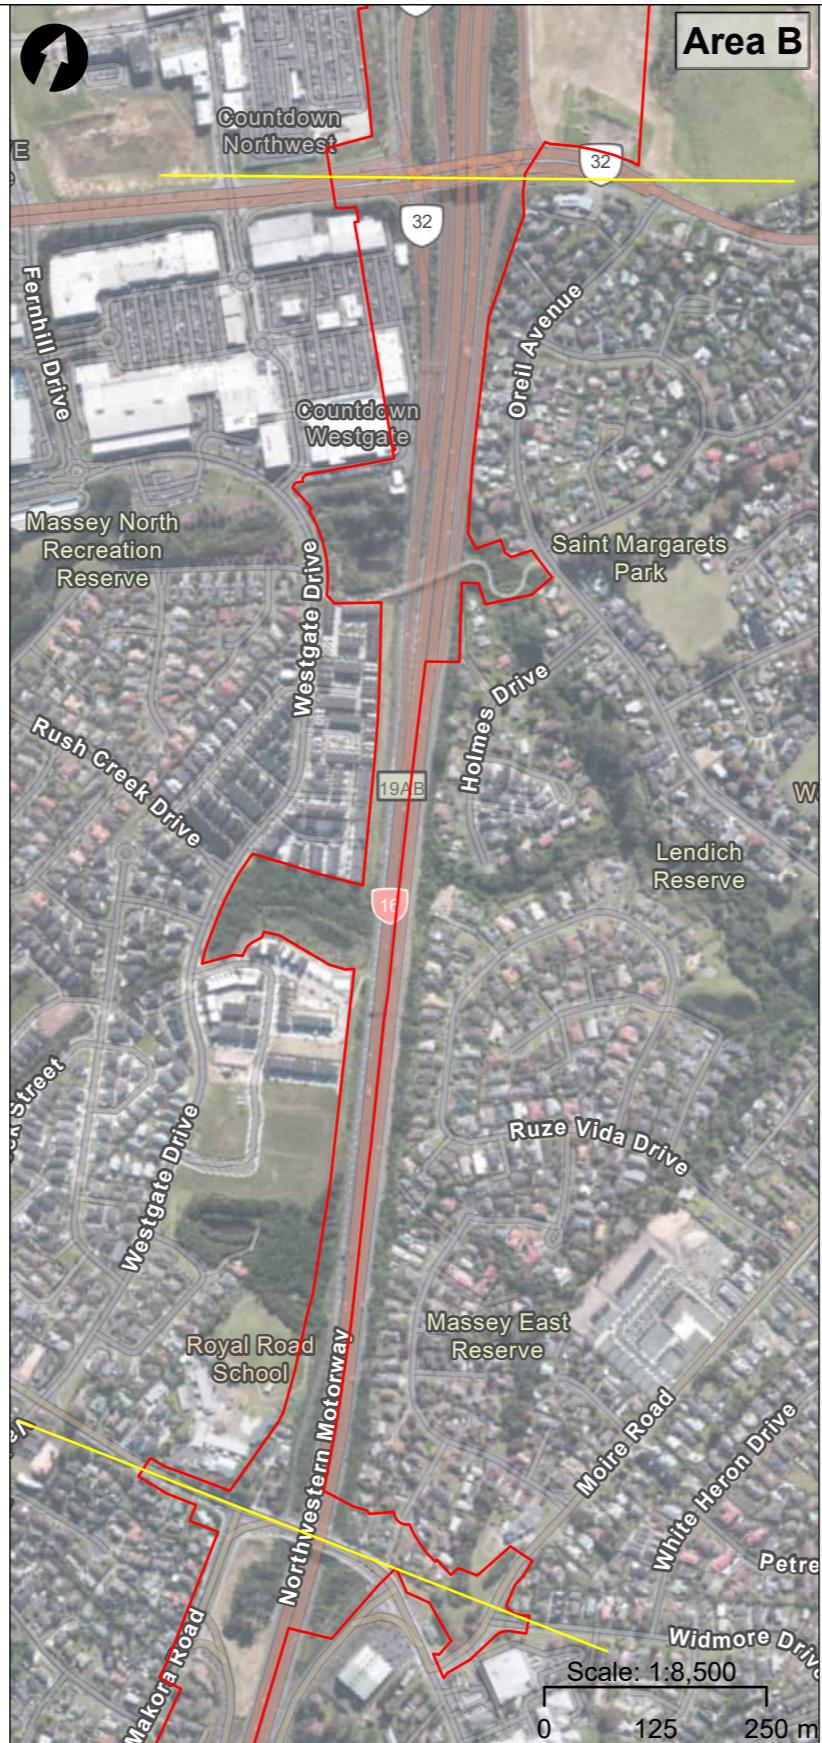
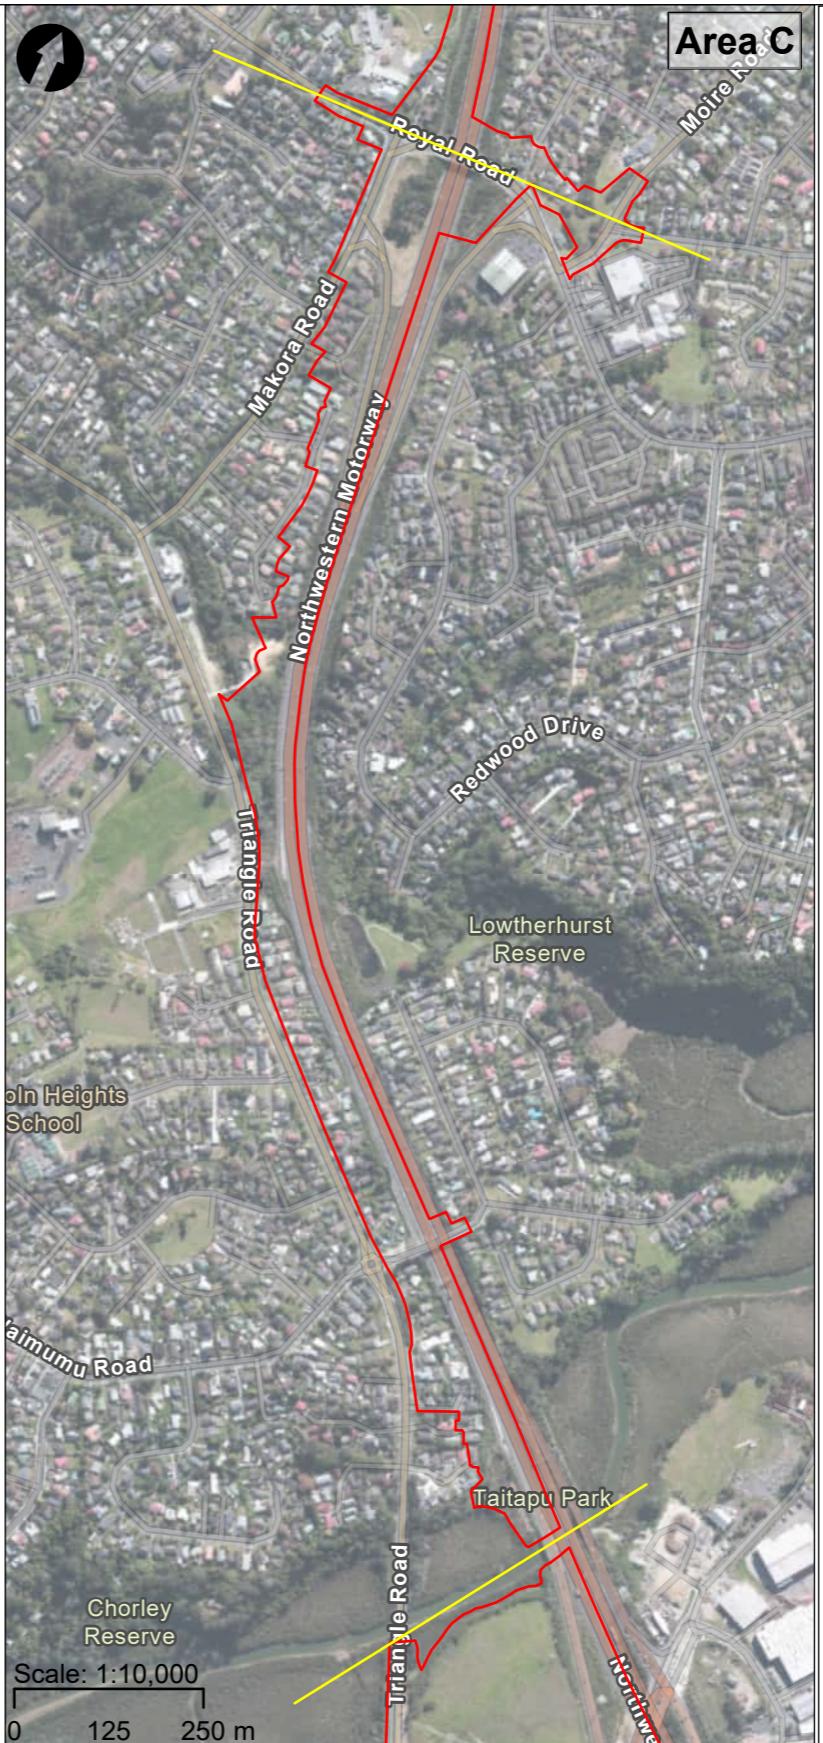
- Assessment Area A: 143 Fred Taylor Drive to Hobsonville Road Bridge
- Assessment Area B: Hobsonville Road Bridge to Royal Road Bridge
- Assessment Area C: Royal Road Bridge to Momutu Stream/Henderson Creek
- Assessment Area D: Momutu Stream/Henderson Creek to Whau River
- Assessment Area E: Eric Armishaw Park to St Lukes Road Bridge
- Assessment Area F: St Lukes Road Bridge to 9 Karaka Street/the Central Motorway Junction

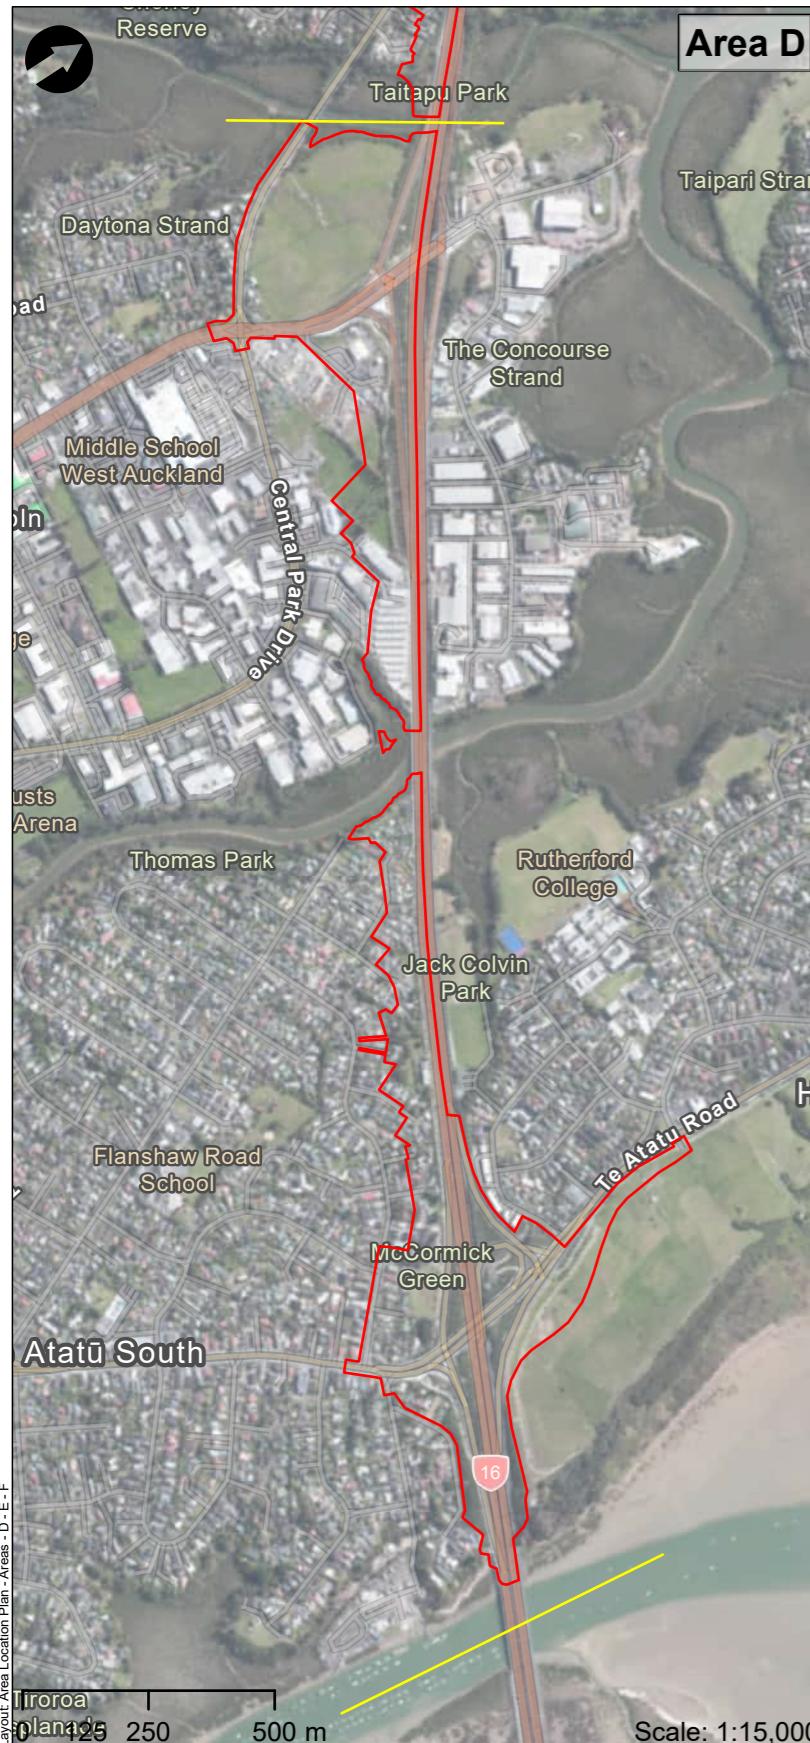
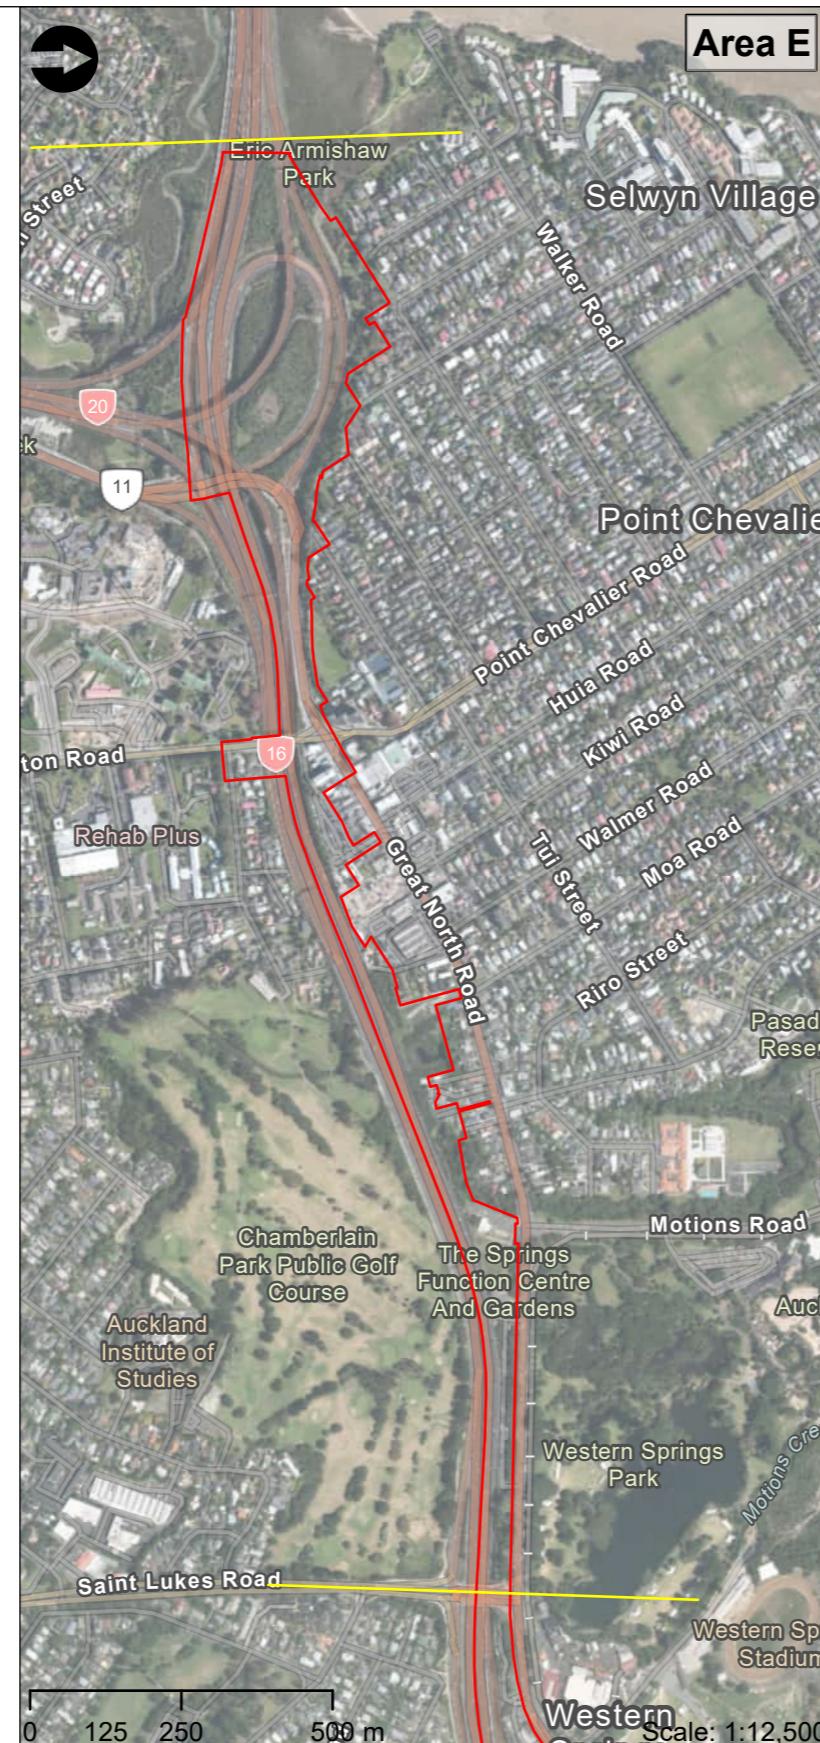
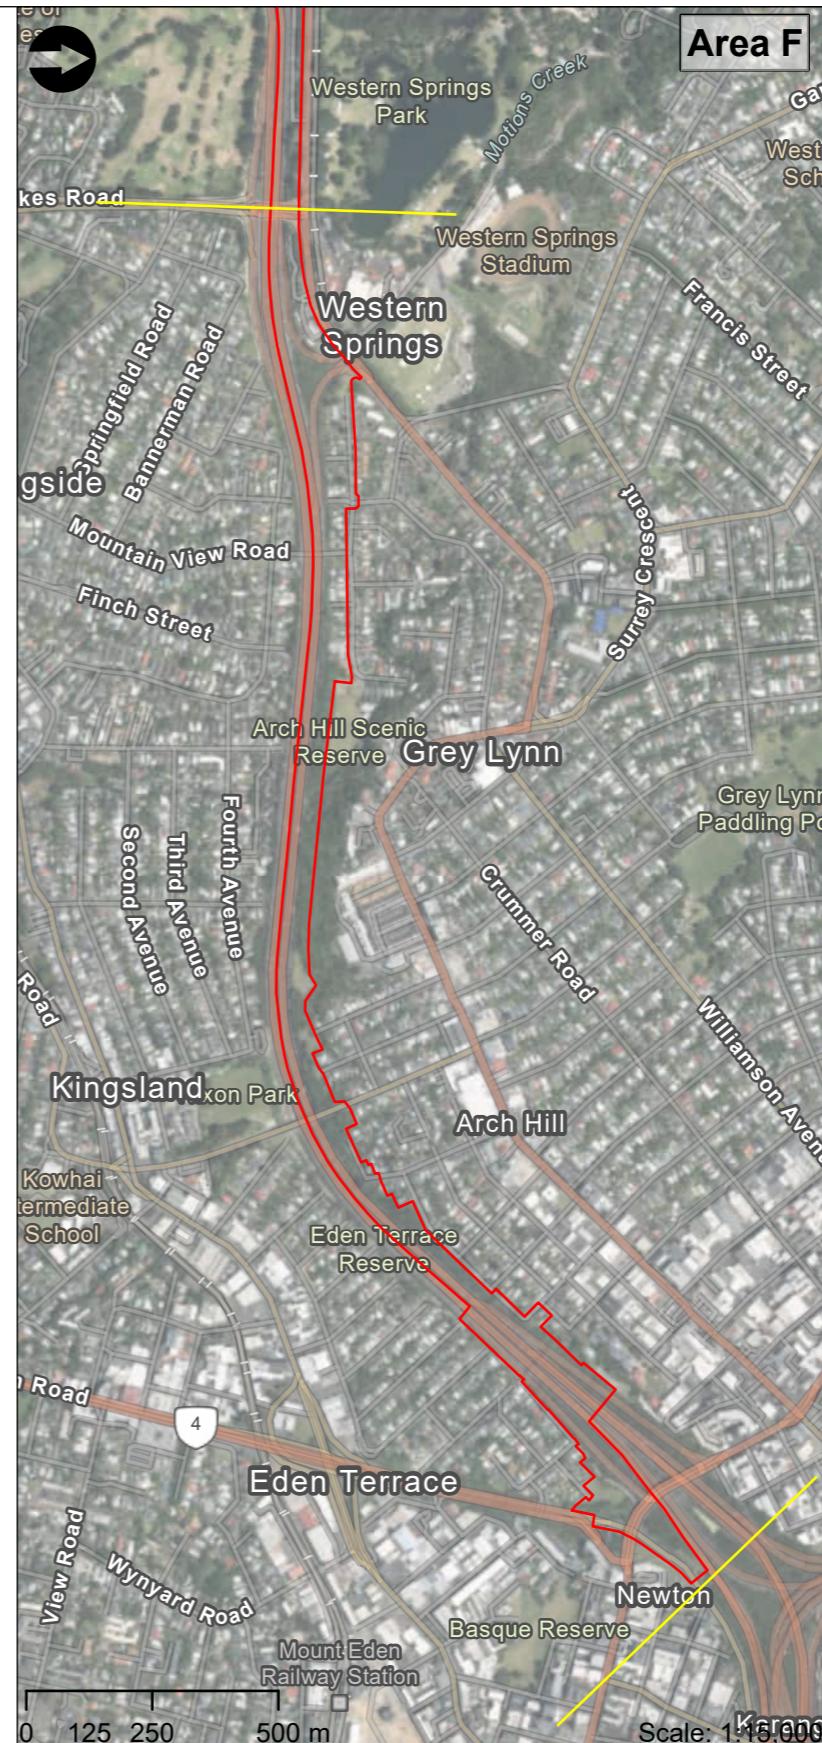
Legend	
<span style="color: yellow;">—</span>	Area Boundary
<span style="color: red;">—</span>	Project Area Outline
<b>NOTE</b>	
<ul style="list-style-type: none"> <li>Assessment Area A: 143 Fred Taylor Drive to Hobsonville Road Bridge</li> <li>Assessment Area B: Hobsonville Road Bridge to Royal Road Bridge</li> <li>Assessment Area C: Royal Road Bridge to Momutu Stream/Henderson Creek</li> <li>Assessment Area D: Momutu Stream/Henderson Creek to Whau River</li> <li>Assessment Area E: Eric Armishaw Park to St Lukes Road Bridge</li> <li>Assessment Area F: St Lukes Road Bridge to 9 Karaka Street/the Central Motorway Junction</li> </ul>

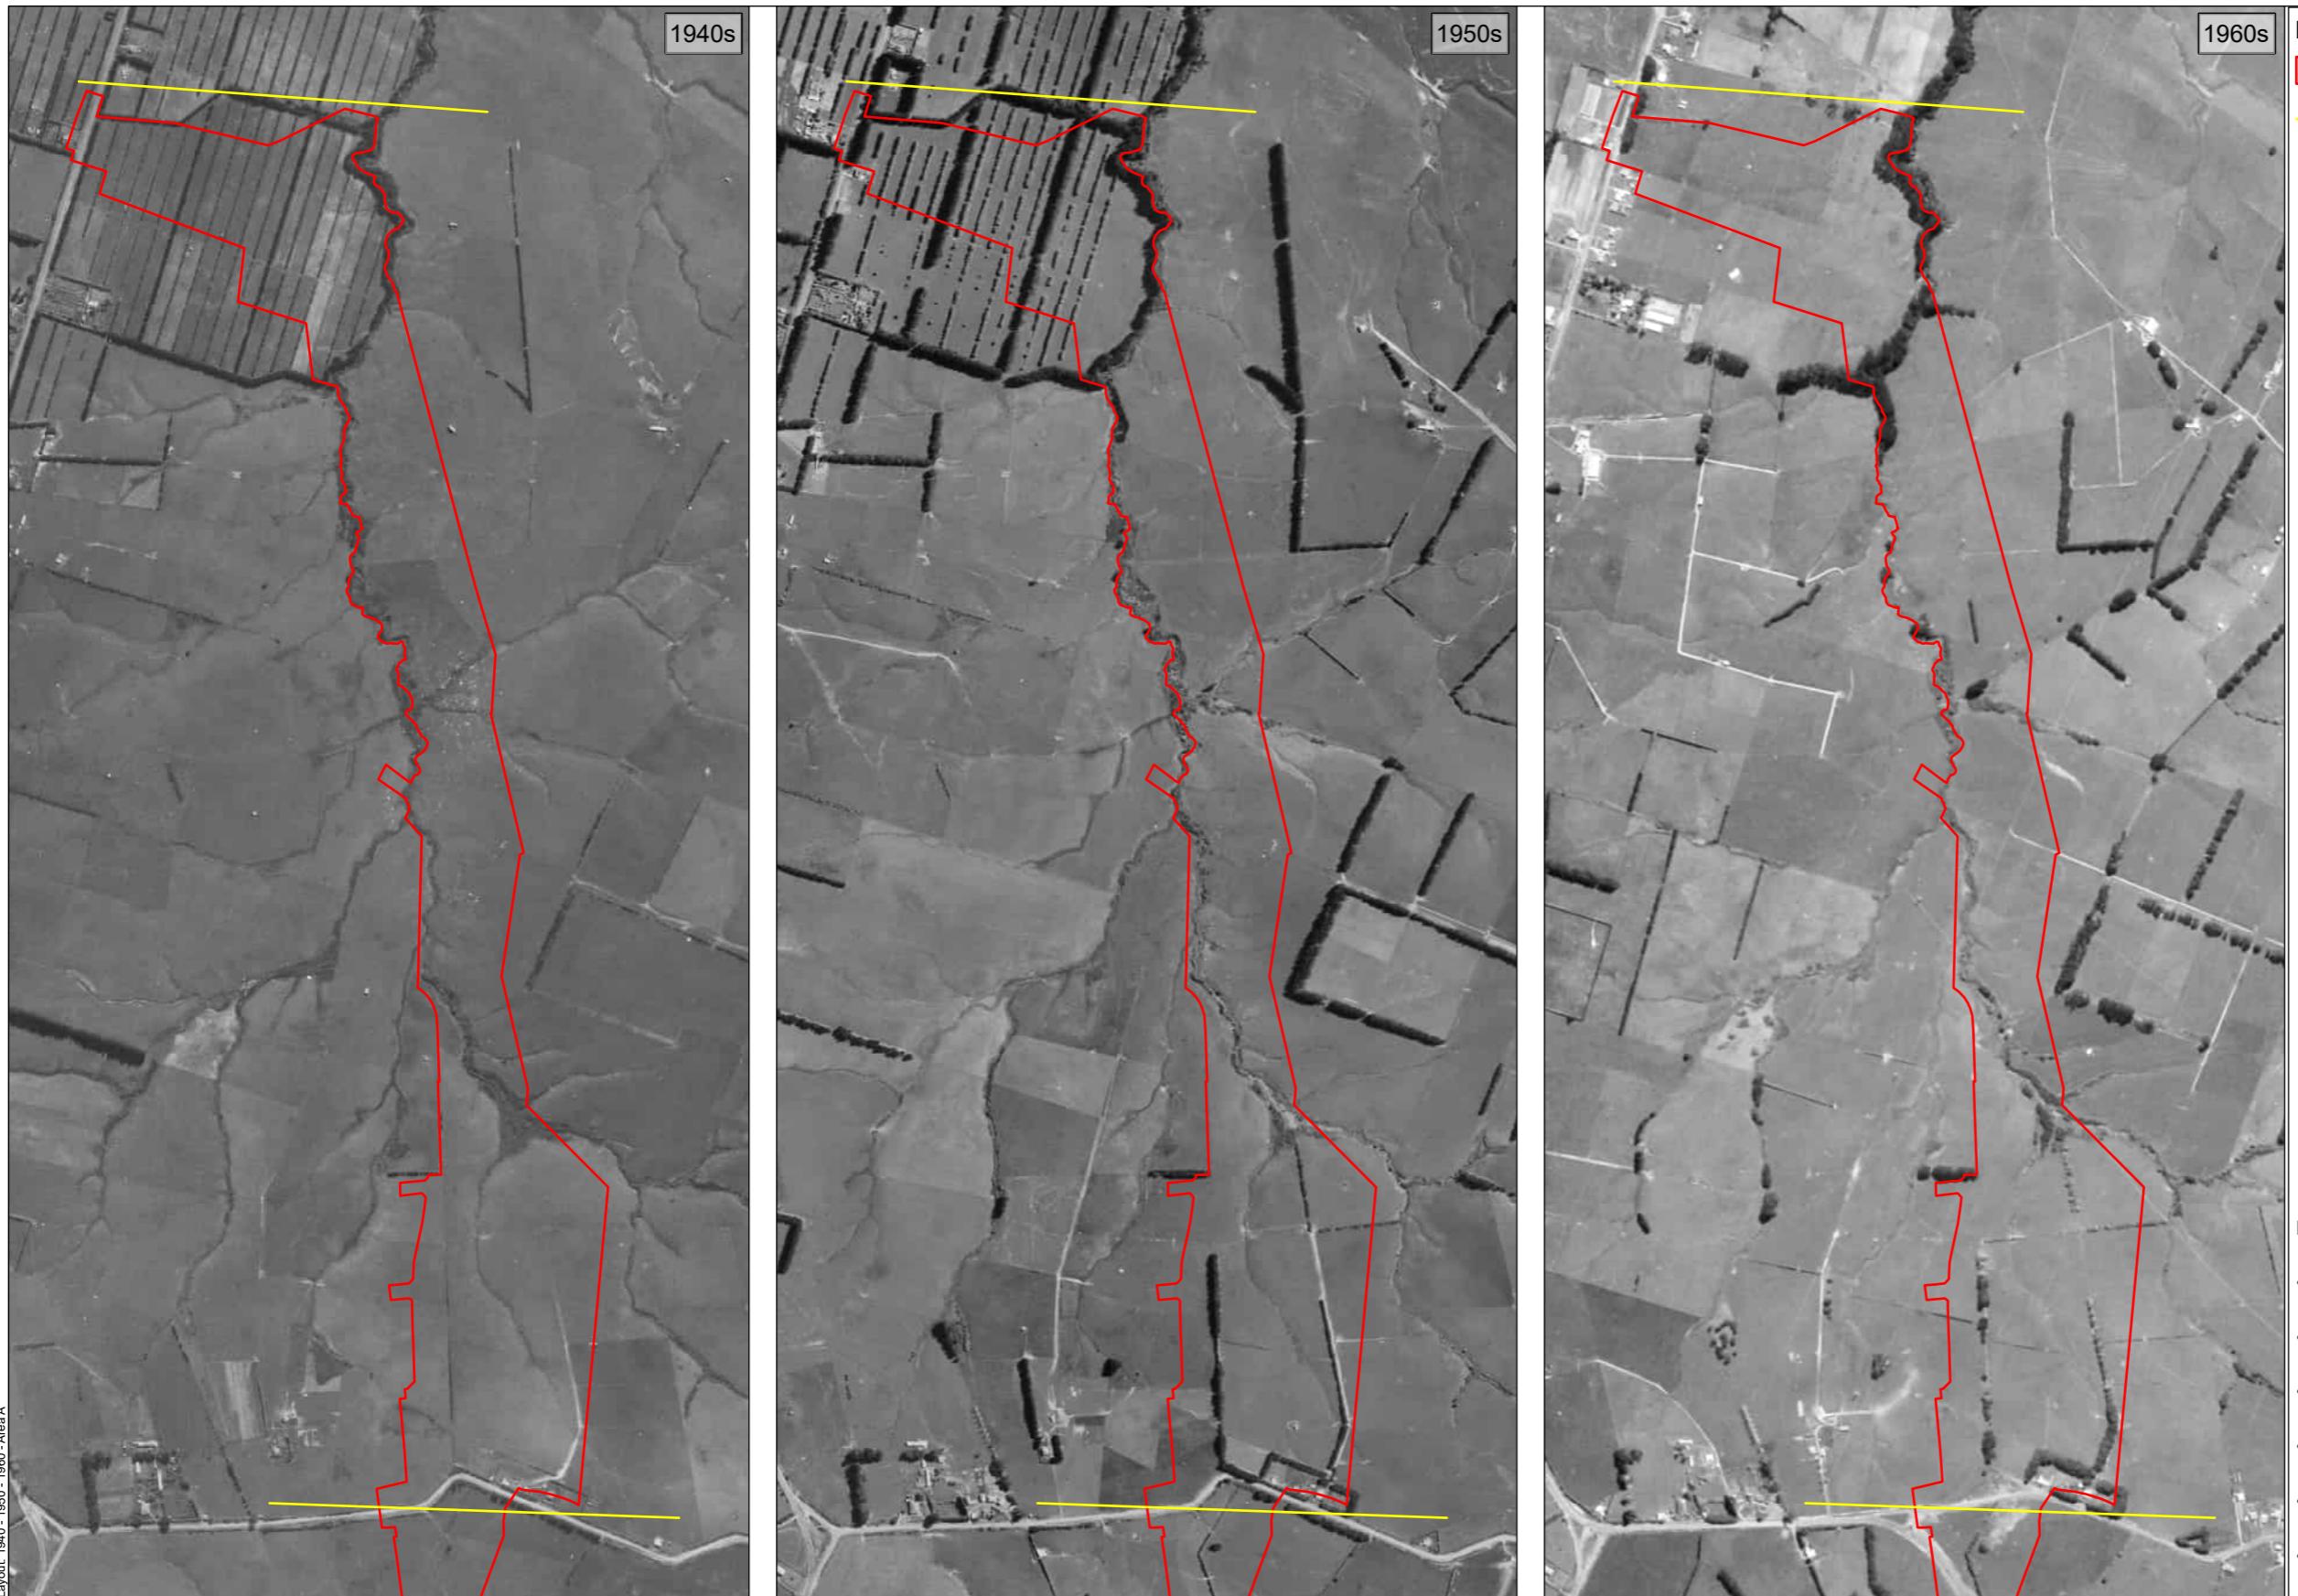
1960s	Horticultural activities in the northern portion of Area A have ceased and this land converted to pasture.	The motorway has been constructed, and it extends the length of Area B. Changes to the 1950s road layout is visible at the southern end. There is a bridge over the main road at the southern boundary of Area B. The small	The orchards and crops have been replaced by the construction of the motorway which extends the length of Area C, with changes to the 1950s road layout. There has been construction of an industrial building adjacent	The motorway running the length of Area D has been constructed, with on ramps and off ramps also constructed. There has been the construction of a substation in the central area. There have been residential developments	The area of soil disturbance in the western end of Area E had expanded. The small area of market gardening has been replaced by residential houses. Some of the farmland in the centre of Area E has had	The oval track in the centre of Area F appears to have become overgrown. A large area of residential houses at the eastern end have been removed.

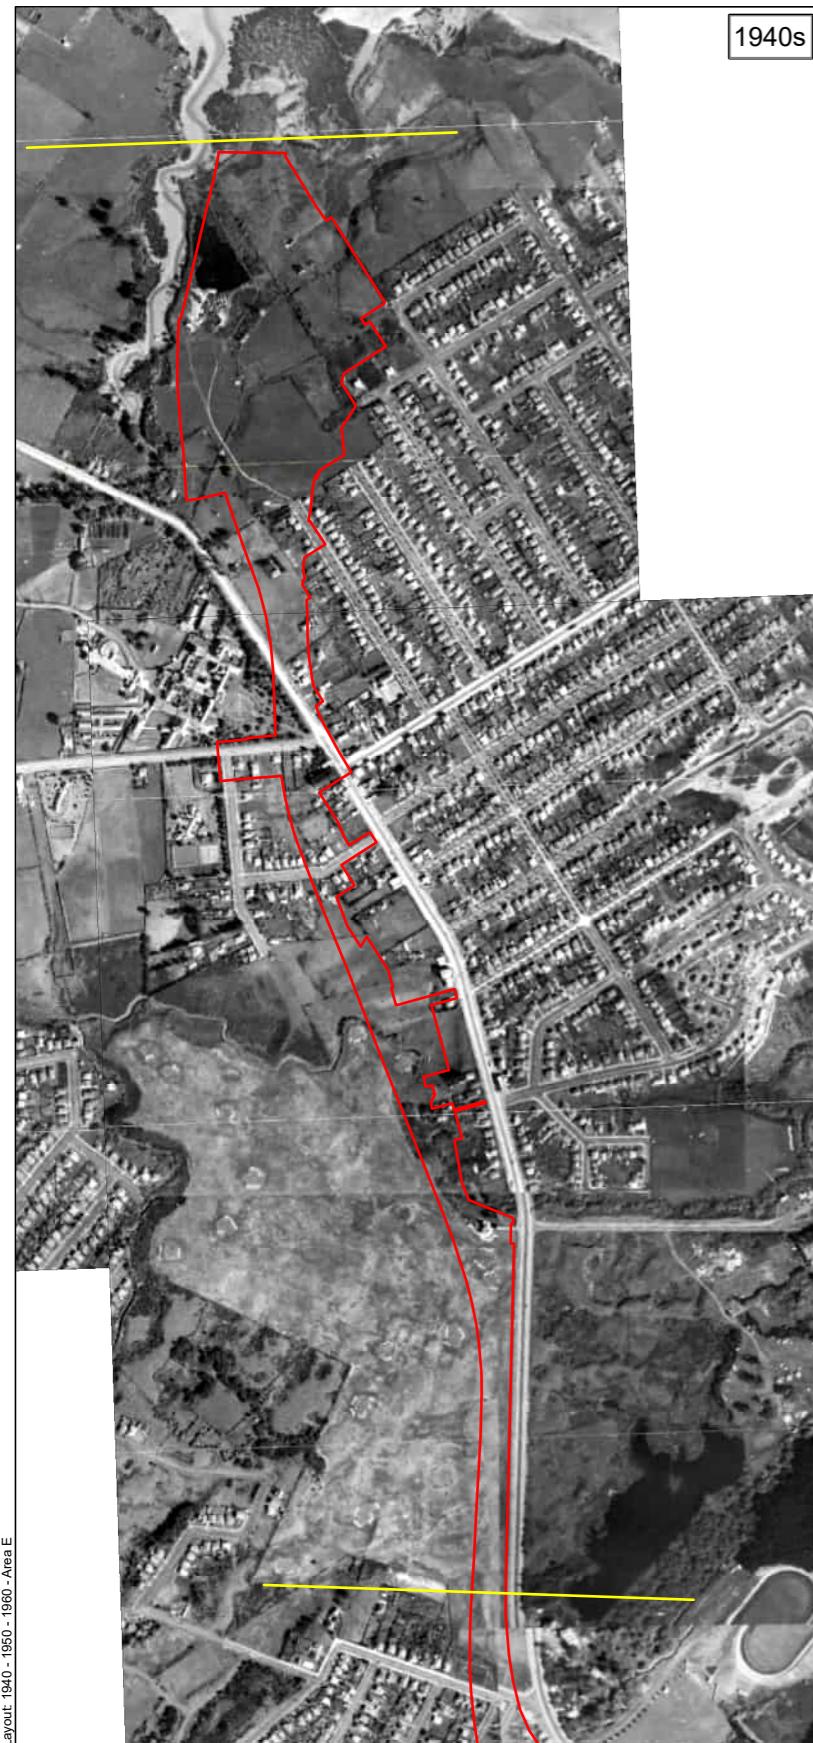
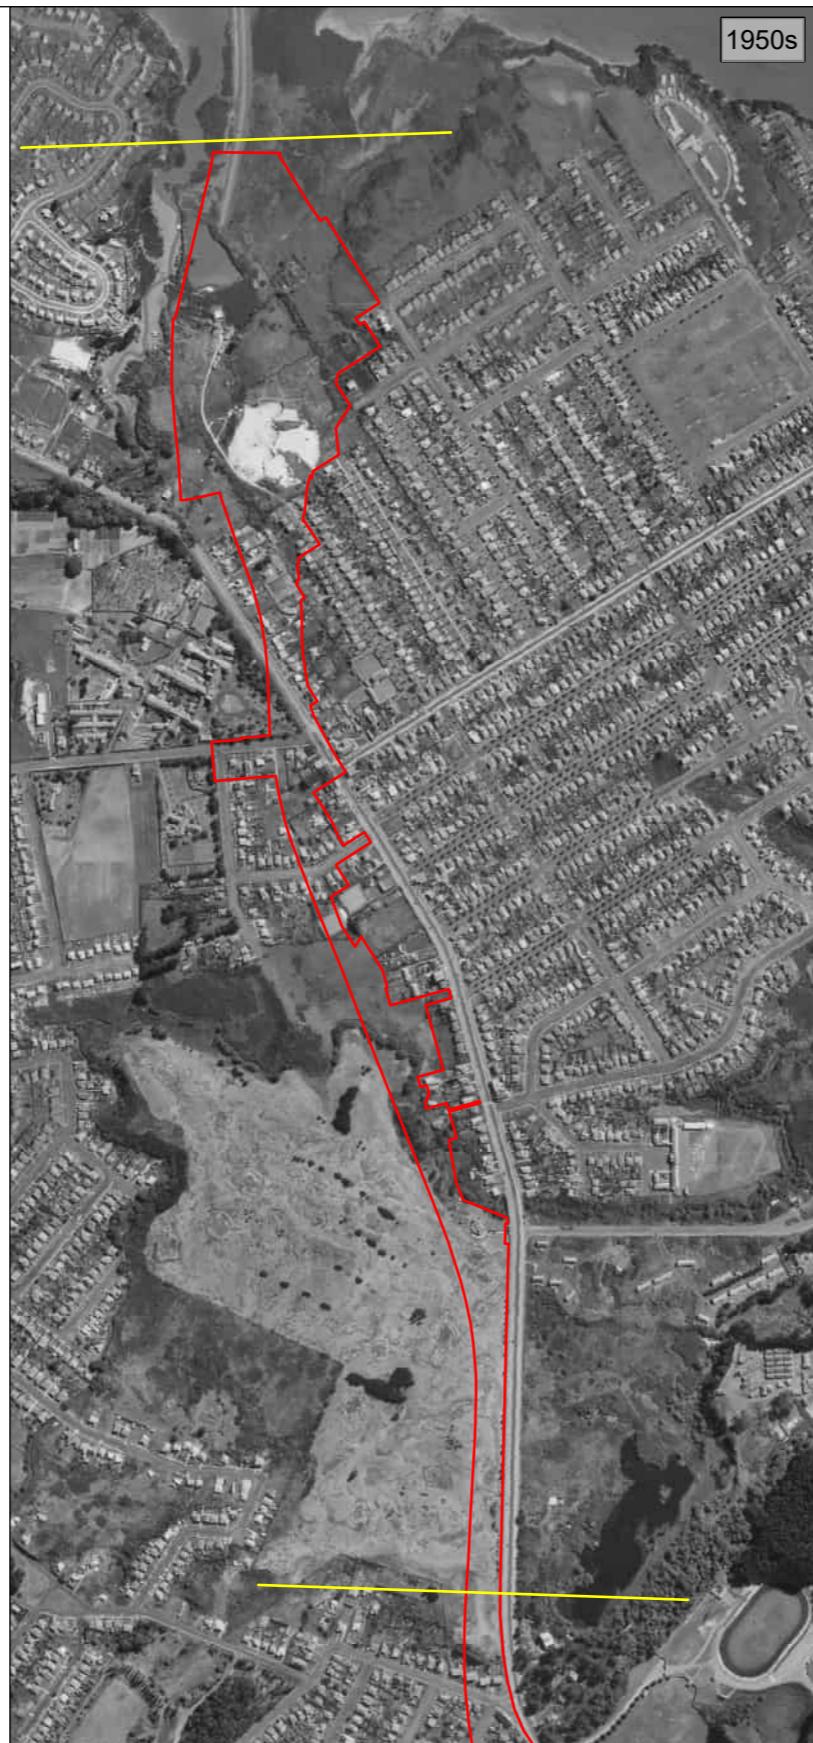
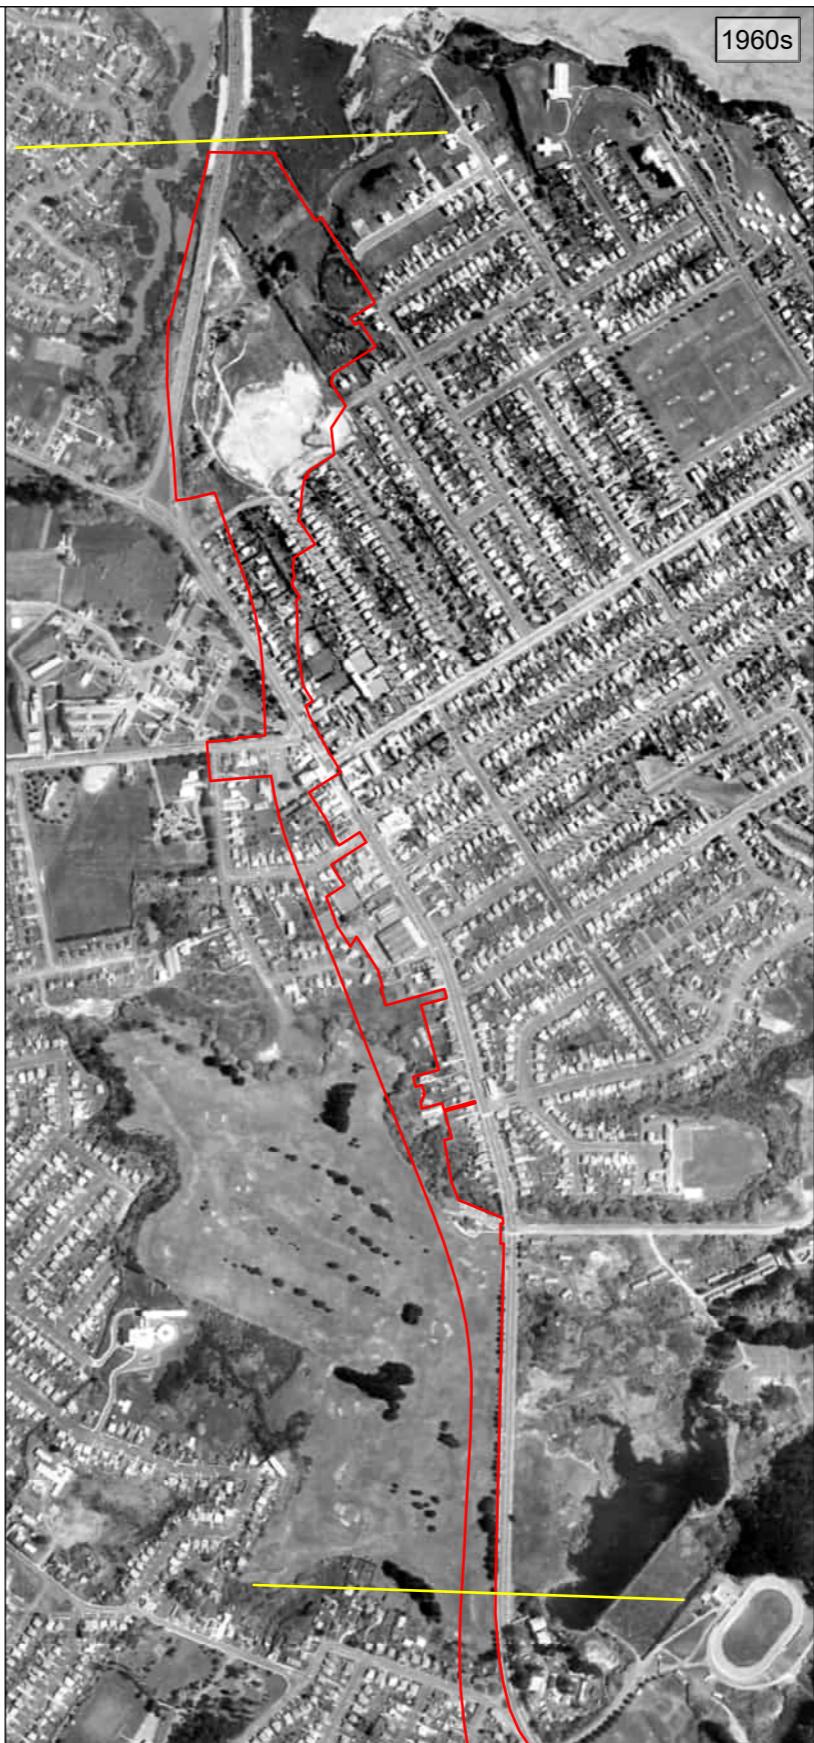
DRAWING TITLE	SCALE:	CLIENT/NAME LOGO:	PROJECT NAME:
HISTORICAL AERIAL PHOTOGRAPHS 1940 - 1950 - 1960 - AREA E	0 125 250 500 750 1,000 m

1940s

1950s

1960s
