# **TE ARA HAUĀURU NORTHWEST RAPID TRANSIT CONTAMINATED LAND PRELIMINARY SITE INVESTIGATION**

TERRY WIDDOWSON

15 DECEMBER 2025

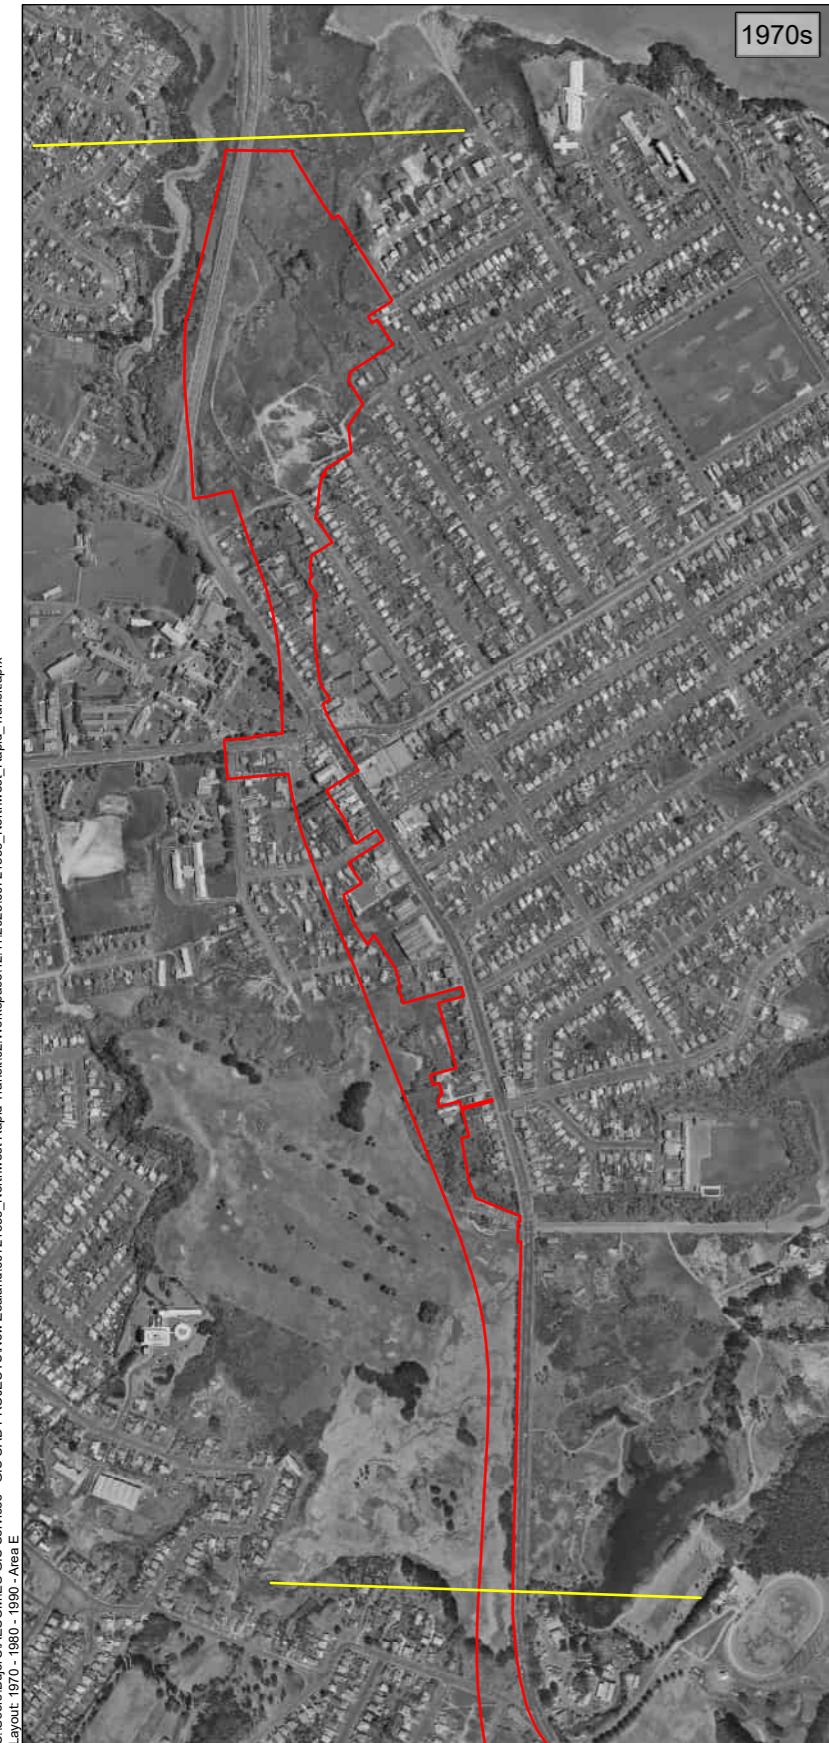
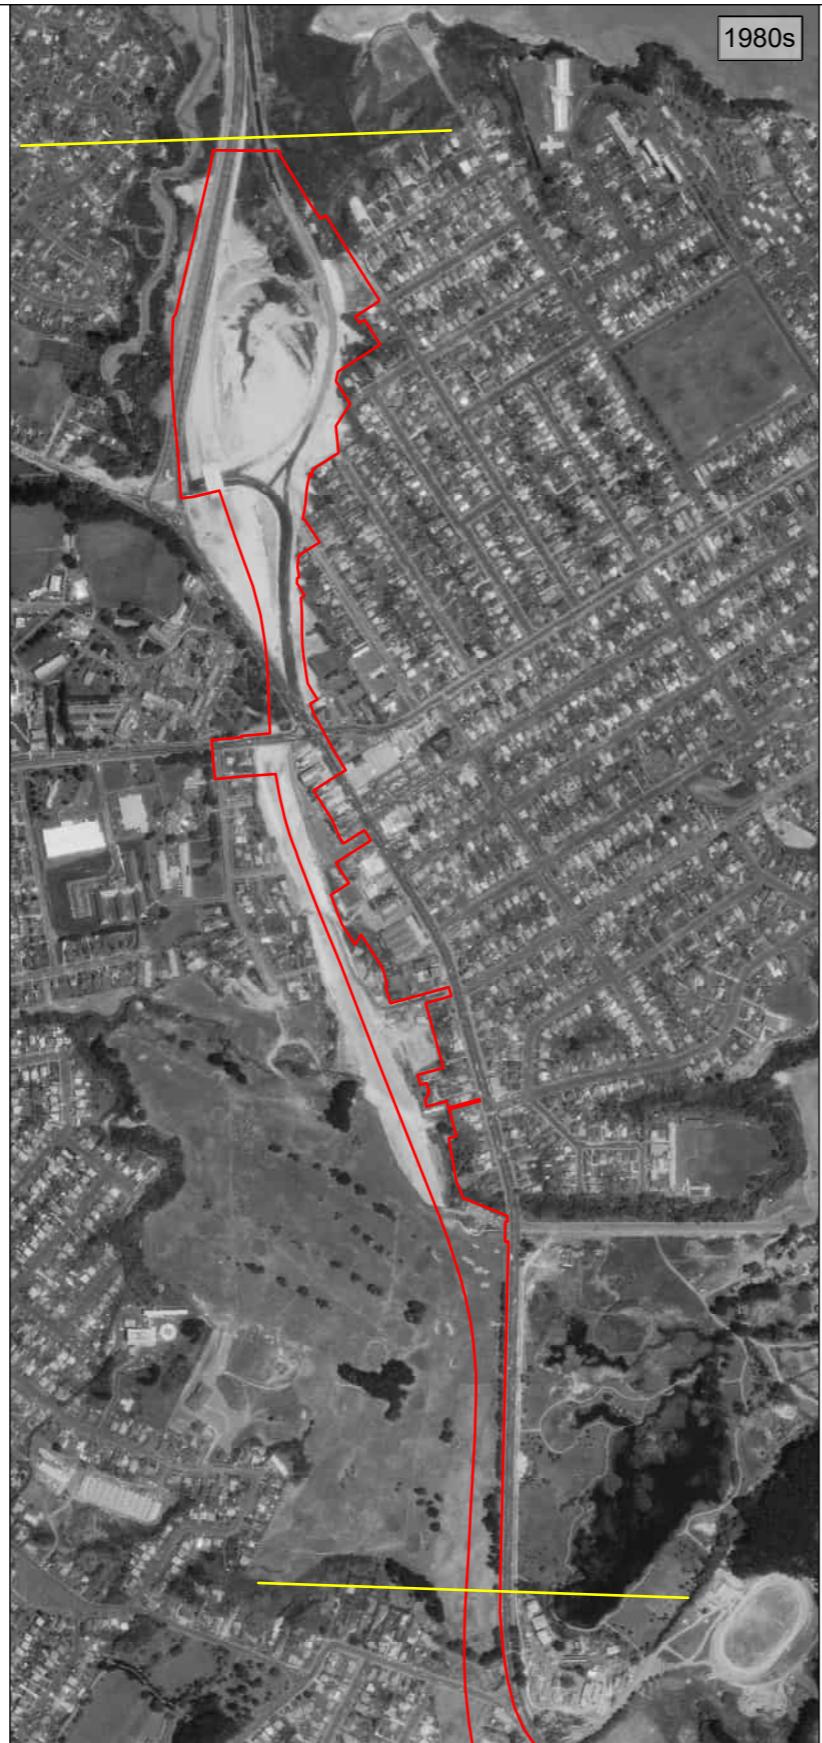
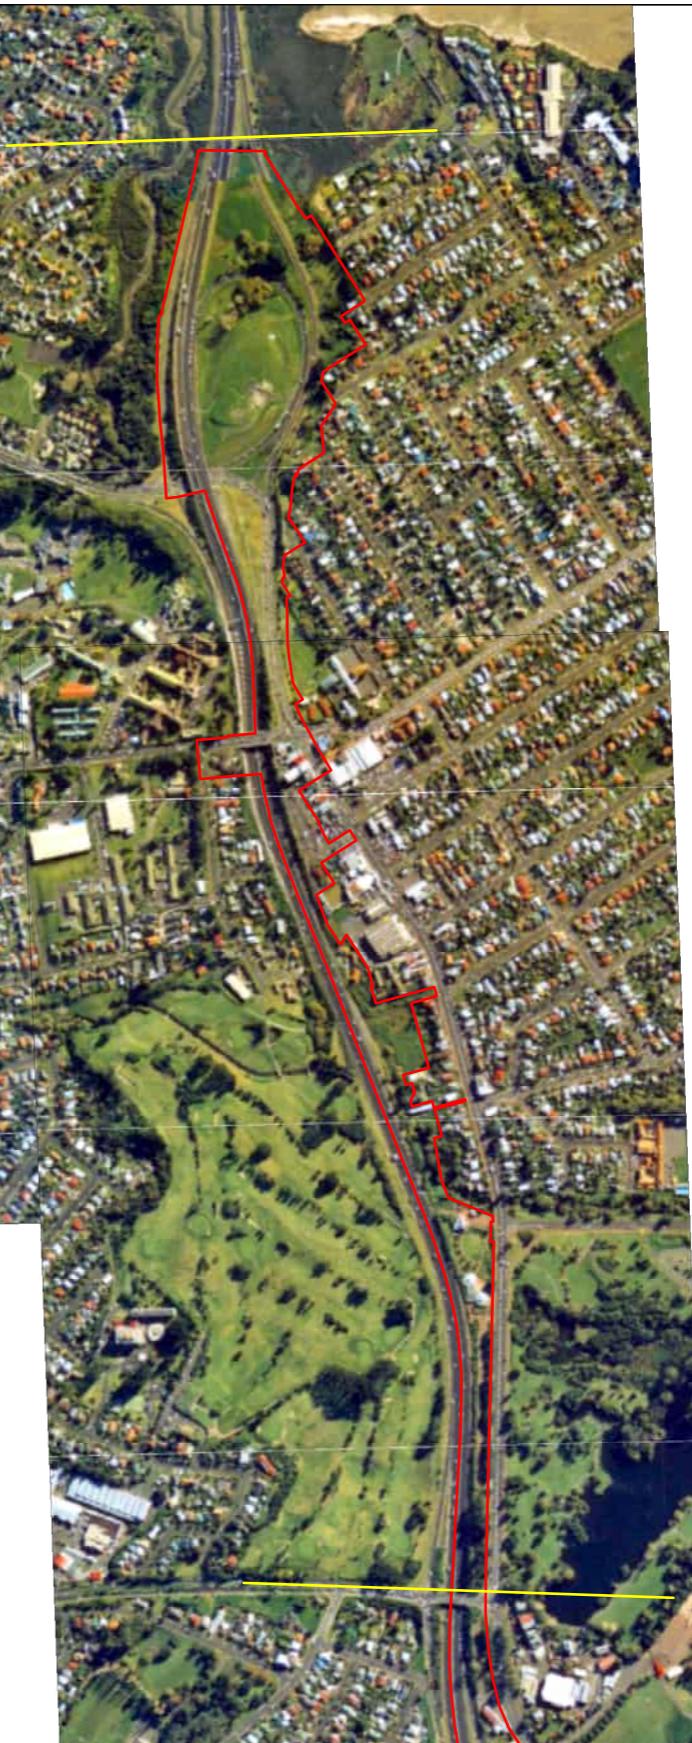
1970s

1980s

1990s

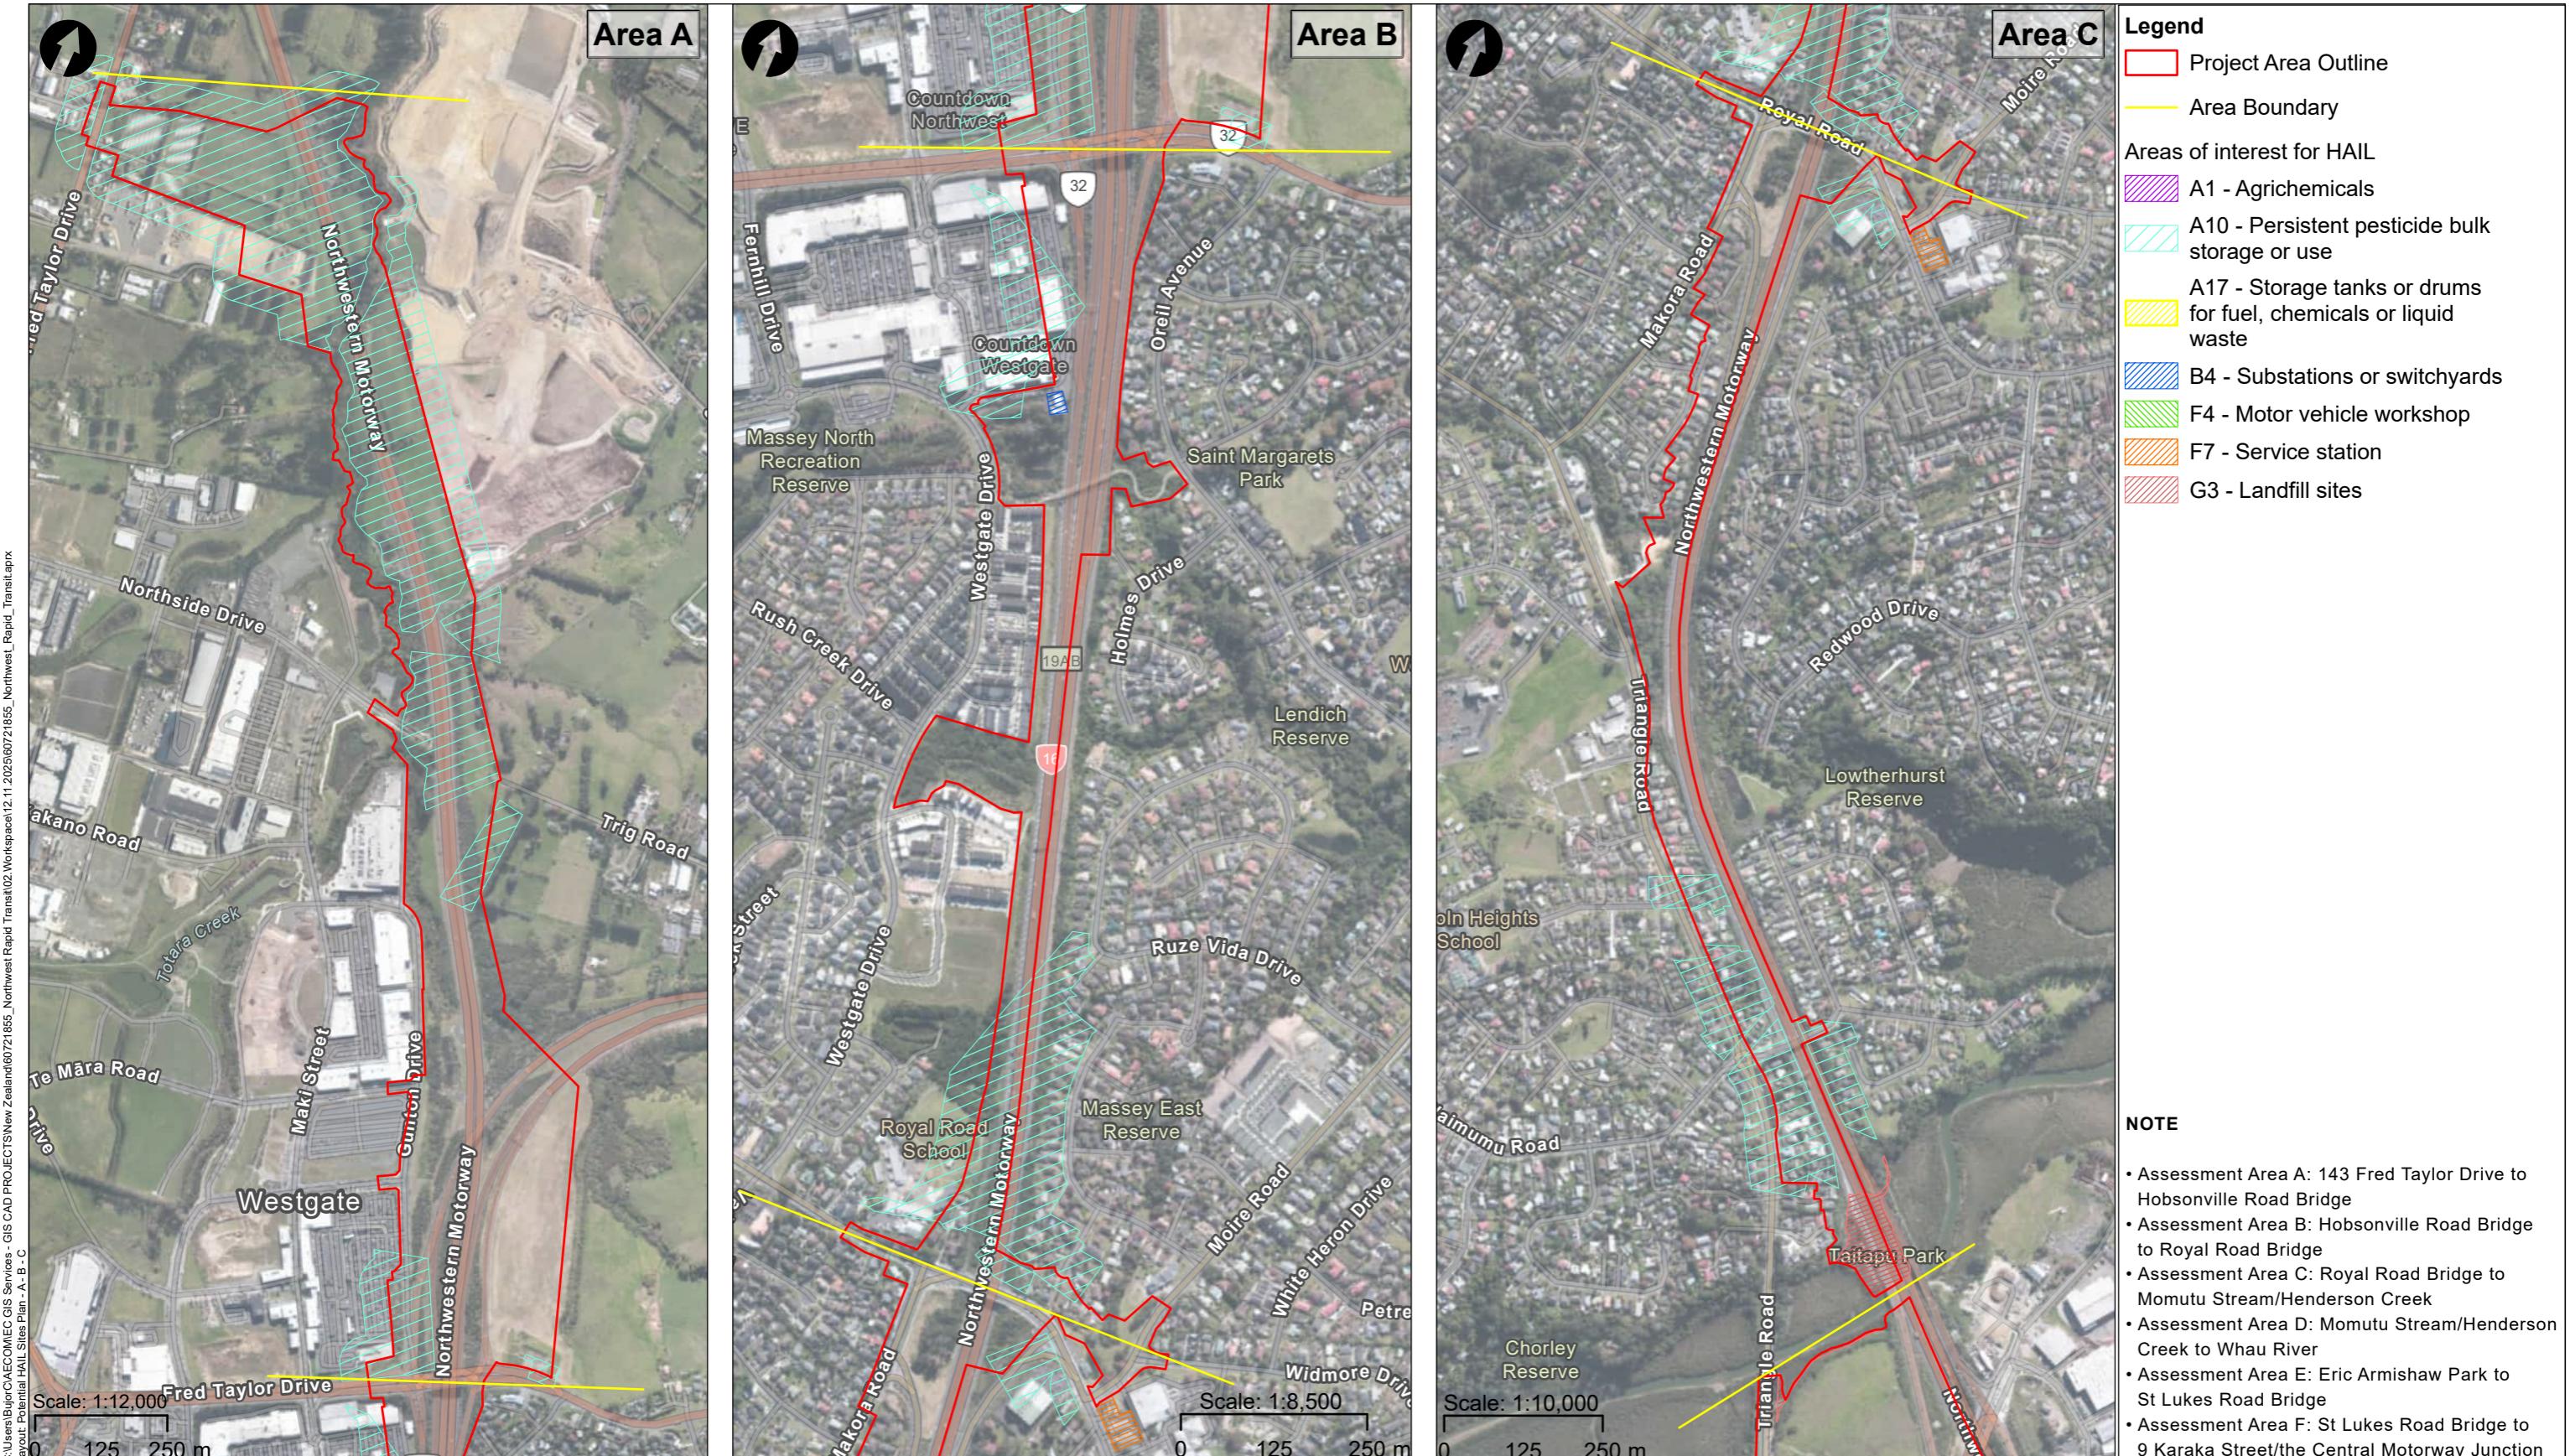
HAIL Category	Number of sites
<b>A10:</b> Persistent pesticide bulk storage or use including sport turfs, market gardens, orchards, glass houses or spray sheds	389
<b>A17:</b> Storage tanks or drums for fuel, chemicals or liquid waste	3
<b>E1:</b> Asbestos products manufacture or disposal including sites with buildings containing asbestos products known to be in a deteriorated condition	2
<b>F4:</b> Motor vehicle workshops	2
<b>F8:</b> Transport depots or yards including areas used for refuelling or the bulk storage of hazardous substances	1
<b>G3:</b> Landfill sites	5
<b>I:</b> Any other land that has been subject to the intentional or accidental release of a hazardous substance in sufficient quantity that it could be a risk to human health or the environment	2
