Appendix A

Field Investigation Data

Project: Russell Road, Silverdale		Location: Russell Road & Upper Orewa Road		Pit Position: Refer to Riley Dwg 240065-SK110		No.: TP01	
Project No.: 240065	Date Excavated: 07 Nov 2024	Ground Level (m): 28.8 m		Co-ordinates : E 1747778.0, N 5949469.0			
Client: Vineway Ltd			Pit Depth: 4.60 m	Reason Terminated: Refusal		Sheet: 1 of 1	Status: FINAL

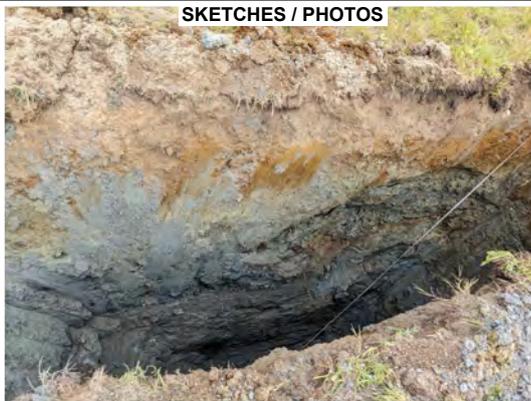
SKETCHES / PHOTOS

Stability: 	Explanations: ▼ Scala Penetrometer Tests Raw data in blows per 100mm ↑ ✓ Vane Shear Strength (kPa) V=Peak, R=Residual, UTP=Unable to penetrate Moisture: M = moist; W = wet; S = saturated	Groundwater: <input type="checkbox"/> None <input checked="" type="checkbox"/> Slow Seep (@1.60m) <input type="checkbox"/> Rapid Inflow ▼ Standing Water Level ◀ Inflow ▶ Outflow	Backfill: <input checked="" type="checkbox"/> Bentonite <input type="checkbox"/> Grout/concrete <input type="checkbox"/> Spoil/arising <input type="checkbox"/> Filter sand	Remarks: 1. 53B Russell Road. 2. Test pit was backfilled upon completion. 3. Perched groundwater encountered at 1.6m depth. 4. Pit collapsed at 1.6m depth on both sides of the pit.	
					All dimensions in metres NOT TO SCALE

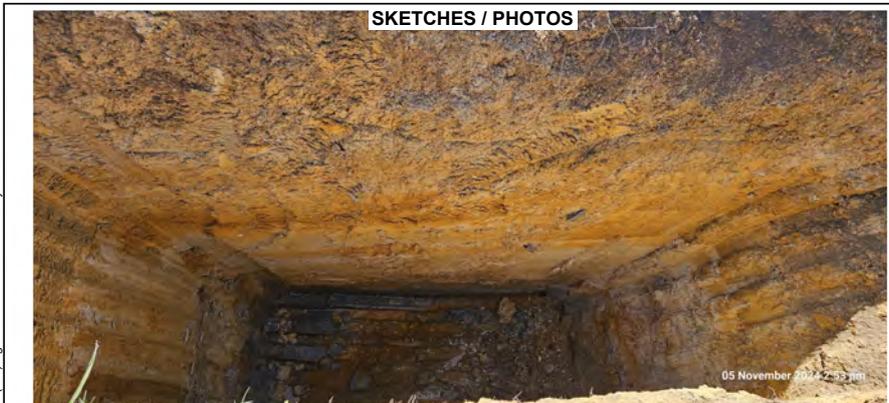
Stability: 	Explanations: ▼ Scala Penetrometer Tests Raw data in blows per 100mm ↑ ✓ Vane Shear Strength (kPa) V=Peak, R=Residual, UTP=Unable to penetrate Moisture: M = moist; W = wet; S = saturated	Groundwater: <input checked="" type="checkbox"/> None <input type="checkbox"/> Slow Seep <input type="checkbox"/> Rapid Inflow ▼ Standing Water Level ◀ Inflow ▶ Outflow	Backfill: <input type="checkbox"/> Bentonite <input type="checkbox"/> Grout/concrete <input type="checkbox"/> Spoil/arising <input type="checkbox"/> Filter sand	Remarks: 1. 53B Russell Road. 2. Test pit was backfilled upon completion. 3. No groundwater encountered. 4. Pit remained stable for the duration of the excavation.	
					All dimensions in metres NOT TO SCALE

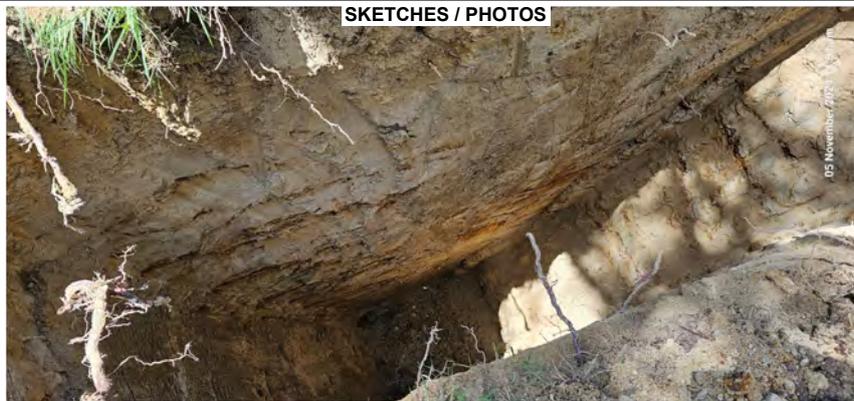
Stability: 	Explanations: ▼ Scala Penetrometer Tests Raw data in blows per 100mm ↑ ✓ Vane Shear Strength (kPa) V=Peak, R=Residual, UTP=Unable to penetrate Moisture: M = moist; W = wet; S = saturated	Groundwater: <input checked="" type="checkbox"/> None <input type="checkbox"/> Slow Seep <input type="checkbox"/> Rapid Inflow ▼ Standing Water Level ◀ Inflow ▶ Outflow	Backfill: <input type="checkbox"/> Bentonite <input type="checkbox"/> Grout/concrete <input type="checkbox"/> Spoil/arising <input type="checkbox"/> Filter sand	Remarks: 1. 55 Russell Road. 2. Test pit was backfilled upon completion. 3. No groundwater encountered. 4. Pit remained stable for the duration of the excavation.
-----------------------	--	--	---	---

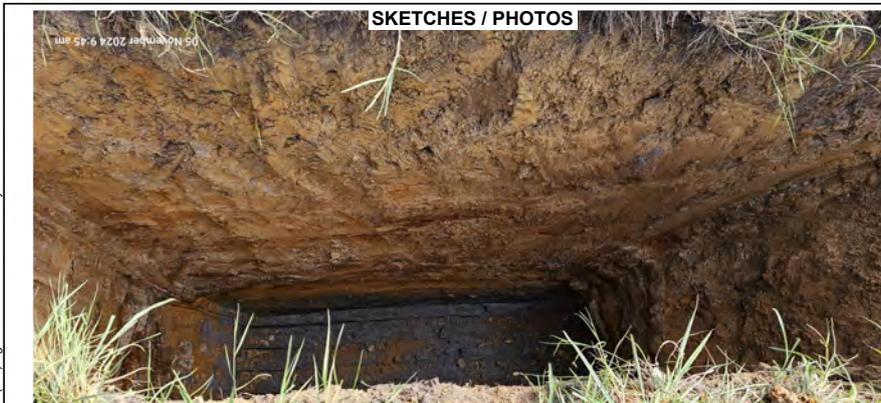
Stability: 	Explanations: ▼ Scala Penetrometer Tests Raw data in blows per 100mm ↑ ✓ Vane Shear Strength (kPa) V=Peak, R=Residual, UTP=Unable to penetrate Moisture: M = moist; W = wet; S = saturated	Groundwater: <input checked="" type="checkbox"/> None <input type="checkbox"/> Slow Seep <input type="checkbox"/> Rapid Inflow ▼ Standing Water Level ◀ Inflow ▶ Outflow	Backfill: <input type="checkbox"/> Bentonite <input type="checkbox"/> Grout/concrete <input type="checkbox"/> Spoil/arising <input type="checkbox"/> Filter sand	Remarks: 1. 55 Russell Road. 2. Test pit was backfilled upon completion. 3. No groundwater encountered. 4. Pit remained stable for the duration of the excavation.	
					All dimensions in metres NOT TO SCALE

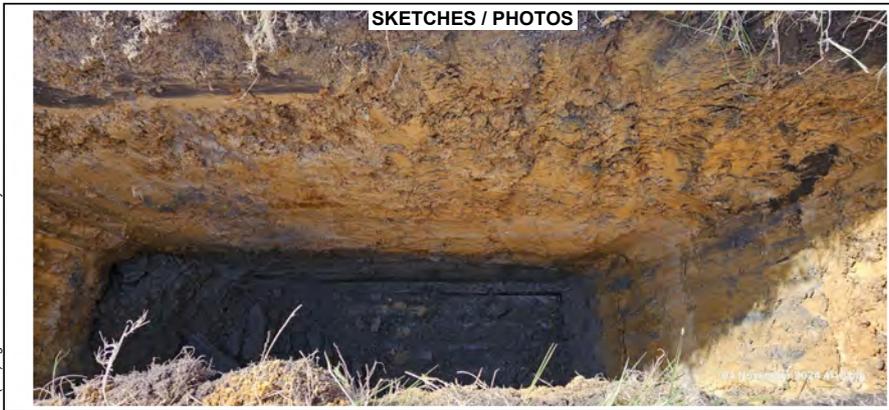
Stability: 3.0 m Dug towards 045° 1.0 m	Explanations: ▼ Scala Penetrometer Tests Raw data in blows per 100mm ↑ ✓ Vane Shear Strength (kPa) V=Peak, R=Residual, UTP=Unable to penetrate Moisture: M = moist; W = wet; S = saturated	Groundwater: <input checked="" type="checkbox"/> None <input type="checkbox"/> Slow Seep <input type="checkbox"/> Rapid Inflow ▼ Standing Water Level ◀ Inflow ▶ Outflow	Backfill: Bentonite Grout/concrete Spoil/arising Filter sand
---	--	--	---

Remarks: 1. 55 Russell Road. 2. Test pit was backfilled upon completion. 3. No groundwater encountered. 4. Pit remained stable for the duration of the excavation.

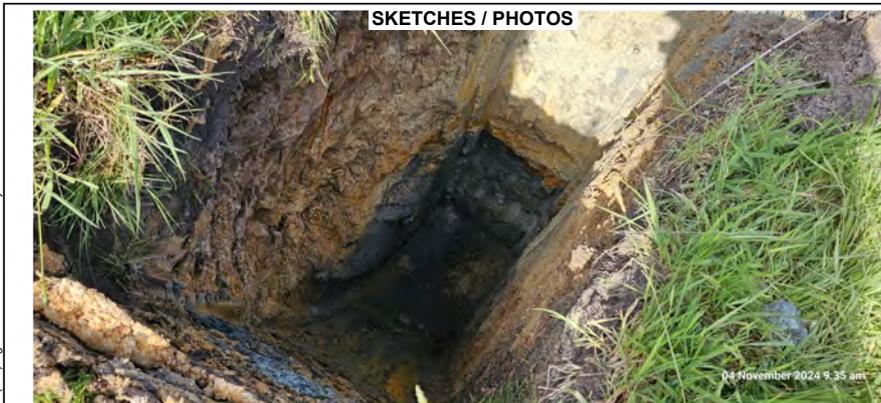
Stability: 	Explanations: ▼ Scala Penetrometer Tests Raw data in blows per 100mm ↑ ✓ Vane Shear Strength (kPa) V=Peak, R=Residual, UTP=Unable to penetrate Moisture: M = moist; W = wet; S = saturated	Groundwater: <input type="checkbox"/> None <input checked="" type="checkbox"/> Slow Seep (@2.90m) <input type="checkbox"/> Rapid Inflow ▼ Standing Water Level ◀ Inflow ▶ Outflow	Backfill: <input checked="" type="checkbox"/> Bentonite <input type="checkbox"/> Grout/concrete <input type="checkbox"/> Spoil/arising <input type="checkbox"/> Filter sand	Remarks: 1. 55 Russell Road. 2. Test pit was backfilled upon completion. 3. Groundwater inflow at 2.9m depth from west and south. 4. Hole collapse on the south face from 0.25m to 3.1m depth.
-----------------------	--	---	--	---

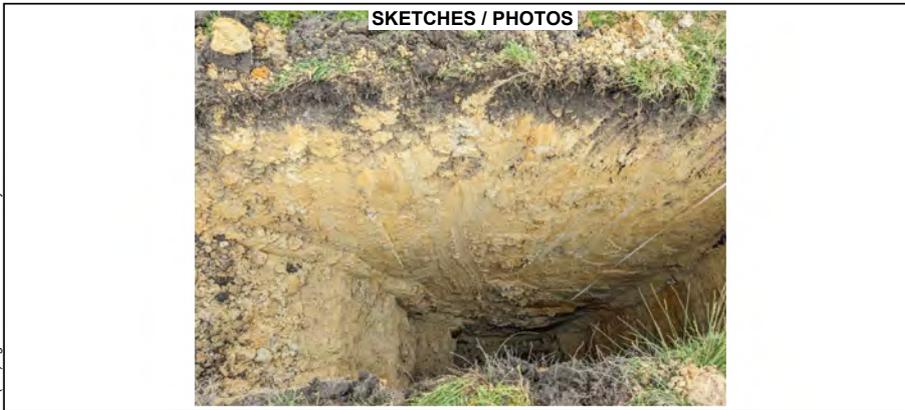
Stability: 3.0 m Dug towards 000° 1.0 m	Explanations: ▼ Scala Penetrometer Tests Raw data in blows per 100mm ↑ ✓ Vane Shear Strength (kPa) V=Peak, R=Residual, UTP=Unable to penetrate Moisture: M = moist; W = wet; S = saturated	Groundwater: <input checked="" type="checkbox"/> None <input type="checkbox"/> Slow Seep <input type="checkbox"/> Rapid Inflow ▼ Standing Water Level ◀ Inflow ▶ Outflow	Backfill: <input type="checkbox"/> Bentonite <input type="checkbox"/> Grout/concrete <input type="checkbox"/> Spoil/arising <input type="checkbox"/> Filter sand
---	--	--	---

Remarks: 1. 130 Upper Orewa Road. 2. Test pit was backfilled upon completion. 3. No groundwater encountered. 4. Pit remained stable for the duration of the excavation.
--
