To: Gordon Litt Farms
 From: Nic Lake (Maven Waikato Limited)
 Subject: Orchard Grove - Infrastructure Technical Memorandum for Referral [E]
 Date: December 2025

Orchard Grove ('the site') is of irregular shape, is approximately 72 hectares, and is situated within the Waikato District directly adjoining the territorial boundary of Hamilton City to the south as shown in Figure 1.

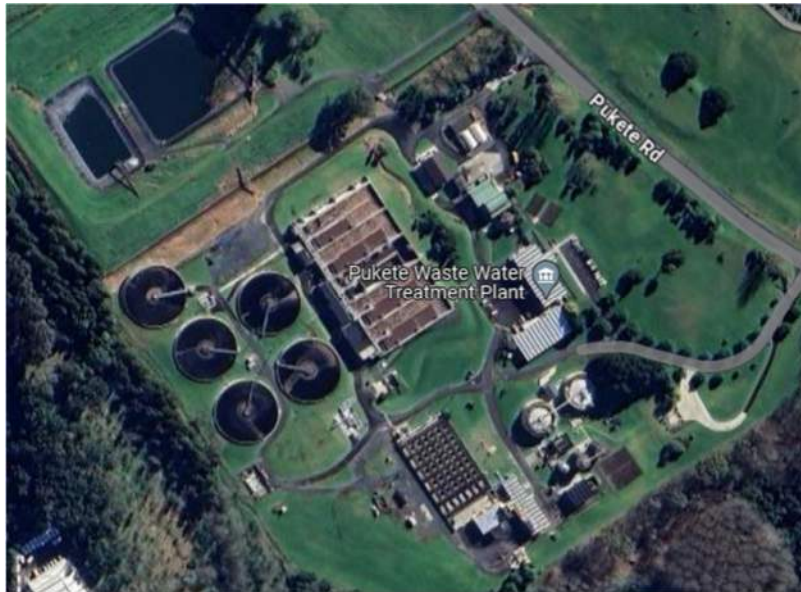
Figure 6: Pukete Wastewater Treatment Plant (Google Map)

Hamilton has one centralised wastewater treatment plant in Pukete that currently treats the wastewater for the entire city. The HCC will be spending \$56 million to upgrade the existing plant to provide additional capacity and upgrade the secondary treatment process at the plant. The upgrade works to the existing plant started in 2018 and were due to be completed by the end of 2024. The upgraded plant will provide for the quality, capacity, and security of Hamilton's wastewater treatment plant for the next 30 years.

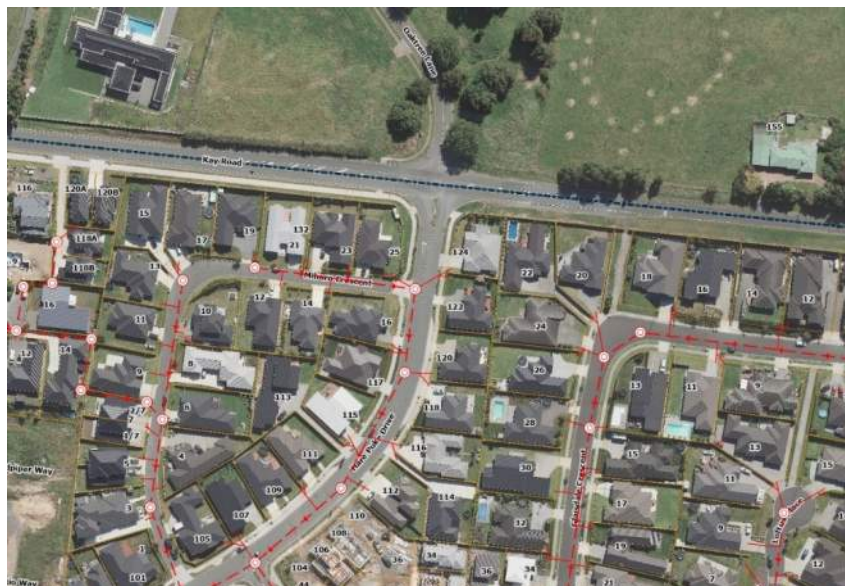
Figure 7: HCC Hare Puke Drive Wastewater Network (HCC GIS)

An existing 1050mm \varnothing wastewater manhole is located at the intersection of Hare Puke Drive and Miharo Crescent (asset ID WWG14035) at a depth of approximately 2.26m with a FGL of RL = 30.00m (HCC GIS), refer to Figure 7. This manhole is connected to a 150mm \varnothing uPVC main that falls towards the south and connects to the 225mm \varnothing trunk main that runs east to west on Borman Road and terminates at the HCC pumpstation on the southern side of Borman Road, approximately 200m to the west of the Borman Road/Hara Puke Drive roundabout, refer to Figure 9.

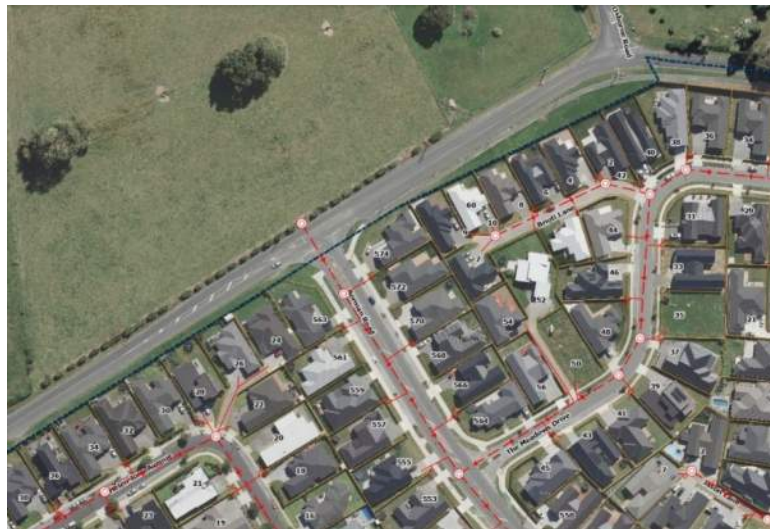
Figure 8: HCC Kay Road Wastewater Network (HCC GIS)

An existing 1050mm \varnothing wastewater manhole is located at the intersection of Borman Road and Kay Road (asset ID WWG13063) at a depth of approximately 3.4m with a FGL of RL = 29.87m (HCC GIS), refer to Figure 8. This manhole is connected to a 150mm \varnothing uPVC main that falls towards the southeast, connects to the 225mm \varnothing trunk main that runs west to east on Borman Road, and terminates at the HCC pumpstation on the southern side of Borman Road, approximately 200m to the west of the Borman Road/Hara Puke Drive roundabout, refer to Figure 9.

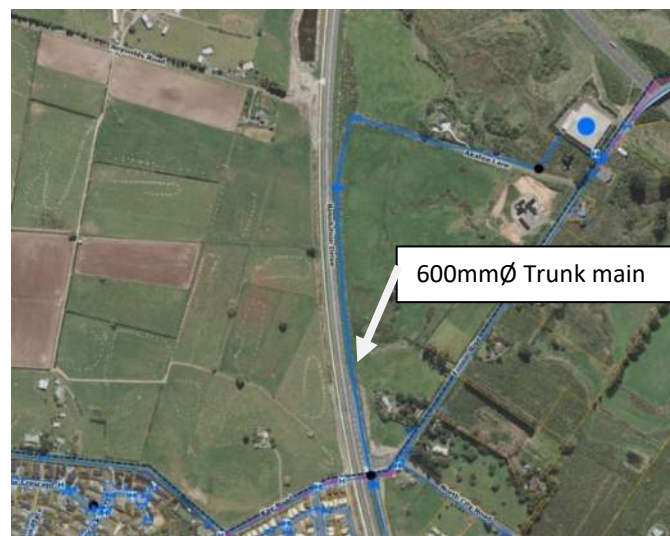
Figure 12: Rototuna Water Reservoir

The nearest water reservoir to the Orchard Grove block is the Rototuna water reservoir (asset ID WSURTOTUNA). The reservoir is located at 77 Ennion Rise, approximately 500m to the east of the proposed development.

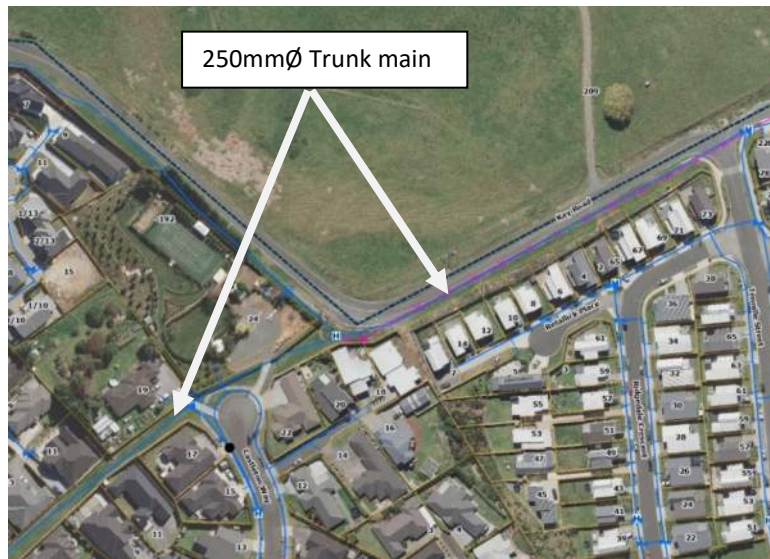
Figure 13: Kay Road Trunk Main (HCC GIS)

While not shown on GIS, it appears that either a 150mm or 250mm bulk main may also run along the southern side of Kay Road. It has been excluded from the desktop study; however additional investigation is recommended.

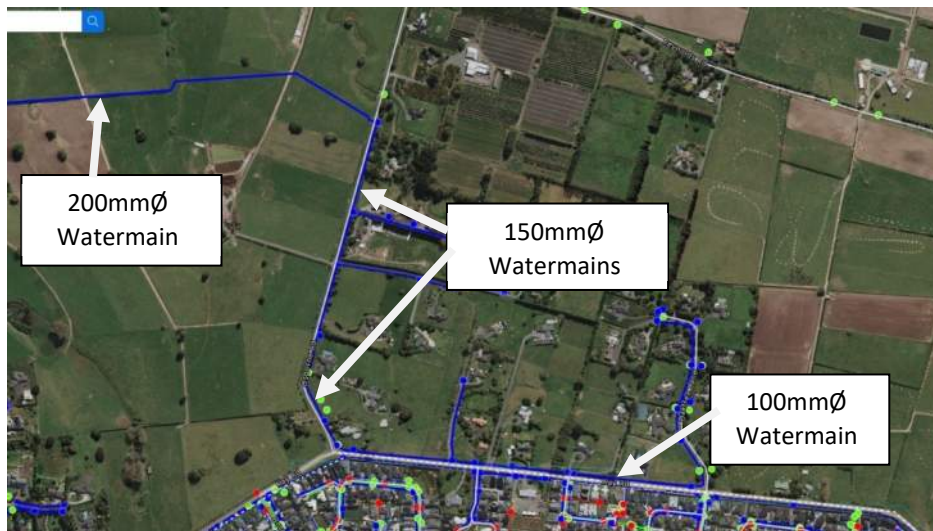
Figure 16: WDC Water Supply Network (COLAB GIS)

An existing WDC 100mmØ PVC-M water main runs along the northern side of Kay Road, between Oaktree Lane and Avian Place, before transitioning into a 150mmØ PVC-M watermain between Avian Place and Osborne Road, continuing along the eastern side of Osborne Road before transitioning into a 200mmØ PVC-M watermain, and heading east through the existing farm paddocks (approximately 300m to the south of the Reynolds Road intersection).

An existing WDC 63mmØOD MDPE rider main runs from Kay Road, along the western side of Oaktree Lane to the end.

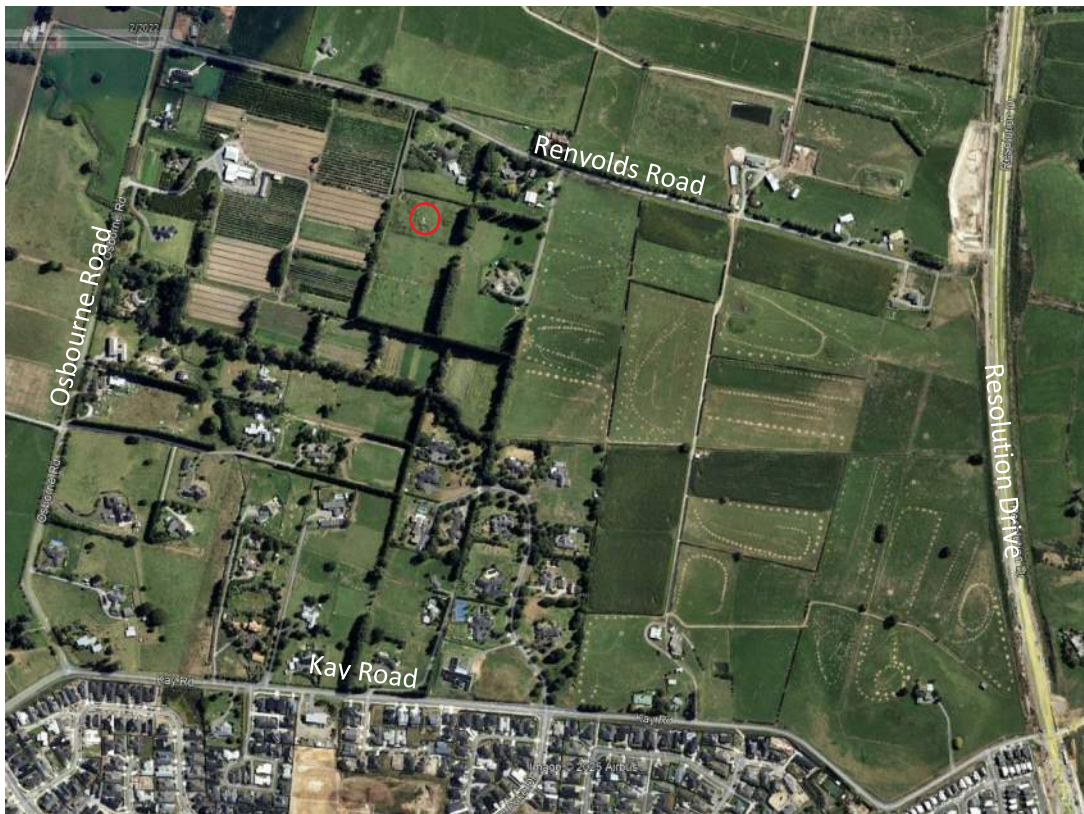
2022
Google
Earth

- Potential uncontrolled fill located behind 40B Reynolds Road (Circled in red).

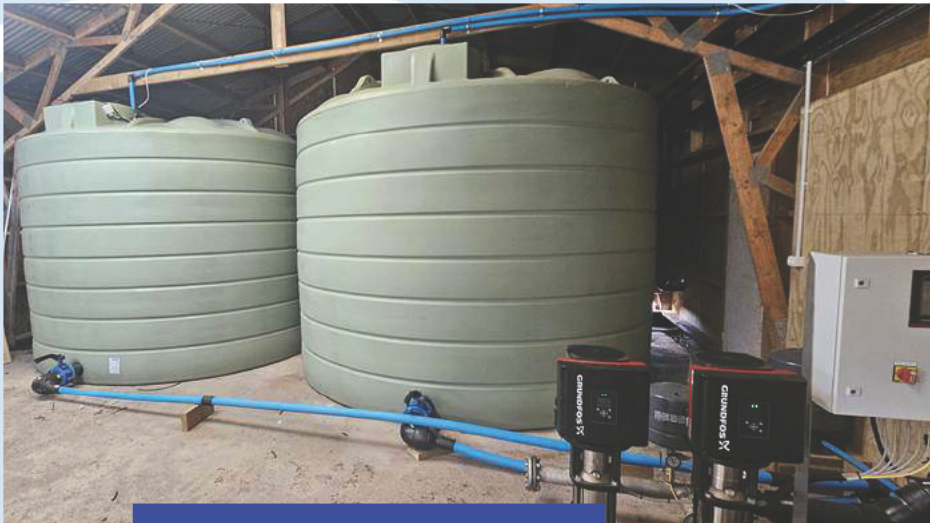
Figure 1
Installations at Waipapa

We designed headworks and reticulation for 26 L/s headworks coupled to a 1 to 16 l/s irrigation pump set and reticulation system. We designed a 12.5 L/s 110 kPa fire reticulation system including water storage. We also designed an 8 L/s Purification with Temple Water and the reticulation system for the complete sports facility.

Figure 1 Below are some photos of the construction. The pumps are in operation and irrigation of the sports fields have been in operation for the last week without any hick ups. We will do official commissioning and hand over early in April.

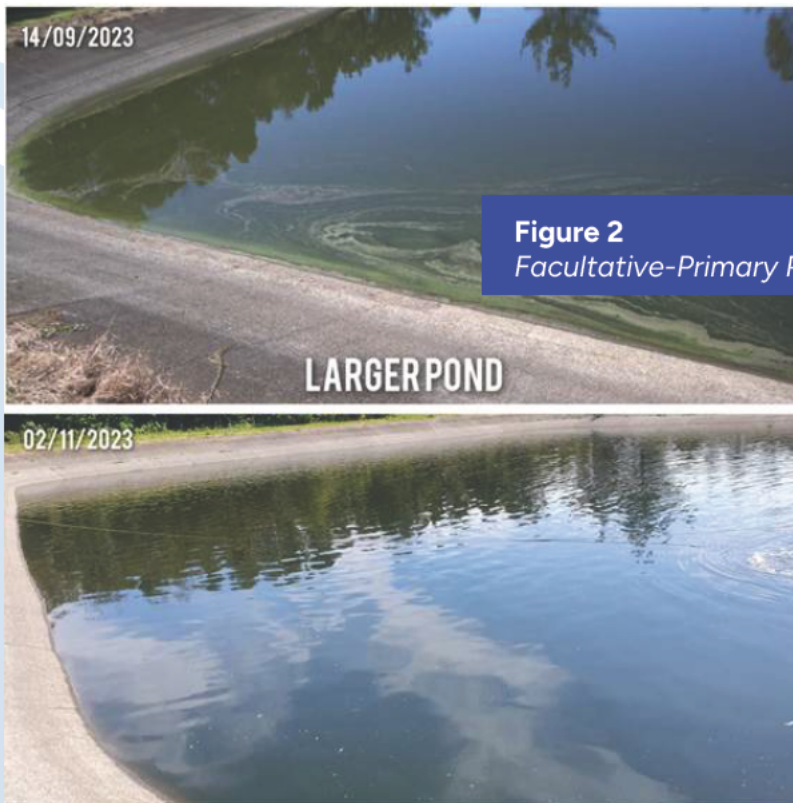
Figure 2 indicates the visible change in the condition of the facultative pond in the first two months of application.

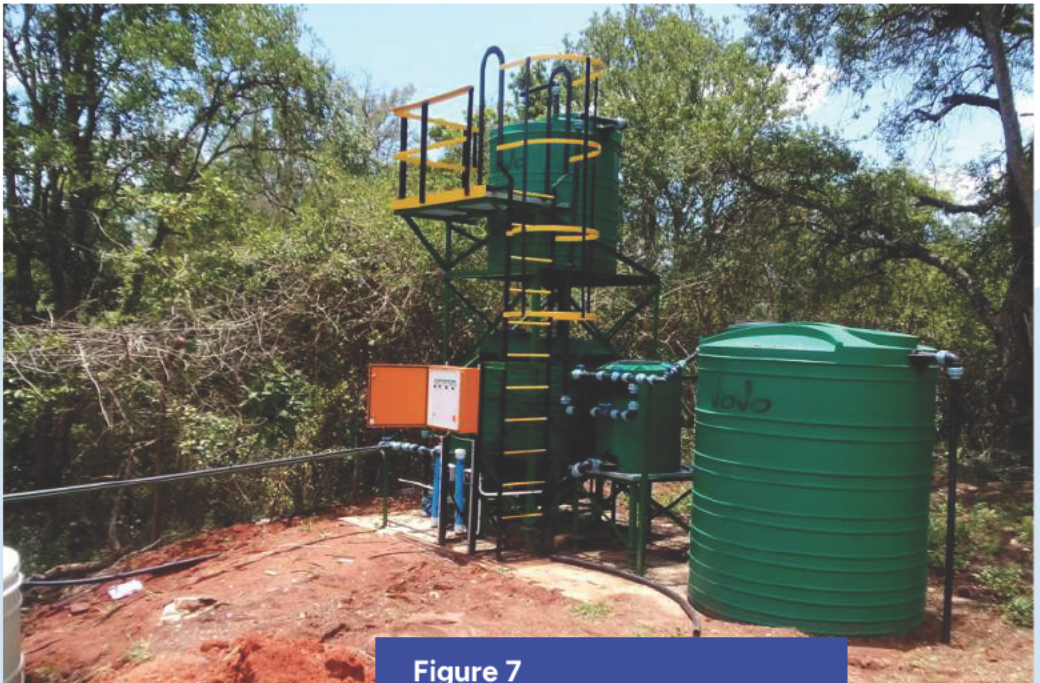
Figure 7
KL/day treatment plant

Figure 7 is a photo of a 12.5 KL/day plant we constructed. The process remains the same for plants from 12 500 L/day up to 120 000 L/day. The blocks expand and increase parabolically as treatment capacity increases.
