Powerhouse Fast-track Application

Preliminary Geotechnical Report

Bowen Peak Development

PRELIMINARY GEOTECHNICAL ASSESSMENT

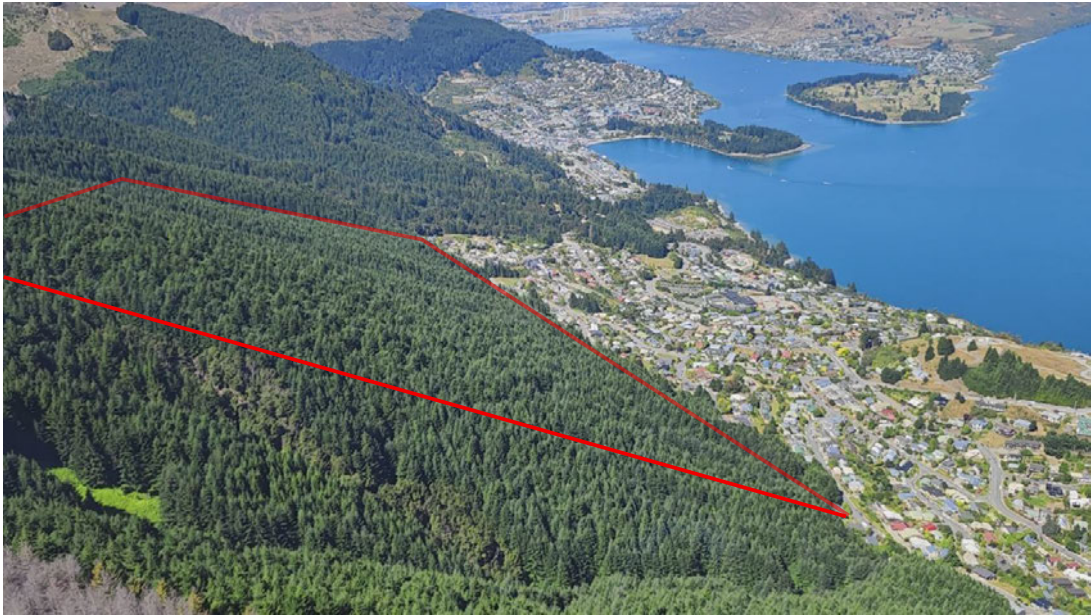
Photo 1: Fernhill Heights area looking northeast. Lot 1 DP 20613 outline indicative only.

The southeast facing hillside has slopes ranging from 20-25° along the broad faces with steeper slopes falling into various unnamed gullies traversing the property. Three major gullies with semi-permanent flows are shown on the topographical map while several smaller gullies carrying only ephemeral flows are also known. Photos 1 & 2 show views of the Fernhill Heights hillside.

The bulk of the slope is thickly wooded with mature conifers. The exceptions are small, cleared areas above the residential areas above Caples Place and Wynyard Crescent. The conifers first took hold in the 1950's then spread rapidly in the following decades up to around 900 m although recent herbicide spraying has constrained further upward spreading of wildings. A few pockets of native trees are present in the damper gullies.

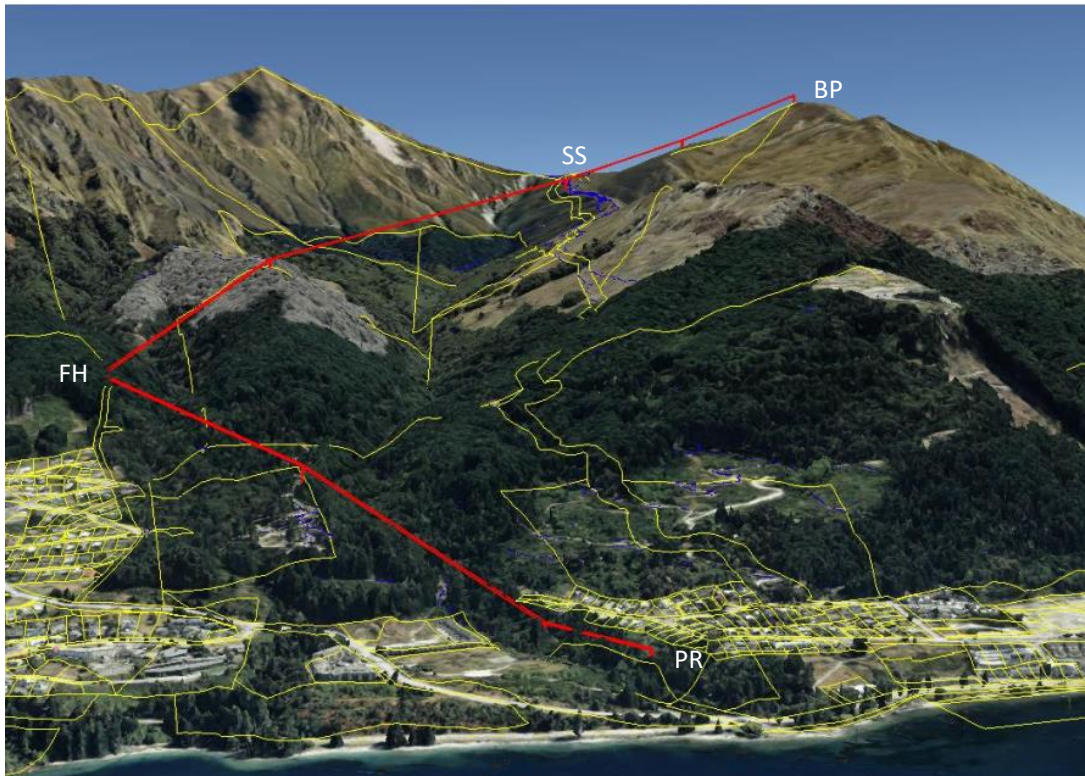
Photo 3: Schematic overlay of funifor route. PR = Powerhouse Reserve station, FH = Fernhill Heights station, SS = Saddle station, BP = Bowen Peak viewing platform.

The lower part passes over a mixture of exotic and native forest draped over the two named creeks, a number of tributaries and their intervening spurs. The bushline is reached above 1000-1060 m with upper slopes dominated by tussock and subalpine vegetation. Photo 3 shows an overall view of the proposed route.

The proposed route (Figure 3) traverses across both One Mile and Two Mile Creek catchments and from there traverses the ridge line between the saddle and Bowen Peak. The route starts from its base at the Powerhouse Reserve (PR) passes through intermediate stations at Fernhill Heights and the Ben Lomond-Bowen Peak Saddle (Te Taumata O Hakiketura) (SS) to terminate at a viewing platform on Bowen Peak (BP). Five pylons provide intermediate support between stations. The route rises some 1300 m over 5,540 m ropeway length.

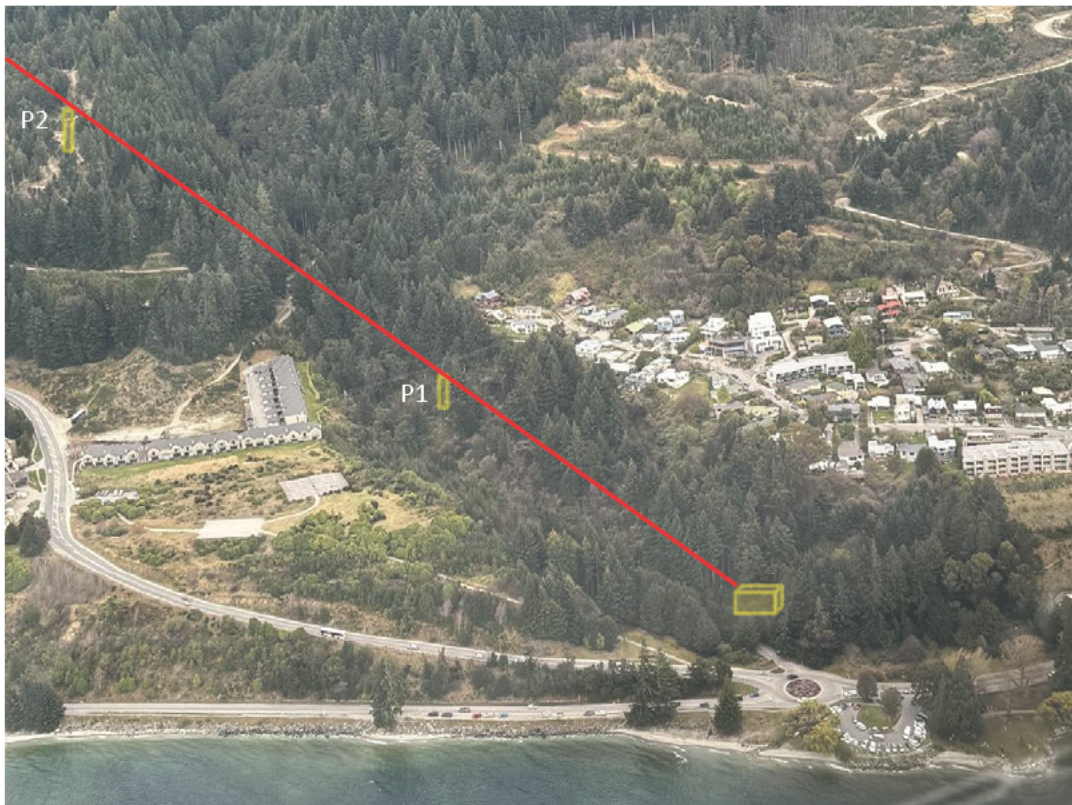
Photo 4: Approximate alignment of lower gondola route from One Mile Powerhouse Reserve station via pylons 1 & 2.

Alluvial fan hazards are shown as affecting the lower One Mile Creek section where the Powerhouse Reserve station and Pylon 1 are located. The Powerhouse Reserve station and Pylon 1 are situated on degraded terraces elevated several metres above the valley floor (+ 11 m and + 9 m respectively). Photo 4 shows an aerial view of the lower part of One Mile Creek with indicative positions of the base station and Pylons 1 & 2.

Rockfall susceptibility areas are shown on Figure 5. The areal extent is quite speculative and not backed by field assessments. The favourable locations of the upslope structures providing a low susceptibility to slope instability also apply to the rockfall threat. The lower structures in One Mile Creek do not have any rock outcrops upslope and thus have nil susceptibility to rockfall. Photos 4 – 8 show overall views of these locations.

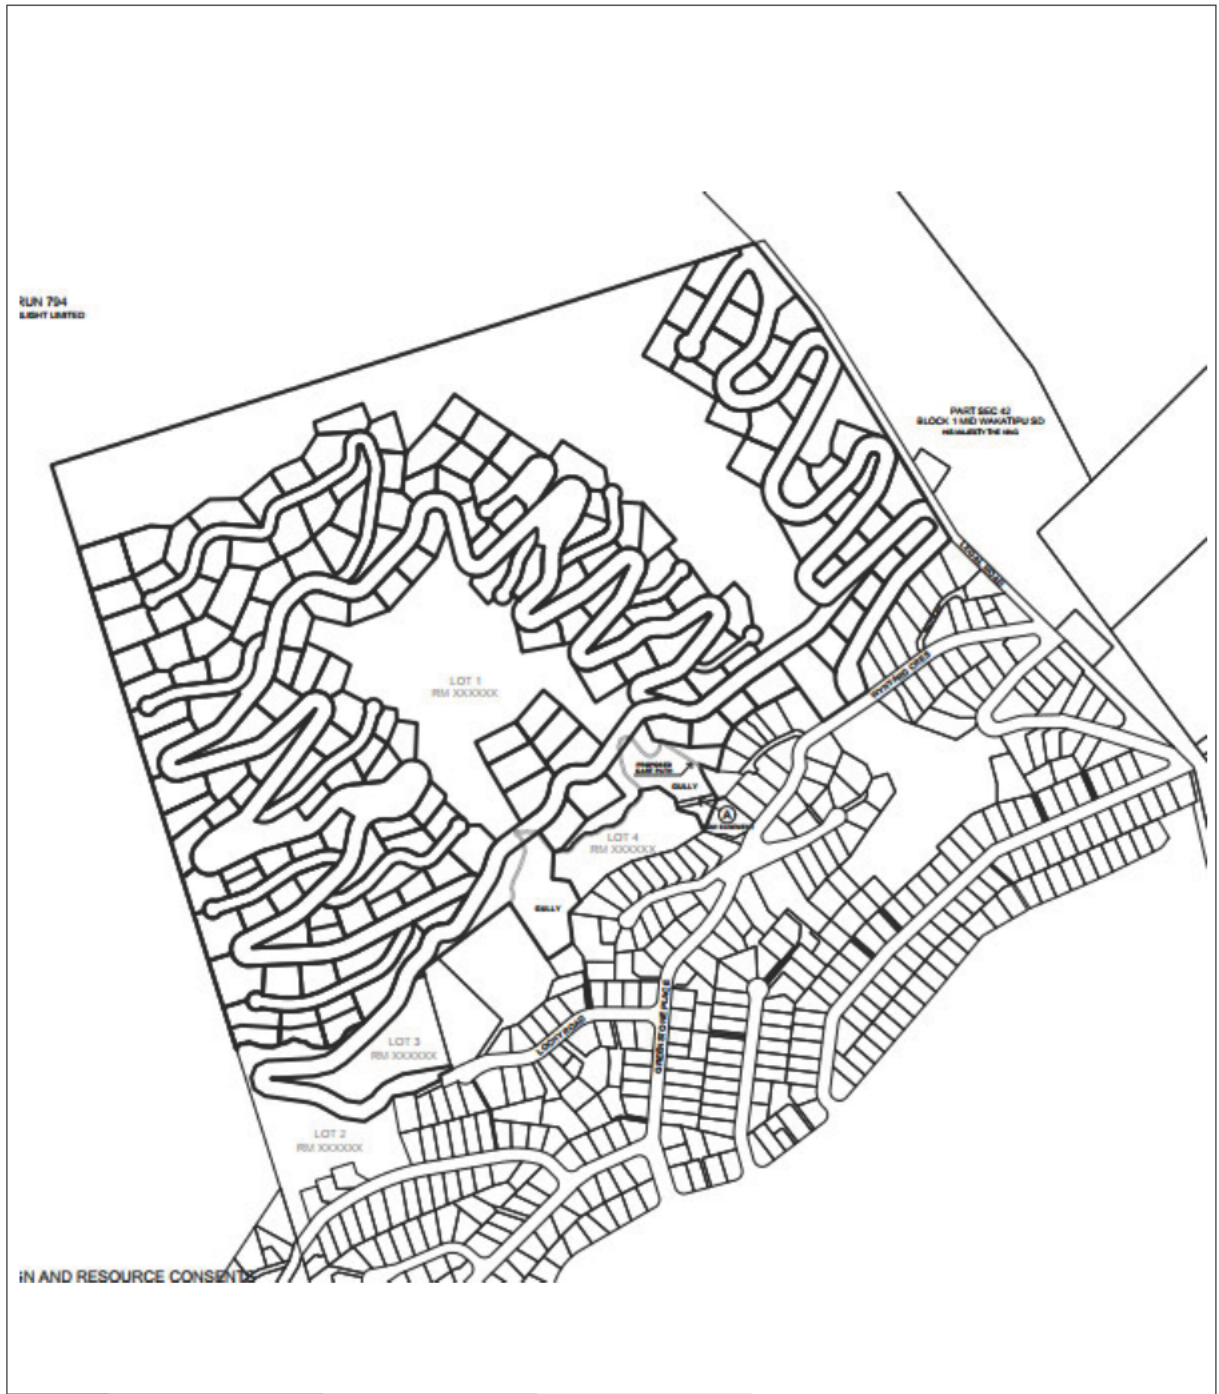
JEFF BRYANT GEOCONSULTING Ltd	PROJECT: Bowen Peak Ltd	FIGURE: 1
	DESCRIPTION: Fernhill Heights Development. Site plan showing preliminary scheme layout as of January 2025.	Scale: NTS
	Source: Clark Fortune Macdonald job 16592 dwg13/001	Report:
		Date: 18/11/2025

be bridged to provide access from one area to another. A preliminary layout for the chalets and roading is shown on Figure 3.

Each chalet will occupy a 28 m x 12 m footprint with the breadth split into two x 6 m platforms separated by a 3 m lift. The cut at the rear will vary in height depending on slope angle and whether the cut is free-standing or needs to be retained. It is anticipated that each platform will be founded on rock with minor or nil parts of the building footprint resting on soil overburden.

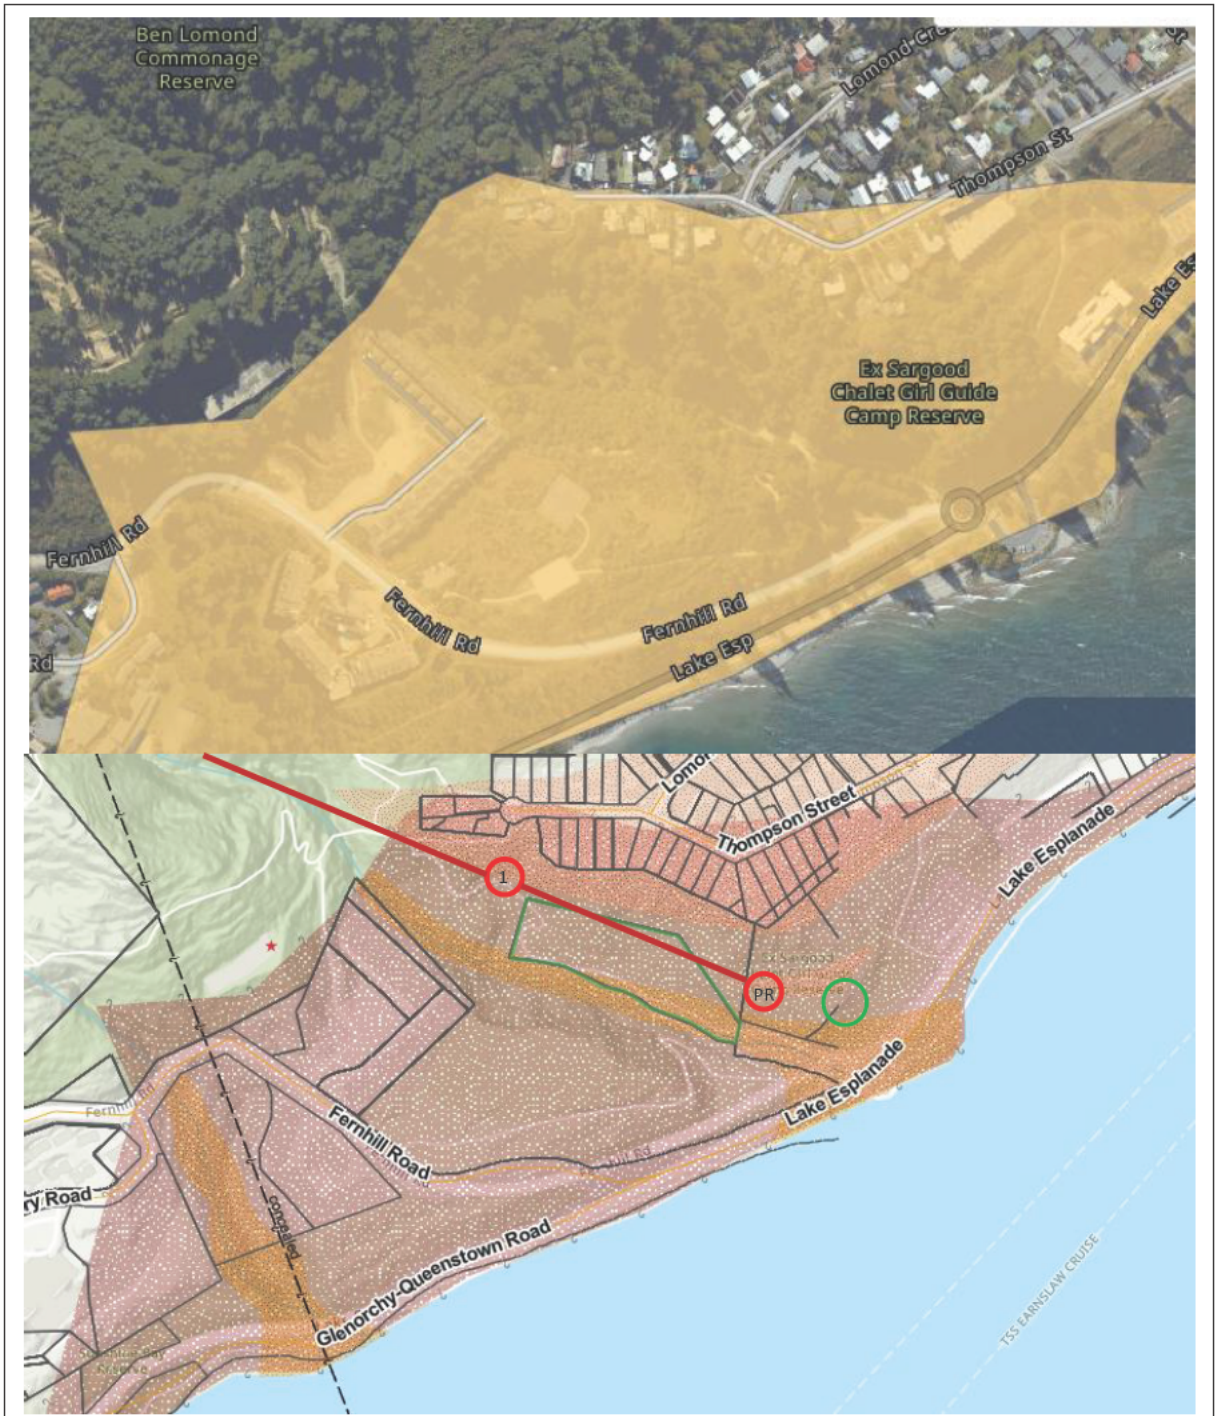
<p>JEFF BRYANT GEOCONSULTING Ltd</p>	PROJECT: Bowen Peak Ltd	FIGURE: 6
	DESCRIPTION: One Mile and Two Mile Creek catchments. Areas of Alluvial fan hazard identified on ORC Otago Natural Hazards Portal.Light (top) and QLDC webmap (lower). Green outlines are HAIL sites 00465.01 (Fernhill closed landfill) and 02036..01 (mine tailings)	Scale: NTS
		Report:
		Date: 18/11/2025

The ORC and QLDC hazard portals both show alluvial fan hazards (sourced from various studies) as being present in the lower part of the valley (Figure 6). Alluvial fan and flood hazards will be addressed in more detailed studies but initial thoughts are that both the base station and Pylon 1 have sufficient horizontal and vertical displacement to put them outside any potential hazard zone.

Two HAIL sites are shown on QLDC webmaps (Figure 6) which are indicated to lie outside the current positions of the Powerhouse Reserve station and Pylon 1. Further investigation is needed to determine whether they will be affected by the proposed developed and what mitigation measures might be necessary to lessen or avoid any hazards.
