## MEMORANDUM

**Document Number:** J-NZ0233-001-M-Rev0

**Document Title:** Site Visit and Preliminary CSM

Mine Waste Management Limited (MWM) has completed this site visit summary memorandum for Santana Minerals Limited (Santana) for the proposed Bendigo-Ophir Gold Project (the Project). MWM has been engaged to provide environmental geochemistry advice for the project to support an assessment of environmental effects (AEE) for the Project.

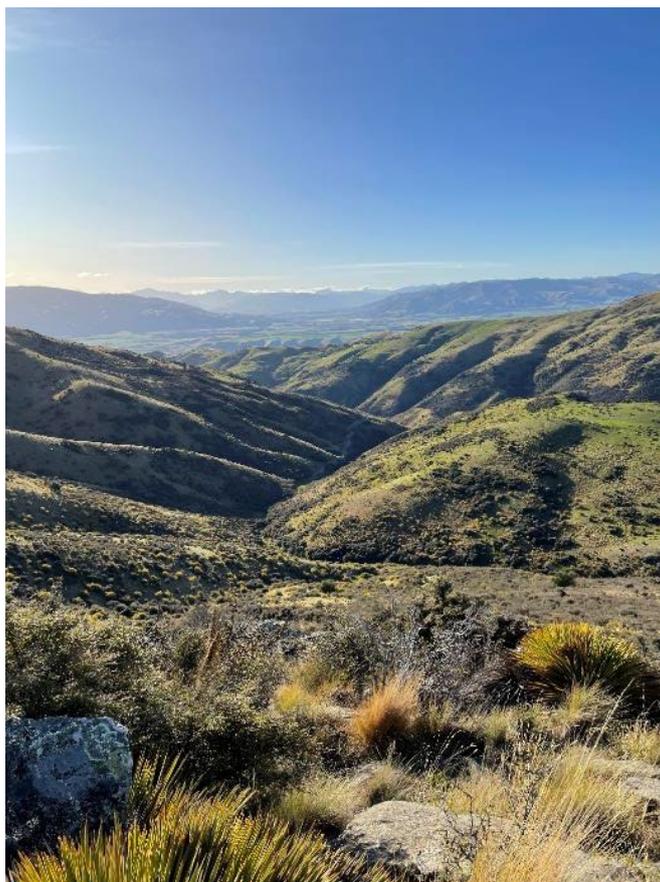
Figure 2: General terrain and vegetation on site. Looking northwest over the Jean Creek Catchment towards the township of Hawea.

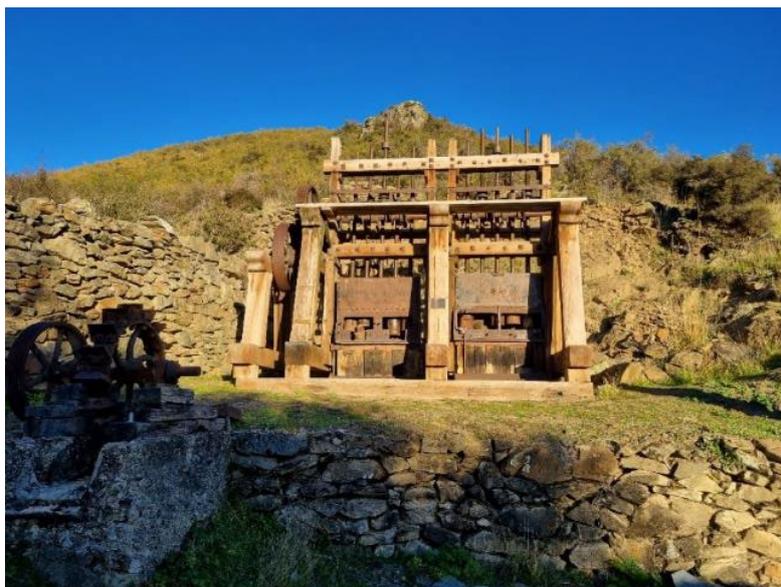
CIT Battery (G41/251), associated adits, and mine workings are located at the downstream end of the Rise and Shine Creek and Clearwater Creek (Figure 8). It is located on the southern extent of the project area and borders the Department of Conservation Land that holds the Alta Battery. The CIT mine has a history of repeated operations and closure, being sold to various owners from the mid-1880s until the 1930s (Lawrence et al., 2019). The site had a 10-stamper battery (Figure 8), two adits, ore bins and mullock piles representing the heritage fabric (Lawrence et al., 2019). These are still evident during the site walkover and can provide information to delineate areas of contamination during future site assessments. A large mullock pile occurs out in front and down slope of the red drives (Figure 8). The mullock pile could provide beneficial geochemical information on long term weathering of the waste rock.

Figure 7: Come in Time (CIT) Battery.

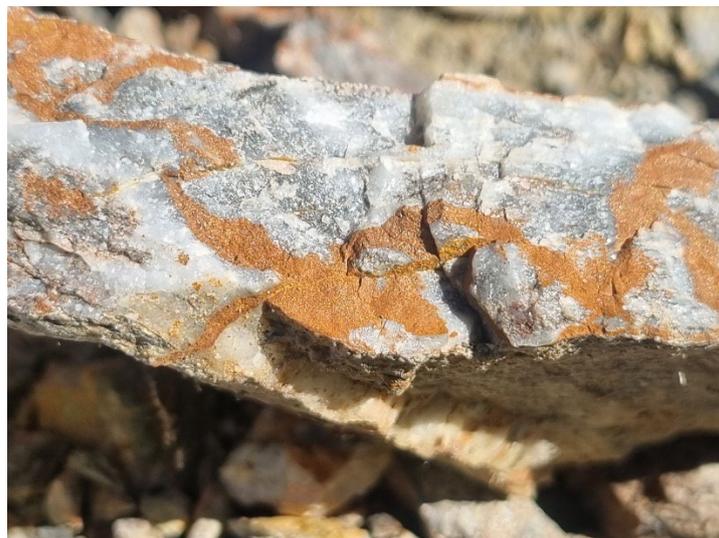
Santana staff were on site with a portable XRF. Qualitative spot testing of a rock sample from RAS with iron veining (Figure 11) indicated As concentrations of ~5,553 ppm compared to the rock without veining that was measured at ~ 200-280 ppm. Arsenic strongly adsorbs to Fe hydroxides and results confirm As mineralisation in the area and association with the ore zones.

Figure 11. Fe-rich rock sample from the RAS Spoil

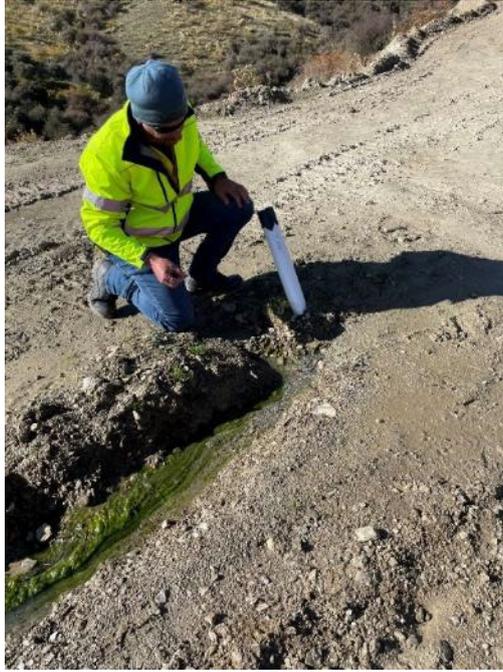
Seepage from groundwater into Ferret Gully and into Shepherds Creek was evident down gradient of MDD015.

- MDD015 - a free flowing drillhole at MDD015 (i.e., groundwater) and the adjacent settling pond (Figure 11). This drillhole is situated within the potential pit footprint.

Figure 12: Site MDD015 drillhole with free-flowing groundwater.
