Auckland Prison Capacity Increase

Volume 2 – Appendix 2G
Archaeological Assessment

AUCKLAND PRISON CAPACITY INCREASE: VOL 2 APPENDIX 2G ARCHAEOLOGICAL ASSESSMENT FINAL

Prepared for Department of Corrections – Ara Poutama Aotearoa
26 March 2026

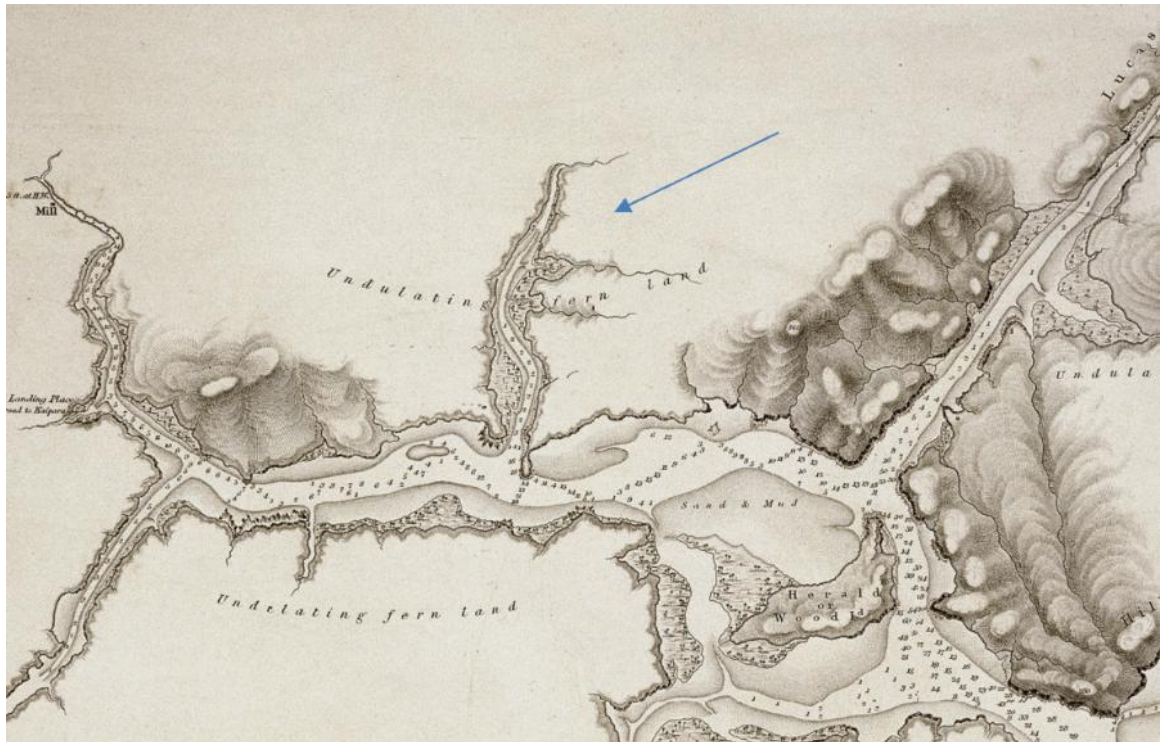
Figure 5. Detail from map titled 'Waitematā River from Kauri Point Auckland Harbour to its sources, surveyed by Comr. B. Drury and the officers of H.M.S. Pandora 1854', with the current Designation area described as 'Undulating Fern Land' indicated by arrow (source: Auckland Libraries Heritage Collections Map 3909)

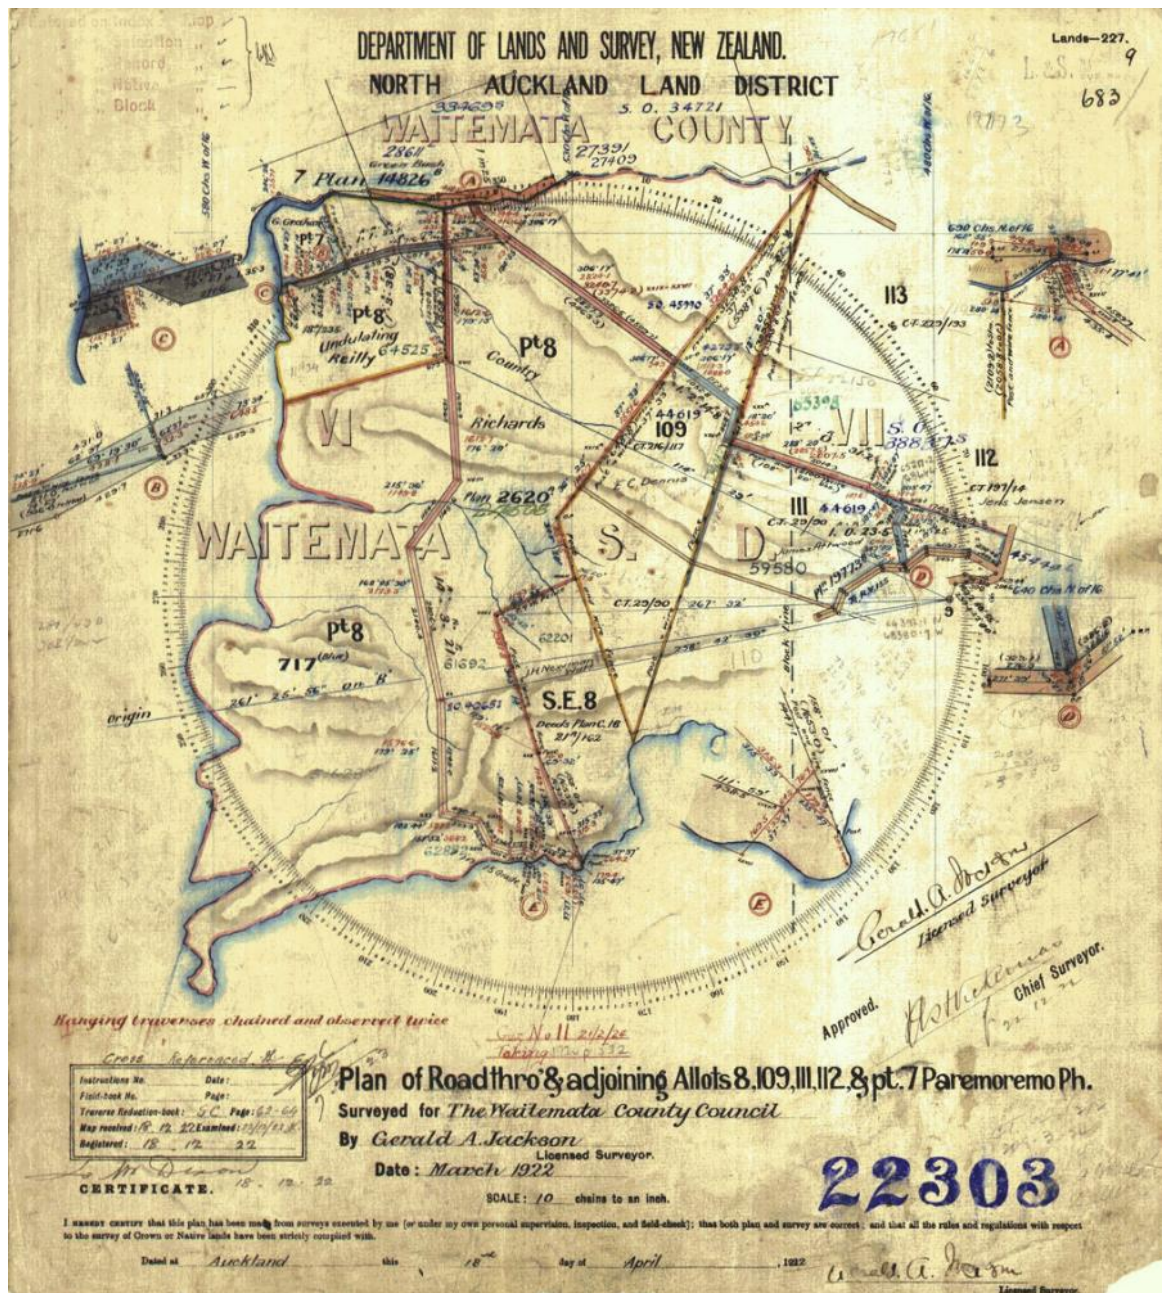
Figure 8. AK SO 22303 plan dated 1922 with the property containing the Auckland Prison Site described as 'Undulating Country' and with the names 'Richards' and 'Reilly' annotated as the owners (source: Quickmap)

23. The 1922 map in Figure 8 shows planned roads in the area including through Allotment 8 and Allotment 109, which established Pāremoremo Road and Sanders Road. The plan has the name 'Richards' annotated on part of Allotment 8 and 'E.C. Dennis' on Allotment 109.

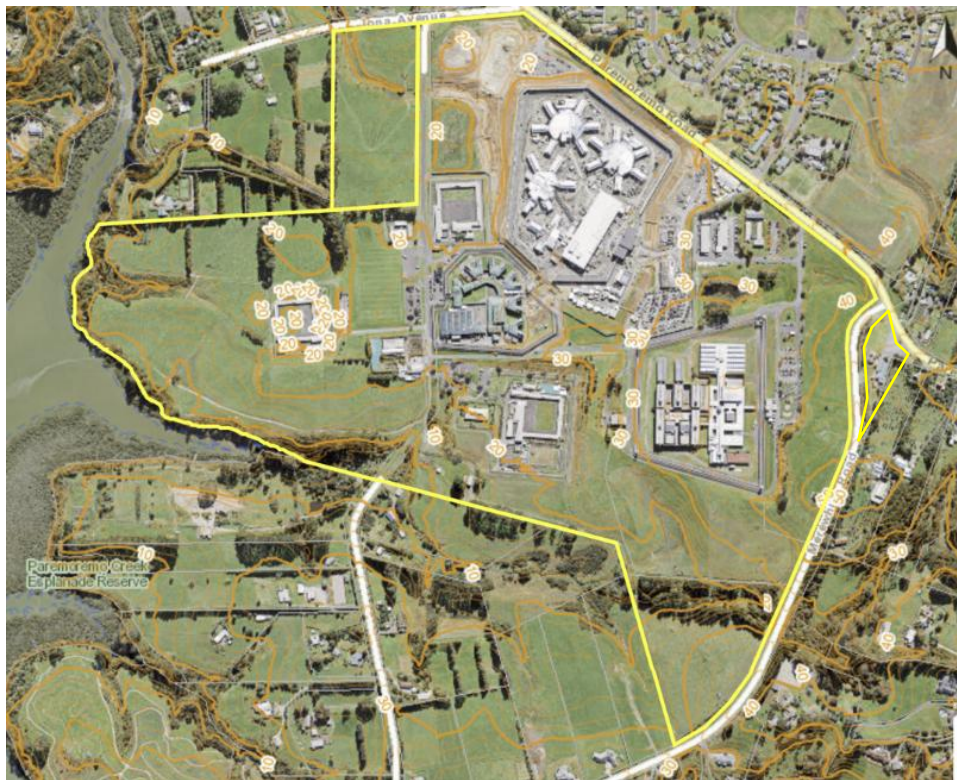
Figure 13. Upper aerial plan with contours showing the Site to the southwest of Pāremoremo Road and lower aerial plan showing the current Designation area to the northeast of Pāremoremo Road- the Prison Village which will be removed from the Designation extent (source: Auckland Council GeoMaps)

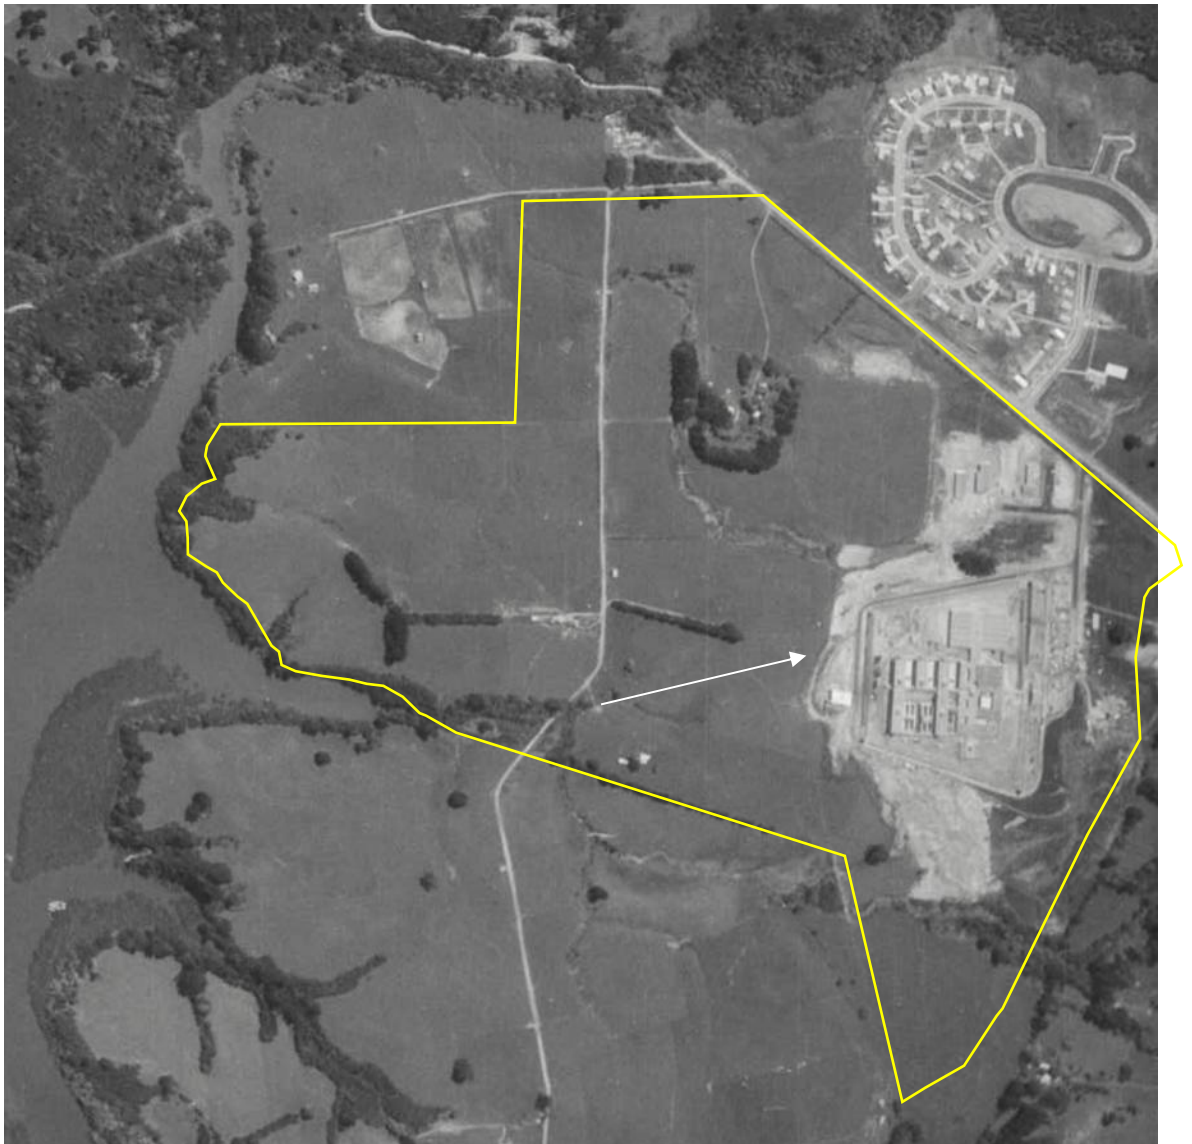
Figure 15. Aerial photograph dated 1968 (Crown 1875 5043 14) showing the works for the Prison in the western part of the Site to the southwest of Pāremoremo Road (indicated by arrow) (sourced from: [http:// retrolens.nz](http://retrolens.nz) and licensed by LINZ CC-BY 3.0)

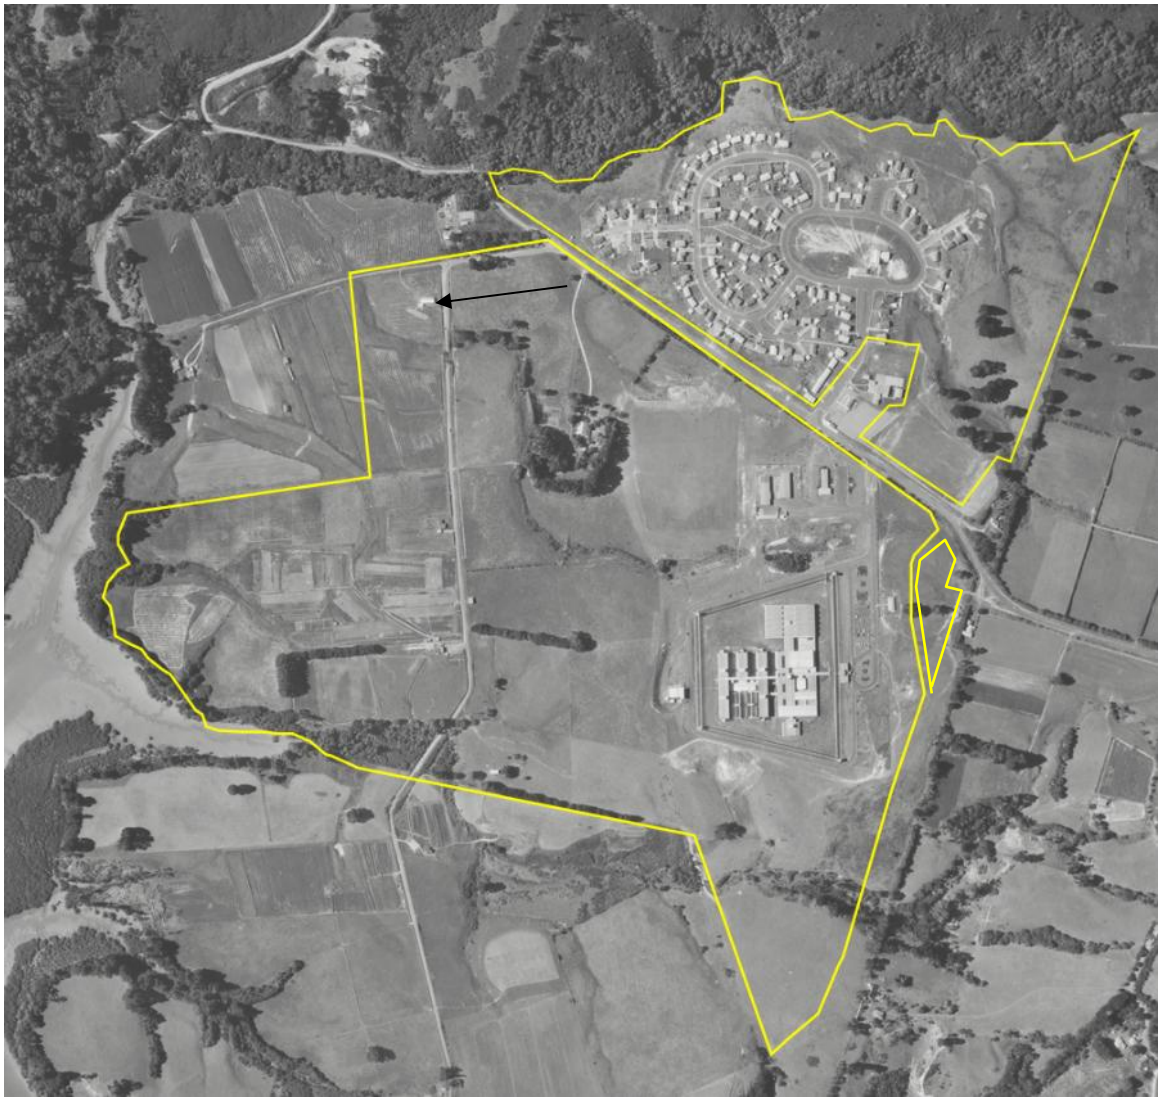
Figure 16. Aerial photograph dated 1973 (Crown 3618 4649 6) showing the current Designation area outlined in yellow with the area to the southwest of Pāremoremo Road showing evidence of cultivation activities in the western part and a building now present in Lot 3 DP 64525 (indicated by arrow) and with the Prison Village constructed to the northeast of Pāremoremo Road (sourced from: <http://retrolens.nz> and licensed by LINZ CC-BY 3.0)

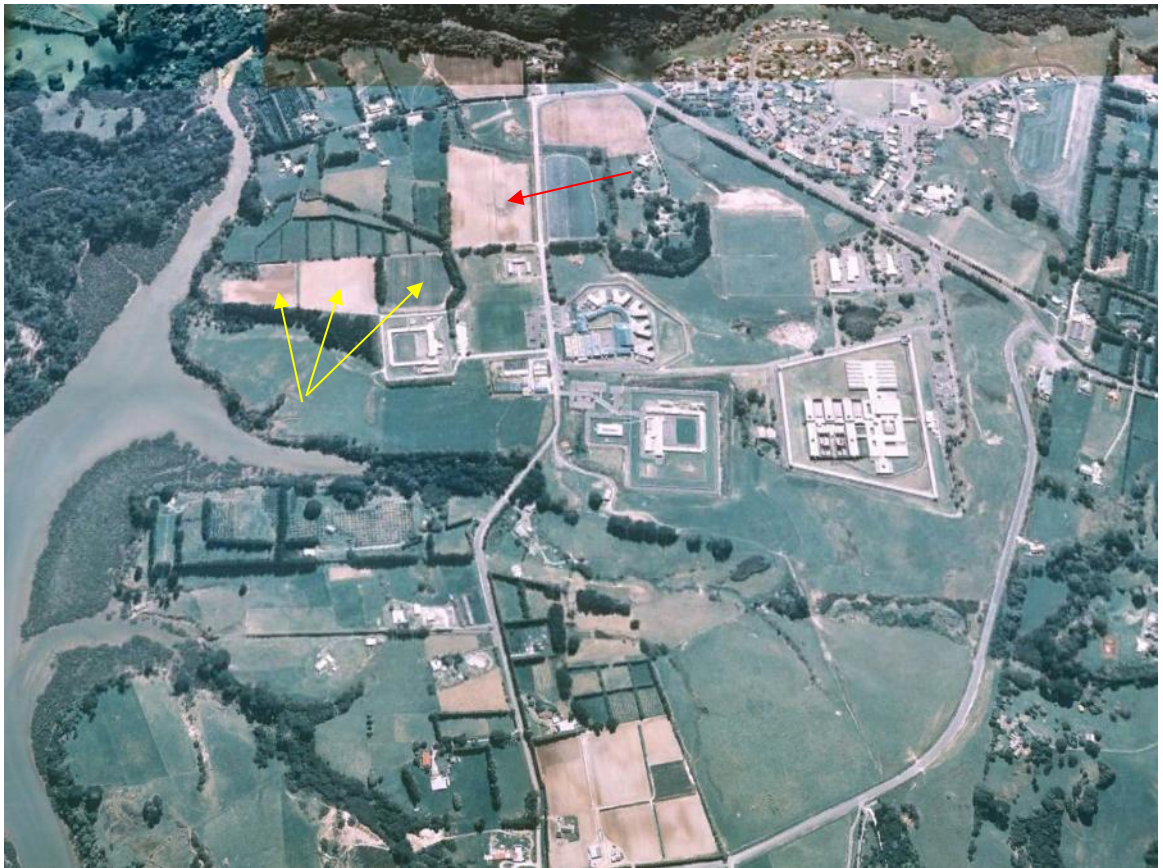
Figure 18. Aerial oblique photograph dated 1997 showing areas of cultivation visible in Lot 3 DP 64525 (red arrow) and in the western area near Pāremoremo Creek in Lot 4 DP 24508 (yellow arrows) (source: Google Earth)

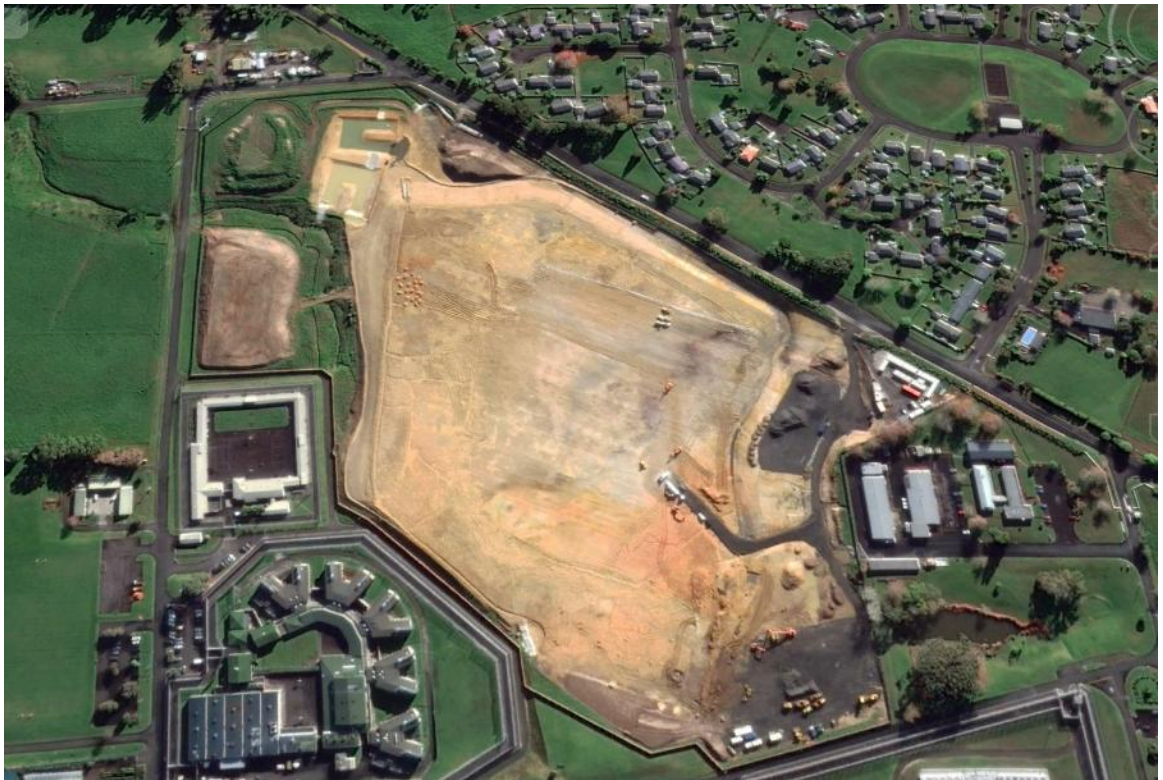
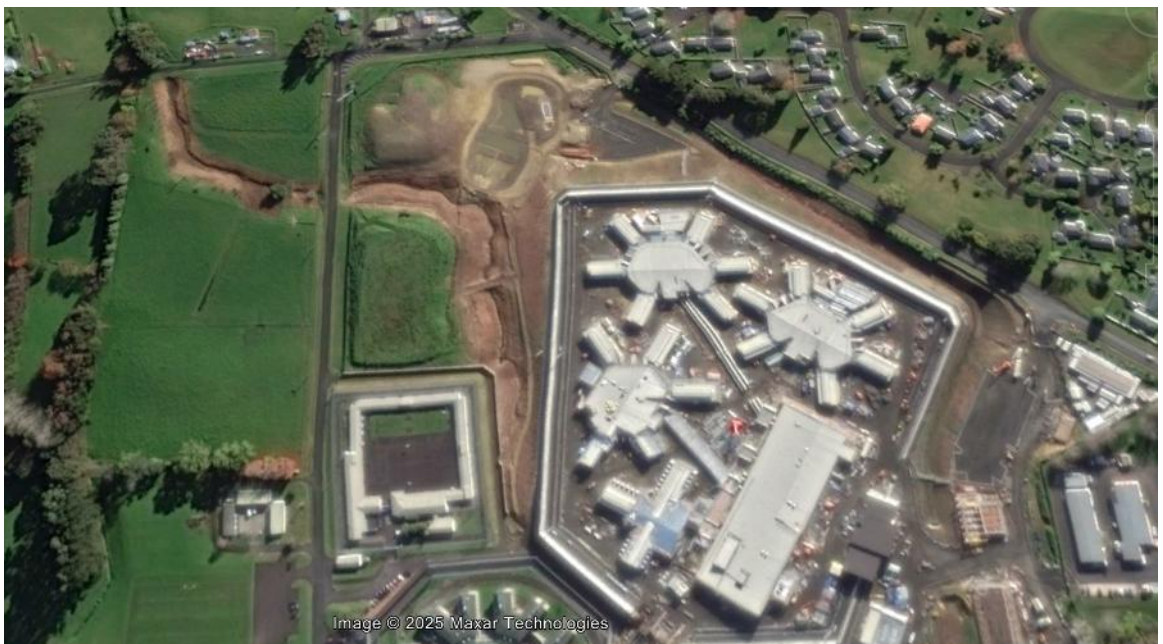
Figure 19. Upper oblique aerial photograph dated 2015 and lower aerial photograph dated 2017 showing the northern part of the Site to the southwest of Pāremoremo Road with earthworks visible, including along the stream (source: Google Earth)

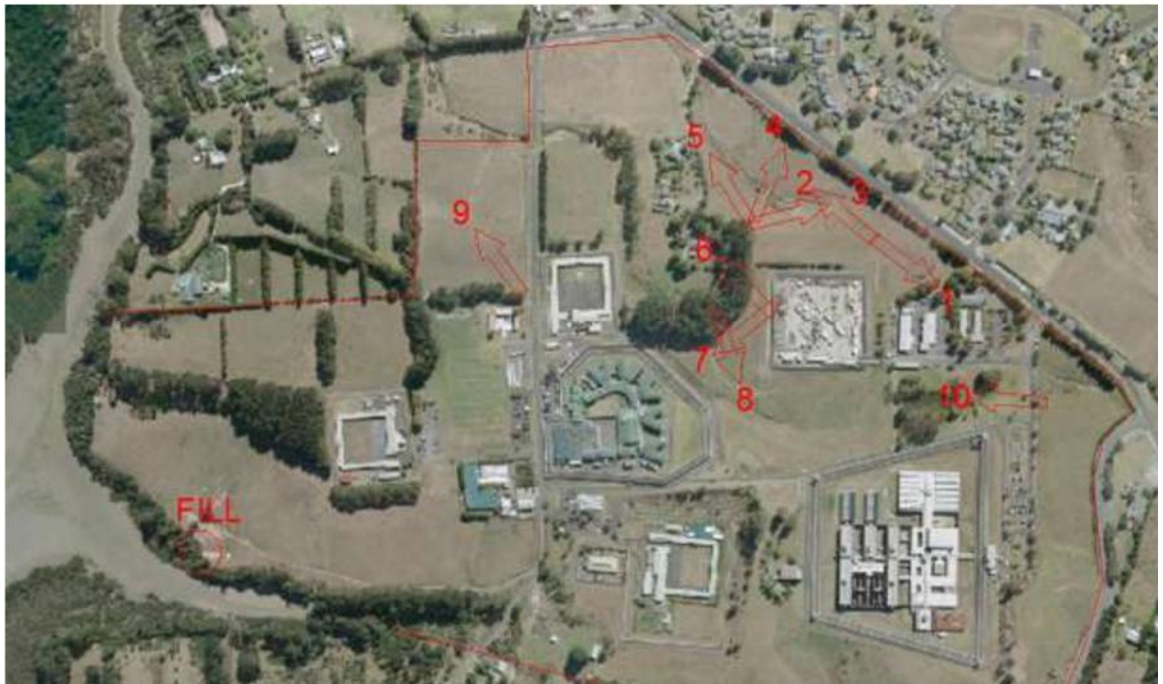
Figure 20. Aerial plan showing the areas that were photographed during the 2013 survey (source: Felgate 2013:16)

36. The survey consisted of a site walkover which was carried out in April 2013 (Felgate 2013) with the general area covered by the survey shown in Figure 20. The survey attempted to identify and concentrate on relatively unmodified areas as it was noted that some areas were modified in the form of cut works for terracing that had occurred for the construction of the older Prison facilities. It was also noted that the ground was very dry during the survey which hindered probing; however, it was noted that there was minimal grass cover and that pugging by cattle had exposed the upper soil levels, so that if shell midden was present, it would likely have been visible. Some fragments of shell mixed in with modern building debris were identified in a previously disturbed area (labelled 10 in Figure 20) which was not deemed to be archaeological in nature.

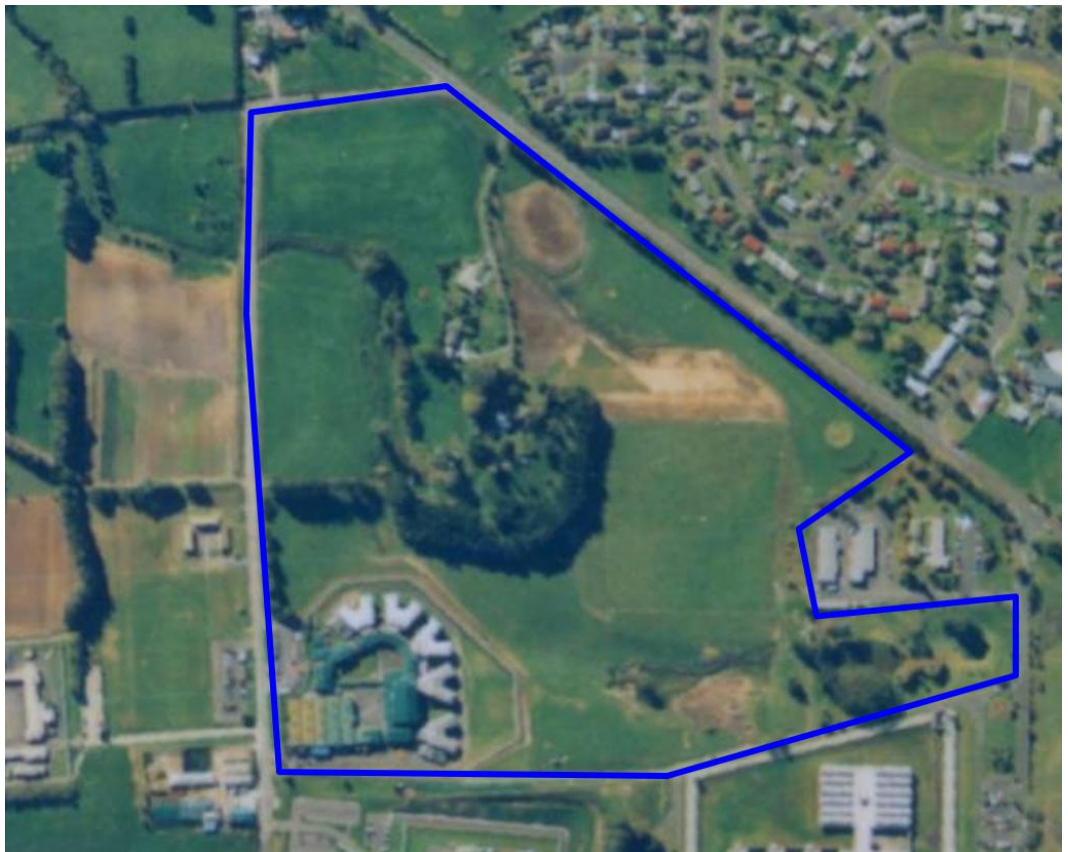
Figure 21. Aerial plan showing the assessment area that was included in the 2014 survey (Auckland GIS Viewer)

38. An archaeological survey was undertaken in July 2014 of the area shown in Figure 21. Probing and test pitting was undertaken; however, it was quickly noted that the top 50cm of soil in much of the proposed construction zone had been modified by previous earthworks. The typical soil profile showed clay and topsoil mixed together with gravel and other debris present in exposed soil. No archaeological features or deposits were identified during the survey (Bickler and Clough 2014: 14)

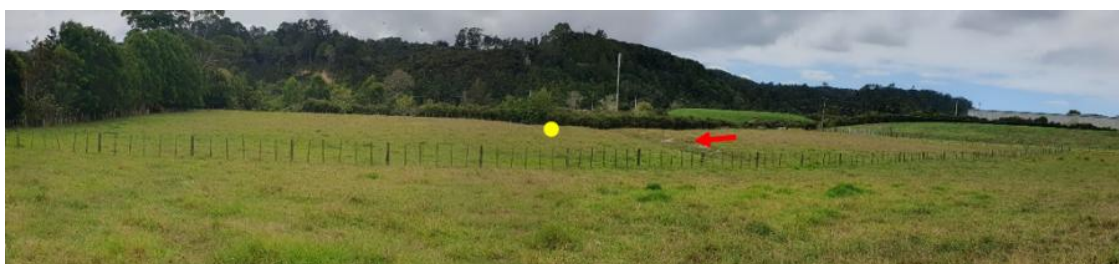
Figure 25. Looking north over the central paddock in Area 1 showing the open drainage channel (arrowed red) and approximate location of TP4 (yellow dot)

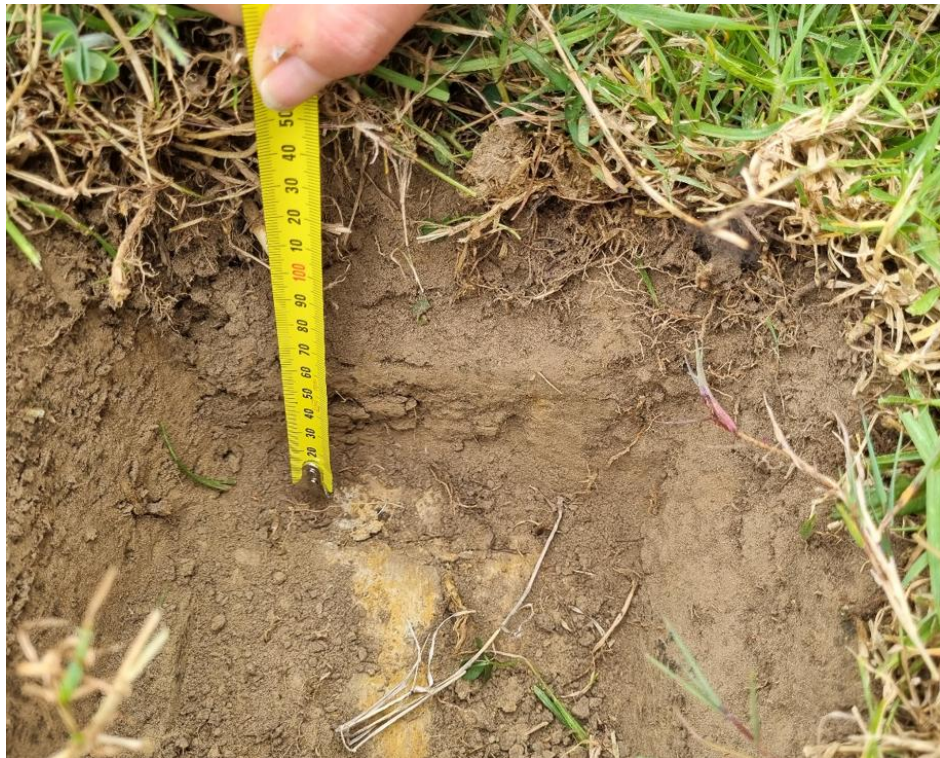
Figure 26. Photograph showing the detail of test pit 4 (TP4) in Area 1

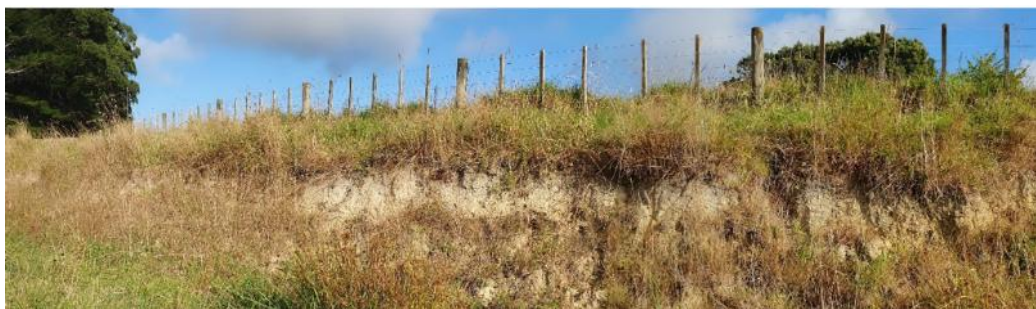
Figure 28. Stitched image showing the exposed stratigraphy in the farm track cut in Area 2

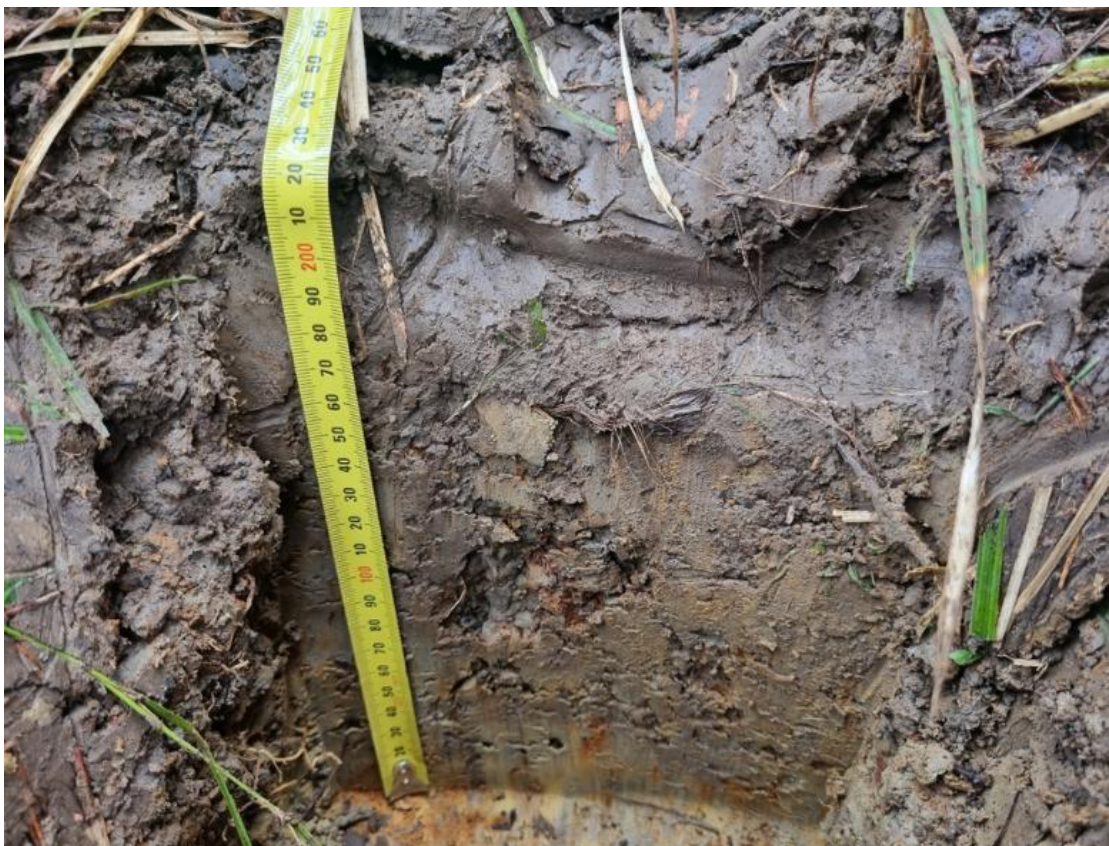
Figure 31. Photograph showing the detail of test pit 1 (TP1) in Area 2 located on the slope between the stream and the fenceline

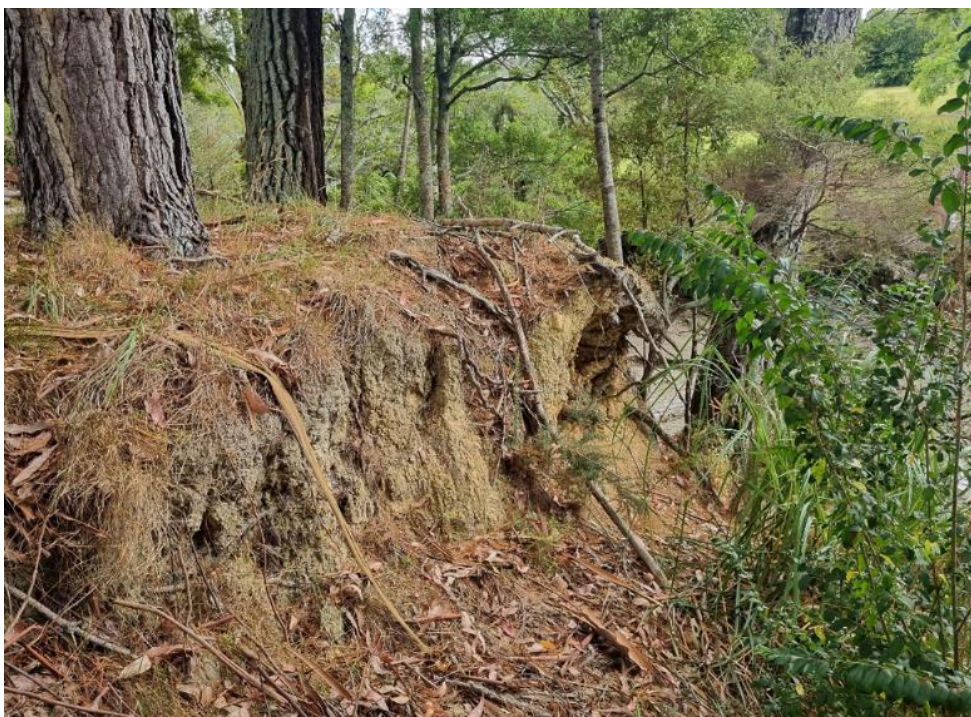
Figure 32. Photograph showing exposed section of eroded creek bank in Area 2

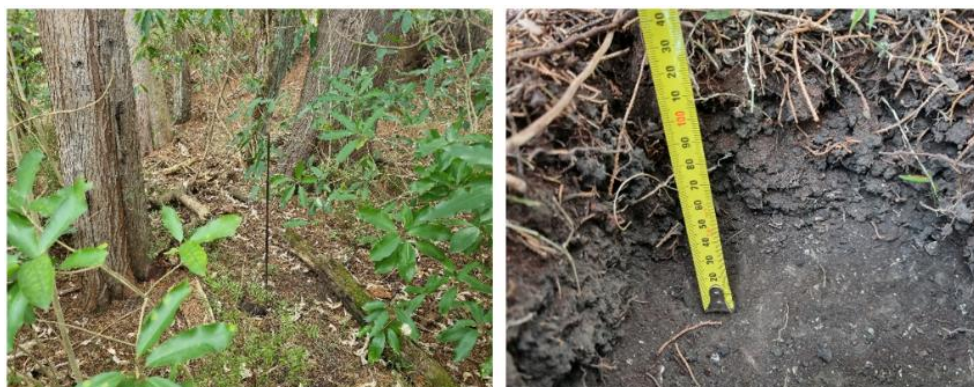
Figure 33. Left photograph showing location of test pit (TP2) on terrace in Area 2 and right showing the detail of the test pit

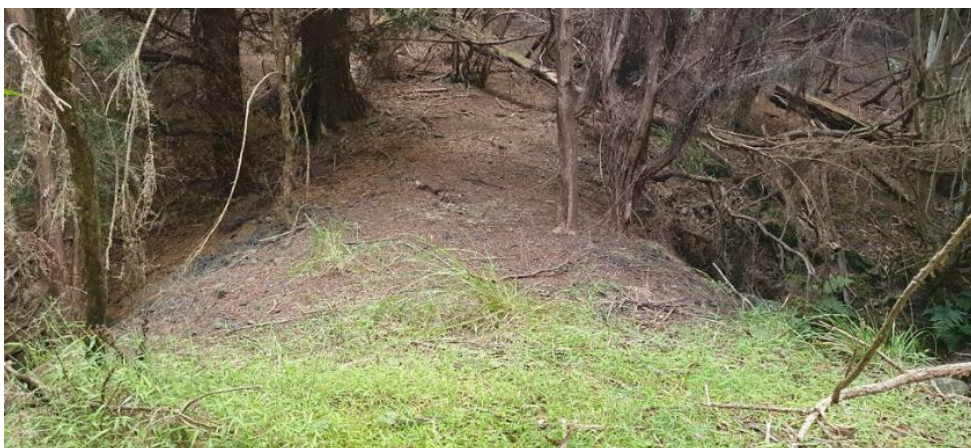
Figure 34. Photograph showing the land bridge over the top of a culvert in Area 2

50. Further along the creek bank there was a cleared area with a few trees, sloping towards the creek before dropping c.60cm to the creek. The stream was noted to continue to the north, bordered by relatively open old growth manuka on both sides. A culvert with a land bridge over the top was present (Figure 34). The stream appears to originate to the east, passing through the field from the southwest corner of the Prison unit. The open grassed area between the farm bridge and the Prison unit did not show any archaeological features.

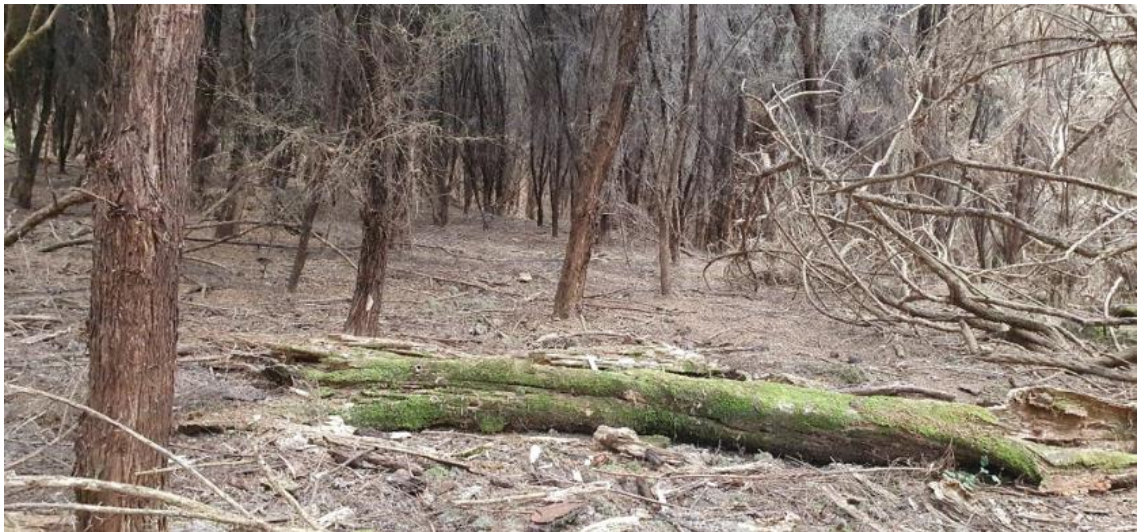
Figure 35. Photograph showing the terrace on the north side of the narrow culverted stream in Area 2, under old growth manuka

51. The area on the northern side of the stream was largely old growth manuka but was situated on a large flattish area above the slope to the stream (Figure 35). The area was c.15m wide x c.40m long and was potentially a location that might have been inhabited for a short time. Probing around the area did not locate any subsurface shell material. A test pit (TP3) was inserted in this area. Measuring 25cm x 25cm x 11cm deep, the grey topsoil was very dry and very firmly compacted and overlay a clay loam (Figure 36).

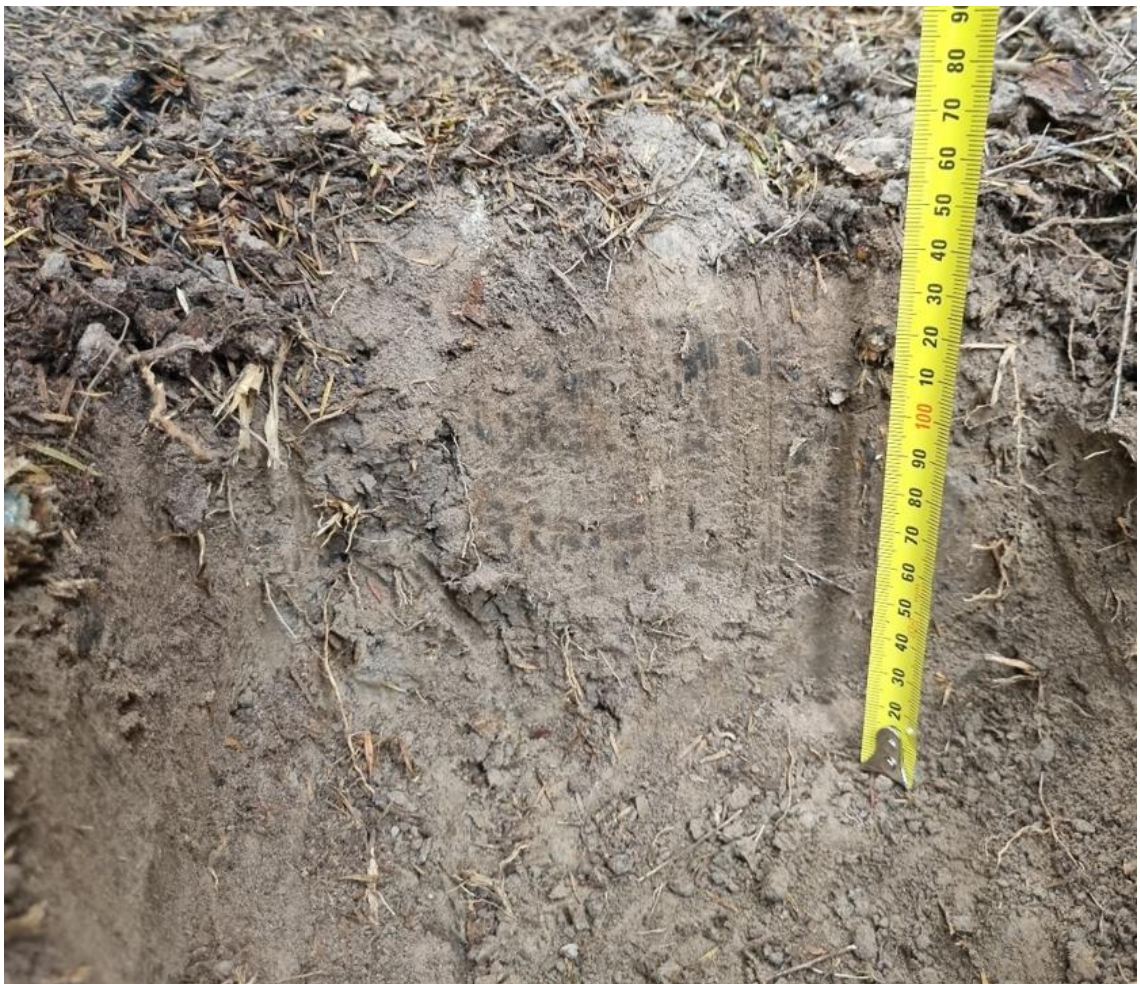
Figure 36. Photograph showing detail of test pit (TP3) in Area 2, showing the hard compacted topsoil

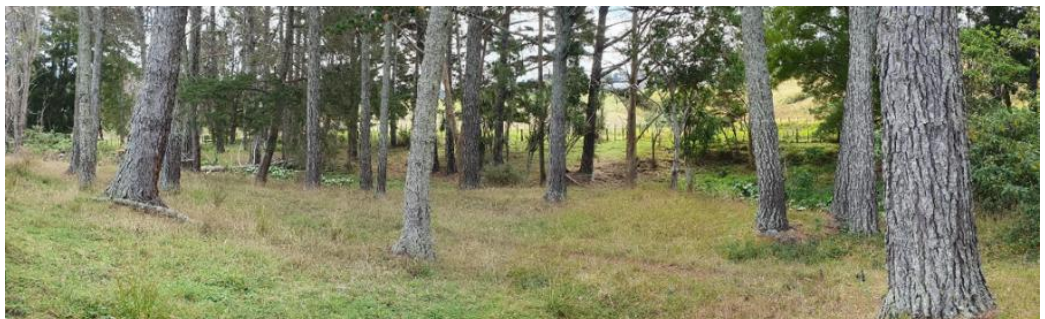
Figure 44. Panorama of part of the lower elevation on the southern side of the stream in Area 3 showing flattish areas and stream passing (right to centre left)

54. At the lowest elevation, at the northern end of the area, was a flattish area under pines bisected by the stream and passing through a culvert beneath Merewhira Road to the east (Figure 44). The areas alongside the stream on both sides were generally in pine, but other species such as gum, cabbage tree (on the northern side), and native shrubs were present. The northern side was reached by a track leading over the stream on the eastern side (Figure 45). The terrace-like area was probed, tree bases and exposed soils were inspected; however, no shell material was located (Figure 46, left). A test pit (TP5) was inserted in the larger terrace area on the southern side of the stream. Measuring 15cm x 15cm, the silty dark grey topsoil was moderately compacted, reaching a depth of 4cm where it overlay a light grey interface of 2cm thickness, in turn overlying hard natural grey clay (Figure 46, right). There were no indications of archaeological remains in area 3.

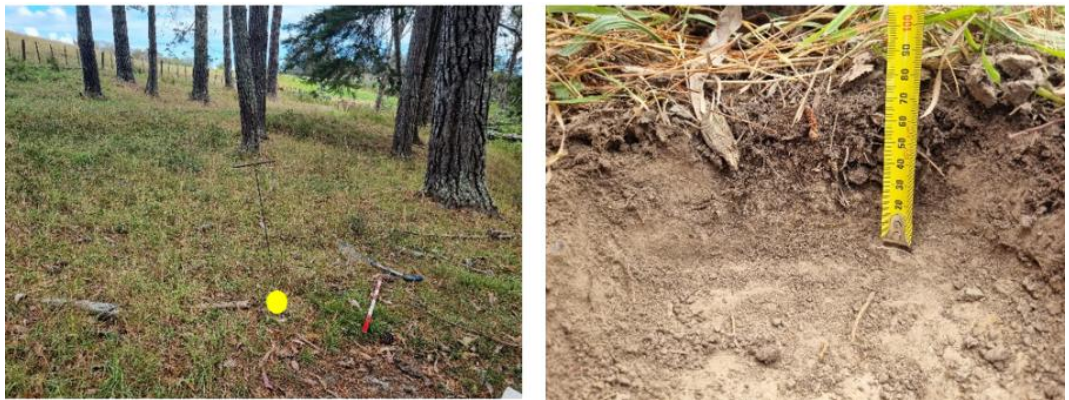
Figure 46. Left photograph showing the location of test pit 5 (TP5) on the flattish area on the southern side of the stream in Area 3 – yellow dot; and right photograph showing the detail of the test pit

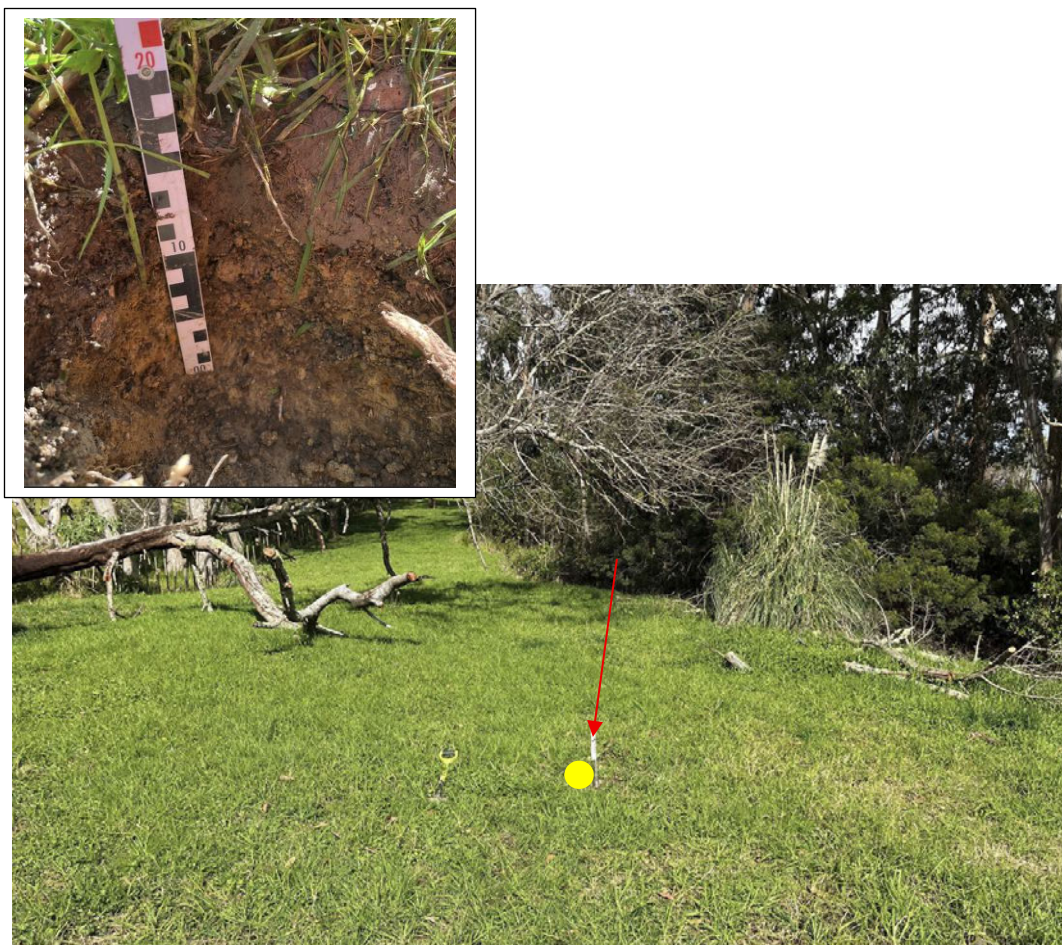
Figure 46. Photograph showing the southern paddock with the location of test pit (TP6) indicated by red arrow, looking south with detail of test pit in upper inset

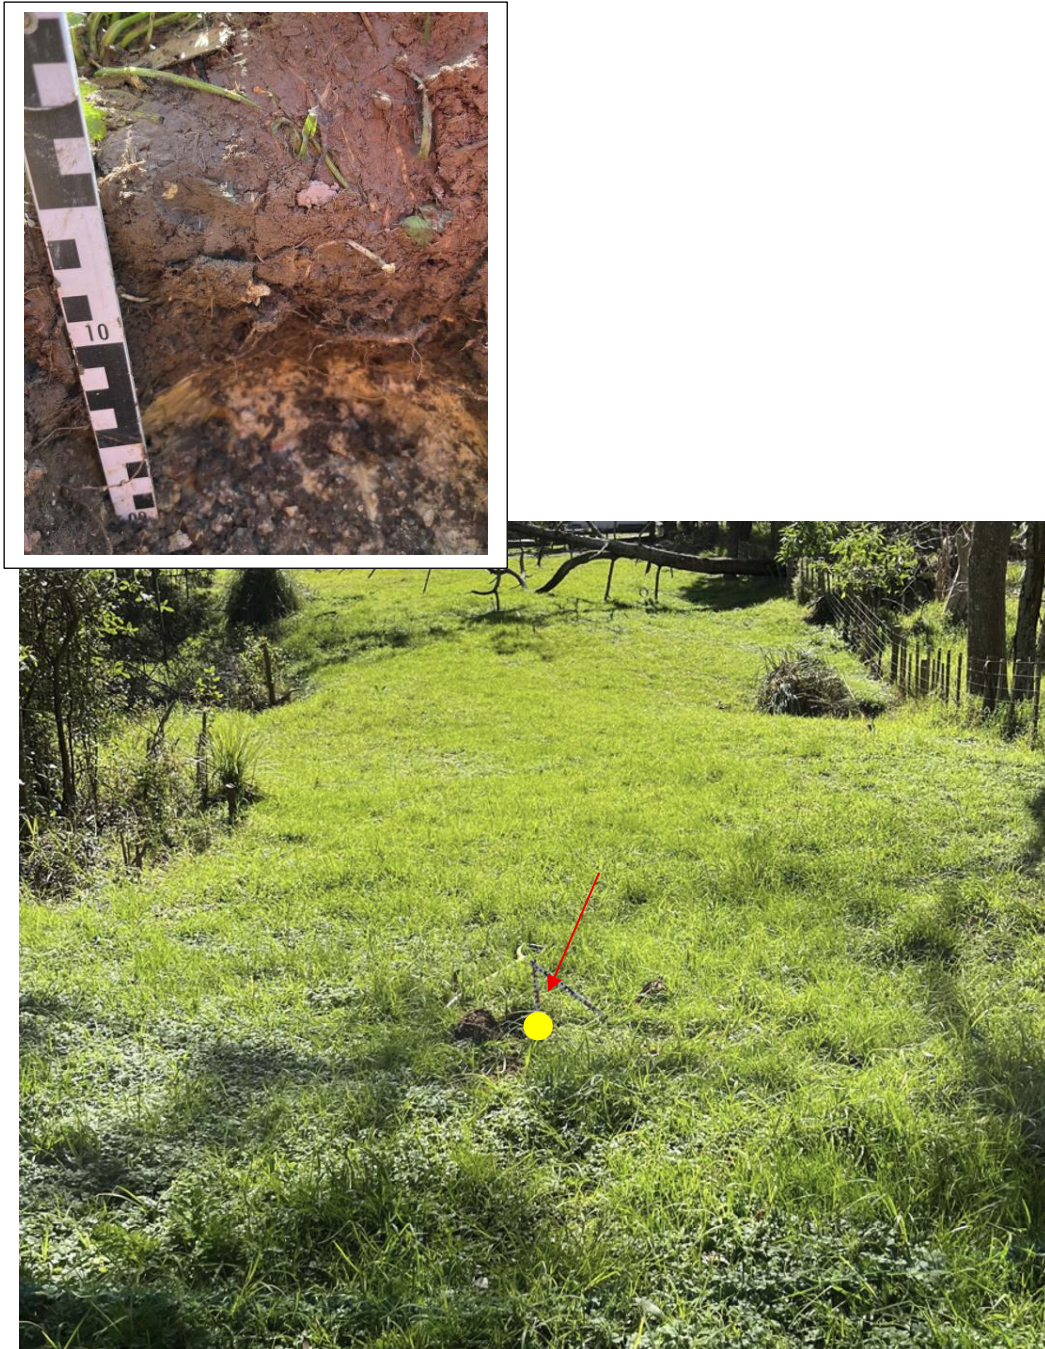
Figure 51. Photograph of the southern paddock showing the location of test pit (TP7) indicated by red arrow and detail of test pit in upper inset

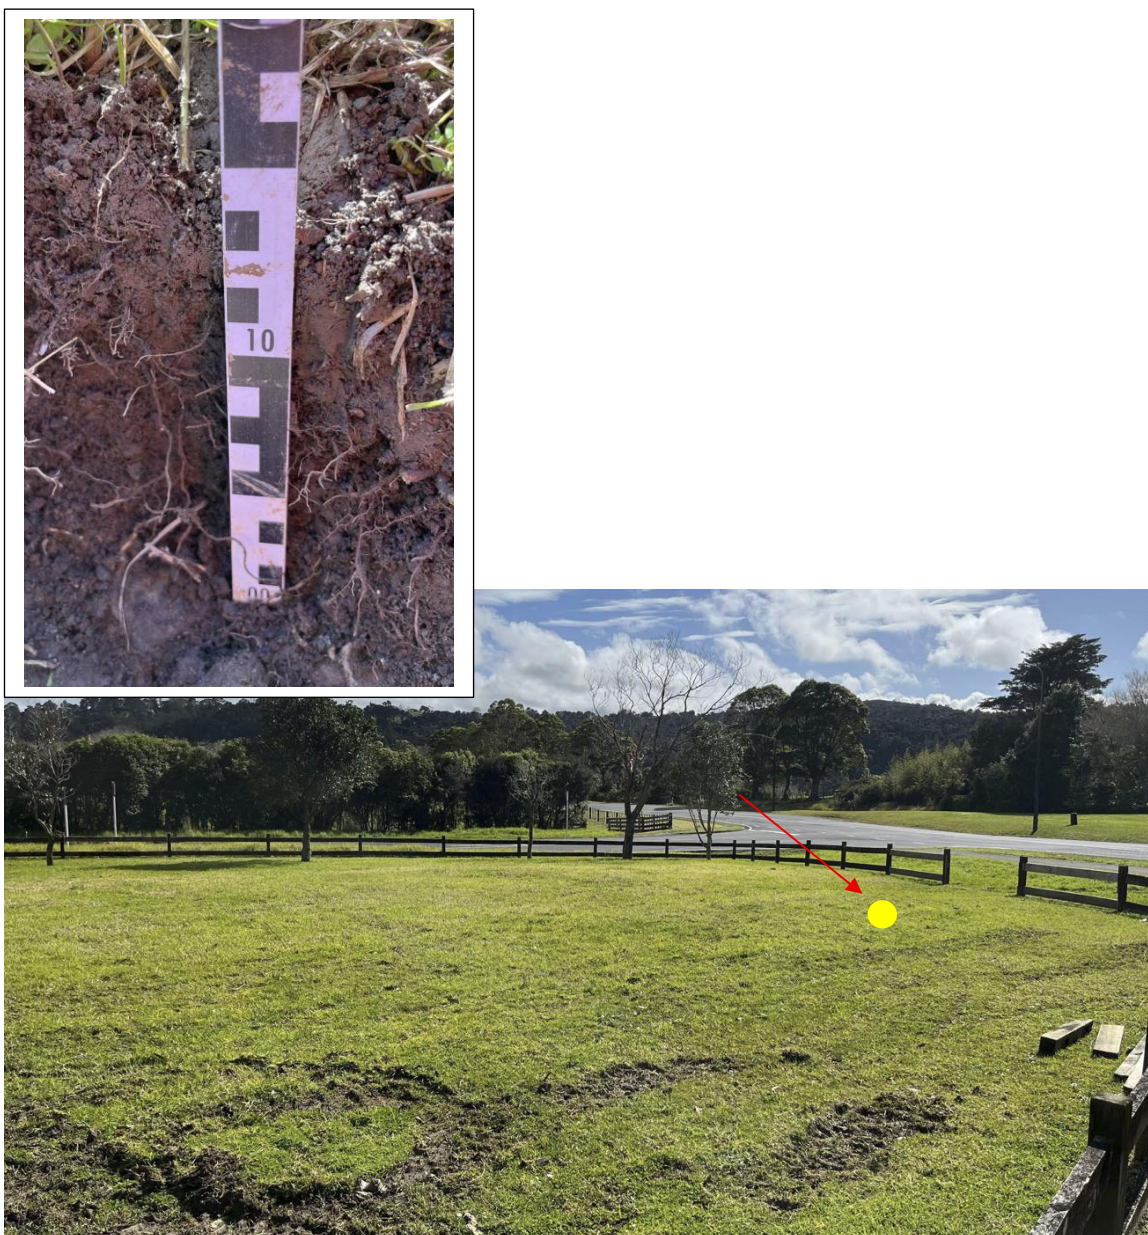
Figure 52. Photograph of the paddock in the northwest of the property with location of test pit (TP8) indicated by red arrow, looking northwest
