**Ngā Wairau – Stage 1 A F Thomas Park
- Contaminated Land**

Preliminary Site Investigation

3-AWWAI.02

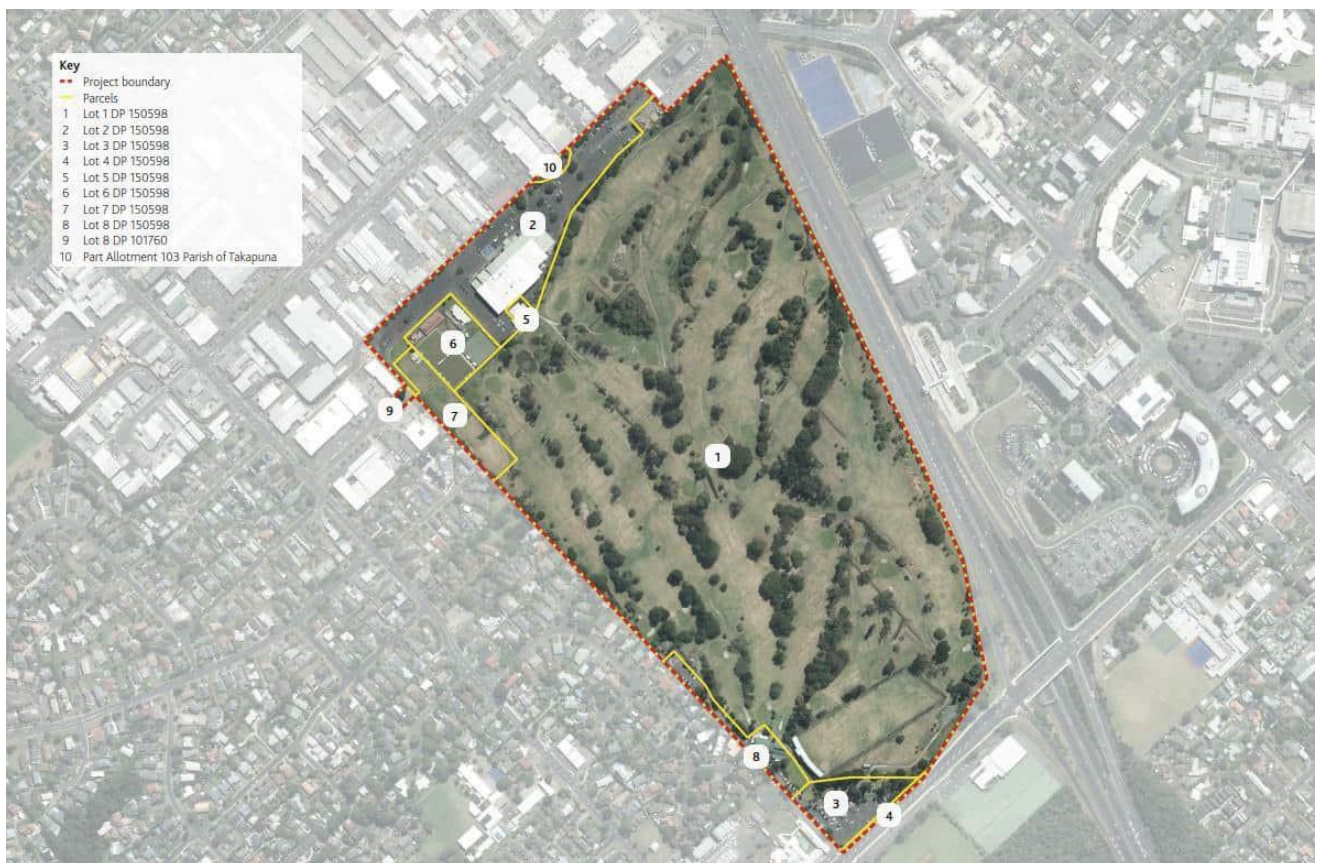
Figure 1: Site location

The Site is located approximately 11 kilometers north of the Auckland central business district situated in a mixed residential and commercial area. The Site location is shown in Figure 1 with general site details provided in Table 2.1.

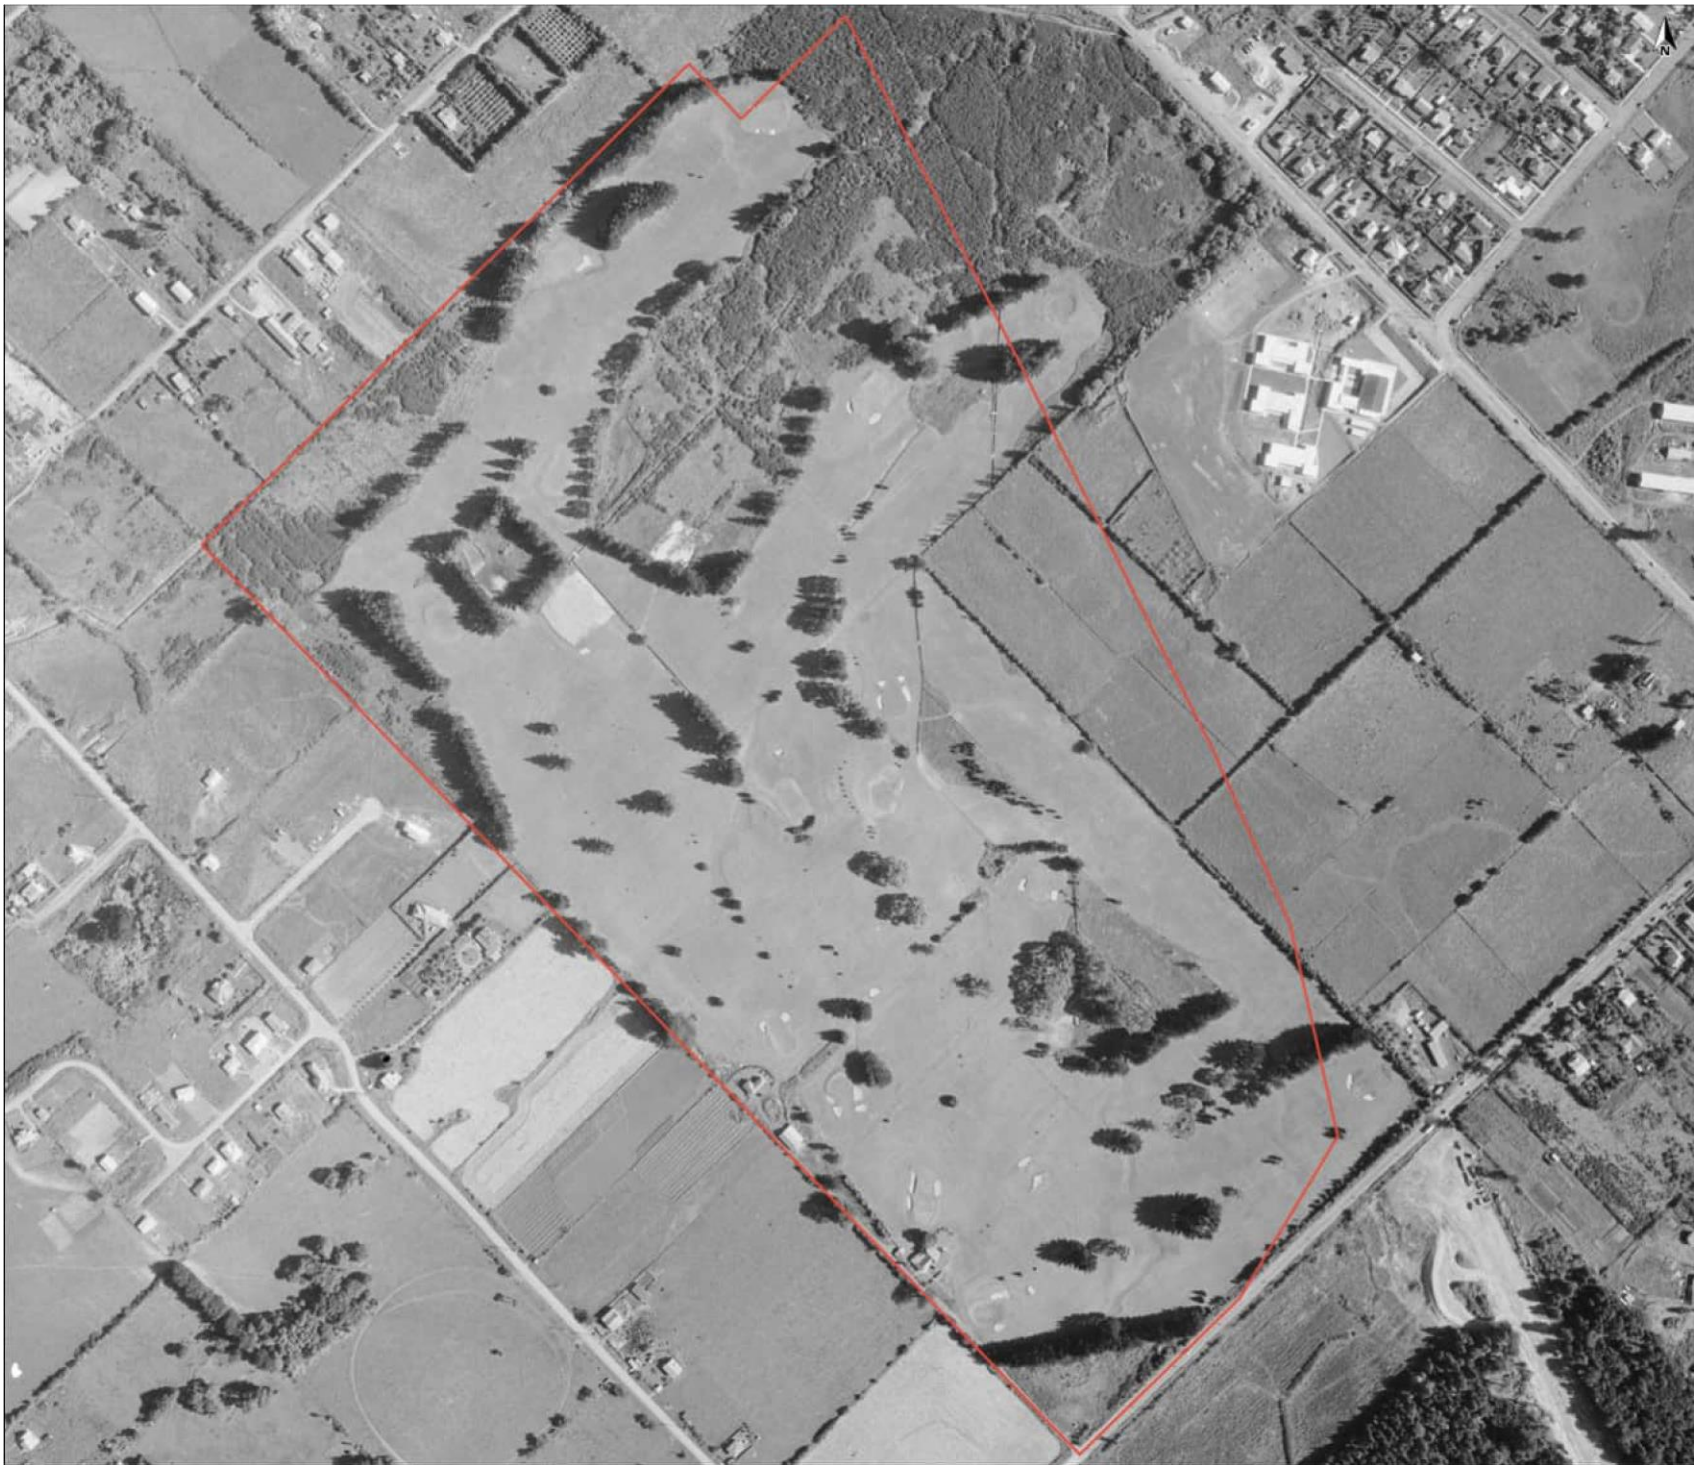
Title, 1957 Aerial Photo		
Client Auckland Council		Slie: A4
Project: Ngo Walrau- Stoge I A F Thomes Pork Works	Drawn: JM	Figure, A-01
Dole: 07-10-2025	Checked: MB	
Proj No: 3-AWWA1.02	Scale: 1:6000	version: Final

Year (Source)	Onsite	Offsite
1957 (Retrolens)	<p>A golf course covers much of the site (sand traps visible across the fields). A section in the southeast of the site appears to be open grassed fields, and the northeastern corner of the site is in low shrubs / trees.</p> <p>Residential houses dotted around or just within site perimeter.</p>	<p>The surrounding environment is suburban residential housing and fields. Wairau Road was established north and east of the site.</p> <p>Sheds with stockpiled material are visible on properties adjacent to the north of the site.</p> <p>Possible small orchards on properties adjacent to the north of the site.</p> <p>Large group of buildings to the east of the site (present day Westlake Girls High School).</p>
1959 (Auckland Council Geomaps)	<p>No changes to the golf course.</p> <p>Earthworks, possibly the sewer main being installed, runs down the centre of the site.</p>	<p>Expansion of sheds towards the northern site boundary.</p> <p>Slight expansion of residential housing on western site boundary.</p>

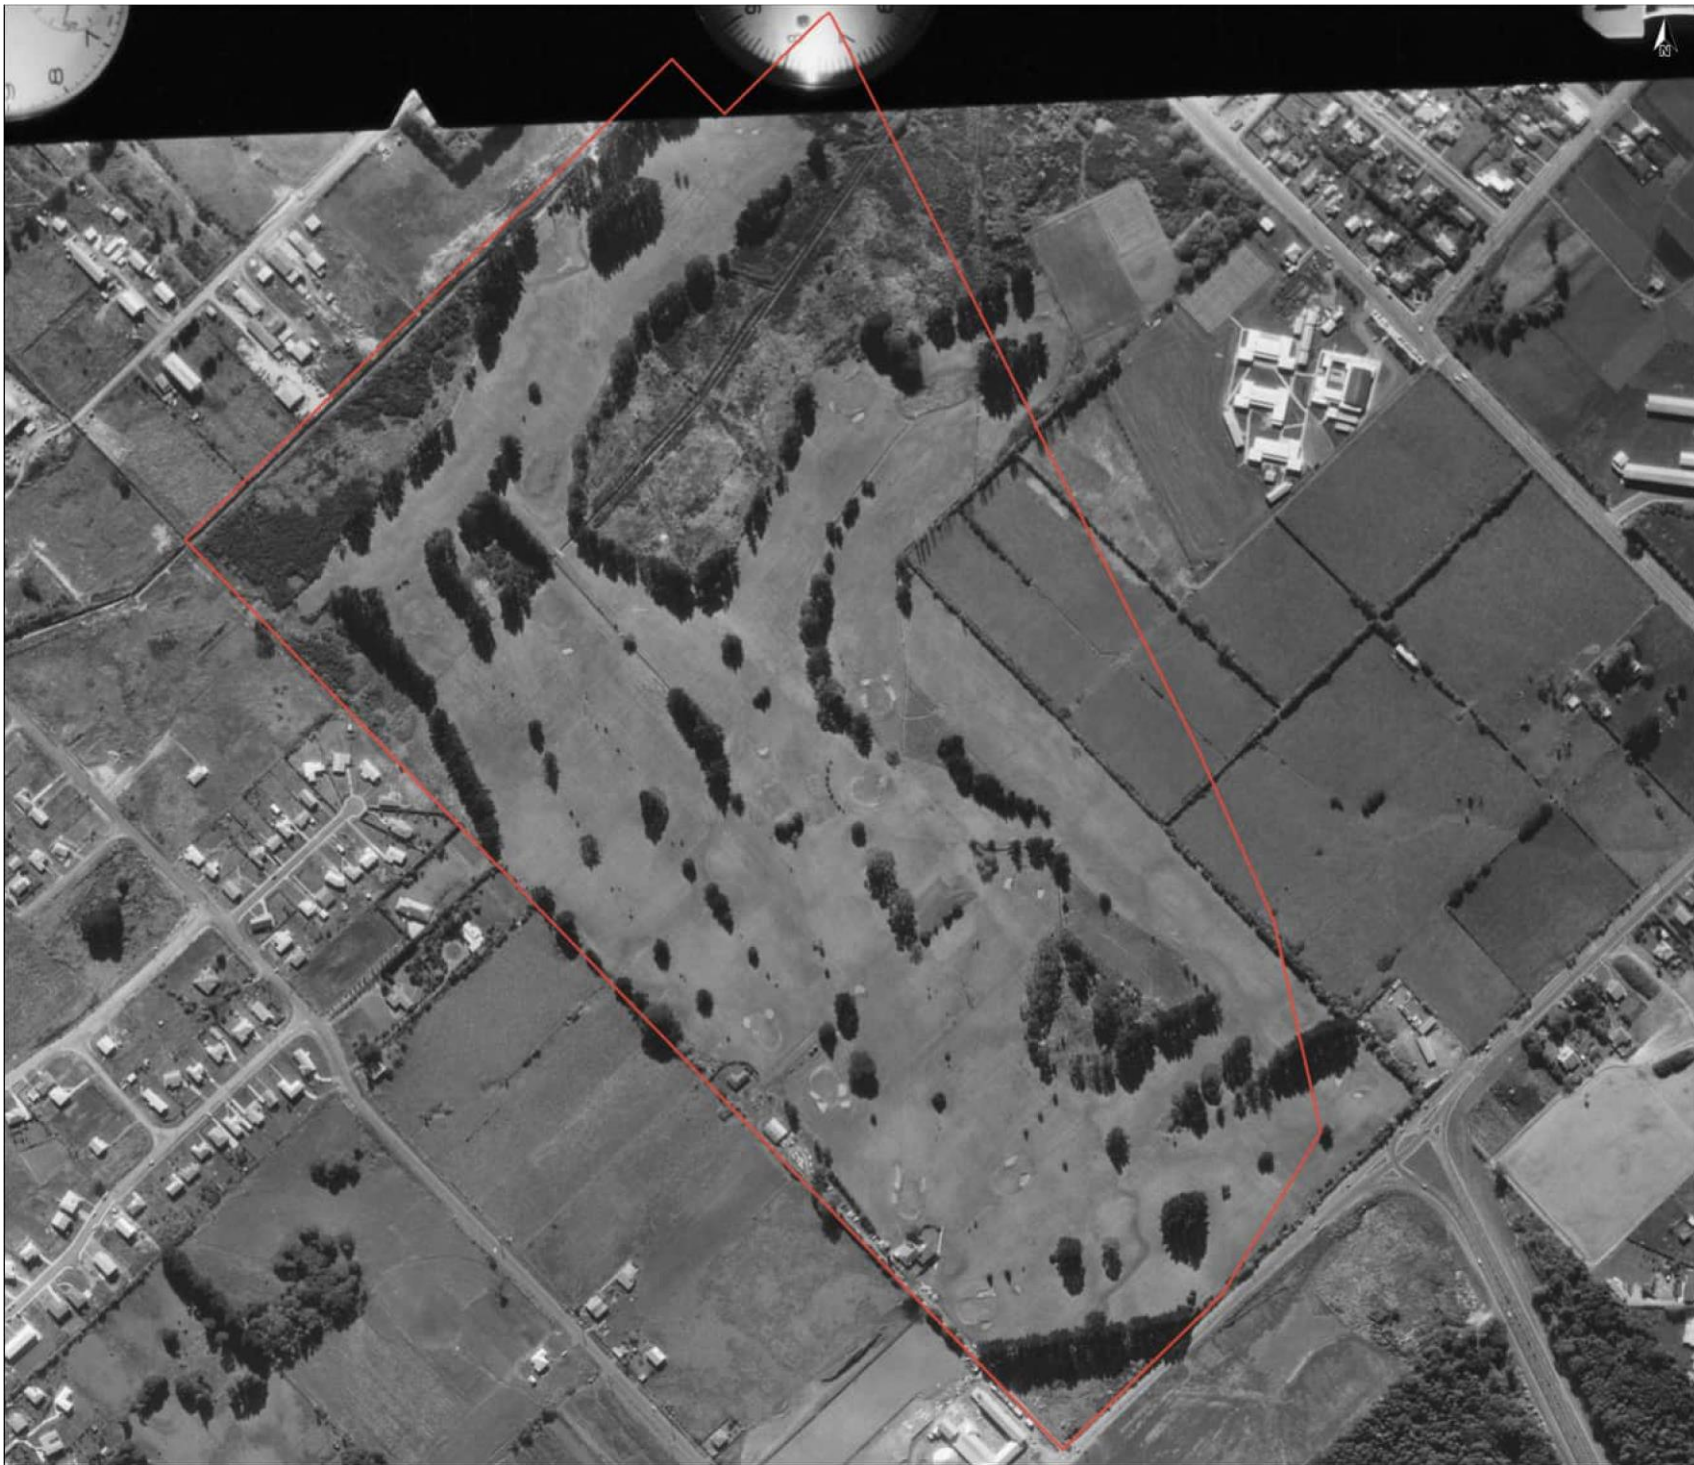
Tiua, 1963 Aerial Photo		
Client Auckland Council		Slie: A4
Project Nga Wairau- Stage 1 A F Thomas Park Works	Drawn: JM	Figure, A-03
Dole: 07-10-2025	Checked: MB	
Proj No: 3-AWWA1.02	Scale: 1:6000	version: Final

1963 (Retrolens)	<p>No changes to the golf course.</p> <p>The dirt track was removed. Channel features observed (presumed stormwater) in northeast of the site.</p>	<p>Commercial / industrial buildings established near southwestern site boundary.</p> <p>Shed with multiple cars outside visible adjacent to the western site boundary.</p>
1968 (Retrolens)	<p>No changes to the golf course.</p> <p>Earth patch visible northwest of site.</p>	<p>The motorway was established adjacent to the eastern boundary.</p> <p>Expansion of residential housing on western site boundary.</p>
1972 (Retrolens)	<p>No changes to the golf course.</p> <p>Patches of bare ground visible in northwestern corner of site.</p>	<p>Expansion of industrial buildings / large sheds adjacent to the northern site boundary.</p> <p>Shopping complex or similar (range of building sizes and many carparks) established near southwestern site boundary.</p> <p>A shed and open structures present immediately north of site (current substation).</p>

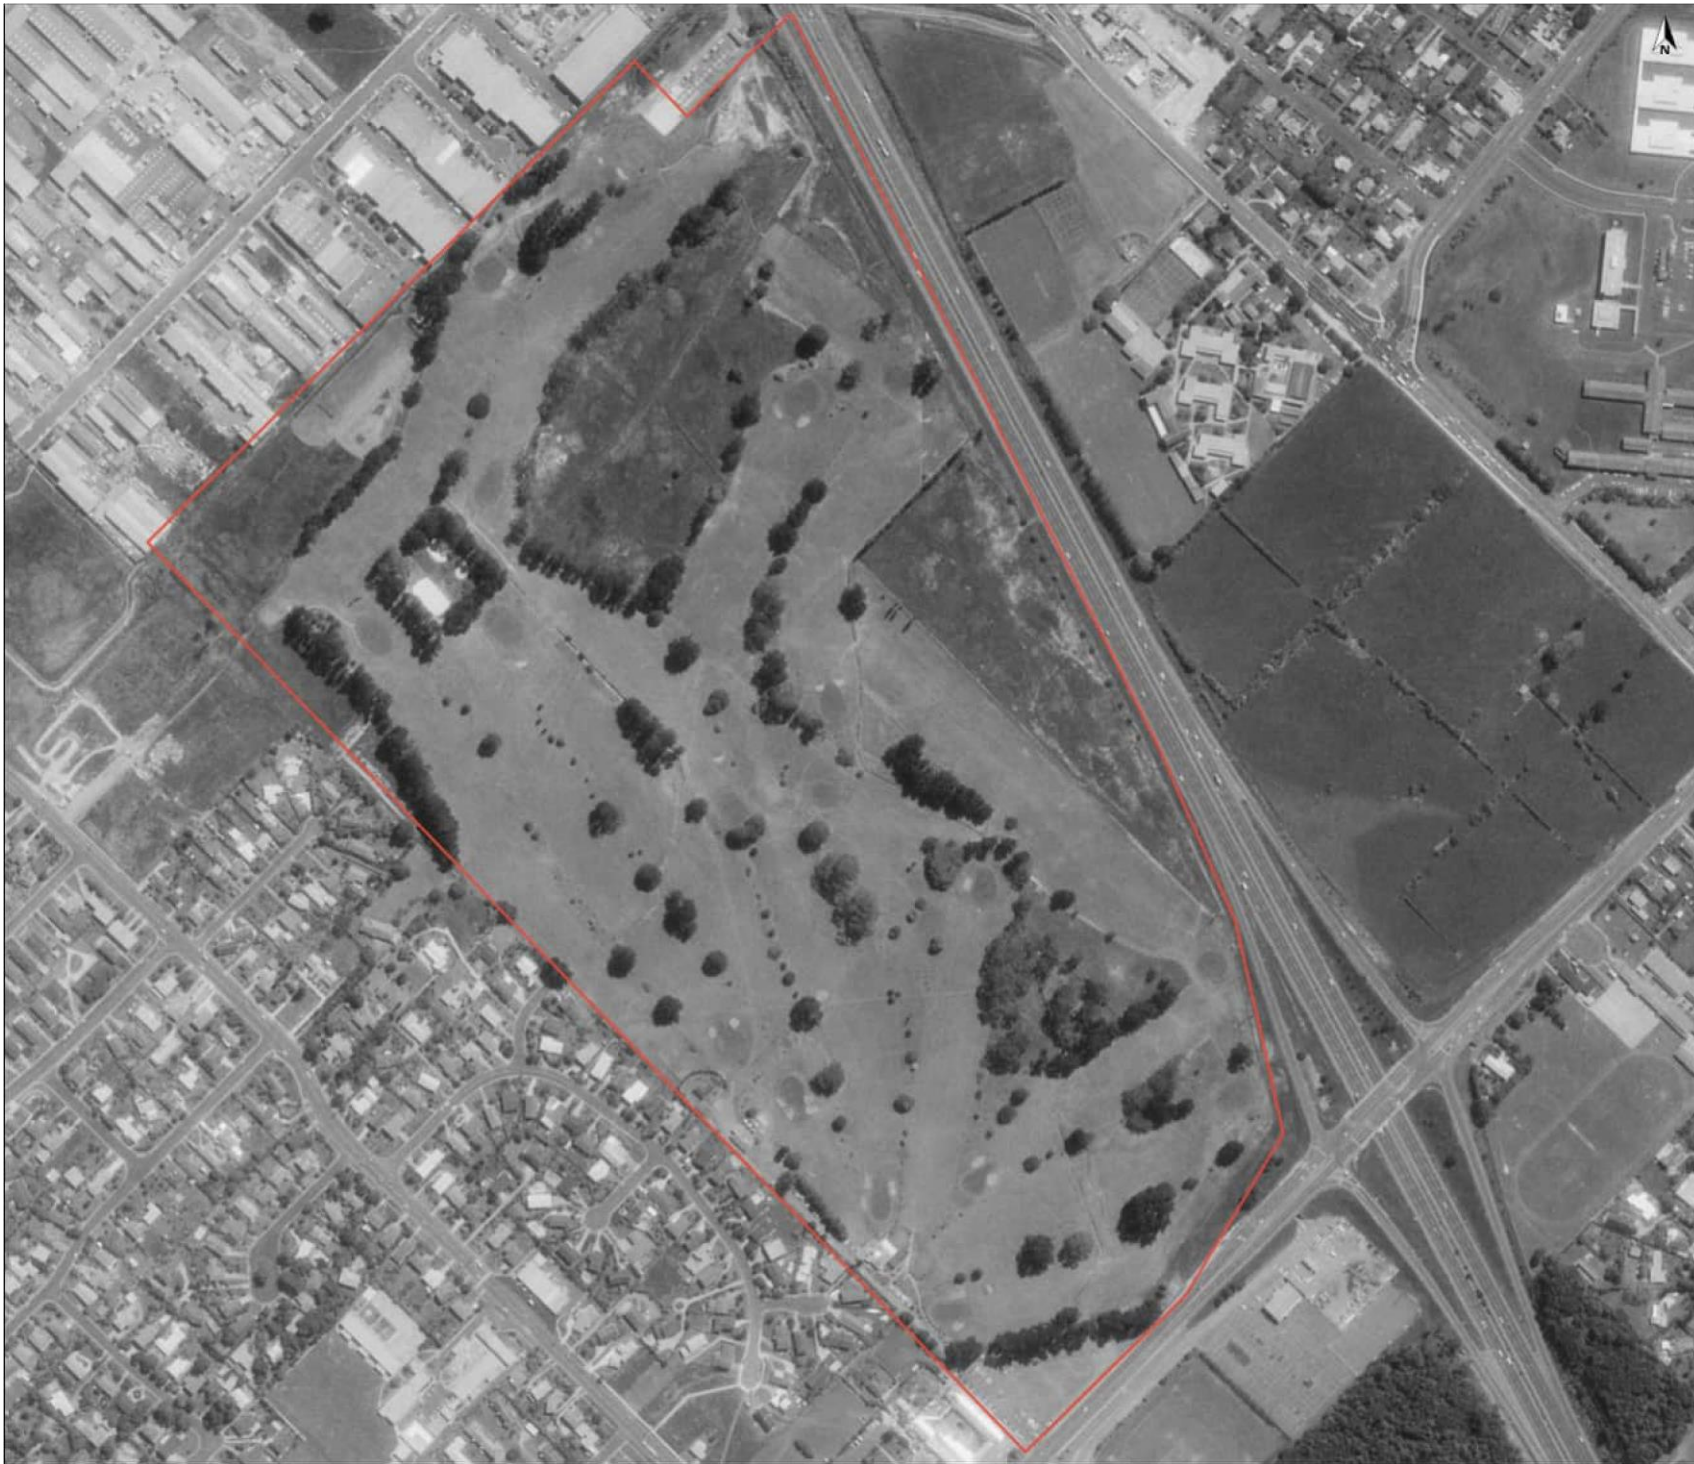
Titu3' 1980 Aerial Photo		
Clifent Auckland Council		Size: A4
Project Ngo Wolrou- Stoge I A F Thomas Pork Works	Drawn: JM	Figure: A-06
Date: 07-10-2025	Checked: MB	
Proj No: 3-AWWA1.02	Scale: 1:6000	version: Final

1980 (Retrolens)	No significant changes.	Further expansion of industrial area to the north of site; now extends along entire northern site boundary. Expansion of residential housing on western site boundary. Expansion of structures north of site (present – day substation).
1988 (Retrolens)	No changes to the golf course. Development of several buildings and possible bowling green in the northwest of site.	Expansion of industrial area to north of site, now extends around the north-eastern corner of site.
1996 (Auckland Council Geomaps)	No significant changes	No significant changes
2001 (Auckland Council Geomaps)	No changes to the golf course. Building in north of site expanded.	No significant changes
2006 (Auckland Council Geomaps)	No changes to the golf course. Carparking extends across northern end of site. Electrical transformer hub now clearly visible in northeastern corner of site.	No significant changes.
