122 Morven Ferry Road,  
Arrow Junction

Prepared for Gibbons Developments Limited

Job No.: 2555087

## Geotechnical Assessment Report

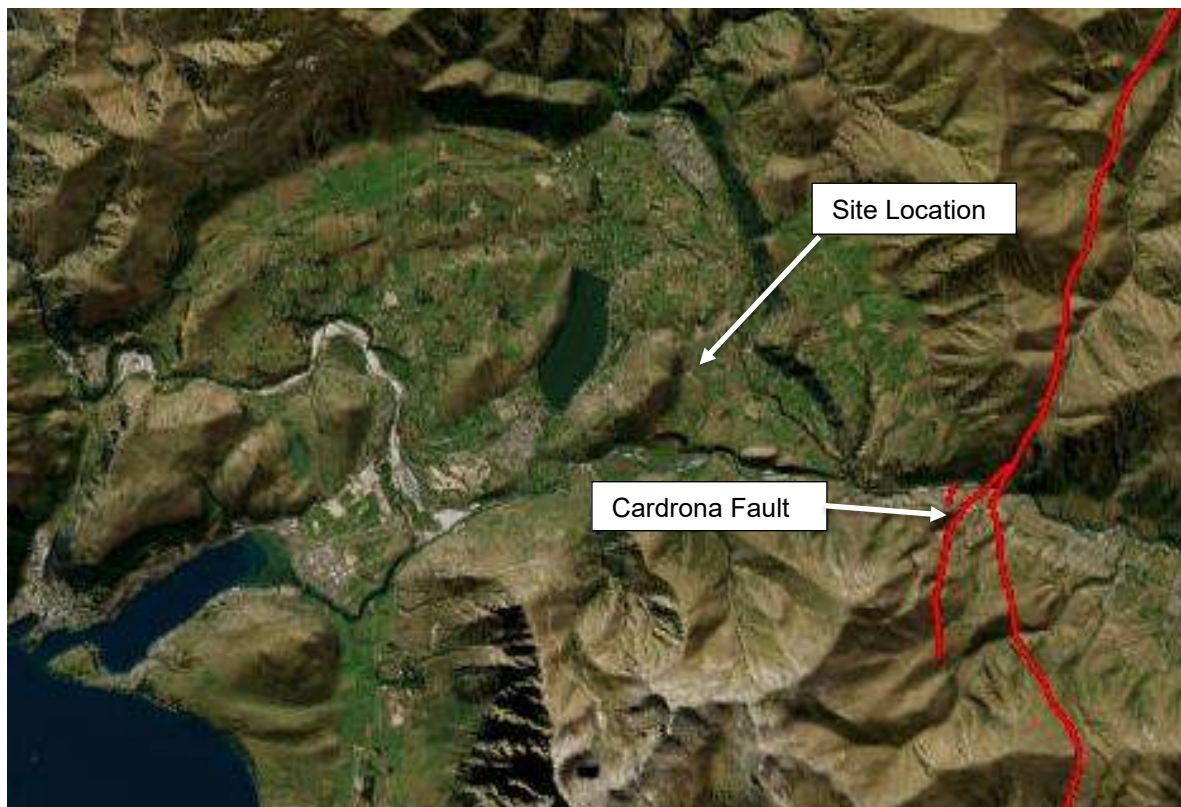
**Figure 2: GNS Fault Maps**

Review of the GNS Active Faults Database<sup>10</sup> indicates that the closest GNS mapped active fault trace is the Cardrona Fault located approximately 10 km southeast of the site as shown in Figure 2. Therefore, the site is located outside the minimum 20.0 m fault avoidance zone recommended by the Ministry for the Environment<sup>11</sup>.

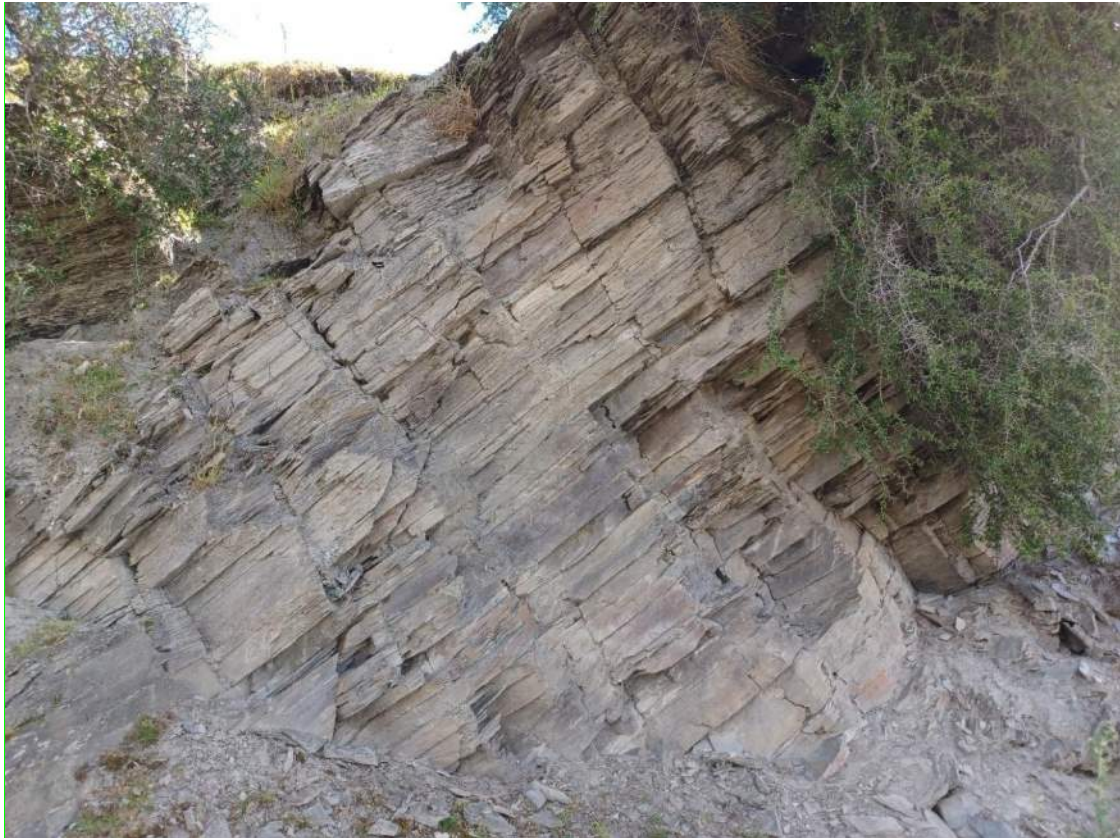
*Photograph 2: Rock face on Morven Hill showing foliations and joint sets.*

See Appendix C for rockfall analysis locality map and supplementary stereonet. See Section 6.9 for annotated photographs of exposed outcrops.

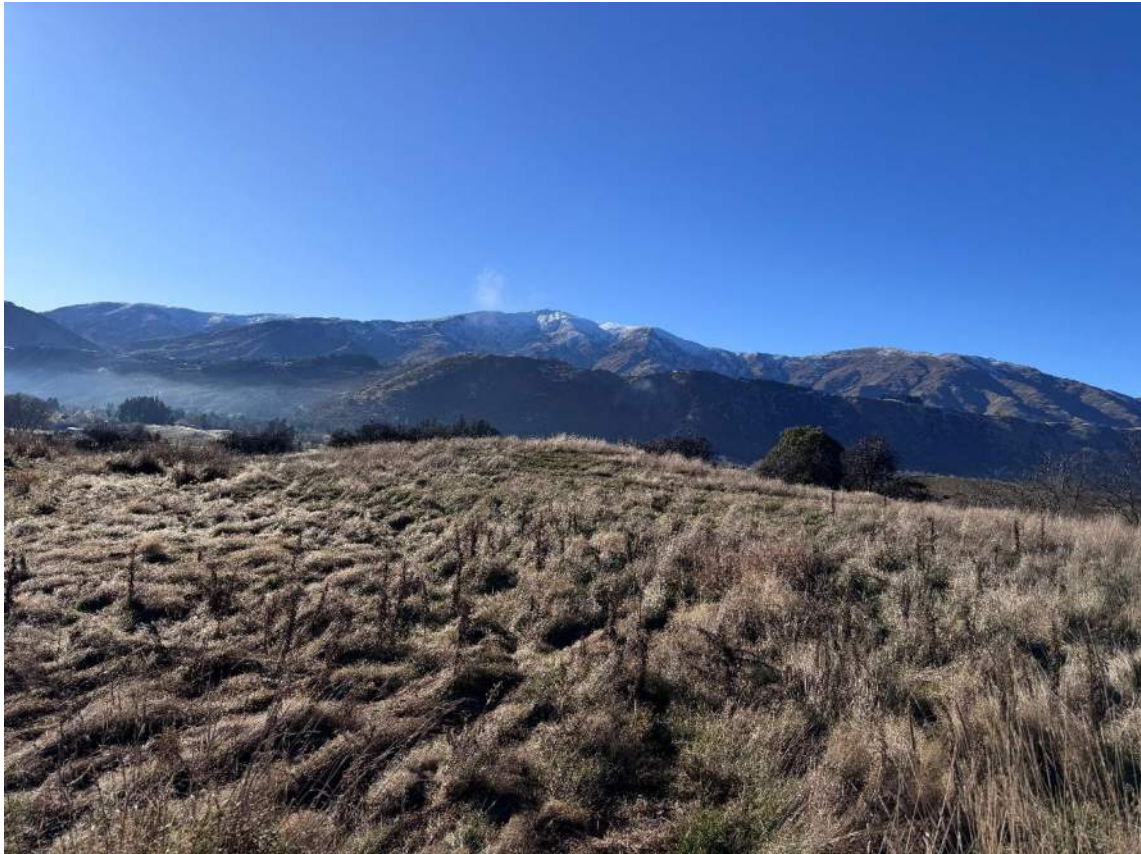
*Photograph 4: Ridgeline area down the middle of site.*

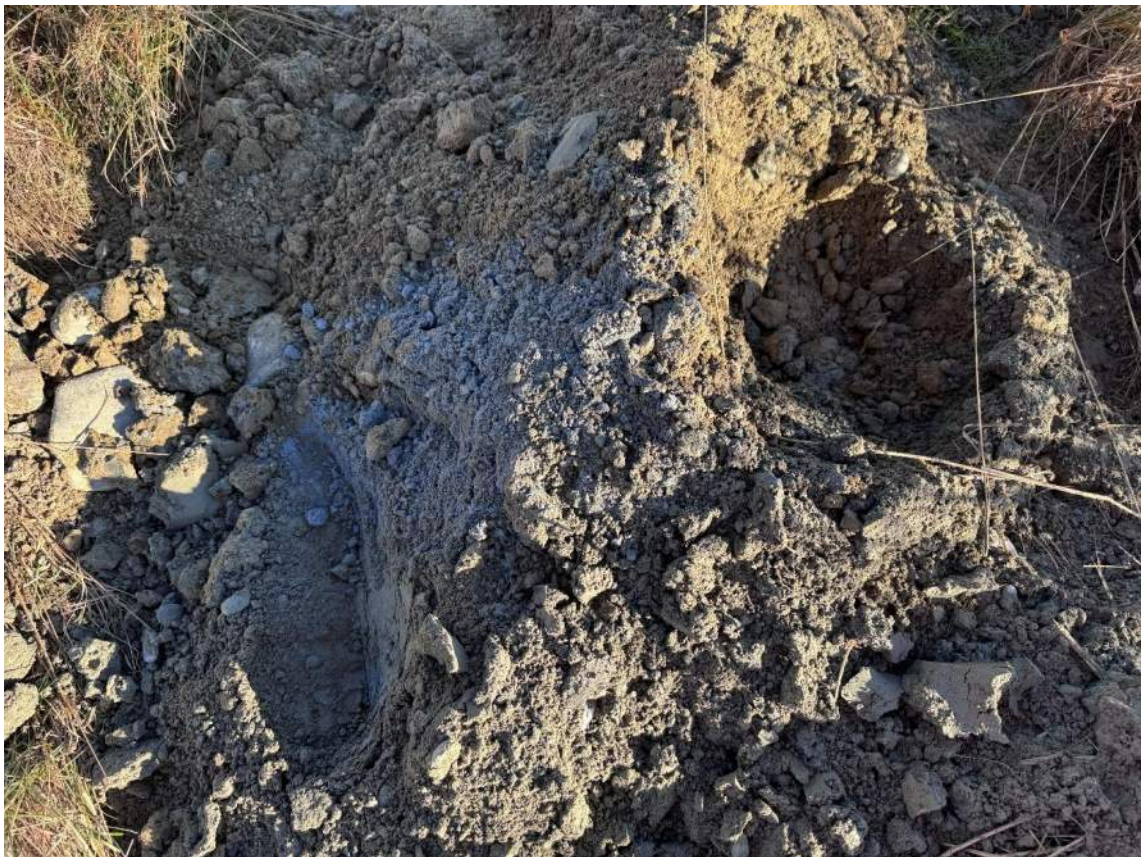
*Photograph 5: Geology found around site.*

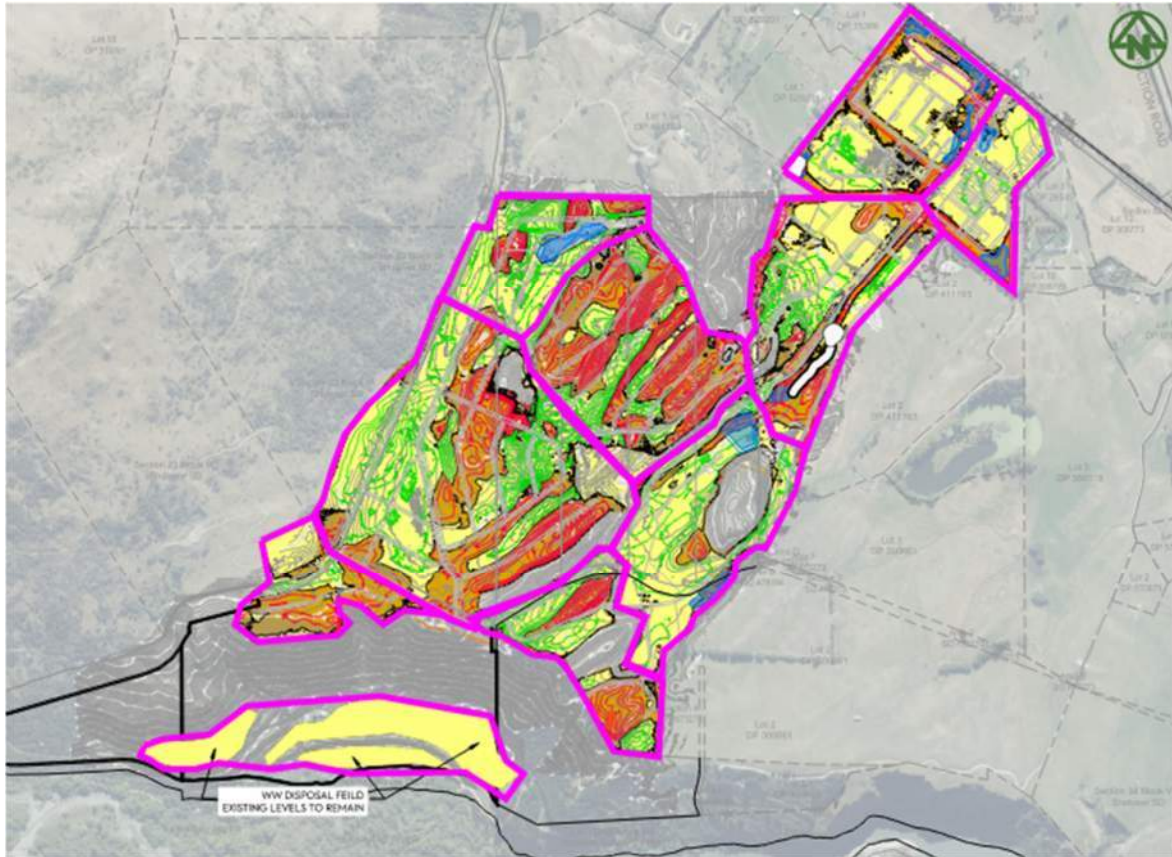
Figure 4 - Earthworks Staging

#### 4.15.EARTHWORKS STAGING PLAN
