# **SHIPYARD AND DRYDOCK FACILITY, MARSDEN POINT, WHANGĀREI HARBOUR: ARCHAEOLOGICAL ASSESSMENT**

Prepared for MBIE

June 2026

By  
Glen Farley (MA Hons)

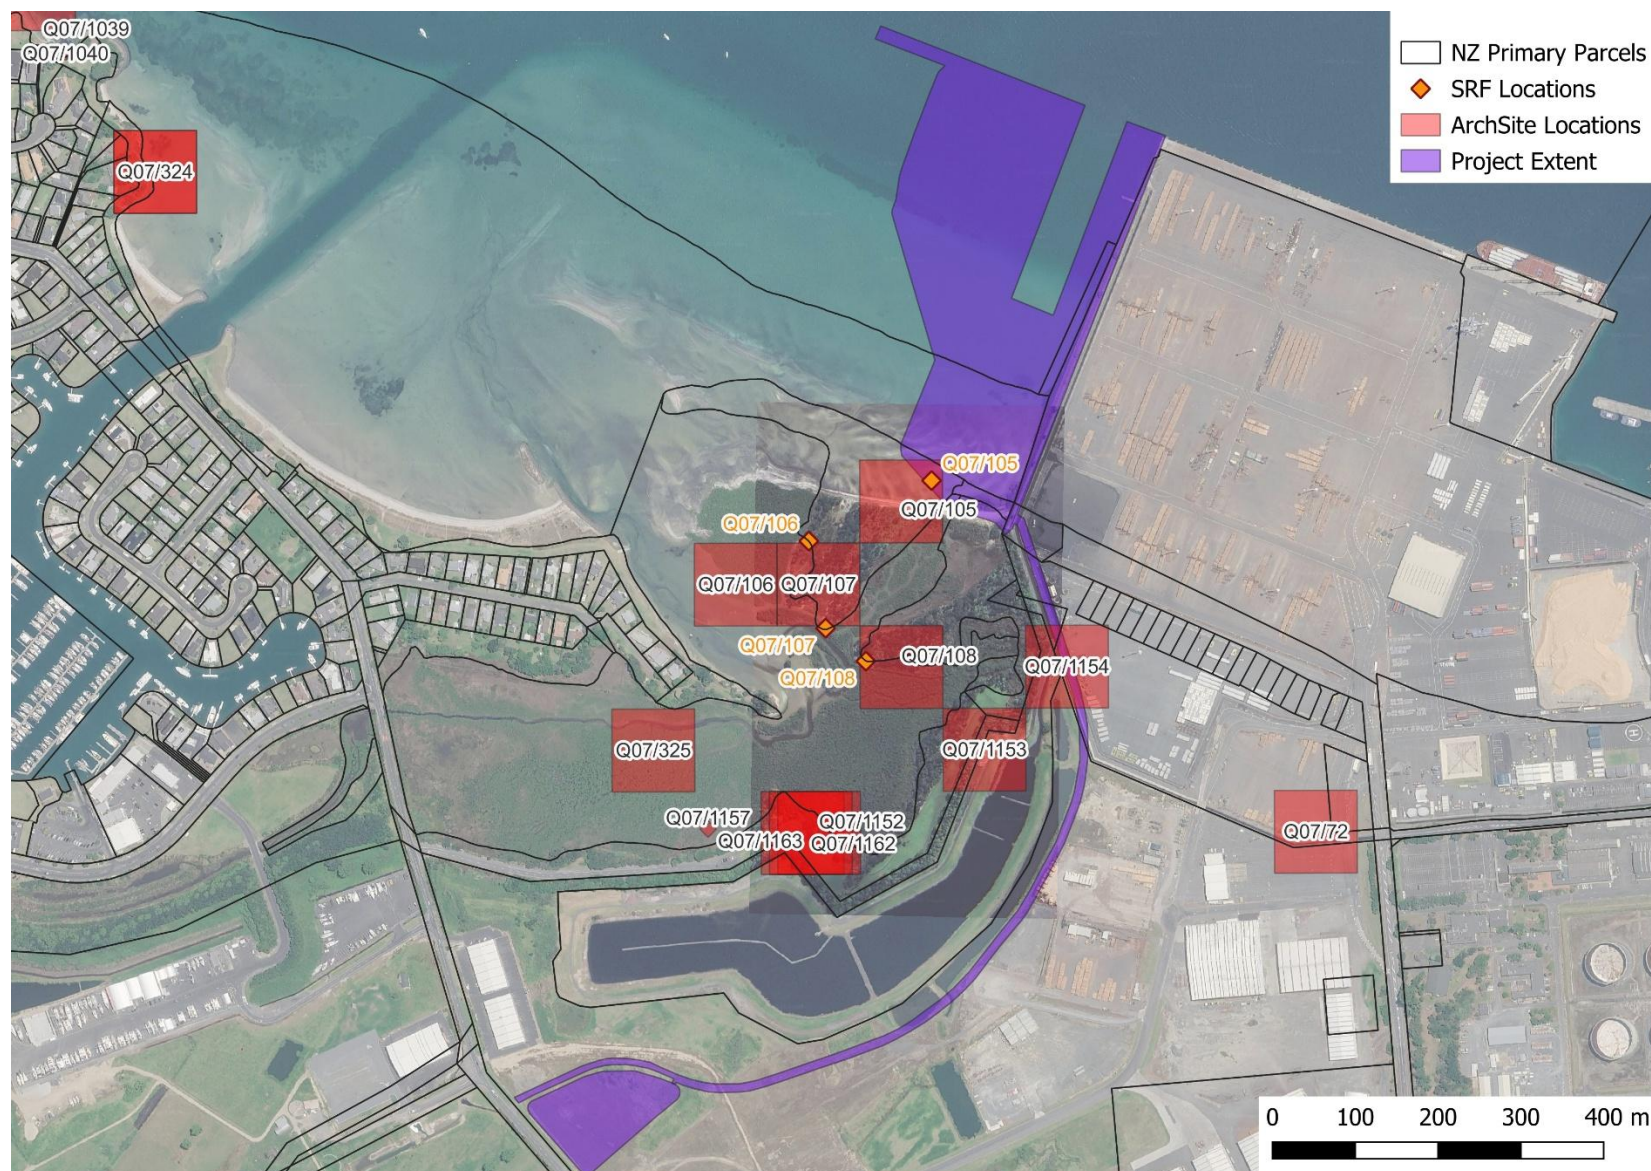
Figure 10. Plan showing project extent with recorded archaeological sites, and site locations derived from site record form plan (orange)

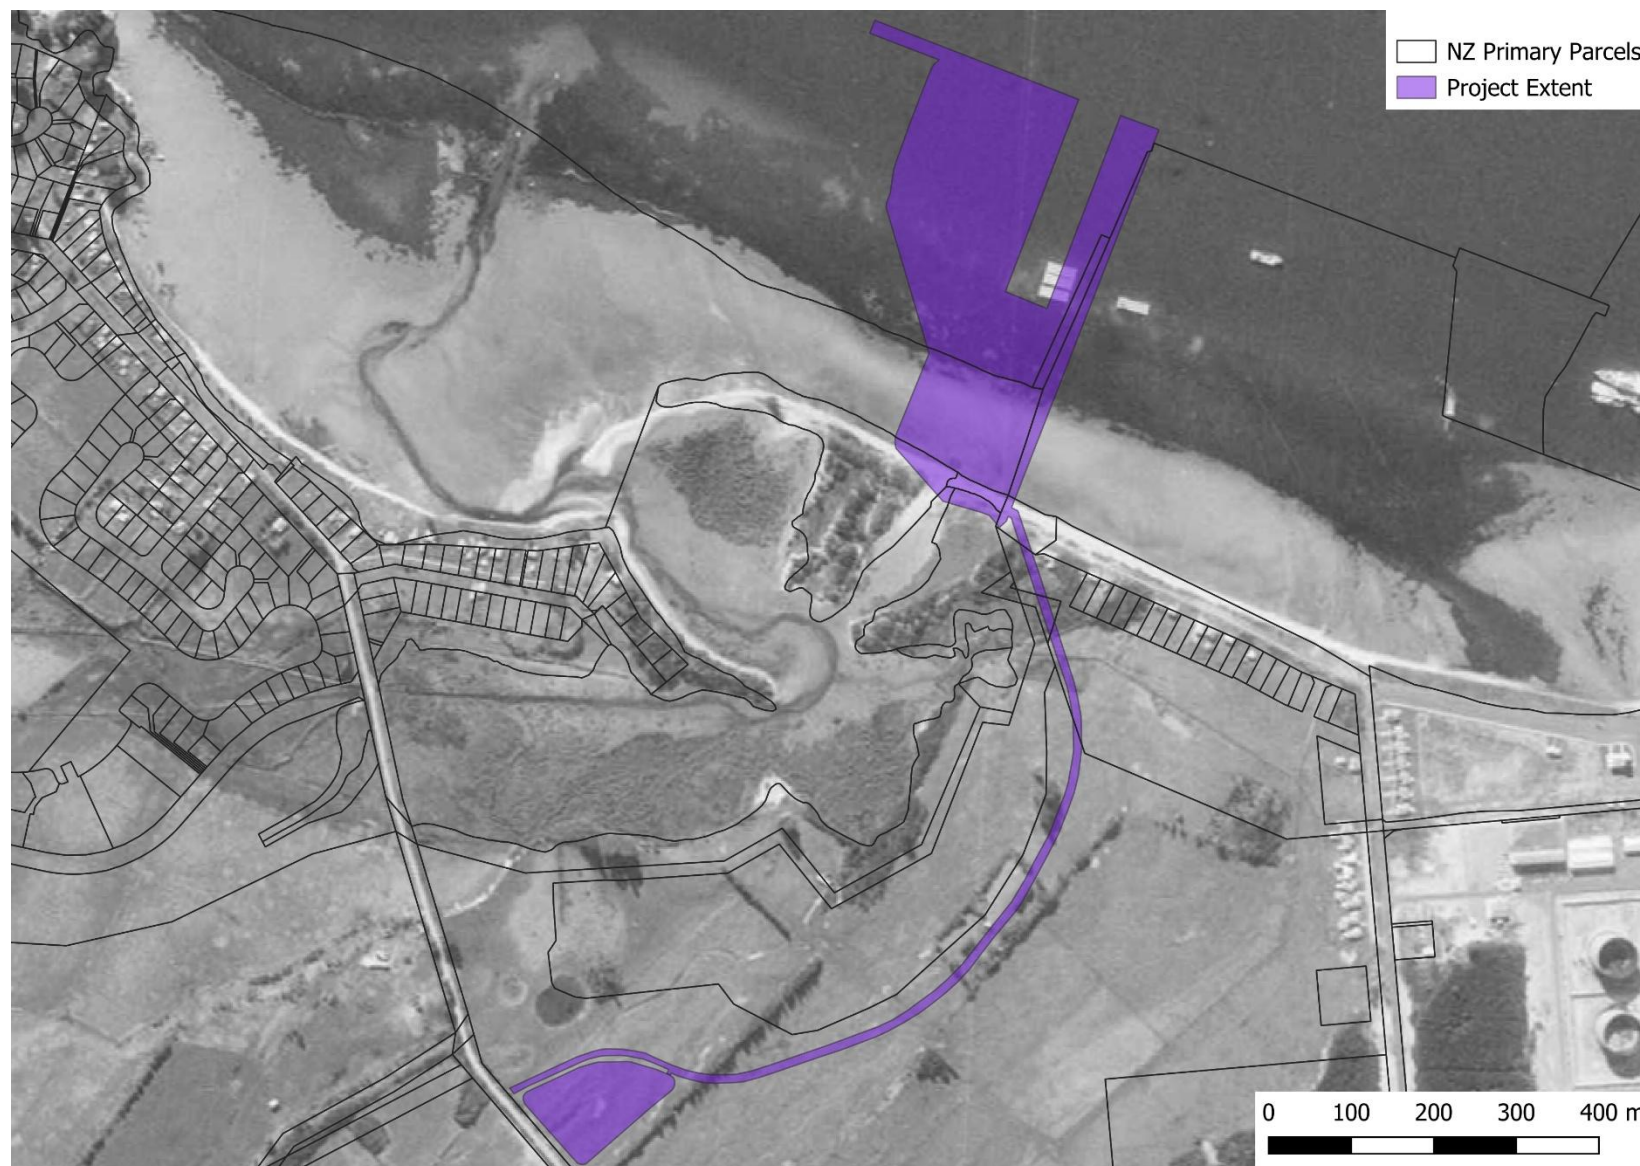
**Figure 13. Georeferenced aerial photograph, dated 1966, in relation to the proposed project extent (source: Retrolens SN1875-5032-18)**

The 1966 aerial (Figure 13) shows the growth of hedges in the area. A drain on the eastern side of the carpark appears to have been abandoned, but a new drain has been cut further to the west.

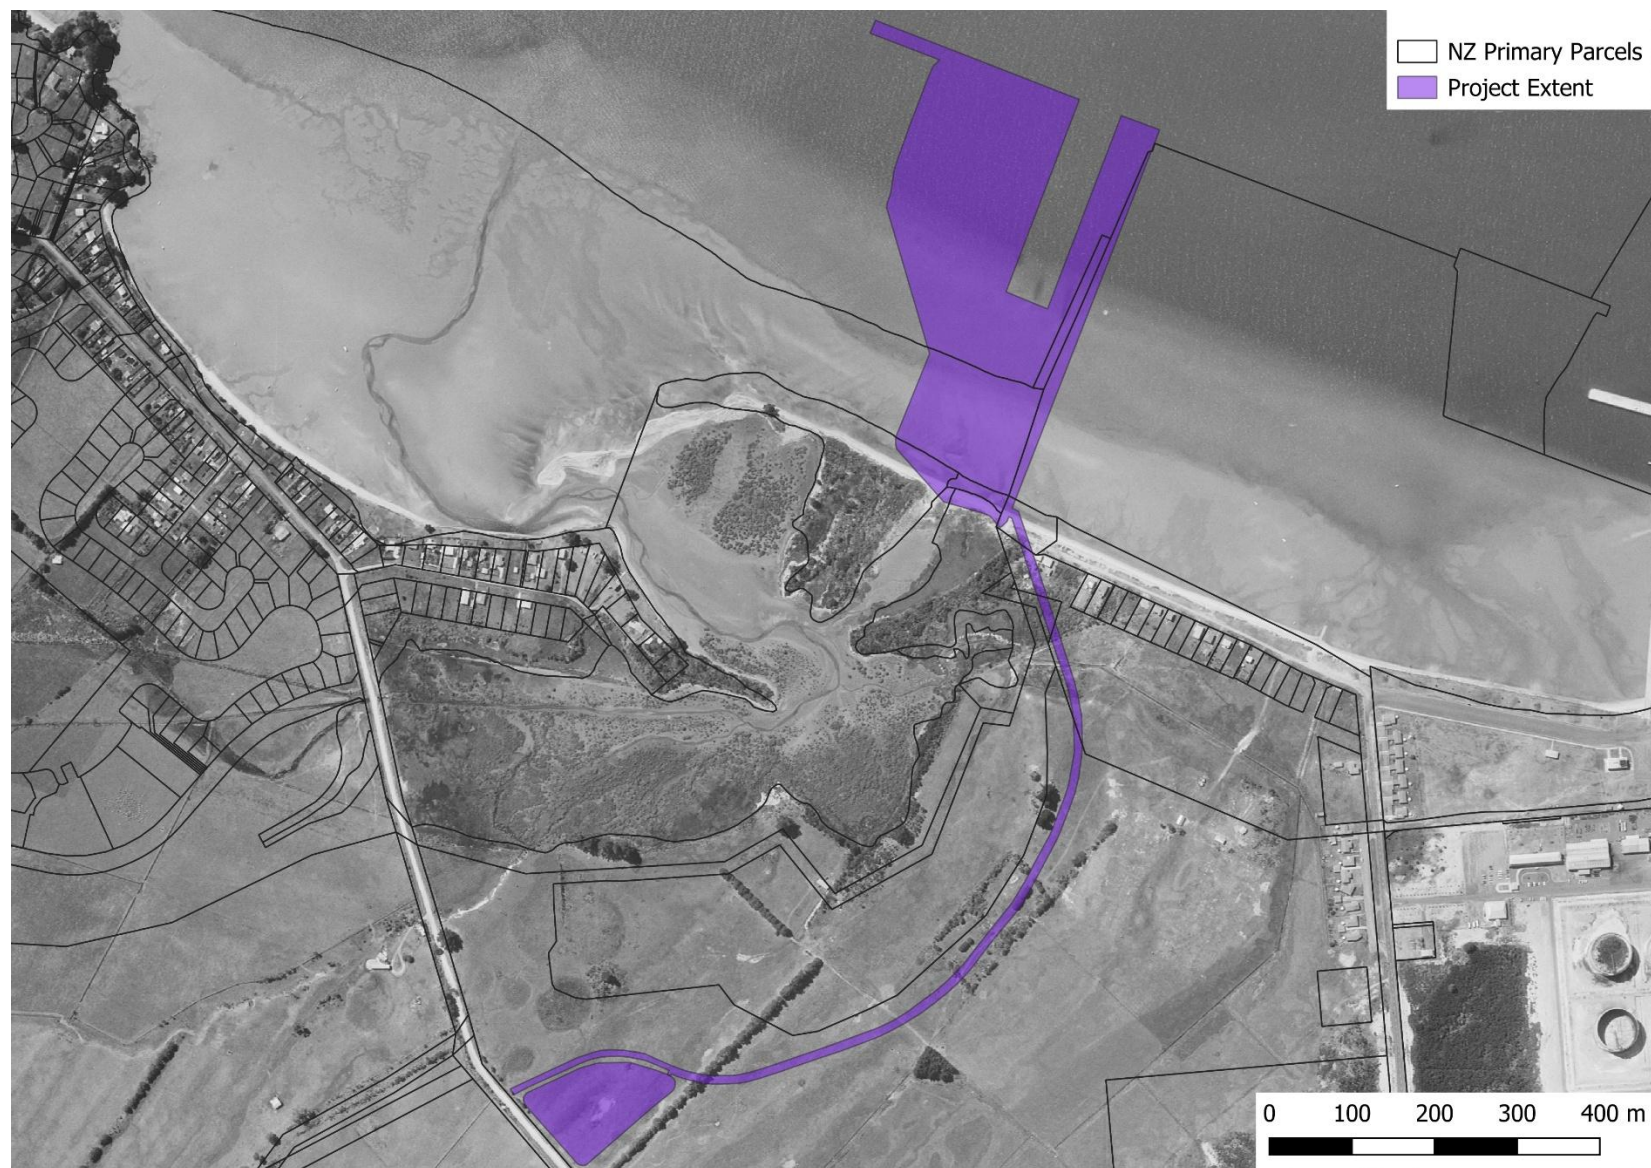
**Figure 14. Georeferenced aerial photograph, dated 1971, in relation to the proposed project extent (source: Retrolens SN3292-4414-14)**

By 1971 (Figure 14), the house situated in close proximity to the proposed access road had been removed, with evidence of drainage clearance and removal of scrub vegetation from the pasture.

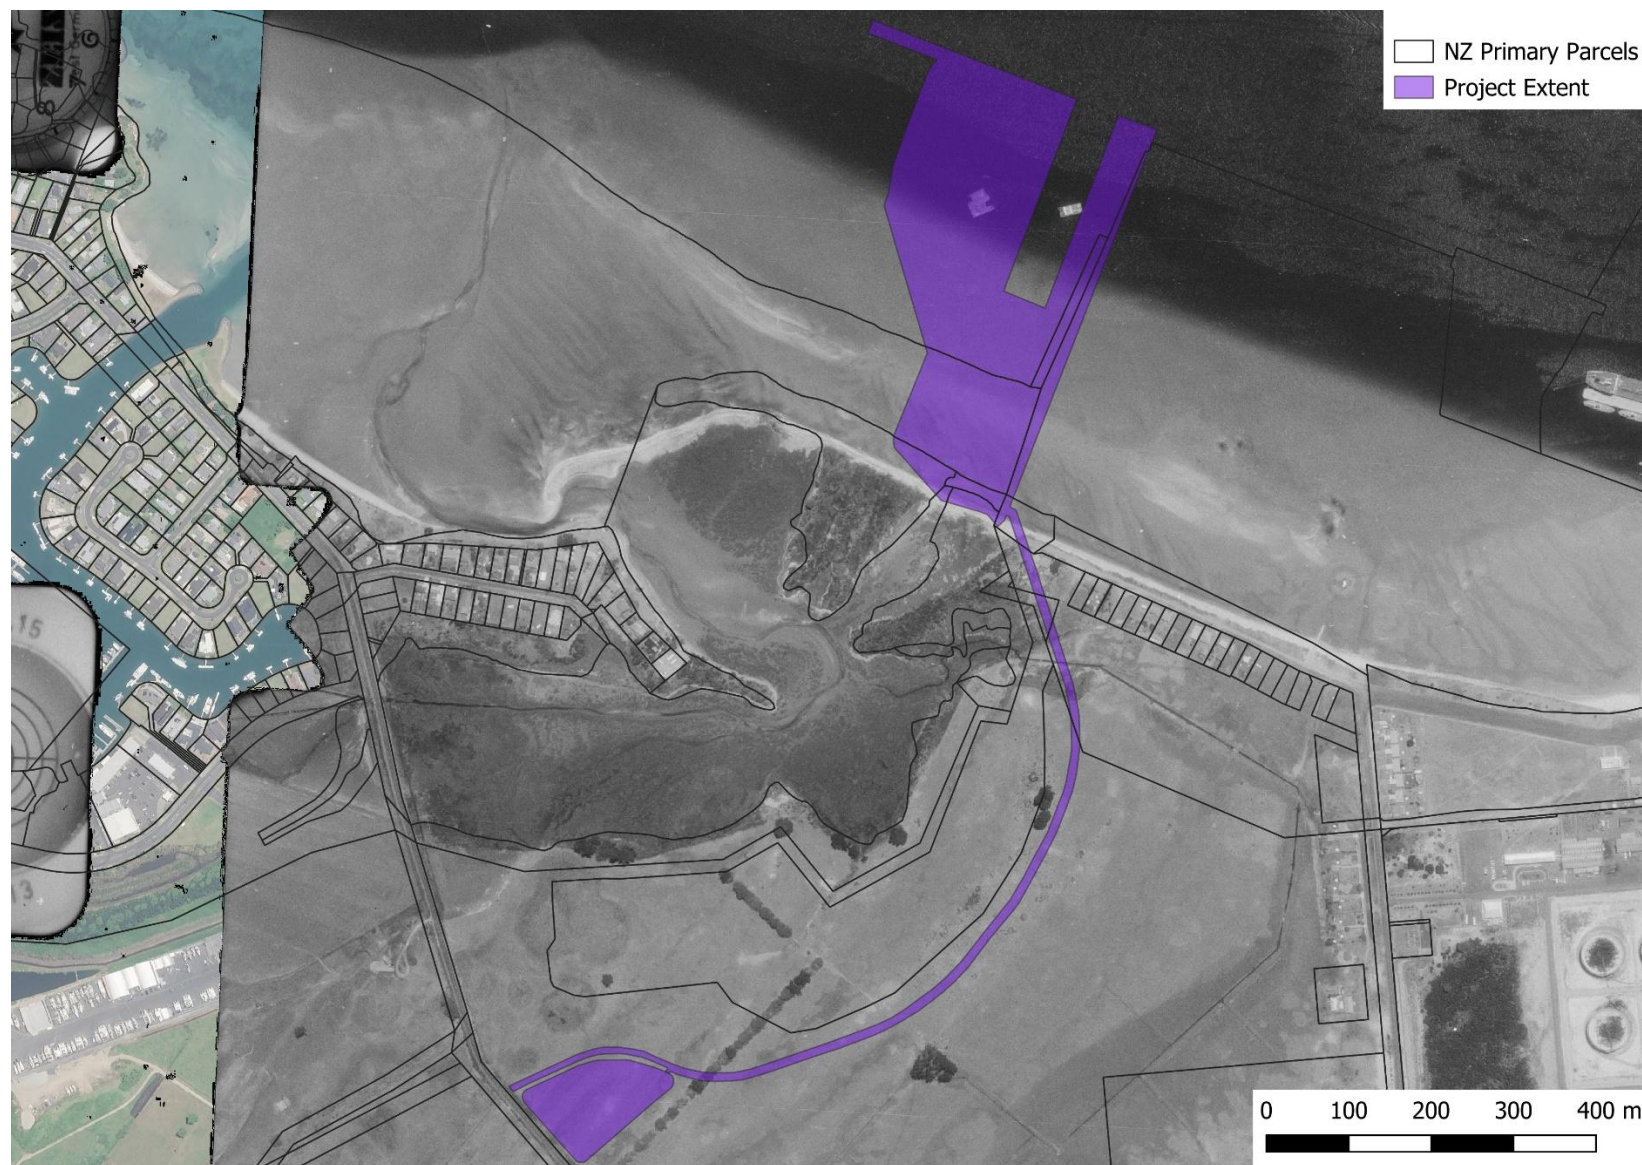
**Figure 15. Georeferenced aerial photograph, dated 1979, in relation to the proposed project extent (source: Retrolens SN5091-K-91)**

By 1979 (Figure 15), all trace of the house and outbuildings had been removed, and much of the landside area of works remained in pasture. The beachfront appears to have eroded southwards by this time and barely intersects the area of reclamation.

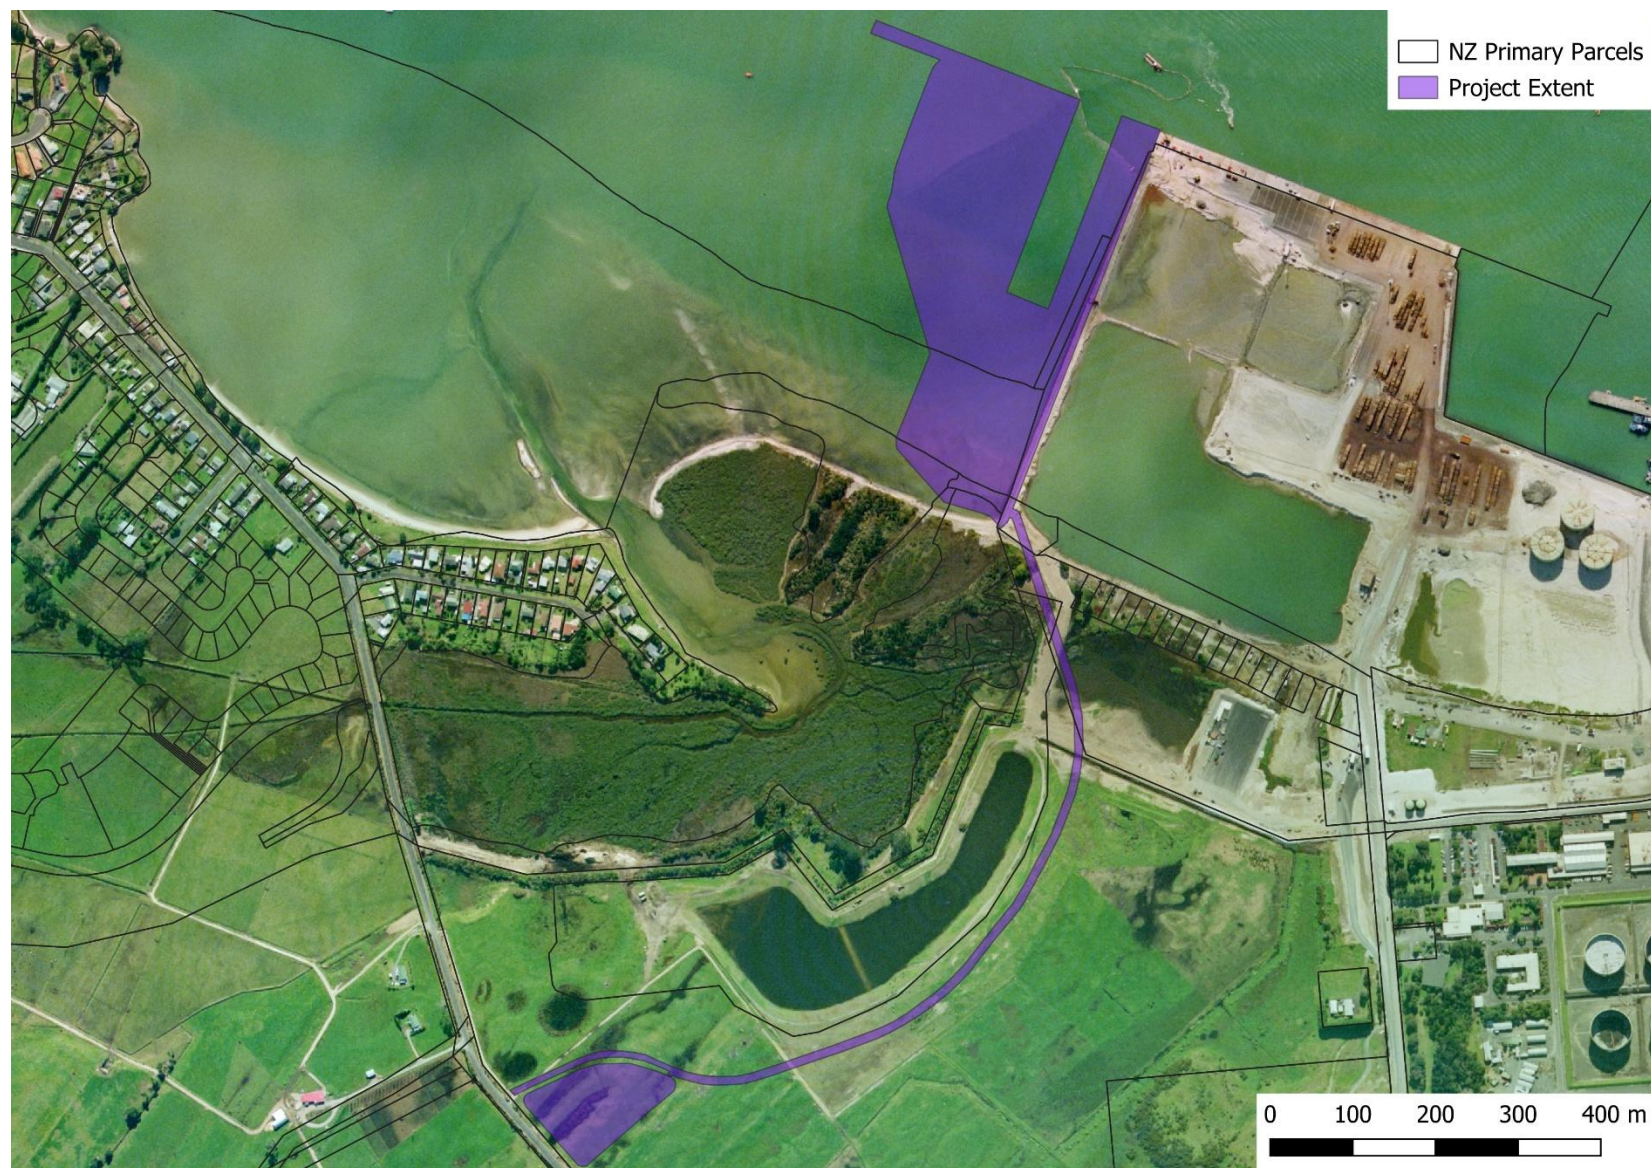
Figure 16. Georeferenced aerial photograph, dated 2004, in relation to the proposed project extent (source: Retrolens SN3292-4414-14)

The 2004 aerial (Figure 16) shows development of Northport underway. The beachfront had changed alignment and retreated further south. A large stormwater pond had been formed, and works had modified parts of the access road alignment. The carpark area remained largely unmodified.

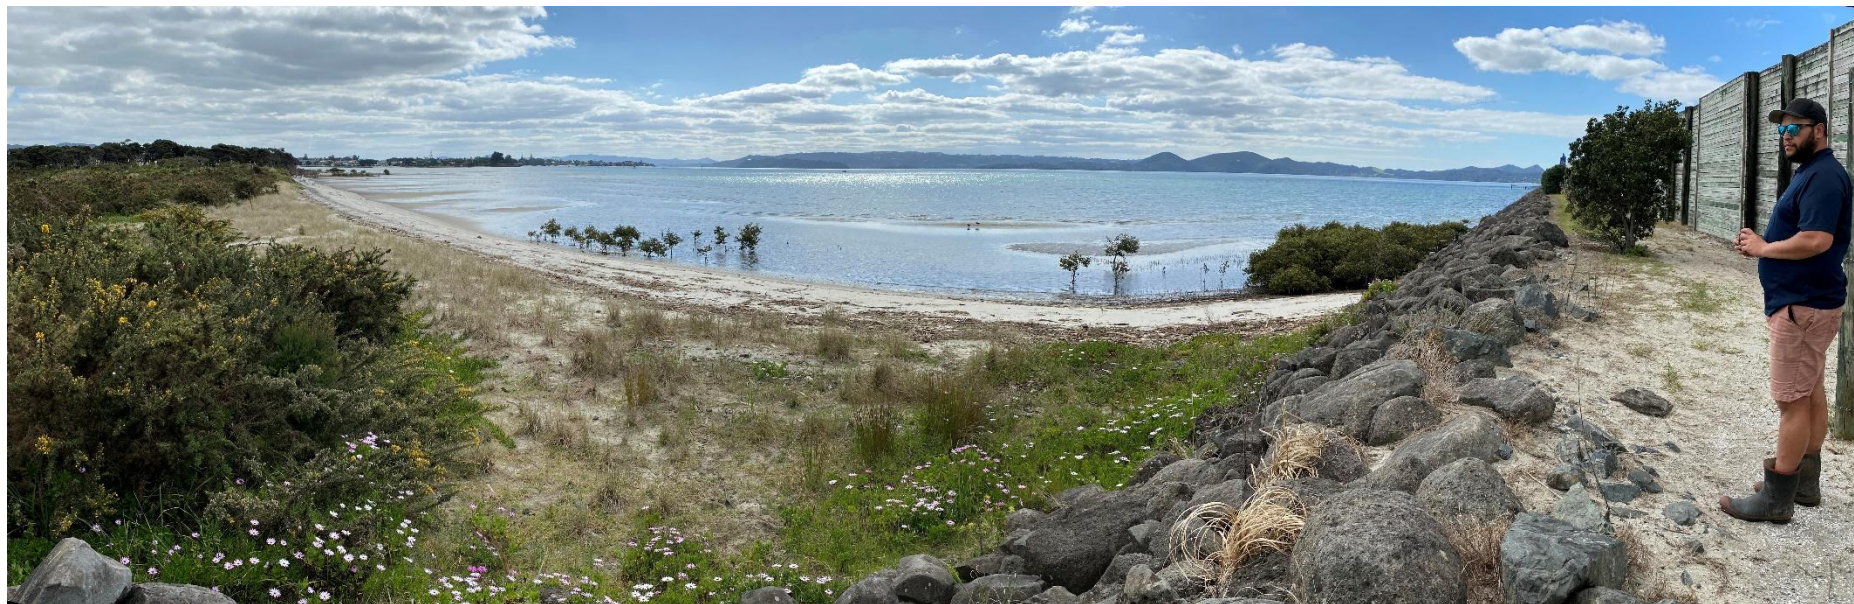
During the survey the beach and beachfront dune environments were examined (Figure 18 to Figure 22), both around the intersection of the beach with the port facility and further to the west. It was noted that the gorse covering had increased in the intervening years which impeded access into the dune environment, although it does appear to have stabilised the dunes to some extent. Some dune sections were eroding and these were inspected (Figure 22).

Figure 18. Stitched panorama with a view from west to north showing Northport at right (September 2020)

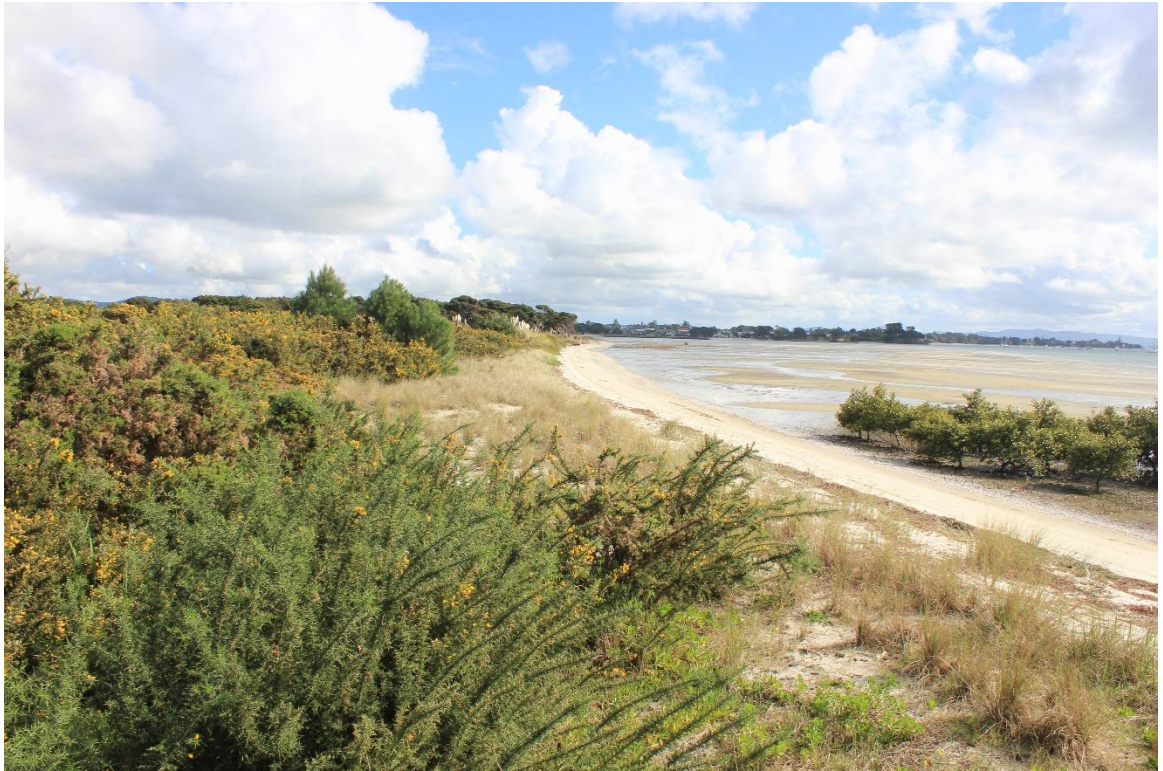
**Figure 19. View showing the current beachfront (May 2026)**

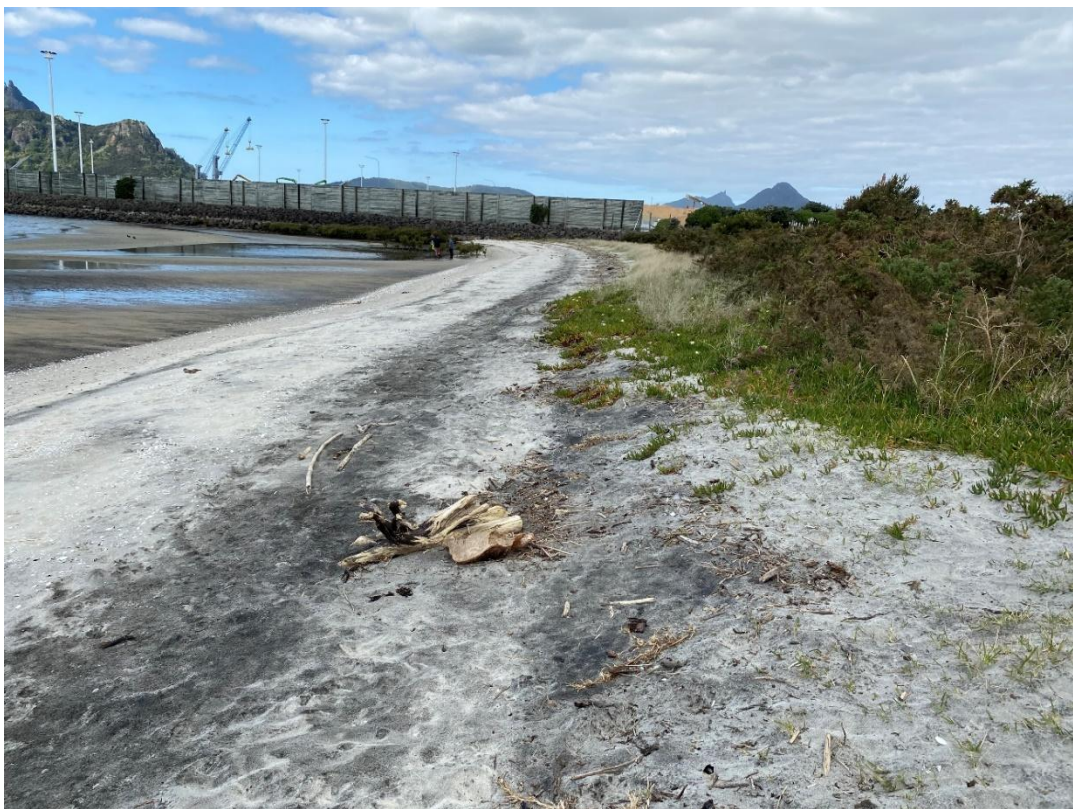
**Figure 20. View facing east along the beach towards Northport (September 2020).**

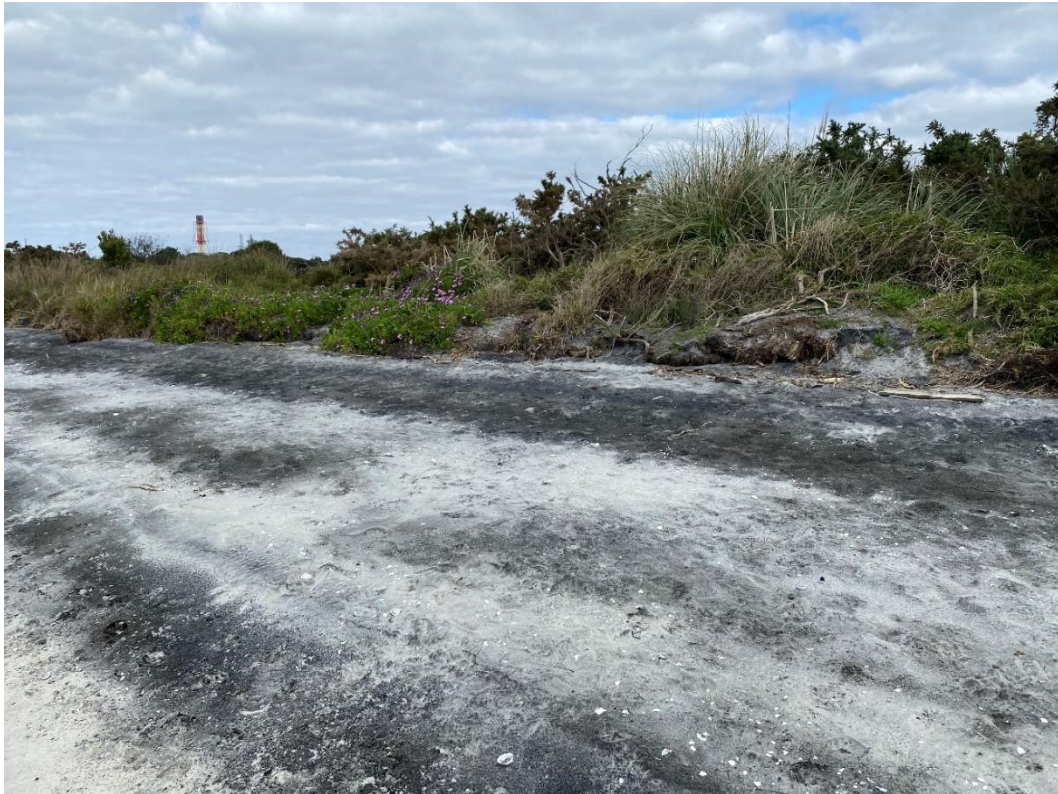
**Figure 21. View showing an example of the beach dunes (September 2020).**

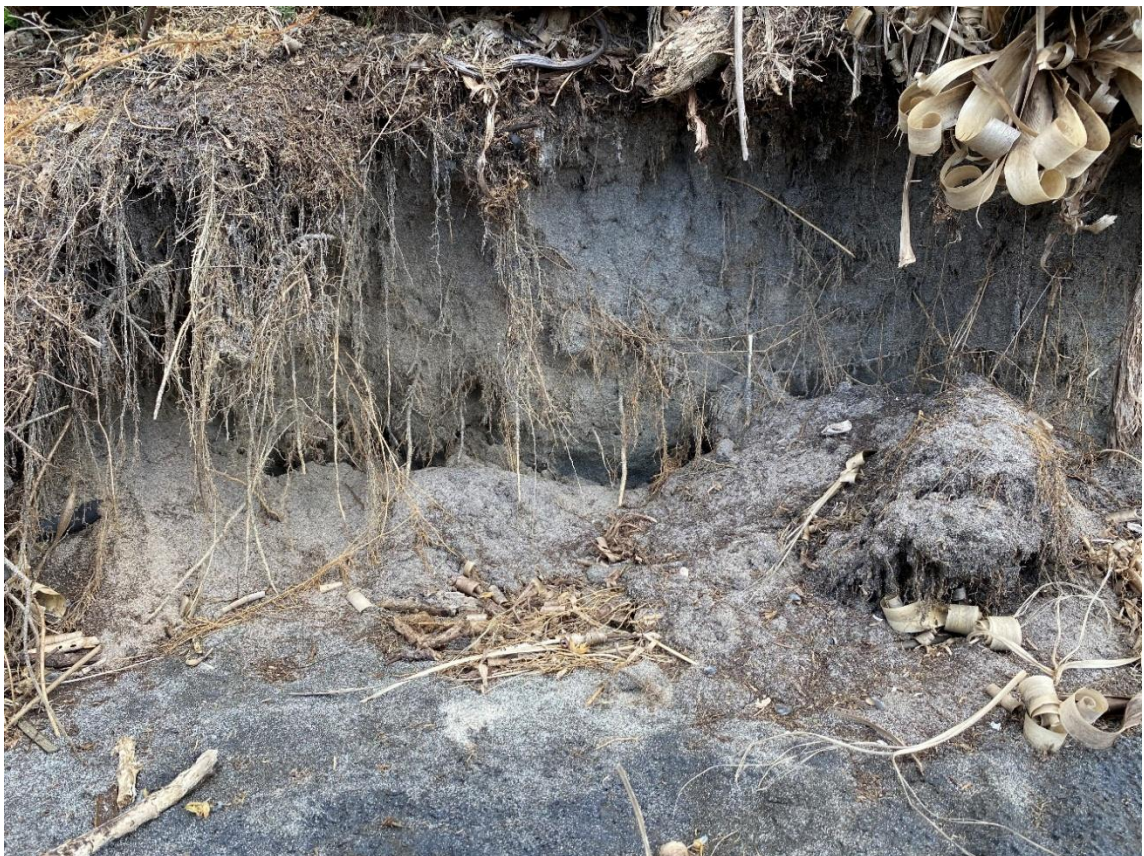
**Figure 22. View showing example dune profile (September 2020).**

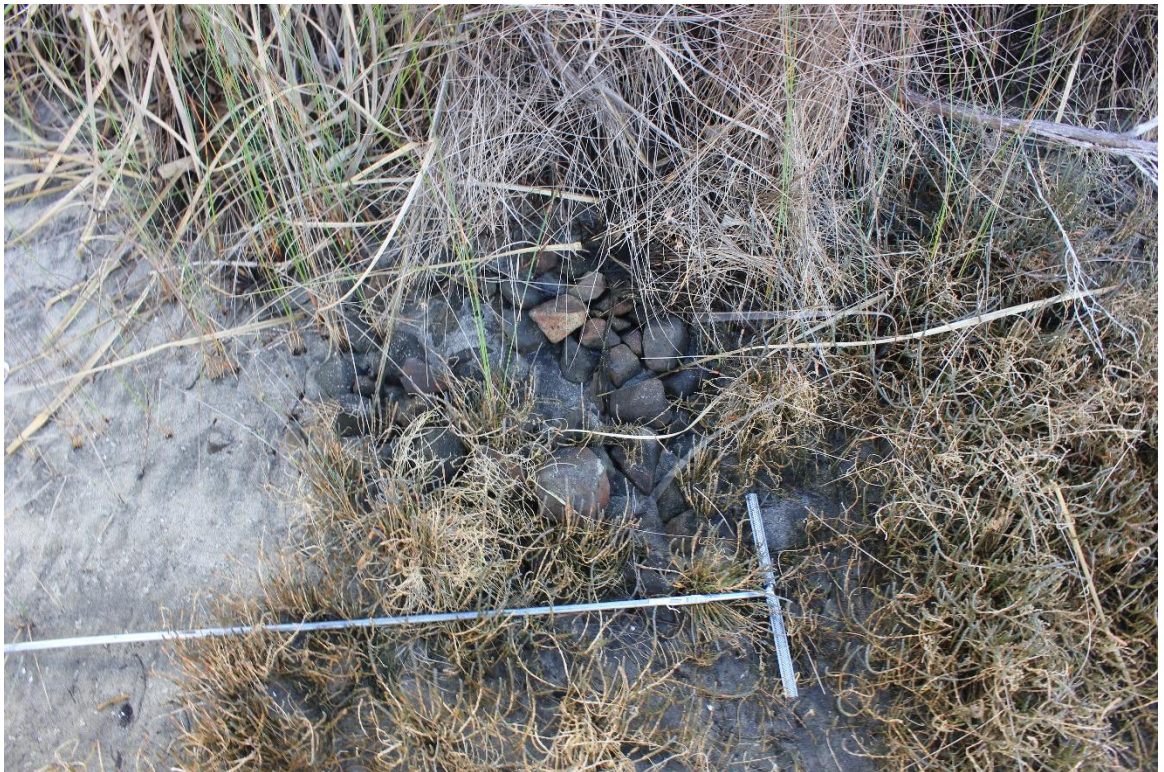
**Figure 23. View shingle eroding hangi deposit, part of Q07/108 (May 2026)**

- Nevertheless, if subsurface archaeological evidence is encountered during construction (for example intact shell midden, hangi, storage pits associated with Māori occupation, or cobbled surfaces, brick or stone foundations, or rubbish pits associated with nineteenth-century European activity), works should cease in the immediate vicinity of the find and Heritage New Zealand Pouhere Taonga and the Council should be notified.

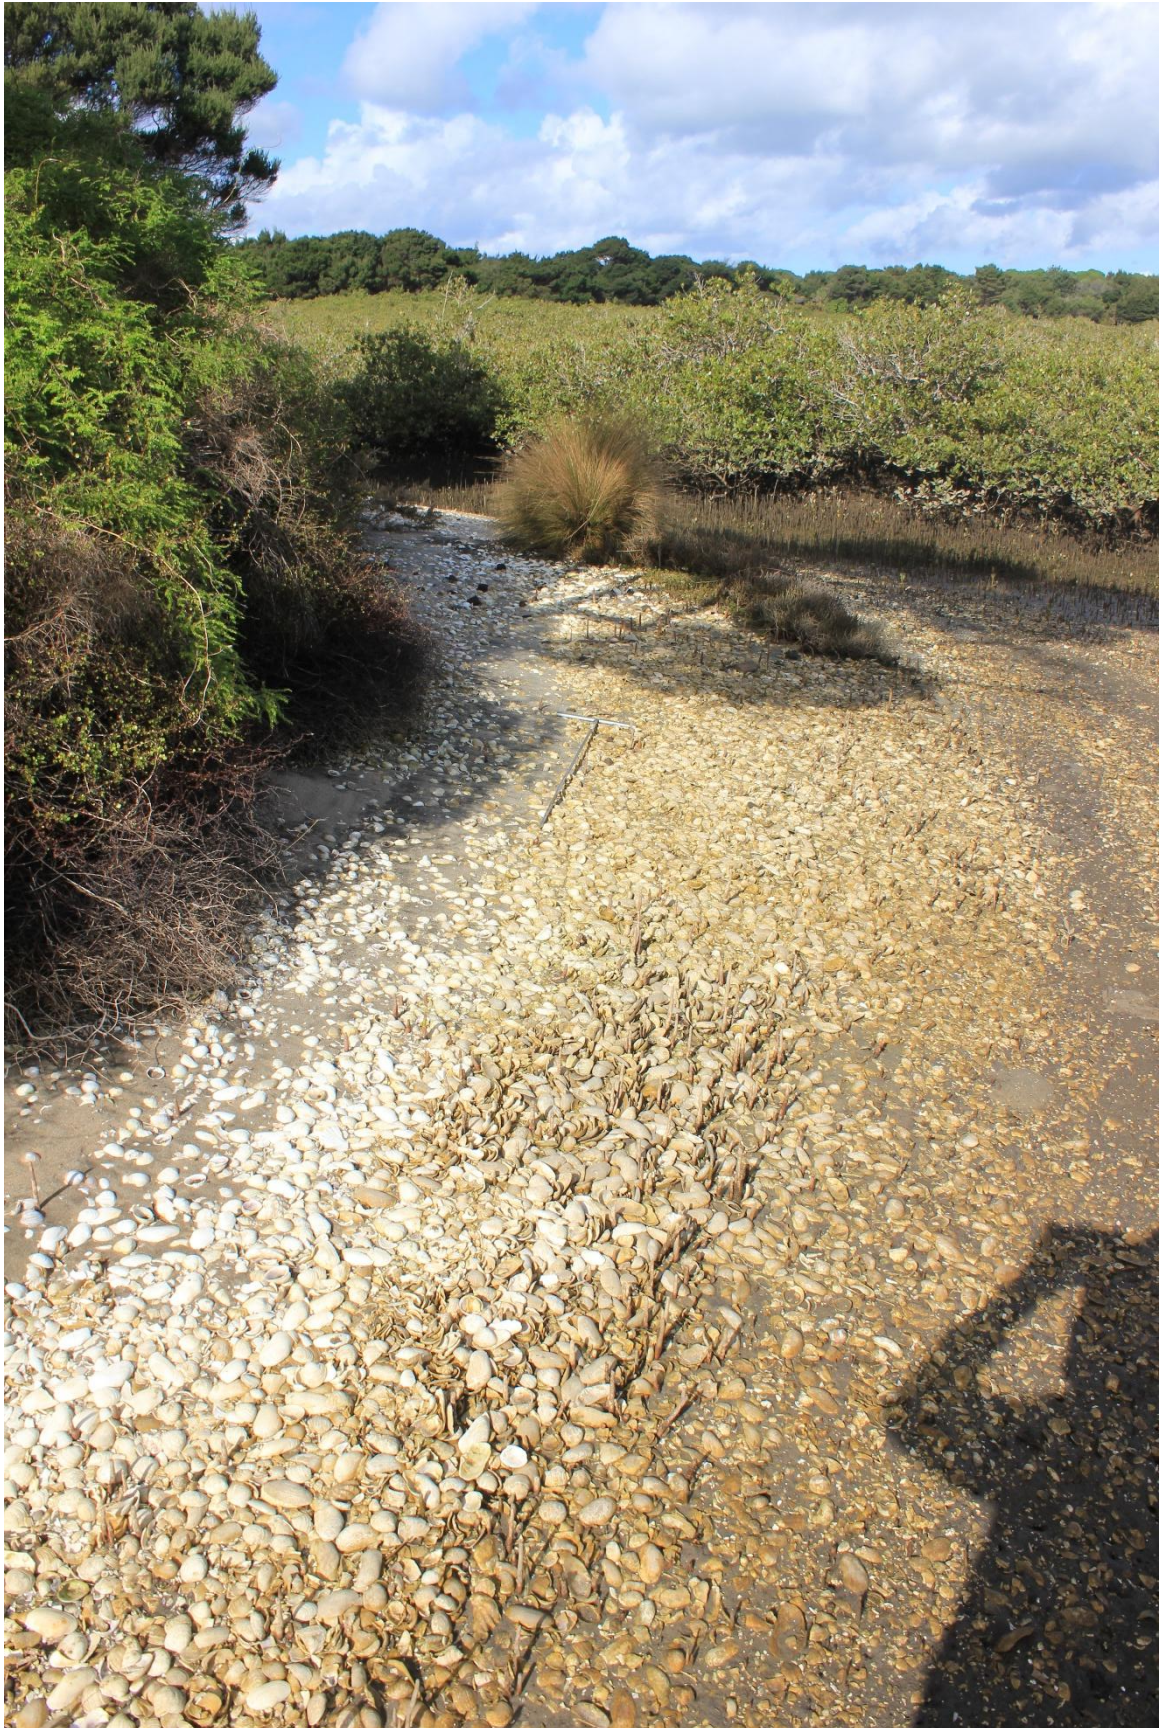
**Figure 24. View facing east showing eroding midden (Q07/108) mingling the natural shell. This spread contains burnt rock and shell material and chert fragments (May 2026)**

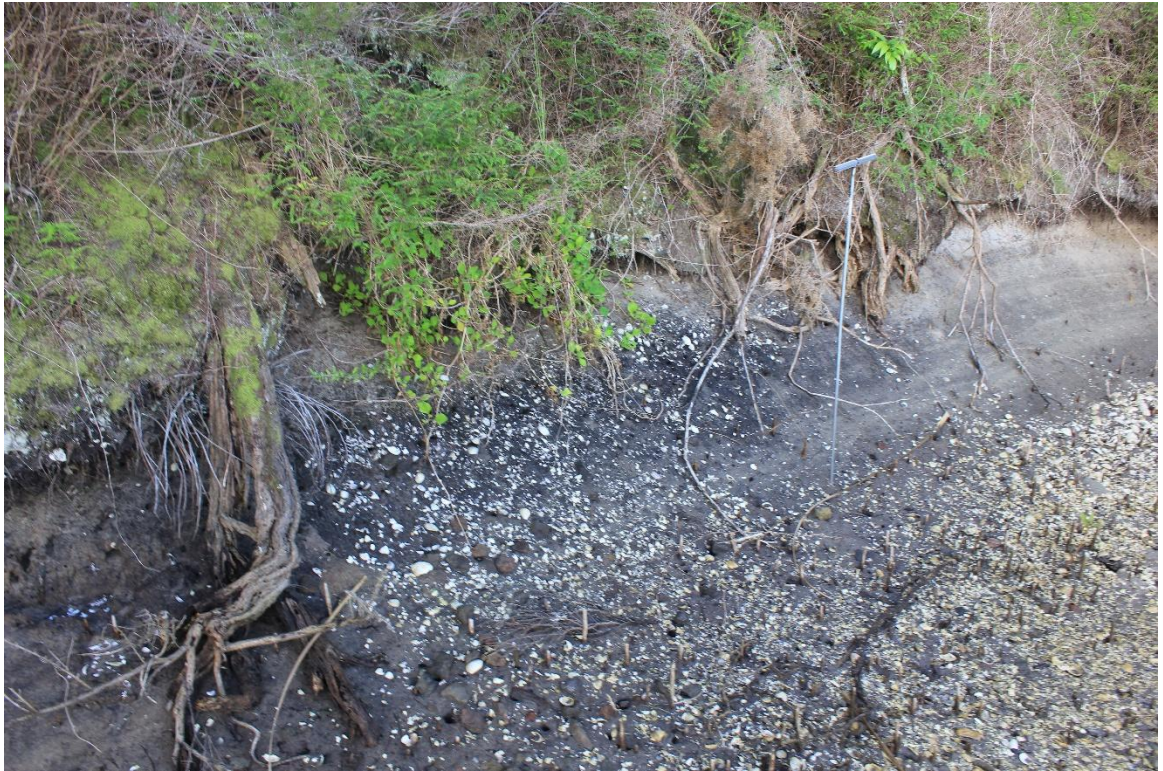
**Figure 25. View showing eroding midden from Q07/108 (May 2026)**

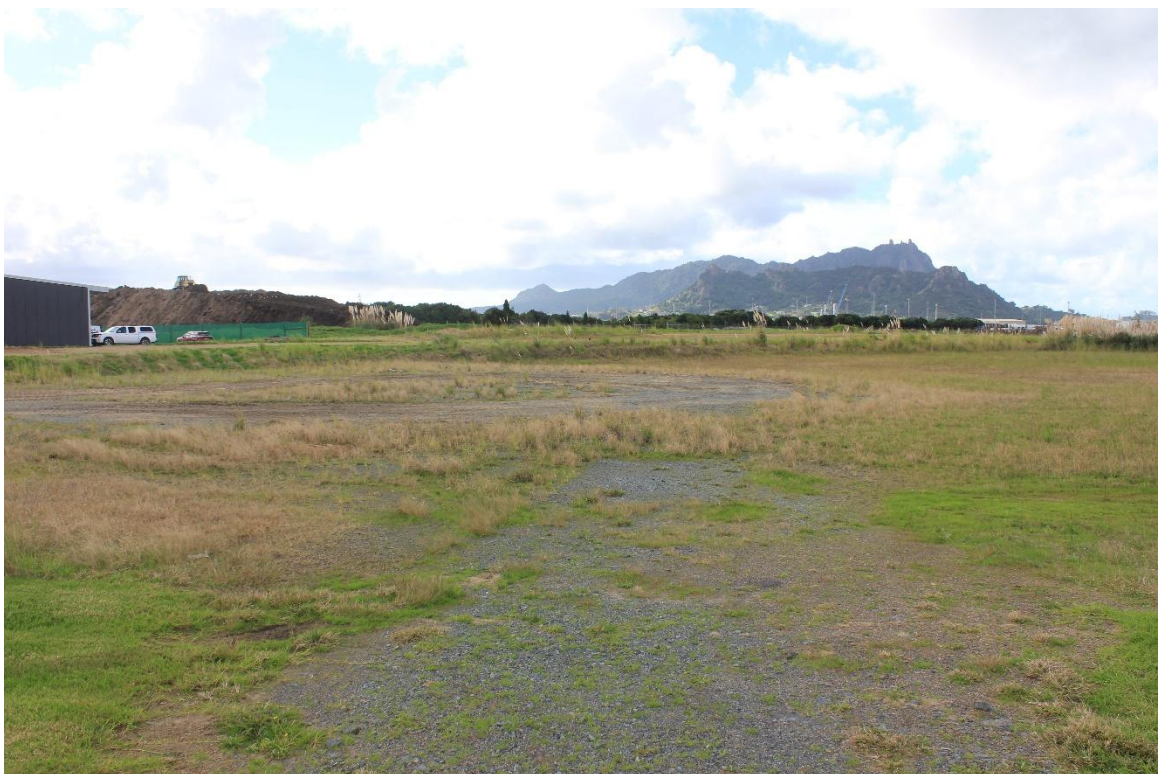
**Figure 26. View showing the carpark location (May 2026)**
