RCL Henley Downs Limited

# 786 KINGSTON ROAD, QUEENSTOWN PRELIMINARY SITE INVESTIGATION

4 APRIL 2025

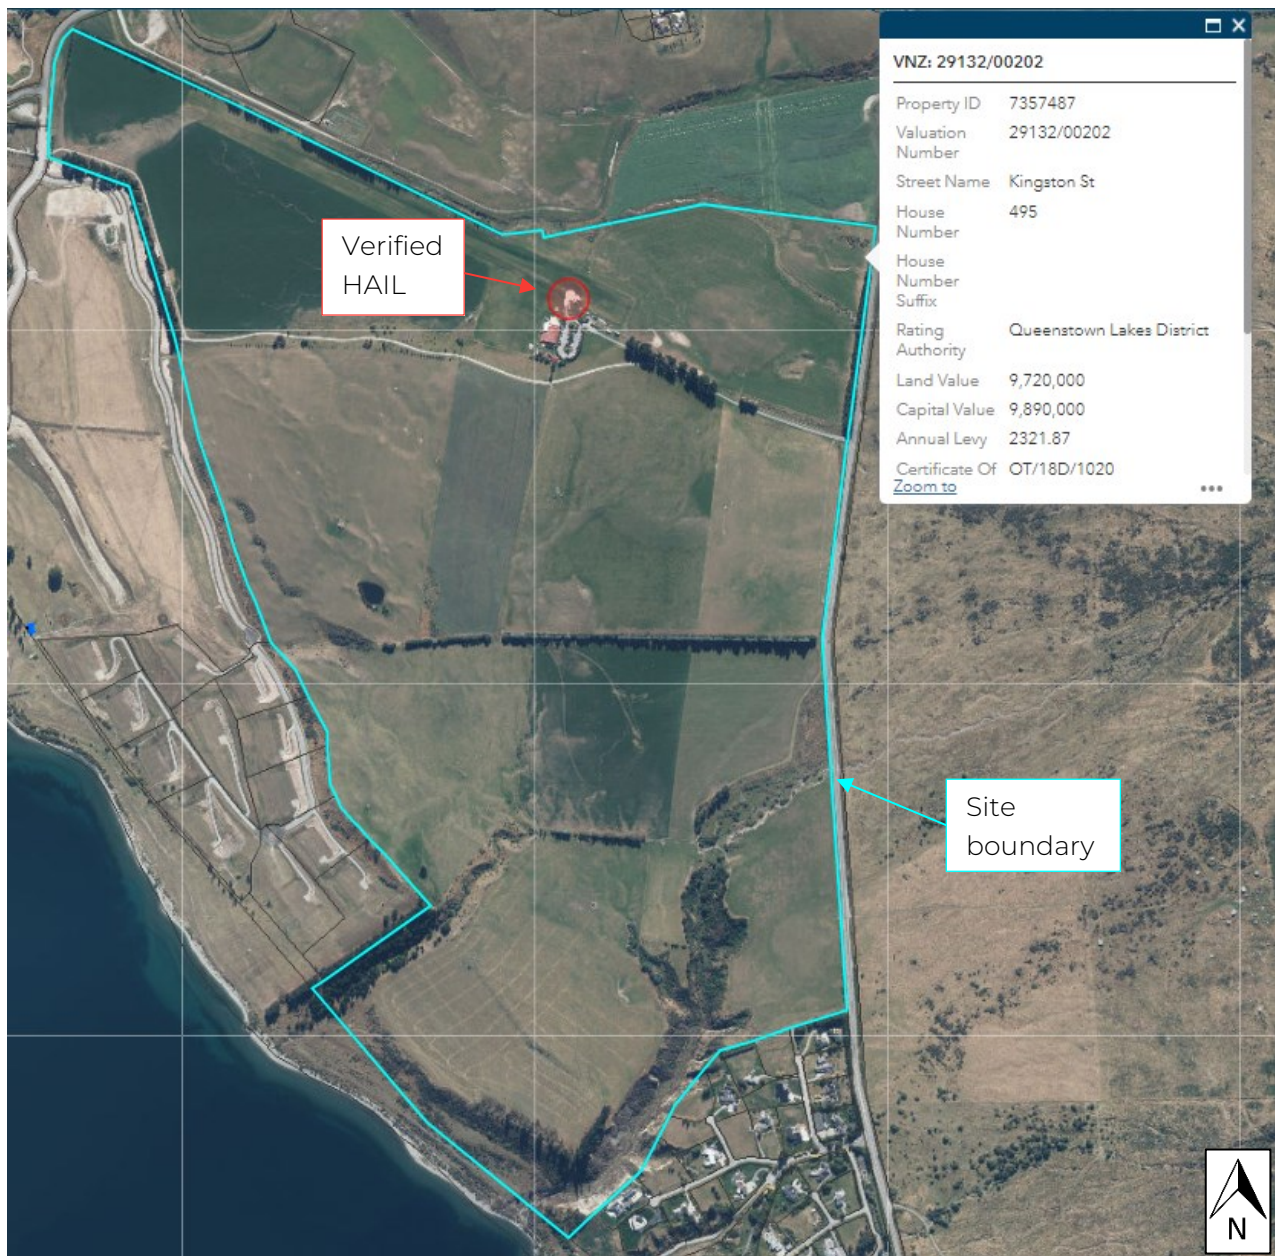
Figure 4: Extract of ORC LLUR

A review of the online Land Use register held by ORC was completed initially in May 2023 and again in January 2025. The updated review has revealed that parts of the site are recorded as HAIL, some verified (red) and some unverified (pink) (Otago Regional Council, 2023). Details of the HAIL activities can be found in Table 5 below, with the HAIL locations indicated on Figure 4.

HAIL.00855.02 786 Kingston Road Fertiliser Storage	A6: Fertiliser manufacture or bulk storage	Anecdotal evidence suggests that bulk storage of fertiliser may have occurred within HAIL.00855.02.	Unverified HAIL – Not Investigated

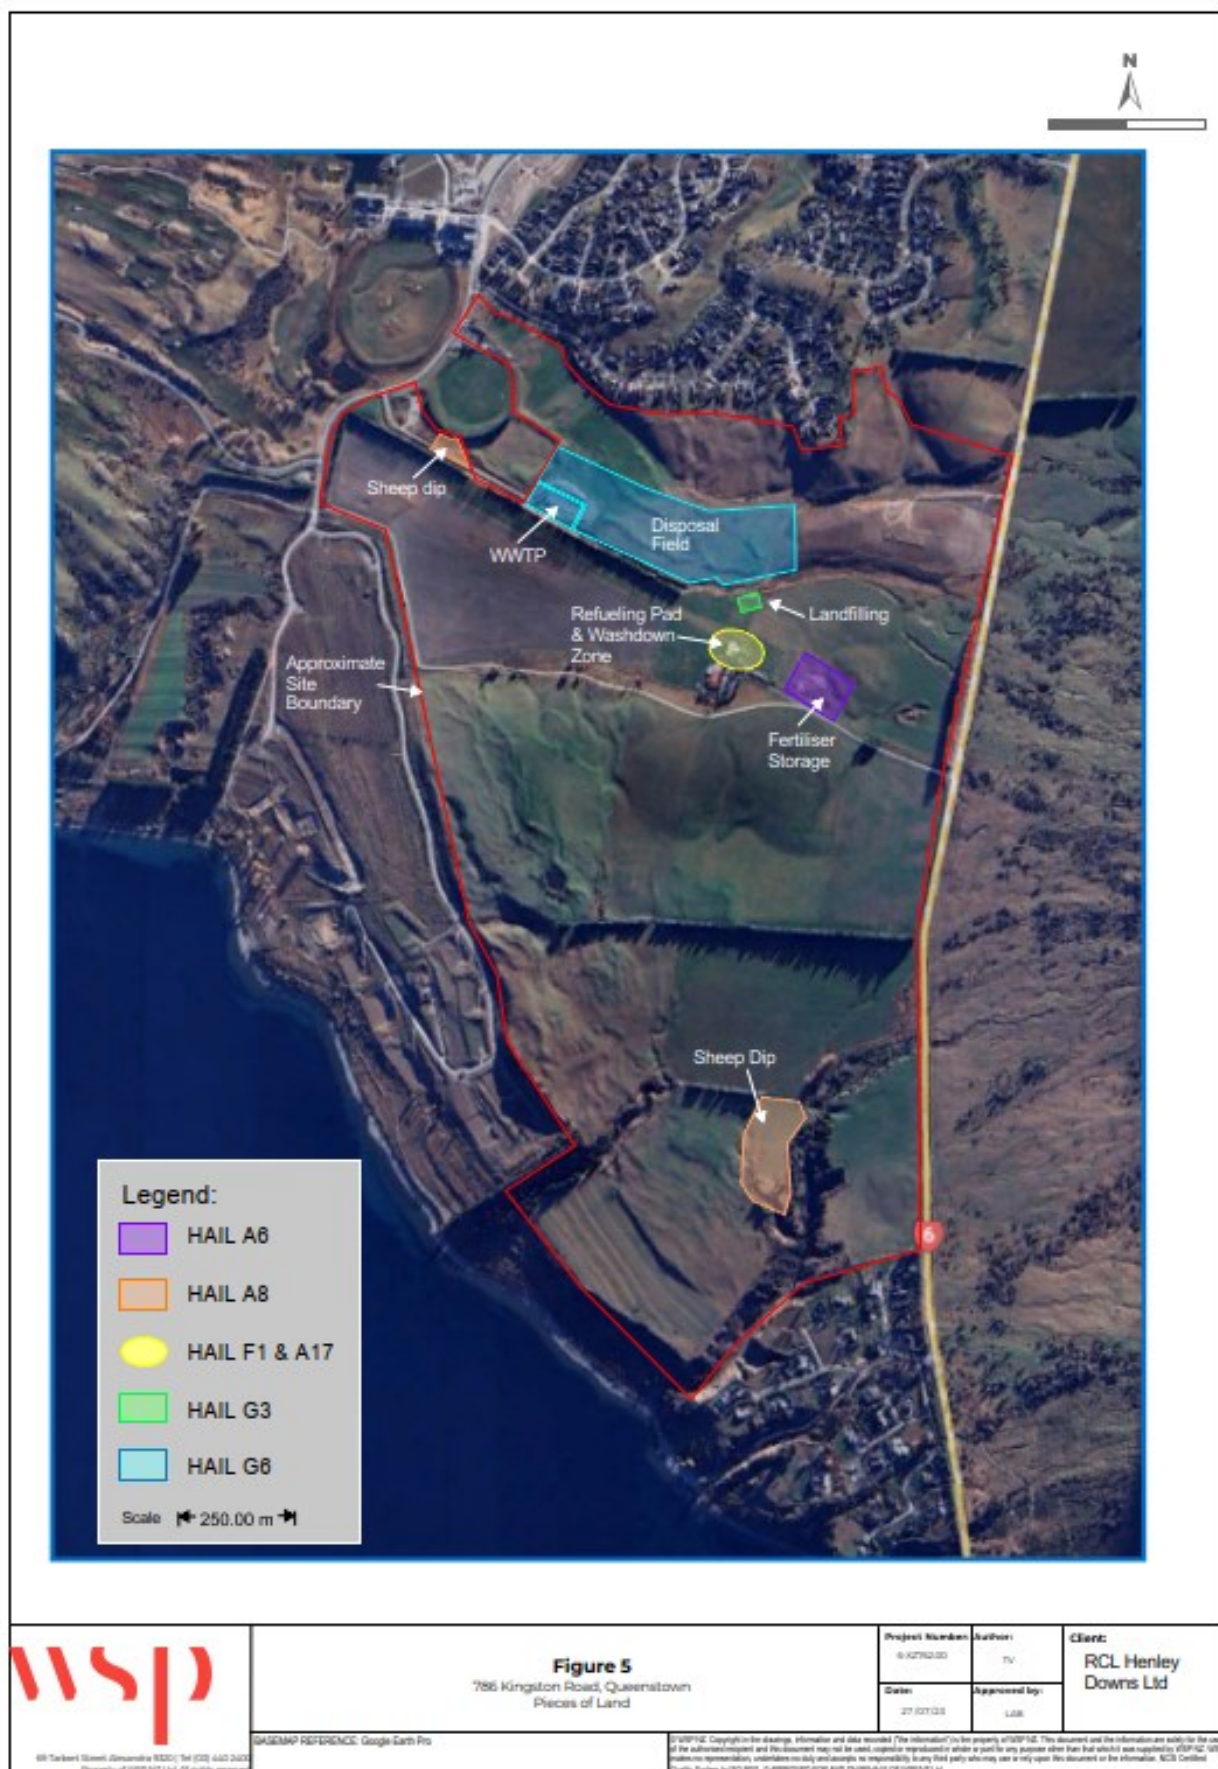
Figure 5: Pieces of Land.

As it is considered more likely than not that HAIL activities have (historically) occurred on various parts of the site, several Pieces of Land (PoL) have been delineated in accordance with Regulation 5(7)(c) of the NESCS (Ministry for the Environment, 2011c) refer to Figure 5 below.

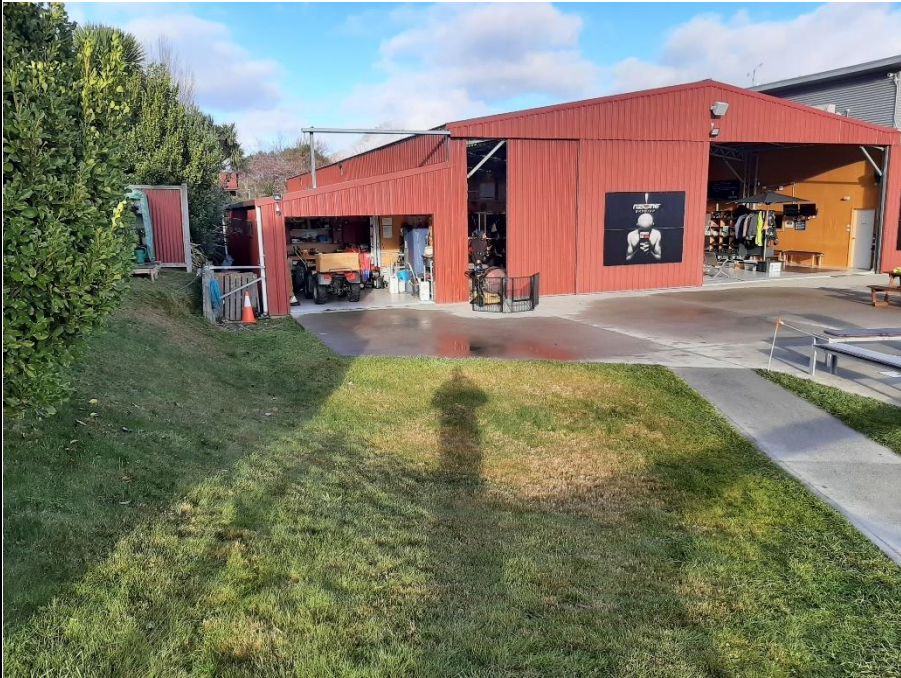
Photo No.	Date	
2	30/06/2023	
<b>Description</b> <p>A refueling pad with above ground fuel storage tank where noted associated with the skydiving facilities.</p>

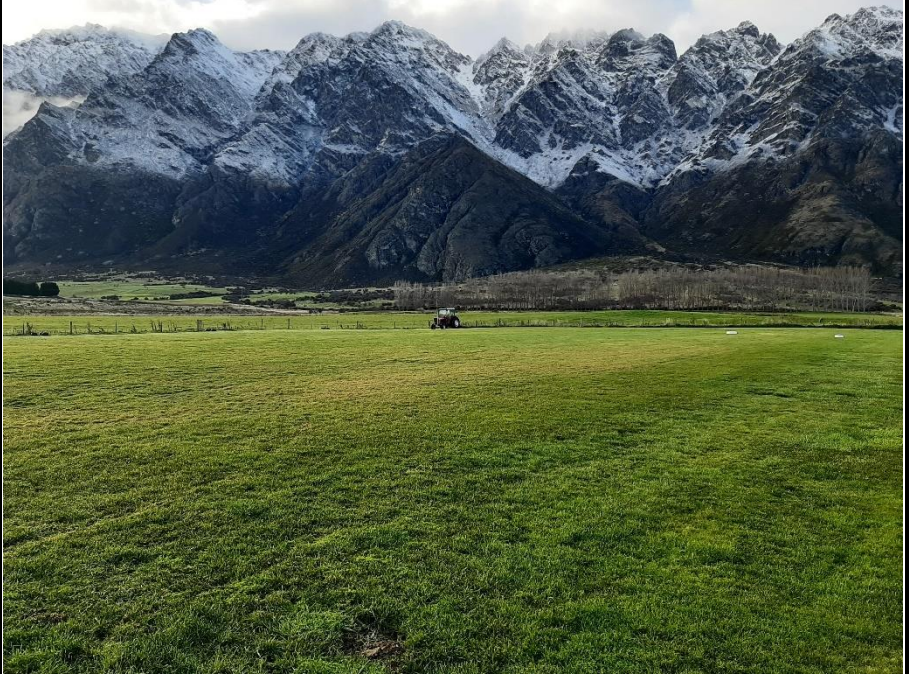
Photo No.	Date	
3	30/06/2023	
<b>Description</b> <p>The Remarkables mountain range can be seen east of the site.</p> <p>The majority of the site comprises rural land used for livestock grazing and hay baling.</p>

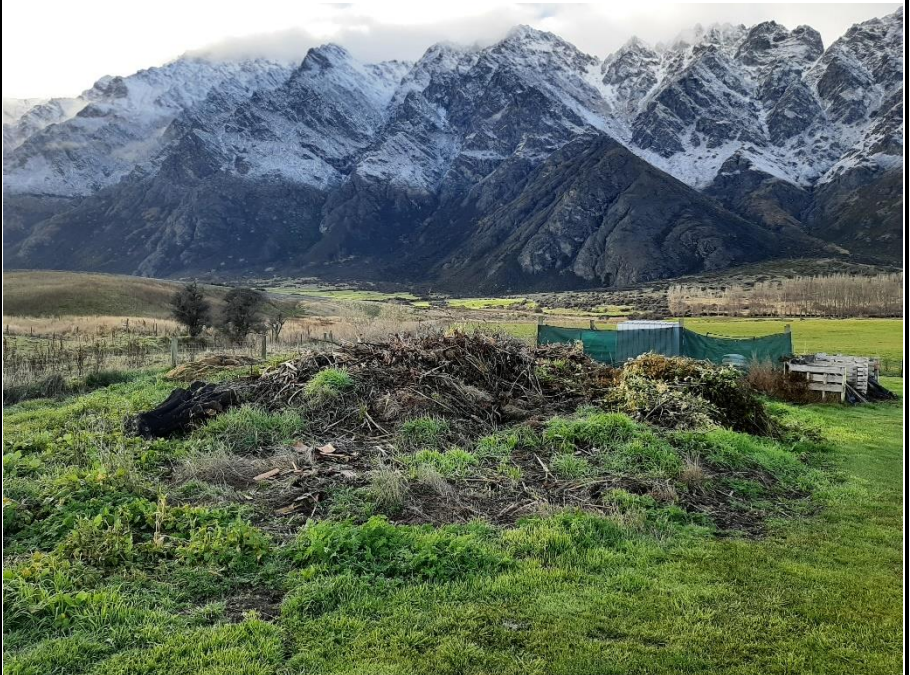
Photo No.	Date	
4	30/06/2023	
<b>Description</b> <p>Photograph no.4 shows the area along the northern boundary of the site (area B as referred to in the historical aerals 2019-current).</p> <p>Green waste disposal is noted.</p>

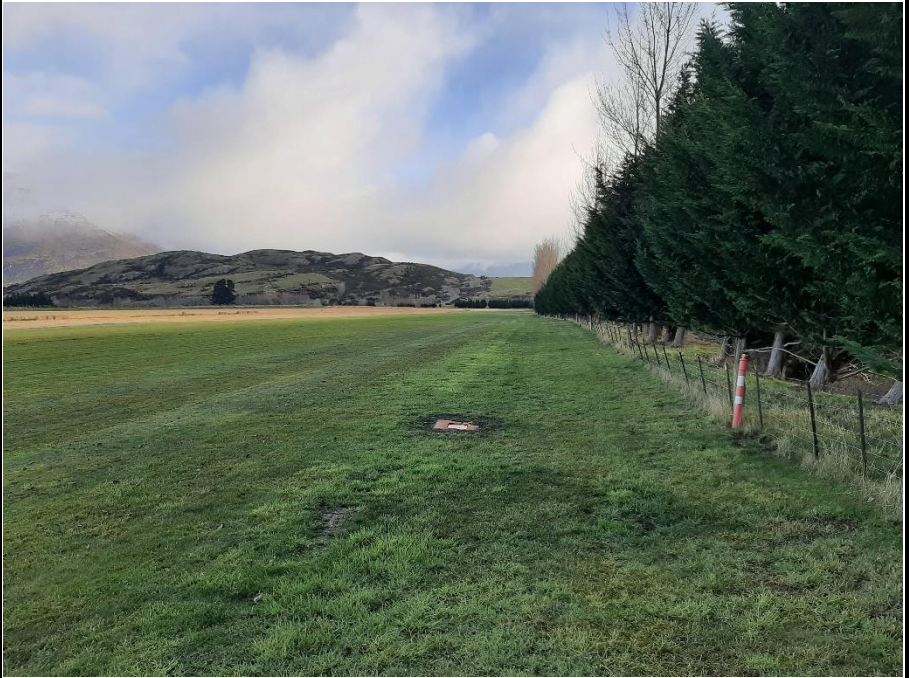
8	30/06/2023	
<b>Description</b> Photograph taken along the airstrip, north of the site. Access to water supply is noted in the center of the airstrip.

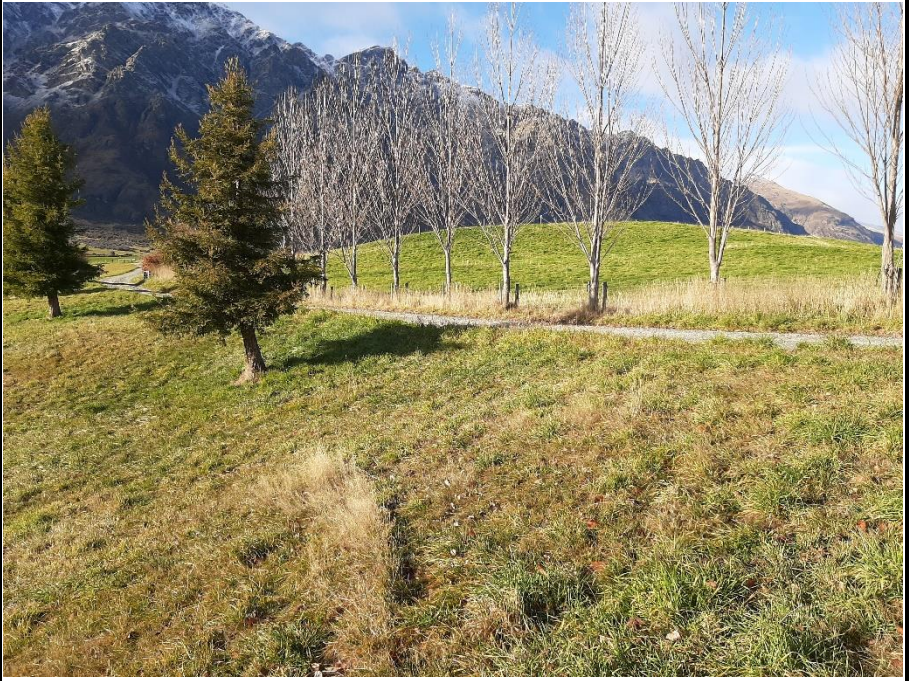
10	30/06/2023	
<b>Description</b> A gravel road crosses the site from Kingston Road in the east to Maori Jack Rd in the west. Photograph taken looking southeastwards.

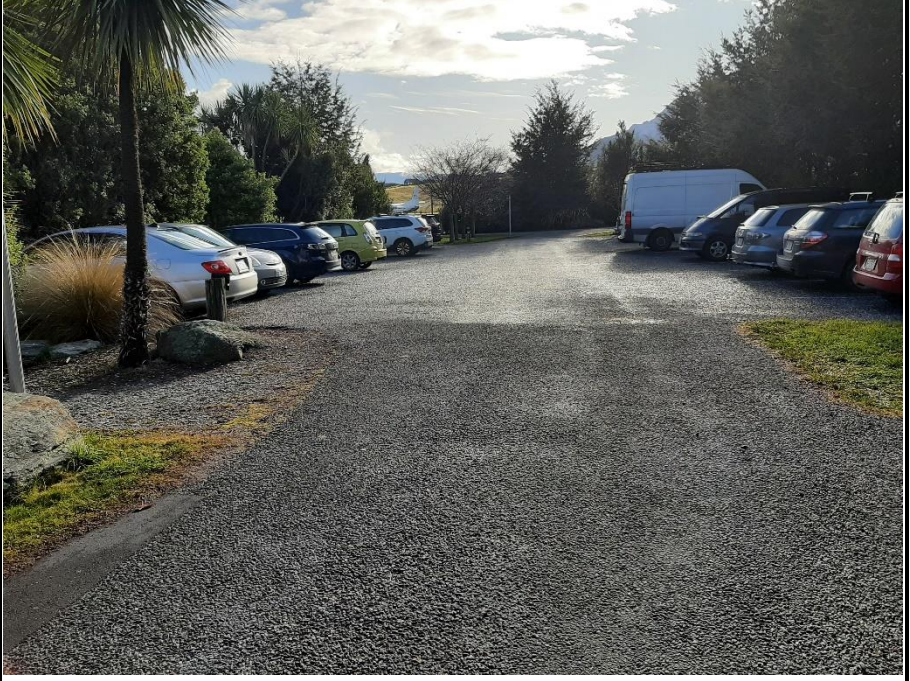
11	30/06/2023	
<b>Description</b> Picture showing the carpark area for the skydiving facilities.

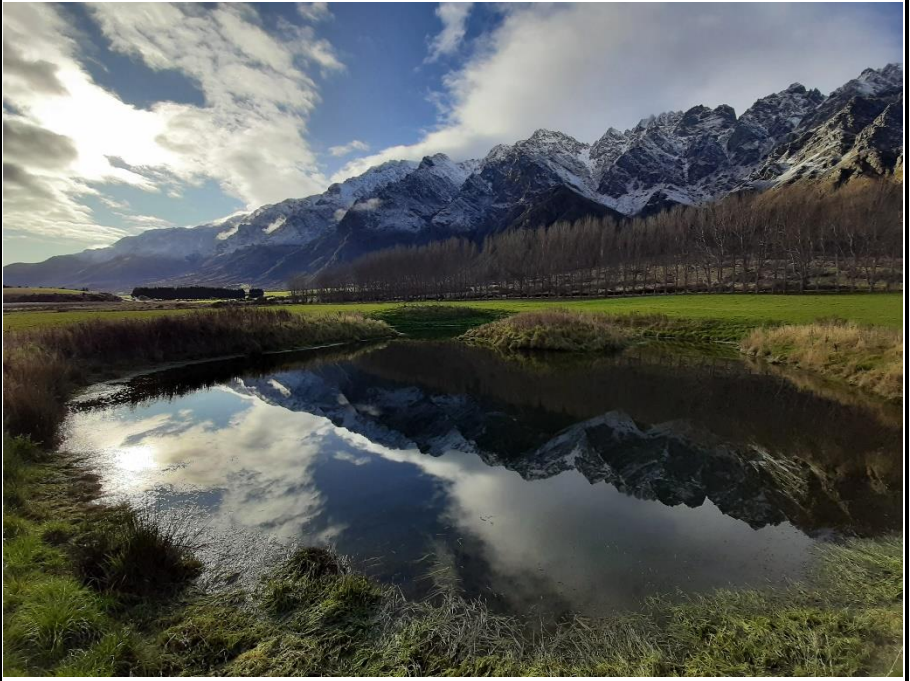
12	30/06/2023	
<b>Description</b> A pond is seen in the north-eastern part of the site.

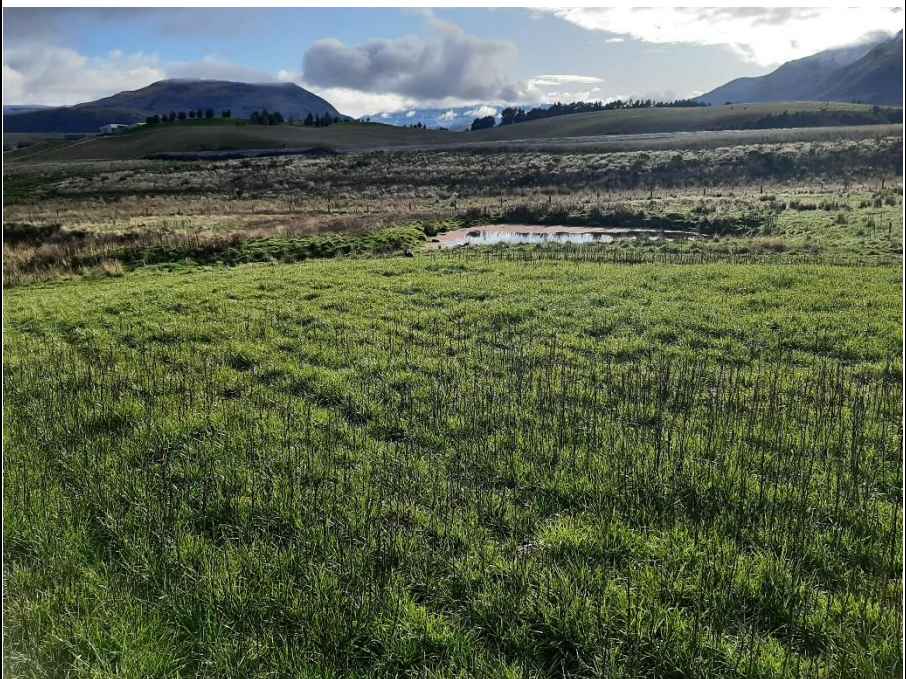
14	30/06/2023	
<b>Description</b> Picture showing the north-easternmost corner of the site. A small retention pond was seen.

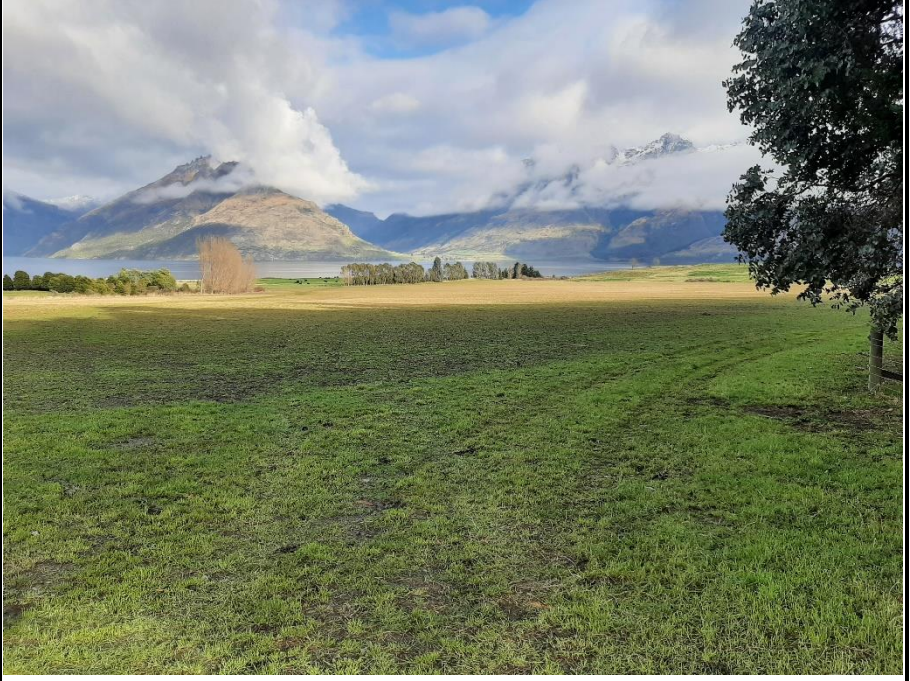
15	30/06/2023	
<b>Description</b> Picture taken in the center of the site, looking south-westwards towards Lake Wakatipu.

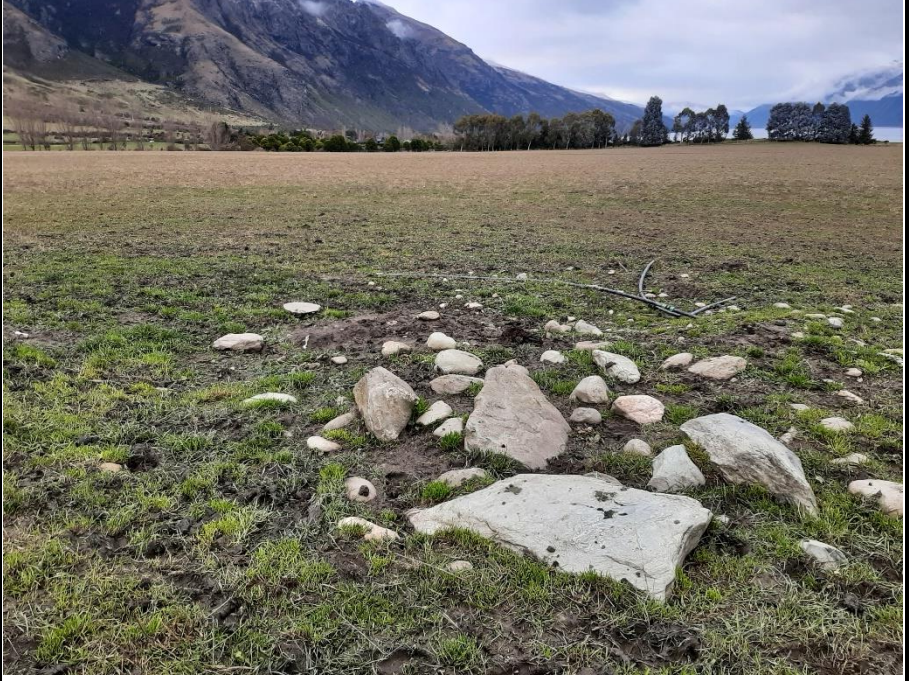
Photo No.	Date	
21	30/06/2023	
<b>Description</b> The paddocks in the western part of the site are currently vacant. An area with rock and former irrigation was seen.

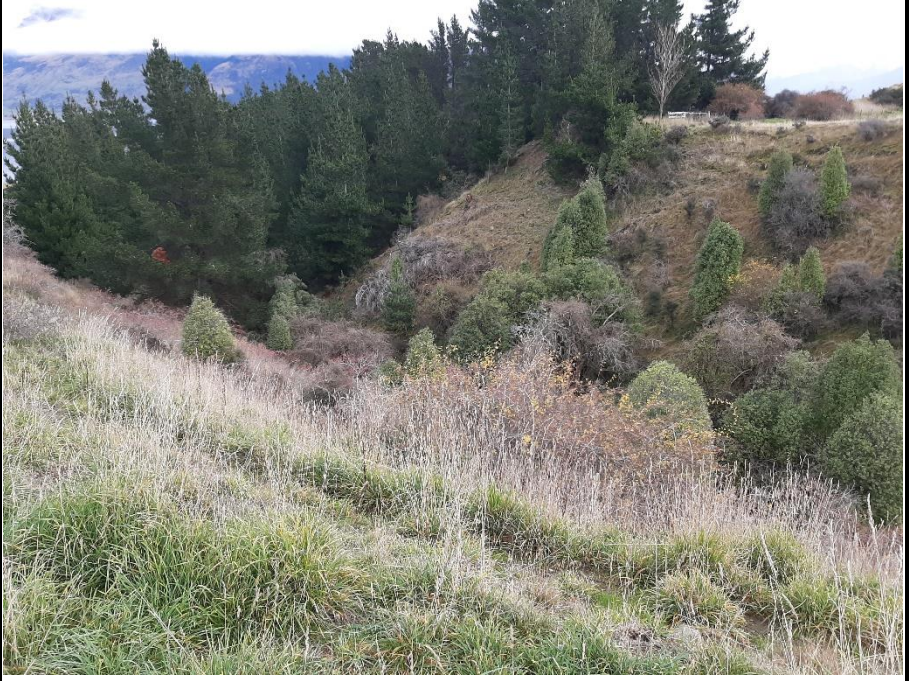
22	30/06/2023	
<b>Description</b> A large gully (fan channel) is seen along the south-western boundary of the site leading towards the lake.

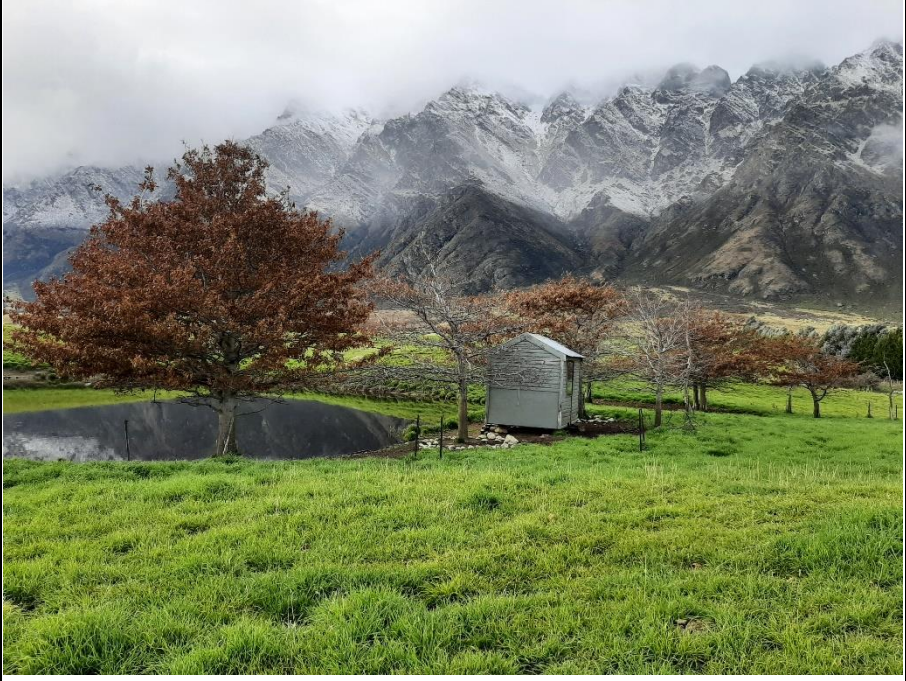
24	30/06/2023	
<b>Description</b> A small pond is noted with a duck shooting hut (maimais) on the bank.

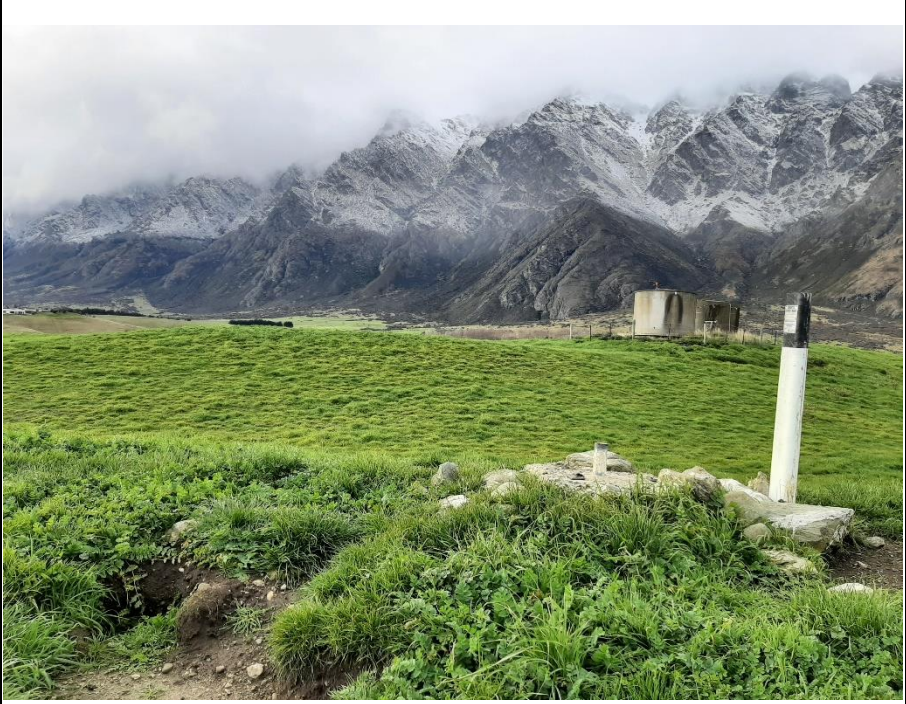
25	30/06/2023	
<b>Description</b> Two water storage tanks are seen in the western part of the site.

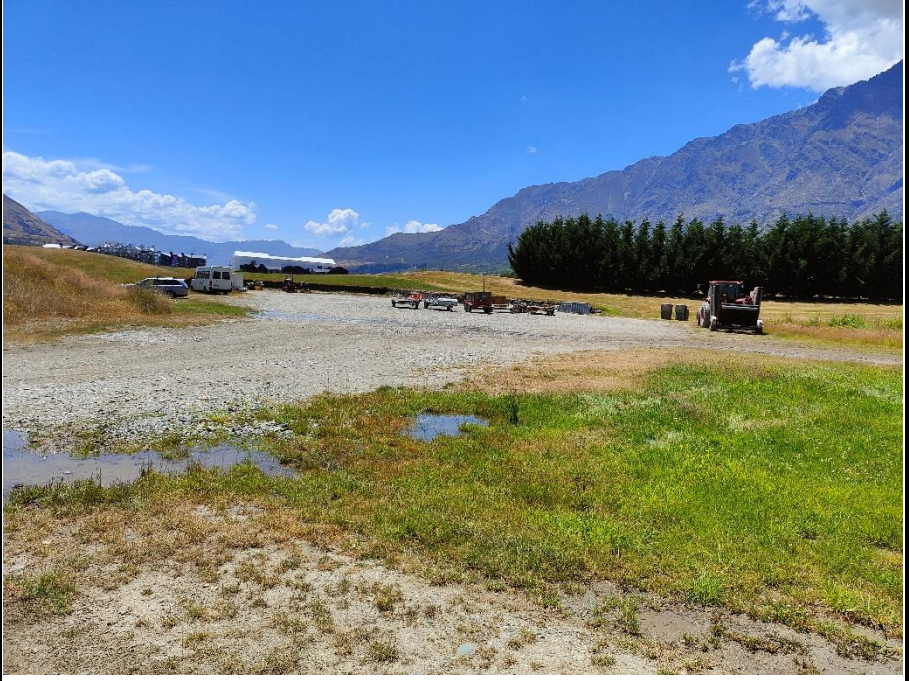
26	15/01/2025	
<b>Description</b> Homestead Bay section of site.  Access road leading from Homestead Bay Road. Set down area and contractor storage area adjacent to road.

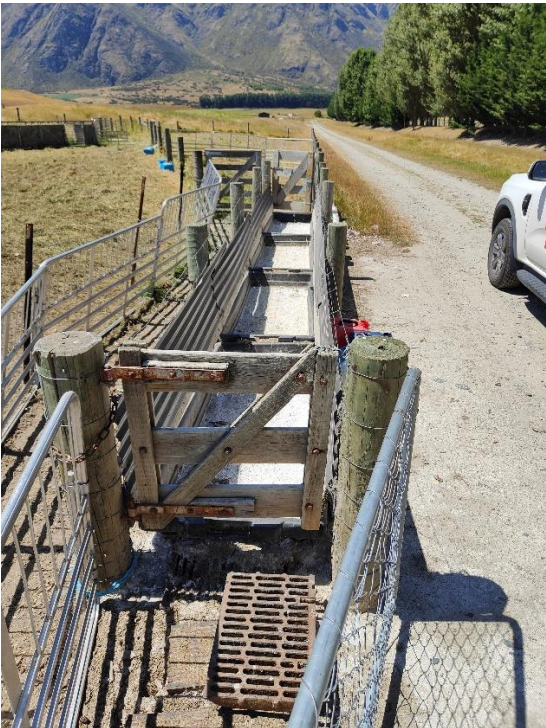
28	15/01/2025	
<b>Description</b> Sheep treatment pens (footbath or drenching) with numerous empty chemical containers stored alongside the fenceline

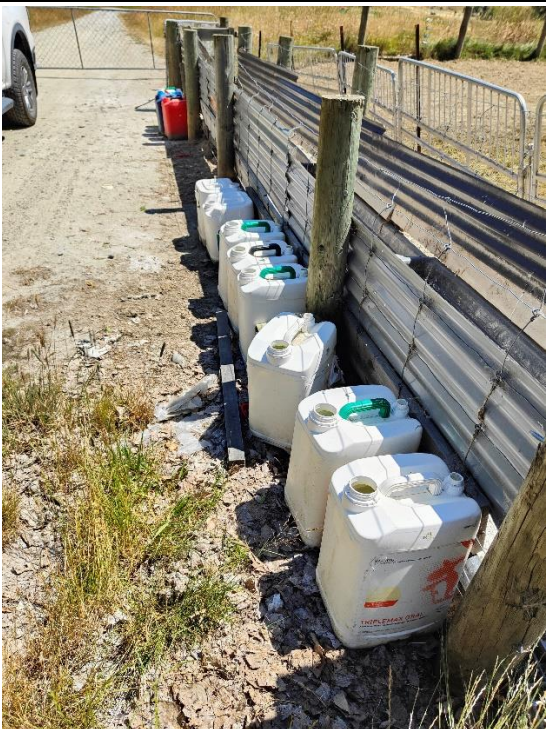
29	15/01/2025	
<b>Description</b> Chemical containers along fence line (empty)

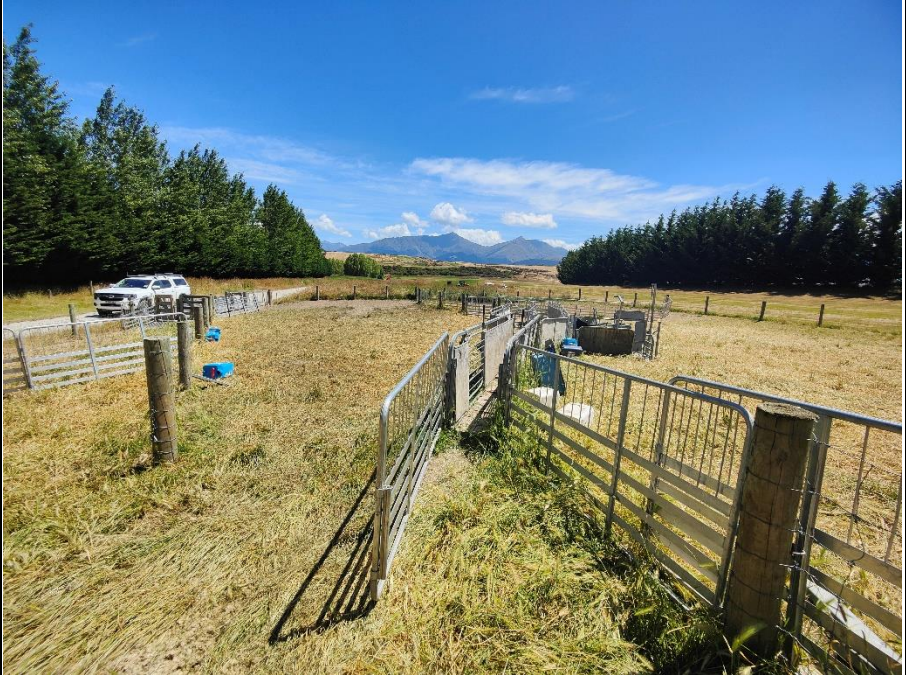
30	15/01/2025	
<b>Description</b> Semi-permanent fencing with containers strewn around pens

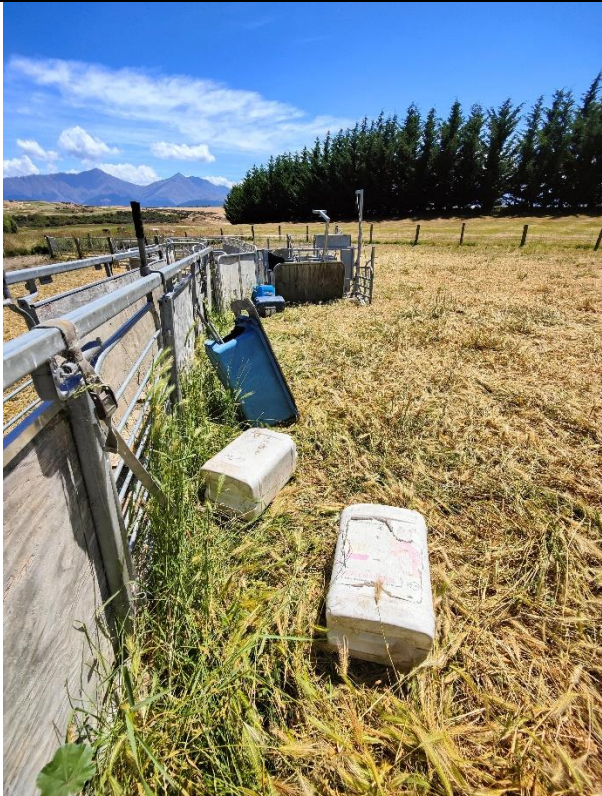
31	15/01/2025	
<b>Description</b> More empty containers

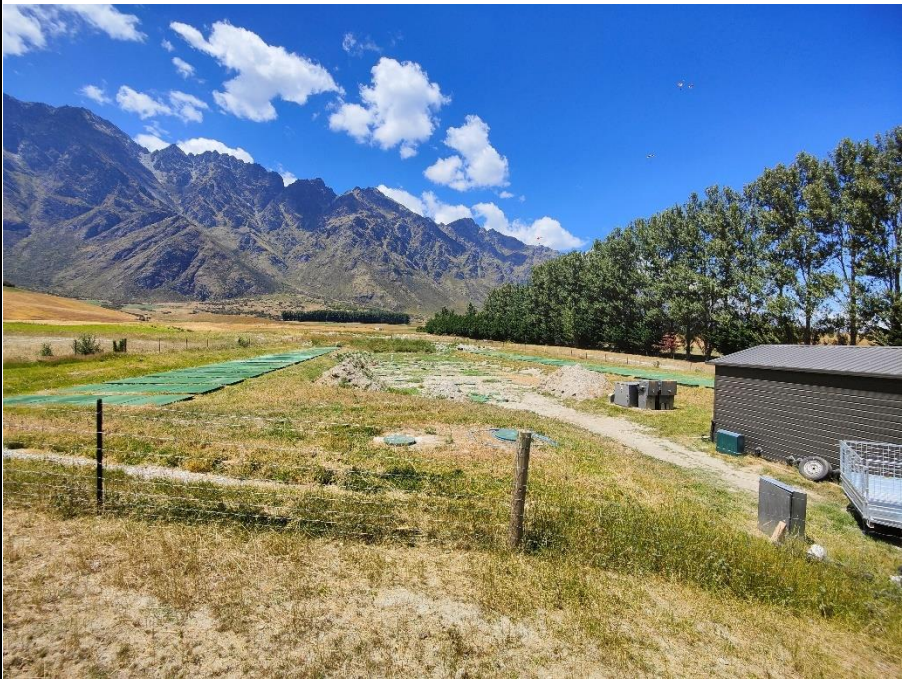
Photo No.	Date		
33	15/01/2025		
<b>Description</b> Jacks Point Wastewater Treatment Plant

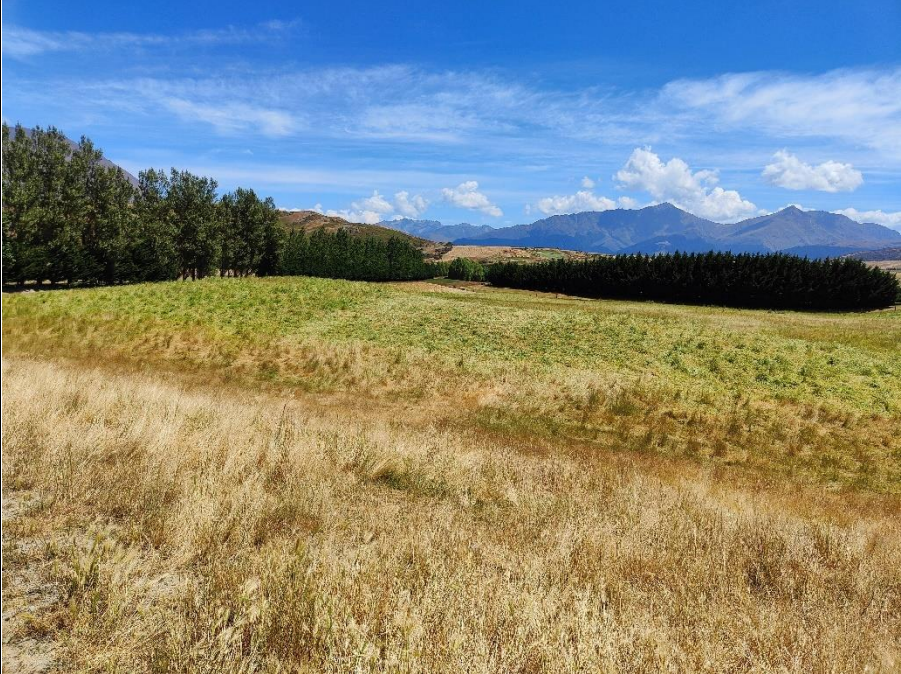
To the north of the WWTP is located the disposal field area which comprises grassed hummocky ground with green coarse vegetation. This area of the site is underlain by a series of drip lines which run from the WWTP. At the eastern part of the disposal field were noted stop taps which appear to have recently been placed (the ground was ungrassed and appeared disturbed) which ran in an east west line across this part of the site. To the north and east of the disposal field, beyond fence lines) the ground rose steeply up to residential development at Jacks Point (north) and to the Cleanfill site (east).

34	15/01/2025	
<b>Description</b> Likely disposal field to the north of the WWTP.

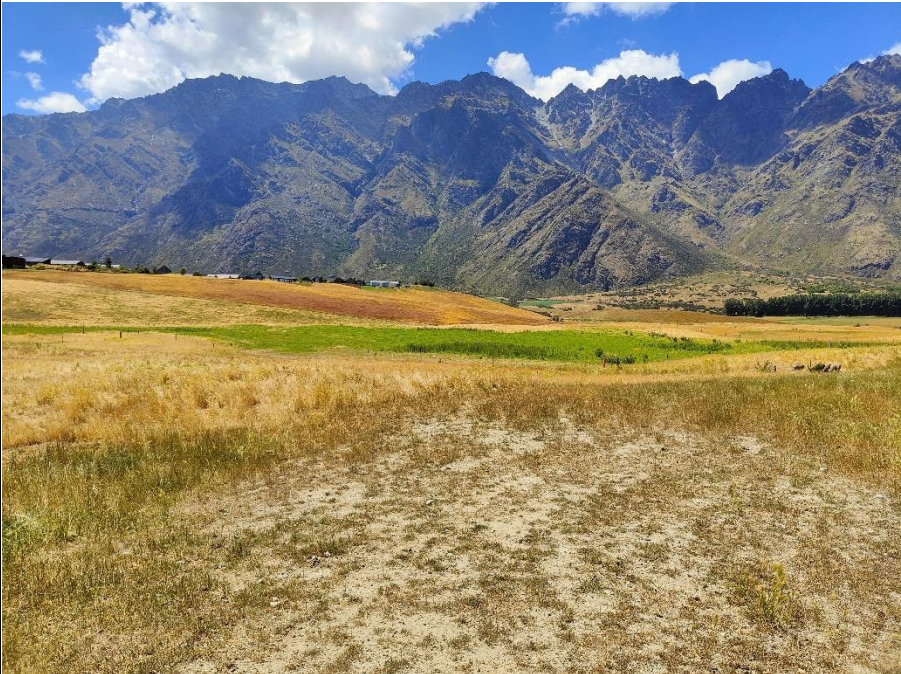
35	15/01/2025	
<b>Description</b> Looking east across open fields of Homestead Bay area of the site with SH6 and Remarkables in background.

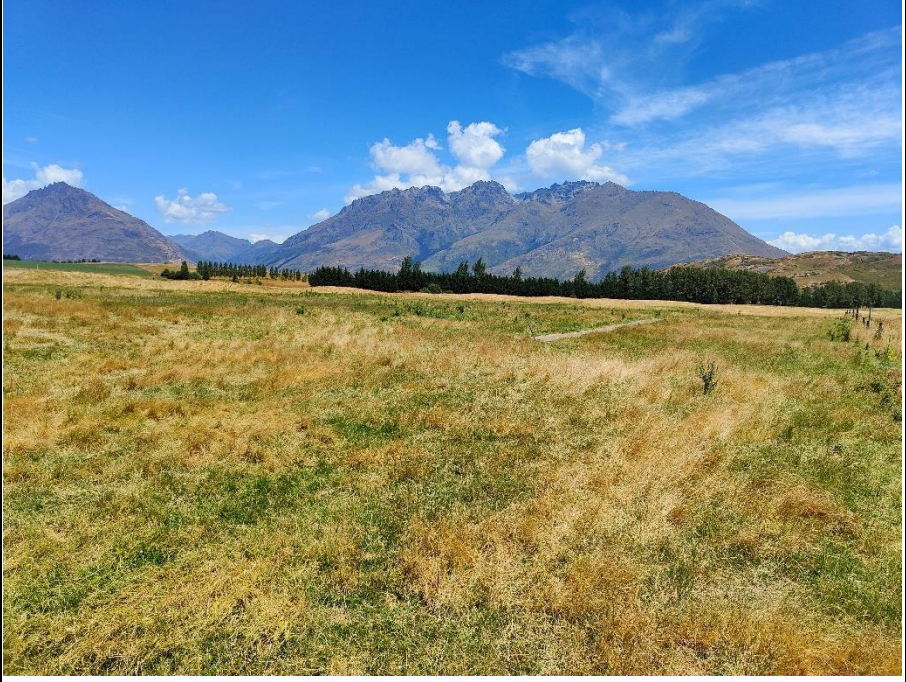
36	15/01/2025	
<b>Description</b> Looking west across Homestead Bay site area with open grassed paddocks (some sheep grazed in fields)

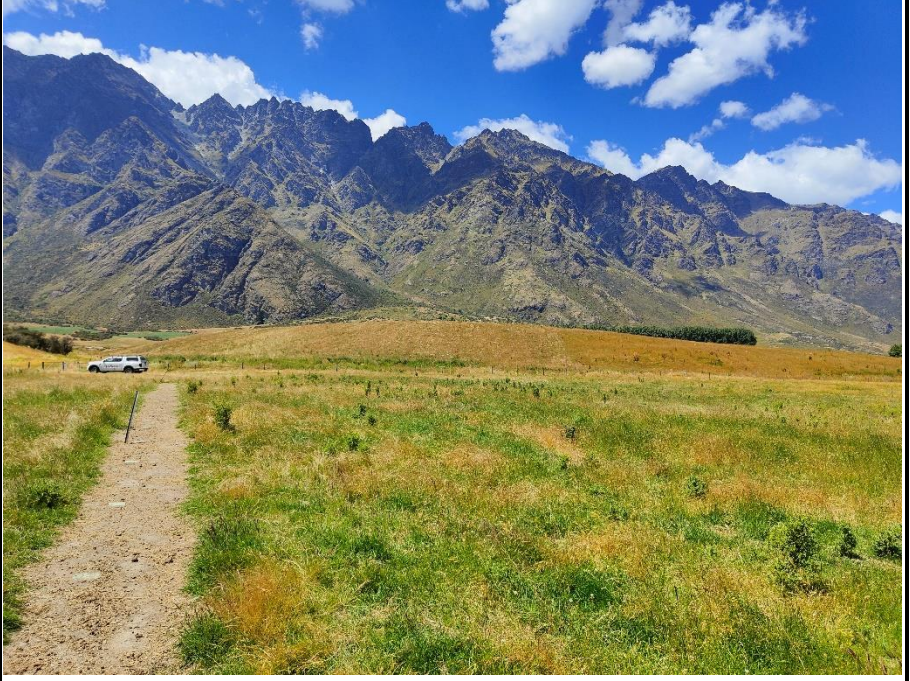
Photo No.	Date	
38	15/01/2025	
<b>Description</b> Looking east with Remarkables in background. Raised area of land where cleanfill has been placed (Base Contracting site)

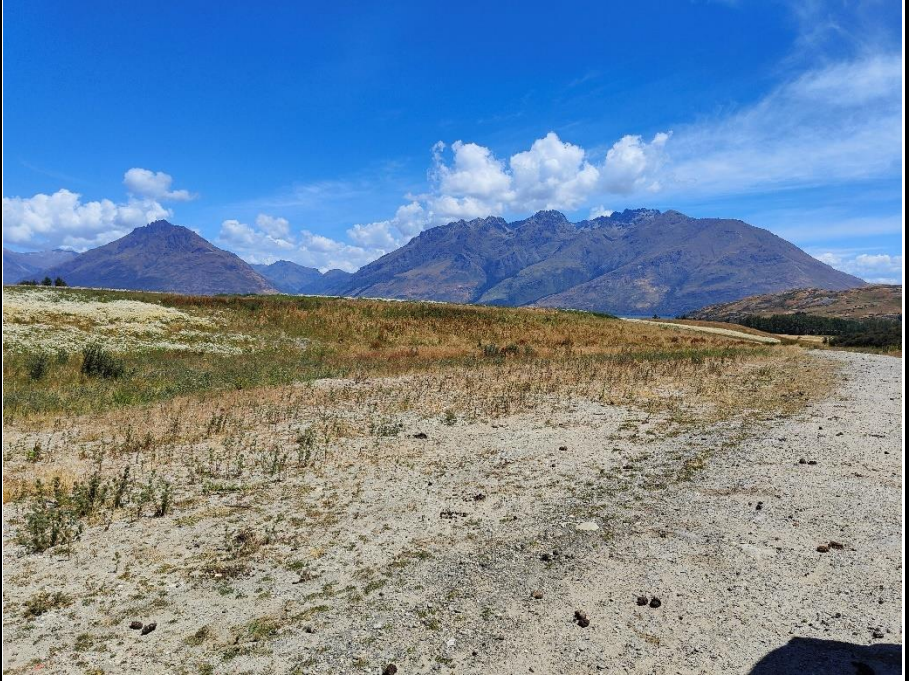
Photo No.	Date	
39	15/01/2025	
<b>Description</b> Base Contracting Cleanfill site, accessed from SH6

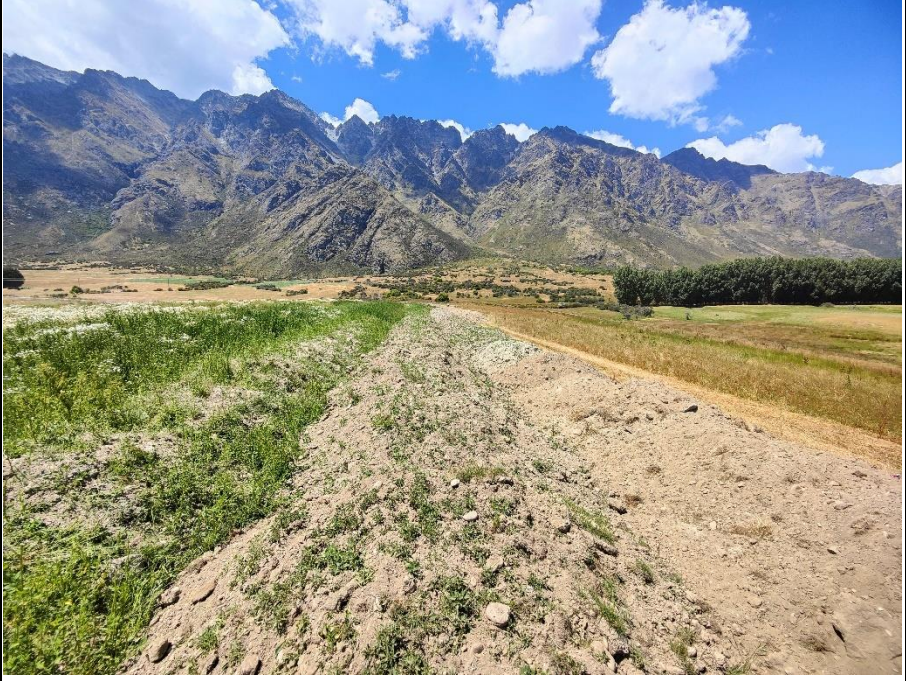
40	15/01/2025	
<b>Description</b> Deposited soil on raised area of site (Base Cleanfill site)

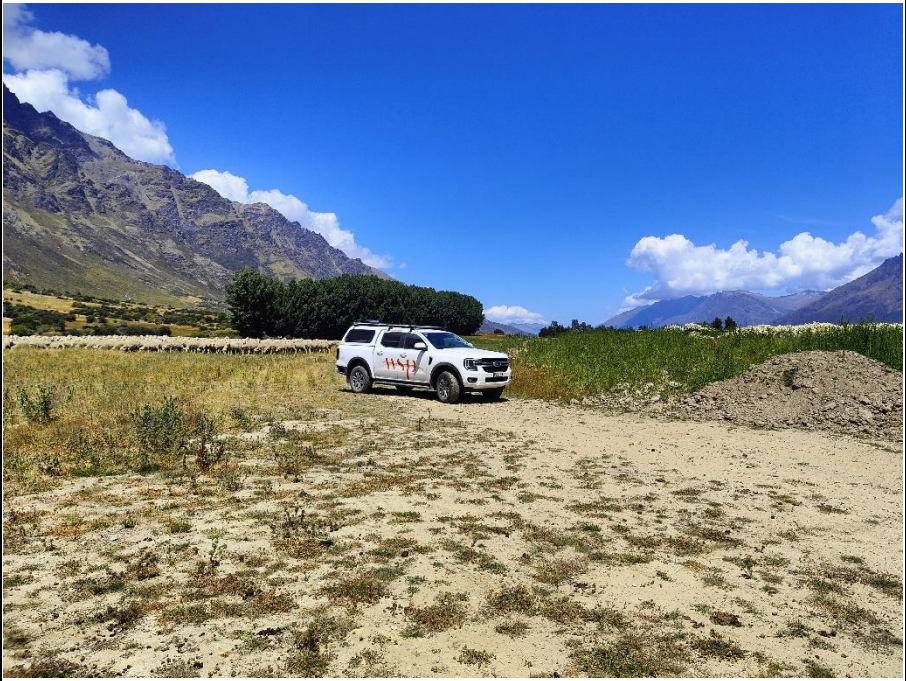
41	15/01/2025	
<b>Description</b> Base Cleanfill site adjacent to SH6 with lots of sheep roaming.

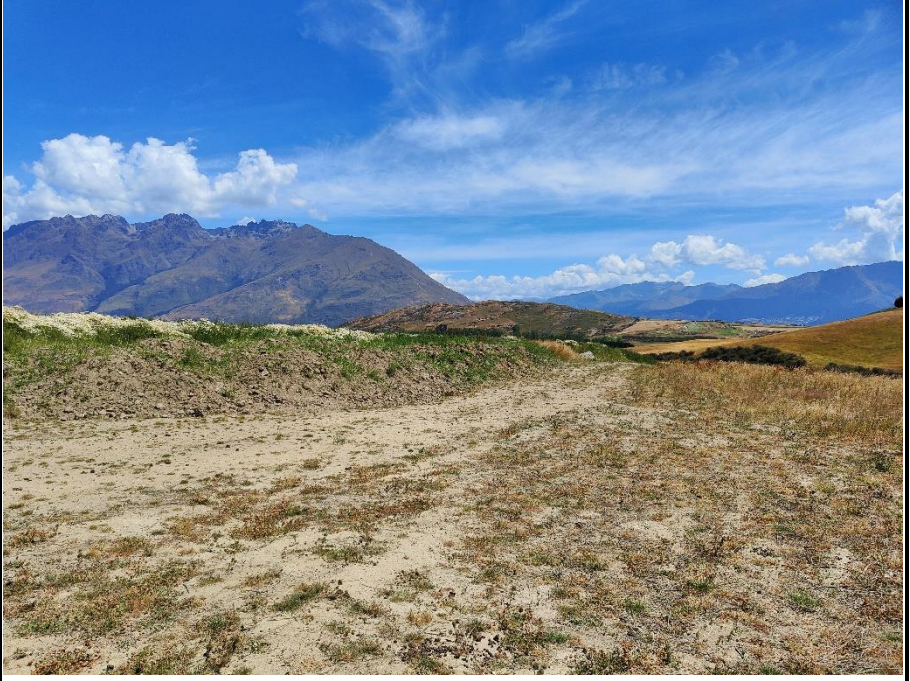
42	15/01/2025	
<b>Description</b> Looking west with multiple levels of cleanfill

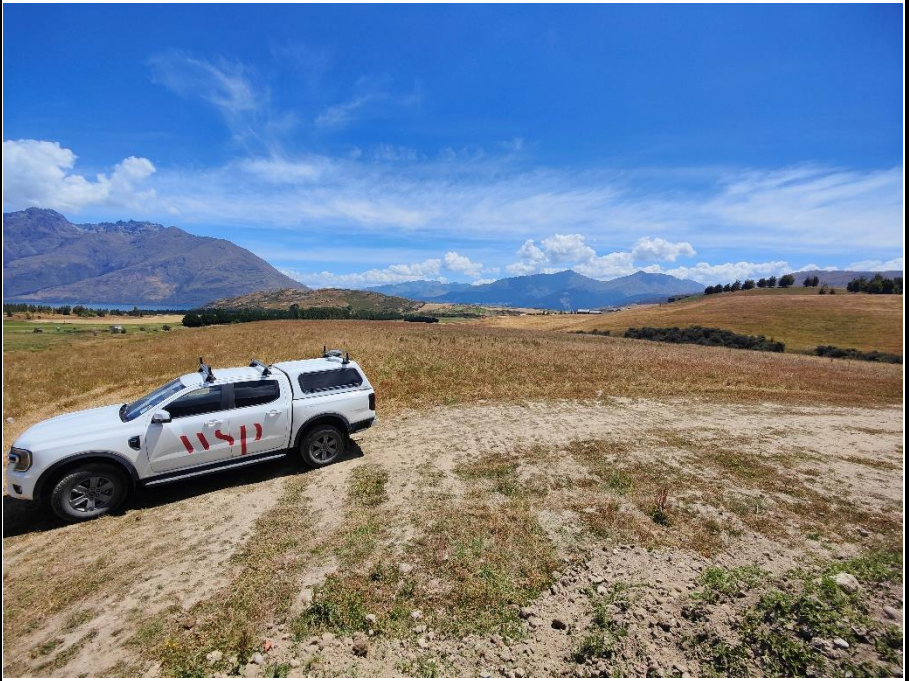
Photo No.	Date

43	15/01/2025	
<b>Description</b> Looking west from Cleanfill site over remaining Homestead Bay site (Lake Whakatipu in background)
