Project:
Wetland Delineation

Client:
Oceana Gold

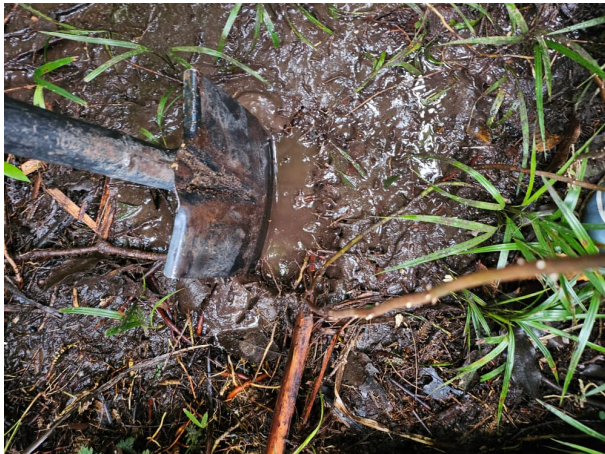
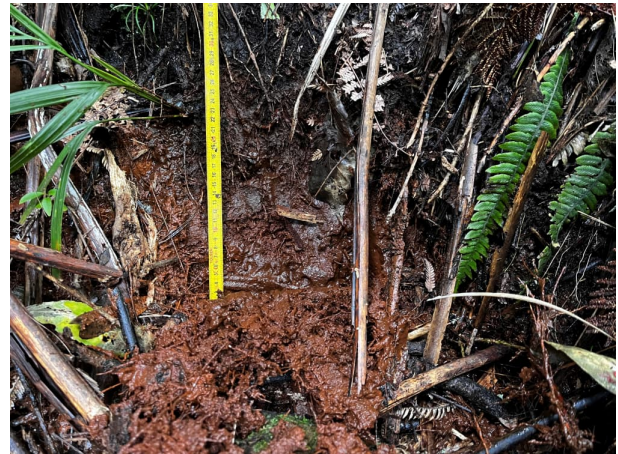
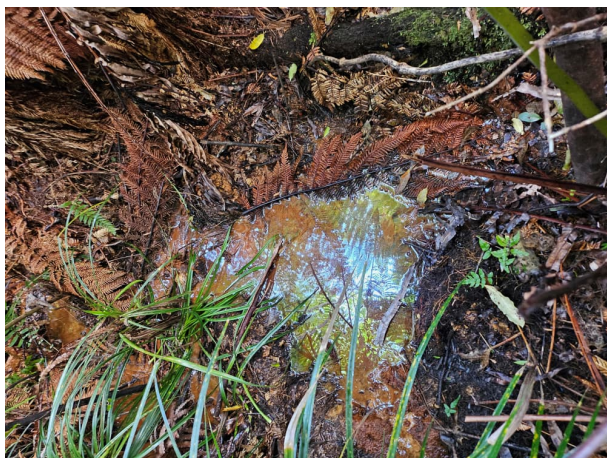
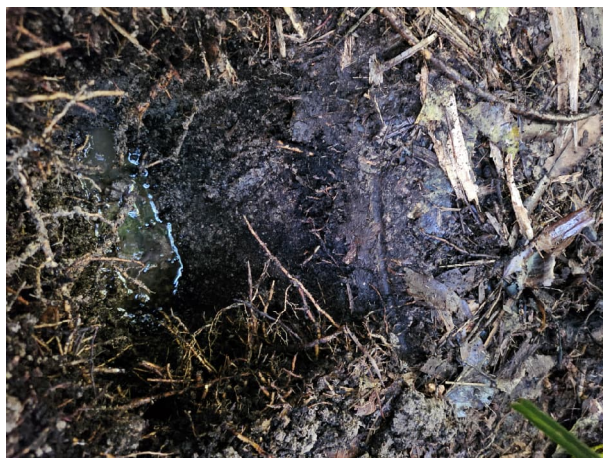
Figure 22. Adams catchment photos.

Both the topsoils and subsoils in surface water-supported wetlands were observed to be very dark brown (**Figure 22 – Photo 1**), or black, but no peat was identified. This is likely due to the steep surrounding topography which creates a fast-flowing, flashy catchment. As a result, the movement of water into the wetland is preventing any peat from forming.

The topsoils in the groundwater-supported wetlands were generally also dark brown or black, but in most cases a bright orange soil was observed (**Figure 22 – Photo 2**). The soils were coated with the slimy, iron-oxidising bacteria (**Figure 22 – Photo 3**). Along with the orange slime, an oily biofilm was also seen. These features were observed in other groundwater wetlands in the project area. Another feature observed in these wetlands was a 5-10 cm layer of peat (**Figure 22 – Photo 4**). This was not something observed in other wetland within the study area. Peat forming in these wetlands was unique to the project area as it is thought to be due to the flatter topography and lack of rapid surface water flows through the area allowing vegetation to accumulate and decay.

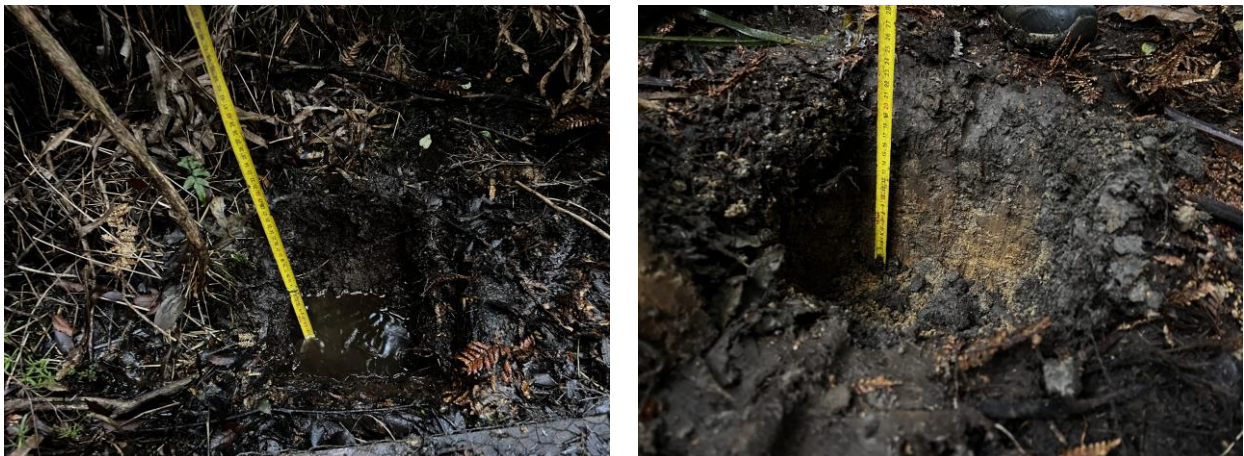
Figure A5. Edmonds 1 photos.

Soils	<p>Surface ponding was underlain by a very dark brown soil (Topsoil 2/2, subsoil 2/2), indicative of a high organic content and considered hydric soils according to the Munsell colour chart. These areas were very fluid and were not possible to dig/auger to the full 1 m depth.</p> <p>The wetland soils without surface water ponding were still highly saturated (Figure A5 – Photo 1). These areas had very dark brown saturated surface soils around 5 cm thick (topsoil 2/2) and were mostly clay with silt throughout. There were lots of organic matter in the topsoil, indicating hydric soils. The subsoil, also dark brown/black (3/1), was likely a silty clay; majority clay with some silt. Grey soils (6/1), which are extremely poorly drained were seen below the water table in places. The subsoil was sticky and had a hydrogen sulphide odour, which is indicative of reducing conditions and another indicator of hydric soil conditions. The water table was evident at, or just below, the surface at these sites.</p>

Non wetland areas, on the extremities of this wetland were clearly very dry (unsaturated) and were characterised by soils which were dark brown with a lighter, mid-brown colour (topsoil 3/3, subsoil 6/8), which are not indicative of hydric soils (Figure A5 – Photo 2). There was a small 2 cm layer of organic matter at the surface, followed by around 5 cm of topsoil. The soil was likely a clay loam; majority clay with some silt. There was no saturation and no water table present. There was some grey and orange mottling observed in sites with close proximity to the wetland boundary, but this is likely the result of leaching, and not indicative of wetland soils.
Key Findings	Based on the topography of the site and field observations, it is likely that Edmonds 1 was surface water-fed from surface runoff during rainfall. Figure A6 shows this as a schematic.

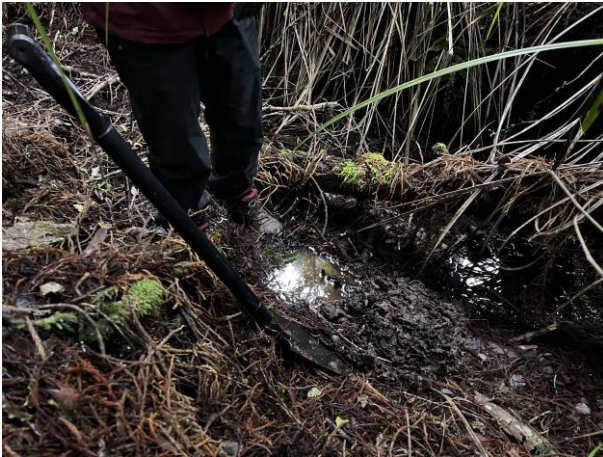
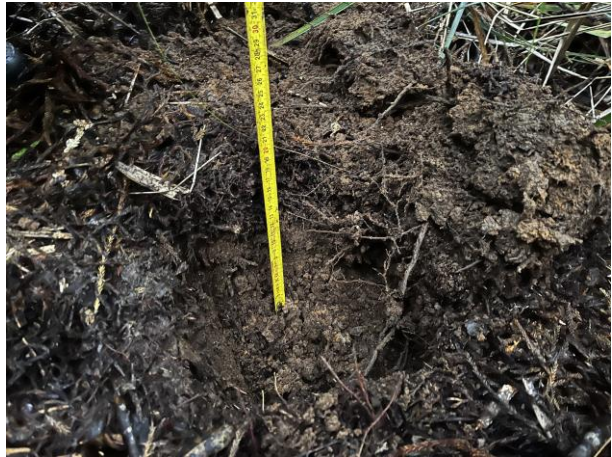
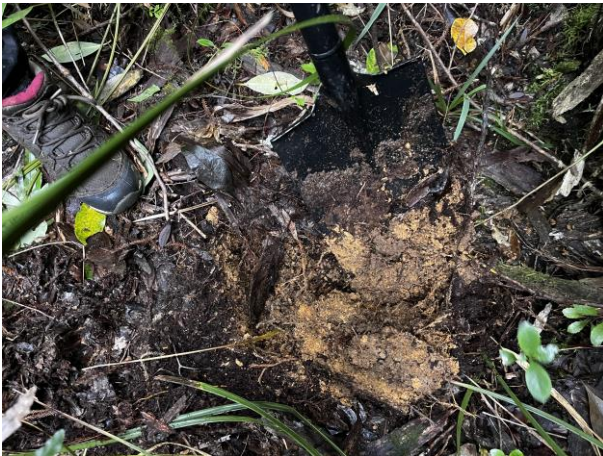
Figure A8. Edmonds 2 photos.

Soils	<p>One of the locations with wetland soils was in a small 6.5 m² depressional area around 1 m lower than surrounding topography (Figure A8 – Photo 1). Surface ponding is underlain by a very dark brown soil (topsoil 2/2, subsoil 2/2). These areas were very fluid and were not possible to dig/auger for a full 1 m profile.</p> <p>The second, smaller depression without surface water ponding was still highly saturated. This area had very dark brown saturated surface soils (topsoil 2/2) and was mostly clay with some silt throughout. The subsoil was also dark brown/black (3/1) and was likely a silty clay. The subsoil was sticky and had a hydrogen sulphide odour.</p> <p>Non wetland areas, were very clearly dry (unsaturated) and were dark brown with a lighter, mid-brown colour (topsoil 3/3, subsoil 6/8). Soil was likely a clay loam; majority clay with some silt with no saturation and no water table present (Figure A8 – Photos 2 and 3).</p>

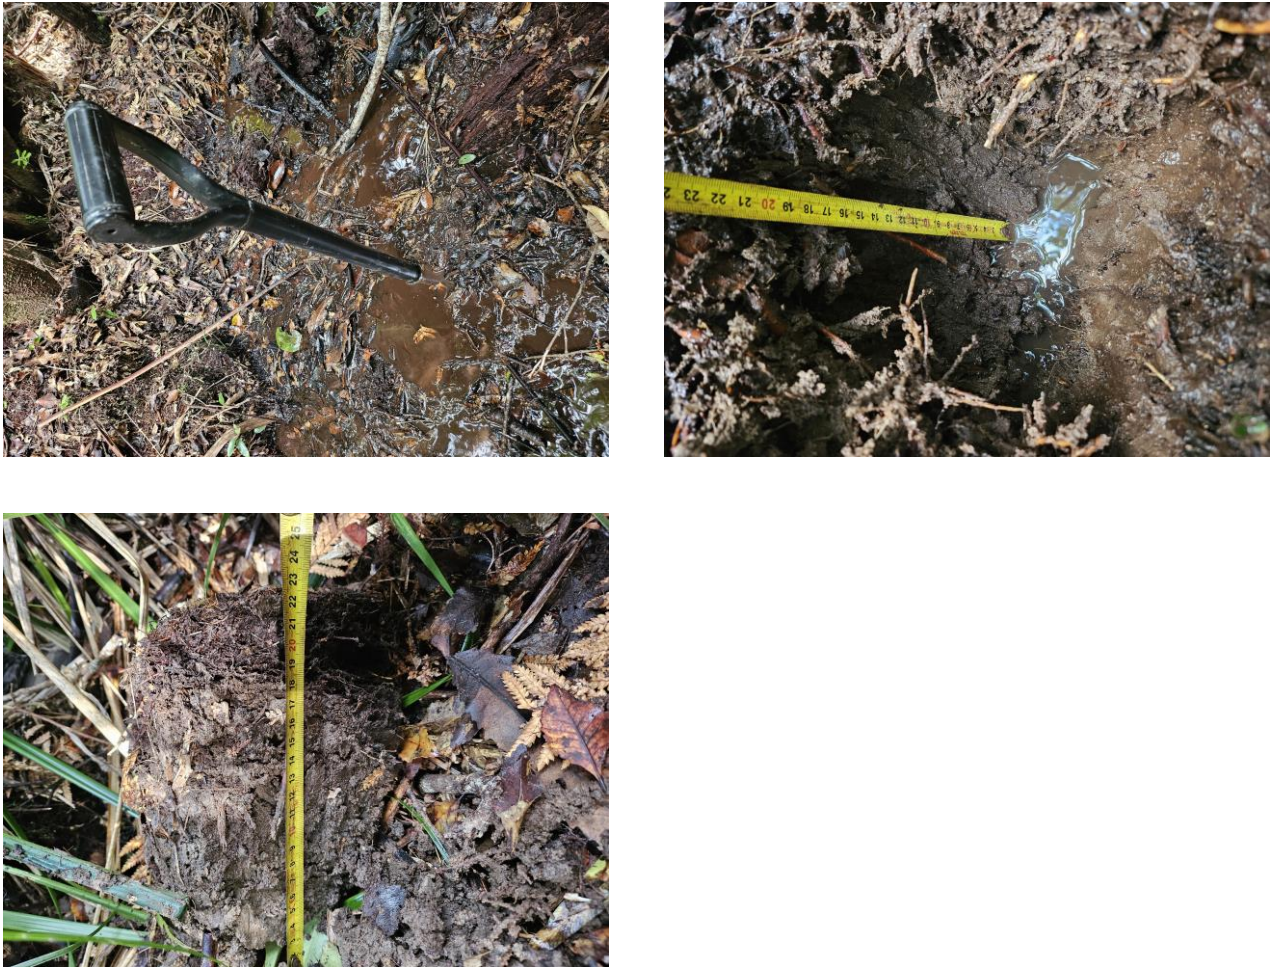
Figure A11. Edmonds 3 photos.

Topic	Comments
Summary	Edmonds 3 (Figure A10) was identified by Bioresearches as a wetland based on the hydrophytic vegetation tests. This assessment has confirmed the feature was a surface water supported wetland based on the soils and hydrology.
Geomorphology	The wetland was located in a fairly flat area surrounded by steeper banks, particularly to the north.
Water Observations	A stream runs through the area which creates a sperate wetland approximately 30m upstream, before feeding into Edmonds 3. The stream had a good amount of flow and was about 30 cm deep in some places which created ponding in the flatter areas where it fanned out.
Soils	<p>Surface ponding as underlain by a very dark brown soil (Topsoil 2/2, subsoil 2/2). These areas were very fluid and were not possible to dig/auger (Figure A11 – Photo 1). Some areas that were not covered by surface ponding were still wet underfoot with rich dark brown saturated surface soils (topsoil 2/2). The subsoil was a dark- to mid- slightly greyish colour (5/1) and was likely a silty clay; majority clay with some silt. The soil was very sticky, and the water table was observed at around 12 cm below ground (Figure A11 – Photo 2).</p> <p>Non wetland areas, (bottom), were unsaturated but remain sticky, likely due to recent rainfall, and were dark brown with a lighter, mid-brown colour (topsoil 3/3, subsoil 6/8). Lots of organic matter was observed, along with worms and grubs. Soil was likely a silty clay; majority clay with some silt. No redox conditions were observed (Figure A11 – Photo 3).</p>

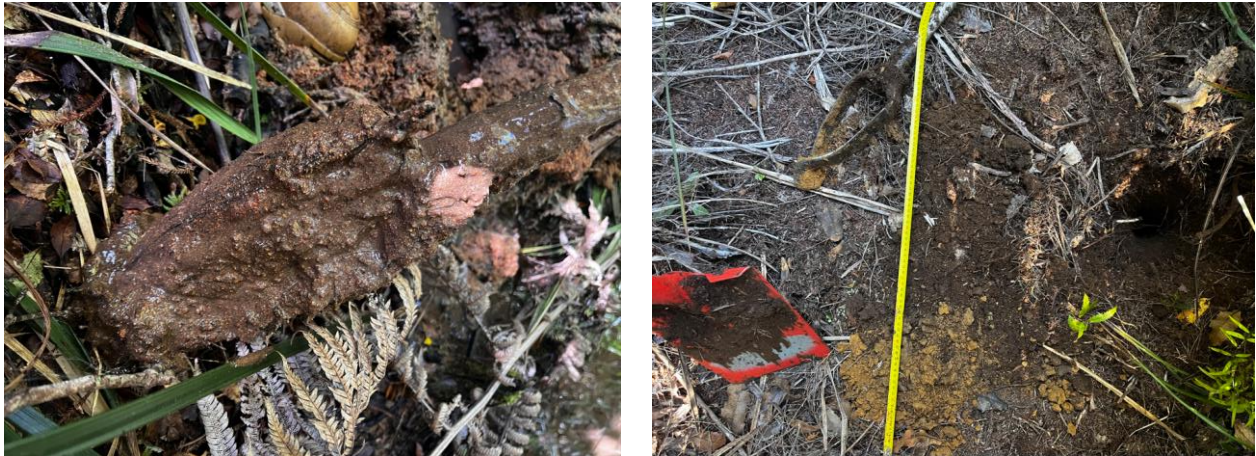
Figure A14. Wetland 4 photos.

Soils	<p>Surface ponding across the site was underlain by a very dark brown soil (topsoil 2/2, subsoil 3/2). These areas were very fluid and were not possible to dig/auger to the full 1 m depth (Figure A14 – Photo 1). When auguring was attempted, the auger sank to about 1.2 m deep without resistance. Some areas that were not covered by surface ponding were still wet underfoot with rich, dark brown, saturated surface soils (topsoil 2/2). These sites were also difficult to auger due to the high fluidity in the subsoil. The subsoil was likely a clay loam; majority clay with some sand and silt causing a gritty texture.</p> <p>Non wetland areas were very clearly dry (unsaturated) and were dark brown with a lighter, mid-brown colour (topsoil 3/3, subsoil 6/8). Soil was likely a clay loam; majority clay with some sand and silt (Figure A14 – Photo 2).</p>

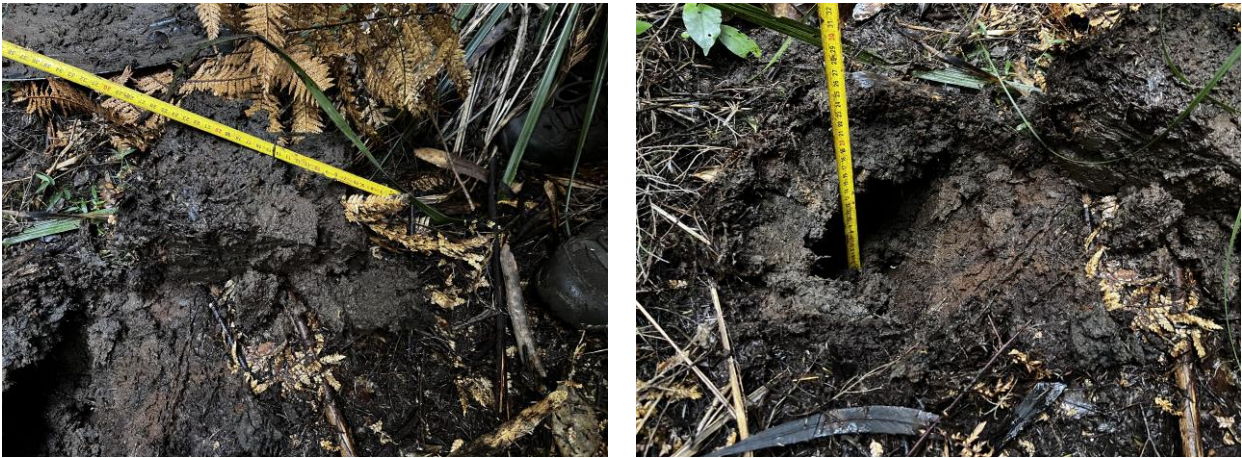
Figure A17. Edmonds 5 photos.

Topic	Comments
Summary	Edmonds 5 (Figure A16) was identified by Bioresearches as a wetland based on the hydrophytic vegetation tests. This assessment has confirmed the feature was a surface water supported wetland based on the soils and hydrology.
Geomorphology	The wetland topography was fairly flat, and gently sloped downwards to the west. Some small banks surrounded the wetland.
Water Observations	Two tributaries flowed through the wetland and converged along the western boundary. The stream running through the site fanned out to create ponding. Three further wetlands are located upstream along the stream.
Soils	<p>Surface ponding in the wetland was underlain by a very dark brown soil (topsoil 2/2, subsoil 2/2). These areas were very fluid and were not possible to dig/auger for a 1 m profile.</p> <p>Wetland areas, without surface water ponding were still highly saturated with a shallow water table. These areas had very dark brown saturated surface soils around 5 cm thick (topsoil 2/2) (Figure A17 – Photo 1). The soils were mostly clay with some silt throughout. The subsoil also dark brown/black (3/1) is likely a silty clay; majority clay with some silt. Grey soils (6/1) were seen in soils below the water table in places (Figure A17 – Photo 2). The subsoil was sticky and had a hydrogen sulphide odour.</p> <p>Non wetland areas were very clearly unsaturated and were dark brown with a lighter, mid-brown subsoil colour (topsoil 3/3, subsoil 6/8). The soil was likely a silty clay; majority clay with some silt. The subsoil was plastic and slightly moist, but this was likely due to recent rainfall. No water table was present.</p>

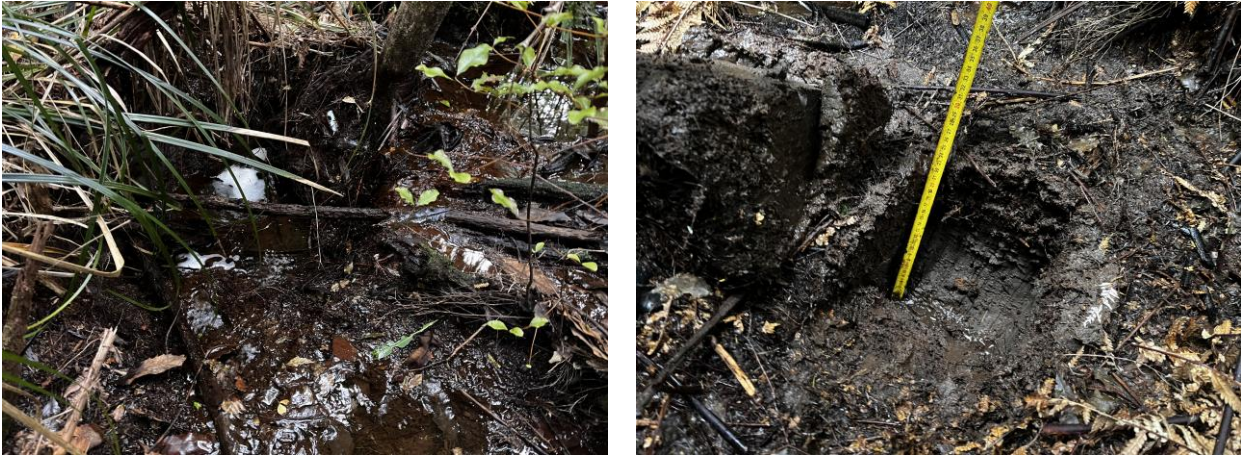
Figure A20. Edmonds 6 photos.

Topic	Comments
Summary	Edmonds 6 (Figure A19) was identified by Bioresearches as a wetland based on the hydrophytic vegetation tests. This assessment has confirmed the feature was a surface water supported wetland based on the soils and hydrology.
Geomorphology	The topography was fairly flat with some small banks that surrounded the wetland.
Water Observations	The wetland followed a stream that flowed centrally through and fanned out to create ponding. One wetland is located downstream along the stream, whilst two more wetlands are located upstream along the stream. A white foam was observed in some of the surface water ponding areas.
Soils	<p>Surface ponding (Figure A20 – Photo 1), was underlain by a very dark brown soil (topsoil 2/2, subsoil 2/2). These areas were very fluid and were not possible to dig/auger for a 1 m profile.</p> <p>Areas without surface water ponding (Figure A20 – Photo 2), were still highly saturated with a shallow water table. These areas had very dark brown saturated surface soils around 5 cm thick (topsoil 2/2). The topsoil was mostly clay with some silt throughout and were quite plastic. The subsoil was likely a silty clay; majority clay with some silt. These were saturated and sticky.</p> <p>Non wetland areas were very clearly unsaturated and were dark brown with a lighter, mid-brown subsoil colour (topsoil 3/3, subsoil 6/8). The soil was likely a silty clay; majority clay with some silt. The subsoil was plastic and slightly moist, but this was likely due to recent rainfall. No water table was present.</p>

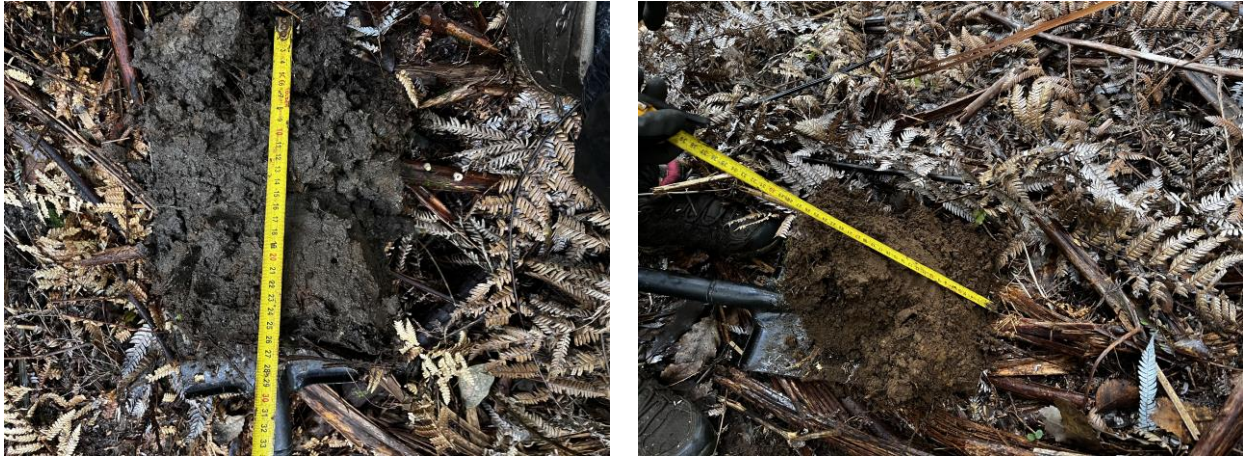
Figure A23. Edmonds 7 photos.

Topic	Comments
Summary	Edmonds 7 (Figure A22) was identified by Bioresearches as a wetland based on the hydrophytic vegetation tests. This assessment has confirmed the feature was a surface water supported wetland based on the soils and hydrology.
Geomorphology	The wetland was located in a small dip in topography. The wetland itself was fairly flat with some small banks that surrounded it.
Water Observations	<p>The wetland follows the stream that runs through the area. Two wetlands are located downstream along the stream, whilst another wetland is located upstream along the stream. A smaller tributary joins the stream and creates a very small area of surface ponding.</p> <p>Based on the hydric soils and hydrology tool assessment, the boundary of the wetland was adjusted to reflect observations.</p>
Soils	<p>Surface ponding was underlain by a very dark brown soil (topsoil 2/2, subsoil 2/2). These areas were very fluid and were not possible to dig/auger for a full 1 m profile.</p> <p>Areas without surface water ponding, were still highly saturated with a shallow water table (Figure A23 – Photo 1). These areas have very dark brown saturated surface soils around 2 cm thick (topsoil 2/2). The soils were mostly clay with some silt throughout. The subsoil was likely a silty clay; majority clay with some silt. These were saturated and sticky. Soils above the water table were gleyed and had orange mottling. Grey soils (6/1) were seen in soils below the water table which was identified at around 16 cm below ground.</p> <p>Non wetland areas were very clearly unsaturated and were dark brown with a lighter, mid-brown colour (topsoil 3/3, subsoil 6/8) (Figure A23 – Photo 2). The soil was likely a silty clay; majority clay with some silt. The subsoil was plastic and slightly moist, but this was likely due to recent rainfall. No water table was present at these sites.</p>

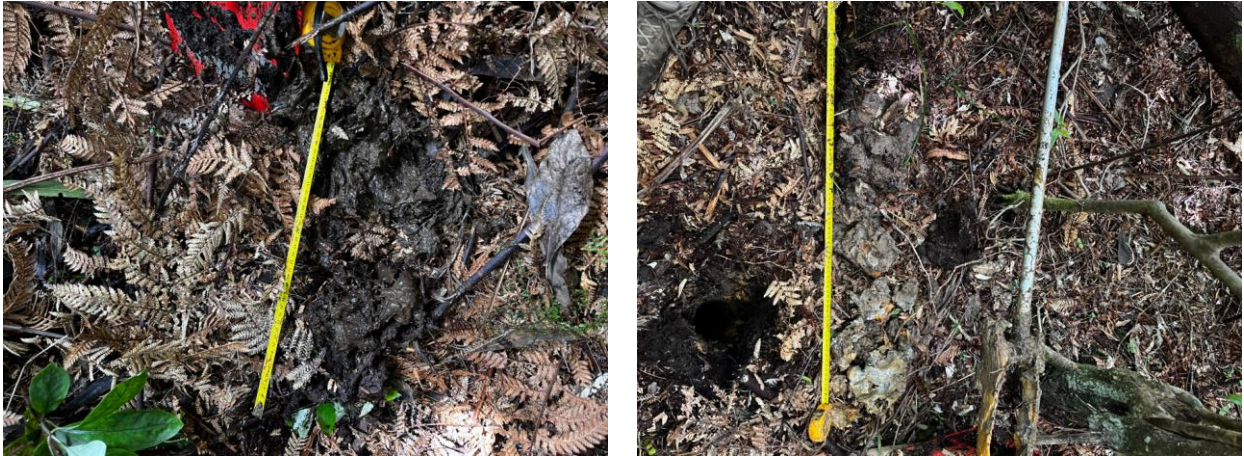
Figure A26. Edmonds 8 photos.

Topic	Comments
Summary	Edmonds 8 (Figure A25) was identified by Bioresearches as a potential wetland pending confirmation. The previous assessment has confirmed the feature was a surface water supported wetland based on the soils and hydrology.
Geomorphology and Vegetation	The wetland was fairly flat and gently sloped to the west. The area was covered by dense wetland vegetation.
Water Observations	Surface water was noted throughout the area despite the extended period of hot, dry weather during the first visit. There was a small stream that ran along the south border of the site. Three wetlands are located downstream along the stream.
Soils	<p>Surface ponding was underlain by a very dark brown soil (Topsoil 2/2, subsoil 2/2). These areas were very fluid and were not possible to dig/auger to the full 1 m depth. Some areas that were not covered by surface ponding (Figure A26 – Photo 1) were still wet underfoot with rich dark brown saturated surface soils (topsoil 2/2). These sites were often difficult to auger due to the high fluidity in the subsoil. Subsoil was likely a silty clay; majority clay with some silt.</p> <p>Other wetland sites showed redox conditions with orange/grey mottles and high saturation (Subsoil 7/1 with orange mottles, particularly along the roots). The soils held shape well due to clay content and saturation and were very sticky (Figure A26 – Photo 2).</p> <p>Non wetland areas were very clearly unsaturated and were dark brown with a lighter, mid-brown colour (topsoil 3/3, subsoil 6/8). Soil was likely a silty clay; majority clay with some silt. Did not hold shape, no saturation.</p>

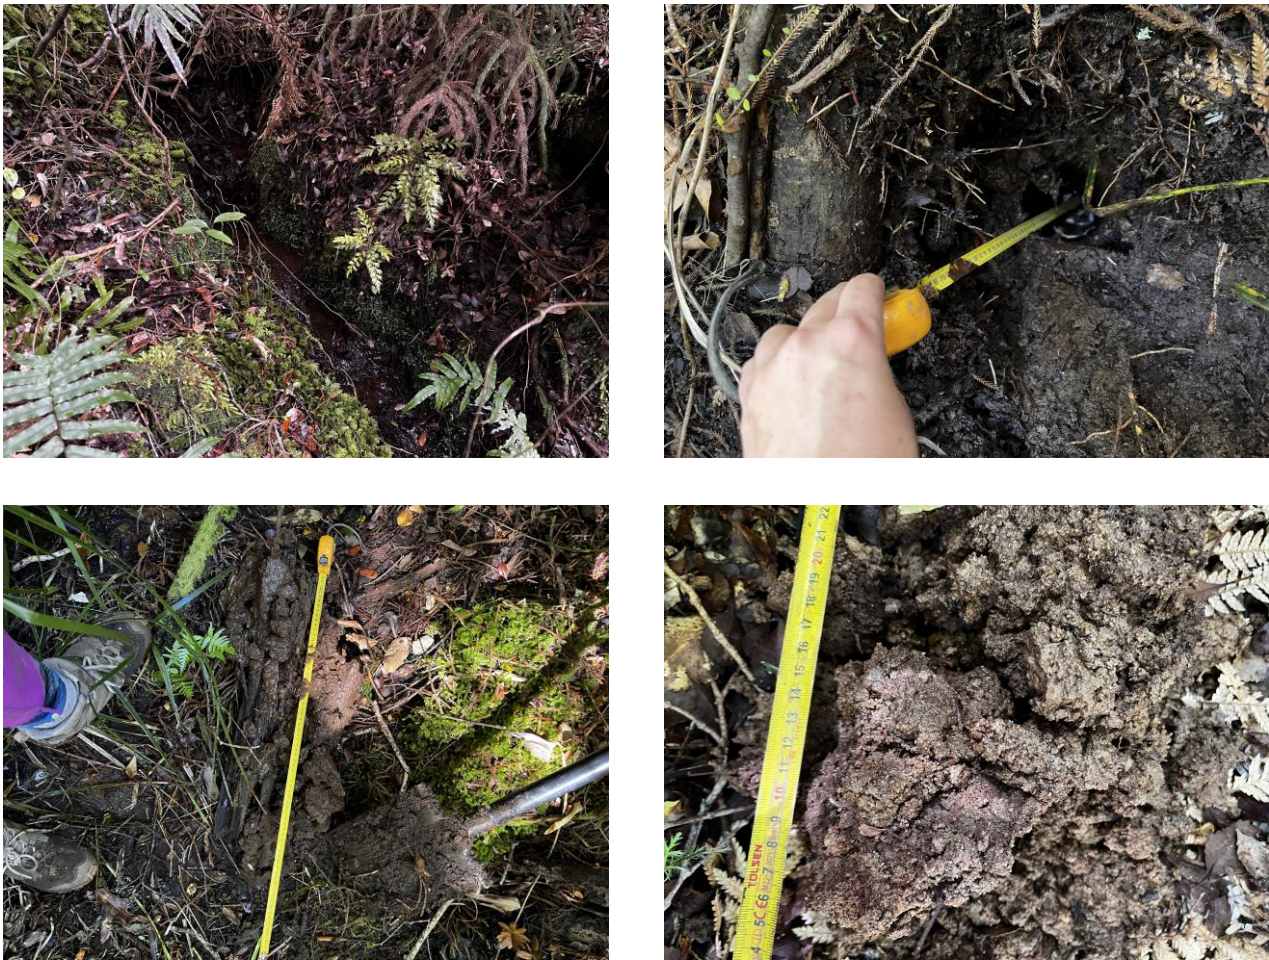
Figure A29. Edmonds 9 photos.

Topic	Comments
Summary	Edmonds 9 (Figure A28) was identified by Bioresarches as a potential wetland pending confirmation. This assessment has confirmed the feature was a surface water supported wetland based on the soils and hydrology.
Geomorphology	The site was located on a fairly flat area at the base of a slope. There was a steep slope to the east which dropped down on to a walking track.
Water Observations	Two or three very small streams ran down through the site (Figure A29 – Photo 1). Surface water was noted throughout the area despite the extended period of hot, dry weather during the first visit.
Soils	<p>Surface ponding was underlain by a very dark brown soil (topsoil 2/2, subsoil 2/2). These areas were very fluid and were not possible to dig/auger to the full 1 m depth (Figure A29 – Photo 2). The area without surface ponding was generally wet underfoot with rich dark brown saturated surface soils (topsoil 2/2). Subsoil was likely a silty clay; majority clay with some silt (Figure A29 – Photo 3).</p> <p>Wetland soils above the water table showed clear redox conditions with grey/orange mottling (subsoil 7/1 with orange mottles, particularly along the roots). Where the water table was very shallow (<20cm) soils were very sticky. Soils with a deeper water table were generally more plastic. Soils below the water table were grey (6/1) (Figure A29 – Photo 4).</p> <p>Non wetland areas were very clearly dry and were dark brown with a lighter, mid-brown colour (topsoil 3/3, subsoil 6/8). Soil was likely a silty clay; majority clay with some gravel. Some sites could not be dug deeper than ~30 cm due to the high amount of roots present. These soils do not hold their shape.</p>

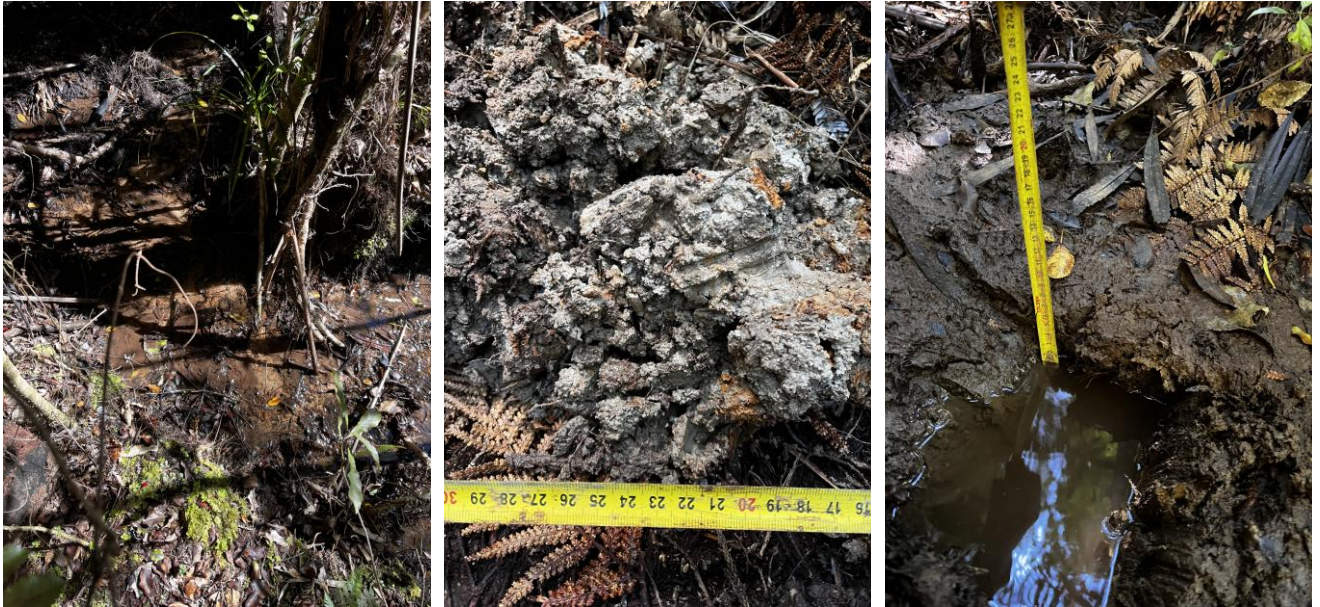
Figure A32. Edmonds 10 photos.

Topic	Comments
Summary	Edmonds 10 (Figure A31) was identified as wetland by Bioresearches. This assessment has confirmed the feature is a surface water supported wetland based on the soils and hydrology.
Geomorphology and Vegetation	The wetland was located on an unmarked trail which ran directly through the site. The wetland did not continue down to Edmonds Stream and the two were separated by a steep drop in topography. The wetland was at a higher elevation than Edmonds Stream. The area was covered by dense wetland vegetation.
Water Observations	There was a small stream that ran directly through the site. Surface water was noted throughout the area despite the extended period of hot, dry weather during the first visit.
Soils	<p>Surface ponding (Figure A32 – Photo 1) was underlain by a very dark brown soil (topsoil 2/2, subsoil 2/2). These areas were very fluid and were not possible to dig/auger to the full 1 m depth. Some areas that were not covered by surface ponding were still wet underfoot with rich dark brown saturated surface soils (topsoil 2/2). These sites were also difficult to auger due to the high fluidity in the subsoil. The subsoil was likely a silty clay; majority clay with some silt.</p> <p>Other wetland sites showed redox conditions with gleyed soil and orange mottles and high saturation (subsoil 7/1 with orange mottles, particularly along the roots) (Figure A32 – Photo 2). Soils held shape well due to clay content and saturation but were very sticky. The water table was identified at around 5 cm below surface level (Figure A32 – Photo 3).</p> <p>Non wetland areas were very clearly dry and were dark brown with a lighter, mid-brown colour (topsoil 3/2, subsoil 6/8). Soil was likely a silty clay; majority clay with some silt. The soils did not hold their shape and had no saturation.</p>

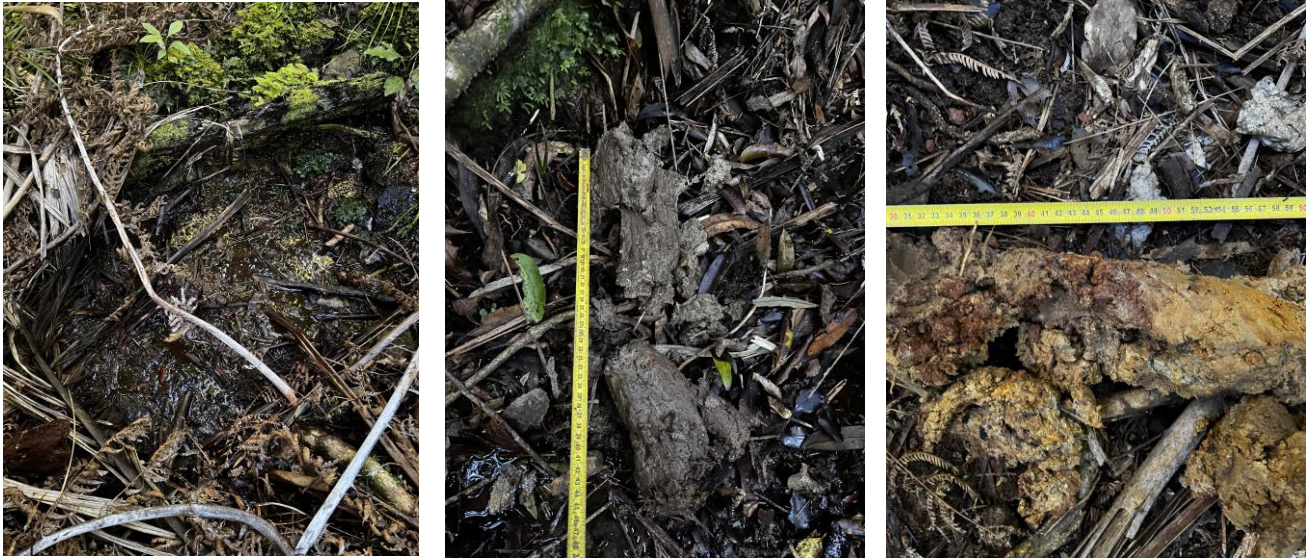
Figure A35. Edmonds 11 photos.

Topic	Comments
Summary	Edmonds 11 (Figure A34) was identified as wetland by Bioresearches. This assessment has confirmed the feature was a surface water supported wetland based on the soils and hydrology.
Geomorphology and Vegetation	The site was bound by the steep topography to the east and west and was located in a small valley within which surface water had collected. Dense vegetation was present, Figure A35 (right).
Water Observations	Surface water was noted throughout the area despite the extended period of hot, dry weather during the first visit. During the first visit the vegetation made access for sampling and auguring difficult. However, a water sample was obtained in the re-visit.
Soils	<p>The wetland areas were a very dark brown, or very dark grey with high fluidity and surface water (topsoil 2/2 or 3/1, subsoil 2/2) (Figure A35 – Photo 1). These areas were very fluid and not possible to auger to get a full 1 m depth profile. Soils were mostly clay with some sand. Wetland areas without surface water ponding were underlain by a gleyed sub-soil which ranged from plastic to sticky (Figure A35 – Photo 2).</p> <p>Non wetland soils were unsaturated and crumbly with a dark, yellowish-brown colour (topsoil 3/4, subsoil 4/4). Soils were mostly clay with some silt and sand. These soils were slightly plastic in places and held their shape (Figure A35 – Photo 3).</p>

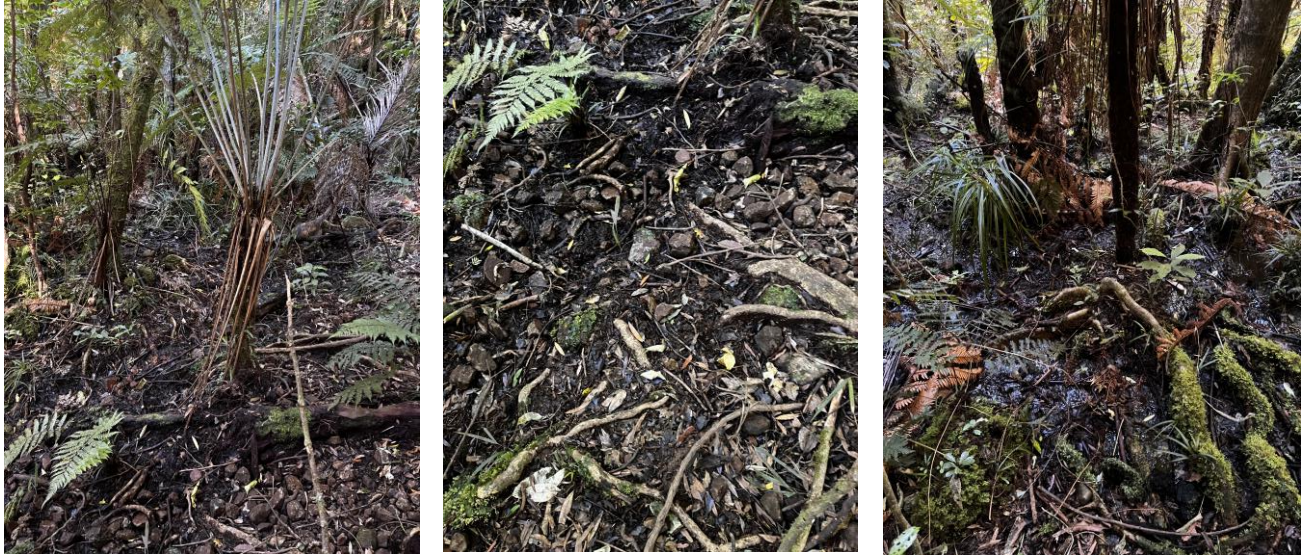
Figure A38. Edmonds 12 photos.

Topic	Comments
Summary	Edmonds 12, (Figure A37) was identified as wetland by Bioresearches. This assessment has confirmed the feature was a surface water supported wetland based on the soils and hydrology.
Geomorphology and Vegetation.	The wetland was particularly steep and consisted of two valleys that ran from west to east, although the contours did not show this. The wetland was located along the dips in the two valleys with the slight mound between the two not showing wetland characteristics (Figure A38 – Photo 1). The area was covered in large boulders and dense vegetation which made digging very difficult (Figure A38 – Photo 2).
Water Observations	At the bottom of the two valleys there were two small streams. Surface water was noted throughout the area despite the extended period of hot, dry weather during the first visit.
Soils	<p>Surface ponding was underlain by a very dark brown soil (topsoil 2/2, subsoil 2/2). These areas were very fluid and were not possible to dig/auger to show a full 1 m depth profile (Figure A38 – Photo 3).</p> <p>The area without surface ponding was generally wet underfoot with rich, dark brown saturated surface soils (topsoil 2/2). The subsoil was likely a silty clay; majority clay with some sand and gravel. Grey soils with orange mottling is noted in the subsoil.</p> <p>Non wetland areas were very clearly dry and were dark brown with a lighter, mid-brown colour (topsoil 3/3, subsoil 6/8). Soil was likely a silty clay; majority clay with some gravel. They did not hold their shape.</p>

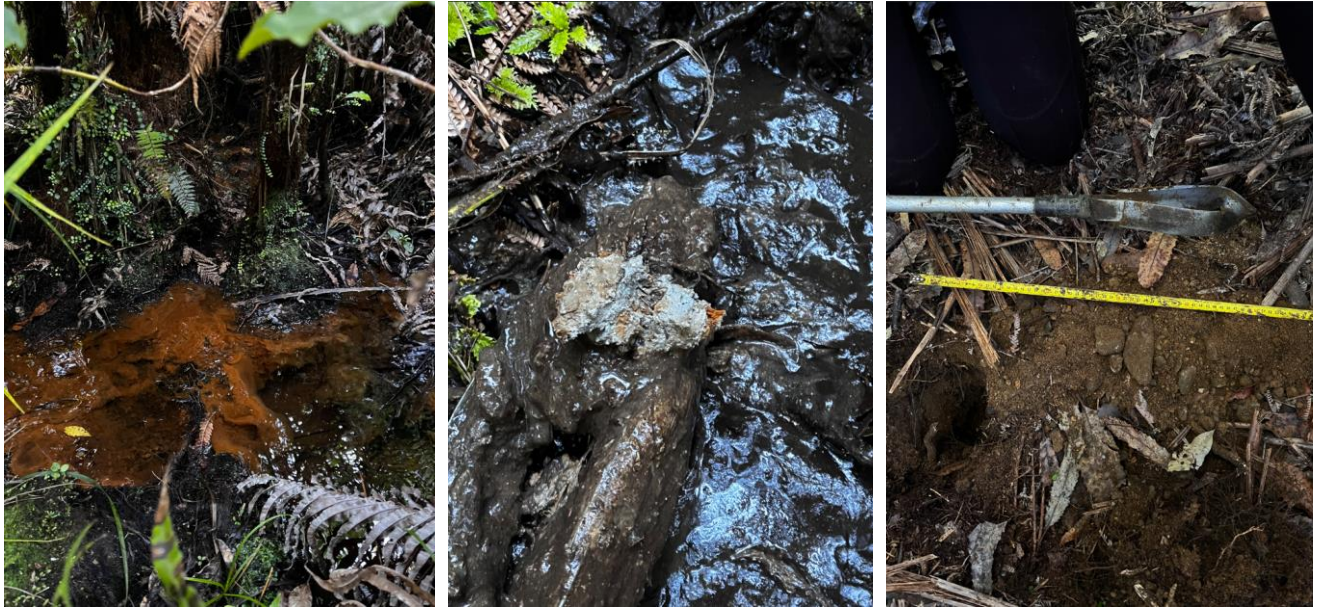
Figure A44. Edmonds 14 photos.

Key Findings	Based on the topography of the site and field observations, it is likely that Edmonds 14 was surface water-fed from the stream at a nearby higher elevation which seeped through the topography. The wetland was also likely supported

by a groundwater spring which emerged at the surface and by surface runoff during rainfall This is shown in **Figure A45** as a schematic.
